Tree Resource Evaluation for Proposed Miami Beach convention Center Hotel Site

January 6, 2019

Summary

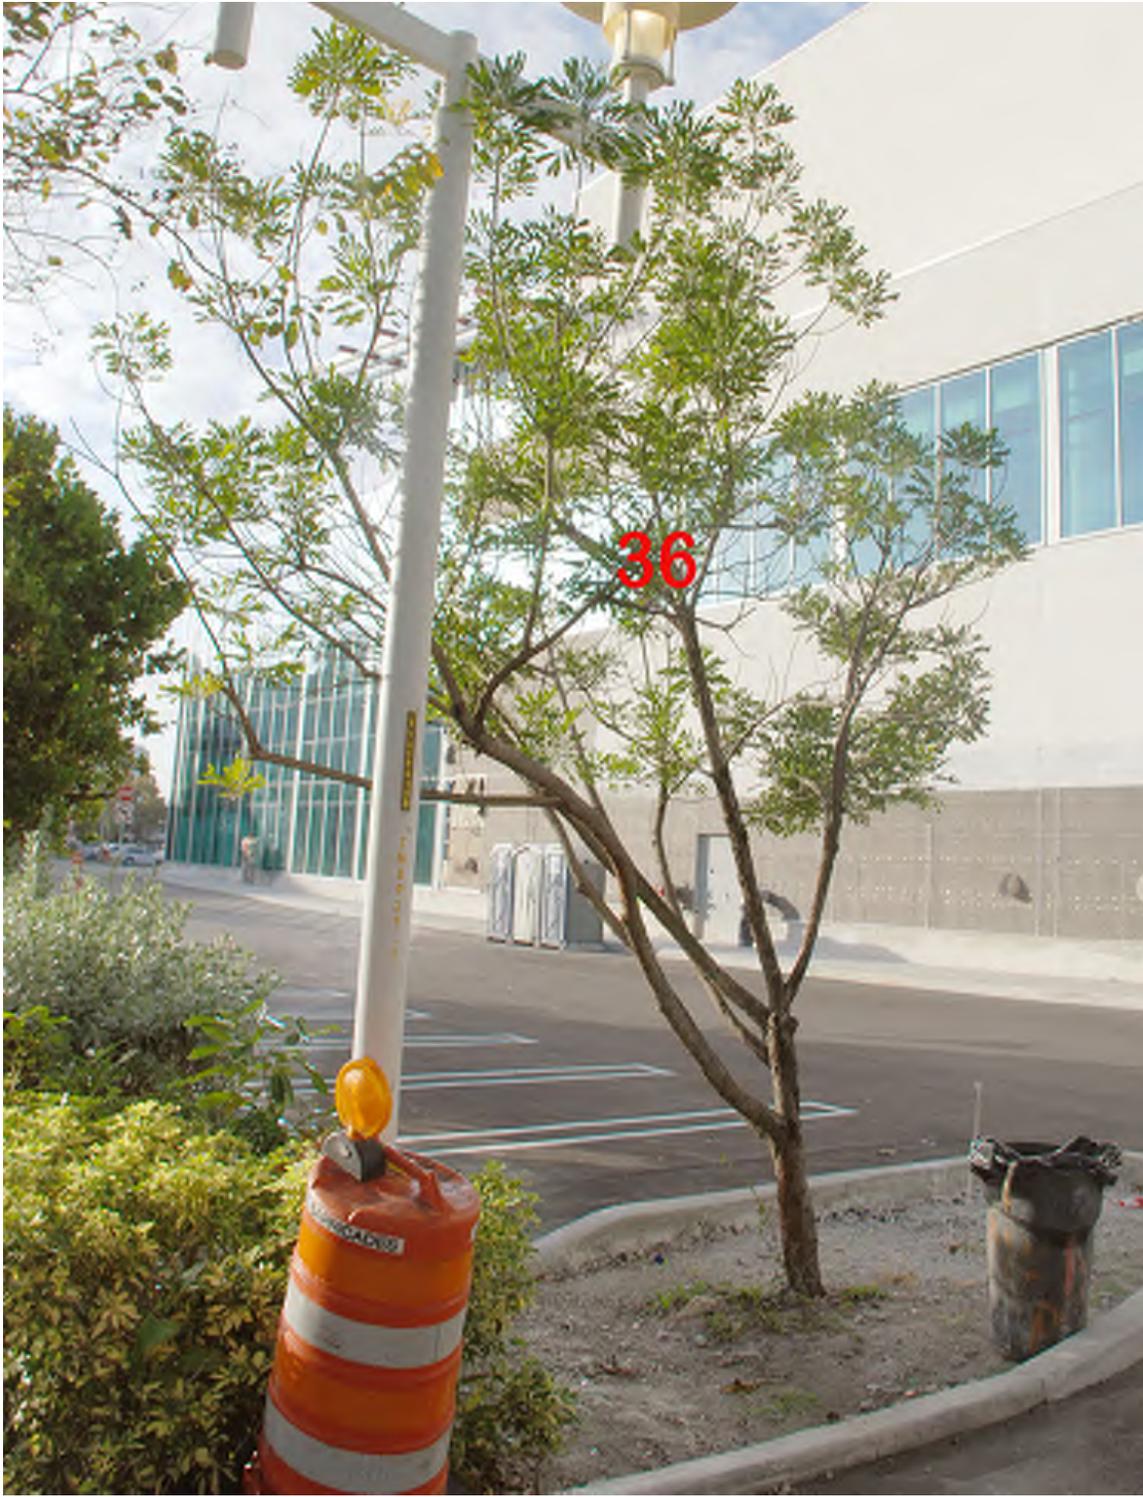
Photo 30 above is tree 36 with apparent soil compaction damage from construction, and sparse foliage.

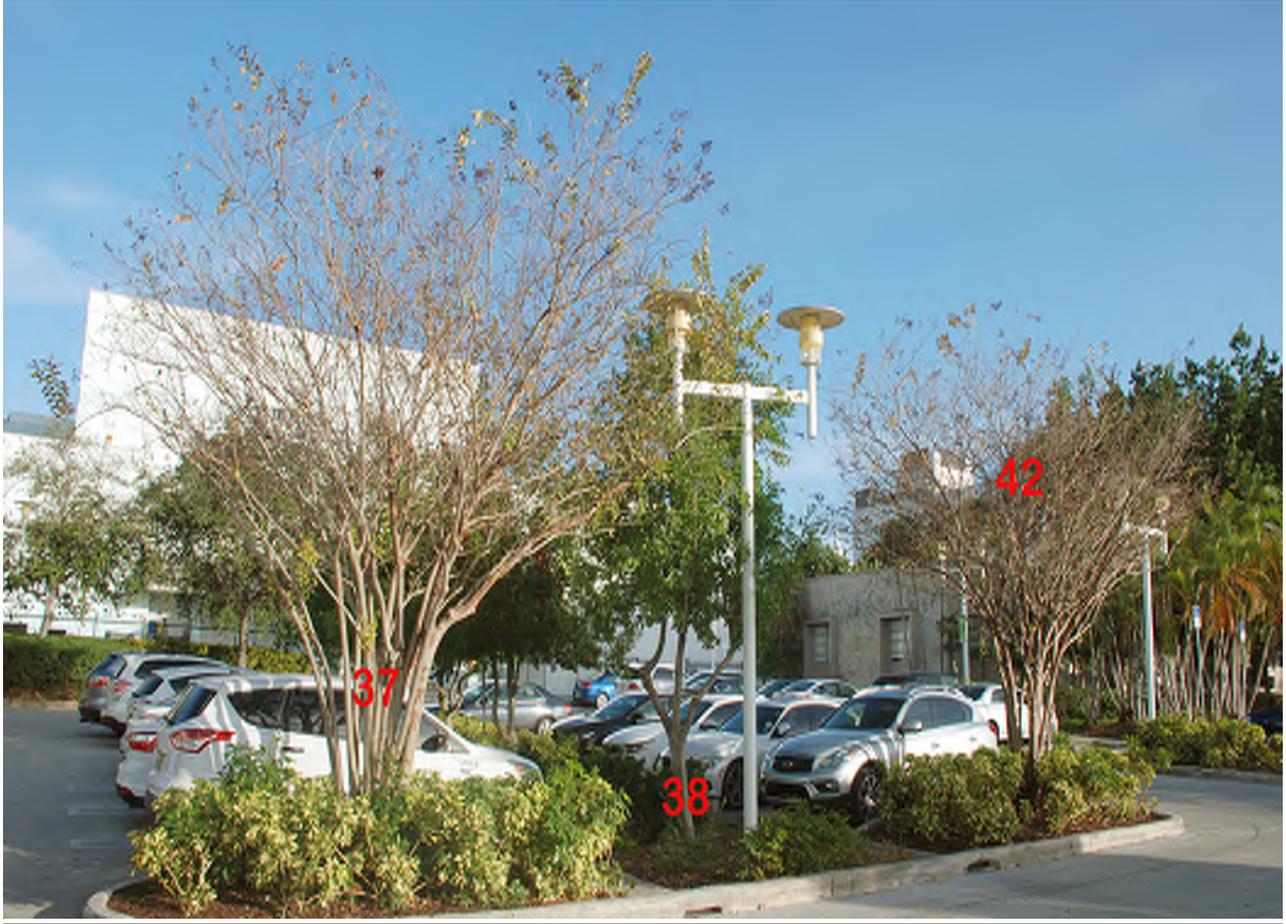
Photo 31 above is trees 37 & 42 with what appears to be normal seasonal canopy foliage loss, and tree 38.

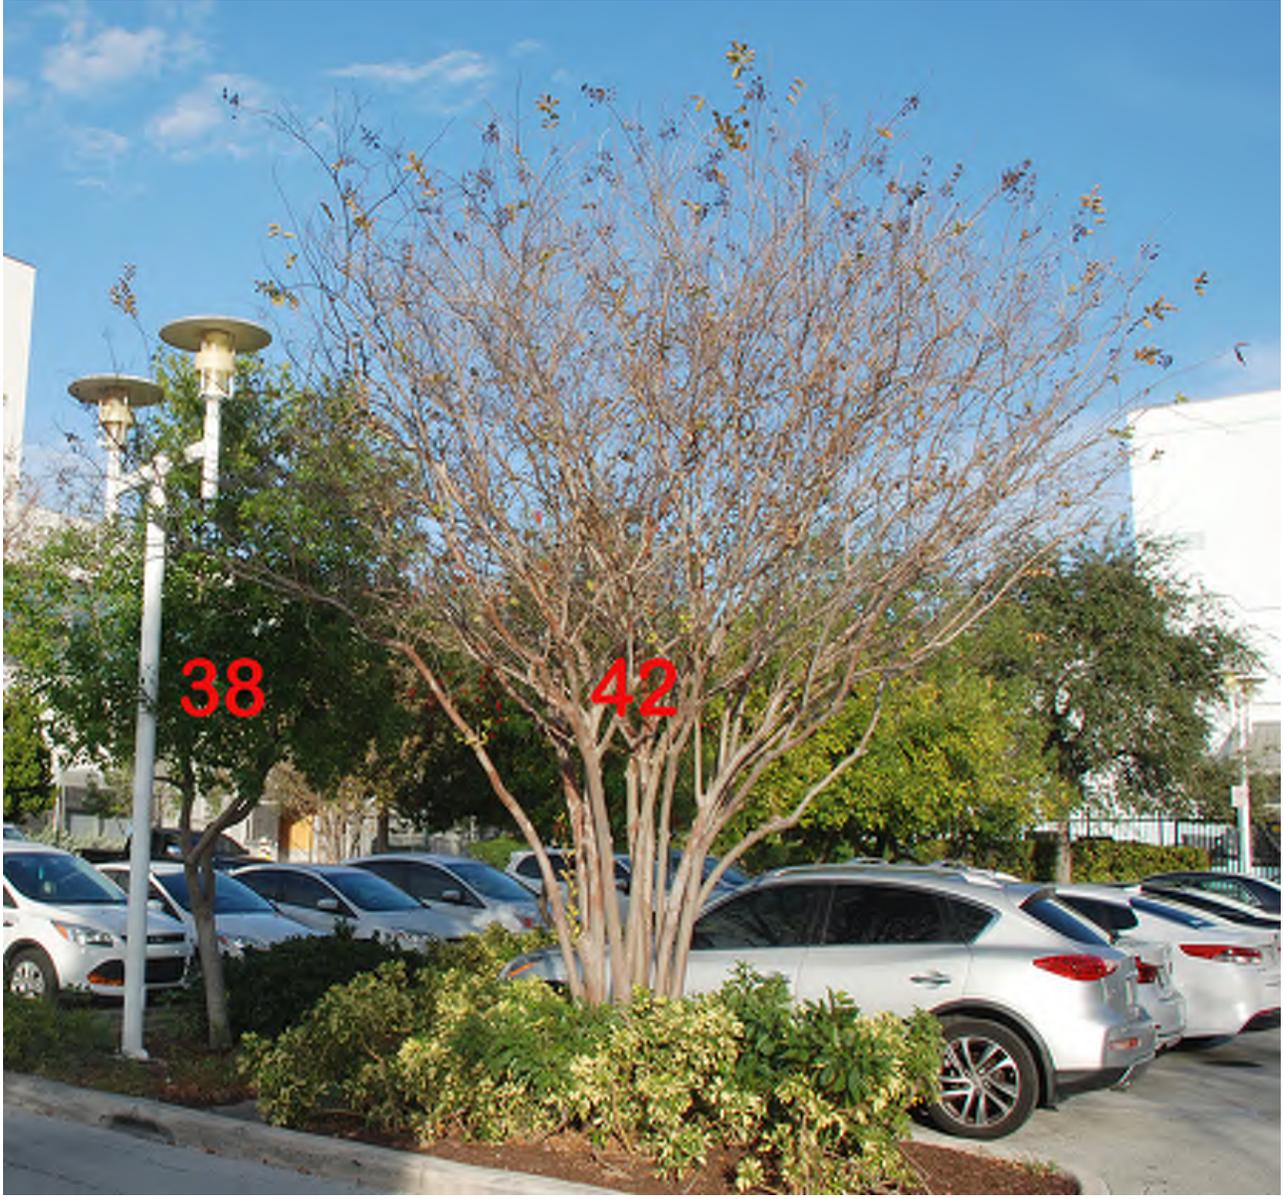
Photo 34 above is tree 42 with what appears to be normal seasonal canopy foliage loss.

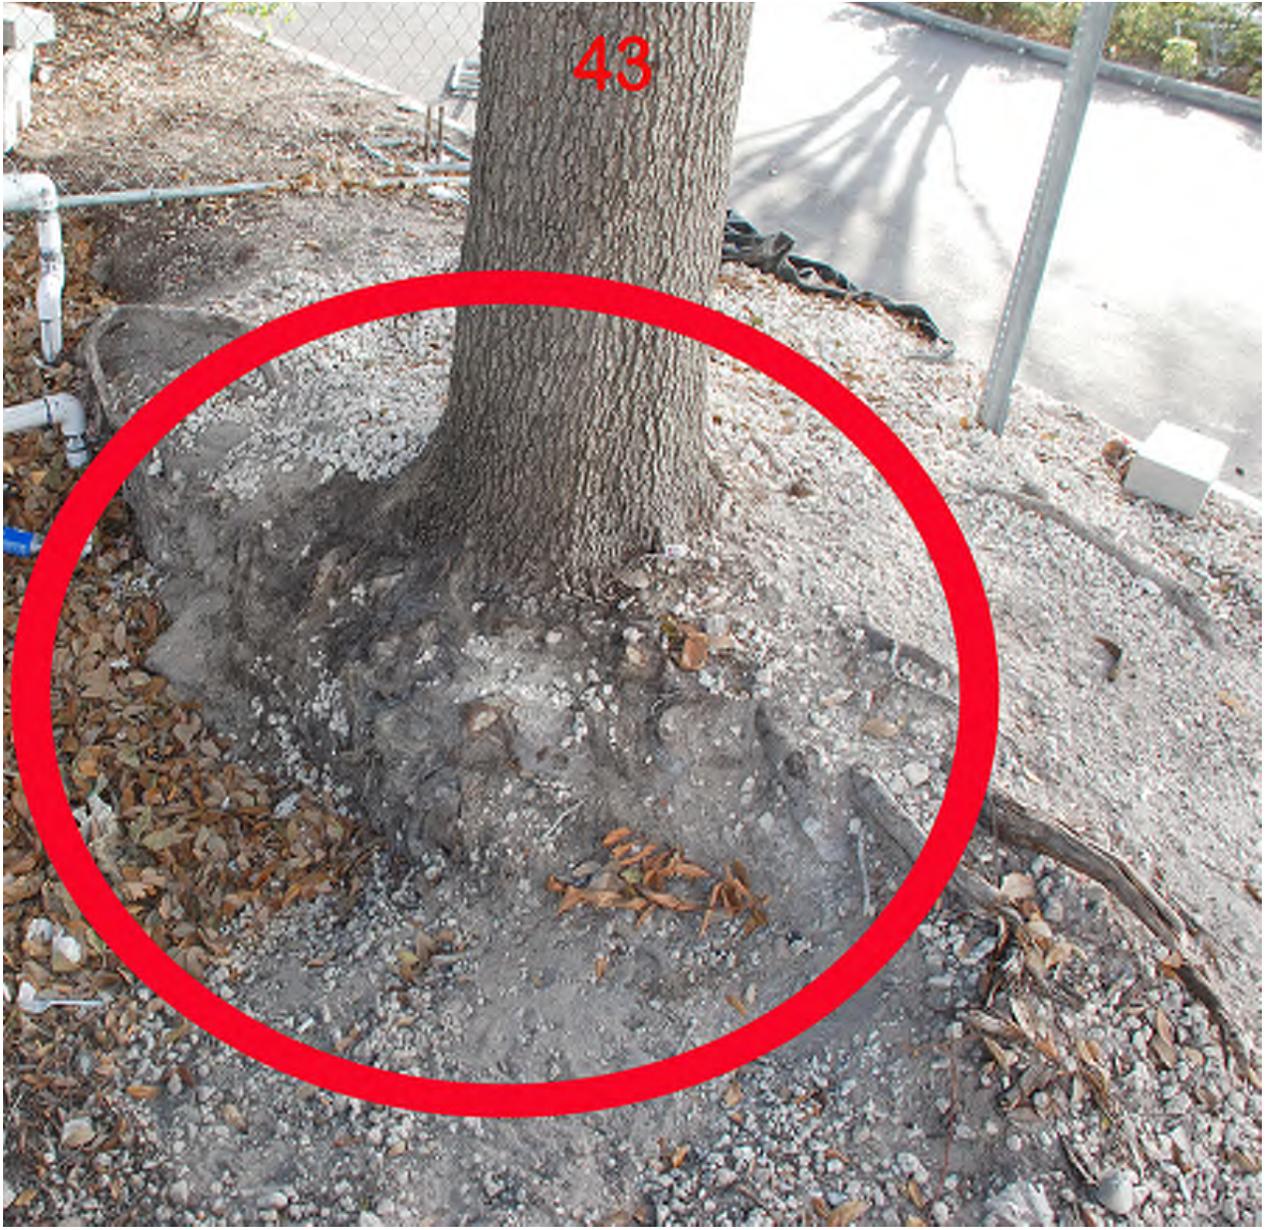
Photo 36 above shows where the entire root mass of tree 43 to the east of the trunk was removed. This tree should be immediately stabilized, and is not a good candidate for relocation.

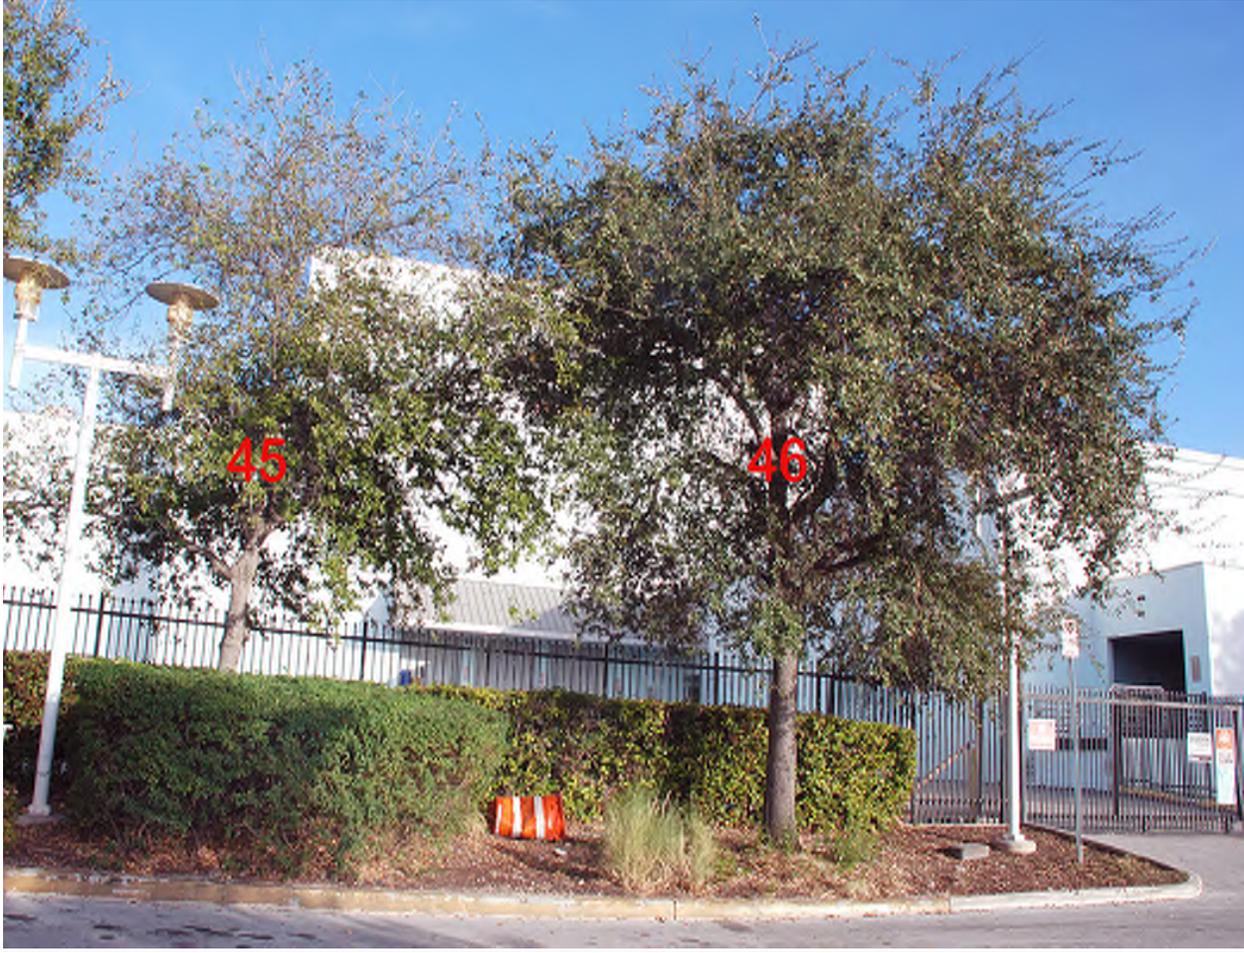
Photo 32 above is tree 45 showing signs of canopy die-back, and is not a good candidate for relocation. Tree 46 appears to be in good condition.

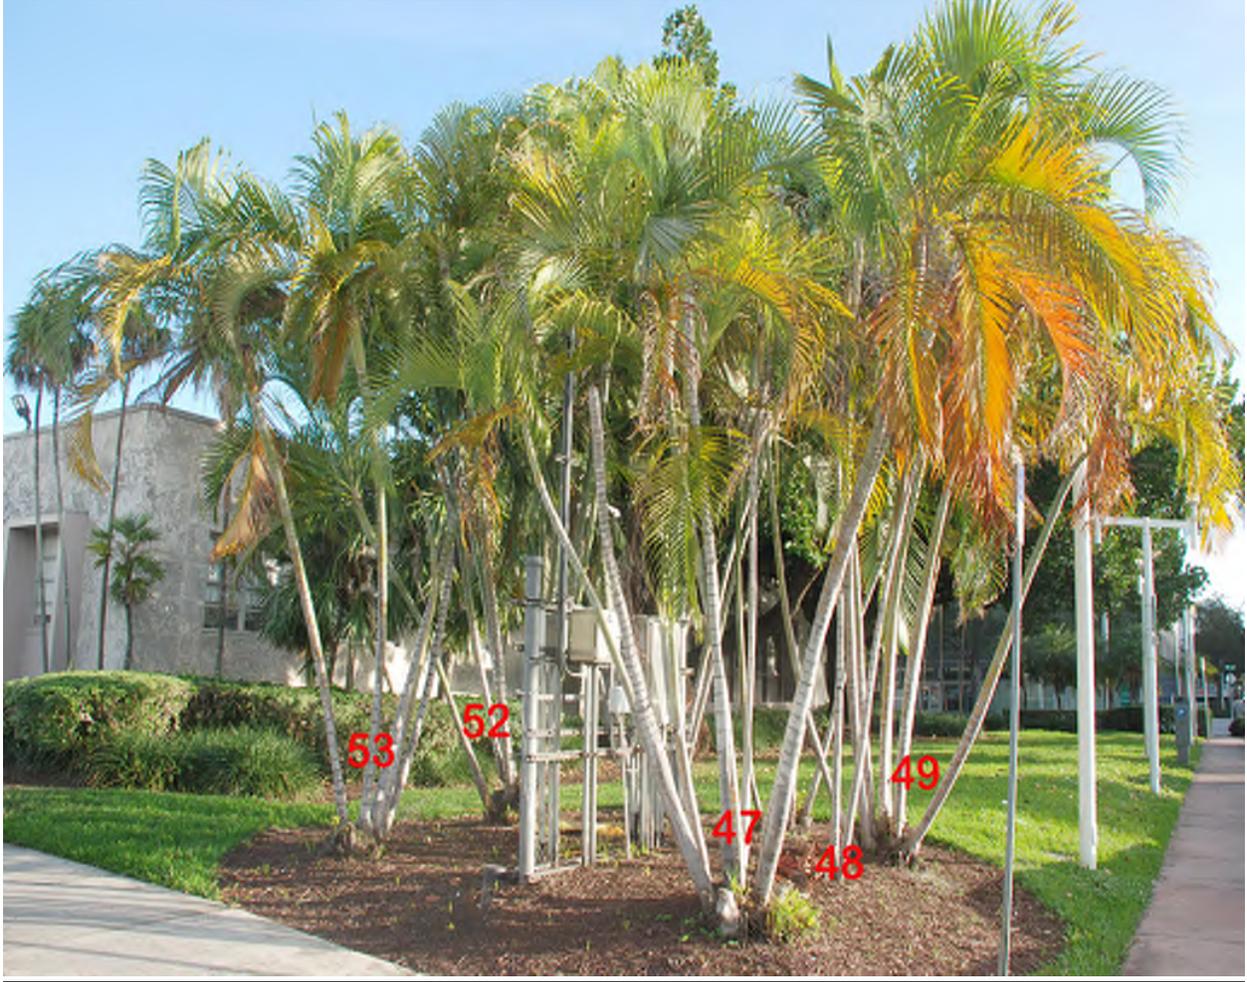
Photo 33 above is a group of areca palms with all their trunks over-pruned. All are in poor condition.

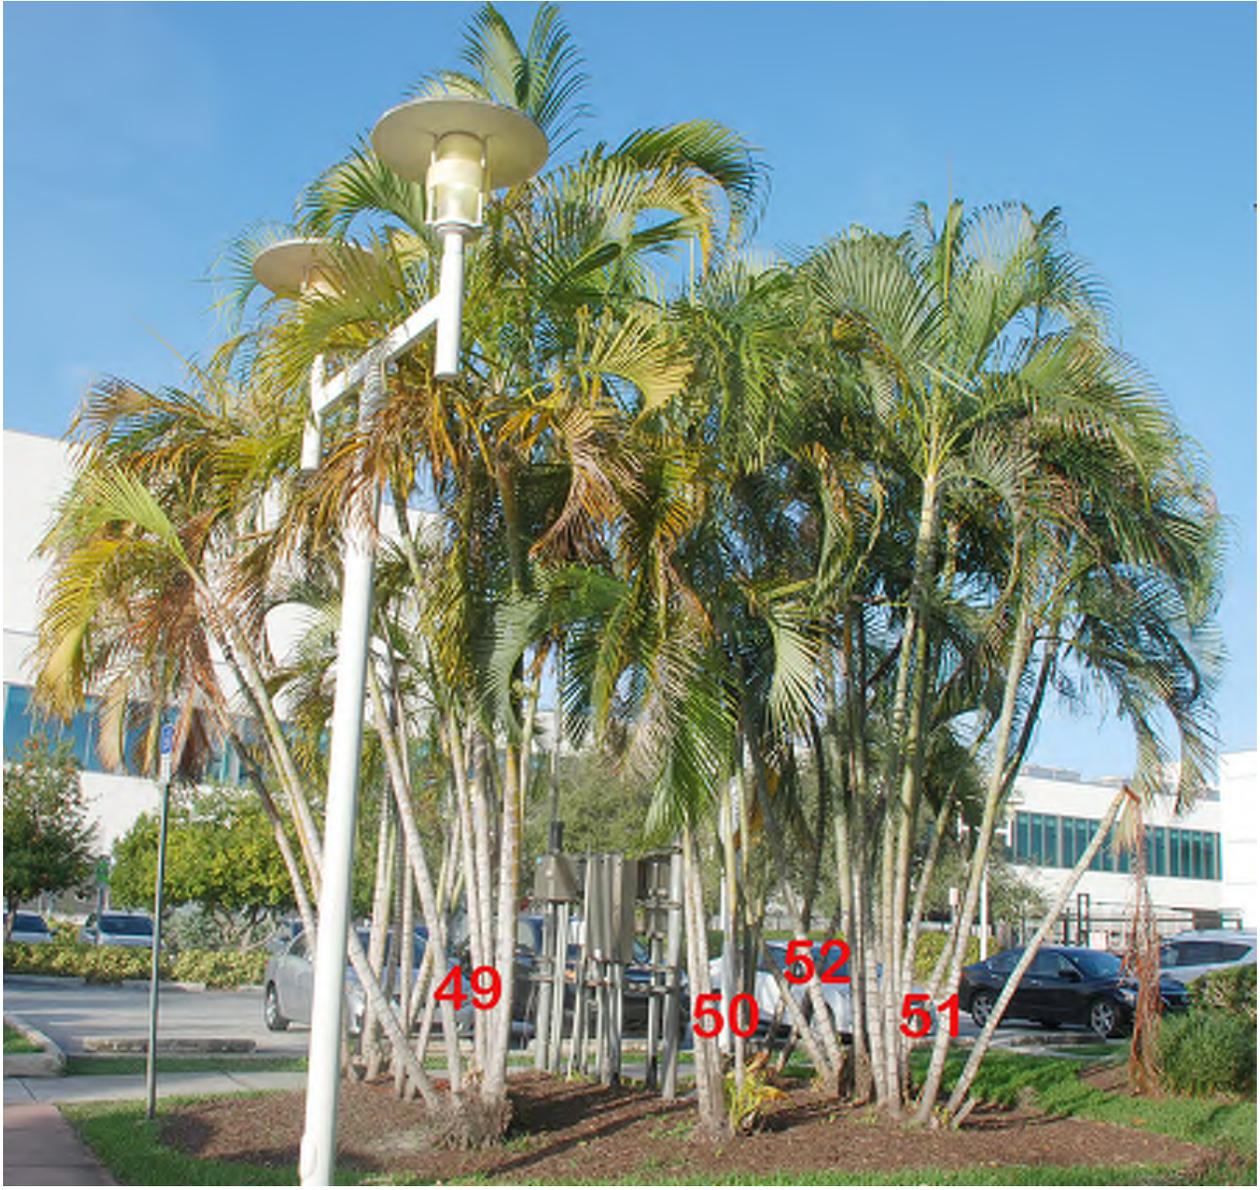
Photo 34 above is a group of areca palms with their trunks over-pruned. All are in poor condition.

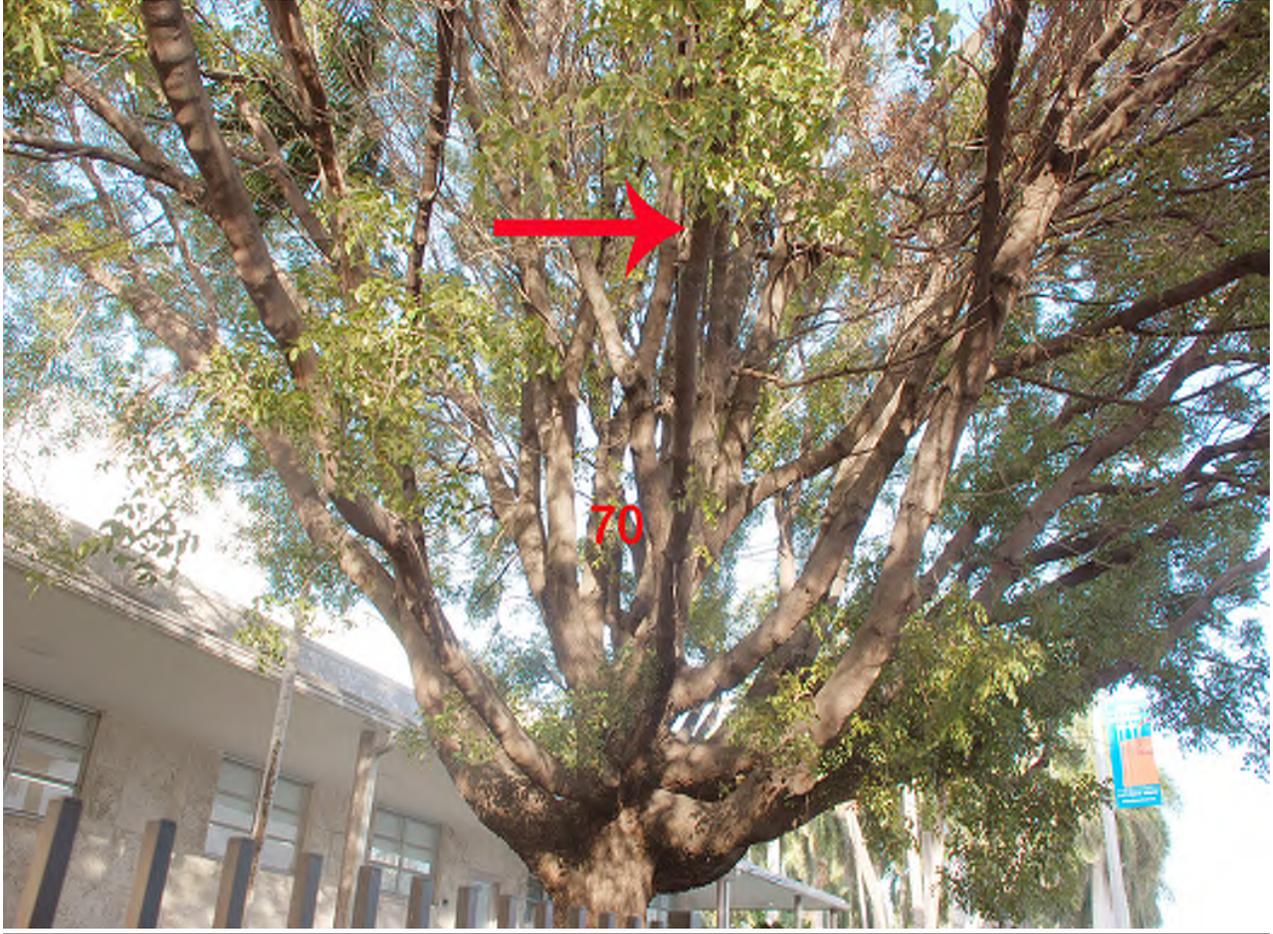
Photo 41 above is the trunk and main structural branches of tree 70 viewed from the west. The arrow indicates where a branch had torn-off.

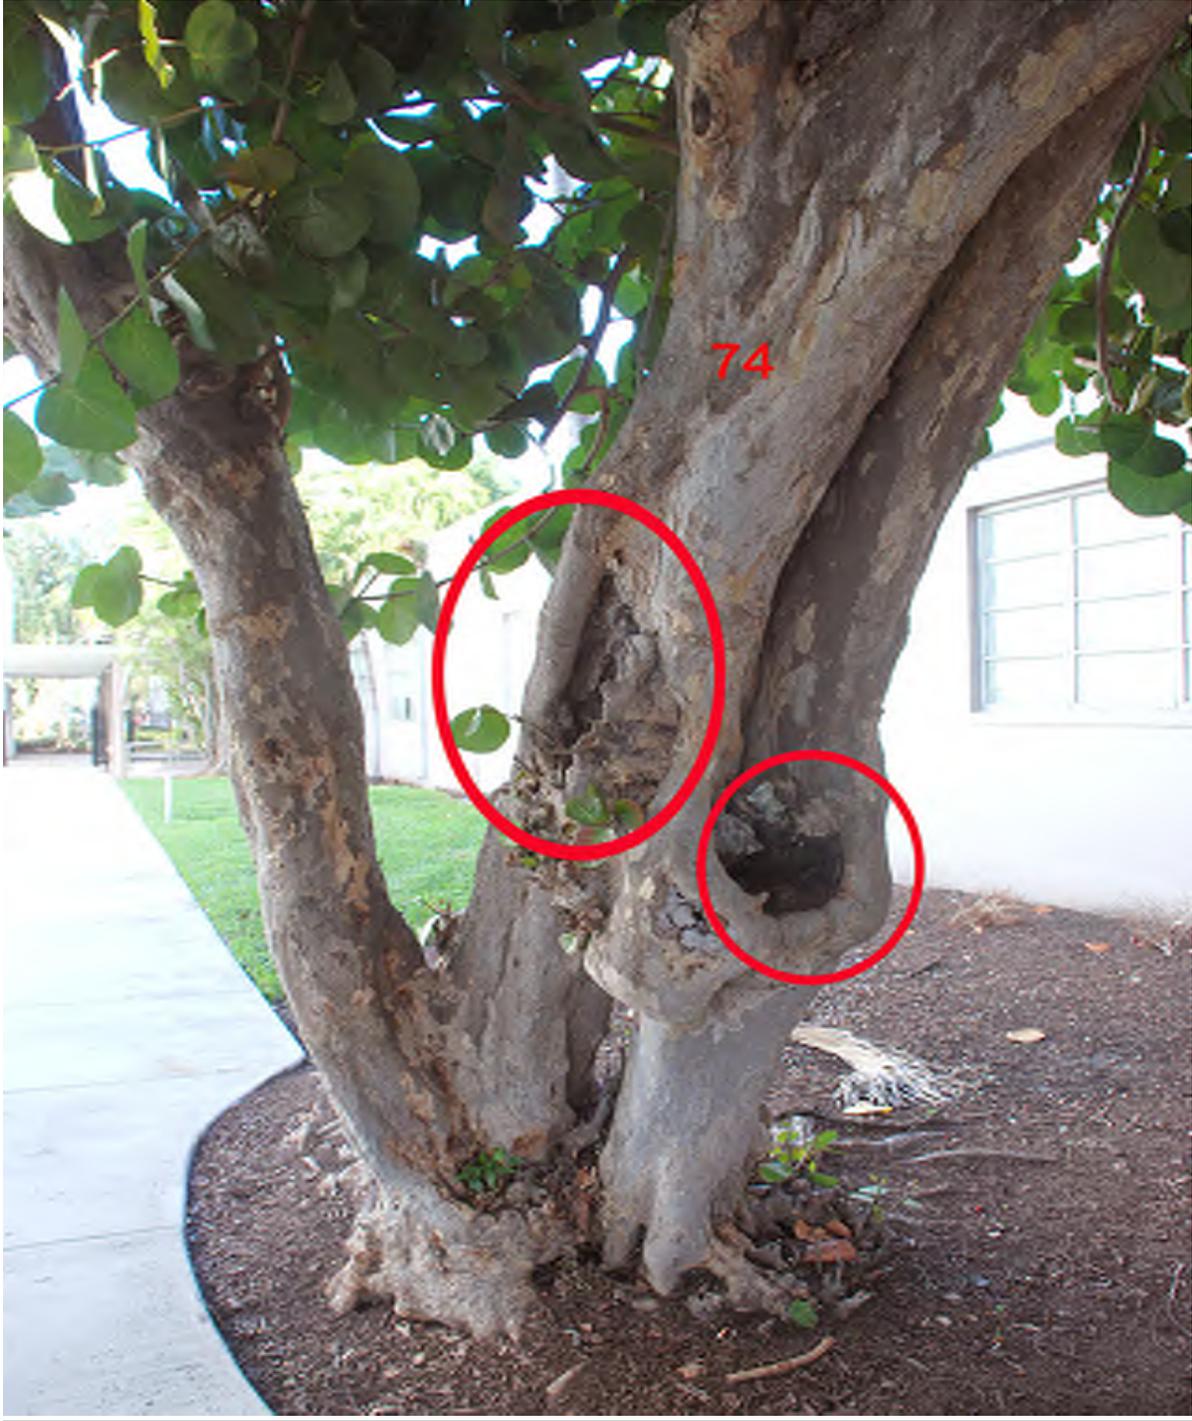
Photo 44 above is the west side of the trunk of tree 74 with cavities and some decay indicated. This tree is likely missing substantial root mass on the north side of the tree due to the adjacent sidewalk which shows no significant signs of uplift due to root activity.

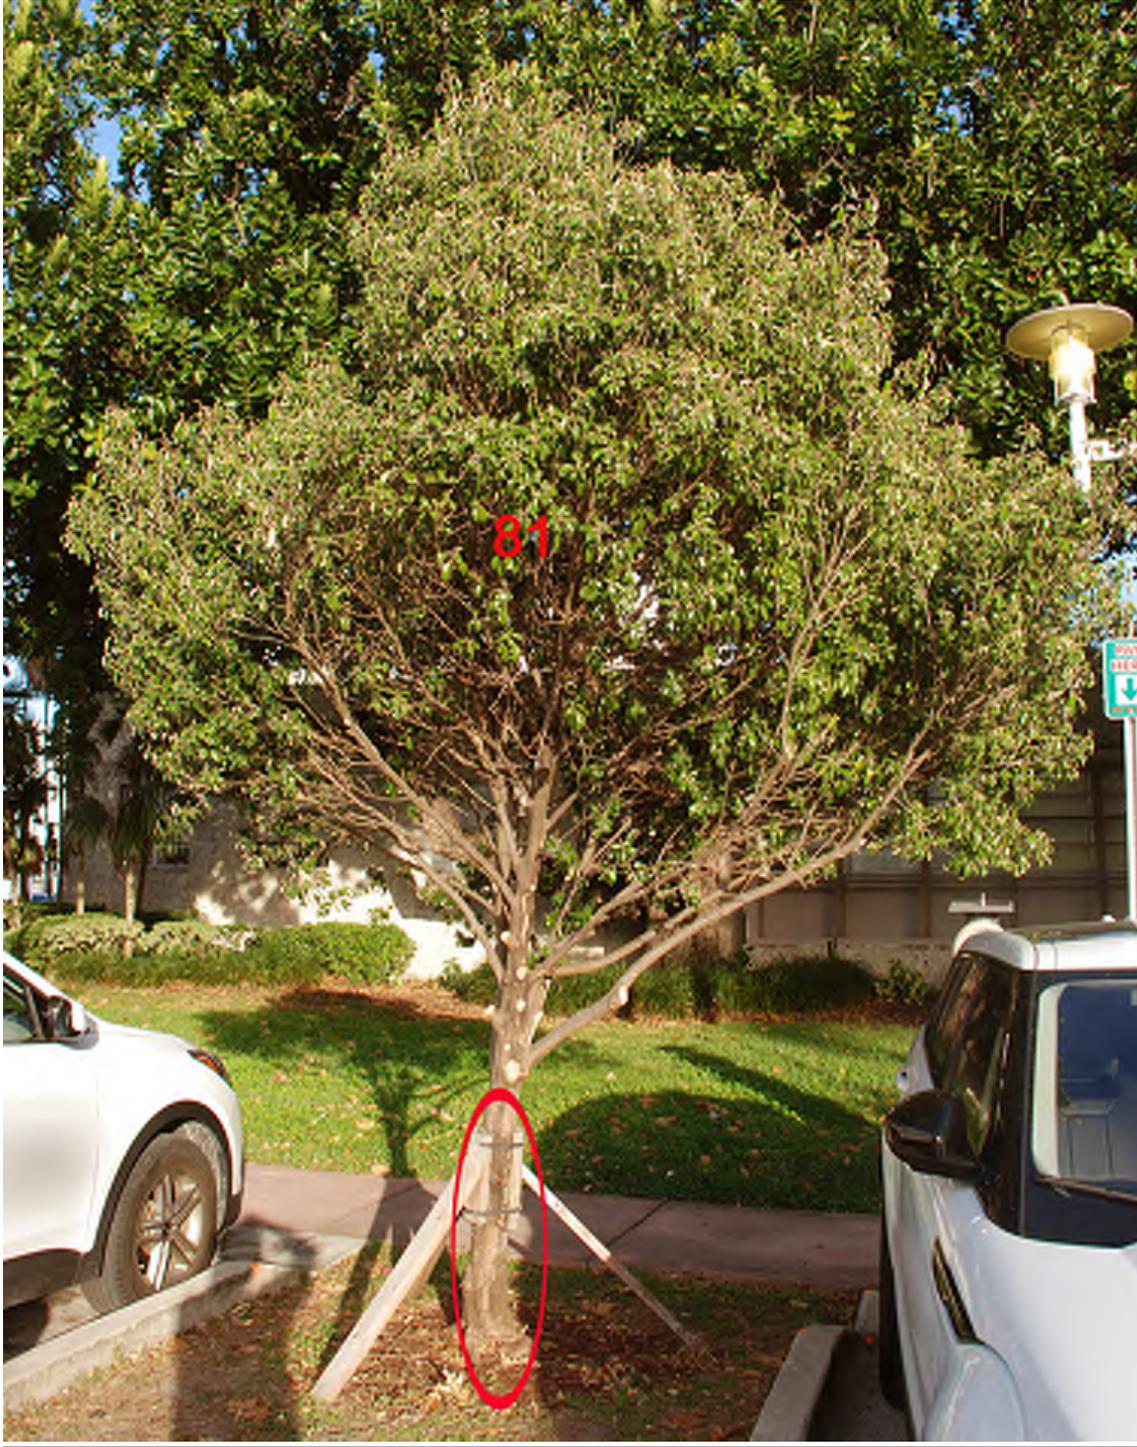
Photo 48 above is tree 81 viewed from the west. See following photo for close-up of trunk damage.

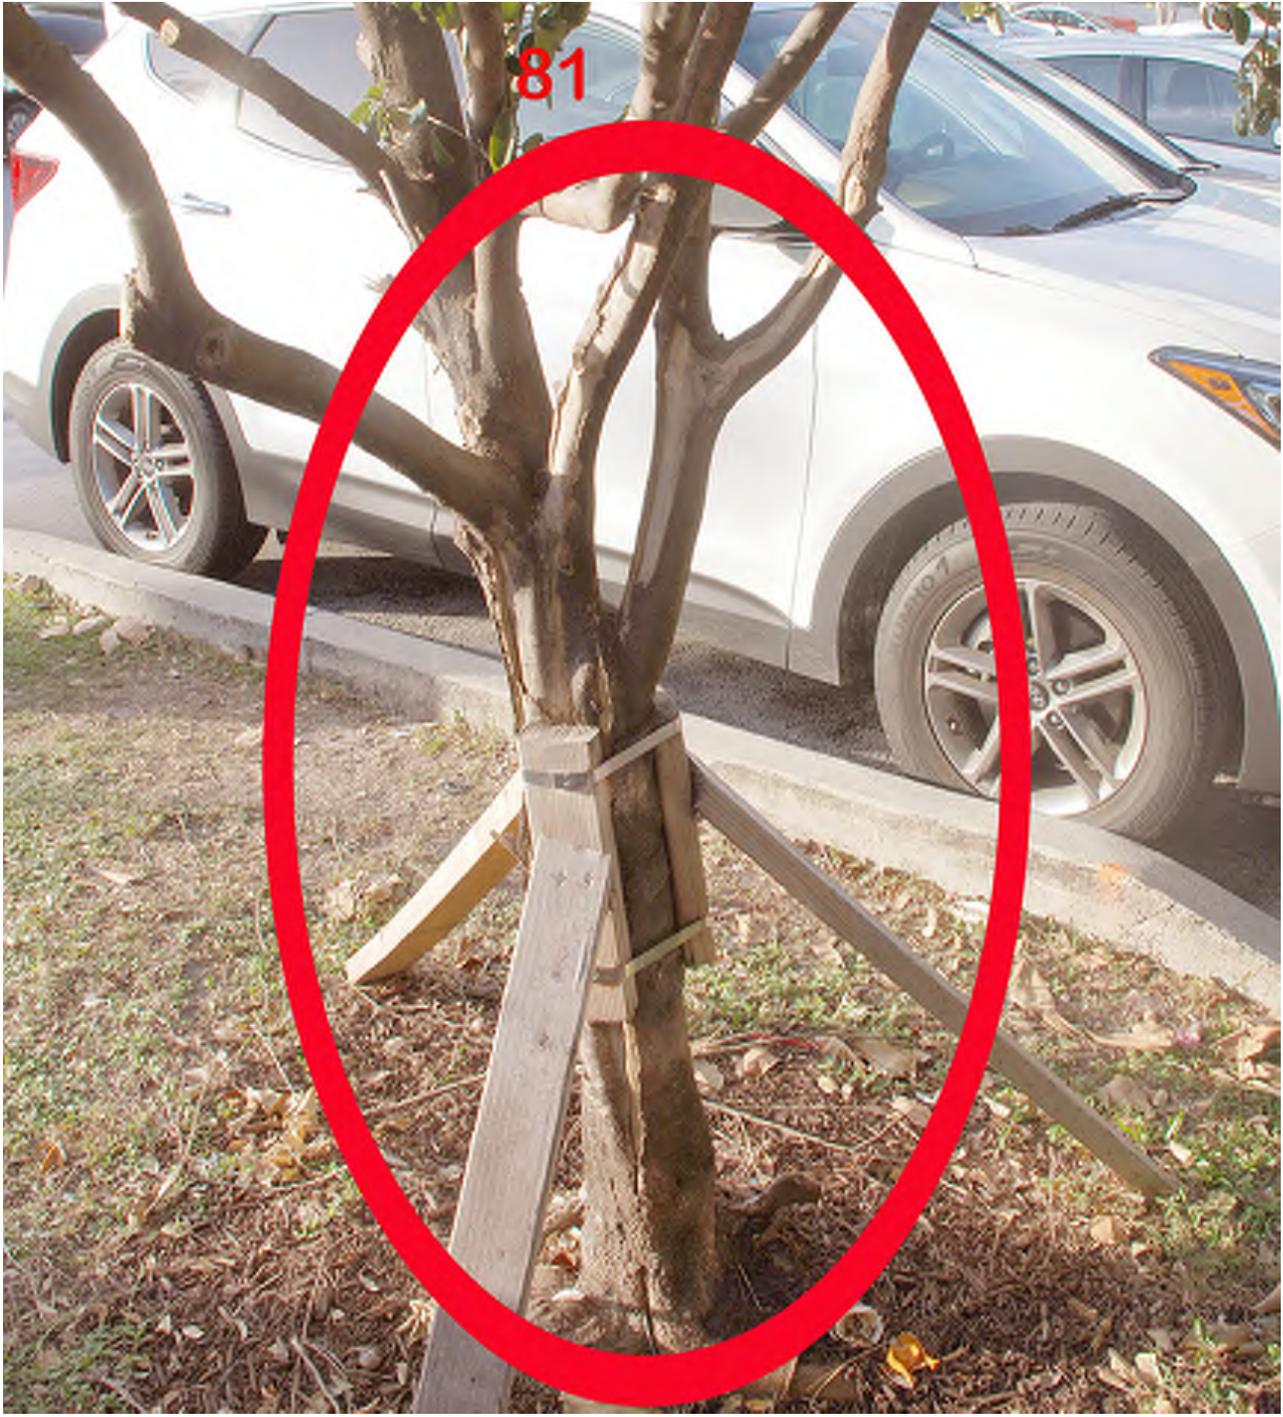
Photo 49 above is a closer view of the damaged trunk of tree 81. This tree should be removed.

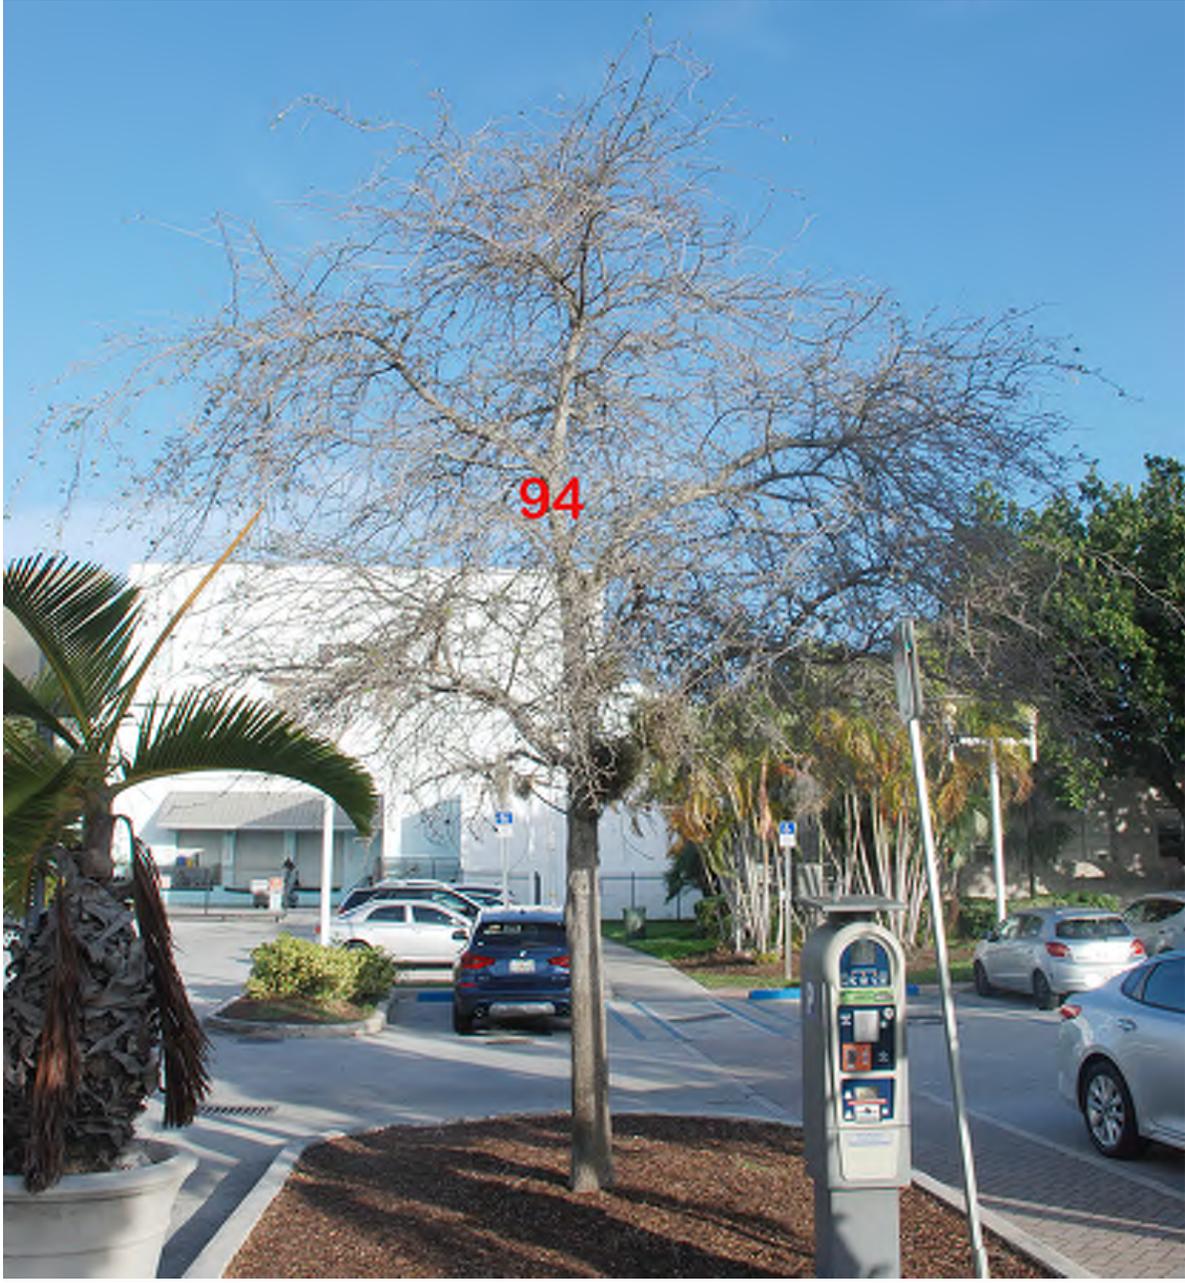
Photo 57 above is tree 94 viewed from the west. This tree is in poor condition and should be removed.
