Tree Resource Evaluation for 925 Lenox Avenue, Miami Beach

July 6, 2016

Summary

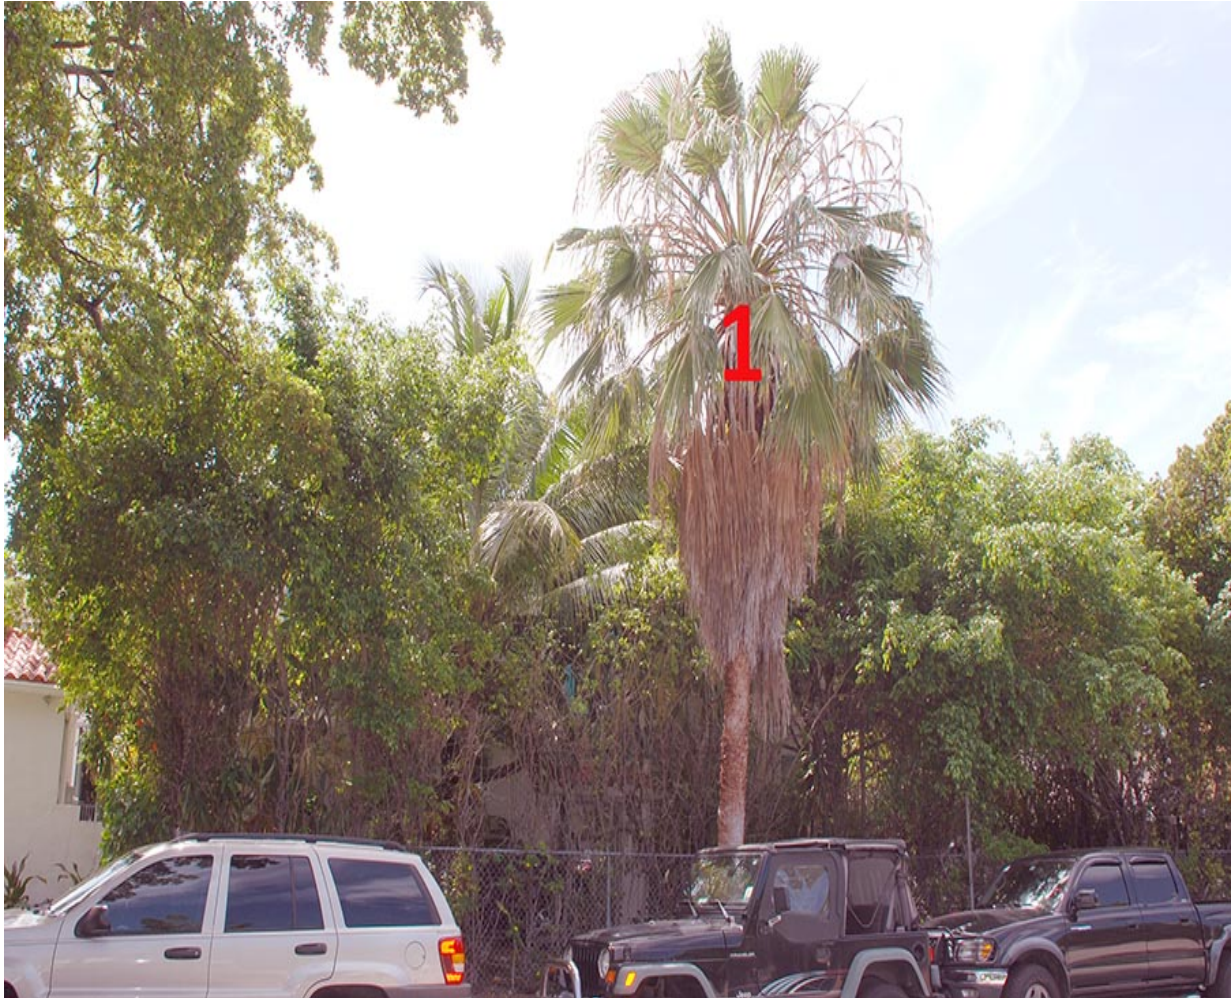
Photo 1 above is palm 1 in the right-of-way along Lenox Avenue looking east. There is an overgrown hedge of *Ficus benjamina* growing along the west and south sides of the property.

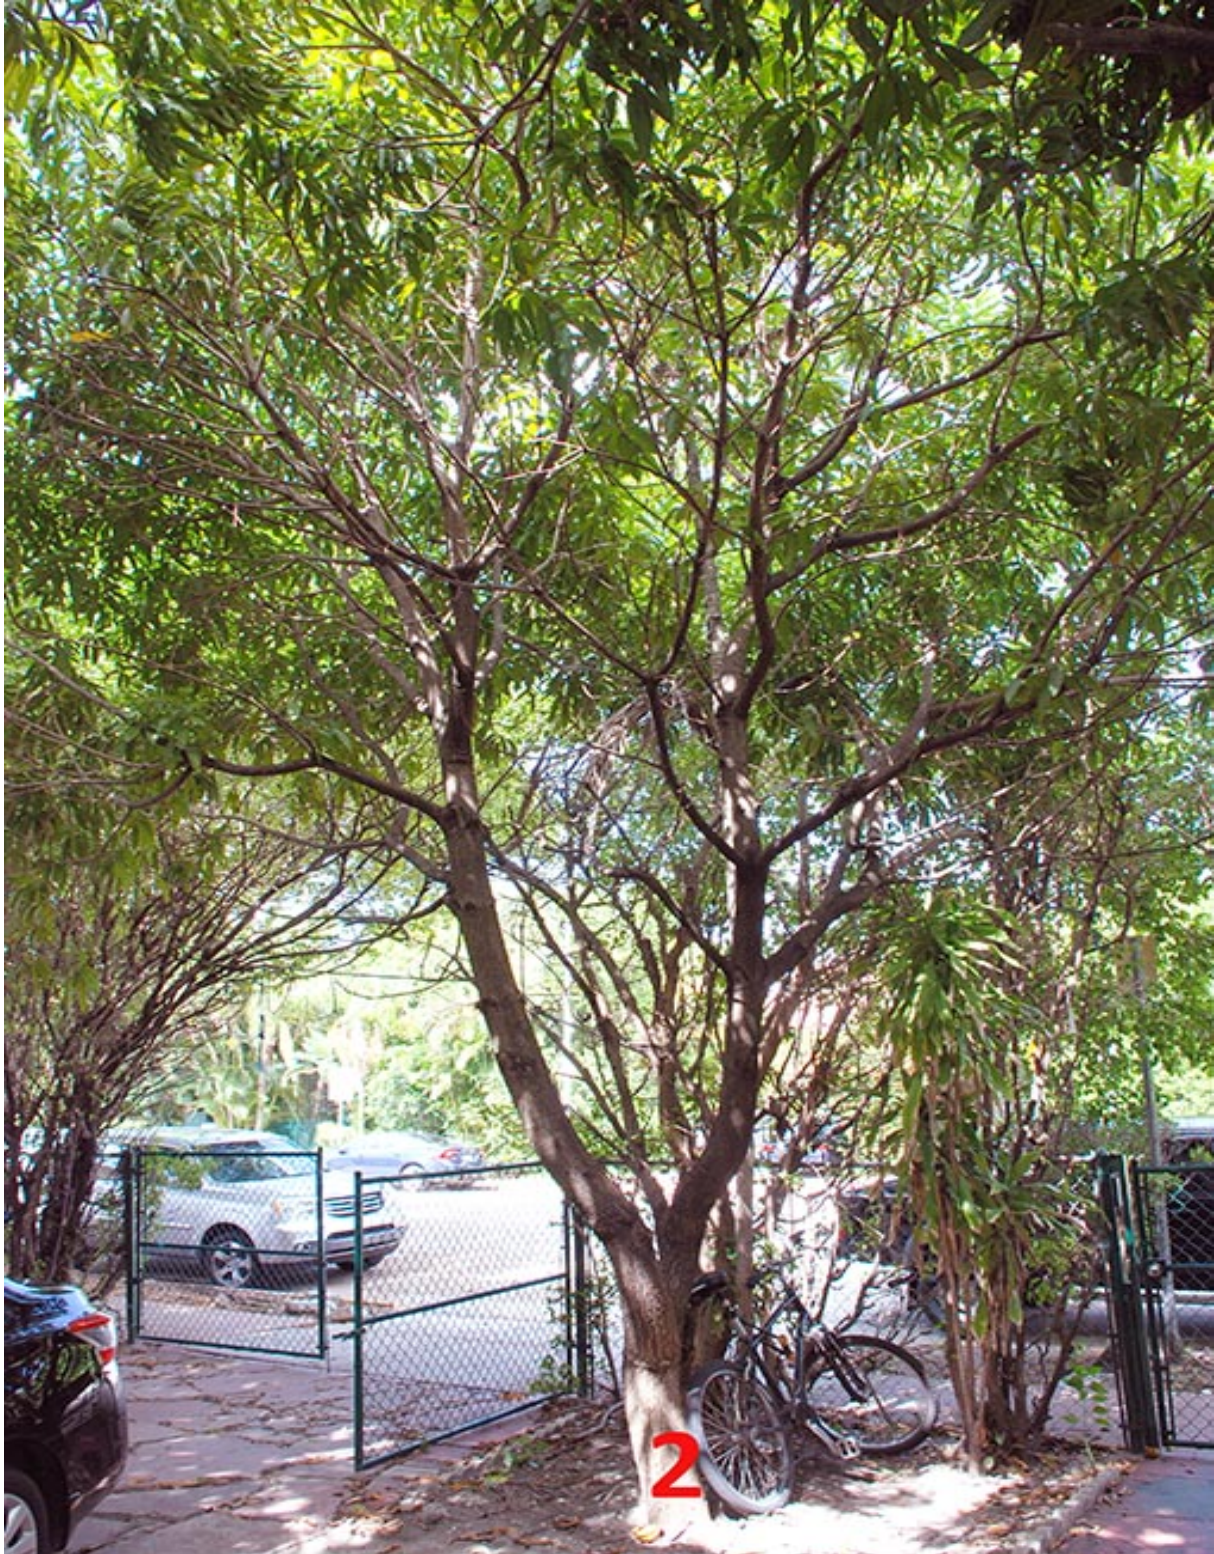
Photo 2 above is mango tree 2 looking west.

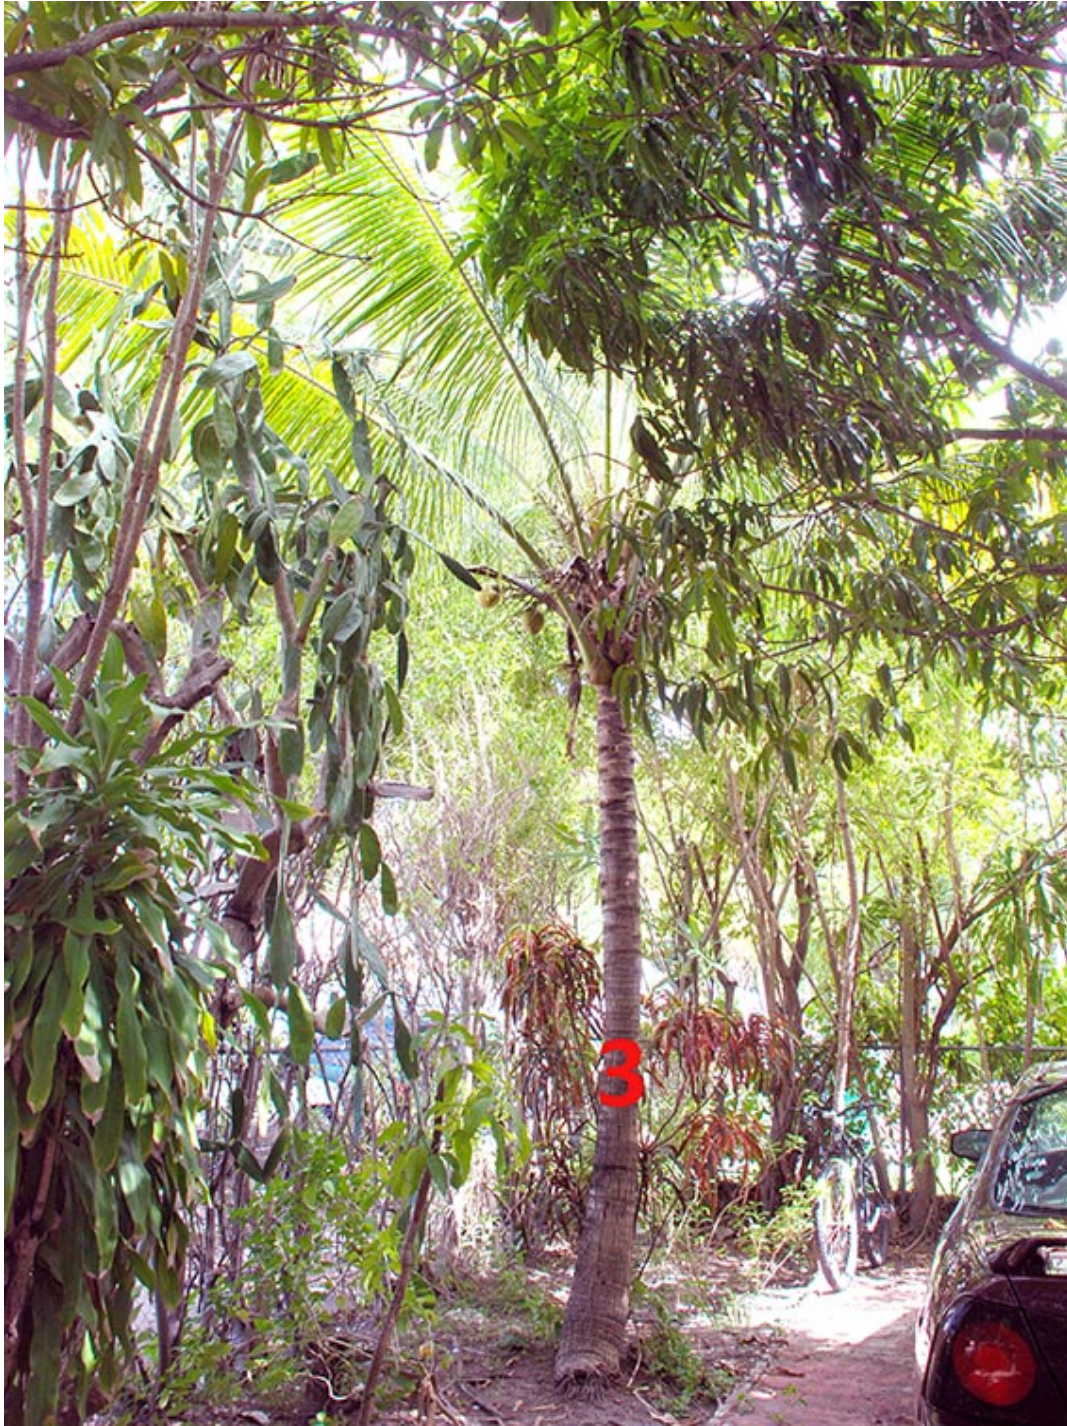
Photo 3 above is coconut 3 near the northwest corner of the property.

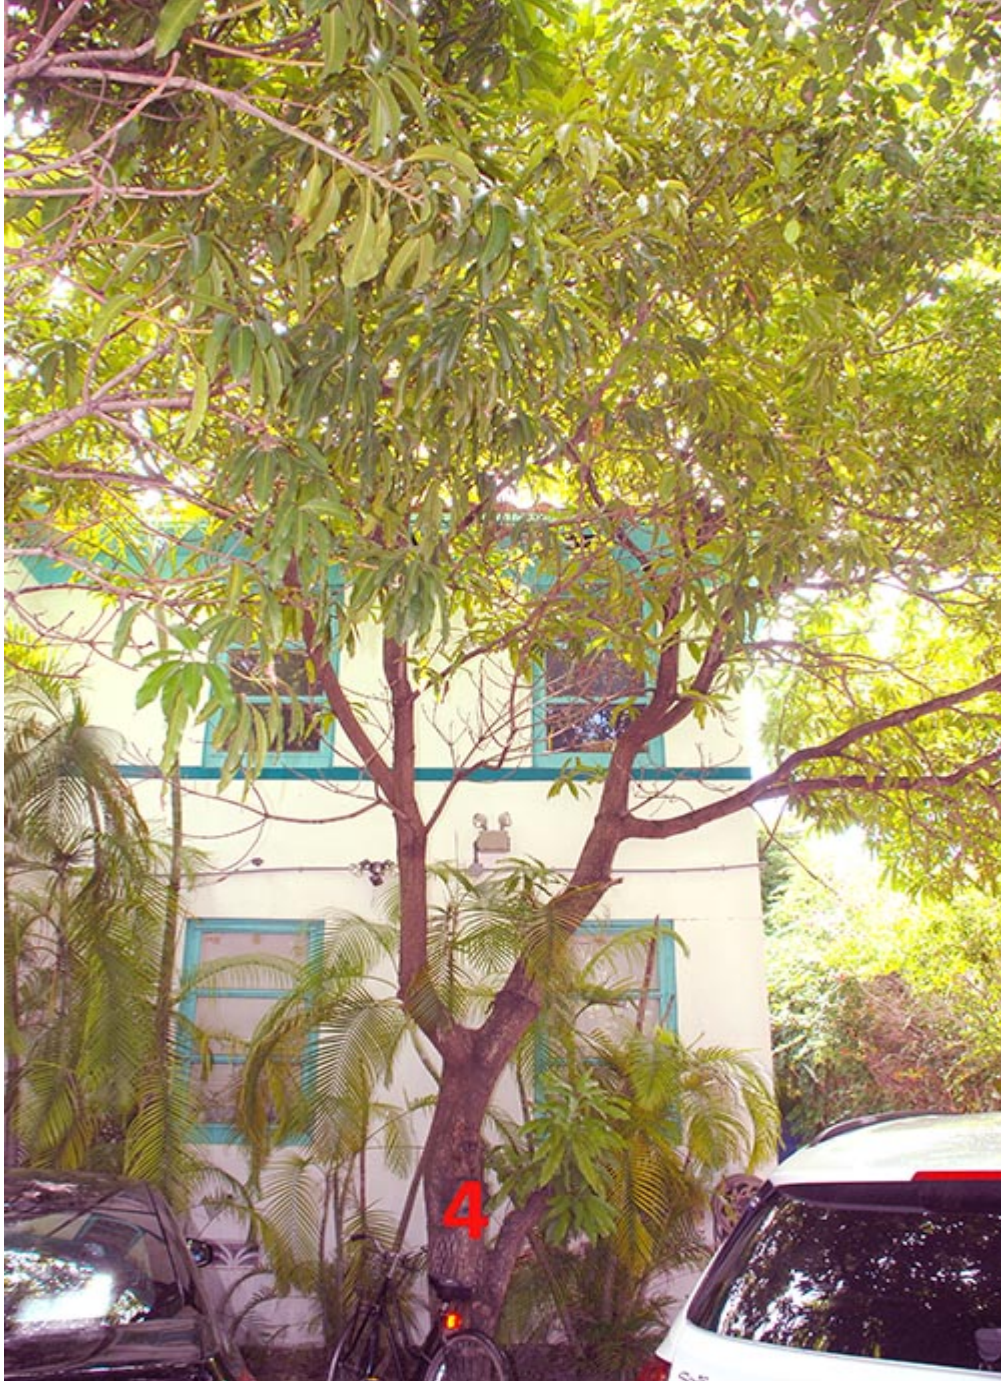
Photo 4 above is mango tree 4 looking to the east.

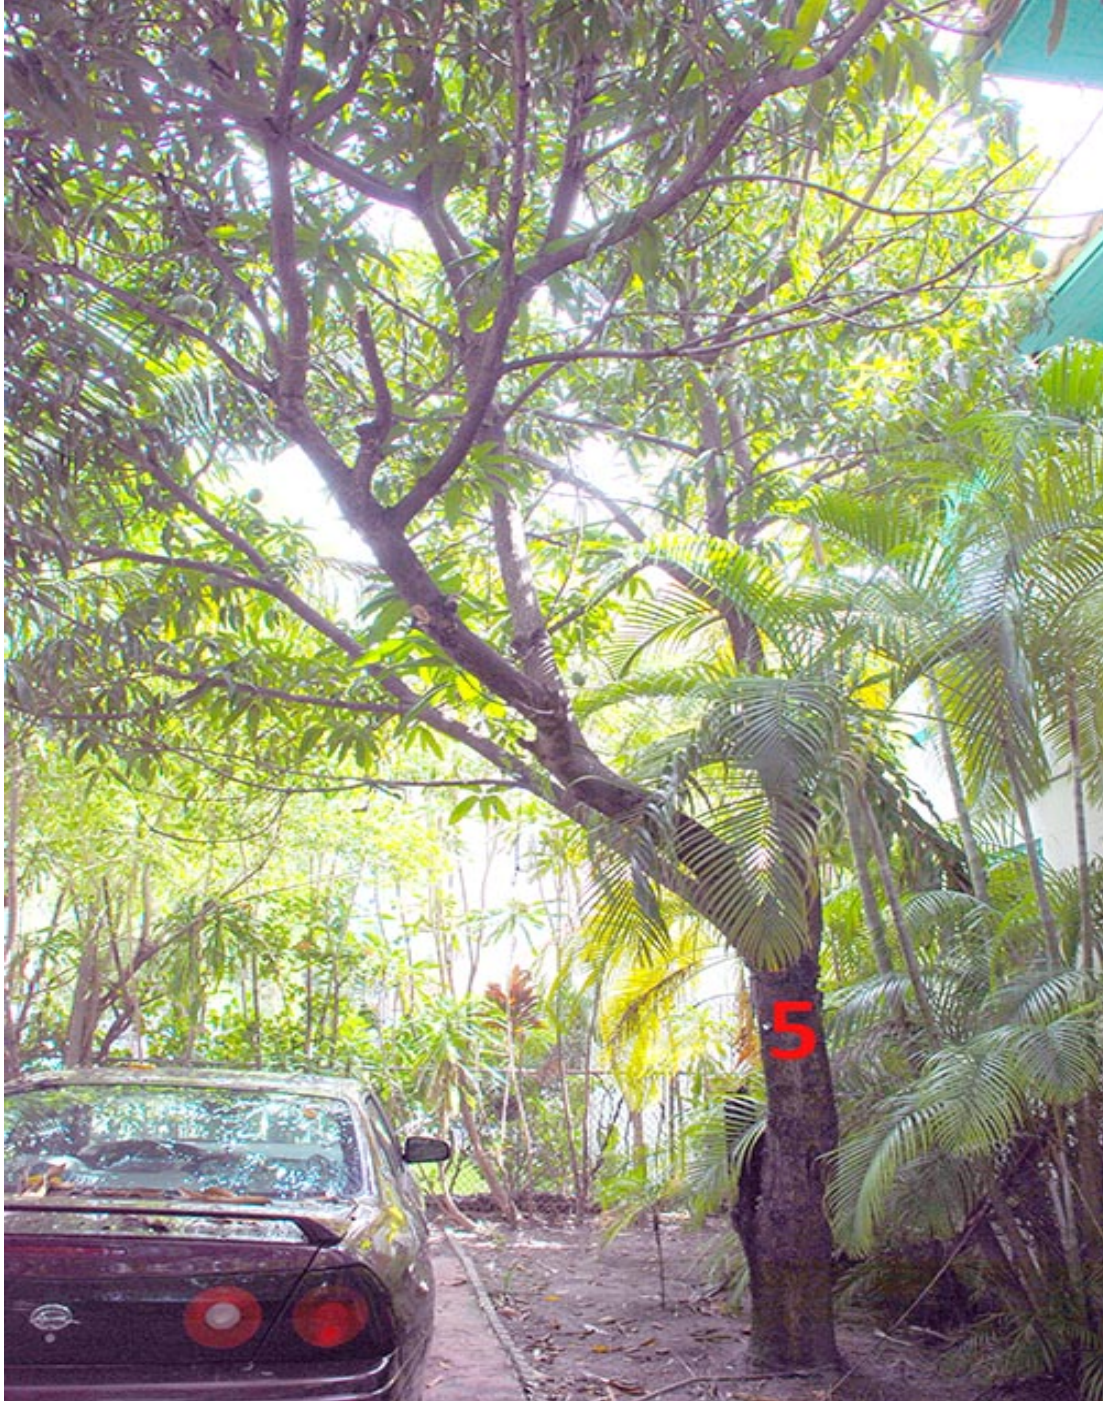
Photo 5 above is mango tree 5 looking north. This tree is in Poor condition and should be removed, see following photo.

I rated the trees and palms in accordance with ANSI A300 (Part 5) – 2005, Annex A, Management Report Information. The trees are rated Good, Moderate or Poor, see Appendix C. I recommend the removal of trees or palms that I rate as Poor.

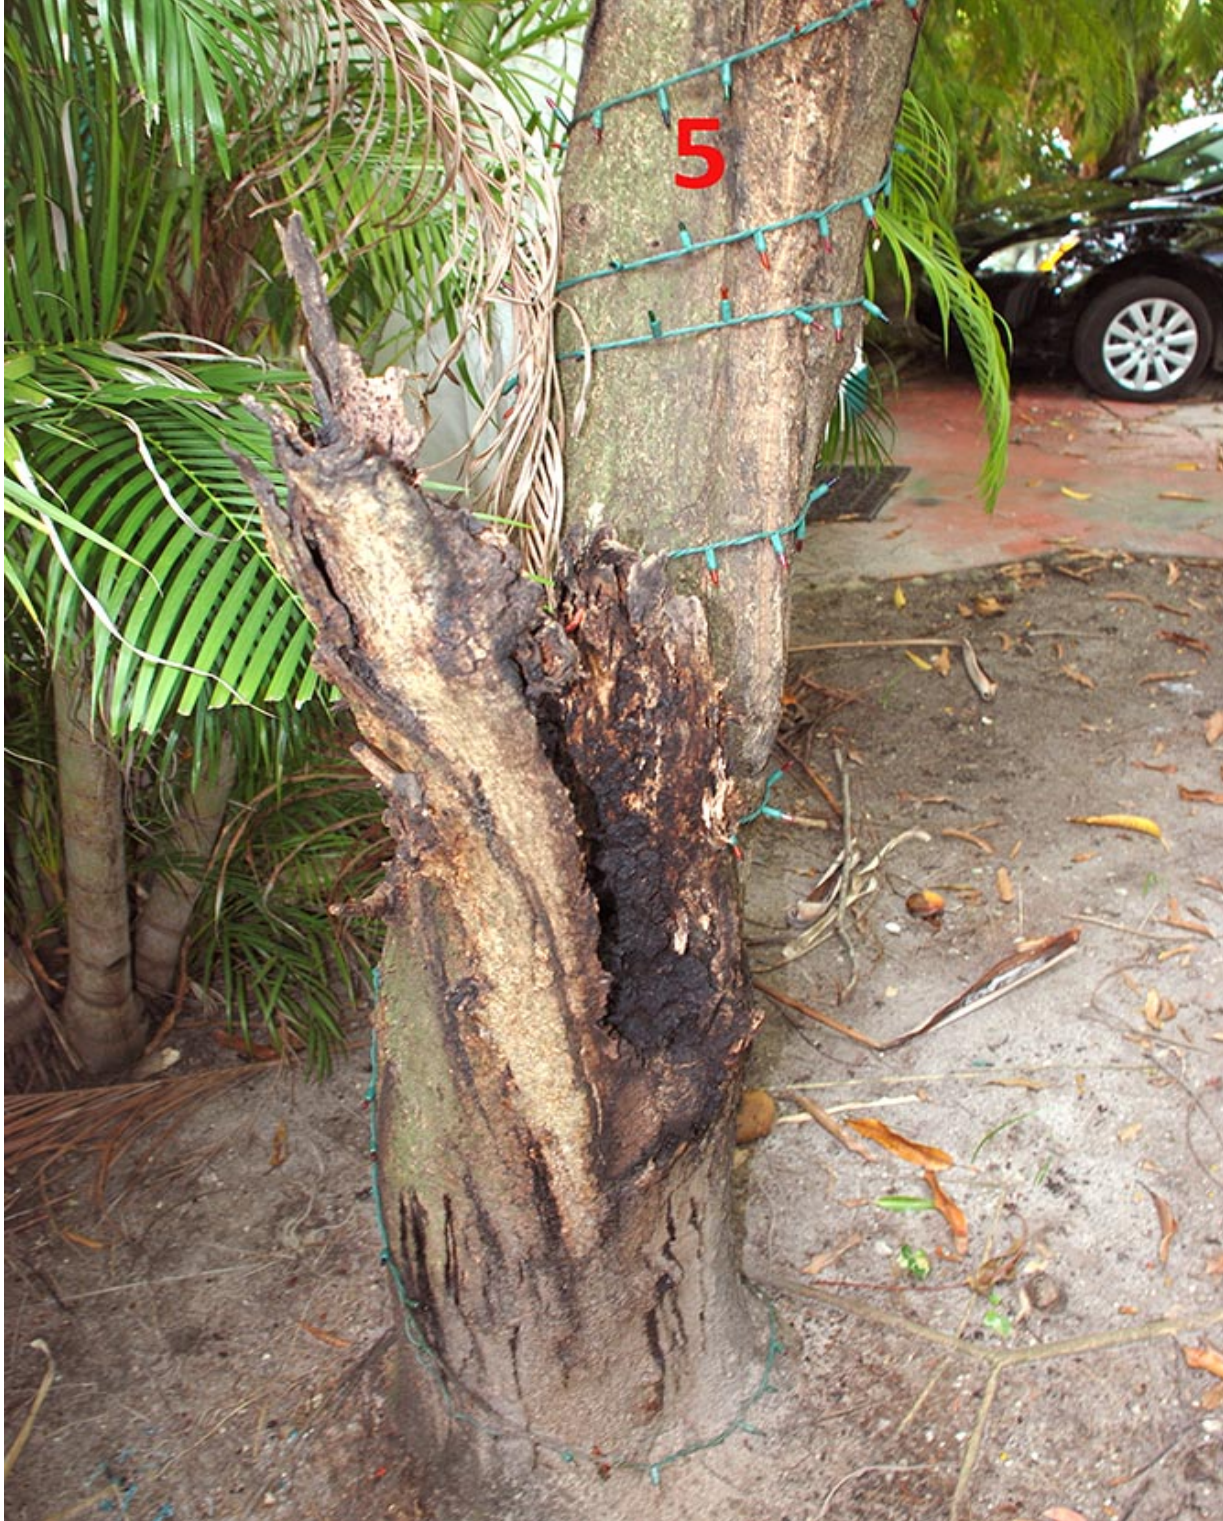
Photo 6 above is a close-up of tree 5. It has extensive decay and damage to it trunk.

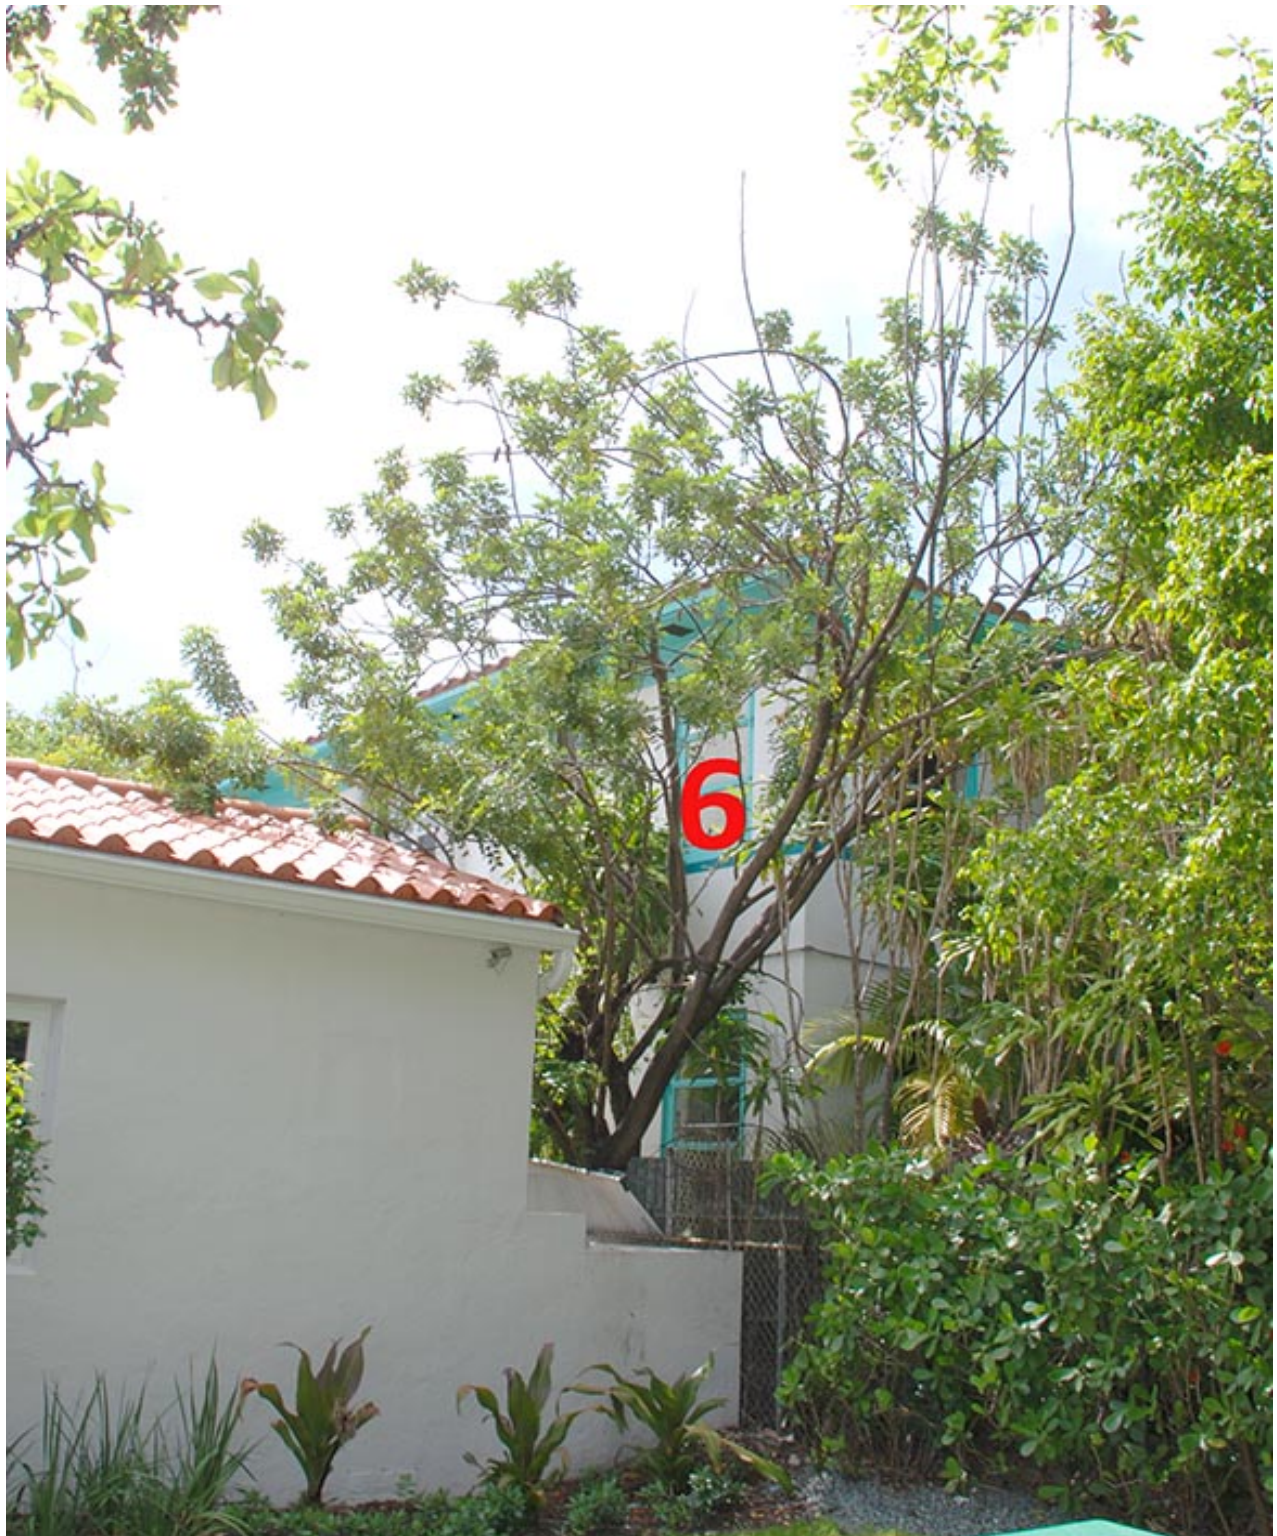
Photo 7 above is tree growing on the north edge of the property. There is some branch die-back in the canopy.

Trees to remain onsite should have the dead wood removed from their canopies by a certified arborist.

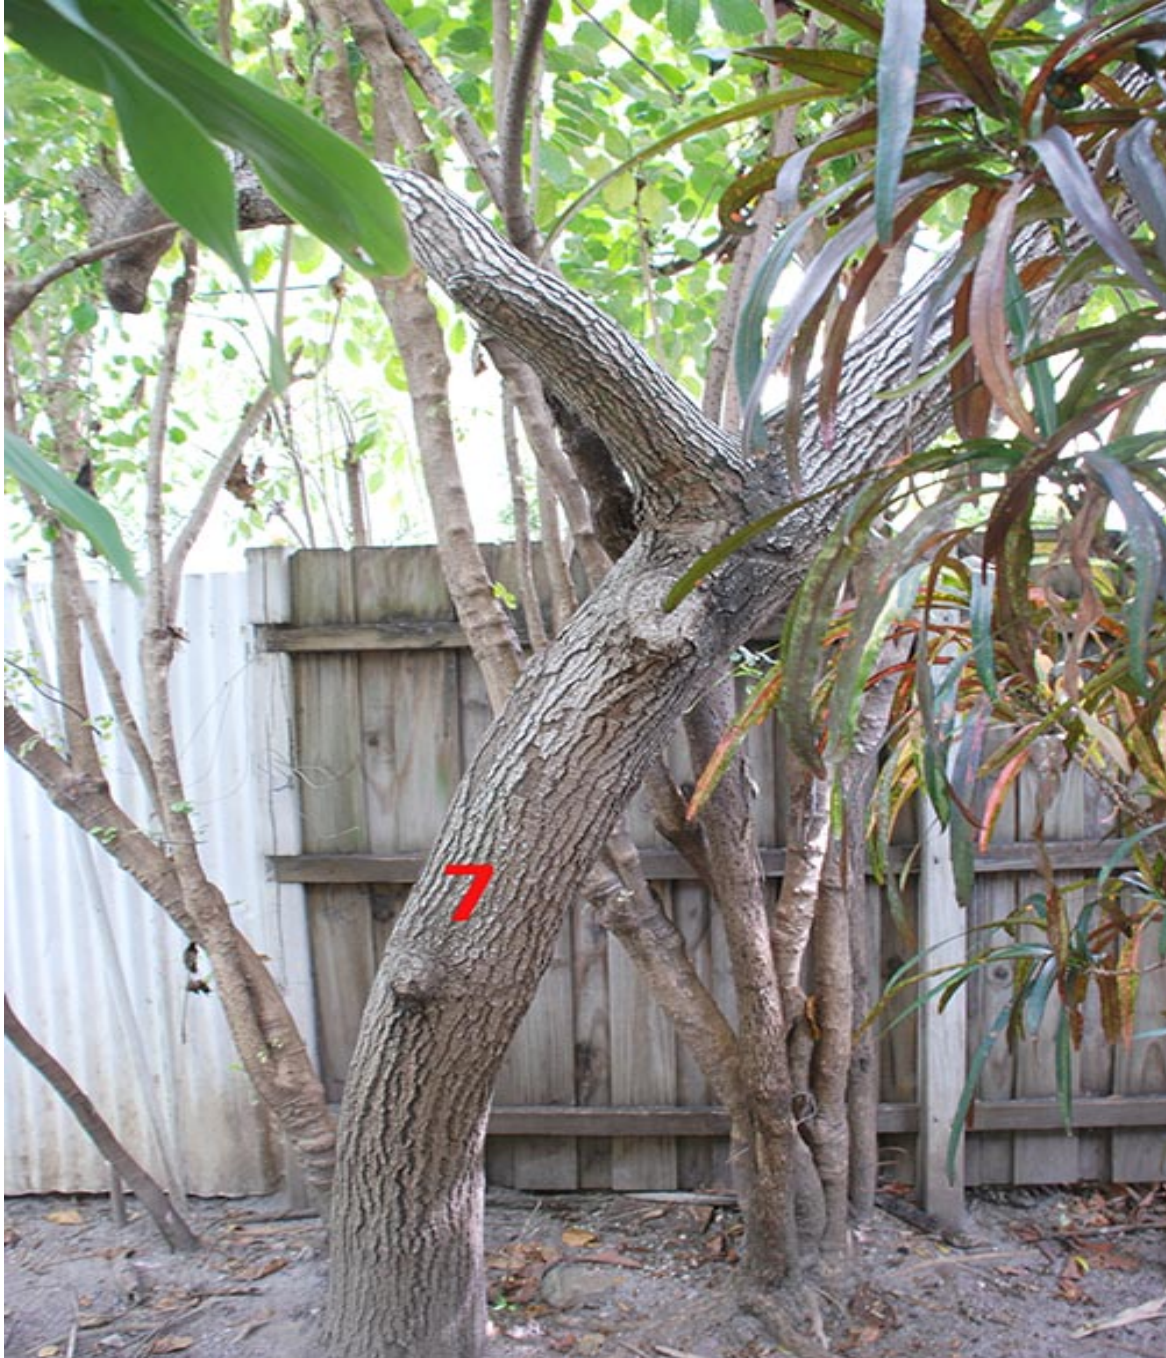
Photo 8 above is tree 7 looking north. It is very dense in this area and it was difficult to photograph the entire tree.

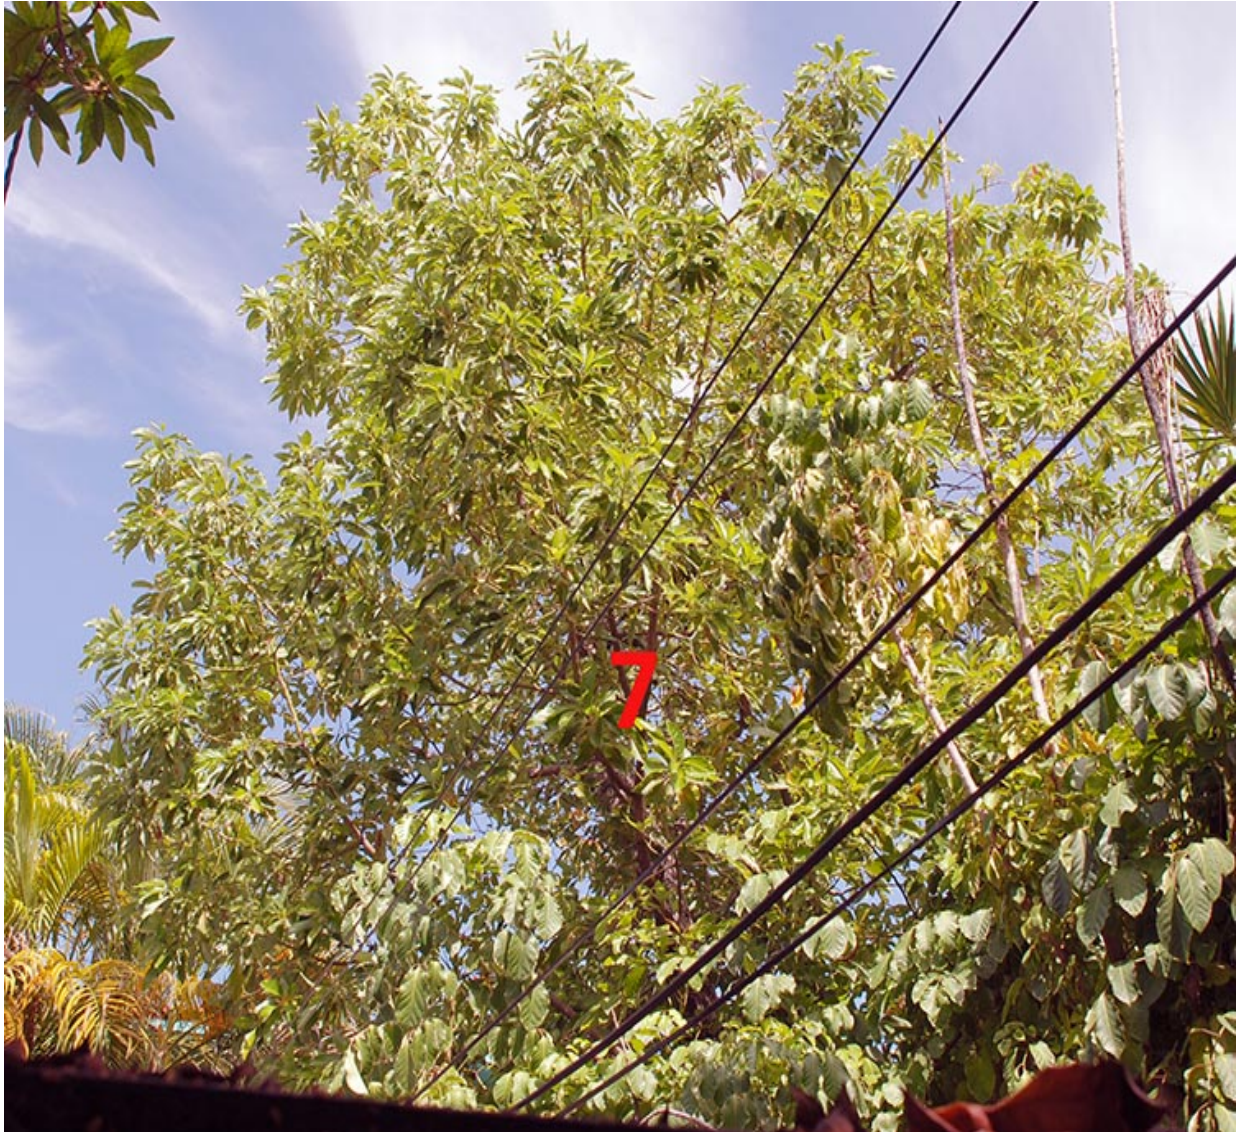
Photo 9 above is the canopy of tree 7 looking west. The power lines to the structure run through the canopy of this tree.

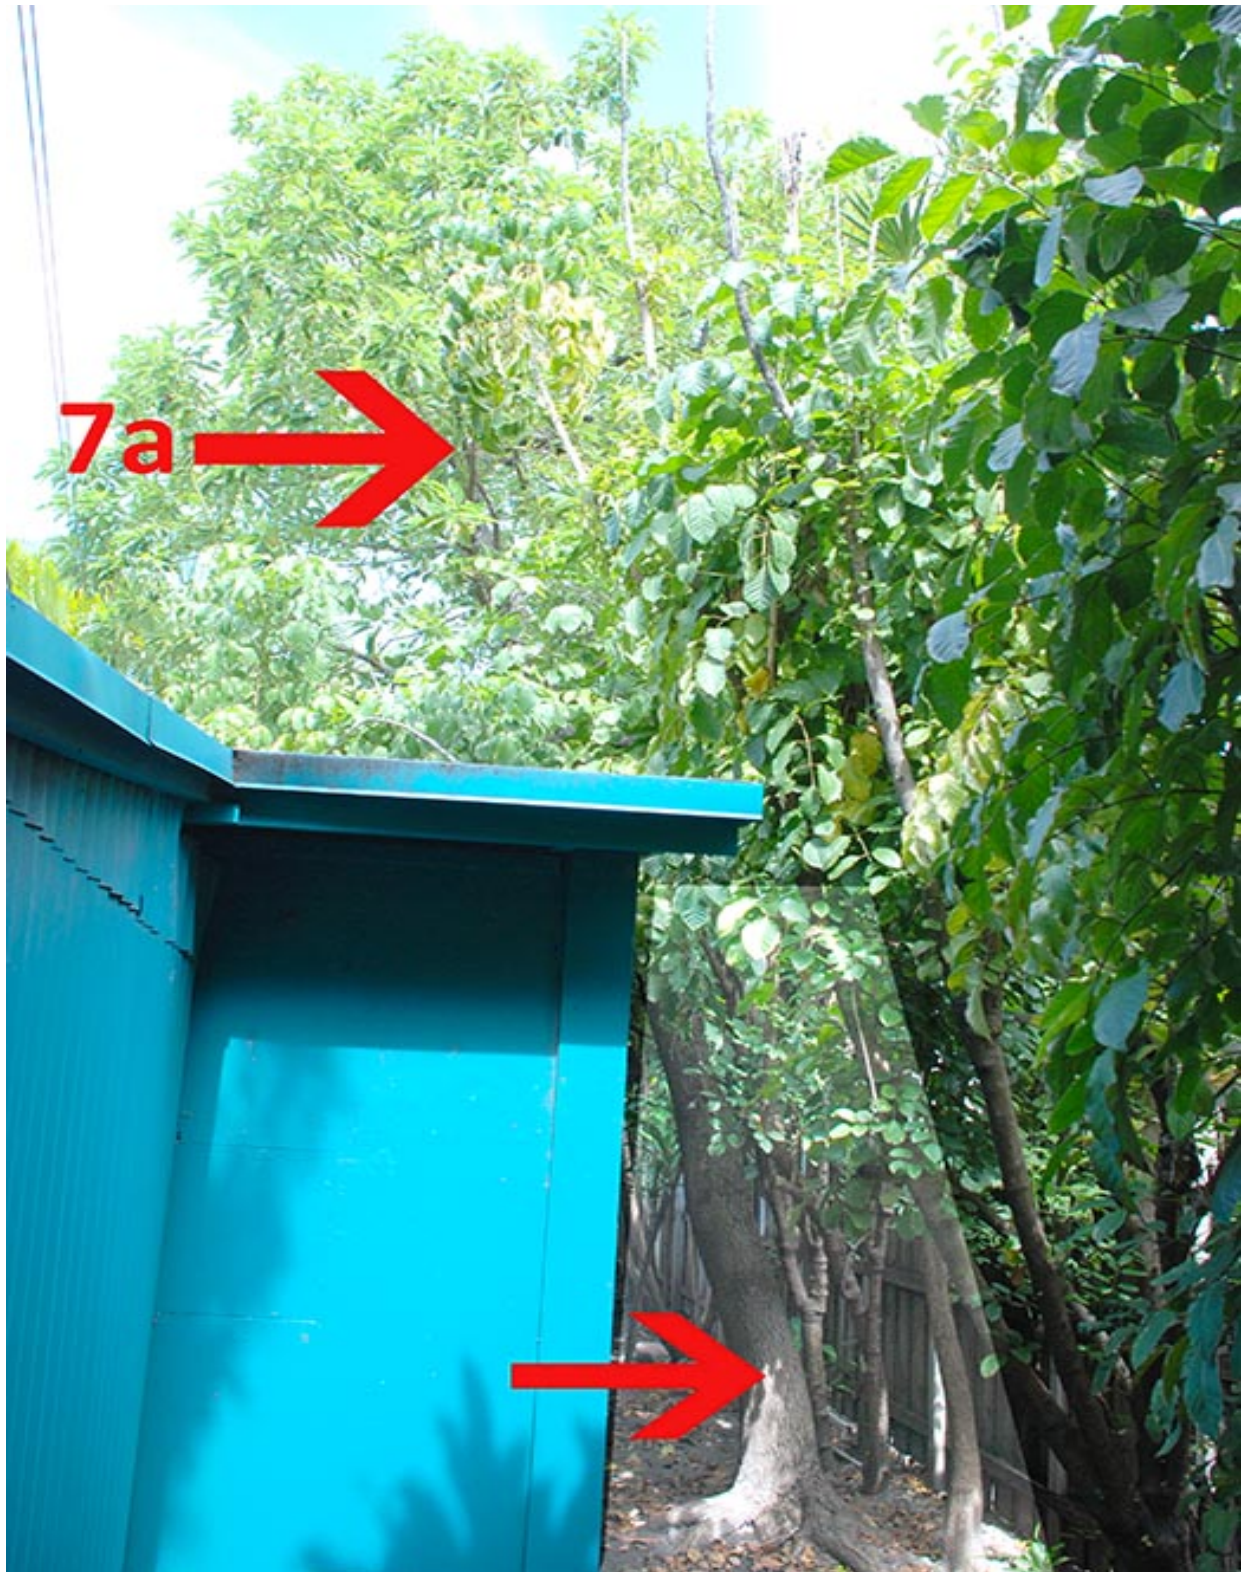
Photo 10 above is tree 7a looking west along the north edge of the property. It is very dense in this area and it was difficult to photograph the entire tree.

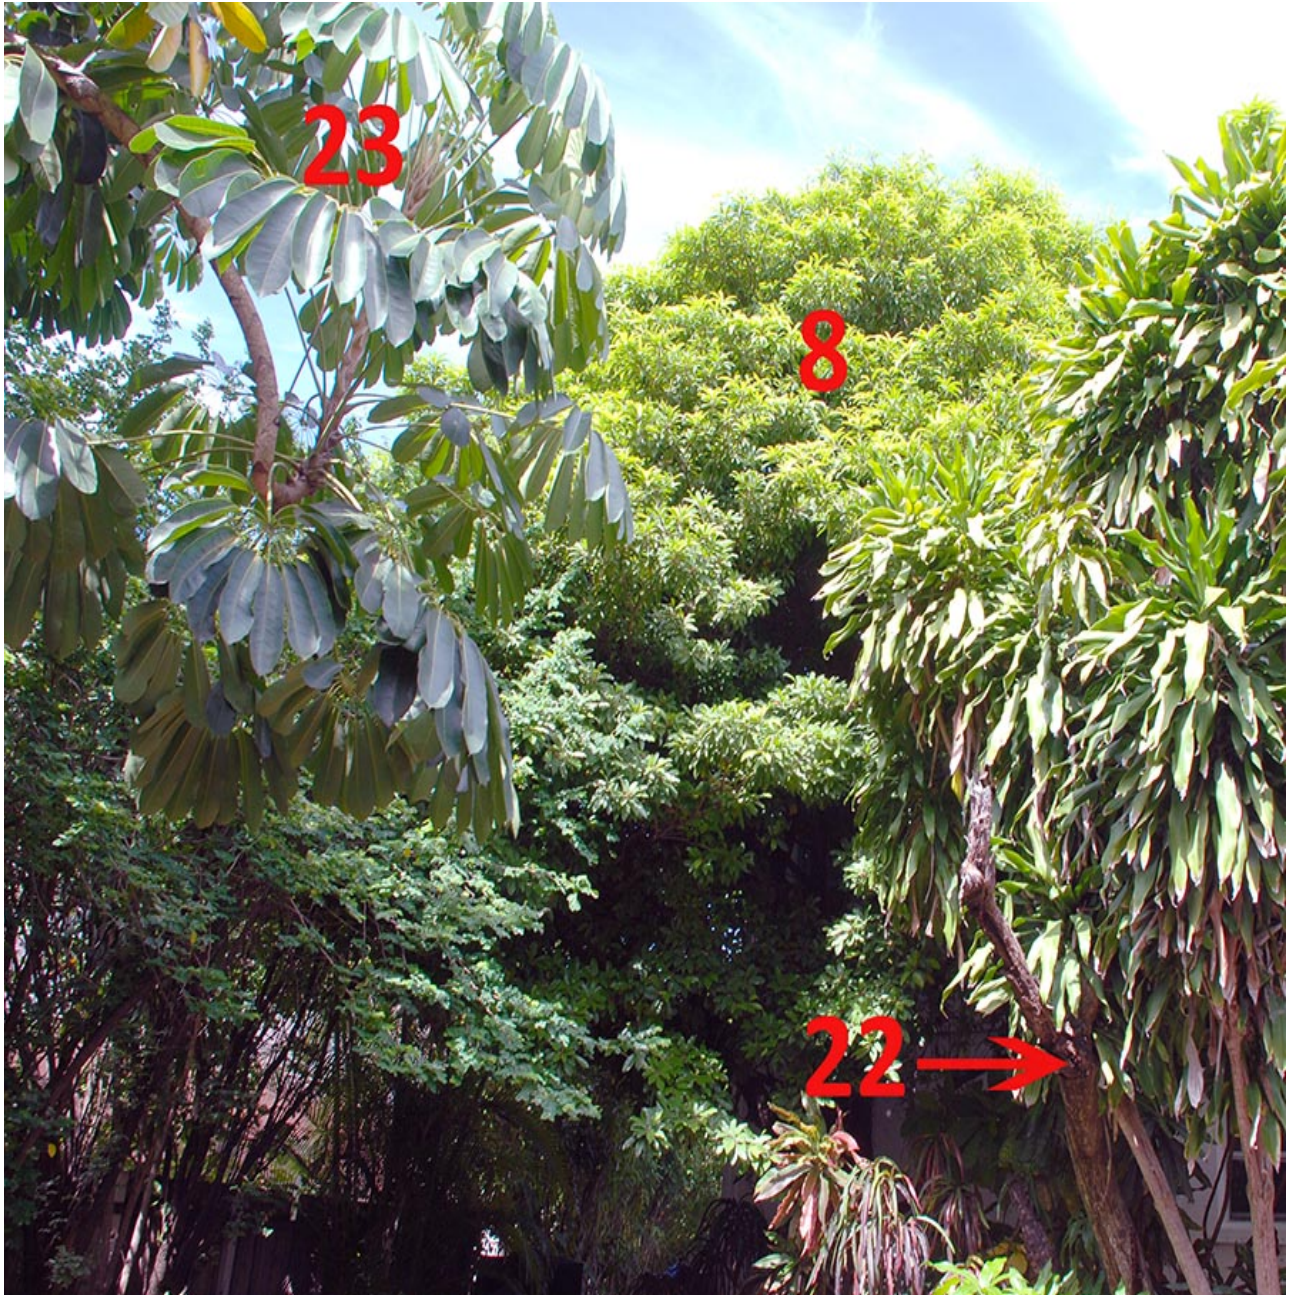
Photo 11 above is trees 8, 22 & 23 looking west. It is very dense in this area and it was difficult to photograph entire trees.

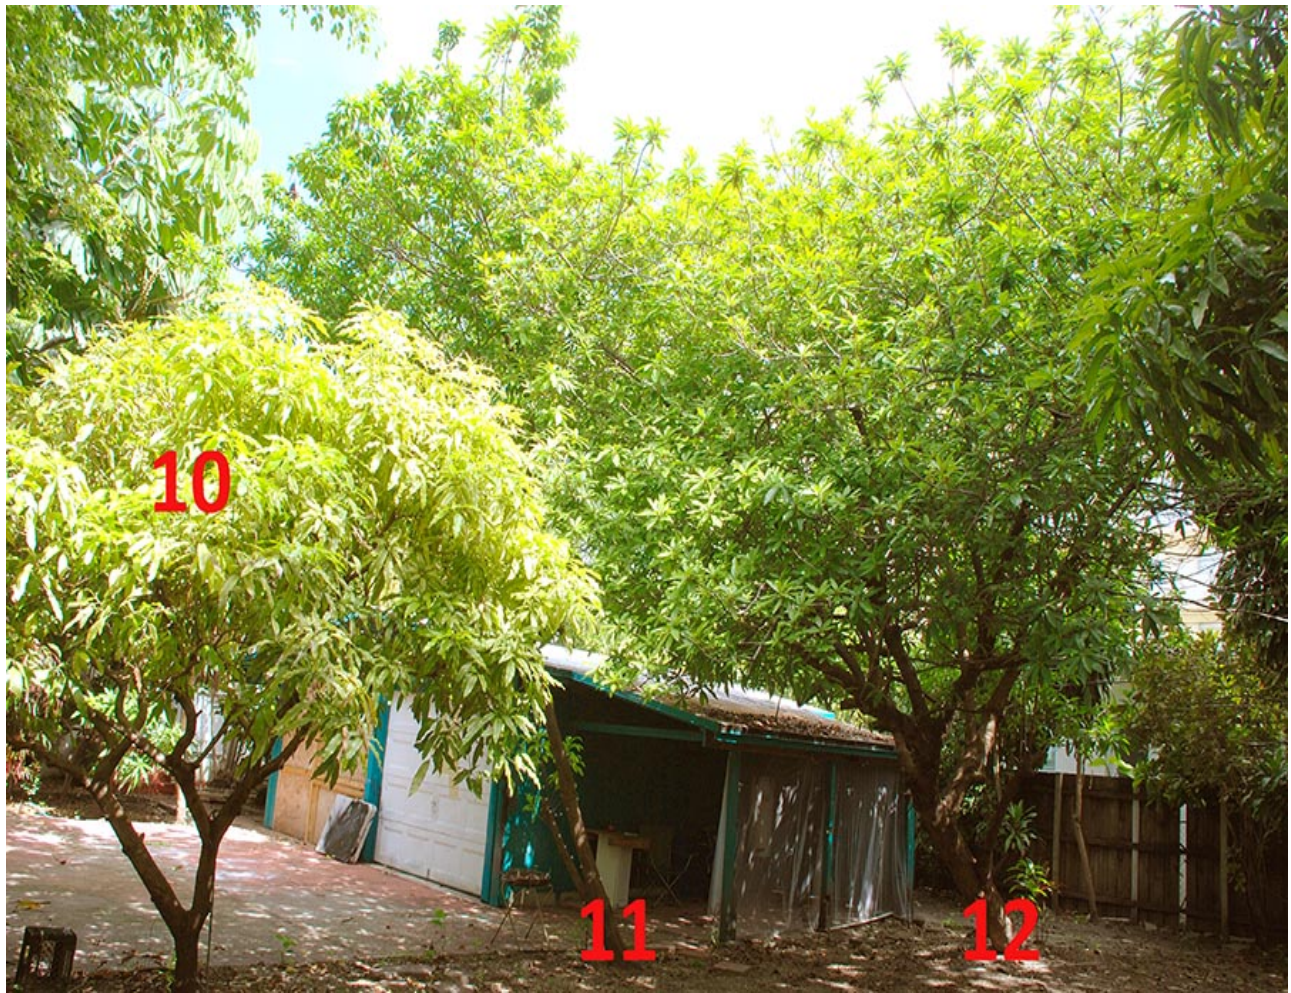
Photo 12 above is trees 10, 11 & 12 looking west. It is very dense in this area and it was difficult to photograph entire trees. Tree 10 has a severe nutrient deficiency.

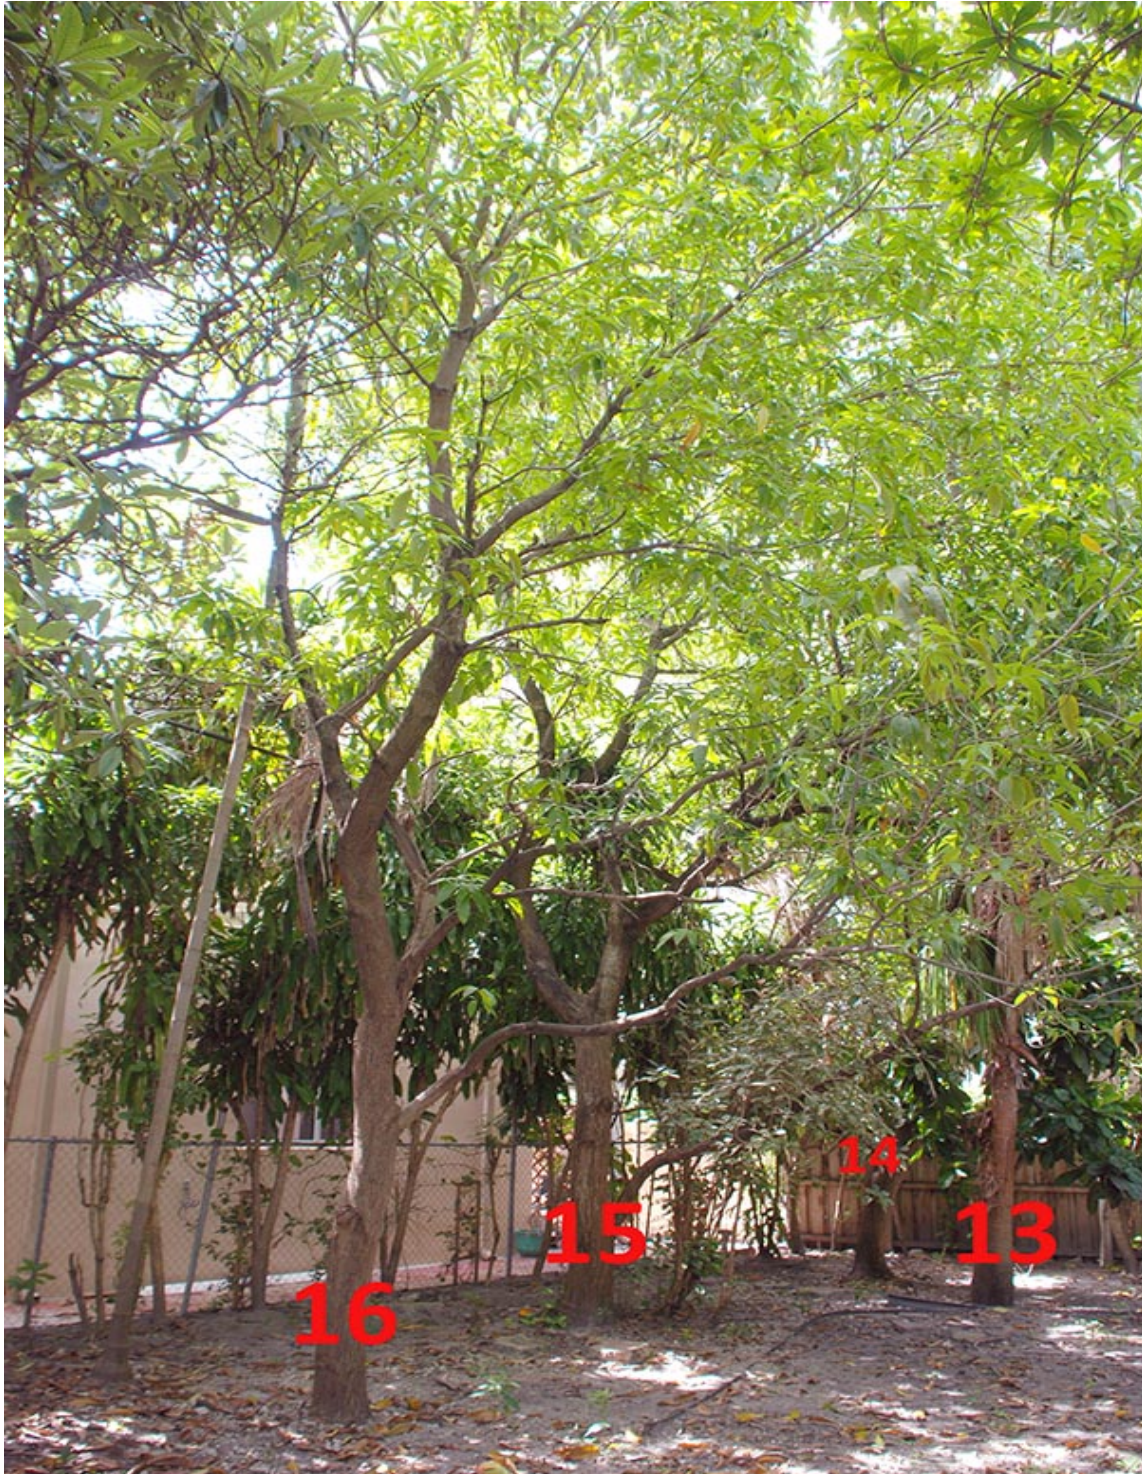
Photo 13 above is trees 14, 15 & 16 with palm 13 near the southeast corner of the property. All of the trees have their canopies in the adjacent power lines. It is very dense in this area and it was difficult to photograph entire trees.

All of the trees along the eastern property line have their canopies in the power lines that run north to south. Regardless of the condition rating, I recommend the removal of these trees as well. See photos 13, 14 & 17 below.
