Tree Resource Evaluation for 925 Lenox Avenue, Miami Beach

July 6, 2016

Summary

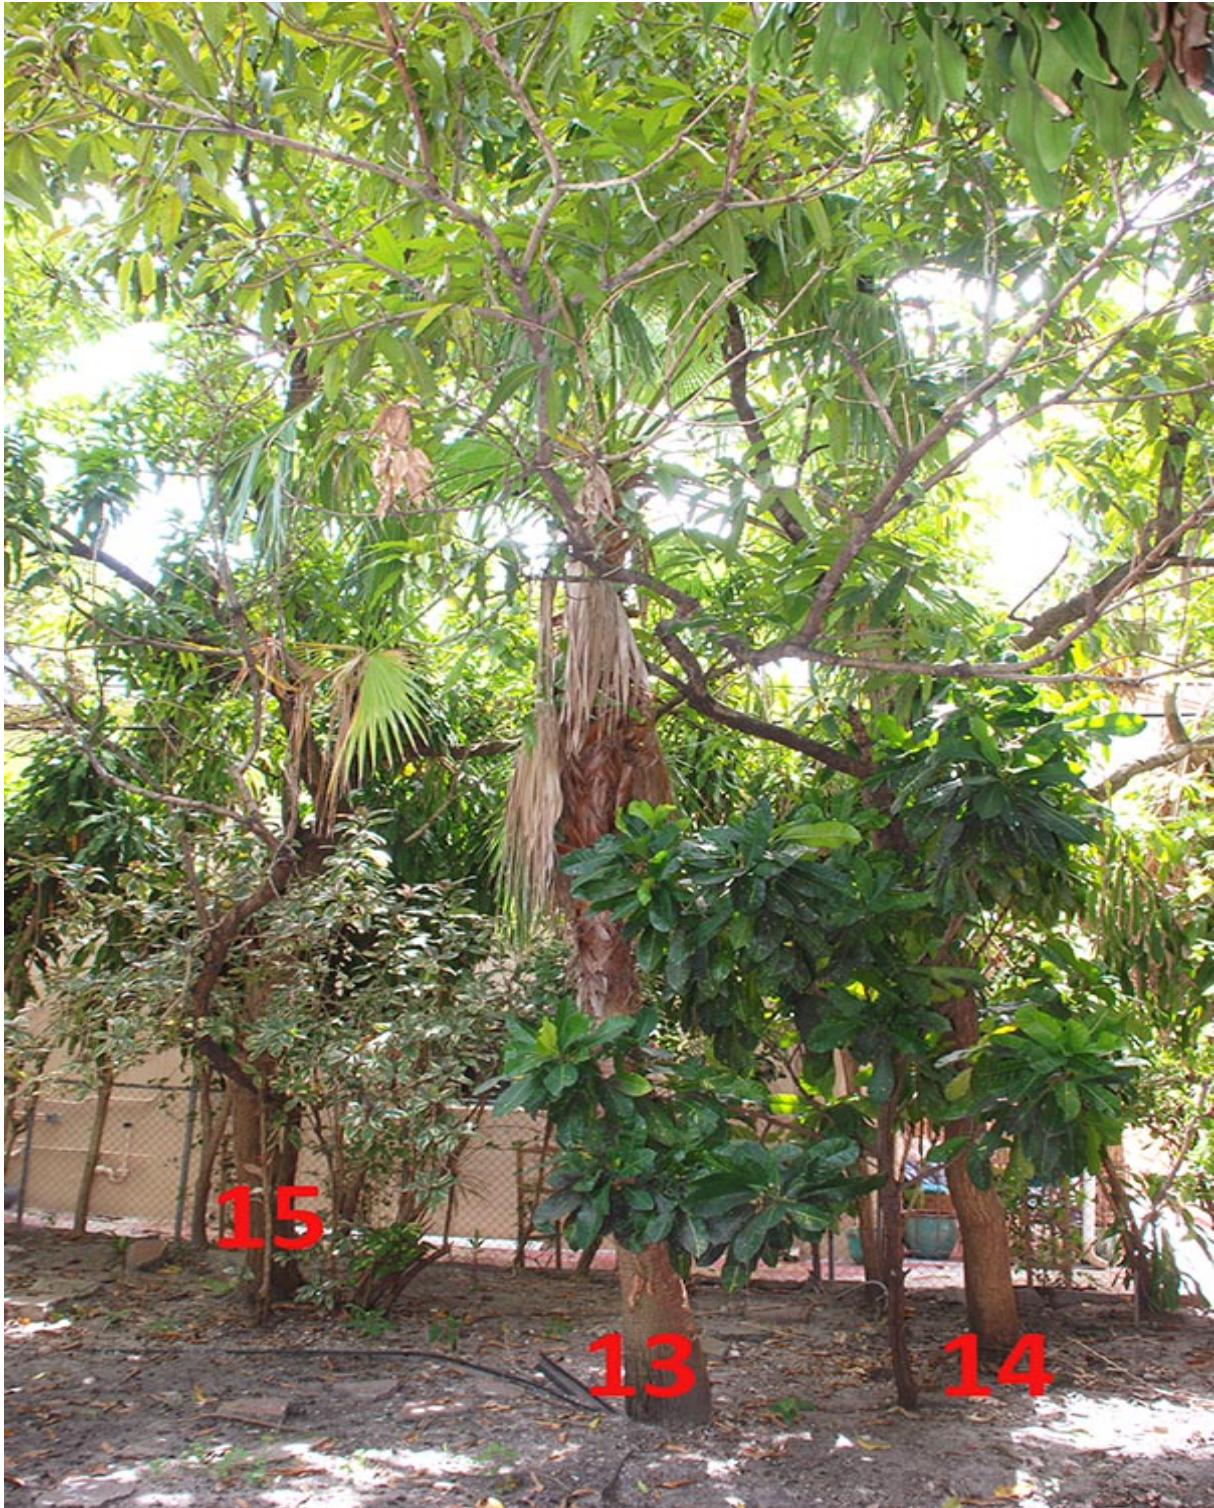
Photo 14 above is trees 14 & 15 with palm 13 near the southeast corner of the property. All of the trees have their canopies in the adjacent power lines. It is very dense in this area and it was difficult to photograph entire trees.

All of the trees along the eastern property line have their canopies in the power lines that run north to south. Regardless of the condition rating, I recommend the removal of these trees as well. See photos 13, 14 & 17 below.

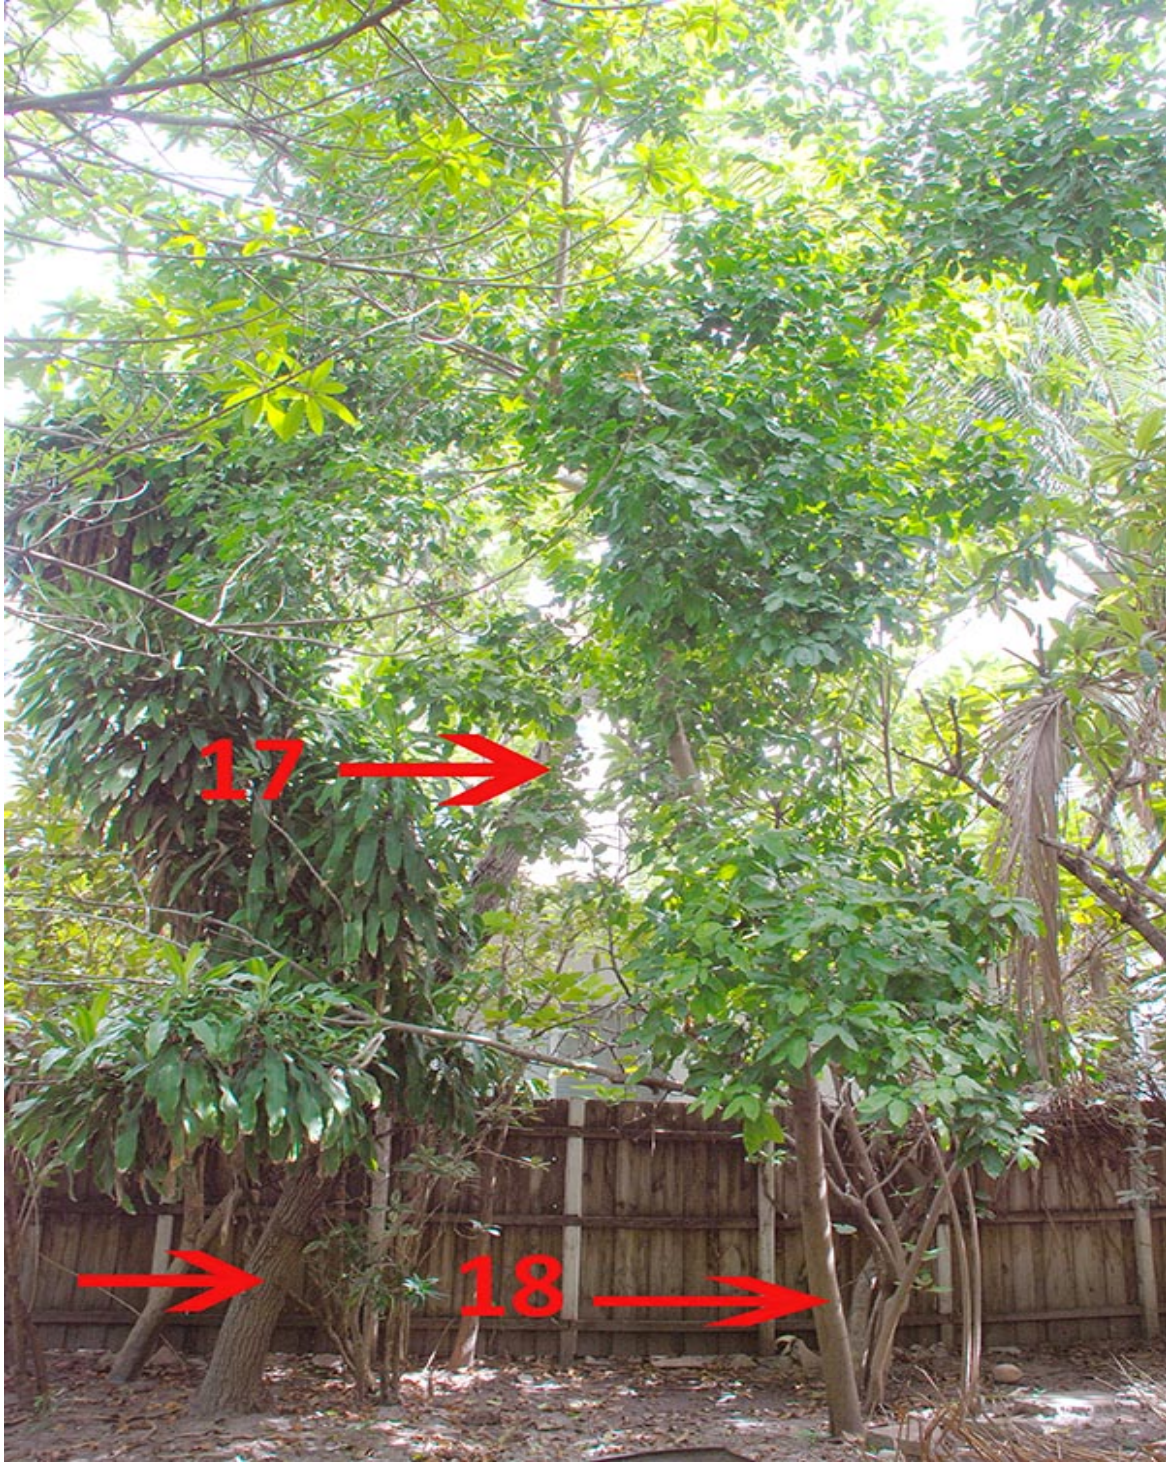
Photo 15 above is trees 17 & 18 along the east edge of the property. All of the trees have their canopies in the adjacent power lines. It is very dense in this area and it was difficult to photograph entire trees.

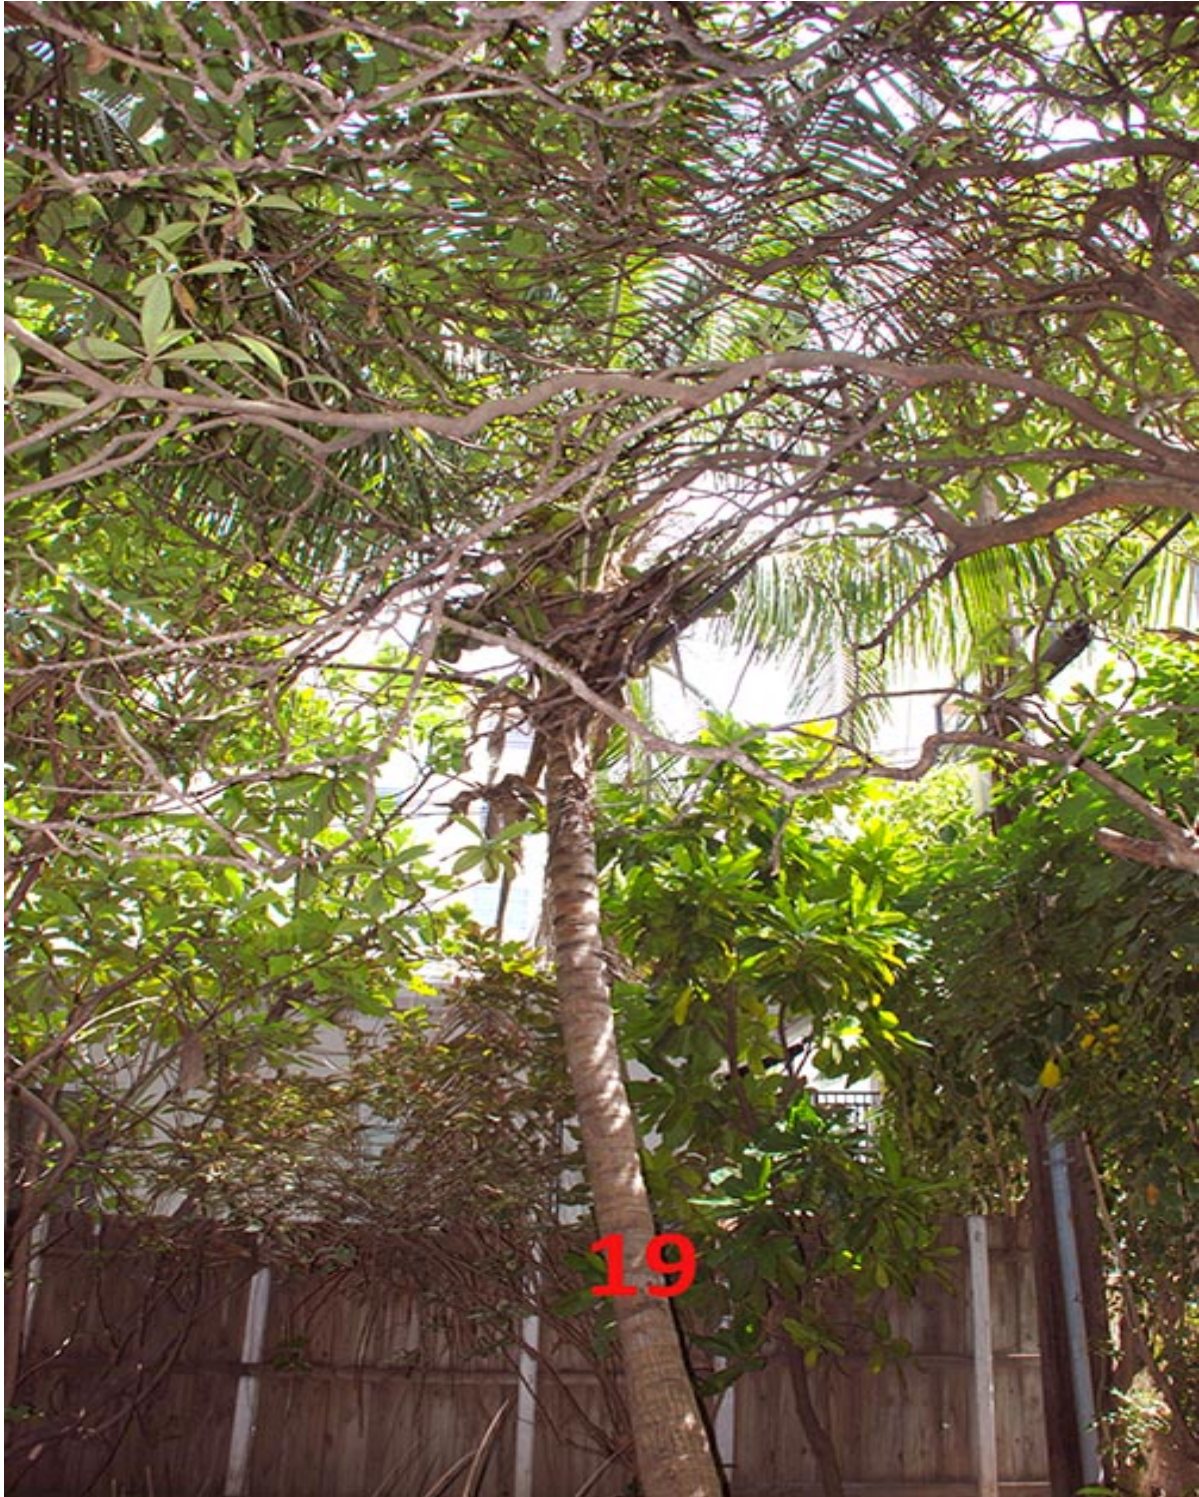
Photo 16 above is coconut 19 near the northeast corner of the property. This palm has its fronds in the adjacent power lines to the right.

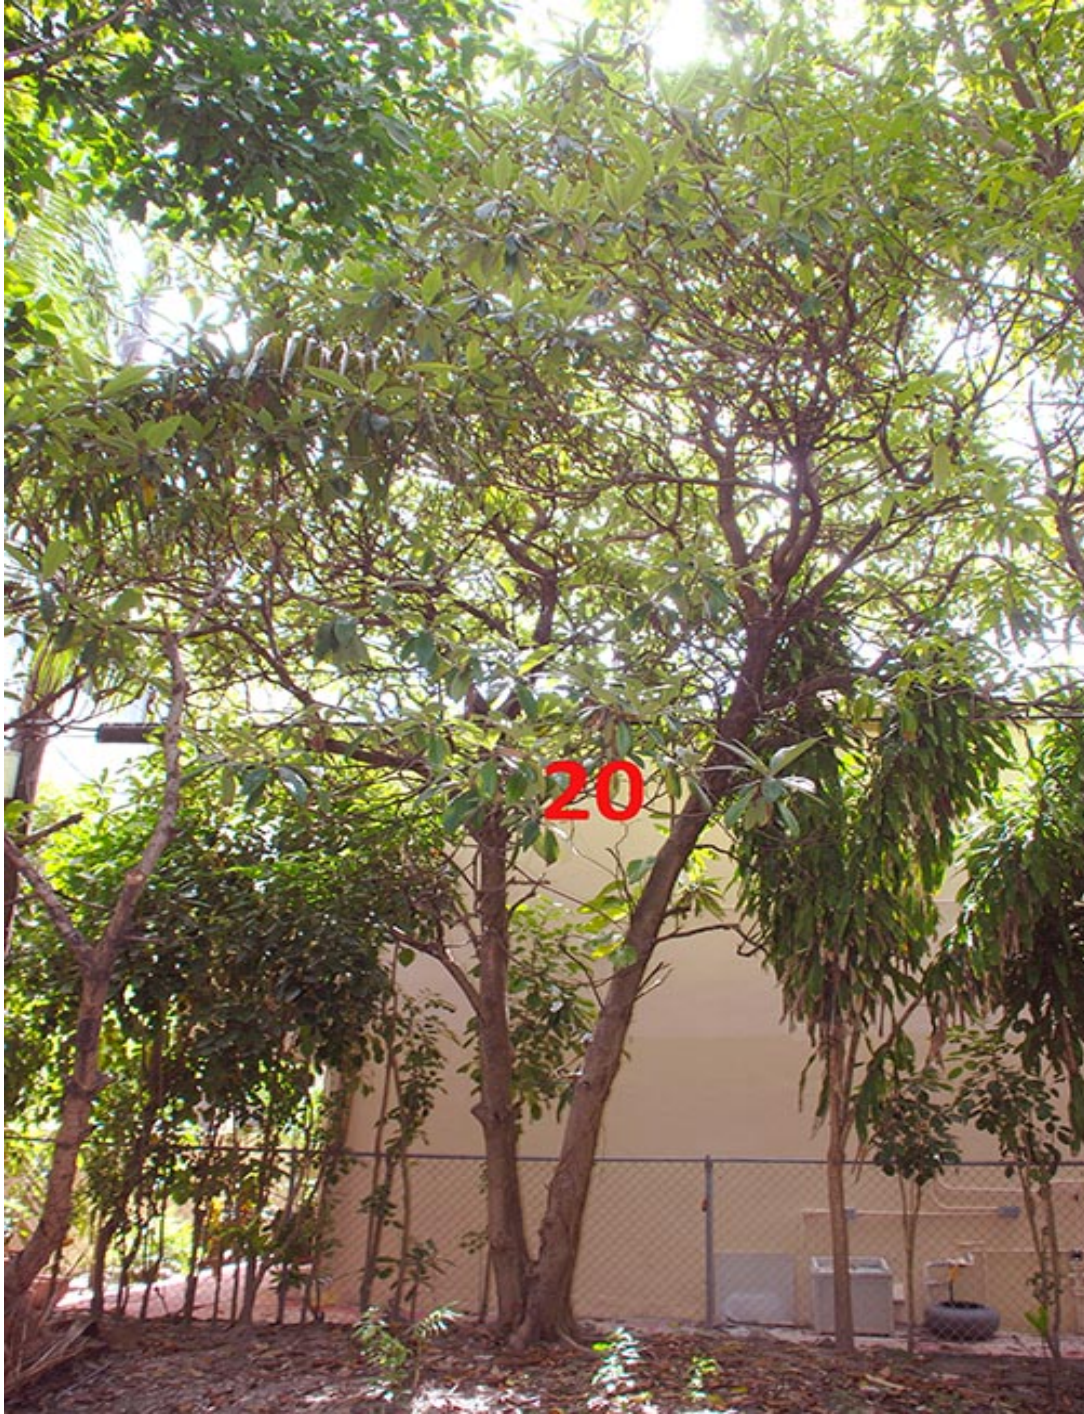
Photo 17 above is tree 20 along the east edge of the property. This tree has its canopy in the adjacent power lines.

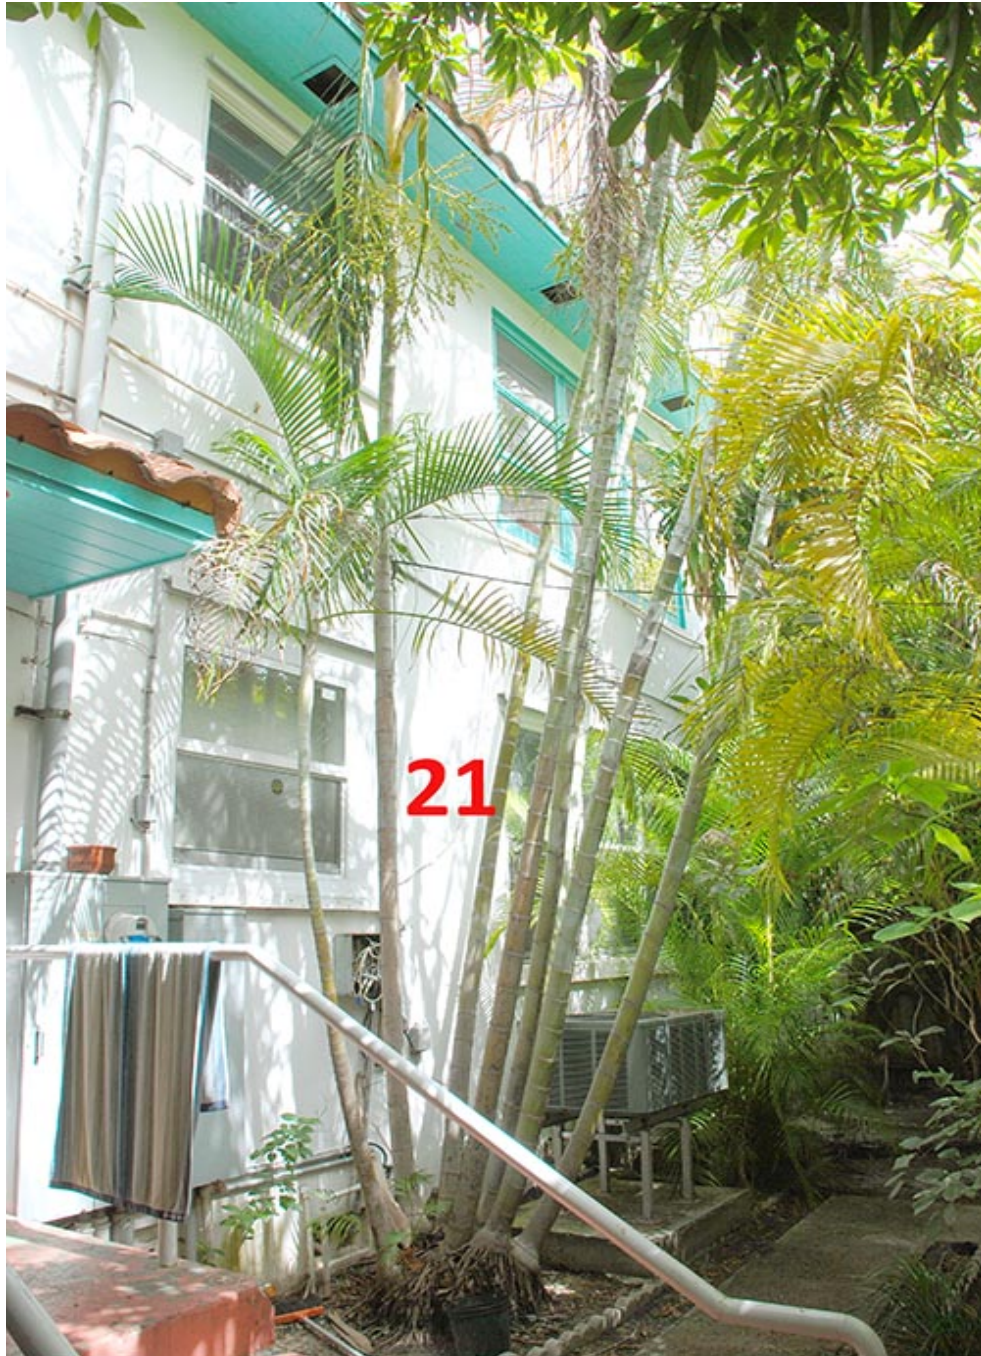
Photo 18 above is palm 21 to the east of the structure.

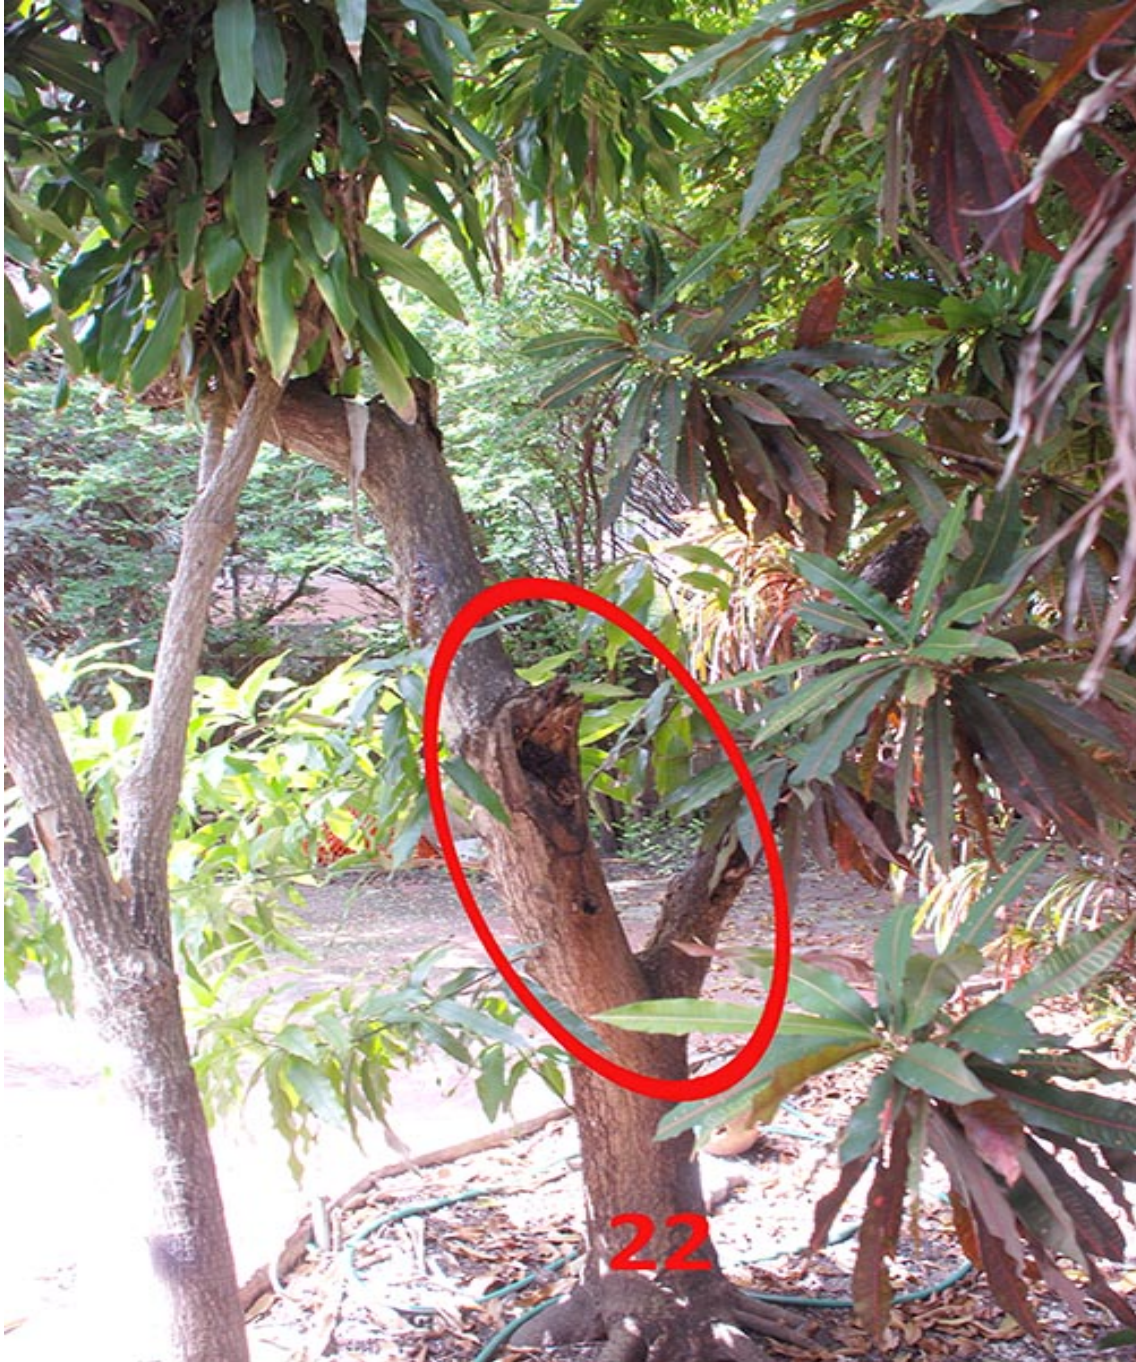
Photo 19 above is a close-up of the decay and damage on tree 22. This tree should be removed

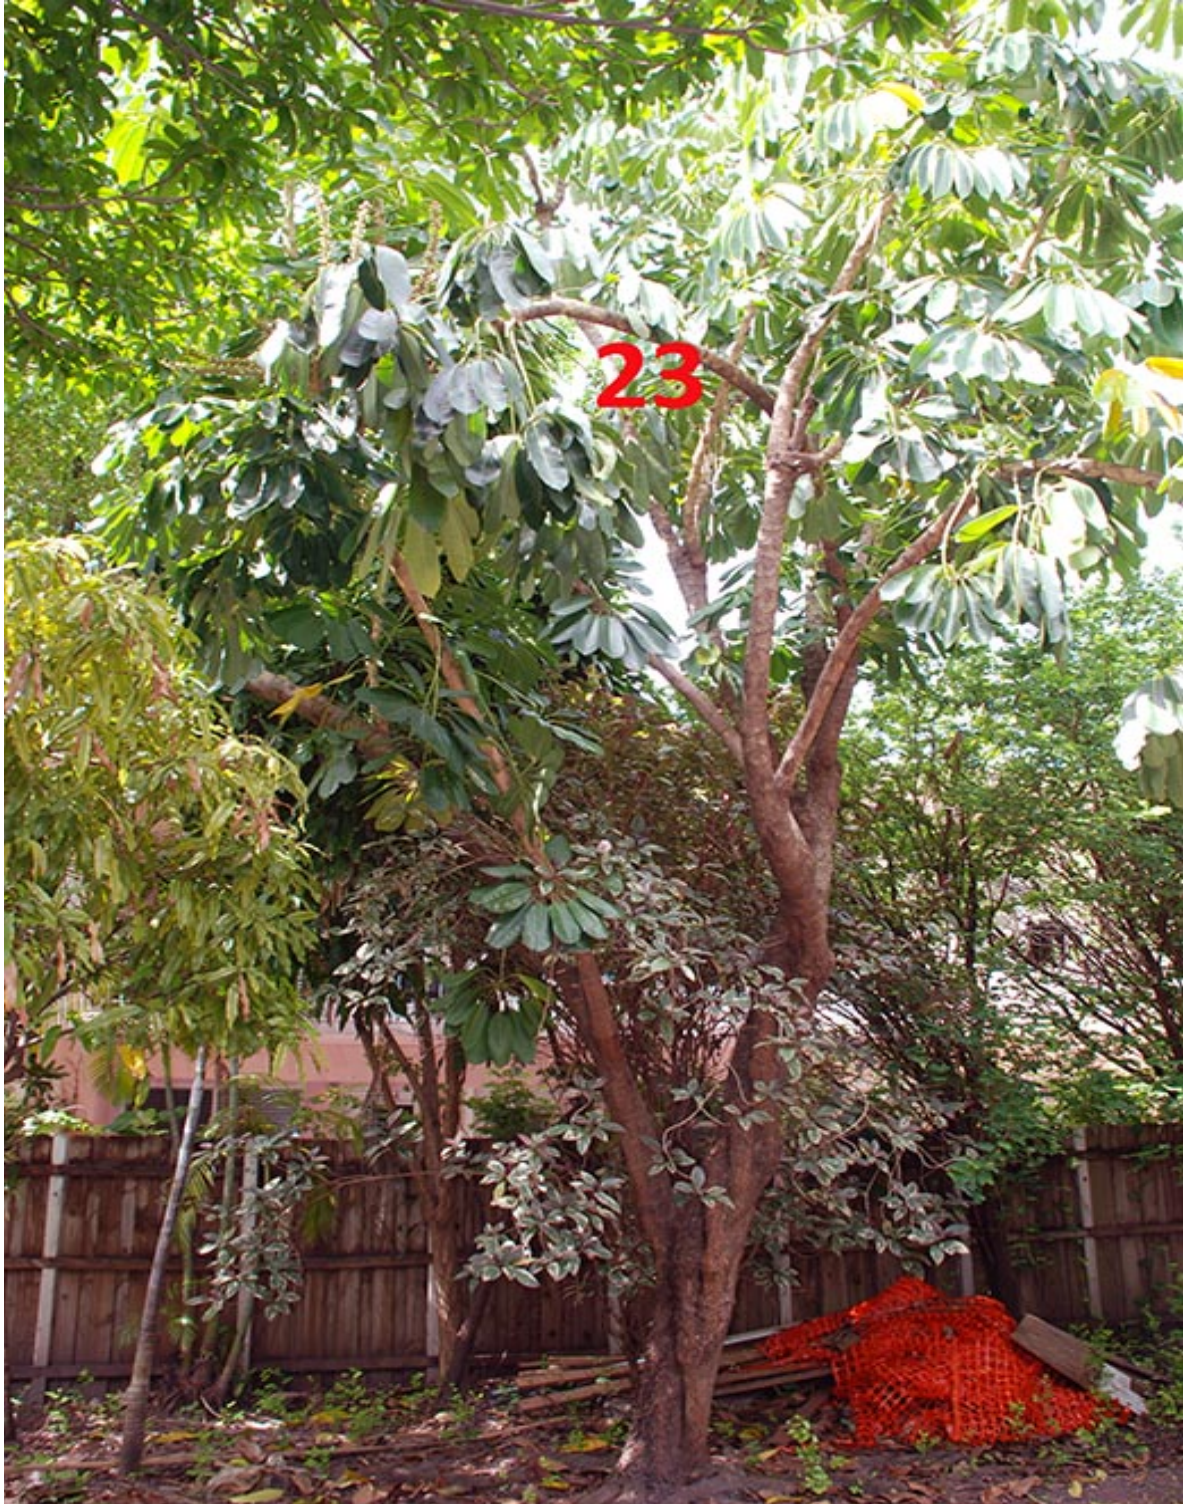
Photo 20 above is umbrella tree 23 looking to the south.

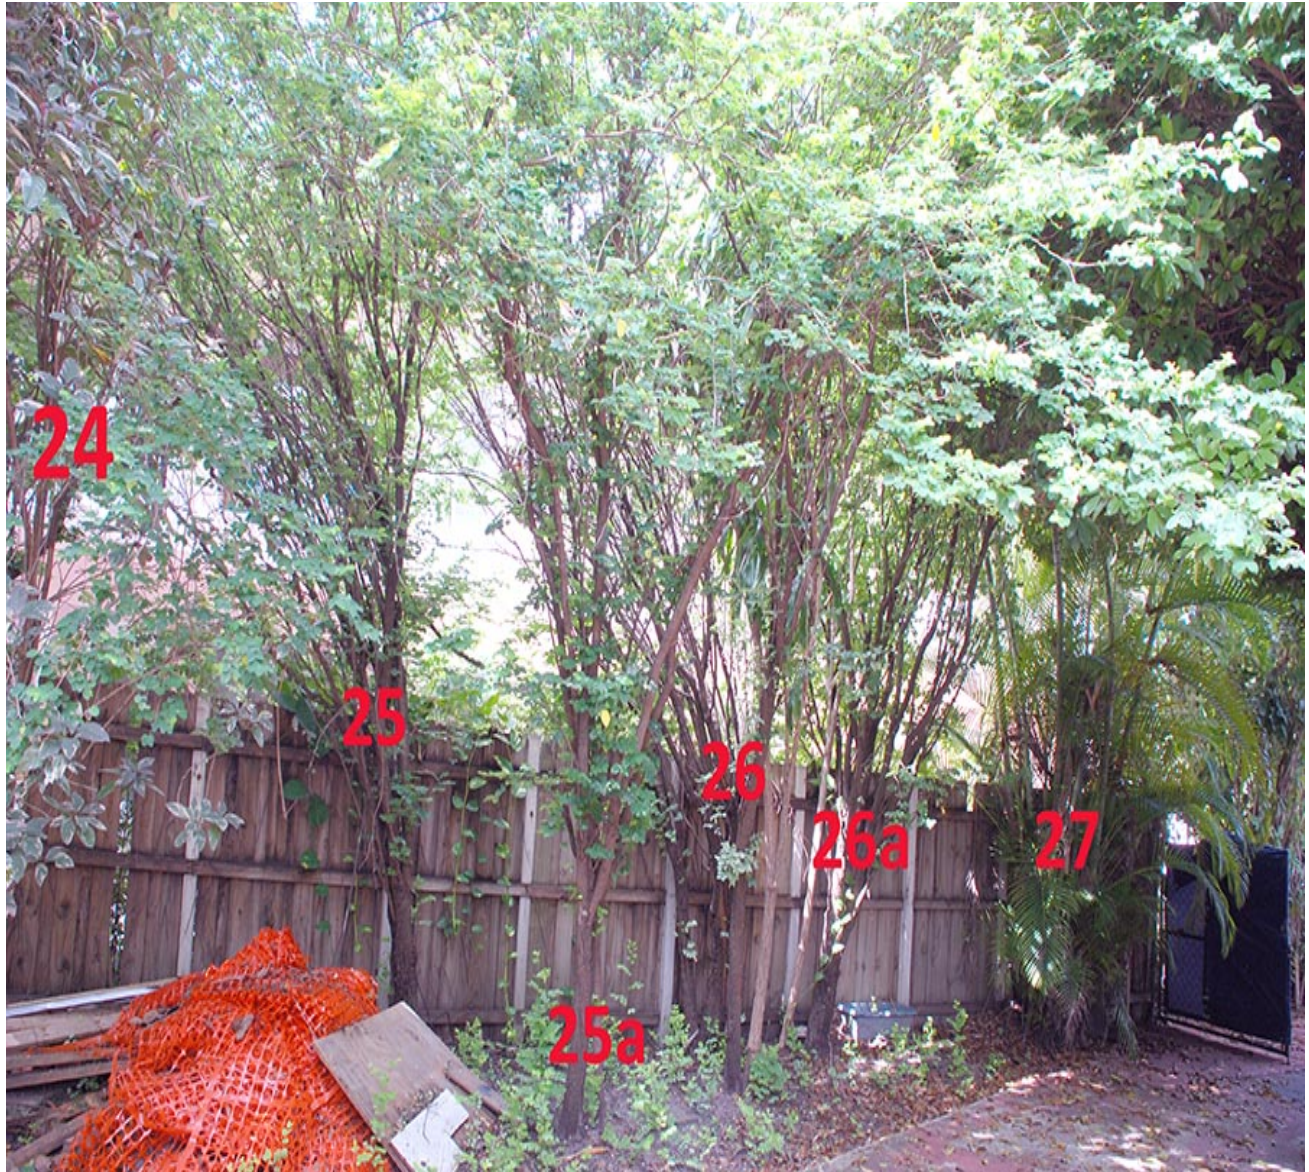
Photo 21 above is 24 through 26a along the south edge of the property. I was unable to identify this group of very shade grown trees/shrubs. Areca palm 27 can also be seen.
