ALVEY TREE CONSULTING LLC

Arborist Report

Park Avenue Hotel
355 19th Street, Miami Beach

3/7/2019

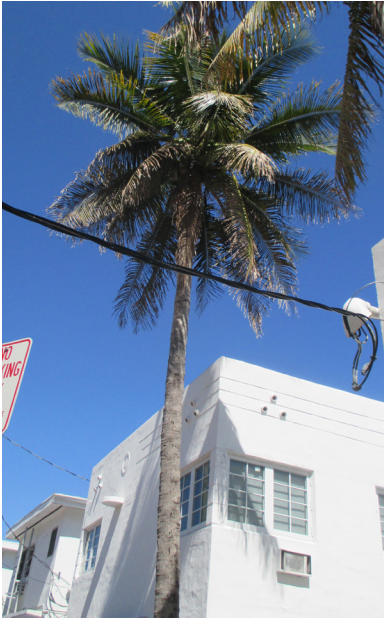
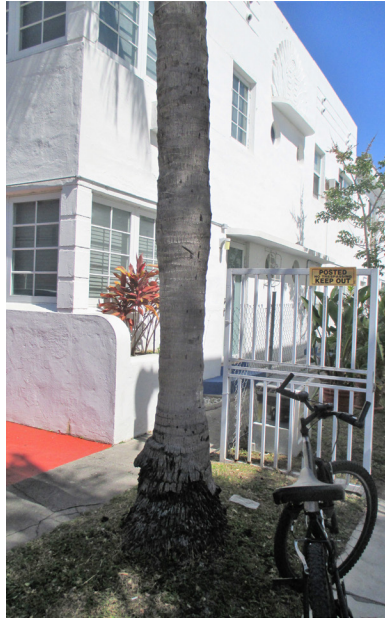
Condition -
Fair

Tree #1 is a Coconut Palm located on the Park Avenue side of the property. This tree is in fair condition - lower dead fronds and coconuts should be removed. There are multiple injuries along the trunk. Protective barriers shall be placed at the drip line of the tree, in this case, 7.5ft from the tree trunk to the edge of protective fencing. Barriers shall be installed prior to the start of any construction or demolition, and shall remain in place until development is completed and until the dept authorizes their removal. Barriers shall be a minimum of 4ft high, and shall be constructed of continuous chain link fence with metal posts at 8ft spacing, or of 2x4 posts with three equally spaced 2x4 rails. Posts may be shifted to avoid roots. No oil, paint, fill, equipment, building materials, building debris, or any other material shall be placed or disposed of within the TPZ. Natural grade shall be maintained, and no vehicles or equipment shall be permitted within the TPZ.

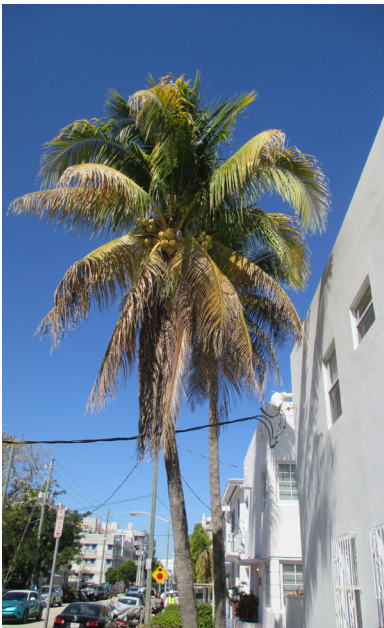
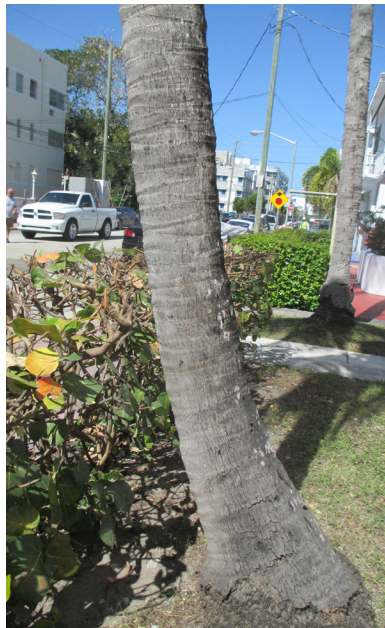
Condition -
Fair

Tree #2 is a Coconut Palm located on the Park Avenue side of the property. This tree is in fair condition - lower dead fronds and coconuts should be removed. Many of the fronds are yellow or brown and there are multiple injuries along the trunk. Protective barriers shall be placed at the drip line of the tree, in this case, 8ft from the tree trunk to the edge of protective fencing. Barriers shall be installed prior to the start of any construction or demolition, and shall remain in place until development is completed and until the dept authorizes their removal. Barriers shall be a minimum of 4ft high, and shall be constructed of continuous chain link fence with metal posts at 8ft spacing, or of 2x4 posts with three equally spaced 2x4 rails. Posts may be shifted to avoid roots. No oil, paint, fill, equipment, building materials, building debris, or any other material shall be placed or disposed of within the TPZ. Natural grade shall be maintained, and no vehicles or equipment shall be permitted within the TPZ.

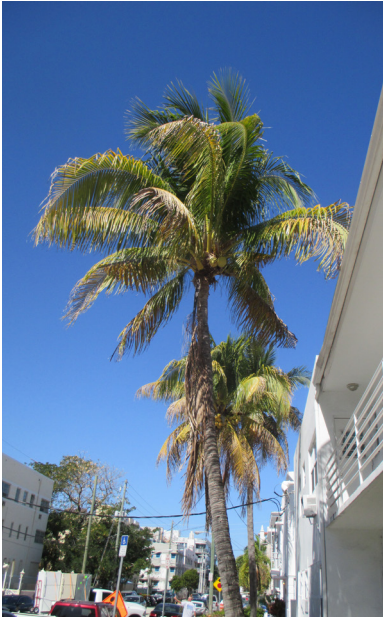
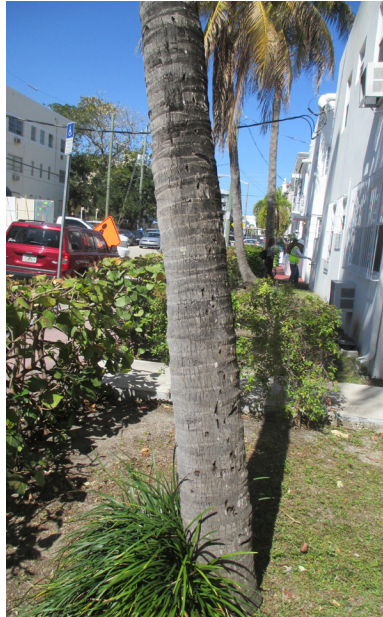
Condition -
Fair

Tree #3 is a Coconut Palm located on the Park Avenue side of the property. It is in fair condition with many yellow or brown fronds and multiple injuries along the trunk. The plans call for this tree to be relocated. If this is to occur, application of a palm fertilizer is recommended prior to relocation. Lower dead fronds and coconuts should be removed.

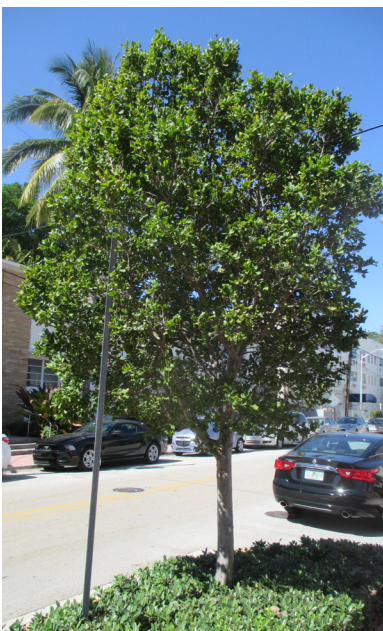
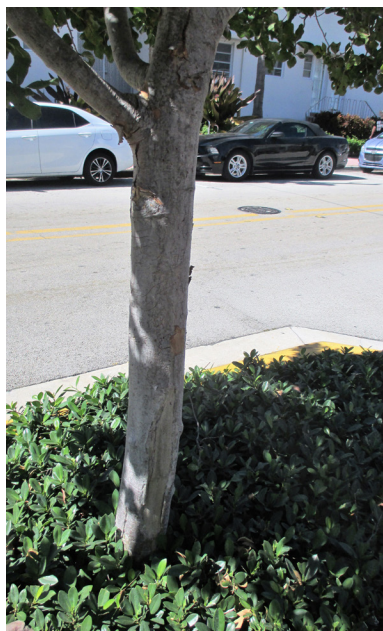
Condition -
Fair

Tree #4 is a Pigeon Plum street tree located along Park Avenue. It is in fair condition - there is some foliar spotting and the tree has good form. This tree has not been incorporated into the landscape plan and will therefore be removed.

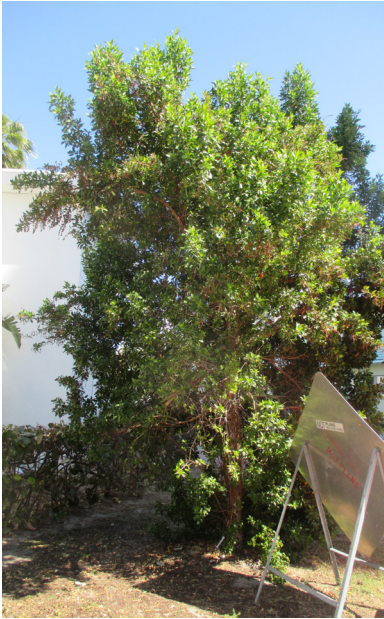
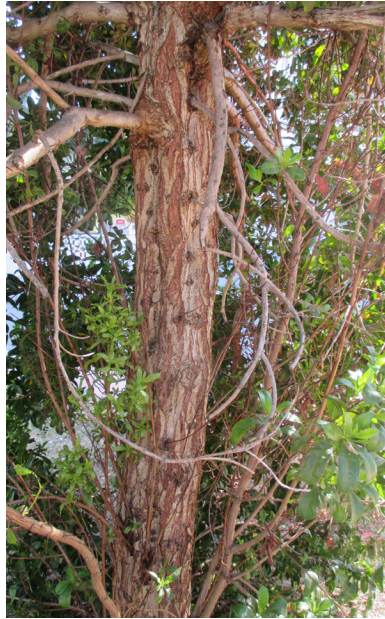
Condition -
Good

Tree #5 is a Green Buttonwood located at the corner of Park Avenue and 19th Street. It is in good condition with a bushy form. A crown raising and removal of some of the basal sucker growth in addition to a crown cleaning and perhaps some structural pruning, can enhance the appearance of this native tree. This tree is to remain and protective barriers shall be placed at the drip line of the tree, in this case, 7.5ft from the tree trunk to the edge of protective fencing. Barriers shall be installed prior to the start of any construction or demolition, and shall remain in place until development is completed and until the dept authorizes their removal. Barriers shall be a minimum of 4ft high, and shall be constructed of continuous chain link fence with metal posts at 8ft spacing, or of 2x4 posts with three equally spaced 2x4 rails. Posts may be shifted to avoid roots. No oil, paint, fill, equipment, building materials, building debris, or any other material shall be placed or disposed of within the TPZ. Natural grade shall be maintained, and no vehicles or equipment shall be permitted within the TPZ.

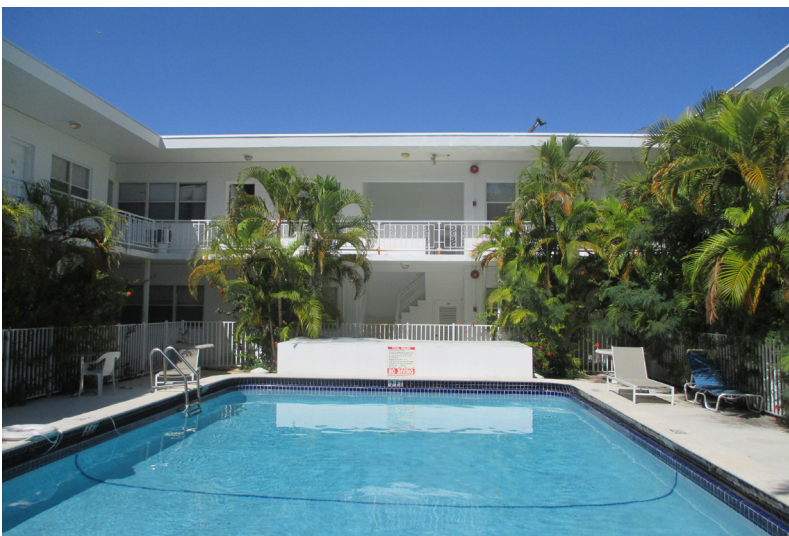
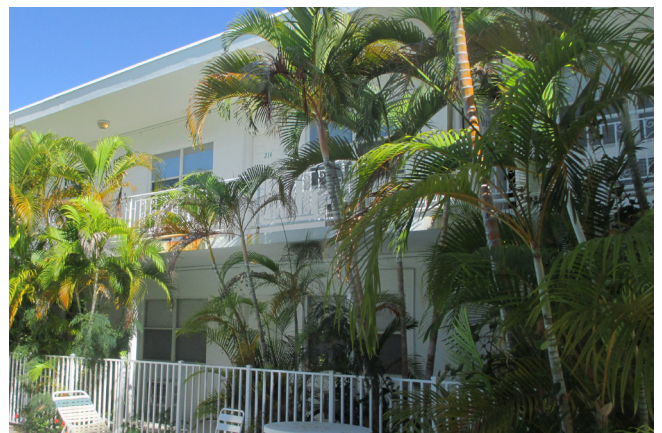
Condition -
Poor

Tree #6 is a hedge of Areca Palms surrounding the interior courtyard and in front of it. They are in poor condition with chlorotic and necrotic leaves. This tree has not been incorporated into the landscape plan and will therefore be removed.

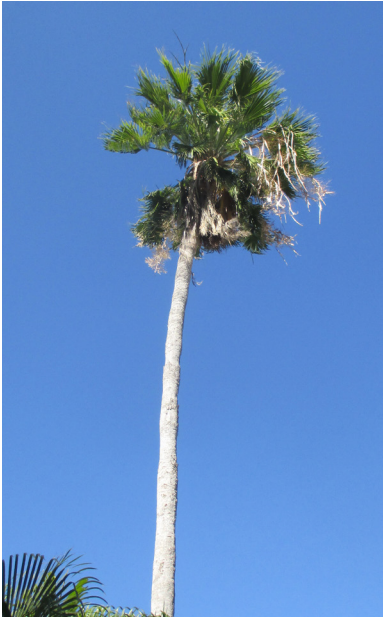
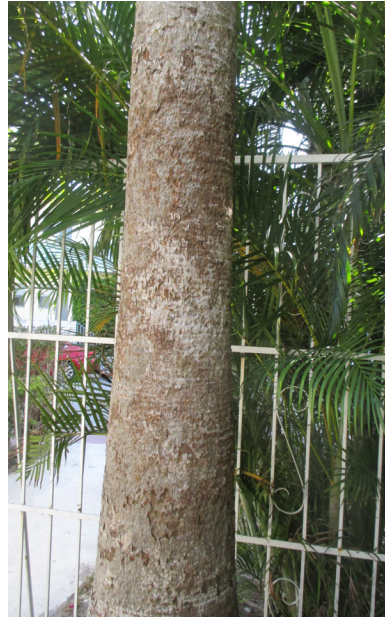
Condition -
Fair

Tree #7 is a Washingtonia Palm located at the front of the courtyard. It is in fair condition - it has a green canopy and some of the pseudo-bark is sloughing off. This tree has not been incorporated into the landscape plan and will therefore be removed.

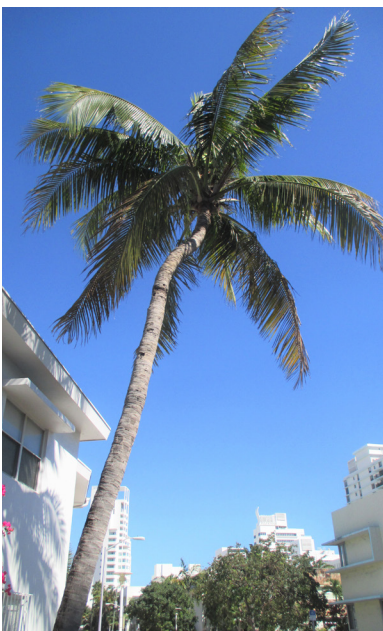
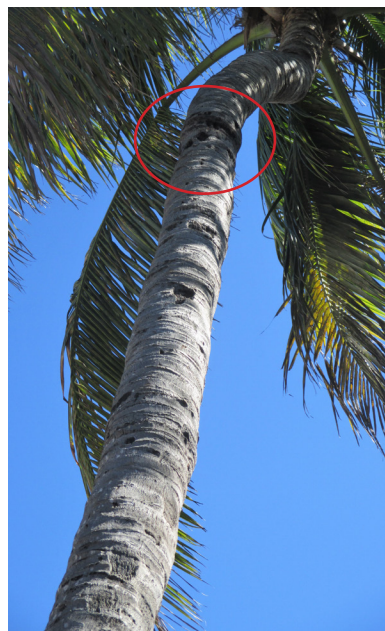
Condition -
Poor

Tree #8 is a Coconut Palm located at the front of the property along 19th Street. It is in poor condition with much yellow and brown on the fronds and multiple injuries along the trunk. One injury in particular is quite deep and occurs around the circumference of the tree (circled in red) near where the trunk kinks. The plans call for this tree to be relocated. If this is to occur, application of a palm fertilizer is recommended prior to relocation. Any lower dead fronds and coconuts should be removed.

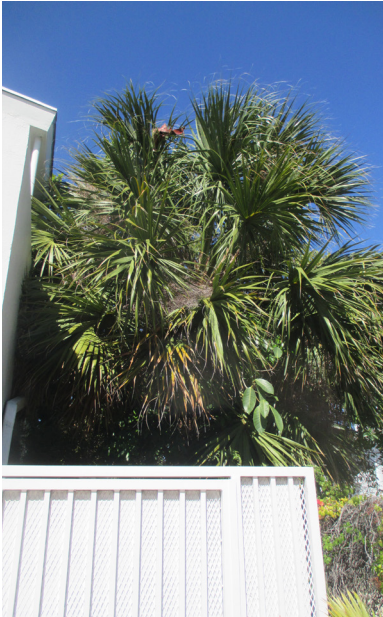
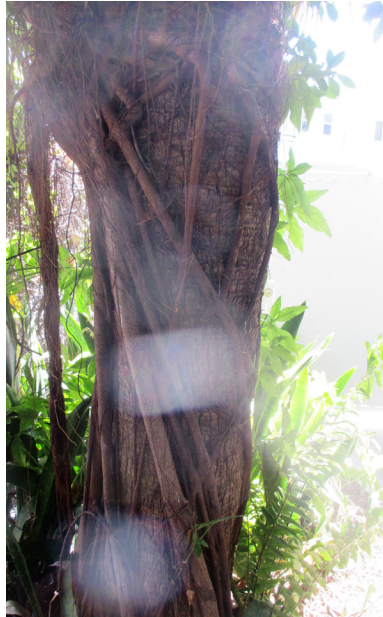
Condition -
Good

Tree #9 is a Sabal Palm located behind the building on the east side of the property. It is in good condition with a full, dense canopy. Vines are growing on the trunk. If this tree is to remain, a 7ft TPZ will need to be established. If this tree is to be relocated elsewhere on the site, care should be taken and irrigation should be focused on, since this species can be fairly difficult to transplant.

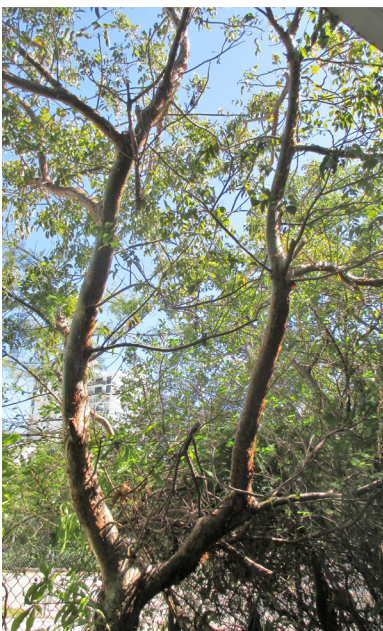
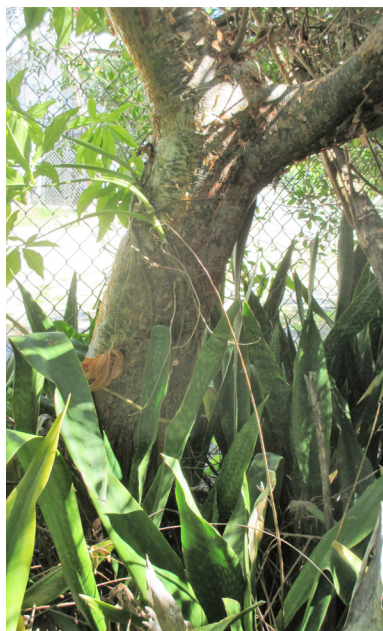
Condition -
Fair

Tree #10 is a Gumbo Limbo located behind the building on the east side of the property. The tree is in fair condition with poor form. This tree is in a location that does not provide adequate growing space, and it should therefore be removed.

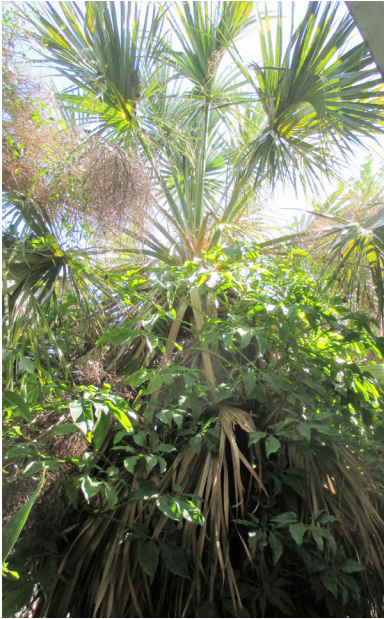
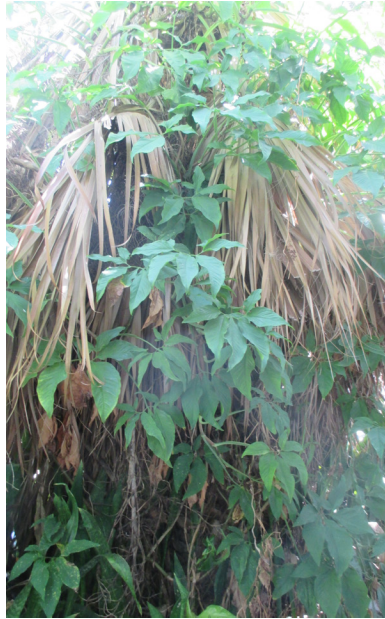
Condition -
Fair

Tree #11 is a Sabal Palm located behind the building on the east side of the property. It is in fair condition with a sparse canopy. Vines are growing on the brown fronds of the lower canopy. If this tree is to remain, a 6ft TPZ will need to be established. If this tree is to be relocated elsewhere on the site, care should be taken and irrigation should be focused on, since this species can be fairly difficult to transplant.

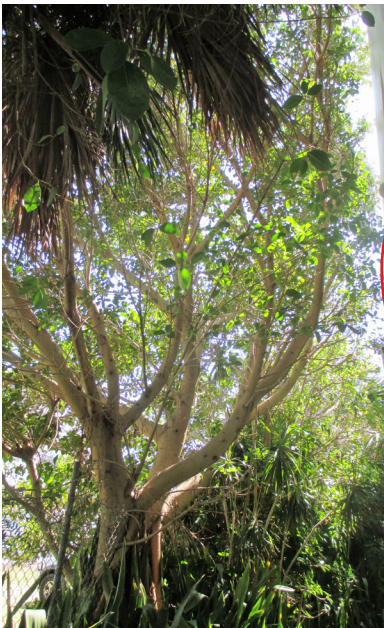
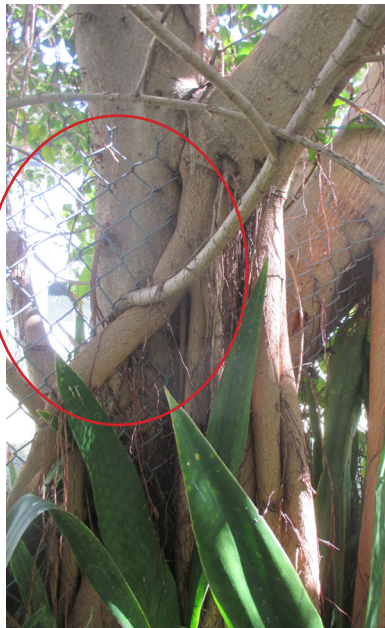
Condition -
Poor

Tree #12 is a Strangler Fig located behind the building on the east side of the property. The tree is healthy but is growing through the chainlink fence (circled in red). This tree is in a location that does not provide adequate growing space, and it should be removed.

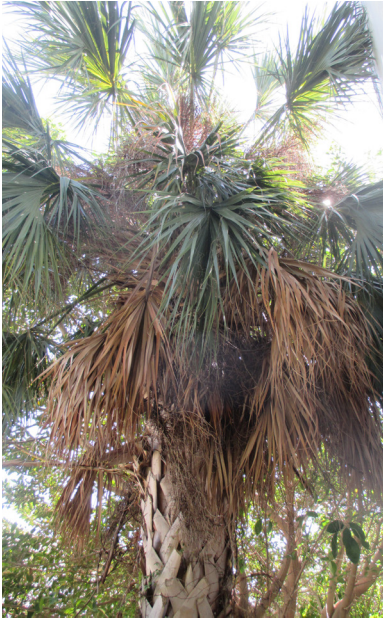
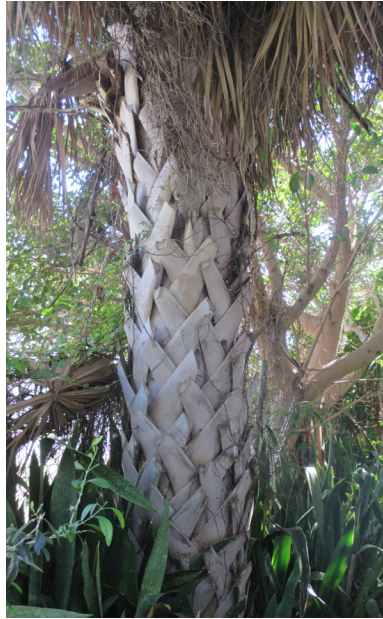
Condition -
Fair

Tree #13 is a Sabal Palm located behind the building on the east side of the property. It is in fair condition with many lower dead fronds. If this tree is to remain, a 6ft TPZ will need to be established. If this tree is to be relocated elsewhere on the site, care should be taken and irrigation should be focused on, since this species can be fairly difficult to transplant.

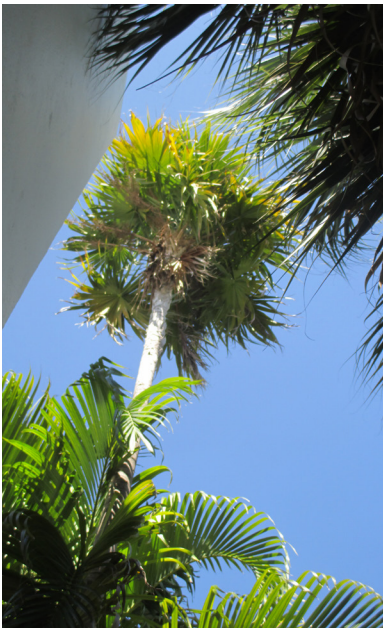
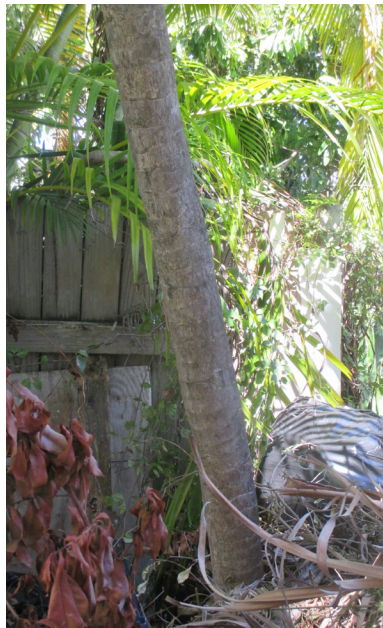
Condition -
Poor

Tree #14 is a Florida Thatch Palm located in the northeast corner of the property. This tree is in poor condition - the foliage is highly chlorotic and the ends of some of the leaflets are necrotic. This tree will need to be removed.

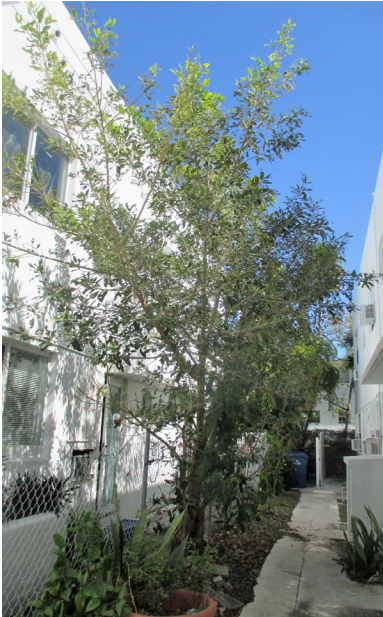
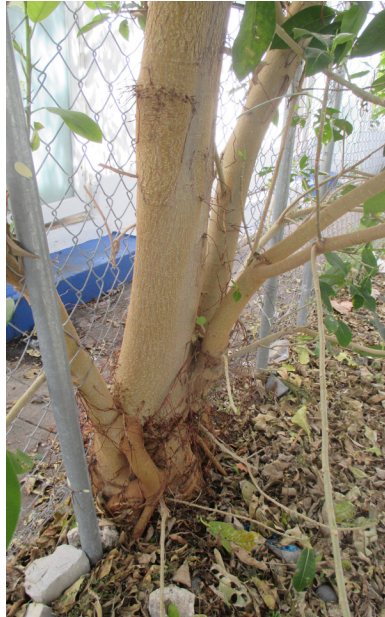
Condition -
Poor

Tree #15 is a small Strangler Fig located at the rear of the building on the north side of the property. This tree has poor form and is growing through the chainlink fence. This is a poor location for such a large maturing tree. This tree will need to be removed.

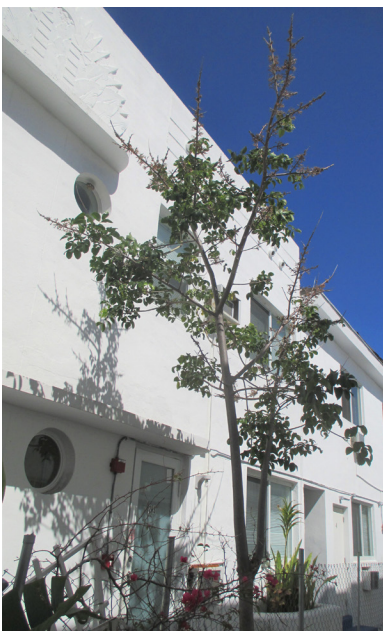
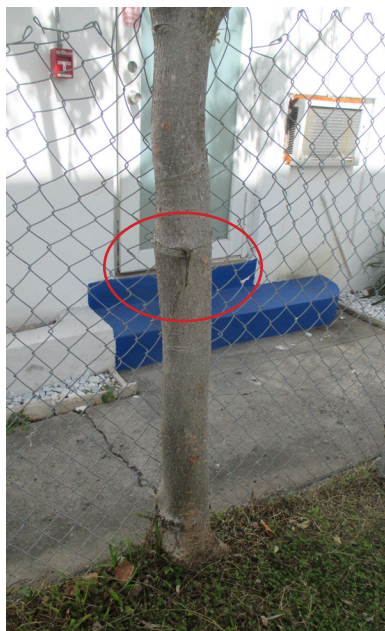
Condition -
Poor

Tree #16 is a Gumbo Limbo located at the rear of the building on the north side of the property. This tree is in poor condition as it is growing through the chainlink fence and has a plastic tie embedded in it (circled in red). This tree will need to be removed.

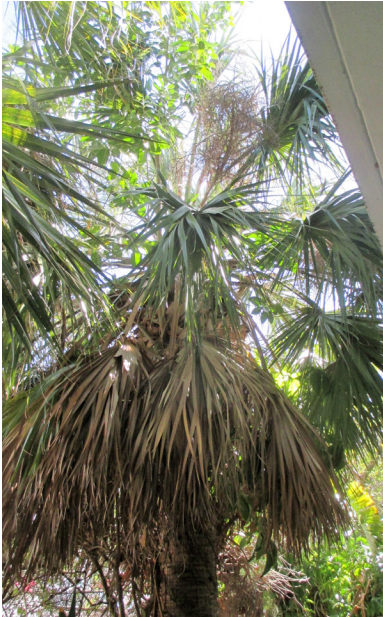
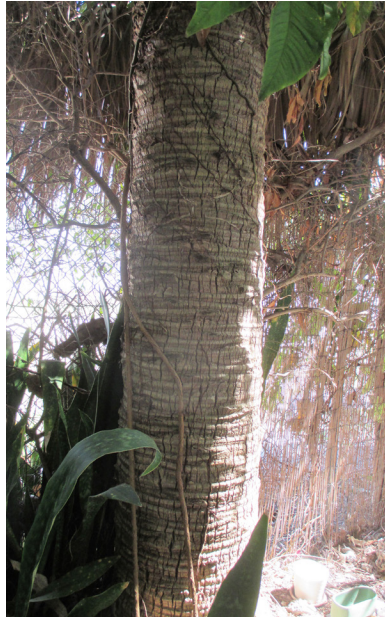
Fair

Tree #17 is a Sabal Palm located behind the building on the east side of the property. It is in fair condition with many lower dead fronds and a sparse canopy. If this tree is to remain, a 6ft TPZ will need to be established. If this tree is to be relocated elsewhere on the site, care should be taken and irrigation should be focused on, since this species can be fairly difficult to transplant.
