Tree Resource Evaluation for 250 Rivo Alto & 110 3rd Rivo Alto Terrace, Miami Beach

February 5, 2020

Summary

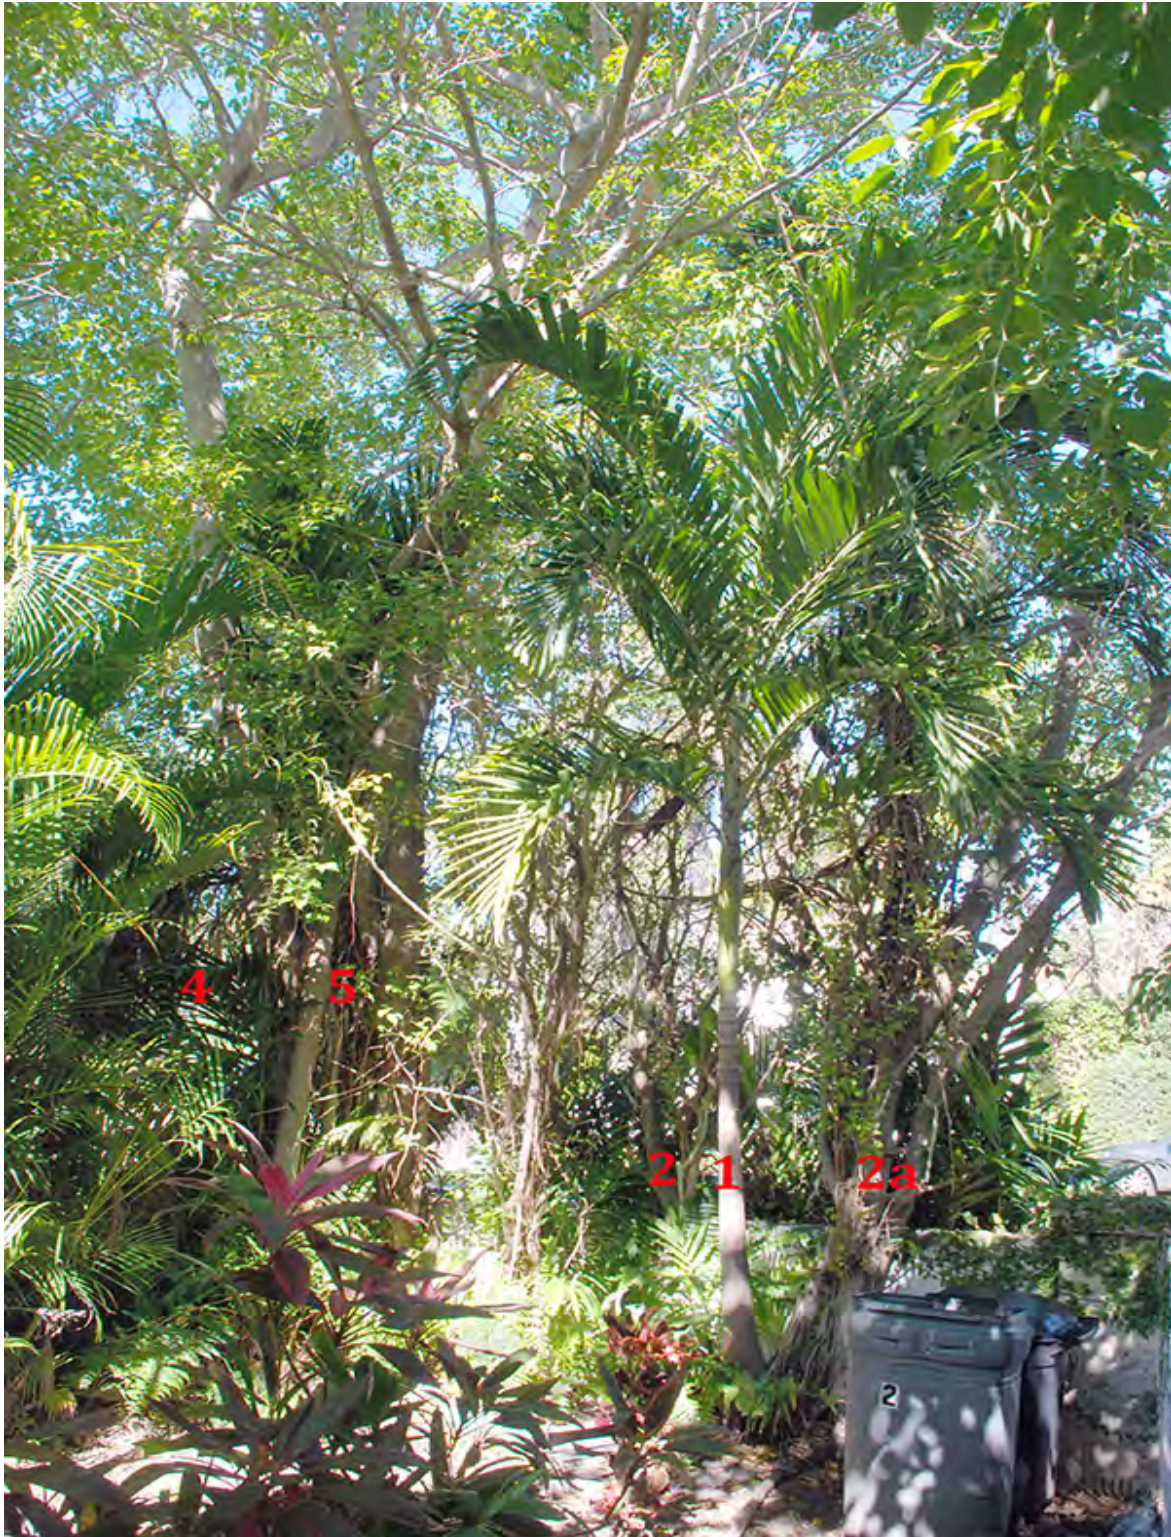
Photo 1 above is palm 1 and *Ficus benjamina* trees 2, 2a, 4 & 5. The ficus are all in poor condition and growing on top of and immediately beside the wall.

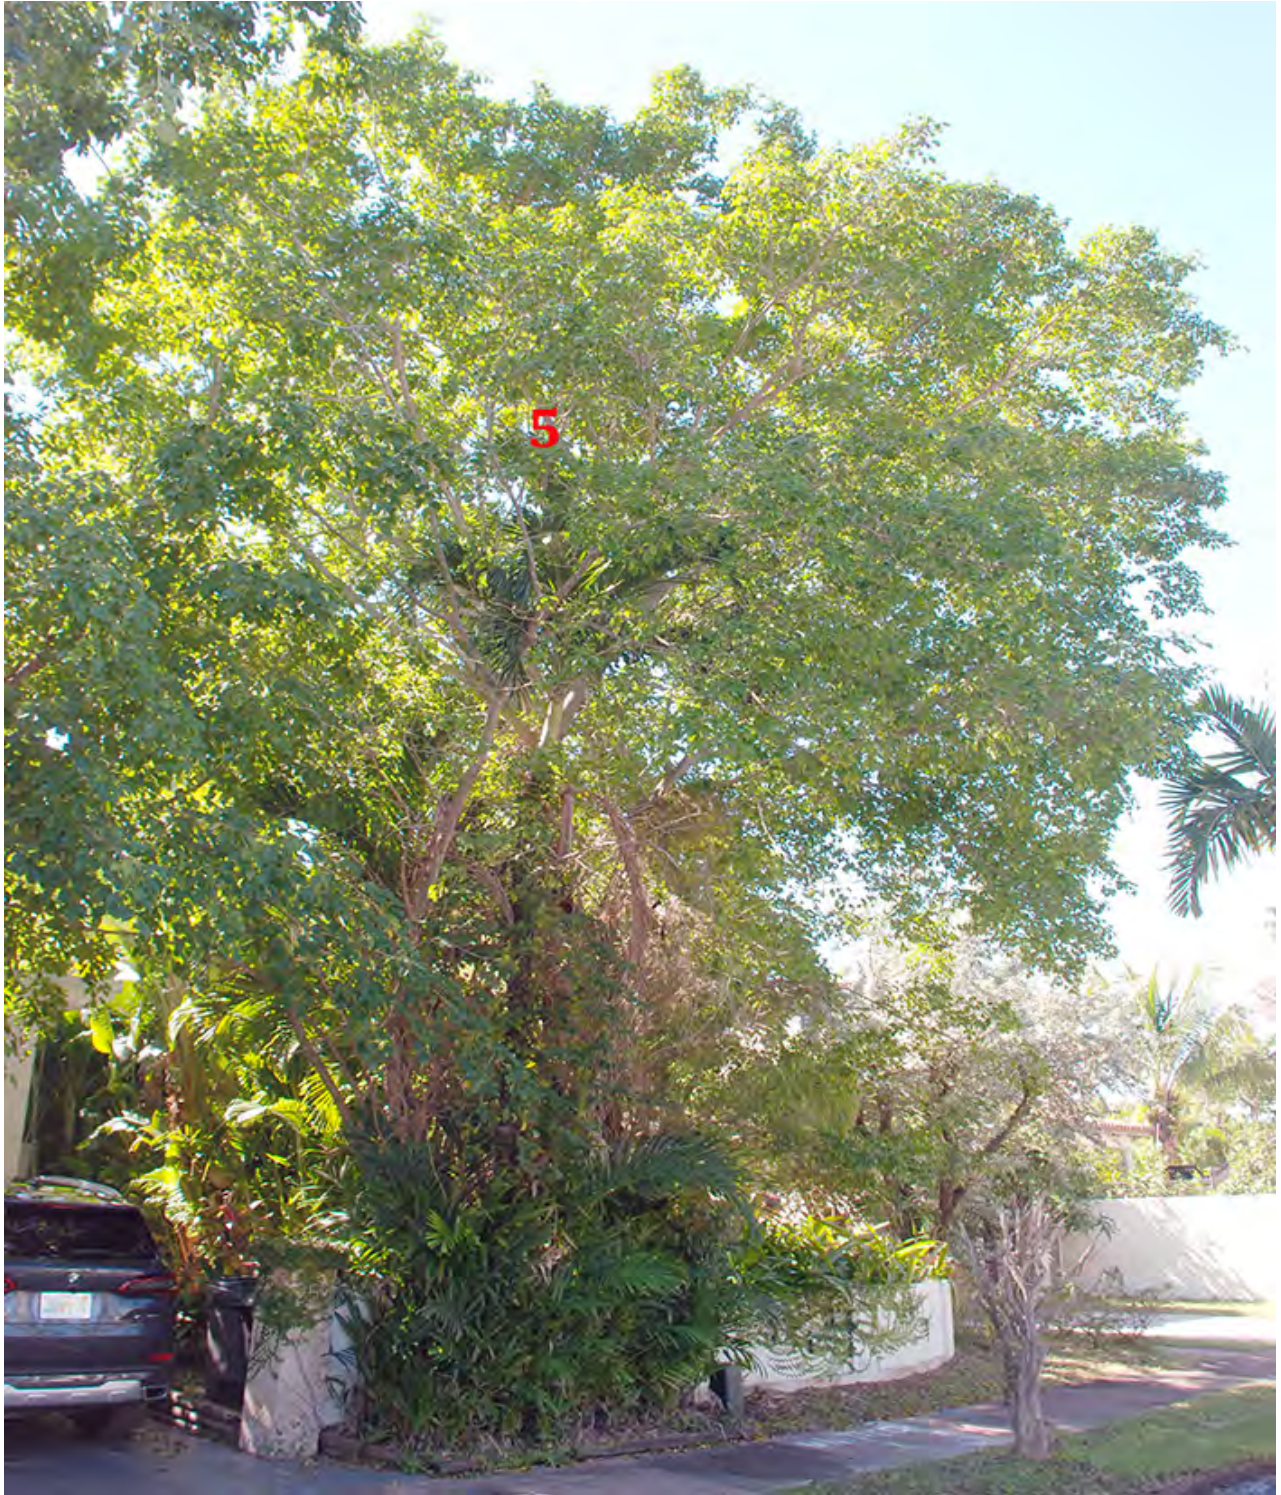
Photo 2 above is a view of tree 5 from the north. This tree is growing on top of and immediately adjacent to the wall and is very prone to failure in a wind event. I recommend the removal of this tree and the adjacent ficus.

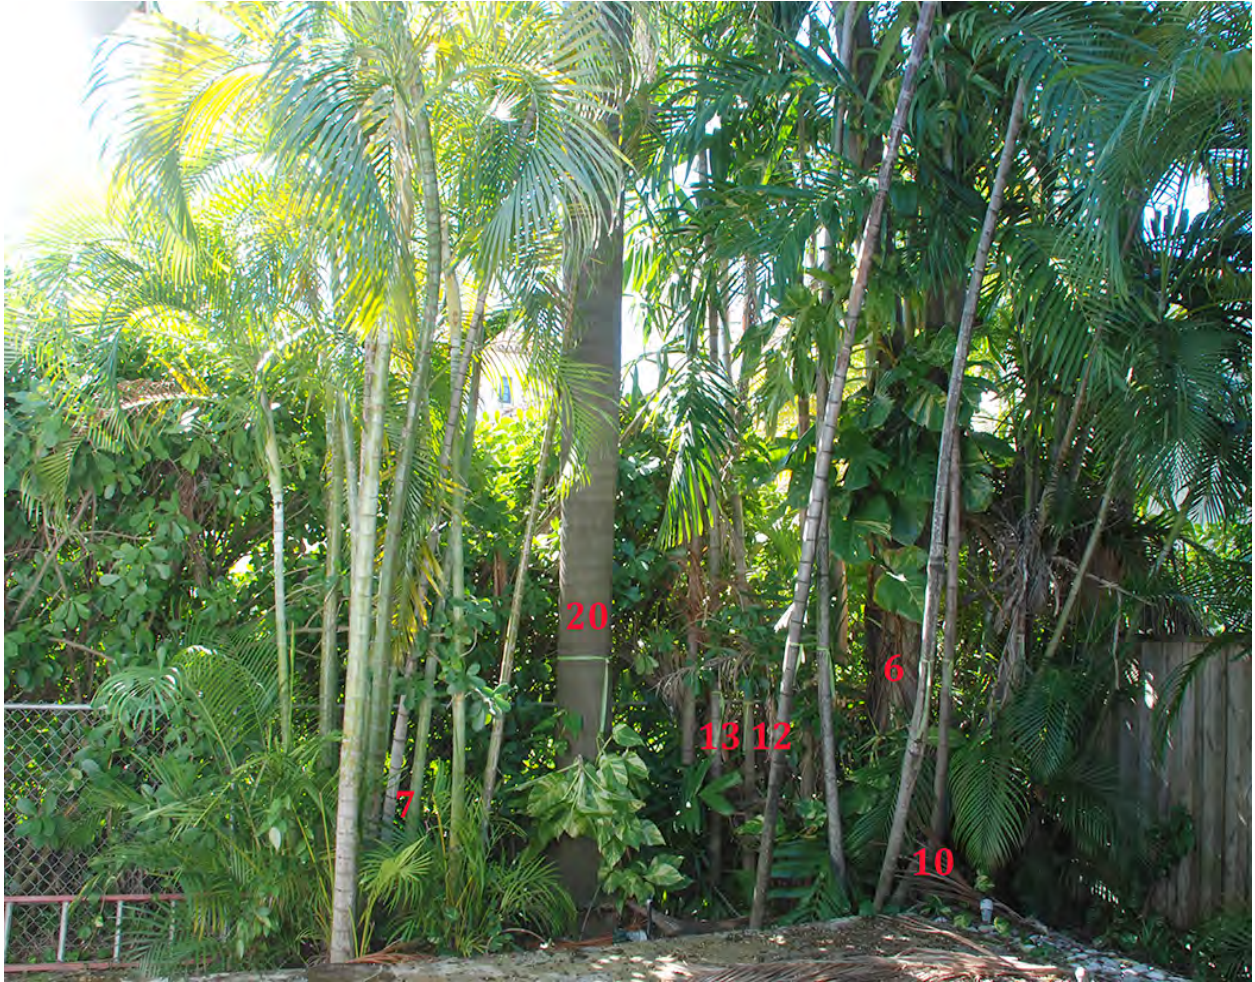
Photo 3 above is a clump of palms 7 through 20 (some of the numbers belong to multi-trunked palms and so are not included. The trunk of tree 6 is also seen.

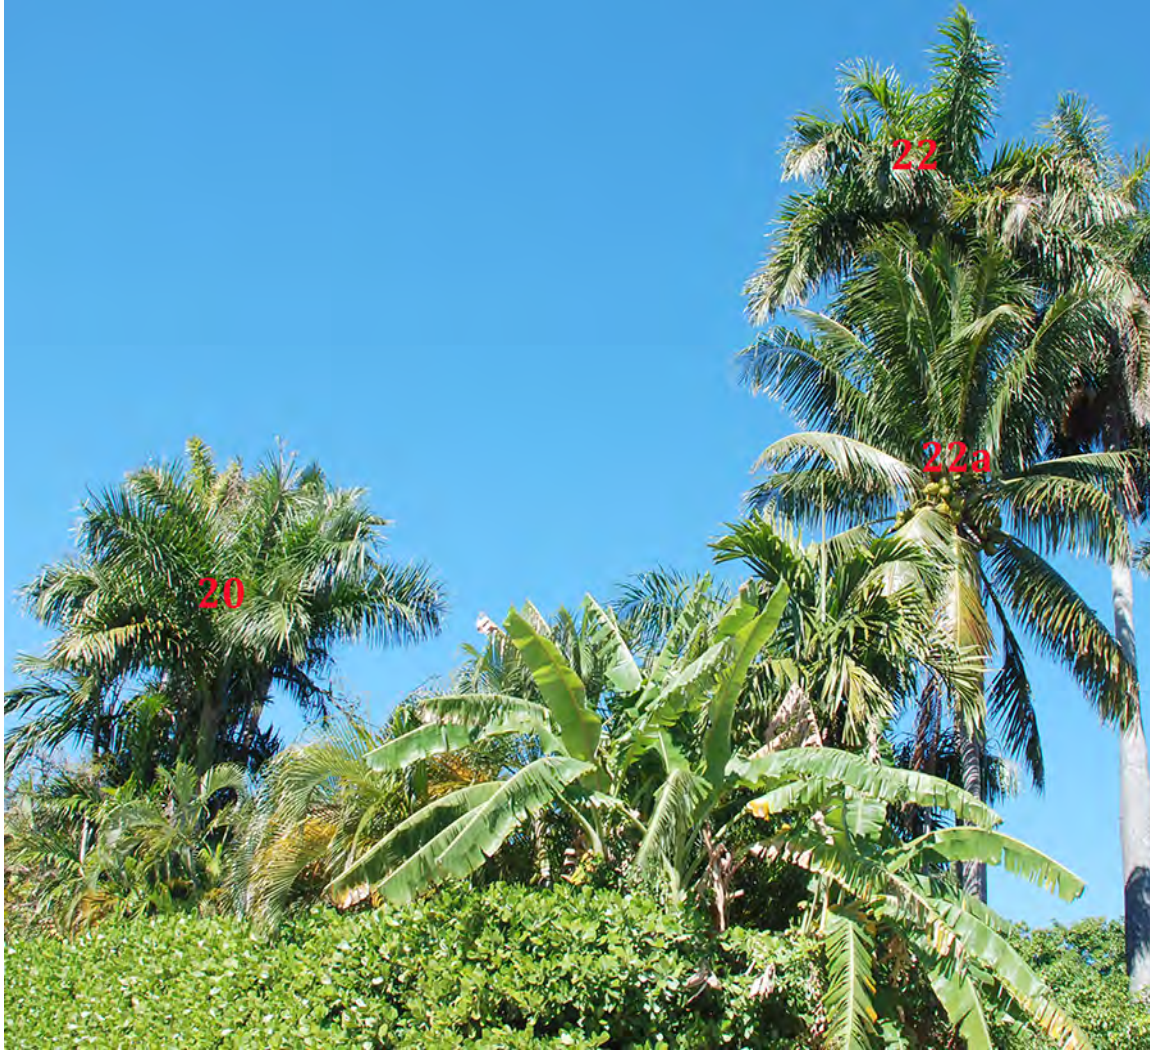
Photo 4 above is palms 20, 22 & 22a viewed from the east.

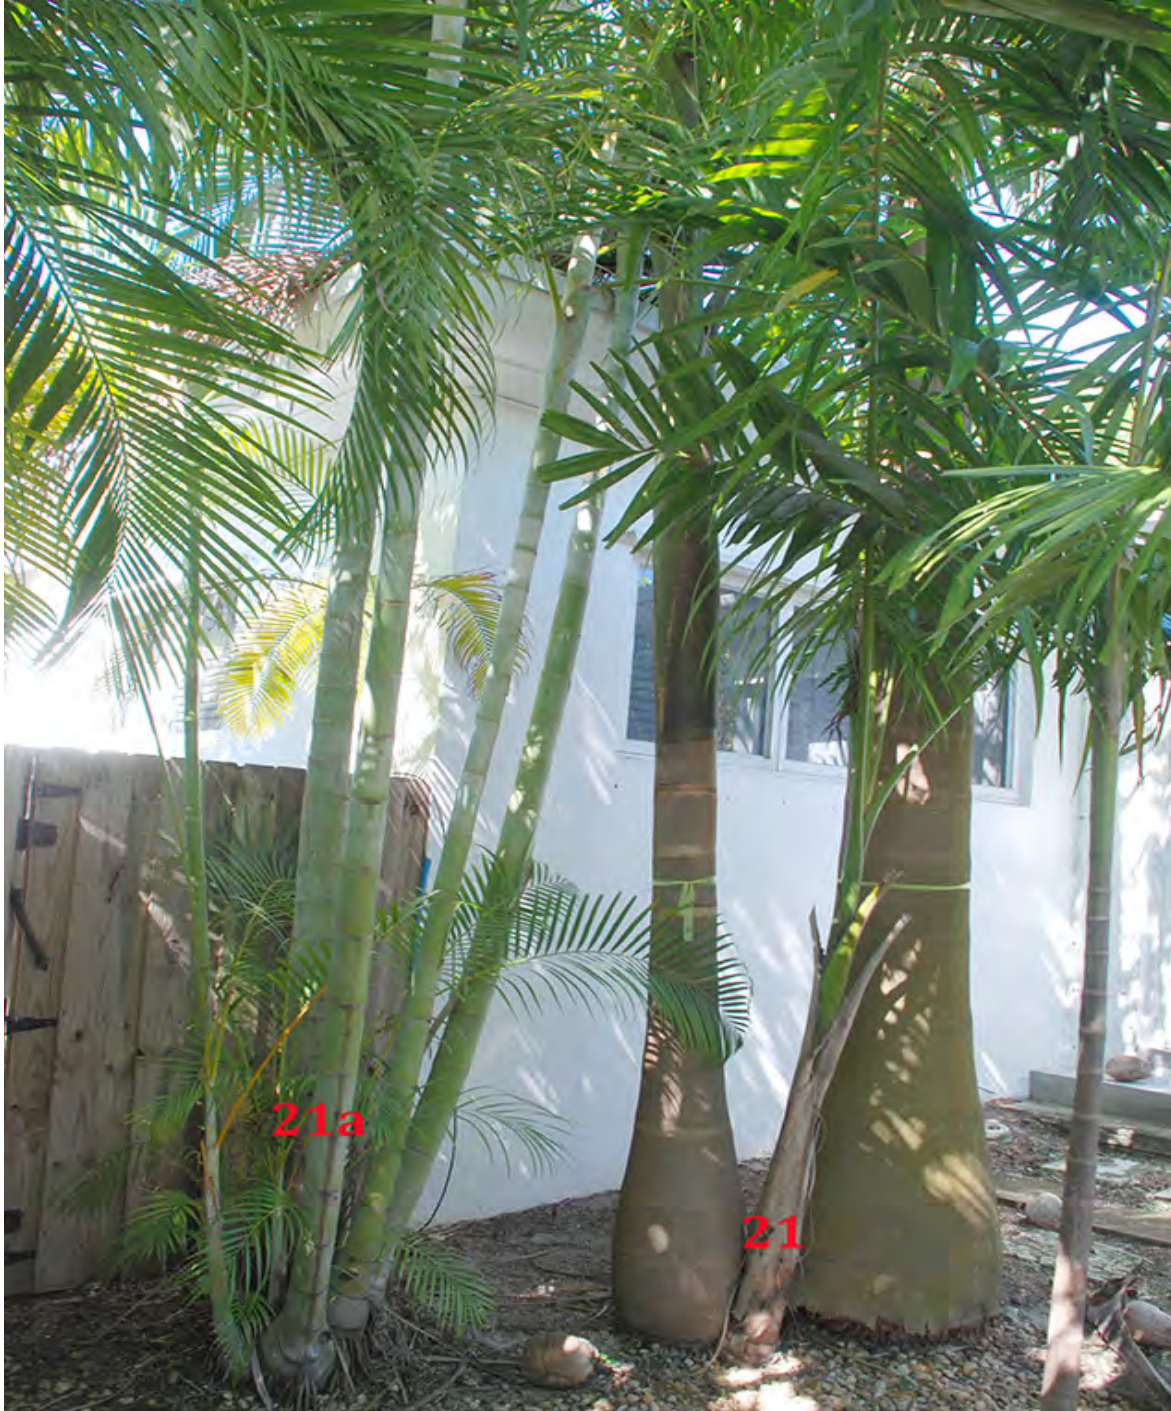
Photo 5 above is multi-trunked palms 21 & 21a.

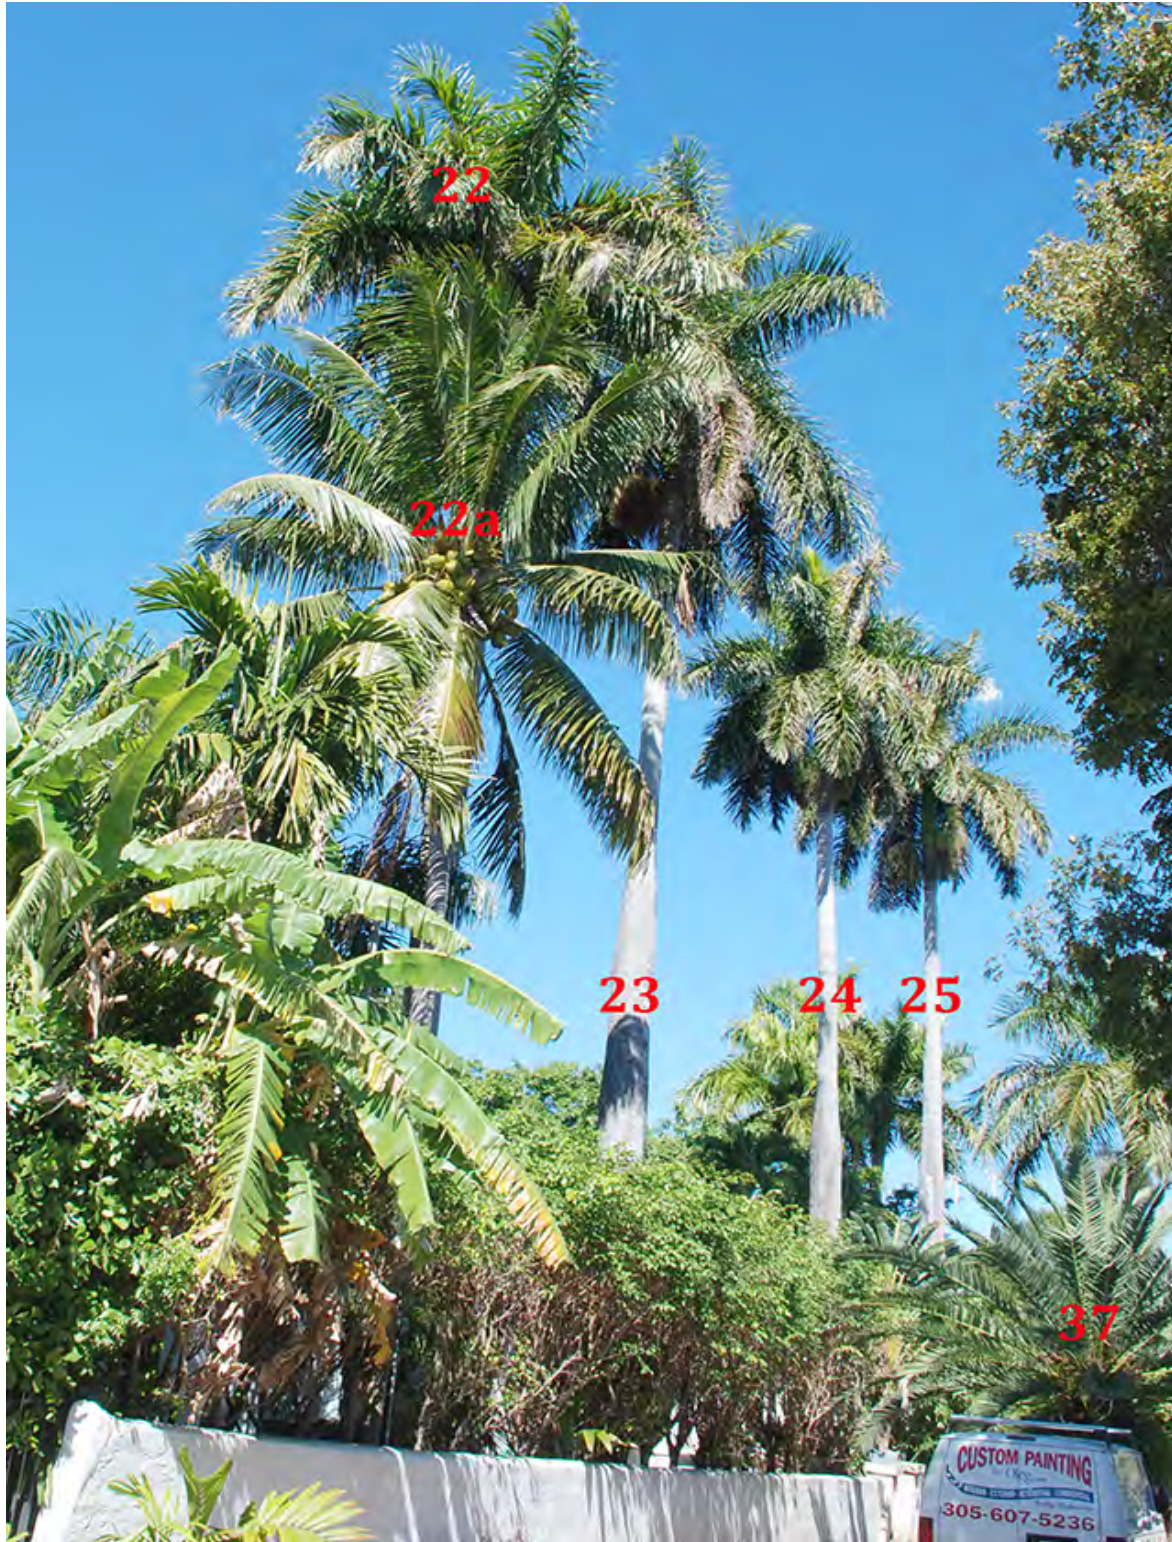
Photo 6 above is palms 22, 22a, 23, 24 & 25 viewed from the southeast.

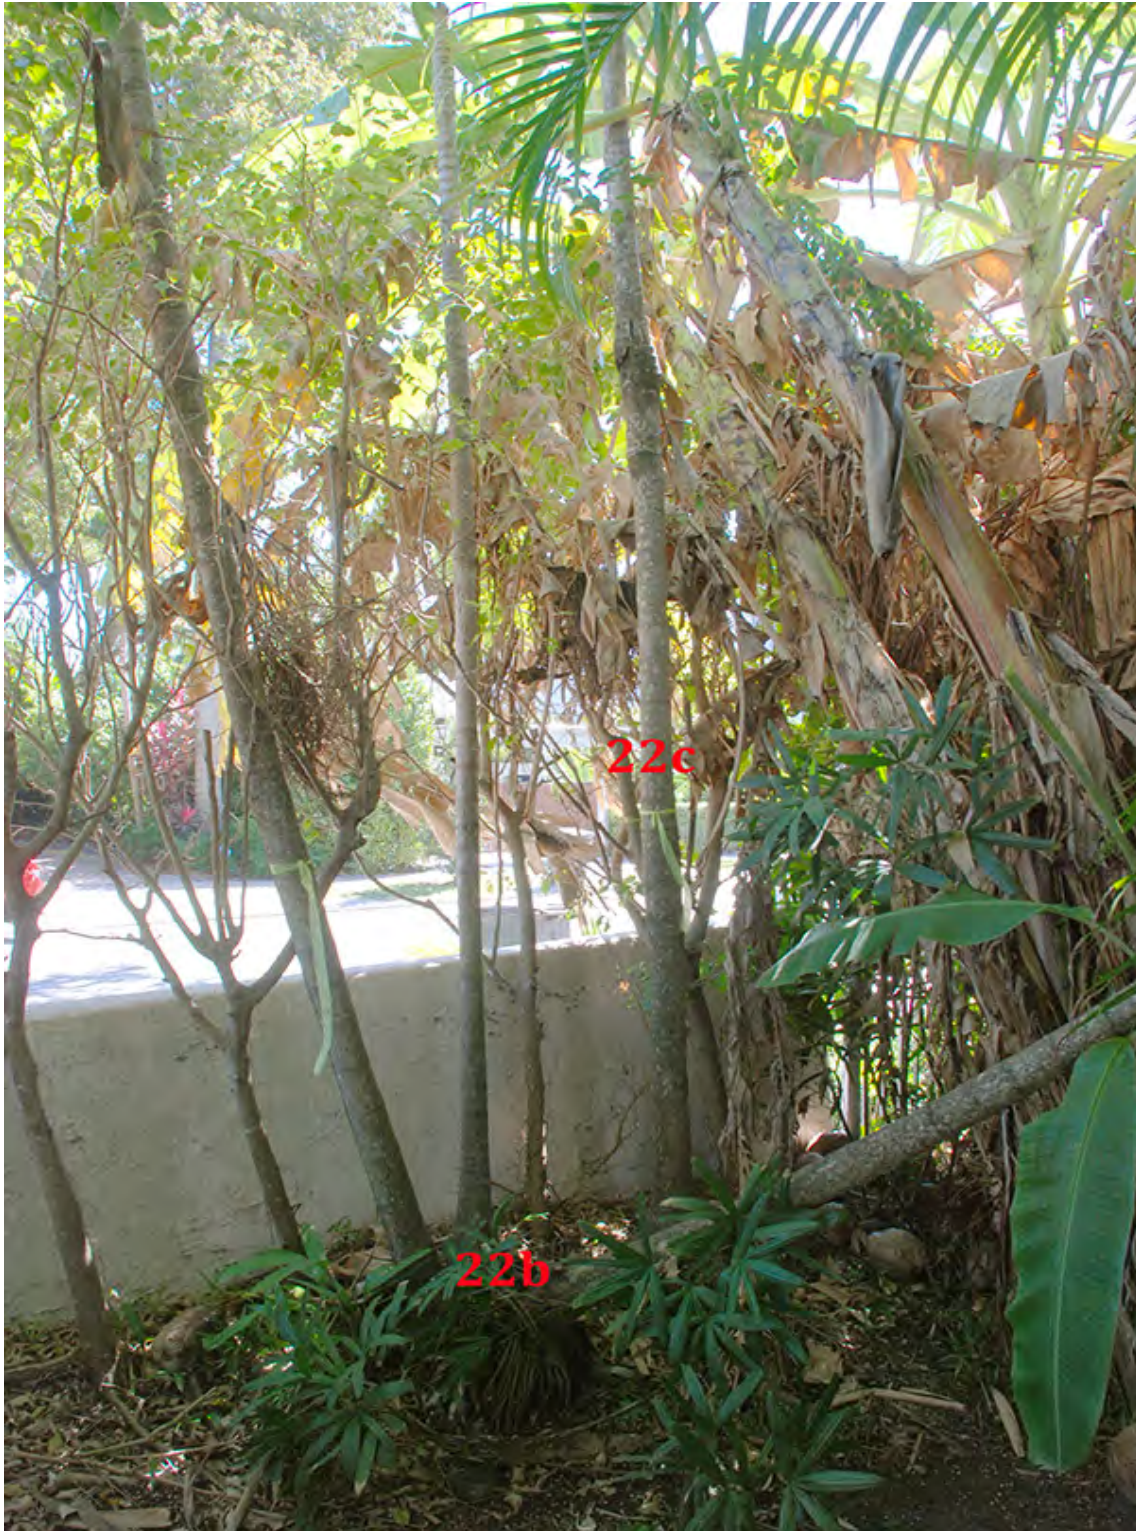
Photo 7 above is multi-trunked palm 22b (see following photo) and palm 22c.

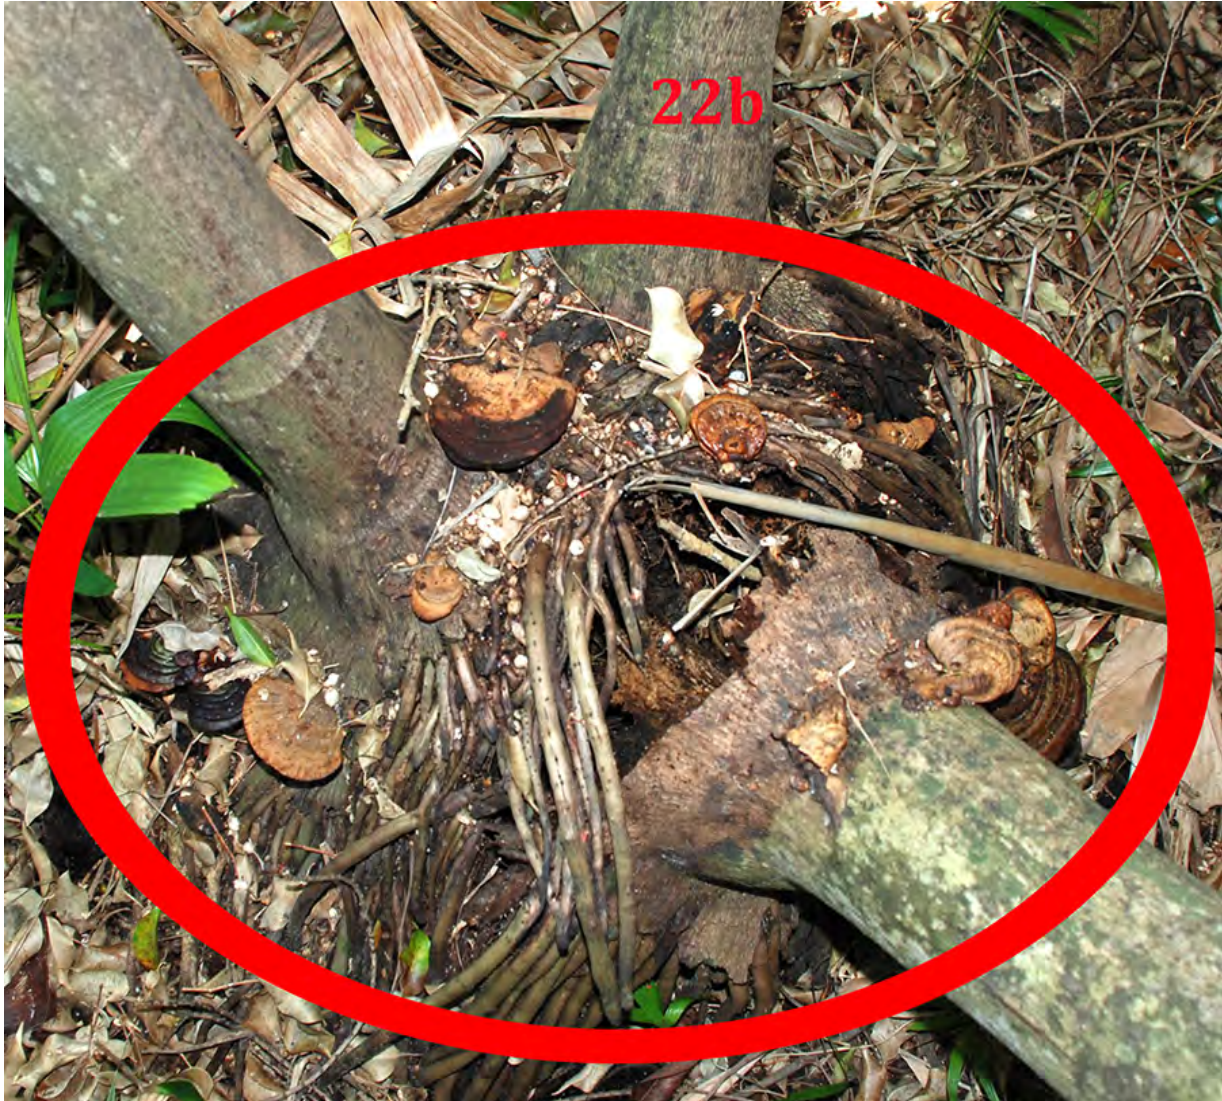
Photo 8 above shows fruiting bodies of *Ganoderma zonatum* that has killed palm 22b.

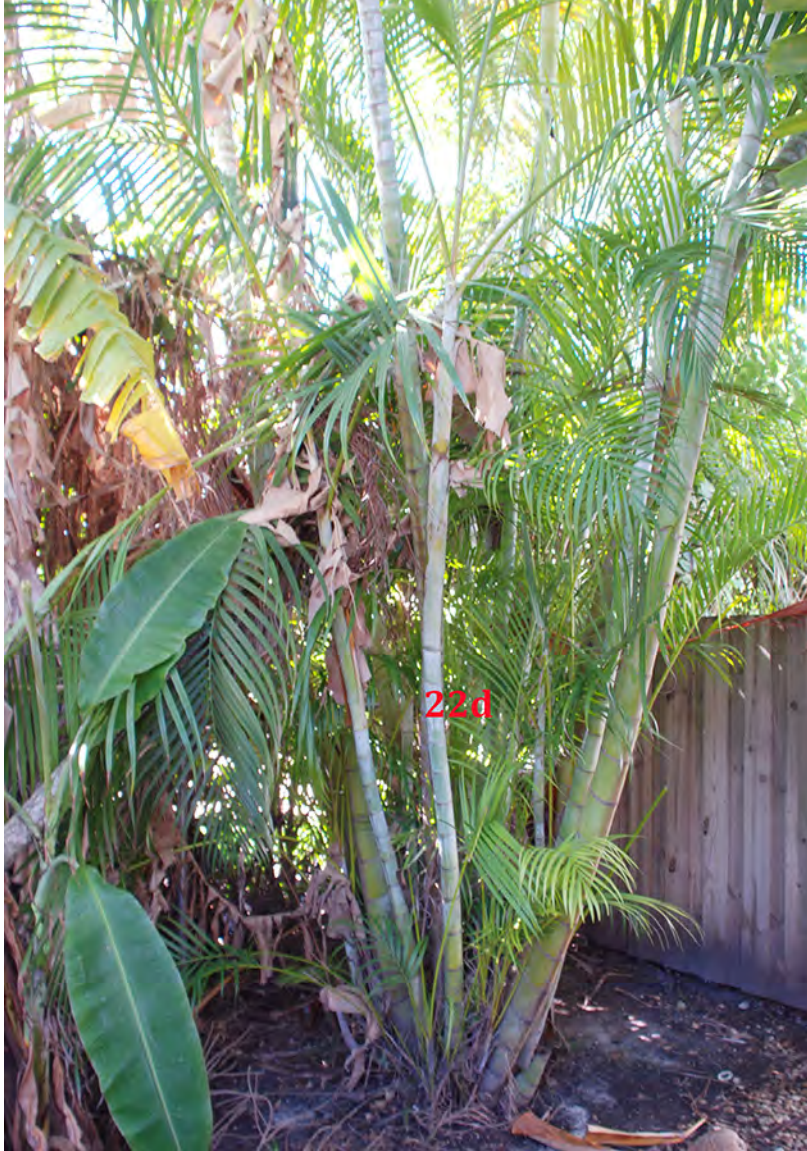
Photo 9 above is palm 22d.

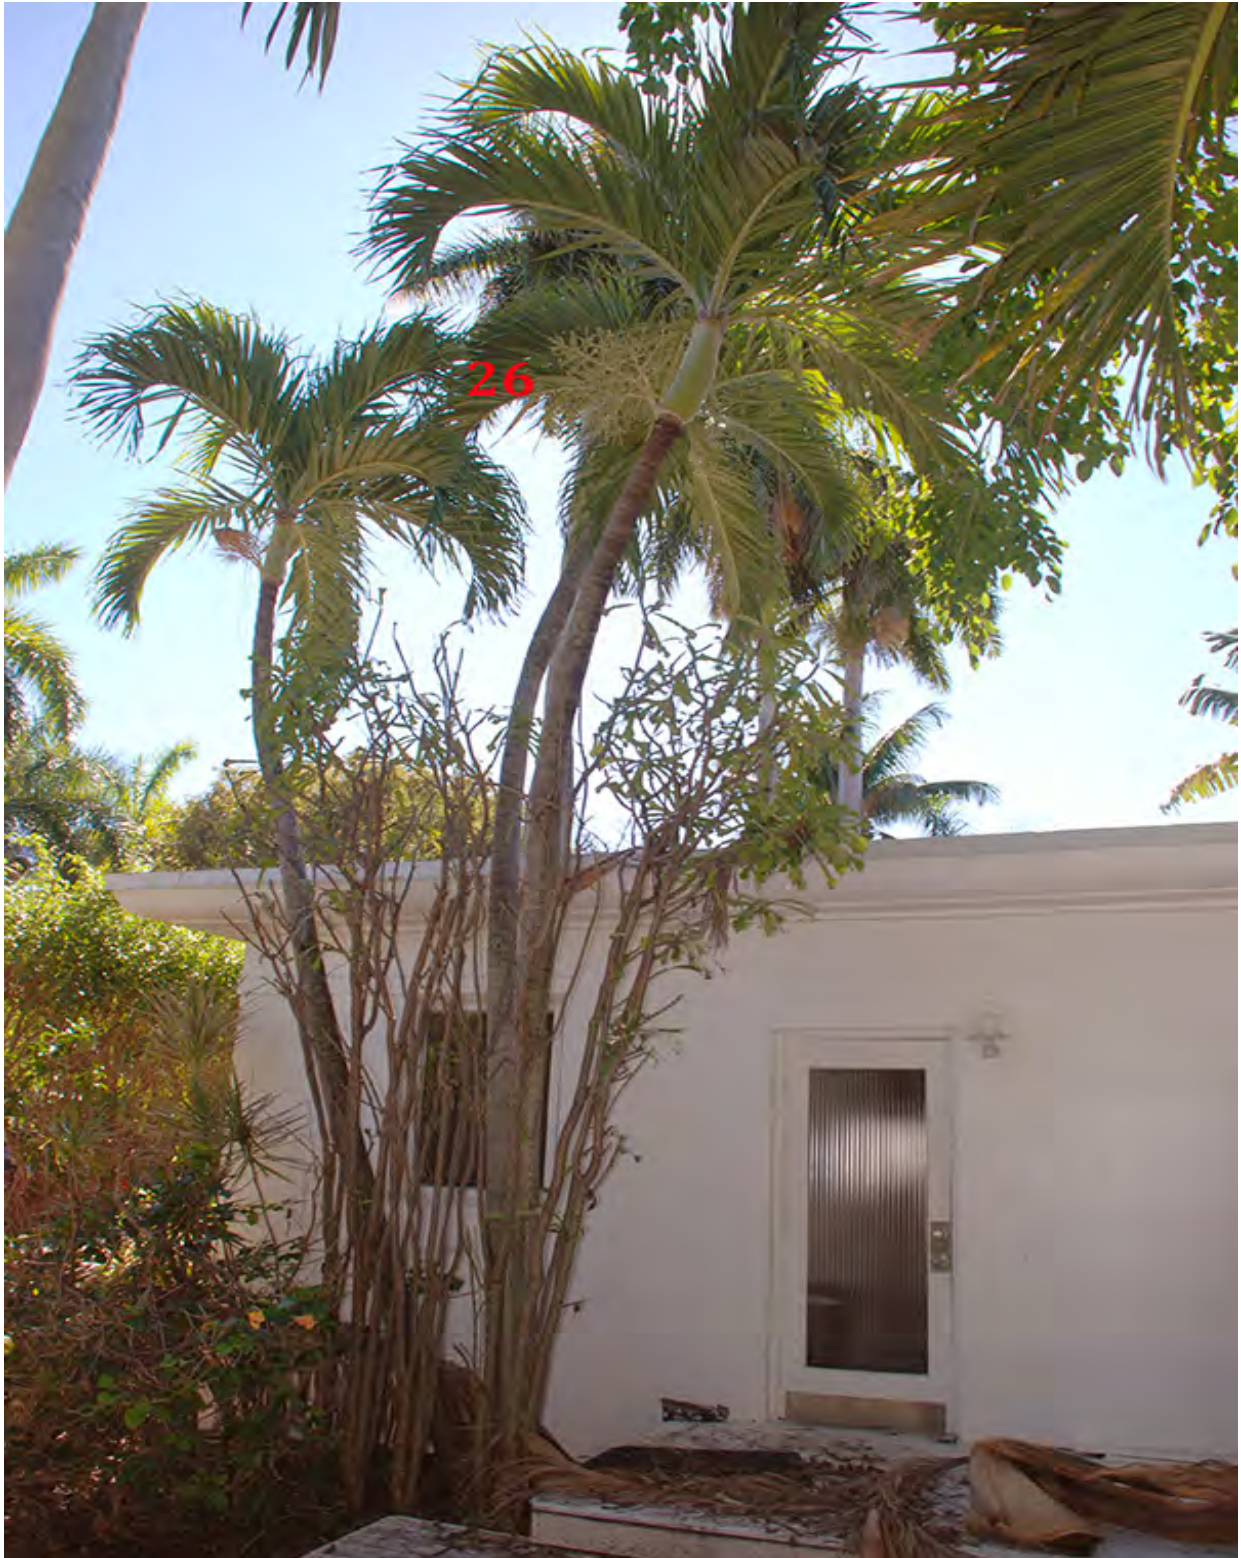
Photo 10 above is multi-trunked palm 26.

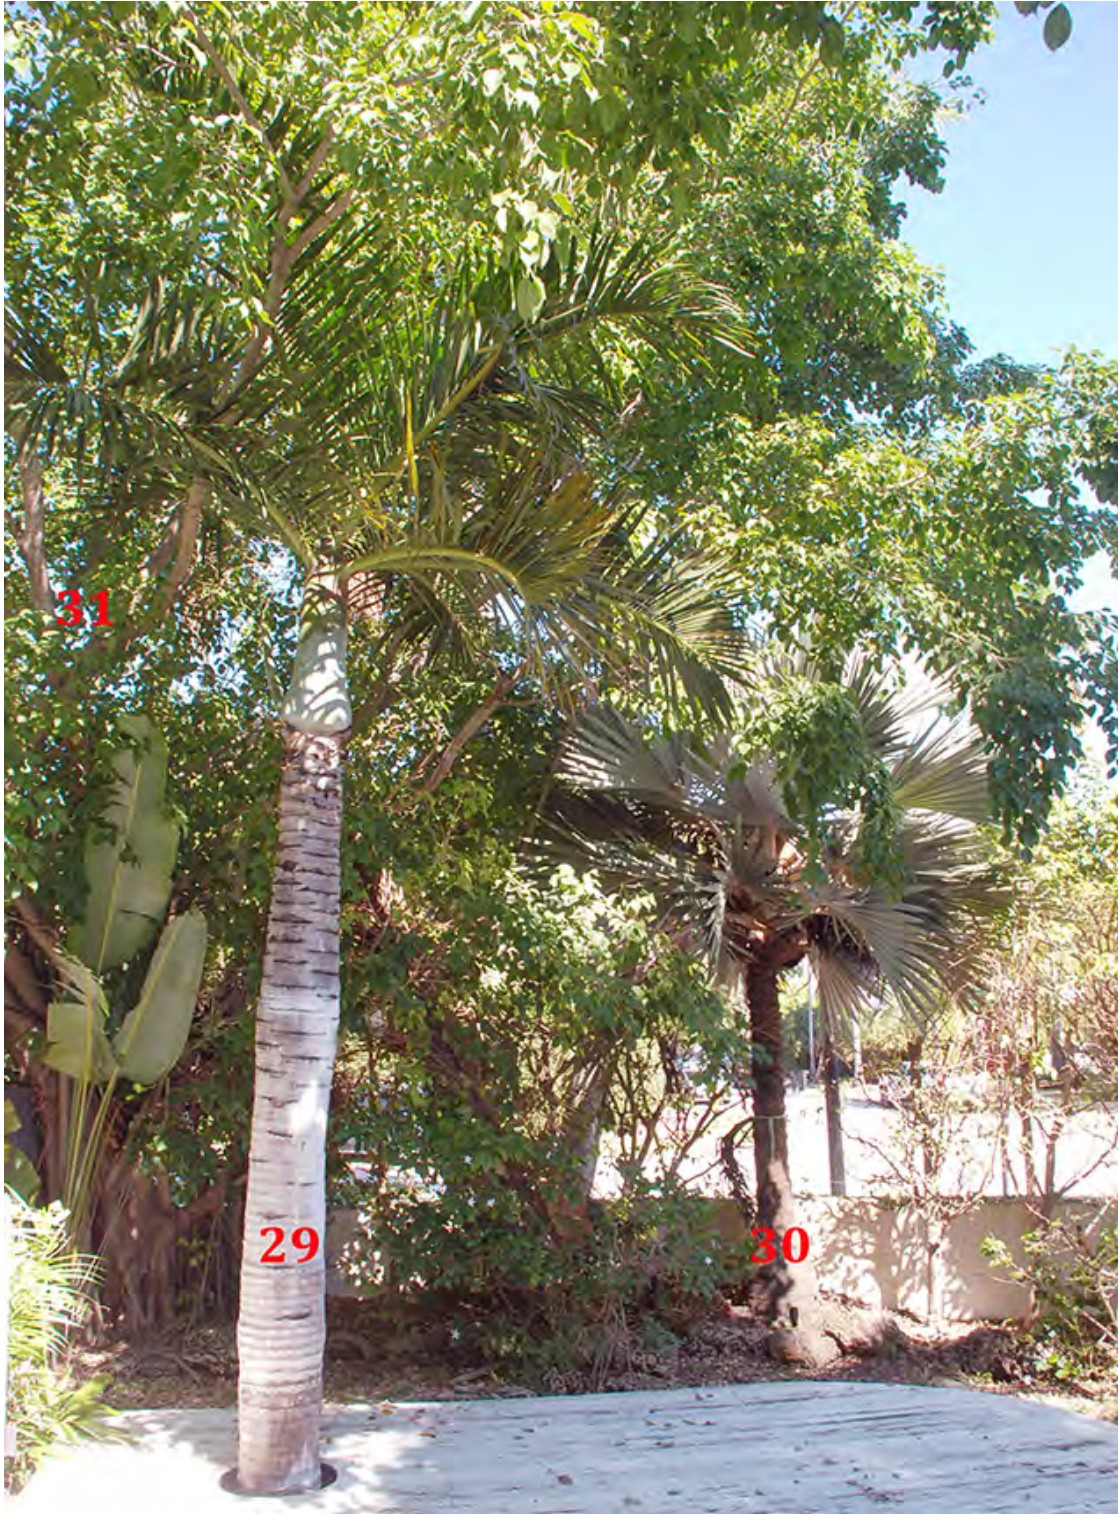
Photo 11 above is palms 29 & 30. These palms are good candidates for relocation.

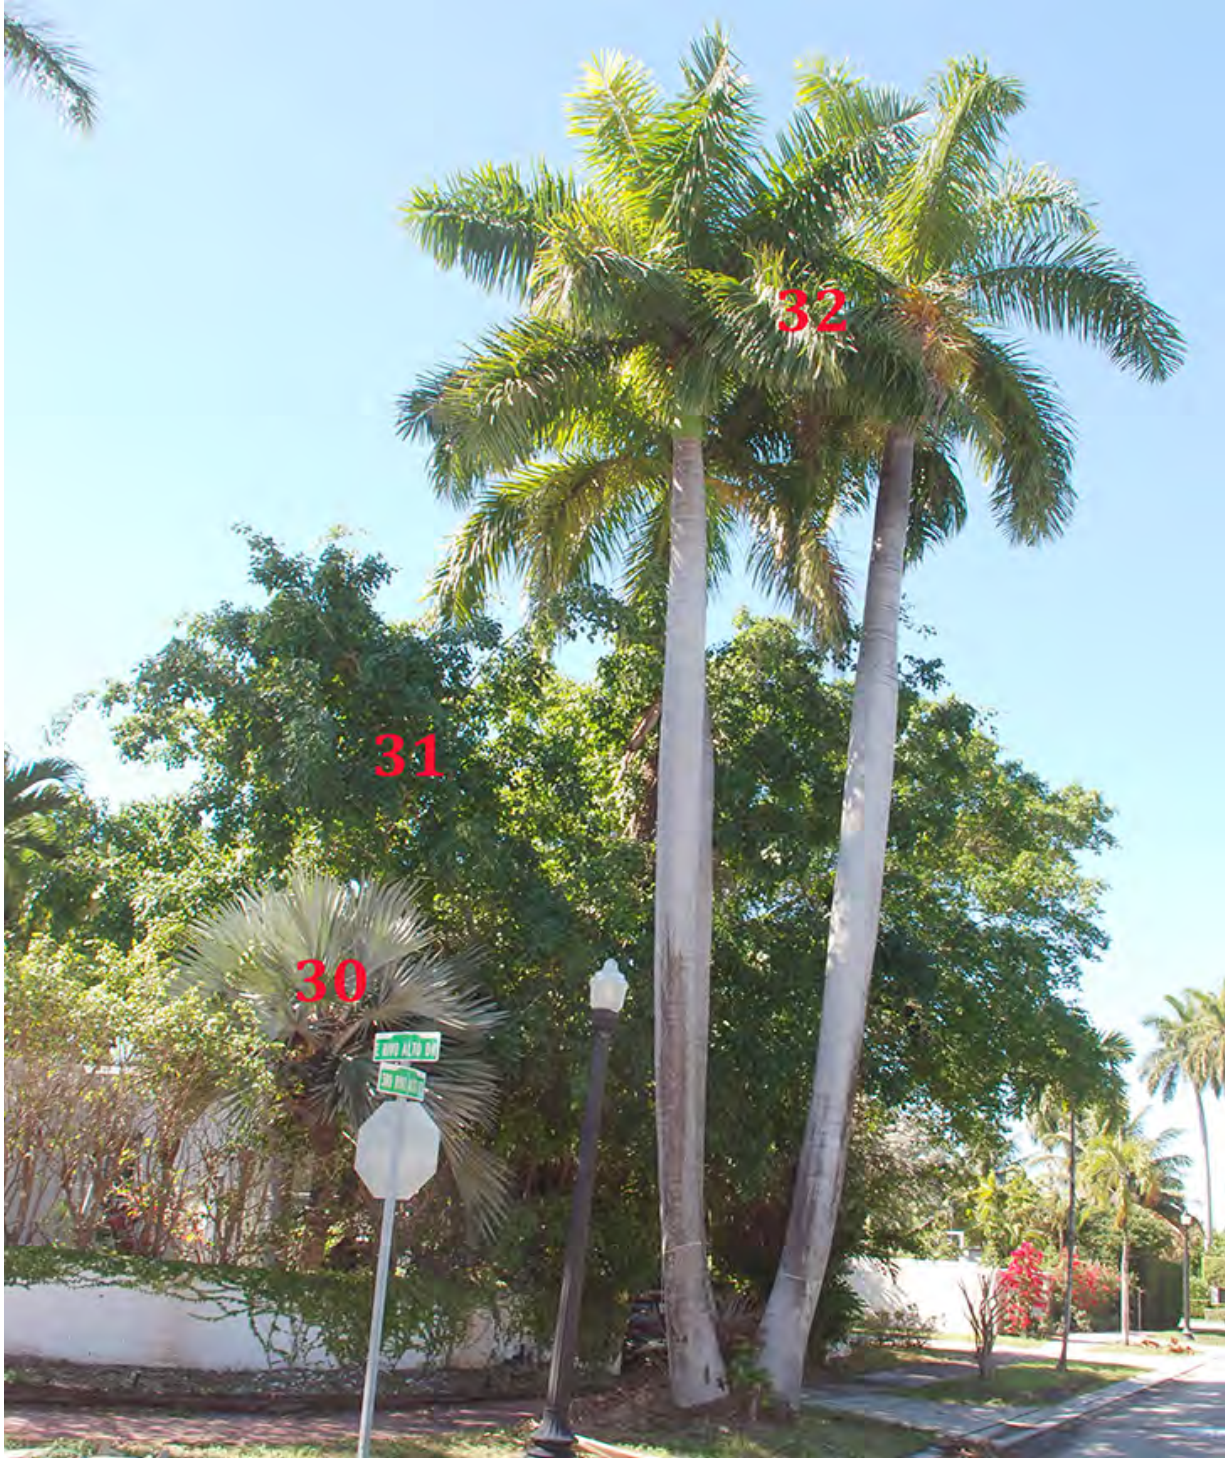
Photo 12 above is multi-trunked palm 32 and tree 31 viewed from the east. Tree 31 is growing on top of and immediately adjacent to the wall. This tree is vulnerable to failure in a wind event and I recommend its removal.

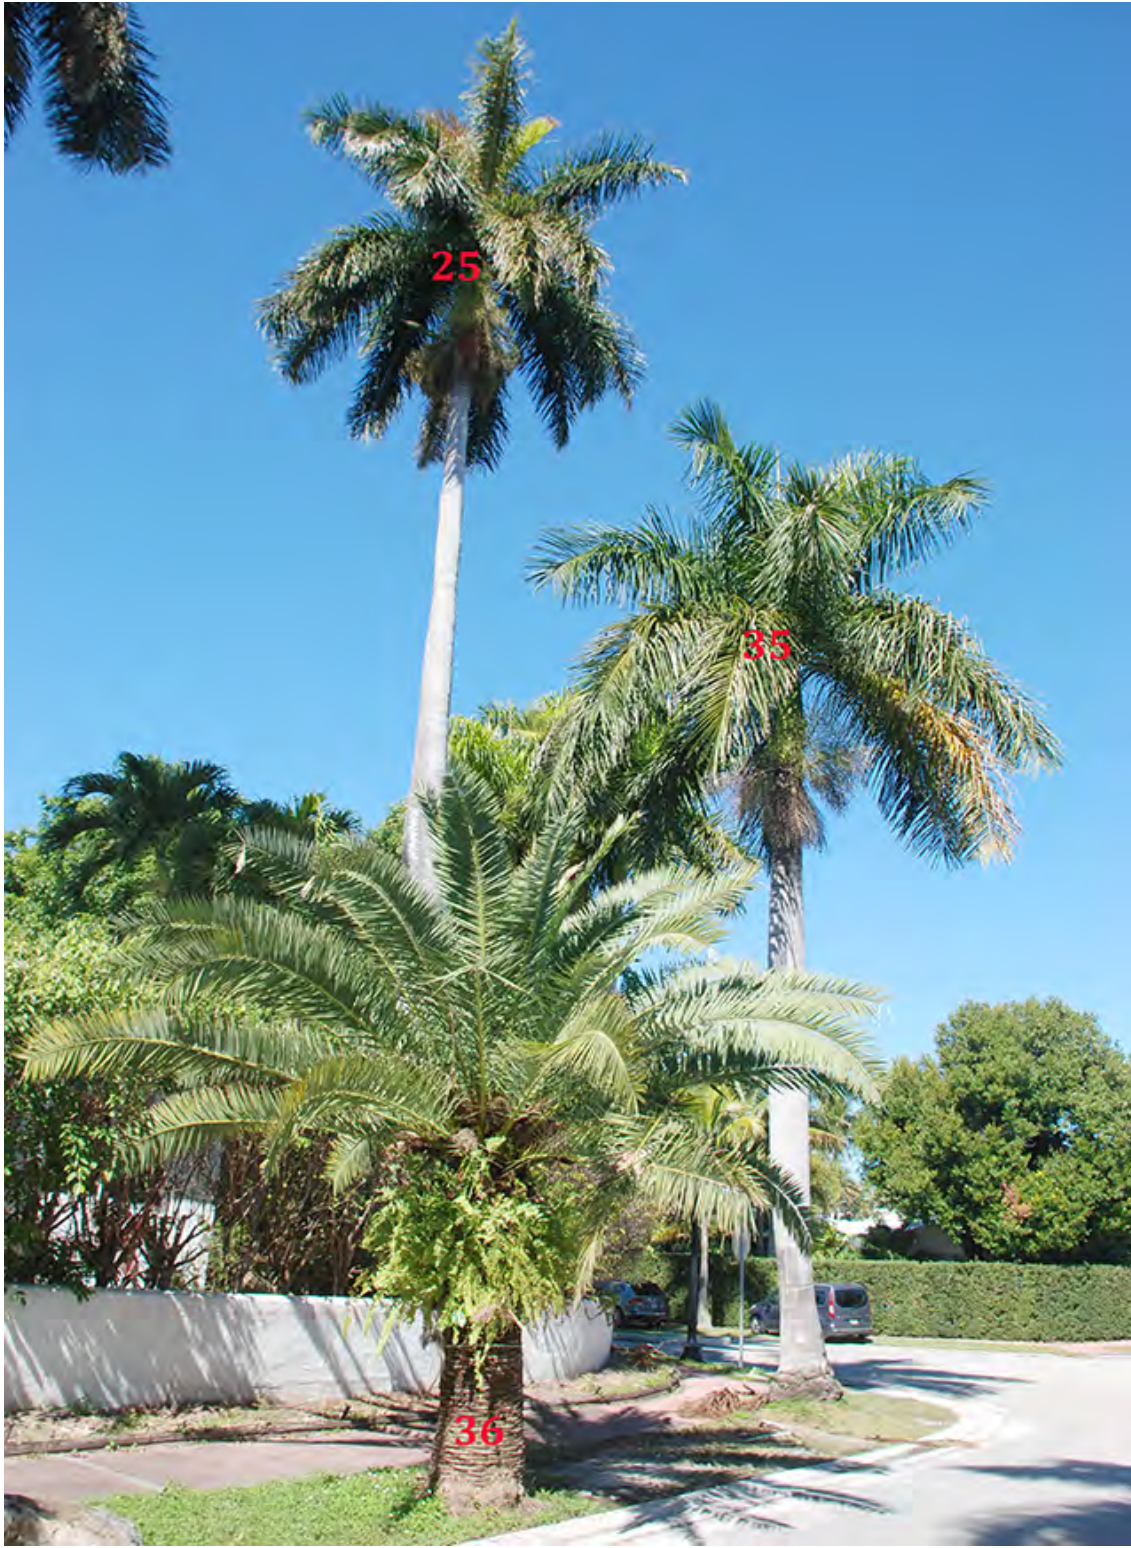
Photo 13 above is palms 25, 35 & 36.

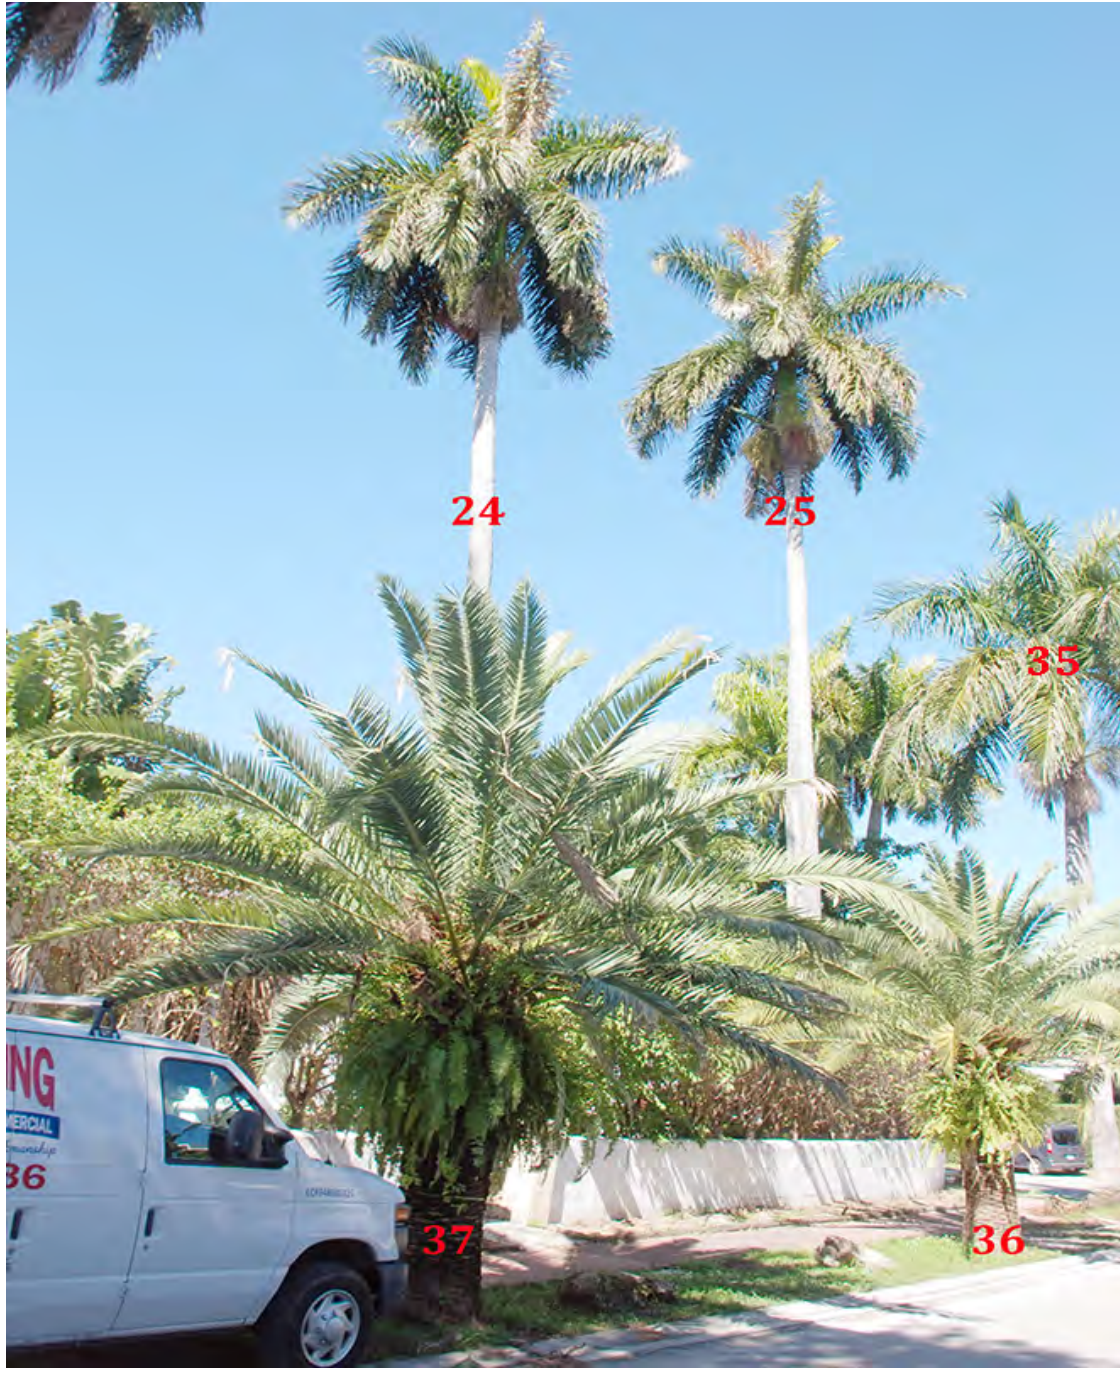
Photo 14 above is palms 36 & 37.
