Tree Resource Evaluation for 250 Rivo Alto & 110 3rd Rivo Alto Terrace, Miami Beach

February 5, 2020

Summary

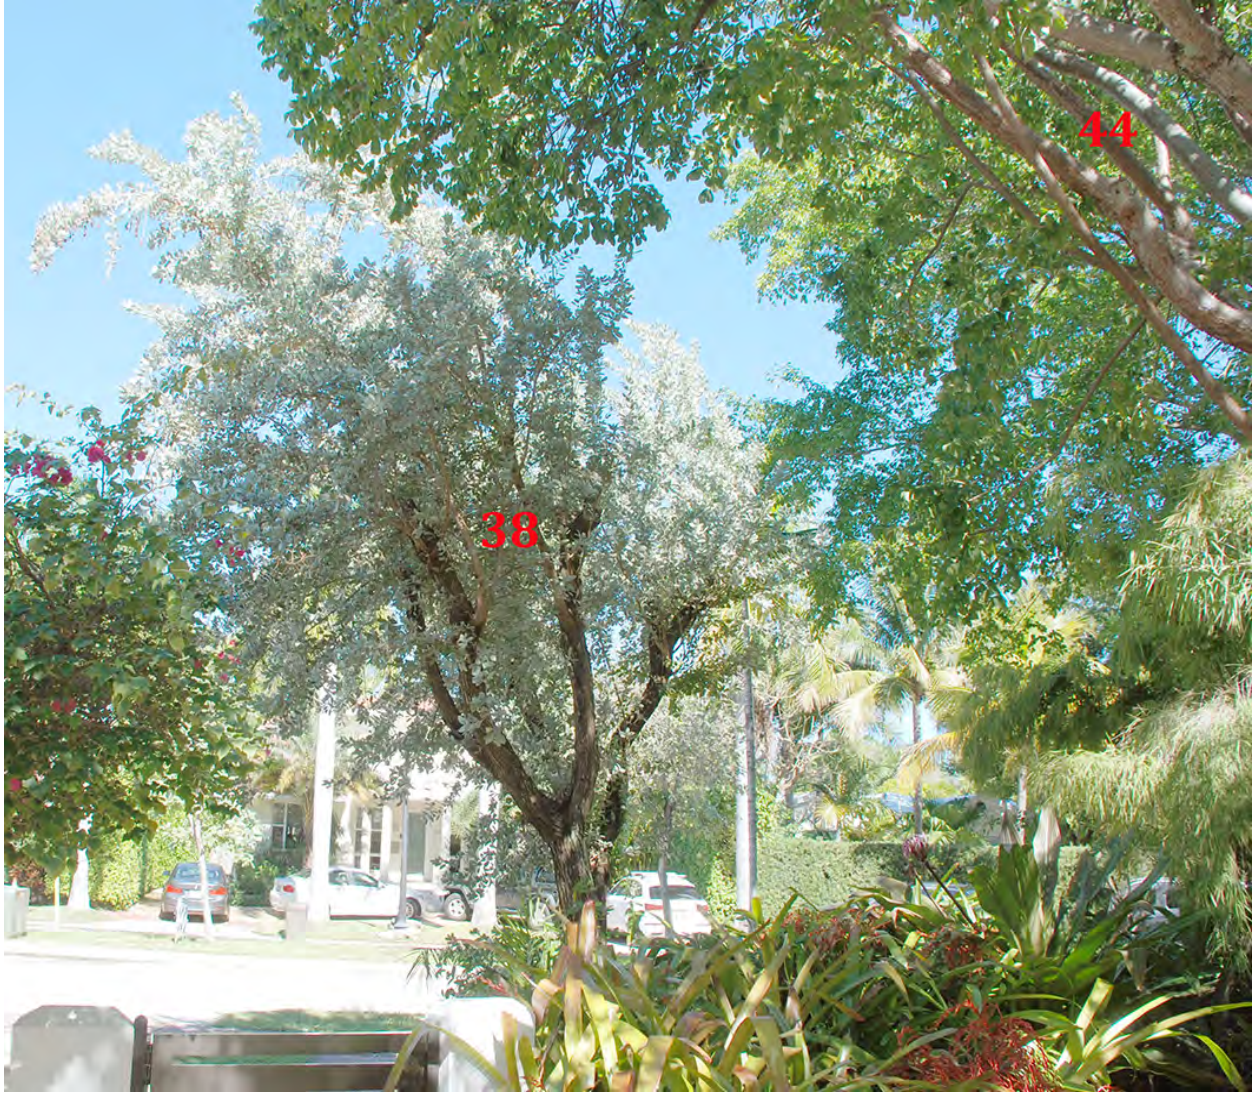
Photo 15 above is tree 38 viewed from the south. See following photo.

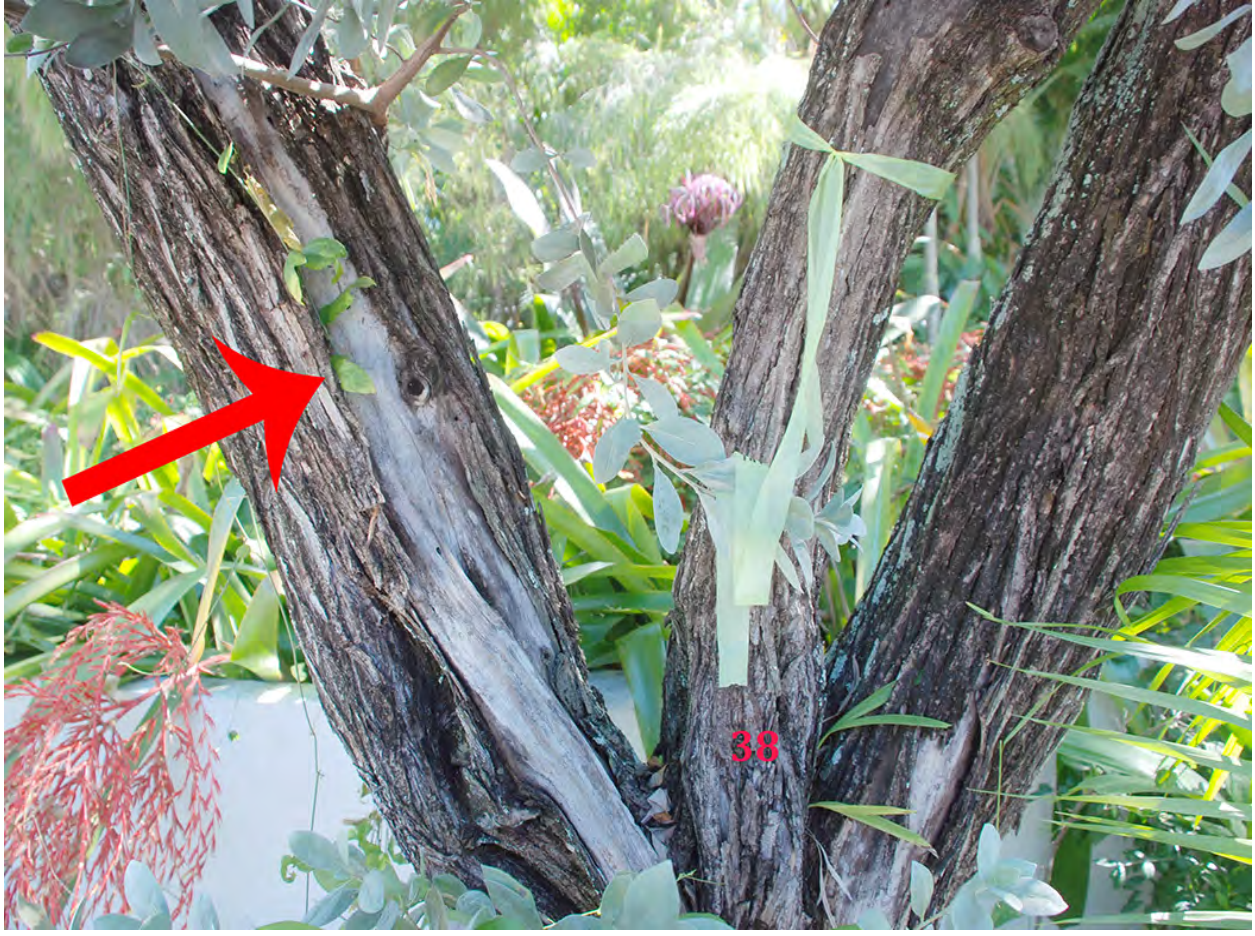
Photo 16 above shows some minor decay on a trunk of tree 38. This tree should be able to isolate the decay. This tree is a good candidate for relocation.

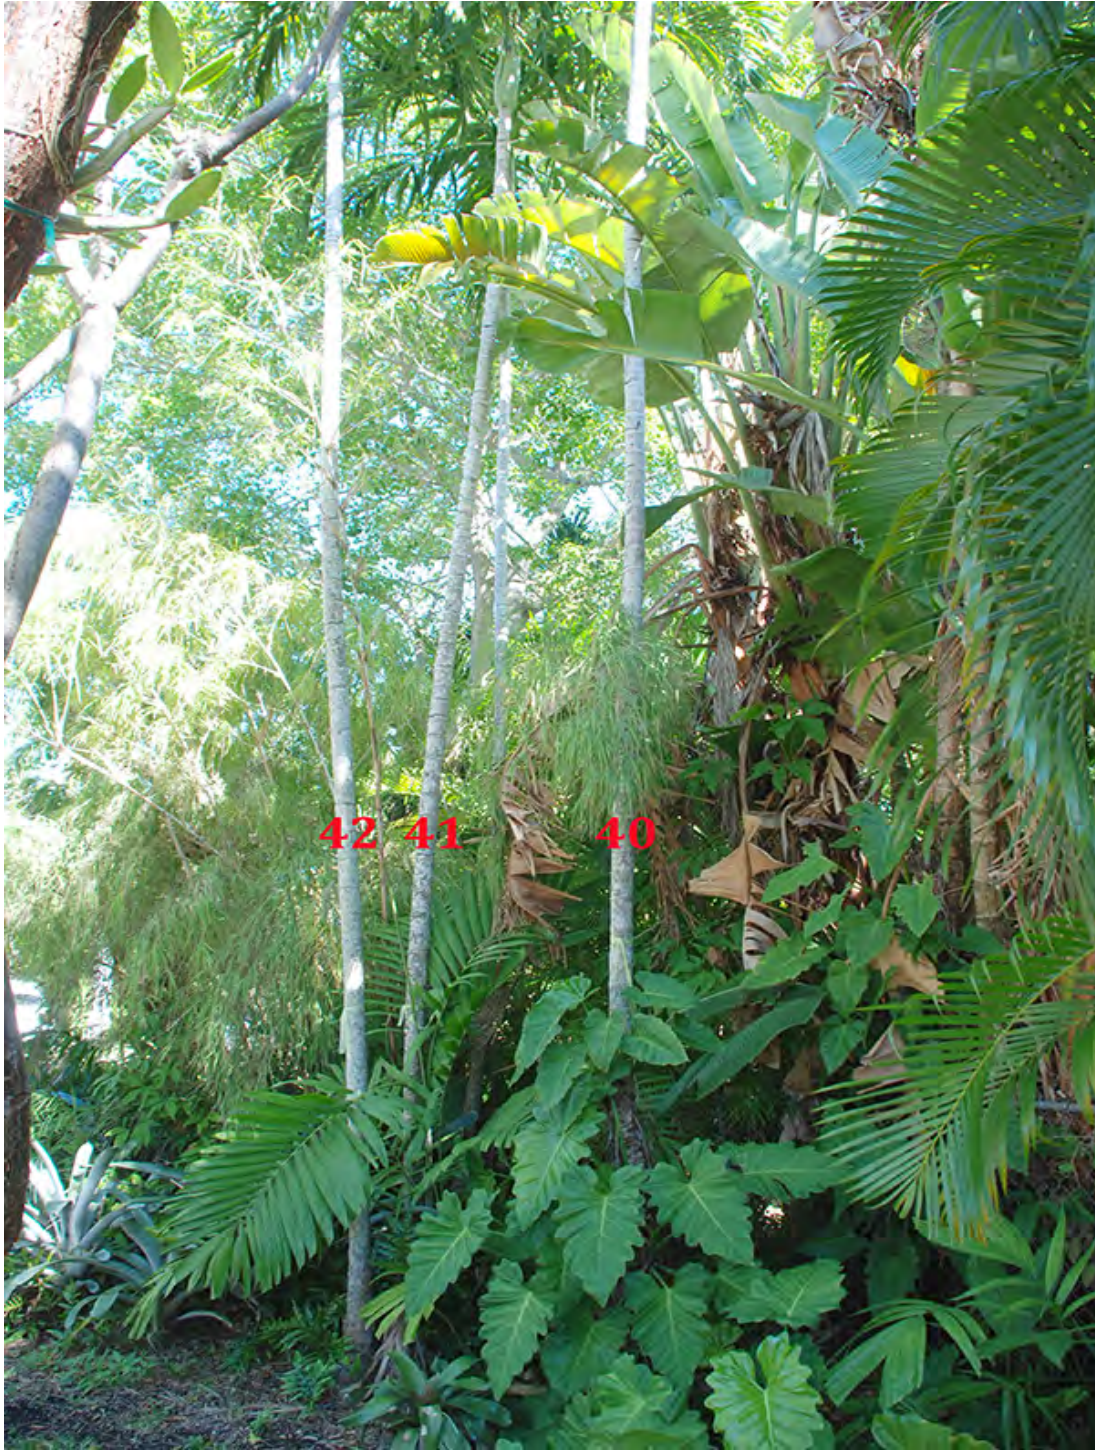
Photo 17 above is palms 40, 41 & 42.

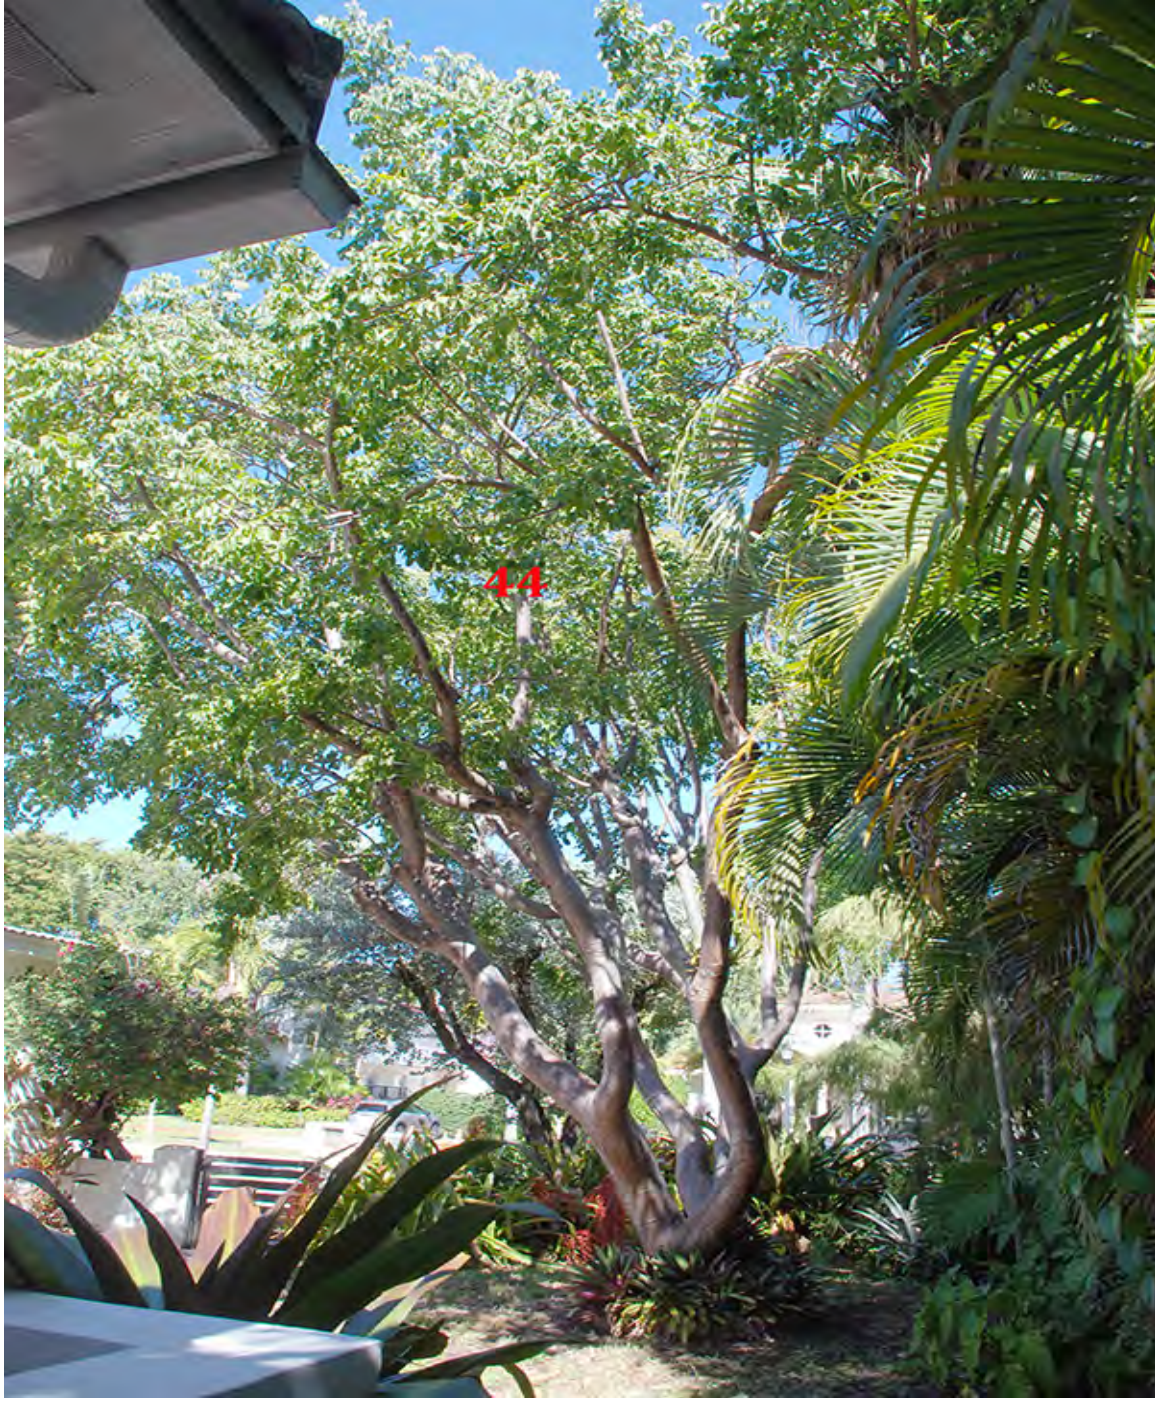
Photo 18 above is tree 44 viewed from the south.

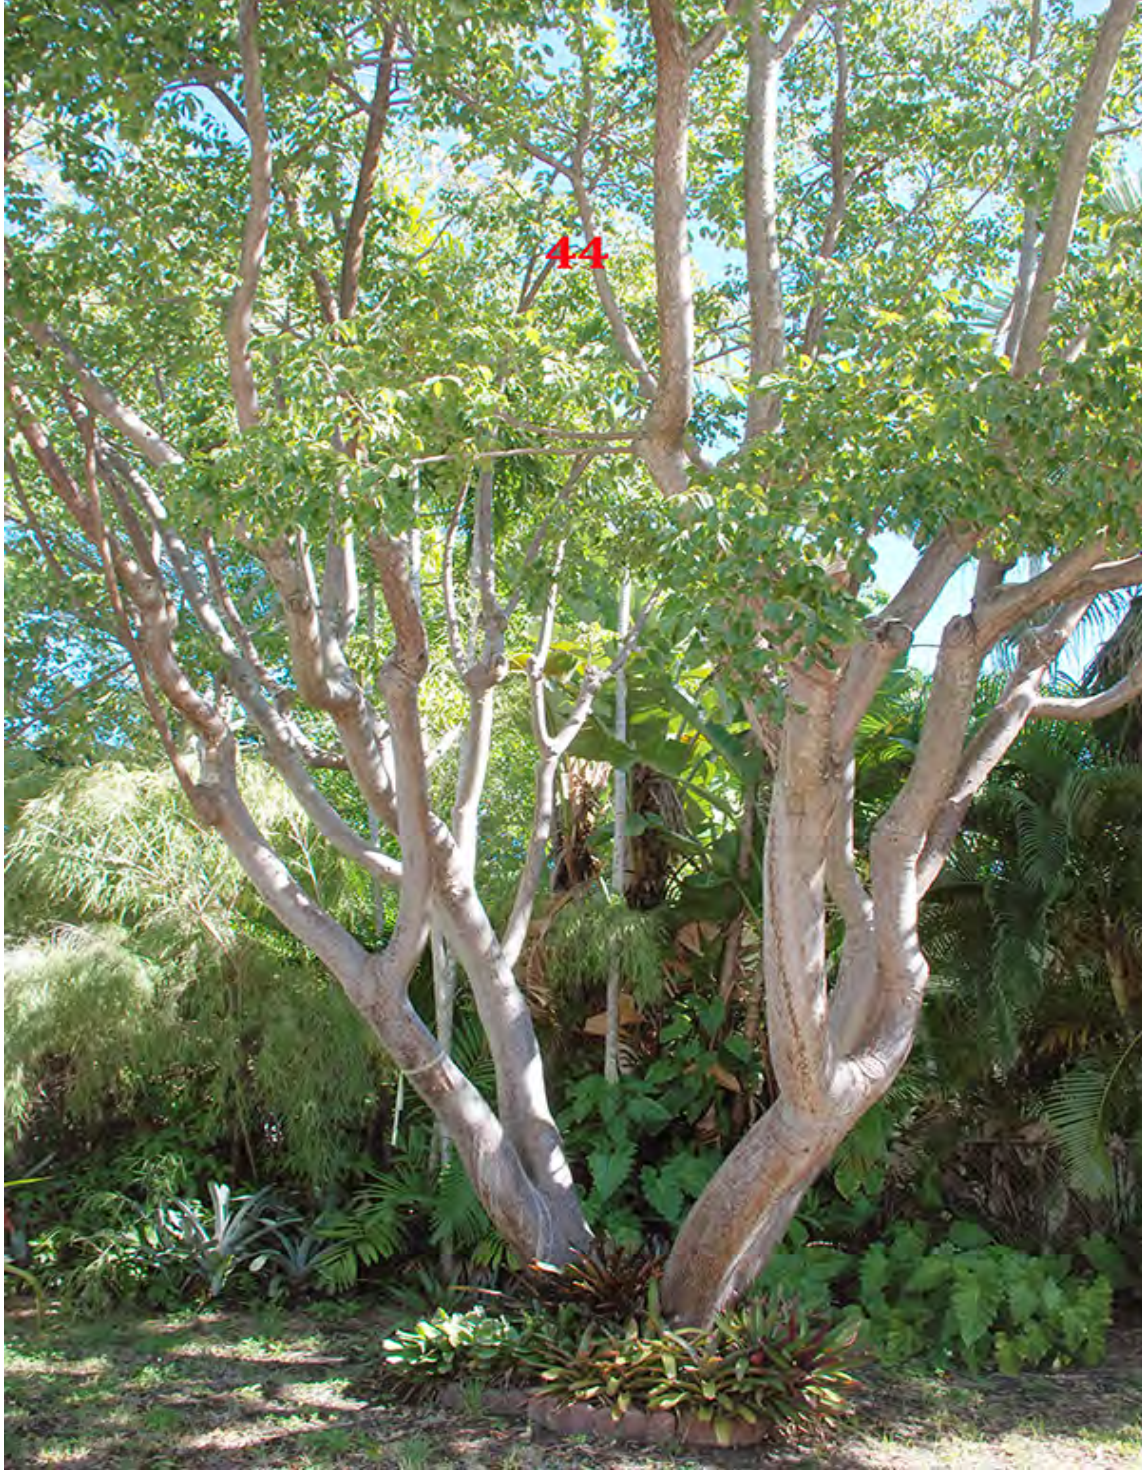
Photo 19 above are the trunks of tree 44 viewed from the west. This tree is a good candidate for relocation.

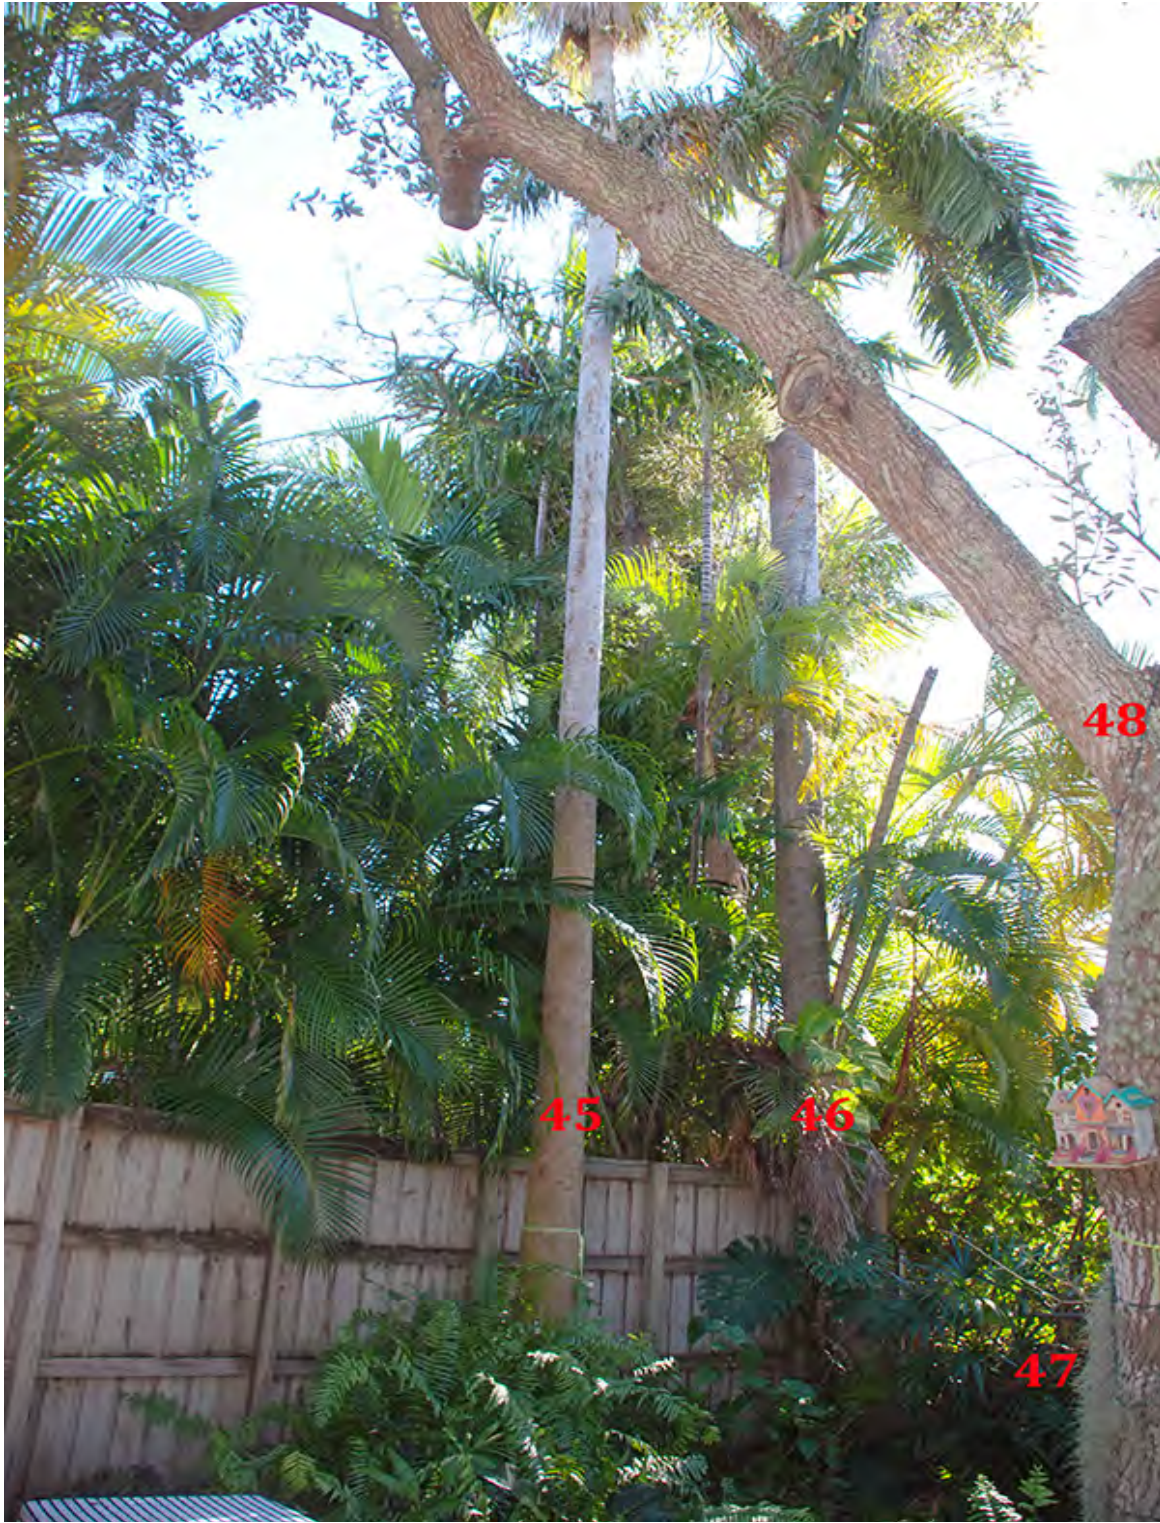
Photo 20 above is palm trunks 45 & 46. Palm trunk 47 can be seen on the ground in the background. This palm is dead and the trunk very decayed.

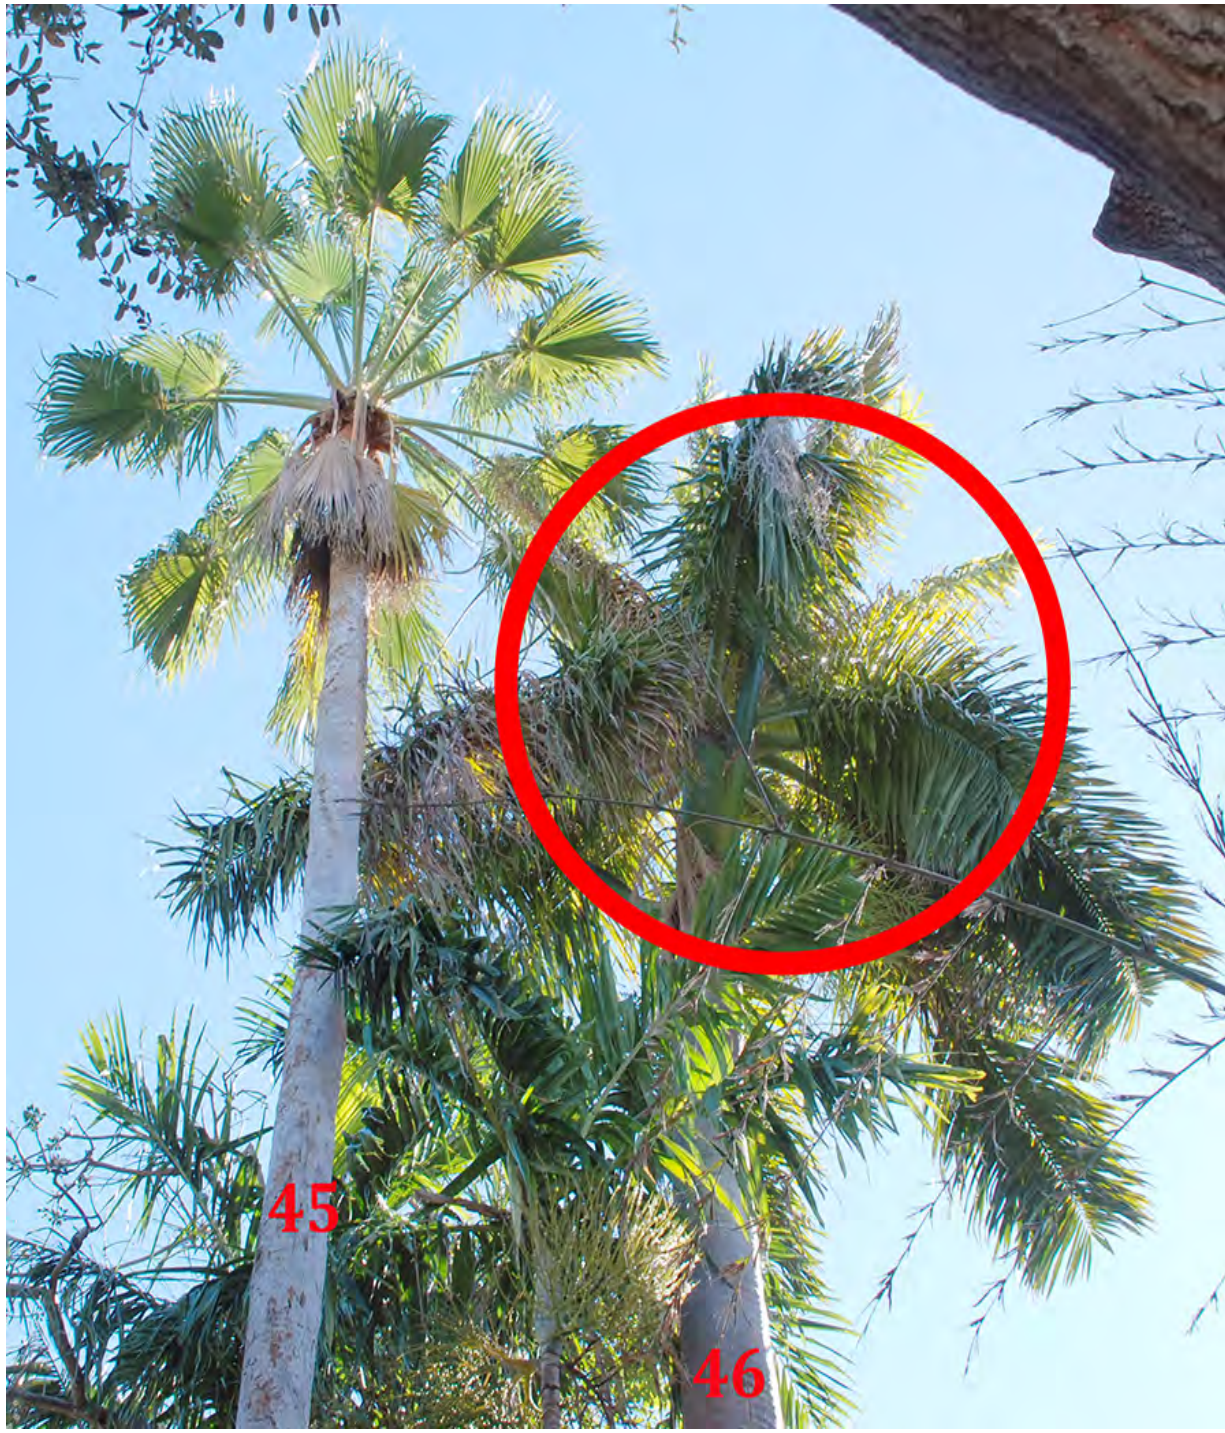
Photo 21 above shows the fronds of palm 46 showing a severe nutrient deficiency. I recommend the removal of this palm.

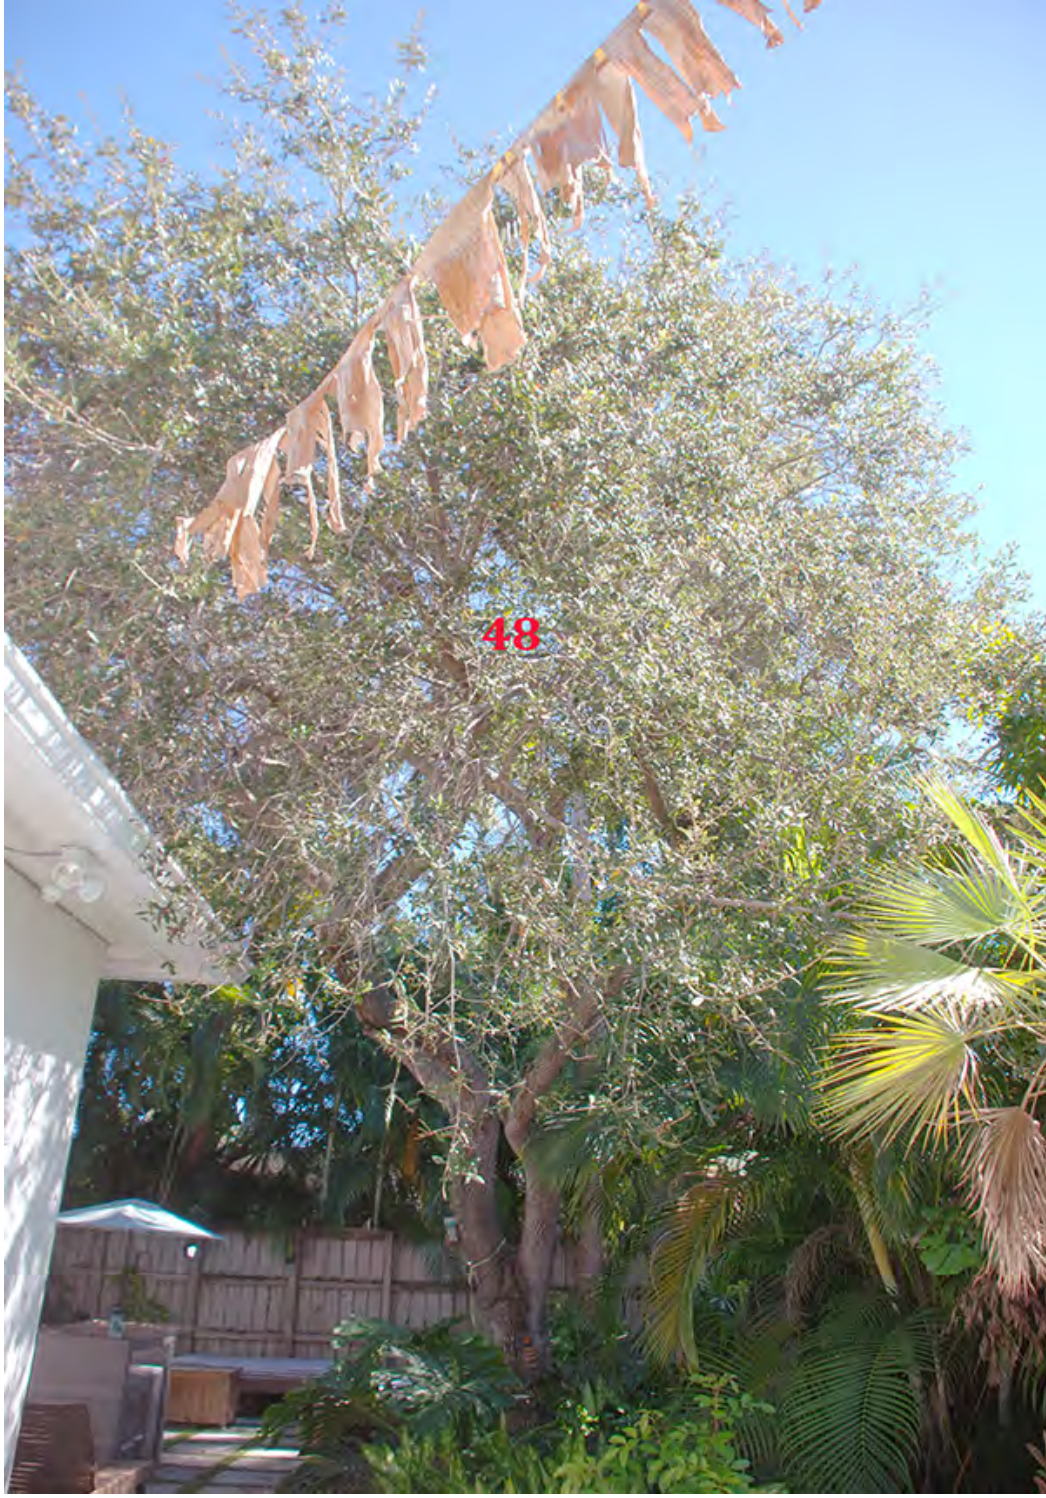
Photo 22 above is tree 48 viewed from the west.

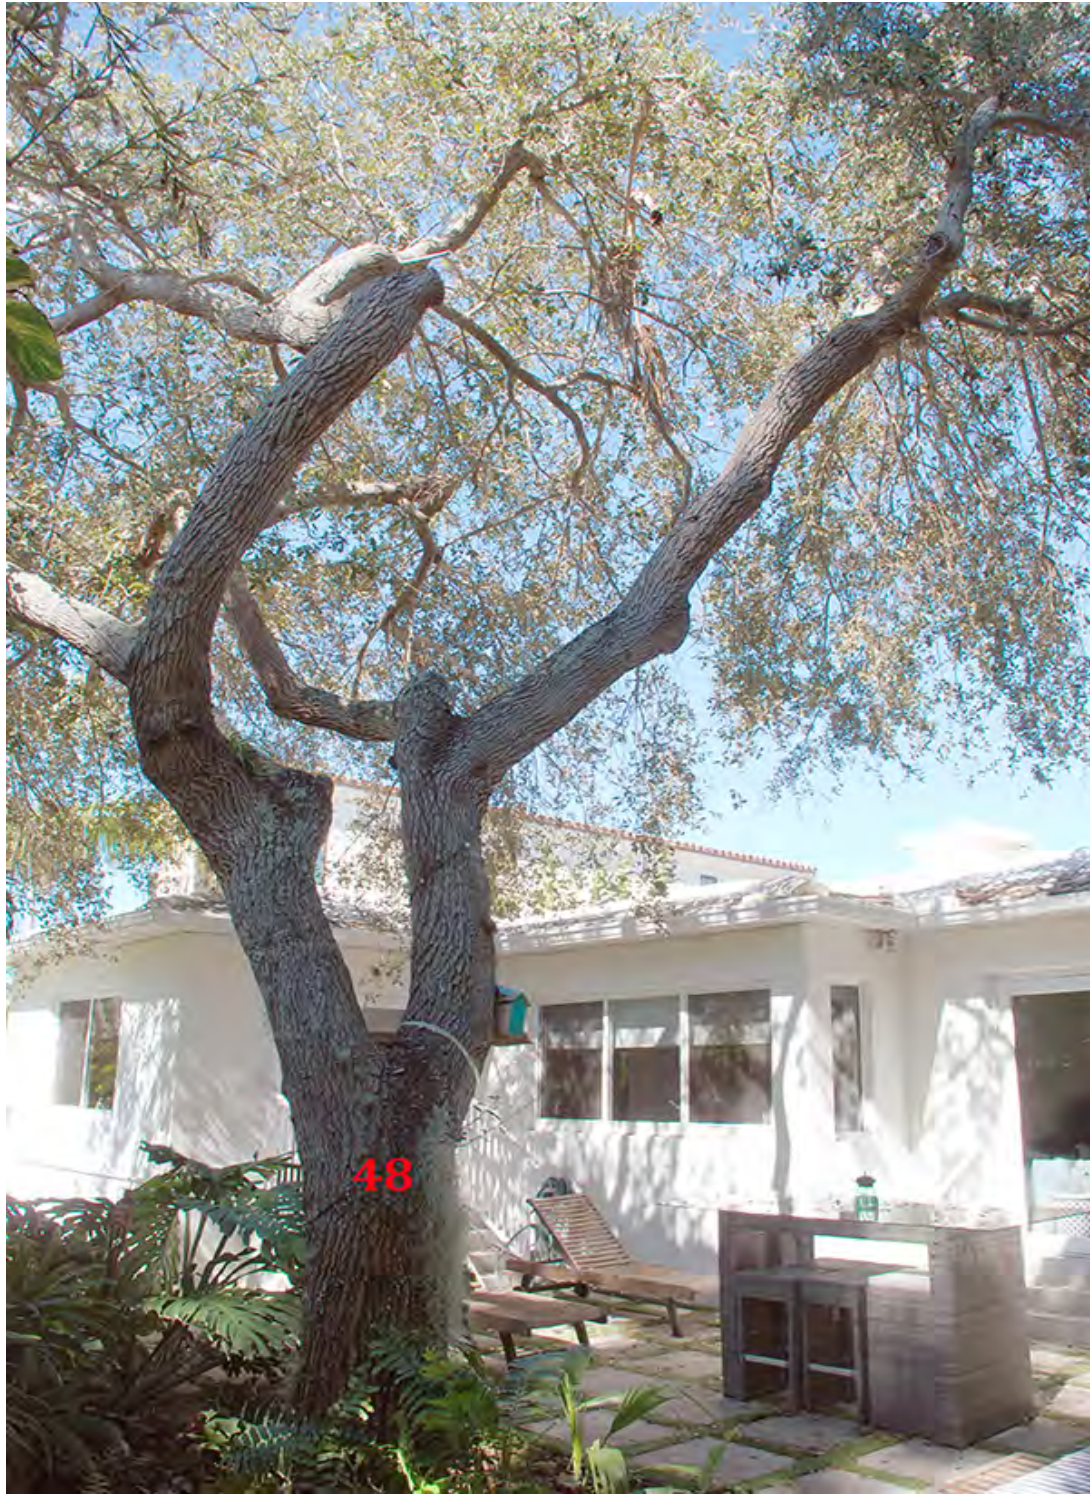
Photo 23 above is the trunk of tree 48 viewed from the east. The majority of the canopy and branches are leaning to the west however this tree is still a good candidate for relocation.

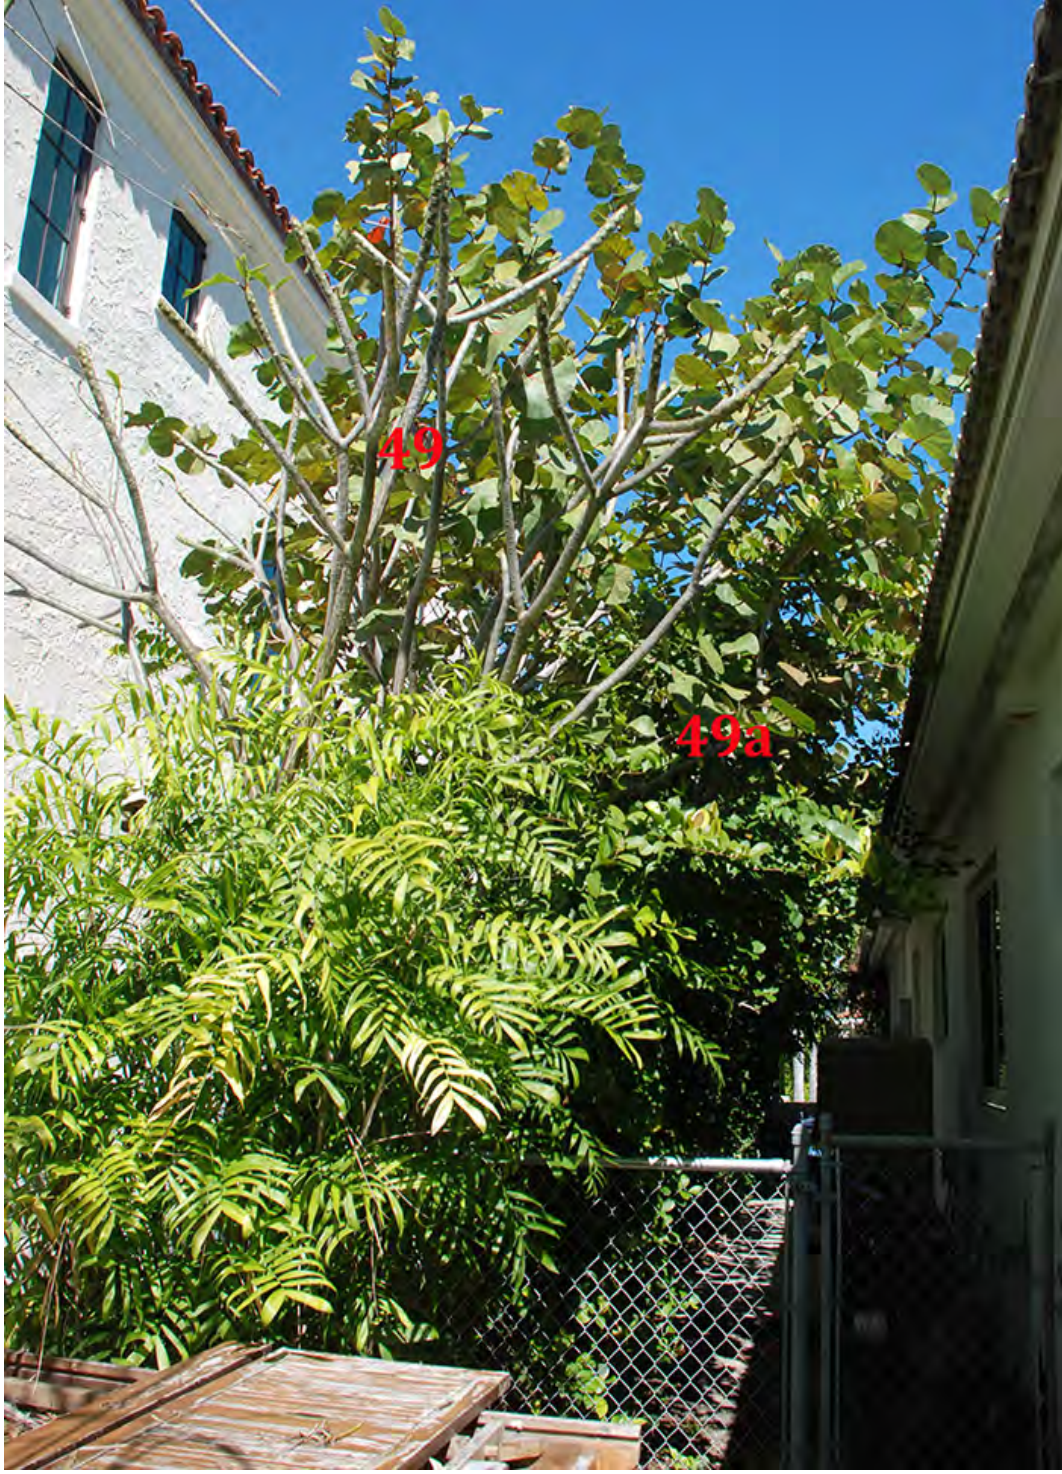
Photo 23 above is trees 49 & 49a viewed from the south.

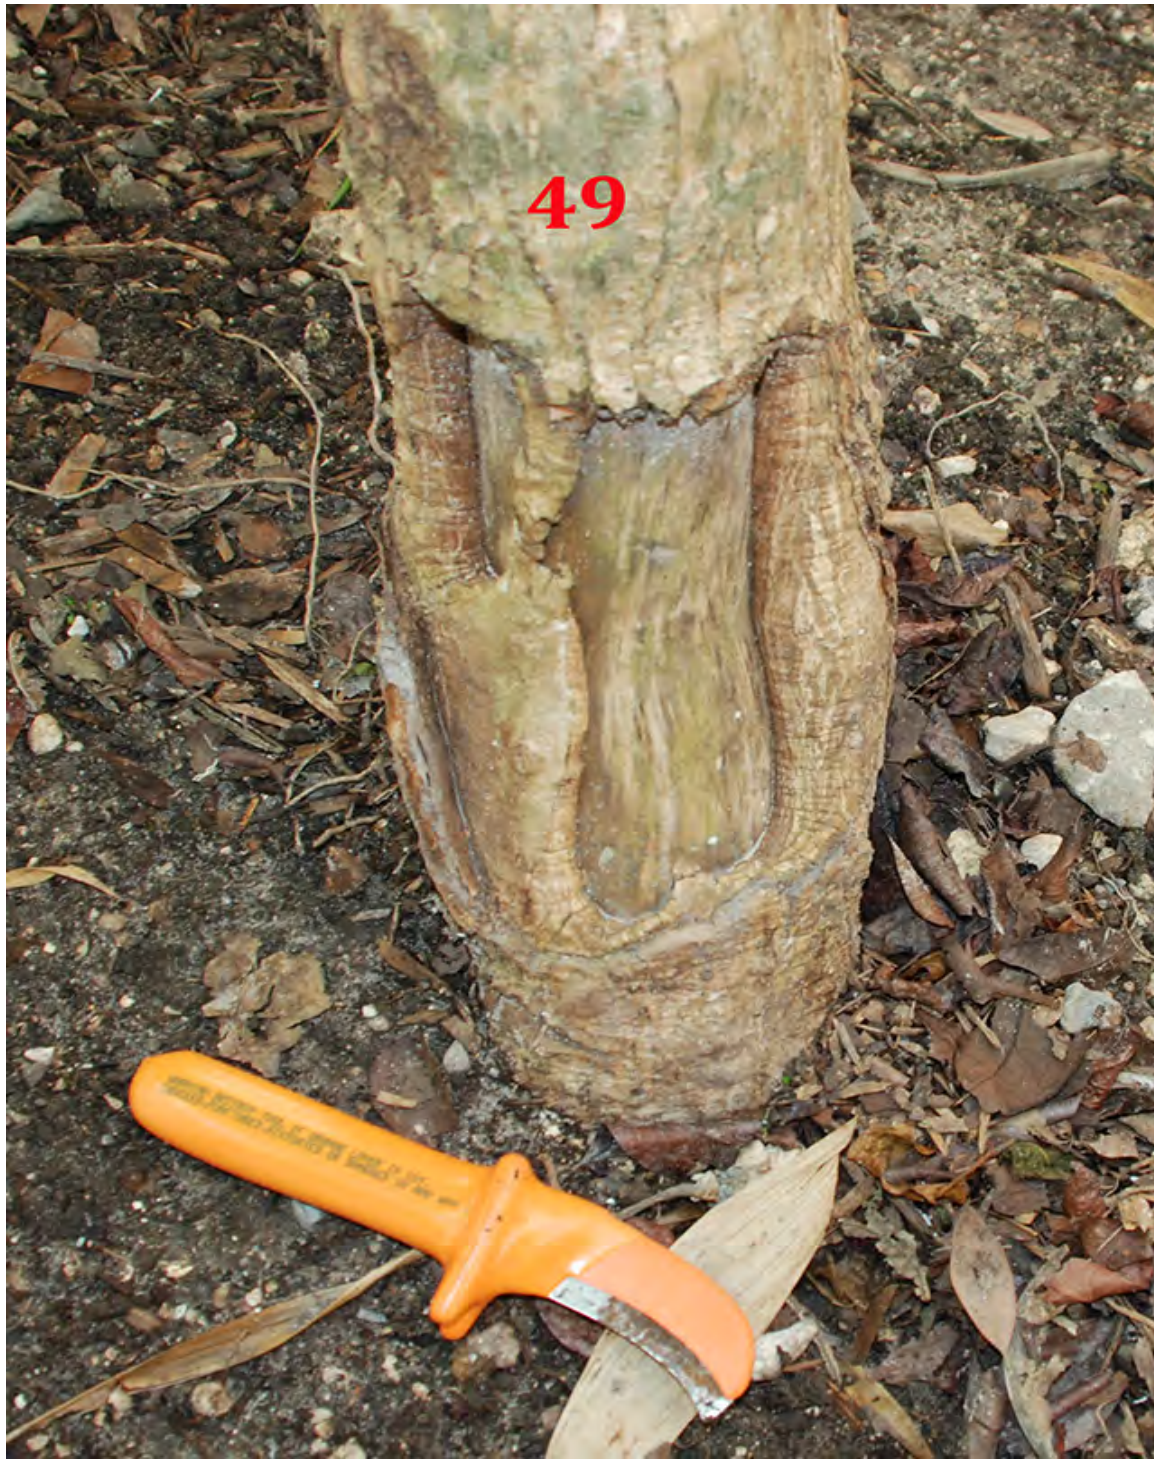
Photo 24 above shows the damaged trunk of tree 49. The orange knife is 7 inches in length.

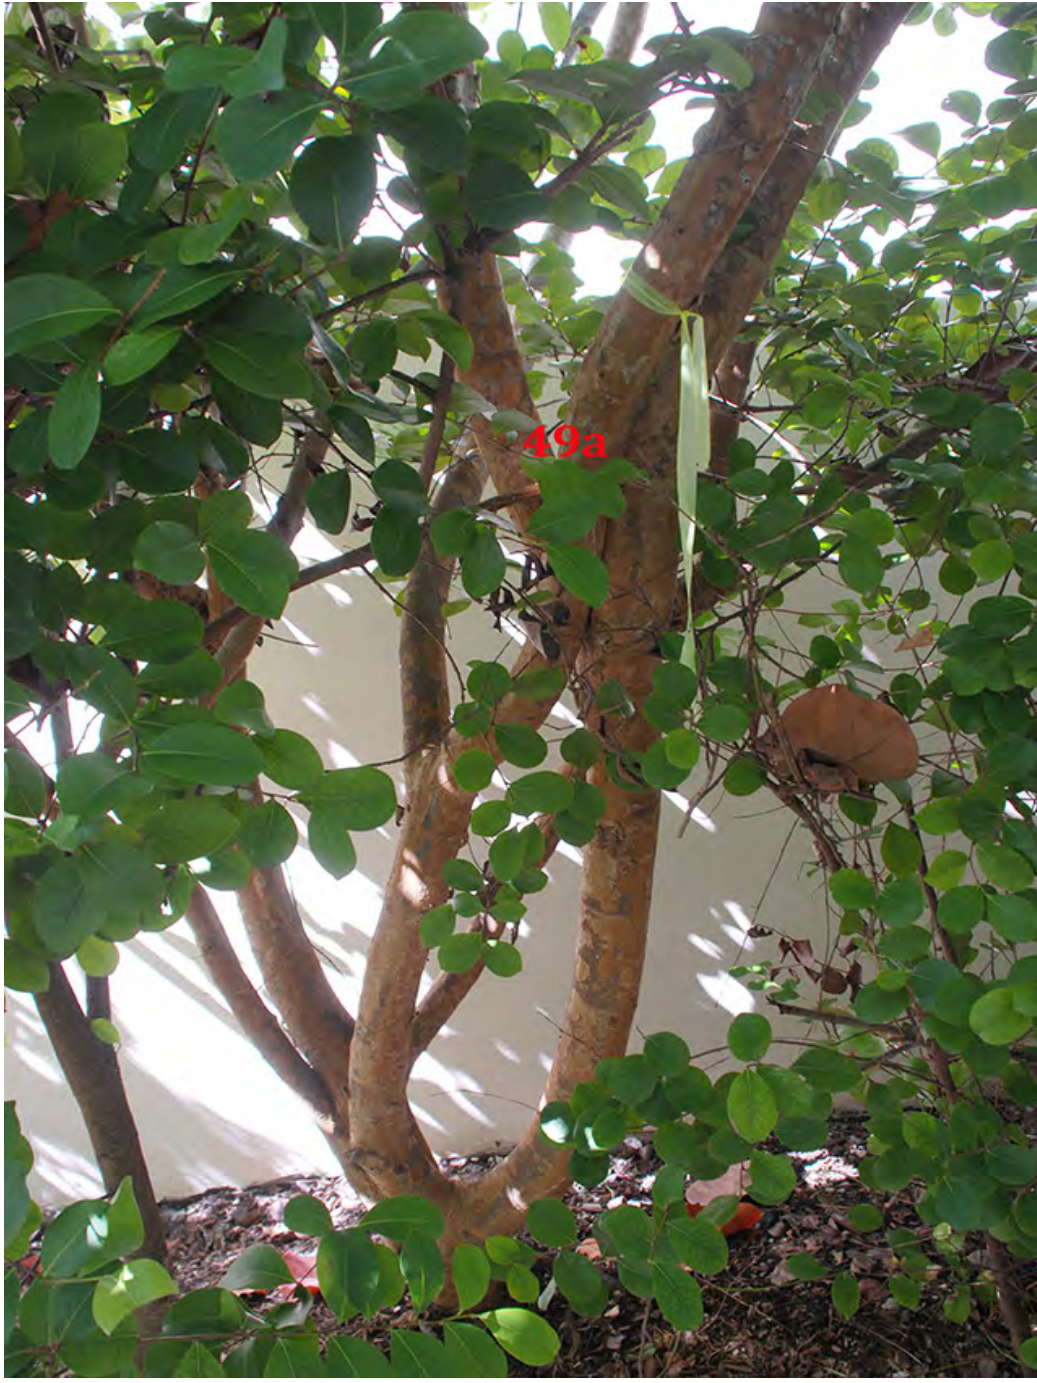
Photo 25 above are the trunks of tree 49a.

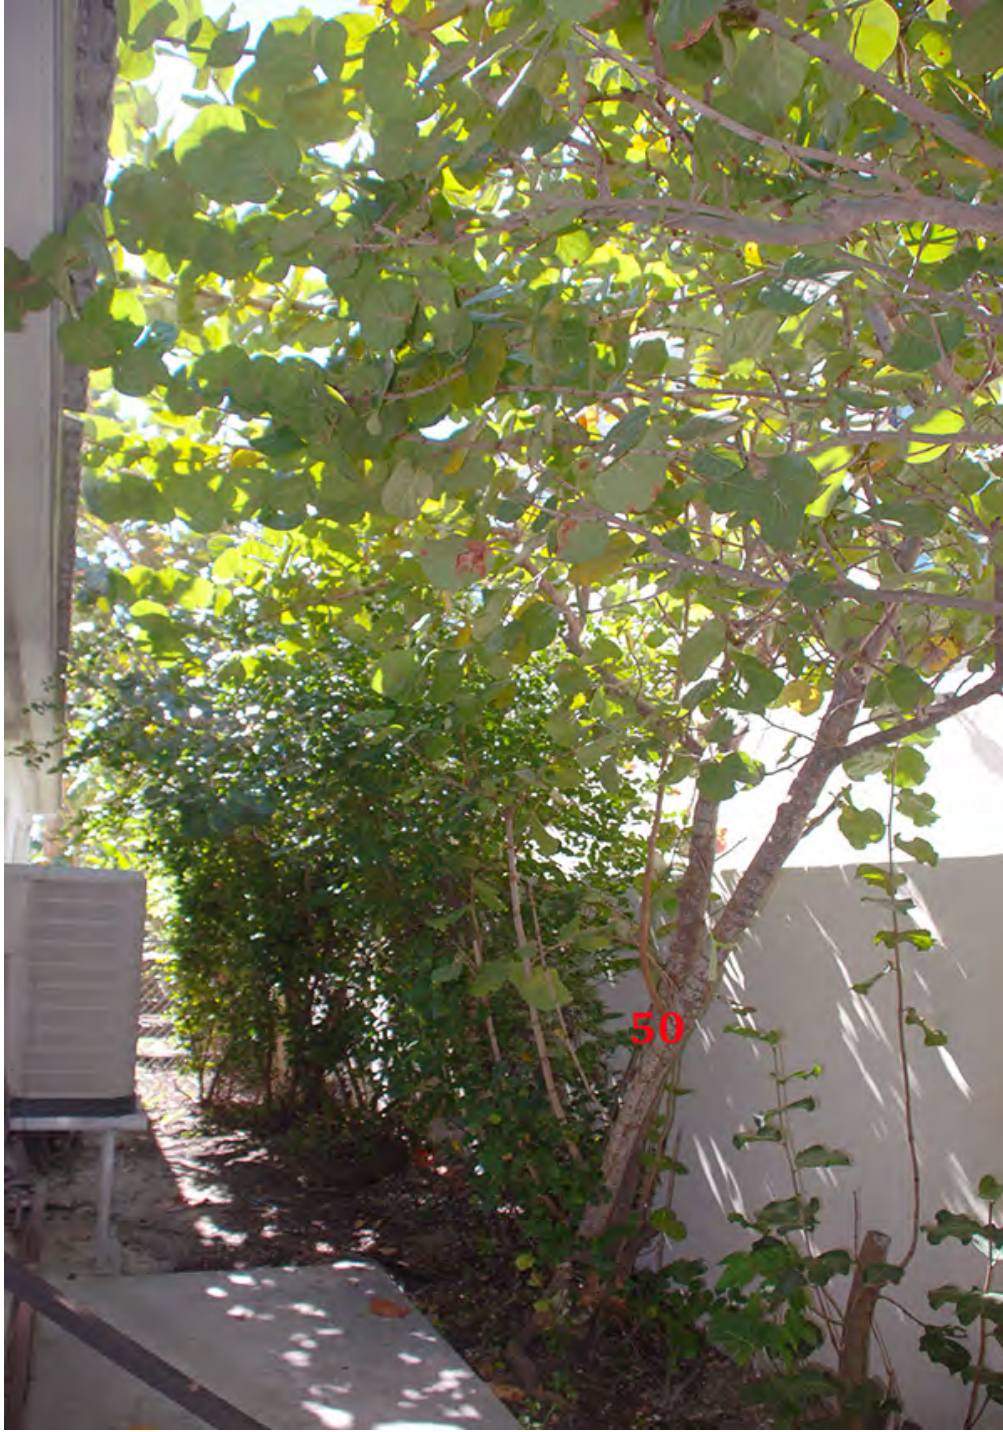
Photo 26 above is the trunk of tree 50.

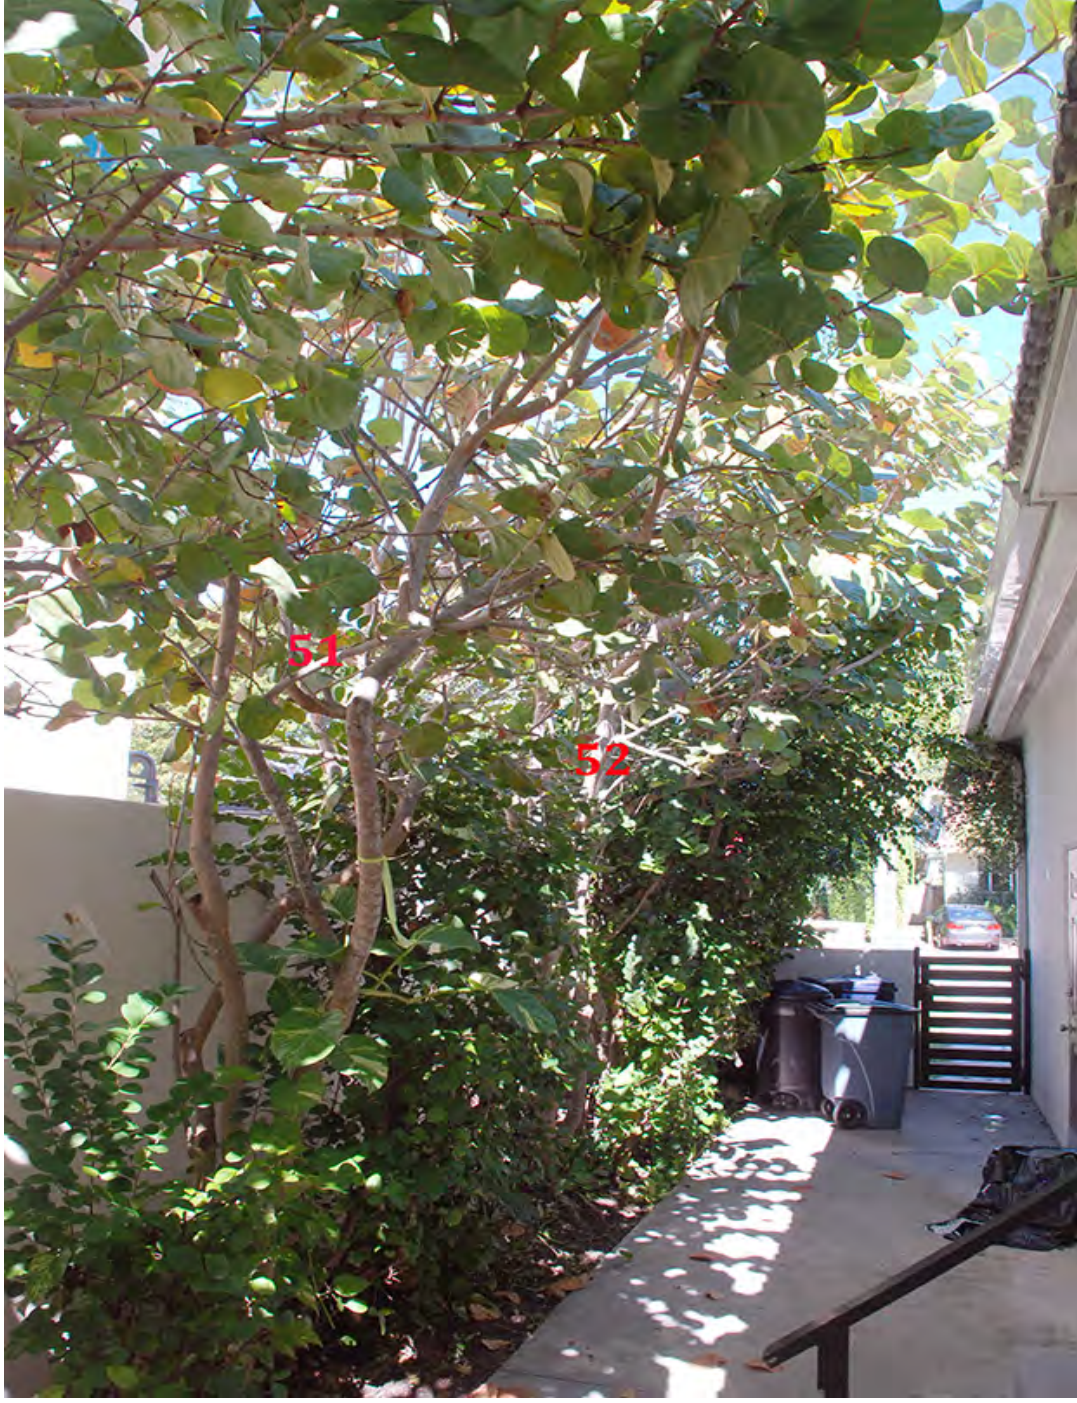
Photo 27 above are trees 51 & 52.
