Tree Resource Evaluation for 250 Rivo Alto & 110 3rd Rivo Alto Terrace, Miami Beach

February 5, 2020

Summary

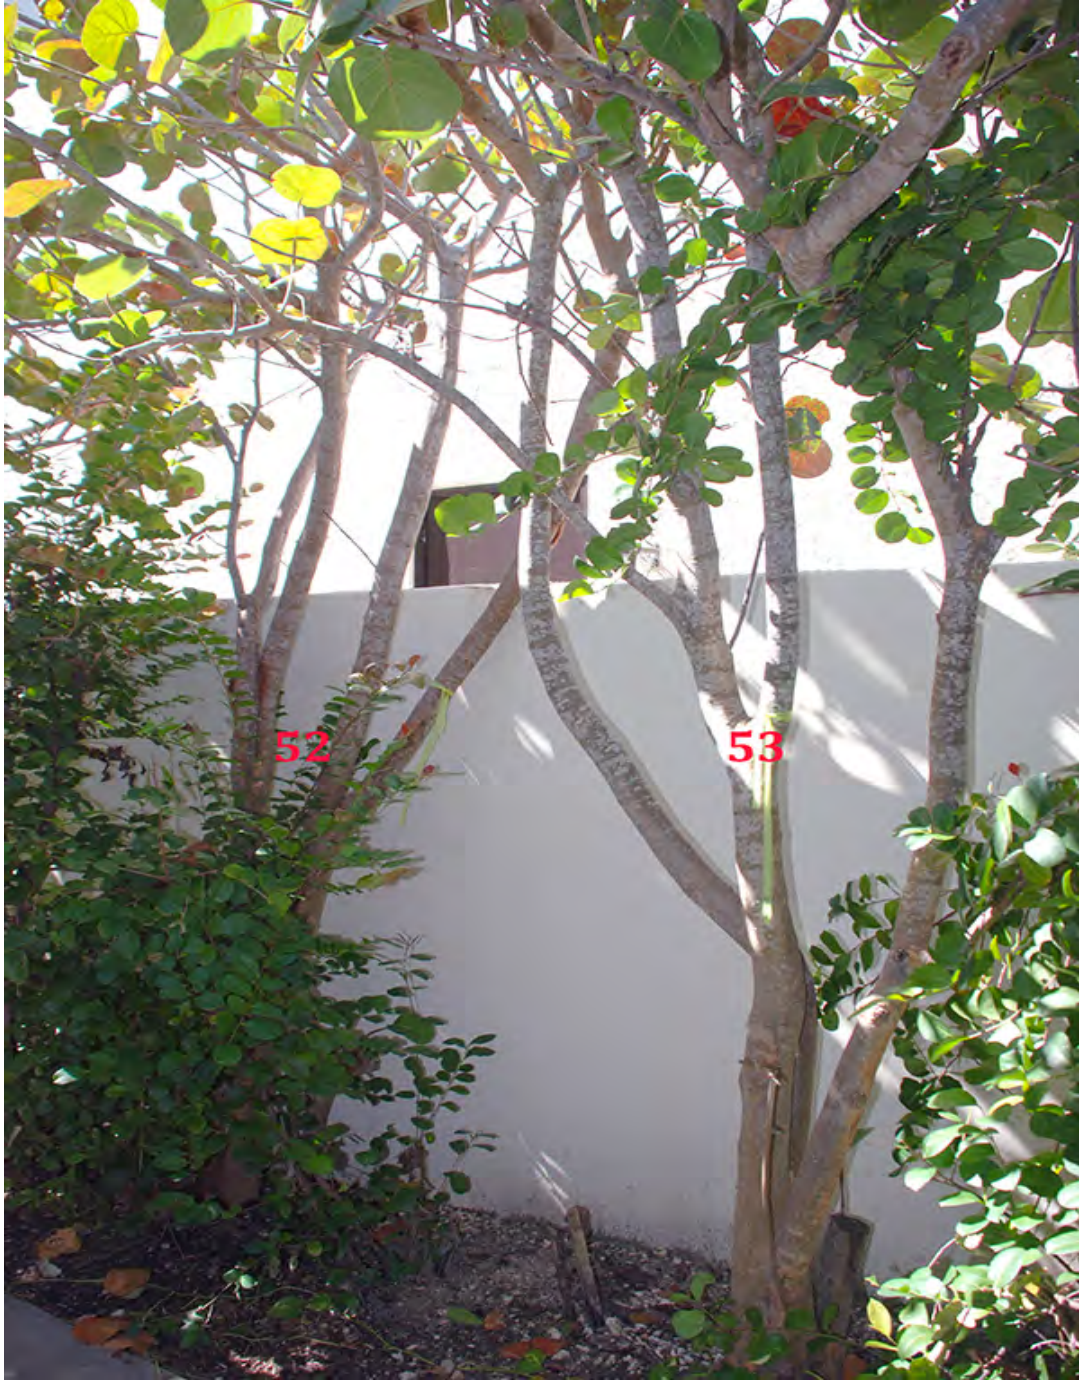
Photo 28 above are trees 52 & 53.

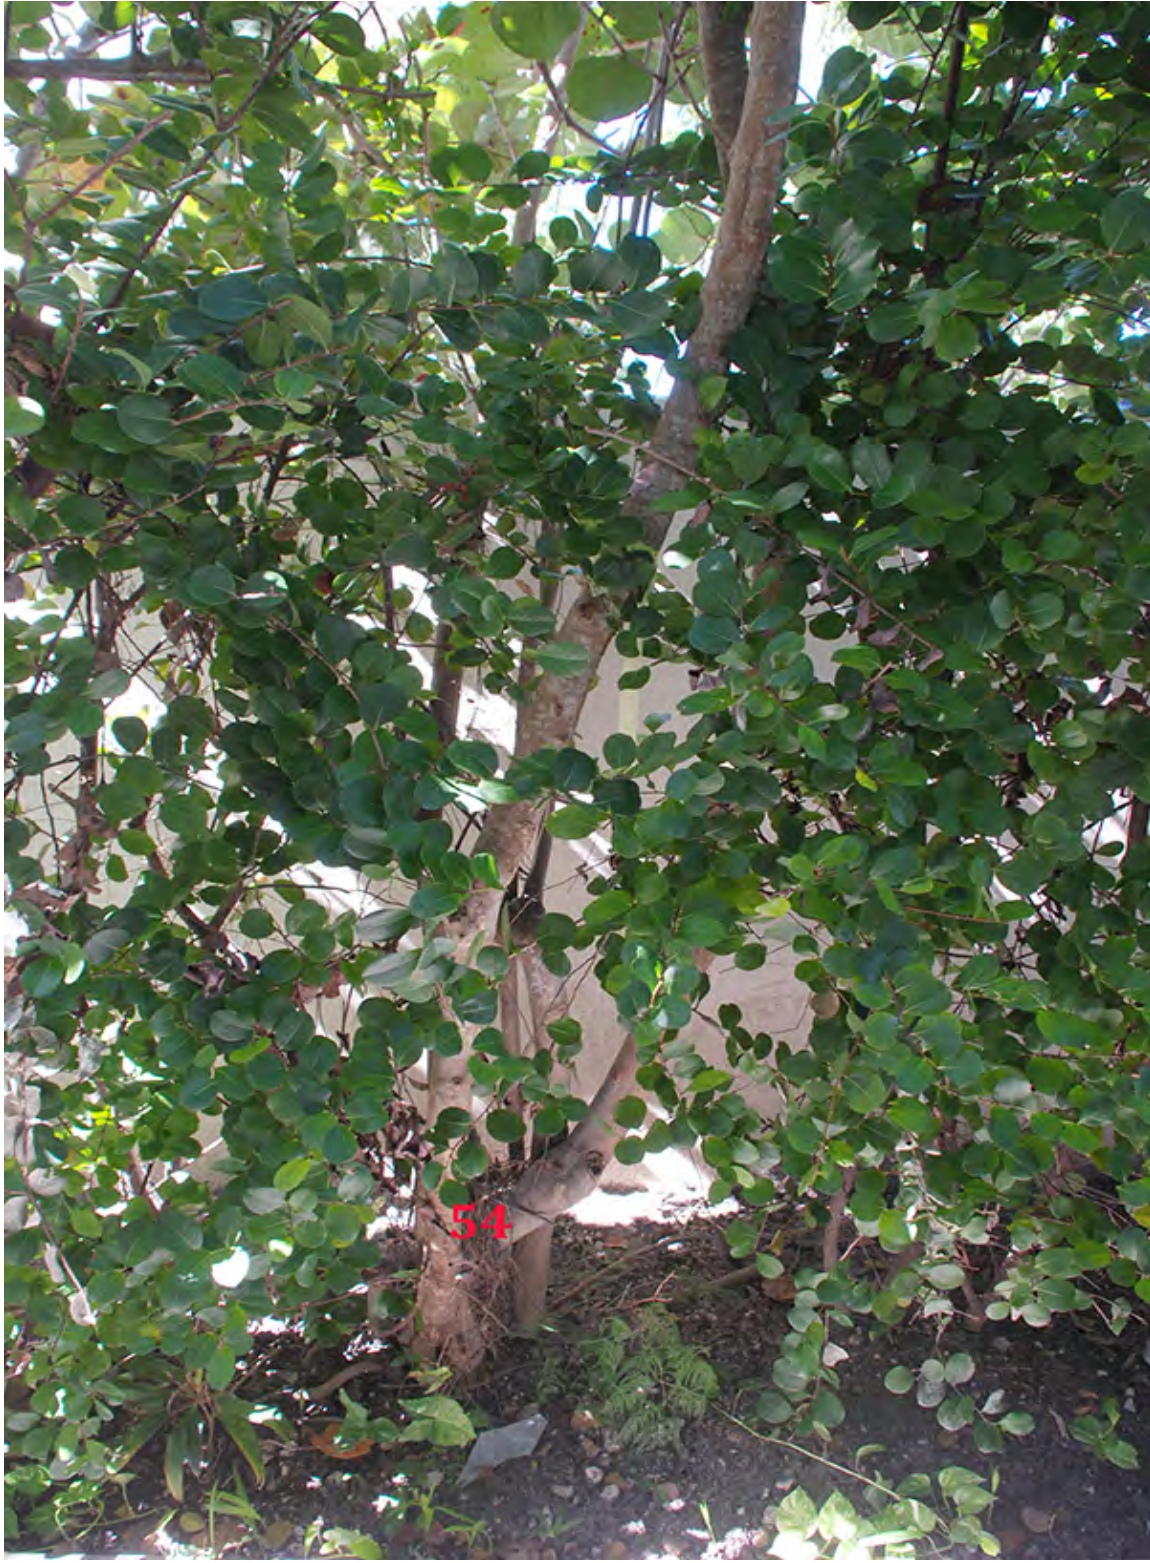
Photo 29 above is the trunk of tree 54.

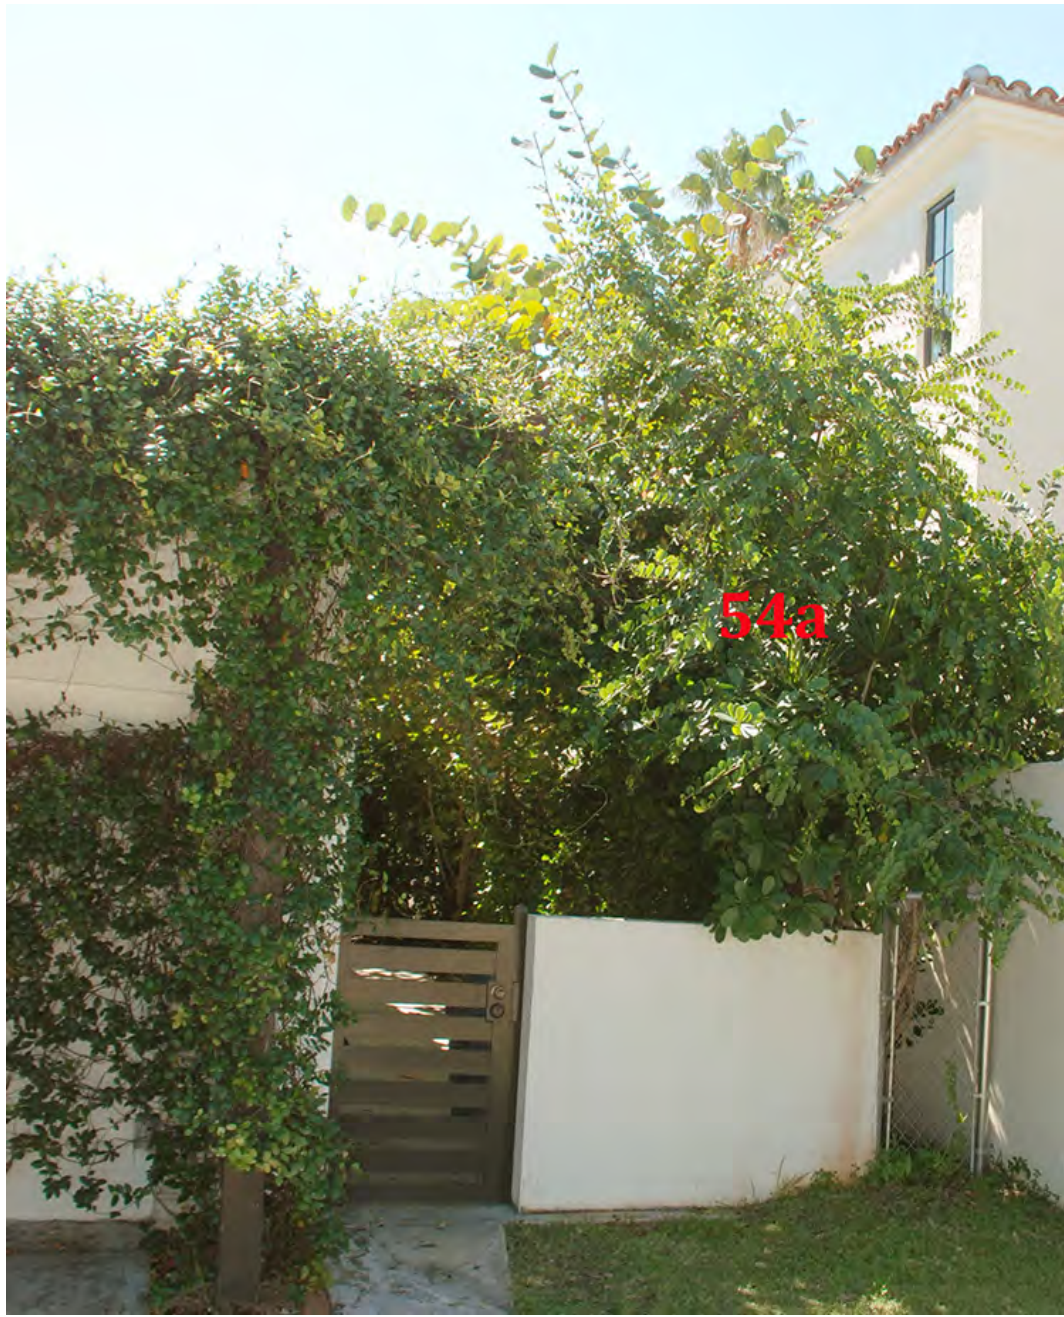
Photo 30 above is tree 54a viewed from the north.

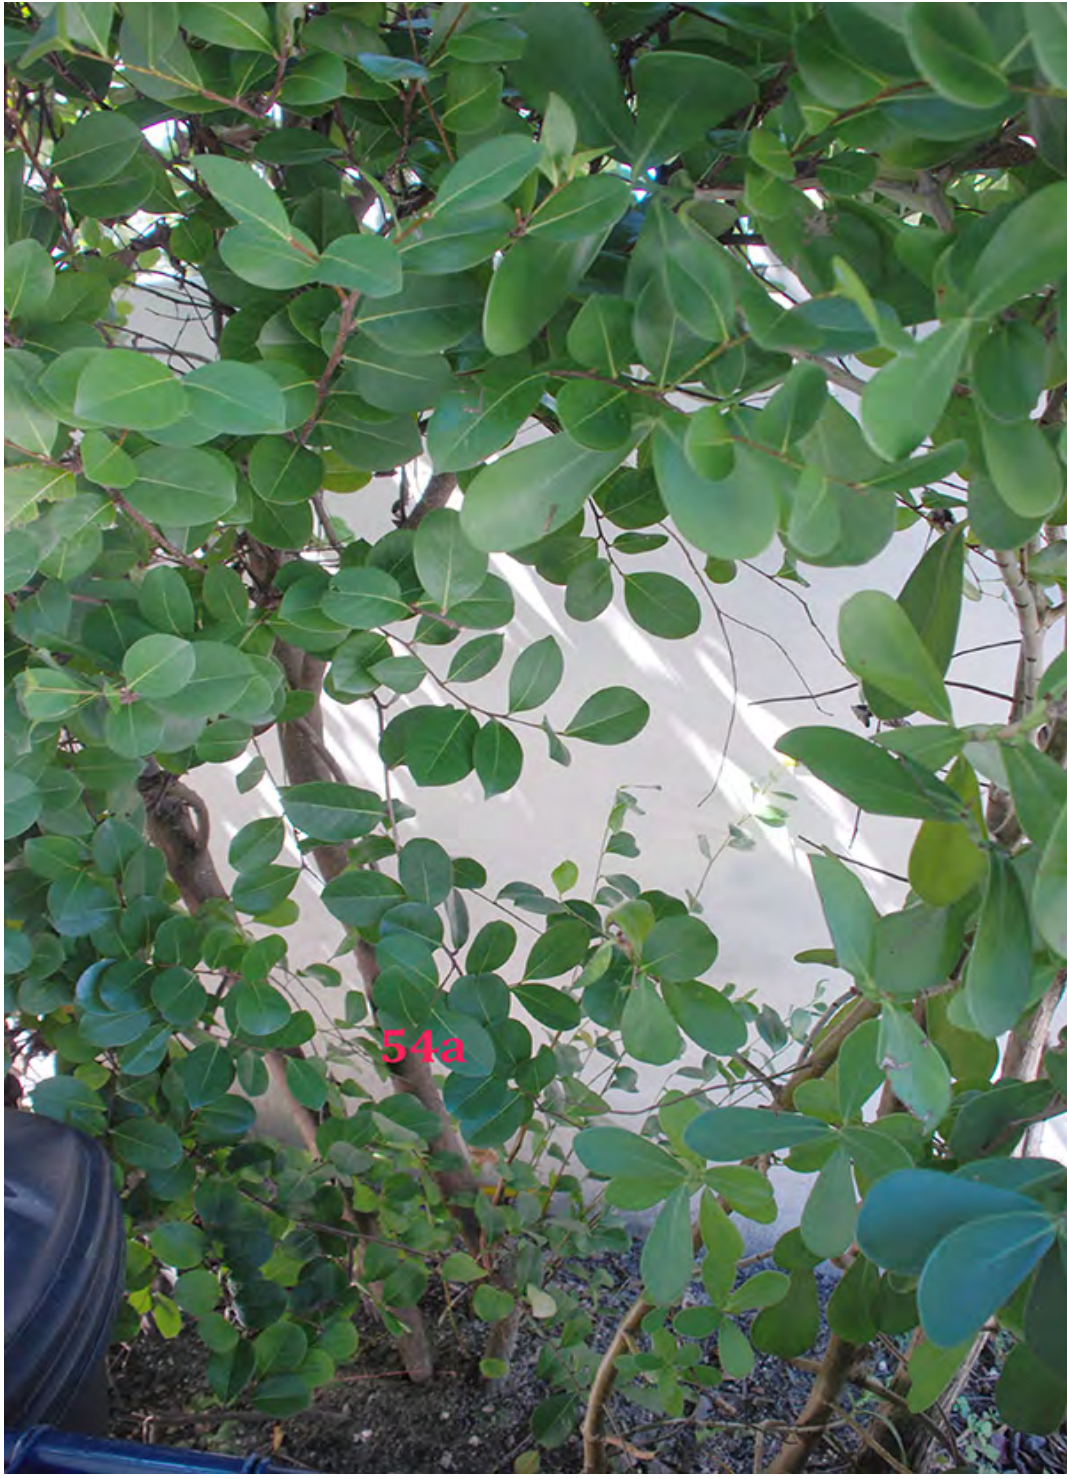
Photo 31 above are the trunks of tree 54a.

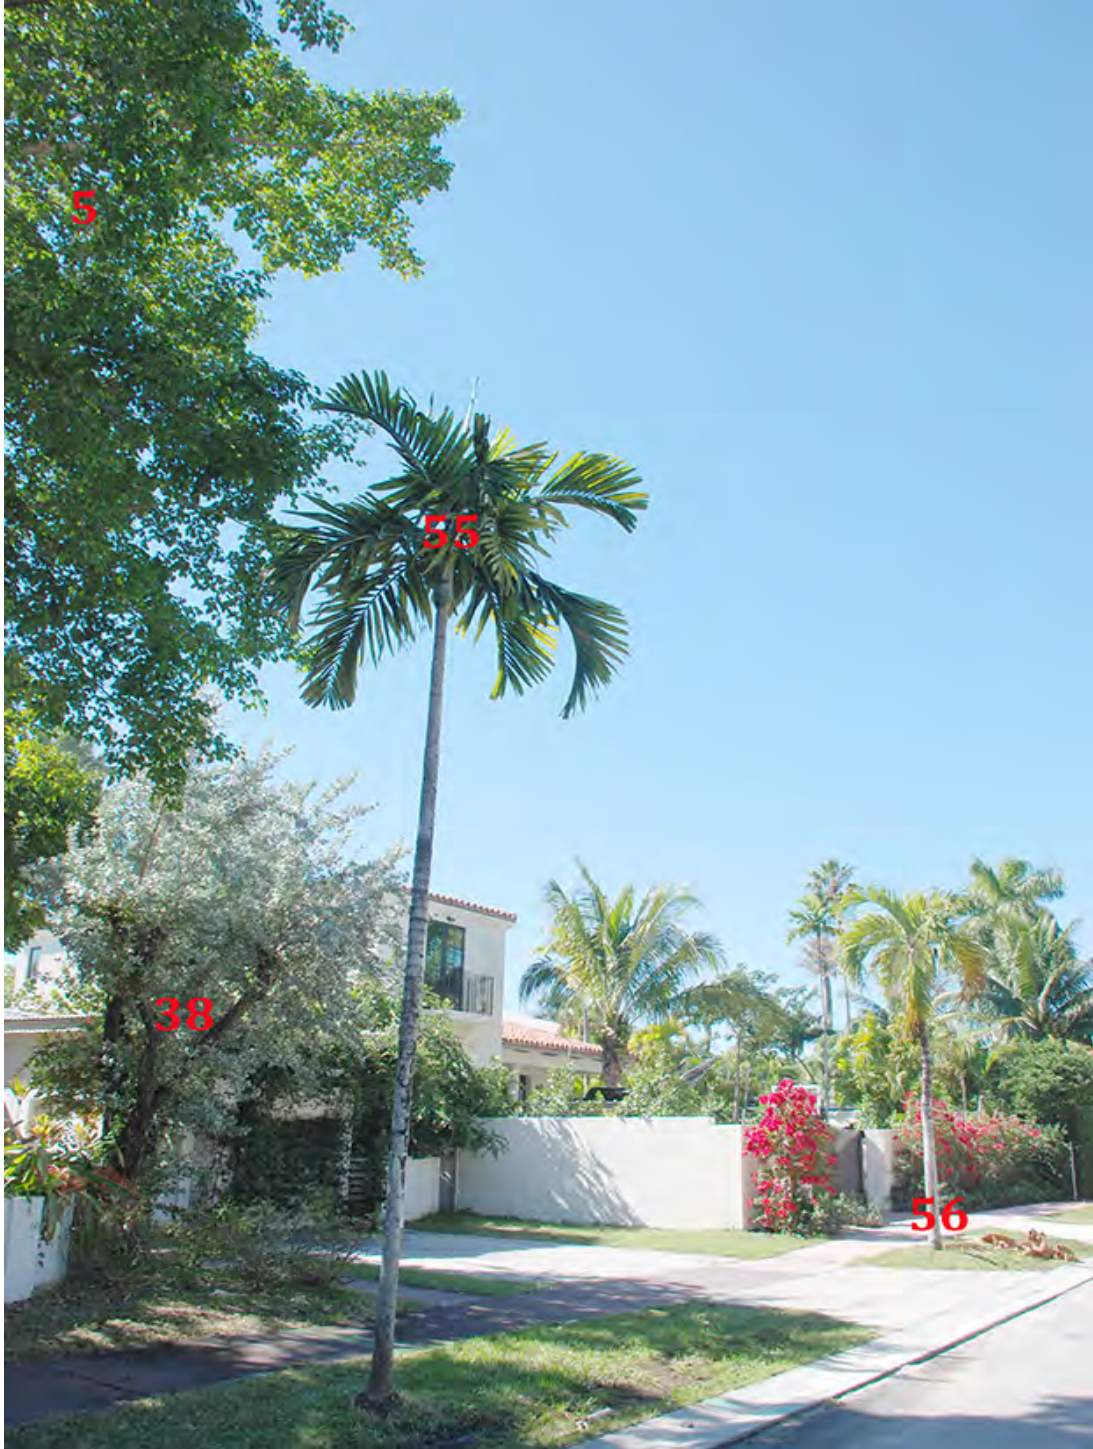
Photo 32 above are palms 55 & 56.

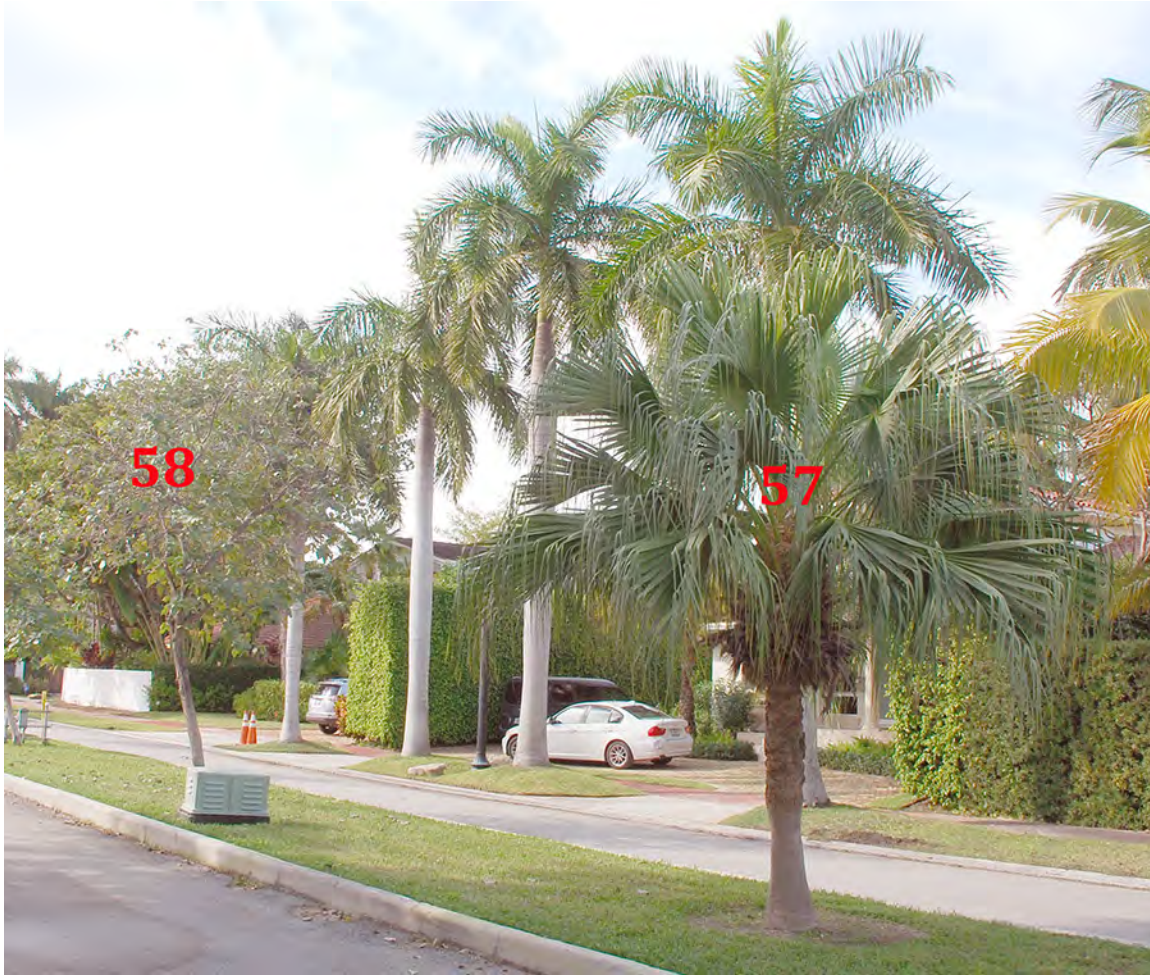
Photo 33 above is palm 57 and tree 58 in the median.

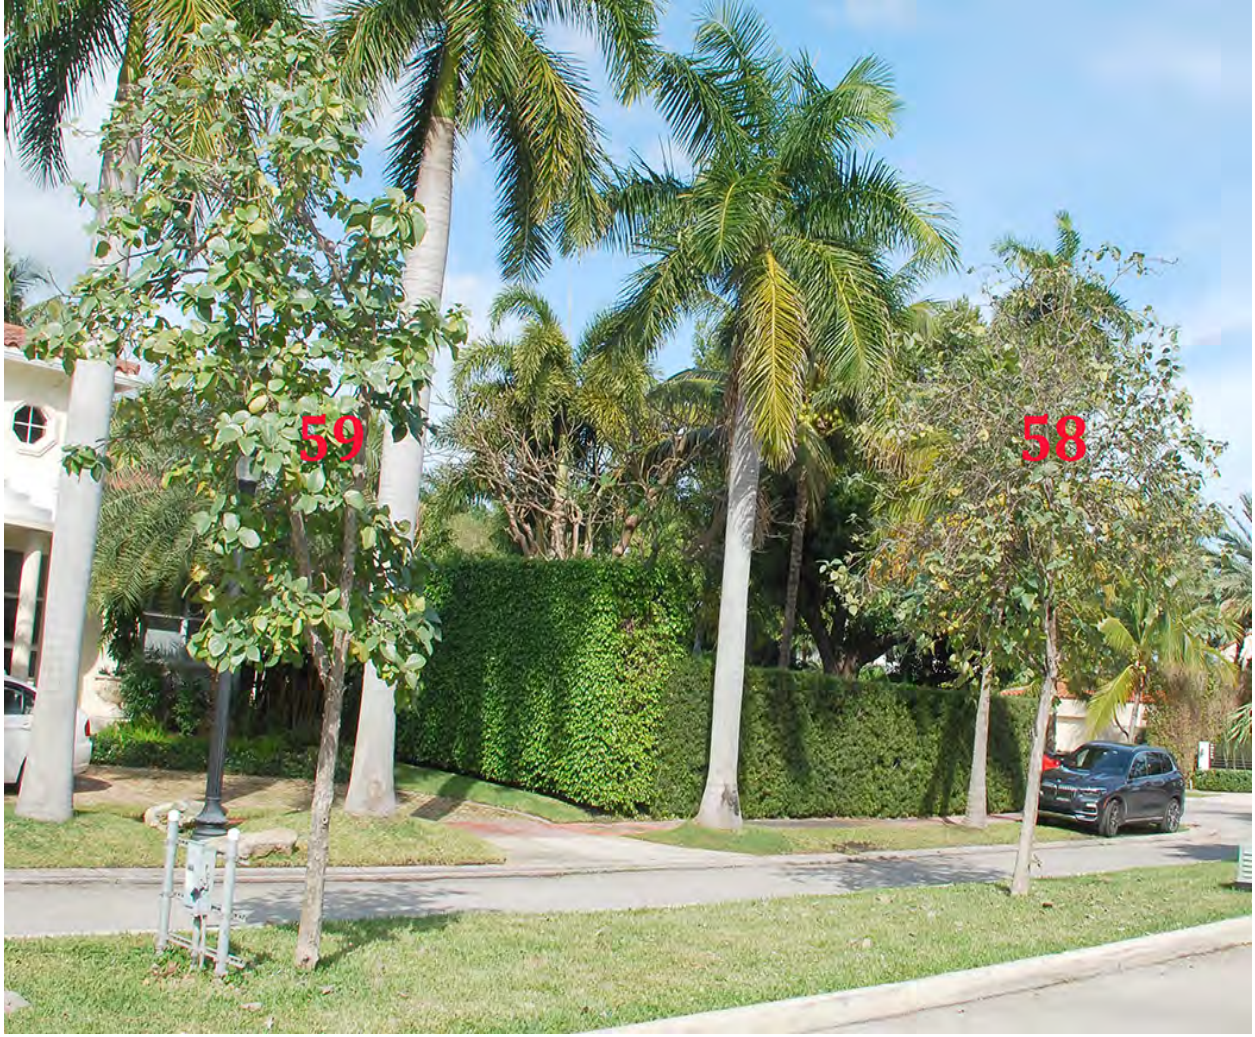
Photo 34 above are trees 58 & 59. See following photos.

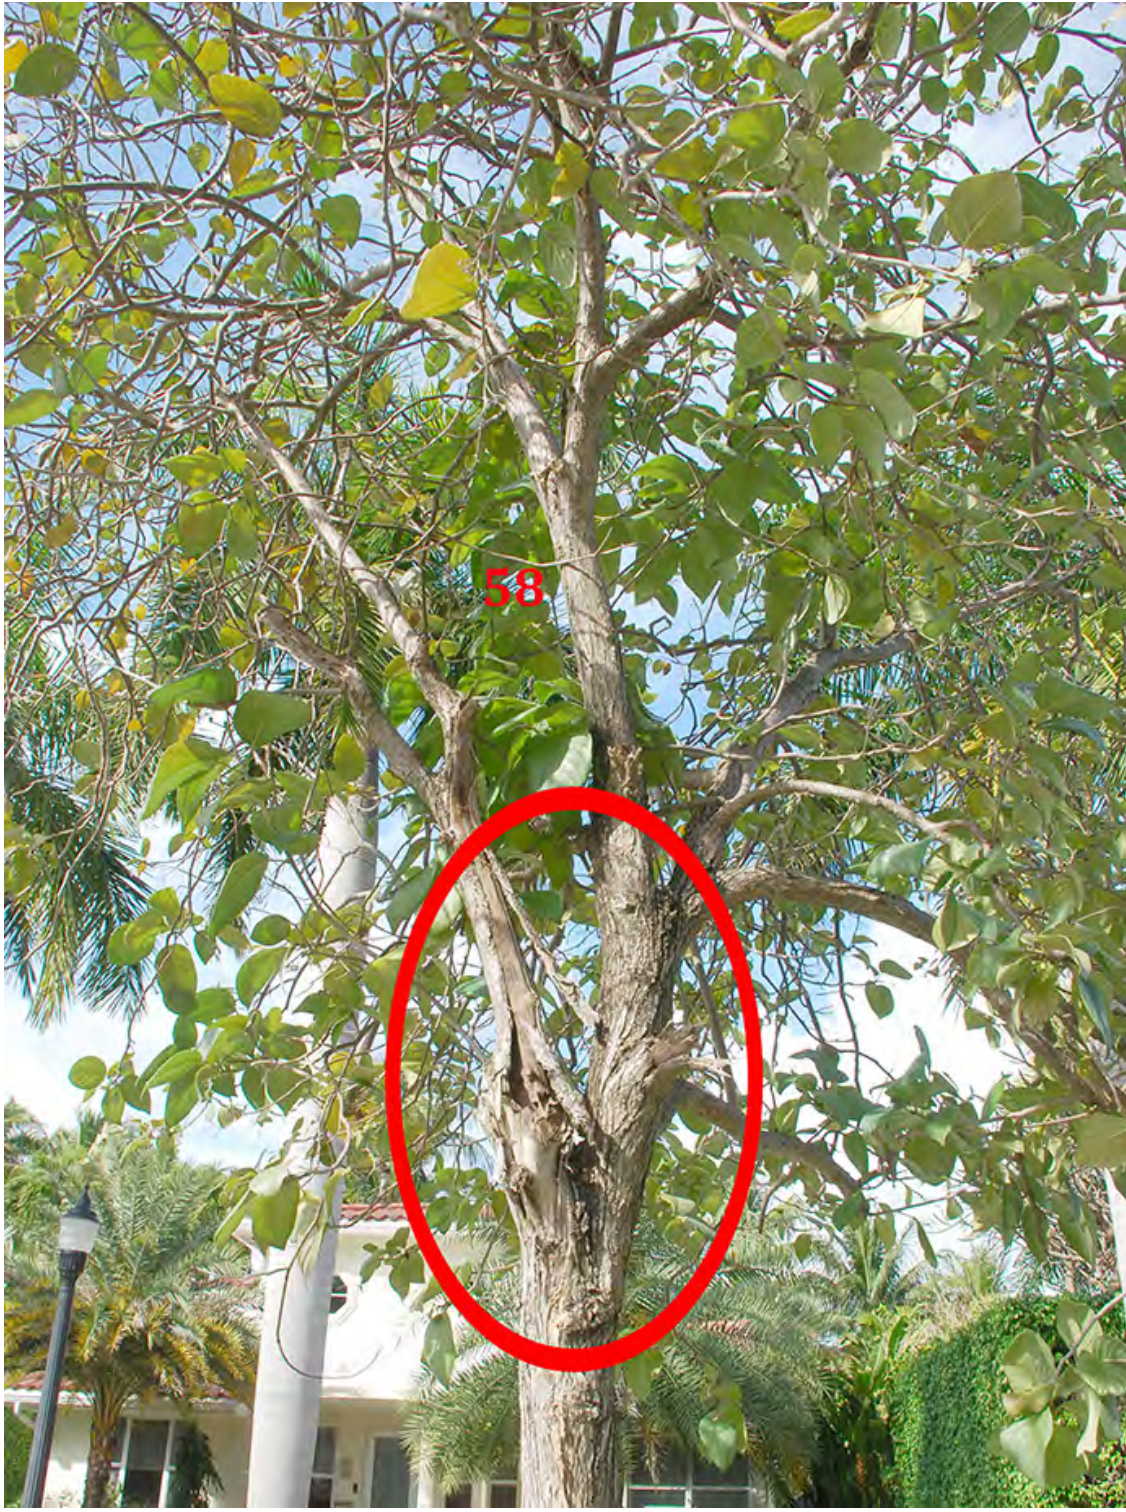
Photo 35 above shows where a branch had been torn-out and has resulted in decay and very weak remaining branch attachments.

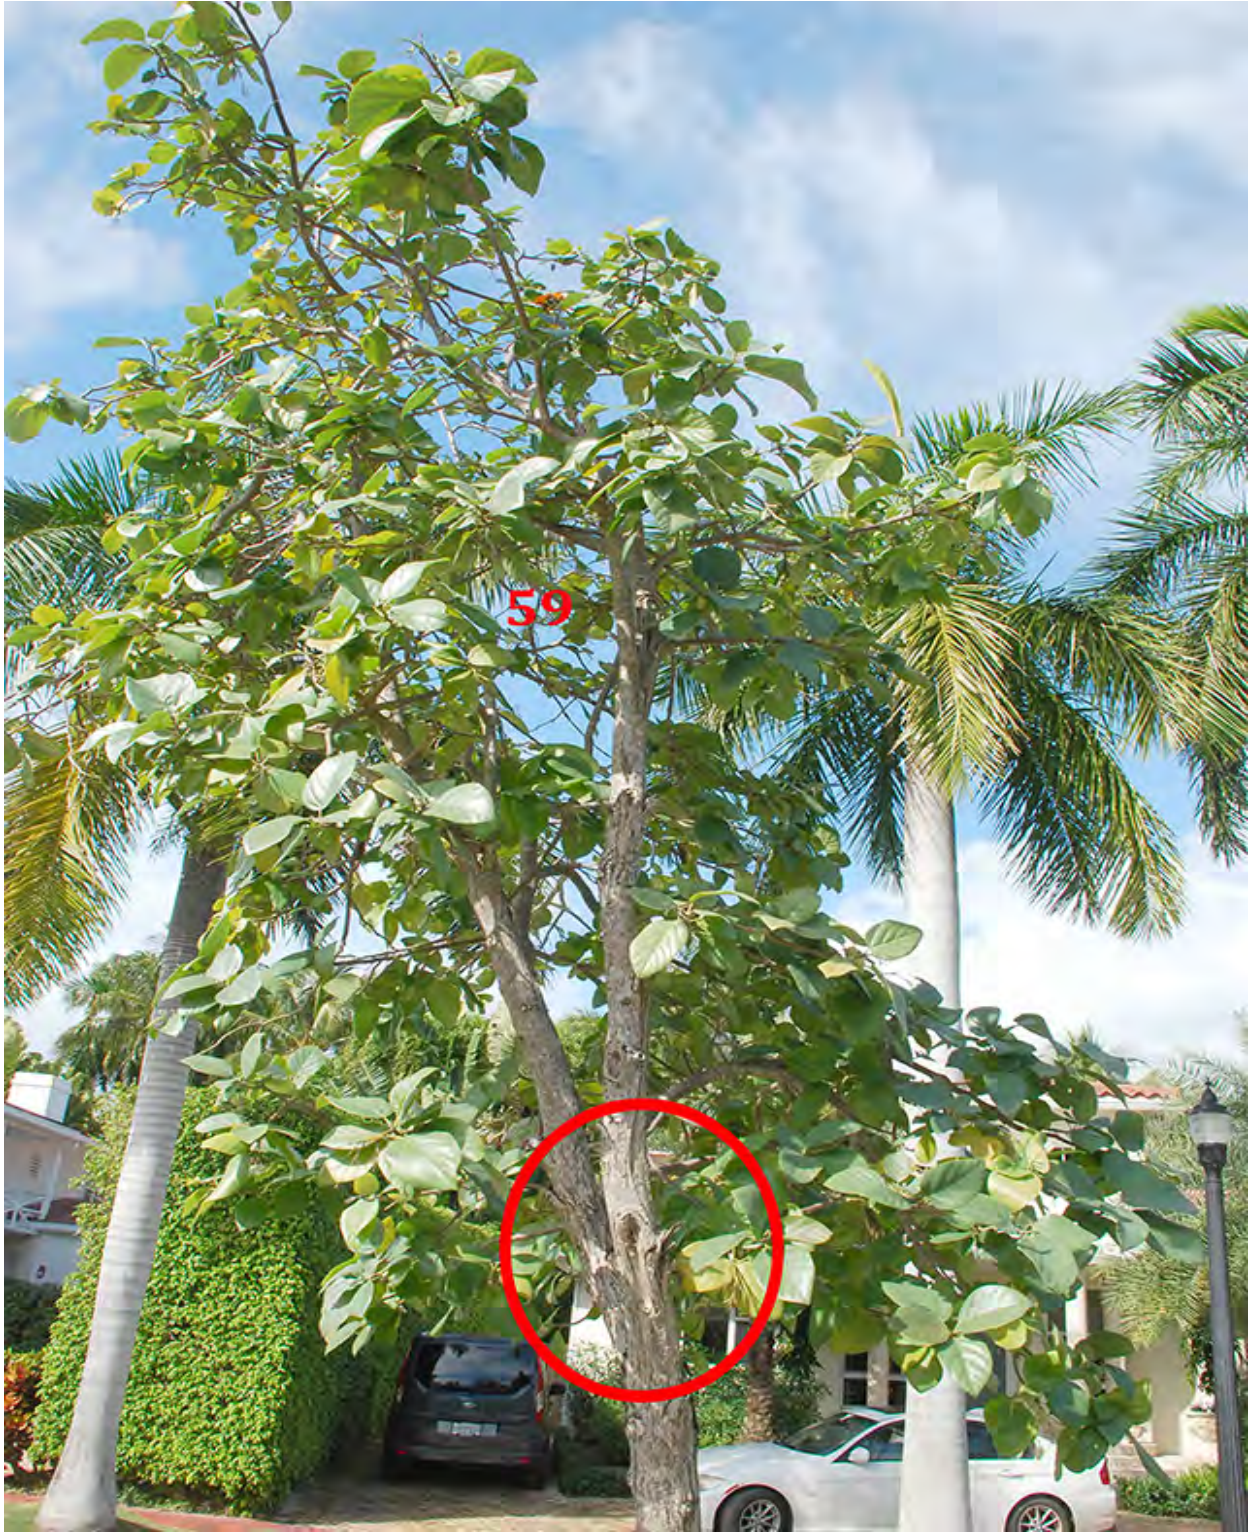
Photo 36 above shows where a branch had been torn-out and has resulted in decay and very weak remaining branch attachments.

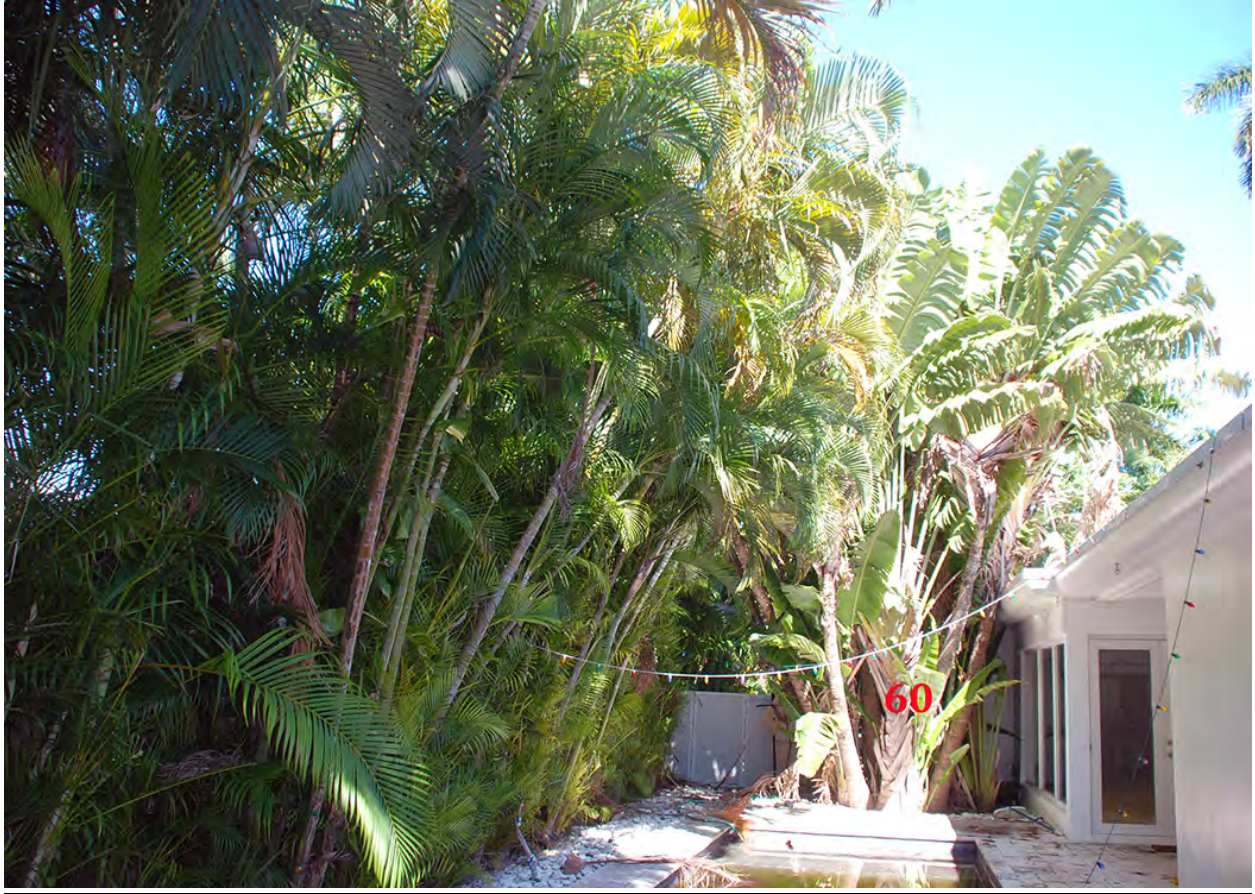
Photo 37 above is traveler's tree 60 viewed from the south.

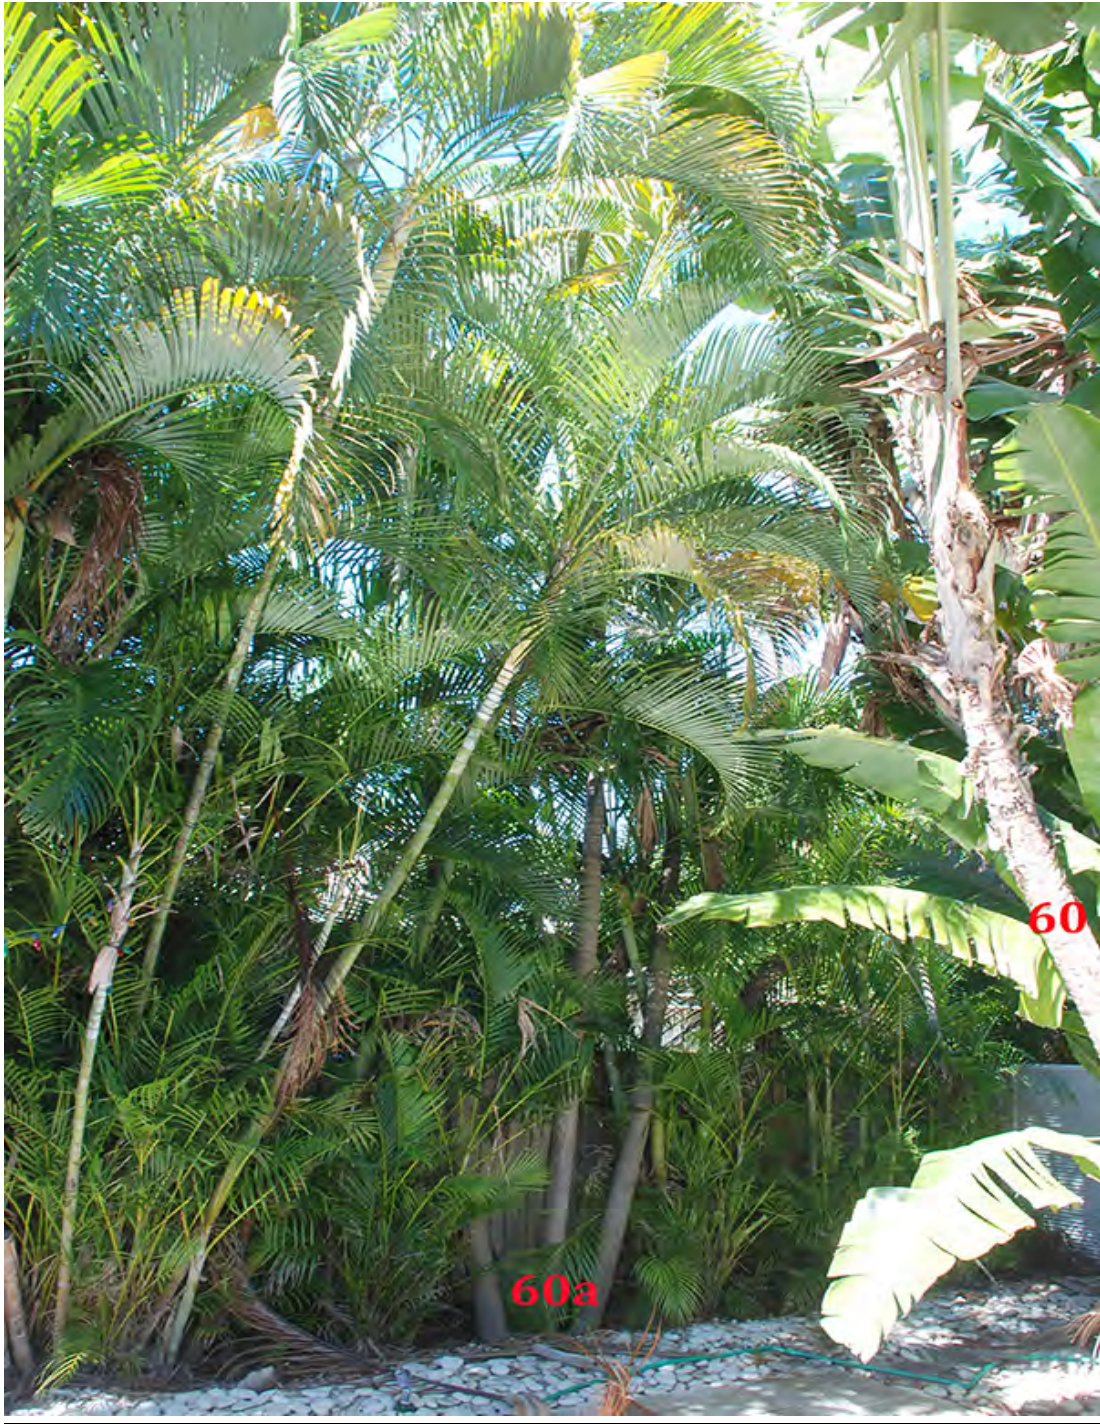
Photo 38 above is multi-trunked palm 60a.

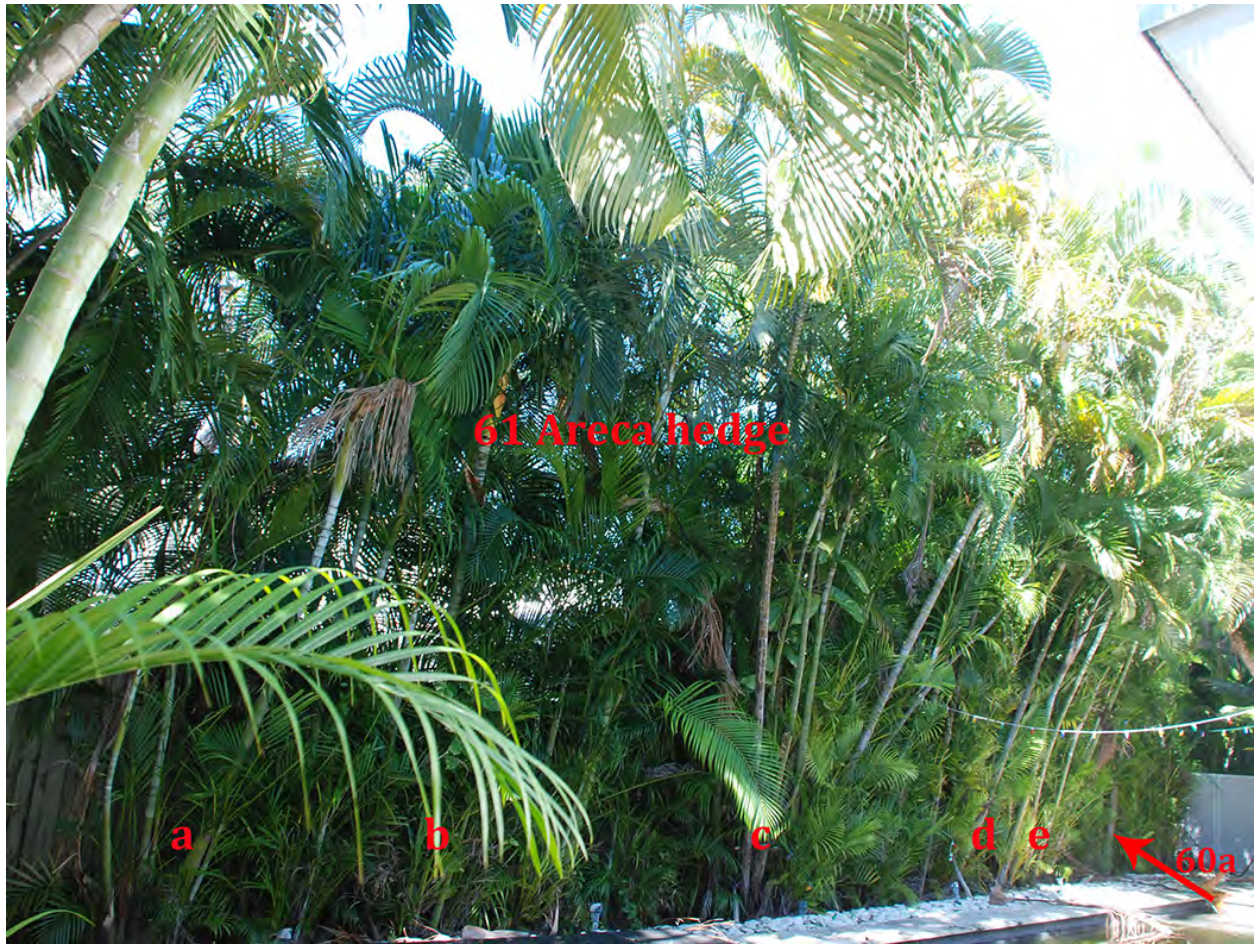
Photo 39 above are palms 61a, 61b, 61c, 61d & 61e.

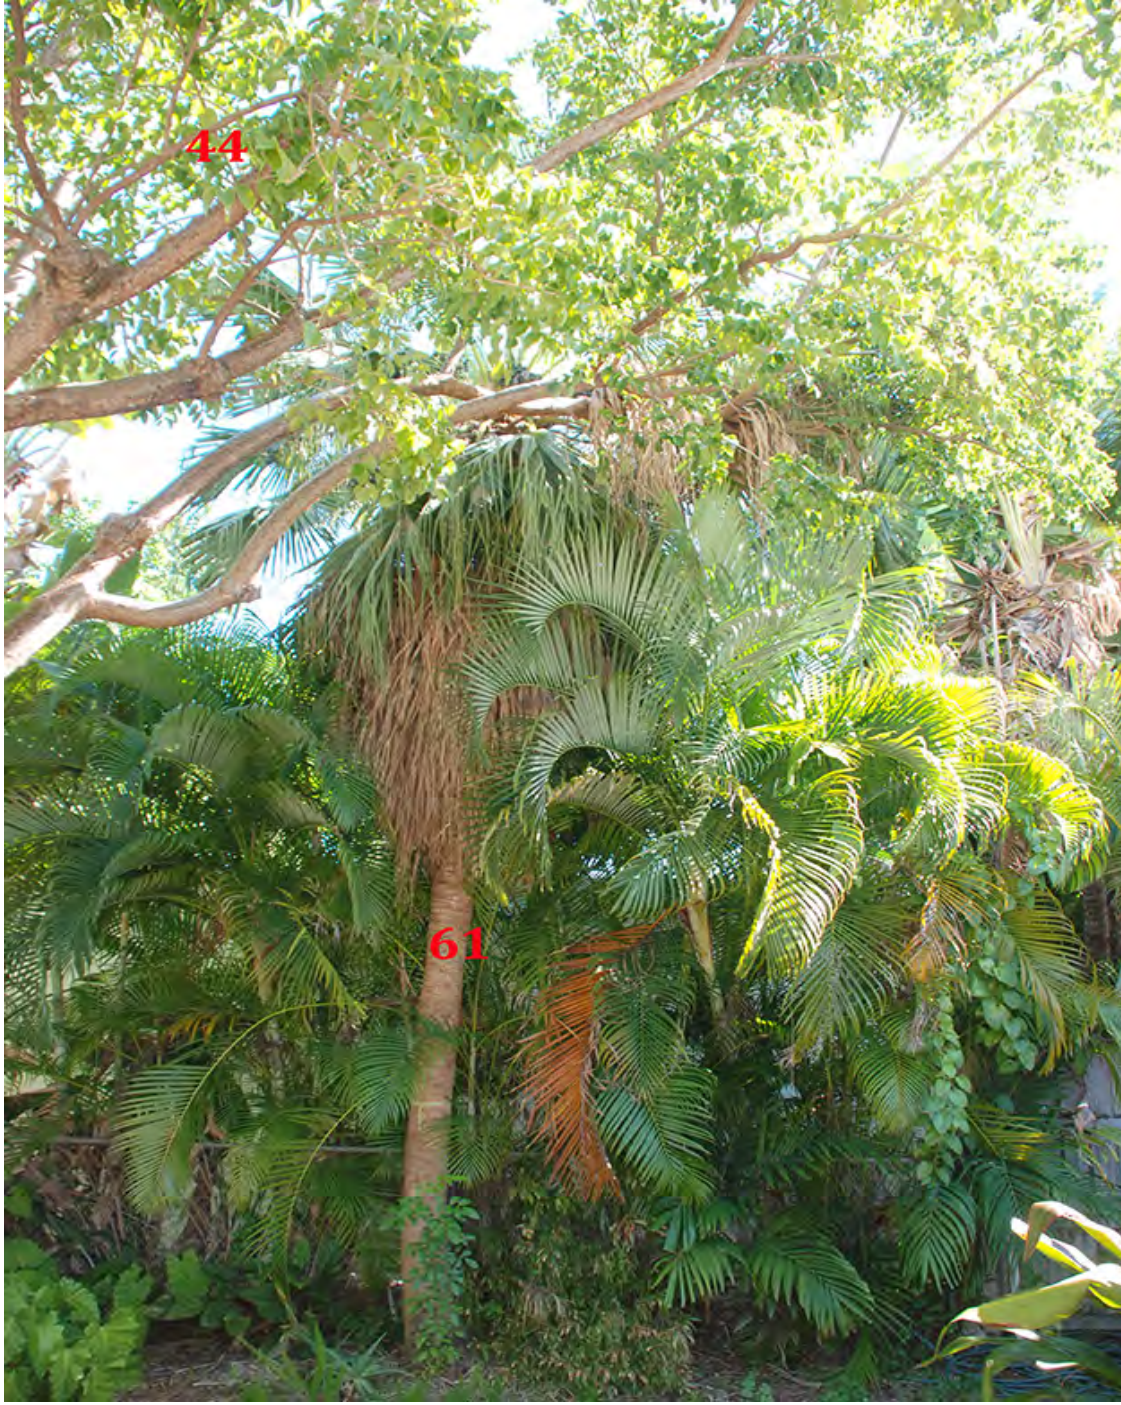
Photo 40 above is palm 61 viewed from the west.
