**5840 North Bay Road Miami Beach, Florida
Specimen Tree Arborist Report**

5840 North Bay Road Miami Beach, Florida
SPECIMEN TREE REPORT

May 6, 2018

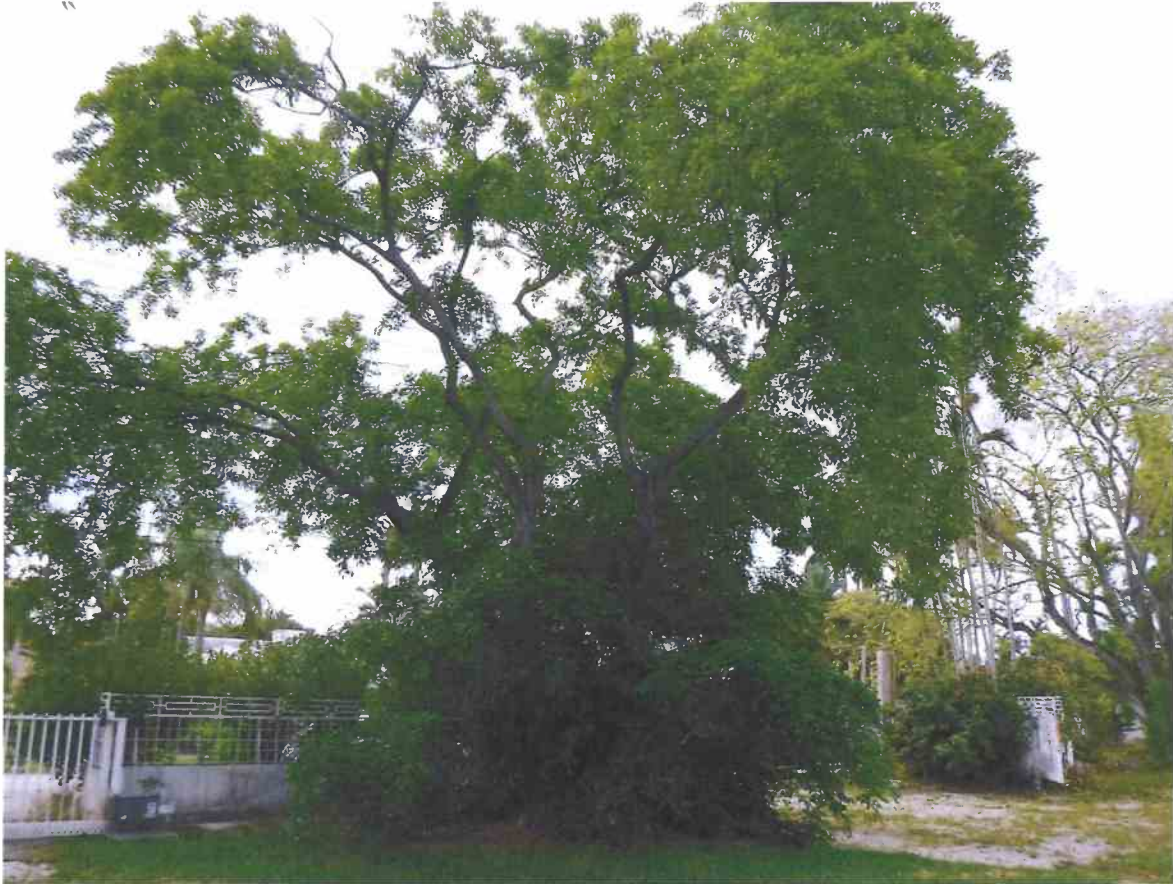
Tree number three

This Pongam is in fair condition with a 60% health condition. The tree is 35 feet tall and 46 feet wide. The diameter measured at two feet above grade was 40 inches. The tree has codominant stems and large pruning wounds on the south side. There is evidence of storm damage with broken limbs two to four inches in diameter within the canopy, and a chain girdling one of the main leaders.

View looking east Pongam, minor dieback within upper canopy

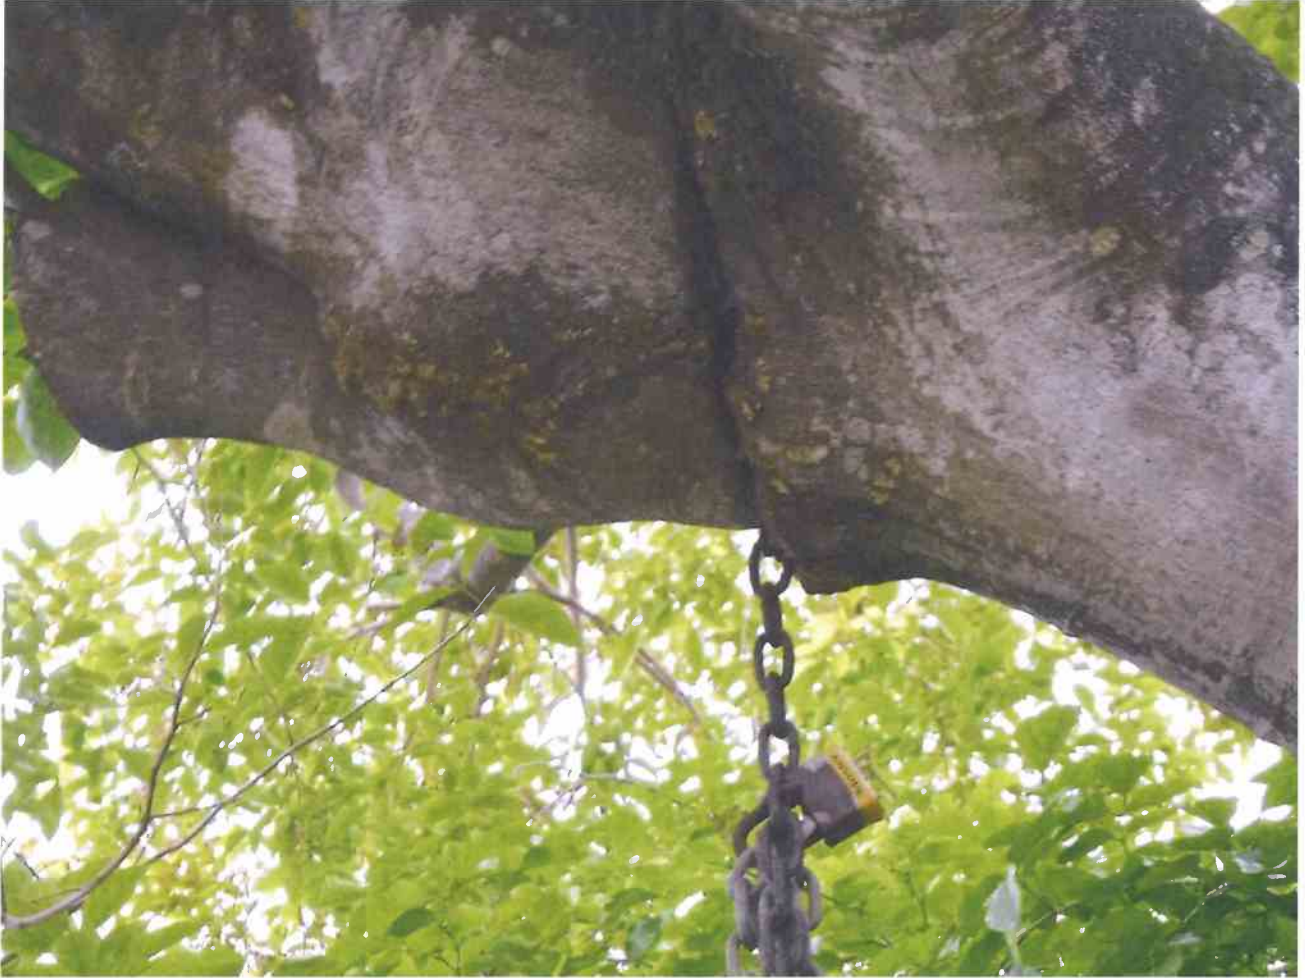
View of girdling material on east stem

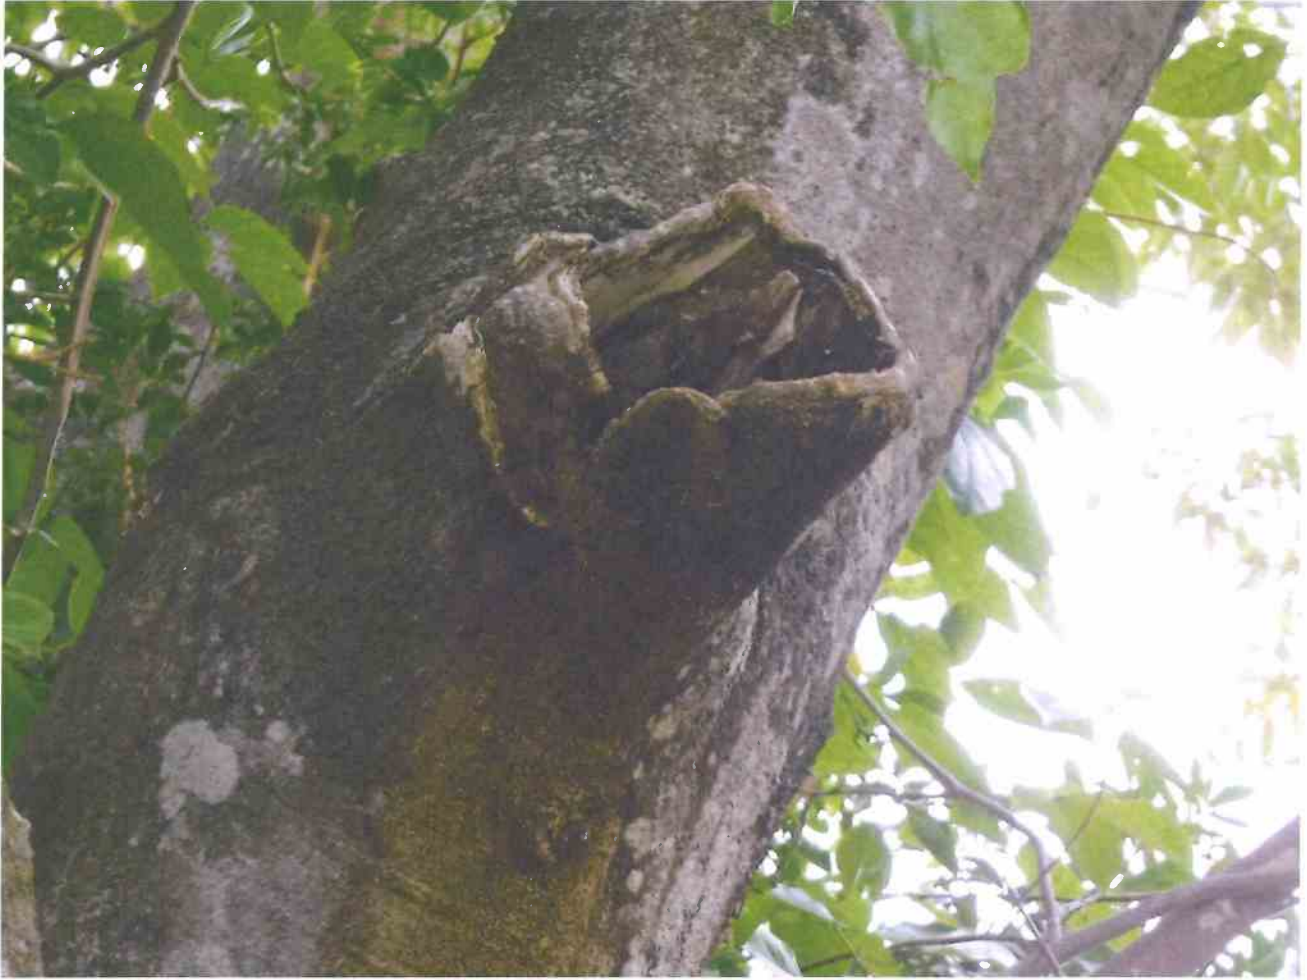
Decay in leader

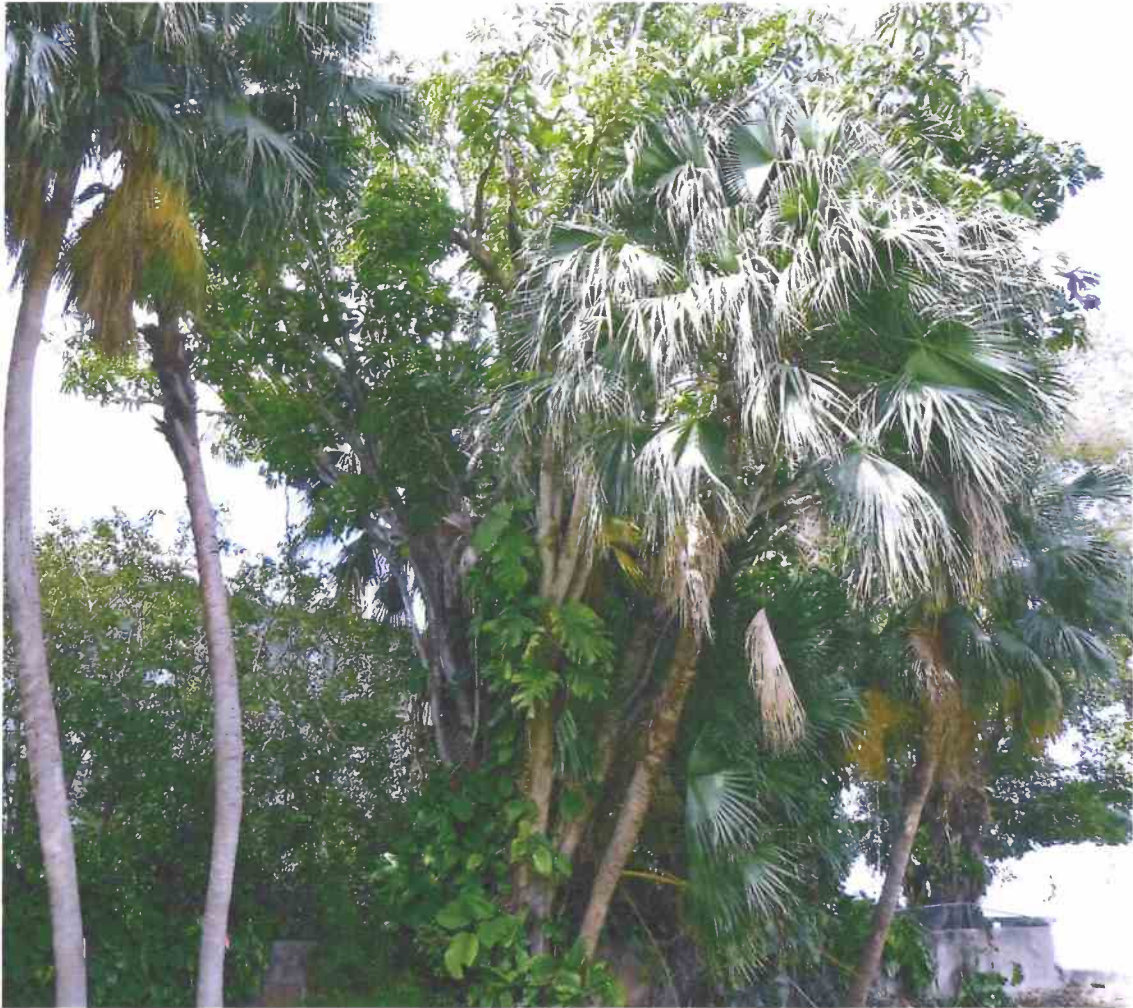
Tree number 20

This Umbrella tree has a height of 35 feet and a width of 24 feet. The diameter of the tree measured 61 inches at breast height and has a rating of 65%. It has two main codominant leaders and some dead branches greater than two inches in diameter. This tree is listed as a Prohibited Species per Miami-Dade Chapter 19.

View of tree looking south west

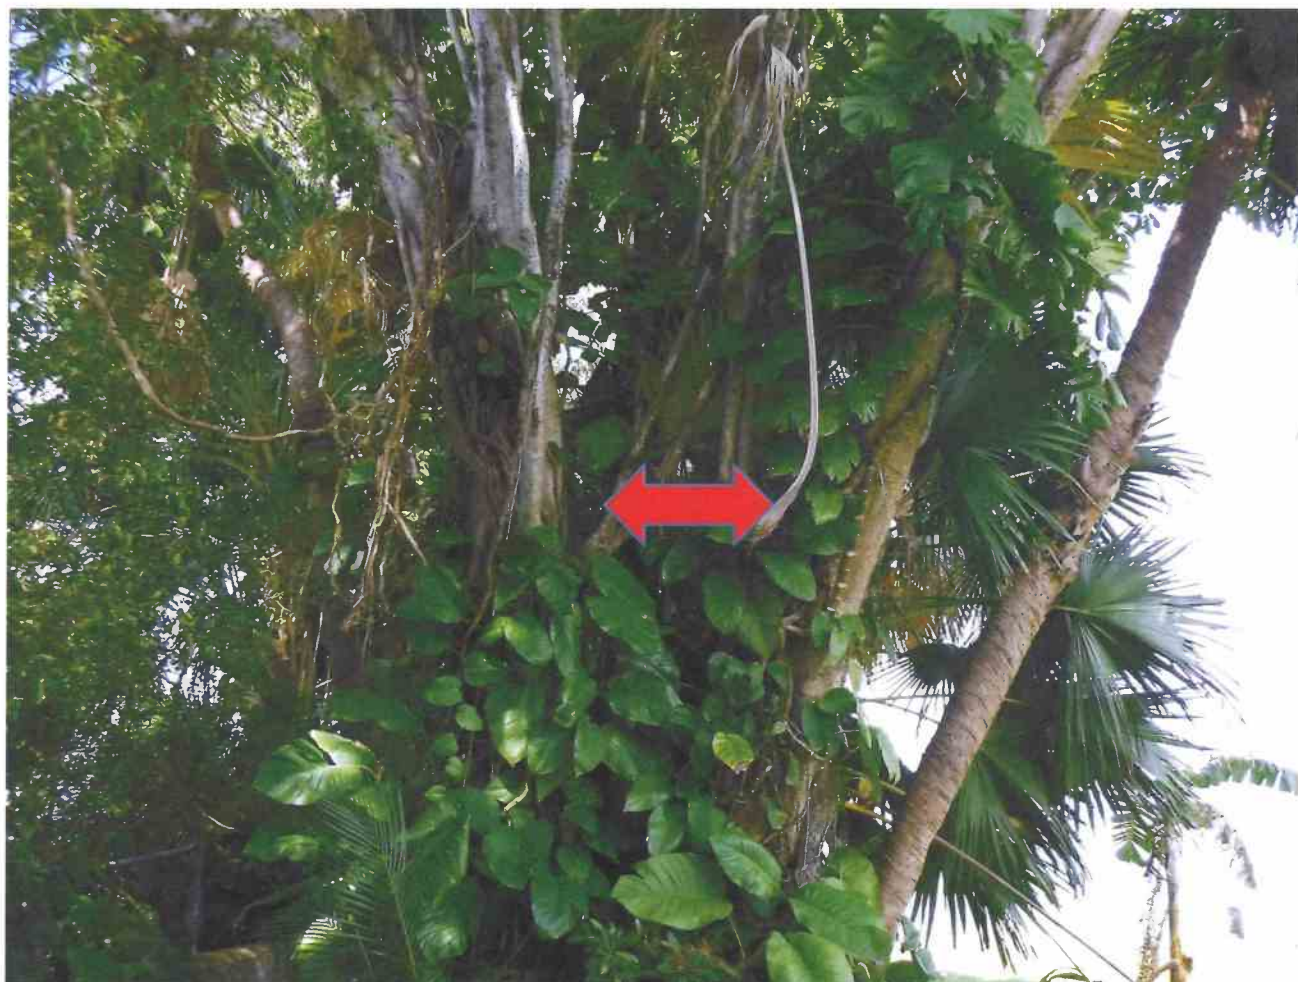
View of codominant leaders

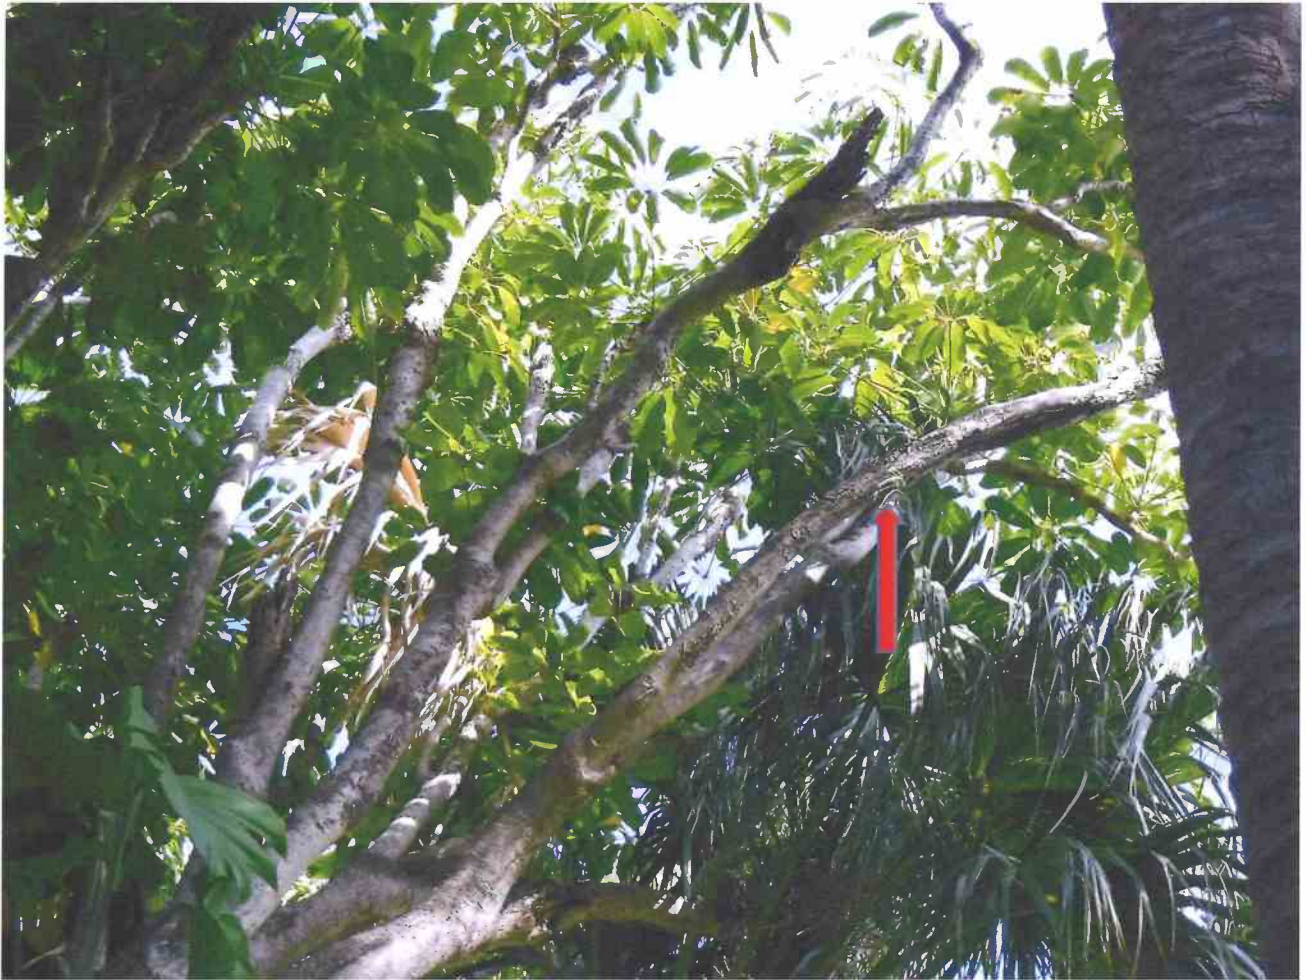
View of dead branches

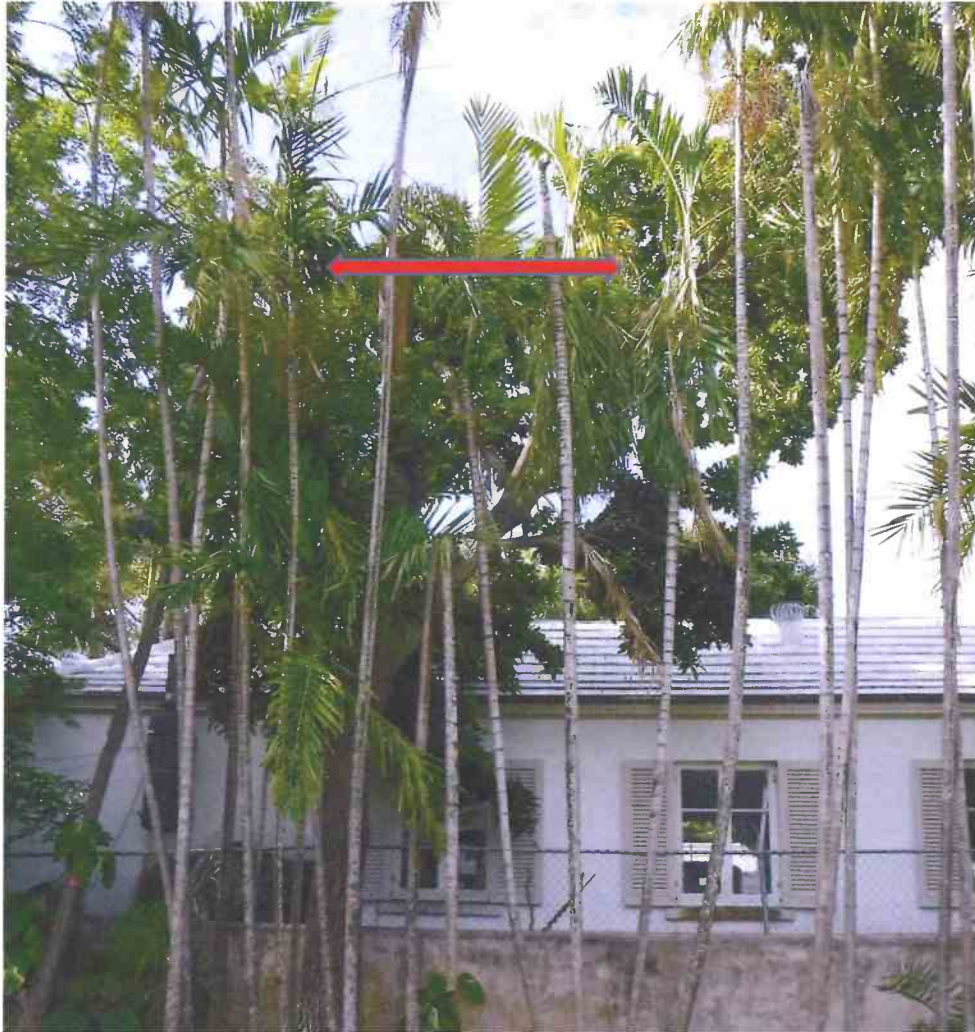
Tree number 26

The Sapodilla is a mature tree with a height of 30 feet and a width of 22 feet and a diameter of 18 inches measured at breast height. It has a health rating of 40%, there is some storm damage to the dominant central leader, as well as an uneven crown hanging over the south neighbor's house.

View looking south

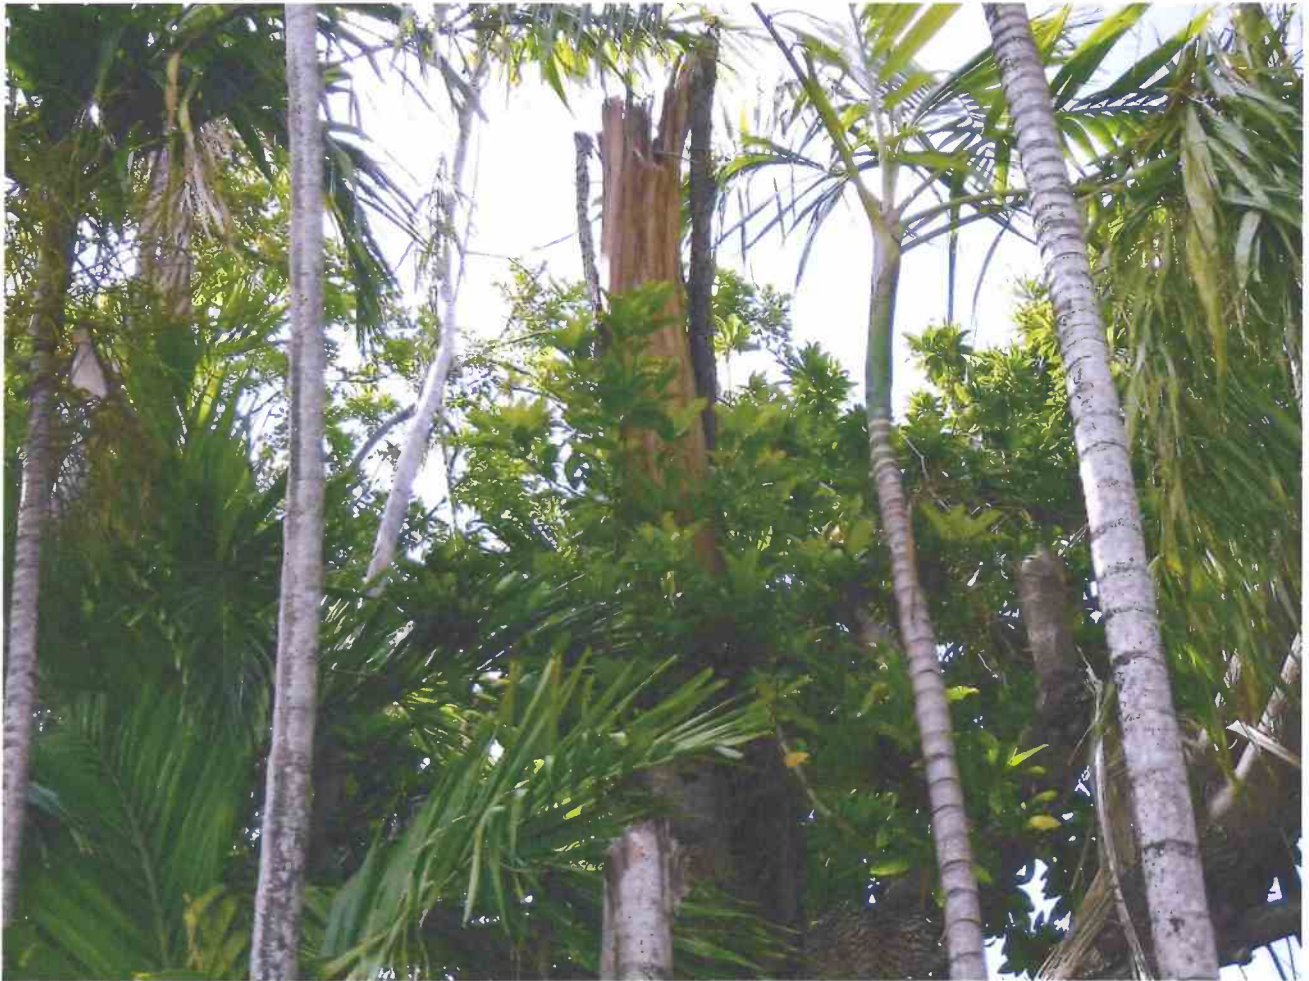
View of broken leader

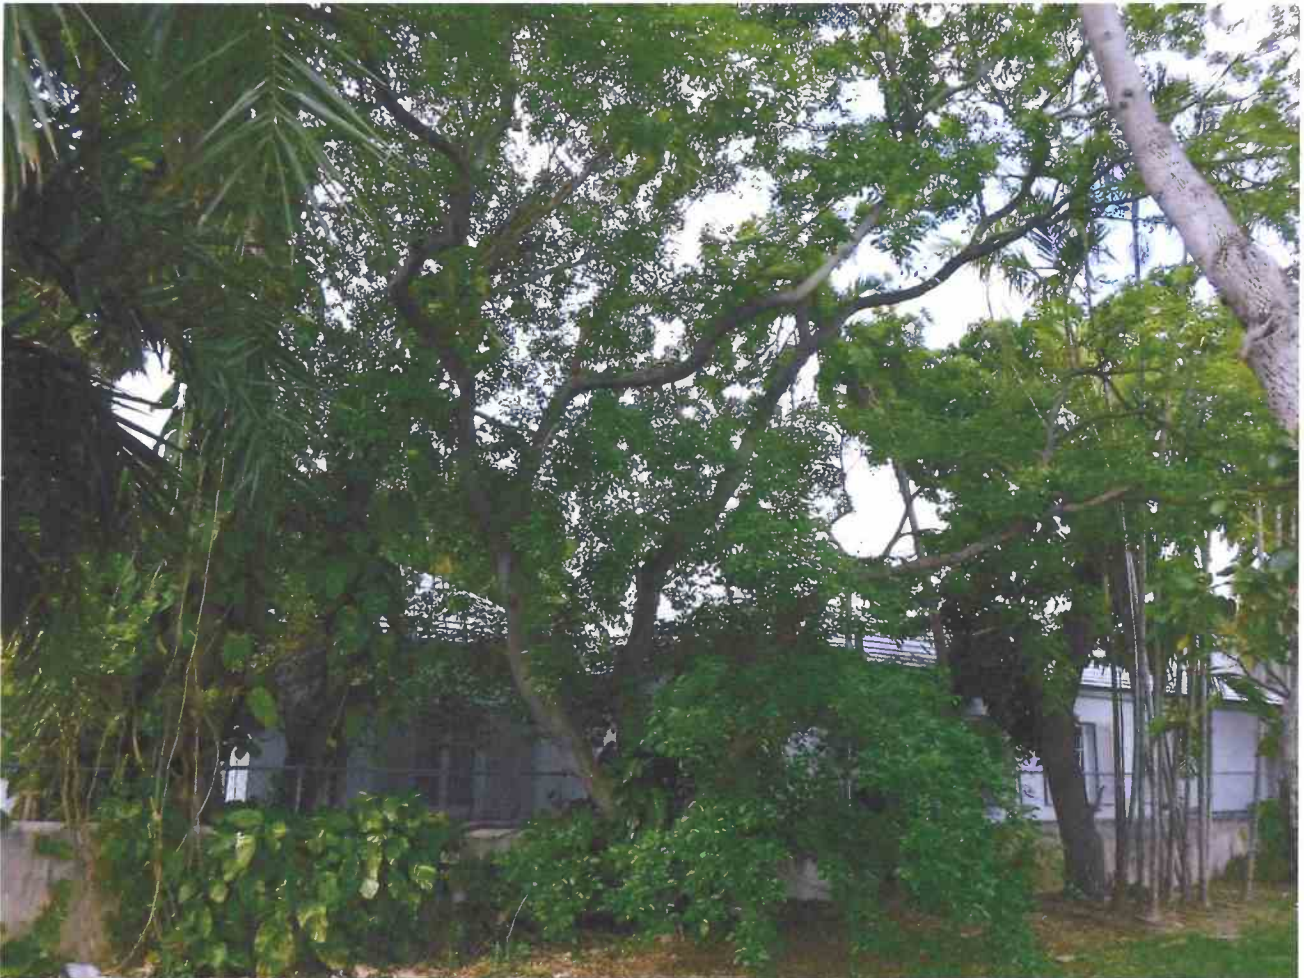
Tree number 28

This Pongam has a height of 40 feet and a width of 34 feet and two stems with diameters of 16 inches and 13 inches measured at breast height. The rating for this tree is 60%. The defects of this tree include codominant leaders and a pruning wound, the location for this tree is also poor.

View looking south west

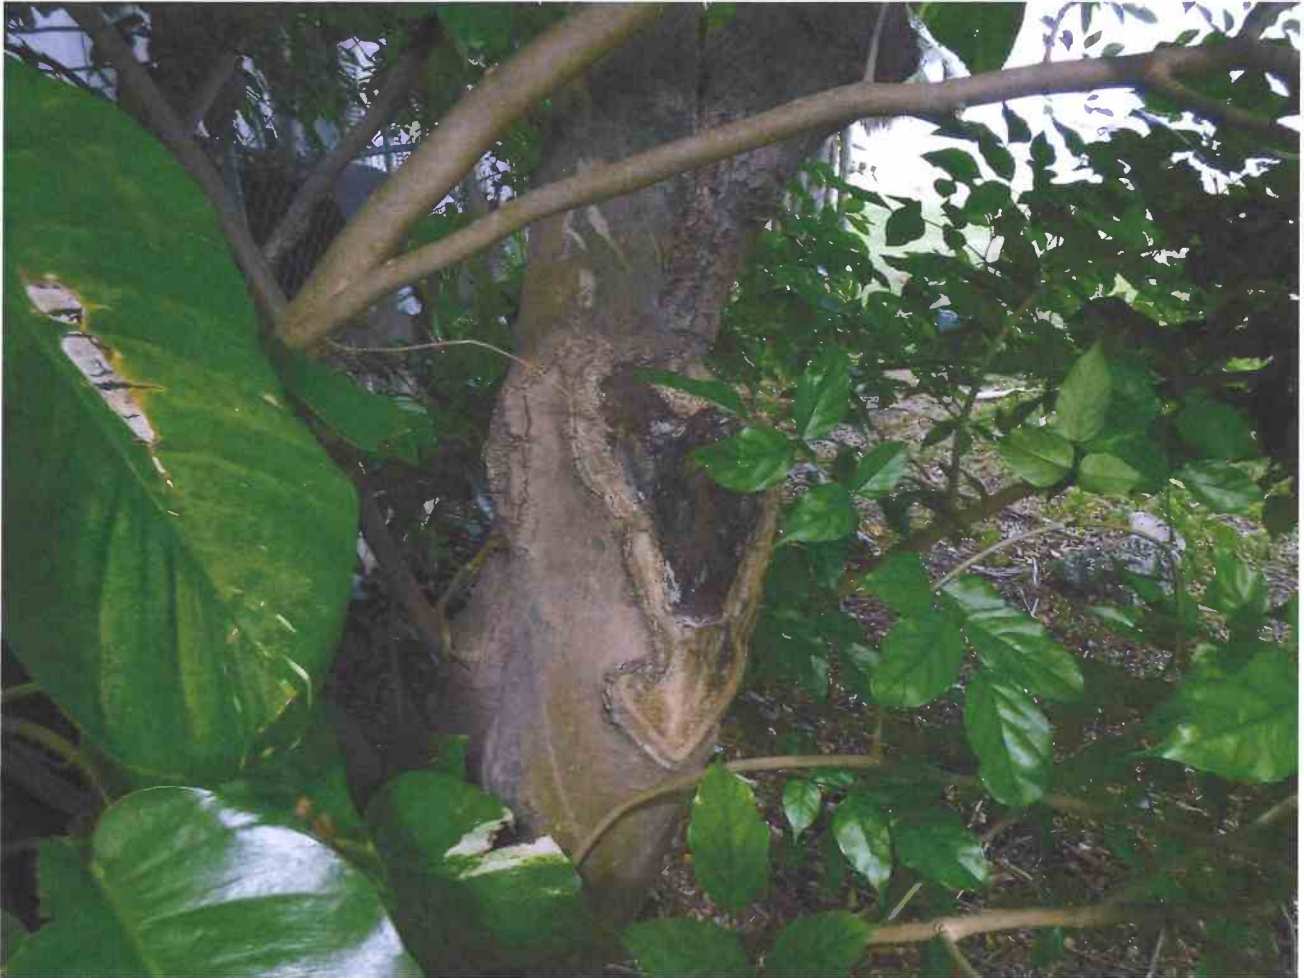
View of wound in stem

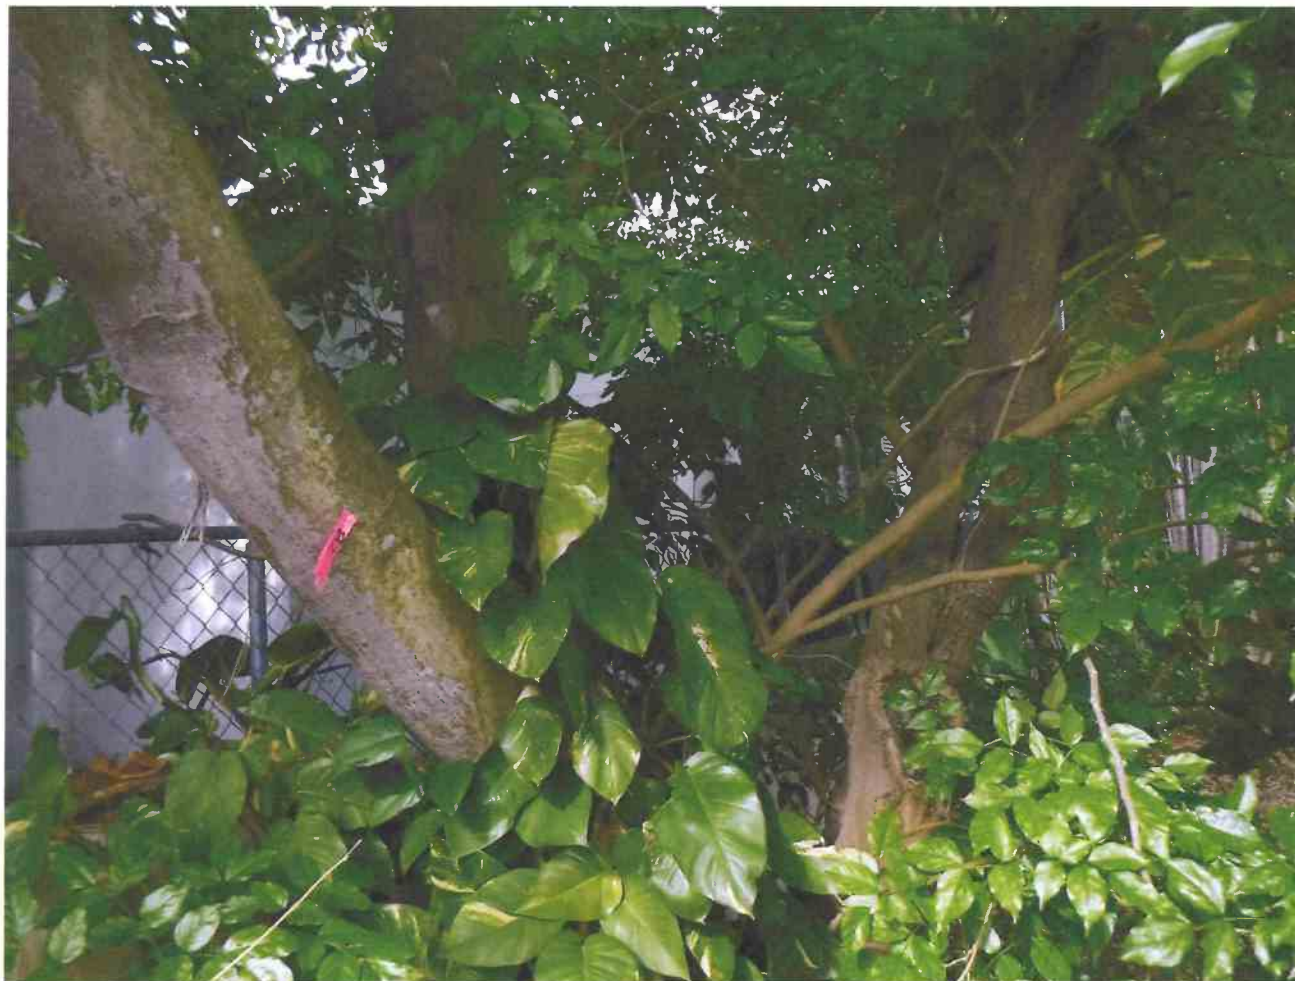
View of codominant leaders

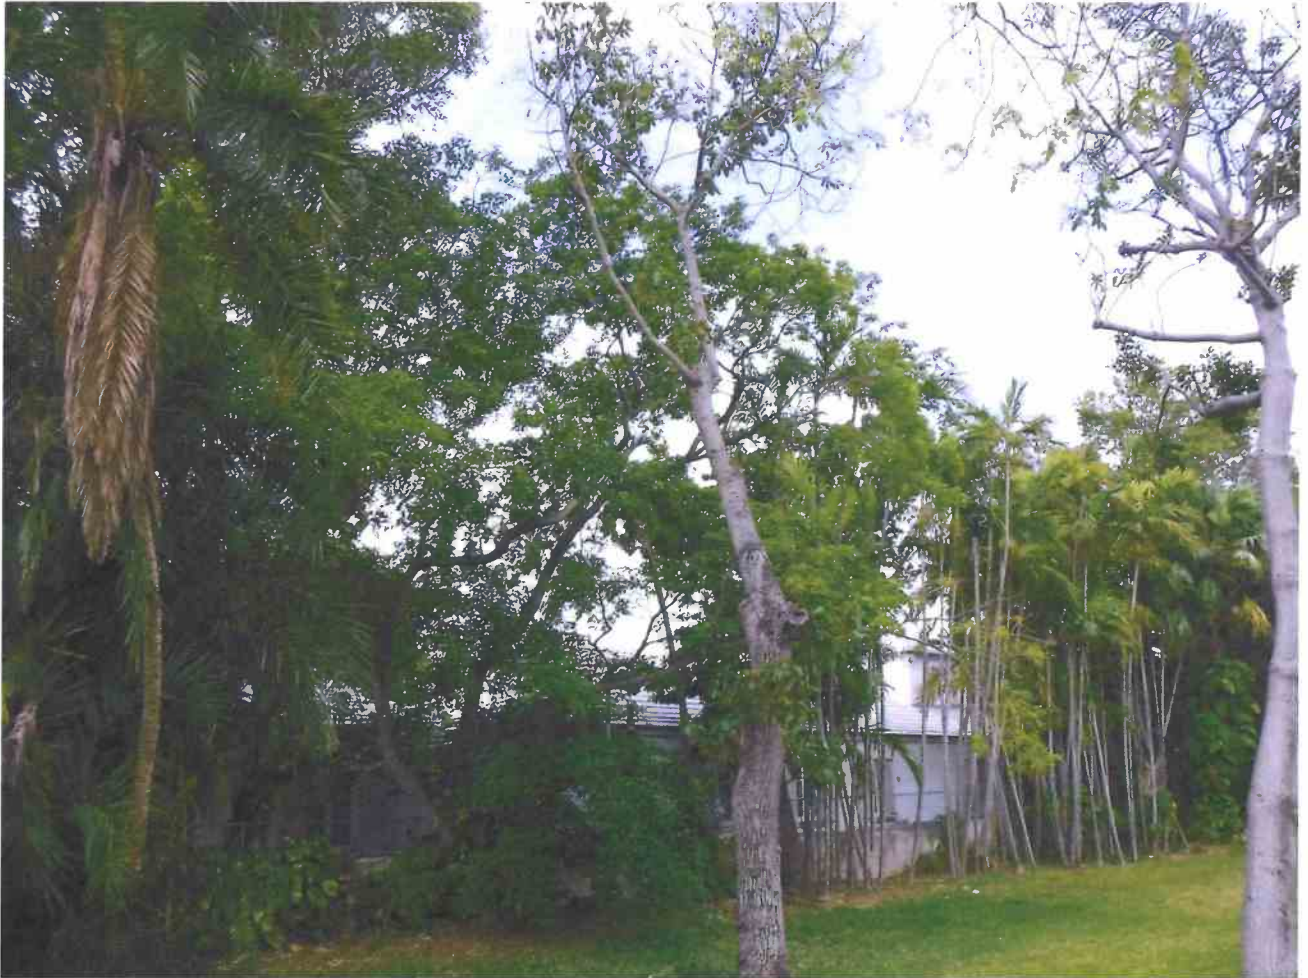
Tree number 30

The Avocado has a height of 40 feet ,a width of 14 feet and a diameter of 17 inches measured at breast height as well as a health rating of 30% due to previous topping/heading cuts, as well as the column of decay in the stem and the low live crown ratio. There is also sings of dieback in the crown.

View looking south west

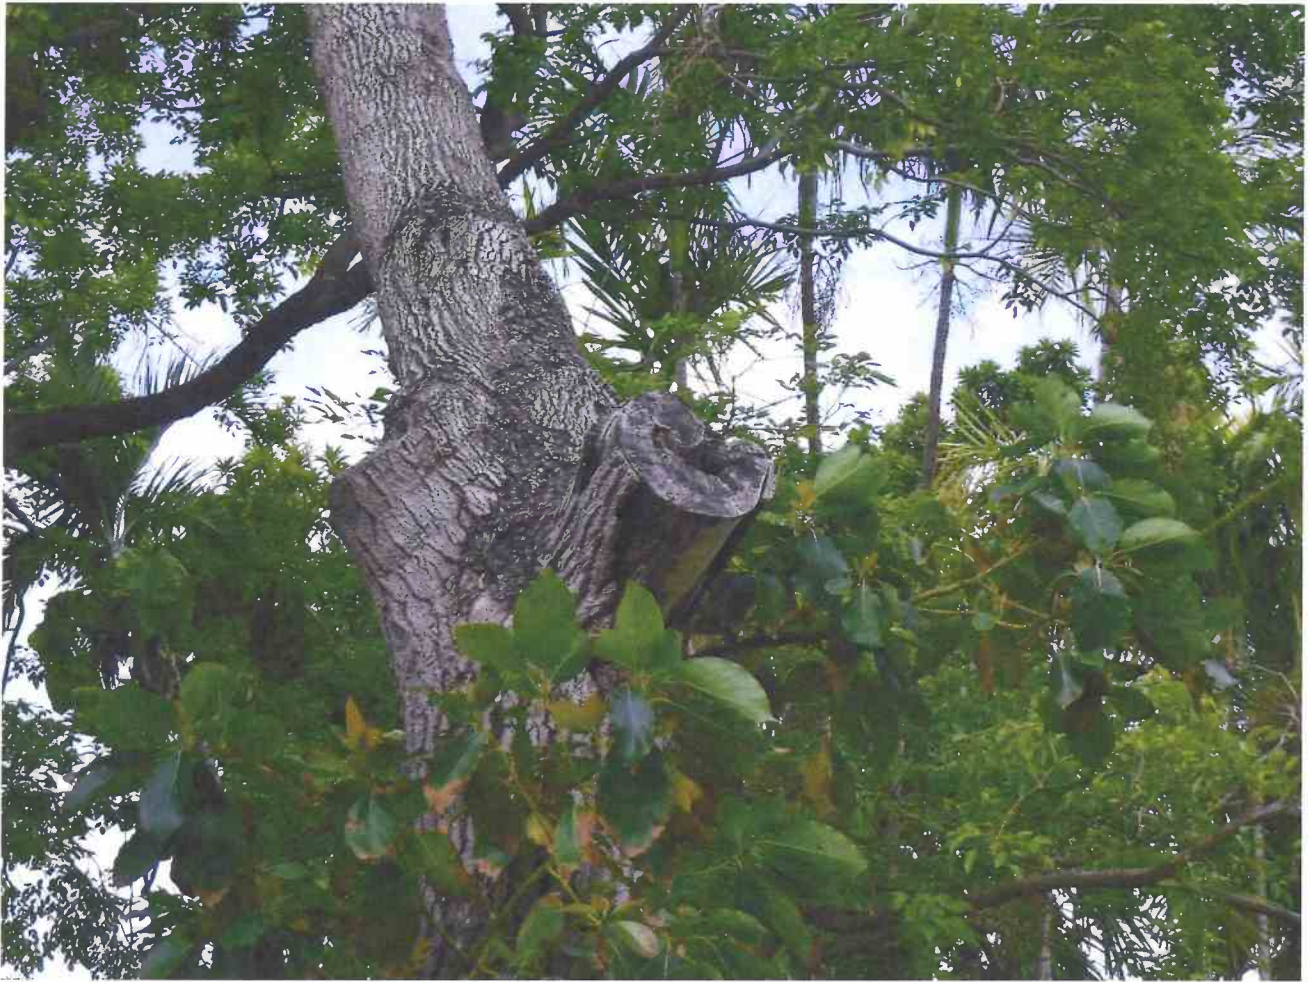
View of old pruning wounds

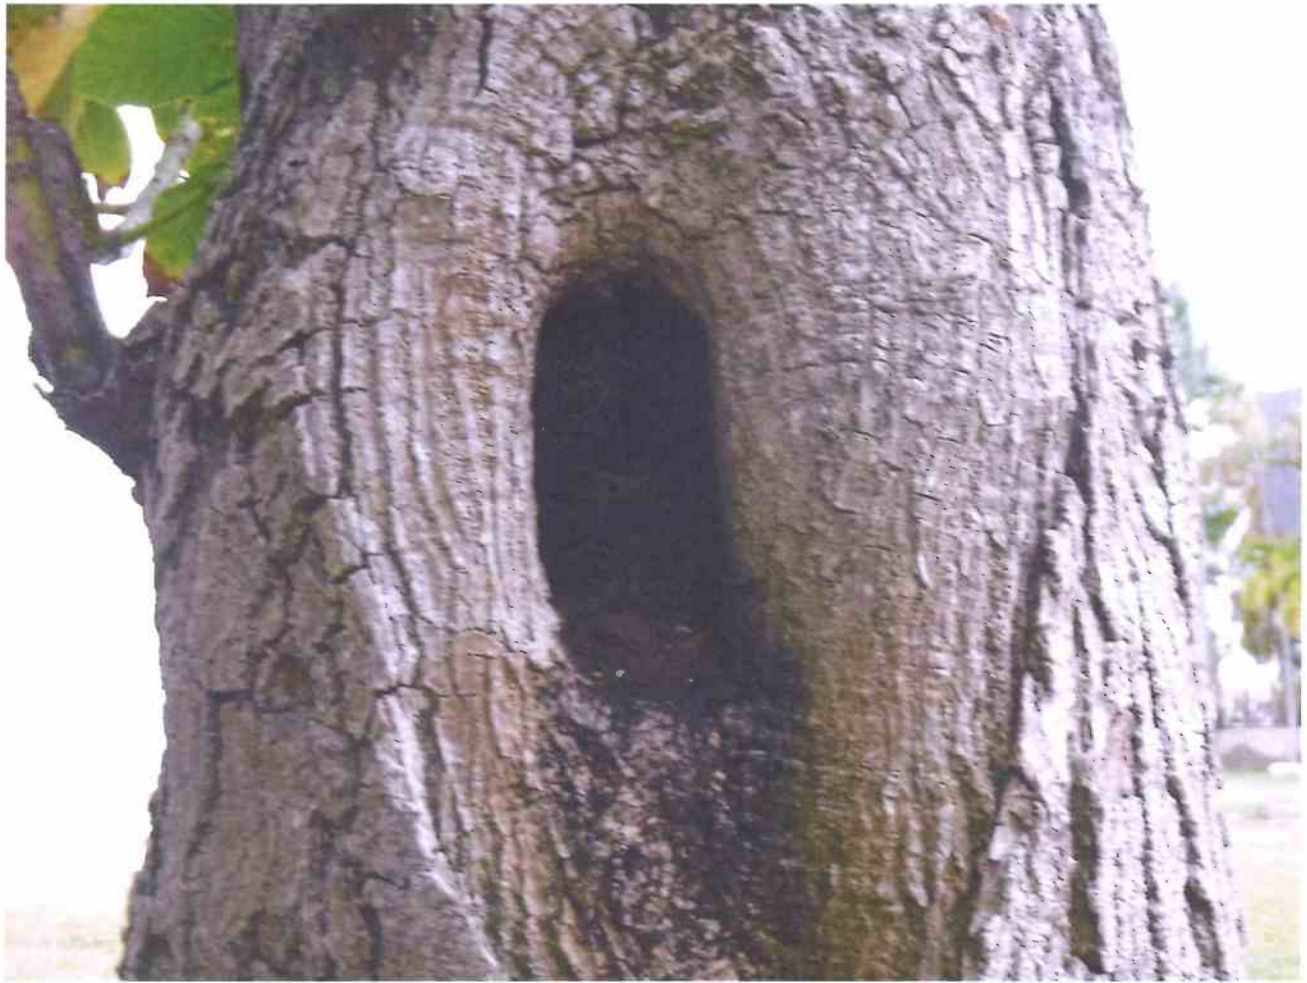
View of pocket of decay in stem

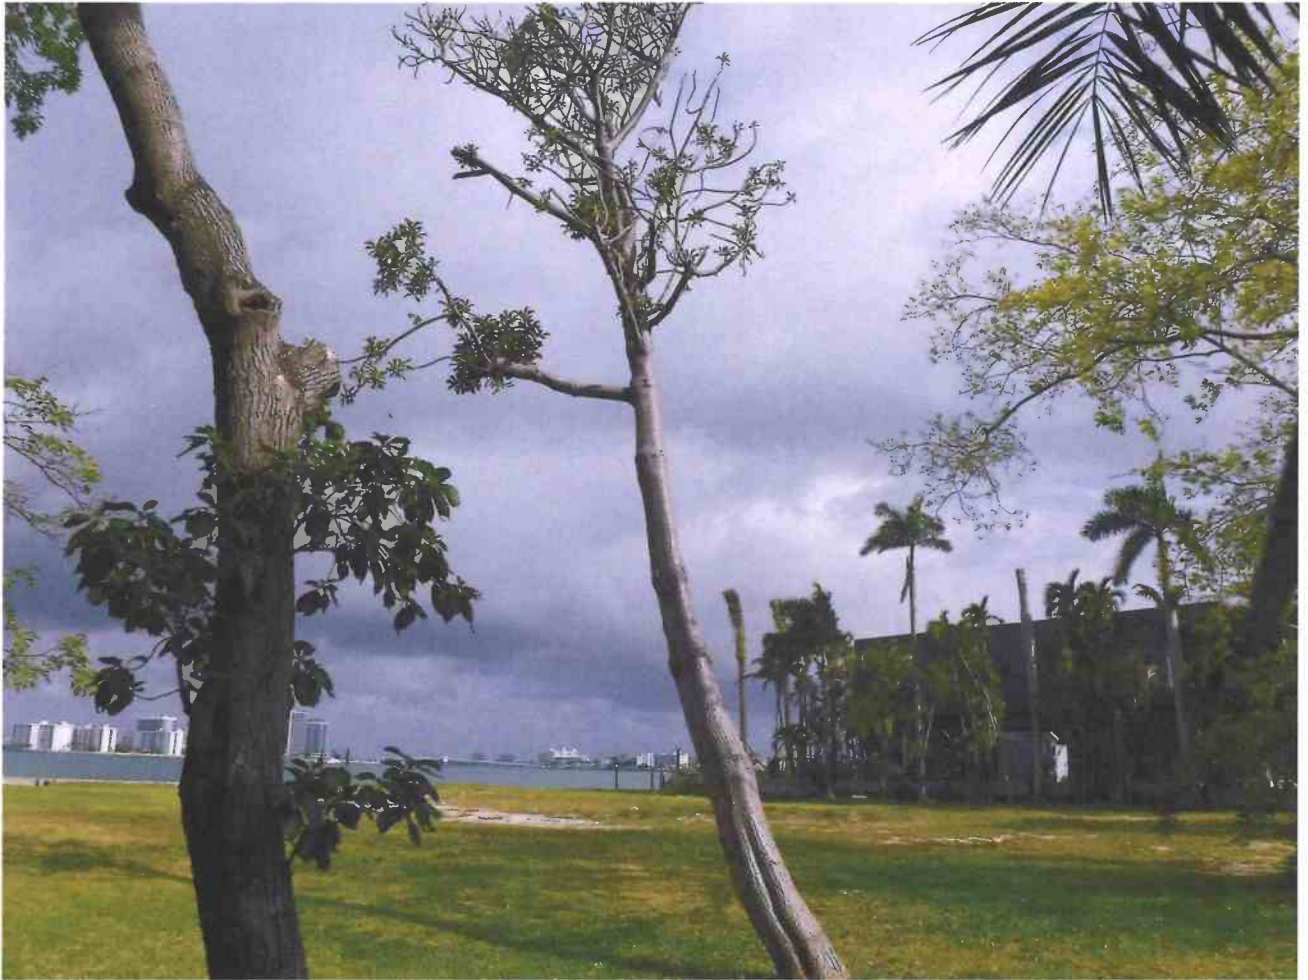
Tree number 31

This is a Euphorbia species with a height of 30 feet as well as a width of 10 feet and a diameter of 16 inches measured at breast height. It has a health rating of 45% due to the fact that it has a severe lean and evidence of soil heaving as well as a low live crown ratio.

View looking North West

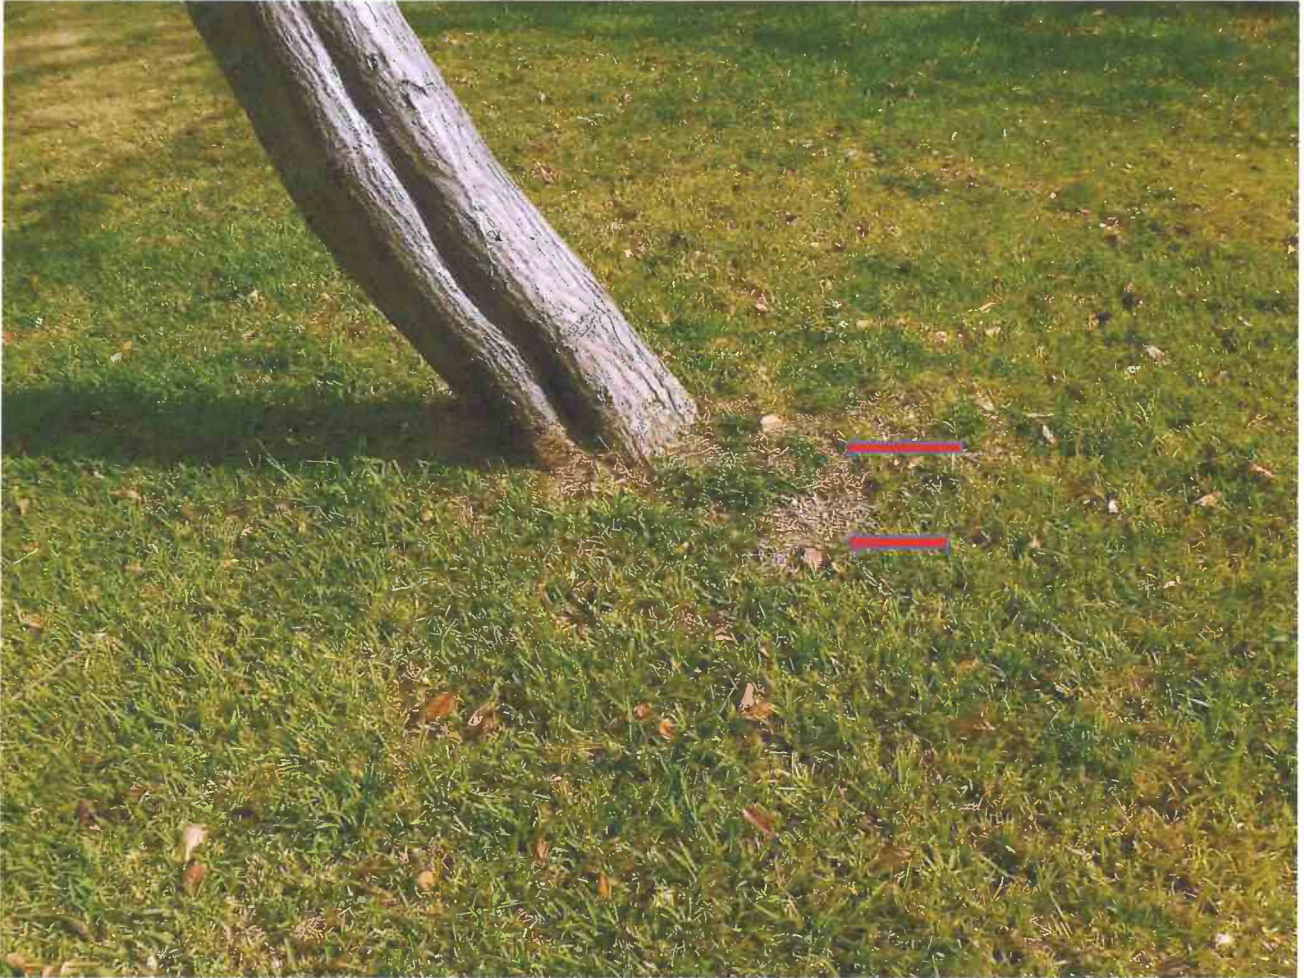
View of soil heaving

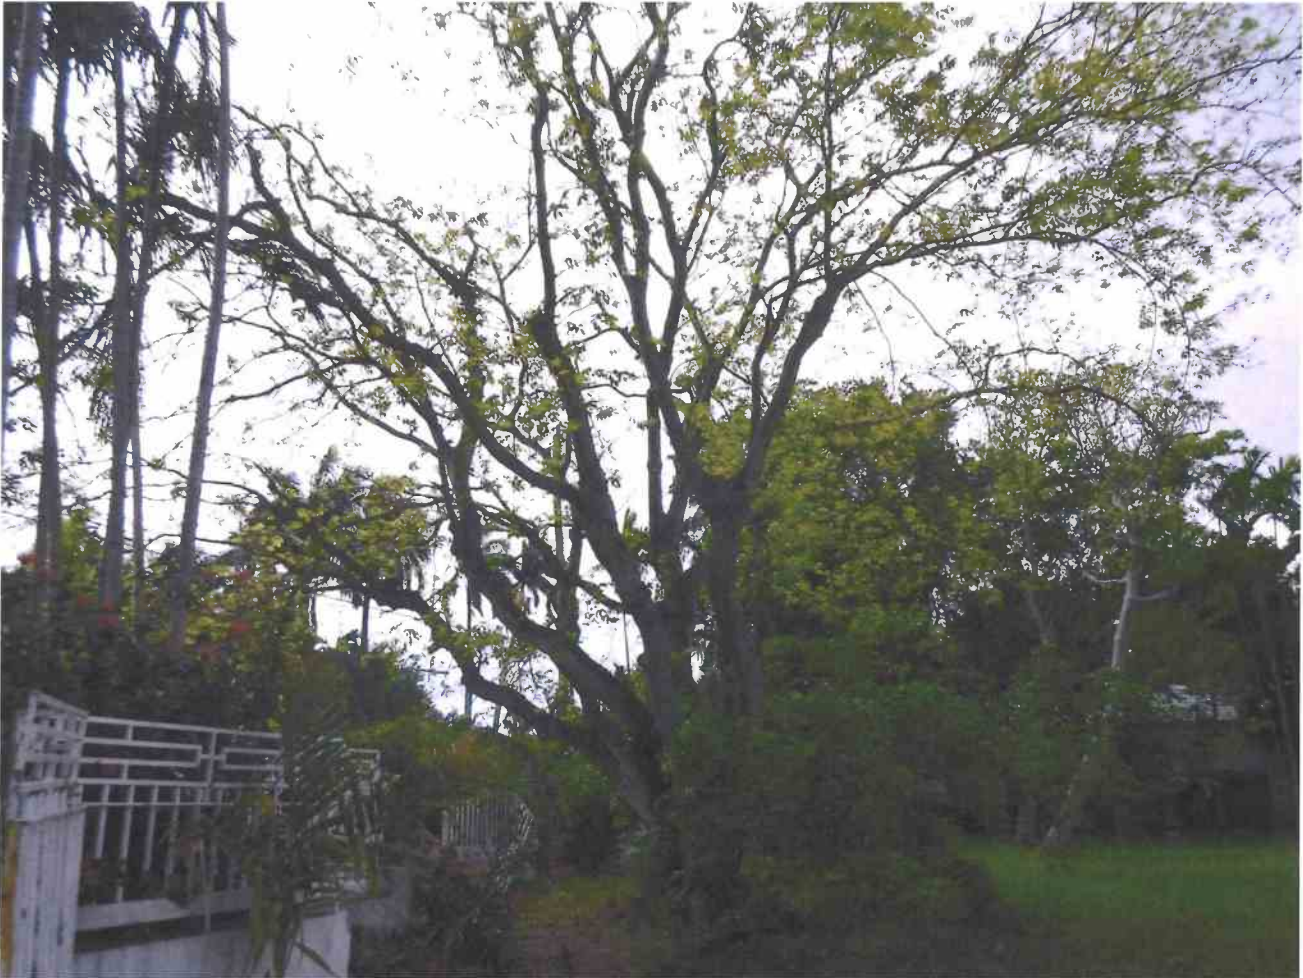
Tree number 32

The Pongam is in fair condition with a 35% health condition. The tree is 35 feet tall and 48 feet wide. The diameter measured at breast height was 40 inches. The tree has included bark, as well as codominant leaders, a wound in the branch on the east side, poor structure , and girdling roots on the east side. The tree has minor storm damage and dieback of leaves present on the outer edge of the canopy.

View looking south heading cuts evident

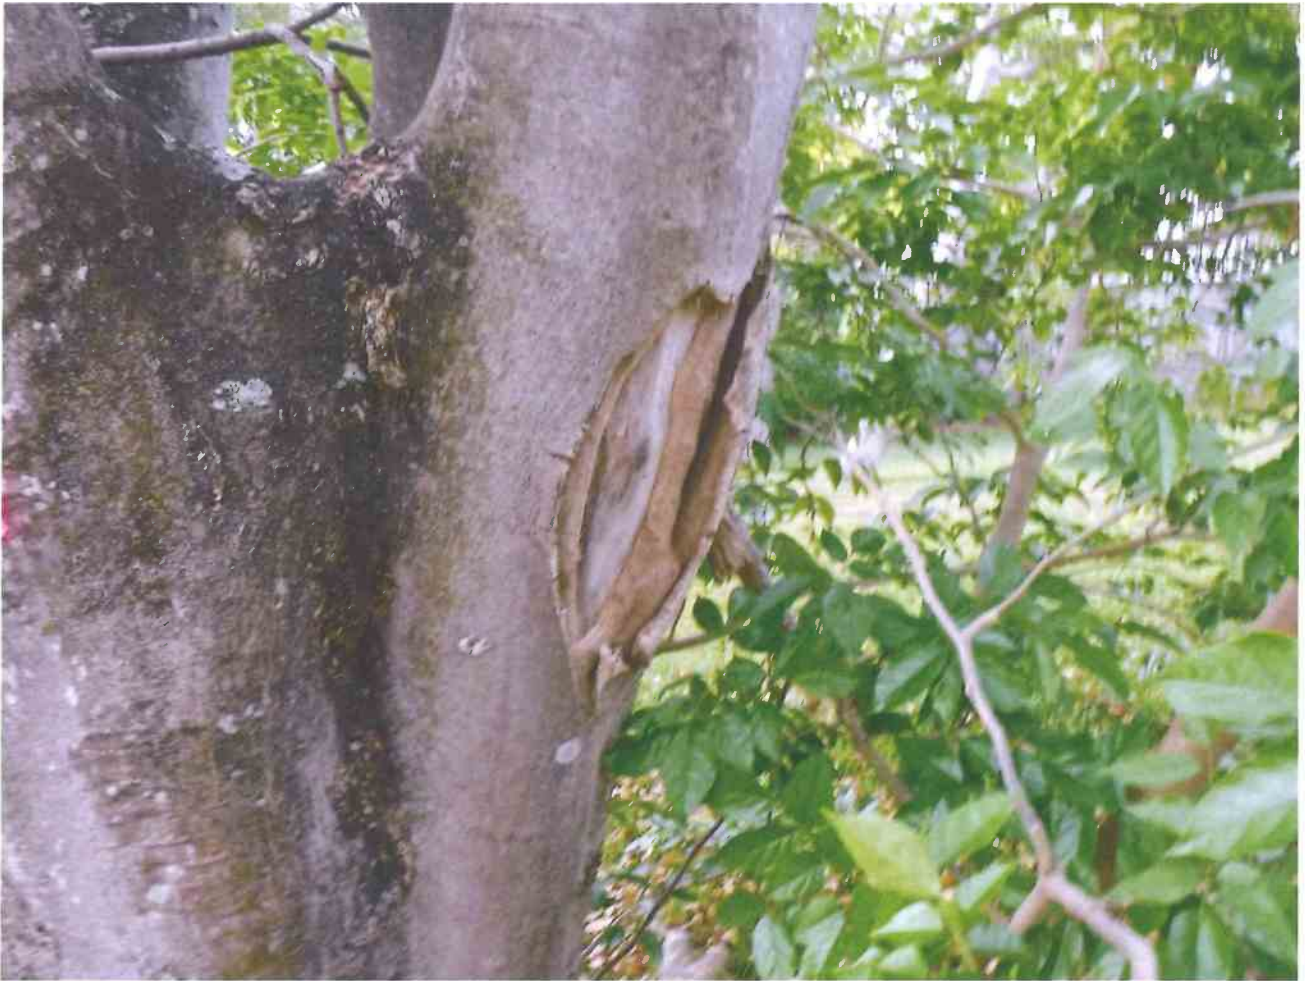
Wound in stem of tree
