**5840 North Bay Road Miami Beach, Florida
Specimen Tree Arborist Report**

5840 North Bay Road Miami Beach, Florida
SPECIMEN TREE REPORT

May 6, 2018

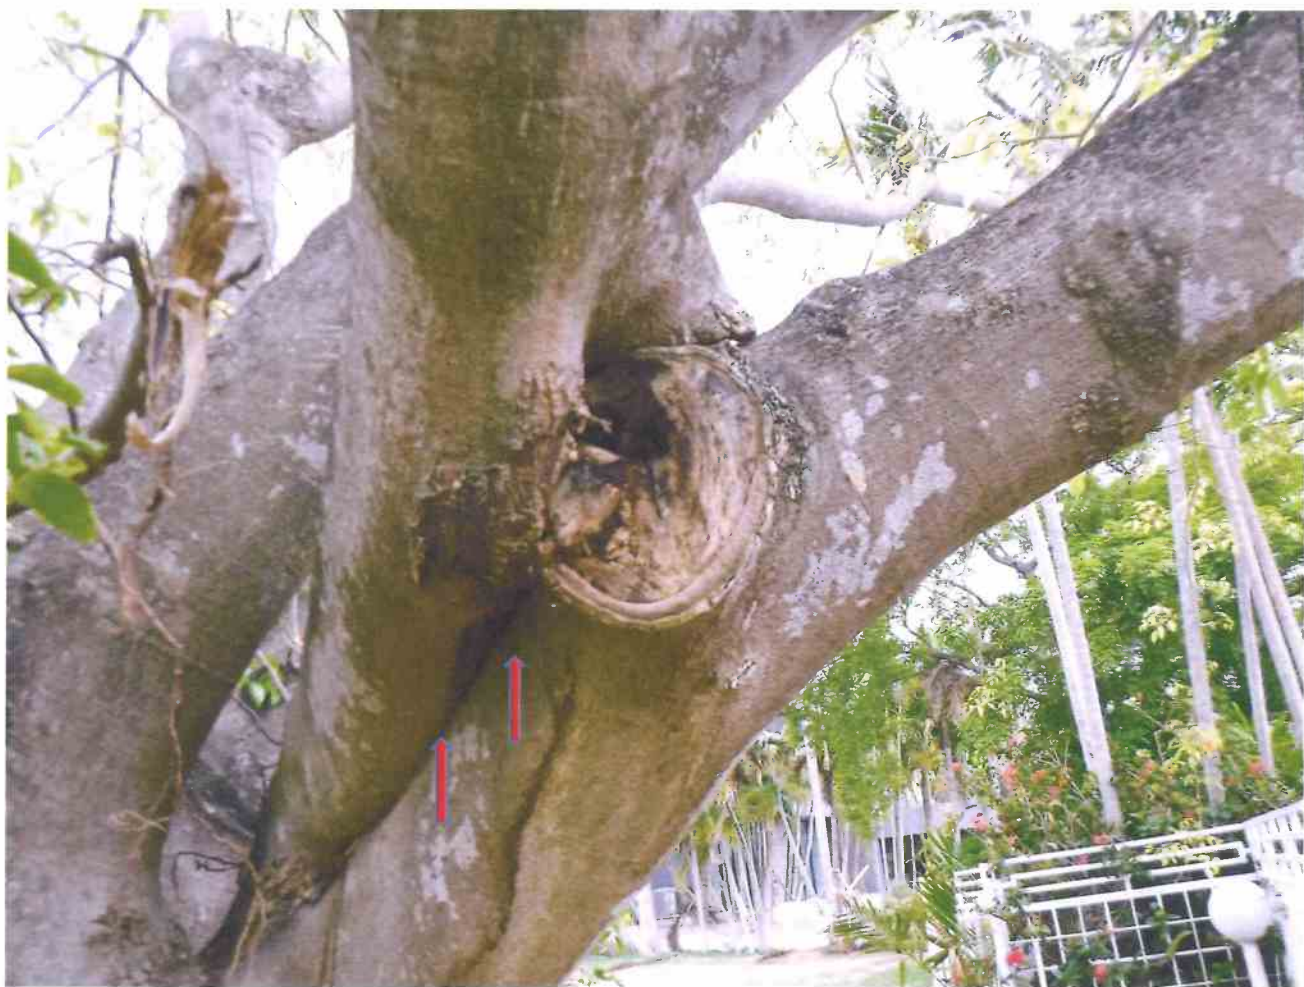
Included bark and wound in branches
