***Tree Resource Evaluation for
The South Seas, Richmond, and Raleigh Hotels,
Miami Beach***

April 4, 2020

Summary

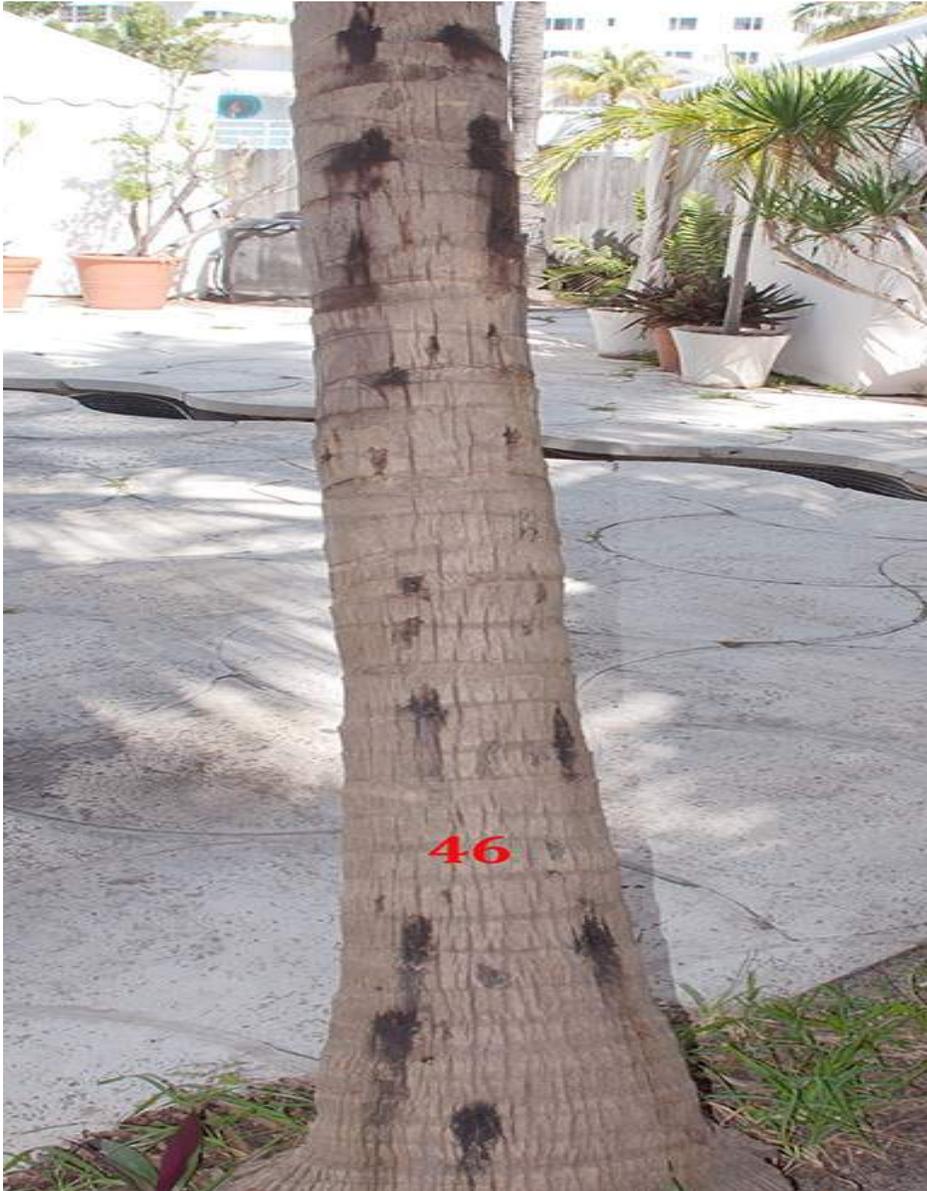
Almost all of the palms that are rated as moderate have holes in their trunks made by climbing spikes. This is a practice that is not allowed in the ANSI A-300 Pruning Standards or the ISA Best Management Practices. These palms should not be relocated. Palms that I have rated as poor and any other palms onsite that have holes in the trunks that are oozing should be removed as this can be an indication of imminent failure.

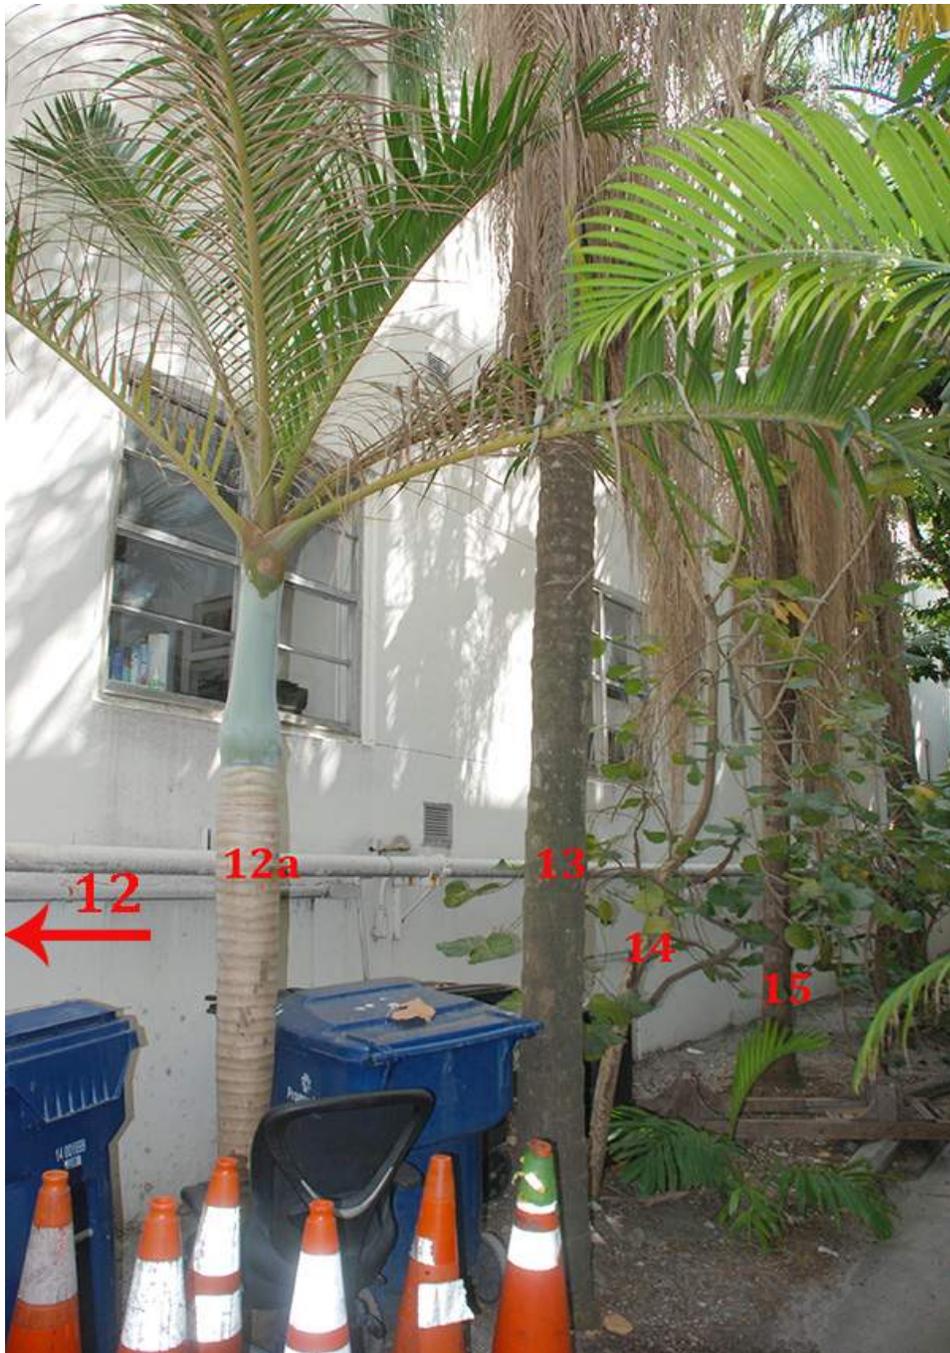
Photo 4 above is palms 21a, 13 & 15 and trees 14 & 15. Palm 12 is out of the photo to the left. All of the queen palms along this building have poor trunk taper and are beginning to pin/narrow.

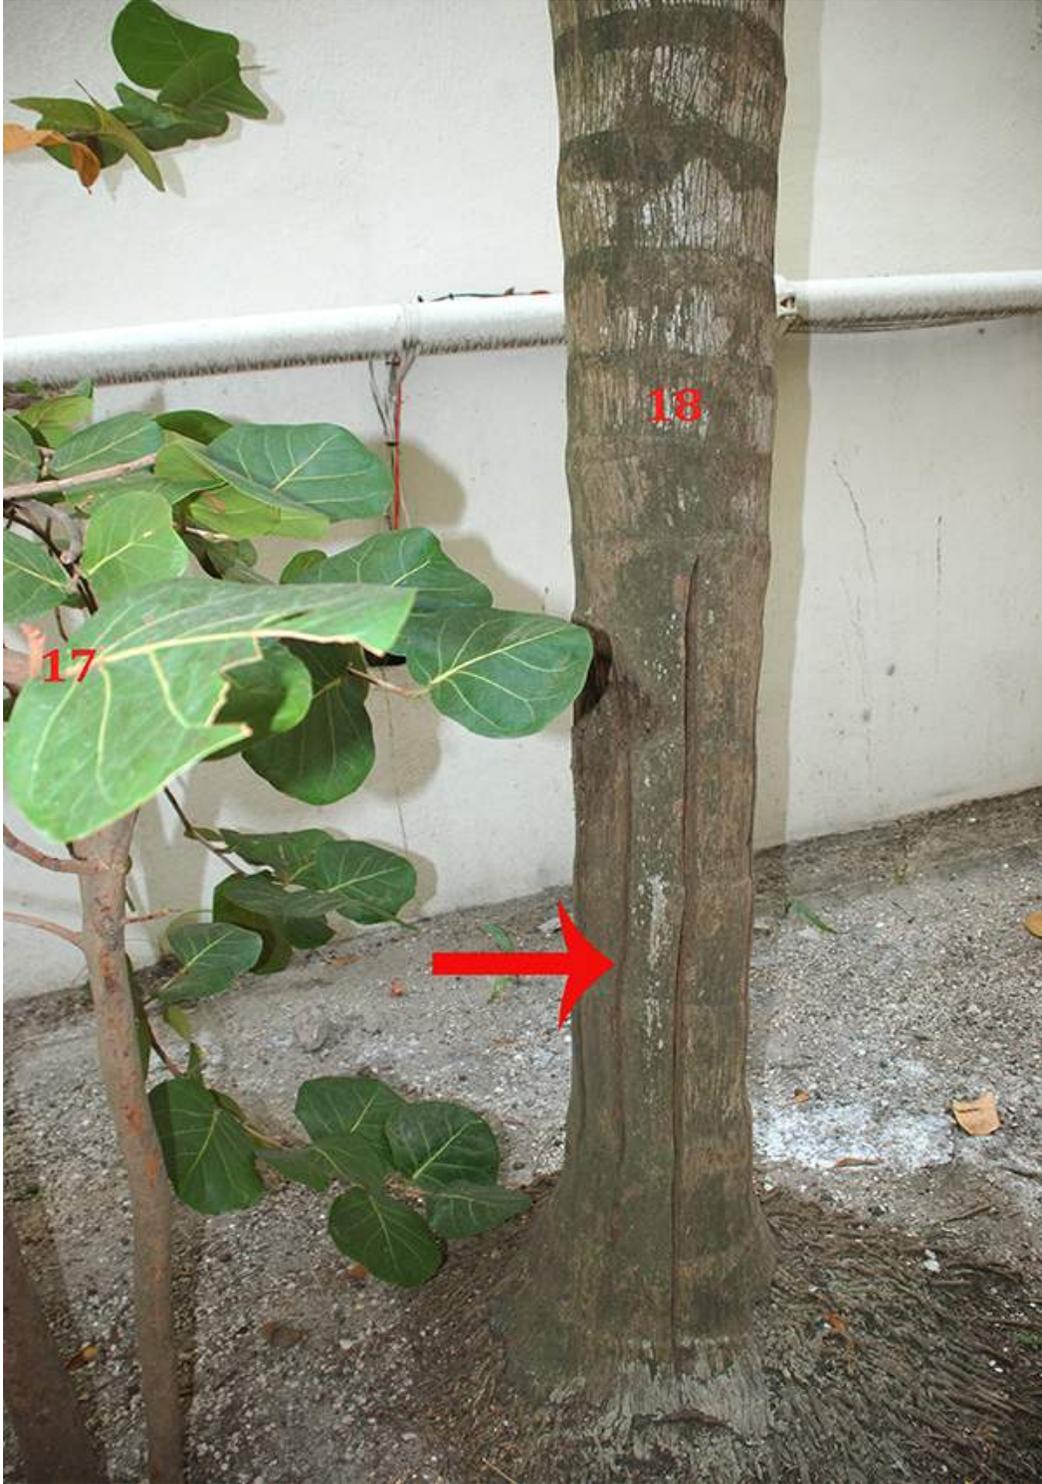
Photo 6 above is the cracked trunk of palm 18.

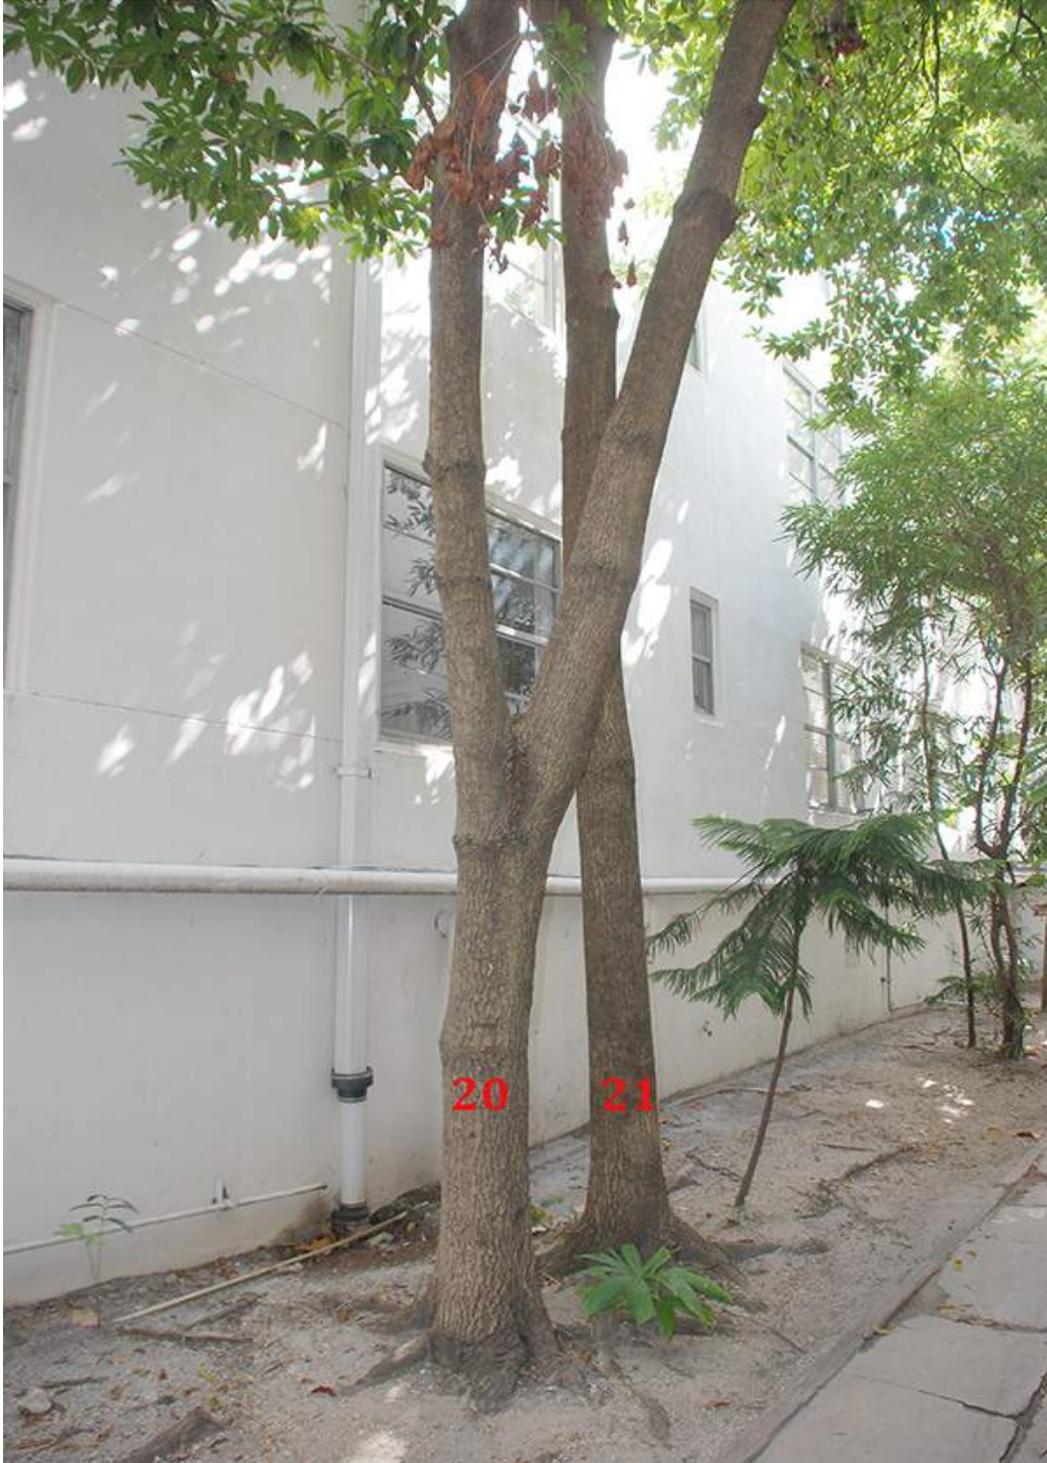
Photo 7 above is trees 20 & 21. These trees are very tall and have poor trunk taper. They are not good candidates for relocation.

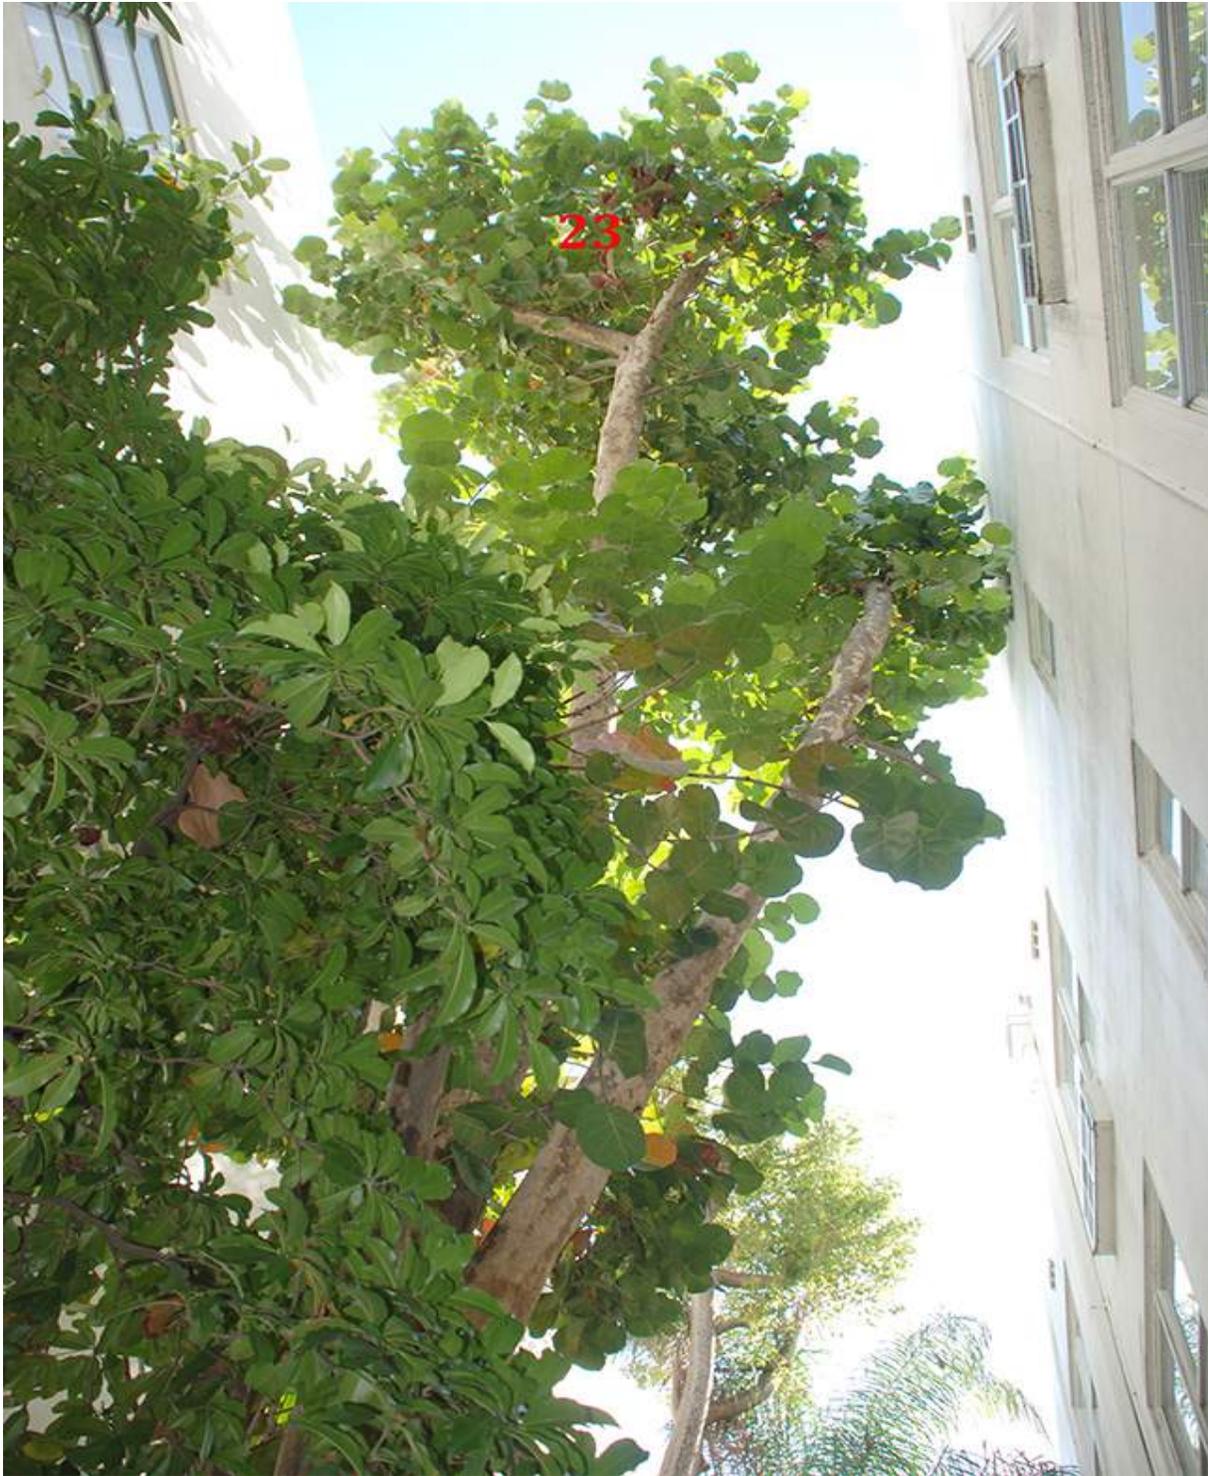
Photo 9 above is the canopy of tree 23. The trunks have very poor taper and the canopy has been over-pruned. This tree is not good candidate for relocation.

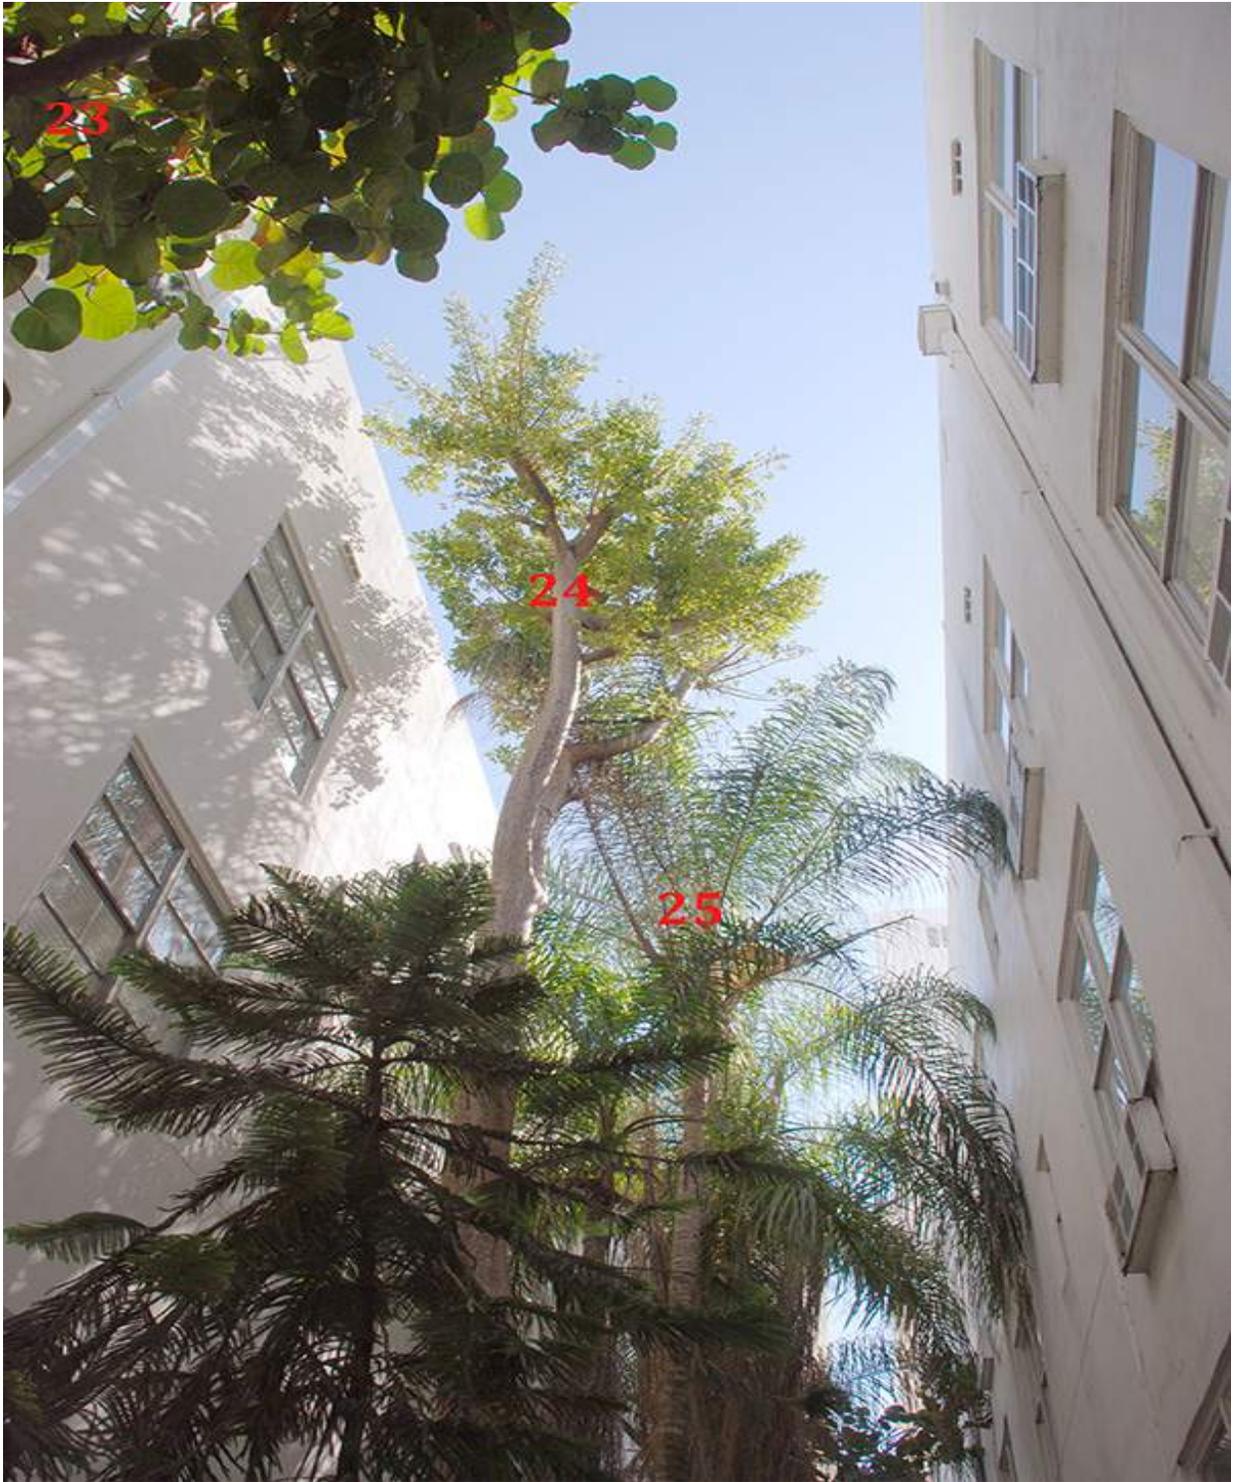
Photo 11 above is the canopy of tree 24 showing very poor trunk taper and an overly pruned canopy. This tree is not good candidate for relocation.

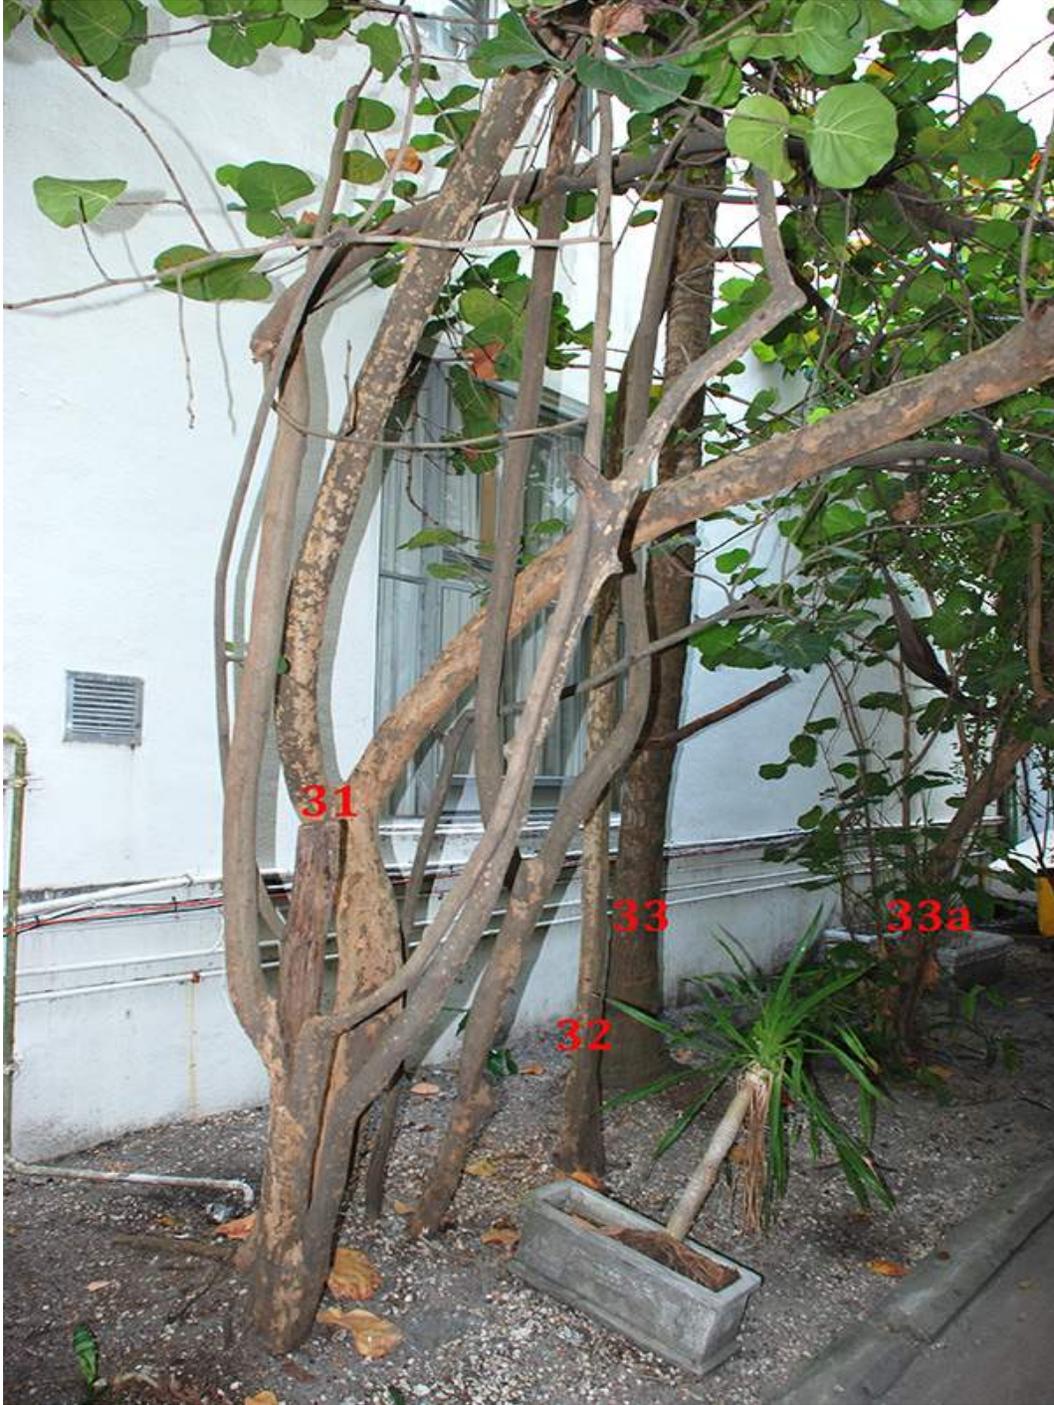
Photo 14 above is trees 31, 32 & 33a with very poor branch structure.

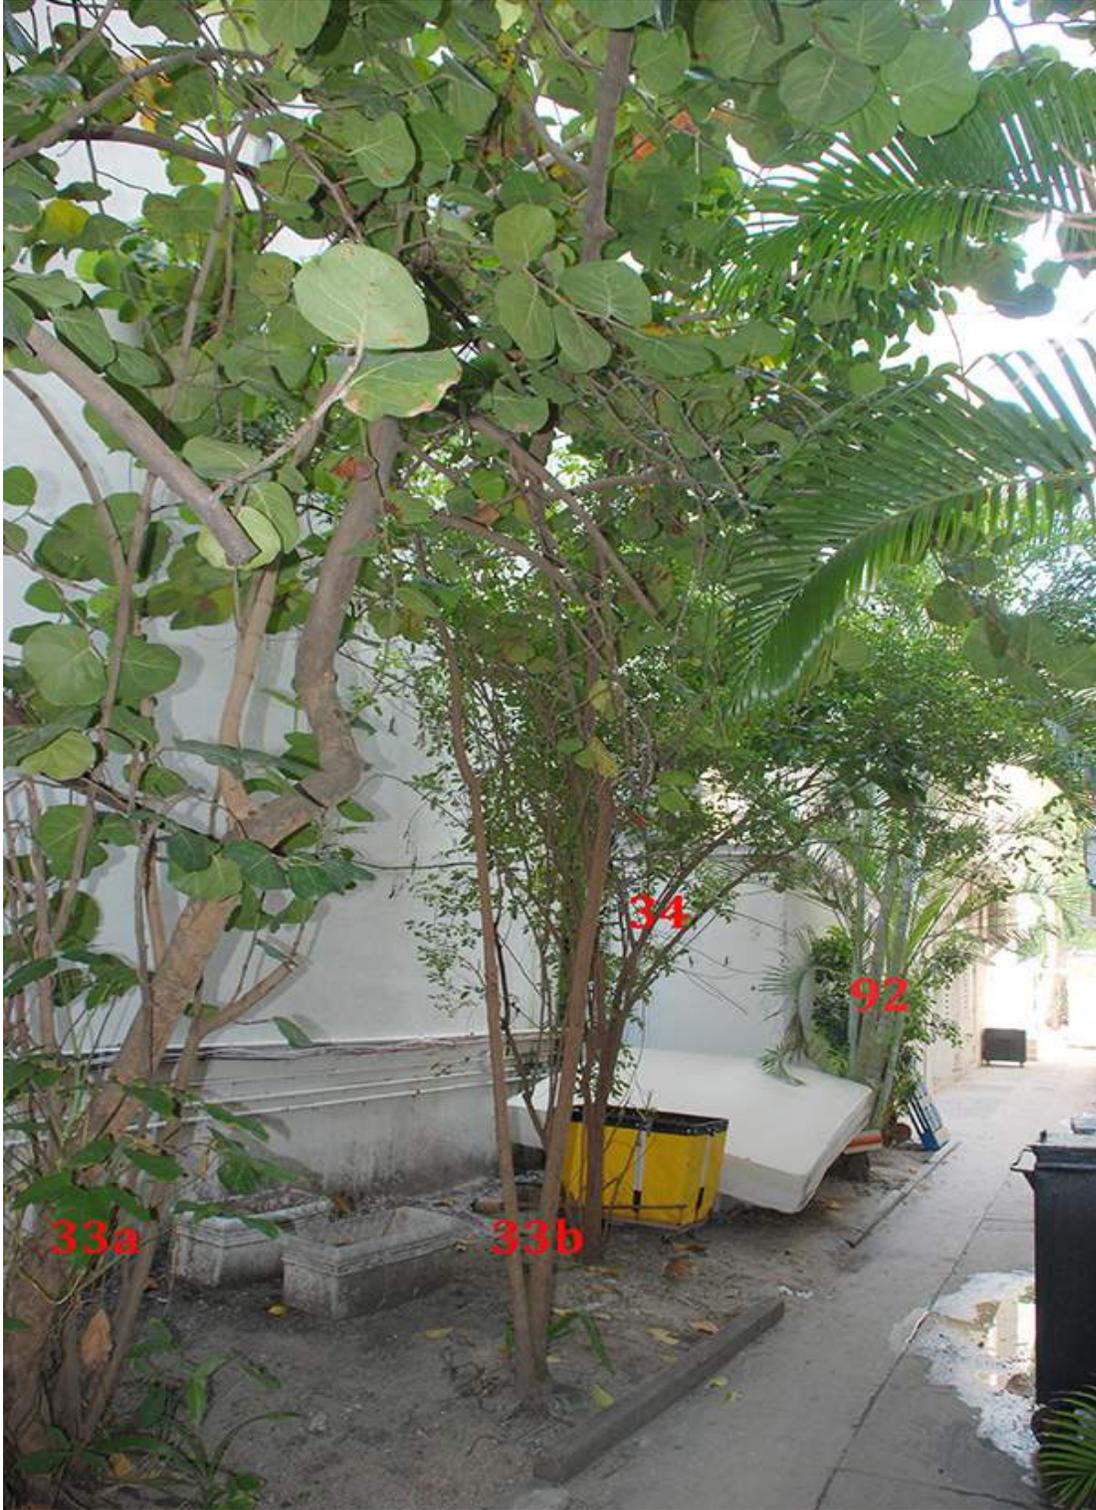
Photo 16 above is trees 33a, 33b, 34 (an invasive species) and palm 92.

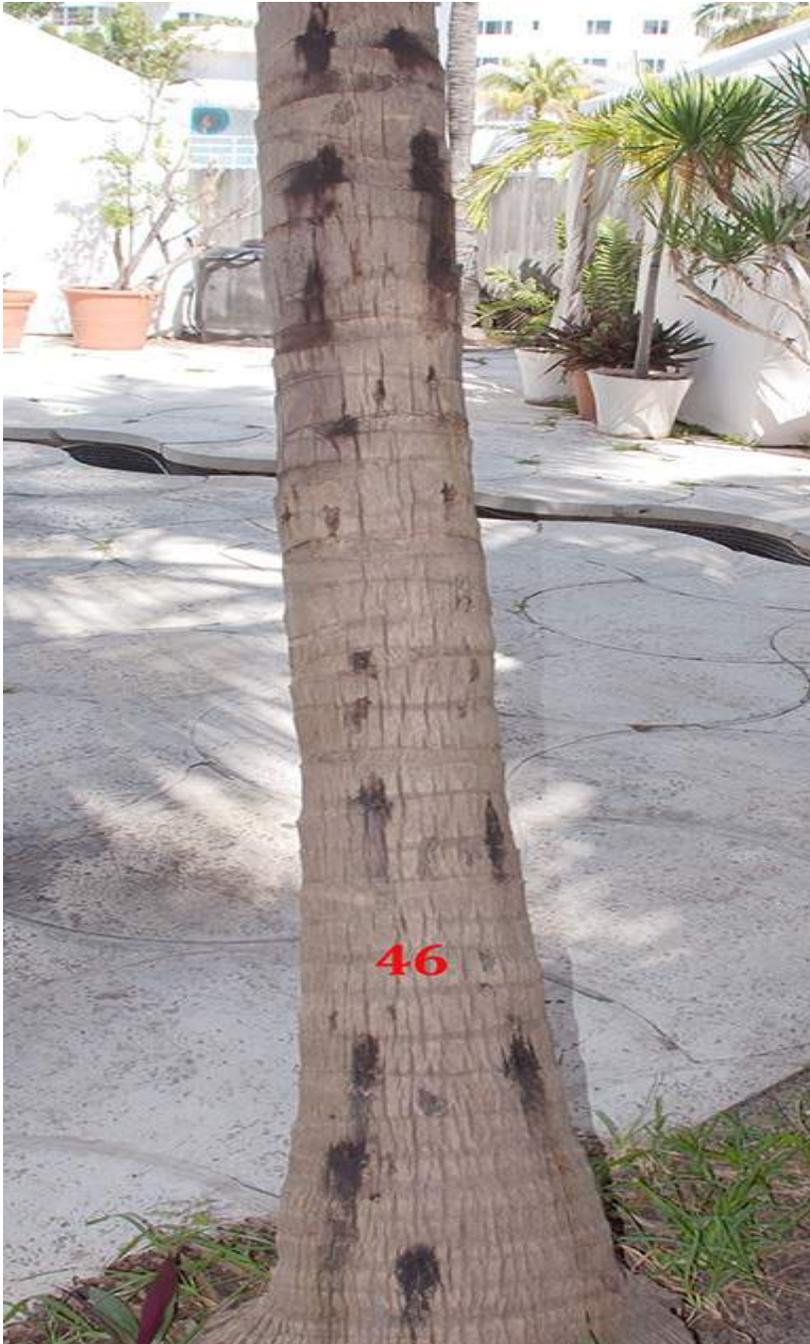
Photo 23 above is the damaged trunk of palm 46. These darkened and oozing spots are holes made by climbing spikes. This palm should be removed.

Almost all of the palms that are rated as moderate have holes in their trunks made by climbing spikes. These palms should not be relocated. If the trunks are oozing, they should be removed.

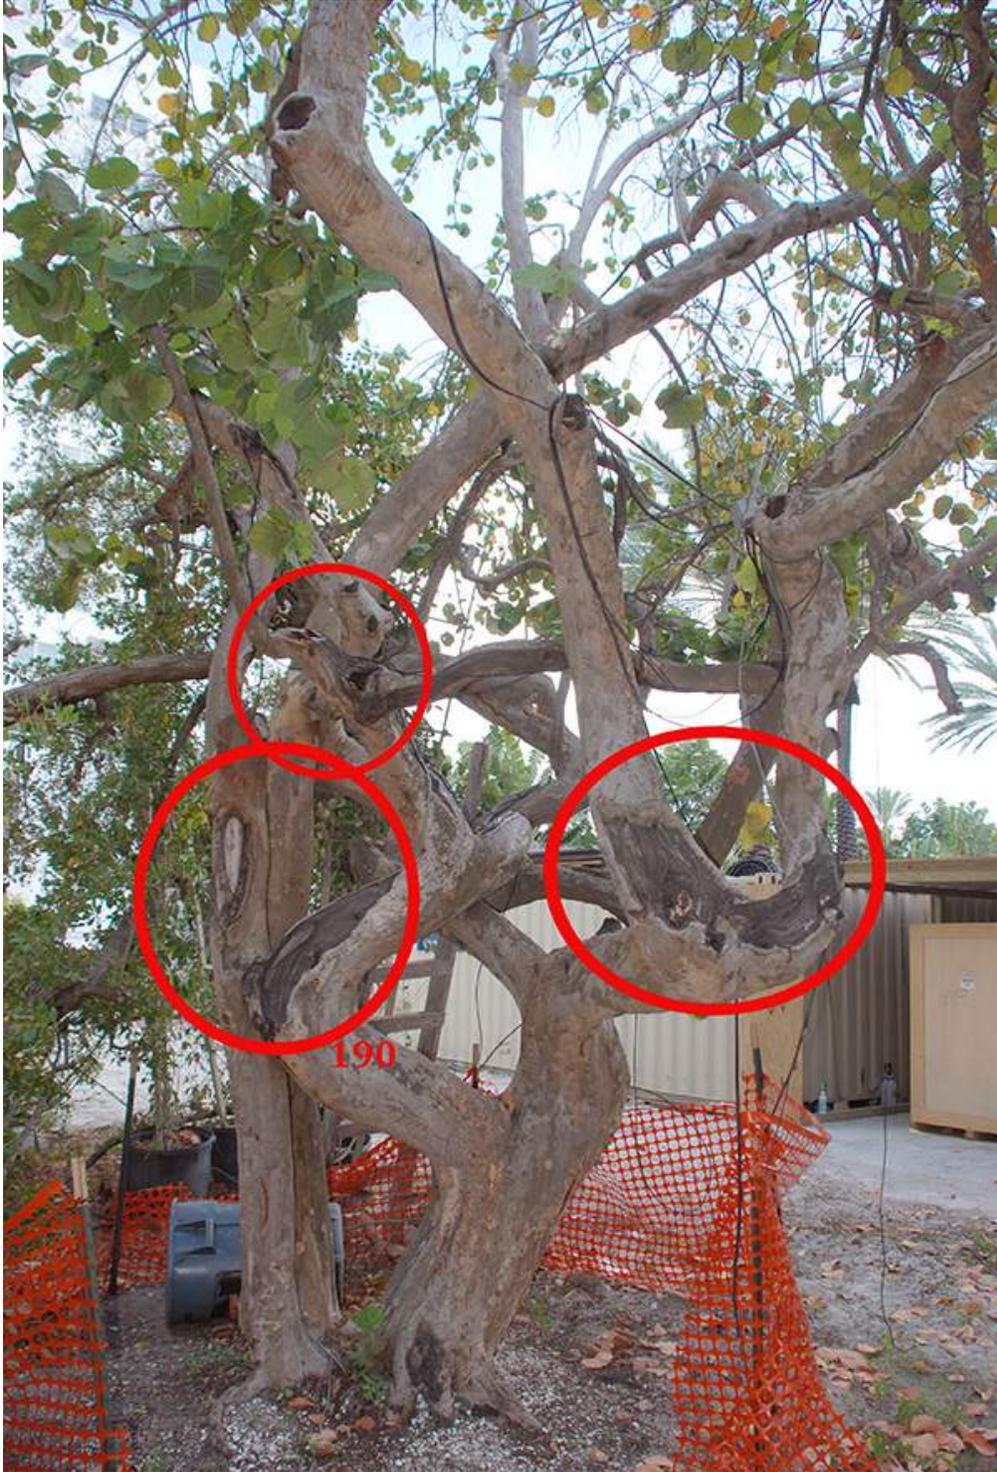
Photo 47 above is the south side of tree 190. The circles indicate significantly decayed areas with dead wood. This tree should not be considered for relocation.

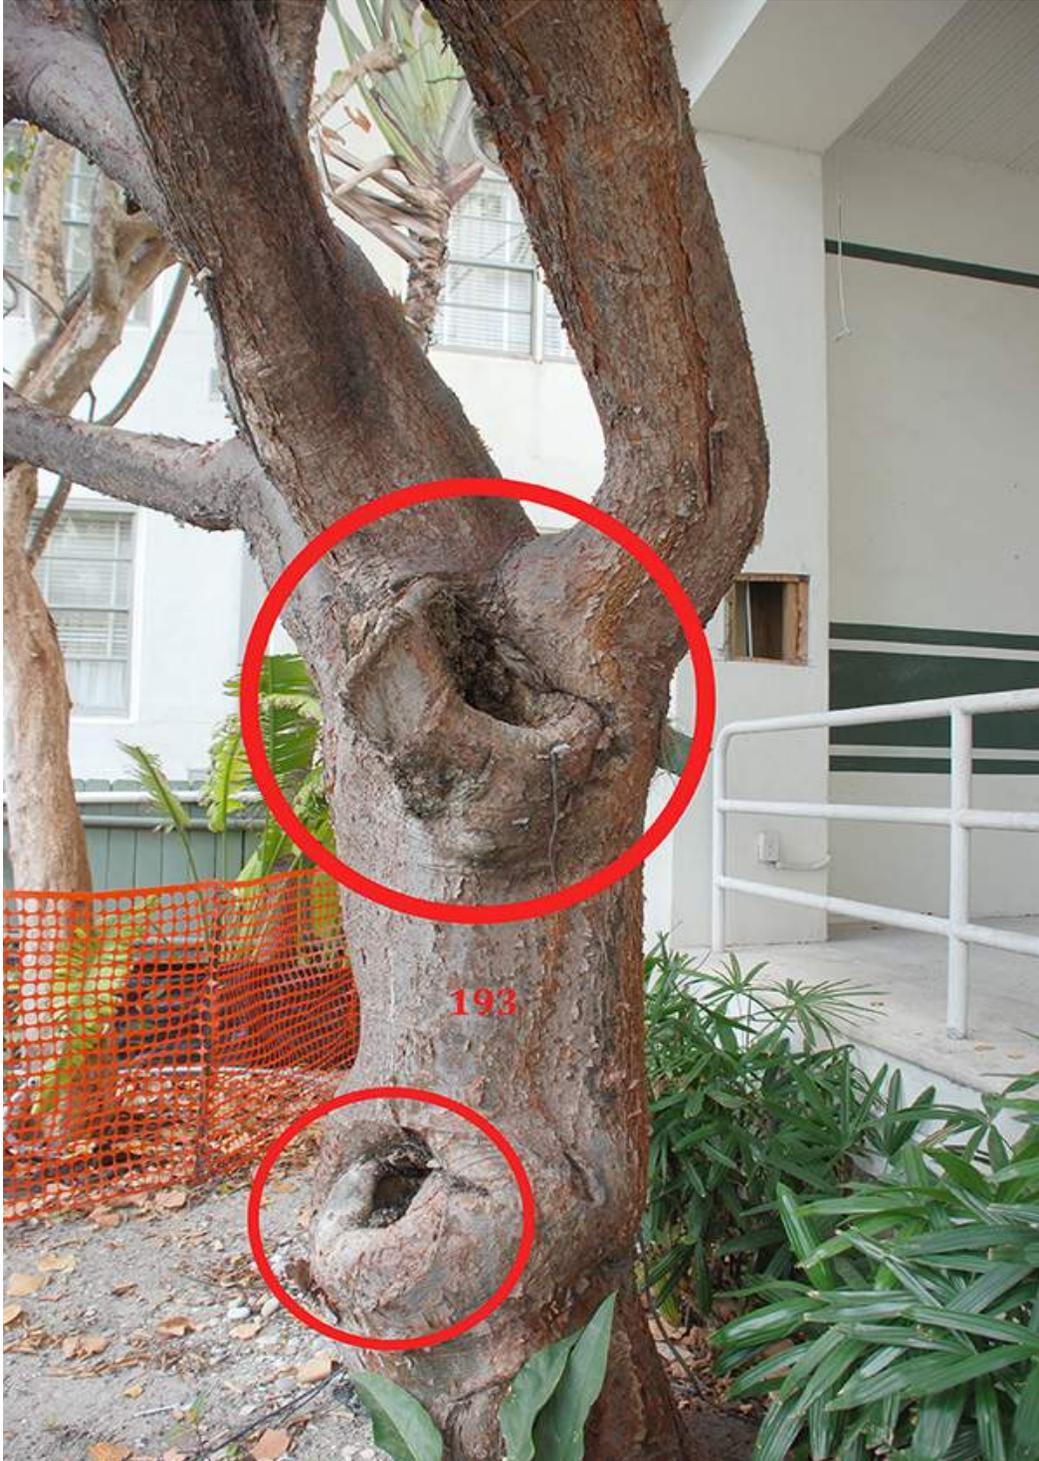
Photo 50 above is the north side of the trunk of tree 193 with the circles indicating large cavities with decay. This tree should not be considered for relocation.

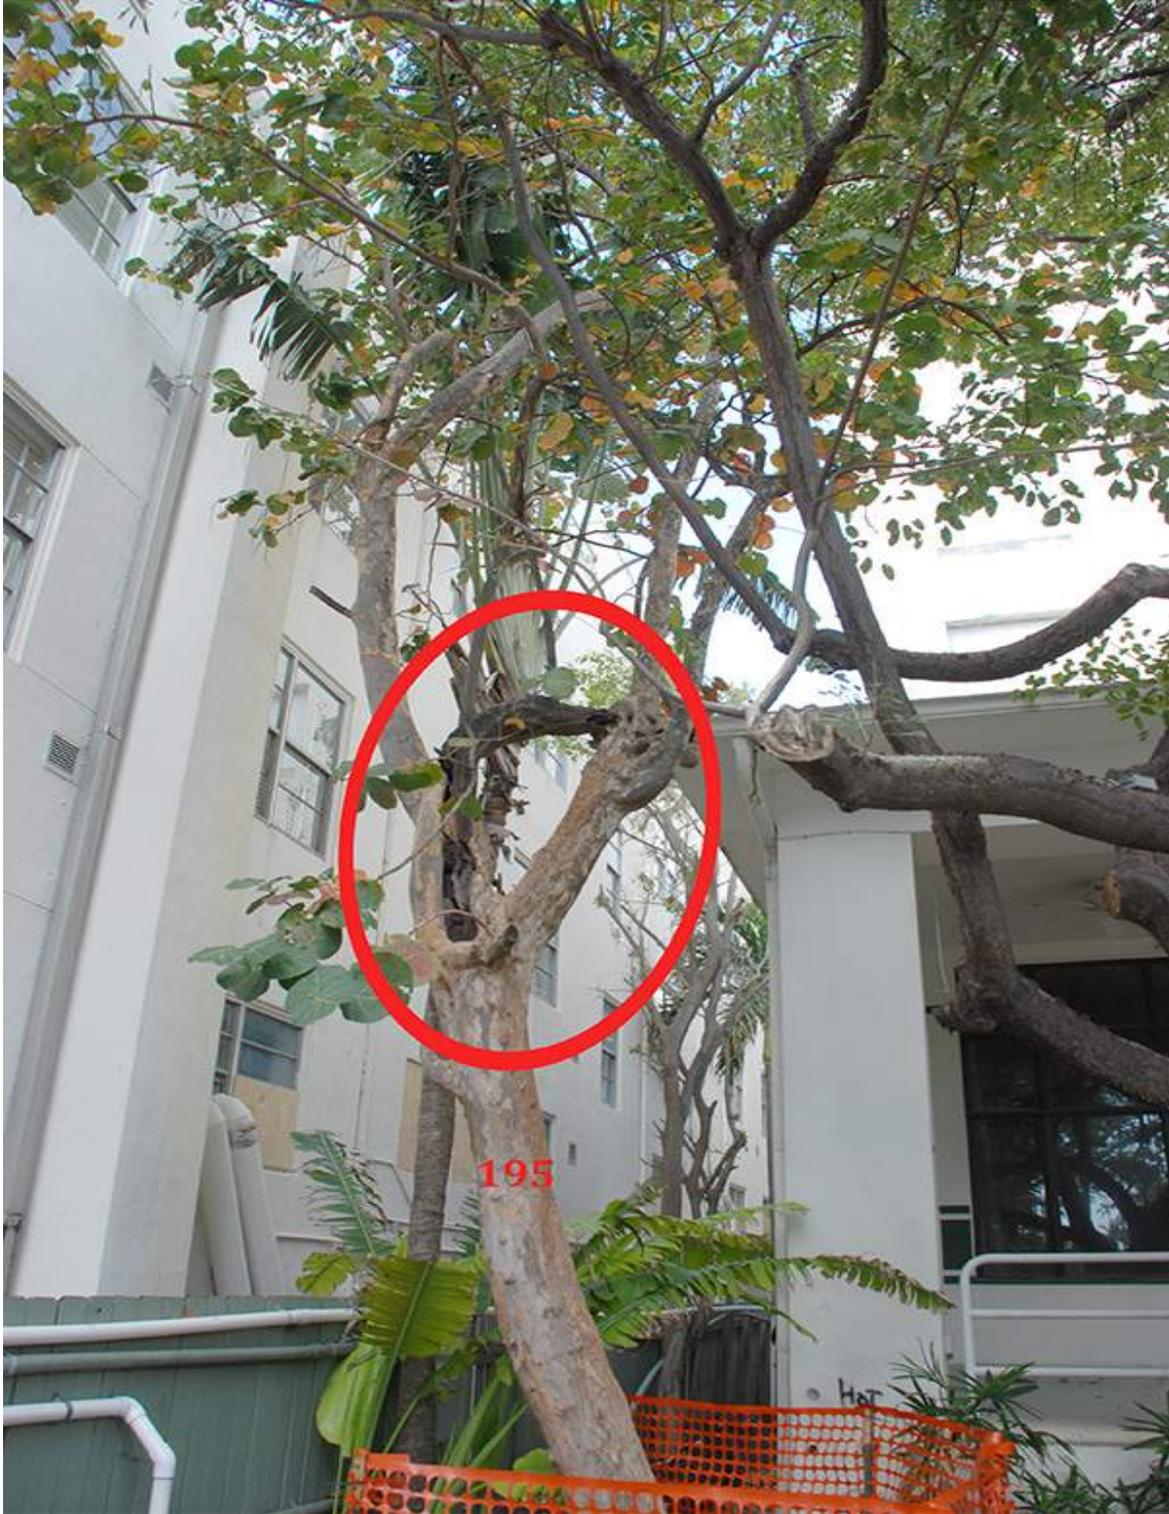
Photo 52 above is tree 195 with significant decay indicated. This tree should not be considered for relocation.

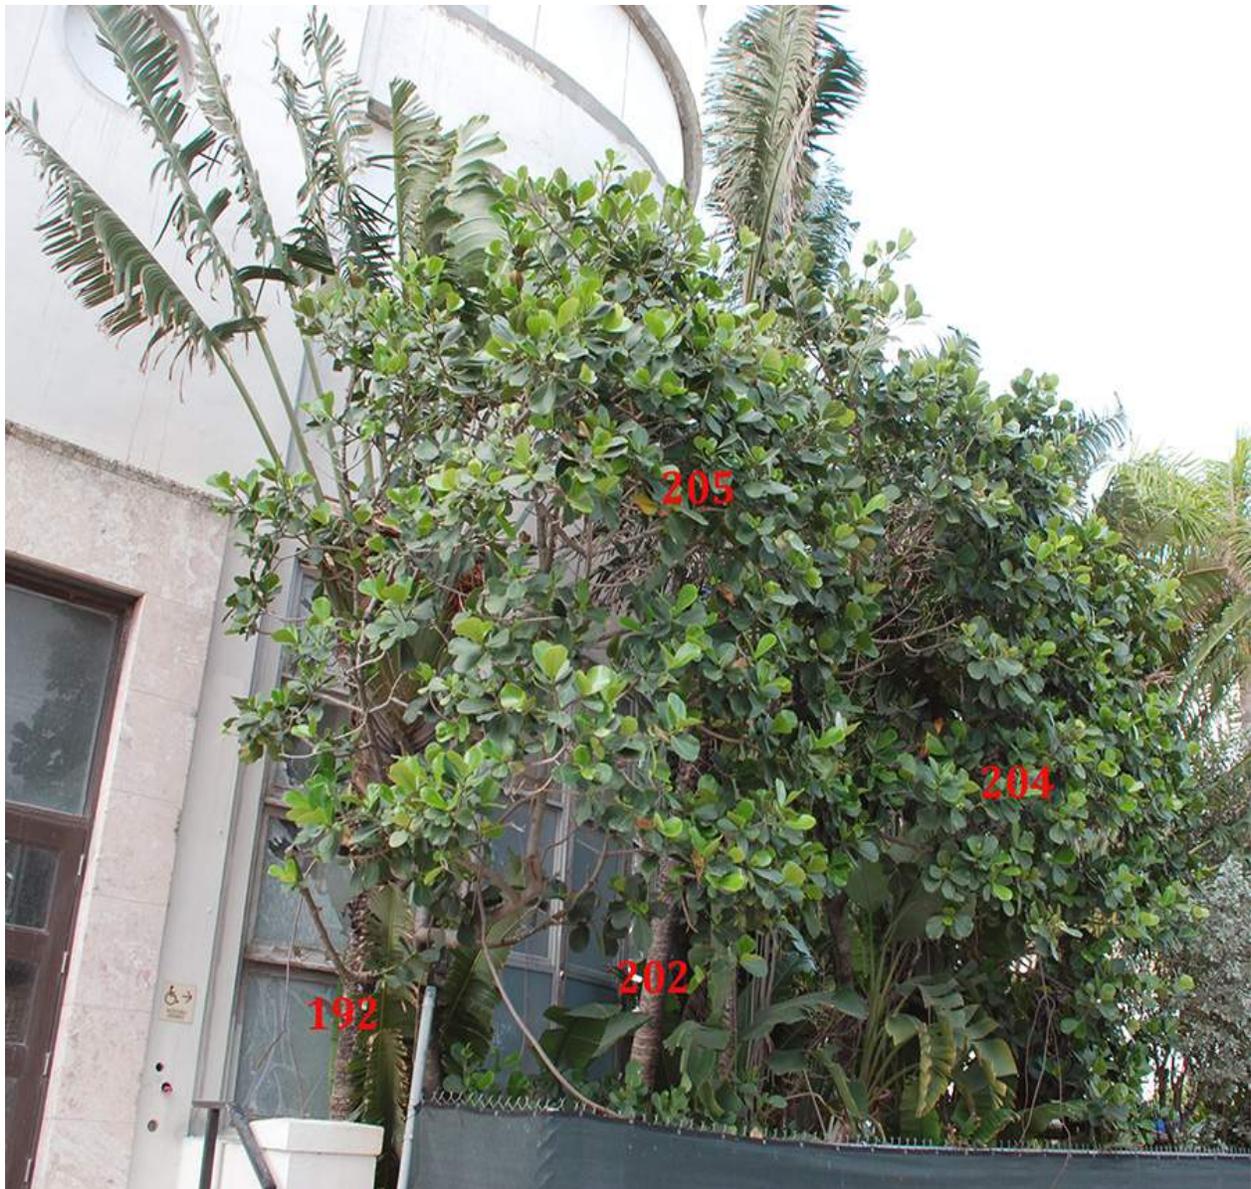
Photo 60 above is trees 204 & 205 and palm 202. These trees should not be considered for relocation.

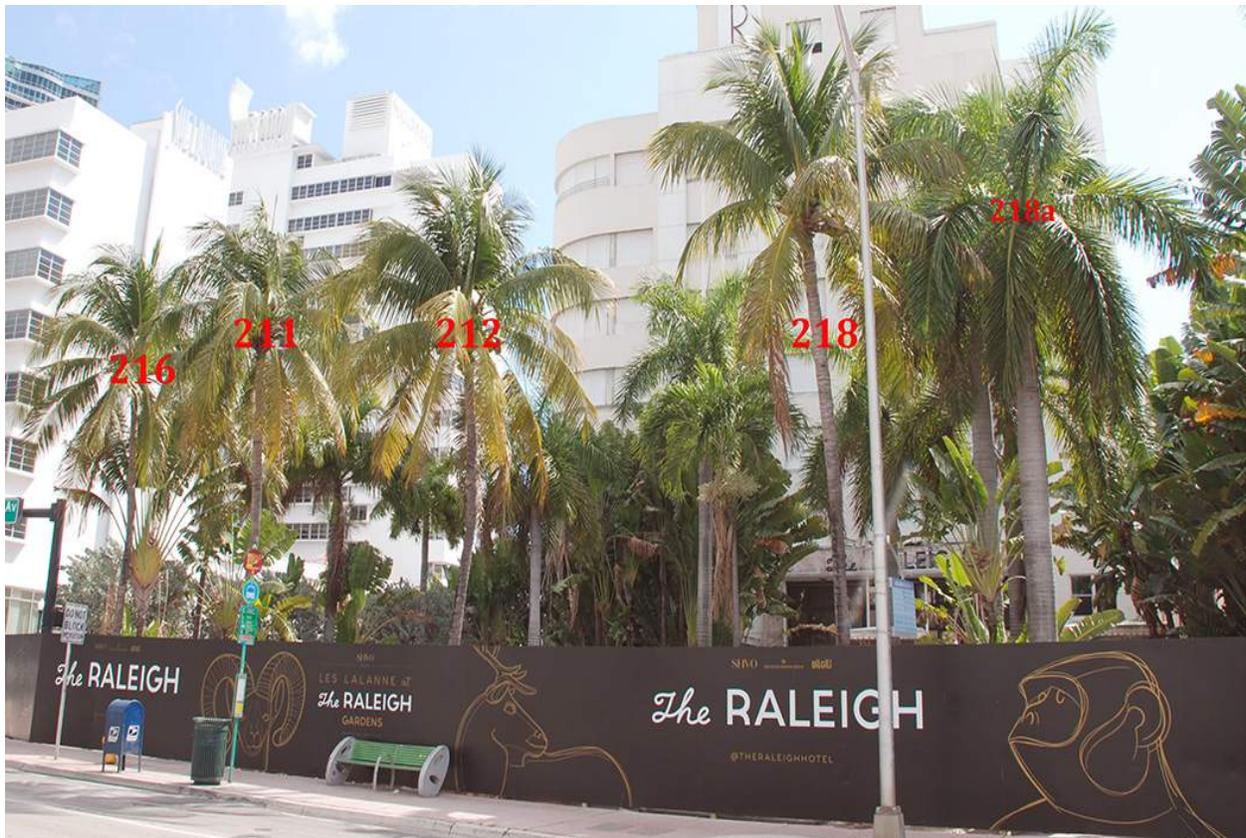
Photo 65 above is palms 211, 212, 216, 218 & 218a. These coconut palms have been recently transplanted to these locations. They may need better irrigation.

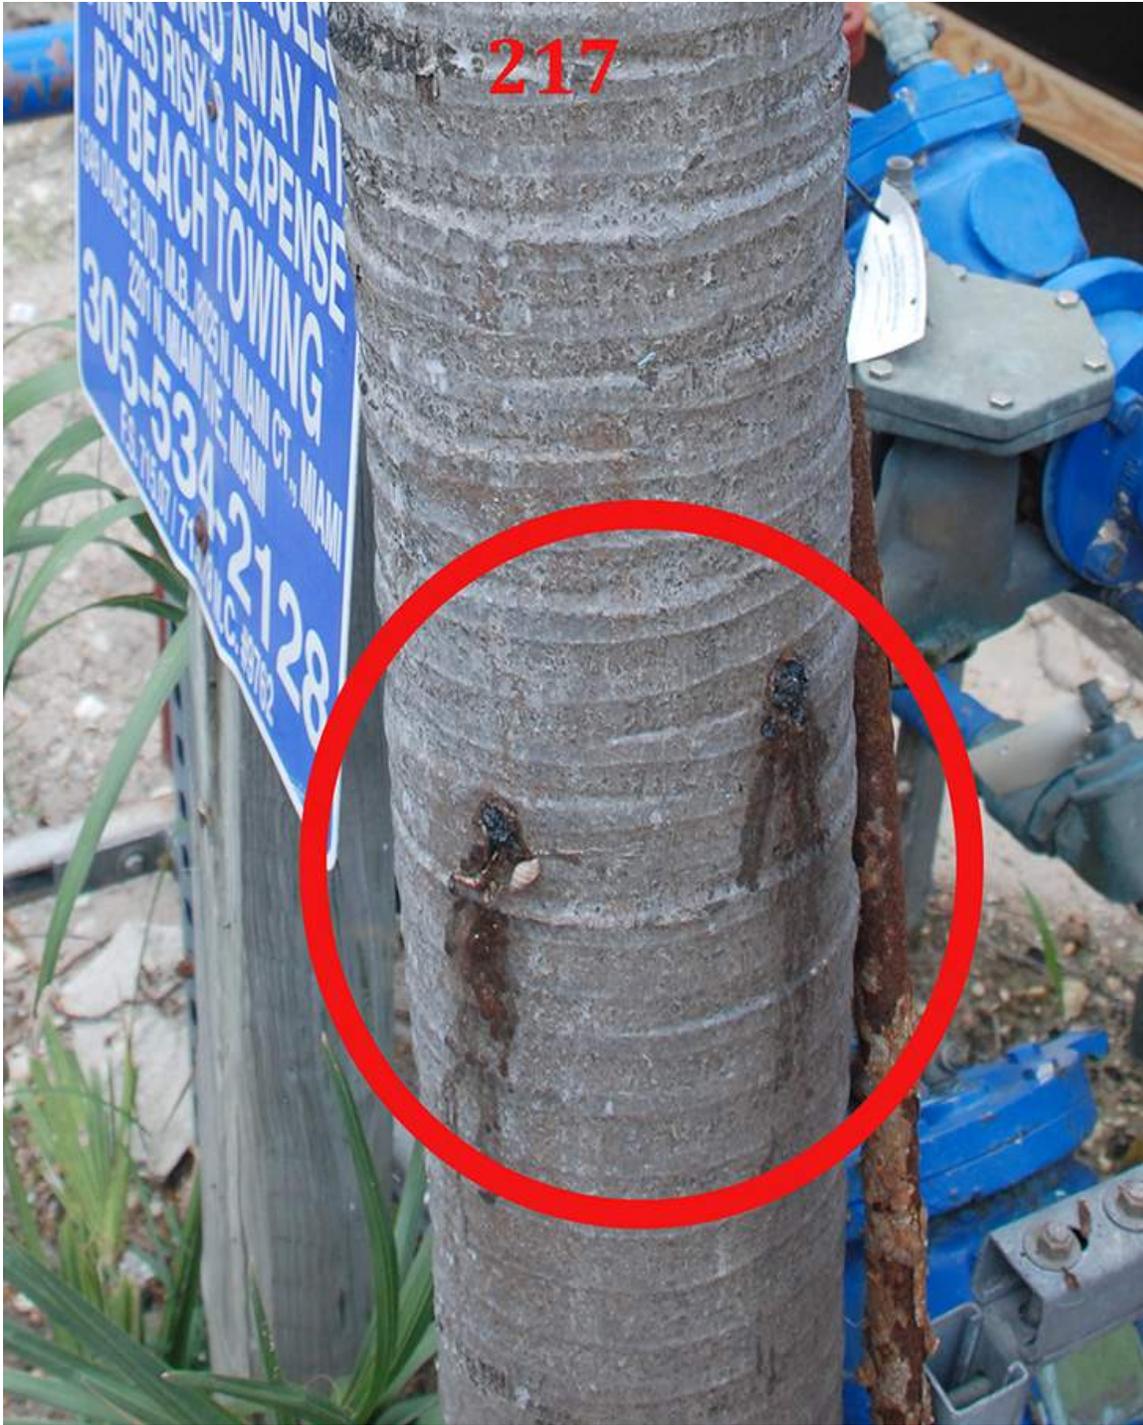
Photo 67 above are two man-made holes in the trunk of palm 217. This palm should be removed.
