***Tree Resource Evaluation for
The South Seas, Richmond, and Raleigh Hotels,
Miami Beach***

April 4, 2020

Summary

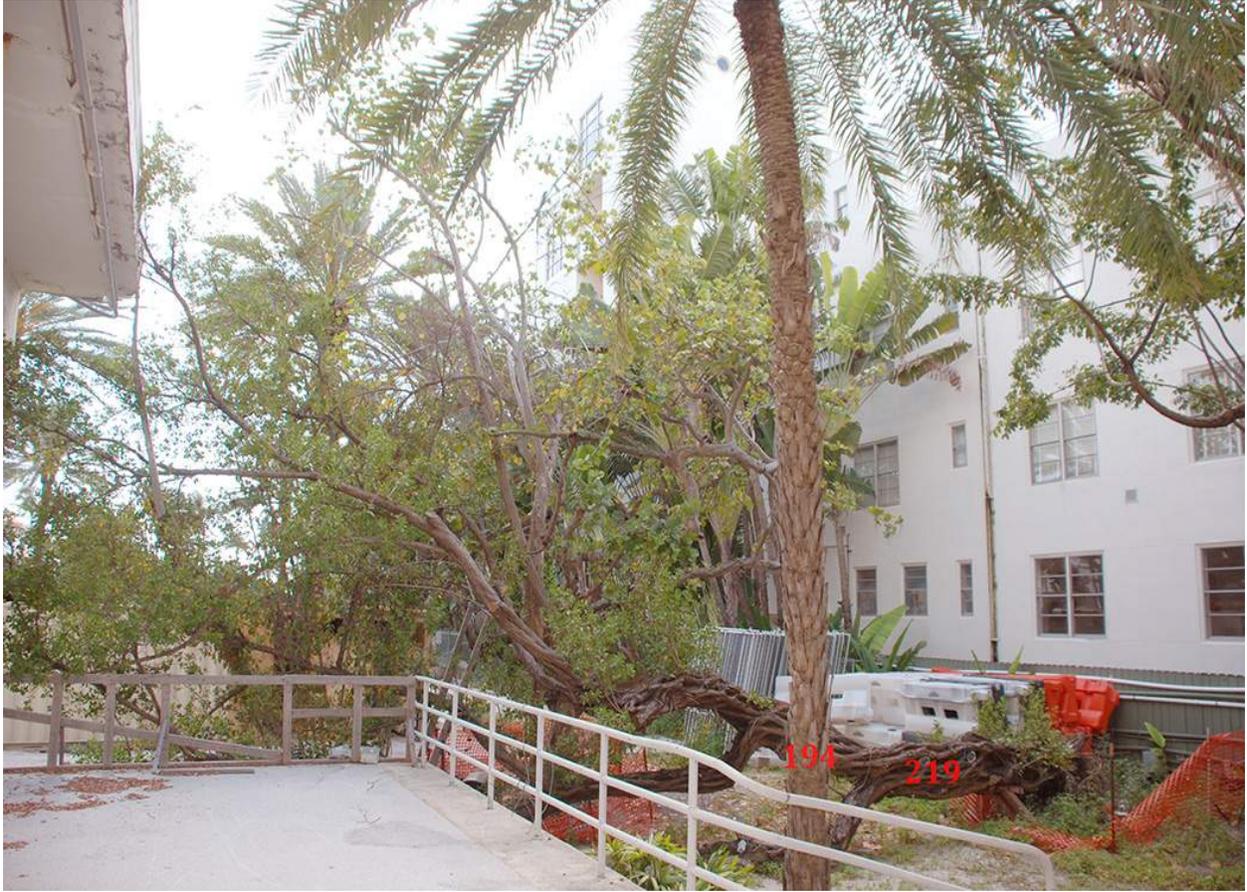
Photo 68 above is tree 219 which has failed. This tree should be removed. See following photo.

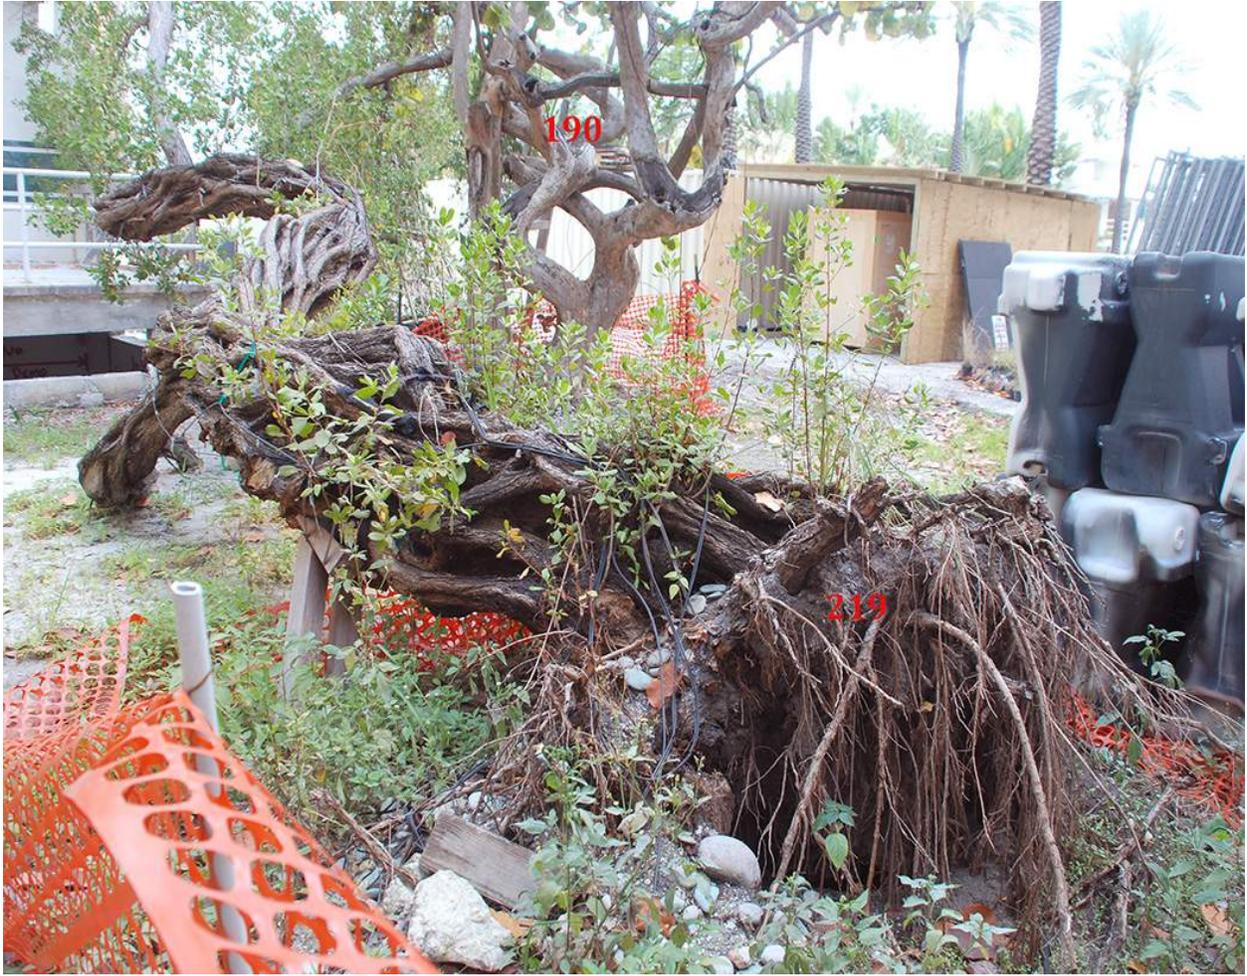
Photo 69 above is the over-trunked root plate of tree 219.
