Biscayne Environmental, Inc.

RE: 790 Lakeview Drive, Miami Beach
Evaluation of Existing Tree Resources
BEI Project No. 2016-26

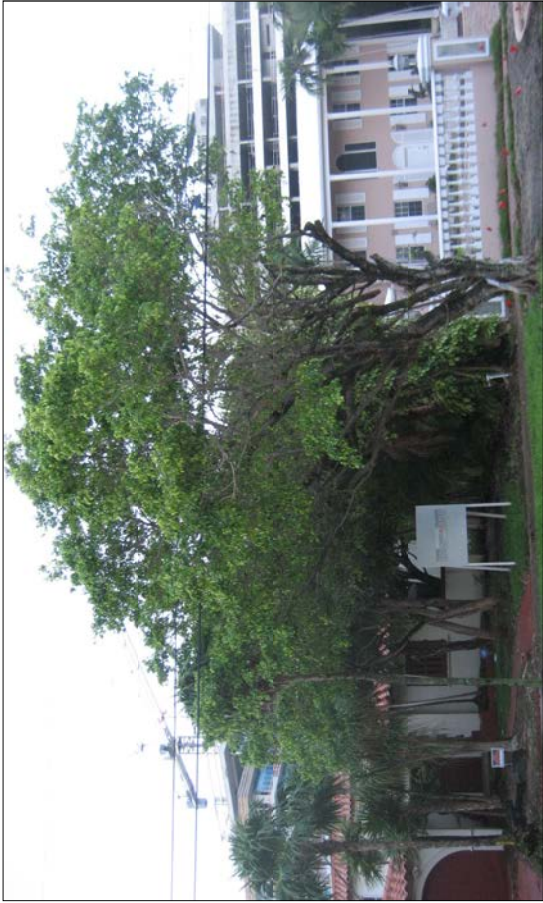
Photo 1 Ficus and thatch palm on west half of ROW and thatch palms in front yard.

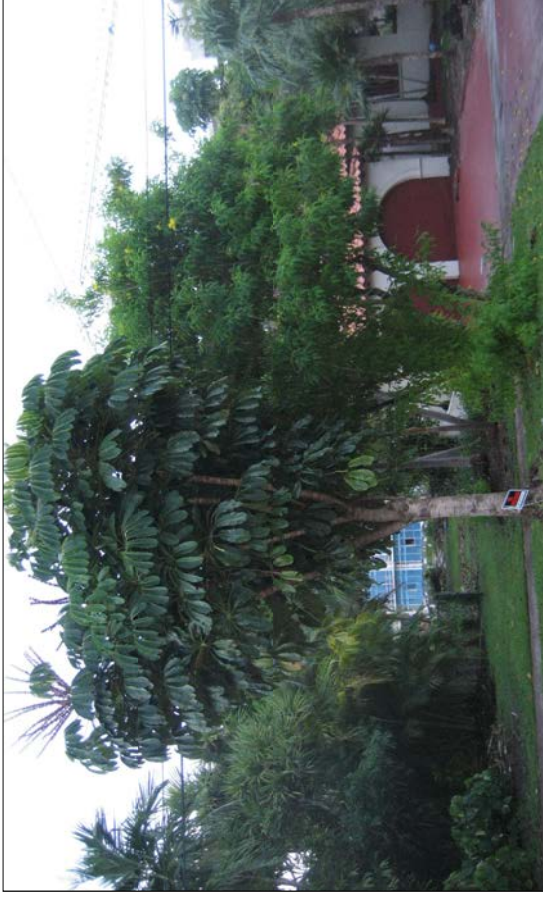
Photo 2 Umbrella tree and yellow elder on east half of ROW and pandanus along east property line in background to left.

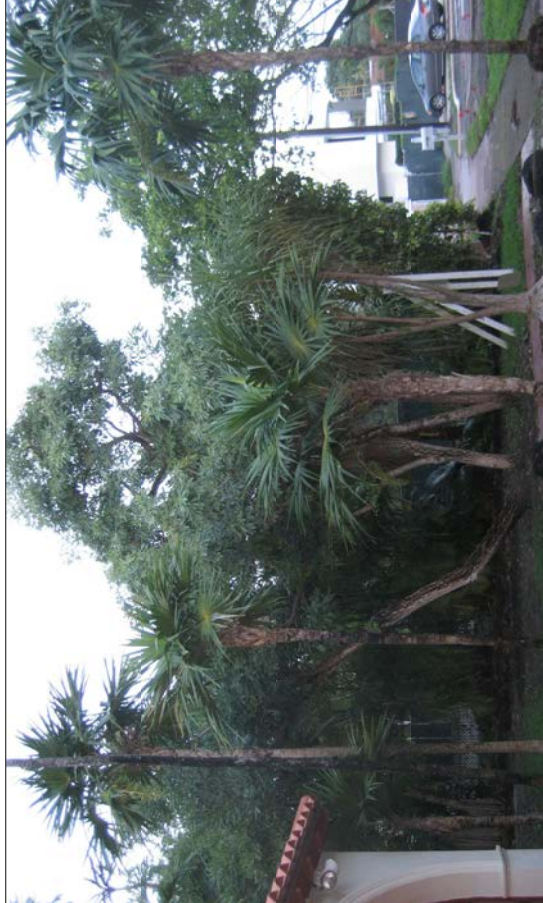
developed adventitious root system which is aesthetically pleasing (see Photo 11). The thatch palms in the front yard and court yard are in good condition and could easily be transplanted or relocated on site (see Photo 3).

Photo 3 View west of thatch palms in front yard with yellow tabebuia canopy visible above thatch palms.

Based on the above findings, the only trees present on the property which are worth incorporating into the landscape plan for the proposed house are the thatch palms and pandanus cluster along the east property line. Since the pandanus cluster is growing along the east property line it should not be in conflict with new construction and could be preserved in place. Since it is likely that the thatch palms will be in conflict with new construction, it is recommended that they be relocated to the setback area of the west property line where they should not be in conflict with new construction. The remainder of the trees on site are either in poor condition or are exempt or prohibited trees and should be removed after a permit has been obtained from the City of Miami Beach.

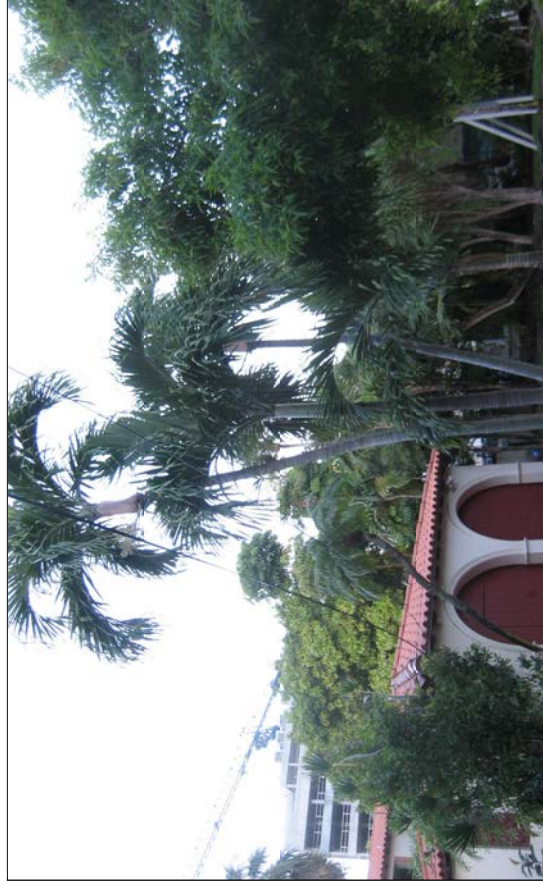
Photo 4 View of Christmas palm cluster and pygmy date palm on east side of front yard.

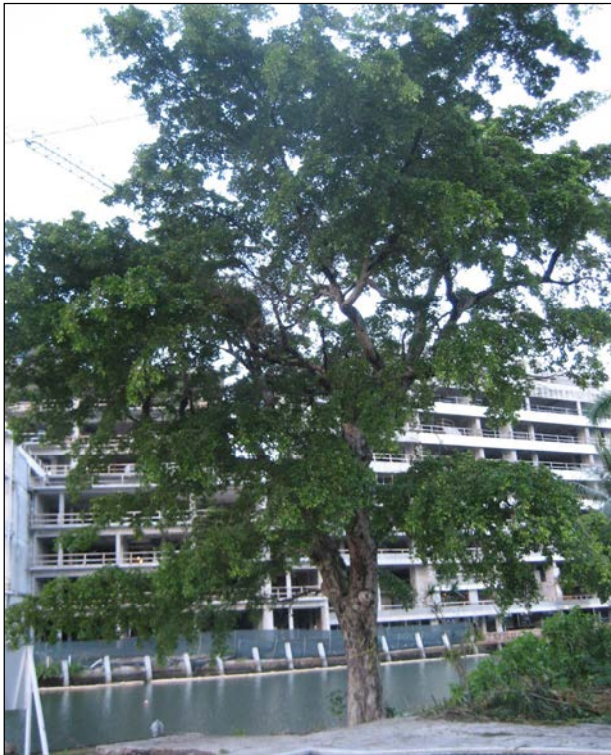
Many of the trees on the property are in poor condition due to previous storm damage and lack of maintenance. In particular, both of the large black olives are in poor condition; the black olive in the back yard next to the seawall has a number of decaying canopy branches and also appears to have lightening damage, and the black olive in the side yard has 3 co-dominant main trunks at breast height and also has decaying canopy branches and was covered with pothos vine at the time of the inspection (see Photos 6-10). The stand of pandanus in the east side yard is in fairly good condition and has a well-

Photo 5 Large black olive in backyard next to seawall.

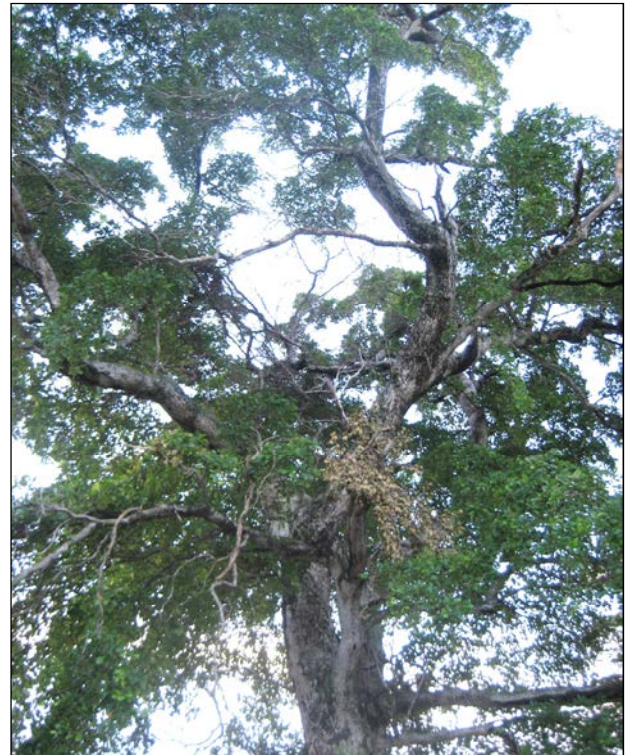
Photo 6 Close-up of decaying/damaged trunk on black olive in backyard.

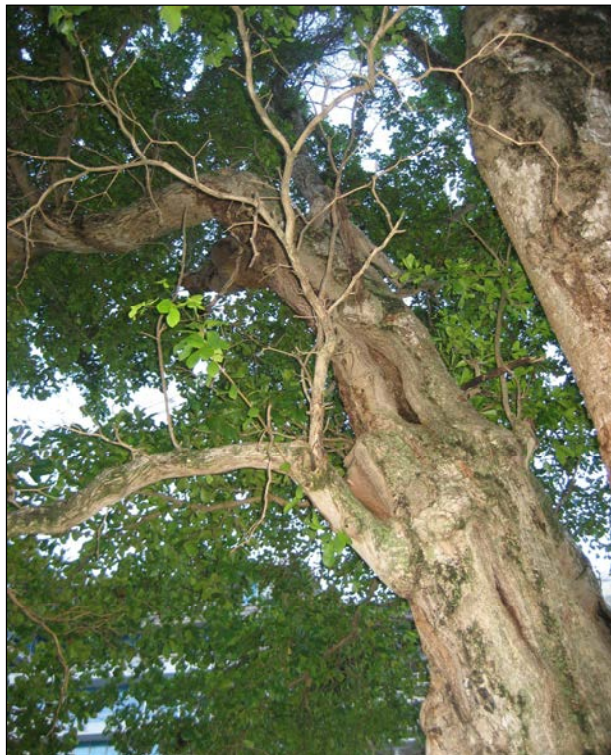
Photo 7 Close-up of trunk damage to black olive in backyard.

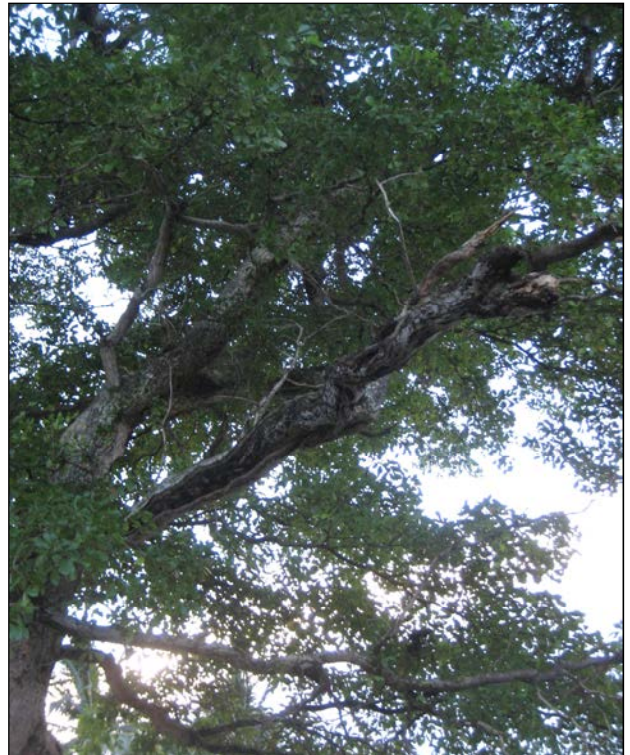
Photo 8 Additional close-up of trunk damage to black olive in backyard.

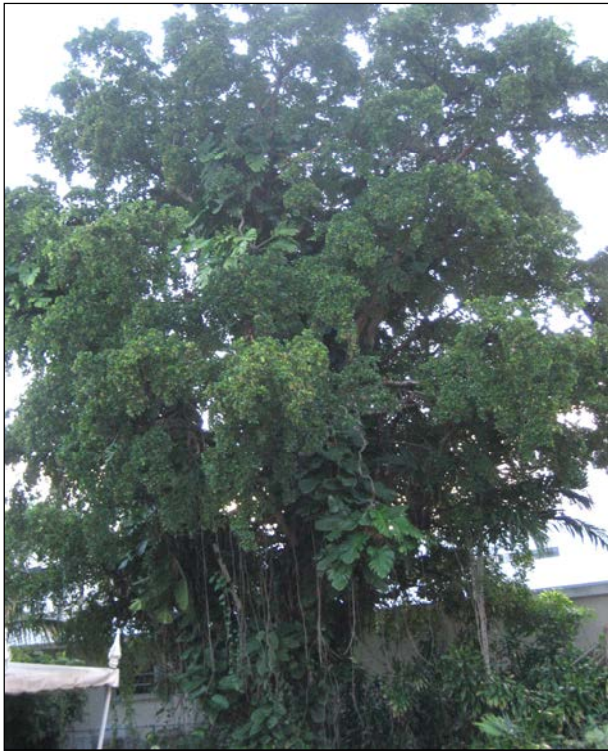
Photo 9 Black olive in east side yard covered with pothos vine.

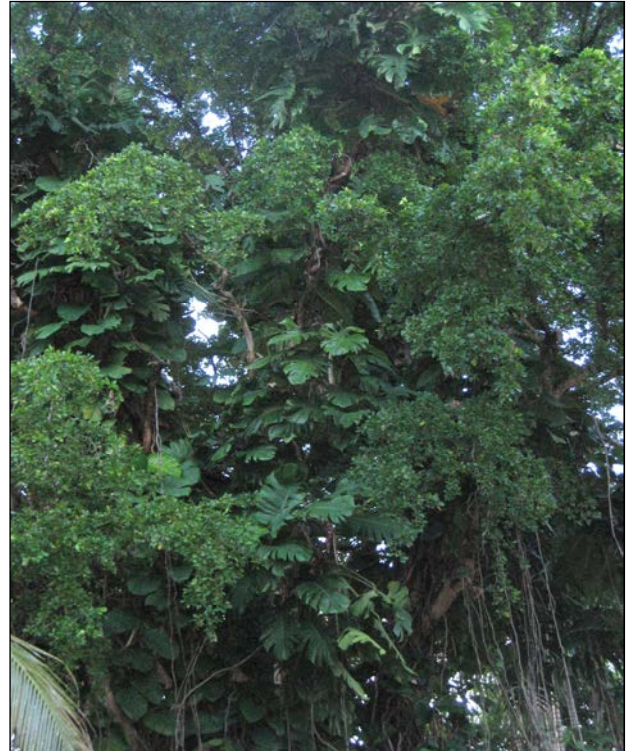
Photo 10 Close-up of pothos vine covering black olive in east side yard.

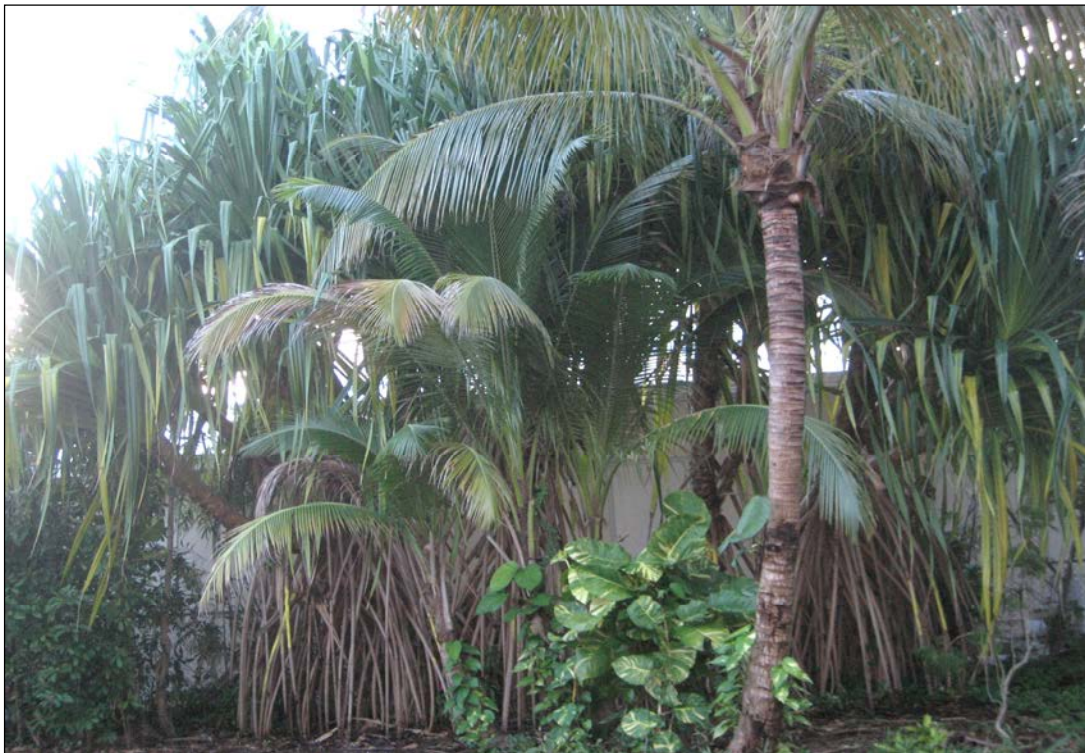
Photo 11 Pandanus cluster growing along east property line. Note adventitious root mass.
