STRUCTURAL CONDITION ASSESSMENT  
1235 Lenox Ave  
Miami Beach, Florida

H200440

March 13, 2020

STRUCTURAL CONDITION ASSESSMENT for  
1235 Lenox Ave  
Miami Beach, Florida

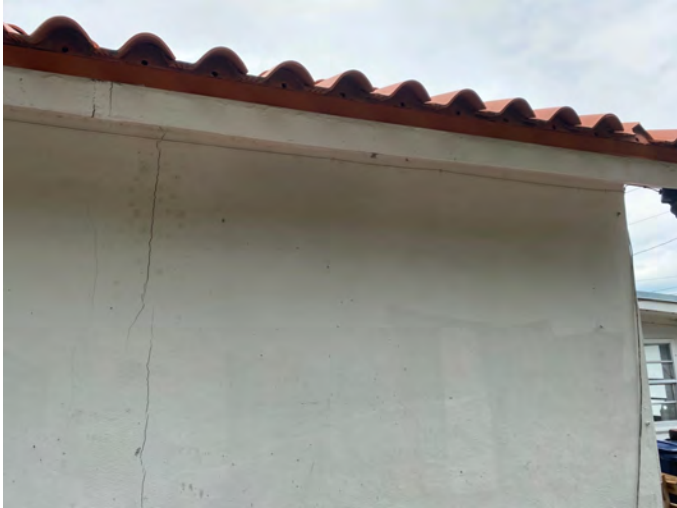
Masonry members; which comprise the exterior walls of the building, is mostly in fair condition. There are several cracks in the masonry that are attributed to age, exposure to the elements, and settlement of the shallow foundations.

Photo 3 - South Elevation CMU cracking

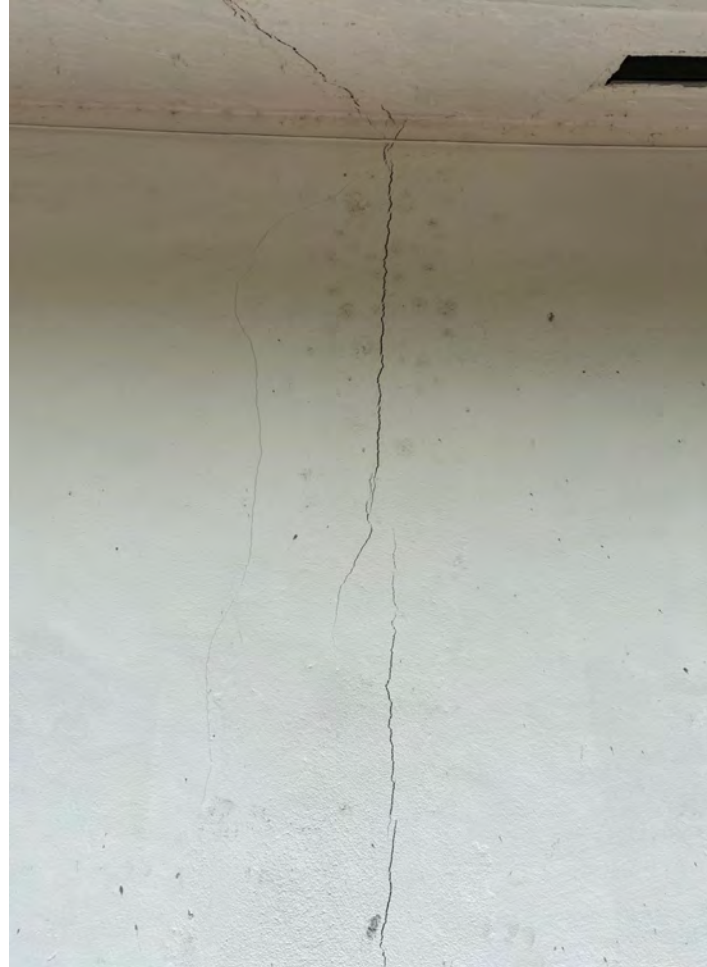
Photo 4 - South Elevation CMU cracking

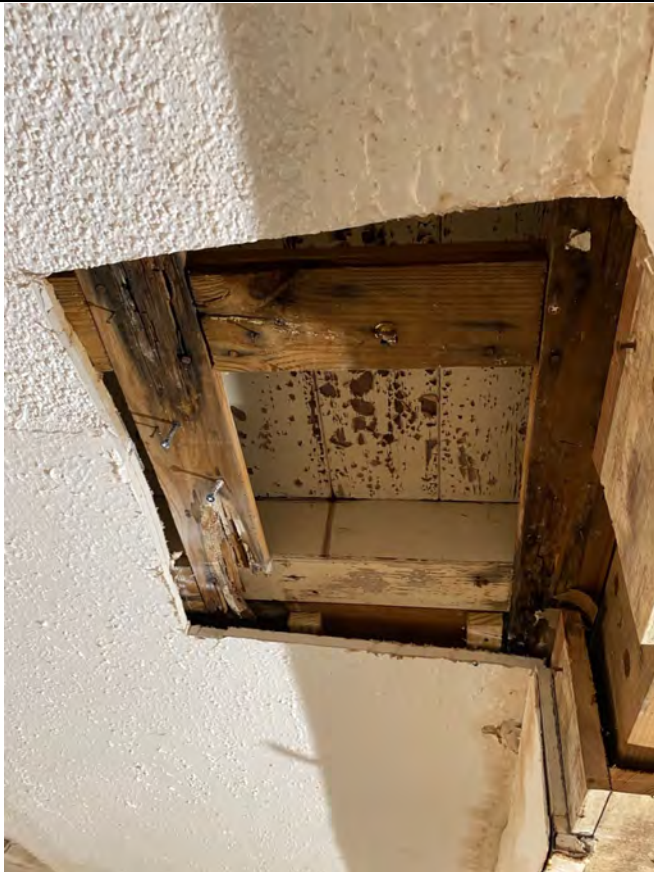
Photo 9 – Ceiling of covered patio

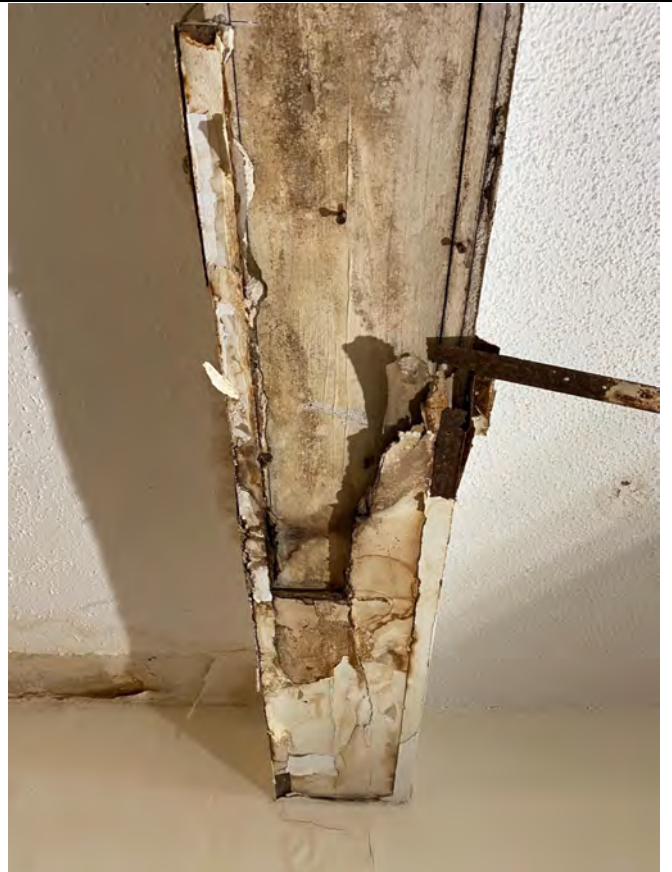
Photo 10 – Edge beam between covered patio and East addition

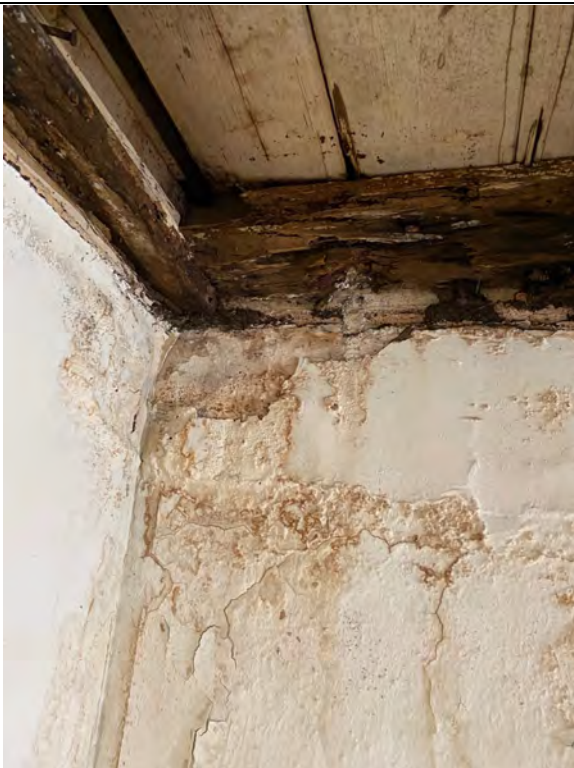
Photo 11 – Ceiling of covered patio

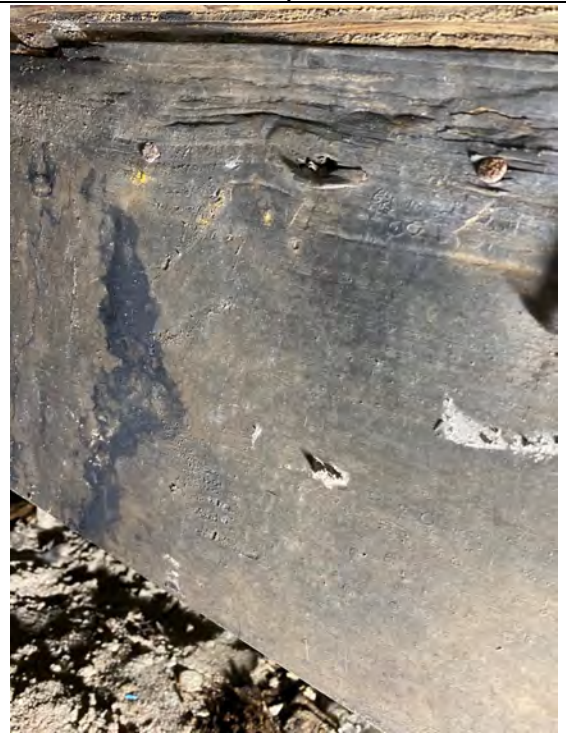
Photo 16 - Crawl space under house showing damaged floor joists

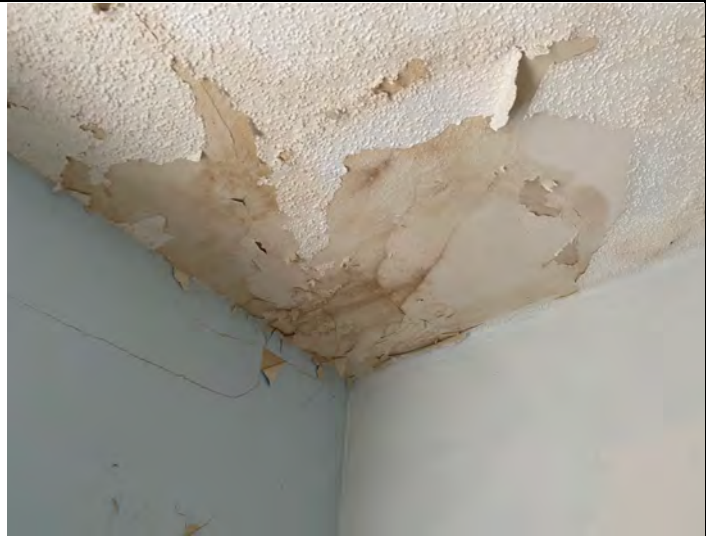
Photo 18 – Roof leaks damage

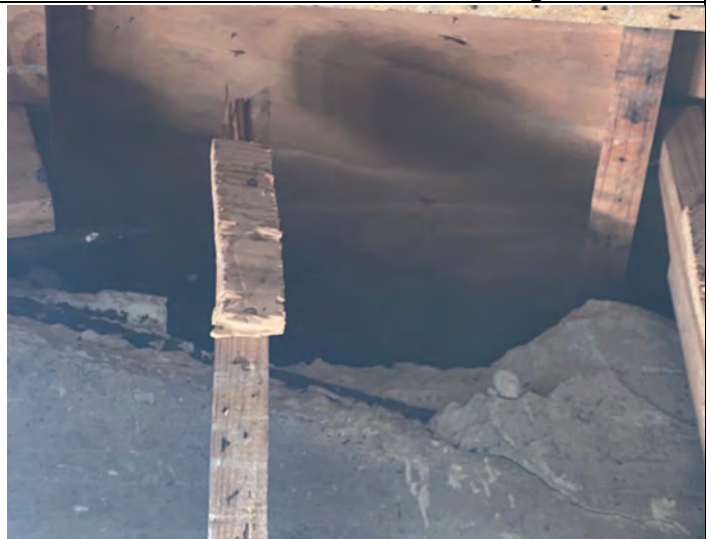
Photo 20 – West elevation concrete spalling and corroded rebars

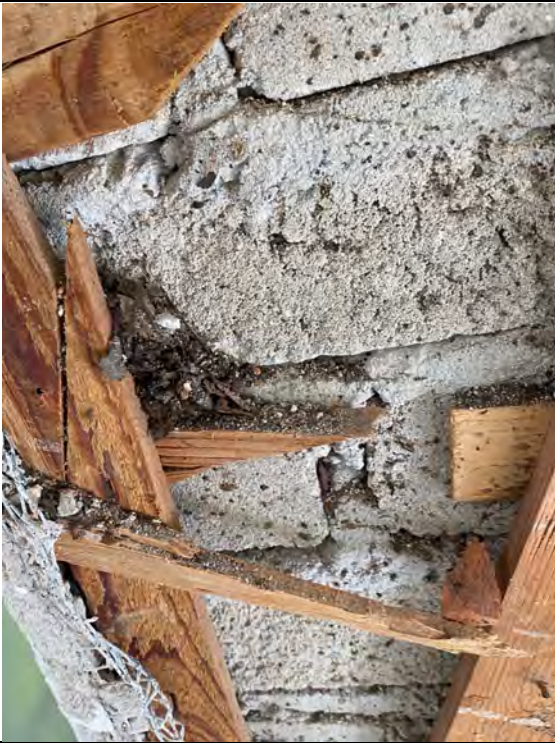
Photo 21 – Termite Damage and SMU

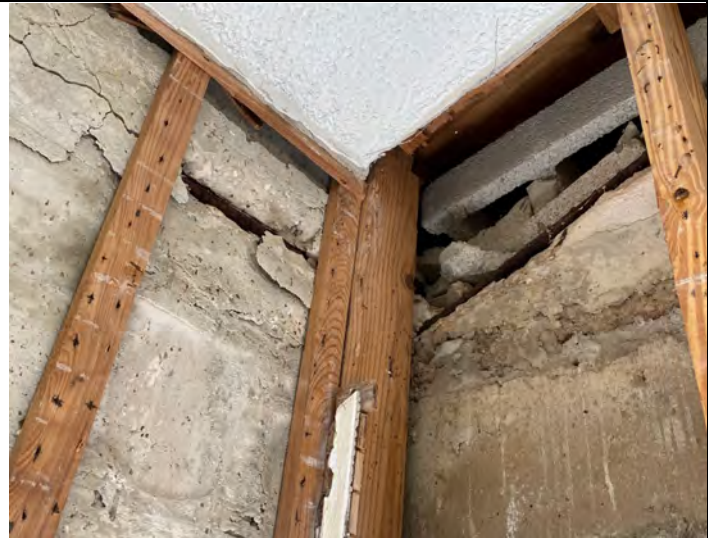
Photo 22 - West elevation concrete spalling and corroded rebar

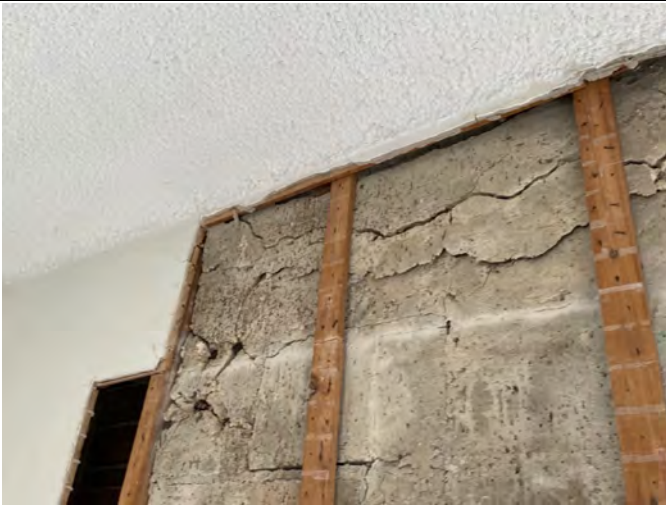
Photo 23 - Concrete beam spalling, at South elevation

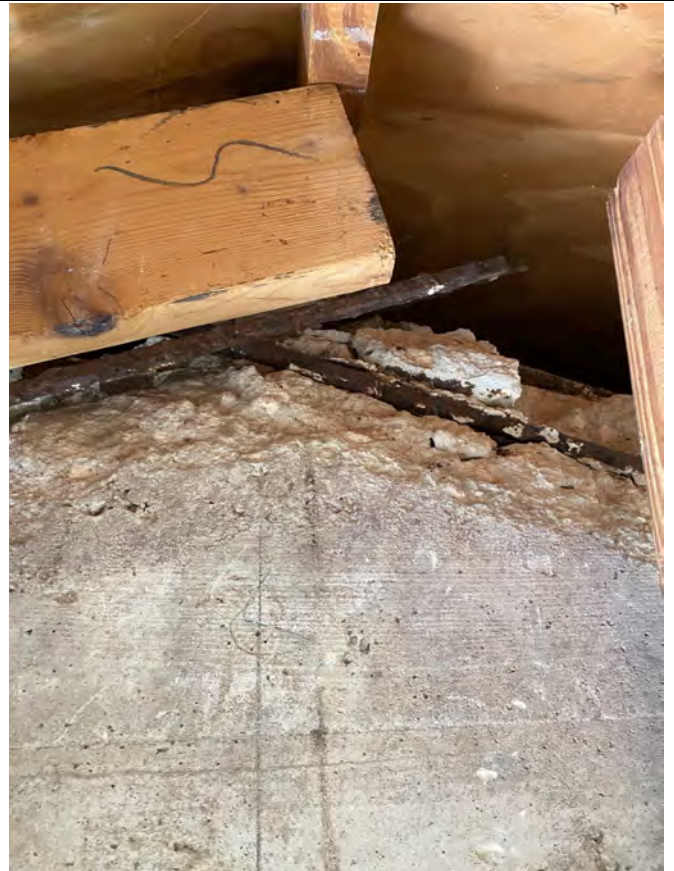
Photo 24 - West elevation concrete spalling and corroded rebar

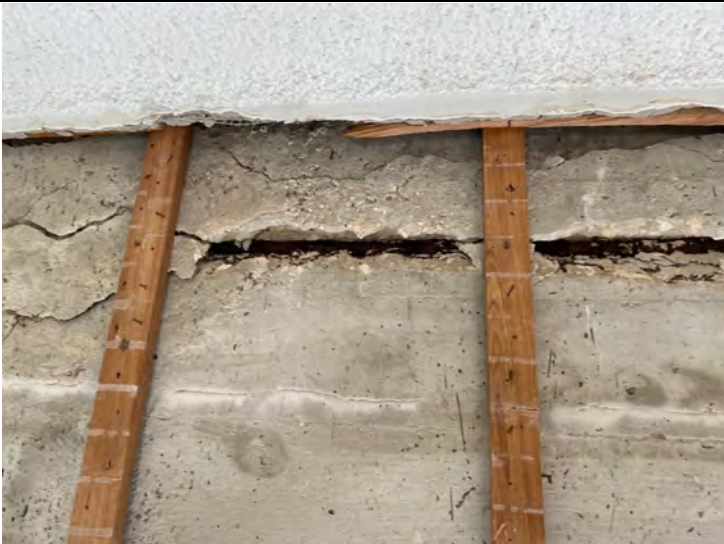
Photo 25 - South elevation concrete spalling and corroded rebar

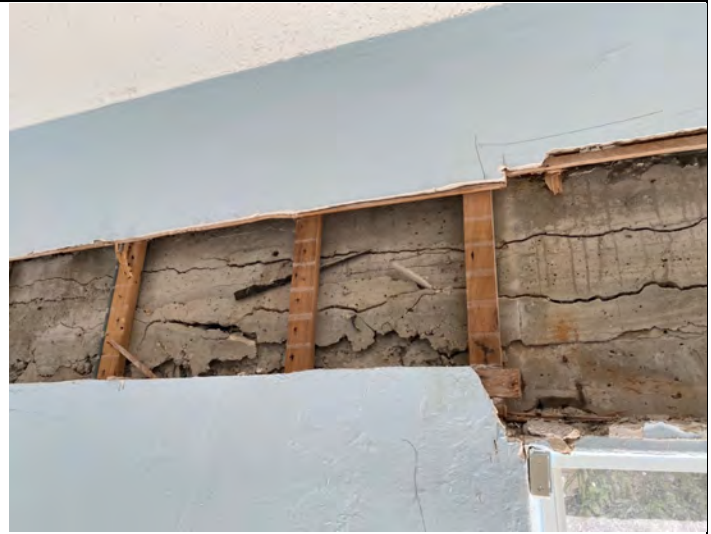
Photo 26 - South elevation concrete spalling and corroded rebar

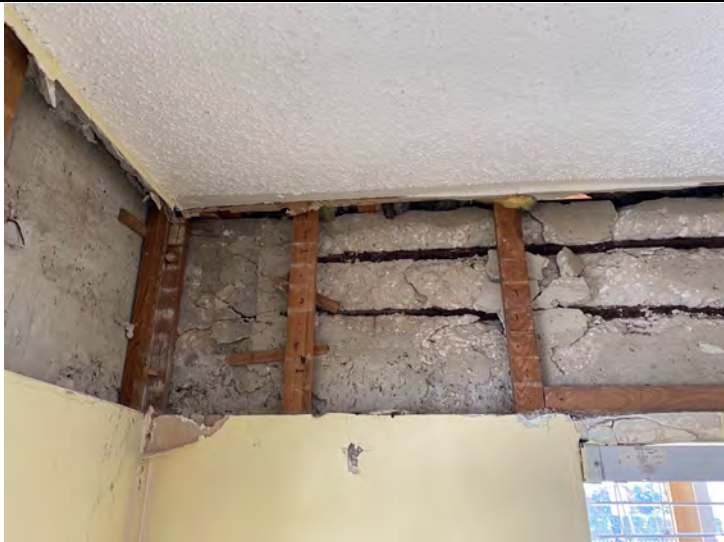
Photo 27 - North elevation concrete spalling and corroded rebar

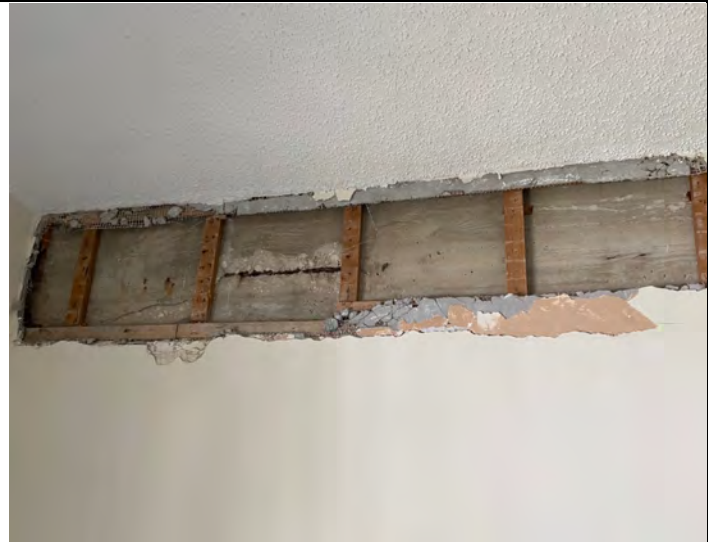
Photo 28 - North elevation concrete spalling and corroded rebar

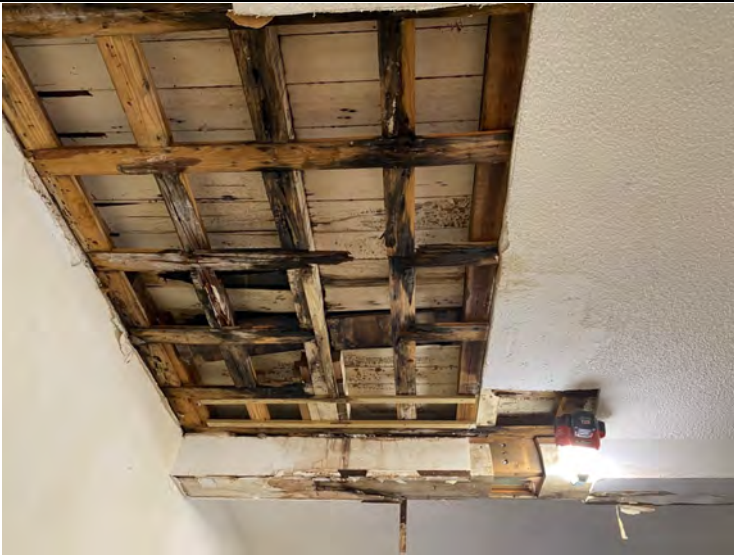
Photo 29 – Covered patio roof damage

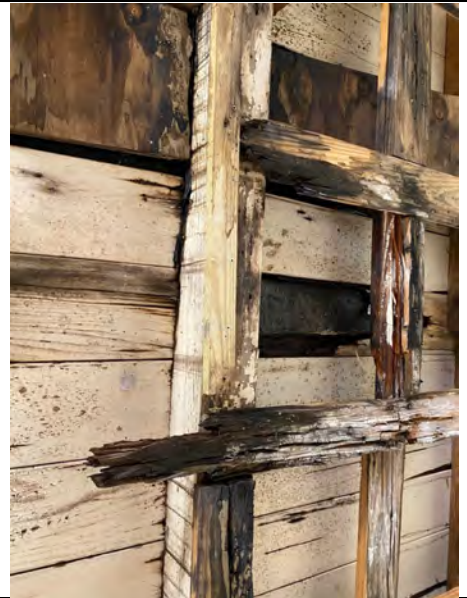
Photo 30 - Covered patio roof damage

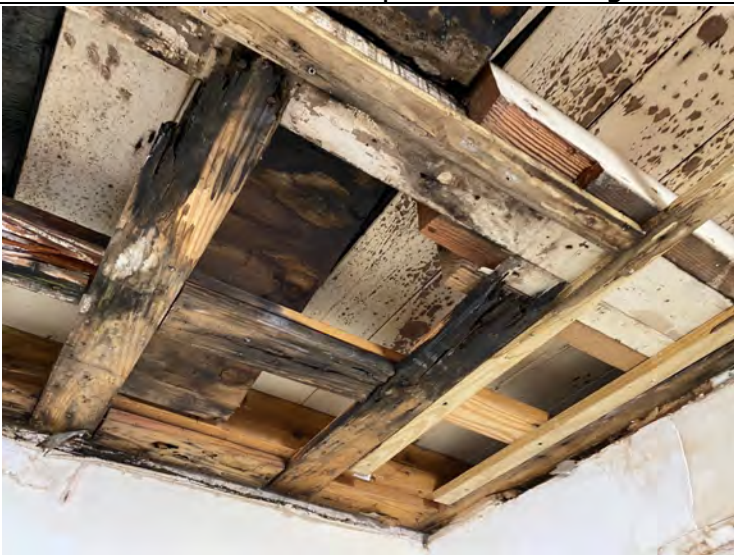
Photo 31 - Covered patio roof damage

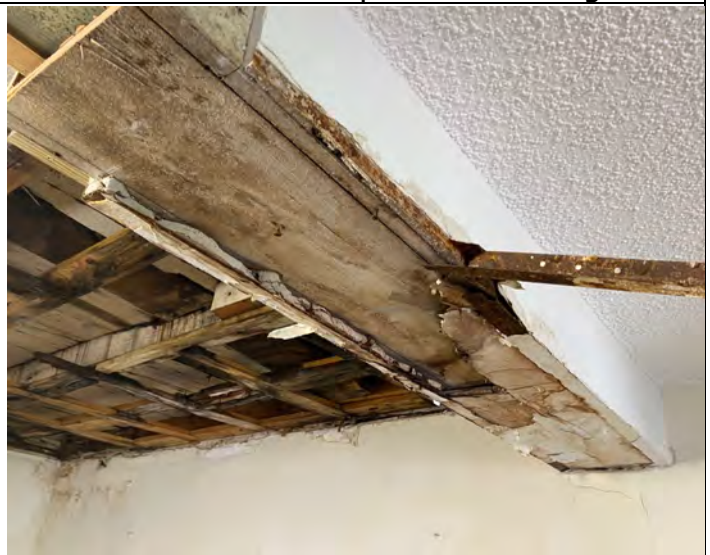
Photo 32 - Covered patio roof damage

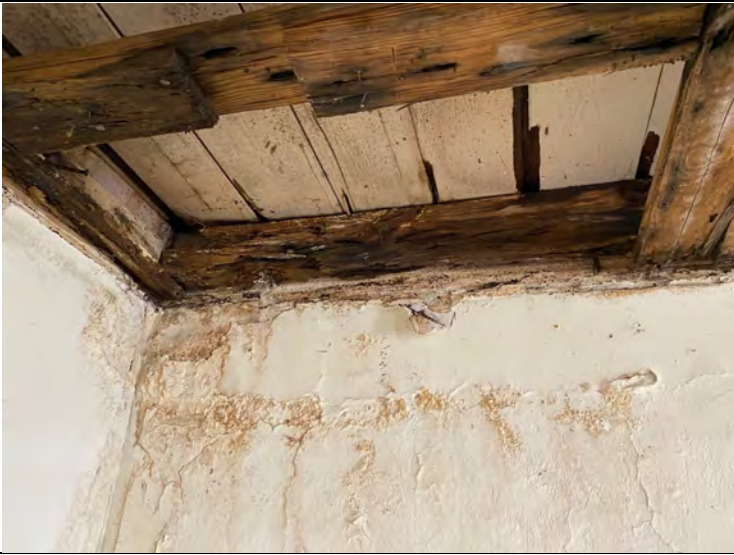
Photo 33 - Covered patio roof damage
