# HOME INSPECTION REPORT

Client Name: **Jacqueline Sankowski**  
Property Address: **828 4th Street**  
Address Line 2:  
City (State): **Miami Beach (FL)**  
ZIP: **33139**  
Phone:

Inspection #: **060320-828**  
Inspection Date: **06/03/2020**  
Inspector: **Jorge Garcia**  
License: **HI 9540**  
Time: **10:00 AM**  
Weather/Temp: **Rainy**

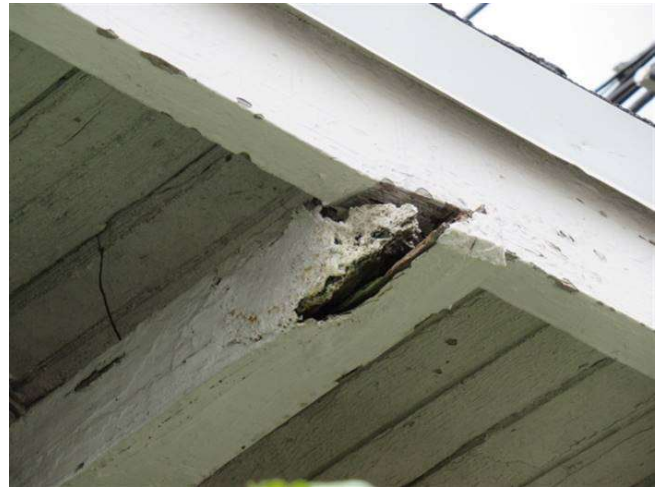
- 1. Wood rot was noted throughout the fascia, overhang and roof framing.**
- 2. Termite damage was noted to the fascia and and roof framing.**

WOOD ROT

5. Recommend further evaluation from a licensed roofing company.

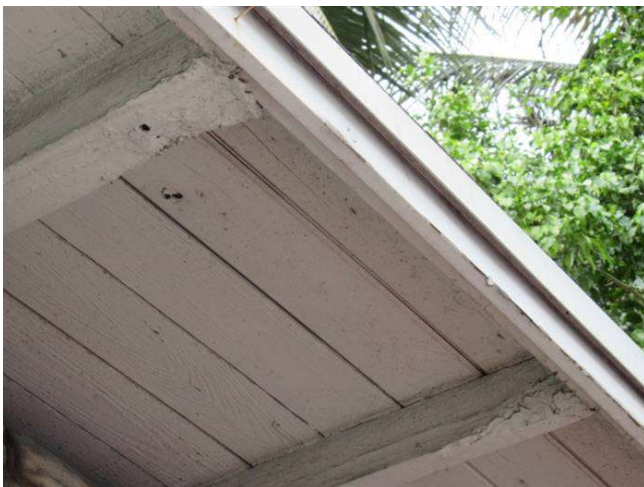
WOOD ROT

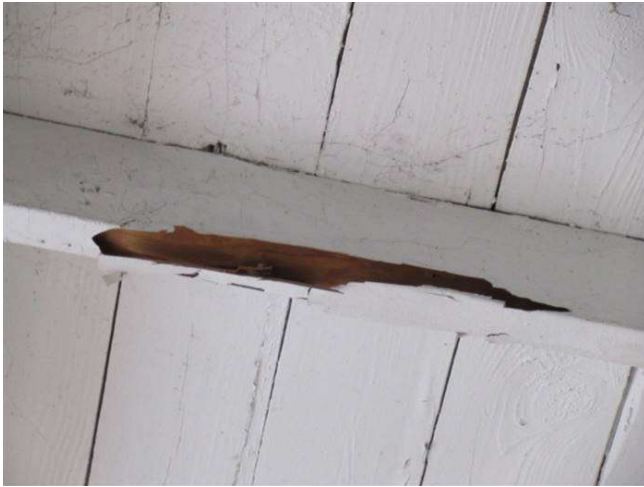
TERMITE DAMAGE

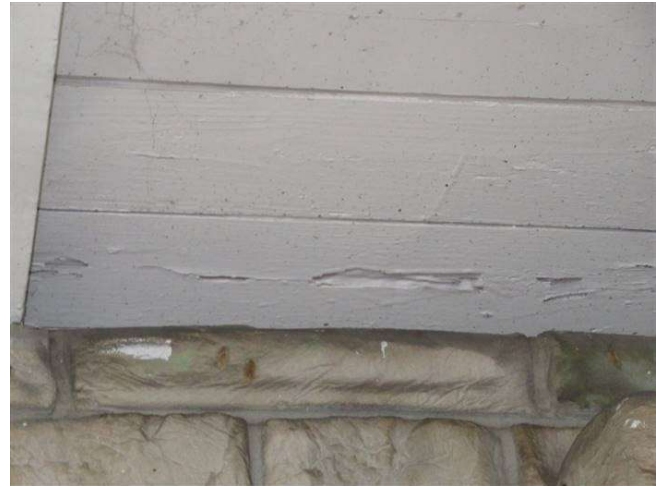
TERMITE DAMAGE

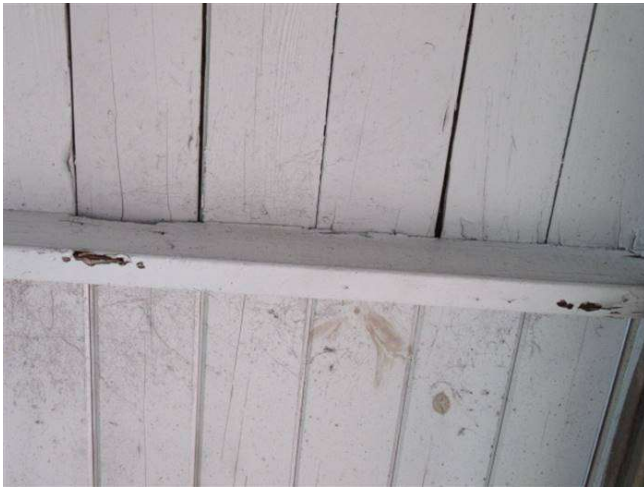
TERMITE DAMAGE

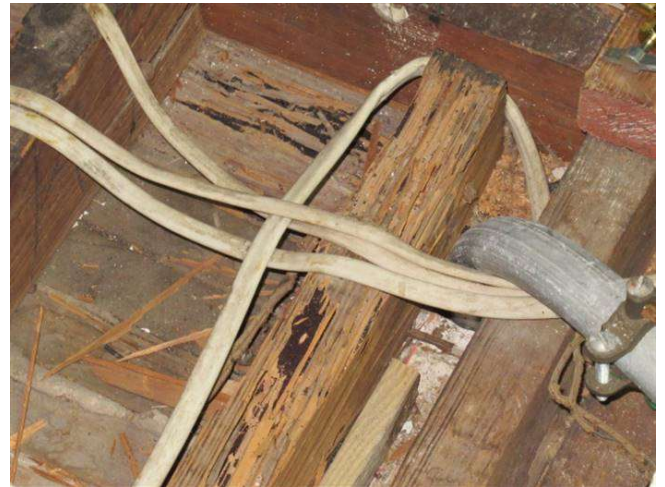
TERMITE DAMAGE

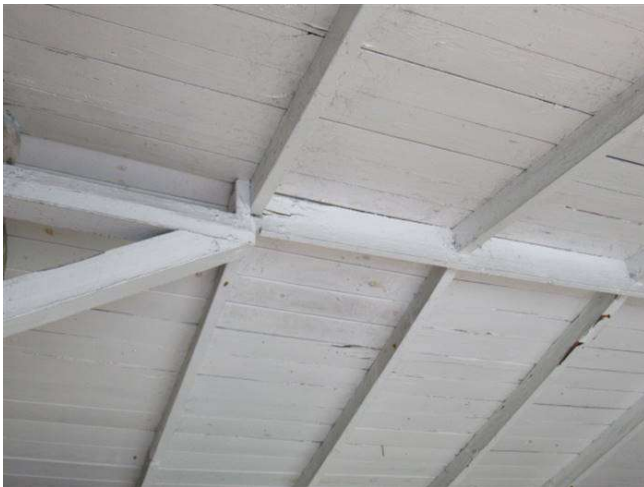
SAGGING ROOF

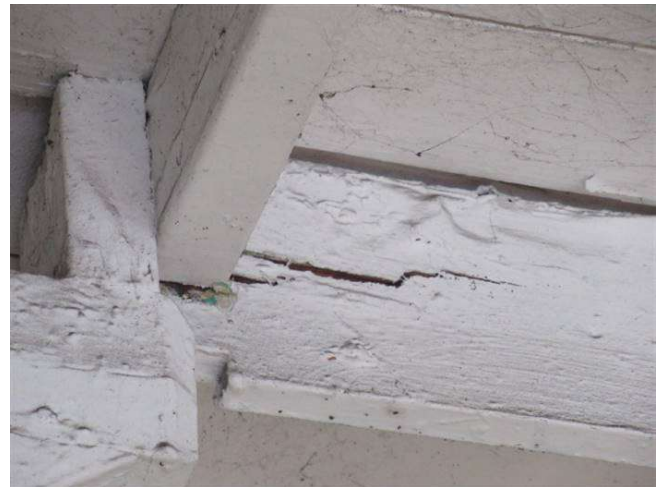
SAGGING ROOF

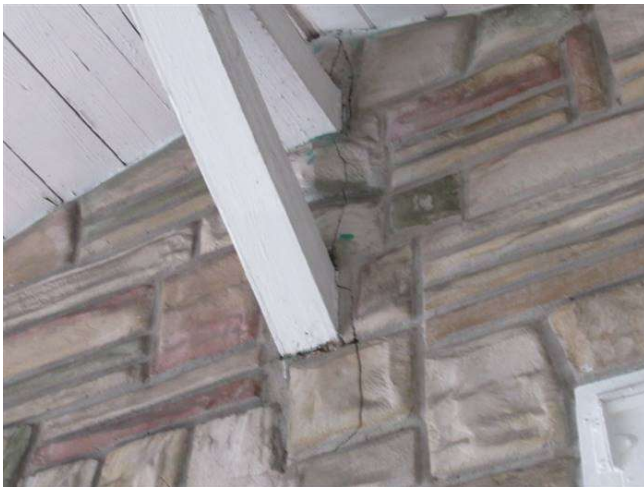
1. Fine and hairline cracks were noted at exterior walls. These cracks are typical and common, and indicative of some differential settlement and movement. Sealing, cosmetic repairs and continued monitoring are recommended. Evaluation by a structurally engineer is recommended if further concern exists.

HAIRLINE CRACKS

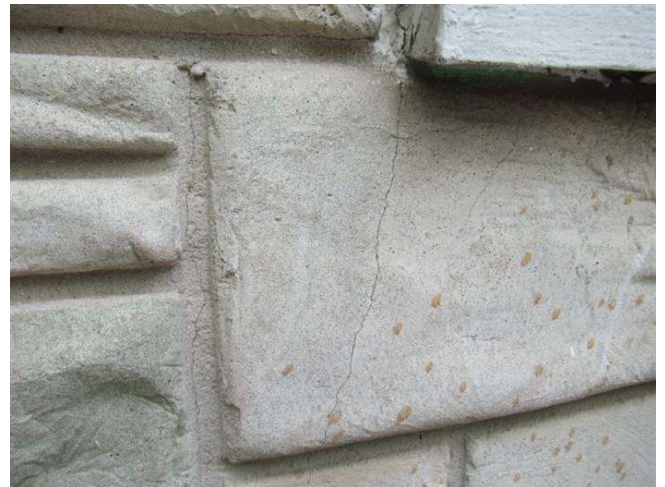
HAIRLINE CRACKS

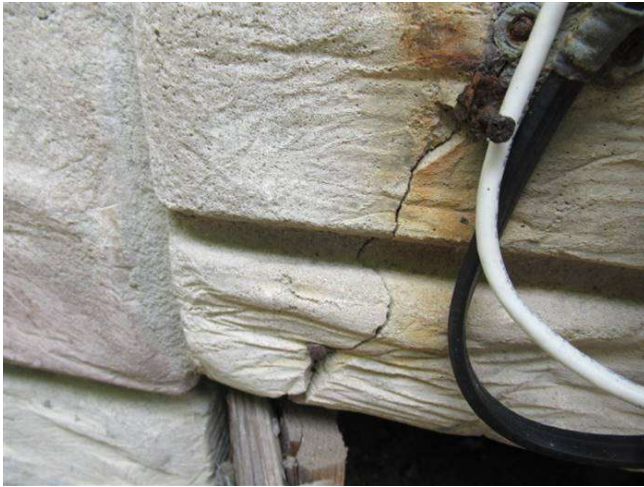
HAIRLINE CRACKS

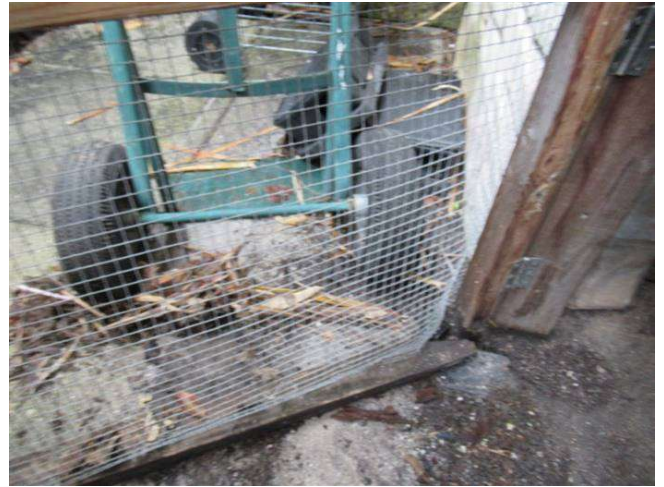
2. The crawlspace access door has wood rot due to moisture penetration.
3. The front entry step has an improper step height causing a trip hazard.
4. Sagging floors were noted at the front entry, northeast bedroom and kitchen.

DAMAGED CRAWLSPACE DOOR

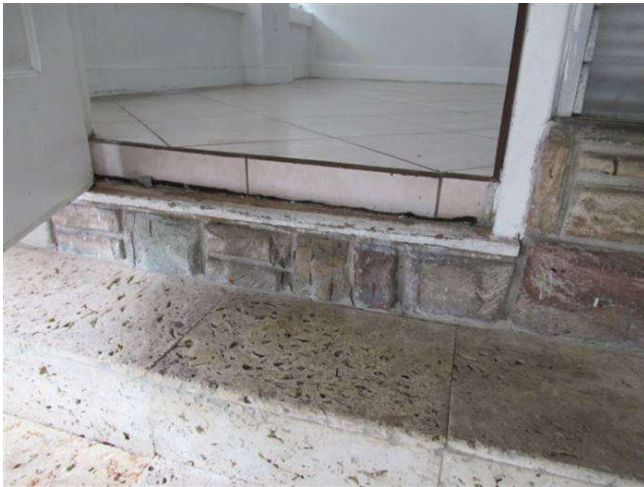
IMPROPER STEP HEIGHT

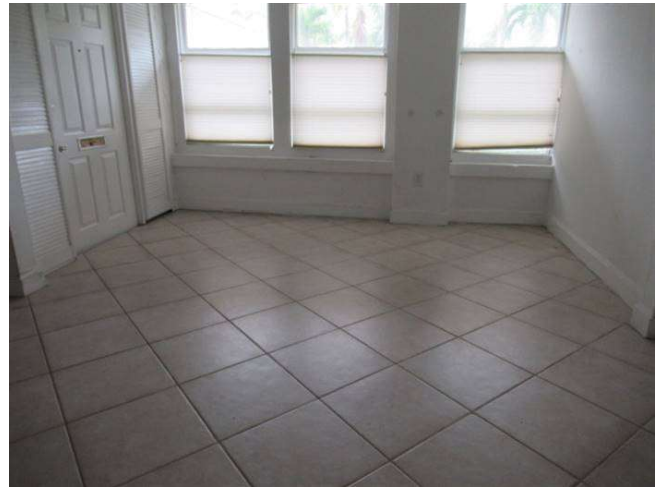
SAGGING FLOORS

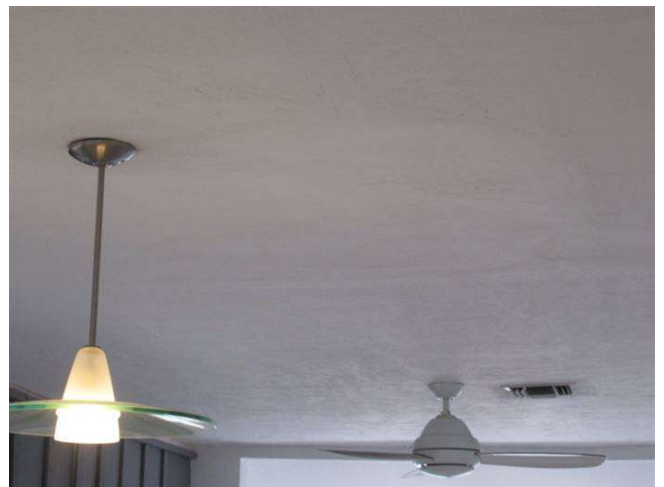
5. The ceilings were noted sagging in several areas.
6. Termite damage and droppings were noted in the northeast bedroom and crawlspace.
7. Chipped and cracked tiles were noted throughout the interior. It is unknown if matching replacement tile exist. We recommend buyer inquire with seller regarding replacement tiles and consult with a tile contractor to determine options and costs. Costs will greatly vary.

SAGGING CEILINGS

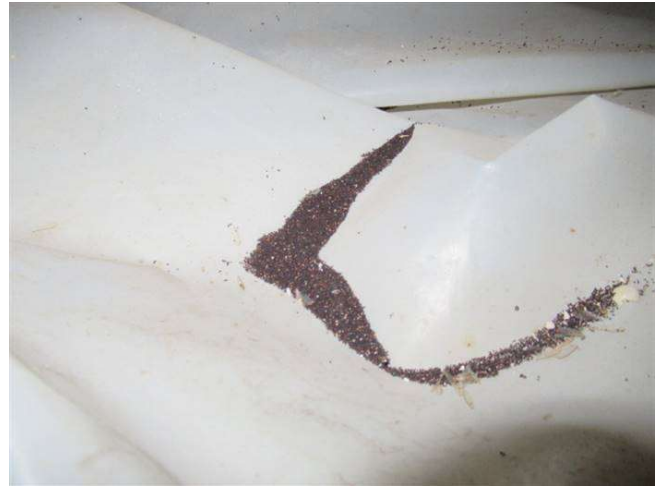
TERMITE DAMAGE/DROPPINGS

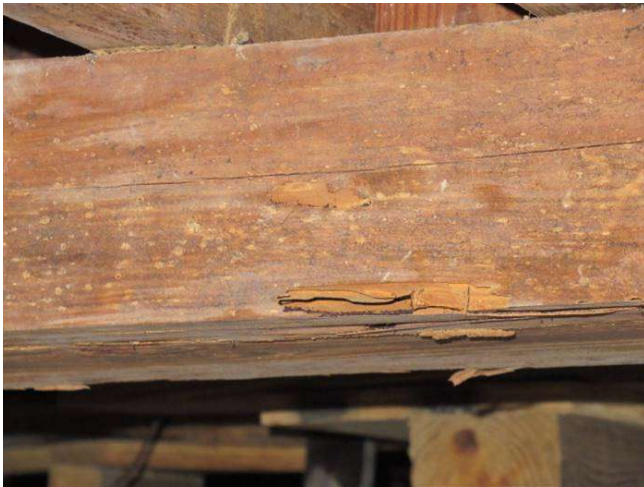
TERMITE DAMAGE/DROPPINGS

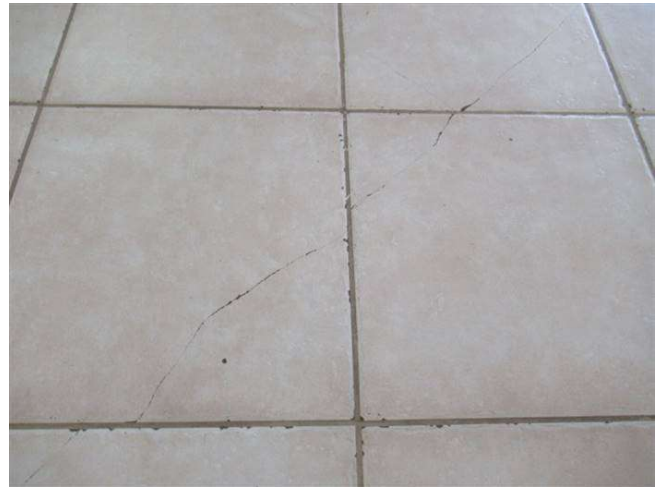
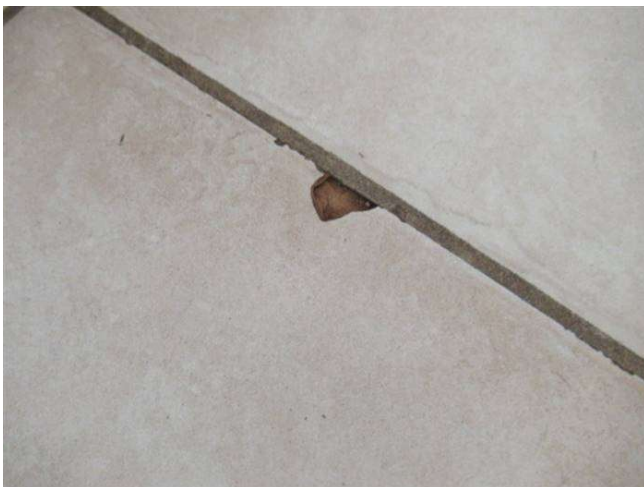
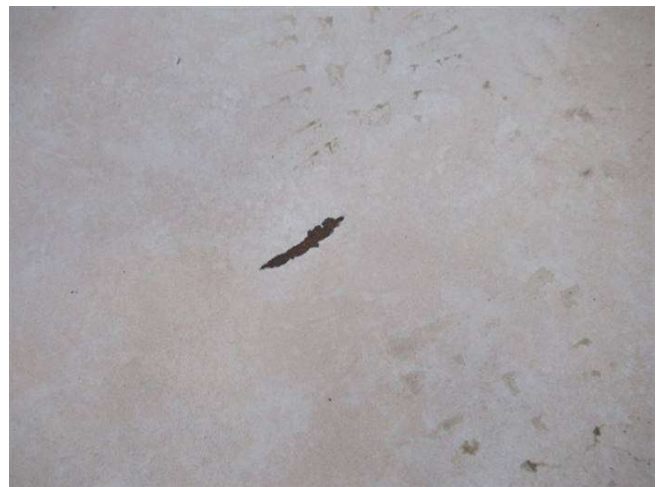
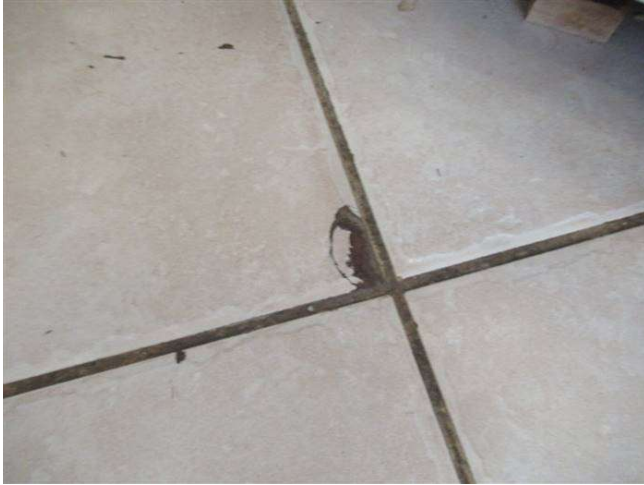
CHIPPED/CRACKED TILES

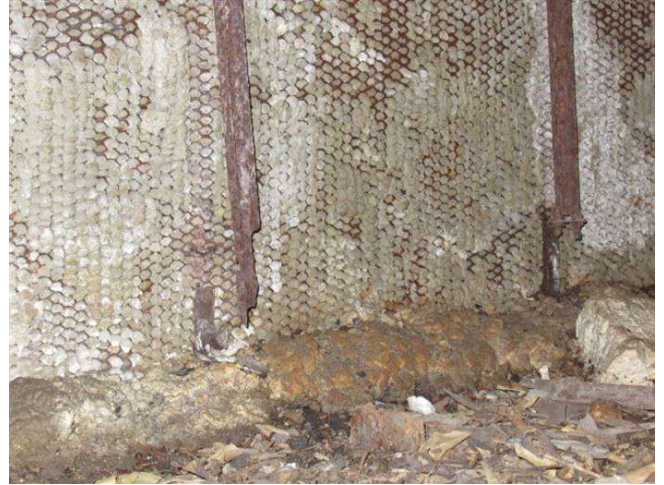
- 8. The exterior wall framing is corroded in the crawlspace.
- 9. Moisture damage was noted in the crawlspace on the subfloors.
- 10. Subterranean termite damage and mud tubes were noted in the crawlspace on the subfloor.
- 11. Improper subfloor supports were noted throughout the crawlspace.
- 12. The subfloor beams are cracked.
- 13. Recommend further evaluation from a licensed pest control company.
- 14. Recommend further evaluation from a licensed contractor.

CORRODED WALL FRAMING

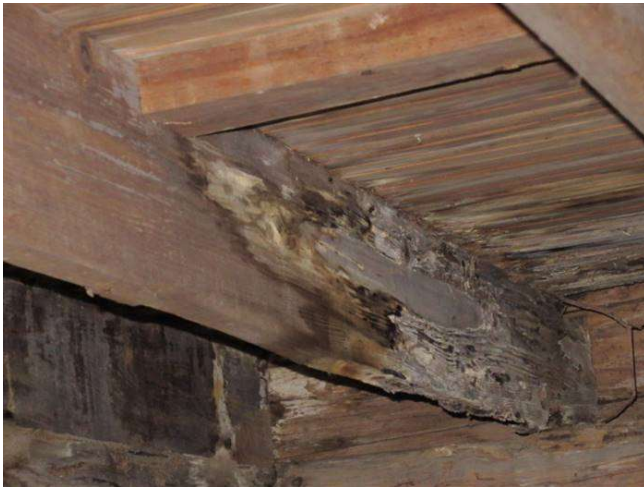
MOISTURE DAMAGE

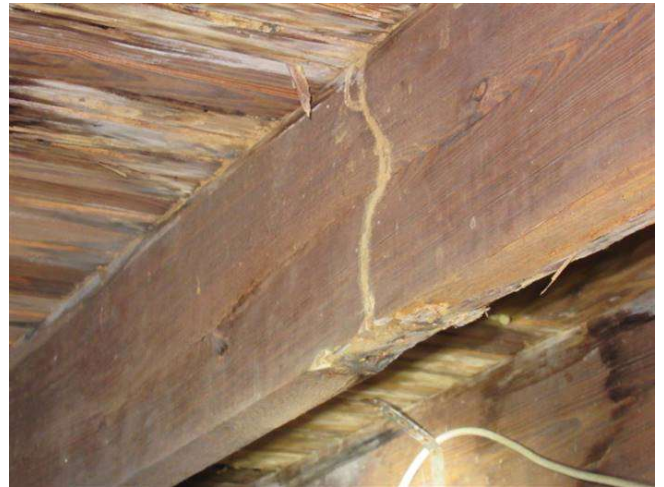
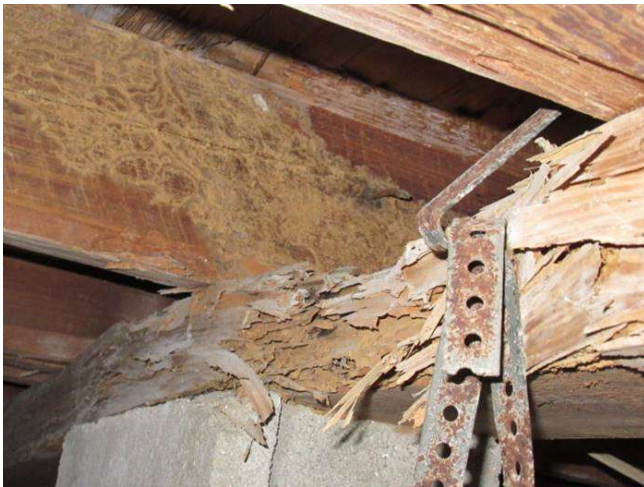
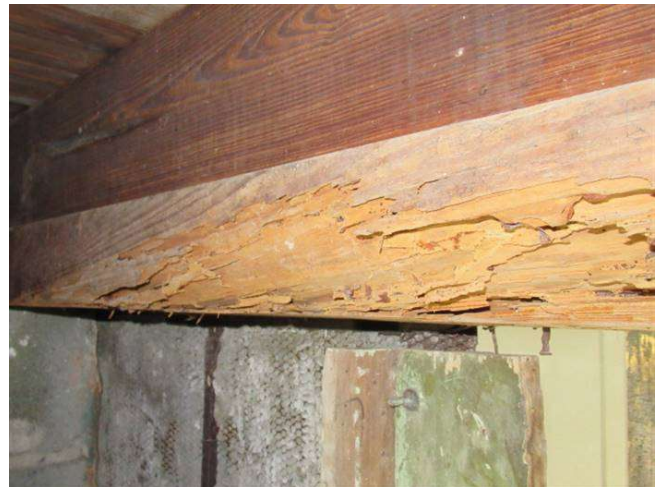
SUBTERRANEAN TERMITE DAMAGE

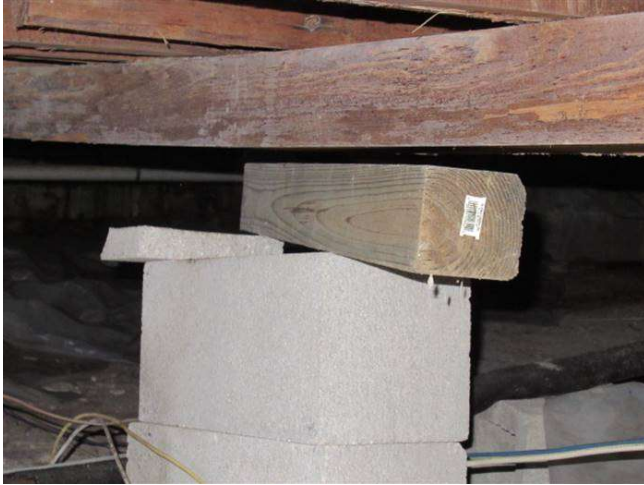
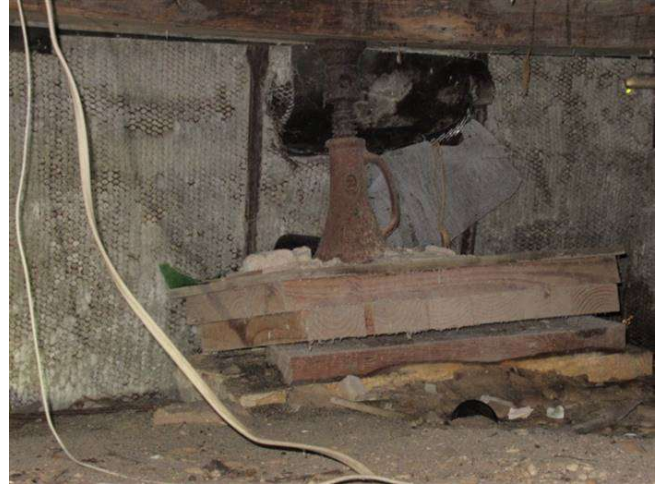
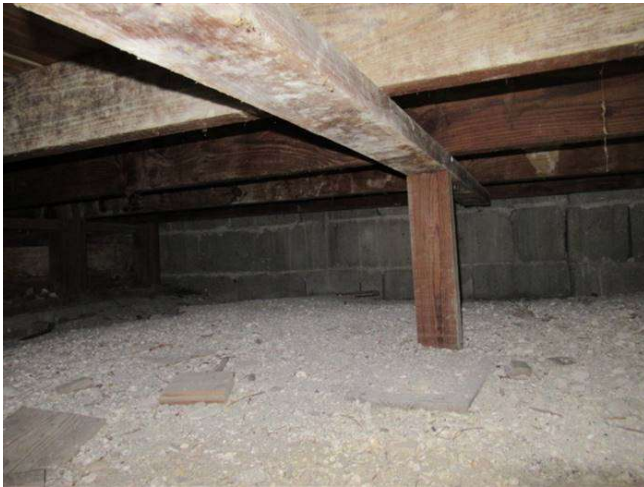
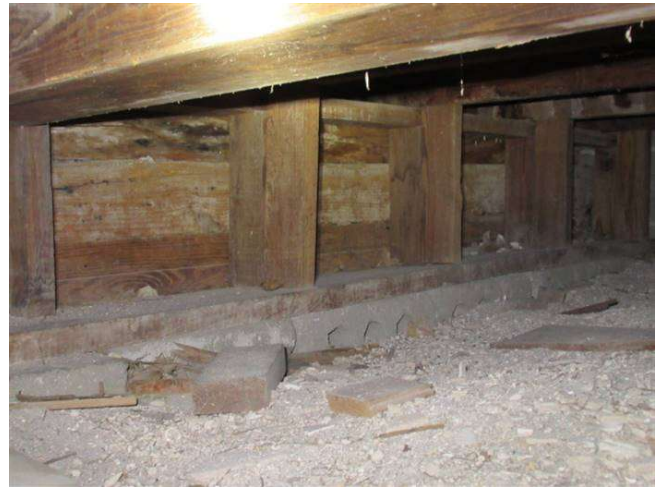
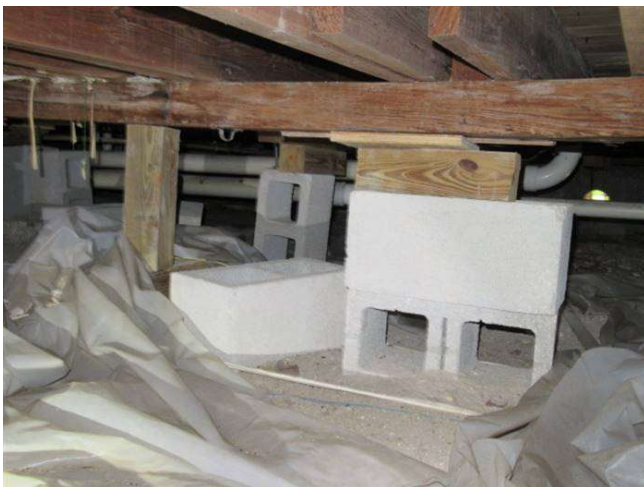
IMPROPER SUBFLOOR SUPPORTS

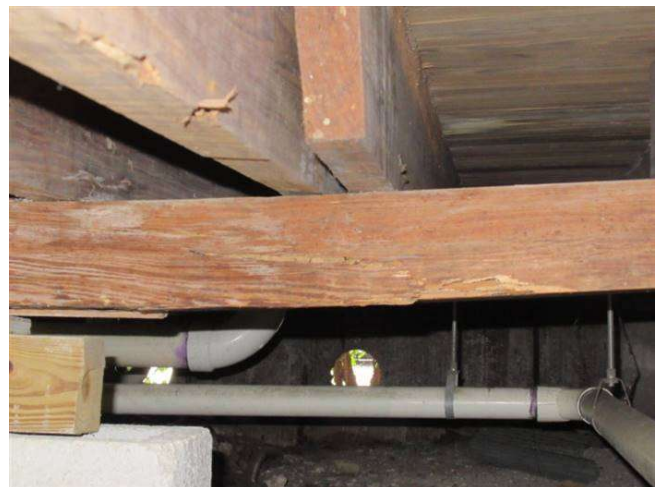
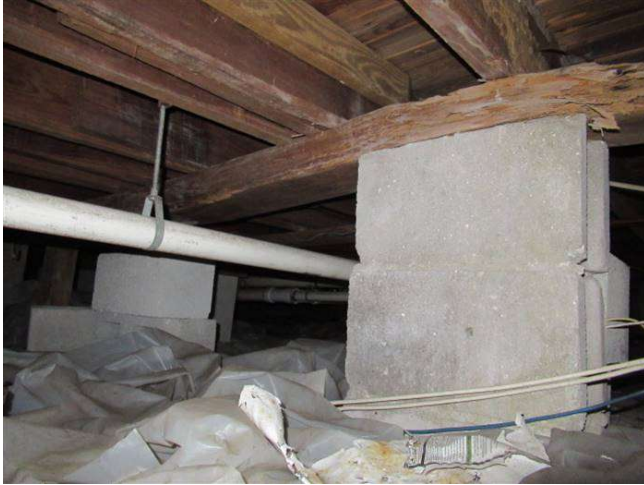
CRACKED SUBFLOOR BEAMS

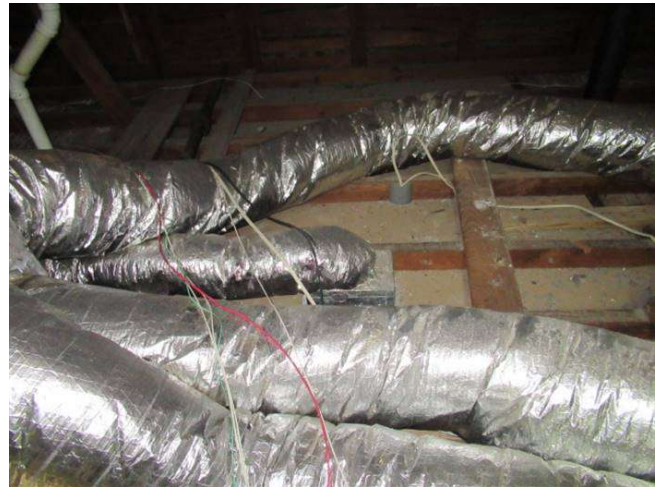
1. Air handler coils are dirty and require cleaning.
2. Recommend sealing the A/C plenum to avoid moisture buildup.
3. Missing insulation was noted in the attic.
4. Ductwork is not properly supported in attic and is resting on ceiling joists.
5. Torn duct work was noted in the attic.
6. Recommend further evaluation from a licensed A/C technician.

MISSING INSULATION

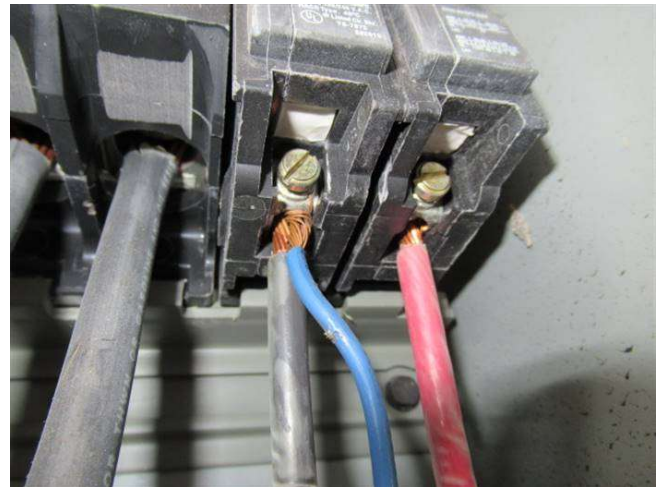
1. The exterior and interior panel covers are damaged.
2. A double tapping was noted at the service disconnect panel.
3. Loose wiring was noted at the service disconnect box.

DAMAGED PANELS

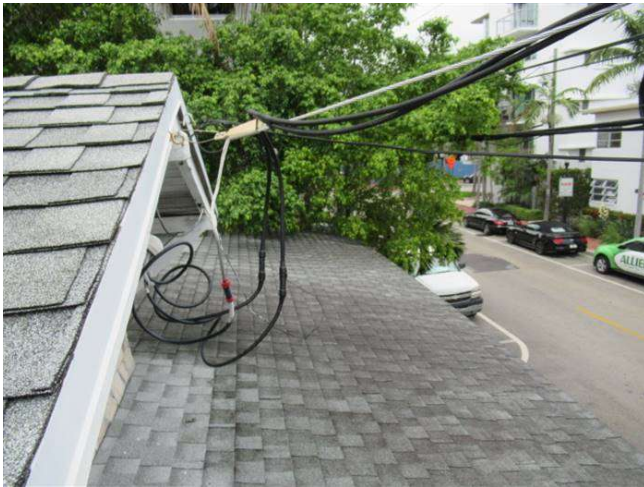
- 4. The mast head conduit is corroded.
- 5. The main feeder conductors over a roof must be a minimum of at least 8 feet.
- 6. Abandoned cloth wiring was noted in the attic.
- 7. Recommend further evaluation from a licensed electrician.

CORRODED CONDUIT

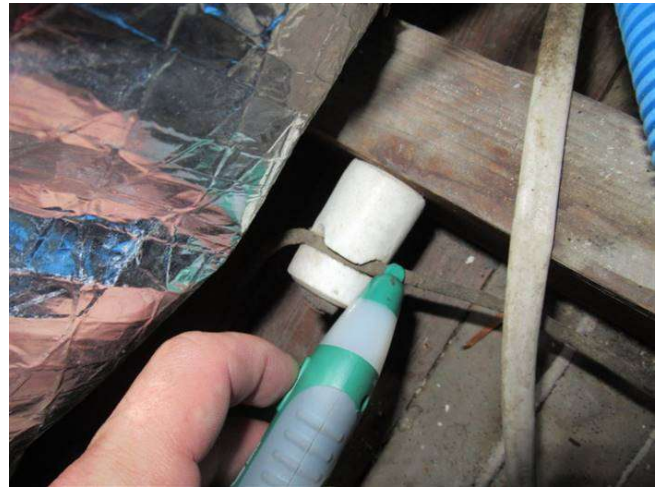
MAIN FEEDERS HEIGHT TO LOW

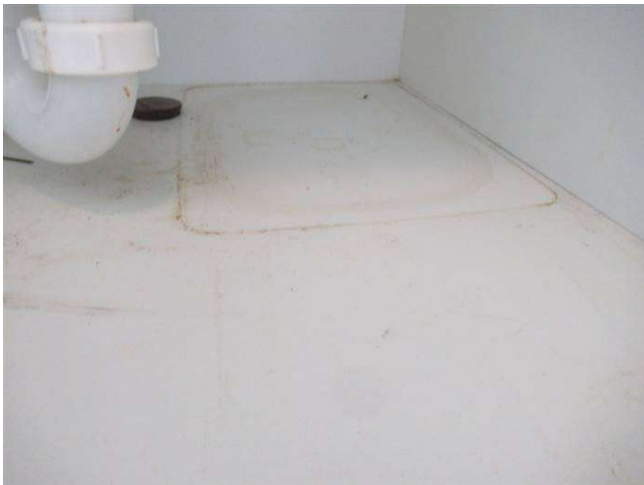
1. The front water supply pipe is loose from the wall.
2. The bathroom vanity is damaged due to moisture penetration.
3. Recommend removing the laminate from the bathroom shower to avoid trapping moisture and hidden damages.
4. The bathroom shower handle leaks when in the open position.
5. Recommend further evaluation from a licensed plumber.

LOOSE PLUMBING

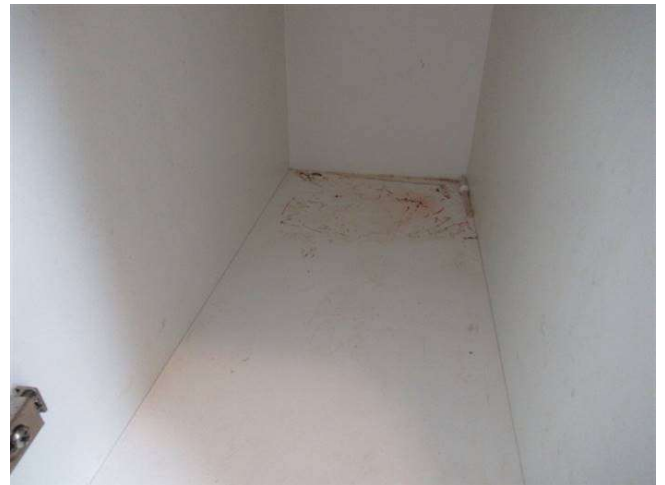
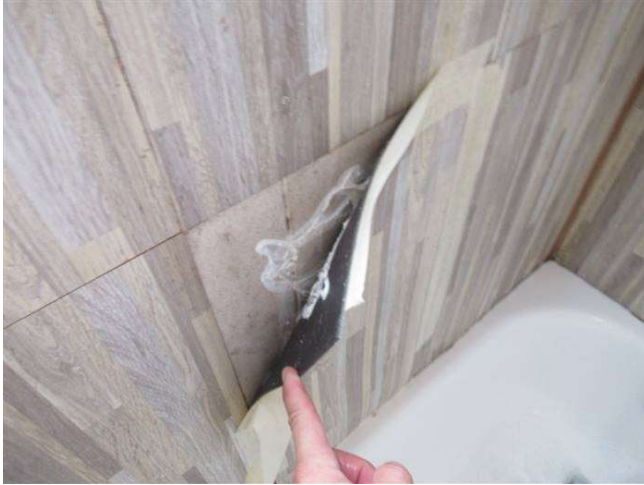
DAMAGED VANITY

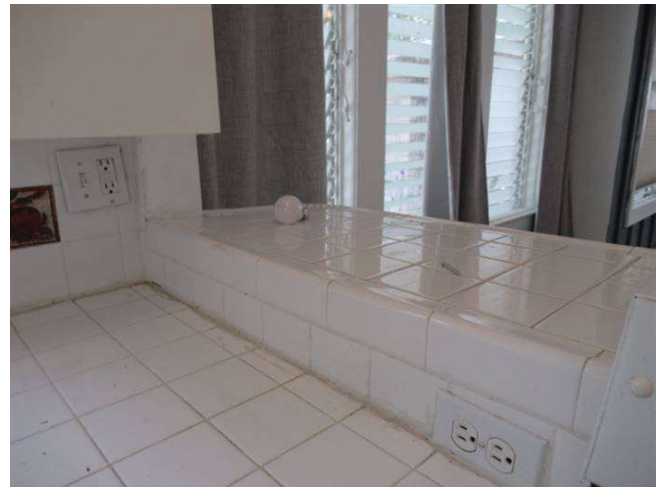
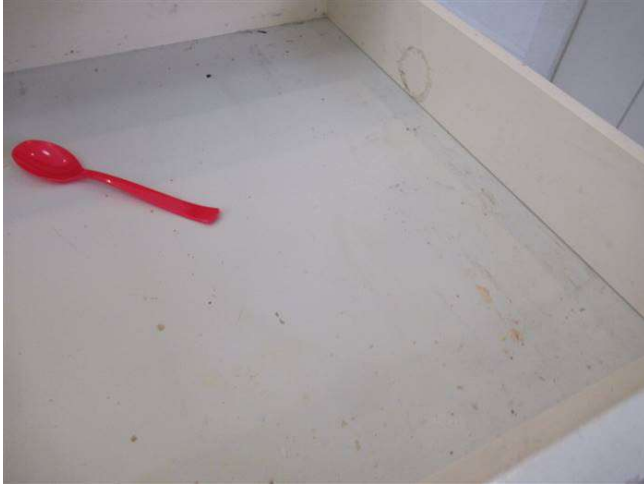
- The kitchen counters are sagging.**
- Moisture damage was noted to the kitchen cabinets.**
- The cabinet have signs of wear and deterioration.**
- Based on age and conditions of the appliances, we recommend buyer budget for replacement of the appliances, in lieu of repairs.**

SAGGING COUNTERS

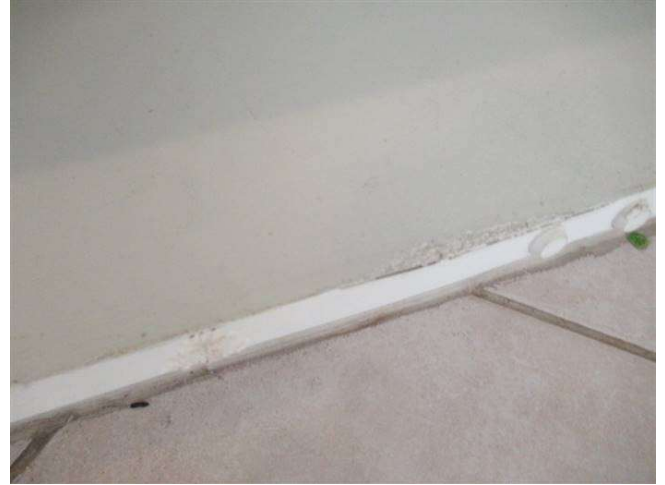
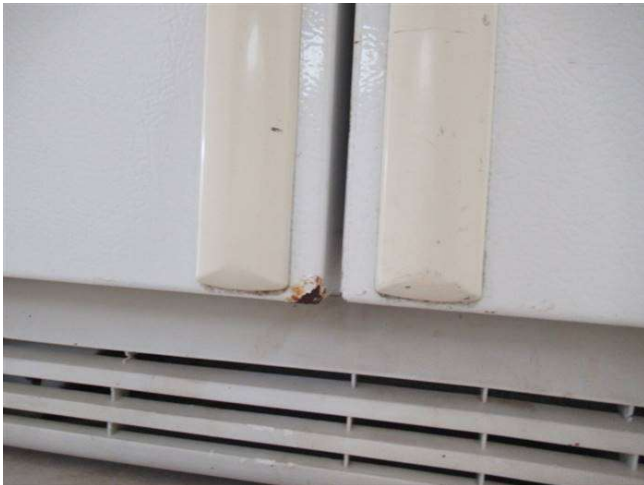
DETERIORATED CABINETS

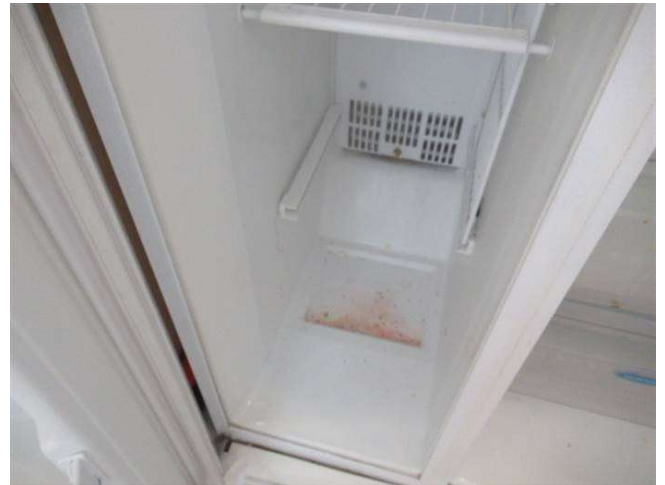
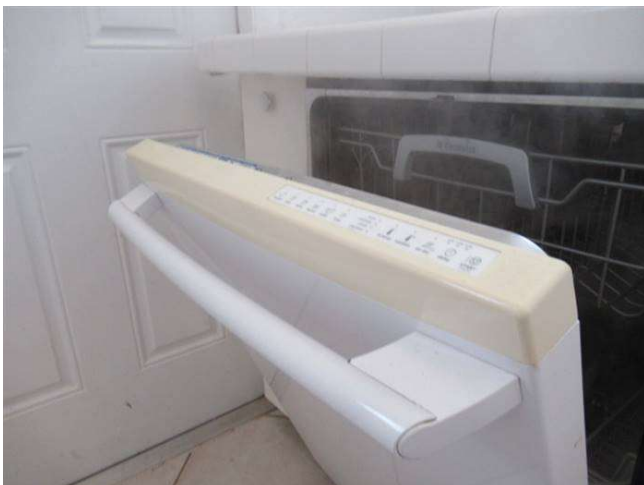
AGE/CONDITION WARRANTS REPLACEMENT

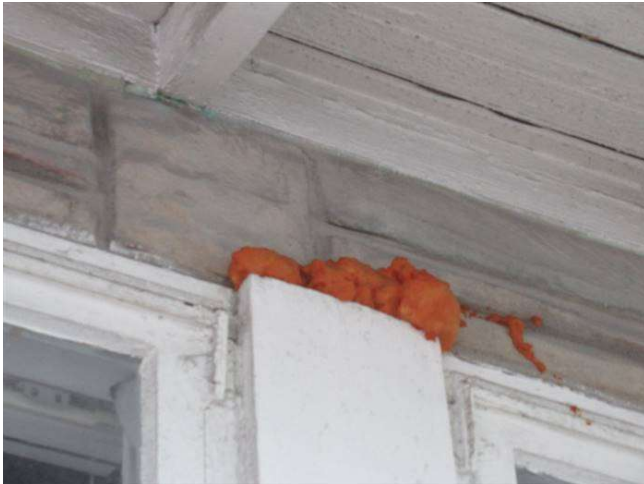
1. Several of the windows were noted sealed.
2. Recommend to properly seal the window framing.
3. A cracked jalousie pane in the kitchen and northeast bedroom was noted.
4. Wood rot was noted at the kitchen exterior door and frame.
5. Several windows were missing the crank handles.
6. The northeast bedroom door is not closing properly.
7. Several of the closet doors are damaged and/or loose.

SEALED WINDOWS

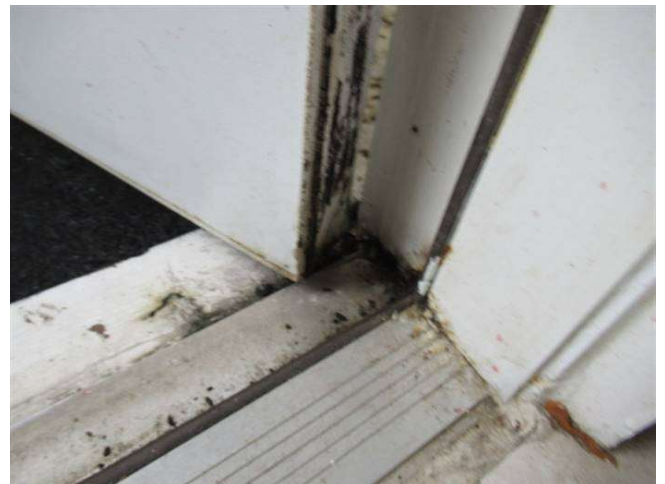
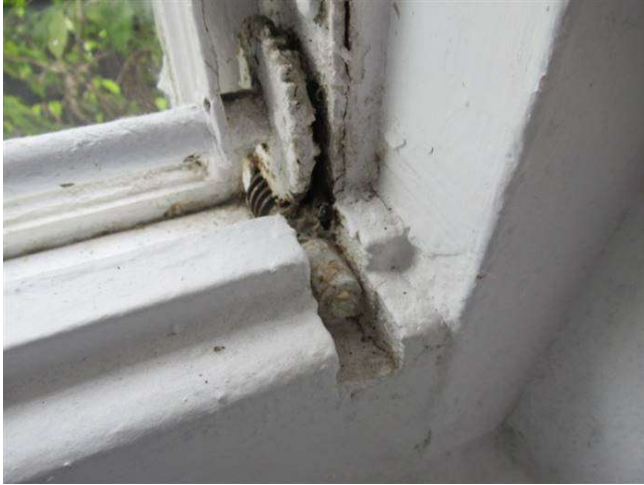
WOOD ROT

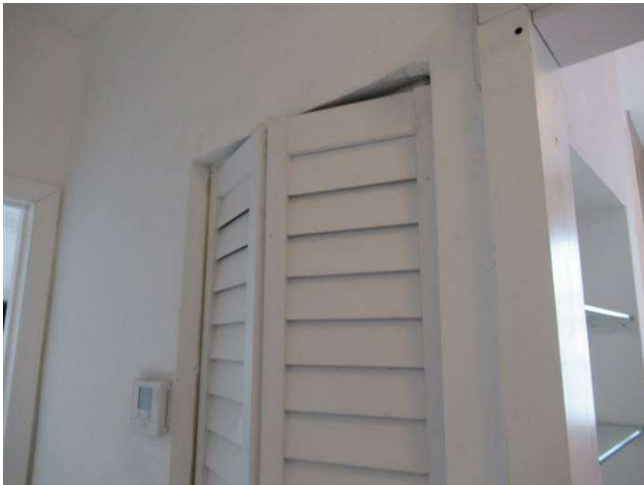
BINDING DOOR

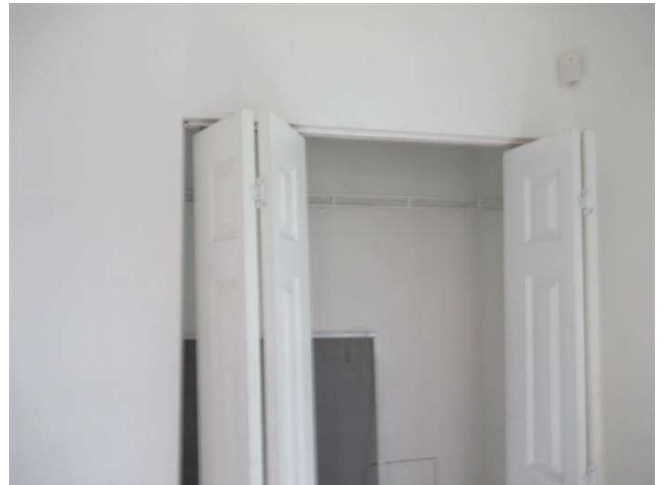
DAMAGED/LOOSE DOORS
