# Arborist Report

92 La Gorce Circle  
Miami Beach

4/16/2021

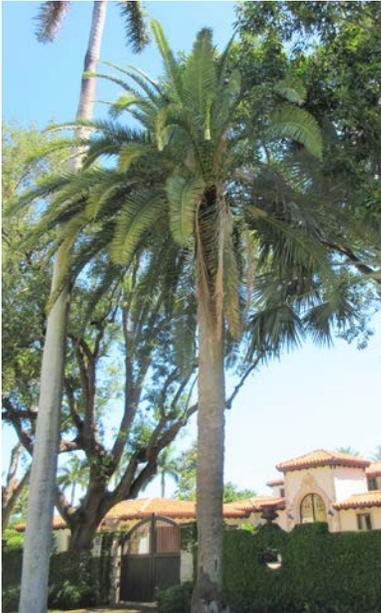
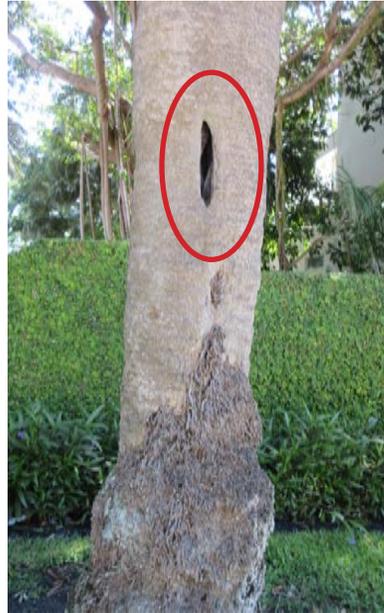
## Tree #1

Tree #1 is a Date Palm street tree located along La Gorce Circle. It is in fair condition with some small cavities with decay on the trunk such as the one circled in red. This tree has not been incorporated into the landscape plan and will therefore be removed.

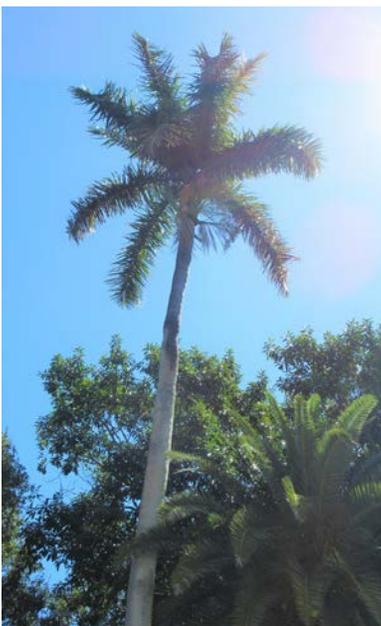
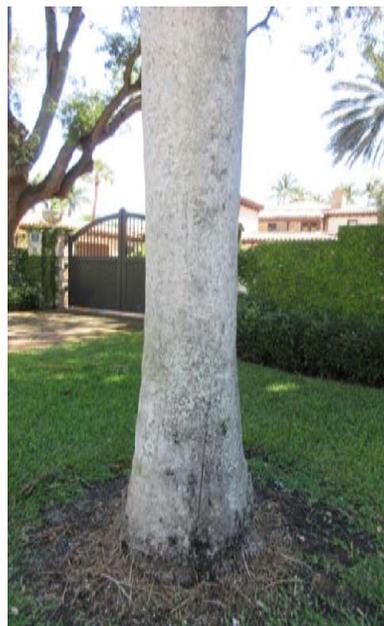
## Tree #2

Tree #2 is a Royal Palm street tree located along La Gorce Circle. It is in fair condition - the canopy is small and the trunk is pencilling.

This tree is to be relocated and root pruning shall occur a minimum of 4-6 weeks prior to digging the palm and shall be performed or supervised by Certified Arborist. Minimum rootball measurement shall be based upon the most recent *Florida Grades & Standards for Nursery Plants*. Prior to transplanting, the apical bud shall be protected by tying up palm fronds. Leaves shall be untied as soon as the palm is planted. When lifting the palm, a nylon sling with adequate padding shall be used and care shall be taken to not injure or compress the trunk. Plant at grade, with 2" of root initiation zone visible if applicable. Transplanting shall occur as soon as possible and no more than 24 hours after being dug for relocation. The backfill soil shall be irrigated during and following relocation. Wooden braces shall be installed to stabilize the tree. Following relocation, a 10ft radius TPZ shall be erected.

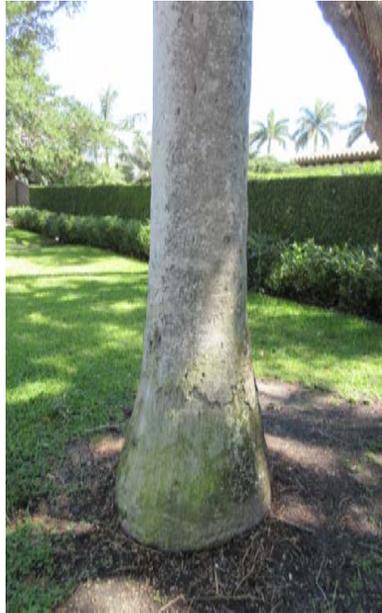
### Tree #3

Tree #3 is a Royal Palm street tree located along La Gorce Circle. It is in fair condition - the canopy is small and the trunk is pencilling.

This tree is to remain and protective barriers shall be placed 10ft from the tree trunk. Barriers shall be installed prior to the start of construction, and shall remain in place until development is completed and until the department authorizes their removal. Barriers shall be a minimum of 4ft high, and shall be constructed of continuous chain link fence with metal posts at 8ft spacing, or of 2x4 posts with three equally spaced 2x4 rails. Posts may be shifted to avoid roots. No materials shall be placed or disposed of within the TPZ. Natural grade shall be maintained within the TPZ.

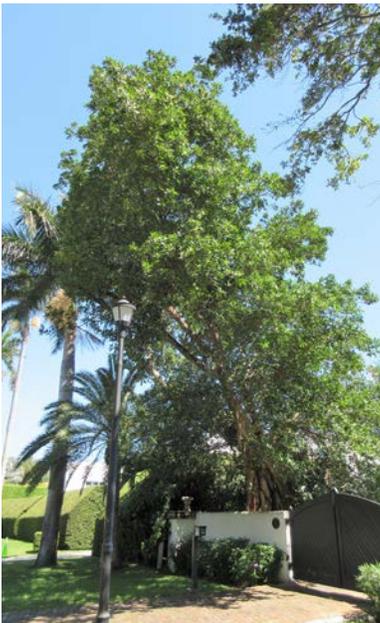
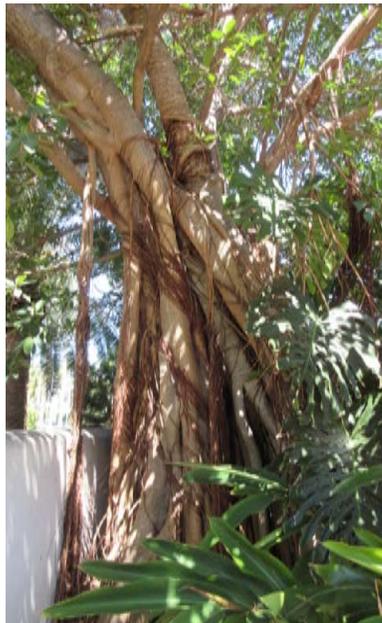
### Tree #4

Tree #4 is a Strangler Fig located in the front northwest corner of the property. It is in fair condition. The canopy is asymmetrical with healthy foliage. There is a palm growing in the canopy of the tree.

This tree is to remain and protective barriers shall be placed 15ft from the tree trunk. Barriers shall be installed prior to the start of construction, and shall remain in place until development is completed and until the department authorizes their removal. Barriers shall be a minimum of 4ft high, and shall be constructed of continuous chain link fence with metal posts at 8ft spacing, or of 2x4 posts with three equally spaced 2x4 rails. Posts may be shifted to avoid roots. No materials shall be placed or disposed of within the TPZ. Natural grade shall be maintained within the TPZ.

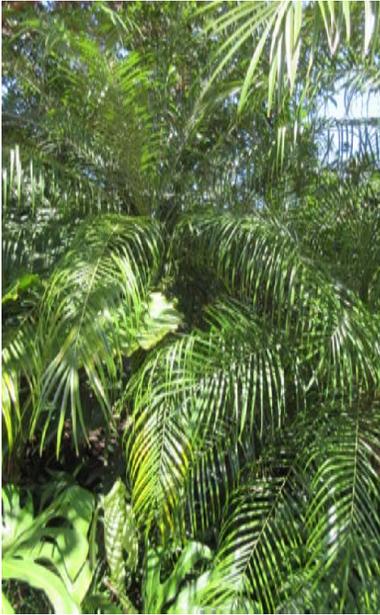
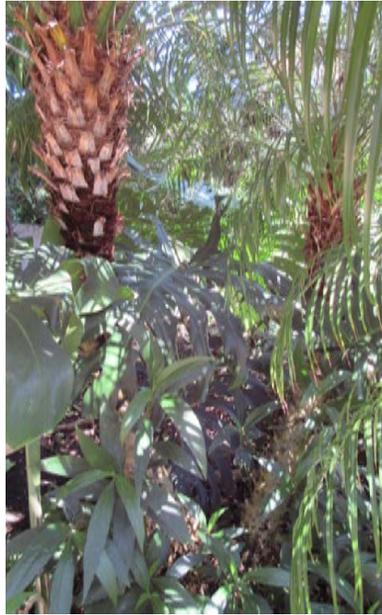
## Tree #5

Tree #5 is a double Pygmy Date Palm located in the front northwest corner of the property. It is in good condition. This tree has not been incorporated into the landscape plan and will therefore be removed.

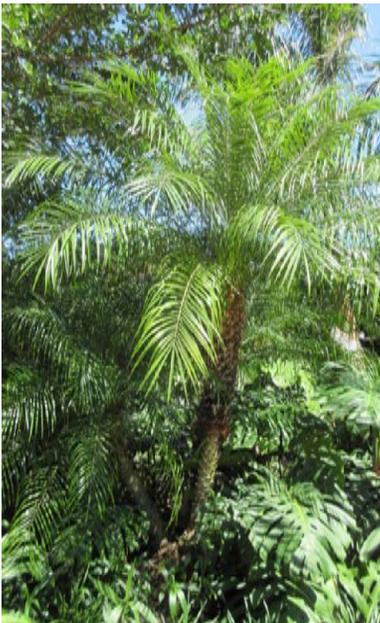
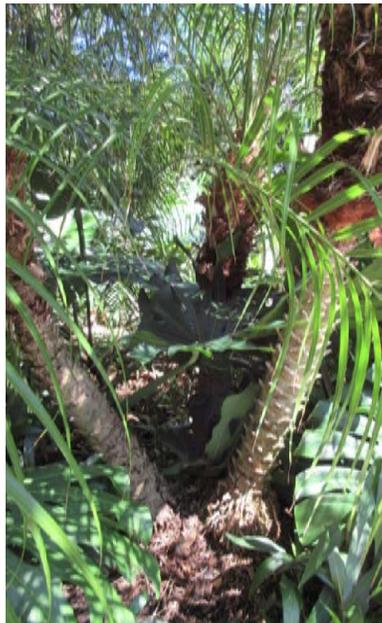
## Tree #6

Tree #6 is a triple Pygmy Date Palm located in the front northwest corner of the property. It is in good condition. This tree has not been incorporated into the landscape plan and will therefore be removed.

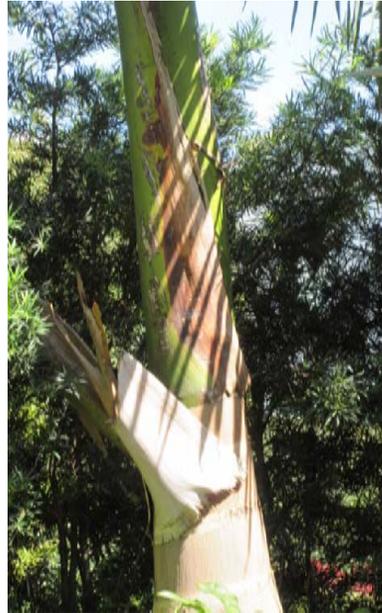
## Tree #7

Tree #7 is a Royal Palm located in the front northwest corner of the property. It is small and in fair condition. Some of the foliage is frizzled. This tree has not been incorporated into the landscape plan and will therefore be removed.

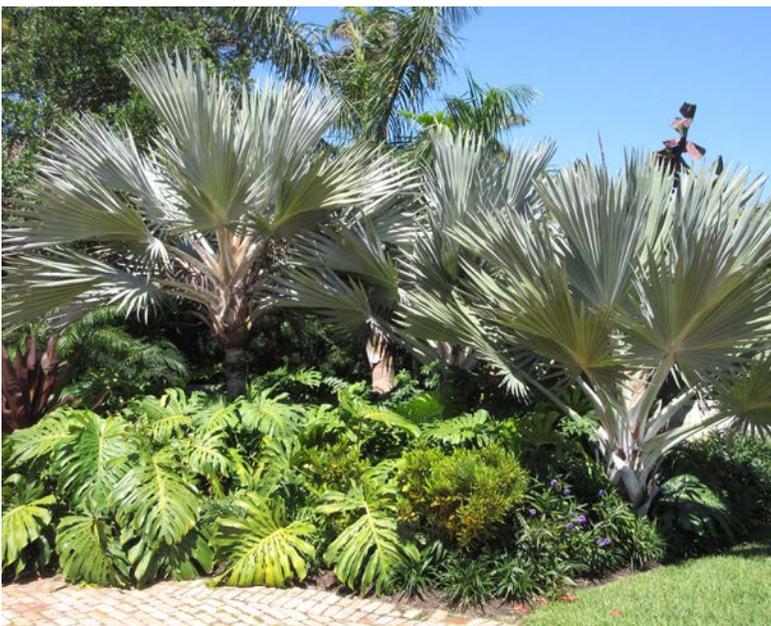
## Trees #8 - 10

Trees #8 - 10 are three Latan Palms located in the front northwest corner of the property. They are in good condition with healthy canopies and nice form. These trees are to be relocated and root pruning shall occur a minimum of 4-6 weeks prior to digging the palm and shall be performed or supervised by Certified Arborist. Minimum rootball measurement shall be based upon the most recent *Florida Grades & Standards for Nursery Plants*. Prior to transplanting, the apical bud shall be protected by tying up palm fronds. Leaves shall be untied as soon as the palm is planted. When lifting the palm, a nylon sling with adequate padding shall be used and care shall be taken to not injure or compress the trunk. Plant at grade, with 2" of root initiation zone visible if applicable. Transplanting shall occur as soon as possible and no more than 24 hours after being dug for relocation. The backfill soil shall be irrigated during and following relocation. Wooden braces shall be installed to stabilize the tree. Following relocation, a 6ft radius TPZ shall be erected.

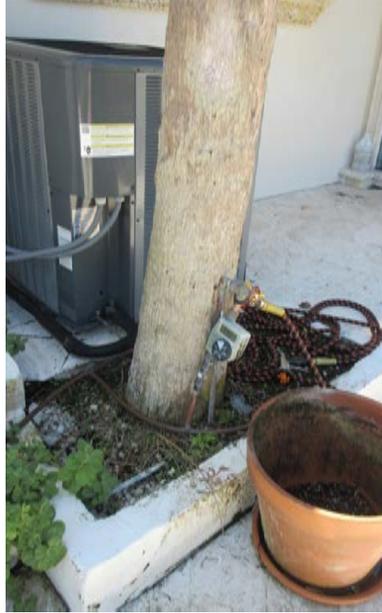
## Tree #11

Tree #11 is a Sabal Palm located on the north side of the house. It is growing in a small raised planter and has a very small rooting space. It is in poor condition with a thin canopy and bleeding cankers on the trunk. This tree has not been incorporated into the landscape plan and will therefore be removed.

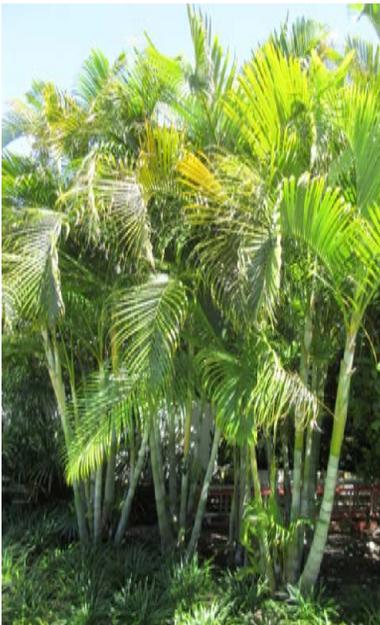
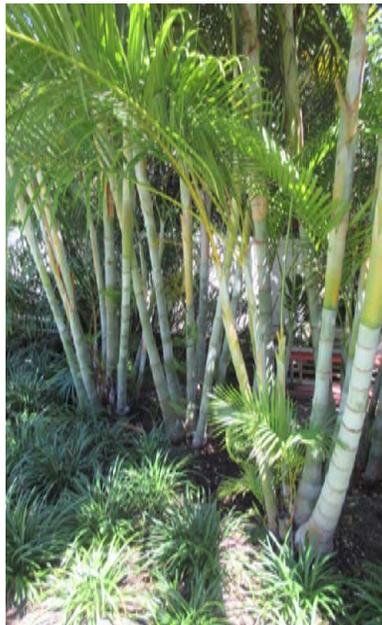
## Trees #12 - 16

Trees #12 - 16 are three Areca Palm clusters located on the north side of the property. They are in fair condition with some chlorotic foliage. These trees have not been incorporated into the landscape plan and will therefore be removed.

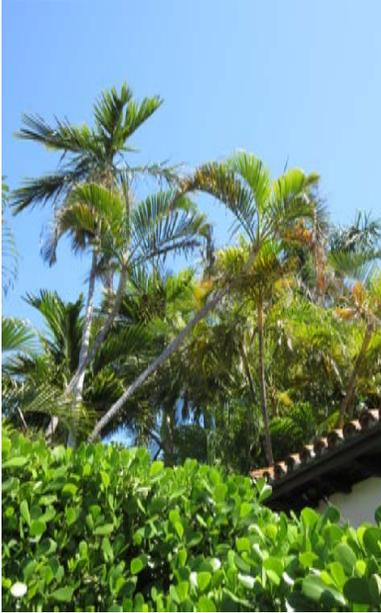
## Tree #17

Tree #17 is two Areca Palm clusters located on the north side of the property. It is in poor condition with a thin canopy and chlorotic and frizzled fronds. This tree has not been incorporated into the landscape plan and will therefore be removed.

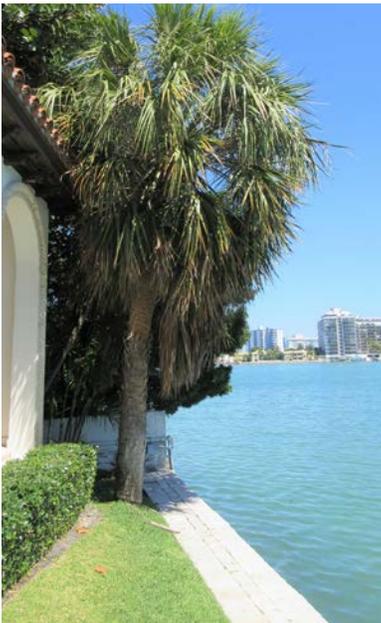
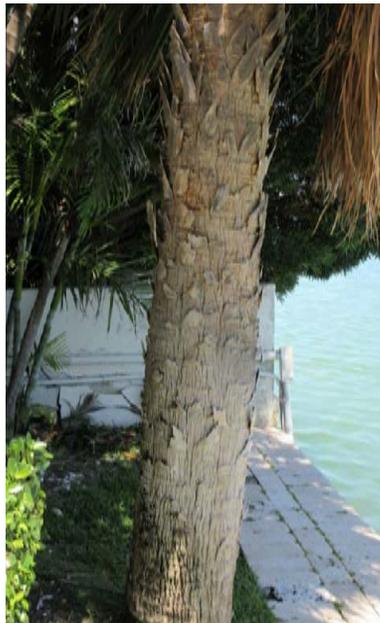
## Tree #18

Tree #18 is a Sabal Palm located in the rear northeast corner of the property. It is in good condition with a green canopy. This tree has not been incorporated into the landscape plan and will therefore be removed.

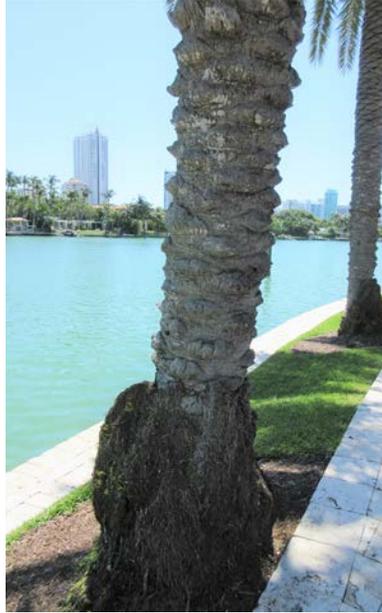
## Tree #19

Tree #19 is a Date Palm located at the rear of the property. It is in good condition with a symmetrical, healthy canopy. This tree has not been incorporated into the landscape plan and will therefore be removed.

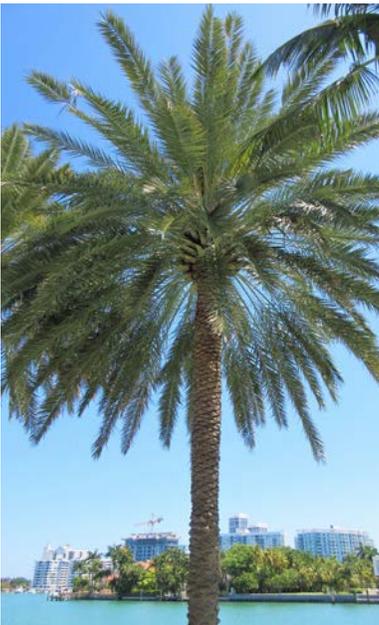
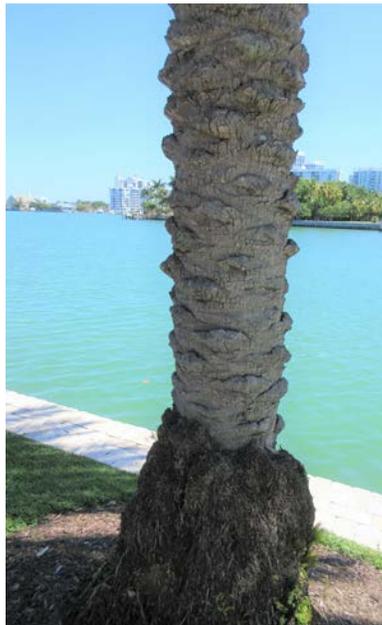
## Tree #20

Tree #20 is a Date Palm located at the rear of the property. It is in good condition with a symmetrical, healthy canopy. This tree has not been incorporated into the landscape plan and will therefore be removed.

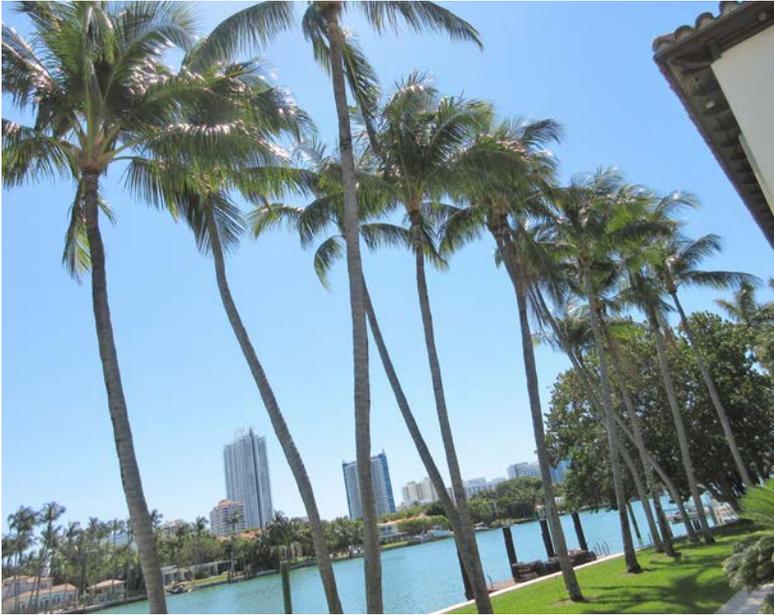
## Trees #21 - 33

Trees #21 - 33 are thirteen Coconut Palms located along the rear of the property. They are in overall good condition. There are no dead fronds nor coconut fruits. There is some climbing spike damage on the trunks. These trees have not been incorporated into the landscape plan and will therefore be removed.

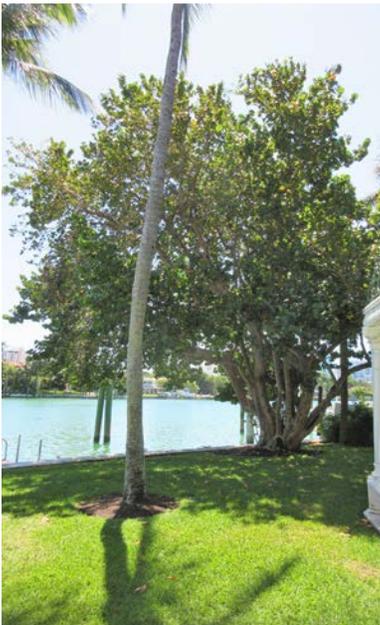
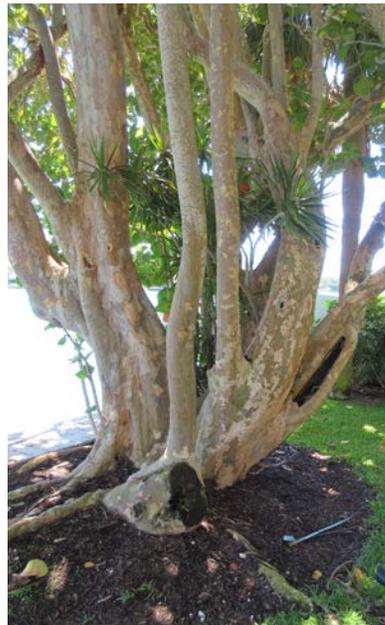
## Tree #34

Tree #34 is a Seagrape located in the rear southeast corner of the property. It is multi-trunked and in good condition. The canopy is dense. The foliage shows some chewing insect damage.

This tree is to remain and protective barriers shall be placed 12.5ft from the tree trunk. Barriers shall be installed prior to the start of construction, and shall remain in place until development is completed and until the department authorizes their removal. Barriers shall be a minimum of 4ft high, and shall be constructed of continuous chain link fence with metal posts at 8ft spacing, or of 2x4 posts with three equally spaced 2x4 rails. Posts may be shifted to avoid roots. No materials shall be placed or disposed of within the TPZ. Natural grade shall be maintained within the TPZ.

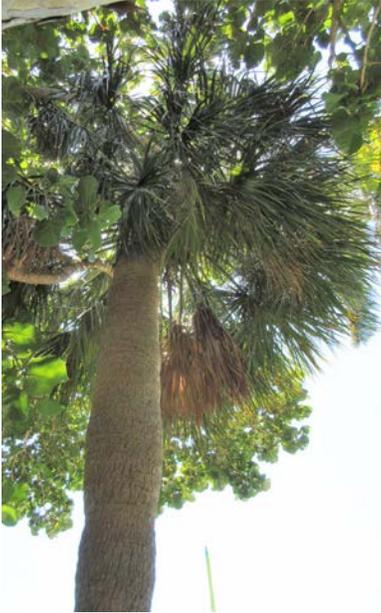
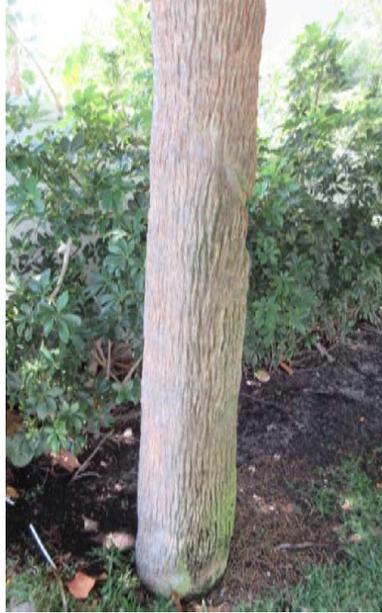
## Tree #35

Tree #35 is a Sabal Palm located in the rear southeast corner of the property. It is growing beneath Seagrape #34 and is in fair condition. The canopy is small and the trunk is curved. This tree has not been incorporated into the landscape plan and will therefore be removed.

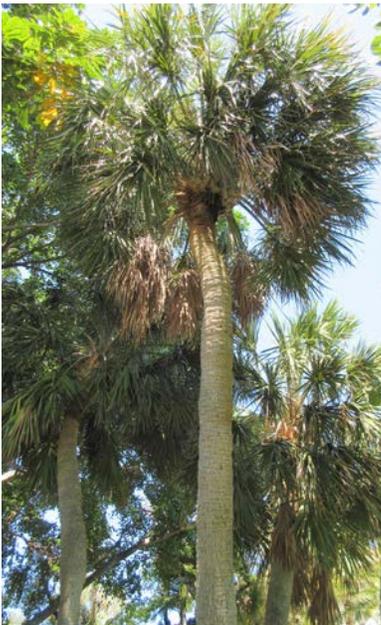
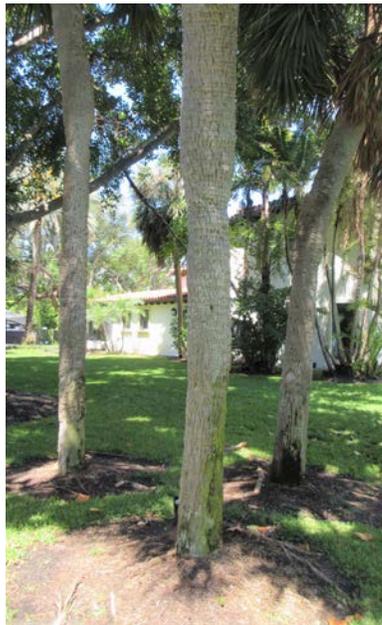
## Trees #36 - 38

Trees #36 - 38 are three Sabal Palms located in the rear southeast corner of the property. They are in fair condition with some lower dead fronds. The pseudobark is sloughing off in some areas. These trees have not been incorporated into the landscape plan and will therefore be removed.

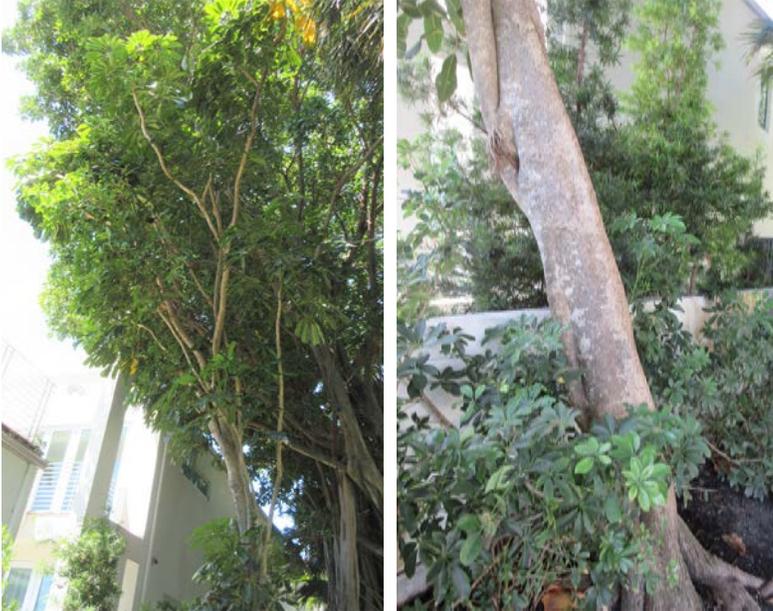
## Tree #39

Tree #39 is an Umbrella Tree located on the south side of the property. It is in fair condition with a small canopy. This species is highly invasive in South Florida and this tree will therefore need to be removed.

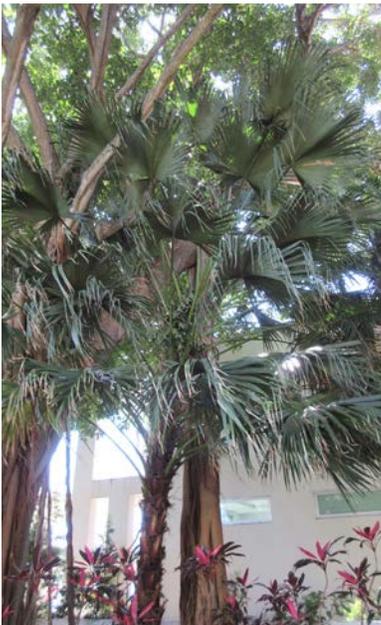
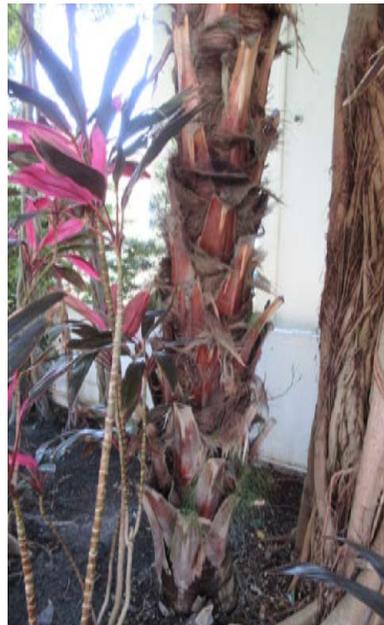
Tree #41 is a Chinese Fan Palm located on the south side of the property. It is growing beneath the canopy of Ficus #40/42. There is some leaf skeletonizer damage to the fronds.

This tree has not been incorporated into the landscape plan and will therefore be removed.

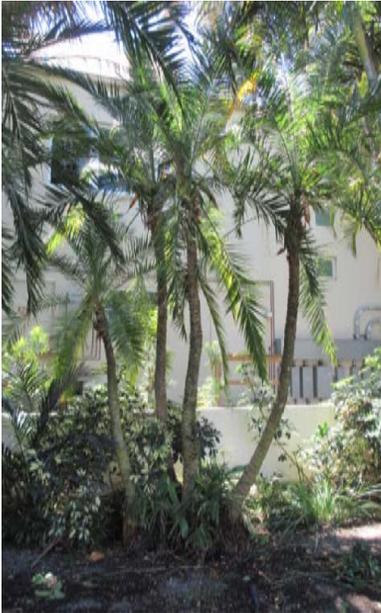
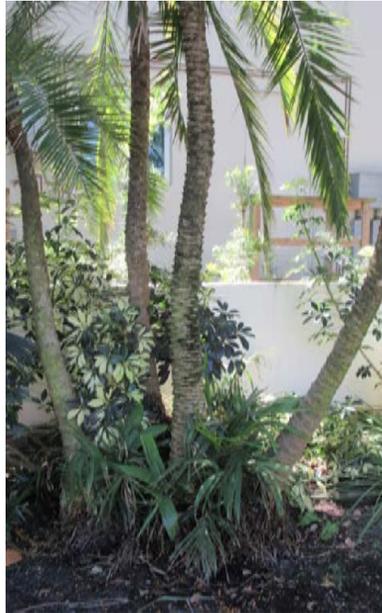
Tree #43 is a Senegal Date Palm cluster located on the south side of the property. It is in good condition. This tree has not been incorporated into the landscape plan and will therefore be removed.

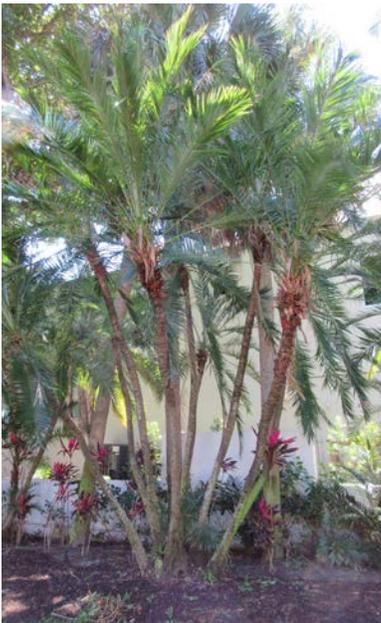
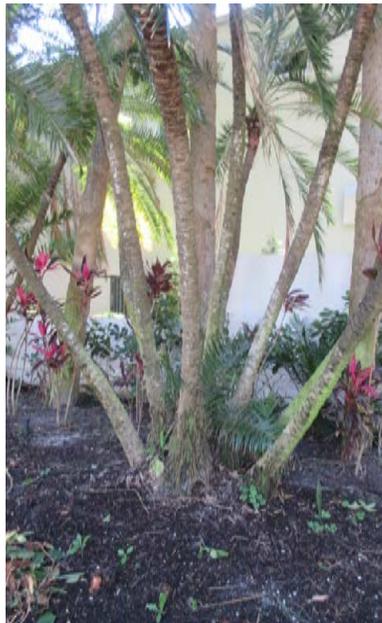
## Tree #44

Tree #44 is a Senegal Date Palm cluster located on the south side of the property. It is in good condition. This tree has not been incorporated into the landscape plan and will therefore be removed.

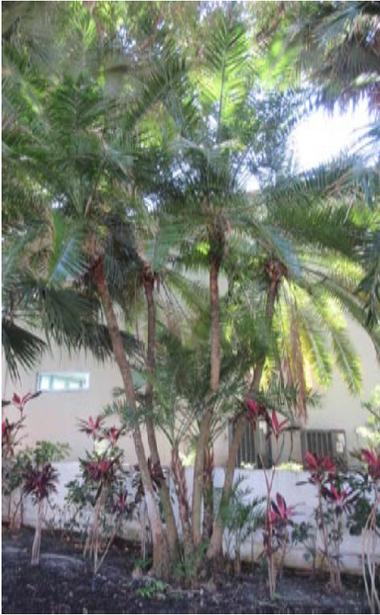
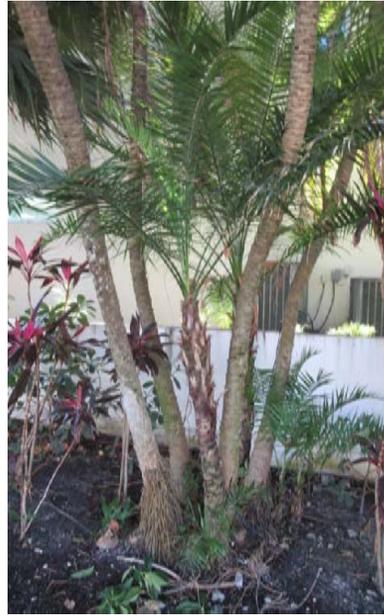
## Tree #45

Tree #45 is a Senegal Date Palm cluster located on the south side of the property. It is in good condition. This tree has not been incorporated into the landscape plan and will therefore be removed.

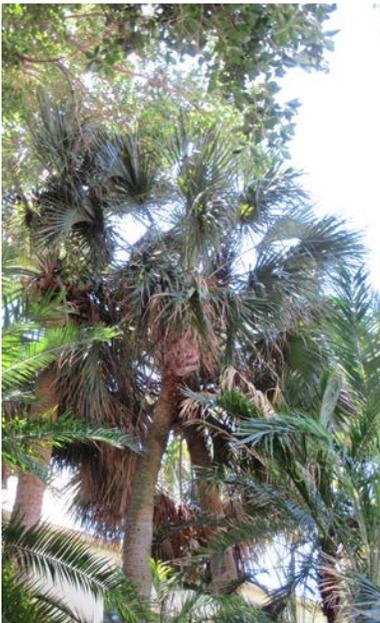
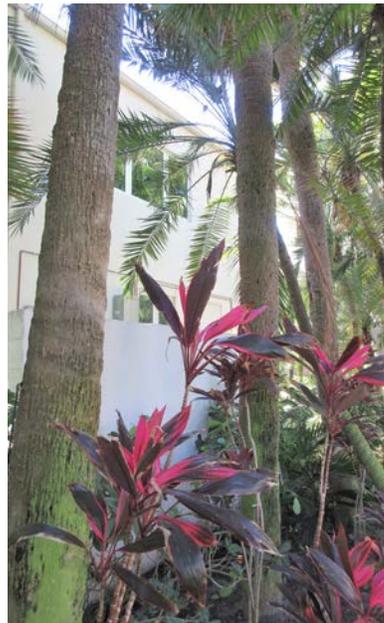
## Trees #46 - 48

Trees #46 - 48 are three Sabal Palms located on the south side of the property. They are in fair condition with some lower dead fronds.

These trees have not been incorporated into the landscape plan and will therefore be removed.

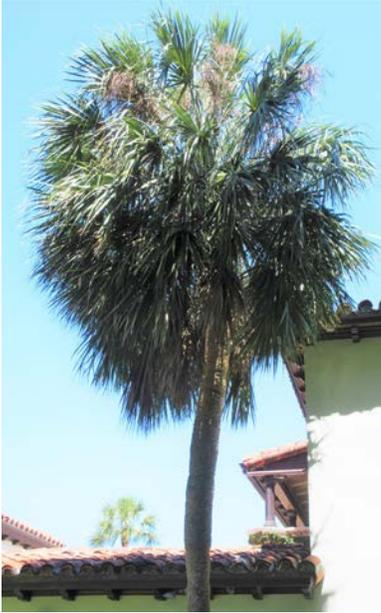
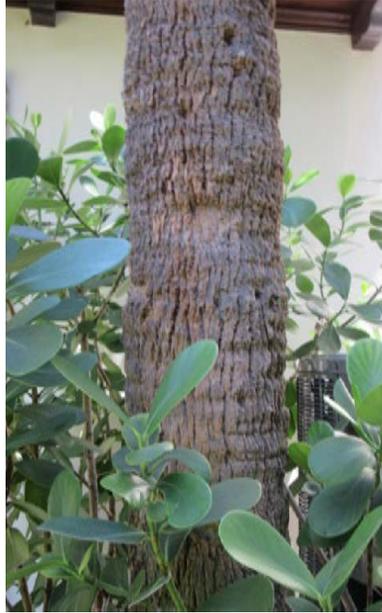
Tree #49 is a Sabal Palm located on the south side of the house. It is in fair condition. This tree has not been incorporated into the landscape plan and will therefore be removed.

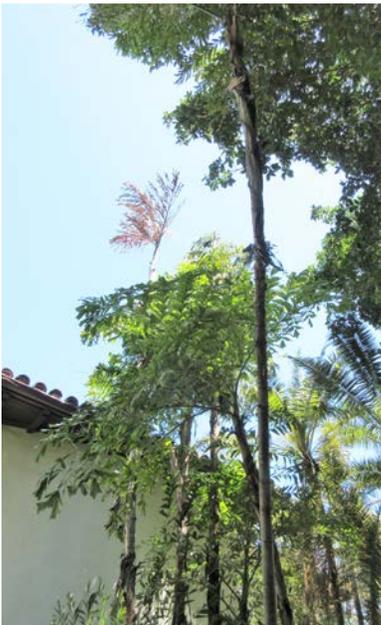
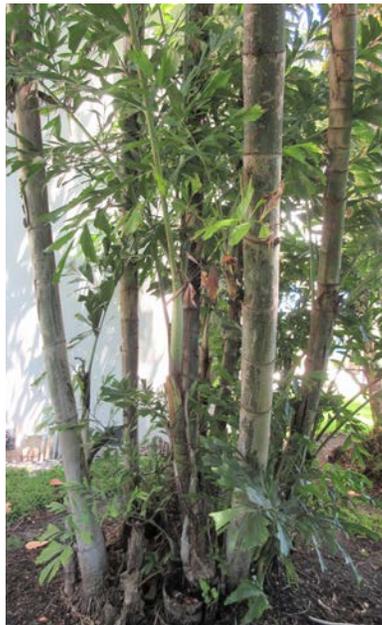
## Tree #50

Tree #50 is a Fishtail Palm cluster located on the south side of the house. It is in poor condition with chlorotic foliage. One of the trunks is dead. This tree has not been incorporated into the landscape plan and will therefore be removed.

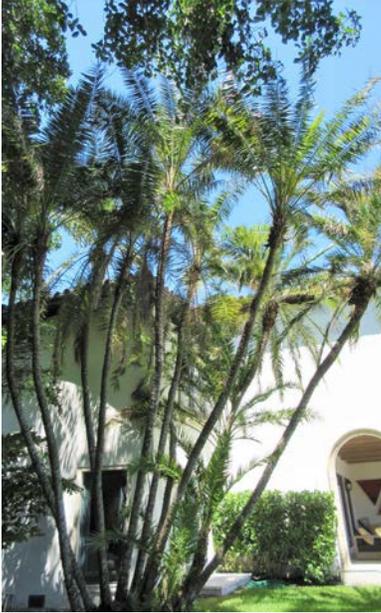
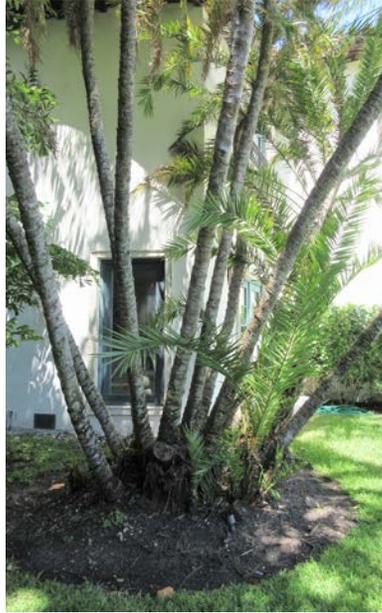
## Tree #51

Tree #51 is a Senegal Date Palm located on the south side of the house. It is in fair condition with some chlorotic fronds. This tree has not been incorporated into the landscape plan and will therefore be removed.

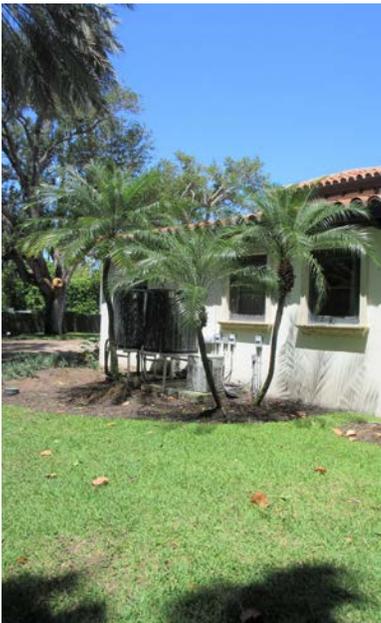
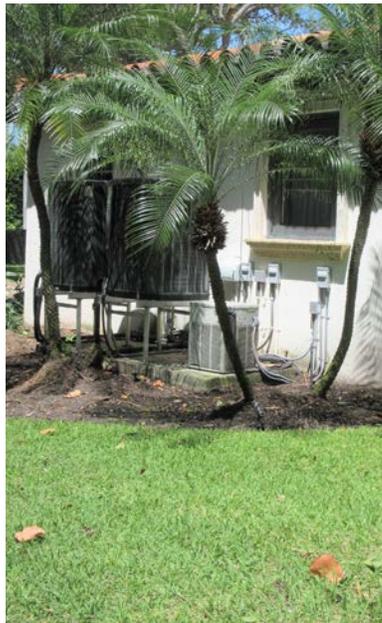
## Tree #52

Tree #52 is a triple Pygmy Date Palm located on the south side of the house. It is in good condition. This tree has not been incorporated into the landscape plan and will therefore be removed.

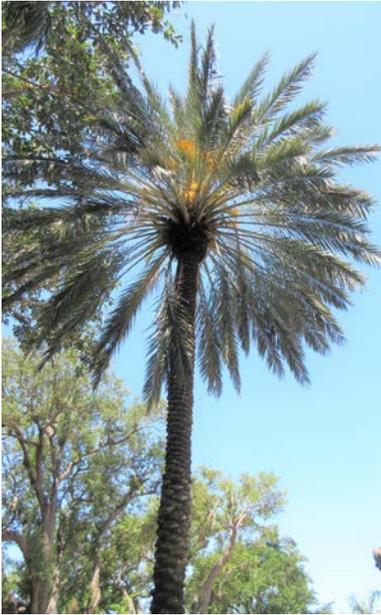
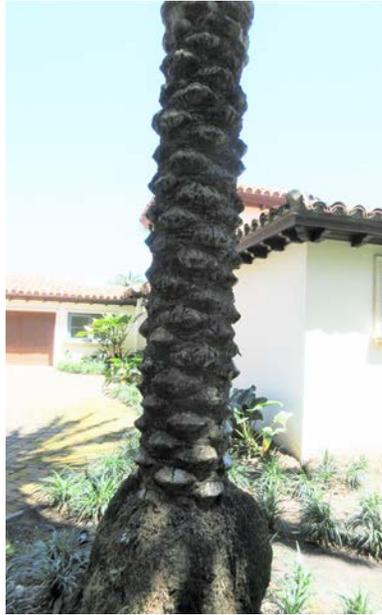
## Tree #53

Tree #53 is a Date Palm located at the front southern corner of the house. It is in good condition with a symmetrical canopy. This tree has not been incorporated into the landscape plan and will therefore be removed.

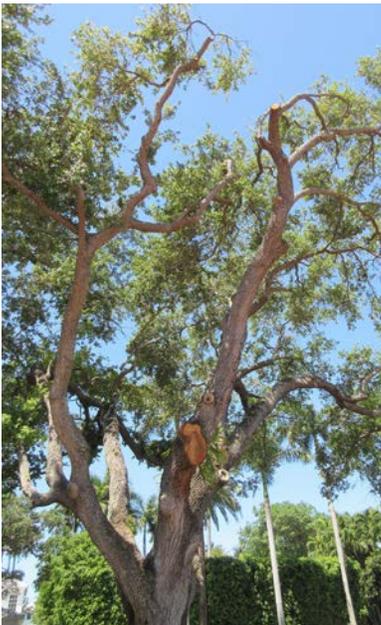
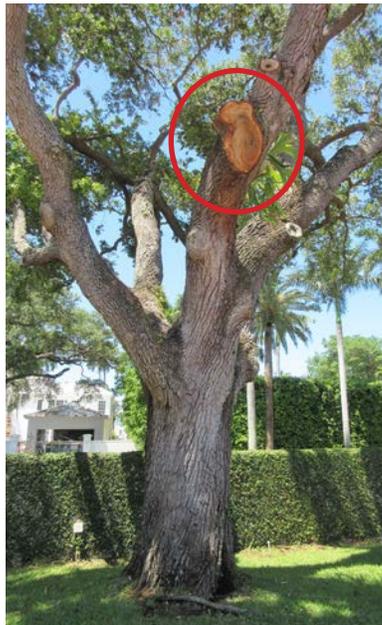
## Tree #54

Tree #54 is a Live Oak located at the front of the property. It is in fair condition. There is a small amount of deadwood. The tree has been pruned recently and one notable poor pruning cut has been made (circled in red). This pruning cut is large at about 12 inches in diameter and will allow for the entry of decay organisms into the tree. Prune to remove deadwood.

This tree is to remain and protective barriers shall be placed 22.5ft from the tree trunk. Barriers shall be installed prior to the start of construction, and shall remain in place until development is completed and until the department authorizes their removal. Barriers shall be a minimum of 4ft high, and shall be constructed of continuous chain link fence with metal posts at 8ft spacing, or of 2x4 posts with three equally spaced 2x4 rails. Posts may be shifted to avoid roots. No materials shall be placed or disposed of within the TPZ. Natural grade shall be maintained within the TPZ. This tree should be monitored on a periodic basis for health and structural integrity.

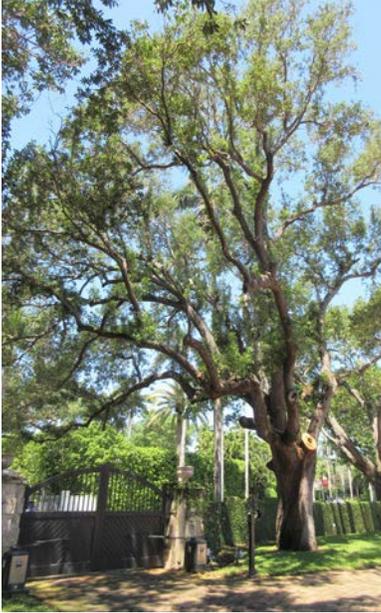
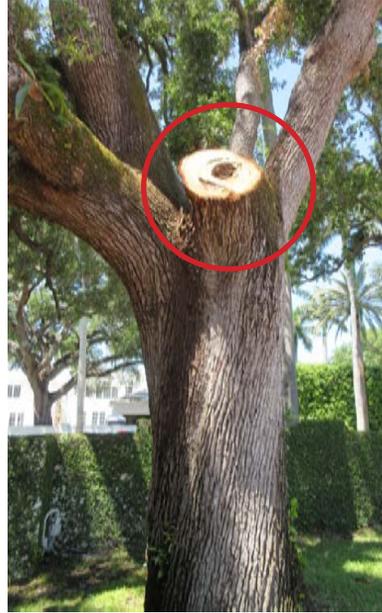
Tree #55 is a Live Oak located at the front of the property. It is in fair condition. There is some deadwood and branch stubs. The tree has been pruned recently and one notable poor pruning cut has been made (circled in red). This pruning cut is large at about 16 inches in diameter and will allow for the entry of decay organisms into the tree. Also, there is little root flare visible. A root collar excavation is recommended. Prune to remove deadwood. This tree is to remain and protective barriers shall be placed 27.5ft from the tree trunk. Barriers shall be installed prior to the start of construction, and shall remain in place until development is completed and until the department authorizes their removal. Barriers shall be a minimum of 4ft high, and shall be constructed of continuous chain link fence with metal posts at 8ft spacing, or of 2x4 posts with three equally spaced 2x4 rails. Posts may be shifted to avoid roots. No materials shall be placed or disposed of within the TPZ. Natural grade shall be maintained within the TPZ. This tree should be monitored on a periodic basis for health and structural integrity.

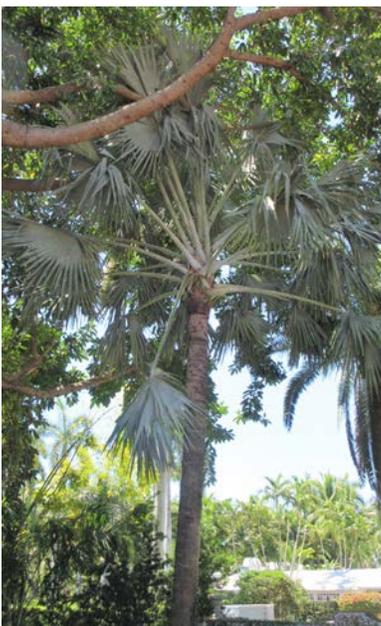
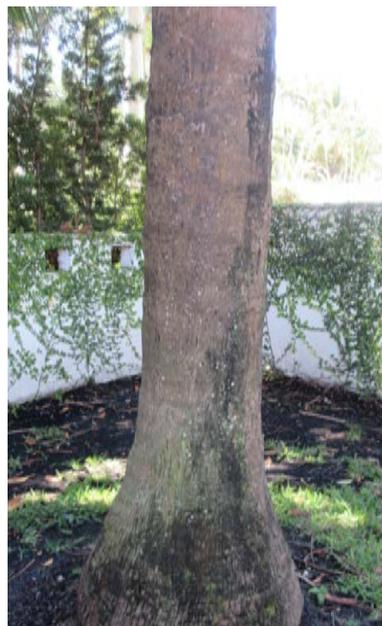
## Tree #56

Tree #56 is a Bismarck Palm located in the front southwest corner of the property. It is growing beneath the canopy of Ficus #58. It is in fair condition. This tree is to remain and protective barriers shall be placed 10ft from the tree trunk. Barriers shall be installed prior to the start of construction, and shall remain in place until development is completed and until the department authorizes their removal. Barriers shall be a minimum of 4ft high, and shall be constructed of continuous chain link fence with metal posts at 8ft spacing, or of 2x4 posts with three equally spaced 2x4 rails. Posts may be shifted to avoid roots. No materials shall be placed or disposed of within the TPZ. Natural grade shall be maintained within the TPZ.

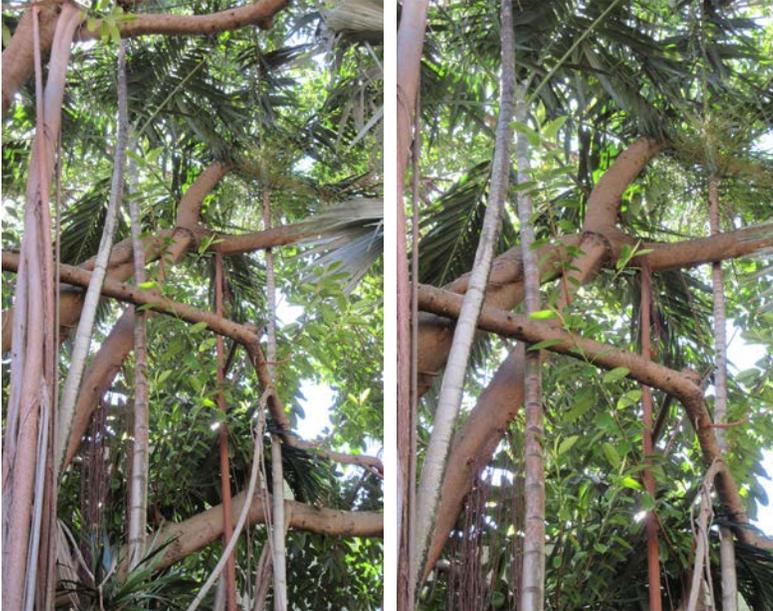
## Tree #57

Tree #57 is a group of four Solitaire Palms located on the south side of the property. They are in fair condition and are growing through the canopy of Ficus #58. These trees have not been incorporated into the landscape plan and will therefore be removed.

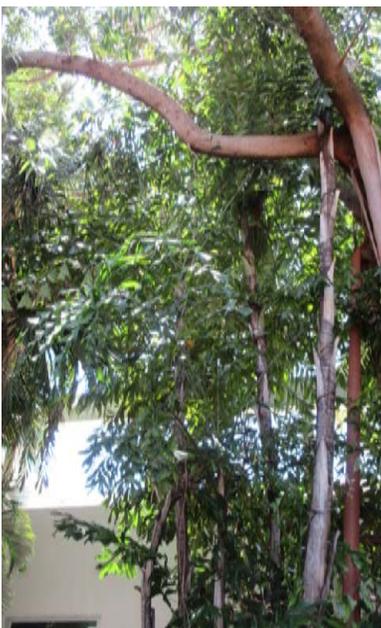
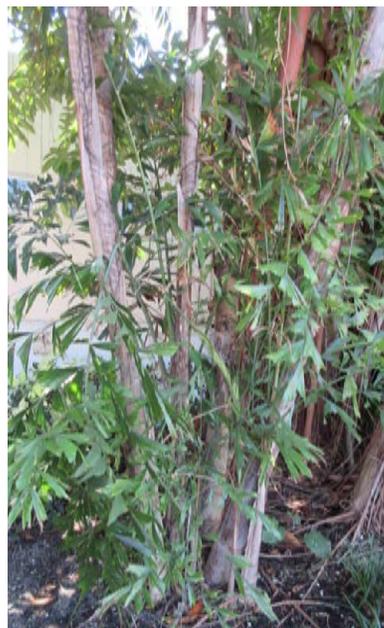
Tree #59 is a Fishtail Palm cluster located on the south side of the property. It is growing beneath the canopy of Ficus #58. It is in fair condition.

This tree has not been incorporated into the landscape plan and will therefore be removed.

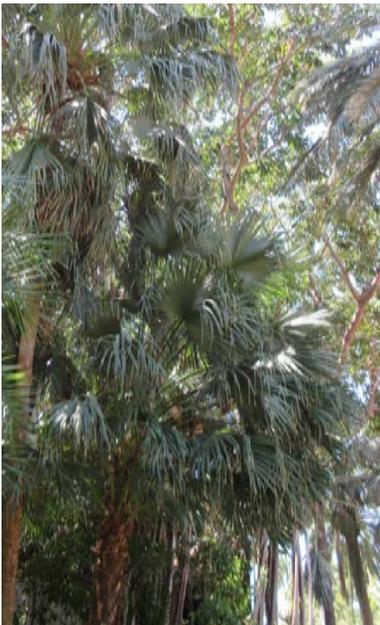
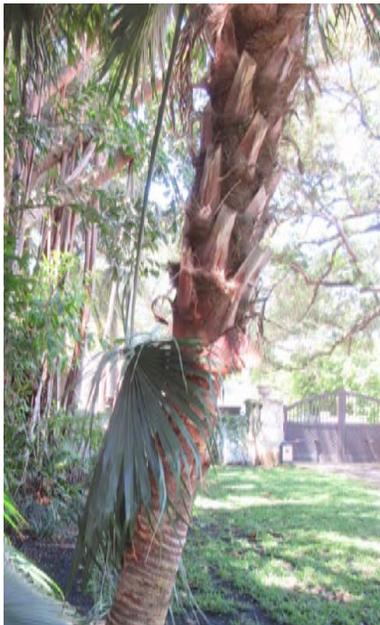
Tree #61 is a Chinese Fan Palm located on the south side of the property. It is in good condition with a healthy canopy. This tree has not been incorporated into the landscape plan and will therefore be removed.

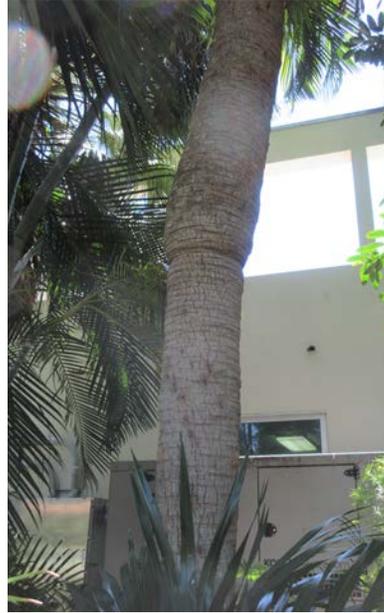
## Tree #62

Tree #62 is a Sabal Palm located on the south side of the property. It is in poor condition with a thin canopy. This tree has not been incorporated into the landscape plan and will therefore be removed.

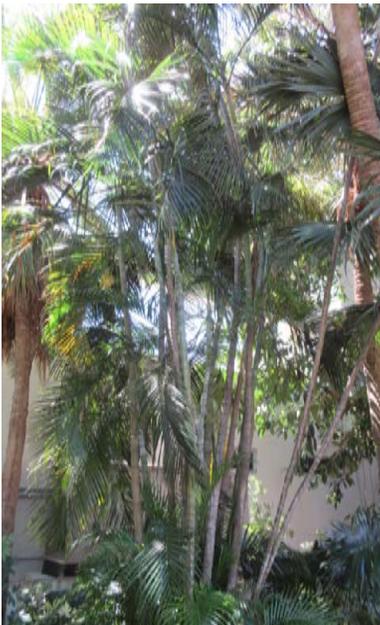
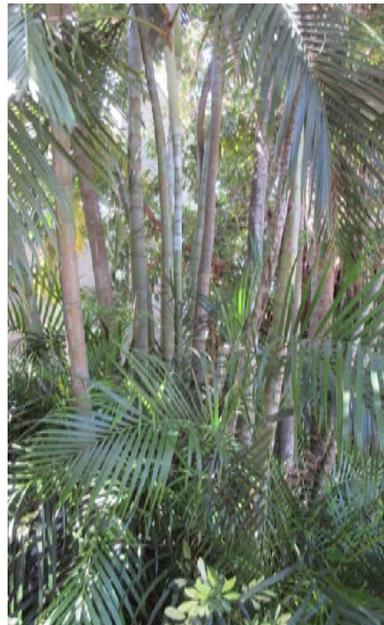
## Tree #63

Tree #63 is an Areca Palm cluster located on the south side of the property. It is in fair condition. This tree has not been incorporated into the landscape plan and will therefore be removed.

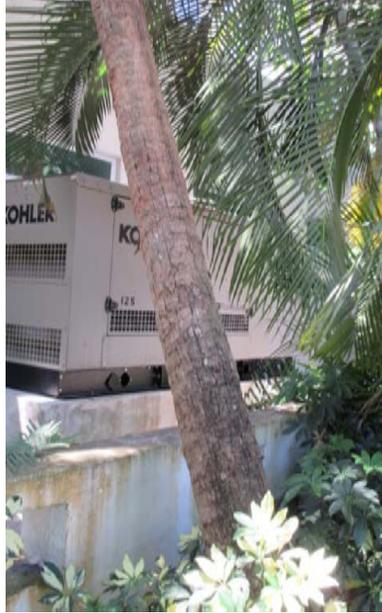
## Tree #64

Tree #64 is a Chinese Fan Palm located on the south side of the property. It is in fair condition - the trunk is leaning and there are many lower dead fronds. This tree has not been incorporated into the landscape plan and will therefore be removed.

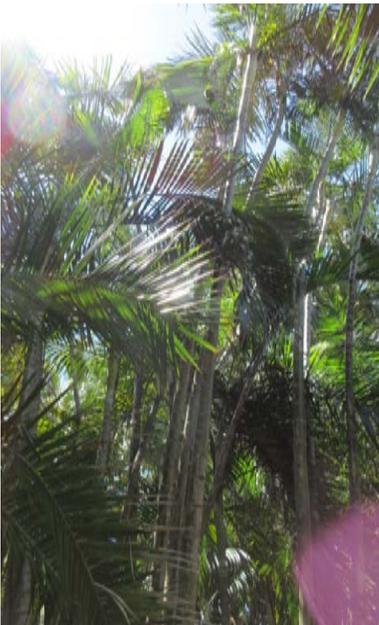
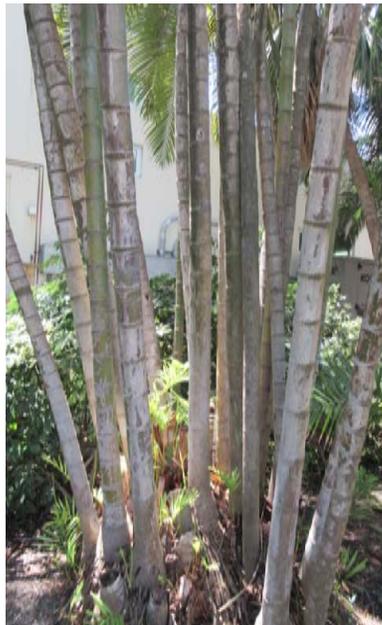
## Tree #65

Tree #65 is an Areca Palm cluster located on the south side of the property. It is in fair condition. This tree has not been incorporated into the landscape plan and will therefore be removed.

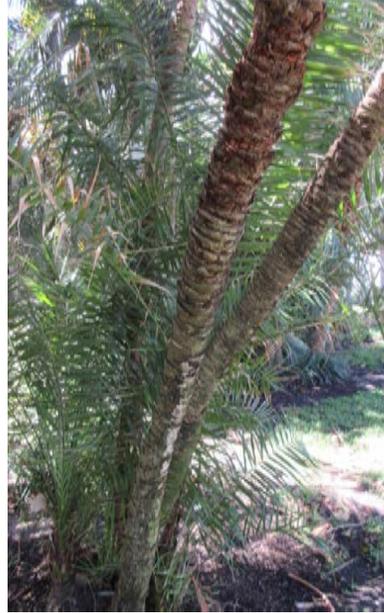
## Tree #66

Tree #66 is a Senegal Date Palm located on the south side of the property. It is in good condition. This tree has not been incorporated into the landscape plan and will therefore be removed.

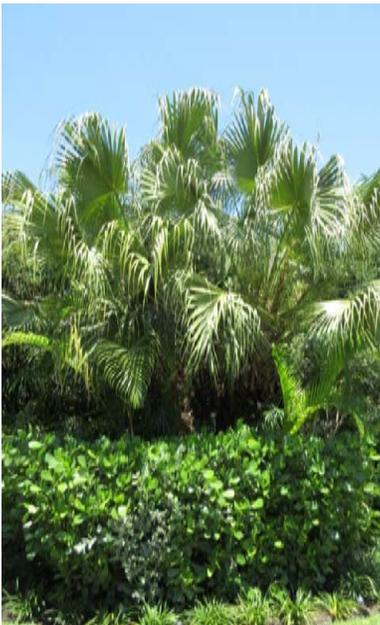
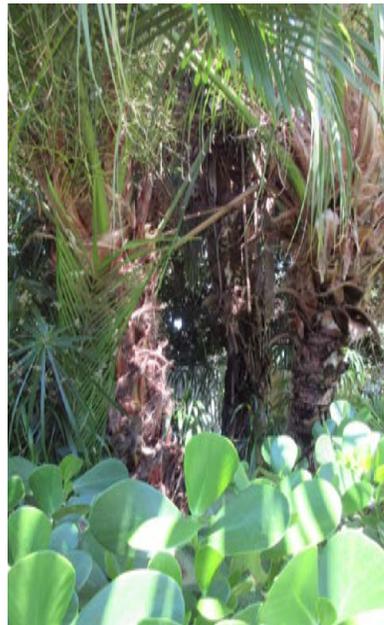
## Tree #67

Tree #67 is a triple Chinese Fan Palm located on the north side of the property. It is small and in good condition with healthy fronds.

This tree has not been incorporated into the landscape plan and will therefore be removed.
