# GENERAL ASSESSMENT REPORT

EXISTING STRUCTURAL SYSTEMS

803 2<sup>ND</sup> STREET  
MIAMI BEACH, FLORIDA

APRIL 5, 2021

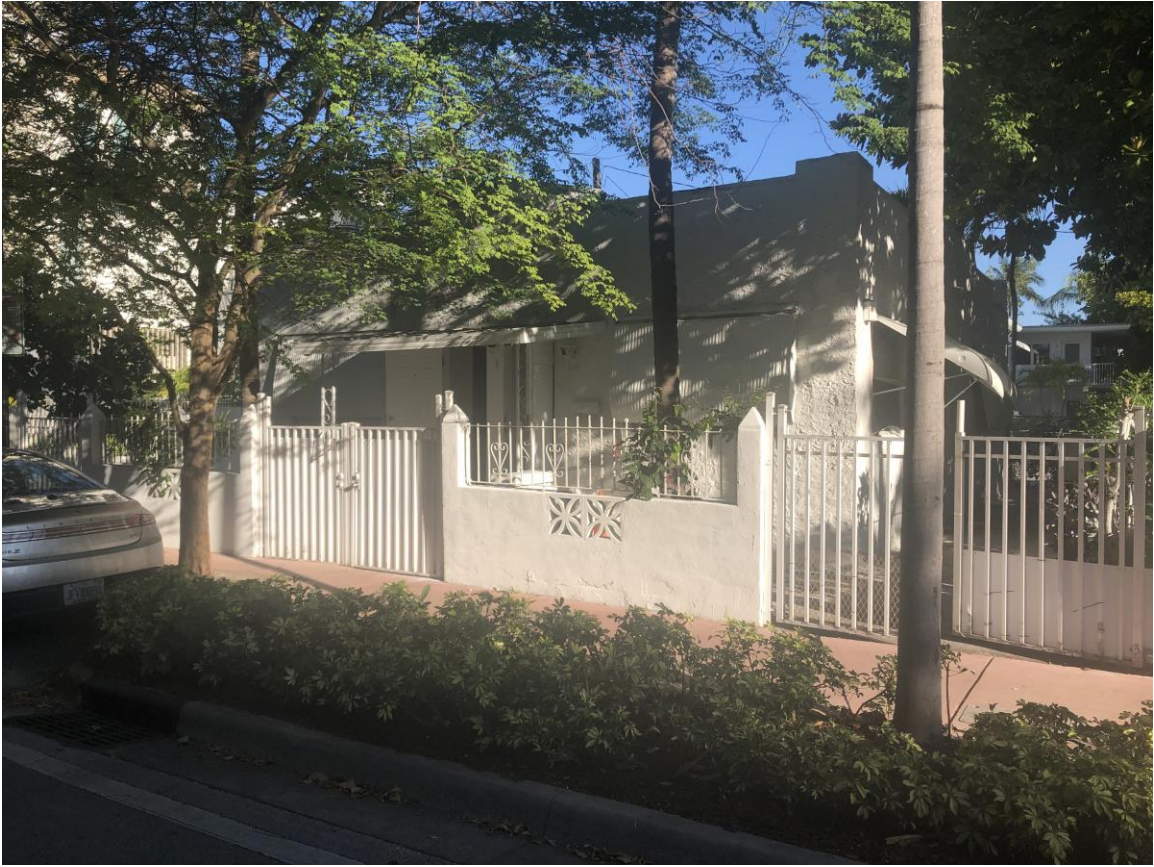
PHOTOGRAPH NO. 1

of the awnings are not well sealed to the wall, and stucco immediately above them is generally cracked. Refer to Photographs Nos. 1, 2, 5, 7, 8, 21, and 24. It appears that there were awnings previously existing at some windows on the north and west sides of the building, but currently all that remains are the top tracks. Refer to Photographs Nos. 31 and 36.

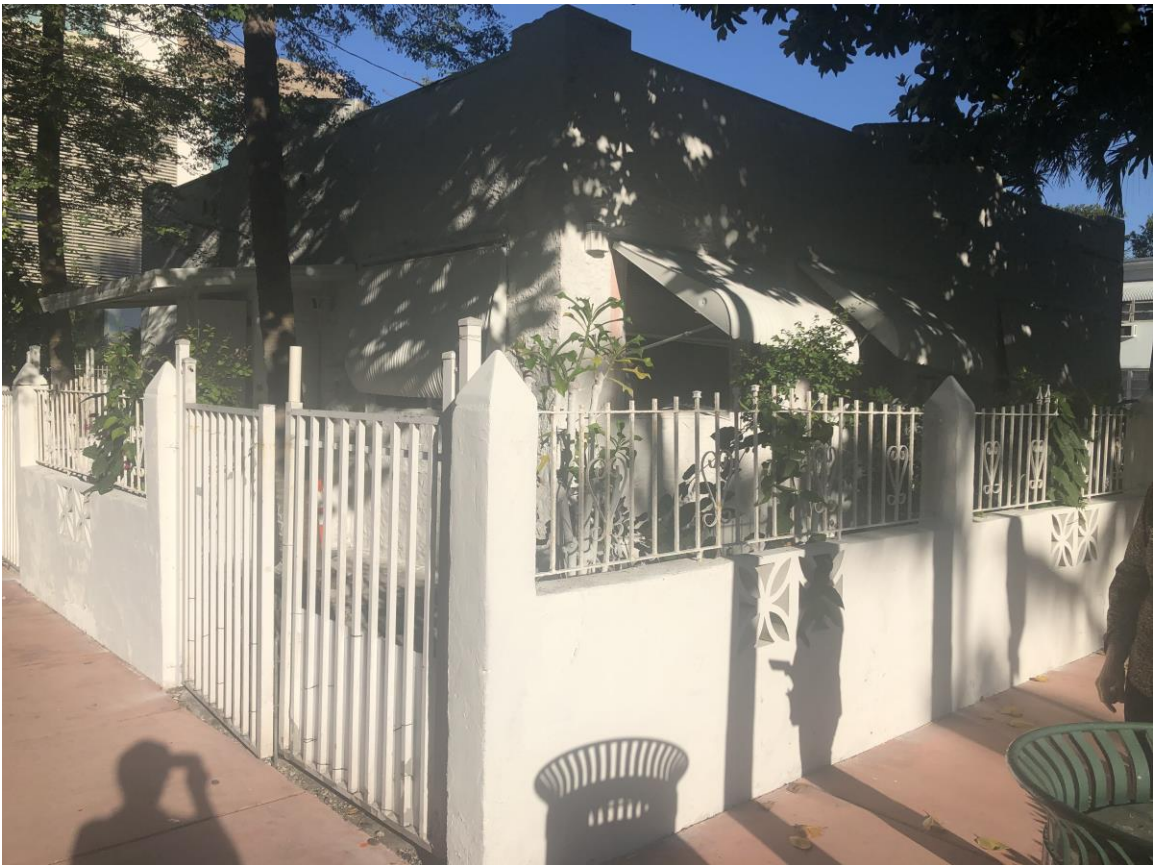
PHOTOGRAPH NO. 2

2. The masonry/metal fences along the east and south property lines also have numerous cracks and areas of missing stucco. Portions of the south perimeter fence are leaning outward. The leaning is likely due to soil settlement. Refer to Photographs Nos. 1, 2, 3, 55, 56, 57, 70, 71 and 72. This fence lacks appropriate strength for its height.

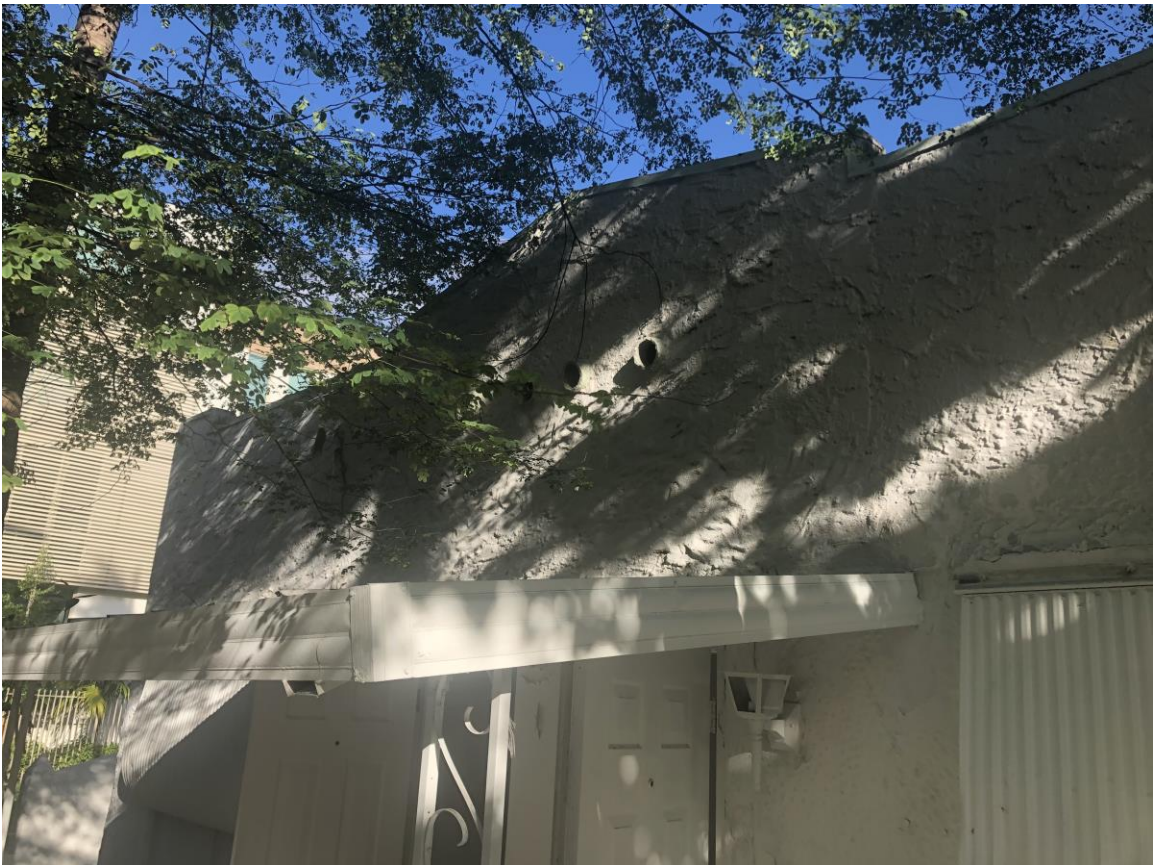
**PHOTOGRAPH NO. 15**

3. The inaccessible attic space is vented by only three small pipe vents on the front of the building and two small pipe vents on the two sides. Refer to Photographs Nos. 15, 33 and 74. These vents do not provide the area of venting long-required by the building codes.

6. The gutter of the aluminum canopy above the front entrances is clogged with debris, and there are plants growing in it. Refer to Photograph No. 15.

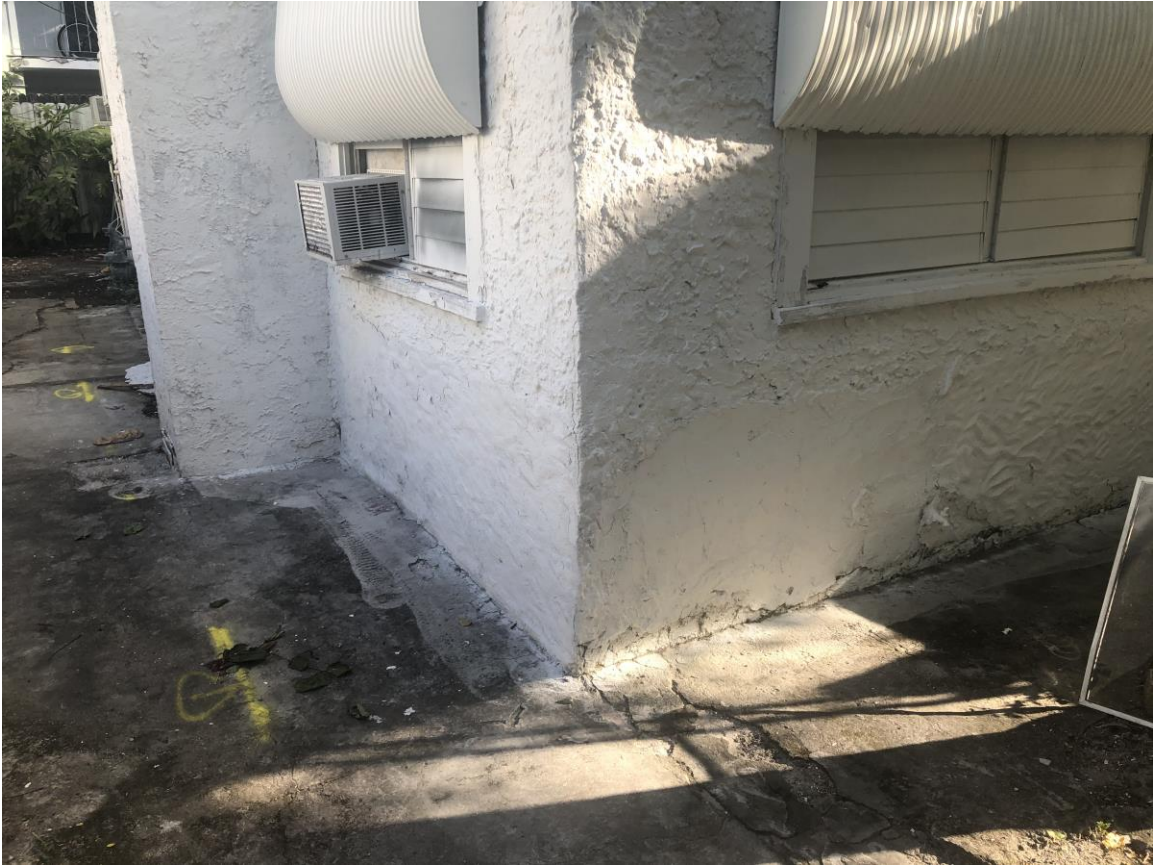
**PHOTOGRAPH NO. 21**

1. Most of the exterior stucco has been replaced, with almost all of the stucco below the window-sill level having been replaced. The replacements have apparently occurred at a number of different times. The replacement areas are of obviously different textures (some very crudely applied). Some of the patches appear to have been extended over adjacent areas of stucco without proper surface preparation, resulting in areas of delamination. Refer to Photographs Nos. 6, 10 through 14, 17, 19 through 22, 26, 30, 31, 33, 34, 36, 39, 58, 59, 60, 64, 75 and 77.

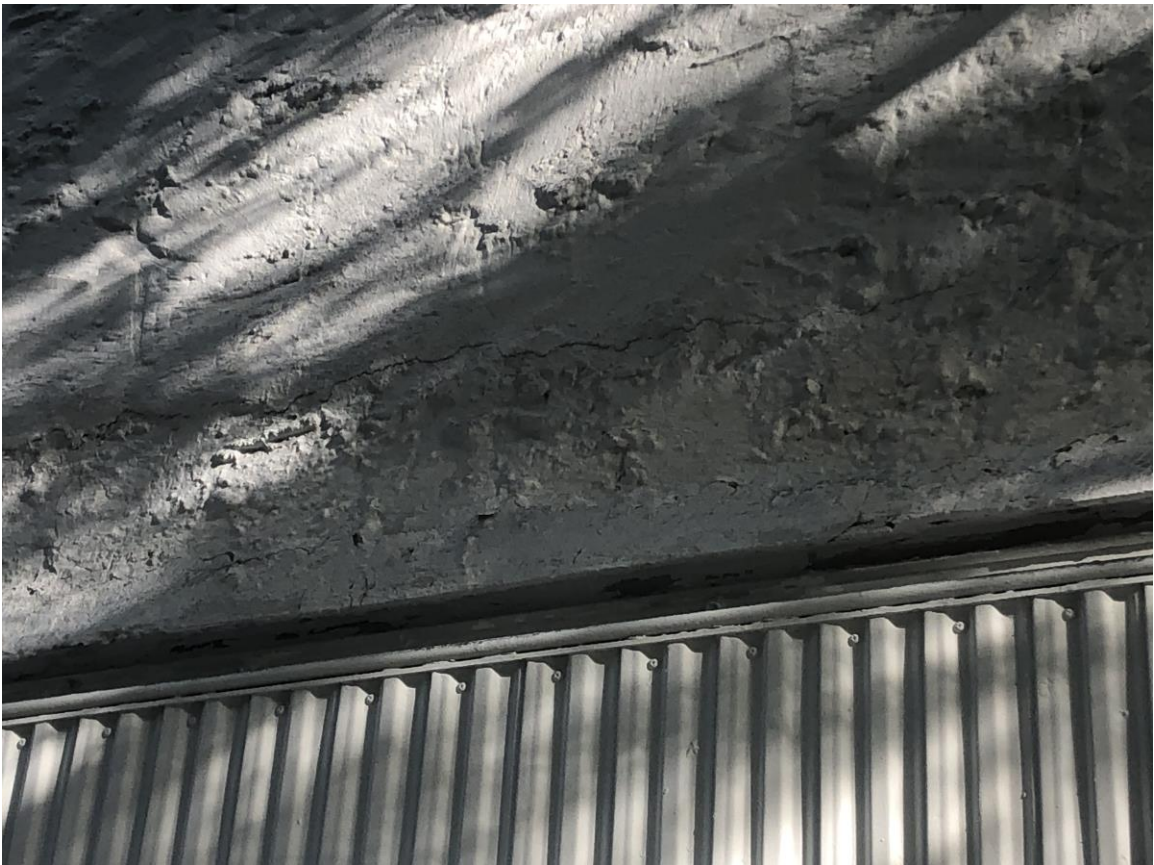
**PHOTOGRAPH NO. 24**

2. There are numerous exterior stucco cracks and numerous holes in the exterior stucco. With the stucco on wood lath and no vapor or moisture barrier, each of these cracks and holes is a source of water intrusion to the structural wood framing behind. Refer to Photographs Nos. 7, 8, 9, 12, 13, 14, 16, 18, 22, 23, 24, 26 through 30, 35, 36, 37, 45, 46, 49, 59, 65 and 68.

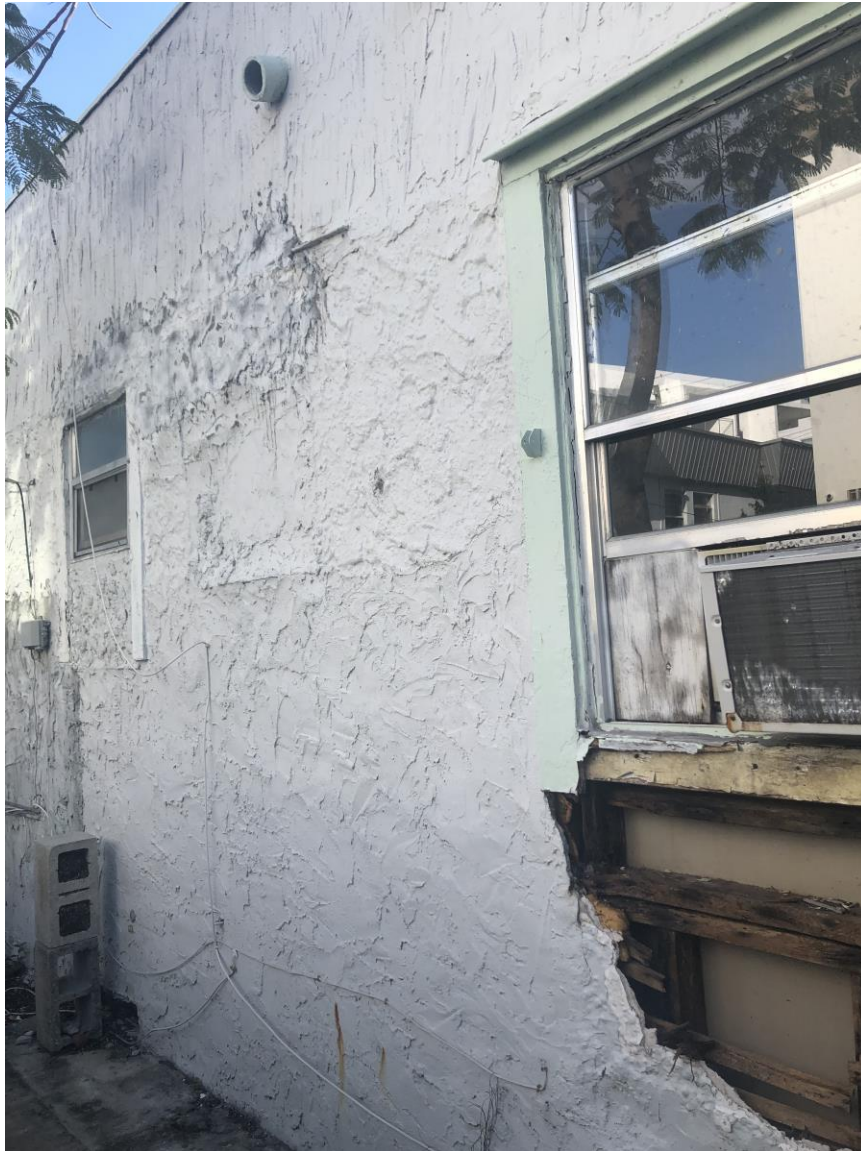
**PHOTOGRAPH NO. 31**

8. None of the existing windows are original to the building. Most of the windows are single-hung aluminum (some painted white, others exposed aluminum), but one window is a slider, and the windows in the southwest room are jalousie. Most of the windows and their seals and caulking are in poor condition. None of the windows have an impact resistance rating. Refer to Photographs Nos. 4, 25, 31, 32, 34, 35, 38, 42, 68, 76, 78, 83 and 93.

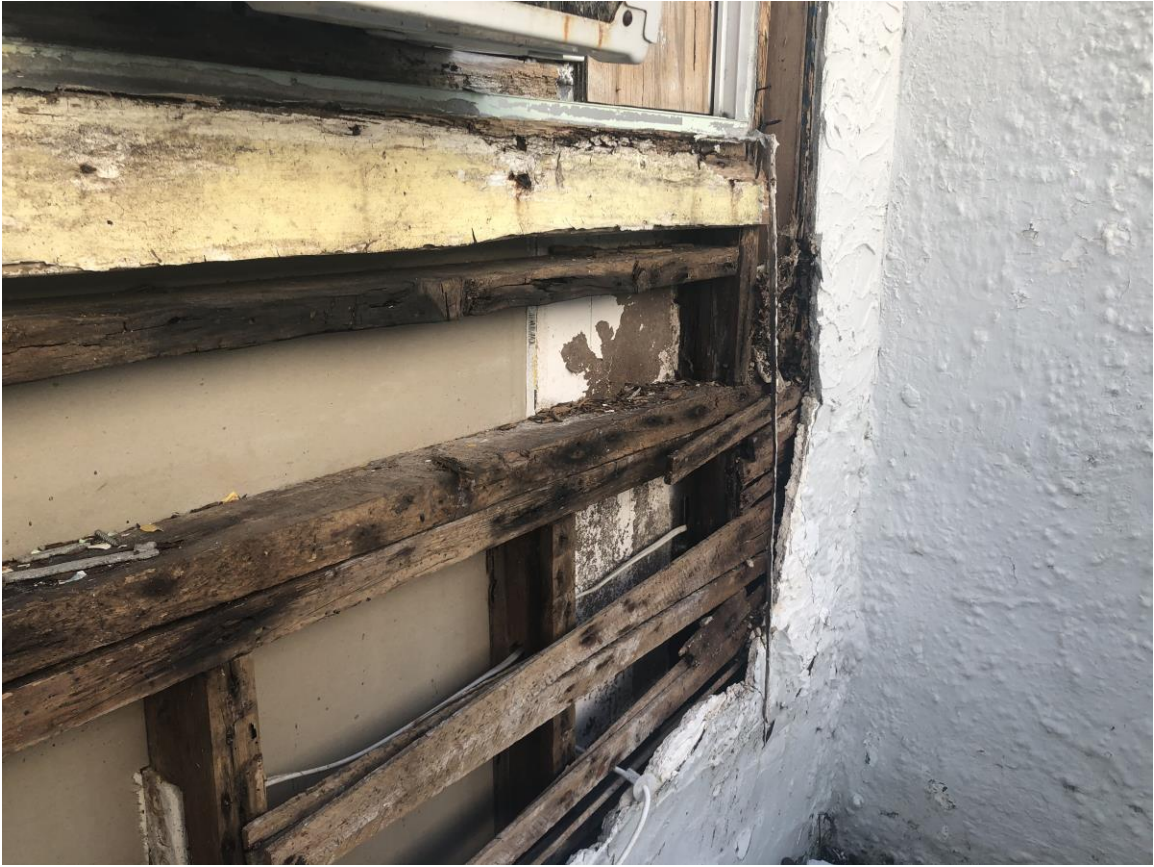
**PHOTOGRAPH NO. 41**

6. A number of the exterior window openings have been modified. Refer to Photographs Nos. 34, 41 and 42. The sills of the two front (south side) windows are at different elevations, the sills of the two rear (north side) windows are also at different elevations, and the sills on the east side are at different elevations. It is likely that the structural framing and cladding for these modified openings is inadequate.

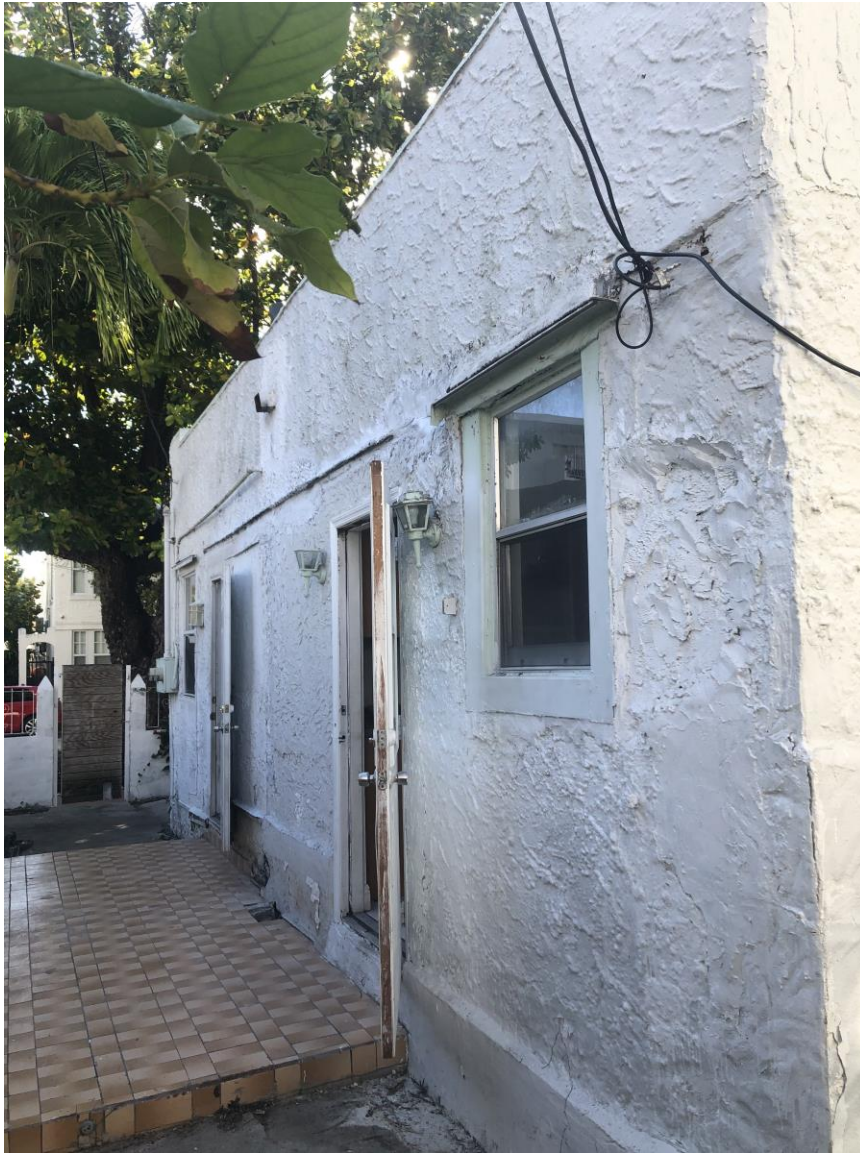
**PHOTOGRAPH NO. 58**

1. There is only one roof scupper (through the rear parapet) for the entire roof, and there is no overflow scupper/drain. Refer to Photographs Nos. 58, 94 and 95.

2. The adjacent tall trees have deposited, and will continue to deposit, a considerable amount of debris on the roof. Such debris could easily clog the one scupper, causing a back-up of water on the roof, which could overload portions of the roof structure. Refer to Photographs Nos. 58, 94 and 95.

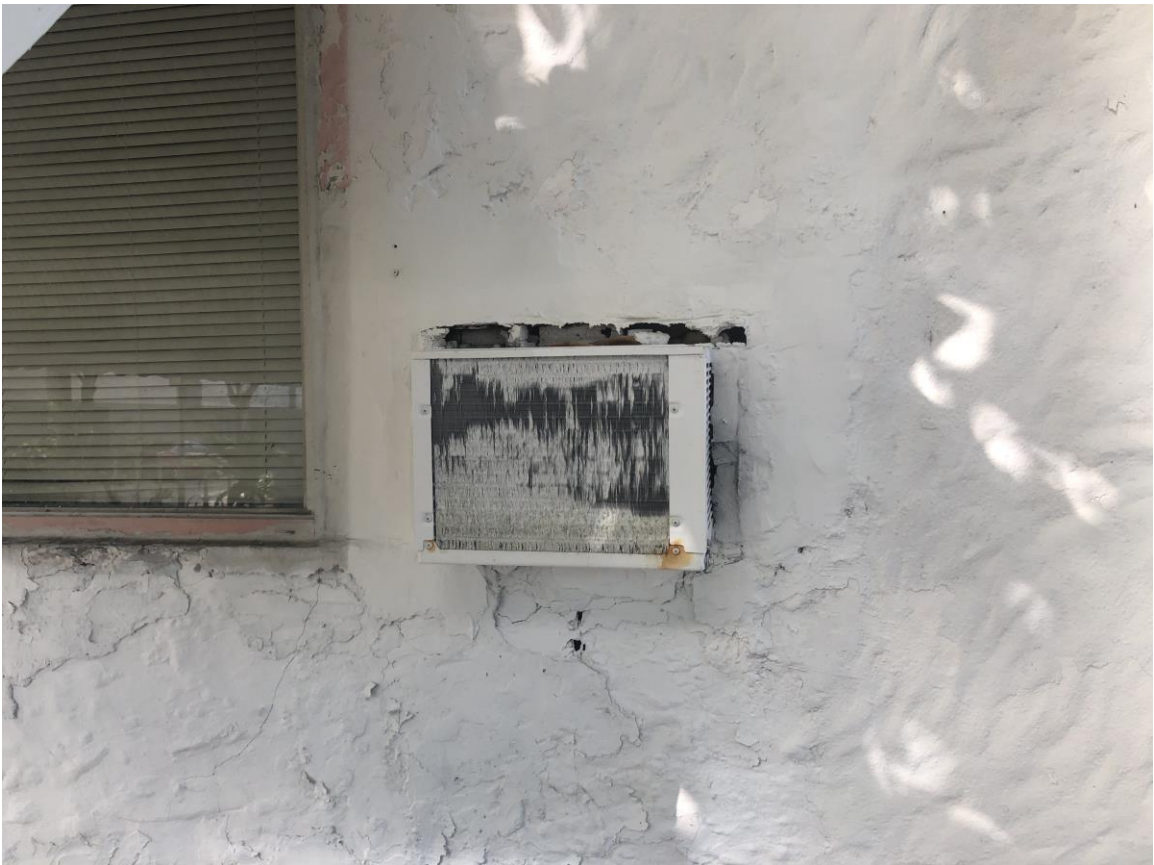
**PHOTOGRAPH NO. 76**

4. There are three through-wall air-conditioning units on the east wall of the building. Each of these units has significant gaps around their perimeters. Refer to Photographs Nos. 74, 76, 78 and 81. These gaps allow water to enter the wall cavities, which is likely causing rot of the concealed wood structural members of the wall and floor.

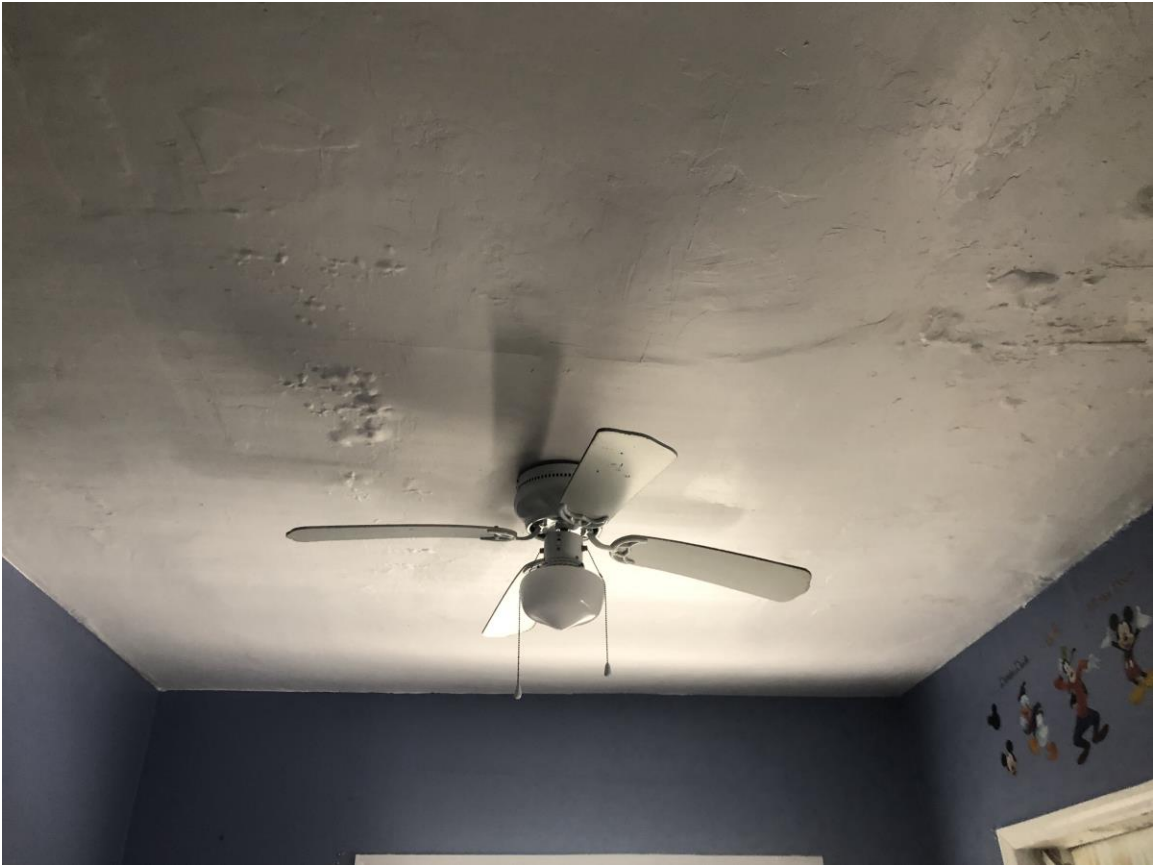
**PHOTOGRAPH NO. 84**

4. There are signs of current or previous roof leaks on the interior of the southeast room. Refer to Photographs Nos. 84, 85, and 86.
5. The presently existing roofing is old, worn and cracked. Refer to Photographs Nos. 94 and 95.

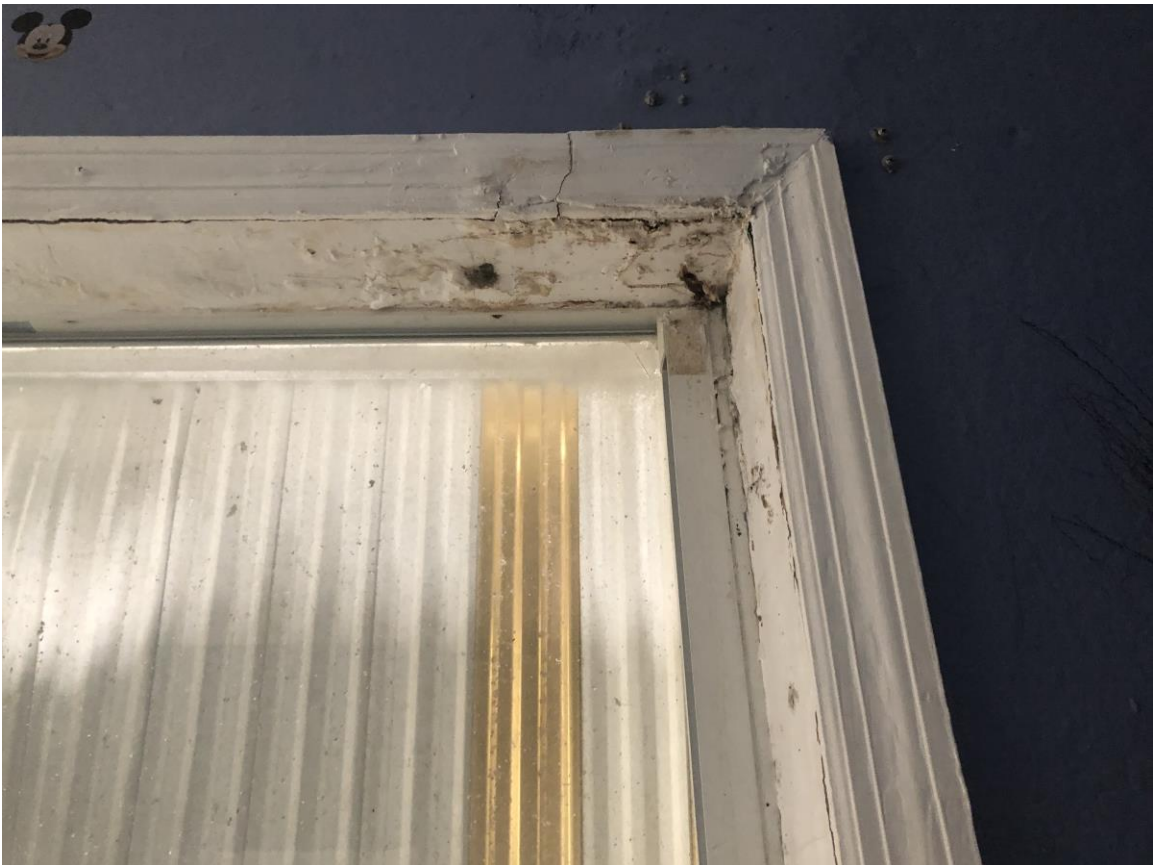
**PHOTOGRAPH NO. 85**

10. Some of the present windows were set in previously existing wood frames. At other windows, the previous casements/frames were removed, and stucco was patched in around them. Some windows have both conditions. Most of the exposed wood casements//frames are rotted. Refer to Photographs Nos. 22, 25, 26, 31 through 36, 38, 43, 44, 58, 61 and 78. Interior window casements are also stained and rotted in some locations. Refer to Photographs Nos. 85, 86 and 87.

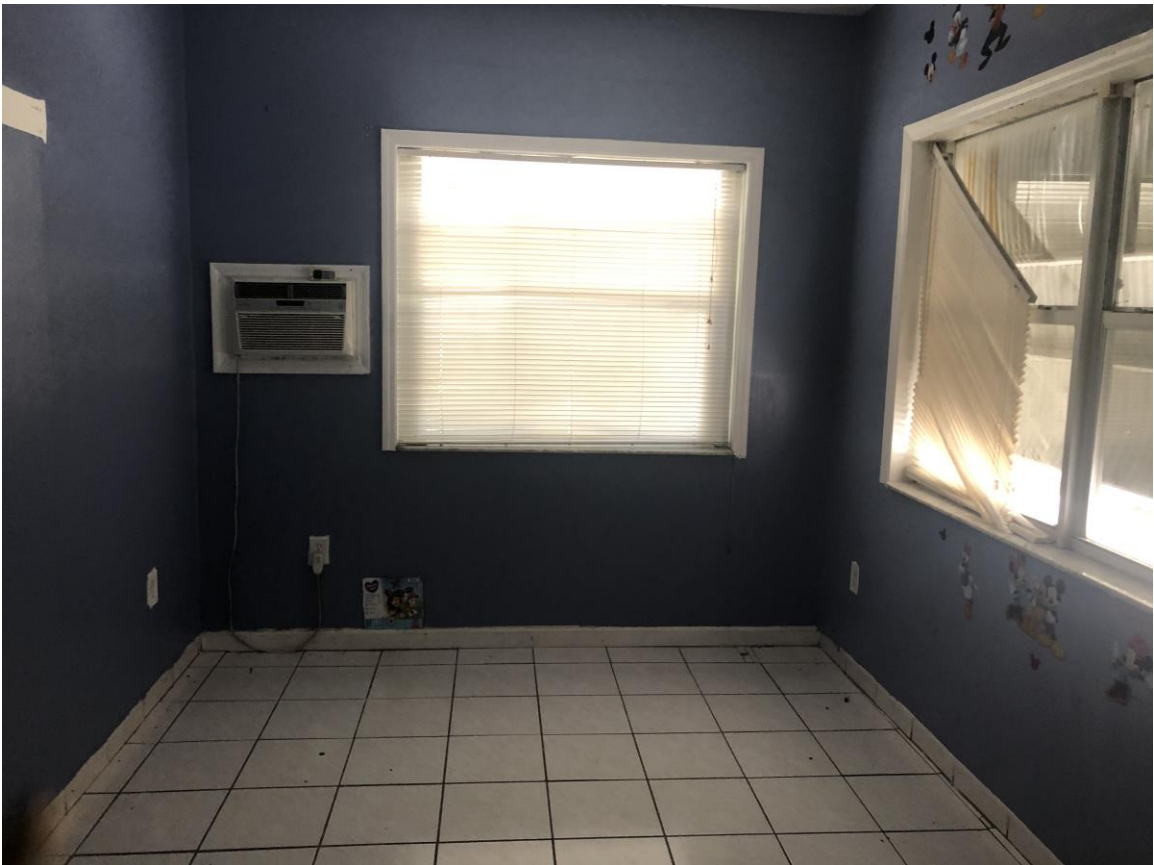
PHOTOGRAPH NO. 88

1. In general, all of the wood-framed floors deflect and vibrate under foot.
2. The floors are uneven in a number of locations. This may indicate inherent weakness, deterioration, long-term deformation and or soil settlements. Refer to Photographs Nos. 88, 89, 91, 92 and 93.

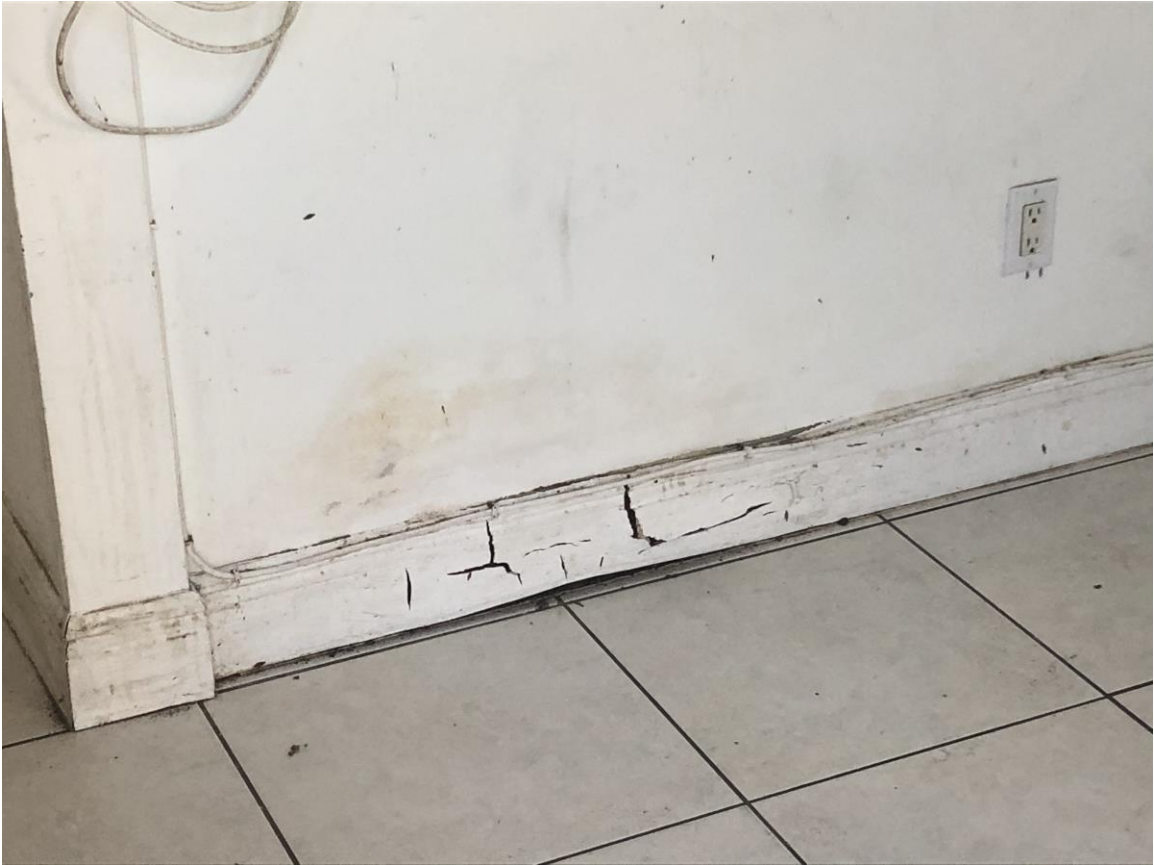
**PHOTOGRAPH NO. 91**

3. The baseboard in the kitchen of the western unit is significantly rotted, along with staining of the wall above and deflection of the floor below. Refer to Photograph No. 91. The bathroom plumbing is on the other side of this wall. This indicates previous or current leaks in the pipes which have most likely damaged the partition framing and bearing plate, floor sheathing and floor joists.

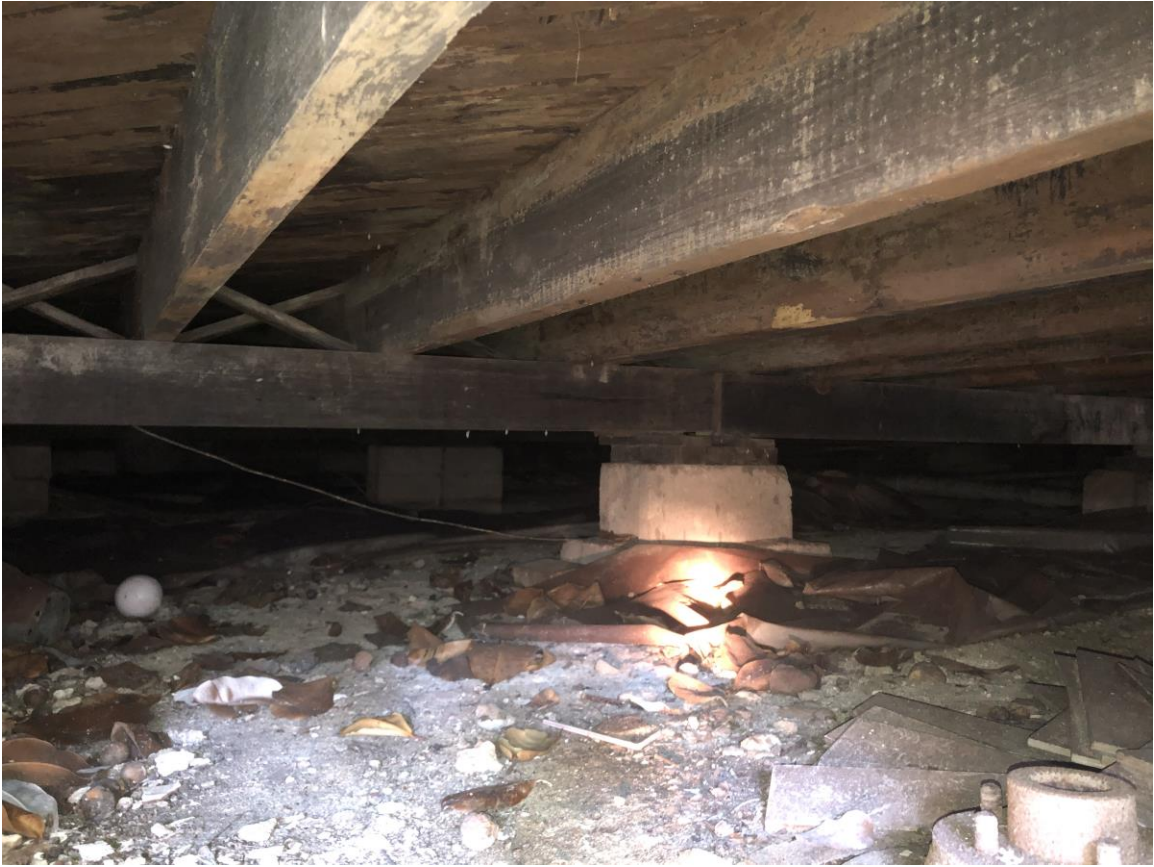
PHOTOGRAPH NO. 96

4. There is a lack of ventilation for the crawl space. There are no vents on the north and south sides. There were two vents on the west side, but they have been covered and/or blocked (refer to Photograph No. 100). There were two vents on the east side of the building, but one has long been boarded over (refer to Photograph No. 74). This lack of ventilation can lead to excessive moisture that can support the growth of fungi that cause rot. Yellow and white powders observed on several of the wood floor members are likely such fungi. Refer to Photograph No. 96.

5. In the area under the floor that was visible, there is insect damage in some of the wood joists and sheathing. Refer to Photographs Nos. 96, 97 and 98.
