Arborist Report

10/22/2021

as requested by you I inspected the site 622 15th Street, Miami Beach, FL 33139 in order to document the trees and palms growing on the property and review the proposed construction in regards to existing trees.

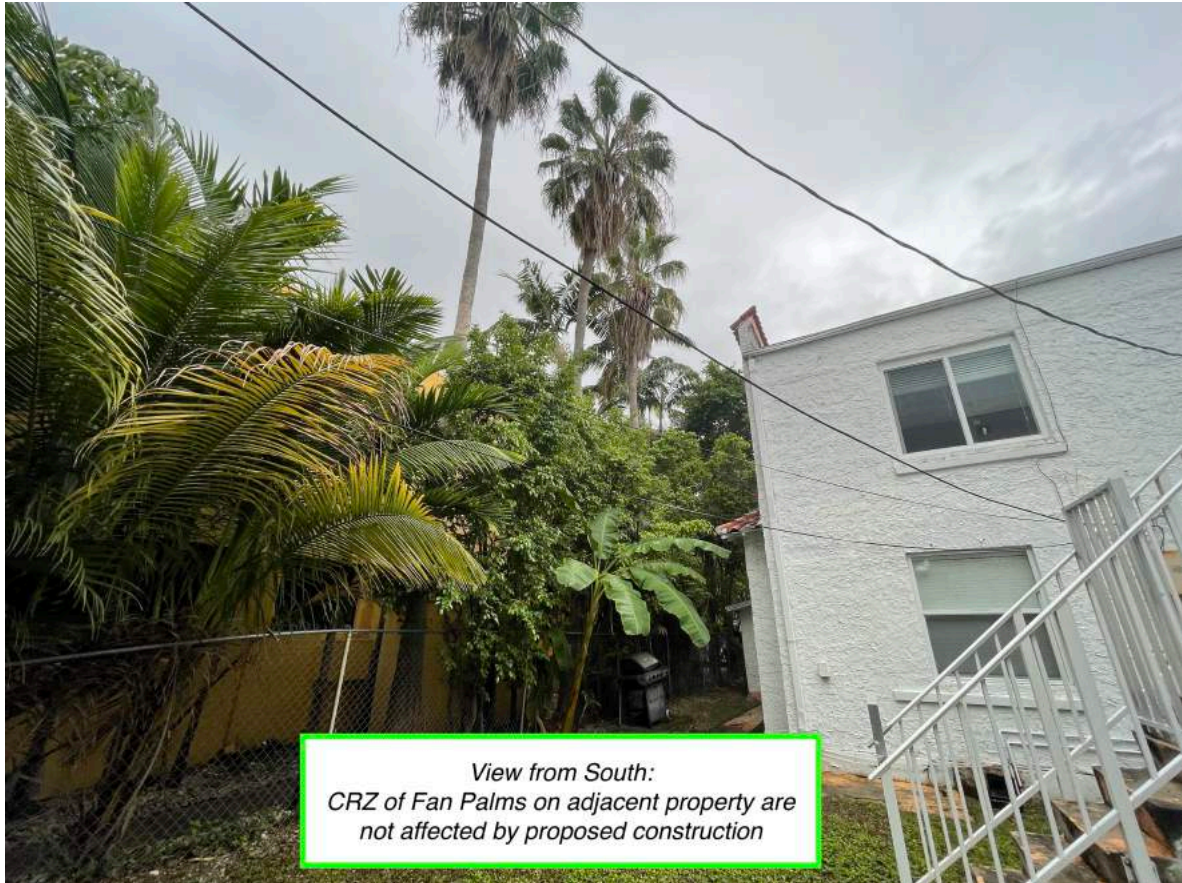
*View from South:
CRZ of Fan Palms on adjacent property are
not affected by proposed construction*

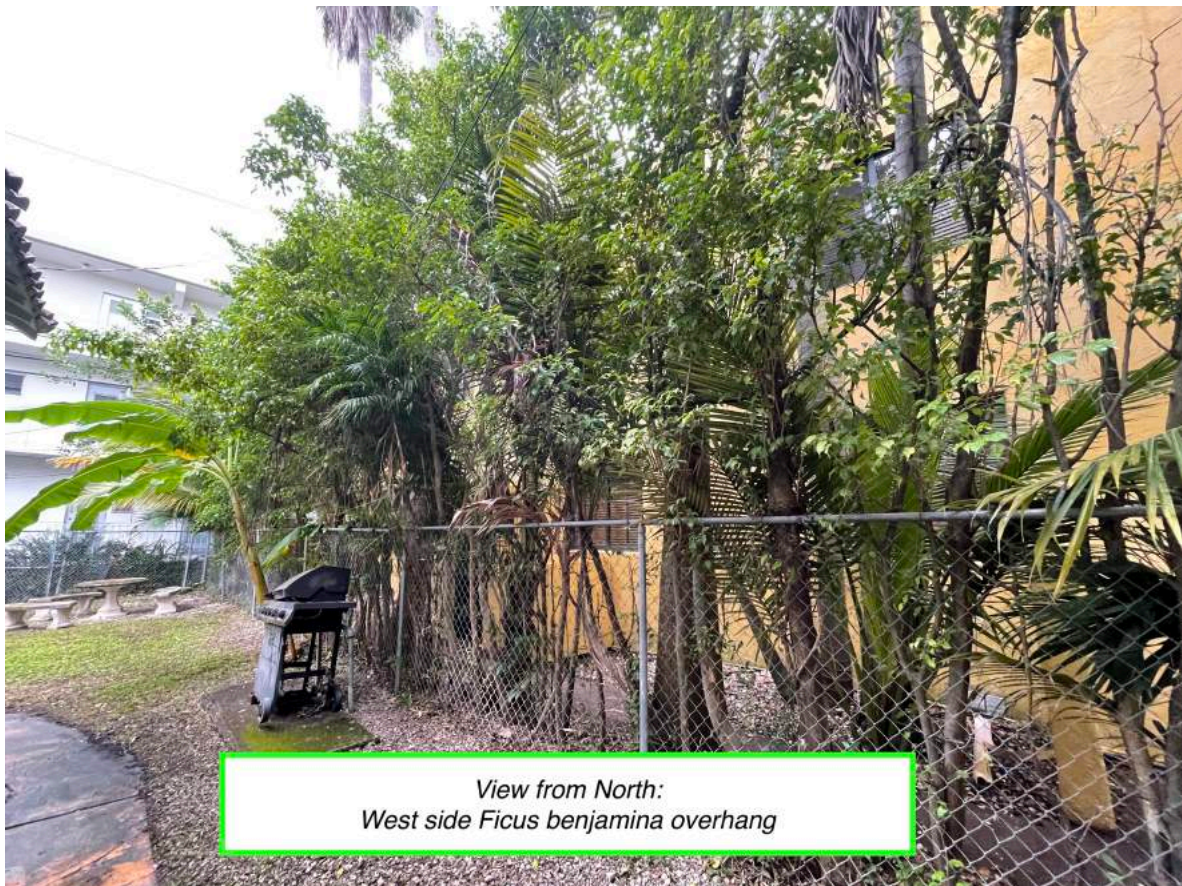
*View from North:
West side Ficus benjamina overhang*
