COMMISSION MEMORANDUM

TO: Honorable Mayor Dan Gelber and Members of the City Commission
FROM: Alina T. Hudak, City Manager

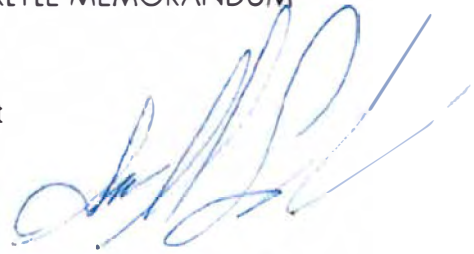
The Byron Carlyle Theater was inspected for structural and electrical safeties in 2018, many deficiencies were noted. The repair of these deficiencies would require lengthy and expensive renovations in order to continue daily operations. The Building Department noted serious concerns with regards to the electrical system; the electrical room is below the crown of road elevation and has been subject to severe flooding over the years.

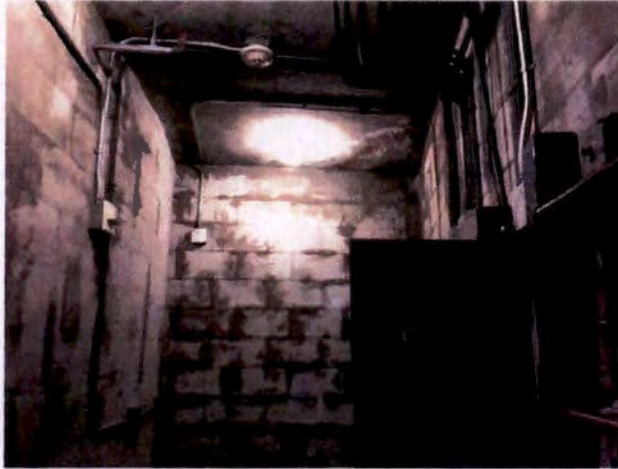
Exhibit "A" O Cinema and Condemned Area Photographs

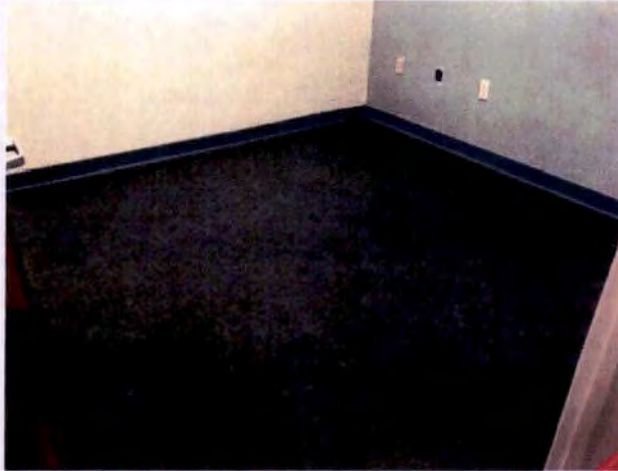
Exhibit "A" O Cinema and Condemned Area Photographs

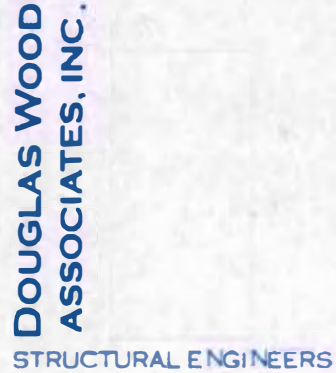
Exhibit "C" Douglas Wood Structural 50 Year Recertification Report

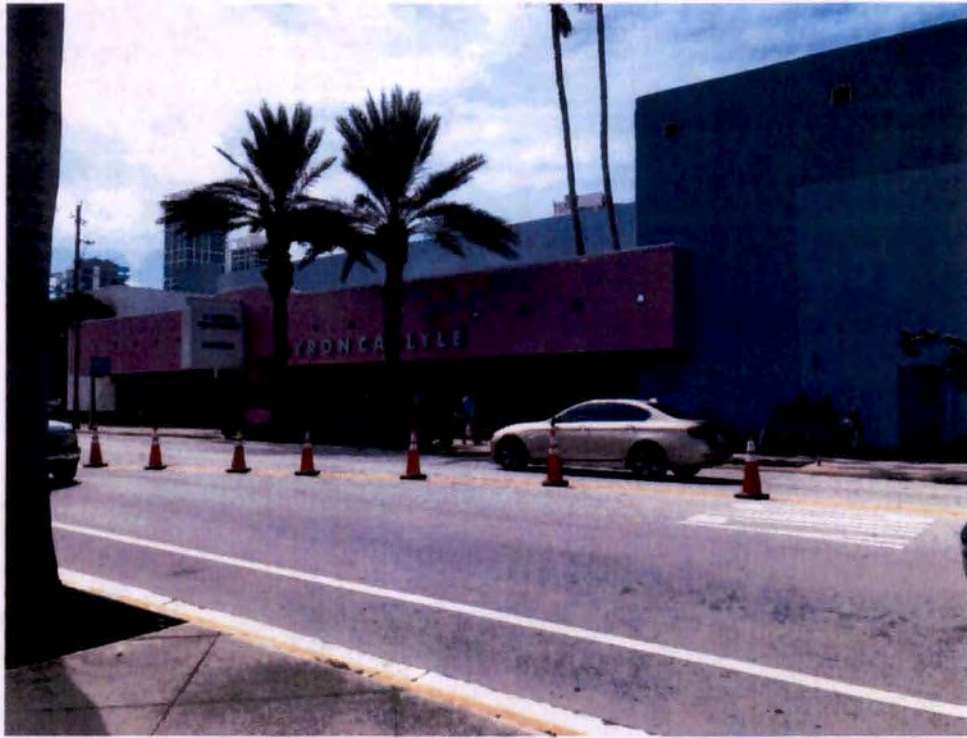
Photograph No. 1 - Overall Photograph of the Building

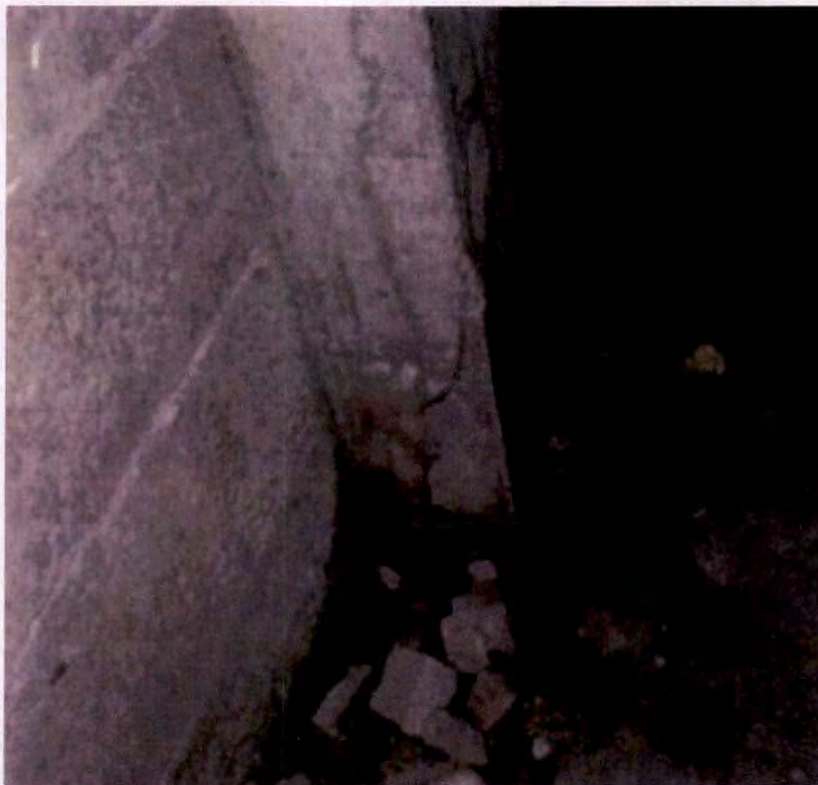
Photograph No. 12 - Spalled Concrete Column at Underground Hall

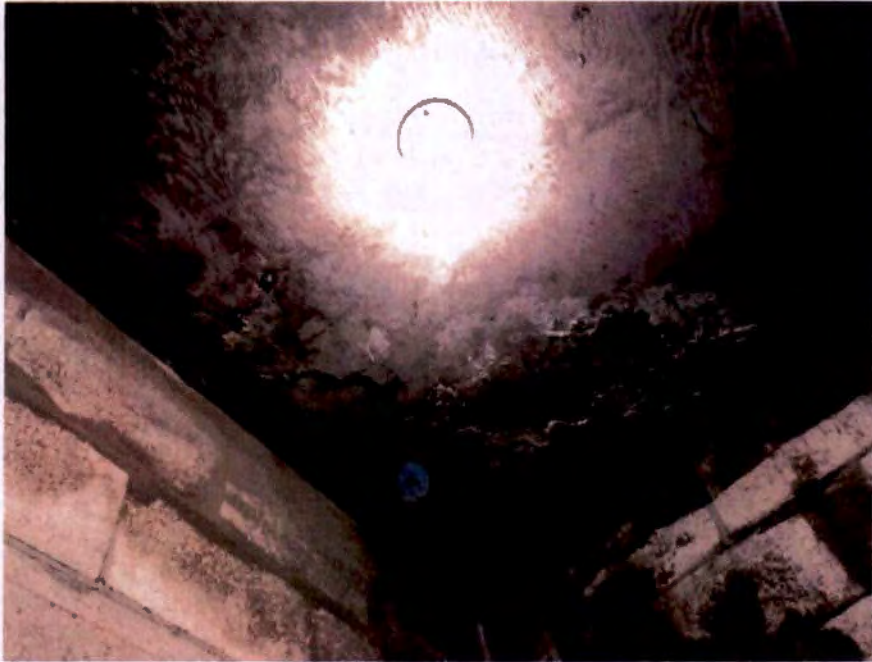
Photograph No. 13 – Spalled Concrete Slab above Electrical Room at Ground Floor

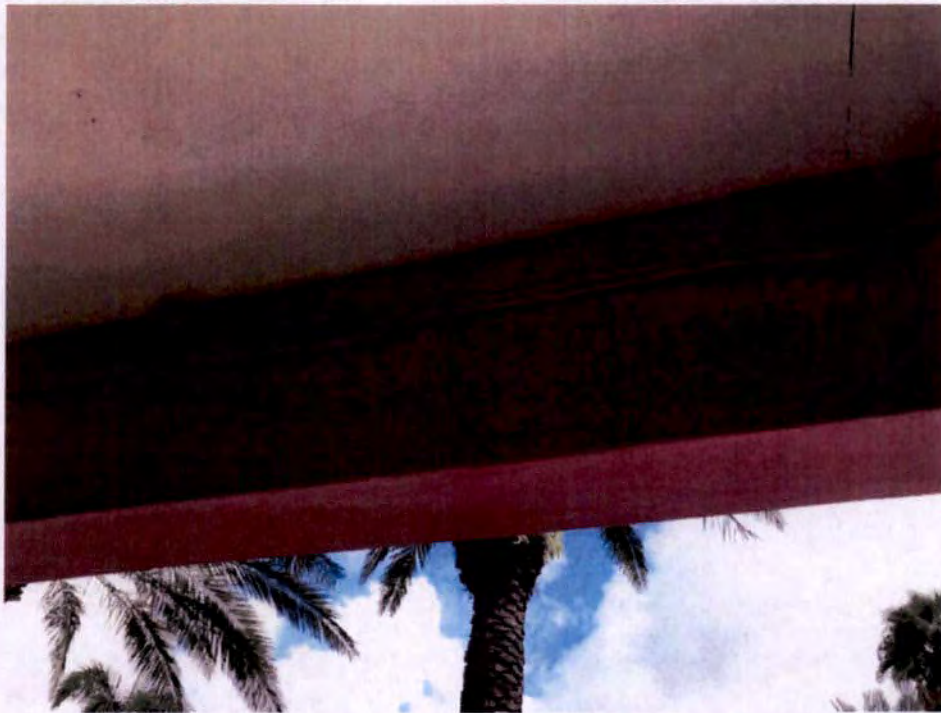
Photograph No. 14 – Spalled Exterior Concrete Beam at North Façade

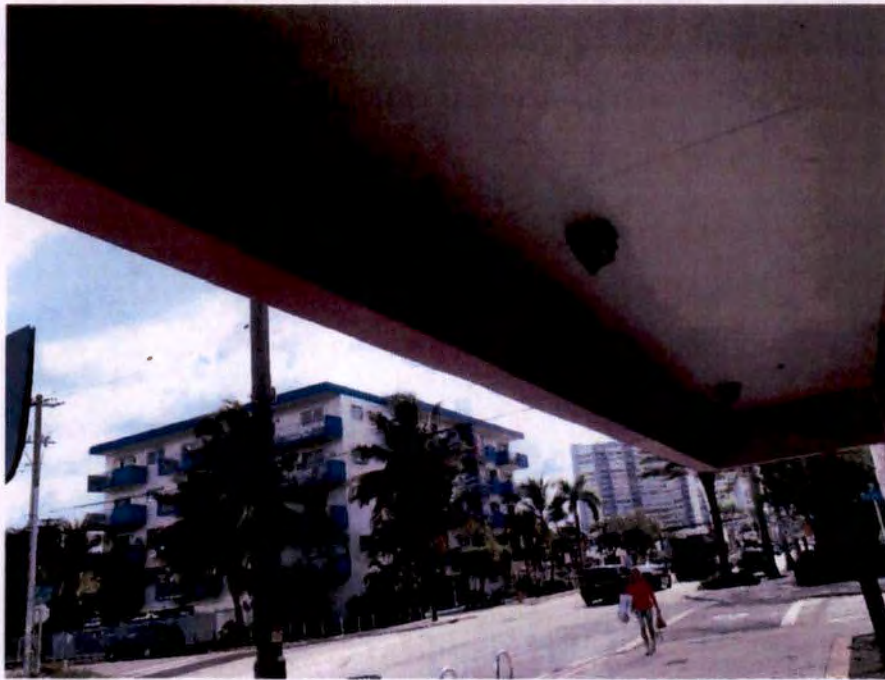
Photograph No. 15 – Spalled Exterior Concrete Beam at North Façade

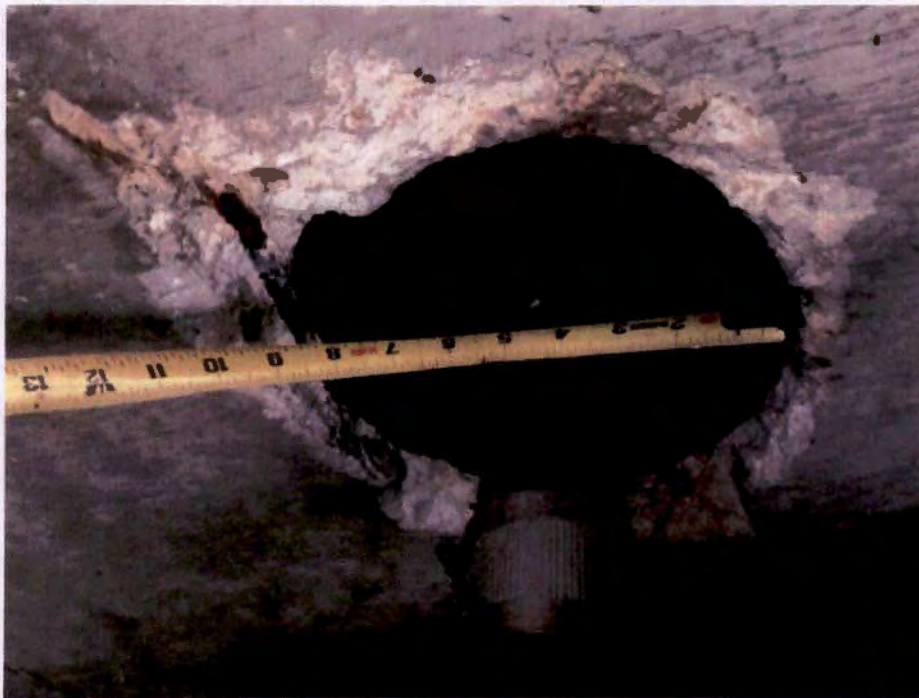
Photograph No. 16 – Opening in Slab above Men's Restroom (near South Façade)

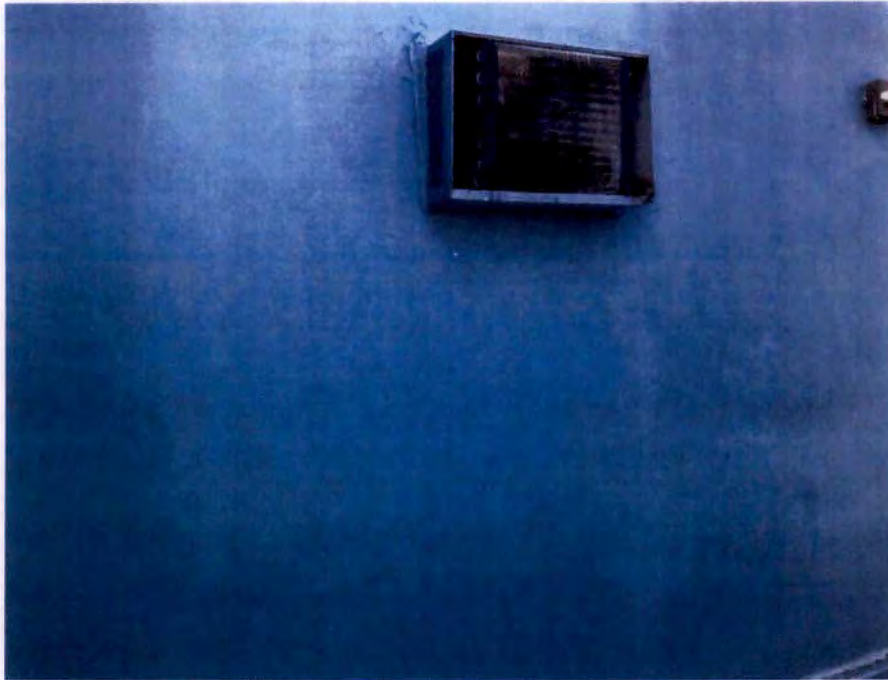
Photograph No. 17 – Uncovered Air Conditioning Unit in 2nd floor Room at the South End of Building (Between east and West Theaters).

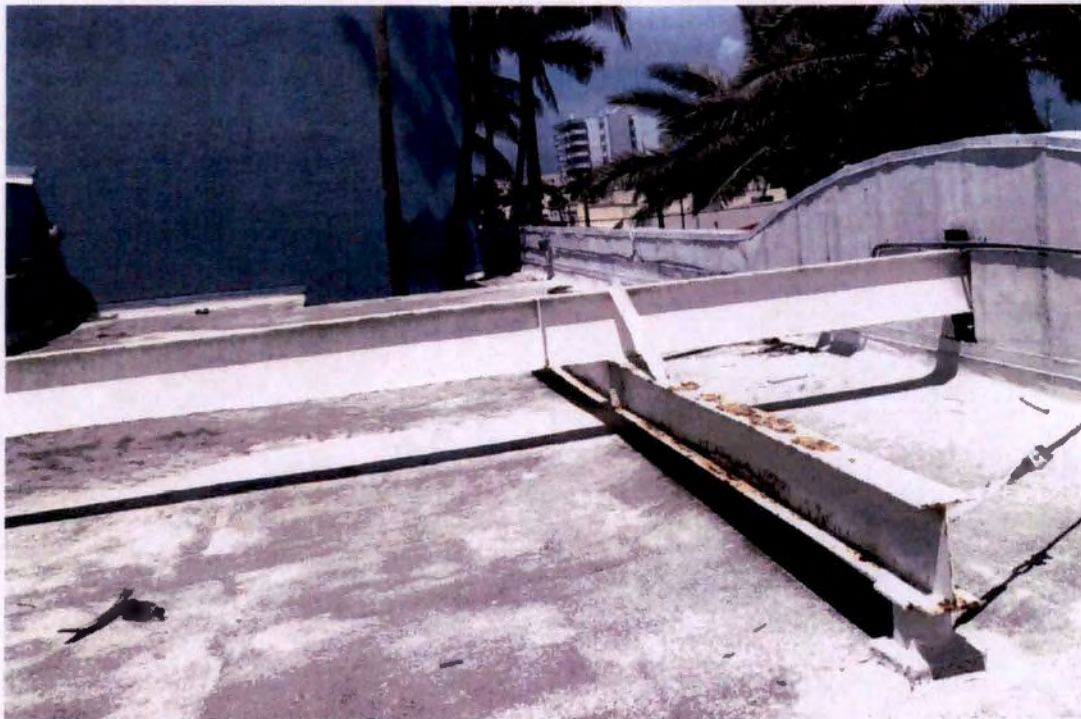
Photograph No. 18 – Corroded Structural Steel Supporting Theater Sign

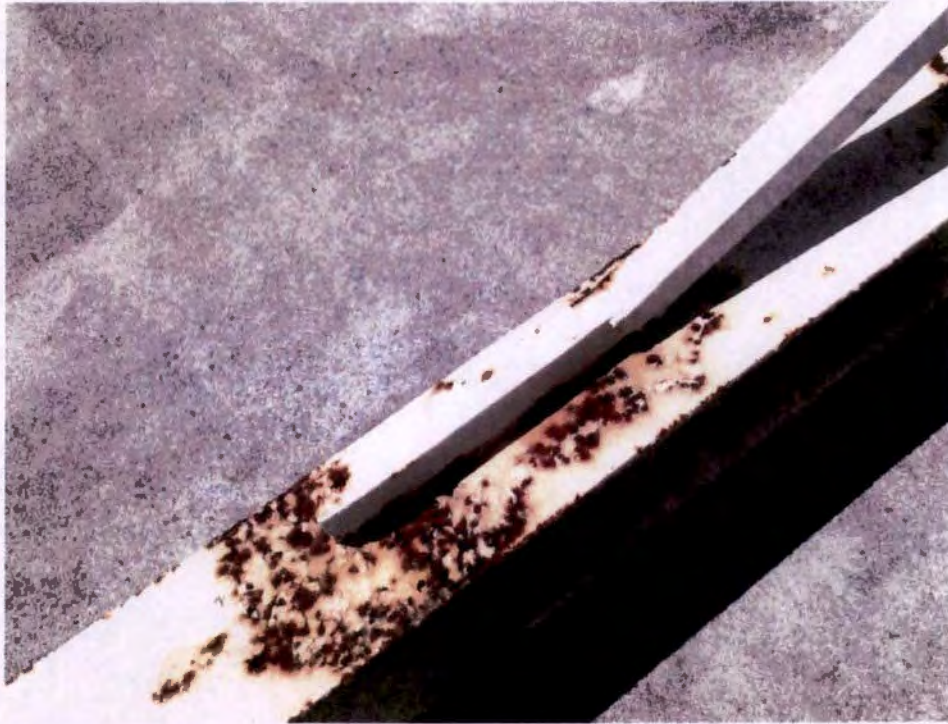
Photograph No. 19 – Corroded Structural Steel Supporting Theater Sign

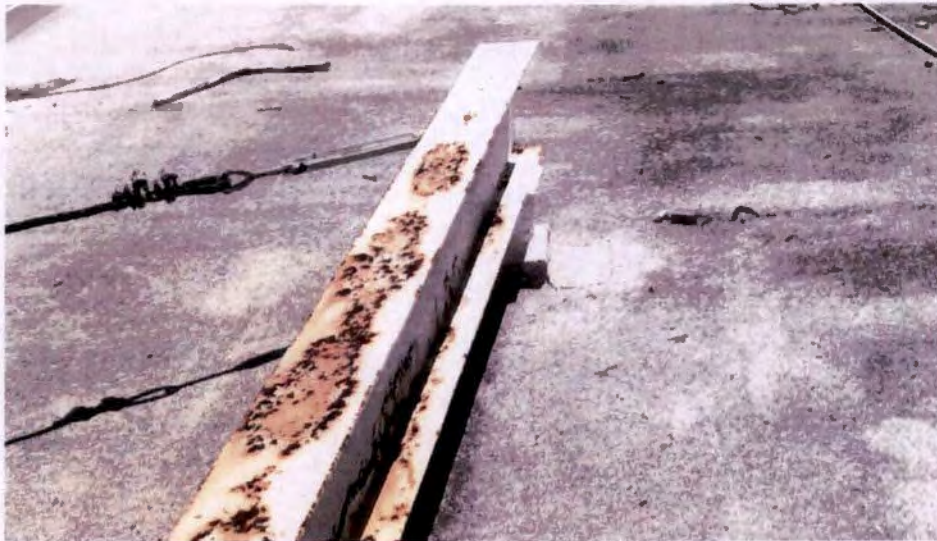
Photograph No. 20– Corroded Structural Steel Supporting Theater Sign

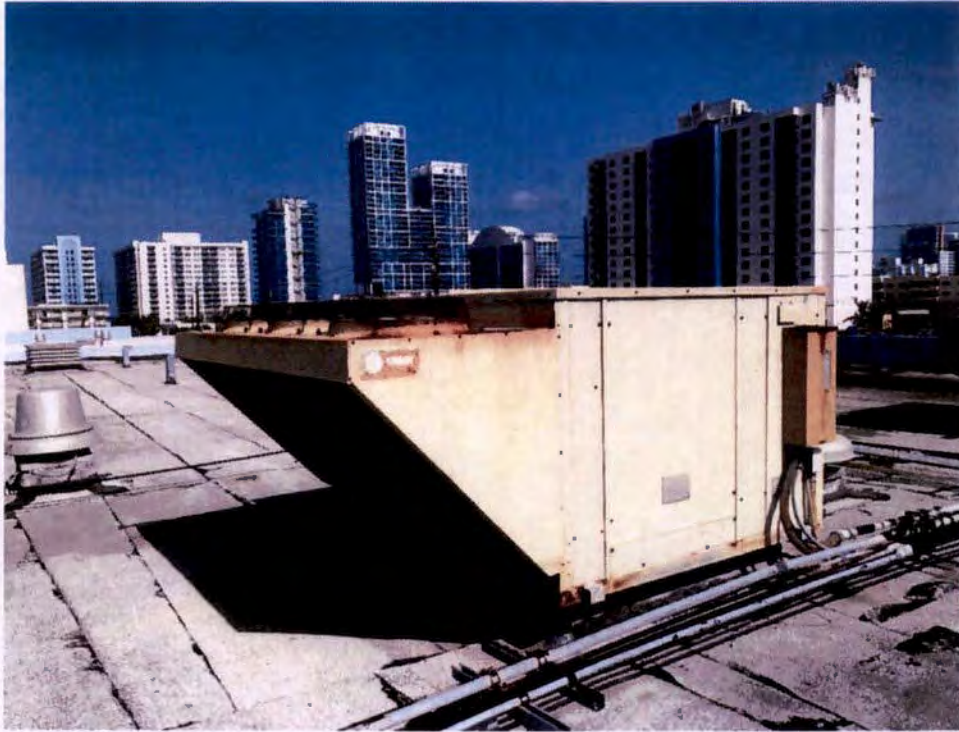
Photograph No. 21 - Rooftop Package Unit at Western Upper Roof

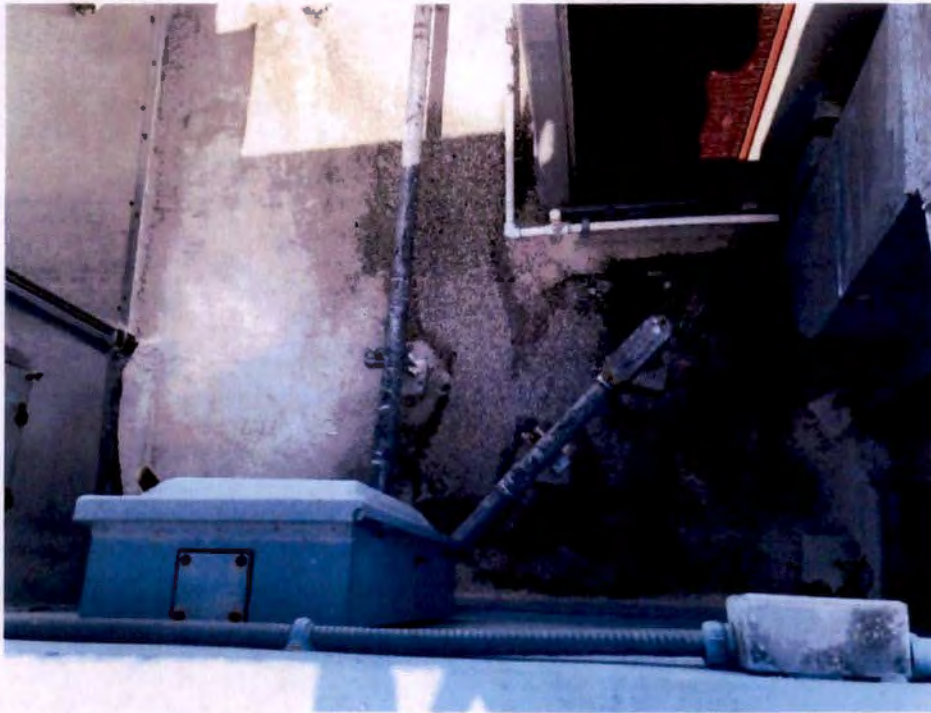
Photograph No. 23 – Deteriorated roofing at Eastern Lower Roof

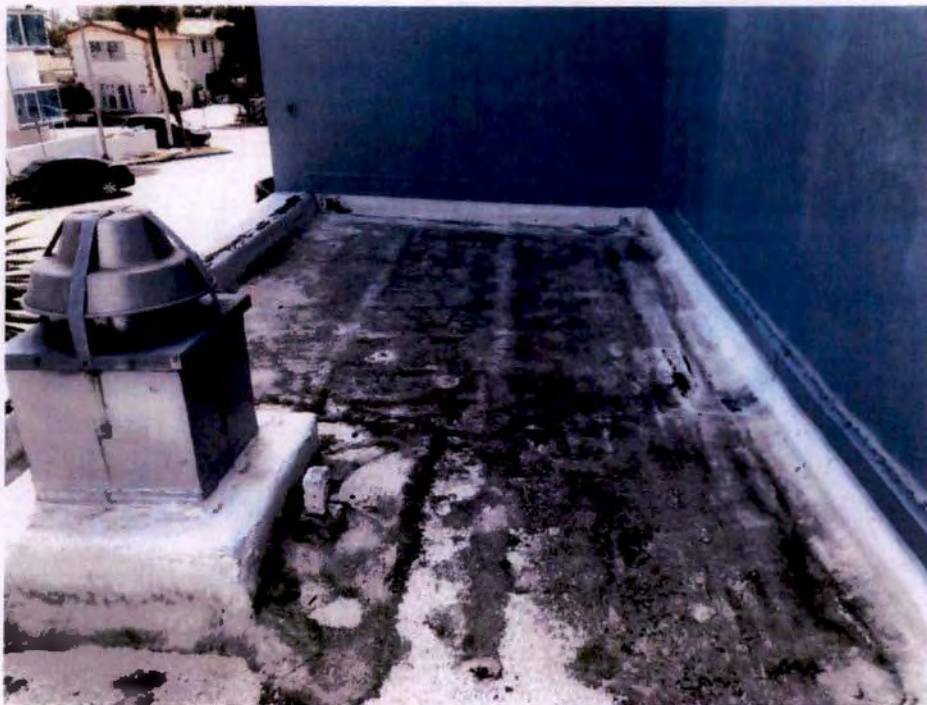
Photograph No. 24 – Deteriorated roofing at Lower Roof at the 2nd Floor towards South Façade

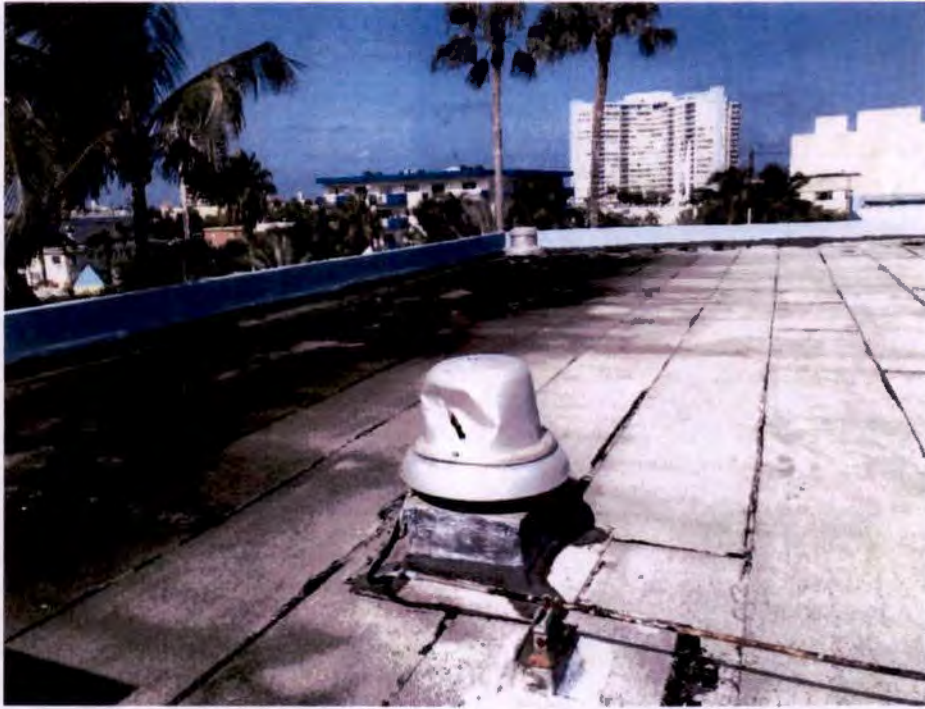
Photograph No. 25 – Deteriorated roofing at Western Upper Roof

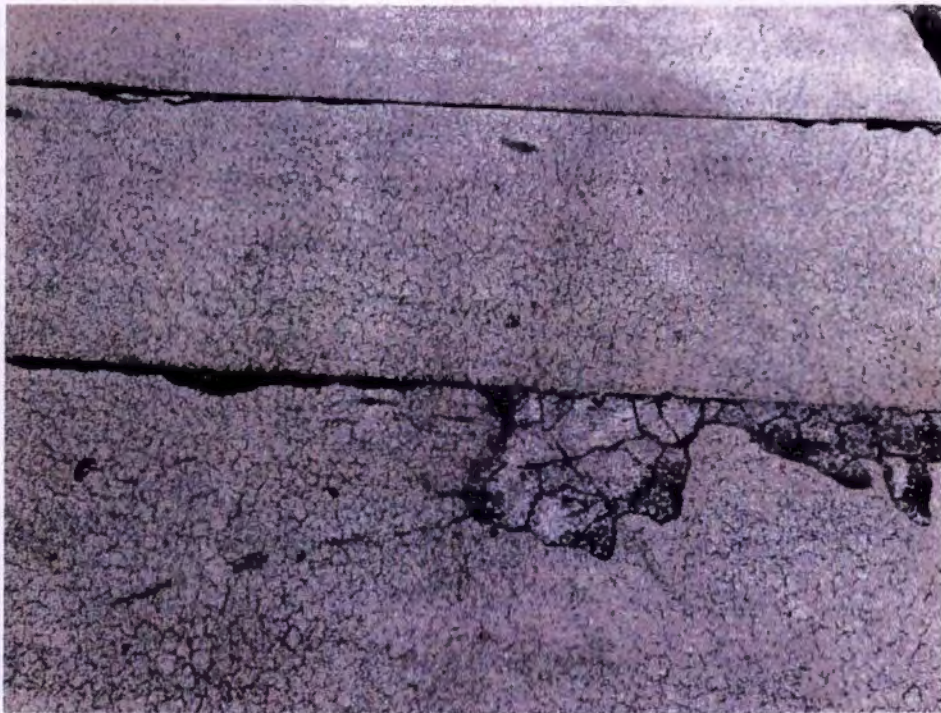
Photograph No. 26 – Deteriorated roofing at Western Upper Roof

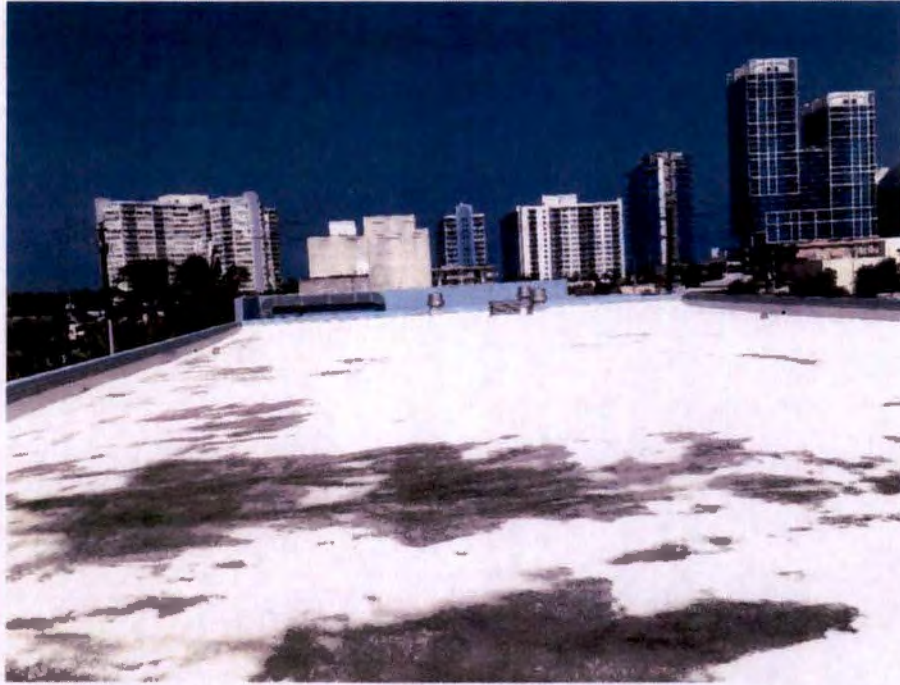
Photograph No. 27 – Deteriorated roofing at Western Upper Roof

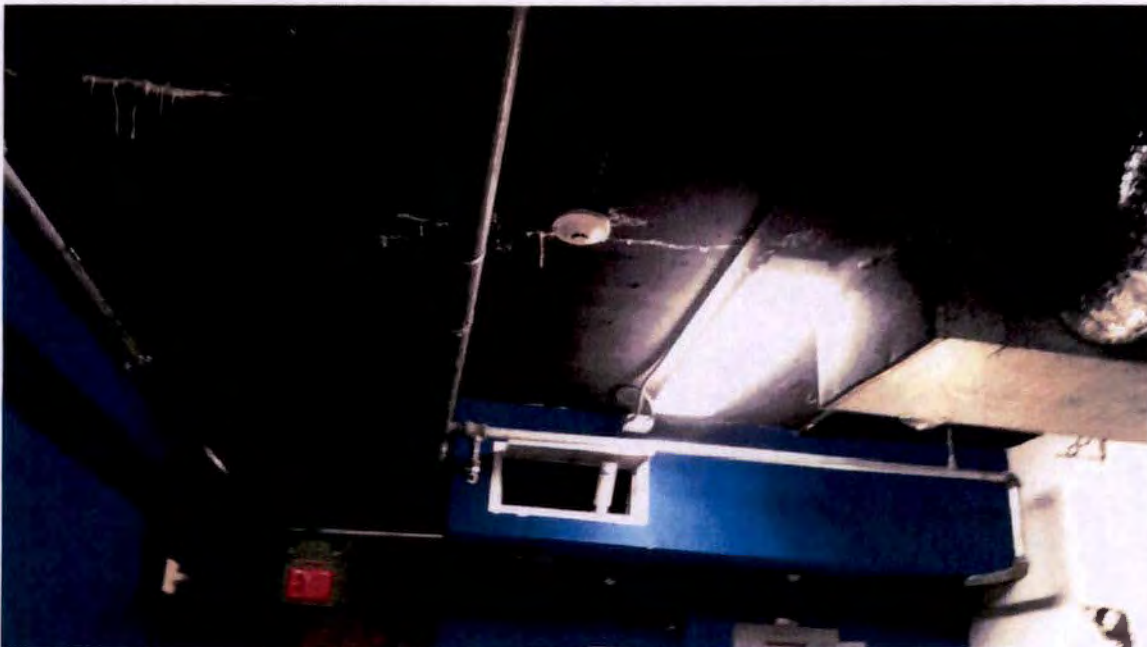
Photograph No. 28 – Efflorescence in Concrete Slab above Projection Room (East Side)

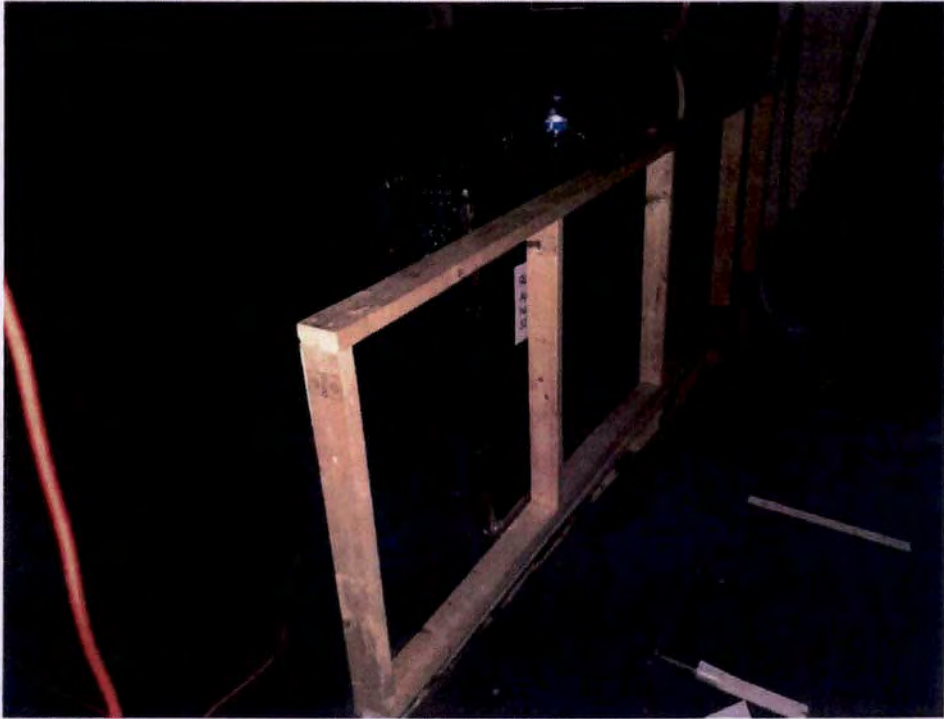
Photograph No. 37 – Loose Wooden Guardrail at East Cinema Theater

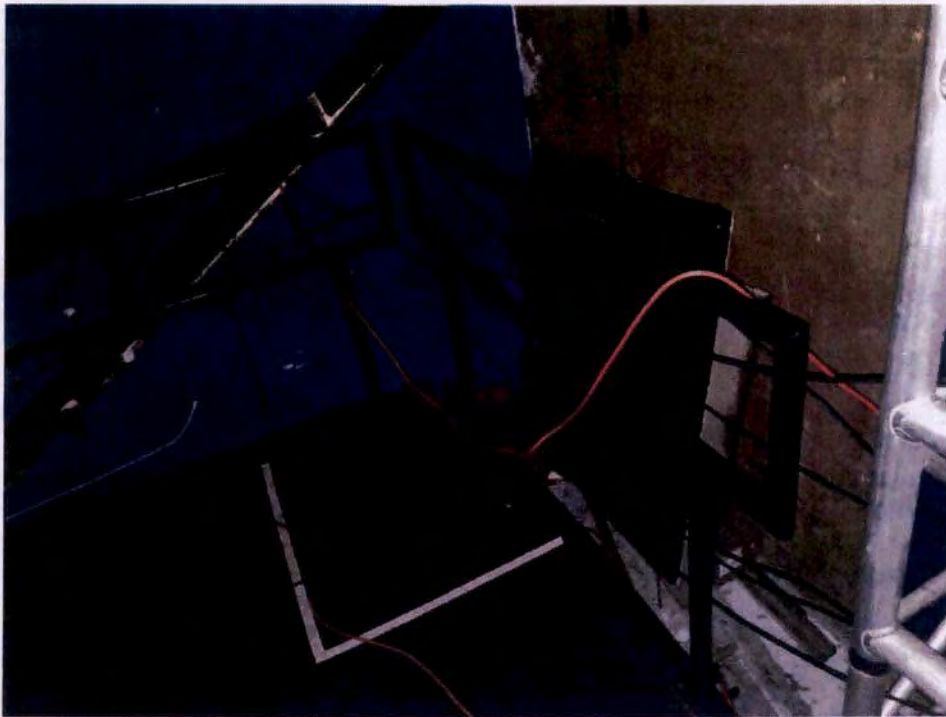
Photograph No. 38 – Loose Metal Guardrail at East Cinema Theater

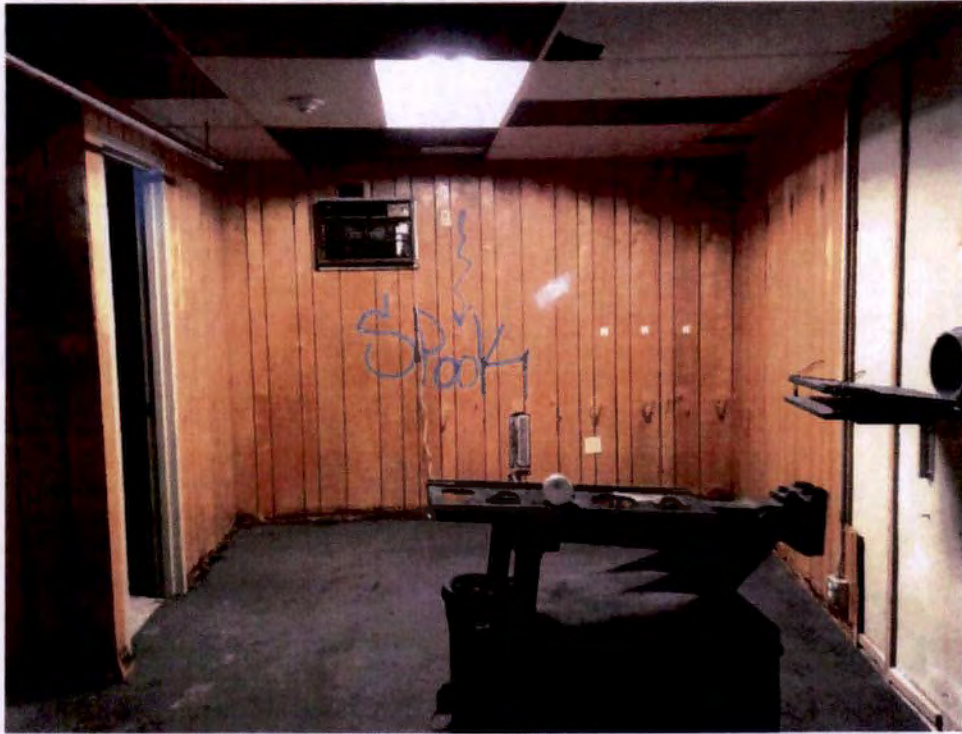
Photograph No. 39 – Deteriorated Interior Wood Paneling in 2nd floor Room at the South End of Building (Between east and West Theaters).

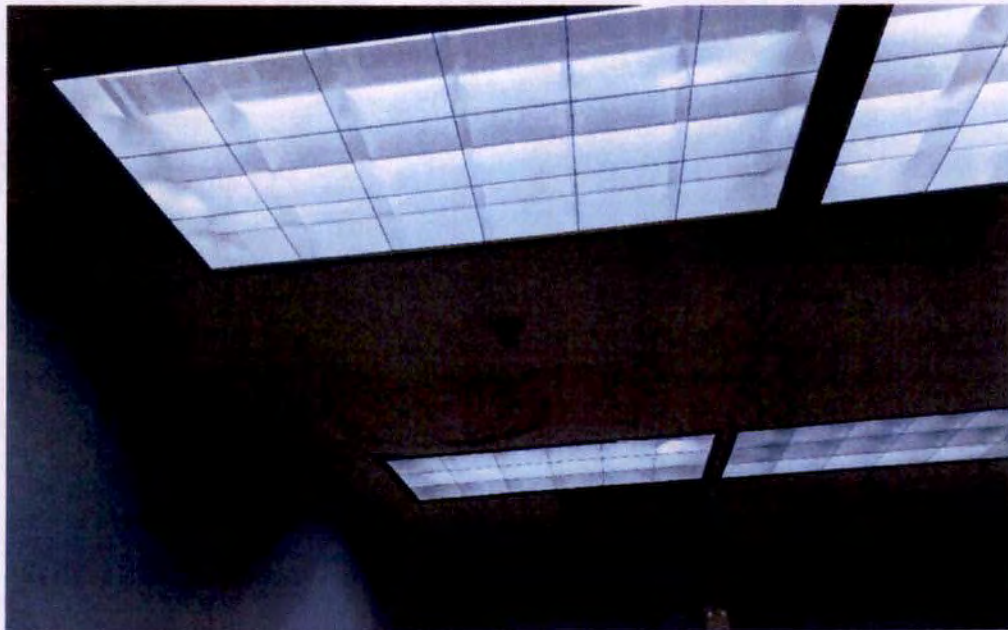
Photograph No. 40 – Stained Ceiling Tiles at Ceiling of First Level

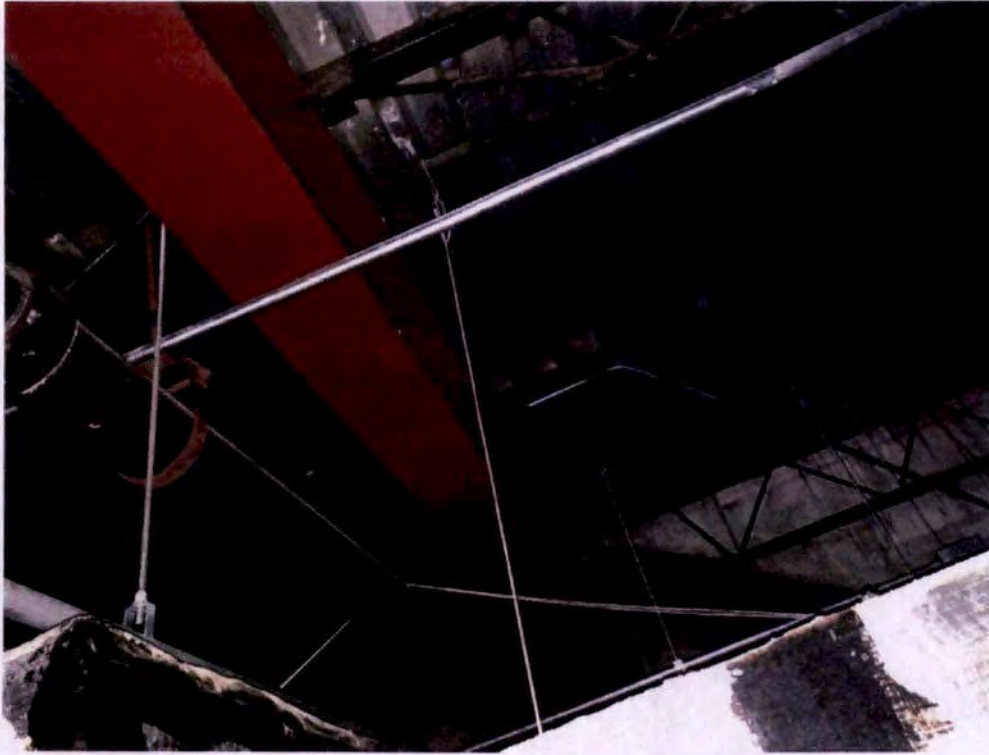
Photograph No. 41 – Underside of roof structure of Low Roof at North Façade

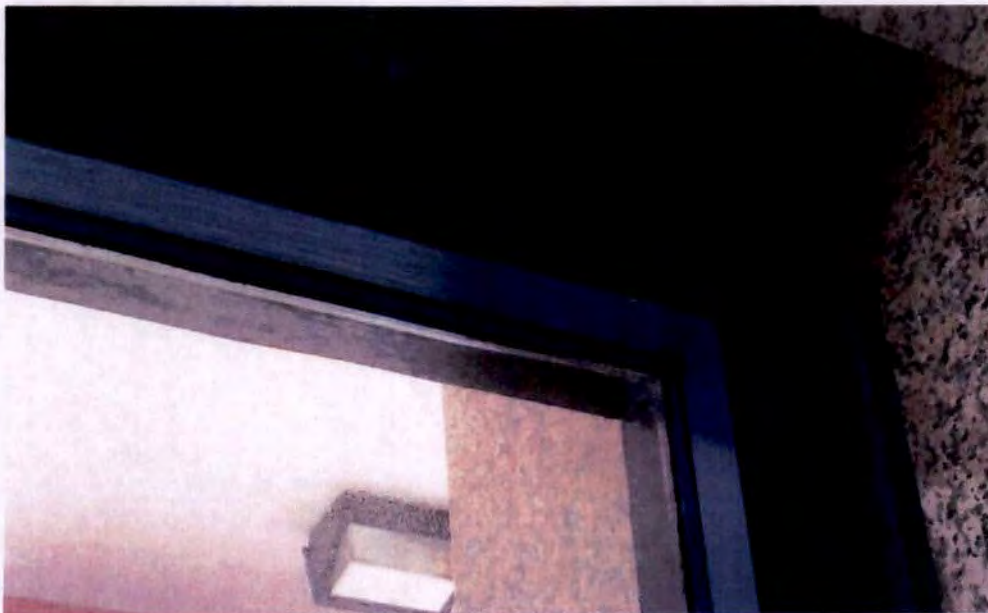
Photograph No. 74 – Missing Sealant at Corner of Fixed Window of North Façade

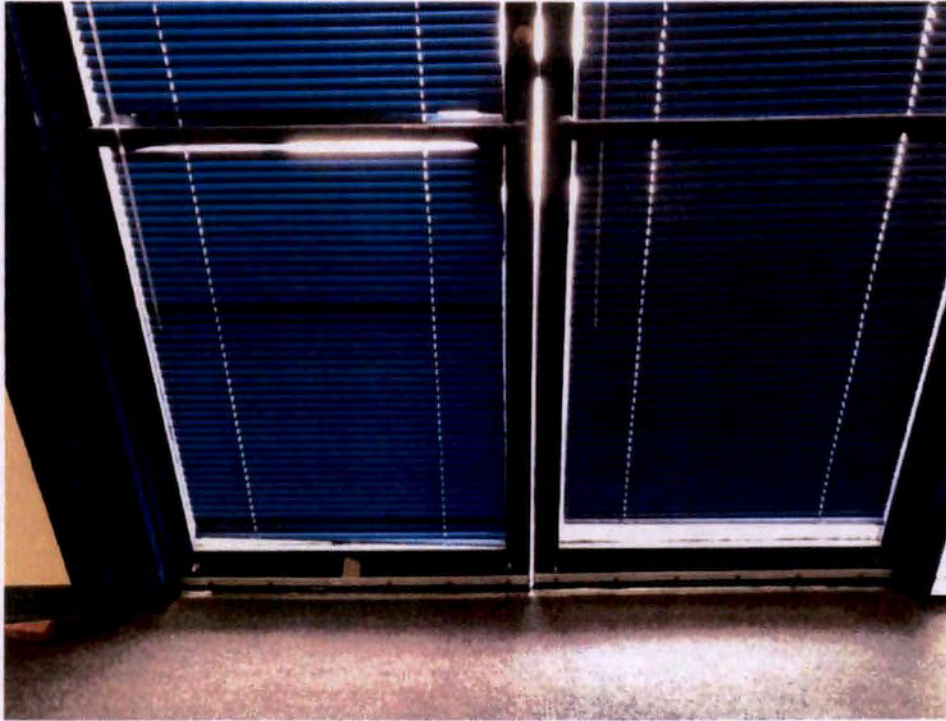
Photograph No. 75 – Considerable Gab between Pair of North Façade Doors

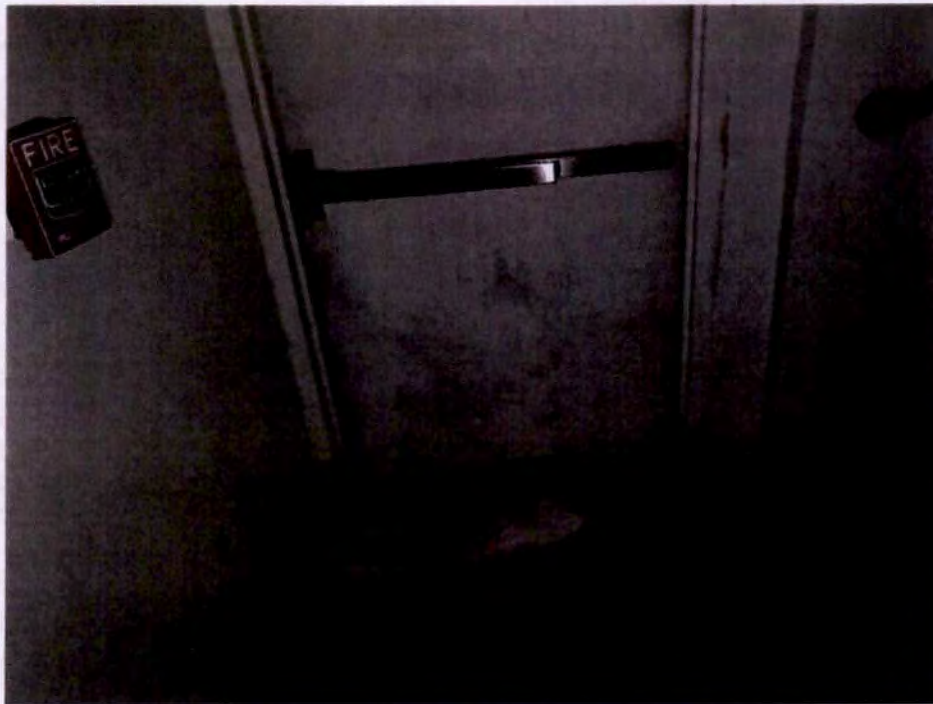
Photograph No. 76 – Corroded Exterior Door at Underground Electrical Room

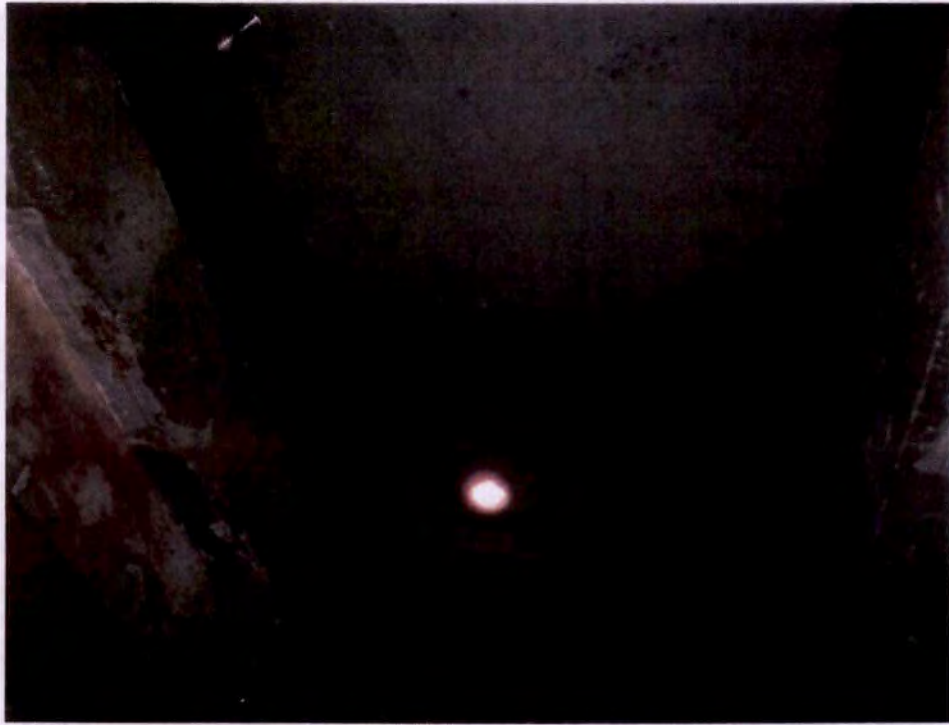
Photograph No. 77 – Lightly Corroded Exterior Door at Steel-framed Exit Staircase for Projection Room of West Cinema Theaters

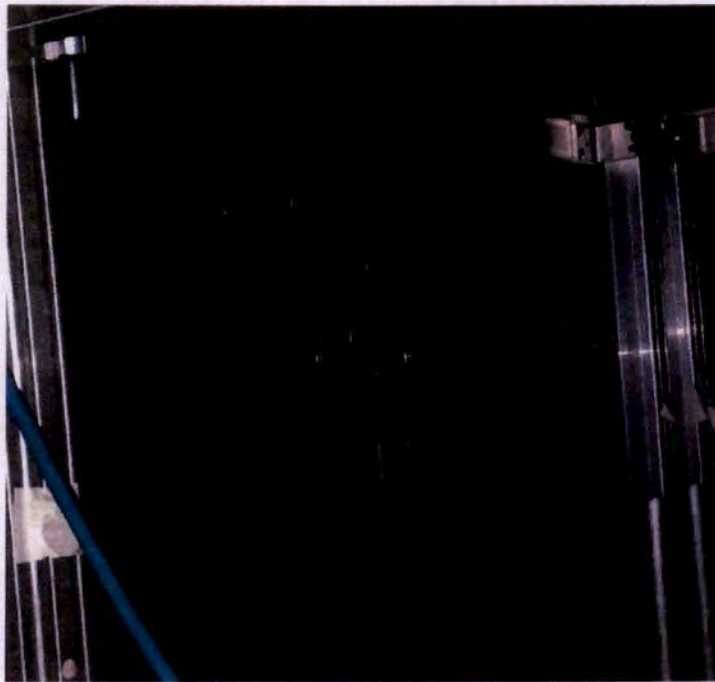
Photograph No. 78 – Crooked Leg of Stage's Aluminum-framed Platform

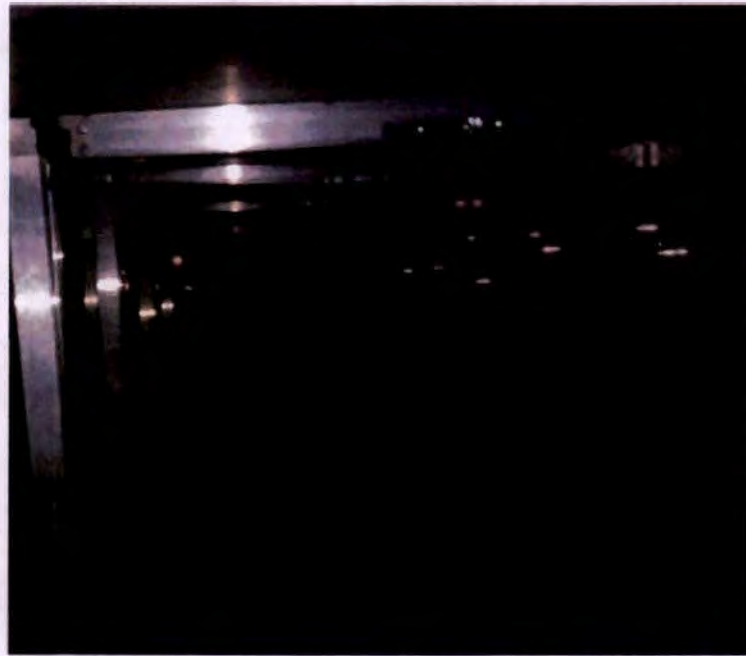
Photograph No. 83 – Loose C.M.U. blocks Supporting East Cinema Theater Platform

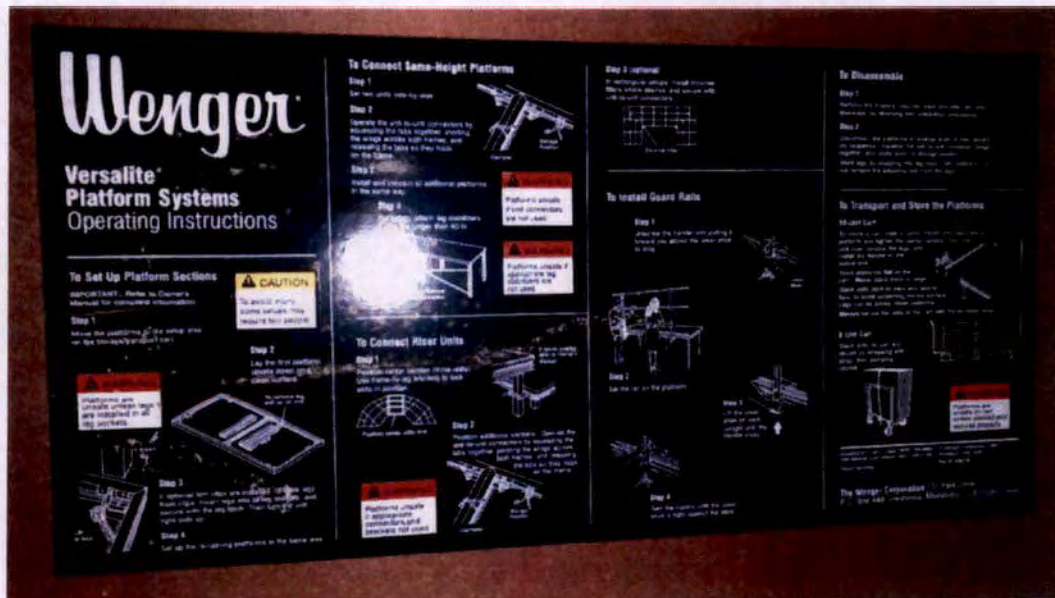
Photograph No. 84 – Stage Versatile Platform System Label – East Cinema Theater

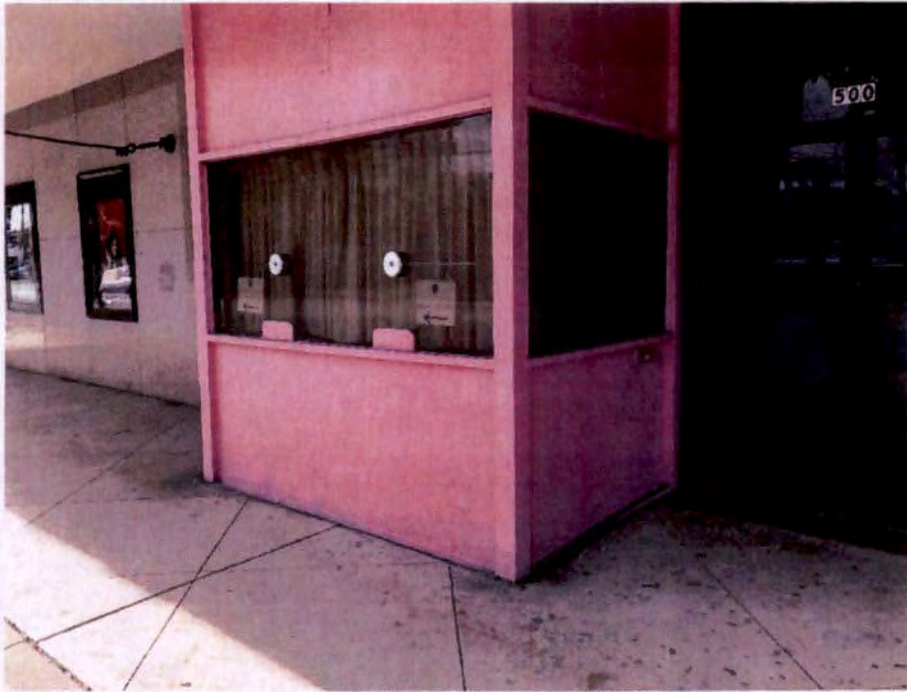
Photograph No. 85 – Ticket Box Office at North Façade

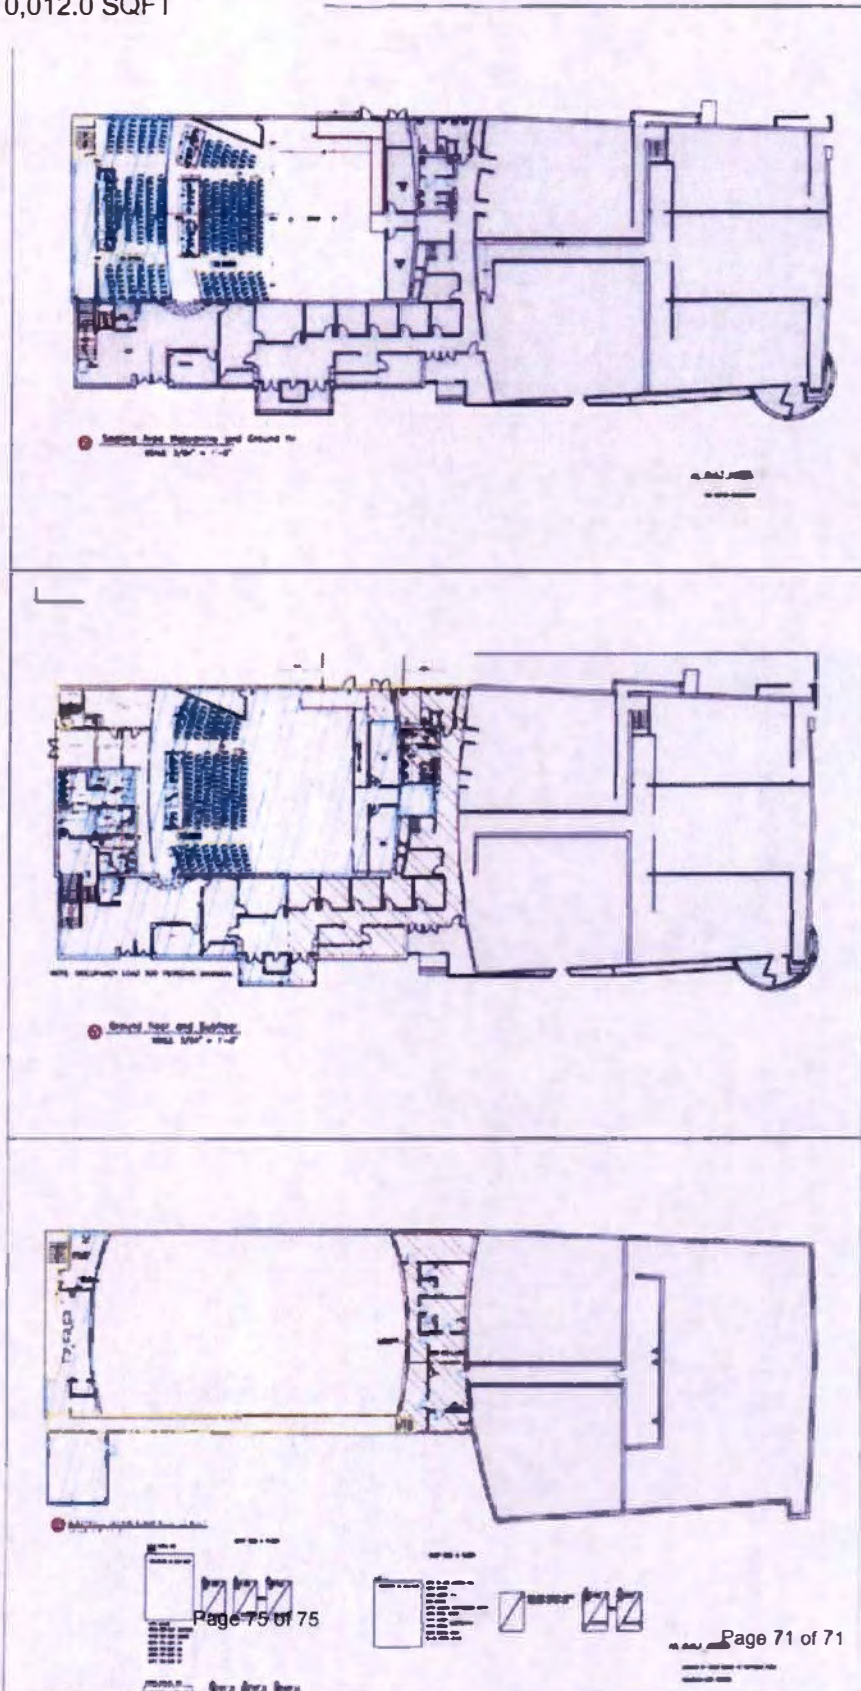
This Conditions Assessment and Recommendations Report for the Byron Carlyle Theater will evaluate the current conditions of the building, and provide recommendations for improvements. The report will briefly recount the history and evolution of the theater leading to a description of its current condition; and how it may operate in the future, or be replaced with new construction, along with associated conceptual cost data. The report will provide recommendations to bring the existing building into an operational state and into compliance with current codes. This Study will also provide one building replacement concept. All scenarios presented will include a theater and / or cultural component to benefit the citizens of Miami Beach, and the region.
