COMMISSION MEMORANDUM

TO: Honorable Mayor Dan Gelber and Members of the City Commission
FROM: Alina T. Hudak, City Manager

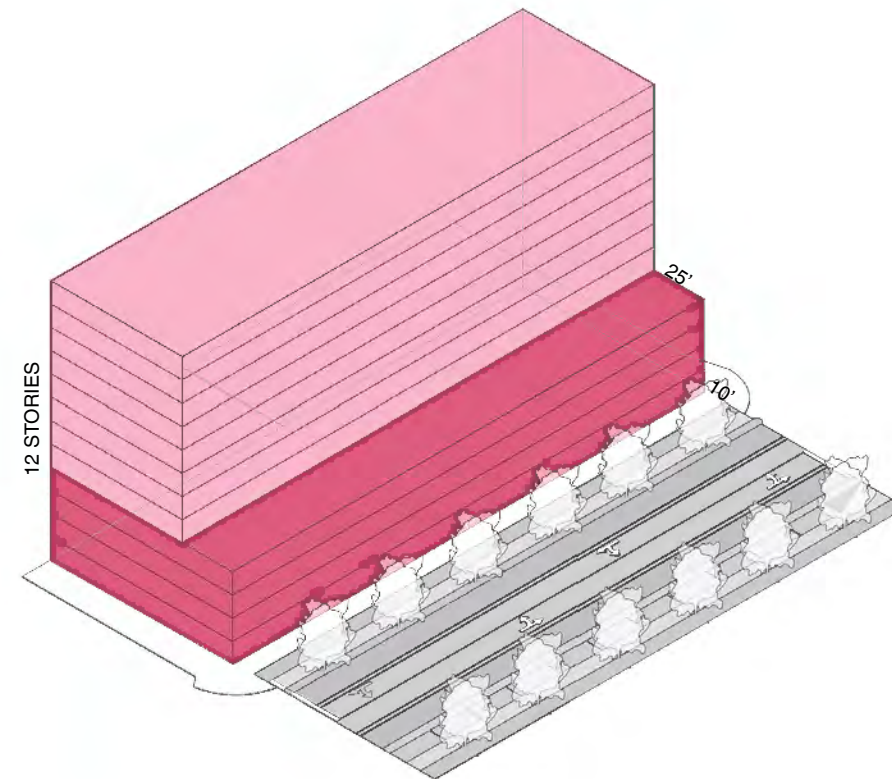
MASSING ON 71ST STREET ACCORDING TO PLAN NOBE

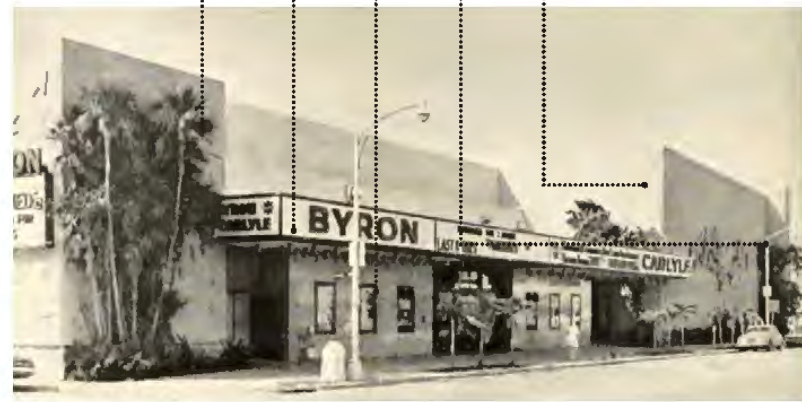
- MAINTAIN TRIANGULAR RELIEF PATTERN
- PRESERVE MARQUEE
- REUSE POSTER FRAMES AS WINDOWS
- REPLACE THEATER VOLUME
- REVIVE MIAMI BEACH ART PIECE

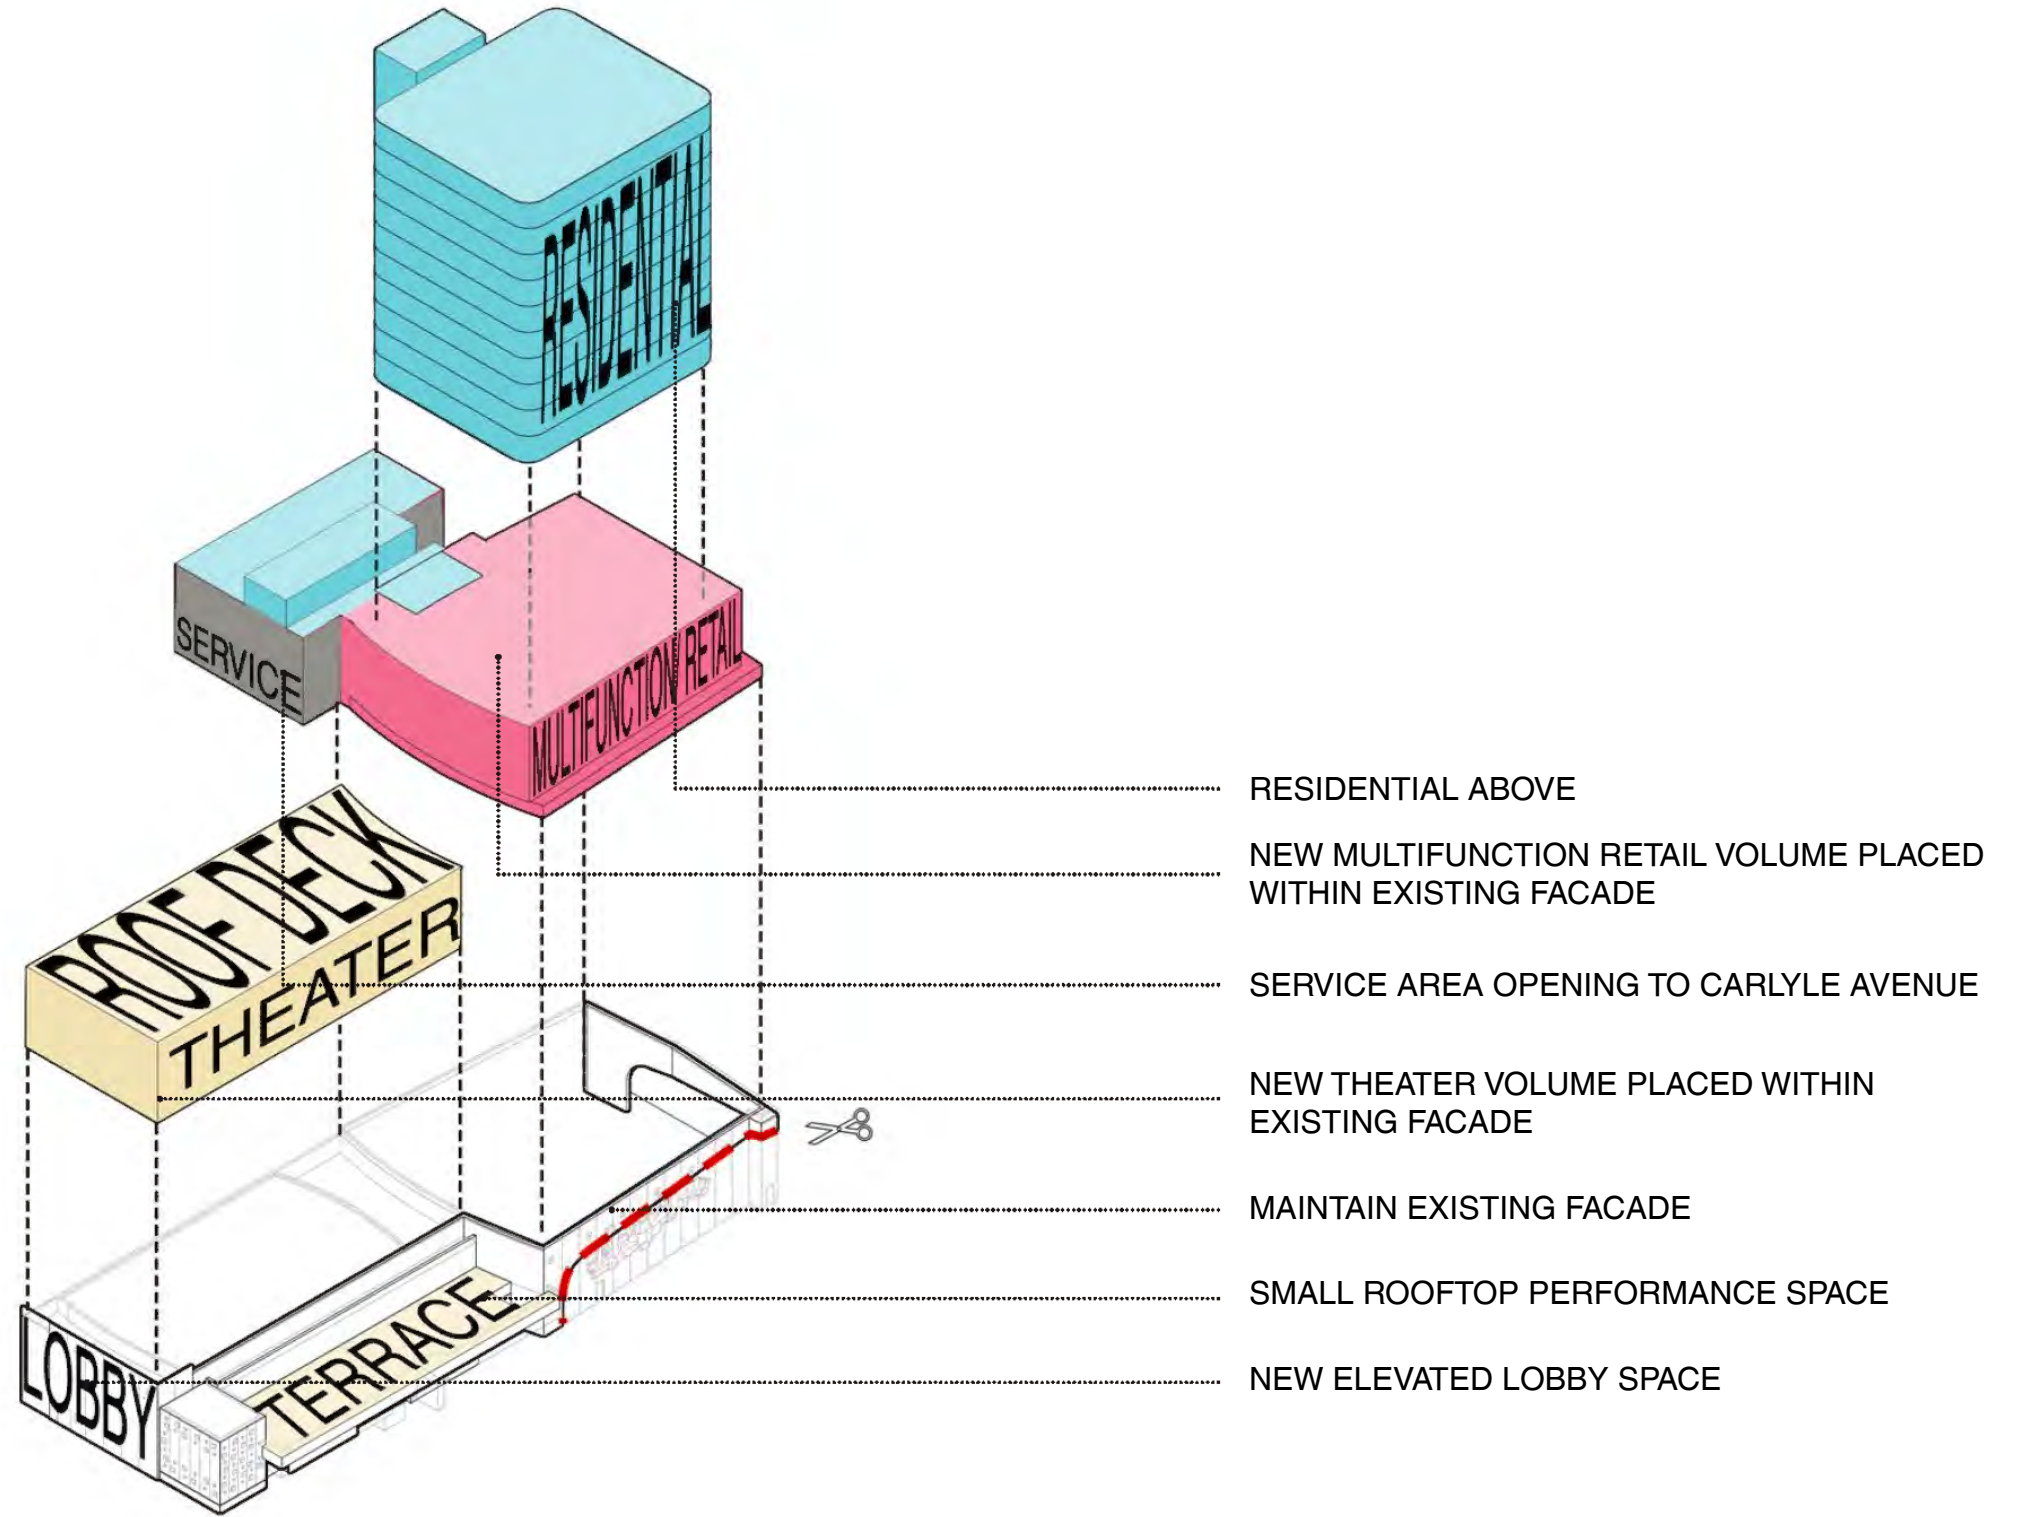
- RESIDENTIAL ABOVE
- NEW MULTIFUNCTION RETAIL VOLUME PLACED WITHIN EXISTING FACADE
- SERVICE AREA OPENING TO CARLYLE AVENUE
- NEW THEATER VOLUME PLACED WITHIN EXISTING FACADE
- MAINTAIN EXISTING FACADE
- SMALL ROOFTOP PERFORMANCE SPACE
- NEW ELEVATED LOBBY SPACE

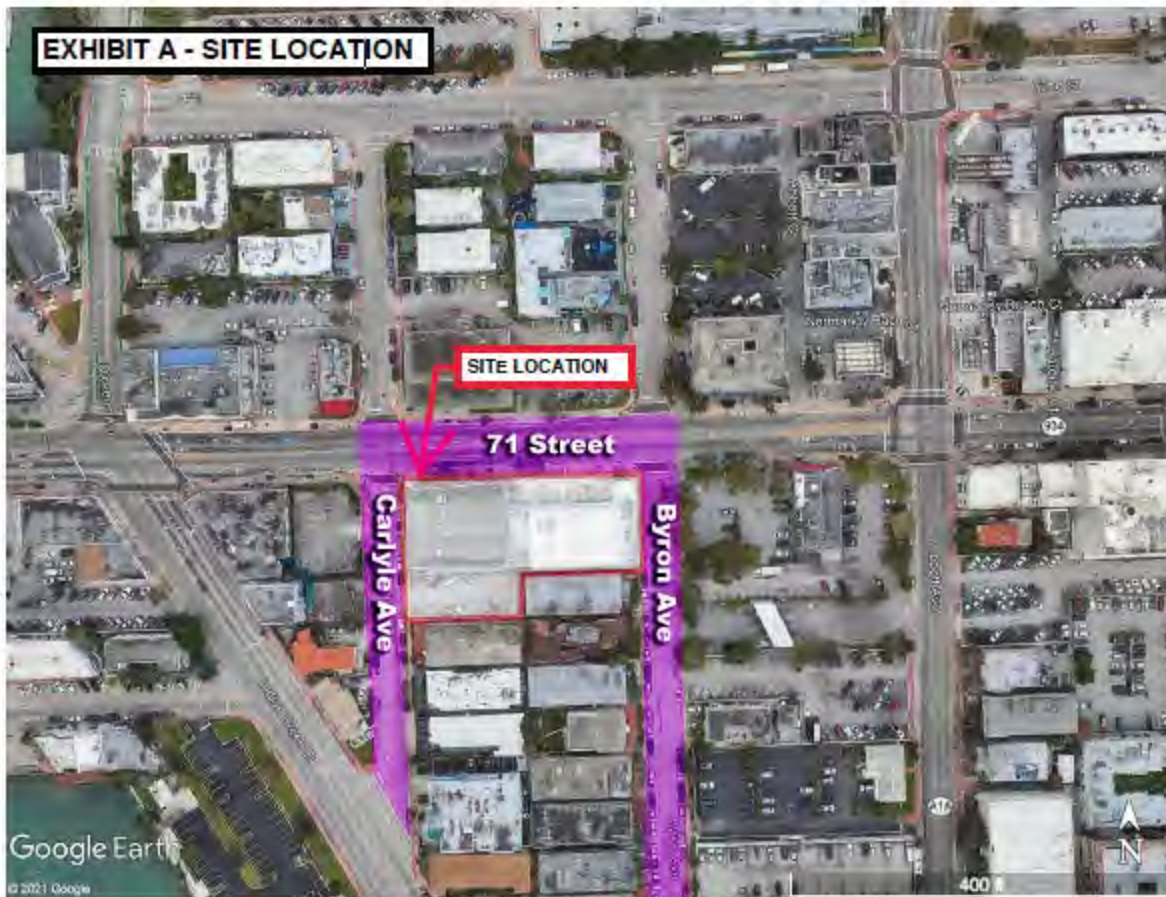
Byron Carlyle Theater (500 71st Street)**Folio: 02-3211-002-1070**
