December 19, 2016

Re: Tree Evaluation and Report for 5712 North Bay Road, Miami Beach, Florida

We visited the above-mentioned property on December 18, 2016 to review the existing trees and palms found on the property and produce a tree evaluation report. Please find below photographs of all of the trees and palms and their health condition at the time of our visit. Please note that our assessment was performed as a level 1, visual inspection from the ground and no aerial inspections were performed.

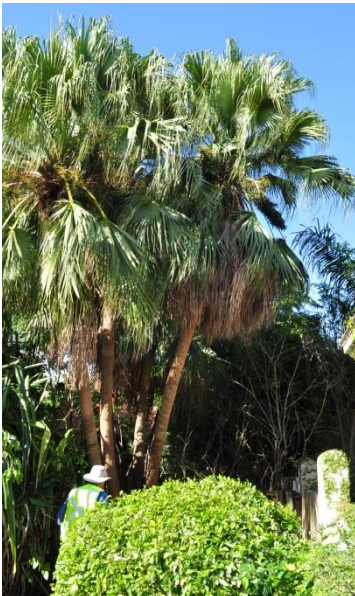
#### Tree #1

Chinese Fan Palm, *Livistona chinensis*, approximately 28 feet tall with a canopy width of 12 feet and a clear trunk of approximately 12 feet. The trunk diameters were 8 and 8 inches. The palm is in good condition with a health condition of 80%. The palm is a double.

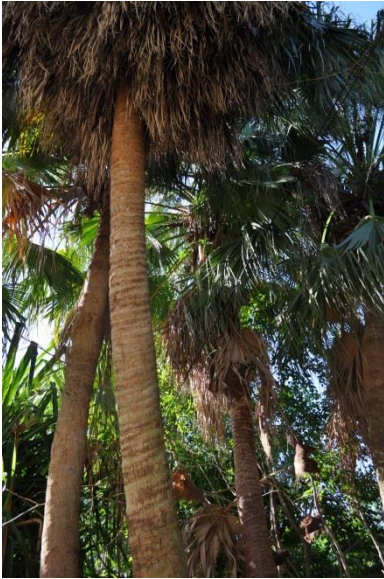
**Tree #2**

Chinese Fan Palm, *Livistona chinensis*, approximately 30 feet tall with a canopy width of 12 feet and a clear trunk of approximately 14 feet. The trunk diameters were 8 and 7 inches. The palm is in very good condition with a health condition of 85%. The palm is a double.

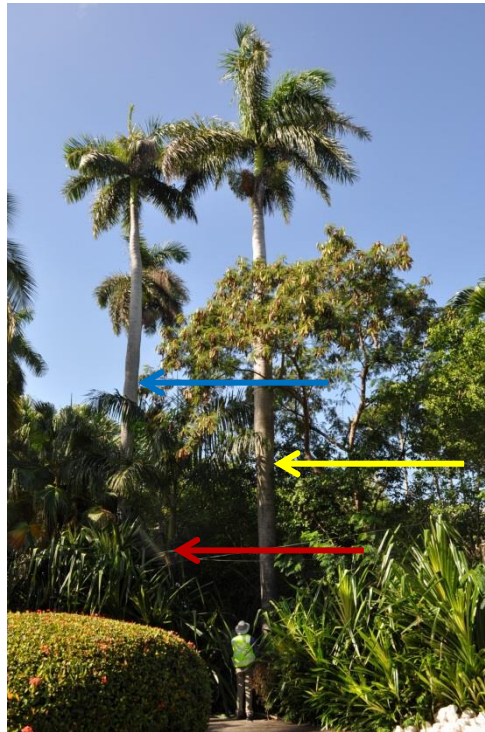
**Tree #3, #4 and #5**

**Tree #3** – Royal Palm, *Roystonea regia*, yellow arrow, approximately 50 feet tall with a canopy width of 15 feet and a clear trunk of approximately 40 feet. The trunk diameter was 18 inches. The tree is in good condition with a health condition of 75%. We observed that the palm has minor trunk wounds and penciling at the top of the trunk.

**Tree #4** - Royal Palm, *Roystonea regia*, red arrow, approximately 16 feet tall with a canopy width of 15 feet and a clear trunk of approximately eight feet. The trunk diameter was 10 inches. The tree is in good condition with a health condition of 75%.

**Tree #5** - Royal Palm, *Roystonea regia*, blue arrow, approximately 50 feet tall with a canopy width of 12 feet and a clear trunk of approximately 40 feet. The trunk diameter was 16 inches. The tree is in fair condition with a health condition of 70%. We observed that the palm has minor trunk wounds and penciling at the top of the trunk and nutritional deficiencies.

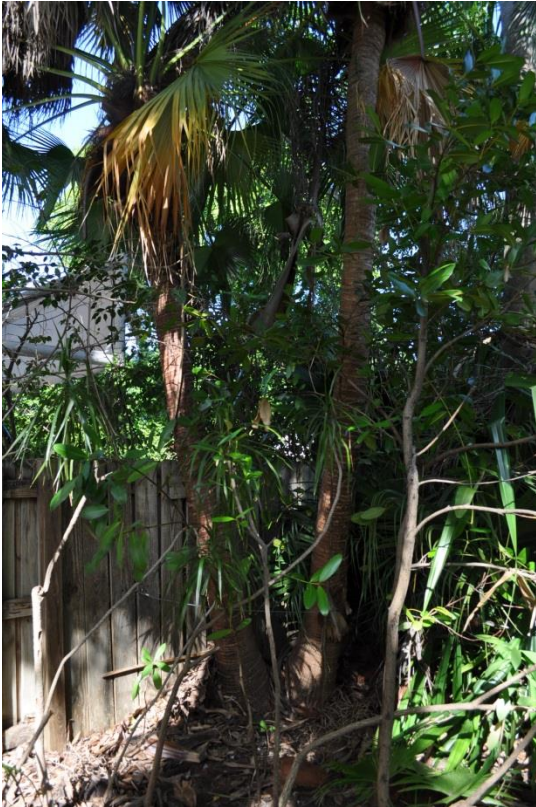
**Tree #6** - Chinese Fan Palm, *Livistona chinensis*, approximately 24 feet tall with a canopy width of 15 feet and a clear trunk of approximately 12 feet. The trunk diameters were 7 and 7 inches. The palm is in good condition with a health condition of 80%. The palm is a double.

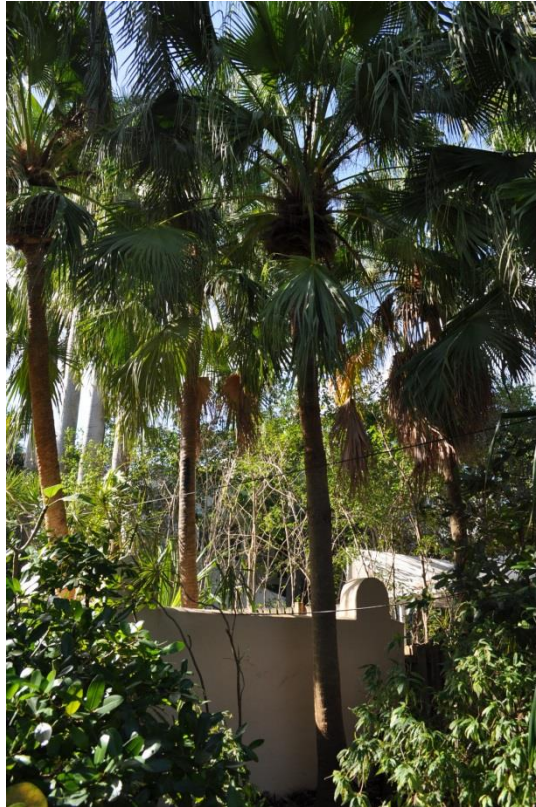
**Tree #7** - Chinese Fan Palm, *Livistona chinensis*, approximately 28 feet tall with a canopy width of 12 feet and a clear trunk of approximately 14 feet. The trunk diameter was 9 inches. The palm is in good condition with a health condition of 80%.

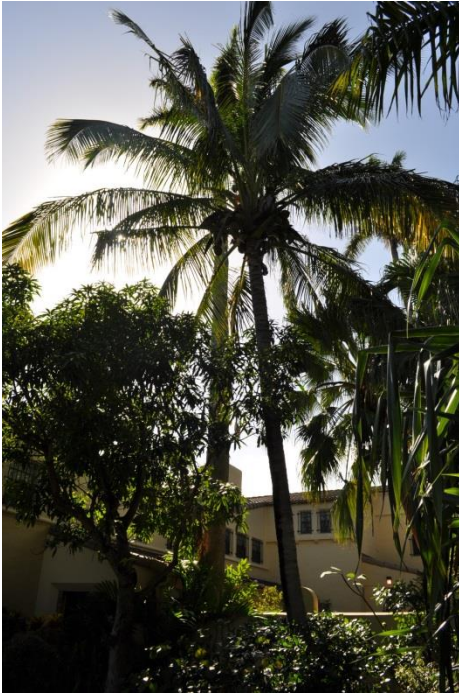
**Tree #8** Coconut Palm, *Cocos nucifera*, approximately 36 feet tall with a canopy width of 20 feet. The clear trunk is approximately 22 feet and the trunk diameter was 12 inches. The palm is in very good condition with a health condition of 85%. We observed minor nutritional deficiencies.

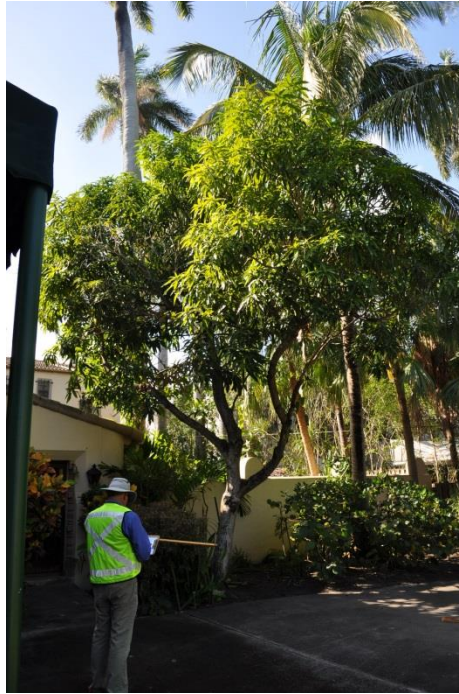
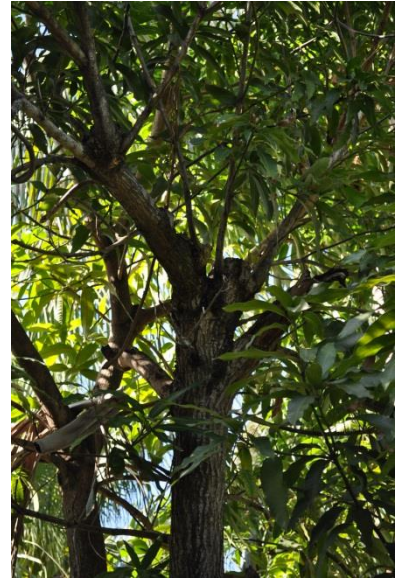
**Tree #9** Mango tree, *Mangifera indica*, approximately 20 feet tall with a canopy width of 25 feet. The trunk diameter was 12 inches. The tree is in fair condition with a health condition of 50%. The tree has codominant trunks and has been hatracked. We also observed dieback of leaves and twigs within the canopy.

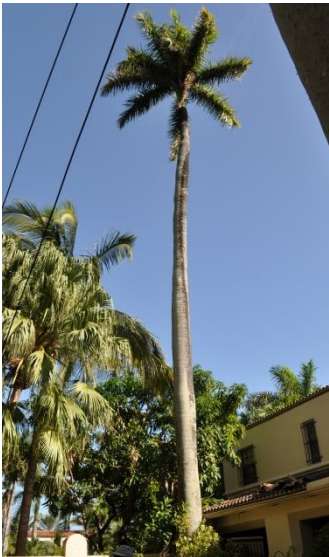
**Tree #10** Royal Palm, *Roystonea regia* approximately 60 feet tall with a canopy width of 18 feet and a clear trunk of approximately 50 feet. The trunk diameter was 26 inches. The tree is in fair condition with a health condition of 70%. We observed that the palm has minor trunk wounds and penciling at the top of the trunk and nutritional deficiencies.

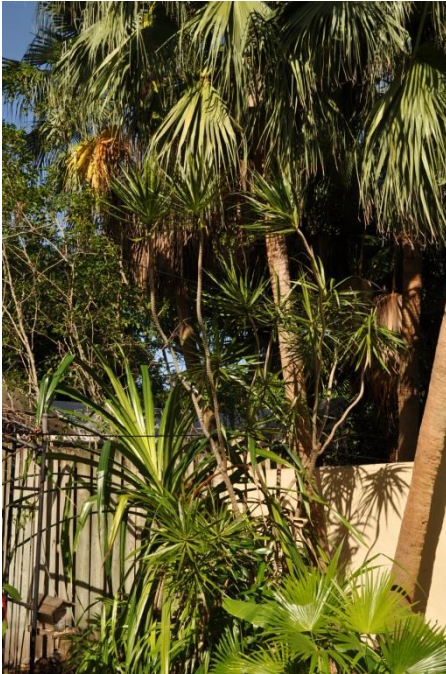
**Tree #11**

Chinese Fan Palm, *Livistona chinensis*, approximately 26 feet tall with a canopy width of 15 feet and a clear trunk of approximately 20 feet. The trunk diameters were 7 and 7 inches. The palm is in very good condition with a health condition of 85%. The palm is a double.

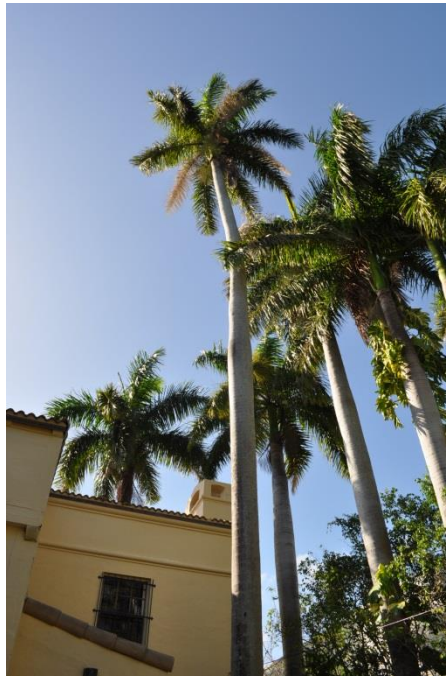
**Tree #12**

Royal Palm, *Roystonea regia* approximately 65 feet tall with a canopy width of 18 feet and a clear trunk of approximately 55 feet. The trunk diameter was 22 inches. The tree is in fair condition with a health condition of 70%. We observed that the palm has minor trunk wounds and penciling at the top of the trunk and nutritional deficiencies.

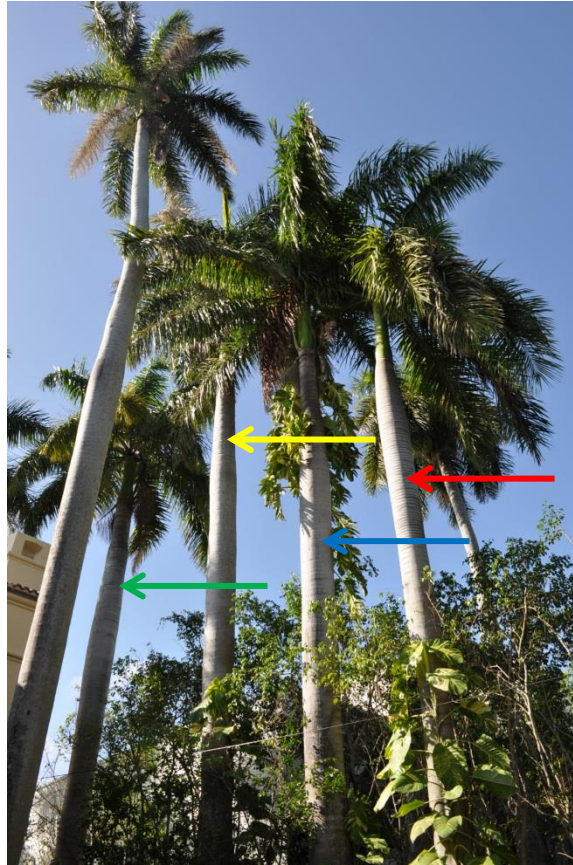
**Tree #13, #14, #15 and #16**

**Tree #13** – Royal Palm, *Roystonea regia*, red arrow, approximately 40 feet tall with a canopy width of 14 feet and a clear trunk of approximately 26 feet. The trunk diameter was 20 inches. The palm is in good condition with a health condition of 80%. We observed that the palm has minor nutritional deficiencies and is over crowded.

**Tree #14** - Royal Palm, *Roystonea regia*, blue arrow, approximately 45 feet tall with a canopy width of 14 feet and a clear trunk of approximately 27 feet. The trunk diameter was 26 inches. The palm is in good condition with a health condition of 80%. We observed that the tree is overcrowded.

**Tree #15** - Royal Palm, *Roystonea regia*, yellow arrow, approximately 50 feet tall with a canopy width of 16 feet and a clear trunk of approximately 30 feet. The trunk diameter was 24 inches. The palm is in good condition with a health condition of 80%. We observed that the tree is overcrowded.

**Tree #16** - Royal Palm, *Roystonea regia*, green arrow, approximately 45 feet tall with a canopy width of 20 feet and a clear trunk of approximately 25 feet. The trunk diameter was 26 inches. The palm is in good condition with a health condition of 75%. We observed minor nutritional deficiencies.

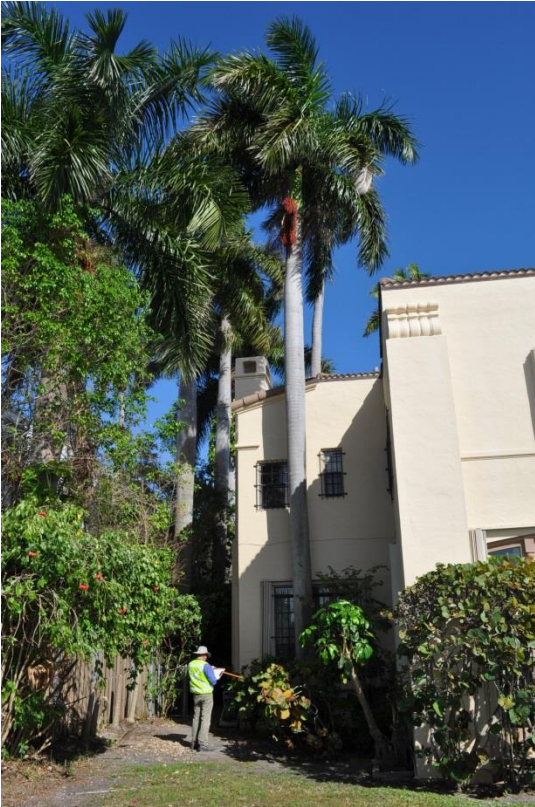
**Tree #17** - Royal Palm, *Roystonea regia*, approximately 45 feet tall with a canopy width of 20 feet and a clear trunk of approximately 25 feet. The trunk diameter was 22 inches. The palm is in very good condition with a health condition of 85%.

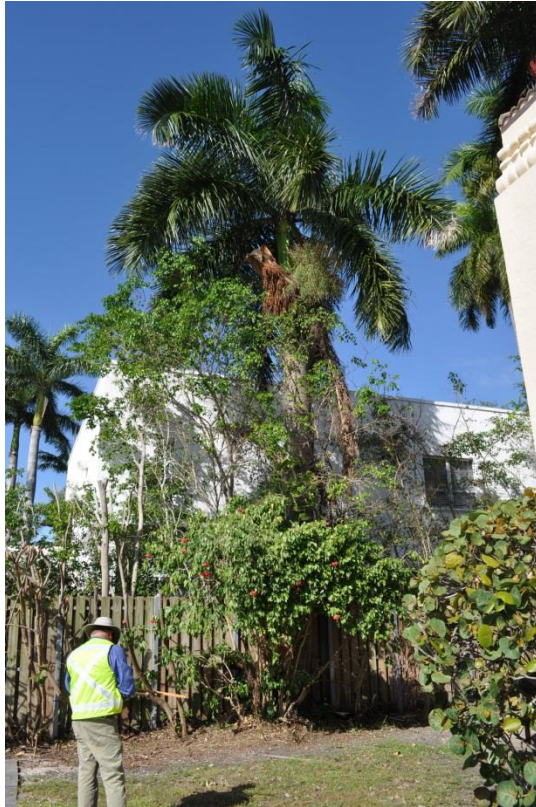
**Tree #18** - Royal Palm, *Roystonea regia*, approximately 32 feet tall with a canopy width of 20 feet and a clear trunk of approximately 20 feet. The trunk diameter was 20 inches. The palm is in good condition with a health condition of 80%. We observed a minor curve at the base of the palm.

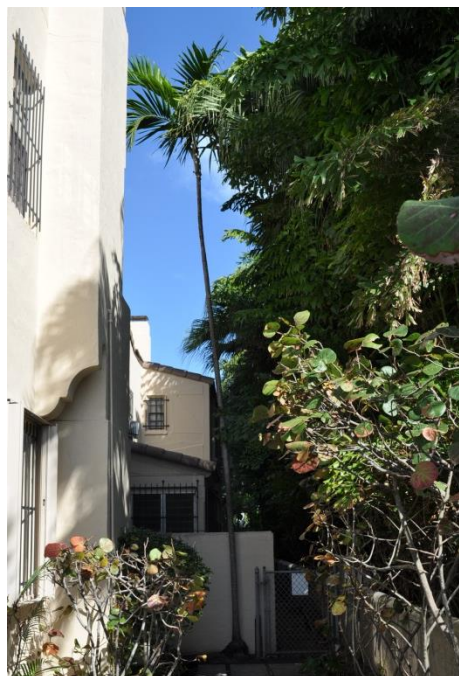
Tree #19

**Tree #19** - Alexander Palm, *Ptychosperma elegans*, approximately 24 feet tall with a canopy width of six feet and a clear trunk of approximately 18 feet. The trunk diameter was three inches. The palm is in fair condition with a health condition of 70%.

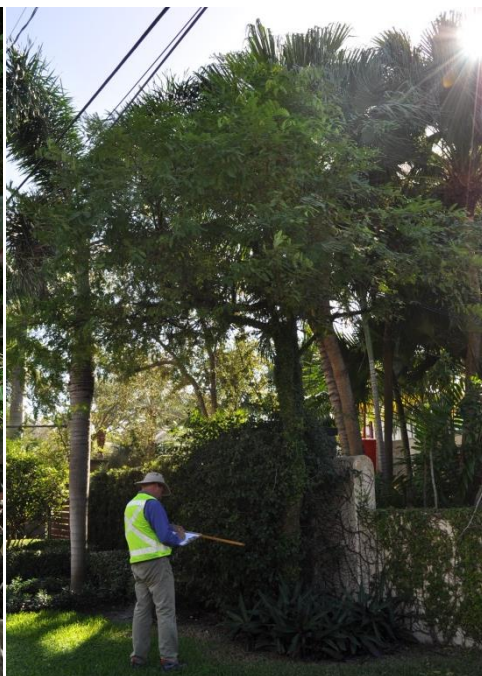
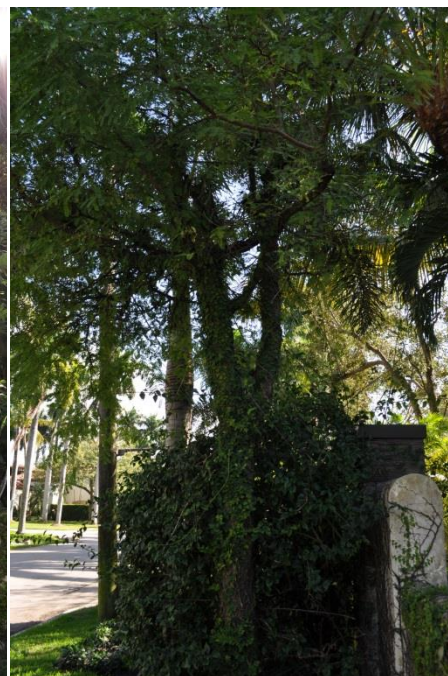
Tree #20

**Tree #20** – Wild Tamarind tree, *Lysiloma latisiliquum*, approximately 16 feet tall with a canopy width of 12 feet. The trunk diameter was eight inches. The tree is in fair condition with a health condition of 55%. We observed codominant trunks at seven feet above the ground and an unbalanced canopy. The tree has vines attached and is planted within close proximity to the overhead power lines.
