ALVEY TREE CONSULTING LLC

**Arborist Report**  
Park Avenue Hotel  
355 19th Street, Miami Beach

3/7/2019

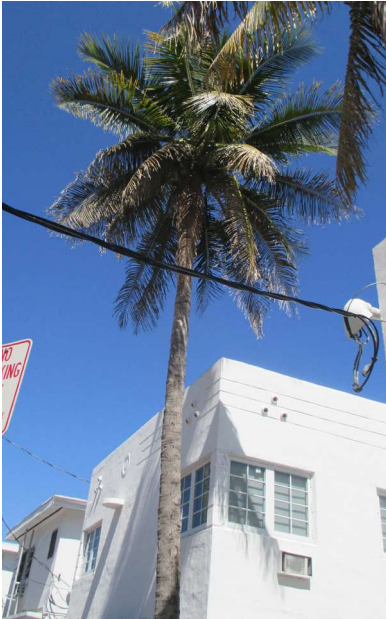
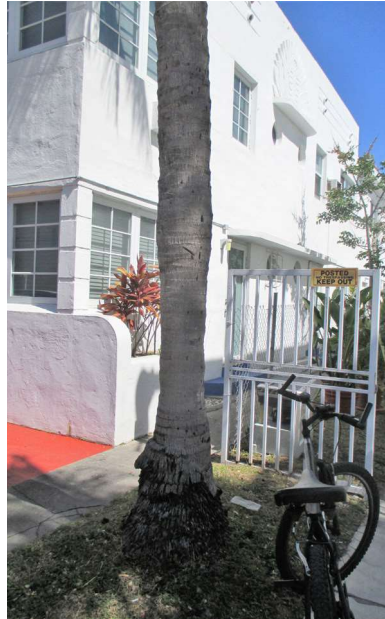
## Tree #1

Tree #1 is a Coconut Palm located on the Park Avenue side of the property. This tree is in fair condition - lower dead fronds and coconuts should be removed. There are multiple injuries along the trunk. Protective barriers shall be placed at the drip line of the tree, in this case, 7.5ft from the tree trunk to the edge of protective fencing. Barriers shall be installed prior to the start of any construction or demolition, and shall remain in place until development is completed and until the dept authorizes their removal. Barriers shall be a minimum of 4ft high, and shall be constructed of continuous chain link fence with metal posts at 8ft spacing, or of 2x4 posts with three equally spaced 2x4 rails. Posts may be shifted to avoid roots. No oil, paint, fill, equipment, building materials, building debris, or any other material shall be placed or disposed of within the TPZ. Natural grade shall be maintained, and no vehicles or equipment shall be permitted within the TPZ.

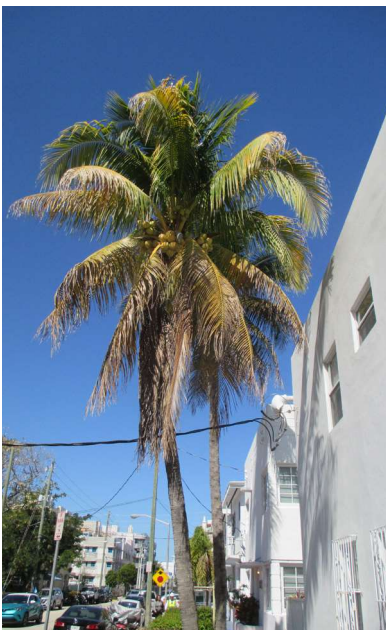
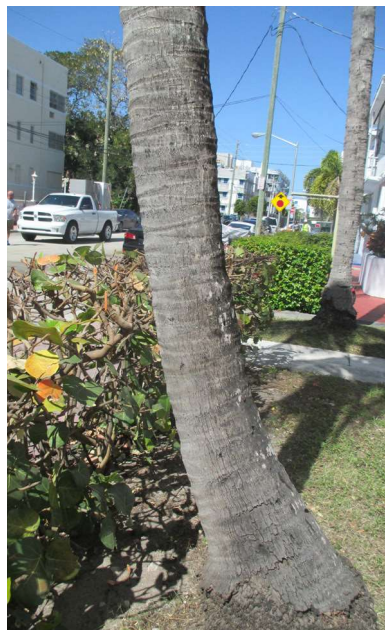
## Tree #2

Tree #2 is a Coconut Palm located on the Park Avenue side of the property. This tree is in fair condition - lower dead fronds and coconuts should be removed. Many of the fronds are yellow or brown and there are multiple injuries along the trunk. Protective barriers shall be placed at the drip line of the tree, in this case, 8ft from the tree trunk to the edge of protective fencing. Barriers shall be installed prior to the start of any construction or demolition, and shall remain in place until development is completed and until the dept authorizes their removal. Barriers shall be a minimum of 4ft high, and shall be constructed of continuous chain link fence with metal posts at 8ft spacing, or of 2x4 posts with three equally spaced 2x4 rails. Posts may be shifted to avoid roots. No oil, paint, fill, equipment, building materials, building debris, or any other material shall be placed or disposed of within the TPZ. Natural grade shall be maintained, and no vehicles or equipment shall be permitted within the TPZ.

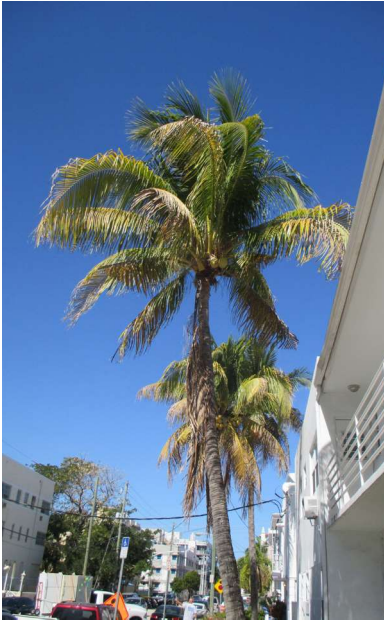
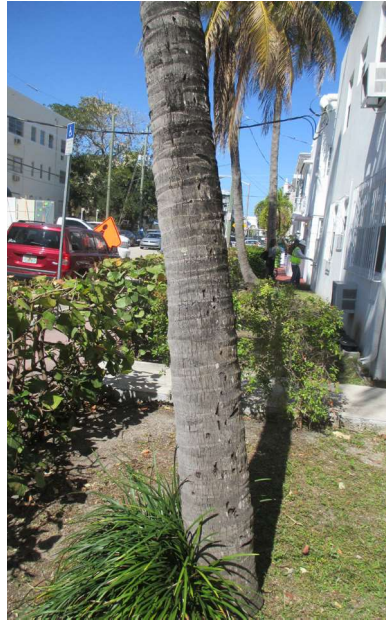
### Tree #3

Tree #3 is a Coconut Palm located on the Park Avenue side of the property. It is in fair condition with many yellow or brown fronds and multiple injuries along the trunk. The plans call for this tree to be relocated. If this is to occur, application of a palm fertilizer is recommended prior to relocation. Lower dead fronds and coconuts should be removed.

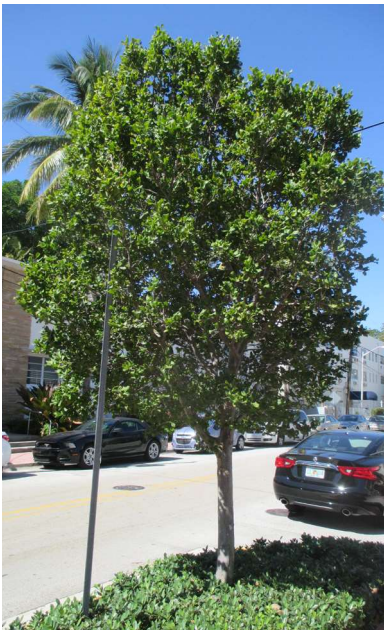
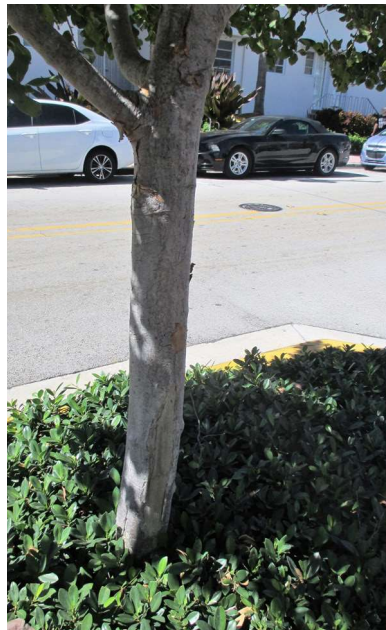
### Tree #4

Tree #4 is a Pigeon Plum street tree located along Park Avenue. It is in fair condition - there is some foliar spotting and the tree has good form. This tree has not been incorporated into the landscape plan and will therefore be removed.

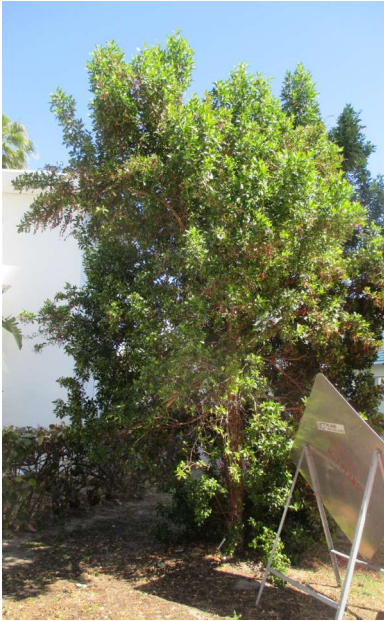
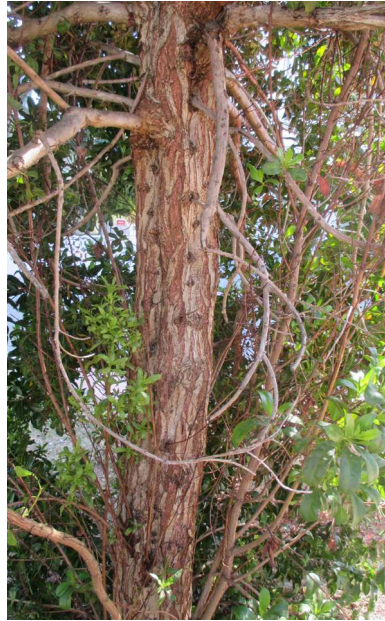
## Tree #5

Tree #5 is a Green Buttonwood located at the corner of Park Avenue and 19th Street. It is in good condition with a bushy form. A crown raising and removal of some of the basal sucker growth in addition to a crown cleaning and perhaps some structural pruning, can enhance the appearance of this native tree. This tree is to remain and protective barriers shall be placed at the drip line of the tree, in this case, 7.5ft from the tree trunk to the edge of protective fencing. Barriers shall be installed prior to the start of any construction or demolition, and shall remain in place until development is completed and until the dept authorizes their removal. Barriers shall be a minimum of 4ft high, and shall be constructed of continuous chain link fence with metal posts at 8ft spacing, or of 2x4 posts with three equally spaced 2x4 rails. Posts may be shifted to avoid roots. No oil, paint, fill, equipment, building materials, building debris, or any other material shall be placed or disposed of within the TPZ. Natural grade shall be maintained, and no vehicles or equipment shall be permitted within the TPZ.

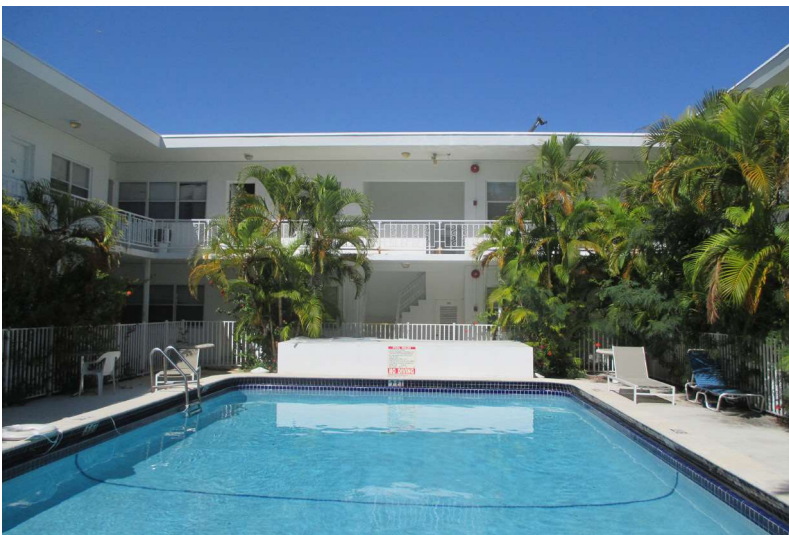
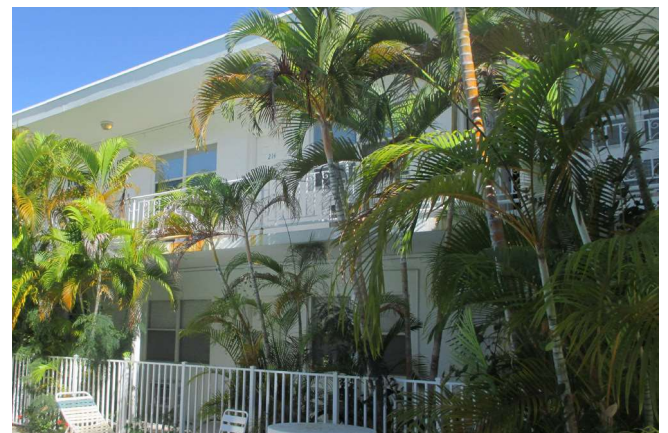
## Tree #6

Tree #6 is a hedge of Areca Palms surrounding the interior courtyard and in front of it. They are in poor condition with chlorotic and necrotic leaves. This tree has not been incorporated into the landscape plan and will therefore be removed.

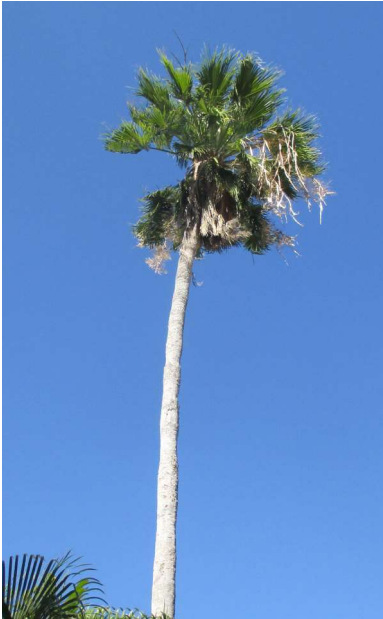
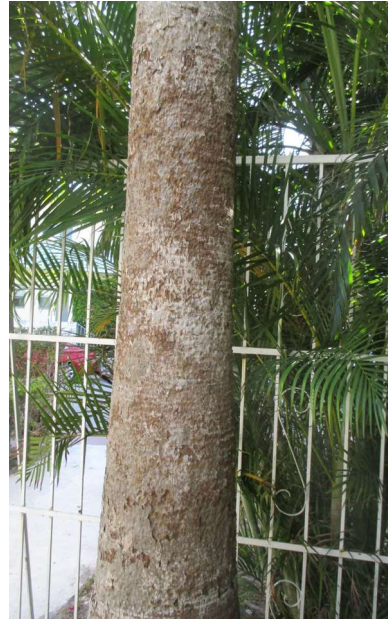
## Tree #7

Tree #7 is a Washingtonia Palm located at the front of the courtyard. It is in fair condition - it has a green canopy and some of the pseudo-bark is sloughing off. This tree has not been incorporated into the landscape plan and will therefore be removed.

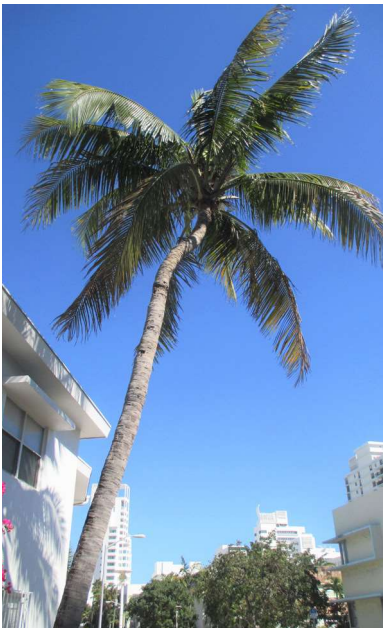
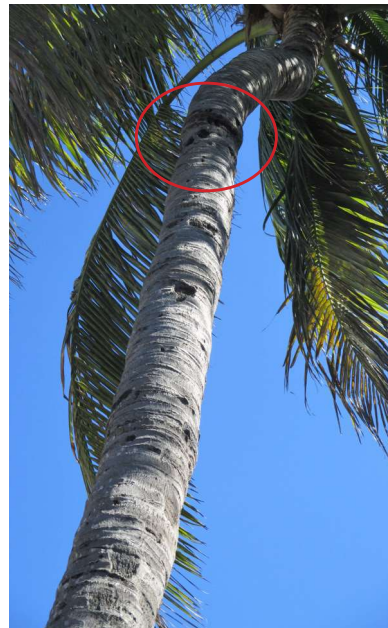
## Tree #8

Tree #8 is a Coconut Palm located at the front of the property along 19th Street. It is in poor condition with much yellow and brown on the fronds and multiple injuries along the trunk. One injury in particular is quite deep and occurs around the circumference of the tree (circled in red) near where the trunk kinks. The plans call for this tree to be relocated. If this is to occur, application of a palm fertilizer is recommended prior to relocation. Any lower dead fronds and coconuts should be removed.

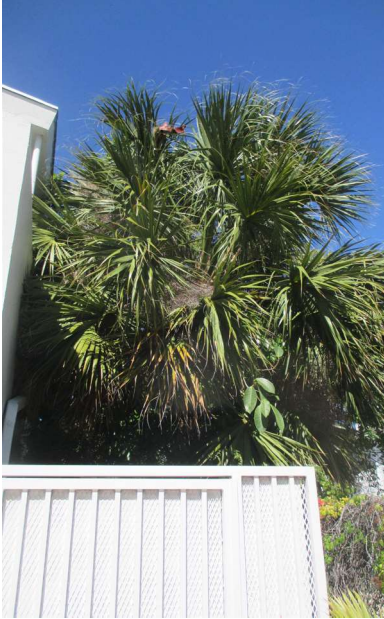
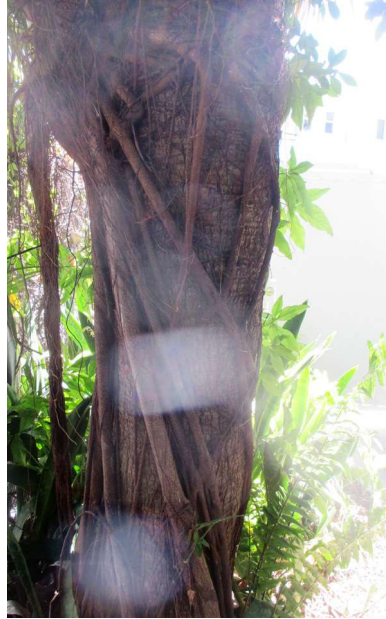
## Tree #9

Tree #9 is a Sabal Palm located behind the building on the east side of the property. It is in good condition with a full, dense canopy. Vines are growing on the trunk. If this tree is to remain, a 7ft TPZ will need to be established. If this tree is to be relocated elsewhere on the site, care should be taken and irrigation should be focused on, since this species can be fairly difficult to transplant.

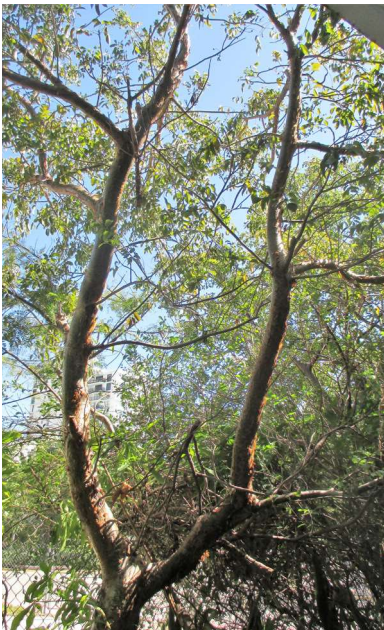
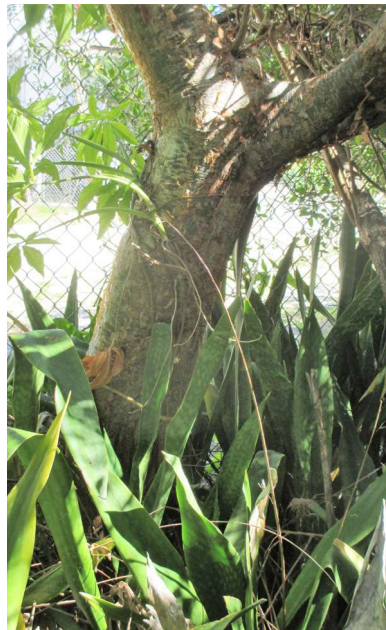
## Tree #10

Tree #10 is a Gumbo Limbo located behind the building on the east side of the property. The tree is in fair condition with poor form. This tree is in a location that does not provide adequate growing space, and it should therefore be removed.

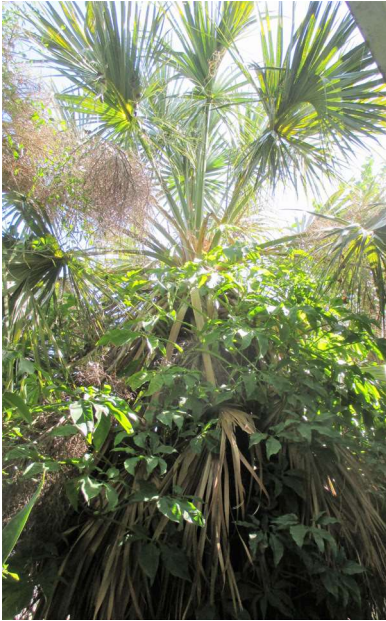
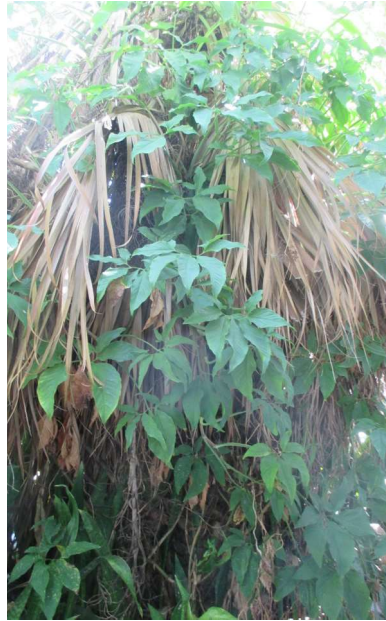
## Tree #11

Tree #11 is a Sabal Palm located behind the building on the east side of the property. It is in fair condition with a sparse canopy. Vines are growing on the brown fronds of the lower canopy. If this tree is to remain, a 6ft TPZ will need to be established. If this tree is to be relocated elsewhere on the site, care should be taken and irrigation should be focused on, since this species can be fairly difficult to transplant.

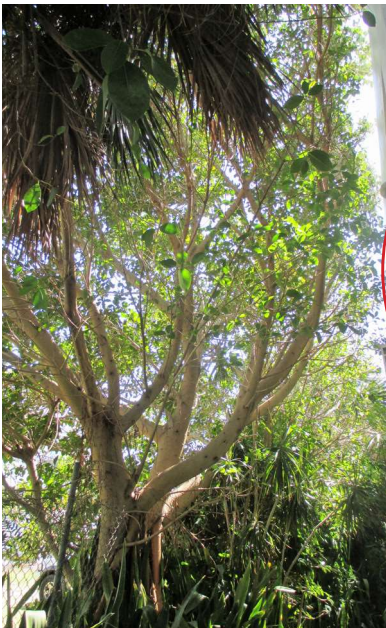
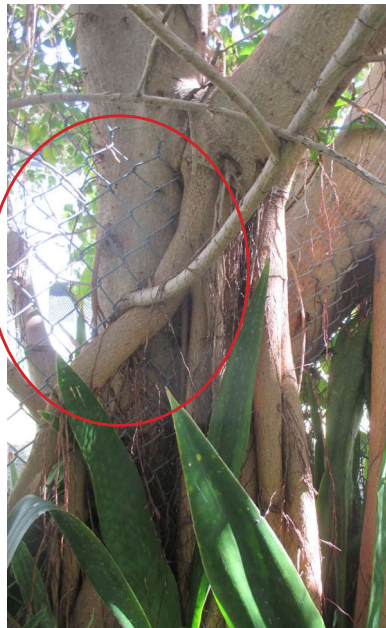
## Tree #12

Tree #12 is a Strangler Fig located behind the building on the east side of the property. The tree is healthy but is growing through the chainlink fence (circled in red). This tree is in a location that does not provide adequate growing space, and it should be removed.

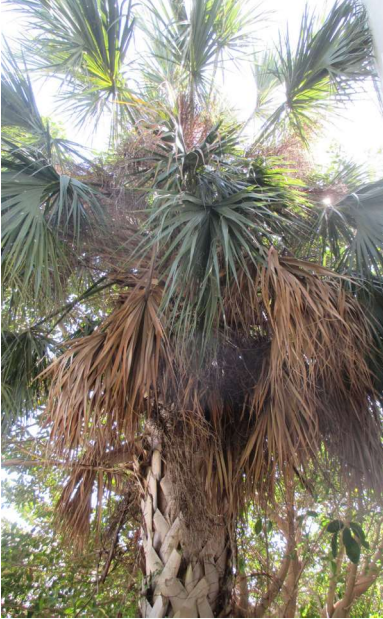
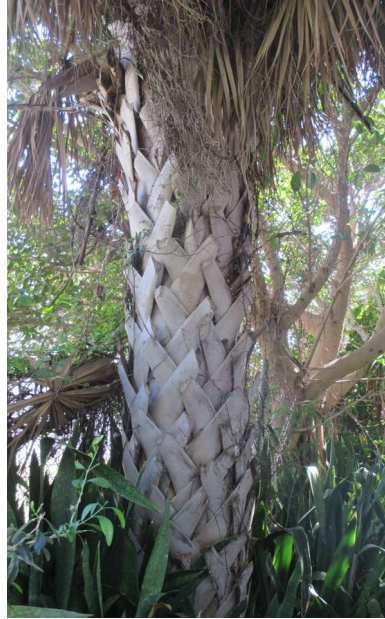
## Tree #13

Tree #13 is a Sabal Palm located behind the building on the east side of the property. It is in fair condition with many lower dead fronds. If this tree is to remain, a 6ft TPZ will need to be established. If this tree is to be relocated elsewhere on the site, care should be taken and irrigation should be focused on, since this species can be fairly difficult to transplant.

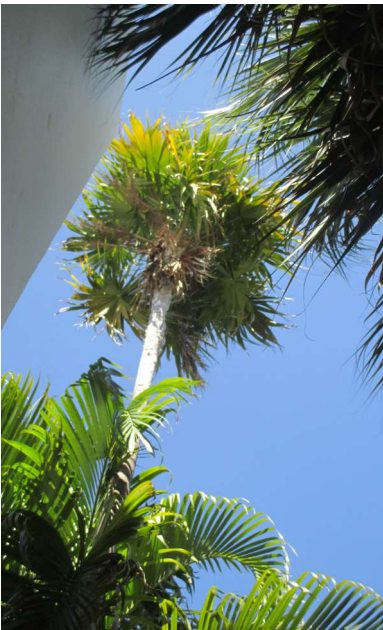
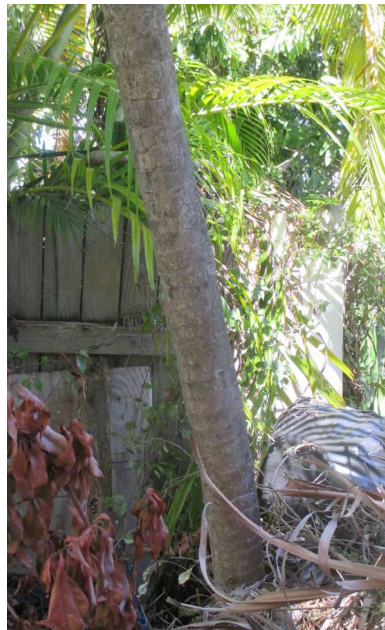
## Tree #14

Tree #14 is a Florida Thatch Palm located in the northeast corner of the property. This tree is in poor condition - the foliage is highly chlorotic and the ends of some of the leaflets are necrotic. This tree will need to be removed.

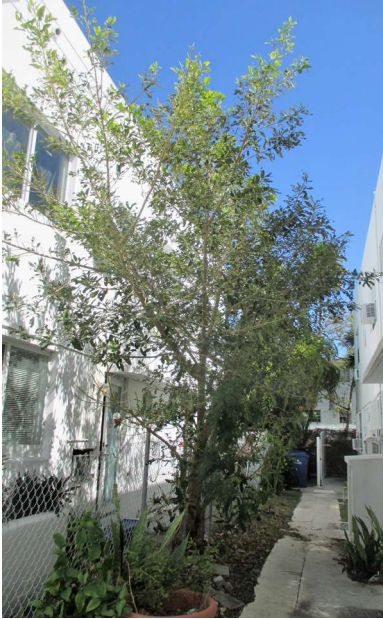
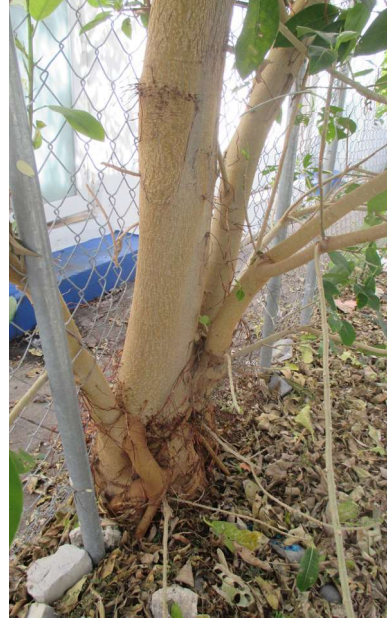
## Tree #15

Tree #15 is a small Strangler Fig located at the rear of the building on the north side of the property. This tree has poor form and is growing through the chainlink fence. This is a poor location for such a large maturing tree. This tree will need to be removed.

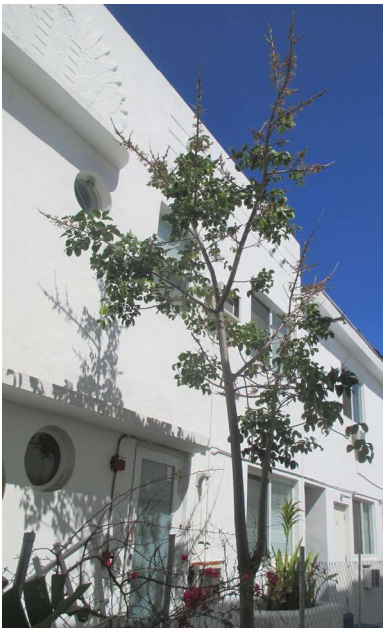
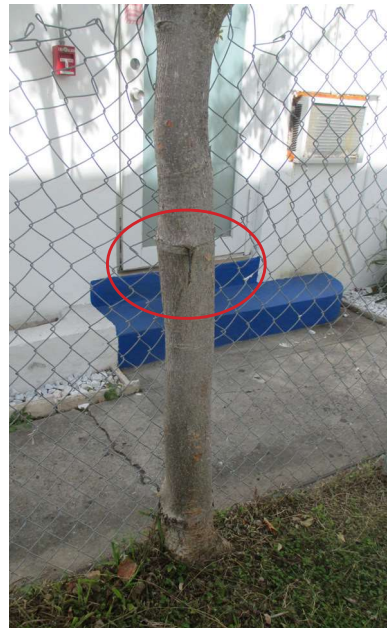
## Tree #16

Tree #16 is a Gumbo Limbo located at the rear of the building on the north side of the property. This tree is in poor condition as it is growing through the chainlink fence and has a plastic tie embedded in it (circled in red). This tree will need to be removed.

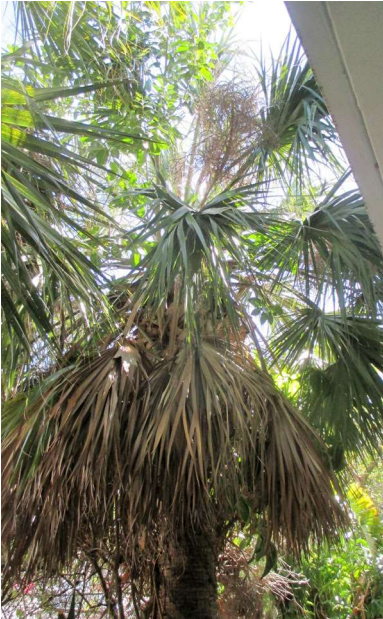
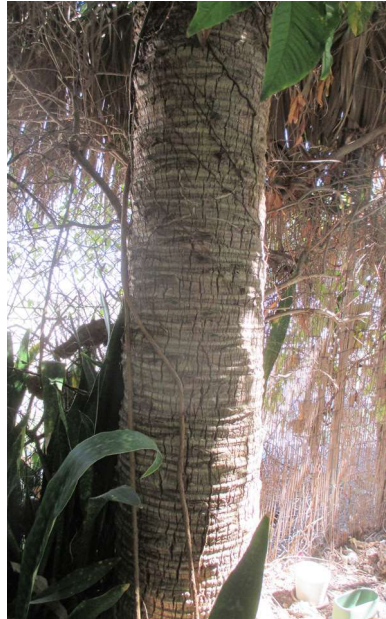
## Tree #17

Tree #17 is a Sabal Palm located behind the building on the east side of the property. It is in fair condition with many lower dead fronds and a sparse canopy. If this tree is to remain, a 6ft TPZ will need to be established. If this tree is to be relocated elsewhere on the site, care should be taken and irrigation should be focused on, since this species can be fairly difficult to transplant.
