*EVALUATION REPORT*

*For Project located at: 7801 ATLANTIC WAY. MIAMI BEACH, FLORIDA. 33141*

The inspection of the building in reference (See Exhibit 1 for graphical representation), located at 7801 Atlantic Way, Miami Beach Fl 33141, took place on Wednesday February 22nd, 2023 and was performed by Mr. Alioskar Ganem P.E. The main objective of the inspection was to identify general areas and critical details of the building components that may compromise the integrity of the Structure and represent a hazard to the users of this property and to ensure that all its components were built following the minimum standards of the Florida Building Code current at the time of construction, including a proper evaluation for the city of Miami Beach Building Department for the construction plans and construction inspections .

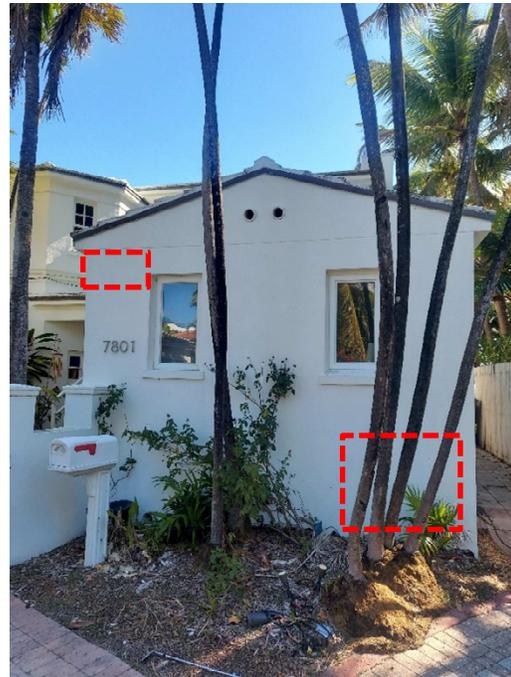
West facade

**Stucco repair areas at facades**

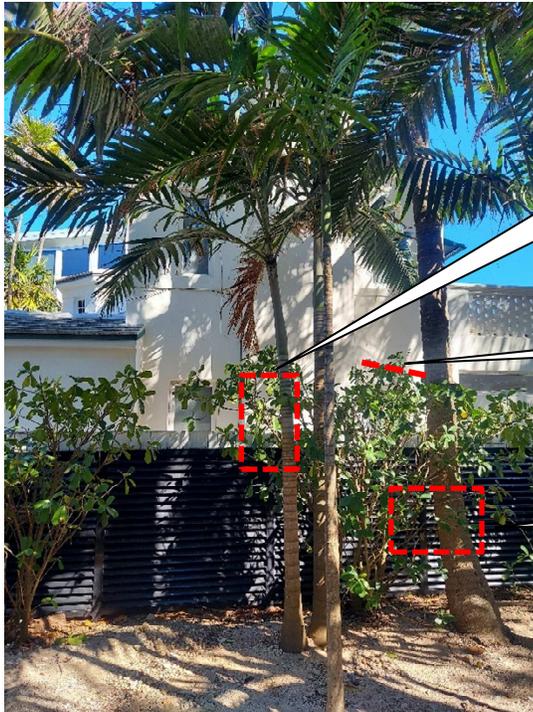
South façade

Stucco in poor condition

Hairline crack.

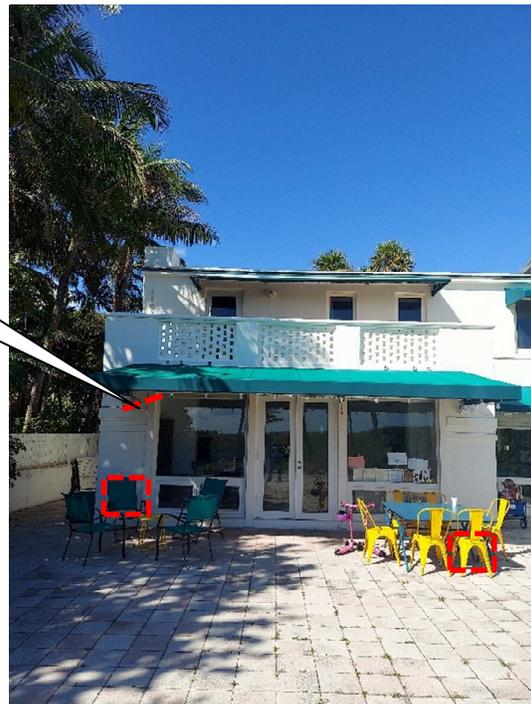
East façade

Stucco in poor condition

Hairline crack.

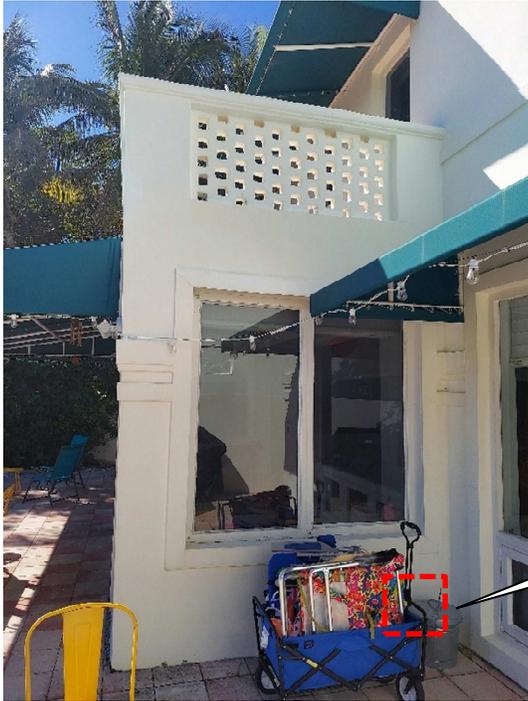
East side

Stucco in poor condition

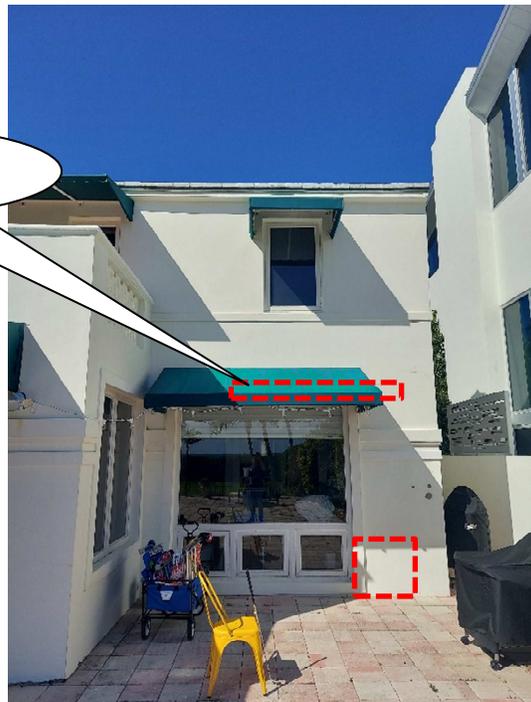
East side

Additionally, as a result of the visual inspection, cracks were observed in bearing elements of reinforced concrete. This is produced as a consequence of the increase in volume of the reinforcing steel produced by an oxidation state. Sulfates attack concrete, forming expansive compounds that cause cracking. Chlorides, if they reach the rebars, cause its corrosion. The cracking caused by sulfates facilitates the penetration of chlorides and the corrosion of the reinforcement. Once the concrete cracks, the integrity and design capacity of the structural element are not guaranteed.

Cracked beam.

It is possible to selectively restore, repair or reconstruct some structural elements in the case of localized failure. However, Failure to meet the required concrete resistance cannot be solved; That is why, based on the results obtained from the tests carried out, a total demolition of the structure is recommended. Future and more exhaustive tests can be carried out to determine additional concealed damages in the different structural elements.

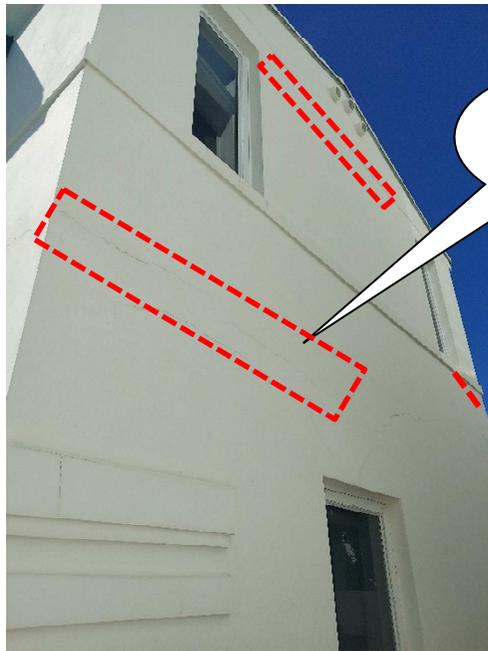
Cracked area.

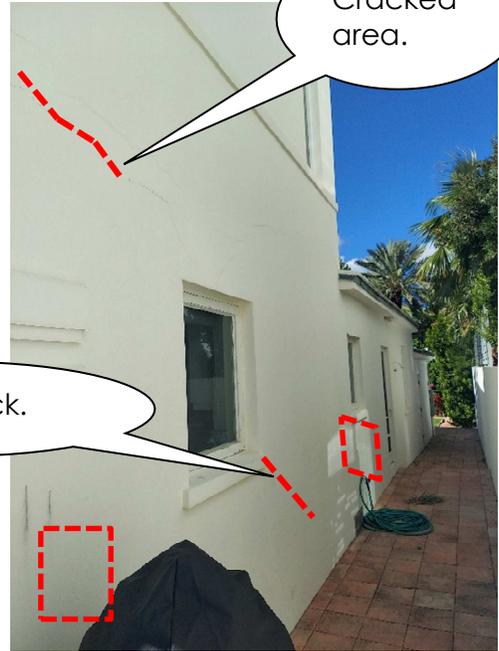
Cracked area.

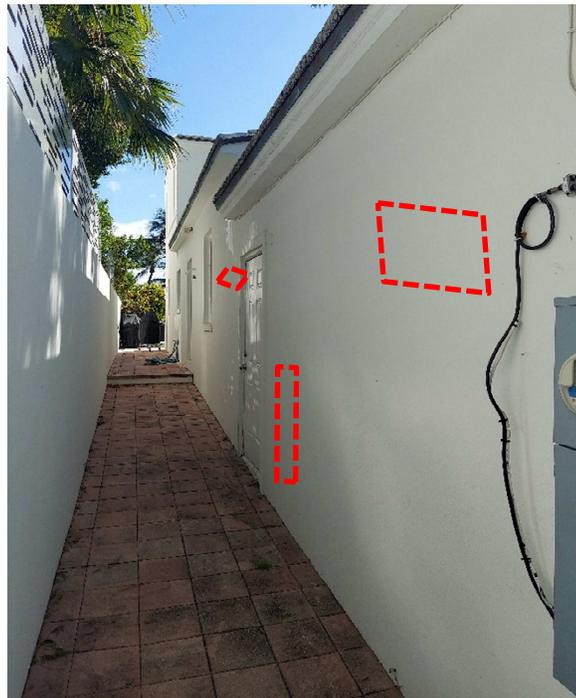
Hairline crack.

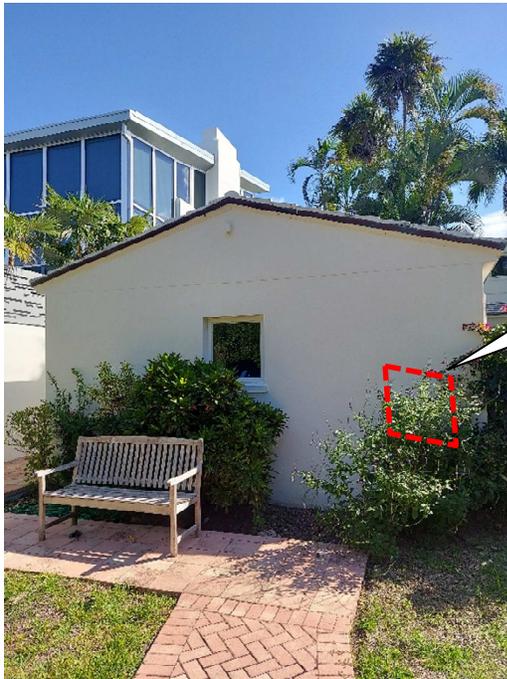
West side

Stucco in  
poor  
condition

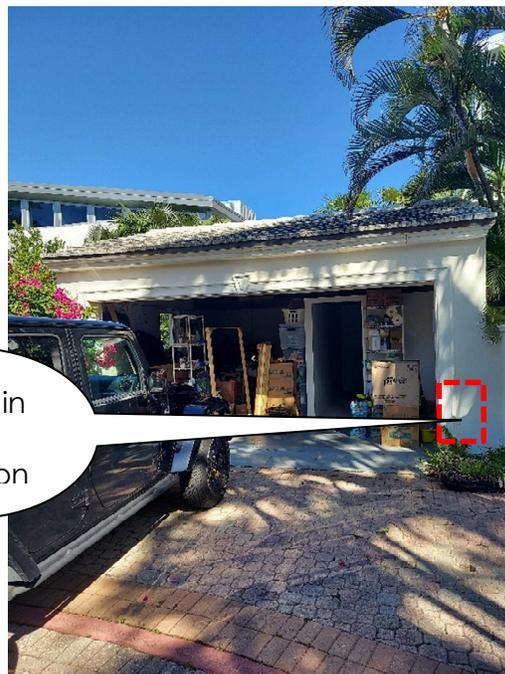
Stucco in  
poor  
condition

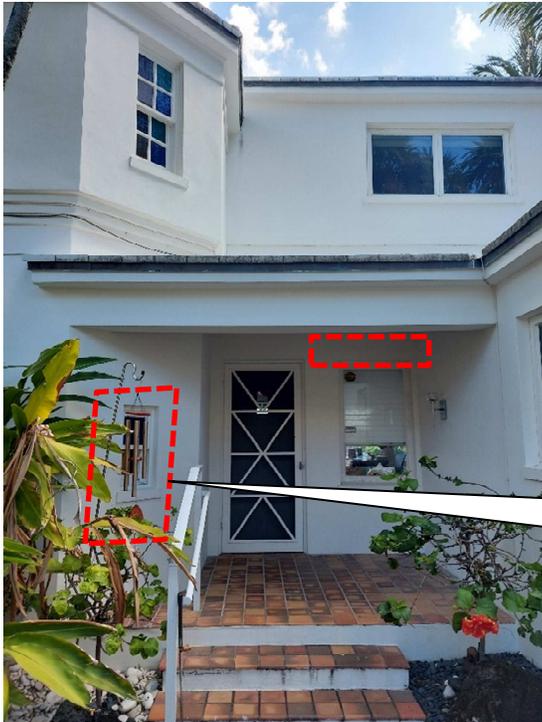
Main entrance

Stucco in poor condition

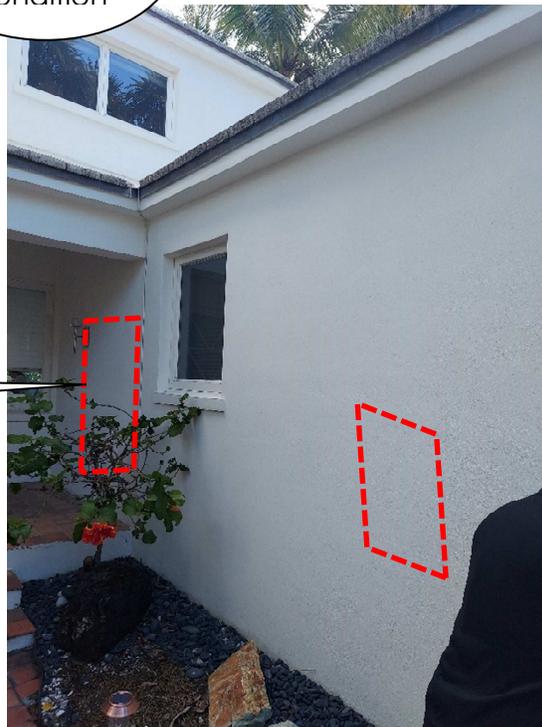
Stucco in poor condition

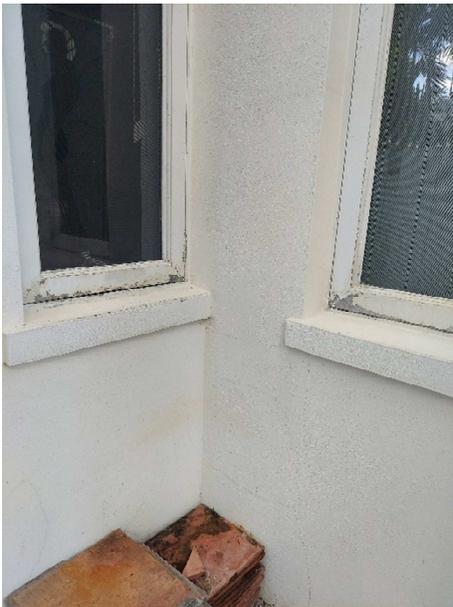
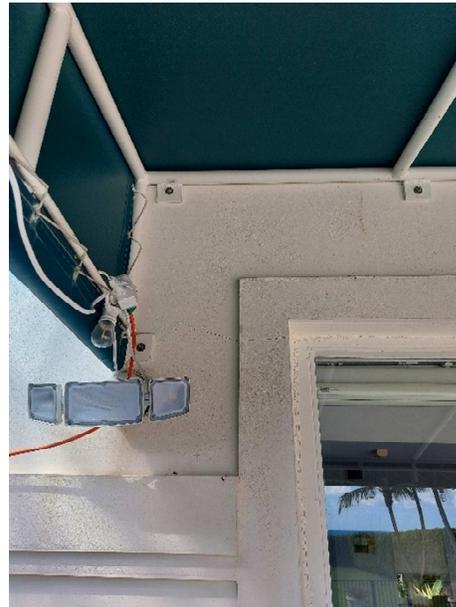
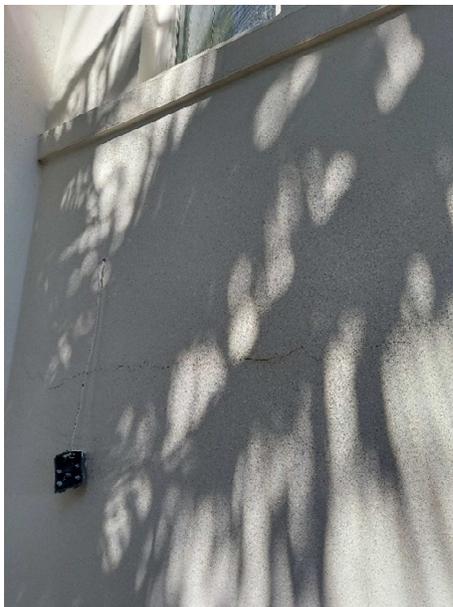
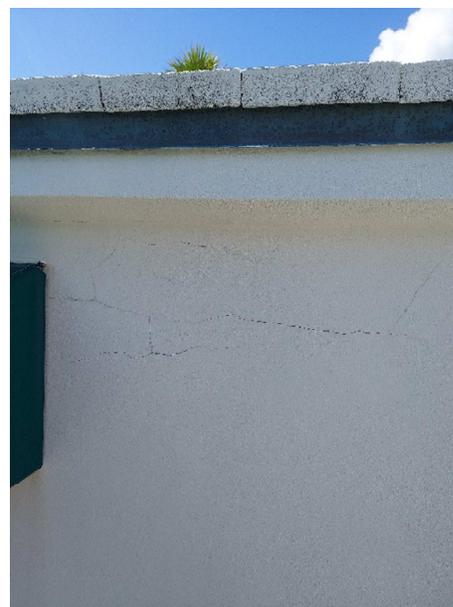
# Façade stucco condition

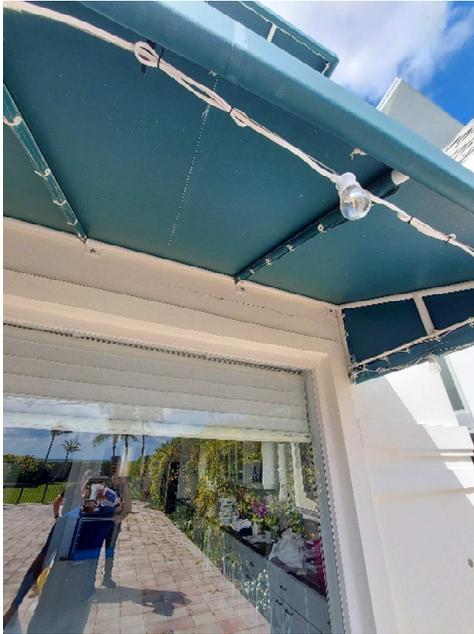
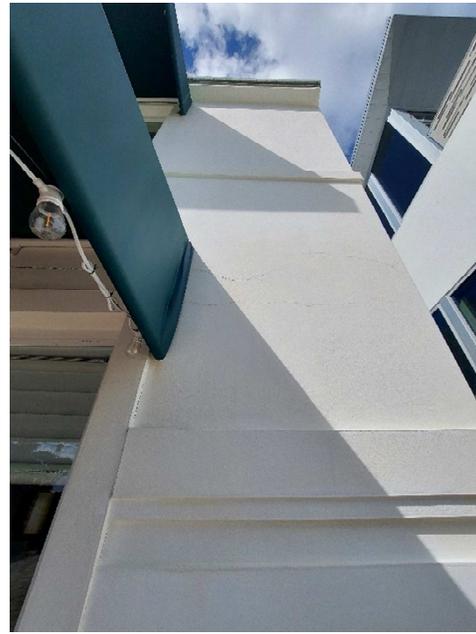
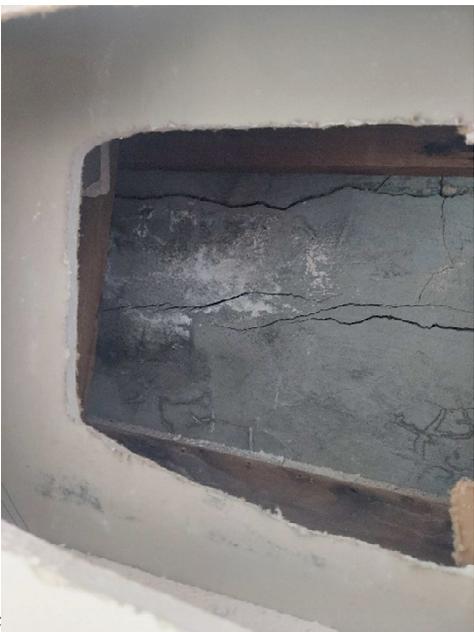
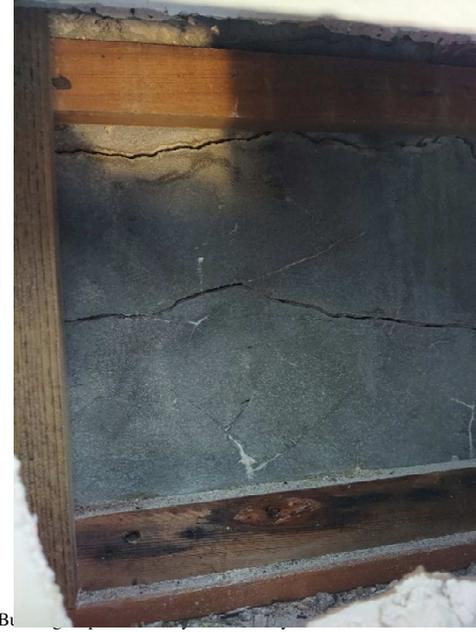
# Cracked beam, east side.
