Patrick Hannah ISA CA FL-6275 A PHCA LLC. 3052825051

829 4th ST. Arborist Report

Re: 829 4th ST. Miami Beach FL, 33139

I visited the above-mentioned property on January 31, 2023, to preform a level 1 assessment on +/- 14 trees on onsite, verify condition and measurements, take photographs, calculate critical root zone (CRZ) and tree protection zones, formulate tree protection guidelines.

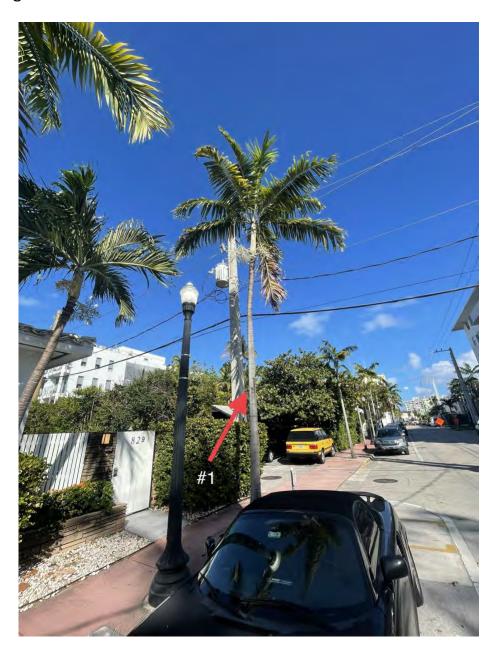
1. Veitchia montgomeryana (Montgomery palm tree) DBH 7", Spread 10', Height 22', this trees condition is good. This tree is on the south east corner of property, on ROW. Minimum 4' TPZ shall be installed to protect 4' CRZ of this tree and done under ANSI A-300 guidelines should this tree need protection during construction. This tree is scheduled to remove.

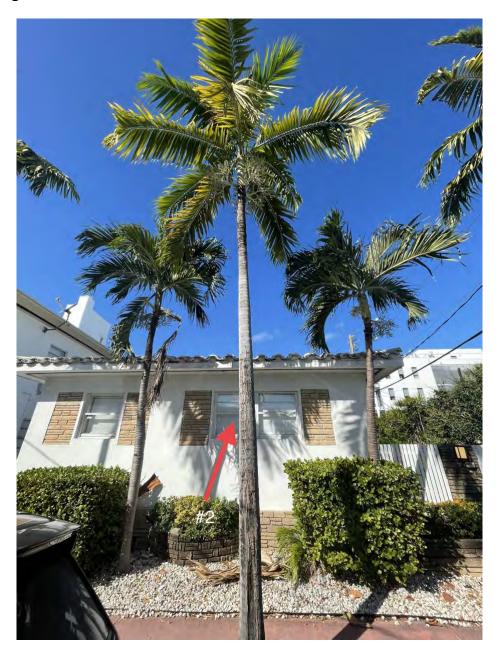
2. Veitchia montgomeryana (Montgomery palm tree) DBH 6", Spread 10', Height 21', this trees condition is moderate. This tree is on the south side of property, on ROW. Minimum 4' TPZ shall be installed to protect 4' CRZ of this tree and done under ANSI A-300 guidelines should this tree need protection during construction. This tree is scheduled to remain.

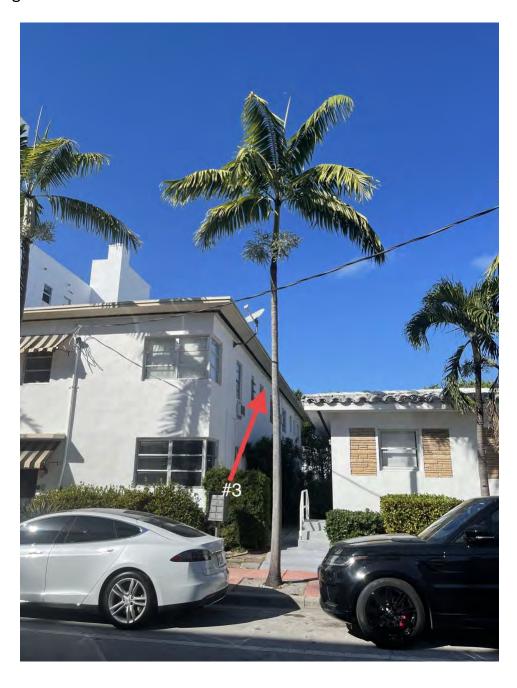
3. Veitchia montgomeryana (Montgomery palm tree) DBH 6", Spread 10', Height 23', this trees condition is fair. This tree is on the south west corner of property, on ROW. Minimum 4' TPZ shall be installed to protect 4' CRZ of this tree and done under ANSI A-300 guidelines should this tree need protection during construction. This tree is scheduled to remain.

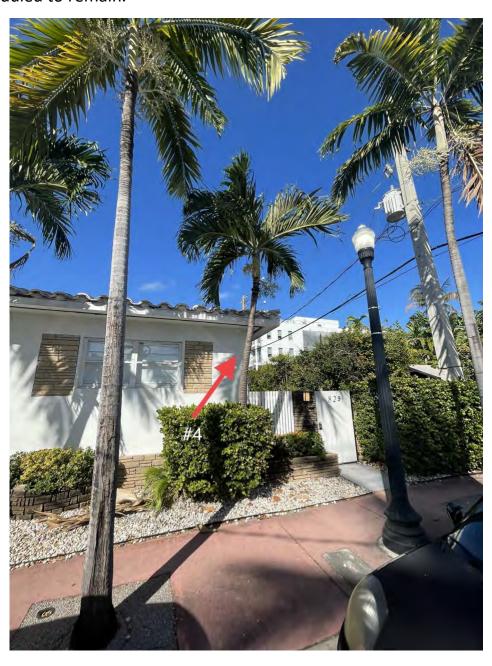
4.Adonidia merrillii (Christmas palm tree) DBH 4", Spread 8', Height 15', this trees condition is fair. This tree is on the south east corner of property. Minimum 4' TPZ shall be installed to protect 4' CRZ of this tree and done under ANSI A-300 guidelines should this tree need protection during construction. This tree is scheduled to remain.

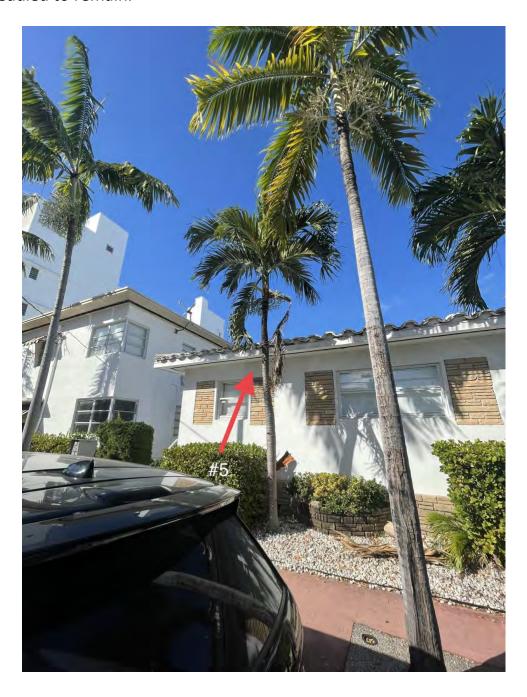
5.Adonidia merrillii (Christmas palm tree) DBH 4", Spread 8', Height 15', this trees condition is fair. This tree is on the south side of property. Minimum 4' TPZ shall be installed to protect 4' CRZ of this tree and done under ANSI A-300 guidelines should this tree need protection during construction. This tree is scheduled to remain.

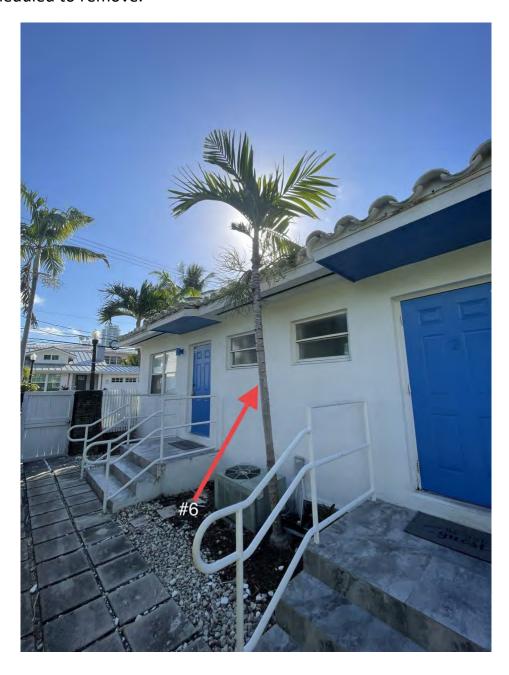
6.Ptychosperma elegans (Solitaire palm tree) DBH 3", Spread 6', Height 14', this trees condition is fair. This tree is on the east side of property. Minimum 4' TPZ shall be installed to protect 4' CRZ of this tree and done under ANSI A-300 guidelines should this tree need protection during construction. This tree is scheduled to remove.

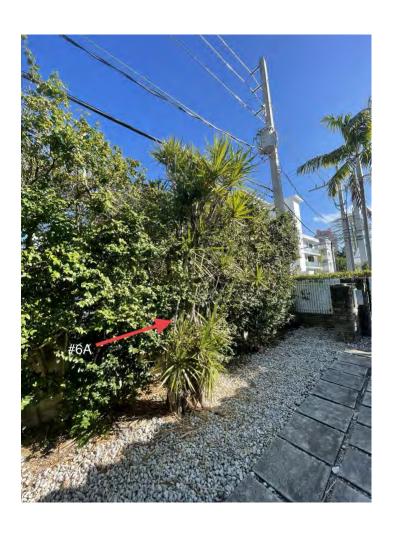
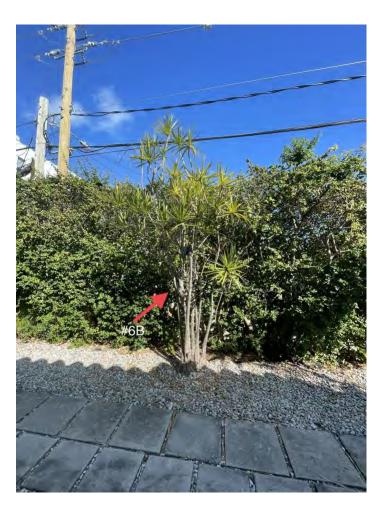
6A,B. Dracaena marginata (Dragon tree) DBH 6"ea., Spread 6'-7'ea., Height 10'-12'ea., these trees conditions are moderate. These trees are on the east side of property. Minimum 4' TPZ ea. shall be installed to protect 4' CRZ's of these trees and done under ANSI A-300 guidelines should these trees need protection during construction. These trees are scheduled to remove.

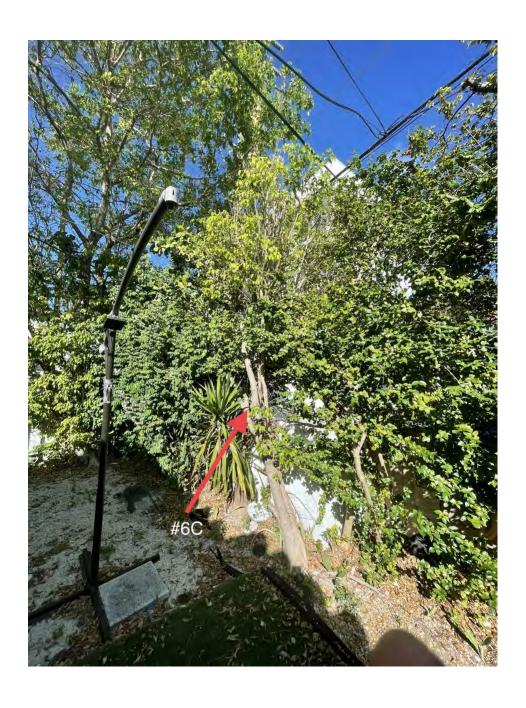
6C. Ficus benjamina (Wheeping Fig tree) DBH 4", Spread 7', Height 13', this trees condition is poor. This tree is on the east side of property. Minimum 6' TPZ shall be installed to protect 6' CRZ of this tree and done under ANSI A-300 guidelines should this tree need protection during construction. This tree is scheduled to remove.

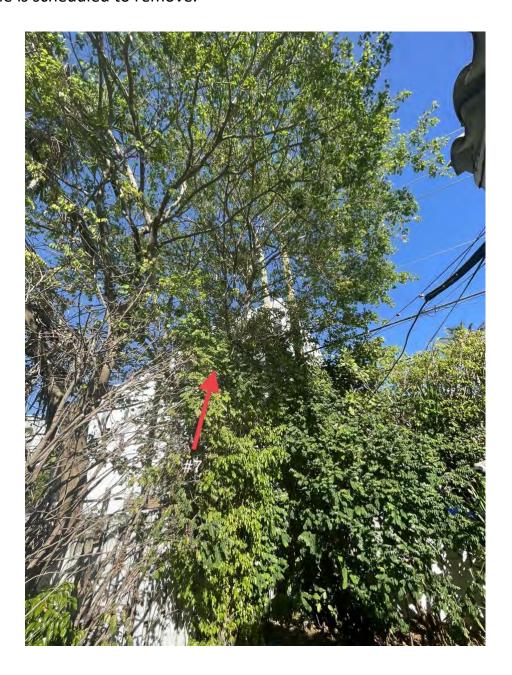
7. Ficus benjamina (Wheeping Fig tree) DBH 9", Spread 20', Height 20', this trees condition is poor. This tree is on the north east corner of property.

Minimum 9' TPZ shall be installed to protect 9' CRZ of this tree and done under ANSI A-300 guidelines should this tree need protection during construction. This tree is scheduled to remove.

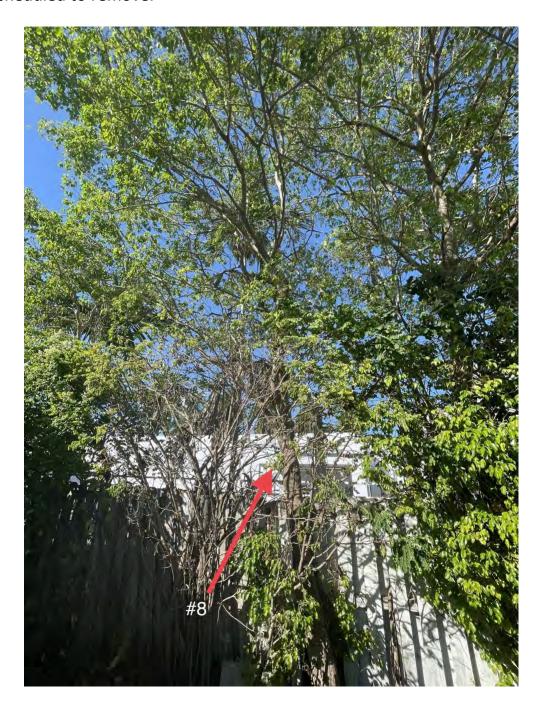
8. Ficus benjamina (Wheeping Fig tree) DBH 6", Spread 20', Height 20', this trees condition is moderate. This tree is on the north side of property. Minimum 6' TPZ shall be installed to protect 6' CRZ of this tree and done under ANSI A-300 guidelines should this tree need protection during construction. This tree is scheduled to remove.

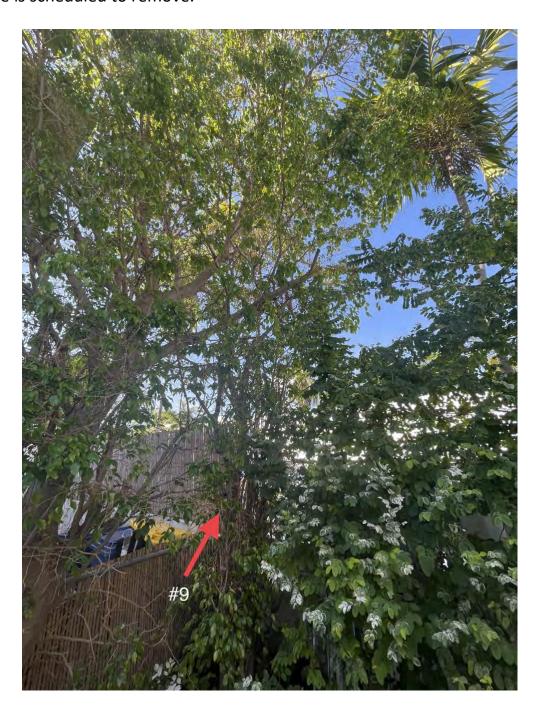
9. Ficus benjamina (Wheeping Fig tree) DBH 6", Spread 15', Height 20', this trees condition is moderate. This tree is on the north west corner of property. Minimum 6' TPZ shall be installed to protect 6' CRZ of this tree and done under ANSI A-300 guidelines should this tree need protection during construction. This tree is scheduled to remove.

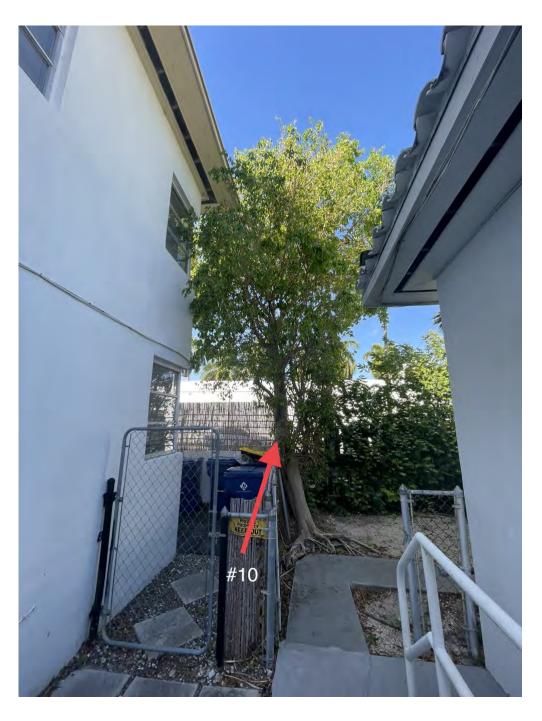
10. Ficus benjamina (Wheeping Fig tree) DBH 11", Spread 15', Height 20', this trees condition is very poor. This tree is on the north west corner of property. Minimum 11' TPZ shall be installed to protect 11' CRZ of this tree and done under ANSI A-300 guidelines should this tree need protection during construction. This tree is scheduled to remove.
