*EVALUATION REPORT*

*For Project located at: 7801 ATLANTIC WAY. MIAMI BEACH, FLORIDA. 33141*

The inspection of the building in reference (See Exhibit 1 for graphical representation), located at 7801 Atlantic Way, Miami Beach Fl 33141, took place on Wednesday February 22nd, 2023, and was performed by Mr. Alioskar Ganem P.E. The main objective of the inspection was to identify general areas and critical details of the building components that may compromise the integrity of the Structure and represent a hazard to the users of this property. The following report examines the strength and viability of the structure from the slab to the roof.

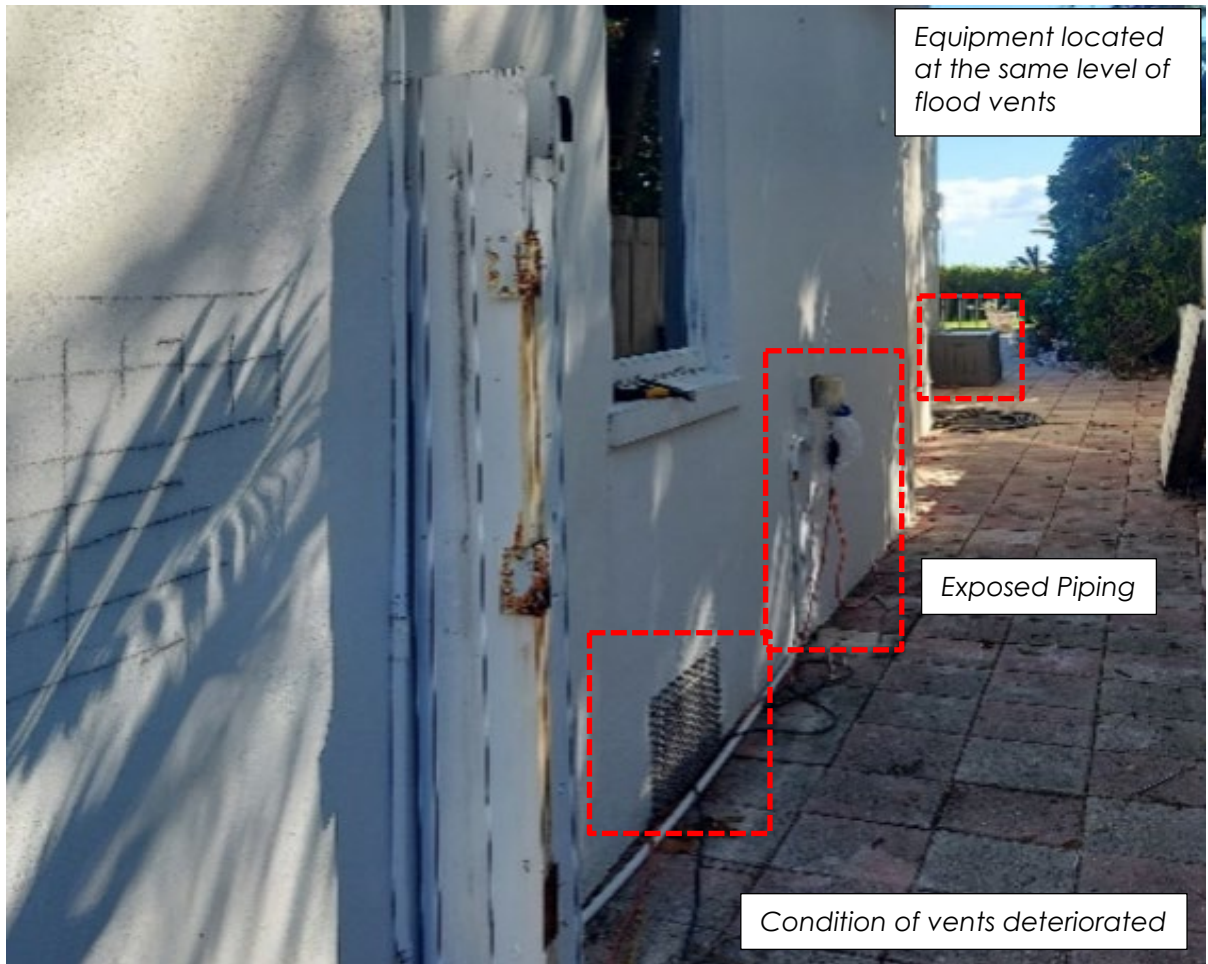
**Figure 1.**

*The current design incorporates flood vents below the recommended 18.2' level and below the slab, which is problematic. Flood vents are openings intended to enable the free flow of water during a flood, reducing the pressure on a building's walls and minimizing structural damage. However, since the habitable space of the building was constructed below the current recommended level, the absence of breakaway walls and the use of flood vents will result in damage to the masonry walls from the wave crest. Electrical equipment and piping below the recommended 18.2' create a hazardous environment, such equipment per code should always be designed above the flood elevation. It is the architect and engineer's responsibility to ensure the safety of occupants, and in this case, demolishing the structure should be considered as an option to provide a safer environment.*

*Figure 1, below, shows the dangerous existing infrastructure. The existing flood vents are in poor condition and are not considered resilient for the preservation of the home in the event of a major storm or flood. Figure 1 also shows the improper location of a/c equipment and the exposed piping from the slab.*

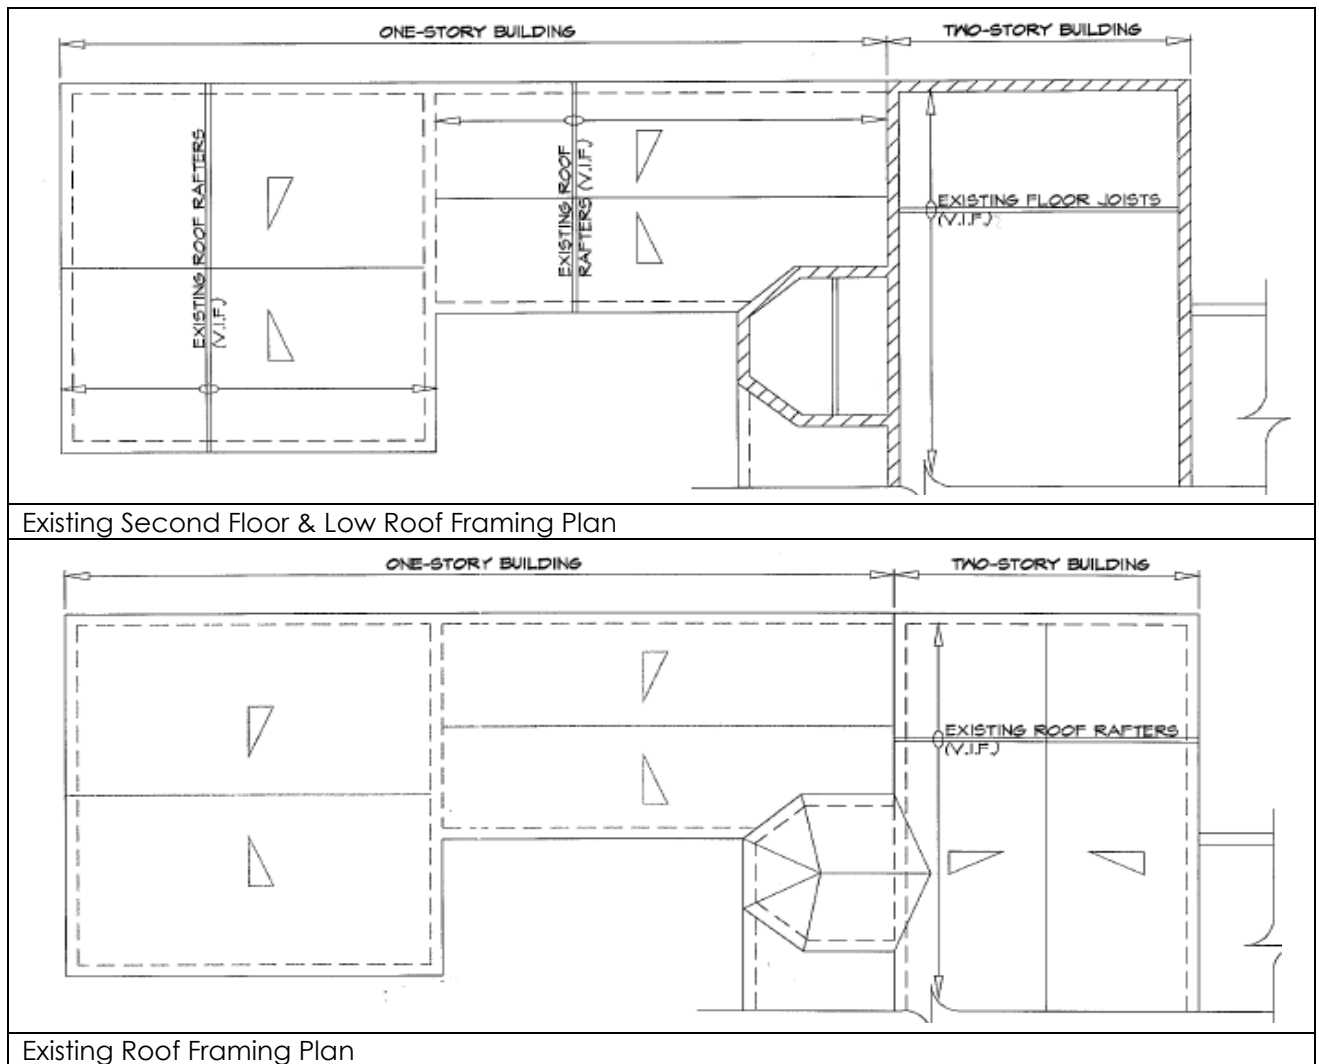
Figure 2.

The existing building consists of a two-story residential home. The existing Structural System is composed of masonry walls, with concrete beams and columns acting as load-bearing elements in the open areas and critical structural zones. See Figure 2 below. The load-bearing diaphragm of the second level consists of joists and roof rafters as part of the composition of the structural system of the home.

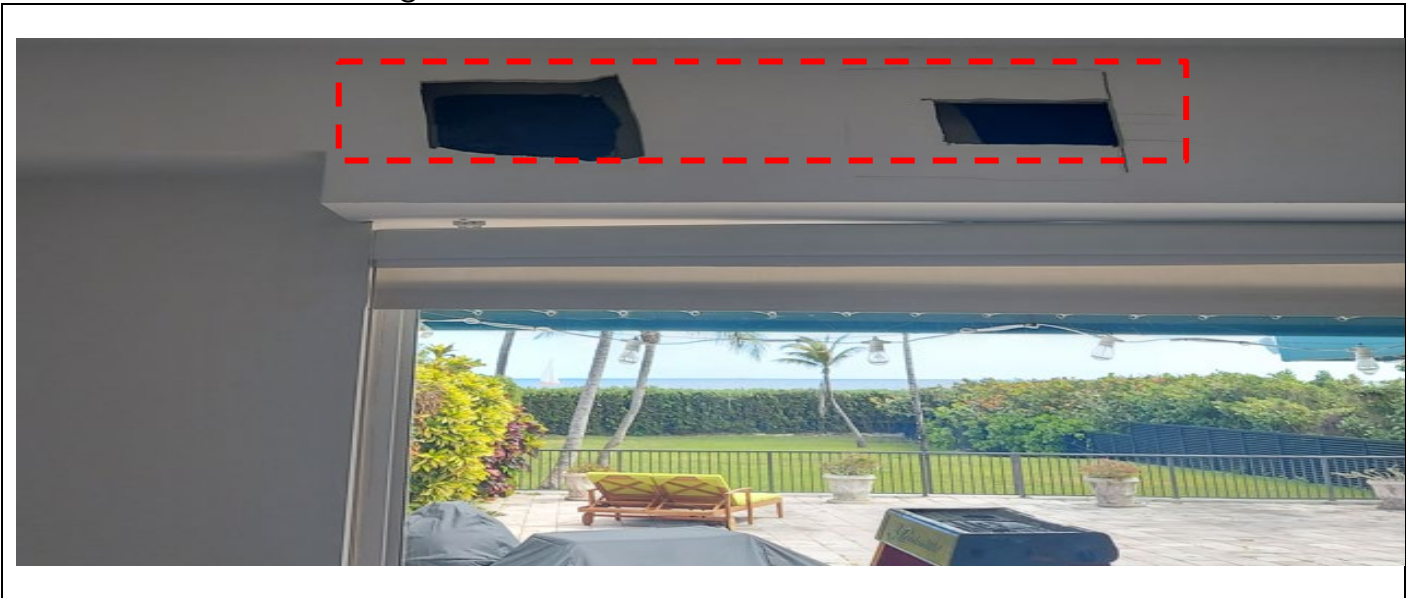
**Figure 3.** Cracking of the concrete in Main beam due to sulphation of the concrete and oxidation of the reinforcing steel

As a result of the visual inspection, cracks were observed in bearing elements of reinforced concrete. See Figure 3 below. This is produced as a consequence of the increase in volume of the reinforcing steel produced by an oxidation state. Sulfates attack concrete, forming expansive compounds that cause cracking. Chlorides, if they reach the rebars, cause its corrosion. The cracking caused by sulfates facilitates the penetration of chlorides and the corrosion of the reinforcement. Once the concrete cracks, the integrity and design capacity of the structural element are not guaranteed.

Cracking of the concrete in Main beam due to sulphation of the concrete and oxidation of the reinforcing steel

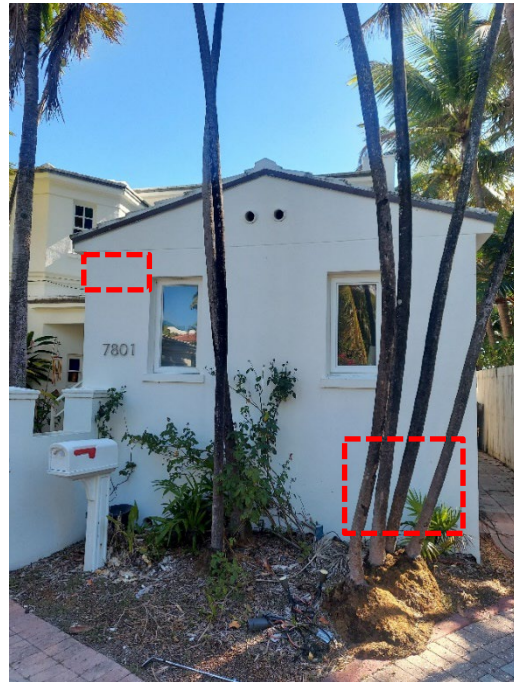
West facade

**Stucco repair areas at facades**

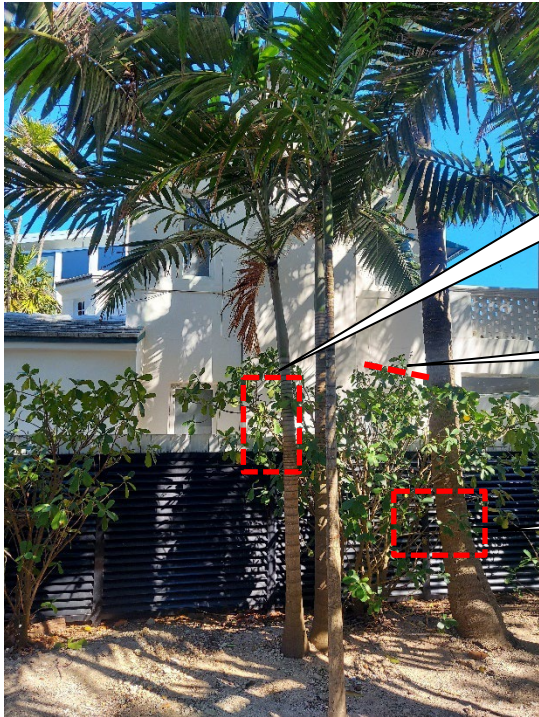
South façade

Stucco in poor condition

Hairline crack.

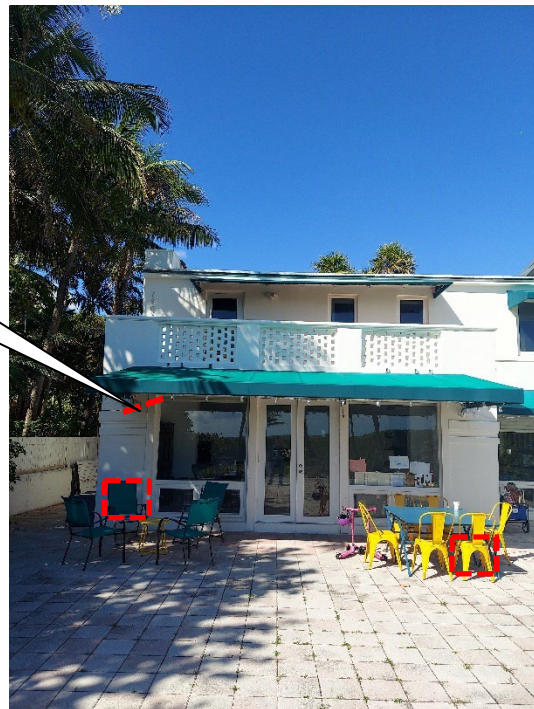
East façade

Stucco in poor condition

Hairline crack.

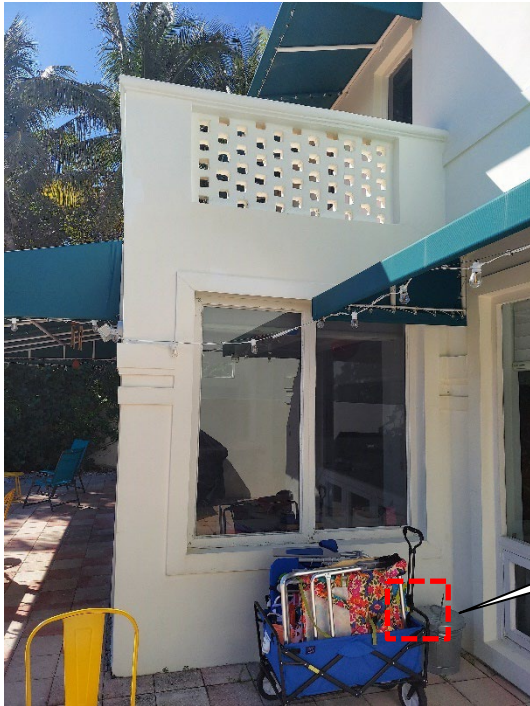
East side

Stucco in poor condition

Cracked beam.

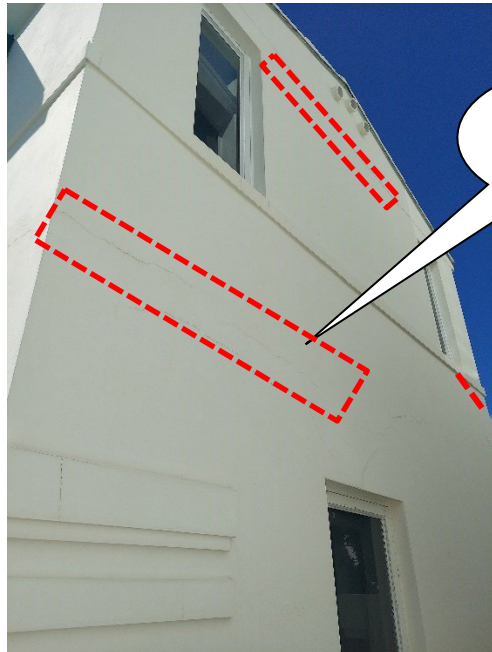
Cracked area.

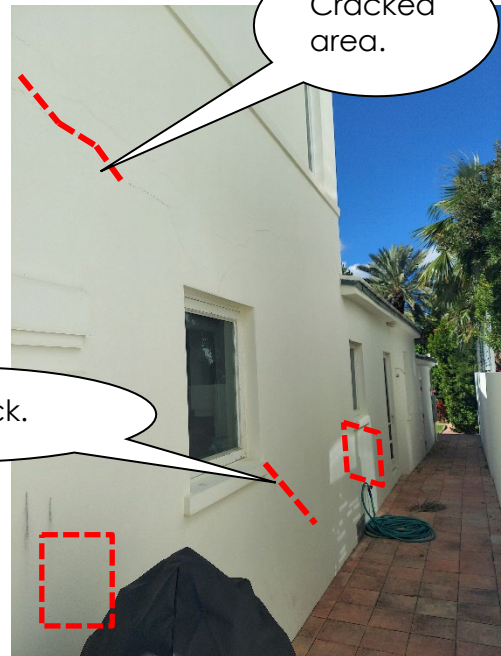
Cracked area.

Hairline crack.

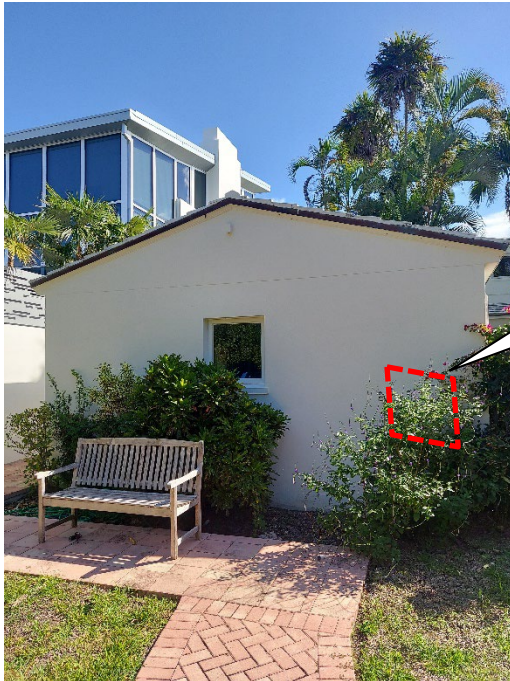
West side

Stucco in  
poor  
condition

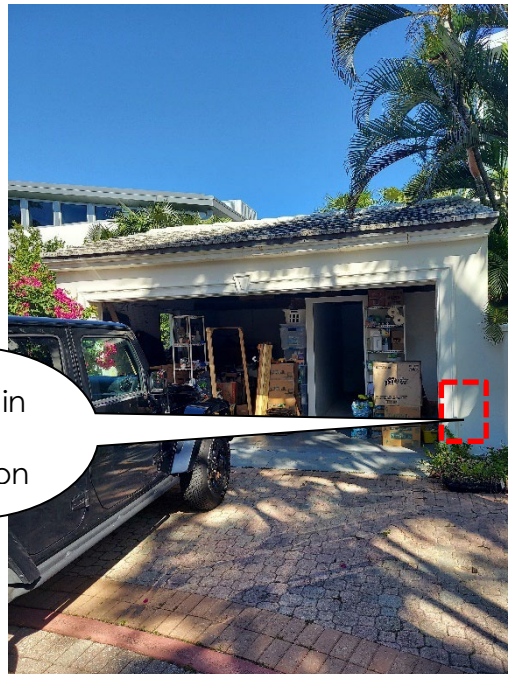
Stucco in  
poor  
condition

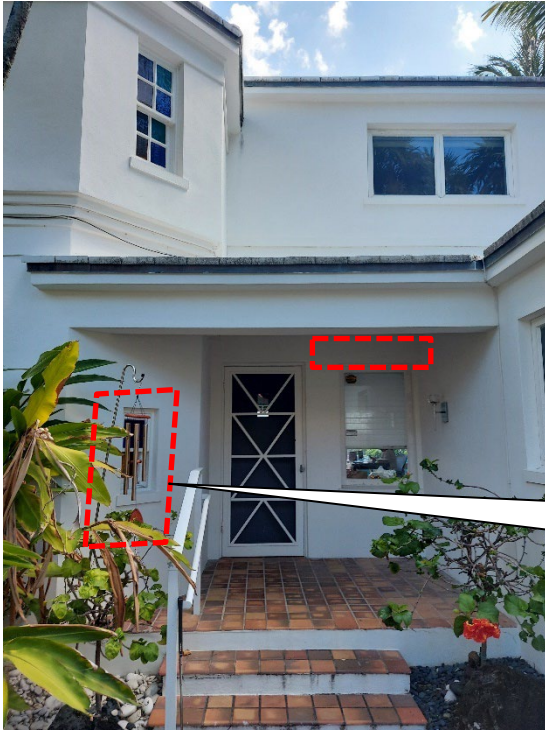
Main entrance

Stucco in poor condition

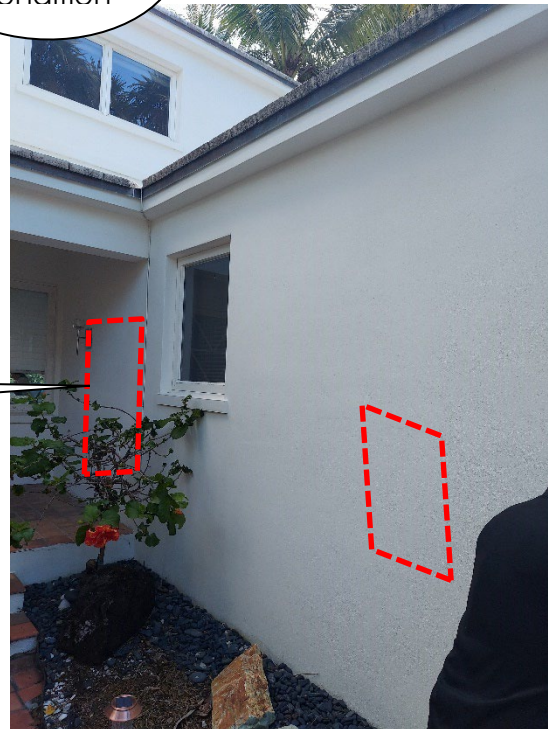
Stucco in poor condition

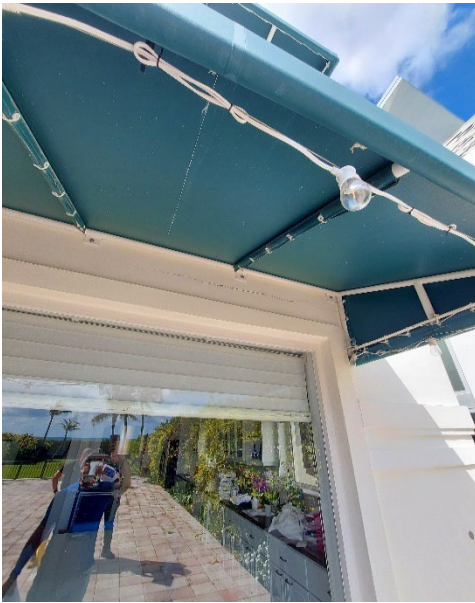
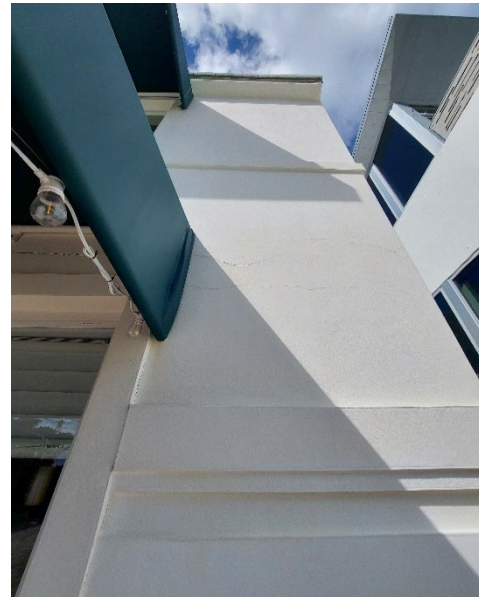
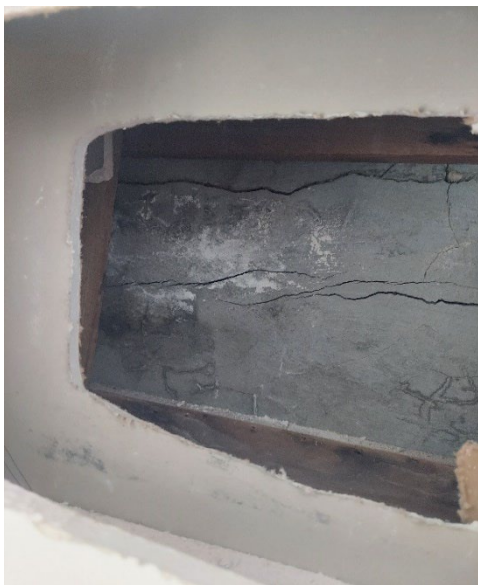
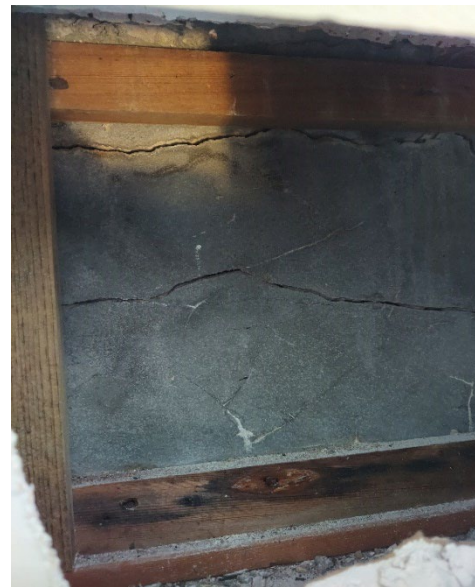
## Cracked beam, east side.
