OPTIMUS STRUCTURAL DESIGN LLC
CONSULTING ENGINEERS

RE: Existing Residence at 1045 Pennsylvania Avenue
Miami Beach, Florida 33139

This report is based on our field observations made on December 21, 2016; review of the proposed structural alterations; visual observations of the existing conditions and available information regarding the project.

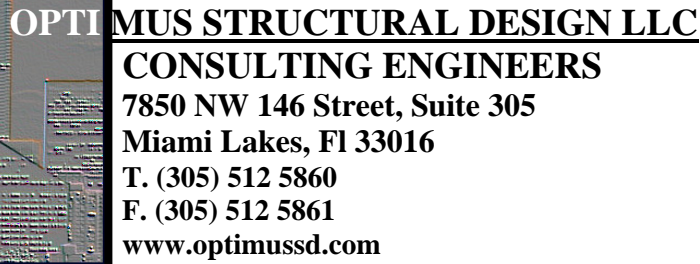
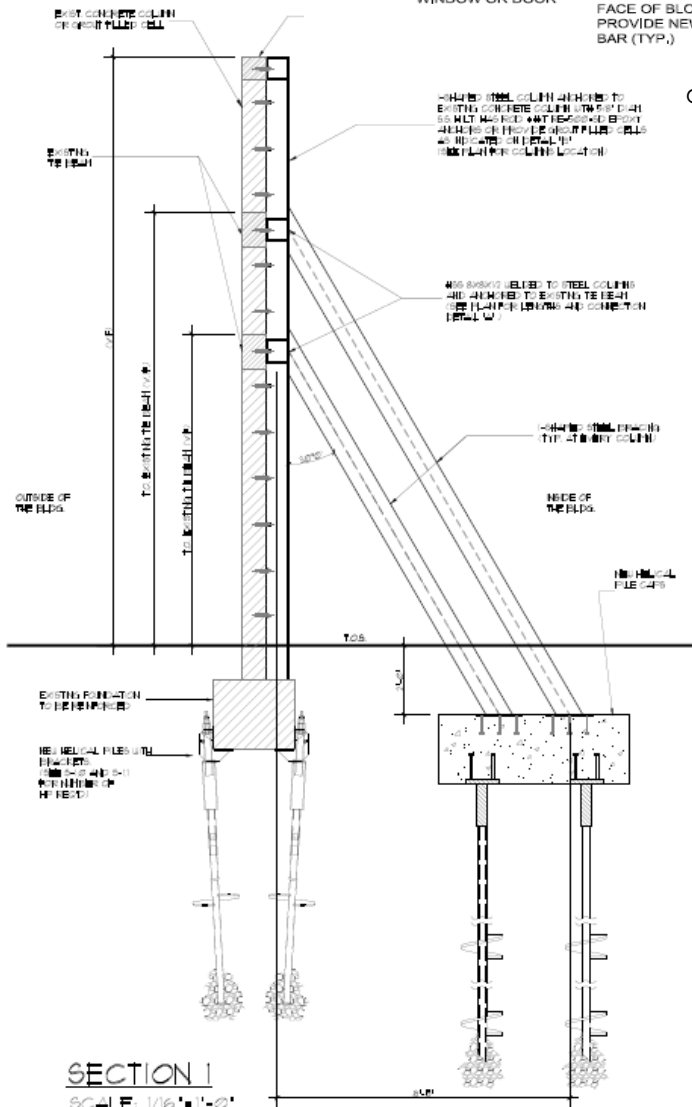
- The existing concrete compressive strength maybe low based on the age of the buildings. Structural retrofit is required which will include reinforcing of the existing exterior CMU walls; repairs of the existing columns and beams and spalled areas will be required as well.
- The existing exterior CMU walls will require reinforcement installed at 24" minimum with additional reinforcement at all corners, intersections and at each window and door opening. All cells will require to be grouted from inside or outside of the wall. Existing

2-#6 VERT. BAR
(TYP. EA. END)
DRILL & EPOXY
INTO EXIST.
TIE-BM (T & B)

FILL ALL CELLS
SOLID W/GROUT

#5 VERT. BAR @24" OC
DRILL & EPOXY
INTO EXIST. TIE-BM (T & B)

SAW-CUT EXTERIOR
FACE OF BLOCK TO
PROVIDE NEW VERT.
BAR (TYP.)

EXIST. 8" CMU
WALL TO REMAIN

POUR PORT
(AS REQUIRED,
TYP.)
