May 25, 2017

**RE: Proposal for Professional AE Services; Evaluation of Existing Log Cabin Structure at North Beach; City property at 8100 Collins Avenue**

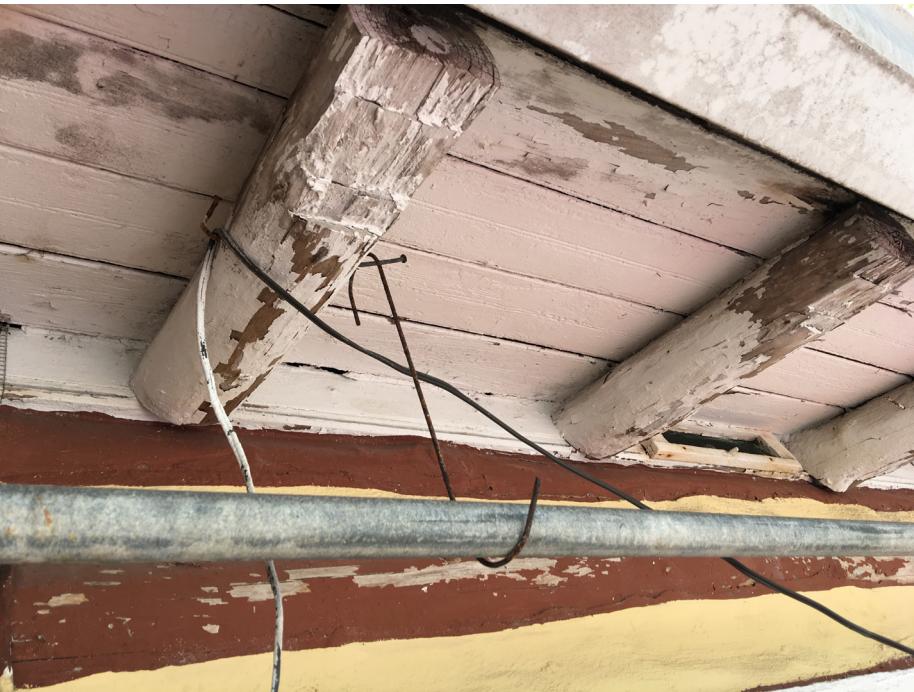
Detail Rotted Wood

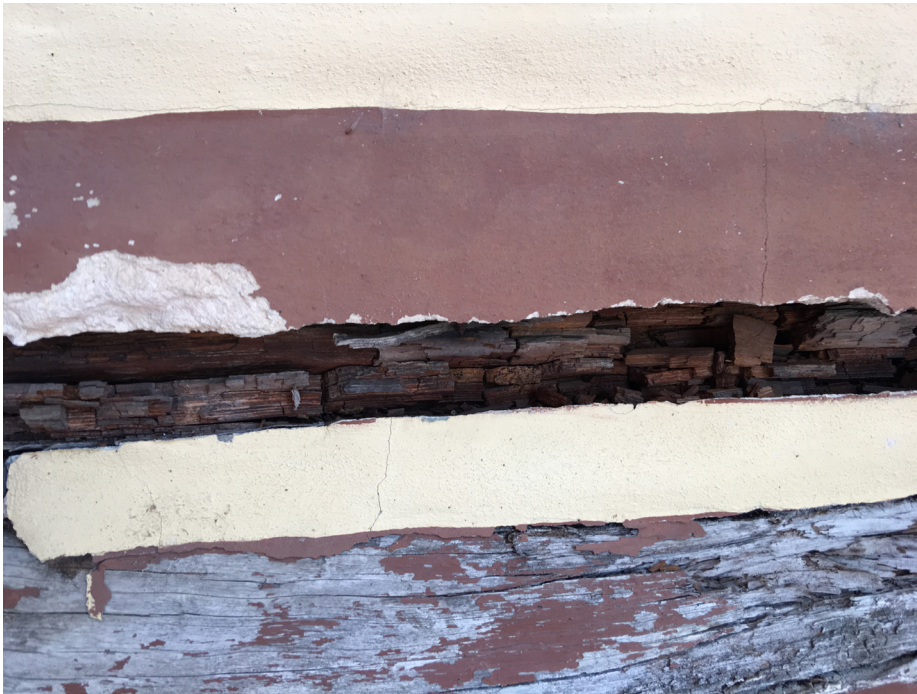
Detail Rotted Wood

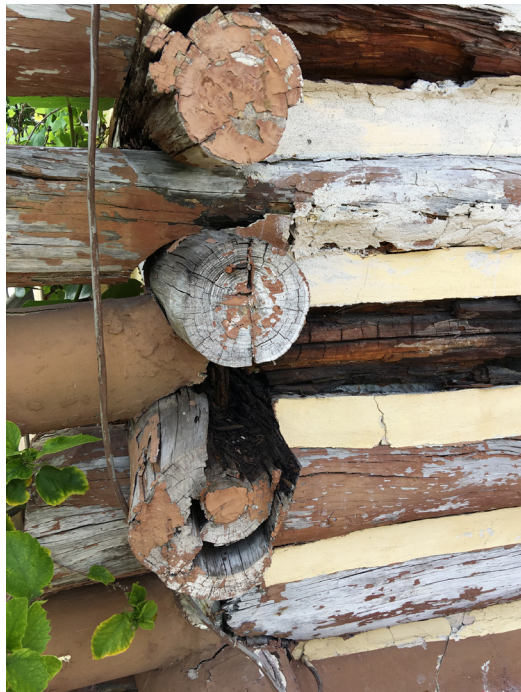
Detail Rotted Wood

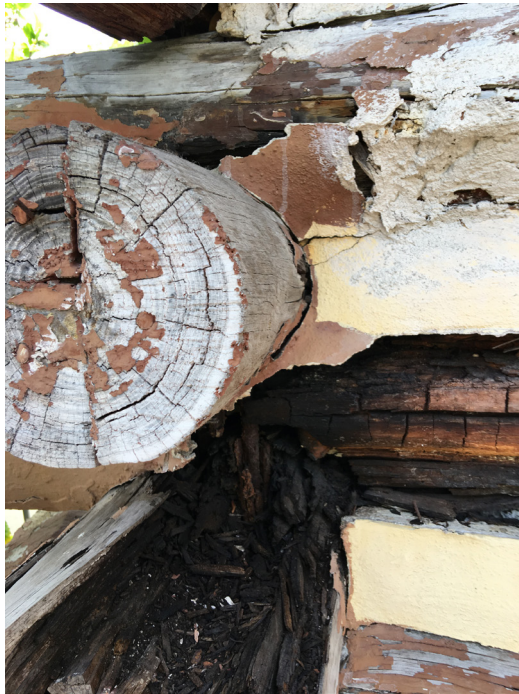
Detail Rotted Wood

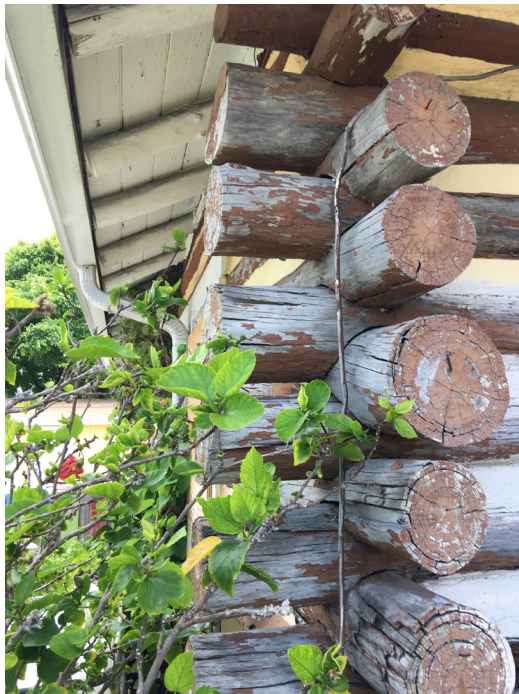
Detail Rotted Wood

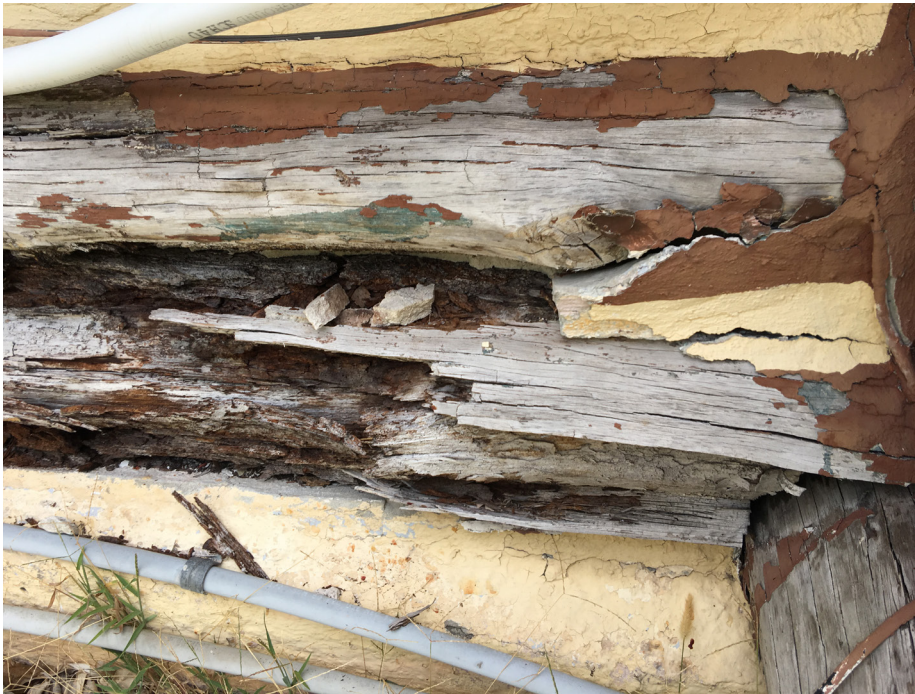
Detail Rotted Wood
