JAMES LEGETTE
Certified Arborist, ISA
Registered Consulting Arborist, ASCA
President, Chief Arborist
Lauderdale Tree Service, Inc.
954-583-1888
www.lauderdaletreeservice.com
4320 S.W. 74th Avenue • Davie, Florida 33314

March 8, 2019

RE: 1420 W. 23rd Street, Miami Beach
Additional Site Photographs

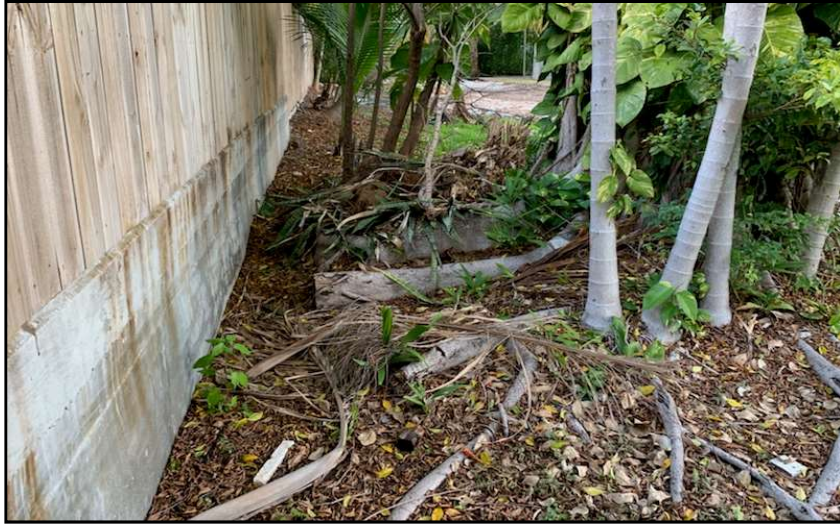
Photo 1 View along west wall showing severed roots of *Ficus nitida*.

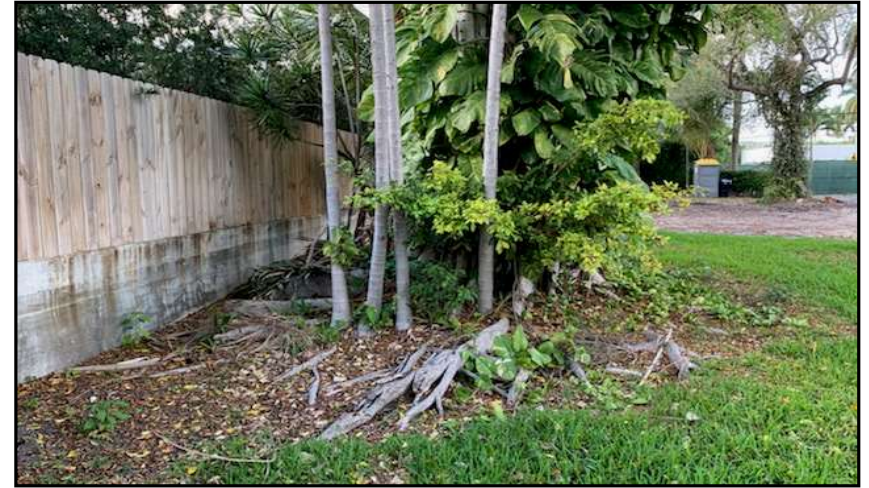
Photo 2 Surface roots of *Ficus nitida* extending toward wall and backyard.

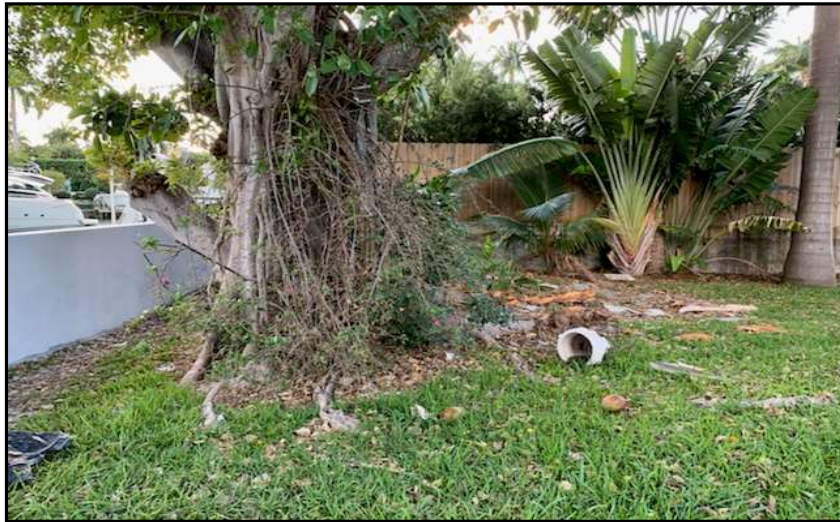
Photo 3 Surface roots of strangler fig running into backyard.

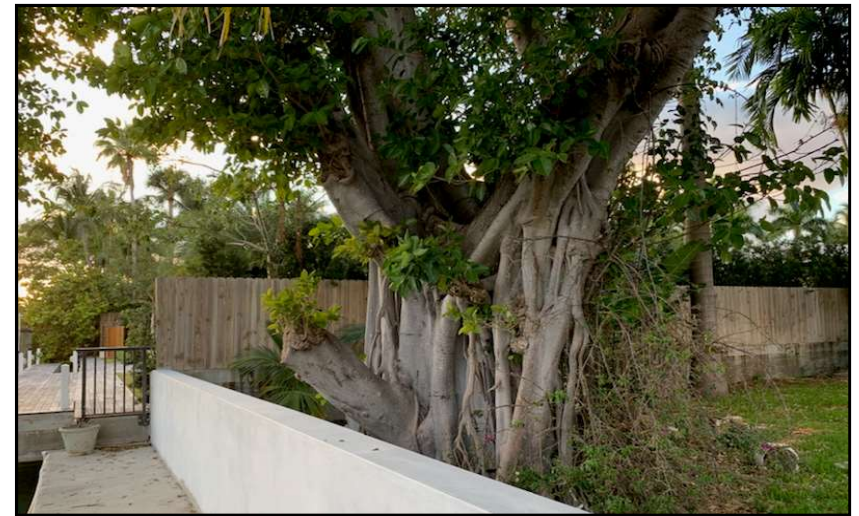
Photo 4 Large stub cut branches of strangler fig.

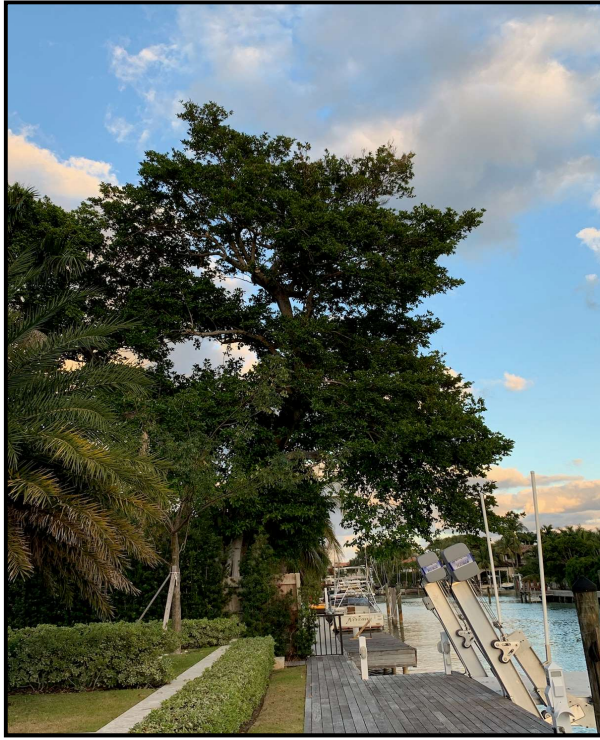
As requested, attached you will find additional photographs documenting the poor condition and structure of the specimen strangler fig (Tree No. 62) and *Ficus nitida* (Tree No. 51) which occur on the west side of the property. The additional photographs illustrate the shearing off of the canopy that has been performed by the neighbor to the west, which has resulted in an unbalanced canopy. Similarly, the photographs show the major roots that have been severed on the west side of the trees to prevent undermining of the adjacent CBS wall and encroachment into the neighbor's yard. Lastly, we have included a number of photographs confirming the decay present in major limbs which is likely the result of previous poor trimming efforts by the neighbor.

Photo 5 View from west neighbor's property showing shear cutting of major branches of strangler fig.

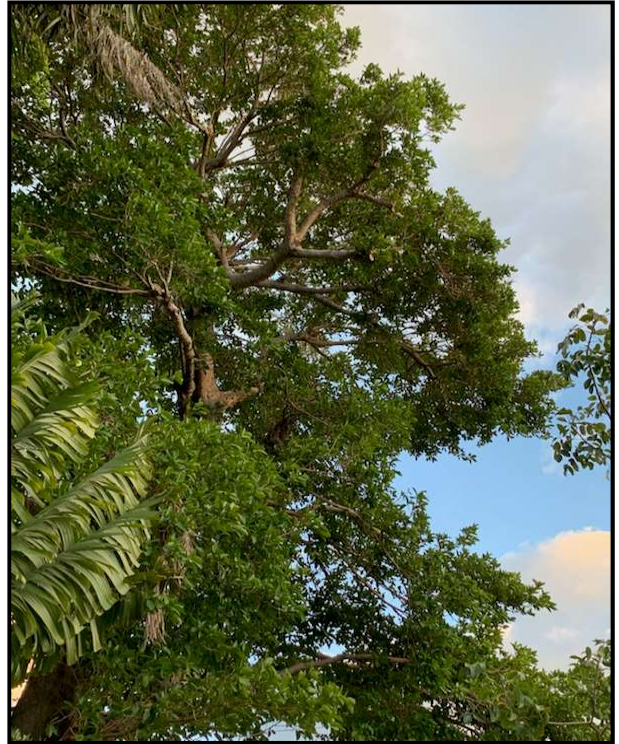
Photo 6 Close-up of shear cut branches on strangler fig.

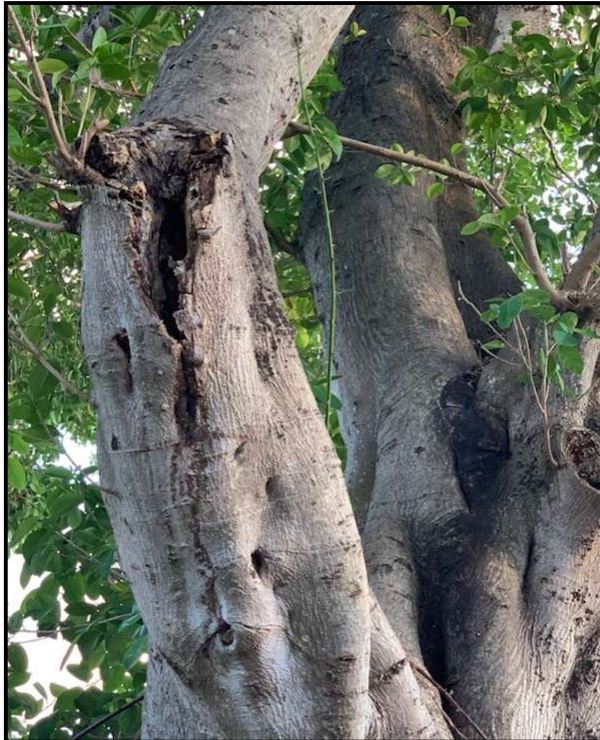
Photo 7 Decay and lesions on major branches of strangler fig.

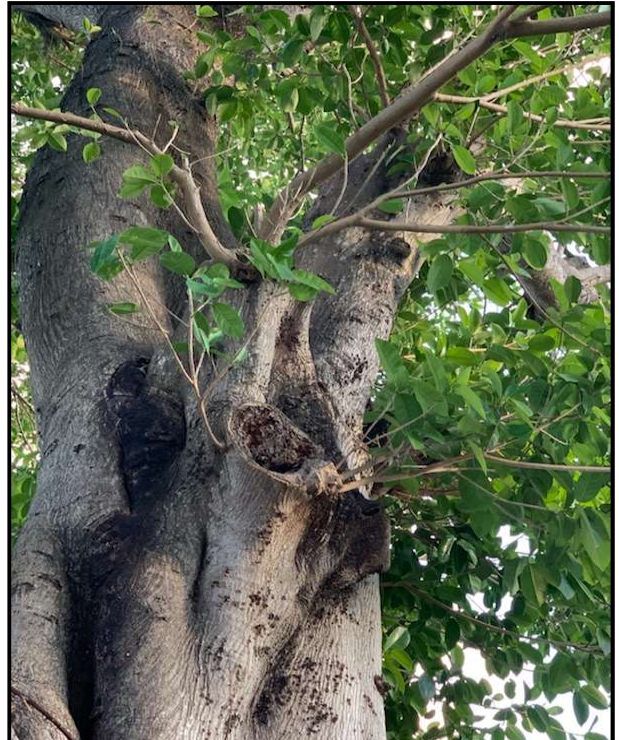
Photo 8 Additional decay on major strangler fig branches.

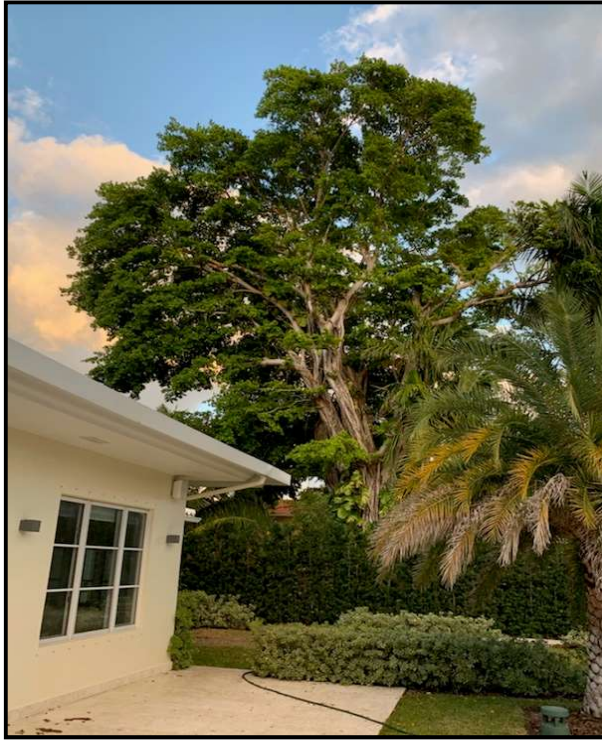
Photo 9 View from west neighbor's property showing shear cutting of *Ficus nitida*.

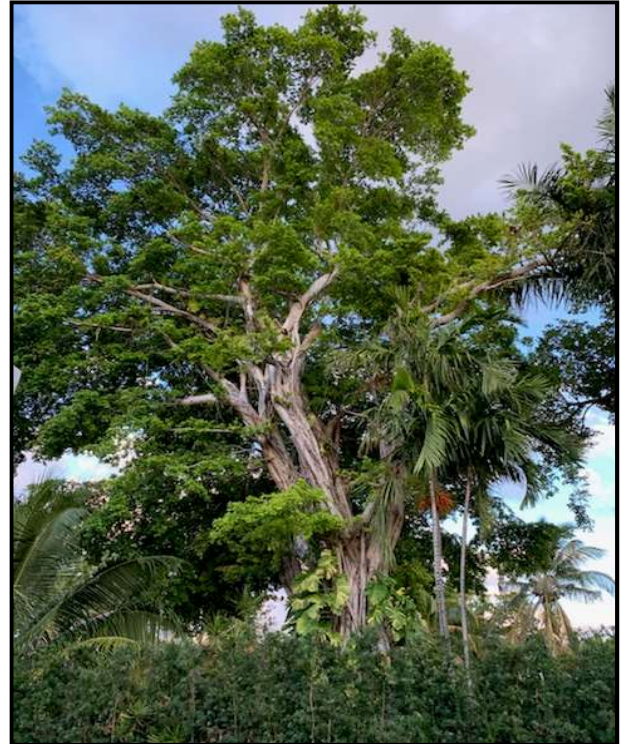
Photo 10 Additional view of shear cutting of *Ficus nitida*.

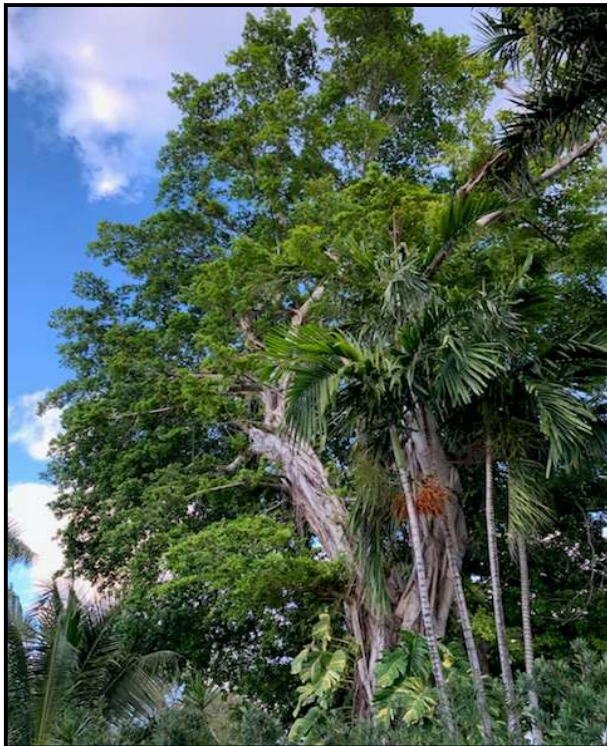
Photo 11 Vertical view of shear cutting of *Ficus nitida* canopy.

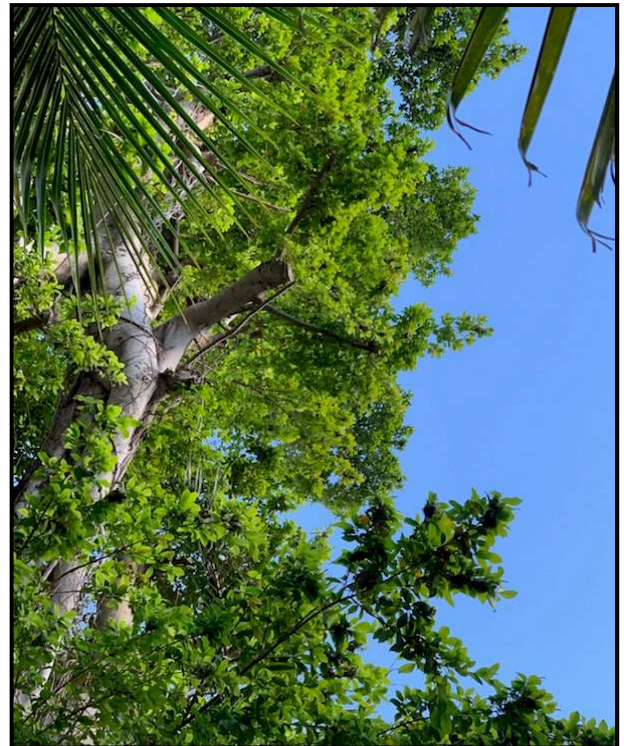
Photo 12 Close-up view of stub cuts resulting from shear cutting of *Ficus nitida*.
