# Arborist Report

12 Star Island Drive  
Miami Beach

4/5/2019

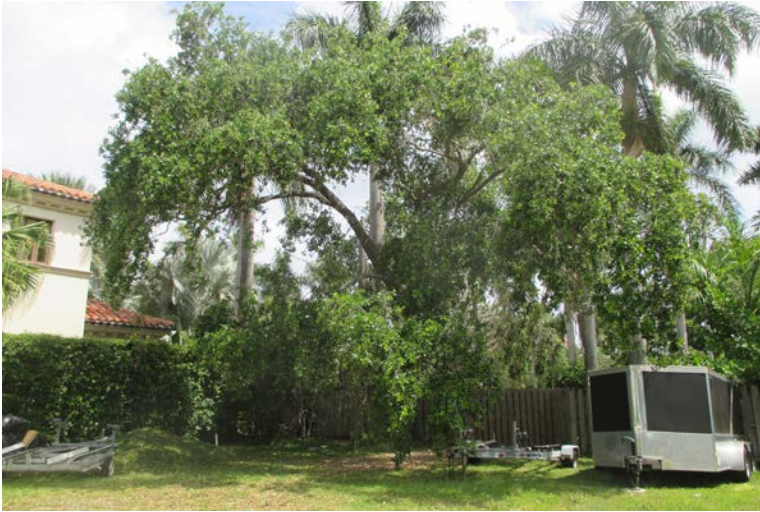
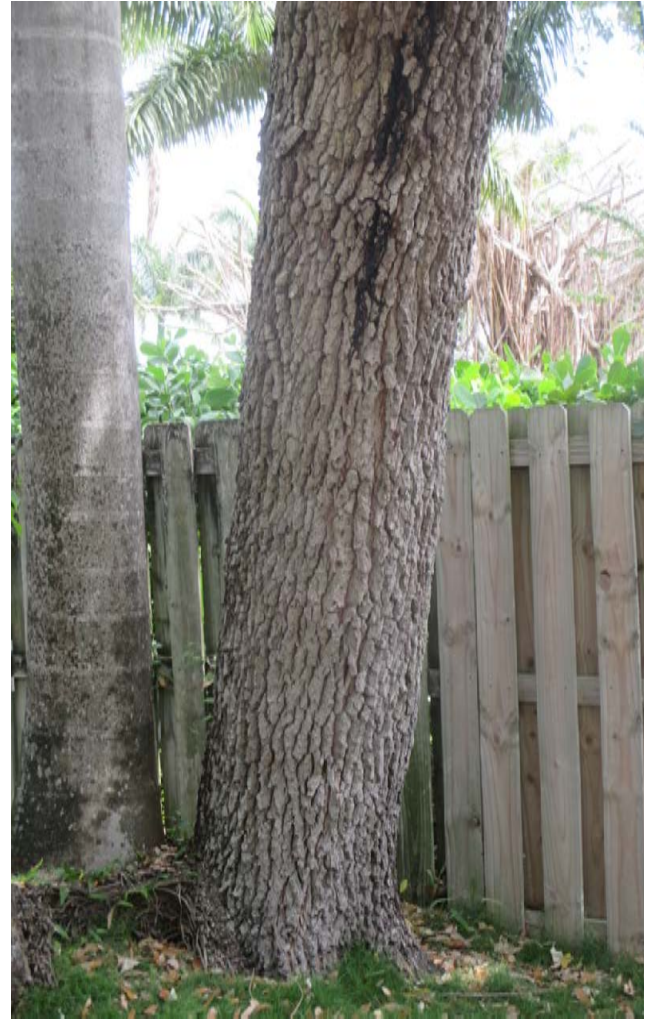
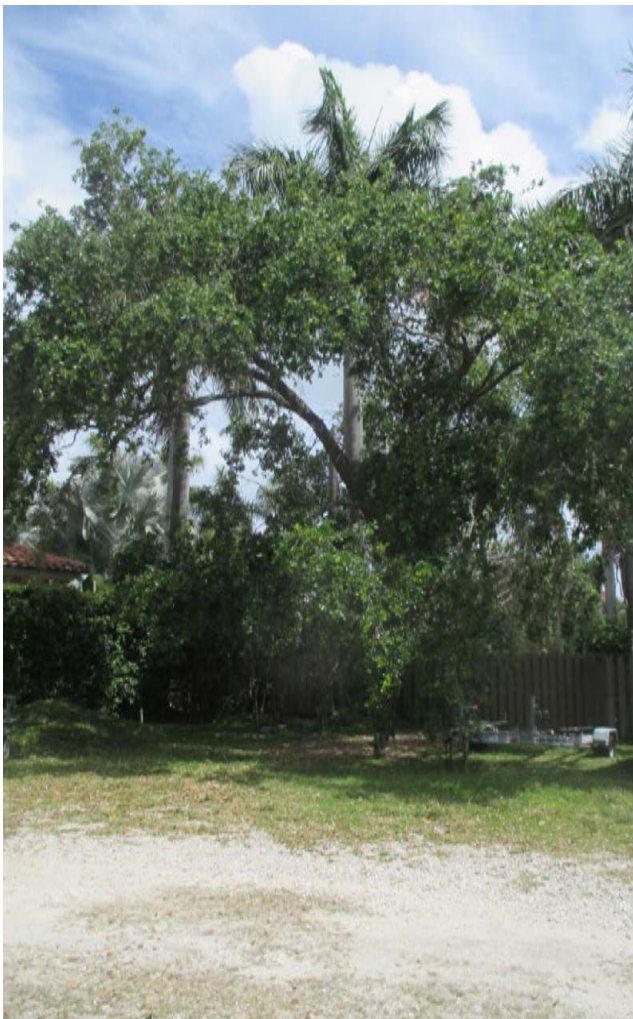
## Tree #20

Tree #20 is a Live Oak located at the front of the property. It is in good condition, with a full, green canopy. The canopy hangs low on the west side, nearly touching the ground. Bacterial wetwood is present, coming from an old pruning wound that has closed over. A palm is growing over the trunk flare on the north side. The tree should be crown-cleaned for deadwood. This tree should be monitored on a periodic basis for health and structural integrity.

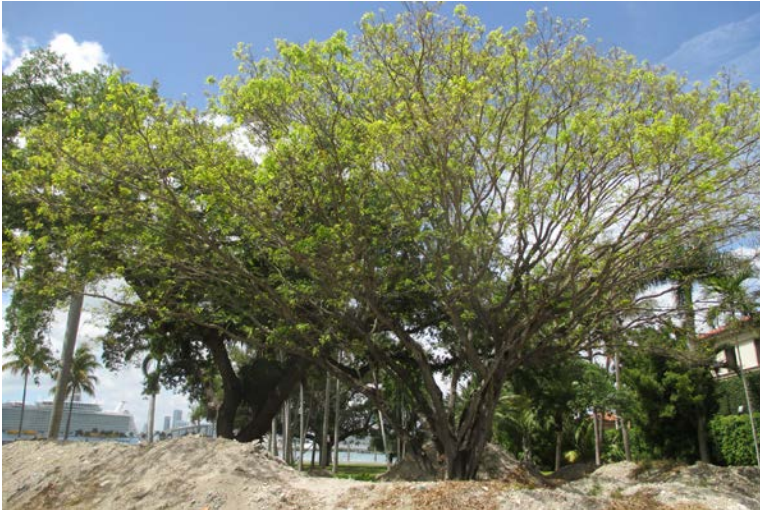
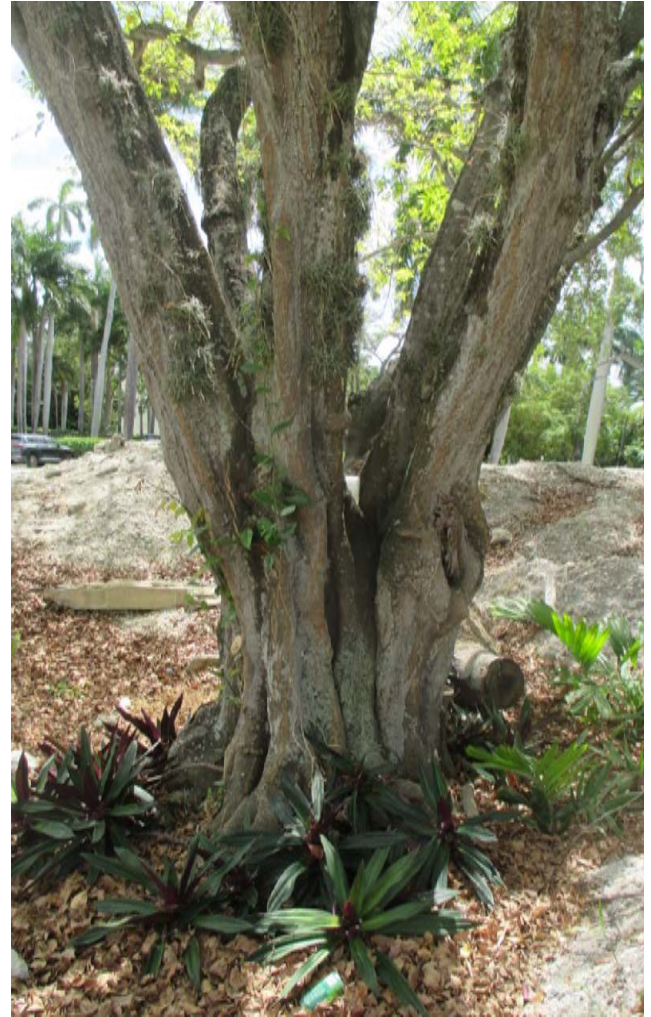
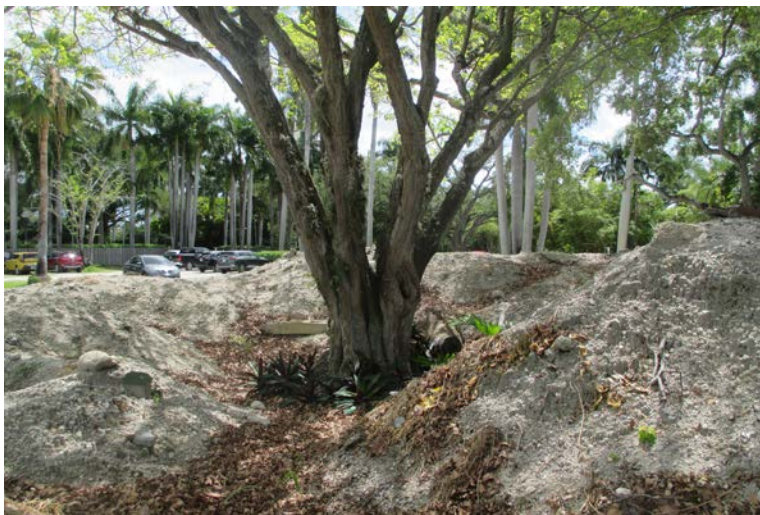
## Tree #26

Tree #26 is a large Pongam located at the center of the property. It is in good condition - new leaves are emerging at this time of year. The tree is multi-trunked, with included bark. There is one cavity on a trunk. Soil has been mounded up around the tree - this should be removed as soon as possible, because a limited amount of air and water will be able to reach the tree roots. The tree should be crown-cleaned for deadwood. This tree should be monitored on a periodic basis for health and structural integrity.

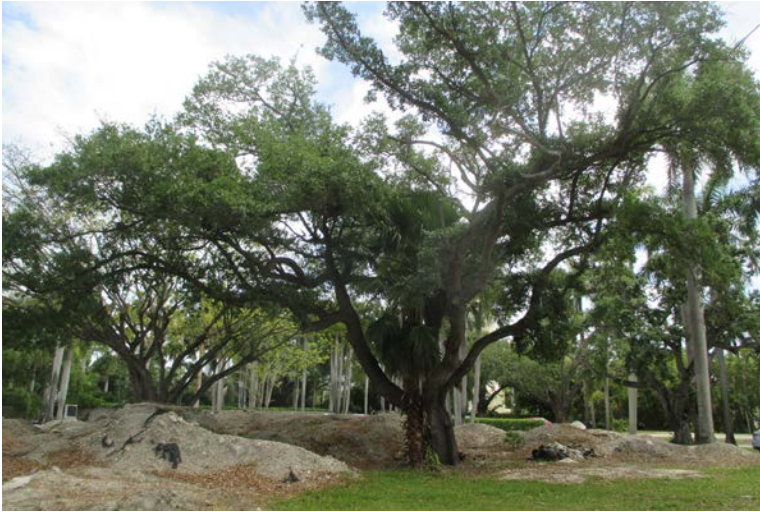
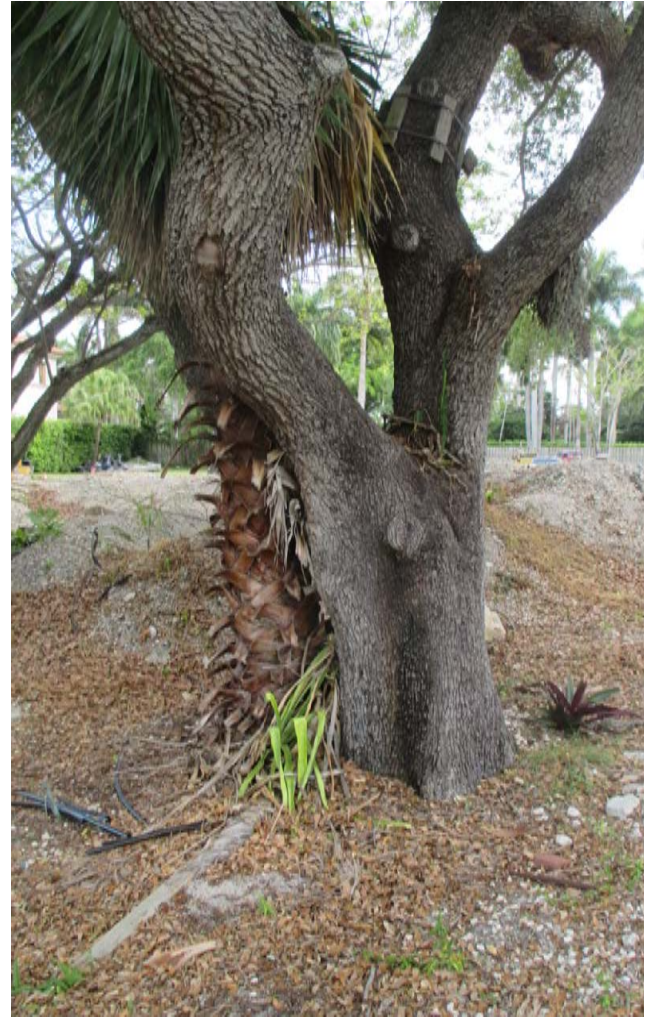
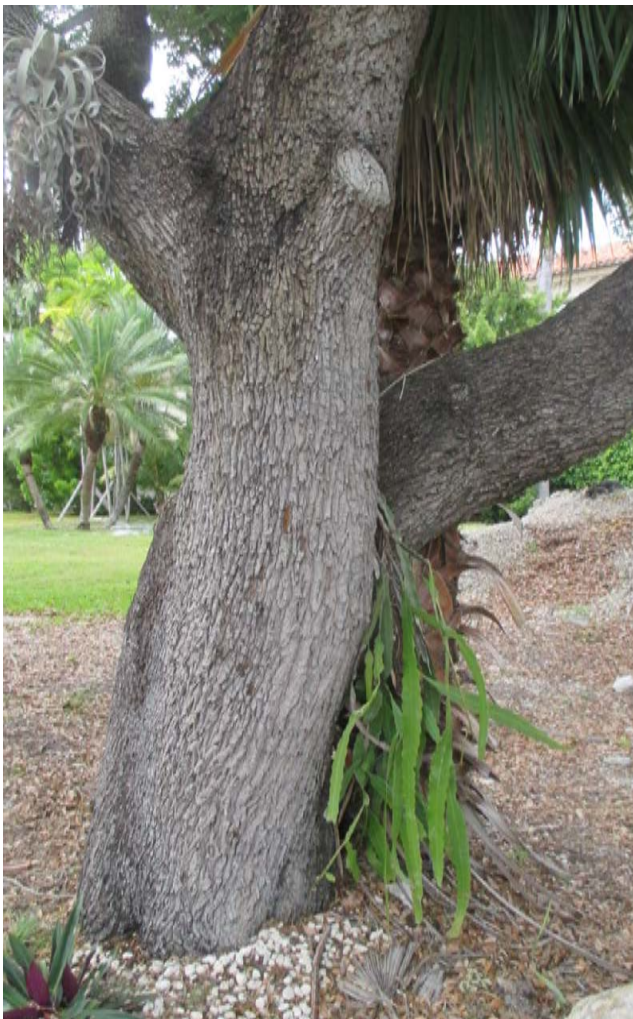
## Tree #27

Tree #27 is a large Live Oak located towards the center of the property. It is in good condition. The canopy is dense and wide-spreading. Old pruning cuts have closed over. Bracing materials left around a main limb should be removed so it is not girdled. Soil has been mounded up around the tree - this should be removed as soon as possible, because a limited amount of air and water will be able to reach the tree roots. The tree should be crown-cleaned for deadwood. This tree should be monitored on a periodic basis for health and structural integrity.

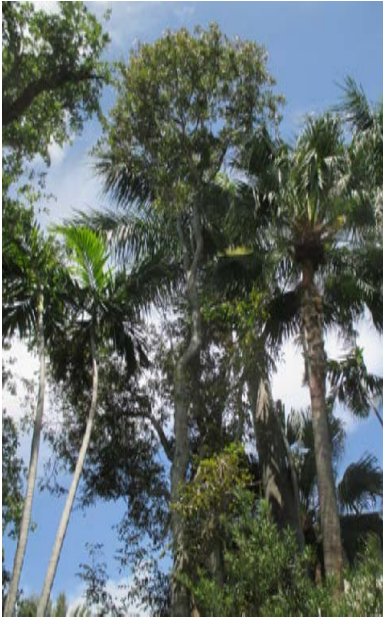
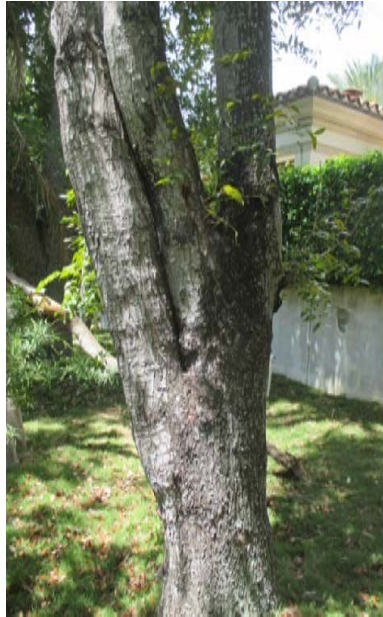
## Tree #57

Tree #57 is a Mahogany located on the north side of the property. It is in poor condition - it has poor form with multiple trunks with included bark that have begun to fuse together. The canopy is narrow and a number of limbs have broken. Old pruning cuts are present with decay. It is recommended that this tree be removed.

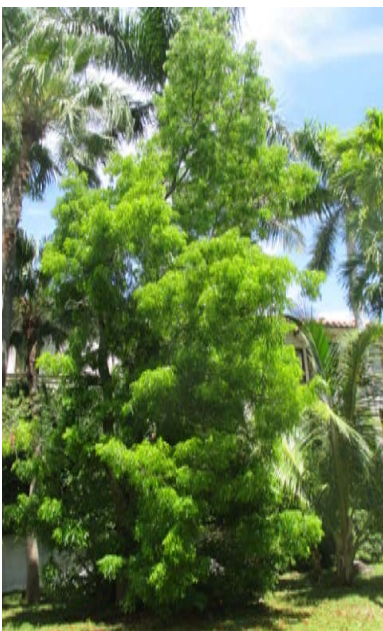
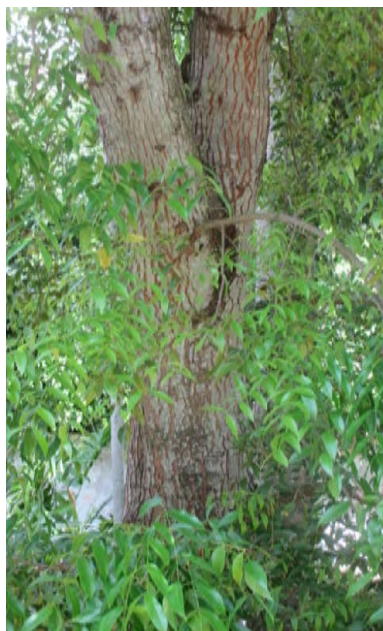
## Tree #58

Tree #58 is an Earleaf Acacia located on the north side of the property. It is in fair condition with a dense crown and poor form. It is double-trunked with included bark. This species is highly invasive and is on the Miami-Dade County Prohibited Plant List and will therefore need to be removed.

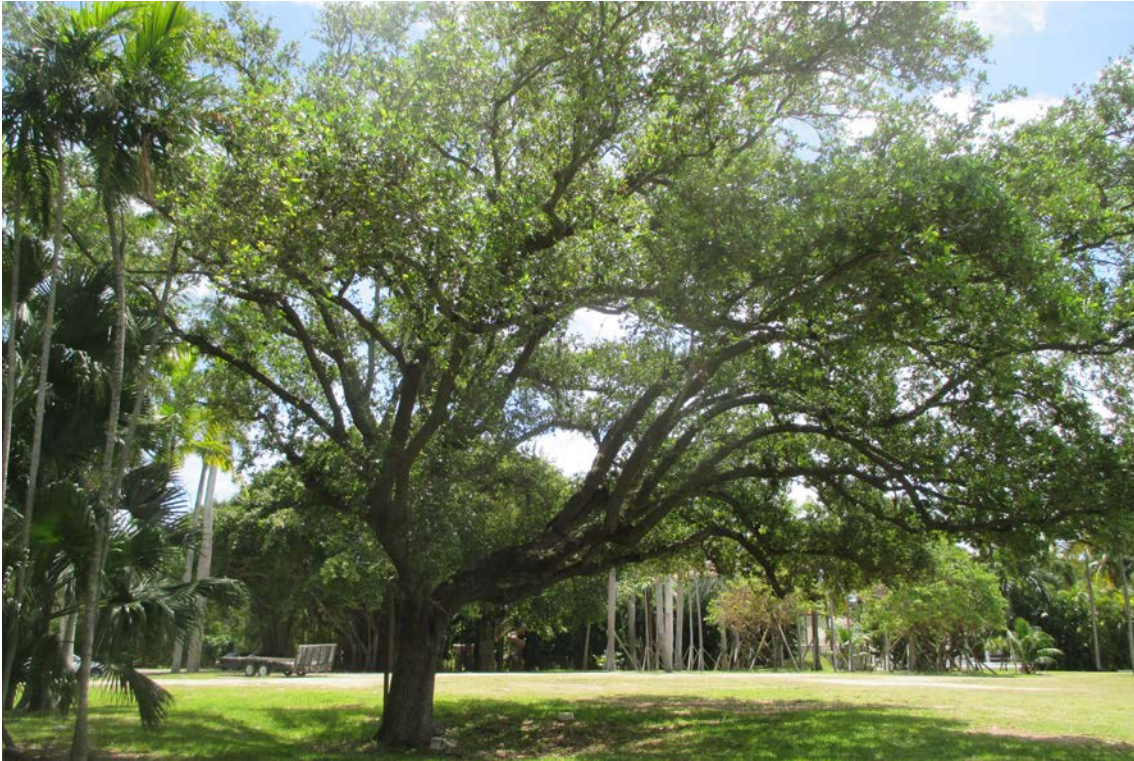
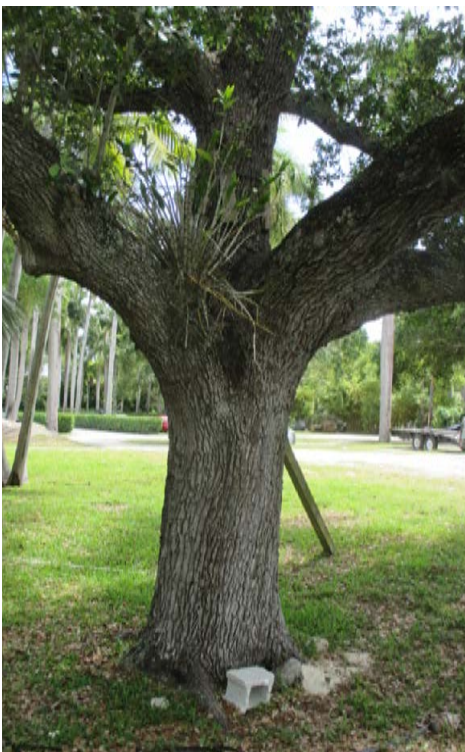
## Tree #60

Tree #60 is a large Live Oak located towards the rear of the property. It is in good condition with a dense, wide-spreading canopy. A number of limbs on the west side of the tree had been hatracked or broken many years ago. Although no decay is visible, it is anticipated that the limbs that have regrown do not have as strong attachments as regular limbs. Bracing materials left around a limb should be removed so it is not girdled. The tree should be crown-cleaned for deadwood. This tree should be monitored on a periodic basis for health and structural integrity.

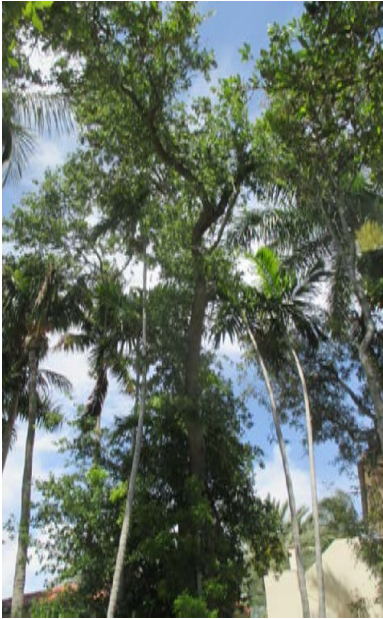
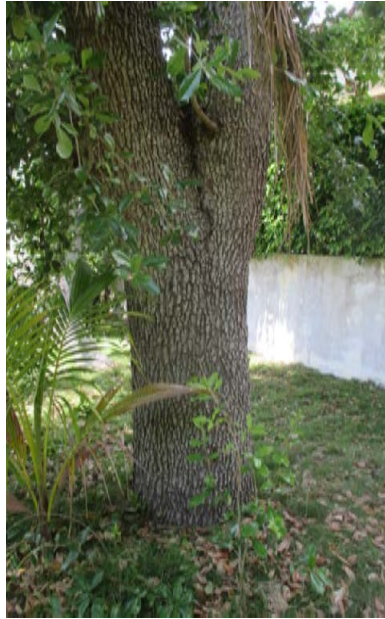
## Tree #61

Tree #61 is a Live Oak located on the north side of the property. It is in fair condition. The trunk divides into two, and there is much sucker growth in the canopy. The tree should be crown-cleaned for deadwood. This tree should be monitored on a periodic basis for health and structural integrity.

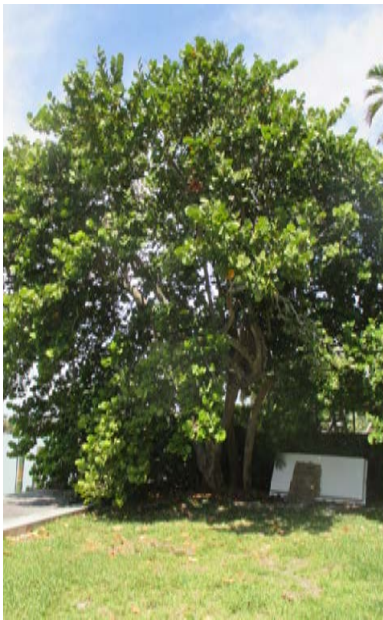
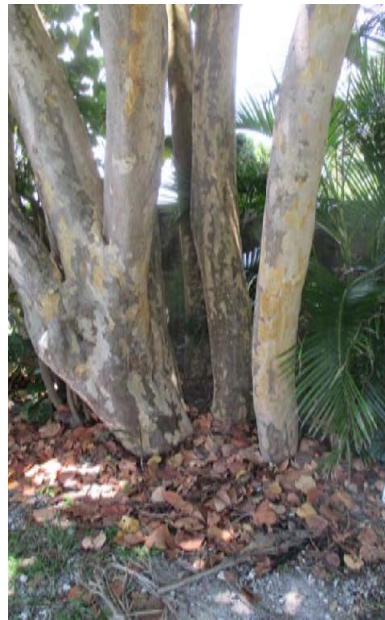
## Tree #69

Tree #69 is a Seagrape located in the rear north corner of the property. It is in good condition. It is multi-trunked and has a dense canopy. It is doing well on the water's edge. There is one relatively large pruning cut and some limbs that are crossing. The small diameter deadwood can be removed.

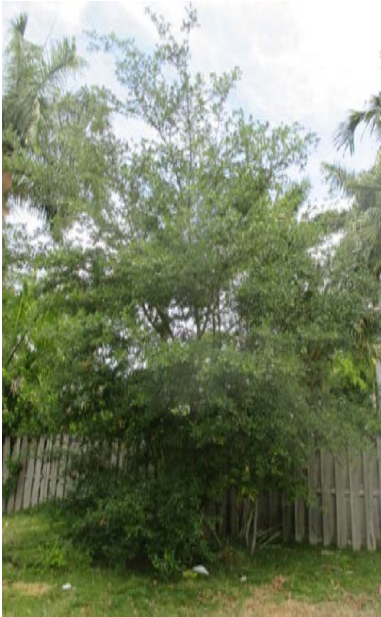
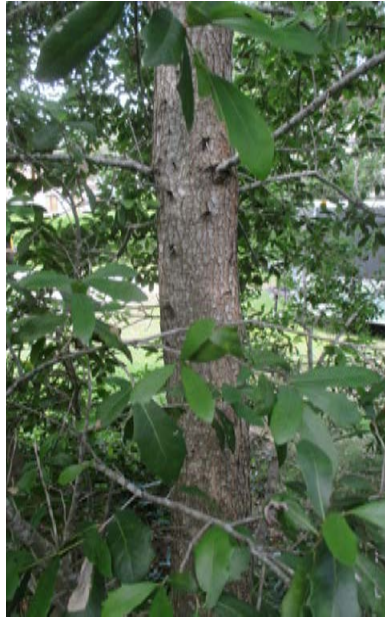
## Tree #154

Tree #154 is a small Live Oak located at the front of the property. It is in good condition with a full, green canopy. Some of the lower branches can be removed and thinned to improve the tree's appearance. This tree's location is approximated in the diagram on the following page.
