Tree Resource Evaluation for 71 La Gorce Circle, Miami Beach

May 6, 2020

Summary

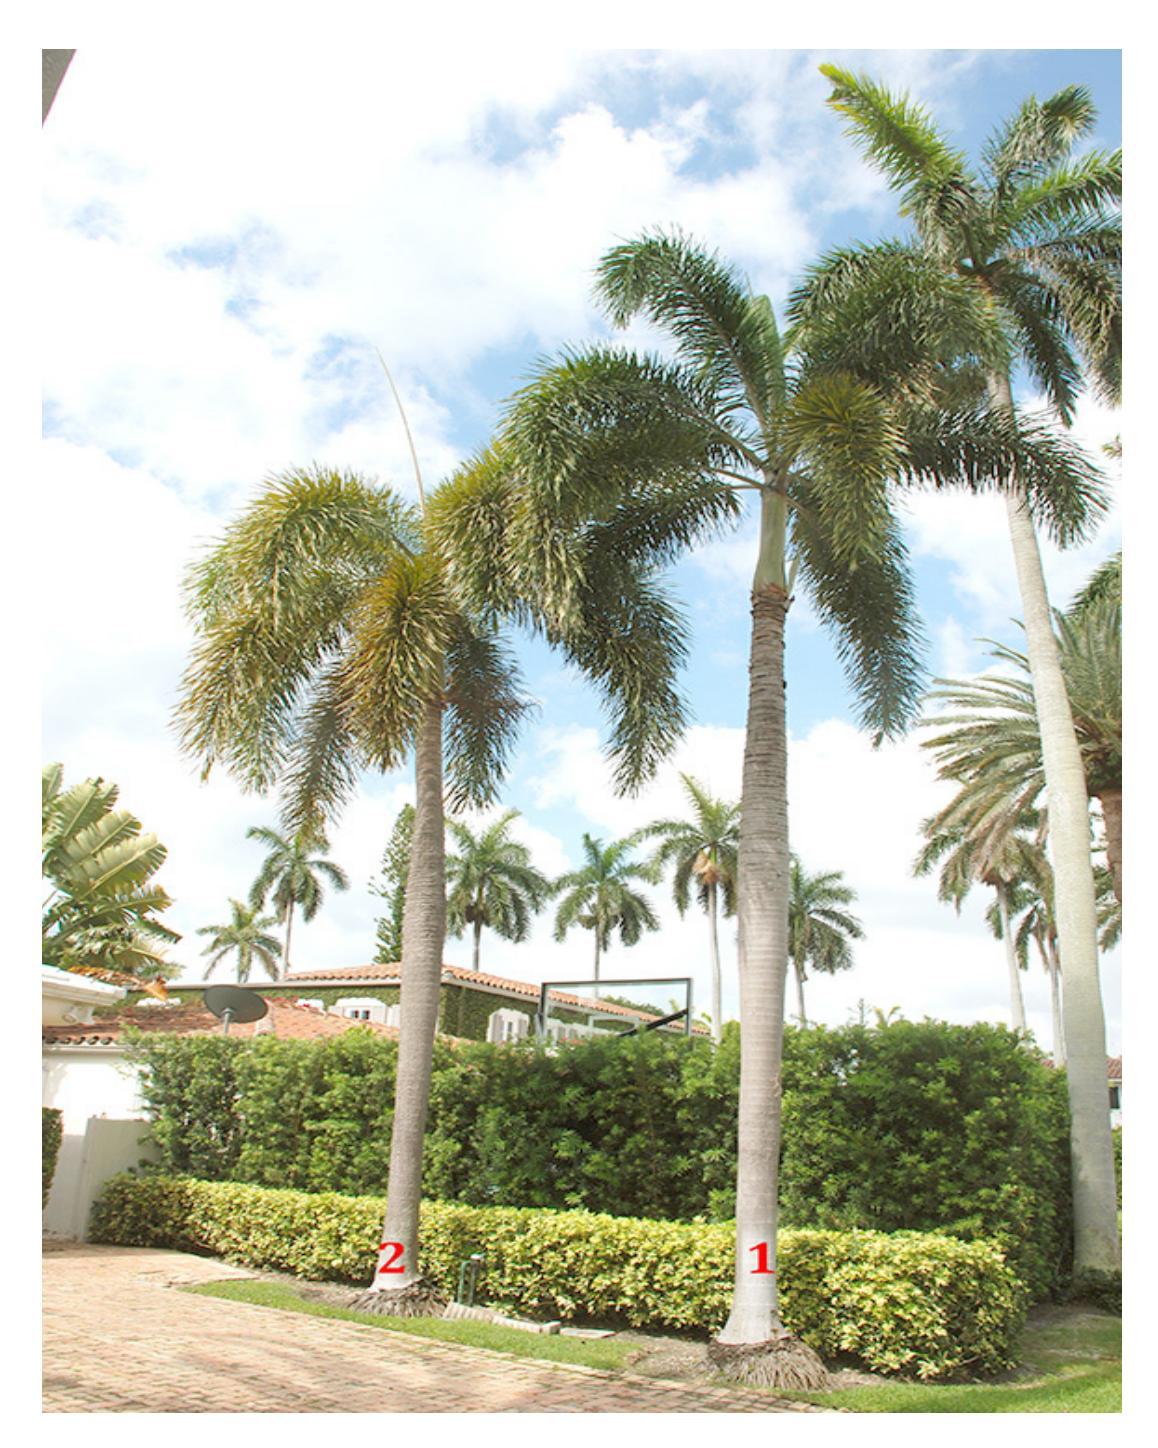
Photo 1 above is palms 1 & 2. Palm 2 is developing a correctable nutrient deficiency.

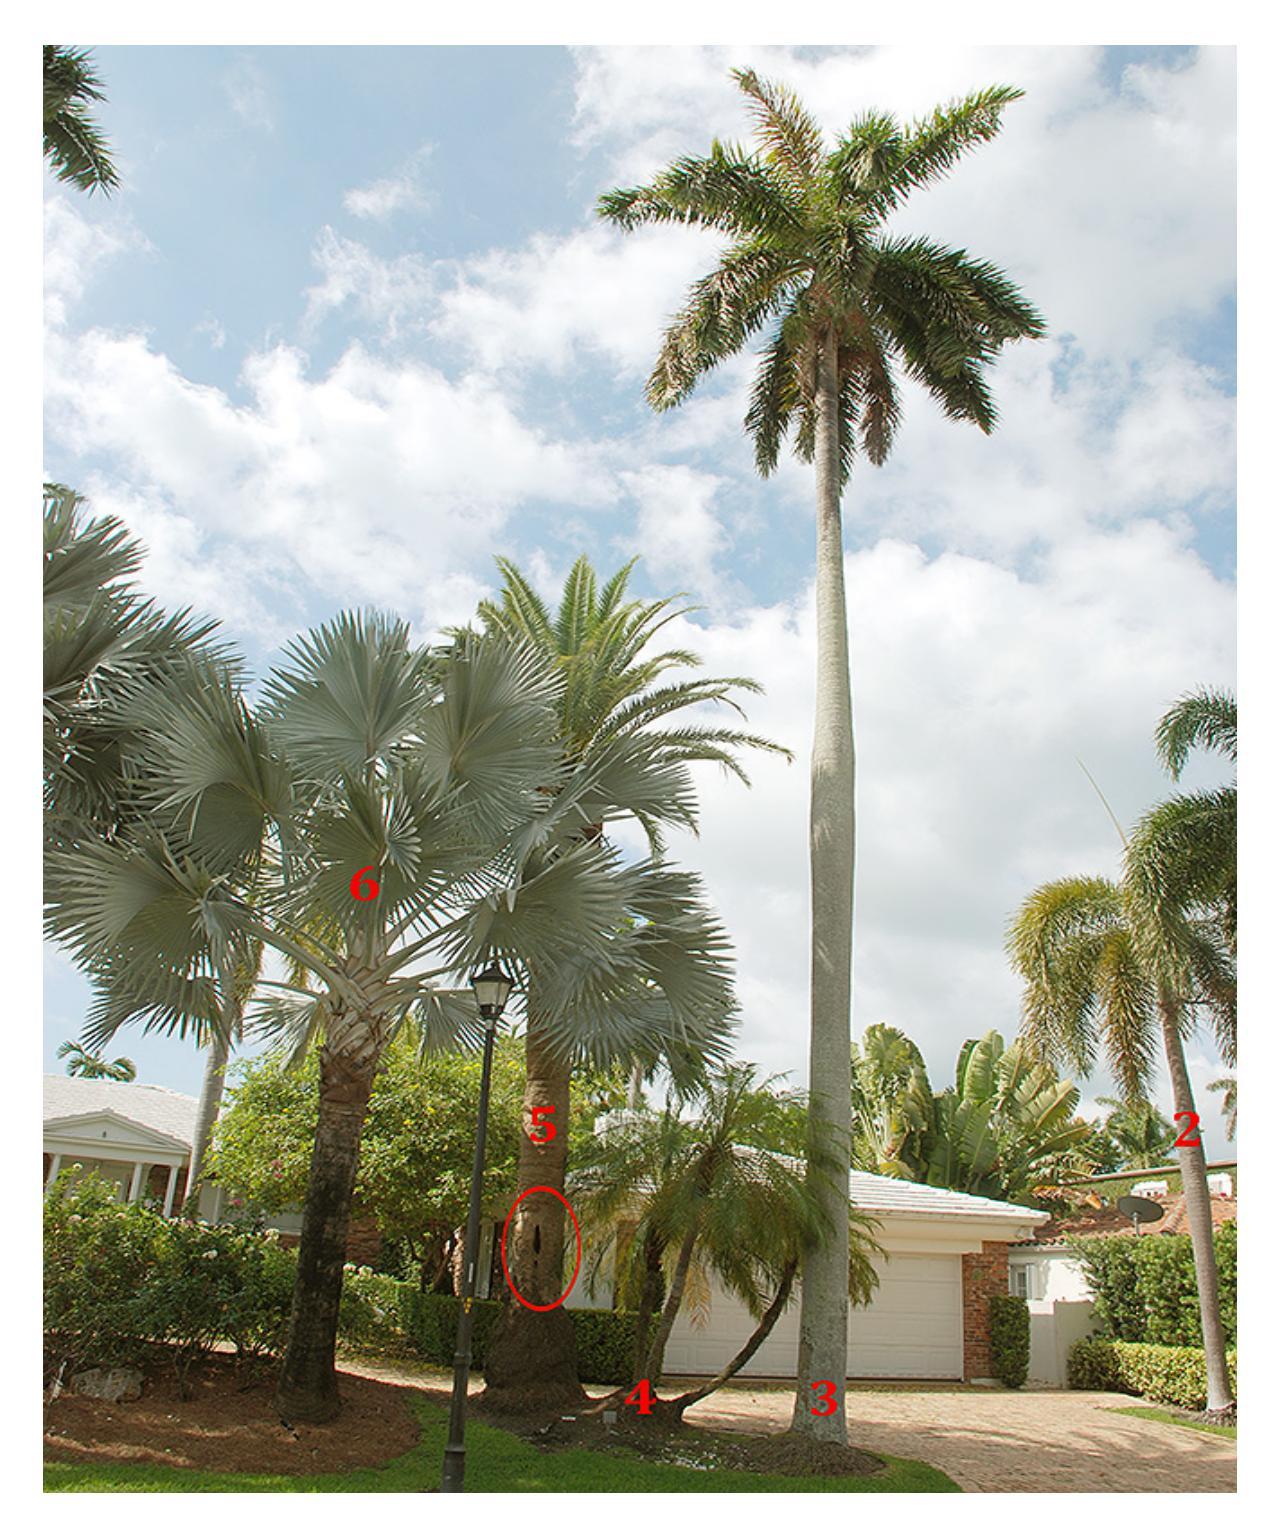
Photo 2 above is palms 3, 4, 5 & 6. Palm 3 appears to have Royal Palm bug on its fronds. This normally corrects itself without the use of pesticides.

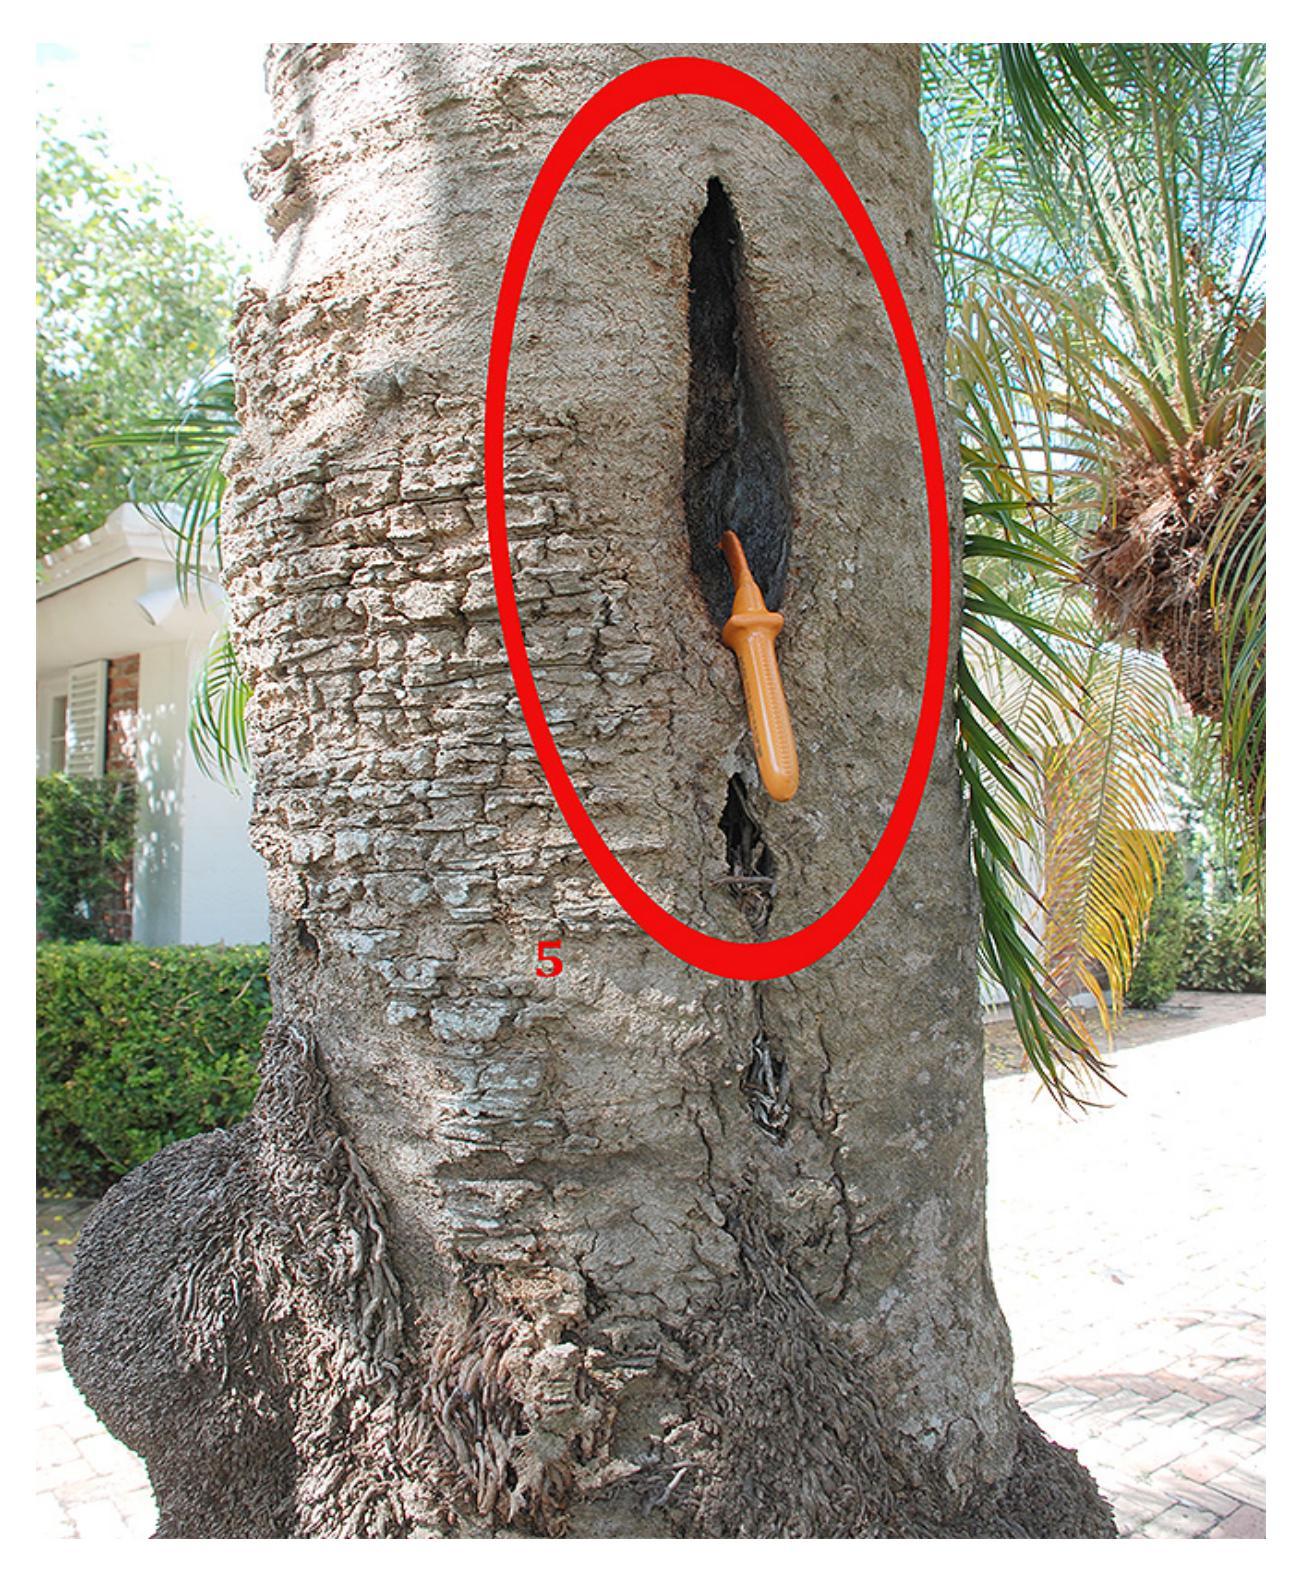
Photo 3 above is the trunk of palm 5. There is a cavity that is about 3 inches deep. There does not appear to be active decay inside. I do not recommend the relocation of this palm. The orange knife is 7 inches in length.

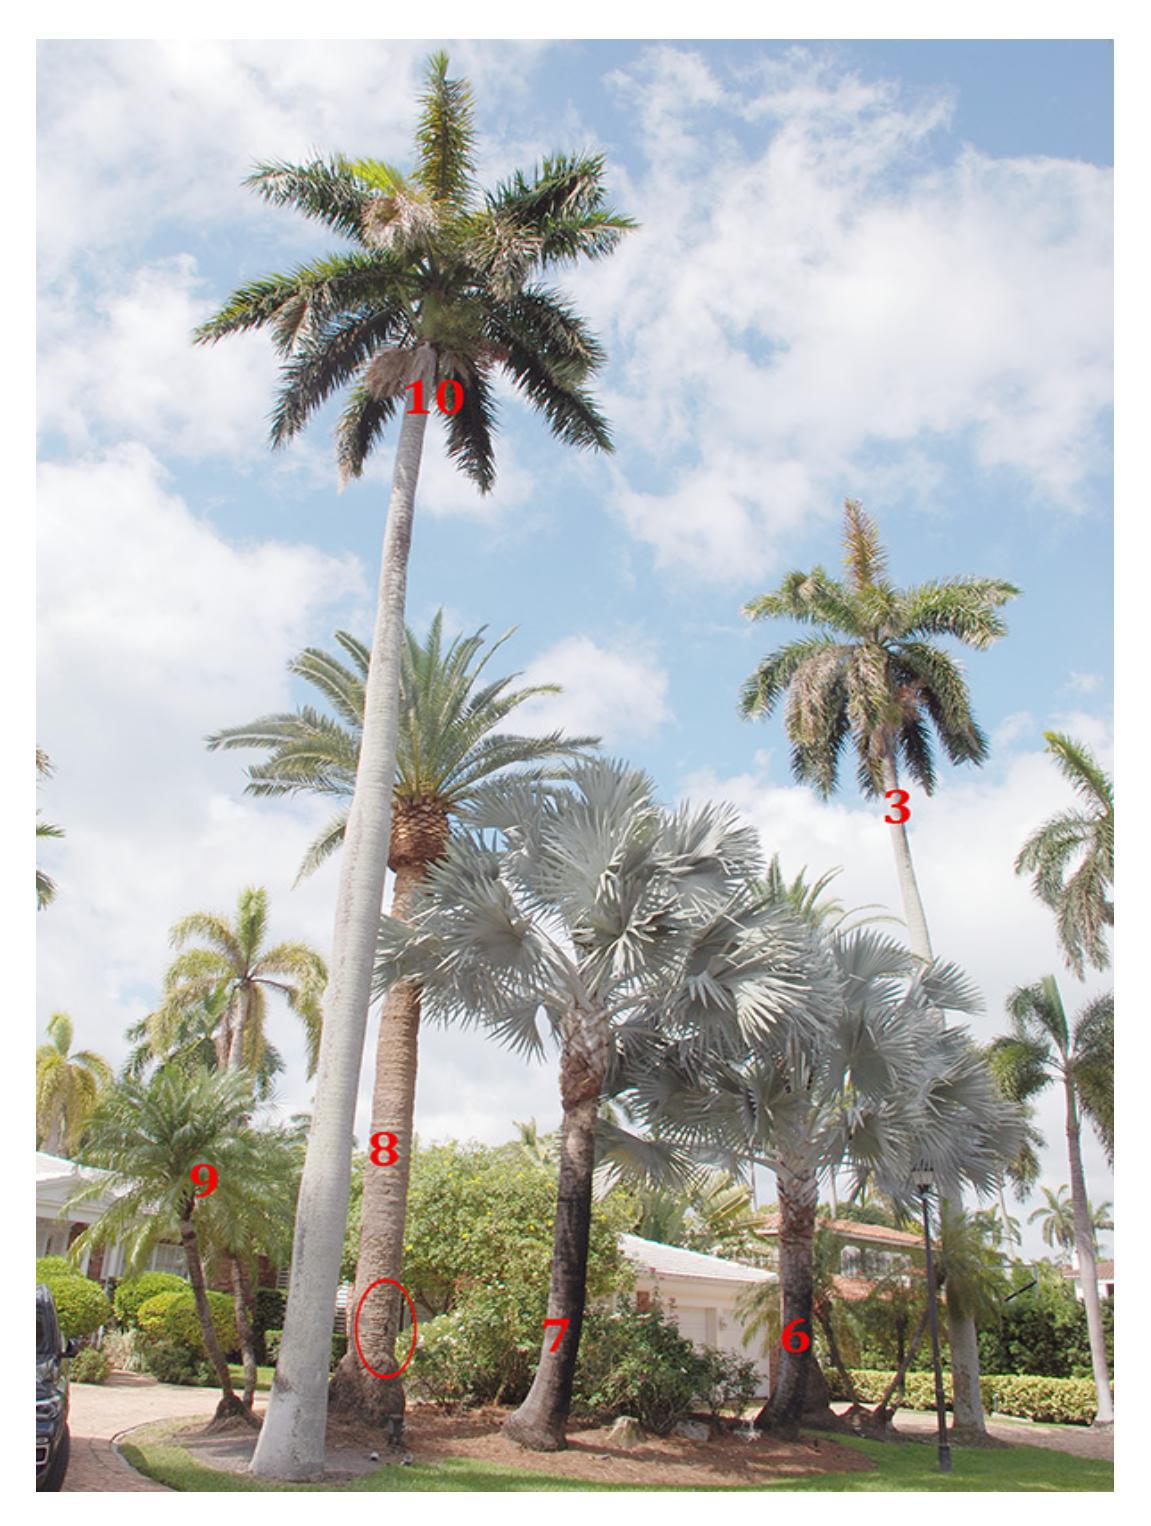
Photo 3 above is palms 6, 7, 8 9 & 10. Palm 10 appears to have Royal Palm bug on its fronds. This normally corrects itself without the use of pesticides.

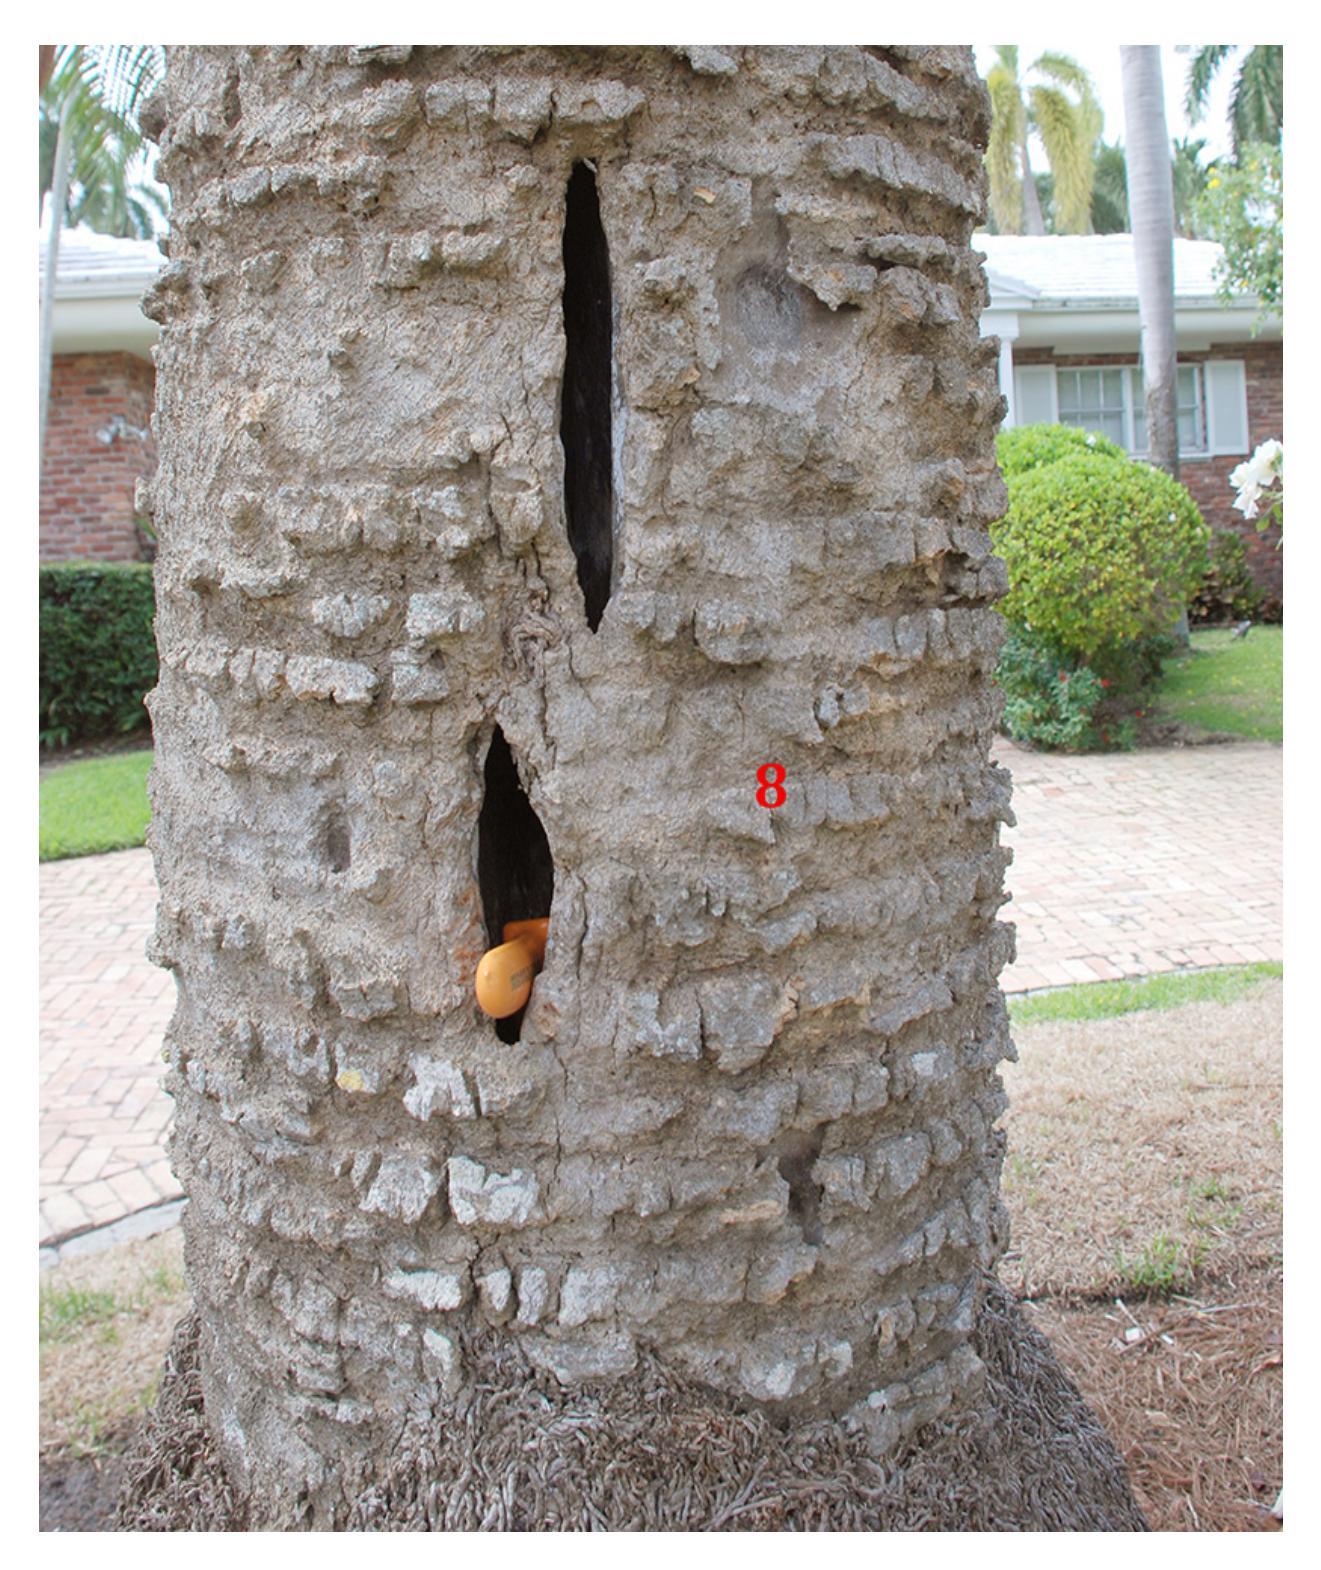
Photo 4 above is the trunk of palm 8. There is a cavity that is 5 to 6 inches deep. There does not appear to be active decay inside. I do not recommend the relocation of this palm. The orange knife is 7 inches in length.

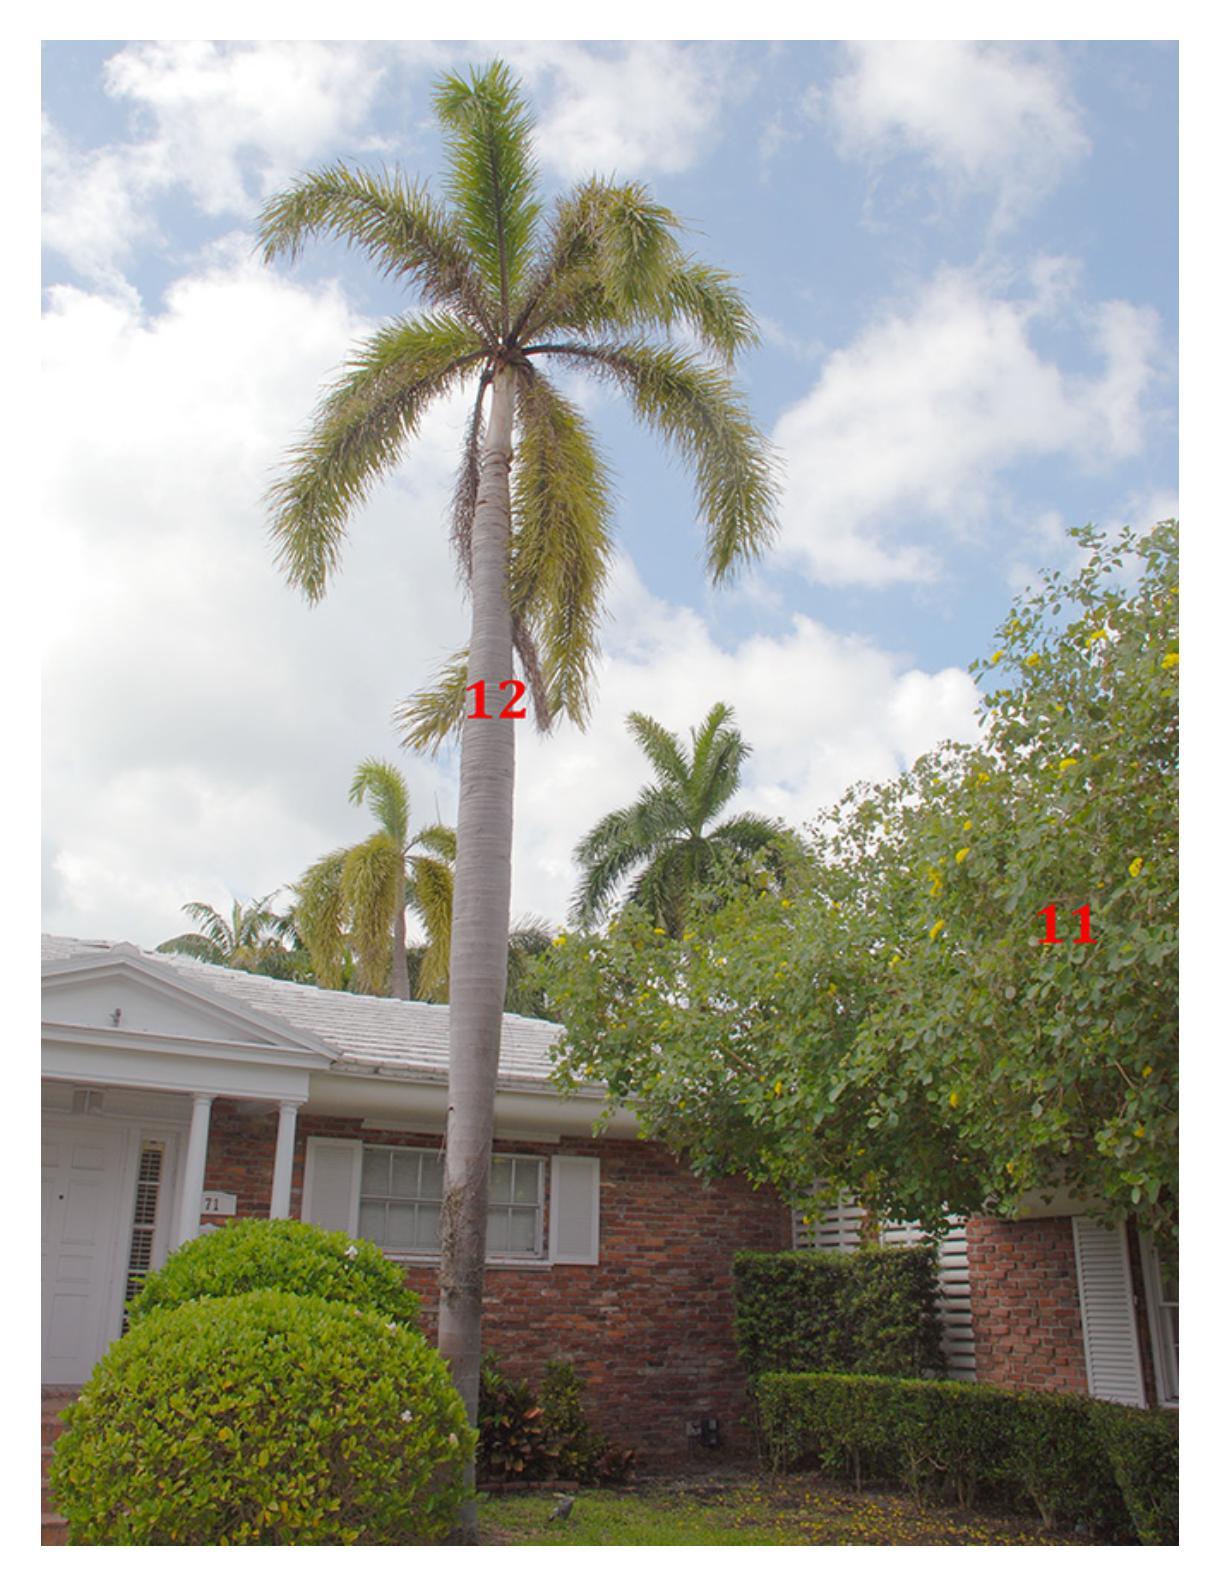
Photo 6 above is palm 12 showing signs of a severe nutrient deficiency. This palm should be removed.

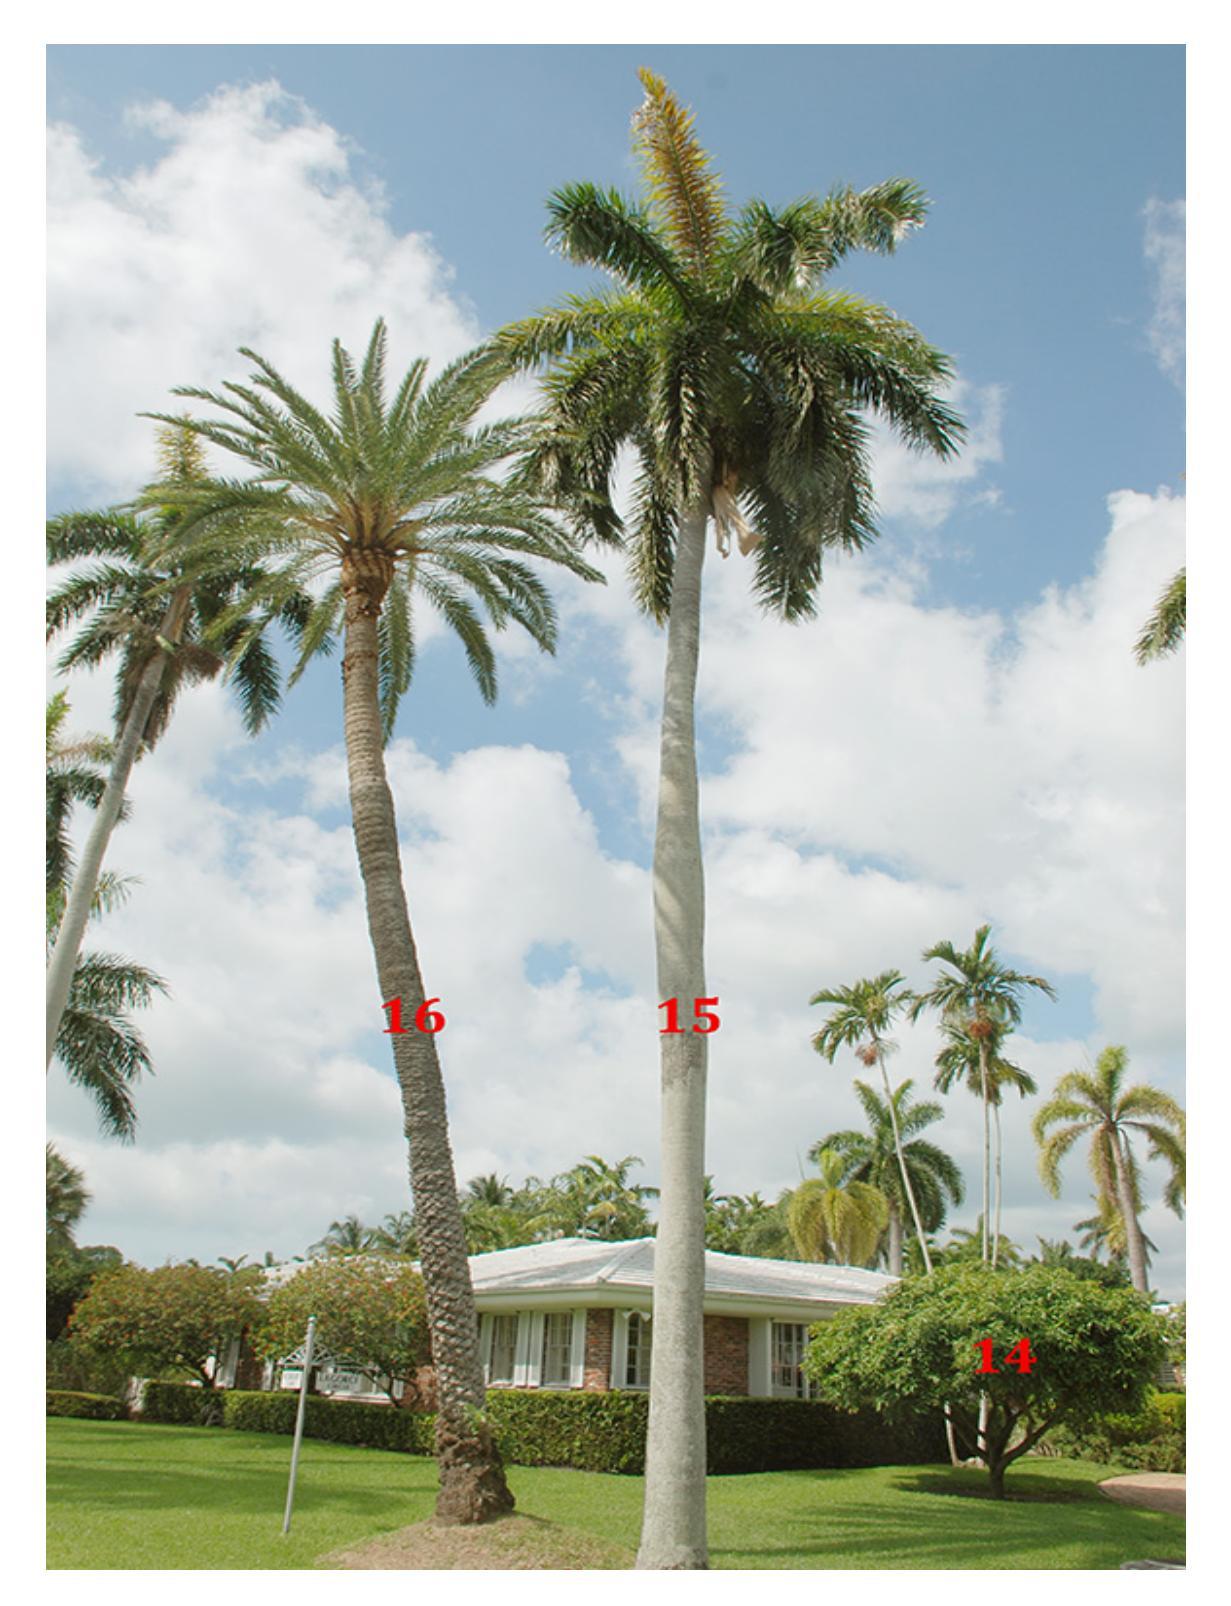
Photo 9 above is palms 15 & 16. Palm 15 appears to have Royal Palm bug on its fronds. This normally corrects itself without the use of pesticides.

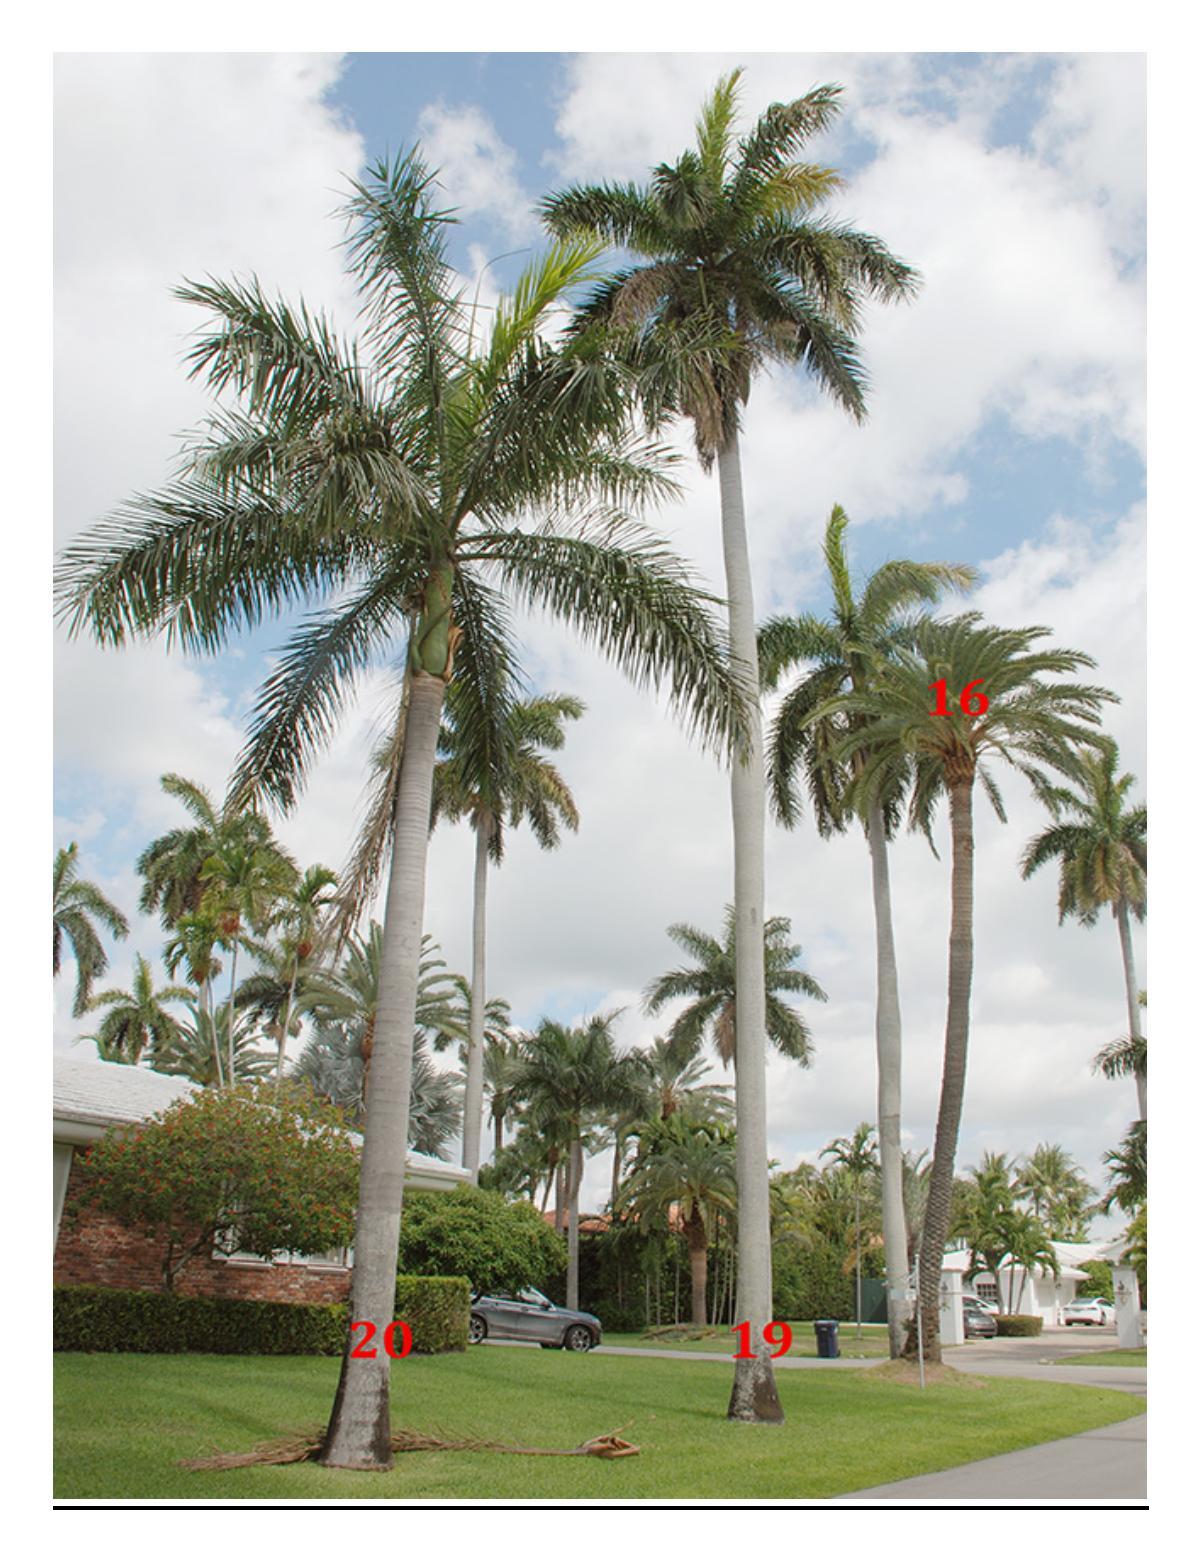
Photo 11 above is palms 19 & 20. Palm 19 appears to have Royal Palm bug on its fronds. This normally corrects itself without the use of pesticides.

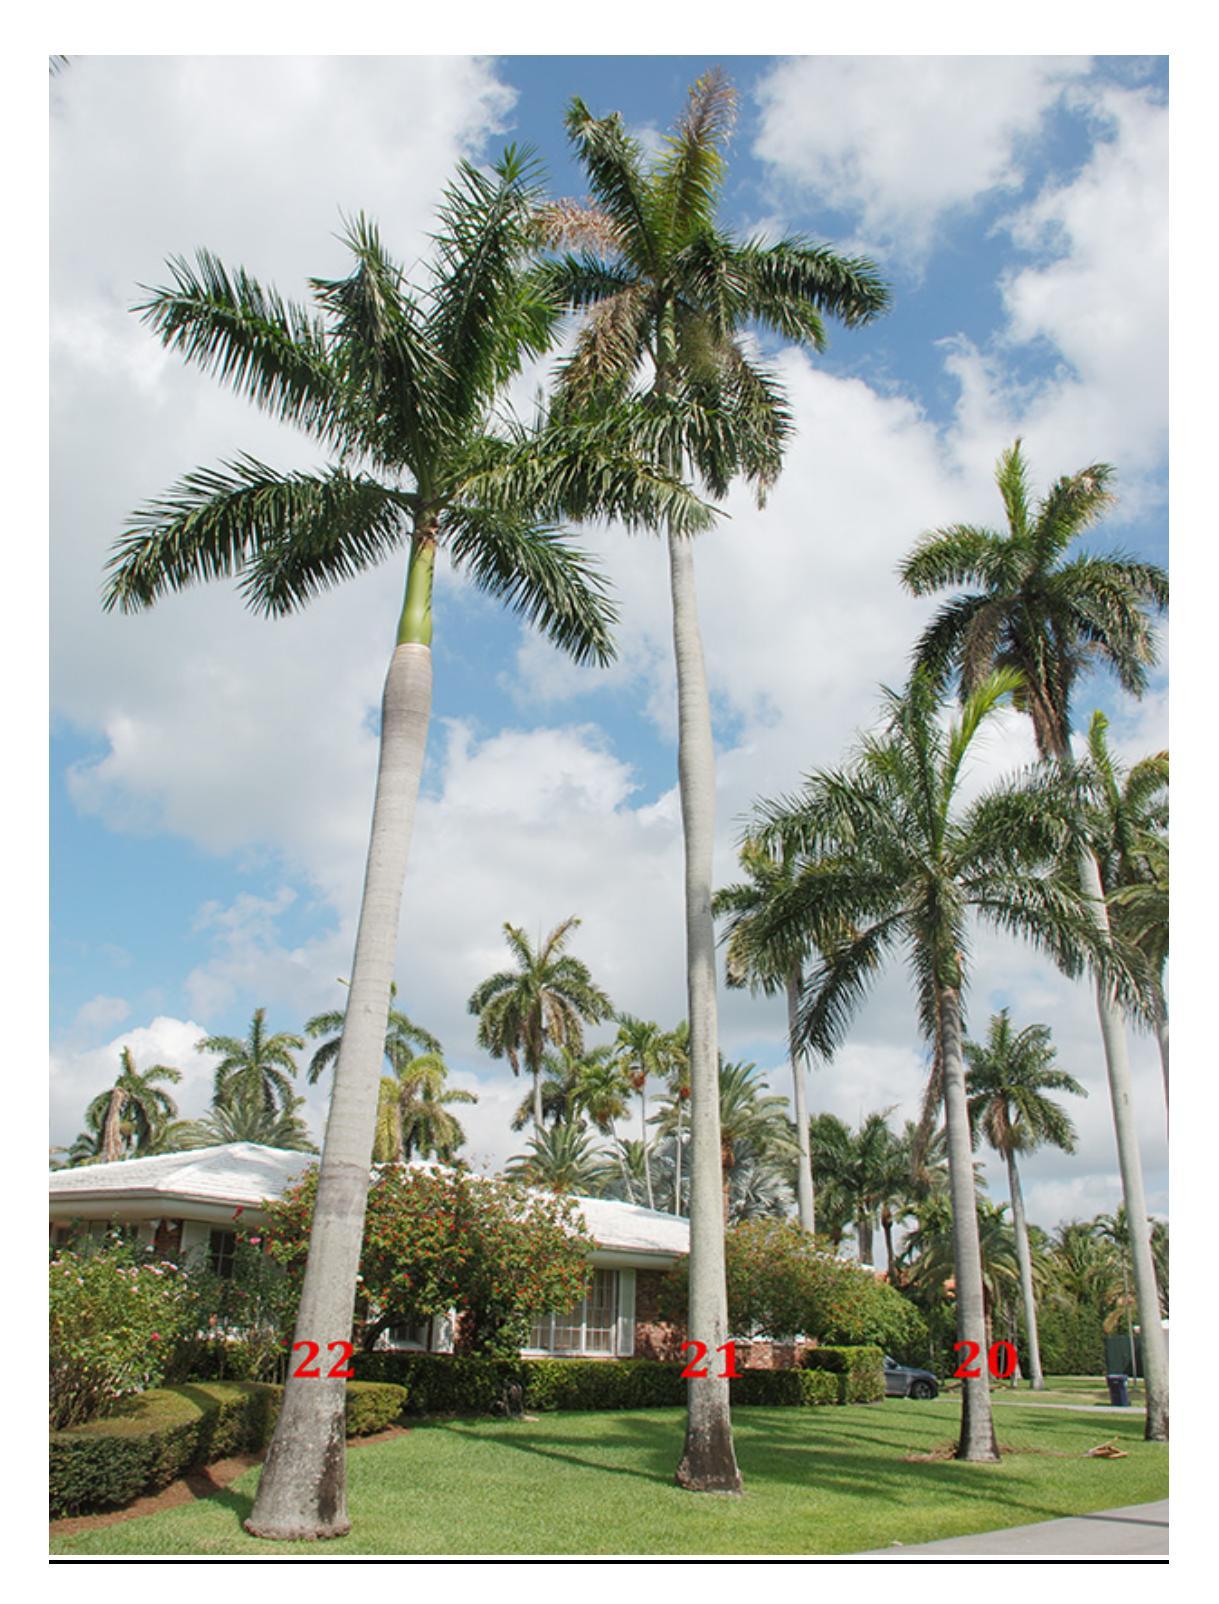
Photo 12 above is palms 20, 21 & 22. Palm 21 appears to have Royal Palm bug on its fronds. This normally corrects itself without the use of pesticides.

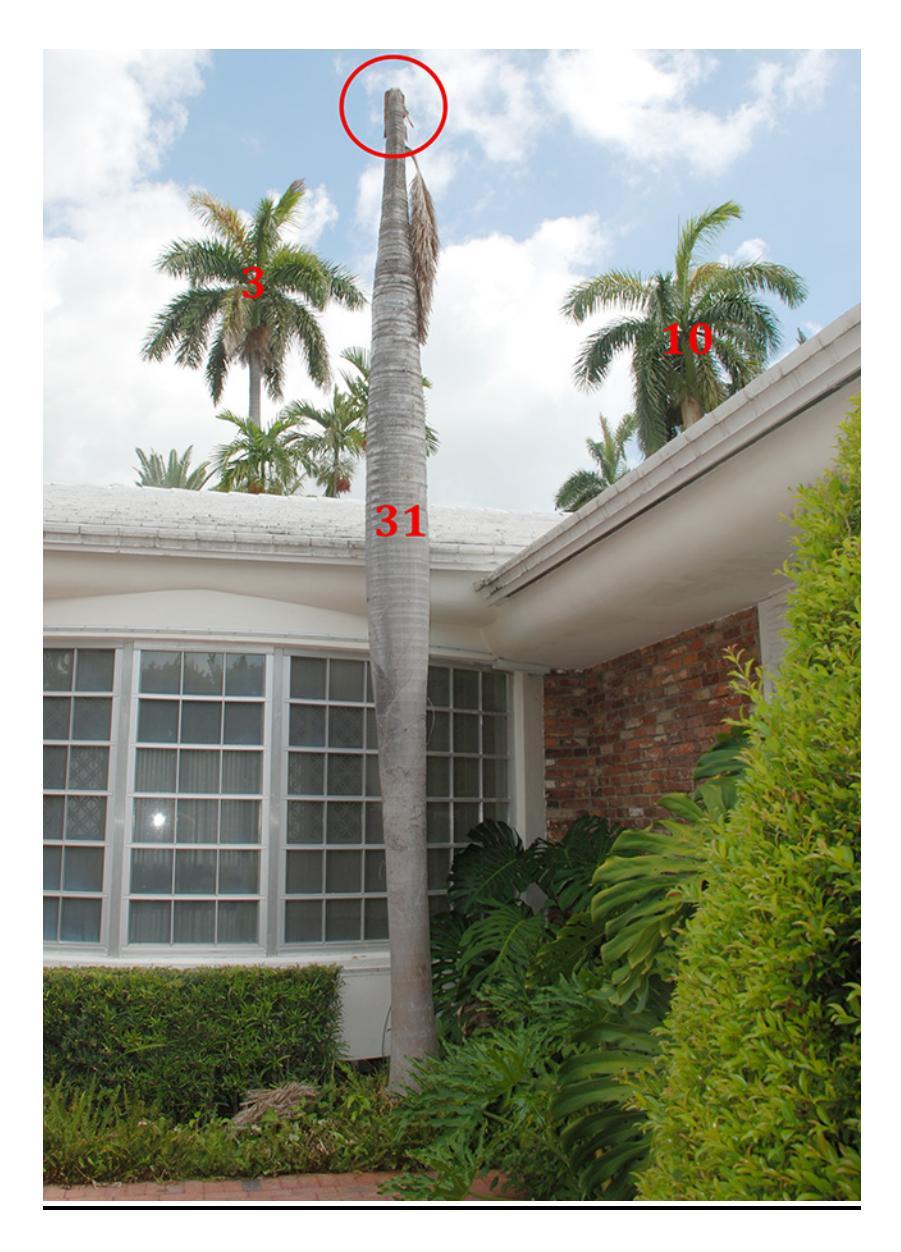
Photo 17 above is dead palm 31.

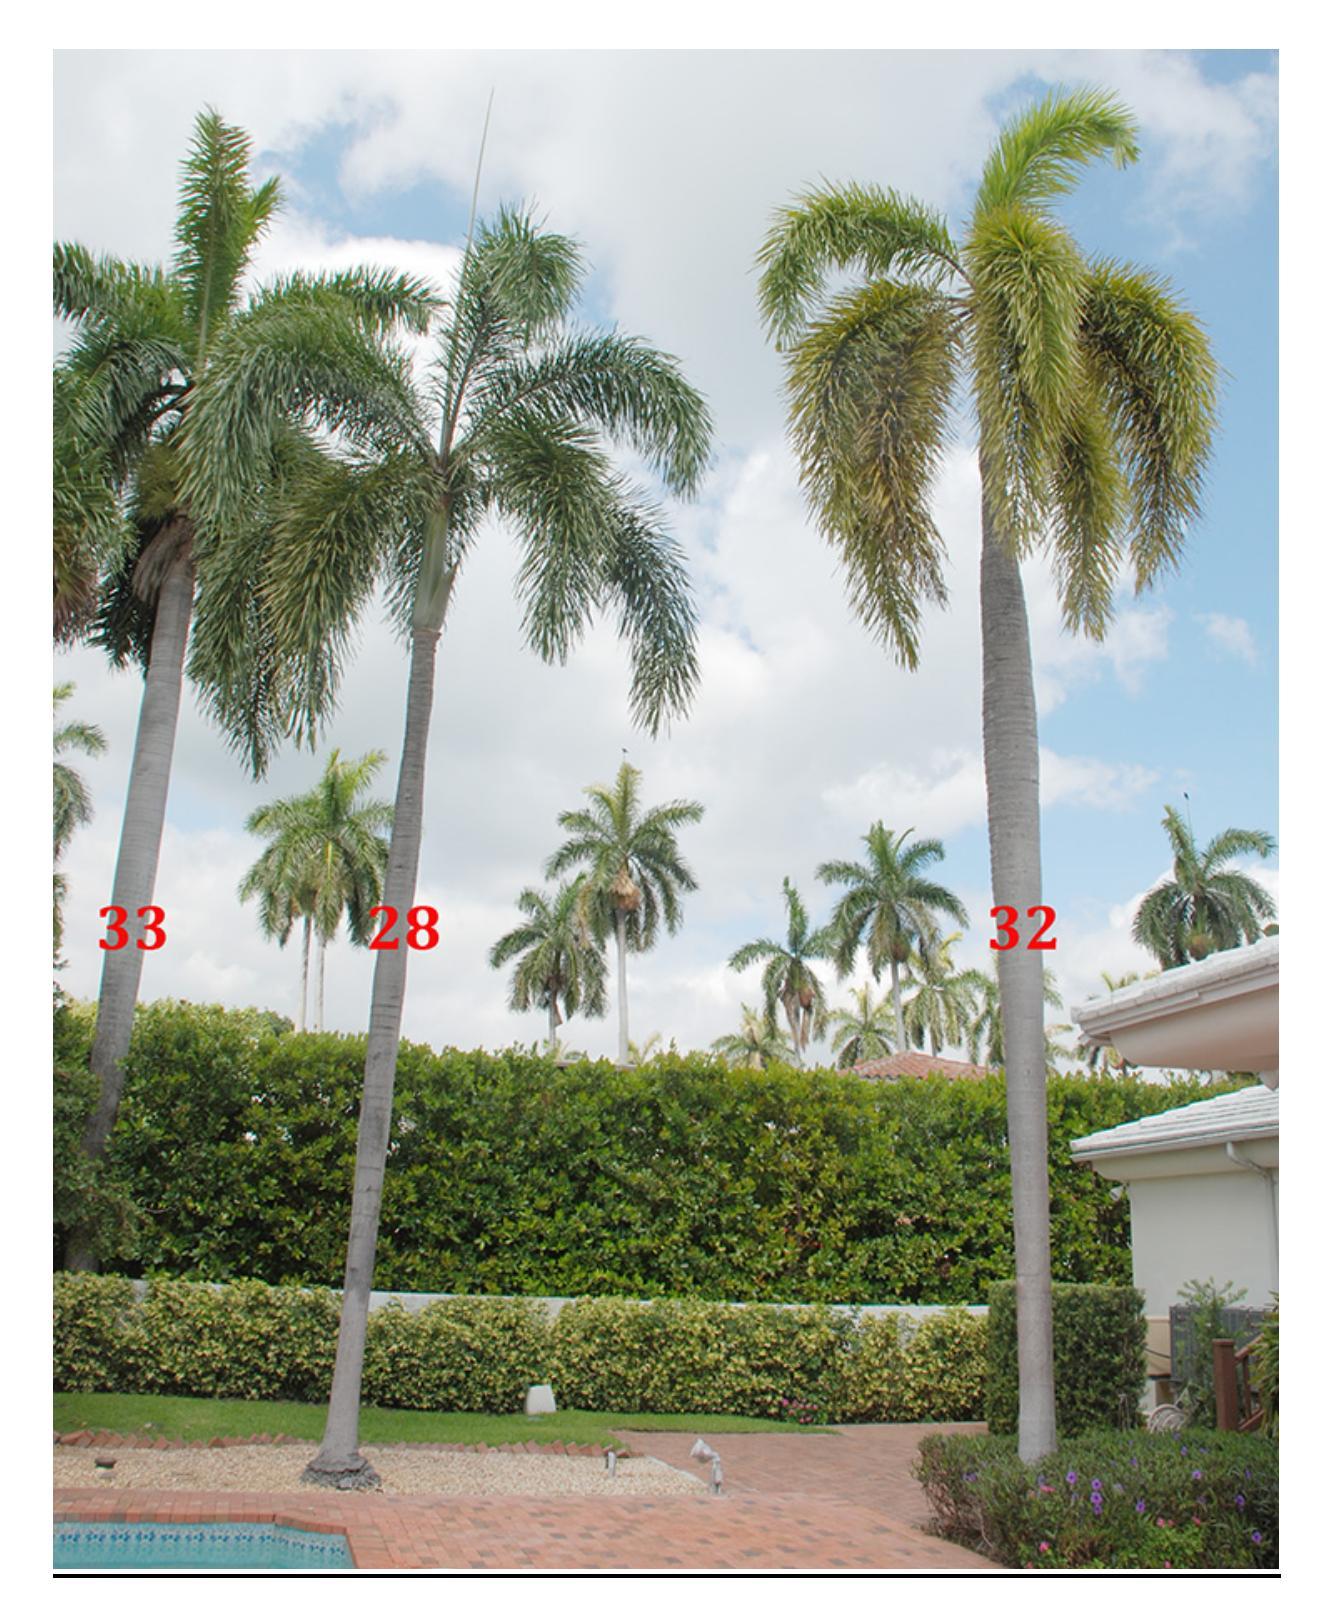
Photo 18 above is palms 28 & 33. Palm 32 has a severe nutrient deficiency and should be removed.
