# FOUNTAINBLEAU SOUTH GARAGE & BALLROOM

## 4360-4370 Collins Avenue

Re: 4441 Collins Avenue Miami Beach, FL

I visited the above-mentioned property on Sunday, March 15, 2020 to evaluate 72 trees, verify condition and measurements, take photographs and note any significant defects.

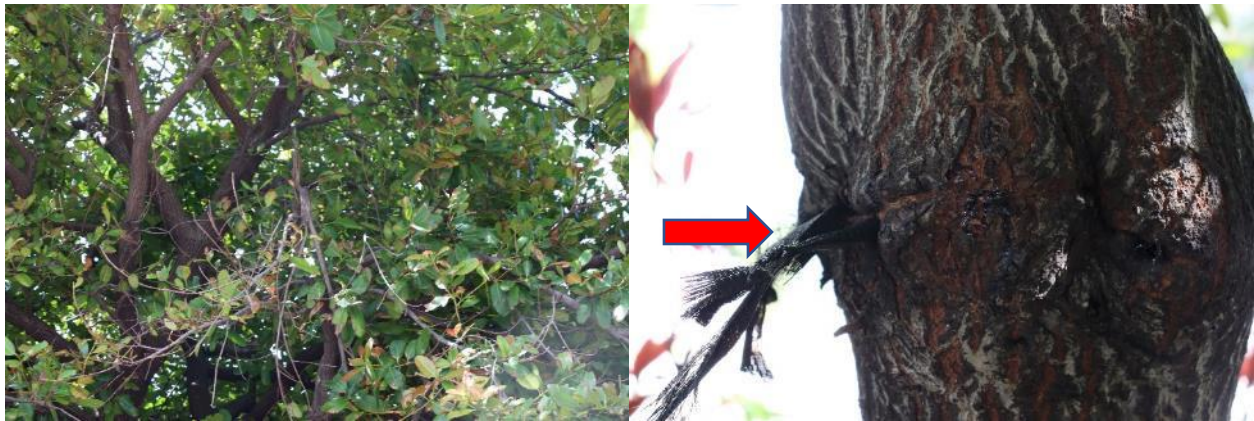
Tree One

Brazilian Beautyleaf (*Calophyllum brasiliense*), facing west.

Note trunk girdling (bracing straps) (red arrow), and trunk lean (south).

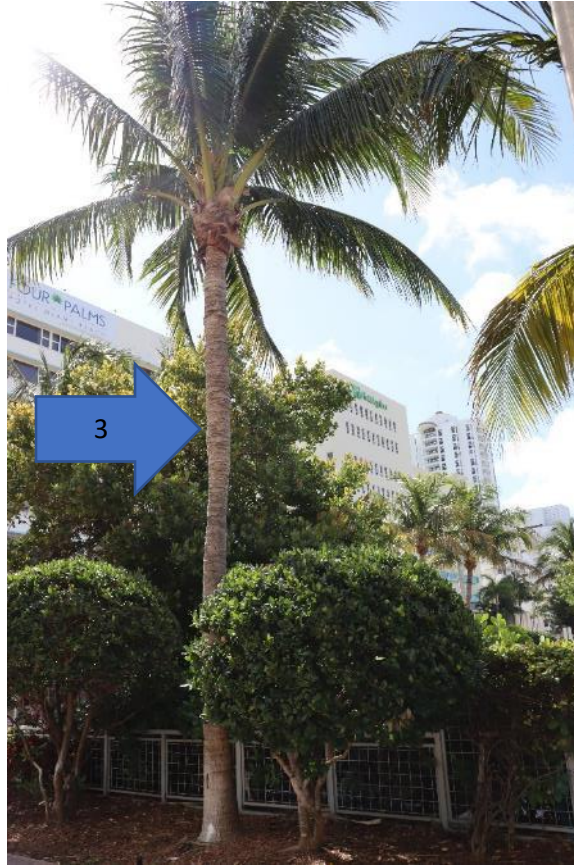
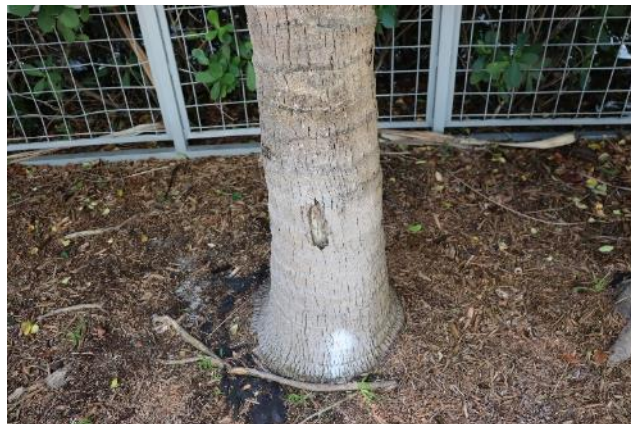
### Tree Three

Coconut Palm (*Cocos nucifera*), facing south.

Note trunk wound and nutrient deficiencies.

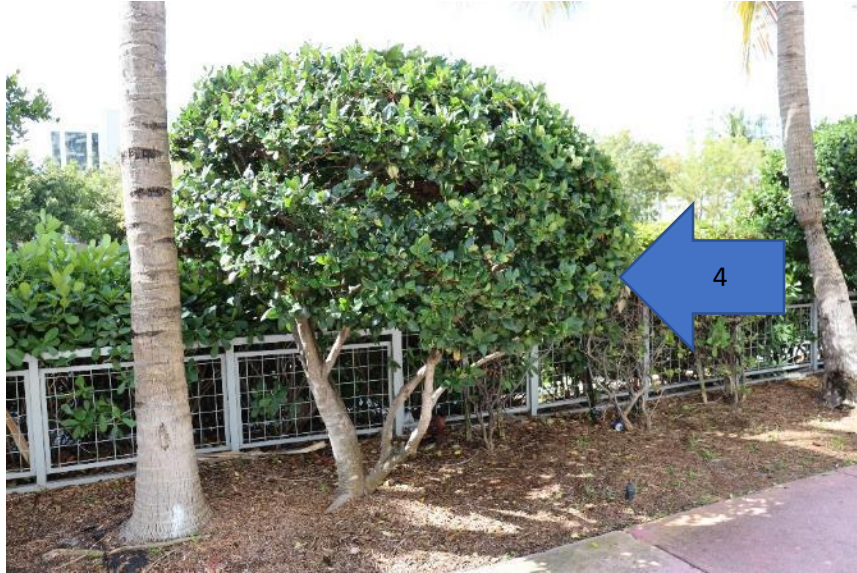
Tree Four

Ligustrum (*Ligustrum japonicum*), facing south.

Note poor structure, shaping and deadwood.

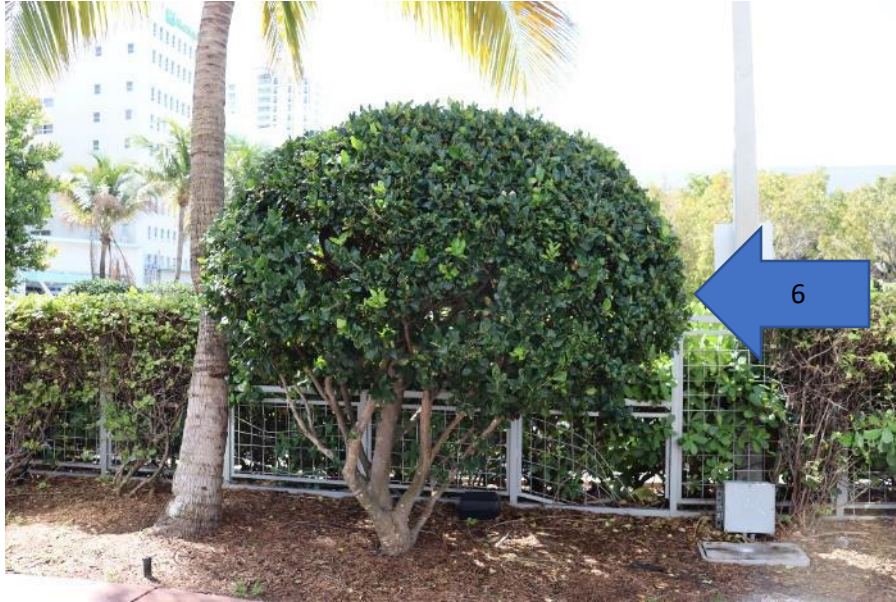
Tree Six

Ligustrum (*Ligustrum japonicum*), facing south.

Note poor structure and shaping.

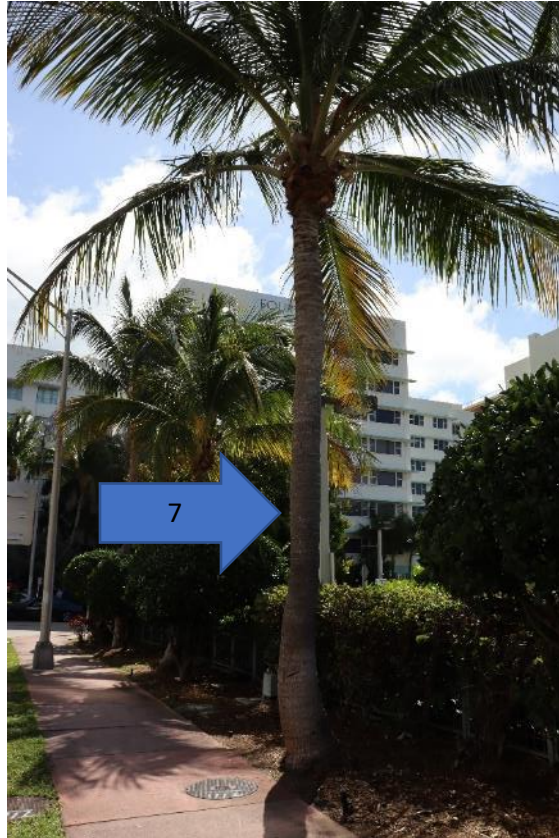
Tree Seven

Coconut Palm (*Cocos nucifera*), facing east.

Note trunk wounds (red arrow).

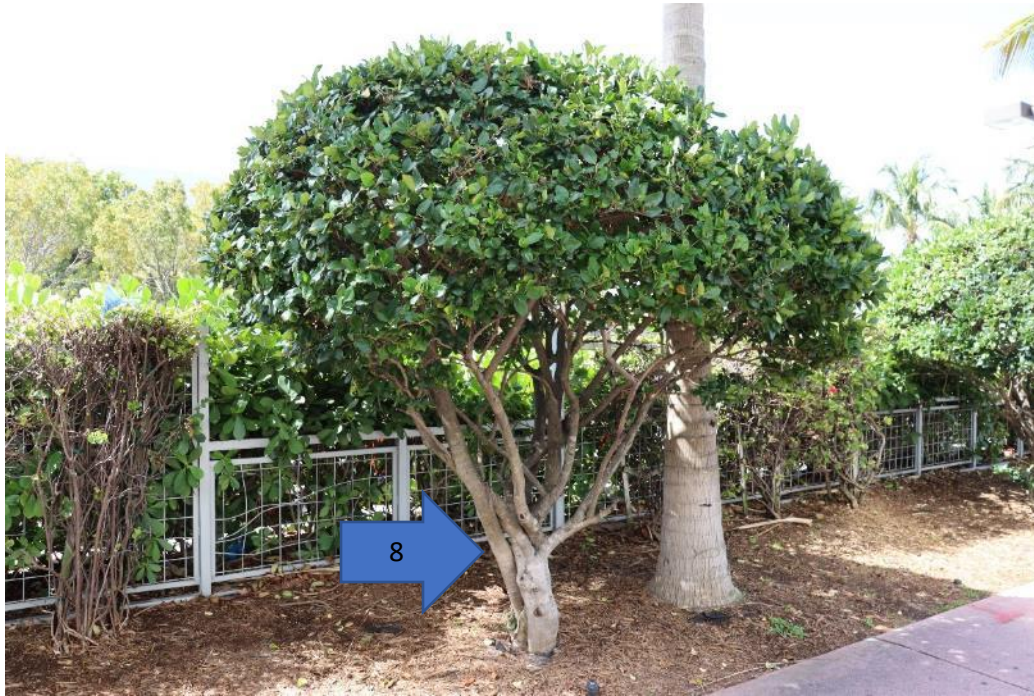
Tree Eight

Ligustrum (*Ligustrum japonicum*), facing south.

Note poor structure and shaping.

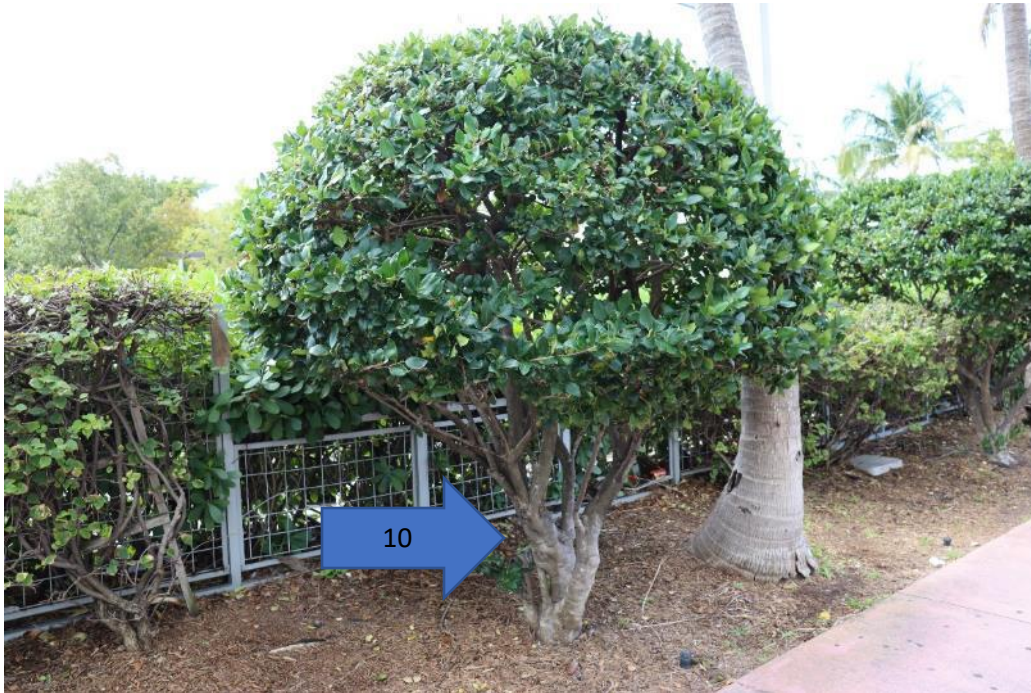
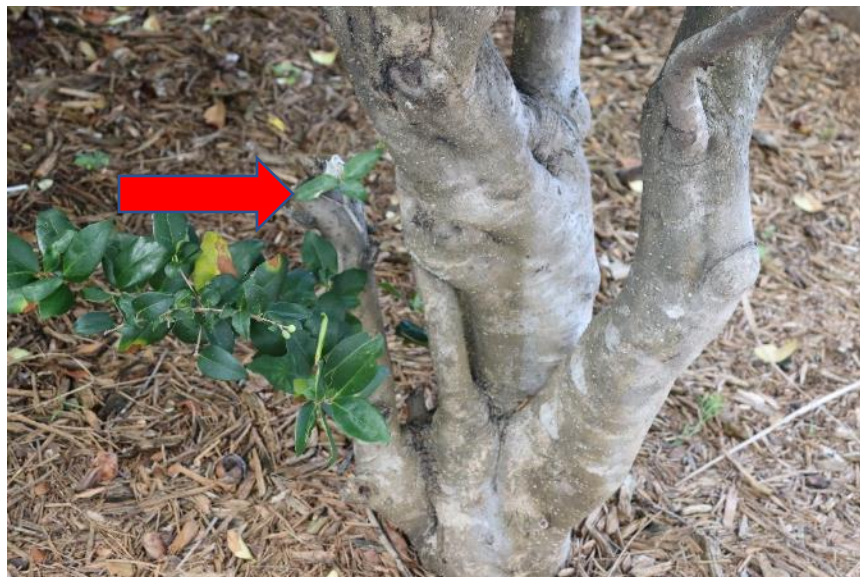
Tree Ten

Ligustrum (*Ligustrum japonicum*), facing west.

Note poor structure and stub cuts (red arrow).

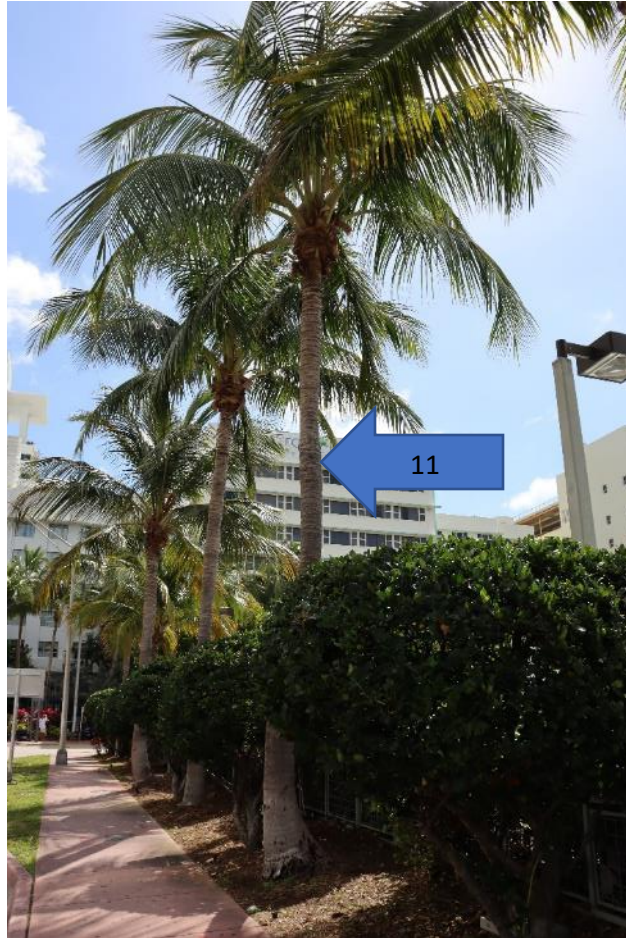
Tree Eleven

Coconut Palm (*Cocos nucifera*), facing east.

Note trunk wounds.

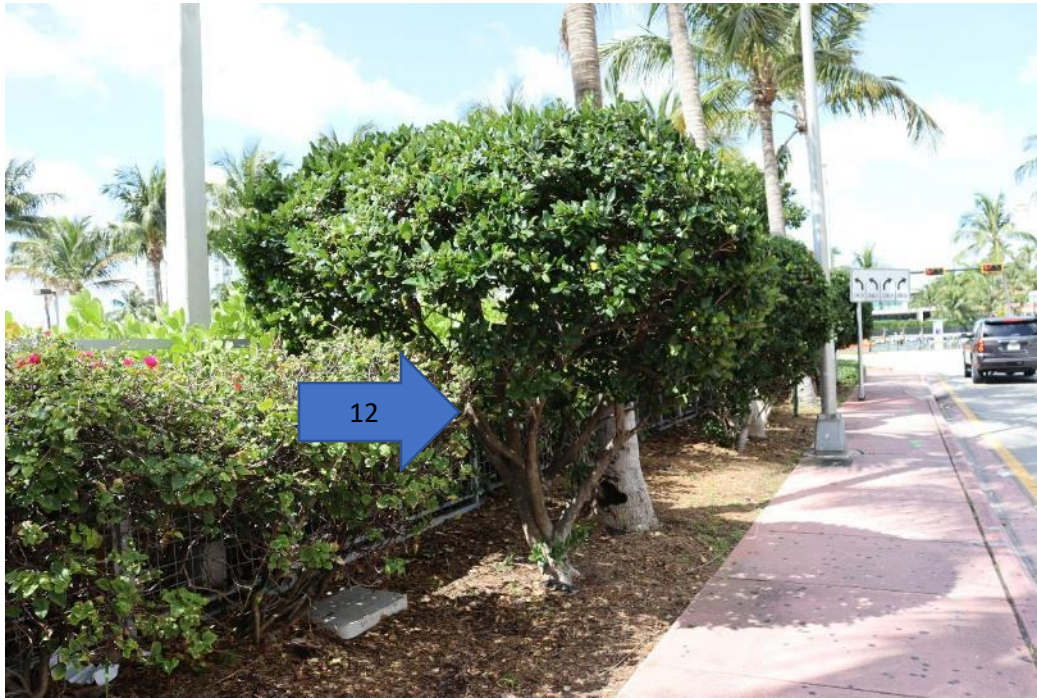
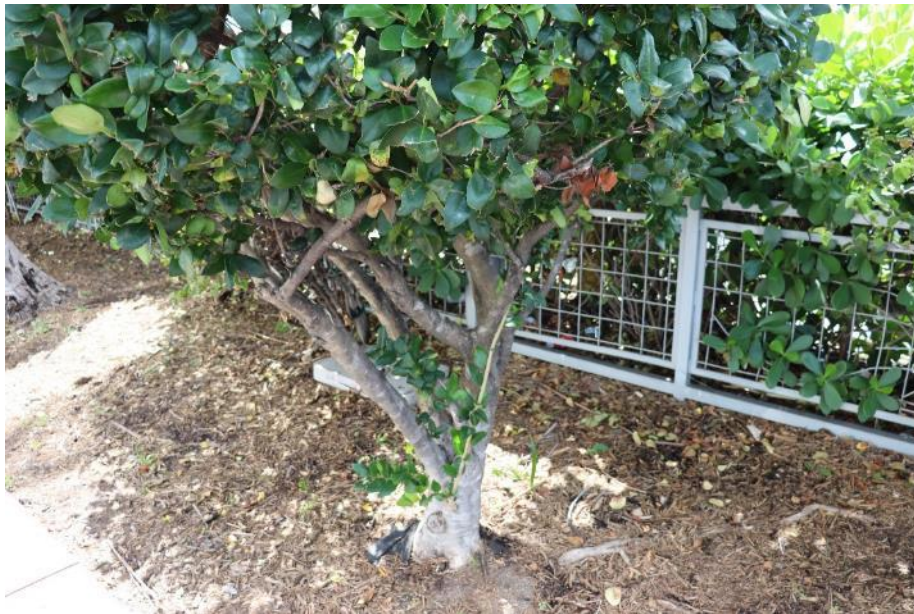
### Tree Twelve

Ligustrum (*Ligustrum japonicum*), facing west.

Note poor structure, shaping and flush cuts.

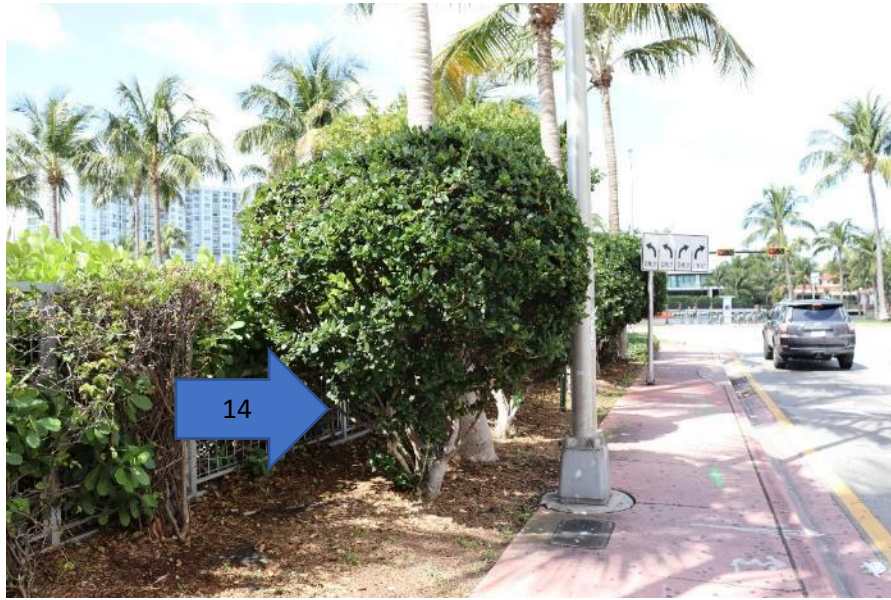
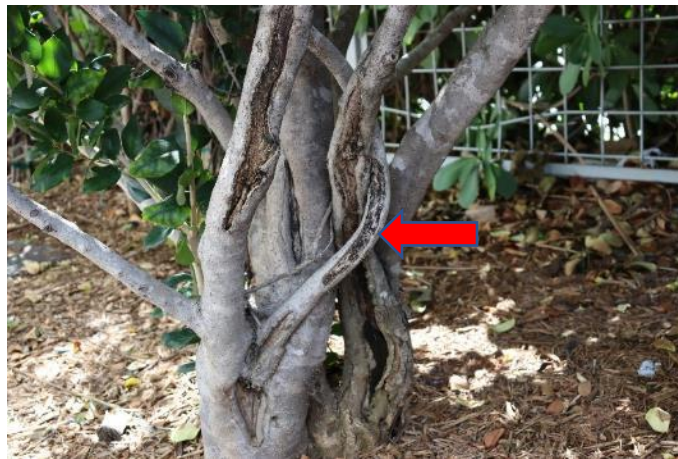
Tree Fourteen

Ligustrum (*Ligustrum japonicum*), facing west.

Note visual evidence of decay (red arrow), shaping and poor structure.

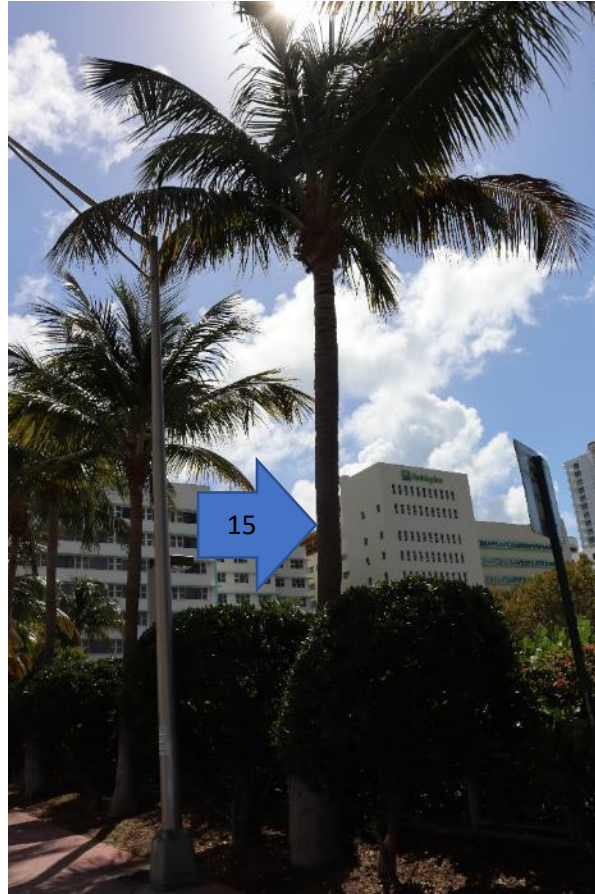
Tree Fifteen

Coconut Palm (*Cocos nucifera*), facing east.

Note trunk wounds.

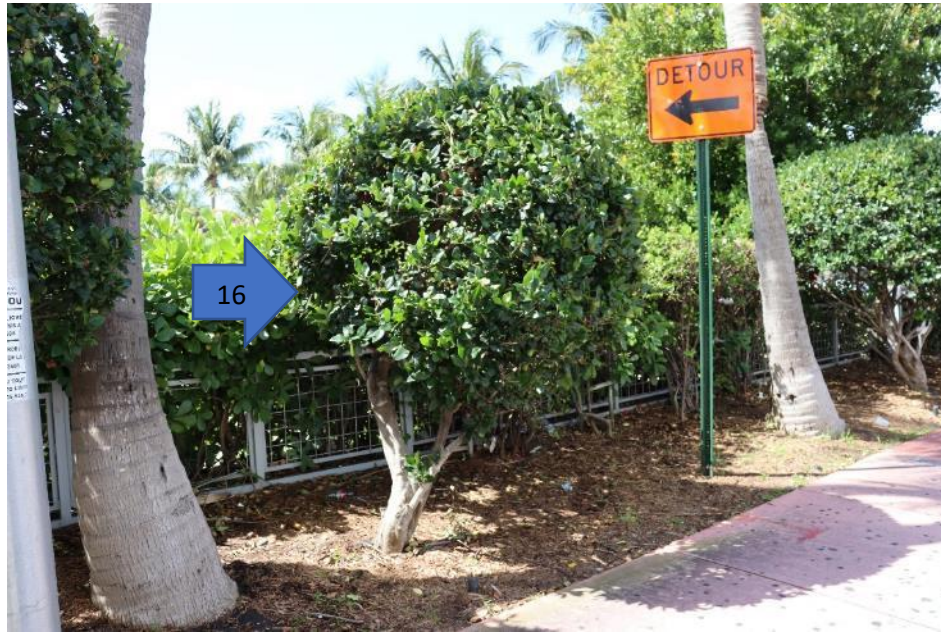
Tree Sixteen

Ligustrum (*Ligustrum japonicum*), facing west.

Note shaping and poor structure.

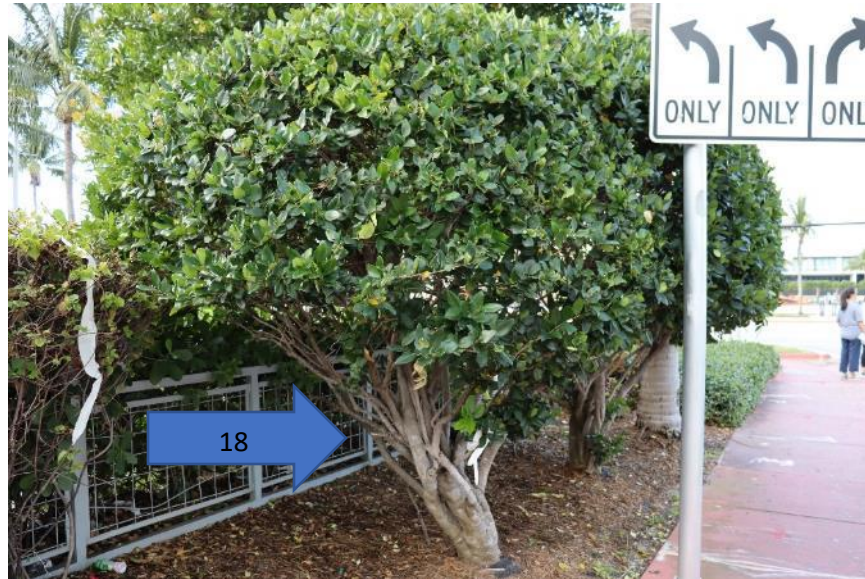
### Tree Eighteen

Ligustrum (*Ligustrum japonicum*), facing west.

Note poor structure, deadwood (red arrow) and shaping.

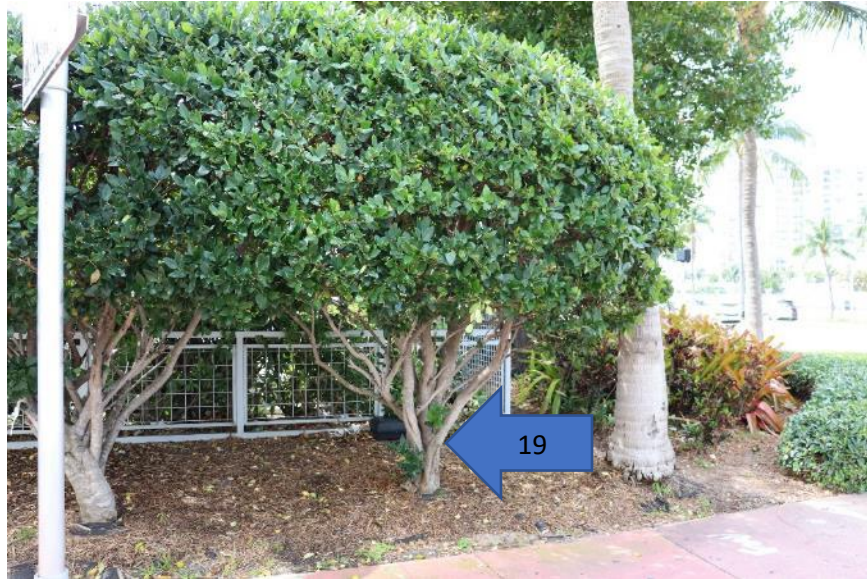
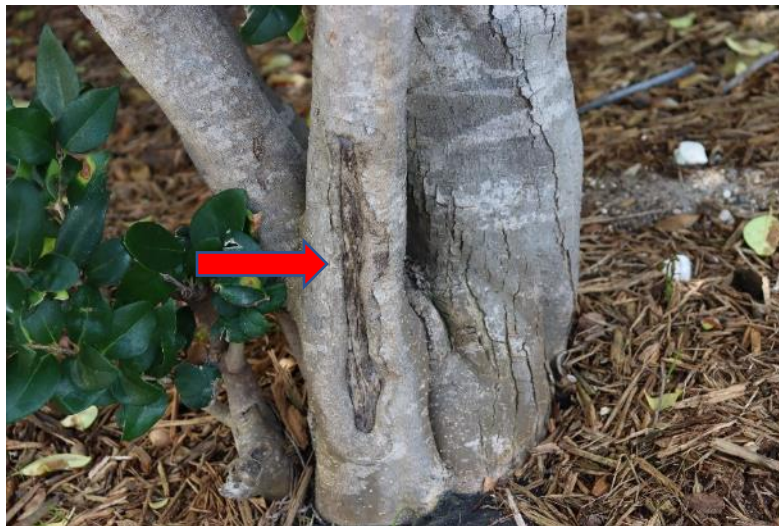
Tree Nineteen

Ligustrum (*Ligustrum japonicum*), facing south.

Note visual evidence of decay (red arrow), poor structure and shaping.

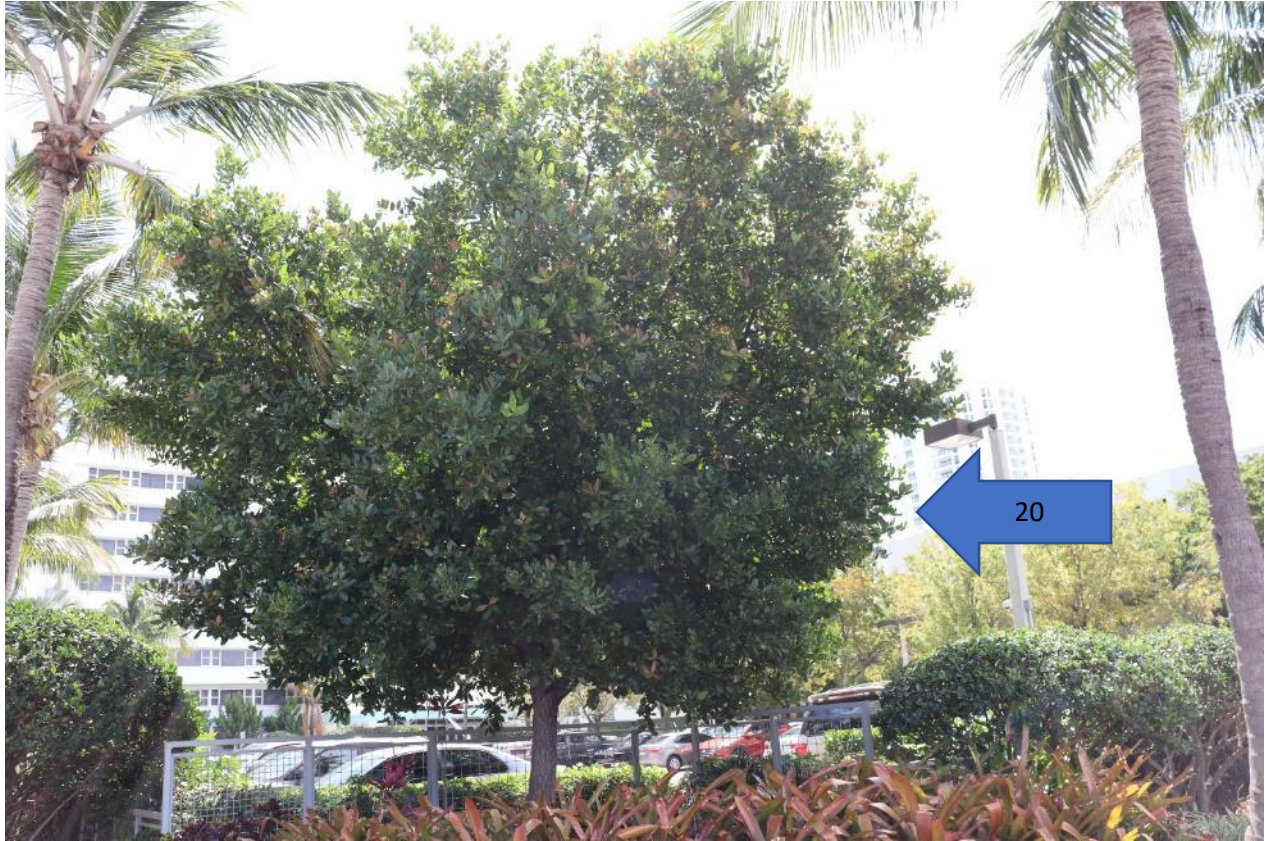
Tree Twenty

Brazilian Beautyleaf (*Calophyllum brasiliense*), facing east.

Note poor structure and trunk girdling (straps) (red arrow).

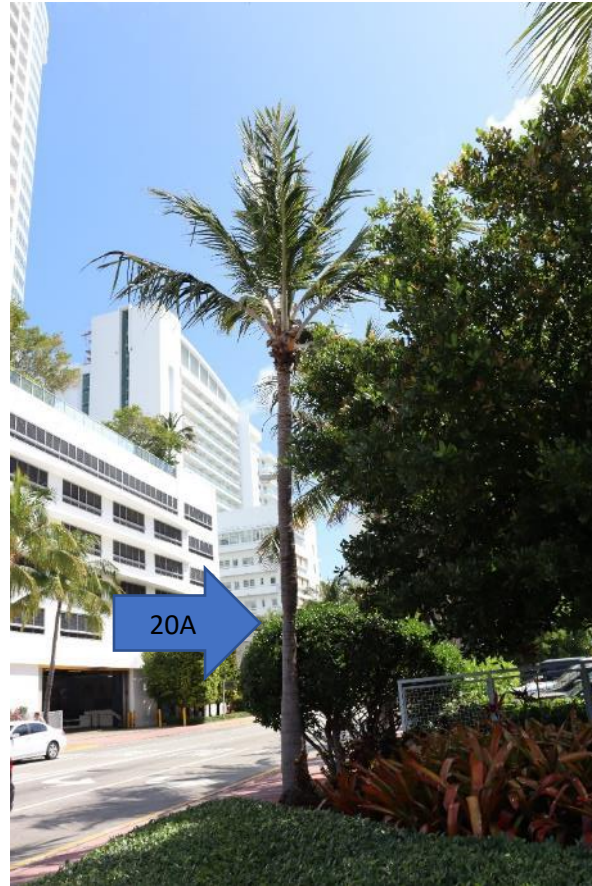
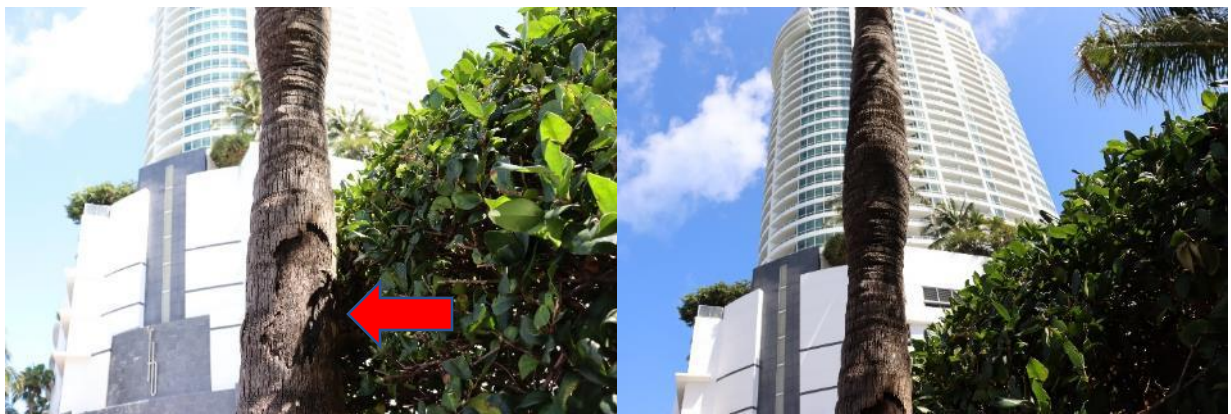
Tree Twenty A

Coconut Palm (*Cocos nucifera*), facing east.

Note pencilling and large trunk wound (red arrow).

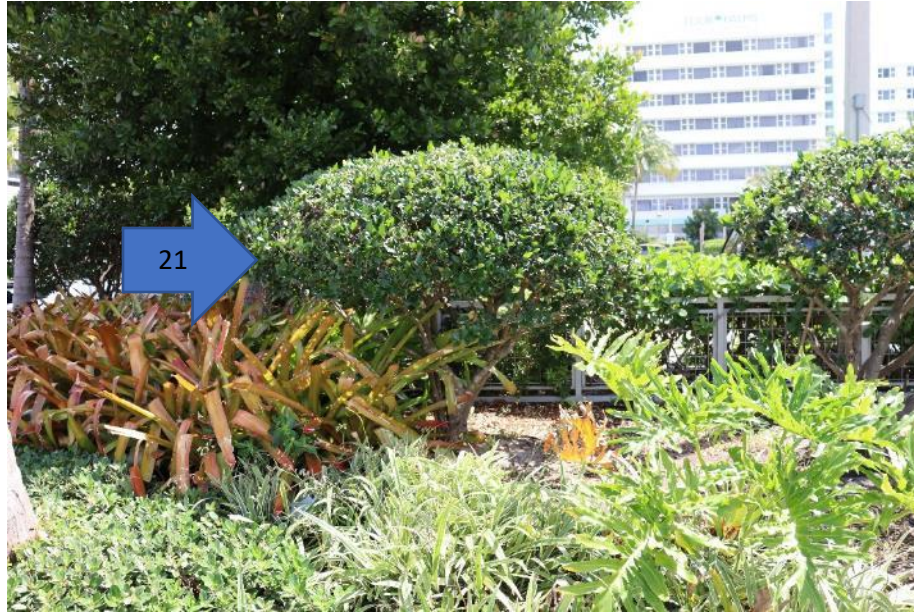
Tree Twenty-One

Ligustrum (*Ligustrum japonicum*), facing east.

Note shaping and poor structure.

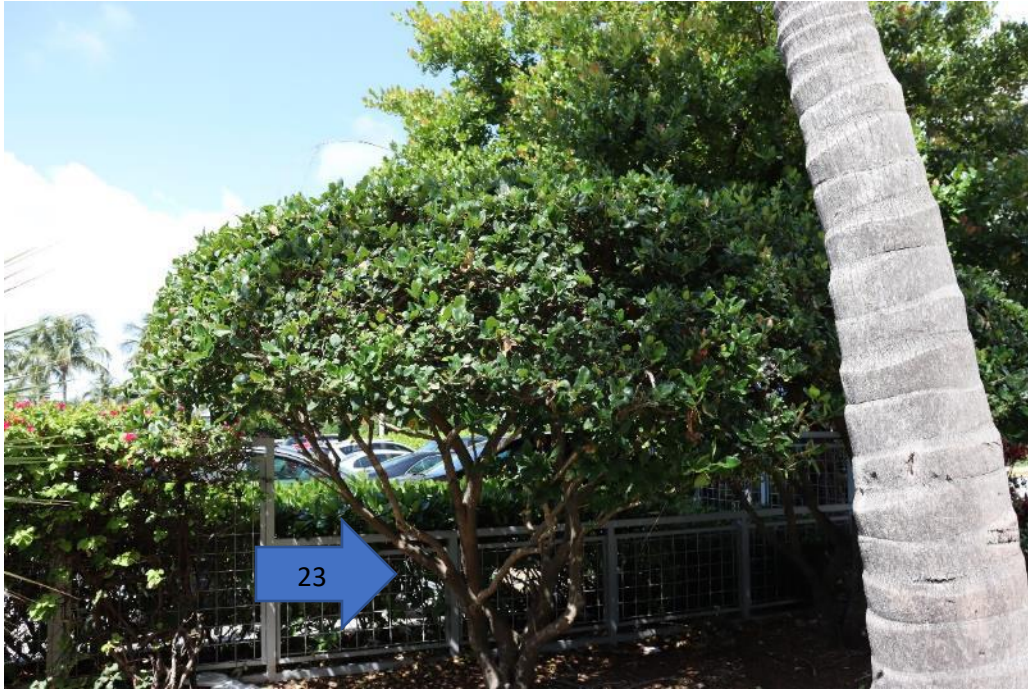
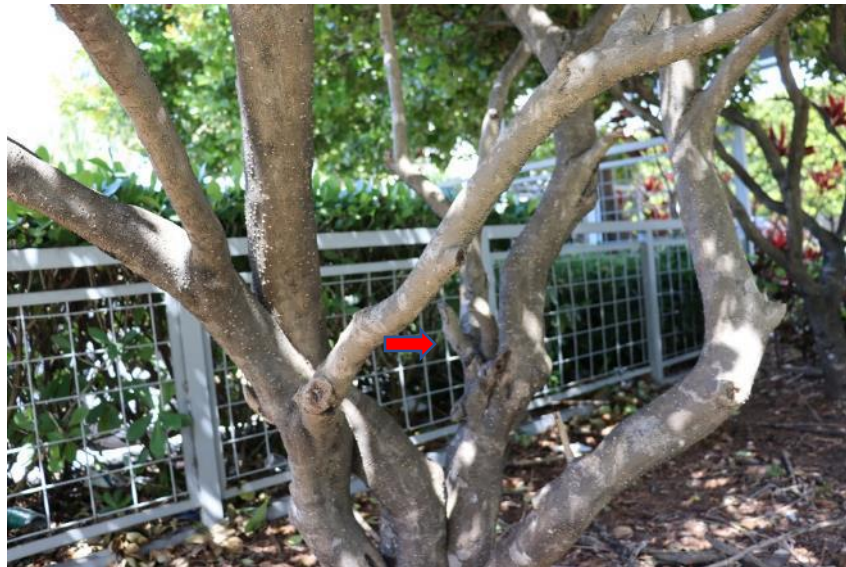
Tree Twenty-Three

Ligustrum (*Ligustrum japonicum*), facing west.

Note shaping, stub cuts (red arrow) and poor structure.

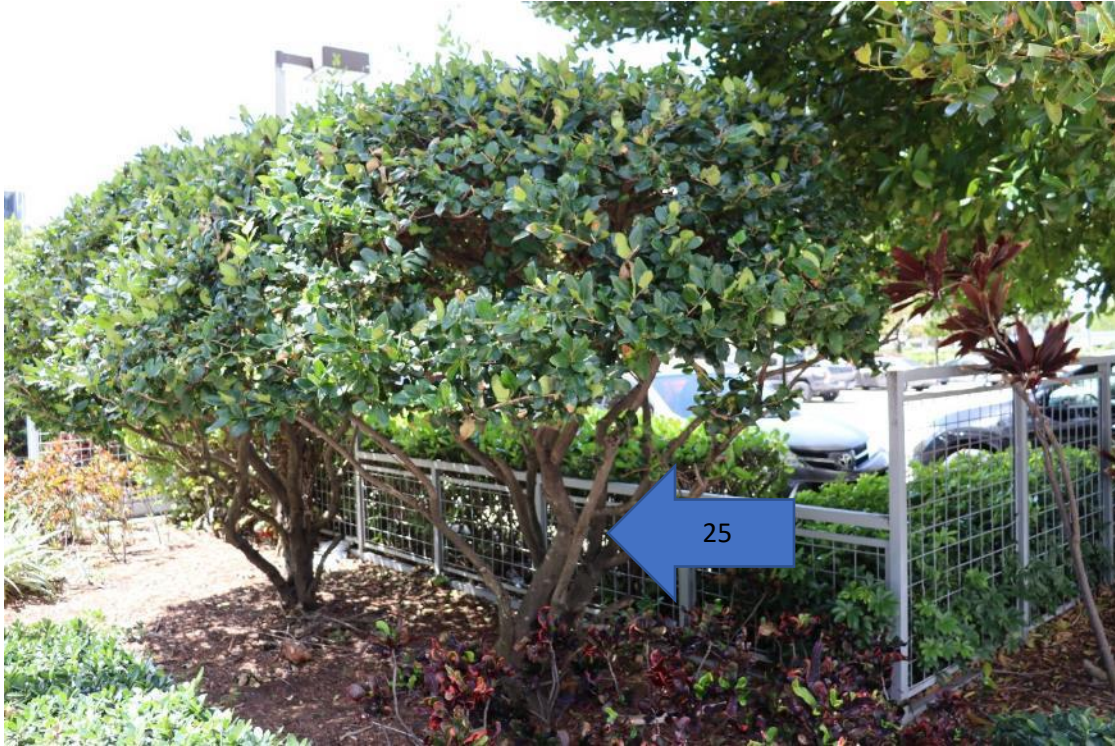
Tree Twenty-Five

Ligustrum (*Ligustrum japonicum*), facing south.

Note shaping, stub cuts (red arrow) and poor structure.

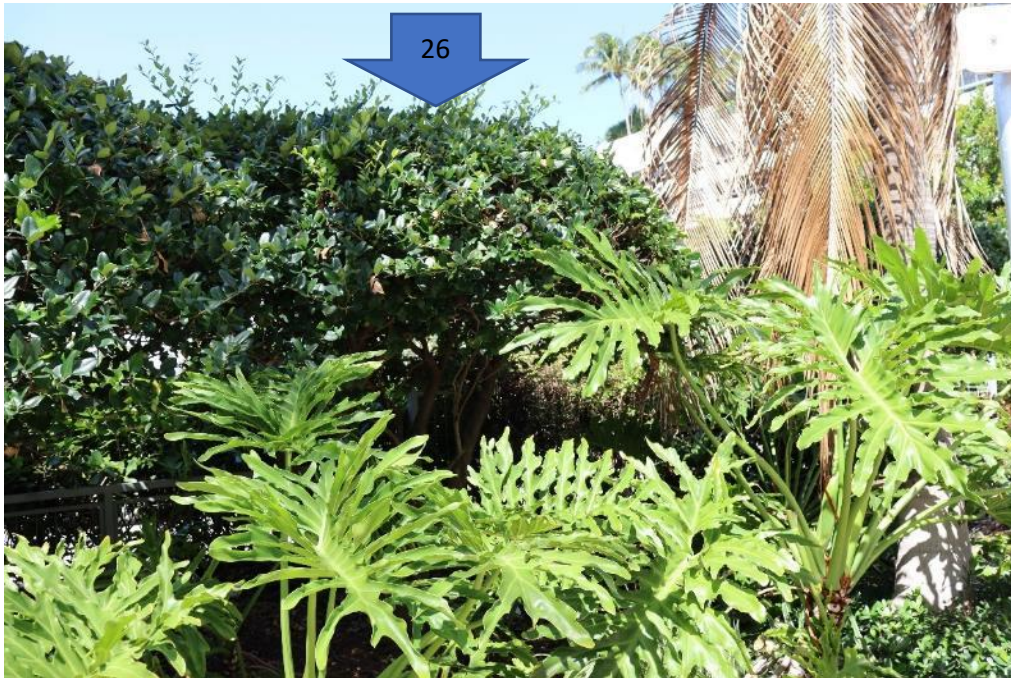
Tree Twenty-Six

Ligustrum (*Ligustrum japonicum*), facing west.

Note shaping, deadwood and poor structure.

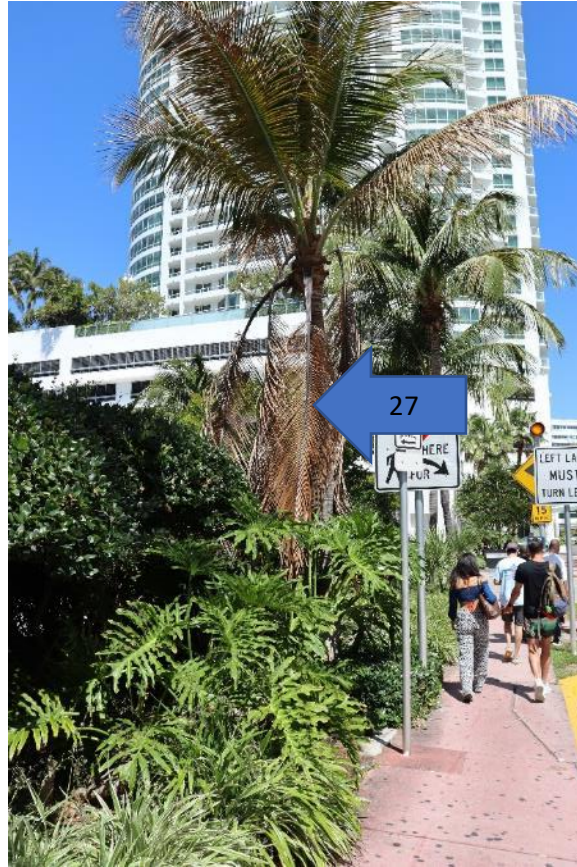
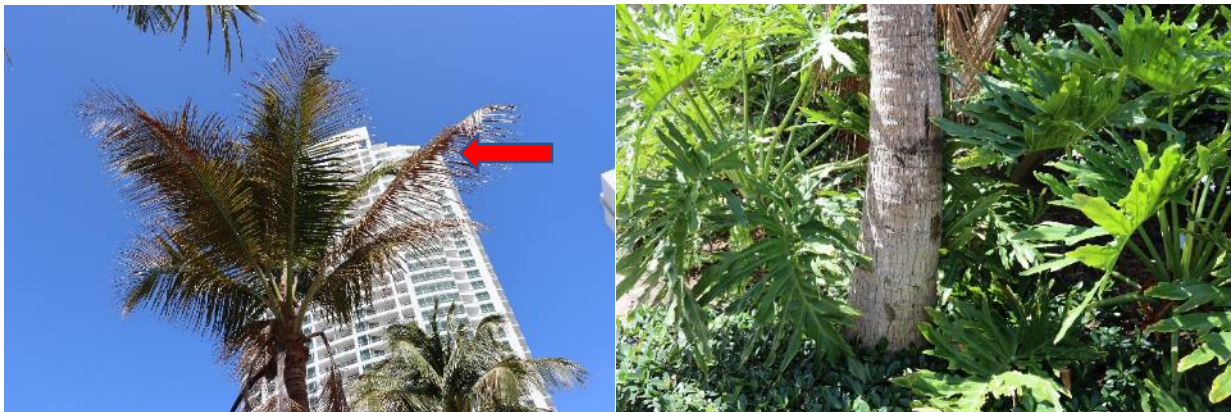
### Tree Twenty-Seven

Coconut Palm (*Cocos nucifera*), facing north.

Note severe frond burn (red arrow) and trunk wounds.

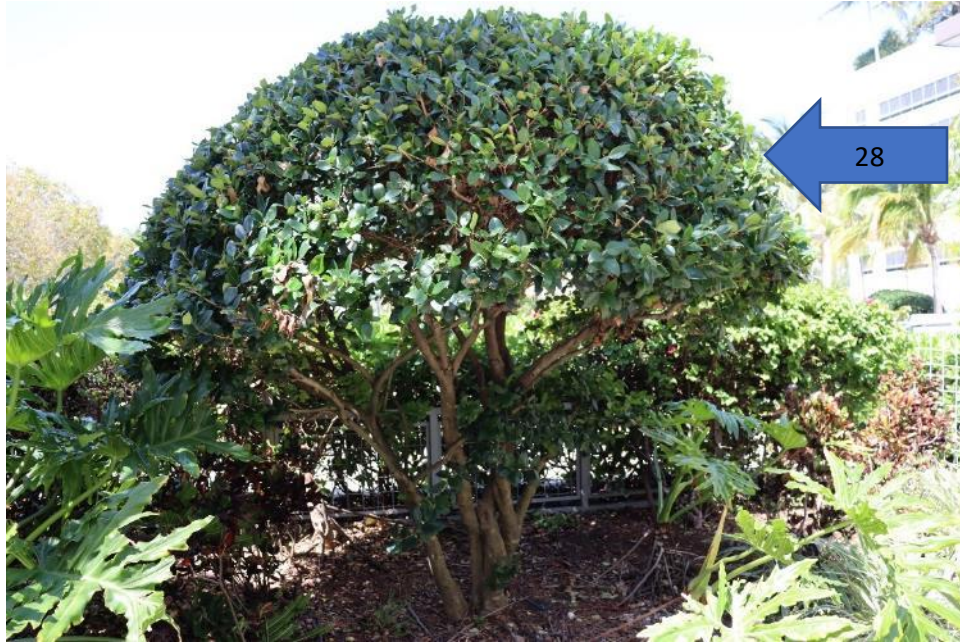
Tree Twenty-Eight

Ligustrum (*Ligustrum japonicum*), facing west.

Note shaping, deadwood and poor structure.

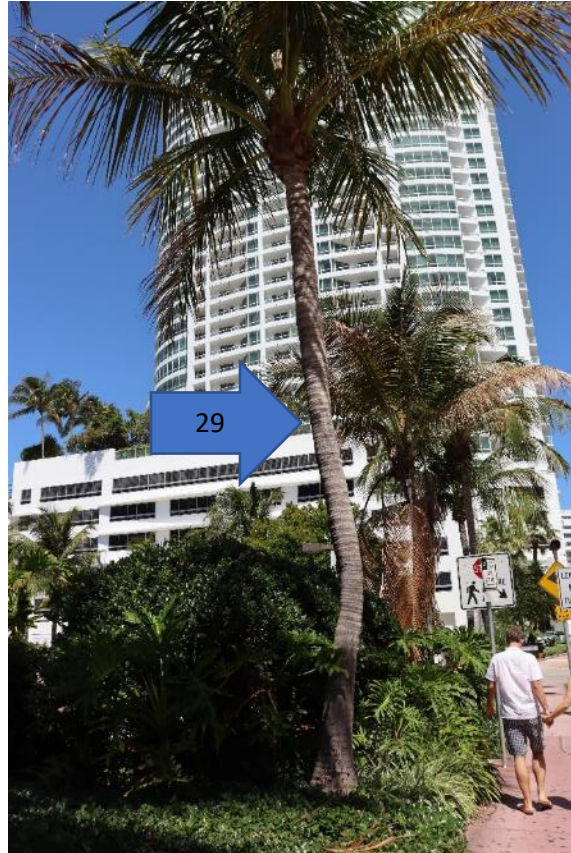
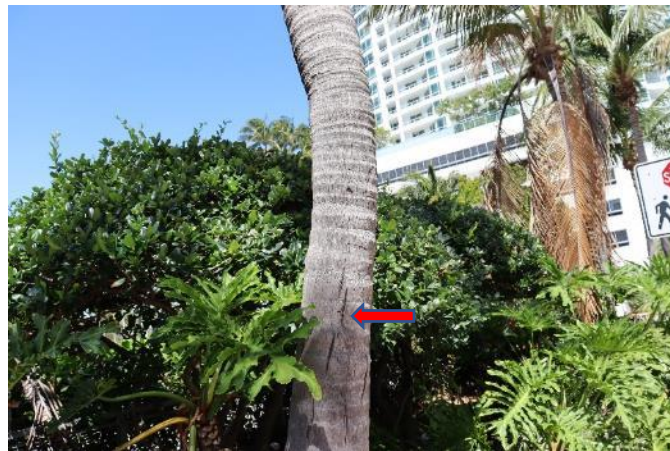
### Tree Twenty-Nine

Coconut Palm (*Cocos nucifera*), facing north.

Note trunk cracks (red arrow) and nutrient deficiencies.

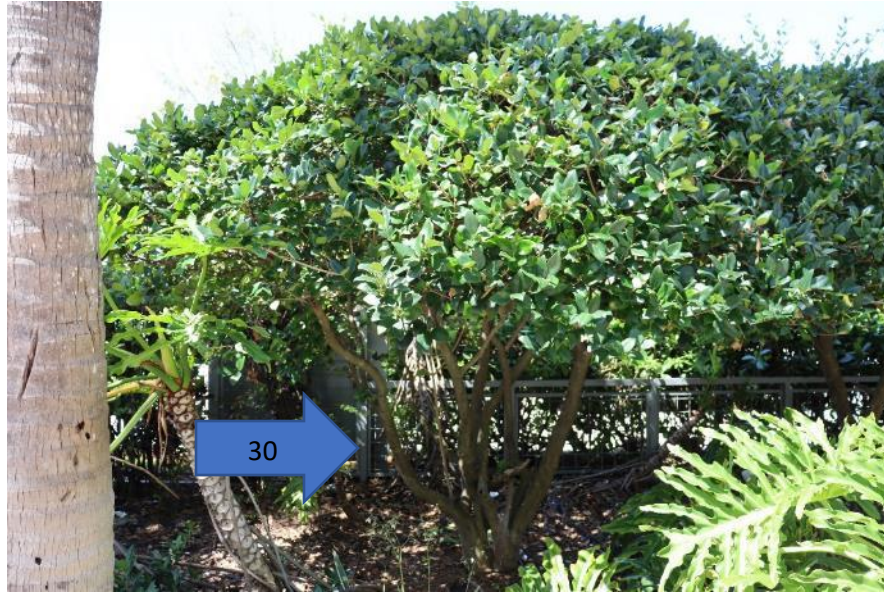
Tree Thirty

Ligustrum (*Ligustrum japonicum*), facing west.

Note shaping, deadwood and poor structure.

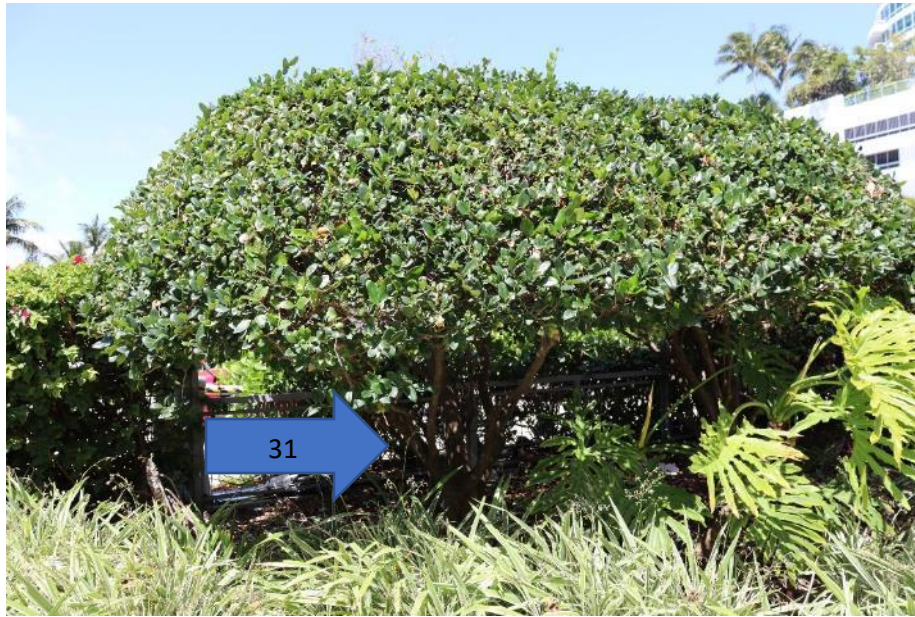
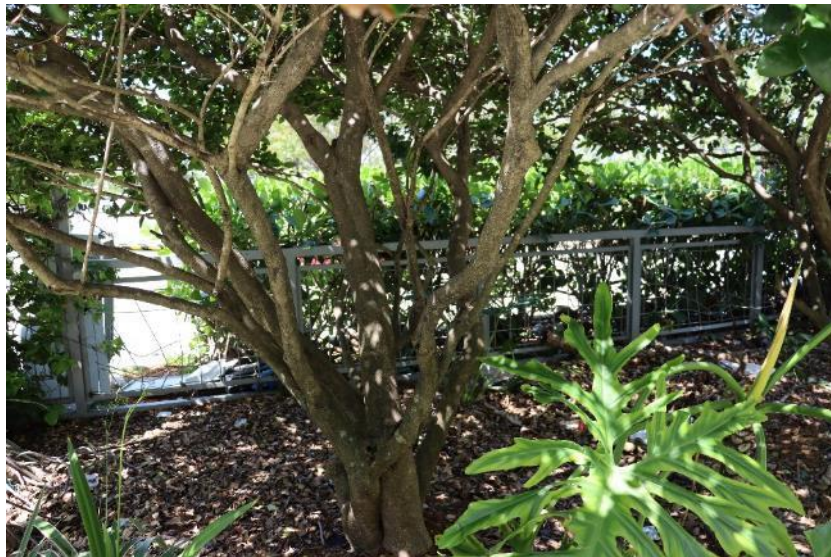
### Tree Thirty-One

Ligustrum (*Ligustrum japonicum*), facing west.

Note shaping, deadwood and poor structure.

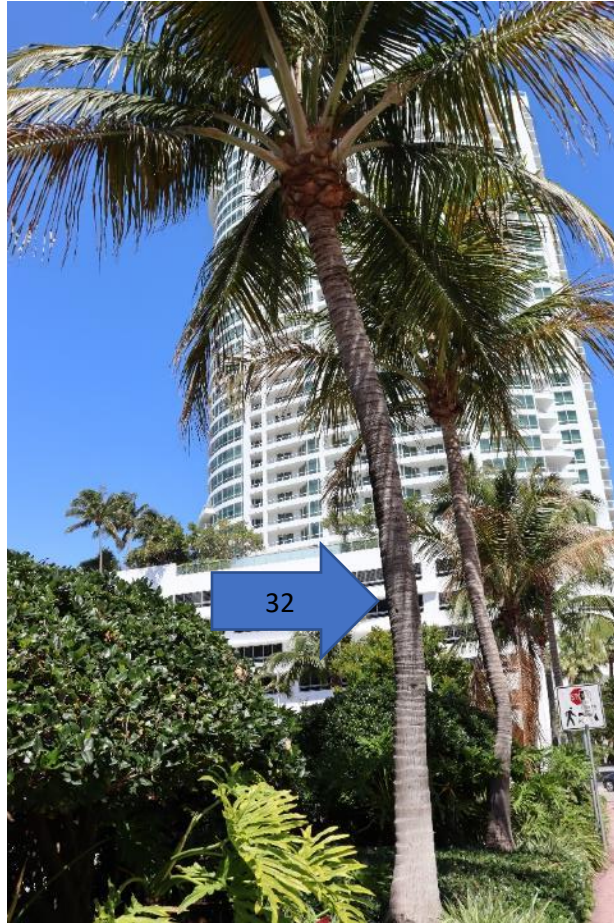
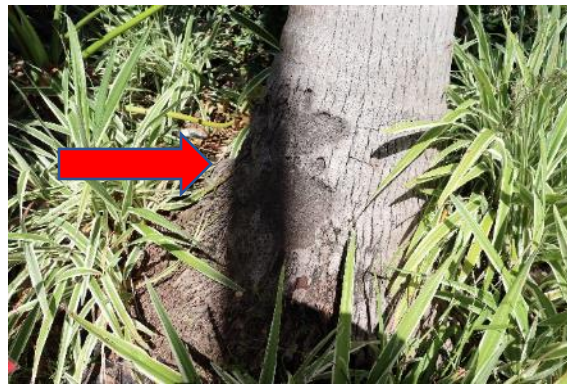
Tree Thirty-Two

Coconut Palm (*Cocos nucifera*), facing north.

Note trunk curve, nutrient deficiencies and large trunk wound (red arrow).

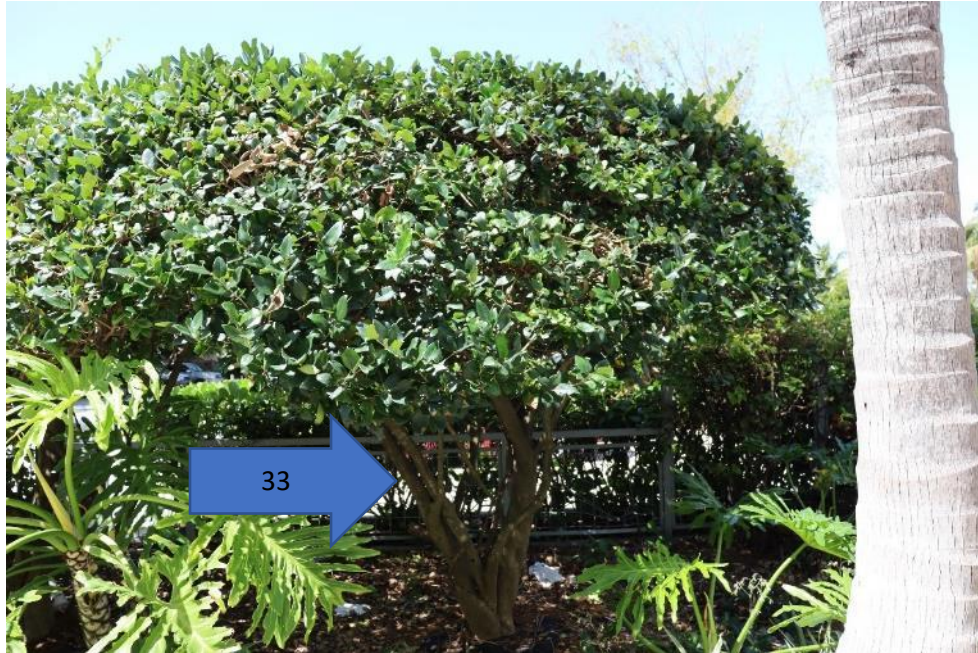
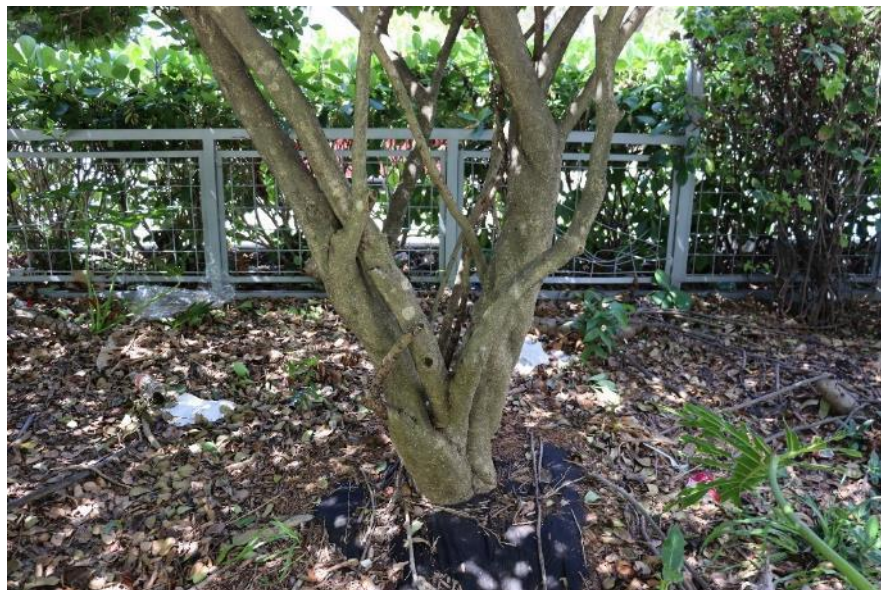
Tree Thirty-Three

Ligustrum (*Ligustrum japonicum*), facing west.

Note shaping, deadwood and poor structure.

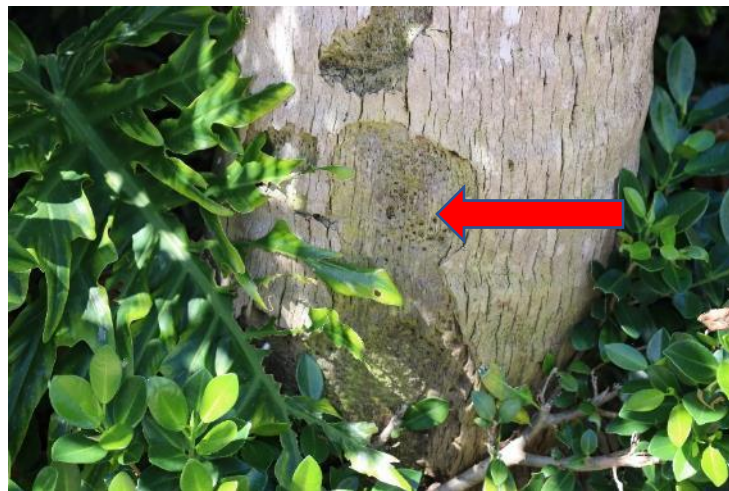
Tree Thirty-Four

Coconut Palm (*Cocos nucifera*), facing south.

Note nutrient deficiencies and large trunk wound (red arrow).

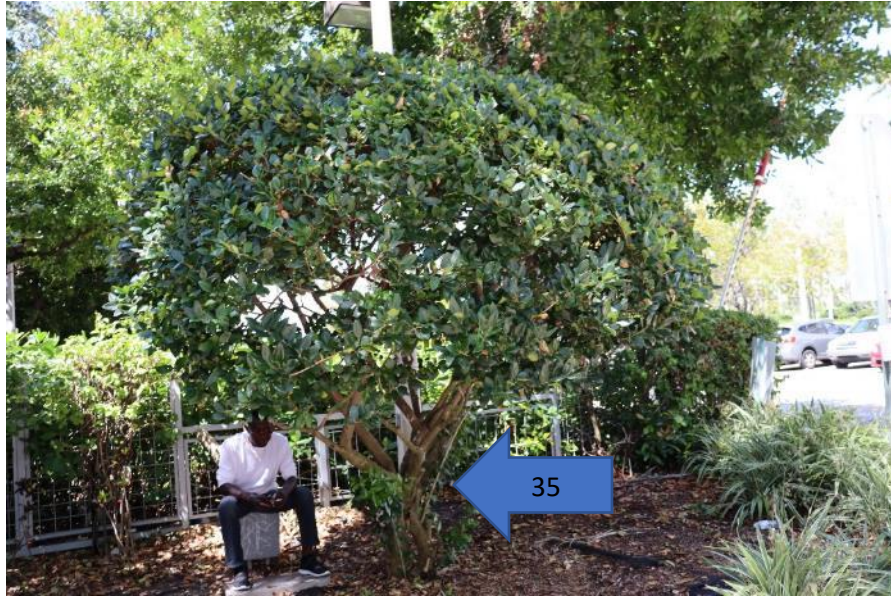
### Tree Thirty-Five

Ligustrum (*Ligustrum japonicum*), facing west.

Note shaping, deadwood and poor structure.
