# FOUNTAINBLEAU SOUTH GARAGE & BALLROOM

## 4360-4370 Collins Avenue

Re: 4441 Collins Avenue Miami Beach, FL

I visited the above-mentioned property on Sunday, March 15, 2020 to evaluate 72 trees, verify condition and measurements, take photographs and note any significant defects.

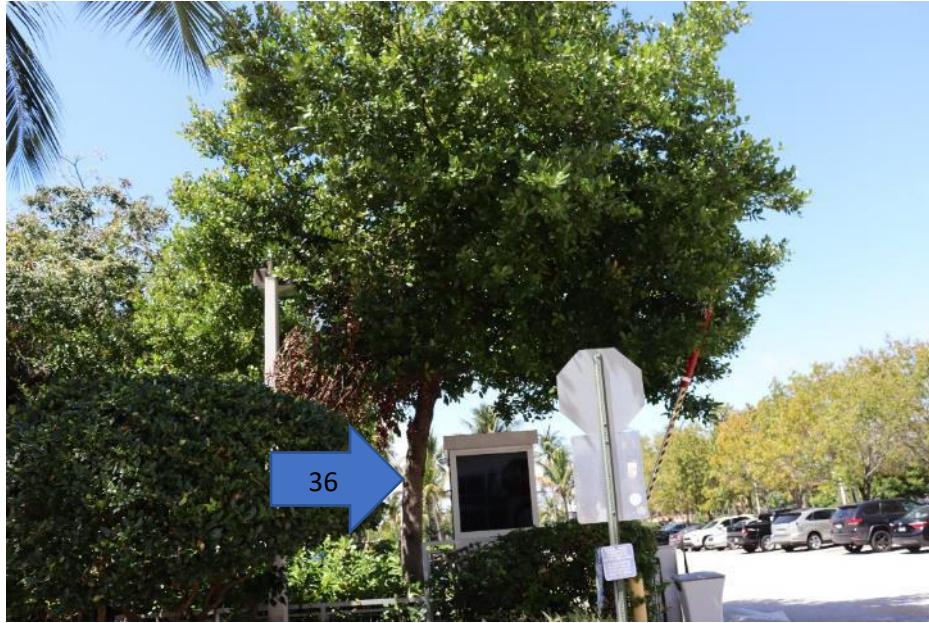
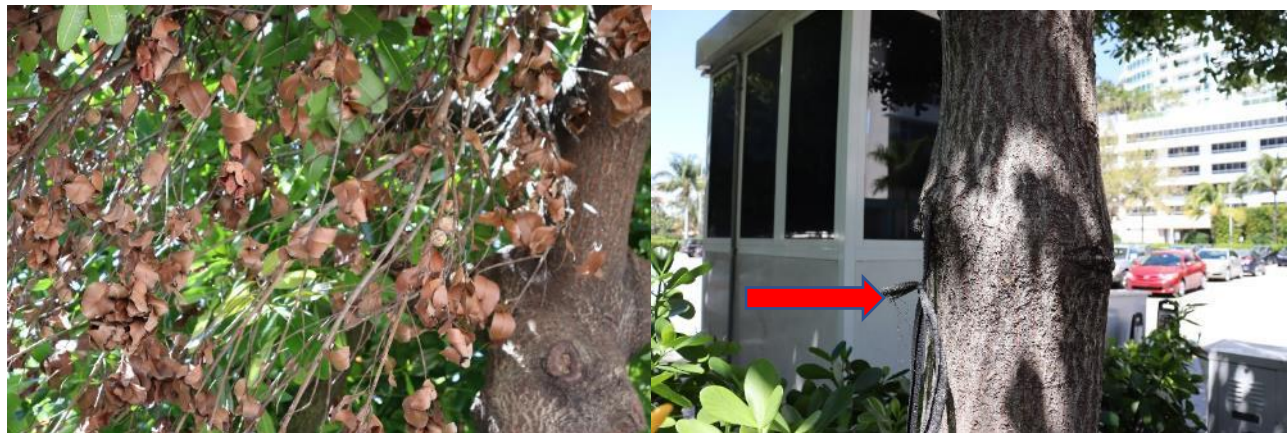
Tree Thirty-Six

Brazilian Beautyleaf (*Calophyllum brasiliense*), facing west.

Note poor structure and trunk girdling (bracing straps) (red arrow).

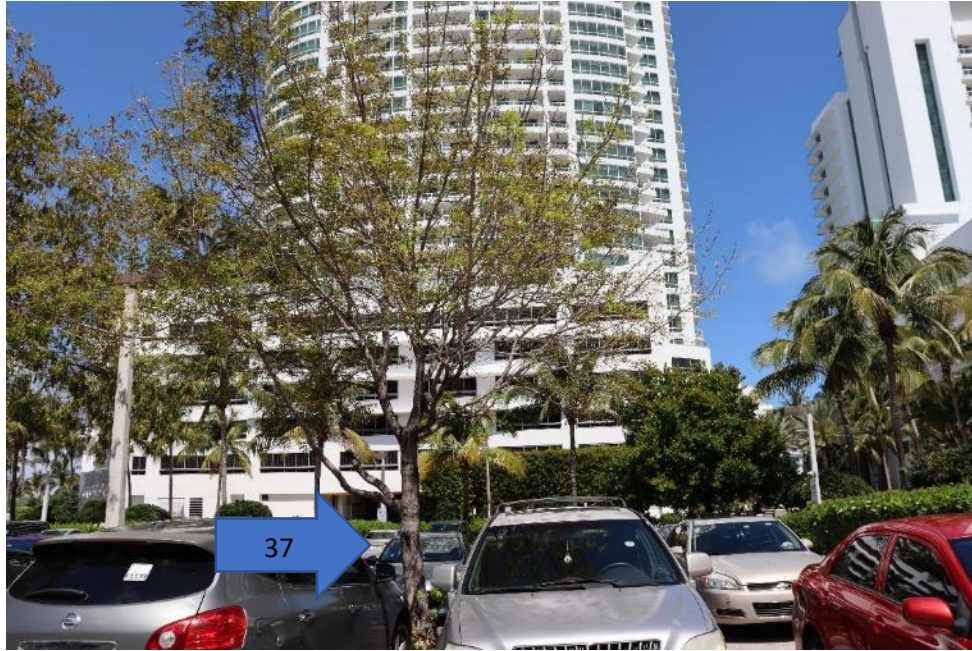
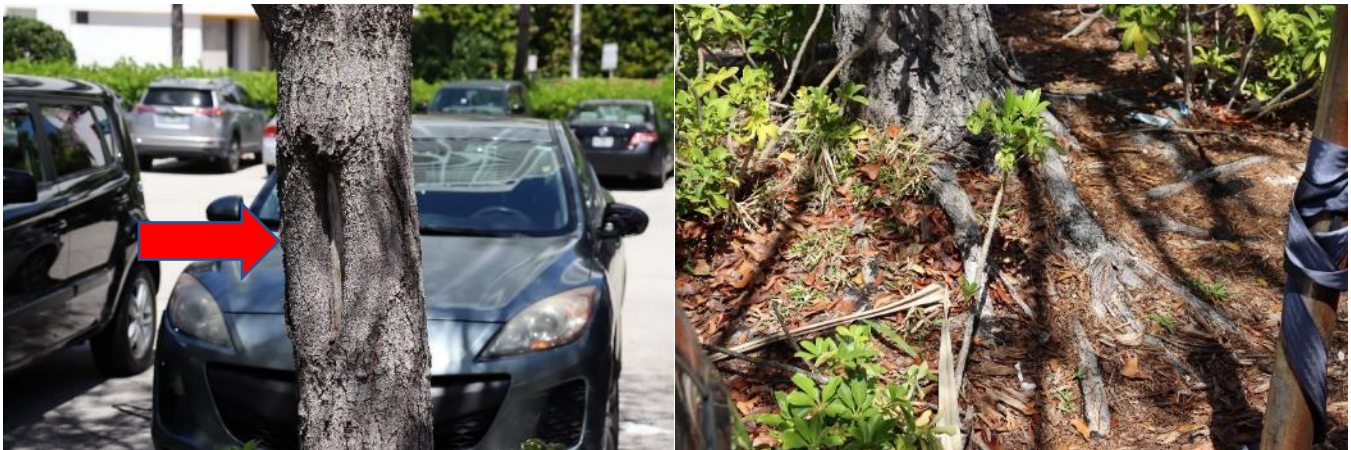
### Tree Thirty-Seven

Mahogany (*Swietenia mahagoni*), facing north.

Note poor structure, large trunk wound (red arrow) and confined root space.

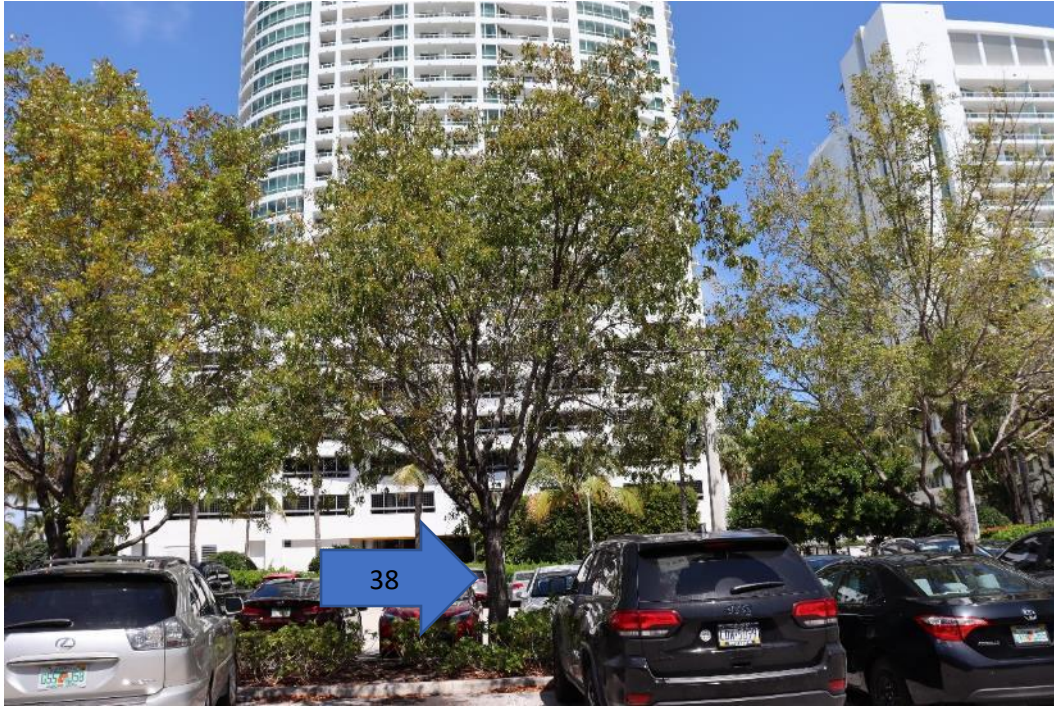
### Tree Thirty-Eight

Mahogany (*Swietenia mahagoni*), facing north.

Note poor structure, stub cuts (red arrow) and canopy over-lifting.

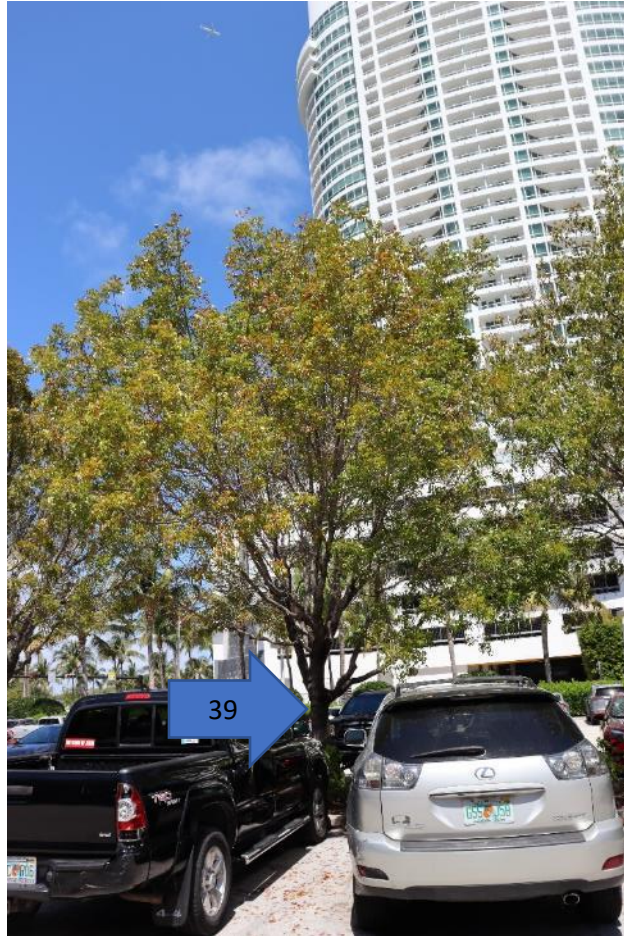
### Tree Thirty-Nine

Mahogany (*Swietenia mahagoni*), facing north.

Note poor structure and stub cuts (red arrow).

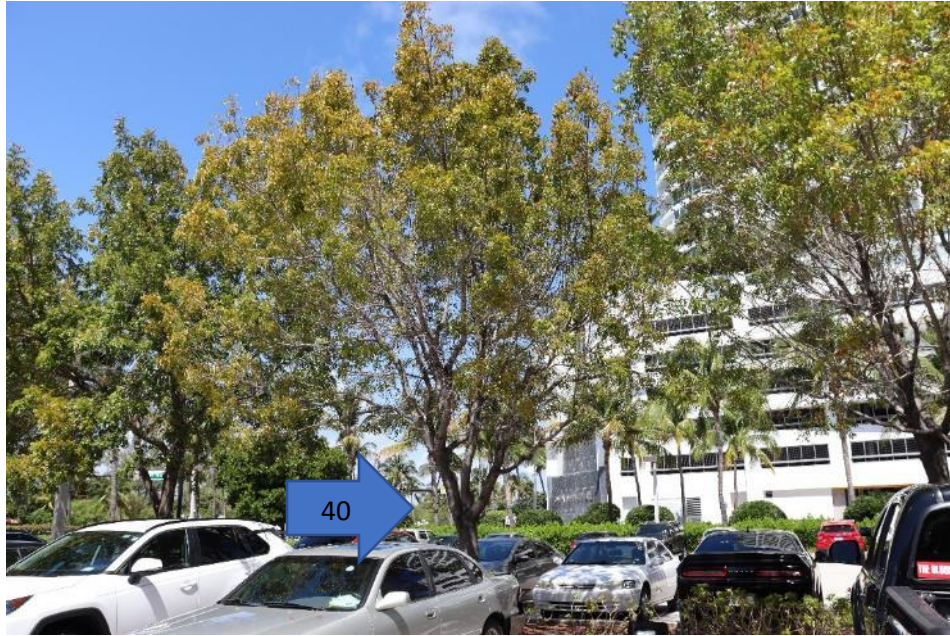
### Tree Forty

Note poor structure and canopy dieback (red arrow)

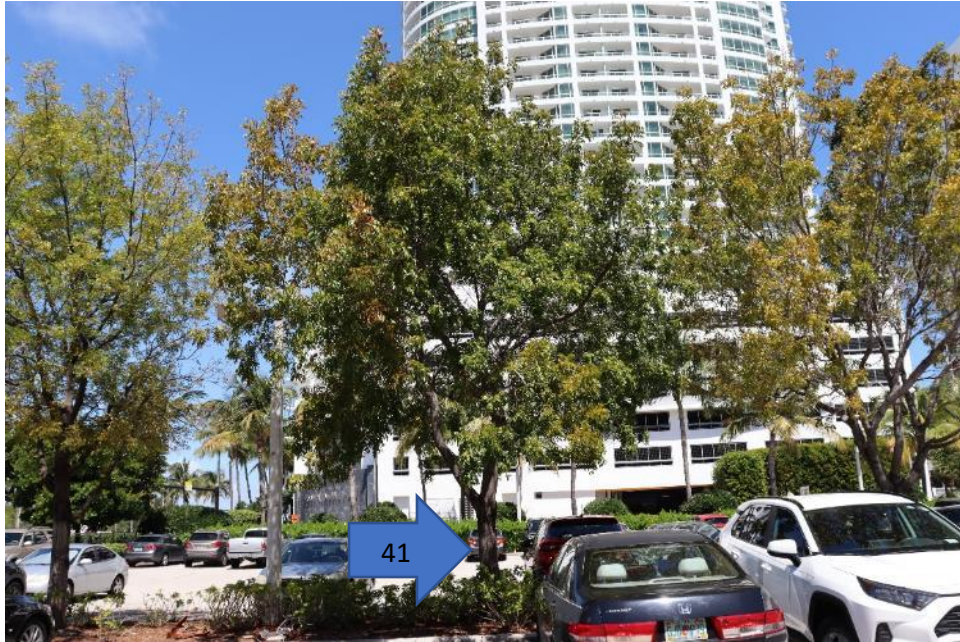
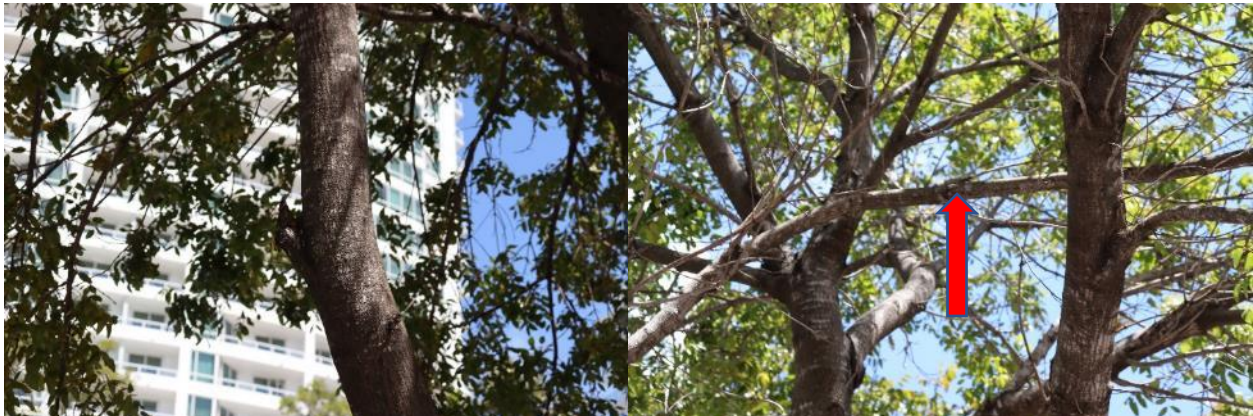
### Tree Forty-One

Mahogany (*Swietenia mahagoni*), facing north.

Note poor structure, deadwood (red arrow) and stub cuts.

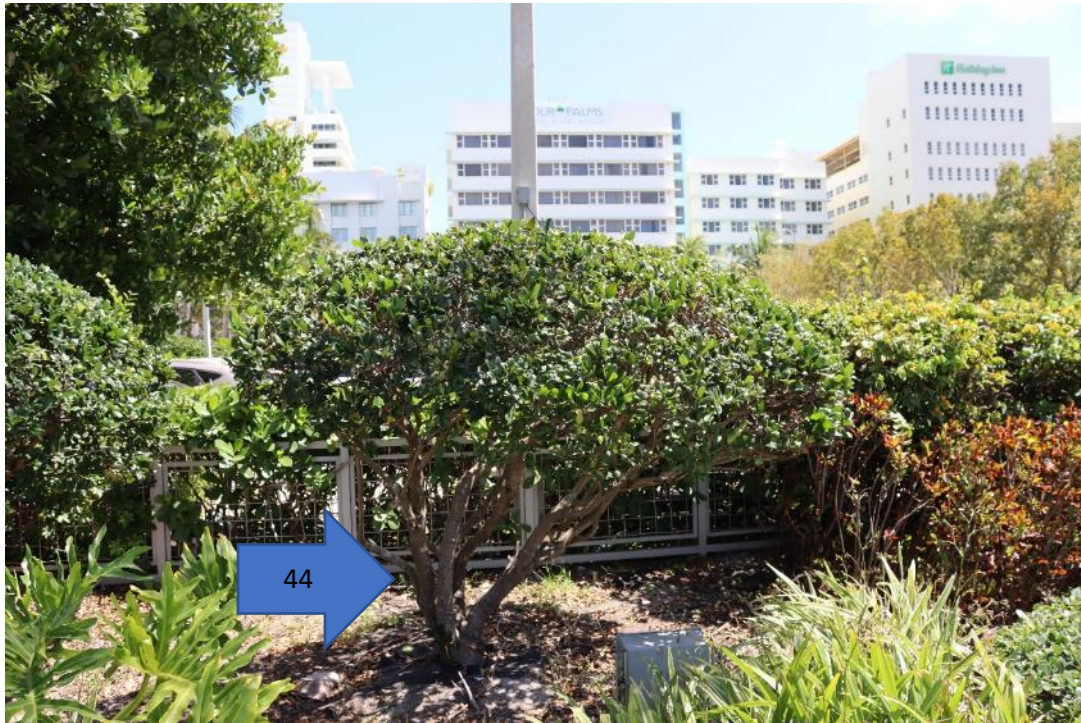
### Tree Forty-Four

Ligustrum (*Ligustrum japonicum*), facing west. Note poor structure, deadwood and shaping.

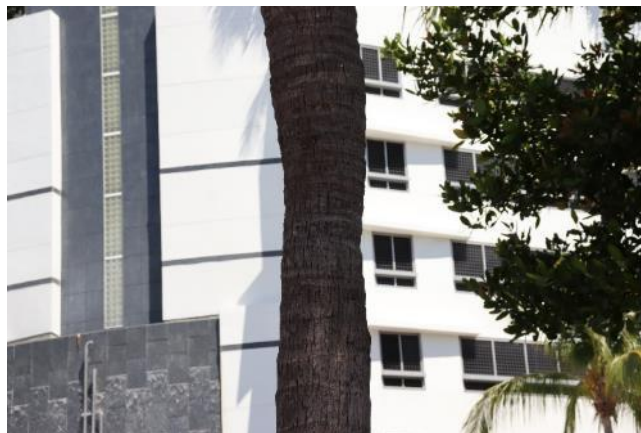
Tree Forty-Four A

Coconut Palm (*Cocos nucifera*), facing north.

Note nutrient deficiencies and pencilling.

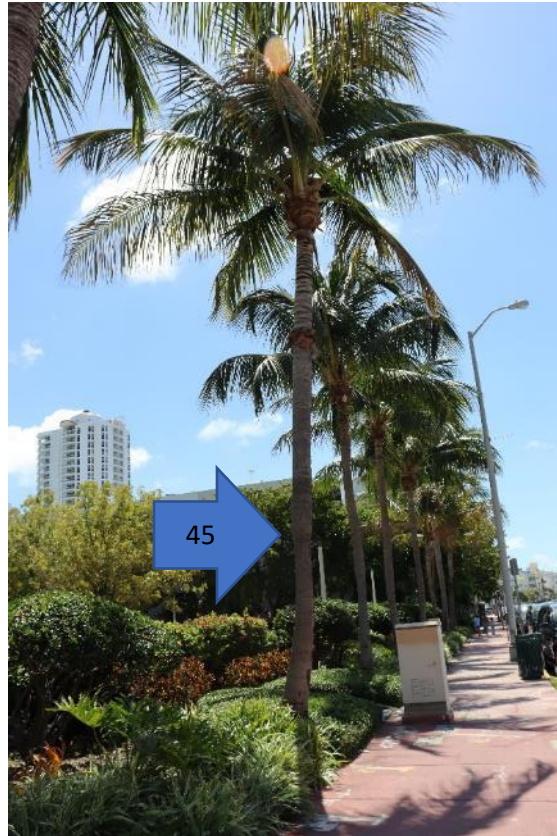
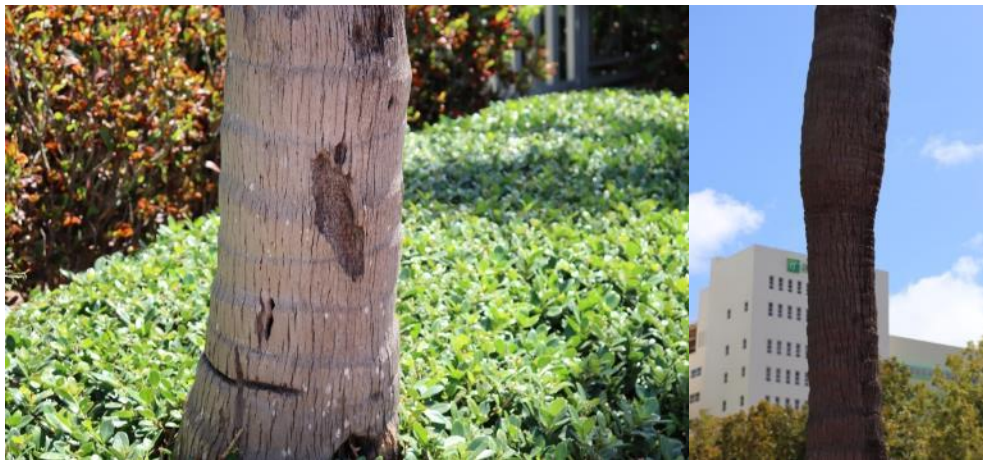
### Tree Forty-Five

Coconut Palm (*Cocos nucifera*), facing south.

Note nutrient deficiencies, trunk wounds and pencilling.

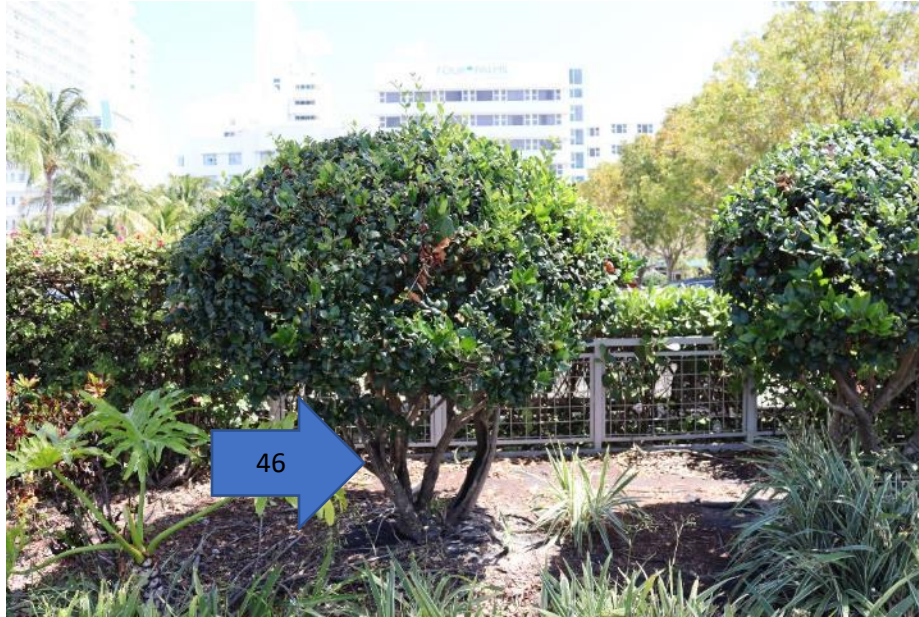
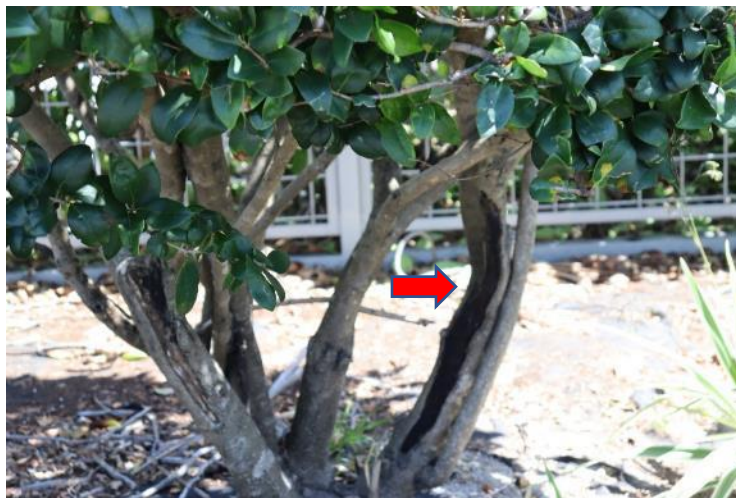
Tree Forty-Six

Ligustrum (*Ligustrum japonicum*), facing east.

Note poor structure, deadwood, visual evidence of decay (red arrow) and shaping.

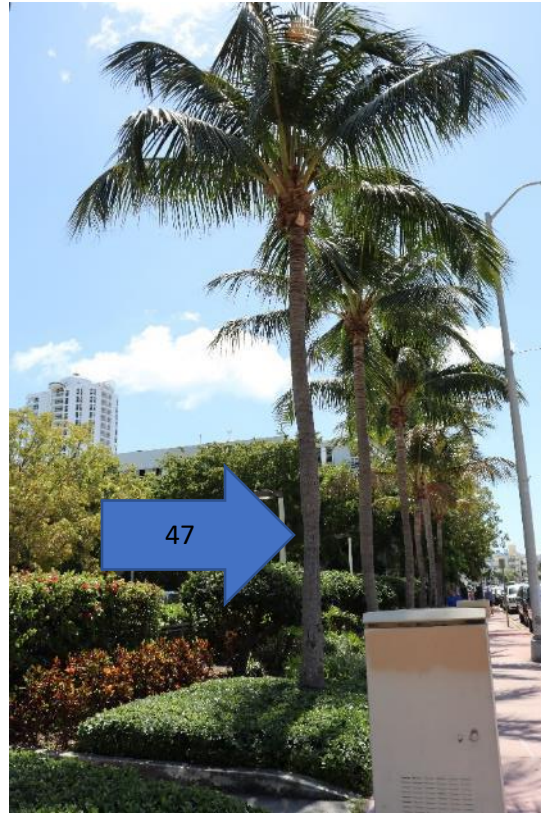
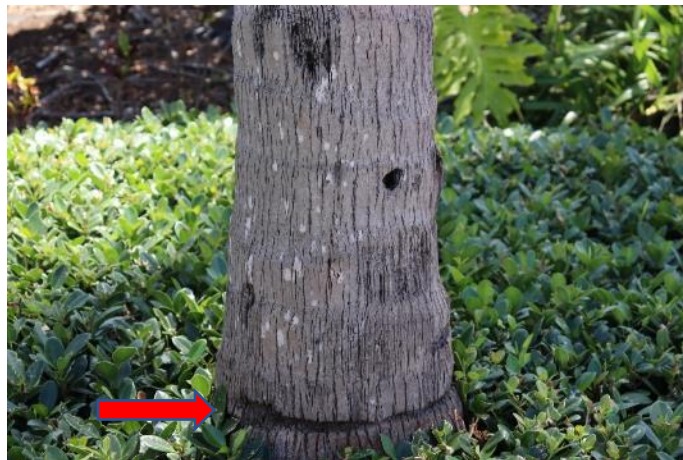
### Tree Forty-Seven

Coconut Palm (*Cocos nucifera*), facing south.

Note nutrient deficiencies, trunk girdling/wounds (red arrow).

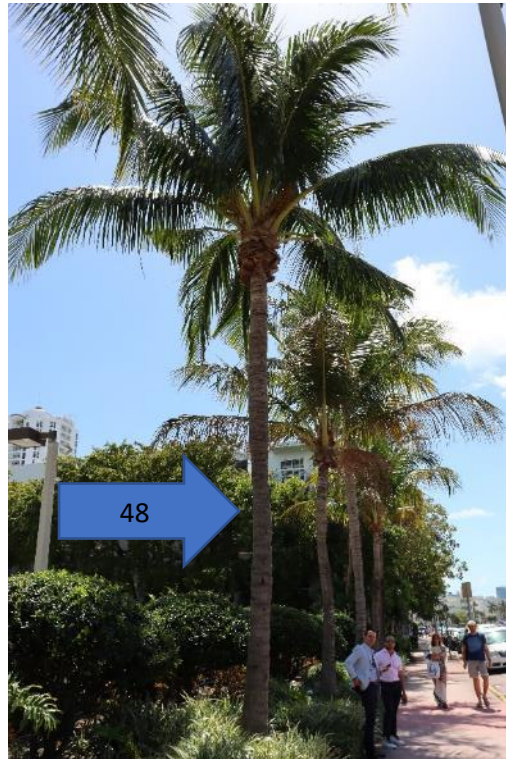
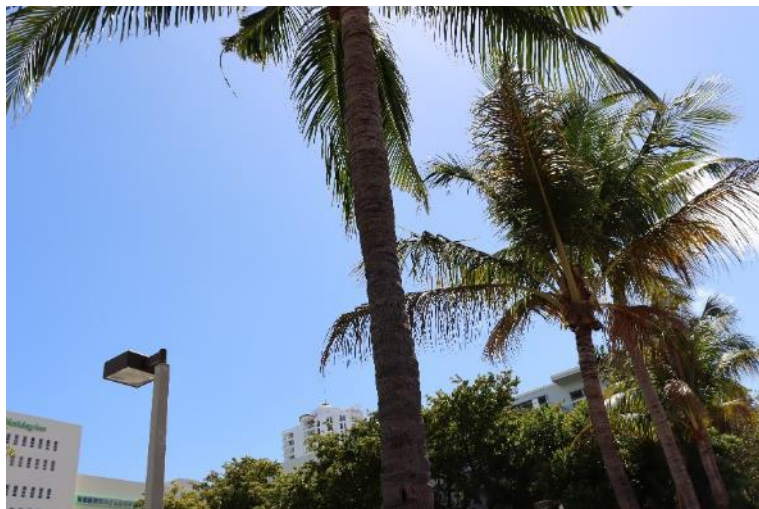
### Tree Forty-Eight

Coconut Palm (*Cocos nucifera*), facing south.

Note nutrient deficiencies and minor pencilling.

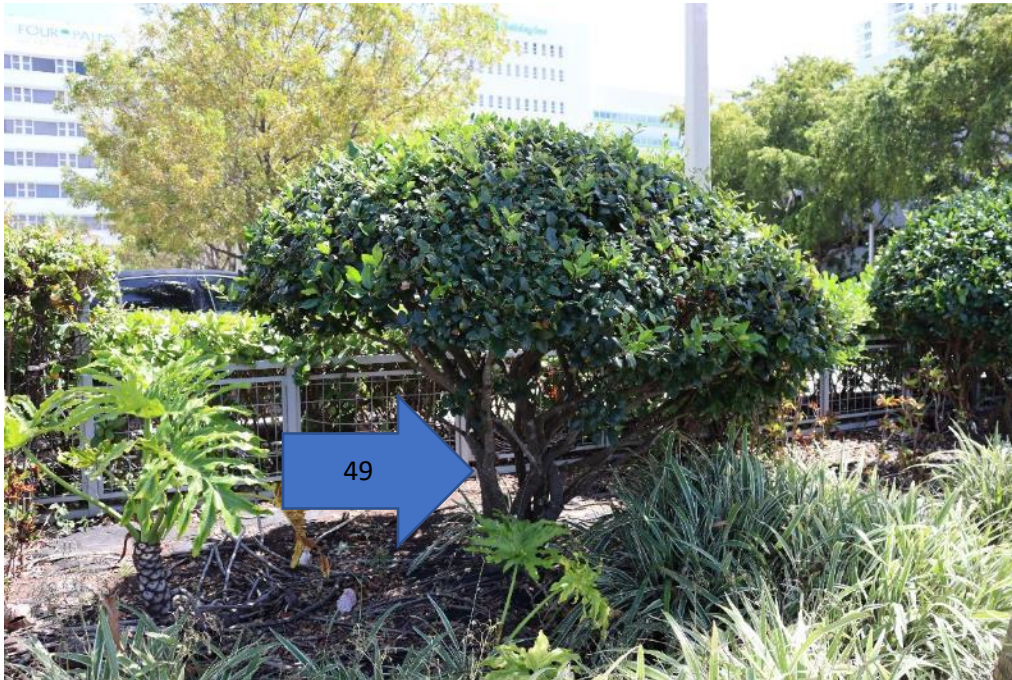
Tree Forty-Nine

Ligustrum (*Ligustrum japonicum*), facing east.

Note poor structure, deadwood and shaping.

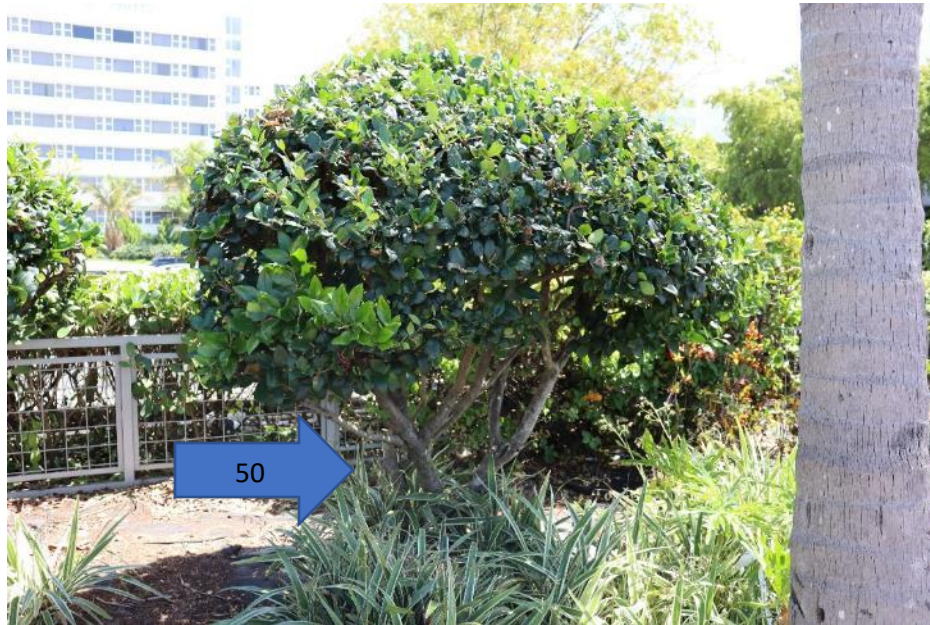
Tree Fifty

Ligustrum (*Ligustrum japonicum*), facing east.

Note poor structure, deadwood and shaping.

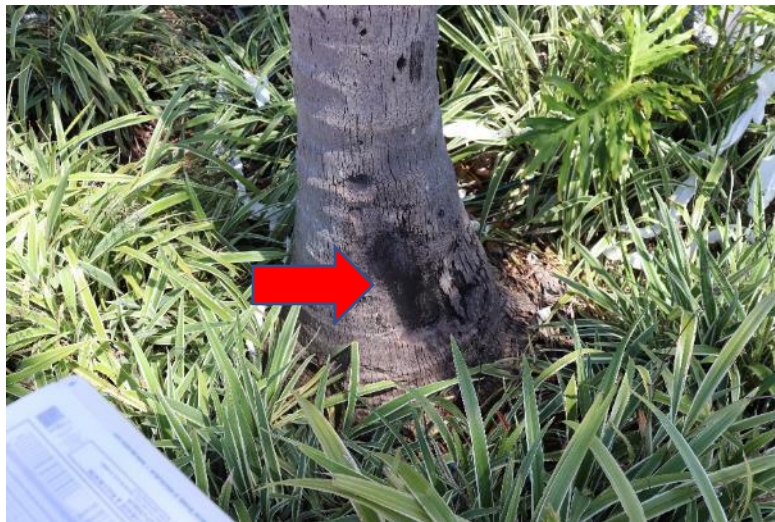
Tree Fifty-One

Coconut Palm (*Cocos nucifera*), facing south.

Note nutrient deficiencies, trunk wounds (red arrow).

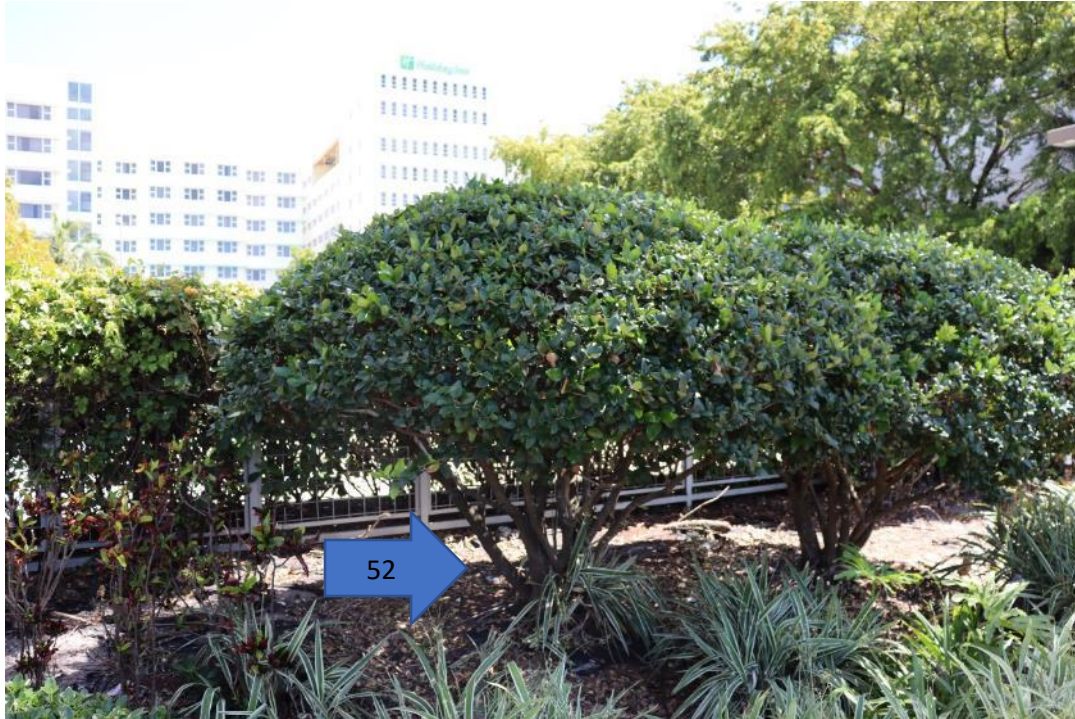
Tree Fifty-Two

Ligustrum (*Ligustrum japonicum*), facing east.

Note poor structure, deadwood and shaping.

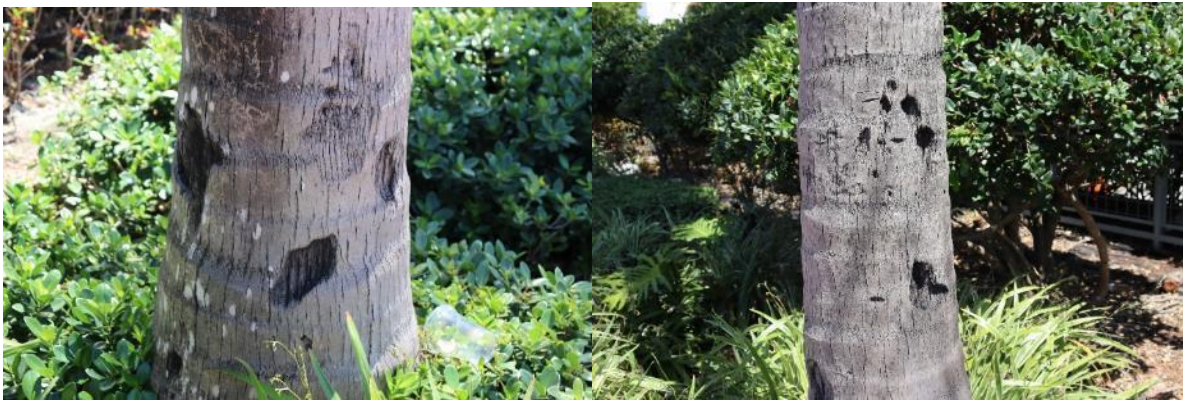
Tree Fifty-Three

Coconut Palm (*Cocos nucifera*), facing south.

Note nutrient deficiencies, pencilling and trunk wounds.

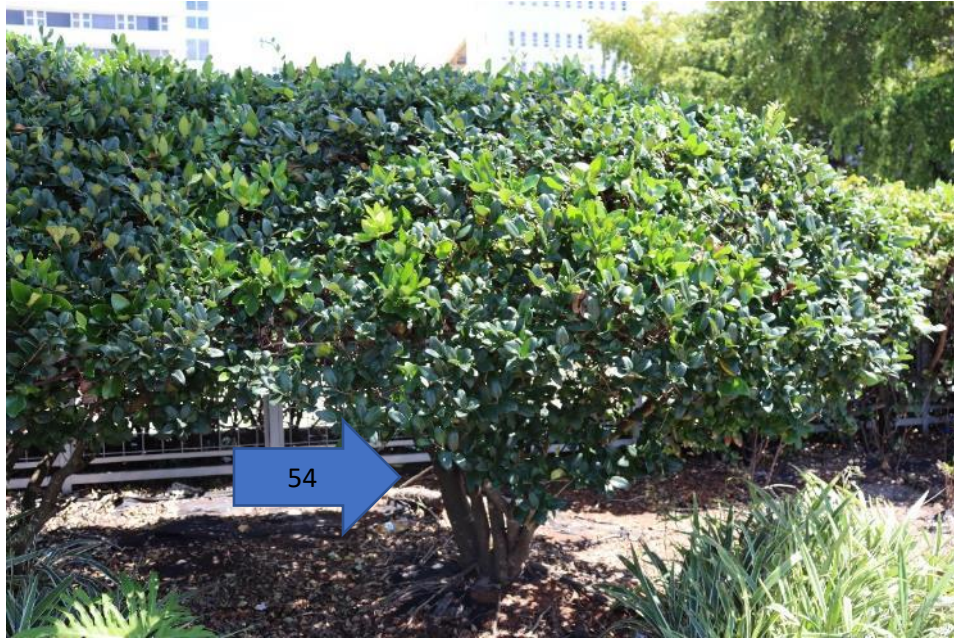
Tree Fifty-Four

Ligustrum (Ligustrum japonicum), facing east.

Note poor structure, deadwood and shaping.

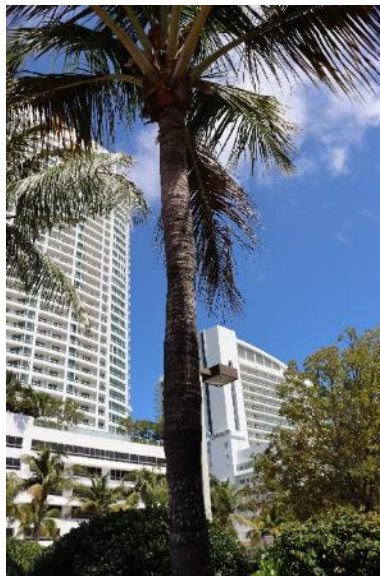
Tree Fifty-Five

Coconut Palm (*Cocos nucifera*), facing north.

Note nutrient deficiencies and pencilling.

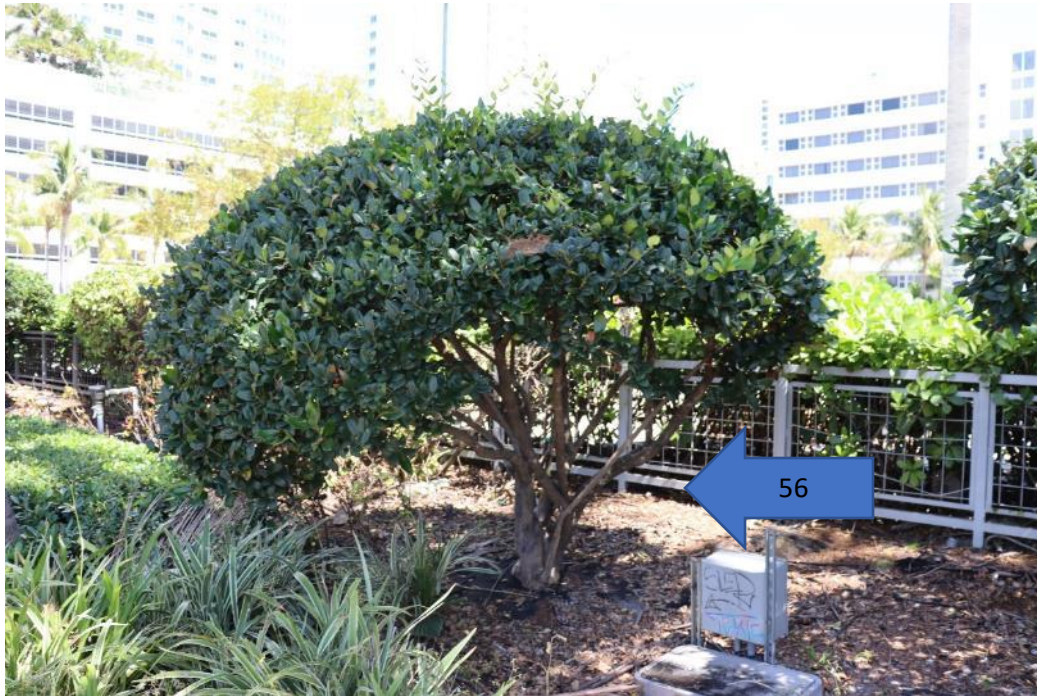
Tree Fifty-Six

Ligustrum (*Ligustrum japonicum*), facing east.

Note poor structure, deadwood and shaping.

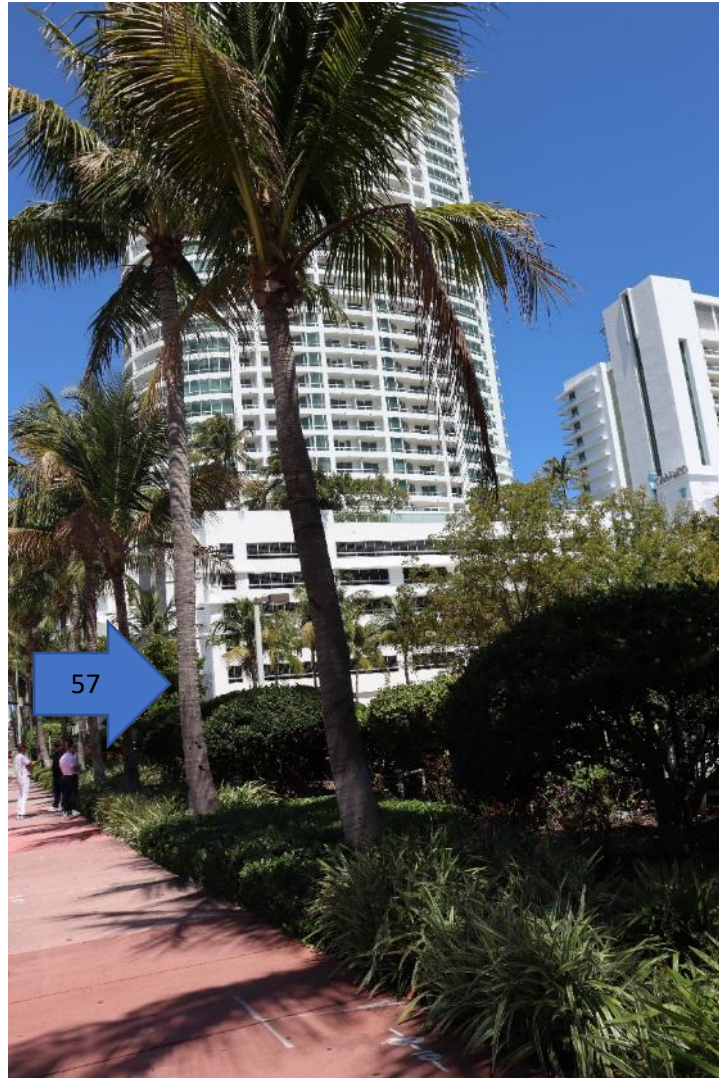
Tree Fifty-Seven

Coconut Palm (*Cocos nucifera*), facing north. Note nutrient deficiencies and trunk wounds.
