# MIAMI BEACH

## PLANNING DEPARTMENT

Staff Notice to Proceed Comments

**DRB20-0551 4424 North Bay Road**

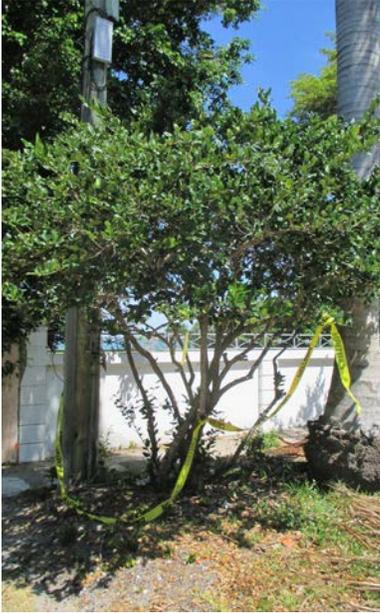
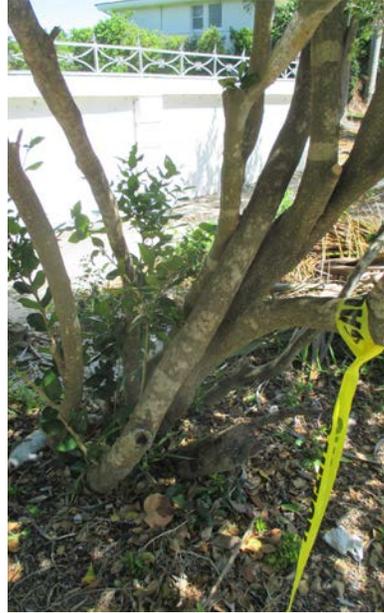
**Condition -**  
Fair

Tree #1 is a Japanese Privet street tree located along North Bay Road. It is multi-trunked and in fair condition. It has a dense canopy with leaf spot on the foliage. This tree has not been incorporated into the landscape plan and will therefore be removed.

**Disposition -**  
Remove

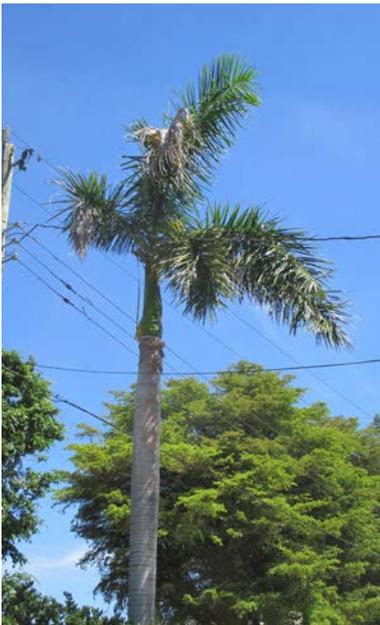
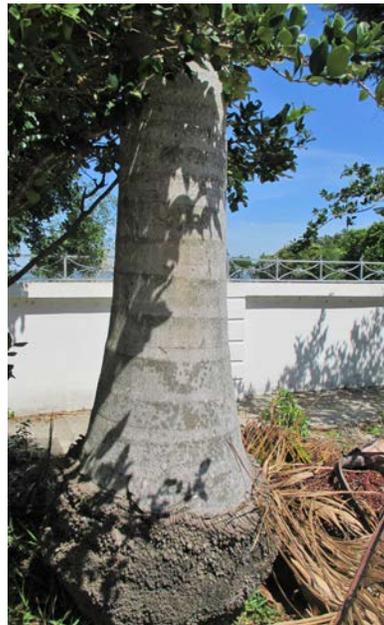
## Tree #2

**Condition -**  
Fair

Tree #2 is a Royal Palm street tree located along North Bay Road. It is in fair condition. Overhead wires are present and the canopy has been pruned away from them, forming a small, thin canopy. This tree has not been incorporated into the landscape plan and will therefore be removed.

**Disposition -**  
Remove

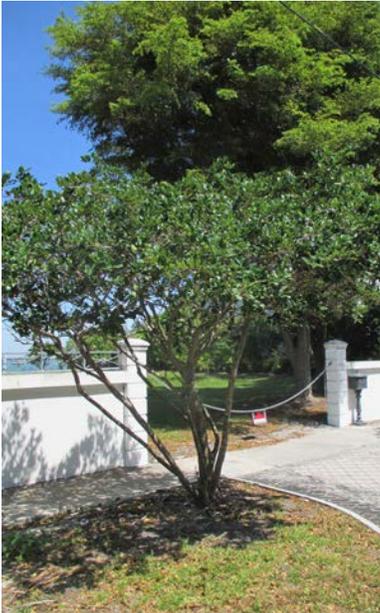
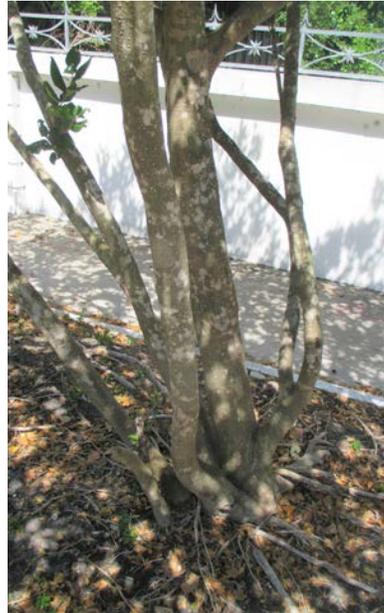
### Tree #3

**Condition -**  
Fair

Tree #3 is a Japanese Privet street tree located along North Bay Road. It is multi-trunked and in fair condition. The canopy is dense and leaf spot is on the foliage. This tree has not been incorporated into the landscape plan and will therefore be removed.

**Disposition -**  
Remove

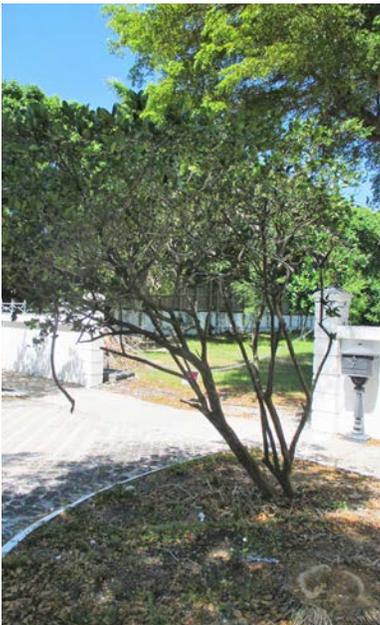
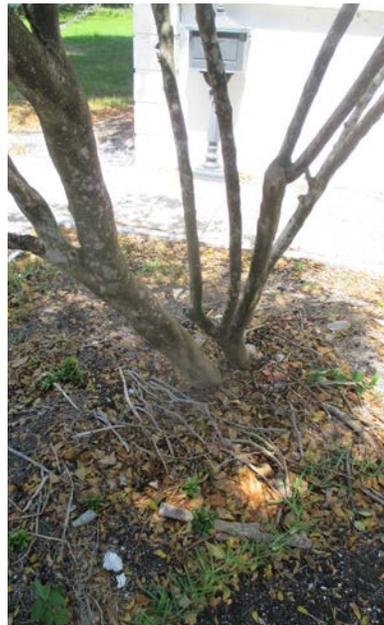
### Tree #4

**Condition -**  
Fair

Tree #4 is a Japanese Privet street tree located along North Bay Road. It is multi-trunked and in fair condition. Leaf spot is on the foliage. This tree has not been incorporated into the landscape plan and will therefore be removed.

**Disposition -**  
Remove

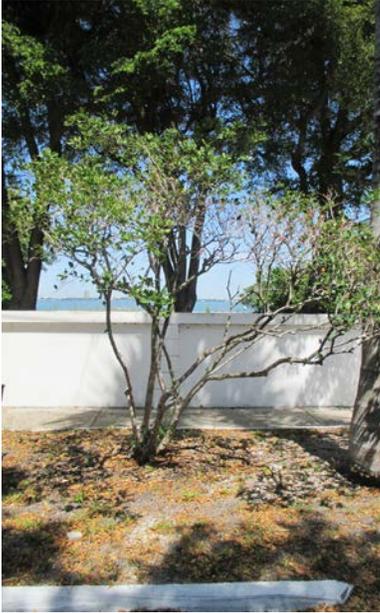
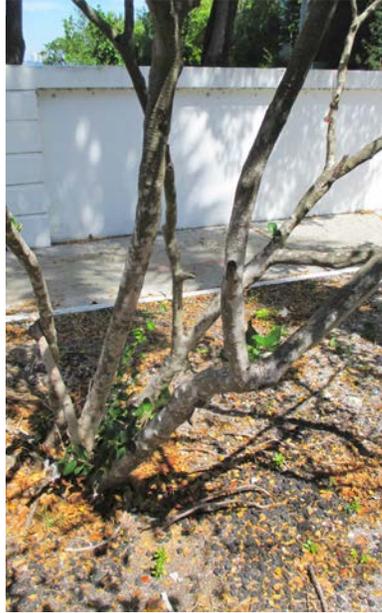
## Tree #5

**Condition -**  
Poor

Tree #5 is a Japanese Privet street tree located along North Bay Road. It is multi-trunked and in poor condition. The canopy is thin with branch dieback. This tree has not been incorporated into the landscape plan and will therefore be removed.

**Disposition -**  
Remove

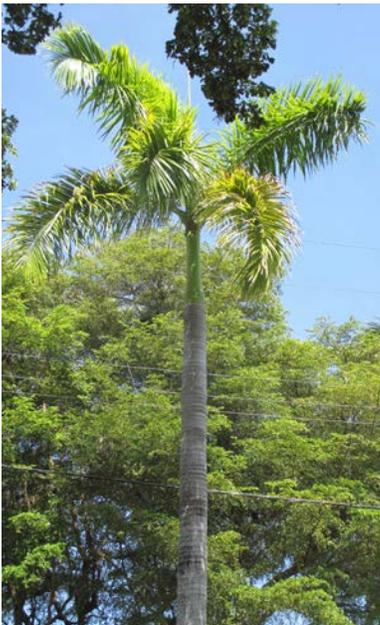
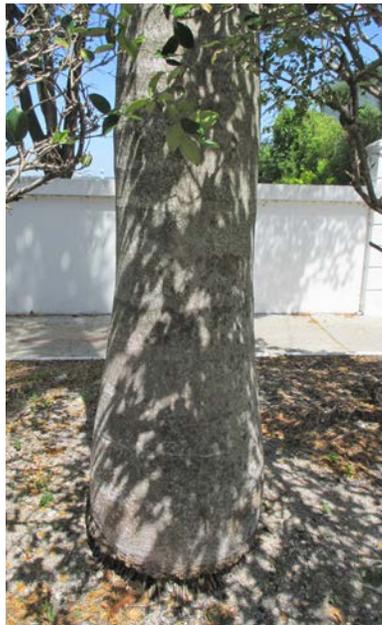
## Tree #6

**Condition -**  
Poor

Tree #6 is a Royal Palm street tree located along North Bay Road. It is in poor condition with a small, very chlorotic canopy. It is recommended that this tree be removed.

**Disposition -**  
Remove

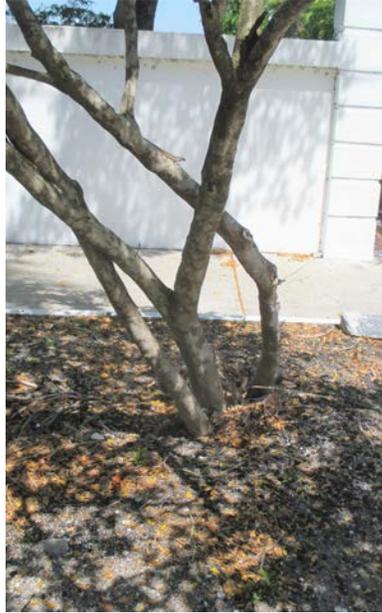
## Tree #7

**Condition -**  
Fair

Tree #7 is a Japanese Privet street tree located along North Bay Road. It is multi-trunked and in fair condition. Leaf spot is on the foliage. This tree has not been incorporated into the landscape plan and will therefore be removed.

**Disposition -**  
Remove

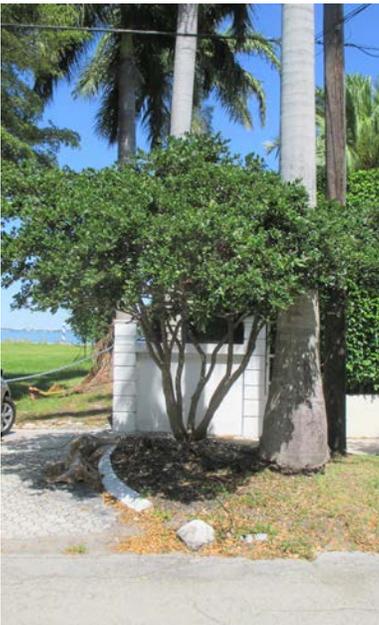
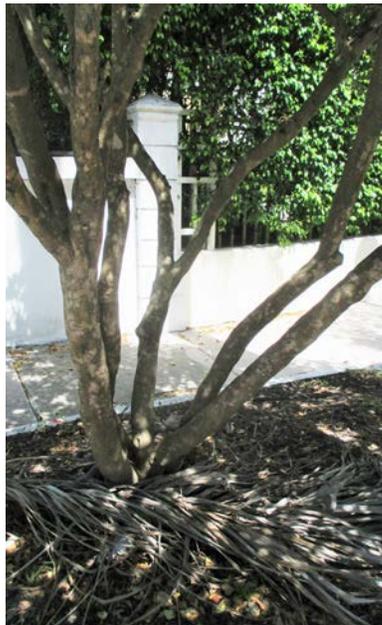
## Tree #8

**Condition -**  
Good

Tree #8 is a Japanese Privet street tree located along North Bay Road. It is multi-trunked and in good condition. The canopy is dense and leaf spot is on the foliage. This tree has not been incorporated into the landscape plan and will therefore be removed.

**Disposition -**  
Remove

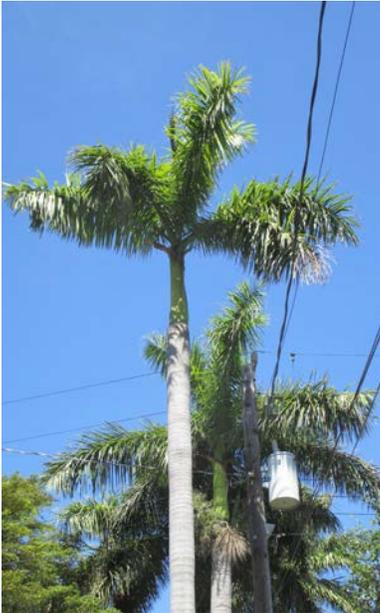
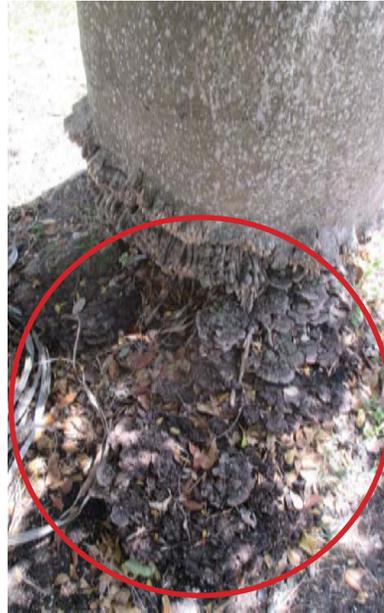
## Tree #9

**Condition -**  
Poor

Tree #9 is a Royal Palm street tree located along North Bay Road. It is in poor condition with a small, thin canopy. Multiple decay conks (circled in red) were observed at the base of the trunk indicating basal rot, likely due to the disease pathogen *Ganoderma zonatum*. This tree will need to be removed as soon as possible.

**Disposition -**  
Remove

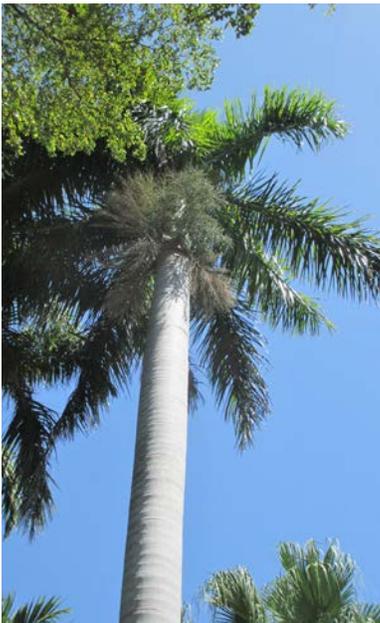
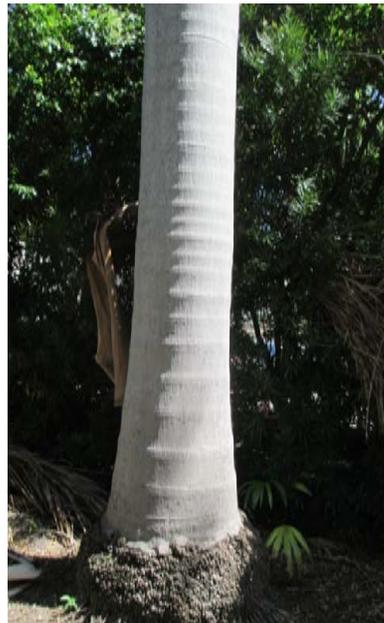
## Tree #10

**Condition -**  
Good

Tree #10 is a Royal Palm located on the north side of the property. It is in good condition with a full canopy and no major trunk injuries observed. This tree is to remain and protective barriers shall be placed 10ft from the tree trunk. Barriers shall be installed prior to the start of construction, and shall remain in place until development is completed and until the department authorizes their removal. Barriers shall be a minimum of 4ft high, and shall be constructed of continuous chain link fence with metal posts at 8ft spacing, or of 2x4 posts with three equally spaced 2x4 rails. Posts may be shifted to avoid roots. No materials shall be placed or disposed of within the TPZ. Natural grade shall be maintained within the TPZ.

**Disposition -**  
Remain - 10ft radius TPZ

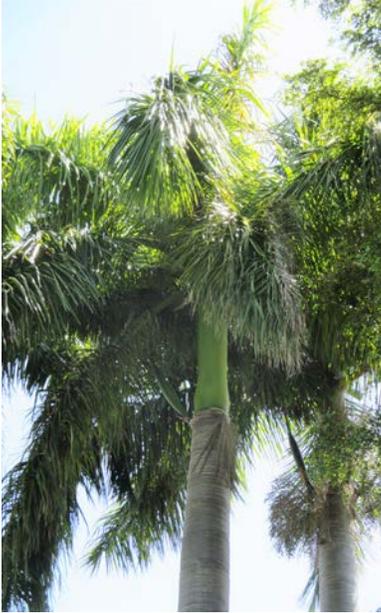
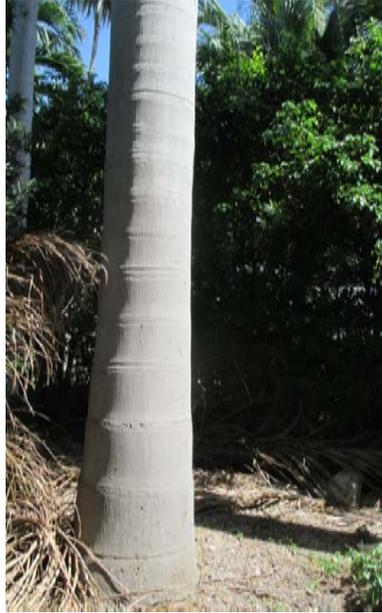
## Tree #11

**Condition -**  
Good

Tree #11 is a Royal Palm located on the north side of the property. It is in good condition with a full canopy and some chlorosis. This tree is to be relocated and root pruning shall occur a minimum of 4-6 weeks prior to digging the palm and shall be performed or supervised by Certified Arborist. Minimum rootball measurement shall be based upon the most recent *Florida Grades & Standards for Nursery Plants*. Prior to transplanting, the apical bud shall be protected by tying up palm fronds. Leaves shall be untied as soon as the palm is planted. When lifting the palm, a nylon sling with adequate padding shall be used and care shall be taken to not injure or compress the trunk. Plant at grade, with 2" of root initiation zone visible if applicable. Transplanting shall occur as soon as possible and no more than 24 hours after being dug for relocation. The backfill soil shall be irrigated during and following relocation. Wooden braces shall be installed to stabilize the tree. Following relocation, a 9ft radius TPZ shall be erected.

**Disposition -**  
Relocate - 9ft radius TPZ

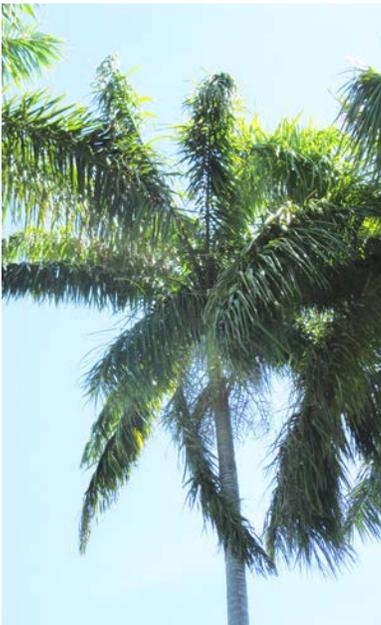
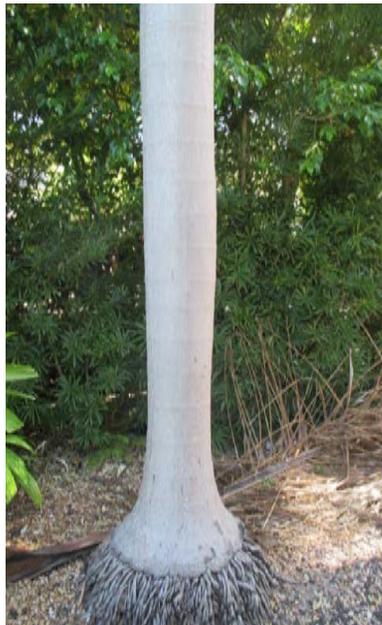
## Tree #12

**Condition -**  
Fair

Tree #12 is a Royal Palm located on the north side of the property. It is in fair condition, is small, and is competing with other nearby palms. This tree has not been incorporated into the landscape plan and will therefore be removed.

**Disposition -**  
Remove

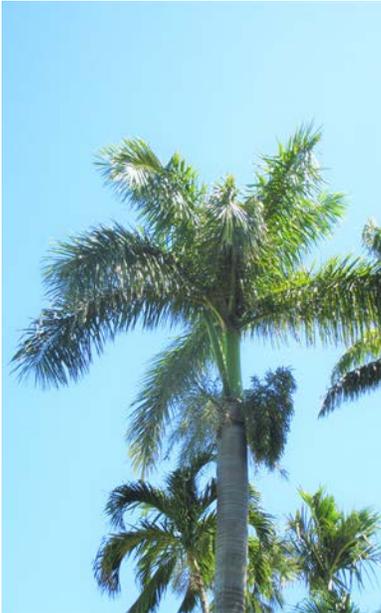
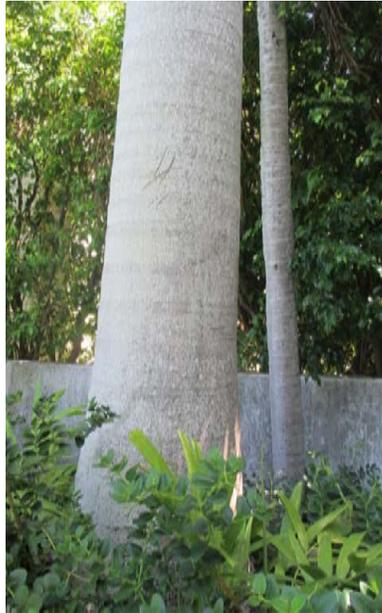
## Tree #13

**Condition -**  
Good

Tree #13 is a Royal Palm located on the north side of the property. It is in good condition with a canopy on the smaller side, and some chlorosis. This tree is to be relocated and root pruning shall occur a minimum of 4-6 weeks prior to digging the palm and shall be performed or supervised by Certified Arborist. Minimum rootball measurement shall be based upon the most recent *Florida Grades & Standards for Nursery Plants*. Prior to transplanting, the apical bud shall be protected by tying up palm fronds. Leaves shall be untied as soon as the palm is planted. When lifting the palm, a nylon sling with adequate padding shall be used and care shall be taken to not injure or compress the trunk. Plant at grade, with 2" of root initiation zone visible if applicable. Transplanting shall occur as soon as possible and no more than 24 hours after being dug for relocation. The backfill soil shall be irrigated during and following relocation. Wooden braces shall be installed to stabilize the tree. Following relocation, a 10ft radius TPZ shall be erected.

**Disposition -**  
Relocate - 10ft radius TPZ

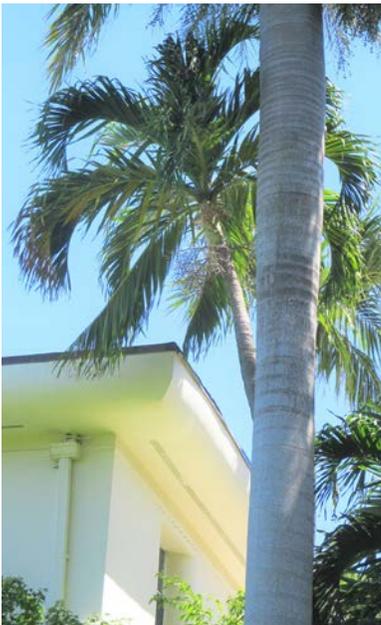
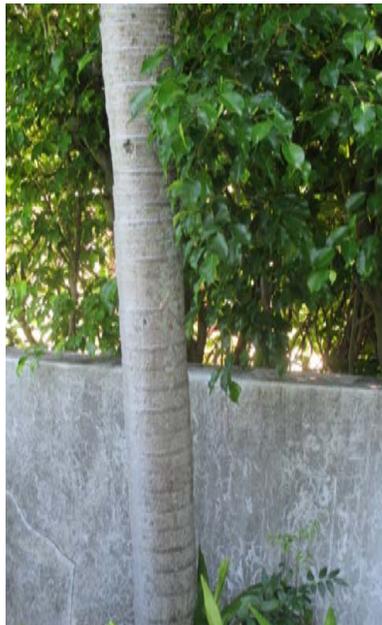
## Tree #14

**Condition -**  
Fair

Tree #14 is a Christmas Palm located on the north side of the property. It is in fair condition with some chlorosis. This tree has not been incorporated into the landscape plan and will therefore be removed.

**Disposition -**  
Remove

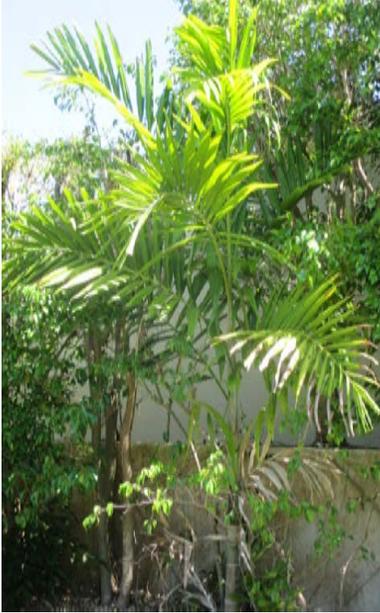
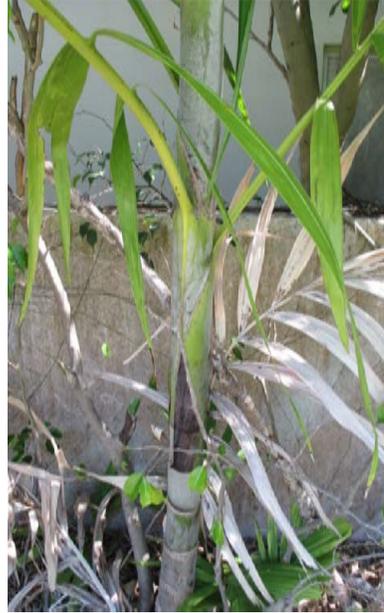
## Tree #15

**Condition -**  
Fair

Tree #15 is a Solitaire Palm located on the north side of the property. It is small and in fair condition with chlorotic foliage. This tree has not been incorporated into the landscape plan and will therefore be removed.

**Disposition -**  
Remove

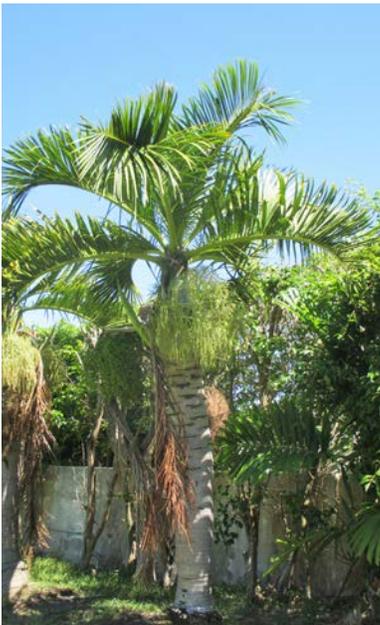
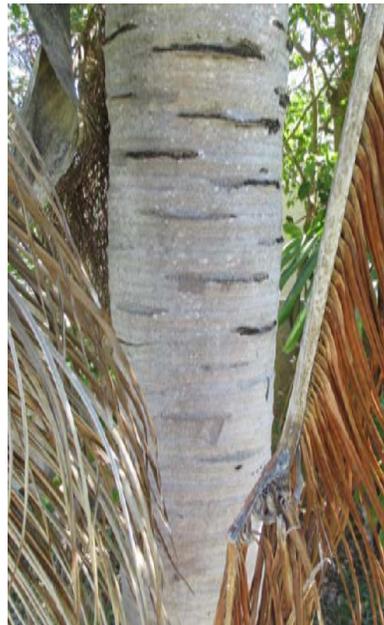
## Tree #16

**Condition -**  
Fair

Tree #16 is a Spindle Palm located on the north side of the property. It is in fair condition with yellow spotting on the foliage and lower dead fronds. This tree has not been incorporated into the landscape plan and will therefore be removed.

**Disposition -**  
Remove

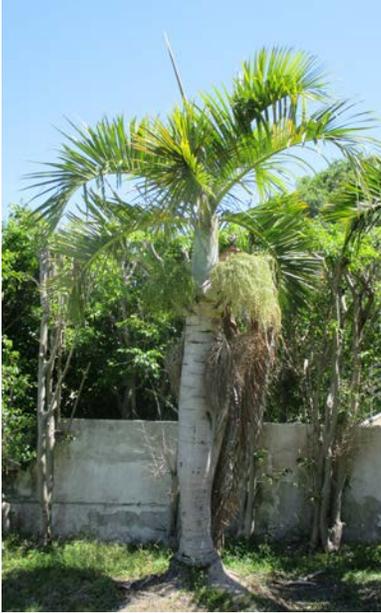
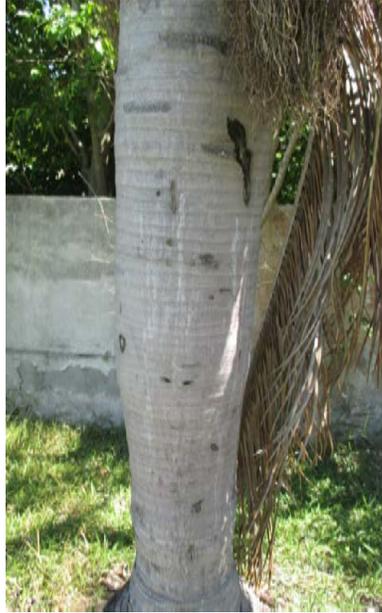
## Tree #17

**Condition -**  
Fair

Tree #17 is a Spindle Palm located on the north side of the property. It is in fair condition with yellow spotting on the foliage and lower dead fronds. This tree has not been incorporated into the landscape plan and will therefore be removed.

**Disposition -**  
Remove

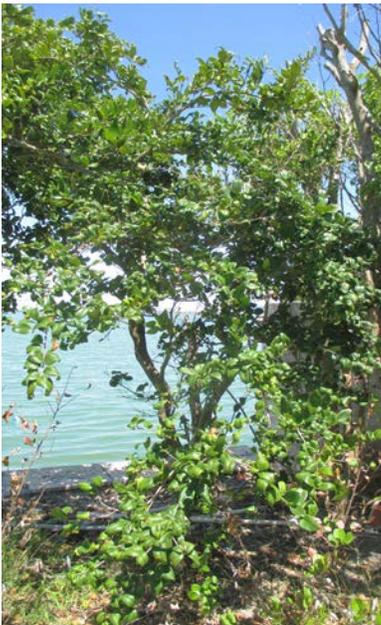
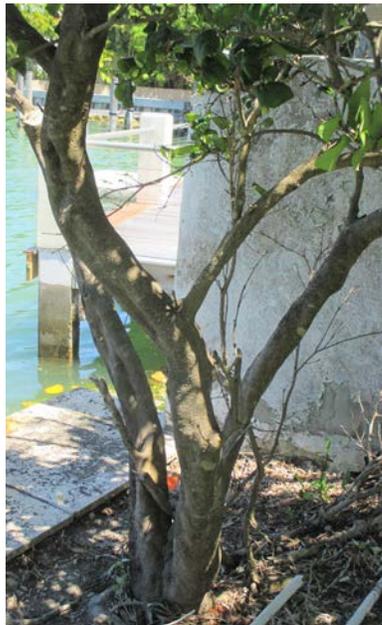
## Tree #18

**Condition -**  
Fair

Tree #18 is a Japanese Privet located at the rear of the property. It is in fair condition with leaf spot and one limb that has been tracked. This tree has not been incorporated into the landscape plan and will therefore be removed.

**Disposition -**  
Remove

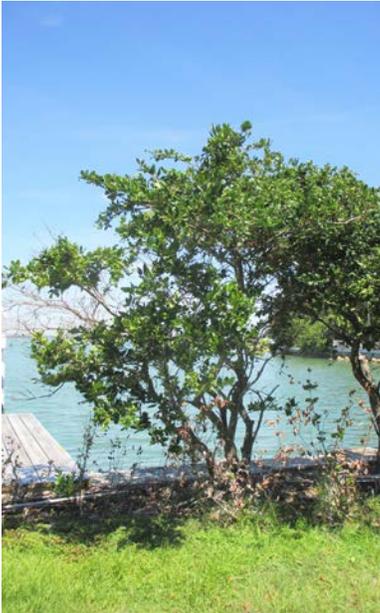
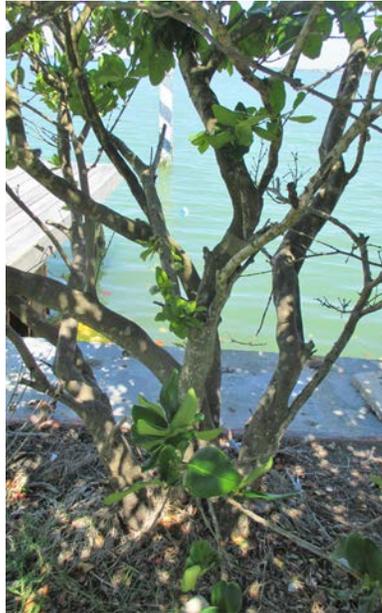
## Tree #19

**Condition -**  
Poor

Tree #19 is a Japanese Privet located at the rear of the property. It is in poor condition with a thin canopy and branch dieback. This tree has not been incorporated into the landscape plan and will therefore be removed.

**Disposition -**  
Remove

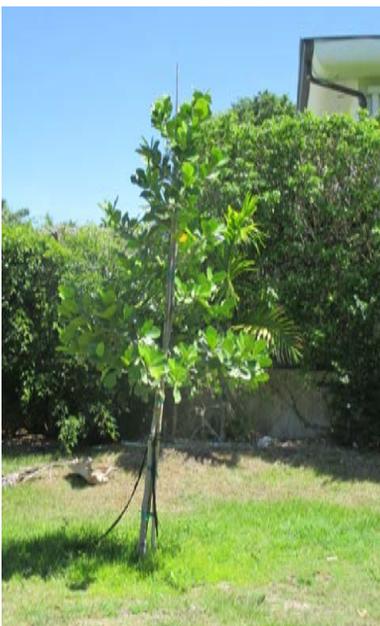
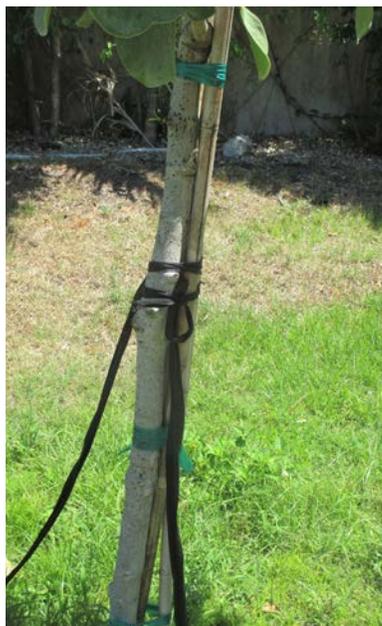
## Tree #20

**Condition -**  
Good

Tree #20 is a Pitch-Apple located towards the north side of the property. It is small and has been recently planted. It is in good condition with good form. Remove ties before they begin to injure the trunk.

**Disposition -**  
Relocate - 3ft radius TPZ

This tree is to be relocated and root pruning shall occur a minimum of 8 weeks prior to digging the tree and shall be performed or supervised by Certified Arborist. Minimum rootball measurement shall be based upon the most recent *Florida Grades & Standards for Nursery Plants*. Transplanting shall be performed or supervised by Certified Arborist. Prior to transplanting, only branches that are dead or broken are to be removed; no live foliage is to be pruned off. When lifting the tree, ensure that the trunk is not damaged. The diameter of the planting hole shall be twice the root ball diameter. Plant at grade, with the trunk flare visible. Transplanting shall occur as soon as possible and no more than 24 hours after being dug for relocation. Proper irrigation shall be provided during and after transplanting. Following relocation, a 3ft radius TPZ shall be erected.

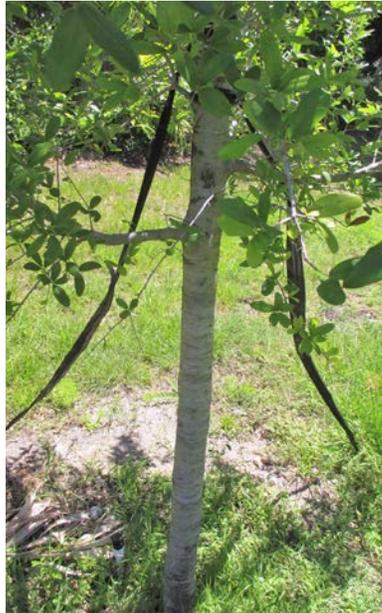
**Condition -**  
Good

Tree #21 is a Live Oak located towards the north side of the property. It is small and has been recently planted. It is in good condition with good form. This tree has not been incorporated into the landscape plan and will therefore be removed.

**Disposition -**  
Remove

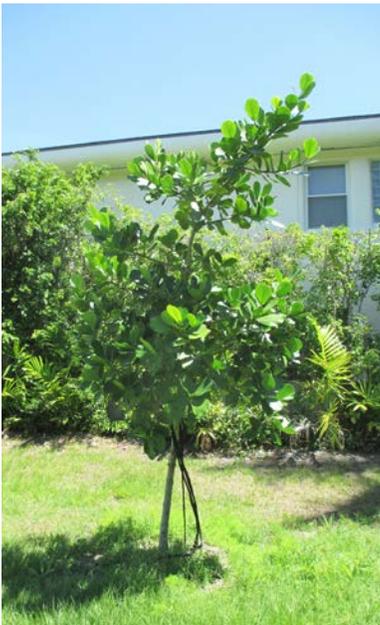
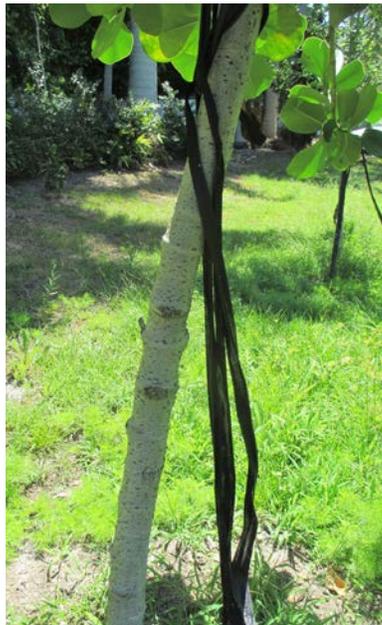
## Tree #22

**Condition -**  
Good

Tree #22 is a Pitch-Apple located towards the north side of the property. It is small and has been recently planted. It is in good condition with good form. Remove ties before they begin to injure the trunk. This tree is to be relocated and root pruning shall occur a minimum of 8 weeks prior to digging the tree and shall be performed or supervised by Certified Arborist. Minimum rootball measurement shall be based upon the most recent *Florida Grades & Standards for Nursery Plants*. Transplanting shall be performed or supervised by Certified Arborist. Prior to transplanting, only branches that are dead or broken are to be removed; no live foliage is to be pruned off. When lifting the tree, ensure that the trunk is not damaged. The diameter of the planting hole shall be twice the root ball diameter. Plant at grade, with the trunk flare visible. Transplanting shall occur as soon as possible and no more than 24 hours after being dug for relocation. Proper irrigation shall be provided during and after transplanting. Following relocation, a 3ft radius TPZ shall be erected.

**Disposition -**  
Relocate - 3ft radius TPZ

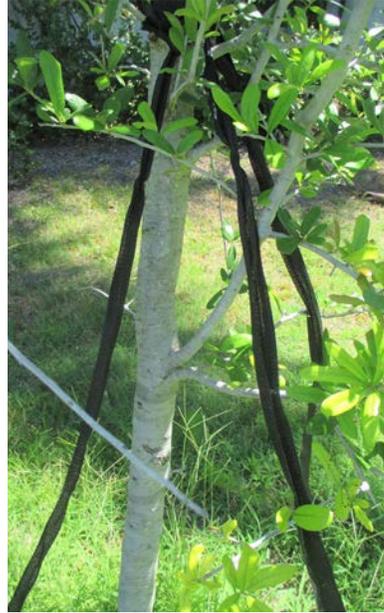
## Tree #23

**Condition -**  
Good

Tree #23 is a Live Oak located towards the north side of the property. It is small and has been recently planted. It is in good condition with good form. Remove ties before they begin to injure the trunk. This tree has not been incorporated into the landscape plan and will therefore be removed.

**Disposition -**  
Remove

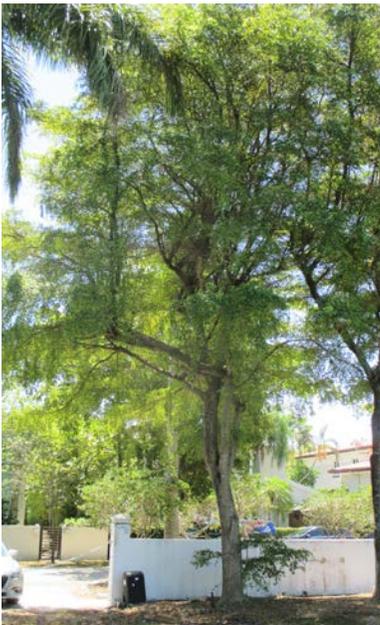
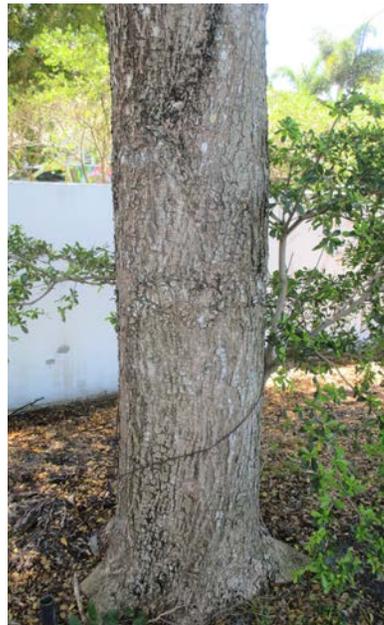
## Tree #24

**Condition -**  
Fair

Tree #24 is a Black Olive located at the front of the property. It is in fair condition - the canopy is dense with some small-diameter deadwood. The tree has poor form, and was hatracked years ago. The canopy now consists of shoot growth from these cut locations. The trunk divides into a number of main limbs with included bark. Prune to remove deadwood.

**Disposition -**  
Remain - 12.5ft radius TPZ

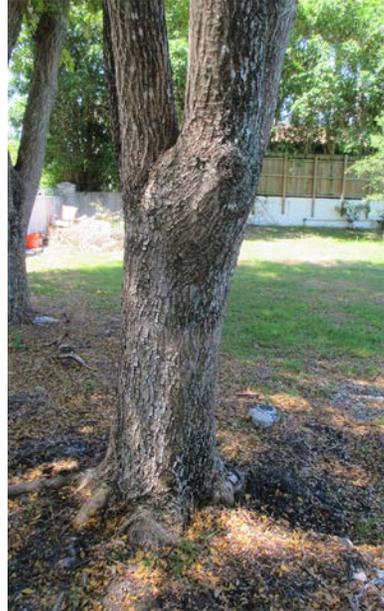
**Condition -**  
Fair

Tree #25 is a Black Olive located at the front of the property. It is in fair condition - the canopy is dense with some small-diameter deadwood. The tree has poor form, and was hatracked years ago. The canopy now consists of shoot growth from these cut locations. The trunk divides into a number of main limbs with included bark. Prune to remove deadwood. This tree is to be relocated and root pruning shall occur a minimum of 8 weeks prior to digging the tree and shall be performed or supervised by Certified Arborist. Minimum rootball measurement shall be based upon the most recent *Florida Grades & Standards for Nursery Plants*. Transplanting shall be performed or supervised by Certified Arborist. Prior to transplanting, only branches that are dead or broken are to be removed; no live foliage is to be pruned off. When lifting the tree, ensure that the trunk is not damaged. The diameter of the planting hole shall be twice the root ball diameter. Plant at grade, with the trunk flare visible. Transplanting shall occur as soon as possible and no more than 24 hours after being dug for relocation. Proper irrigation shall be provided during and after transplanting. Following relocation, a 12.5ft radius TPZ shall be erected.

**Disposition -**  
Relocate - 12.5ft radius TPZ

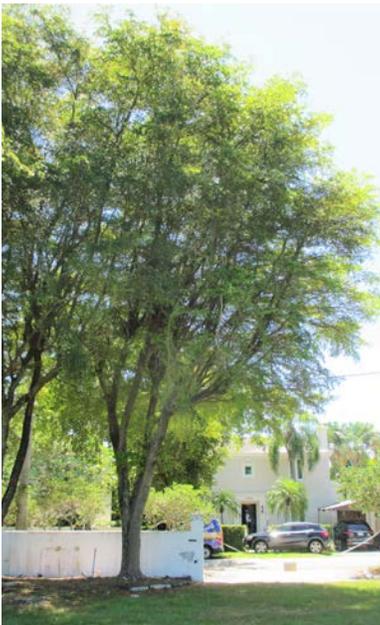
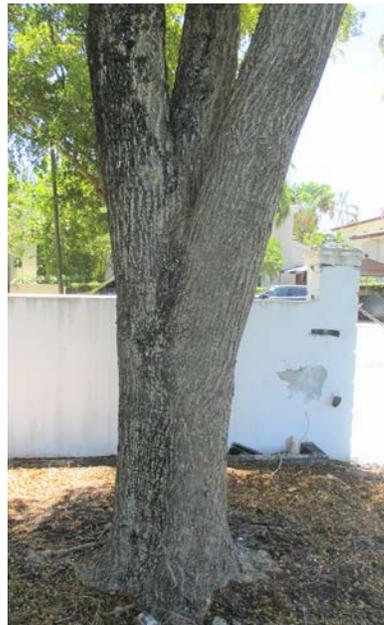
## Tree #26

**Condition -**  
Fair

Tree #26 is a Black Olive located at the front of the property. It is in fair condition - the canopy is dense with some small-diameter deadwood. The tree has poor form, and was hatracked years ago. The canopy now consists of shoot growth from these cut locations. The trunk divides into a number of main limbs with included bark. Prune to remove deadwood. This tree is to remain and protective barriers shall be placed 12.5ft from the tree trunk. Barriers shall be installed prior to the start of construction, and shall remain in place until development is completed and until the department authorizes their removal. Barriers shall be a minimum of 4ft high, and shall be constructed of continuous chain link fence with metal posts at 8ft spacing, or of 2x4 posts with three equally spaced 2x4 rails. Posts may be shifted to avoid roots. No materials shall be placed or disposed of within the TPZ. Natural grade shall be maintained within the TPZ.

**Disposition -**  
Remain - 12.5ft radius TPZ

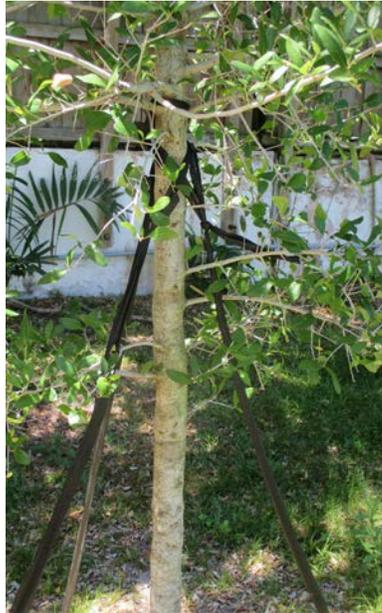
## Tree #27

**Condition -**  
Good

Tree #27 is a Live Oak located towards the south side of the property. It is small and has been recently planted. It is in good condition with good form. This tree has not been incorporated into the landscape plan and will therefore be removed.

**Disposition -**  
Remove

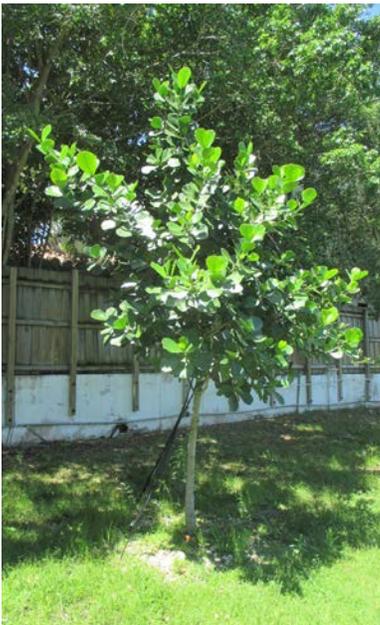
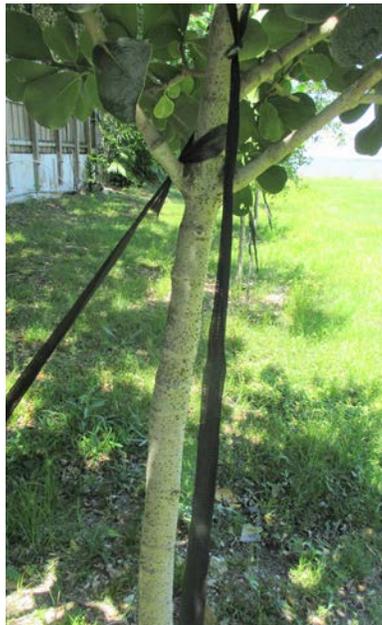
## Tree #28

**Condition -**  
Good

Tree #28 is a Pitch-Apple located towards the south side of the property. It is small and has been recently planted. It is in good condition with good form. Remove ties before they begin to injure the trunk.

**Disposition -**  
Relocate - 5ft radius TPZ

This tree is to be relocated and root pruning shall occur a minimum of 8 weeks prior to digging the tree and shall be performed or supervised by Certified Arborist. Minimum rootball measurement shall be based upon the most recent *Florida Grades & Standards for Nursery Plants*. Transplanting shall be performed or supervised by Certified Arborist. Prior to transplanting, only branches that are dead or broken are to be removed; no live foliage is to be pruned off. When lifting the tree, ensure that the trunk is not damaged. The diameter of the planting hole shall be twice the root ball diameter. Plant at grade, with the trunk flare visible. Transplanting shall occur as soon as possible and no more than 24 hours after being dug for relocation. Proper irrigation shall be provided during and after transplanting. Following relocation, a 5ft radius TPZ shall be erected.

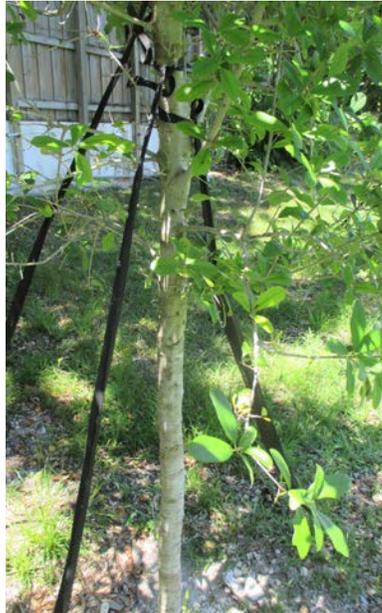
**Condition -**  
Good

Tree #29 is a Live Oak located towards the south side of the property. It is small and has been recently planted. It is in good condition with good form. This tree has not been incorporated into the landscape plan and will therefore be removed.

**Disposition -**  
Remove

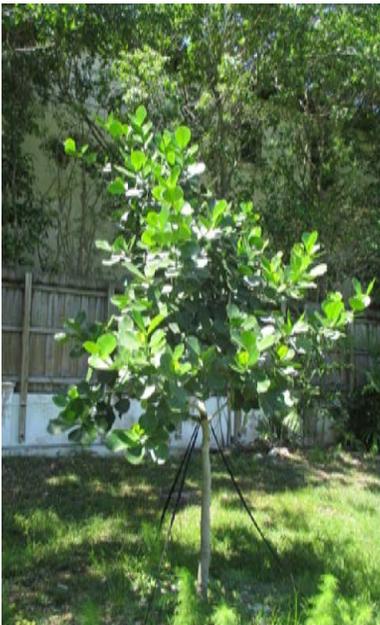
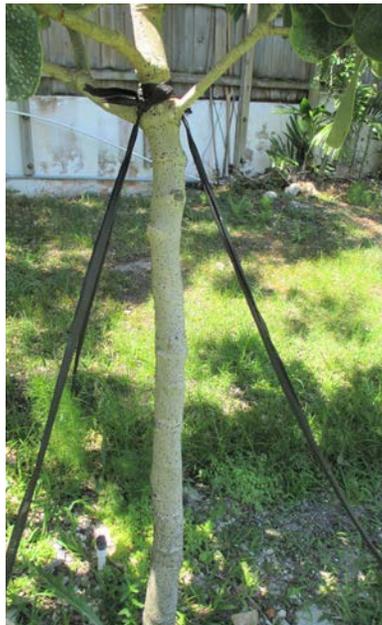
## Tree #30

**Condition -**  
Good

Tree #30 is a Pitch-Apple located towards the south side of the property. It is small and has been recently planted. It is in good condition with good form. Remove ties before they begin to injure the trunk.

**Disposition -**  
Relocate - 4ft radius TPZ

This tree is to be relocated and root pruning shall occur a minimum of 8 weeks prior to digging the tree and shall be performed or supervised by Certified Arborist. Minimum rootball measurement shall be based upon the most recent *Florida Grades & Standards for Nursery Plants*. Transplanting shall be performed or supervised by Certified Arborist. Prior to transplanting, only branches that are dead or broken are to be removed; no live foliage is to be pruned off. When lifting the tree, ensure that the trunk is not damaged. The diameter of the planting hole shall be twice the root ball diameter. Plant at grade, with the trunk flare visible. Transplanting shall occur as soon as possible and no more than 24 hours after being dug for relocation. Proper irrigation shall be provided during and after transplanting. Following relocation, a 4ft radius TPZ shall be erected.

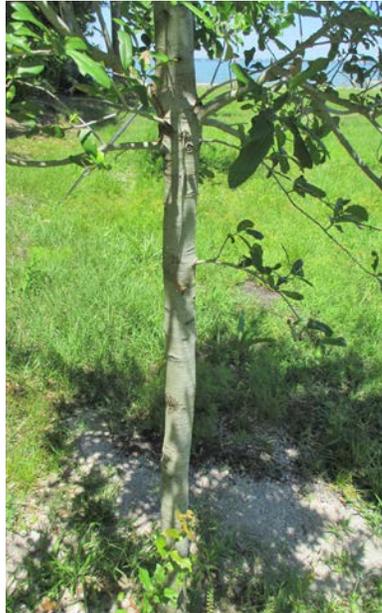
**Condition -**  
Good

Tree #31 is a Live Oak located towards the south side of the property. It is small and has been recently planted. It is in good condition with good form. This tree has not been incorporated into the landscape plan and will therefore be removed.

**Disposition -**  
Remove

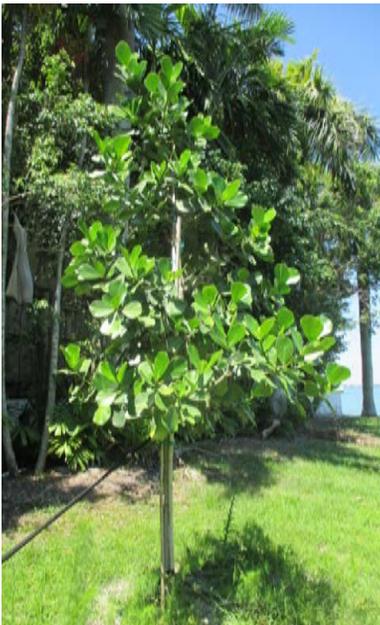
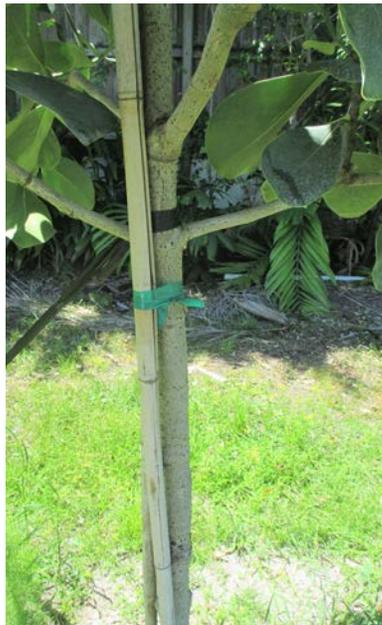
## Tree #32

**Condition -**  
Good

Tree #32 is a Pitch-Apple located towards the south side of the property. It is small and has been recently planted. It is in good condition with good form. Remove ties before they begin to injure the trunk.

**Disposition -**  
Relocate - 4ft radius TPZ

This tree is to be relocated and root pruning shall occur a minimum of 8 weeks prior to digging the tree and shall be performed or supervised by Certified Arborist. Minimum rootball measurement shall be based upon the most recent *Florida Grades & Standards for Nursery Plants*. Transplanting shall be performed or supervised by Certified Arborist. Prior to transplanting, only branches that are dead or broken are to be removed; no live foliage is to be pruned off. When lifting the tree, ensure that the trunk is not damaged. The diameter of the planting hole shall be twice the root ball diameter. Plant at grade, with the trunk flare visible. Transplanting shall occur as soon as possible and no more than 24 hours after being dug for relocation. Proper irrigation shall be provided during and after transplanting. Following relocation, a 4ft radius TPZ shall be erected.

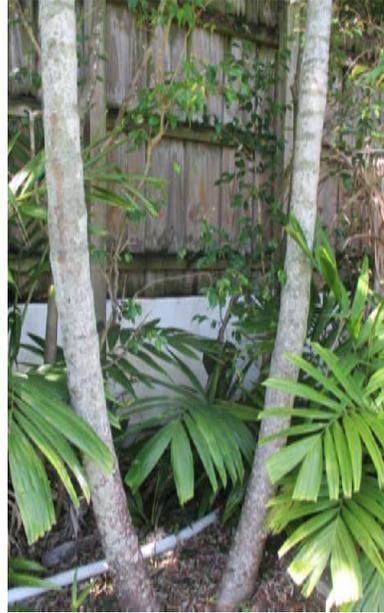
**Condition -**  
Fair

Tree #33 is a double Solitaire Palm located along the south side of the property. It is in fair condition with some tattered fronds. This tree has not been incorporated into the landscape plan and will therefore be removed.

**Disposition -**  
Remove

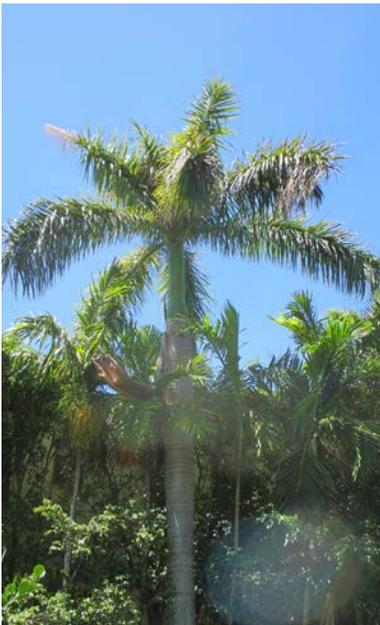
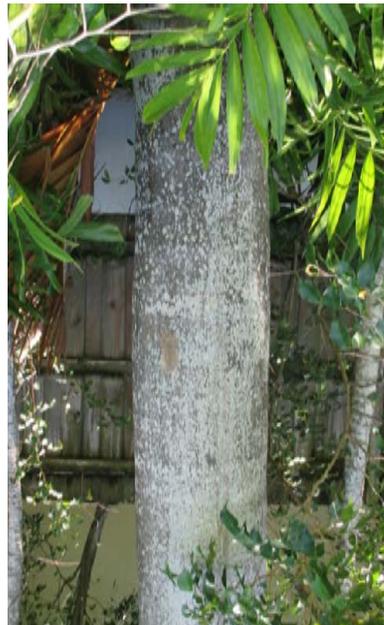
## Tree #34

**Condition -**  
Fair

Tree #34 is a Royal Palm located along the south side of the property. It is in fair condition with a small canopy with some fronds that are chlorotic and frizzled.

**Disposition -**  
Remain - 10ft radius TPZ

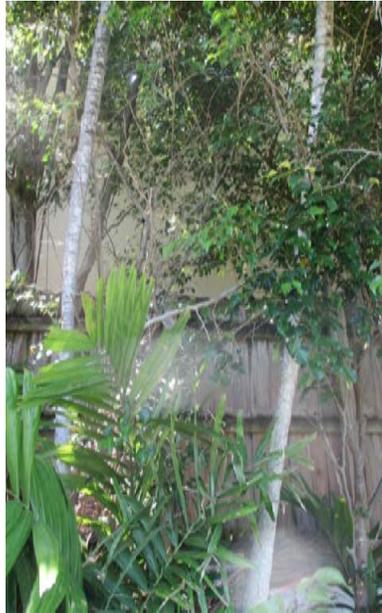
**Condition -**  
Fair

Tree #35 is a double Solitaire Palm located along the south side of the property. It is in fair condition with some chlorosis. This tree has not been incorporated into the landscape plan and will therefore be removed.

**Disposition -**  
Remove

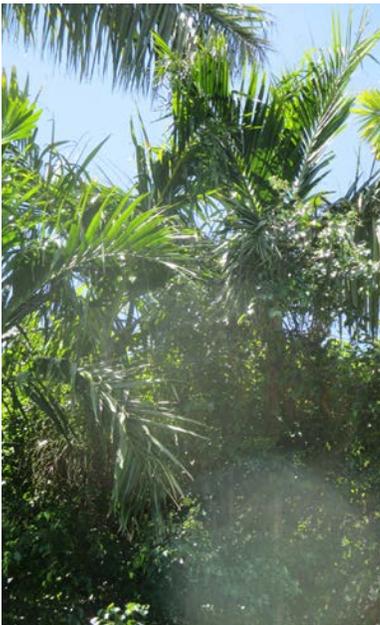
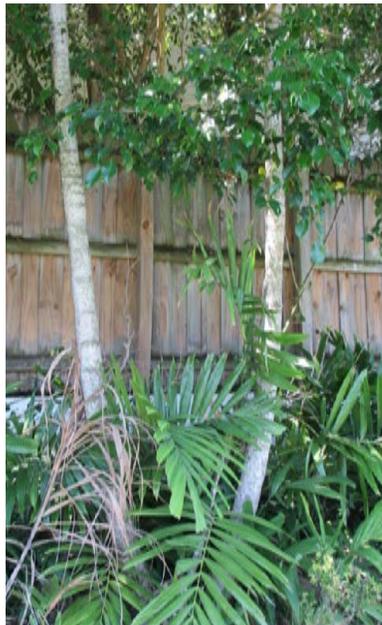
## Tree #36

**Condition -**  
Fair

Tree #36 is a double Solitaire Palm located along the south side of the property. It is in fair condition with some fronds that are tattered. This tree has not been incorporated into the landscape plan and will therefore be removed.

**Disposition -**  
Remove

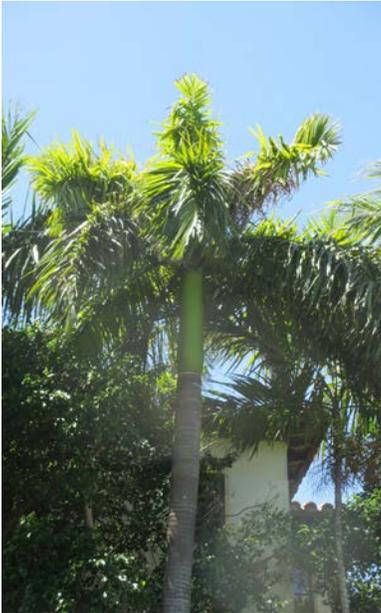
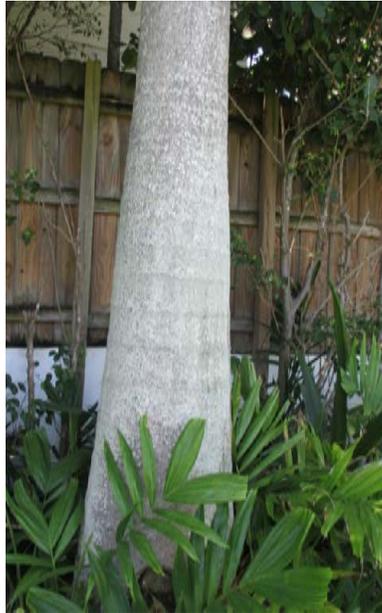
## Tree #37

**Condition -**  
Poor

Tree #37 is a Royal Palm located along the south side of the property. It is in poor condition with a small, chlorotic canopy. A wound is at the base of the trunk with decay. It is recommended that this tree be removed.

**Disposition -**  
Remove

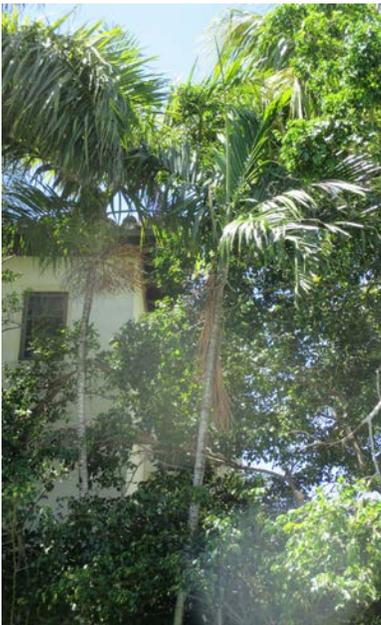
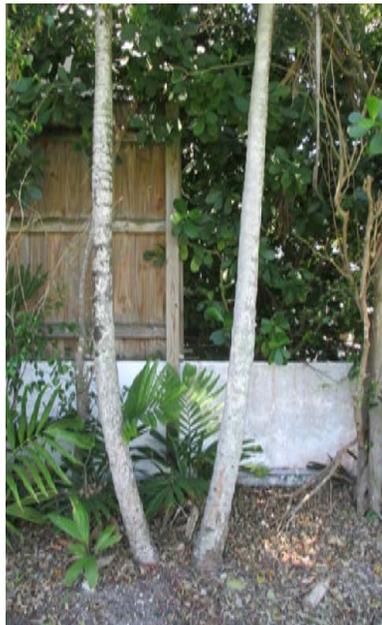
**Condition -**  
Fair

Tree #38 is a double Solitaire Palm located along the south side of the property. It is in fair condition and is competing with other nearby vegetation. This tree has not been incorporated into the landscape plan and will therefore be removed.

**Disposition -**  
Remove

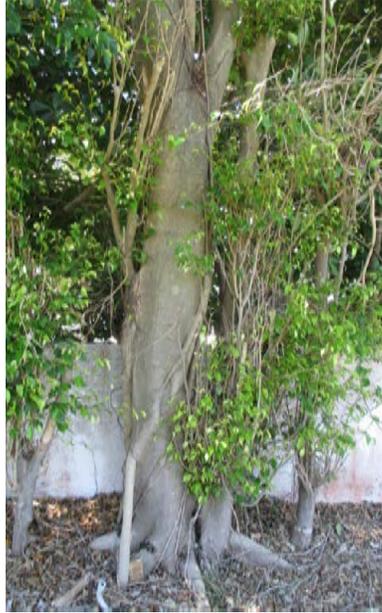
**Condition -**  
Poor

Tree #39 is a Weeping Fig located on the south side of the property. It is in poor condition with poor form, as the main leader has been hatracked. This tree has not been incorporated into the landscape plan and will therefore be removed.

**Disposition -**  
Remove

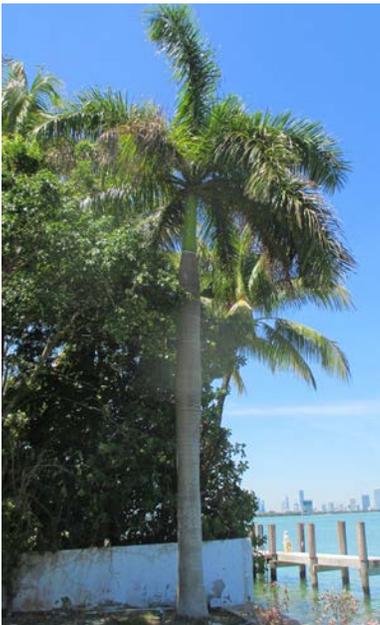
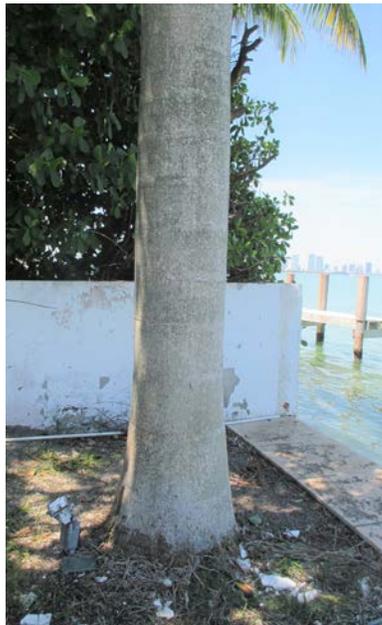
**Condition -**  
Fair

Tree #40 is a Royal Palm located in the rear southwest corner of the property. It is in fair condition with some foliage that is frizzled.

**Disposition -**  
Remain - 10ft radius TPZ
