Tree Resource Evaluation for

727 77th Street, Miami Beach, aka Lehrman School

April 28, 2020

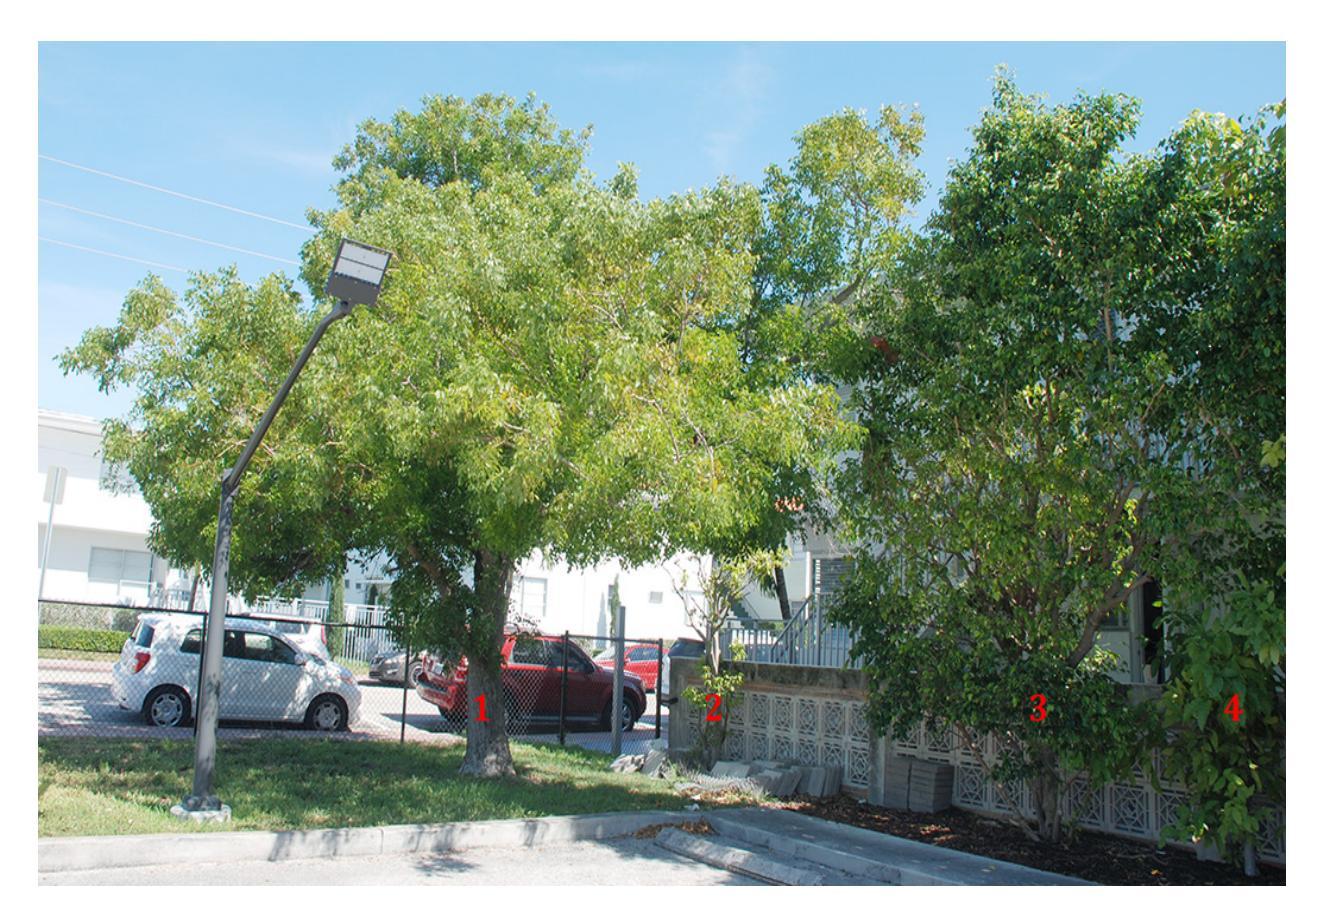
Photo 1 above is tree 1 viewed from the east. Trees 2 through 4 are part of an over-grown *Ficus benjamina* hedge.

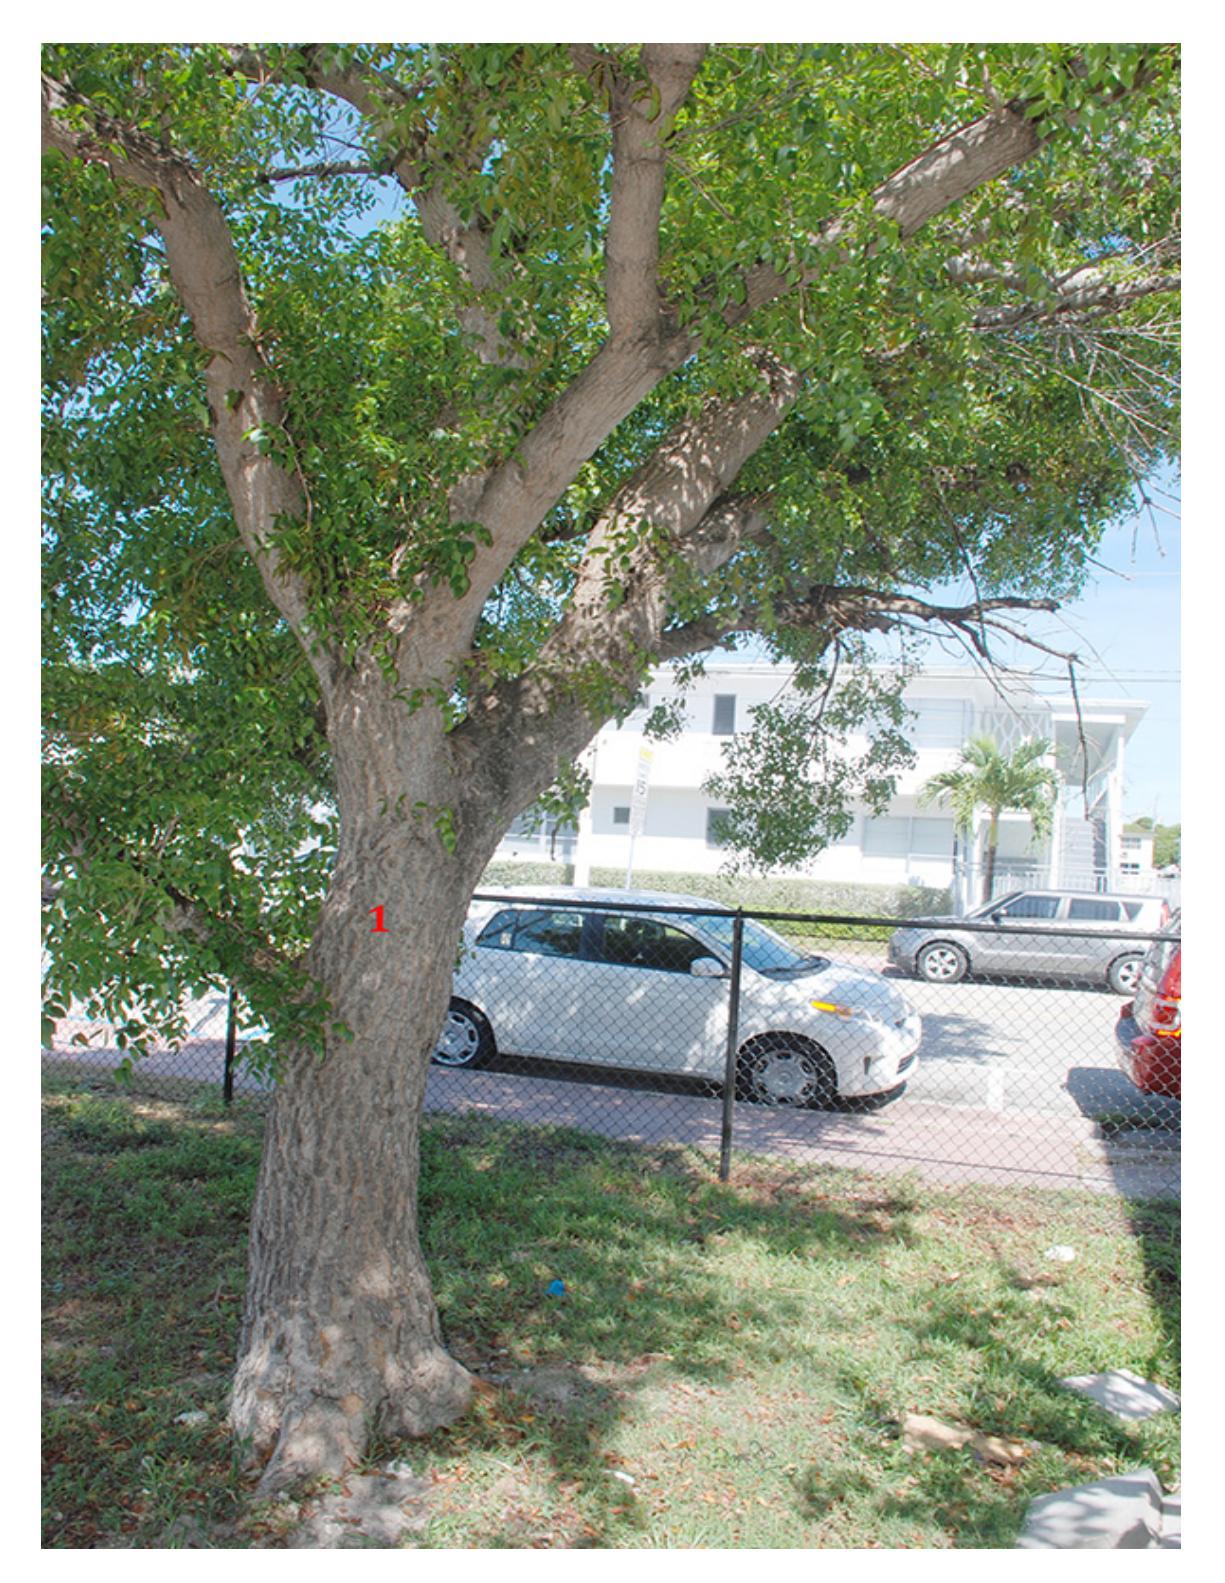
Photo 2 above is the trunk of tree 1. I found no signs of decay, cavities, or fungal fruiting bodies on the root collar or trunk. This tree is a good candidate for relocation.

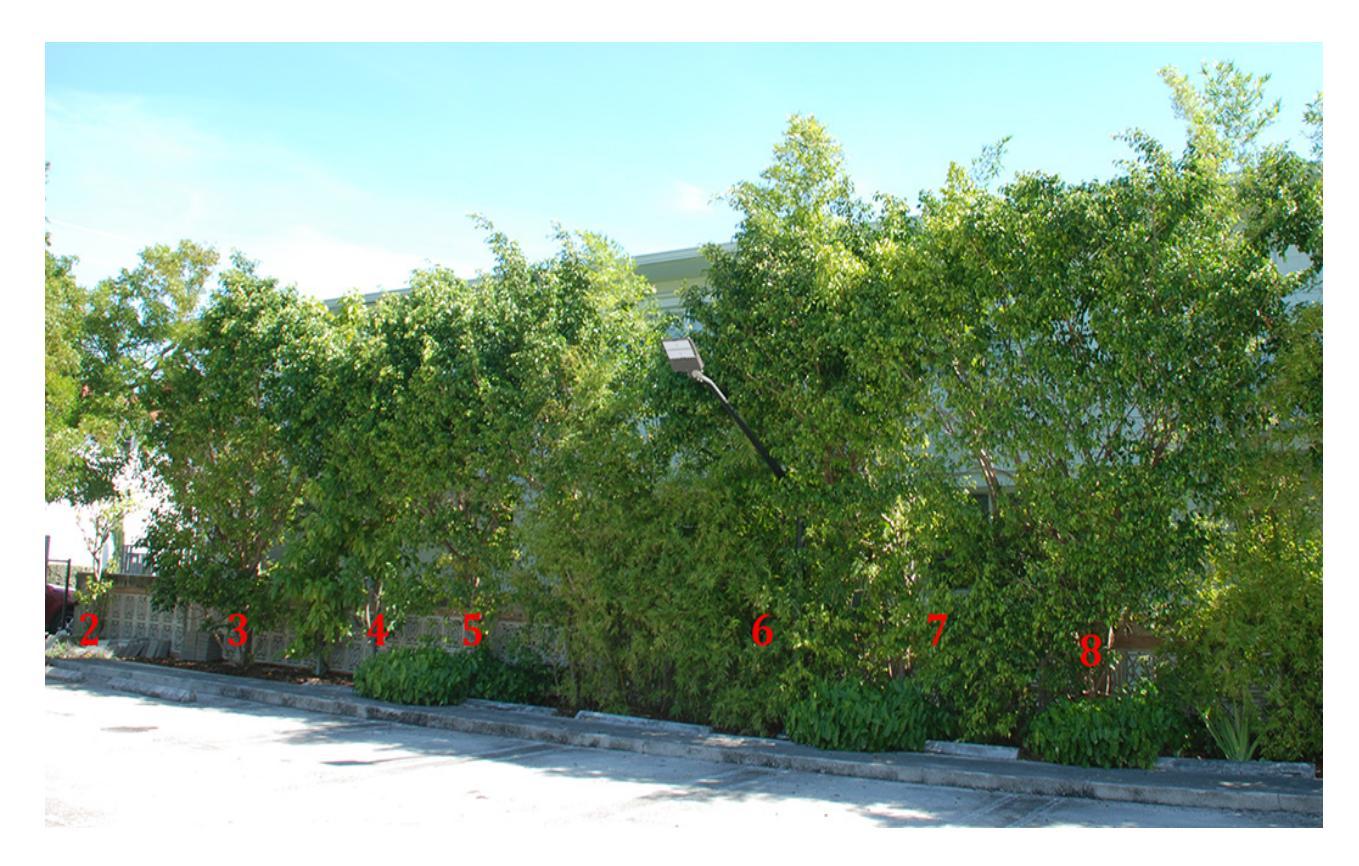
Photo 3 above is trees 2 through 8, part of an over-grown *Ficus benjamina* hedge.

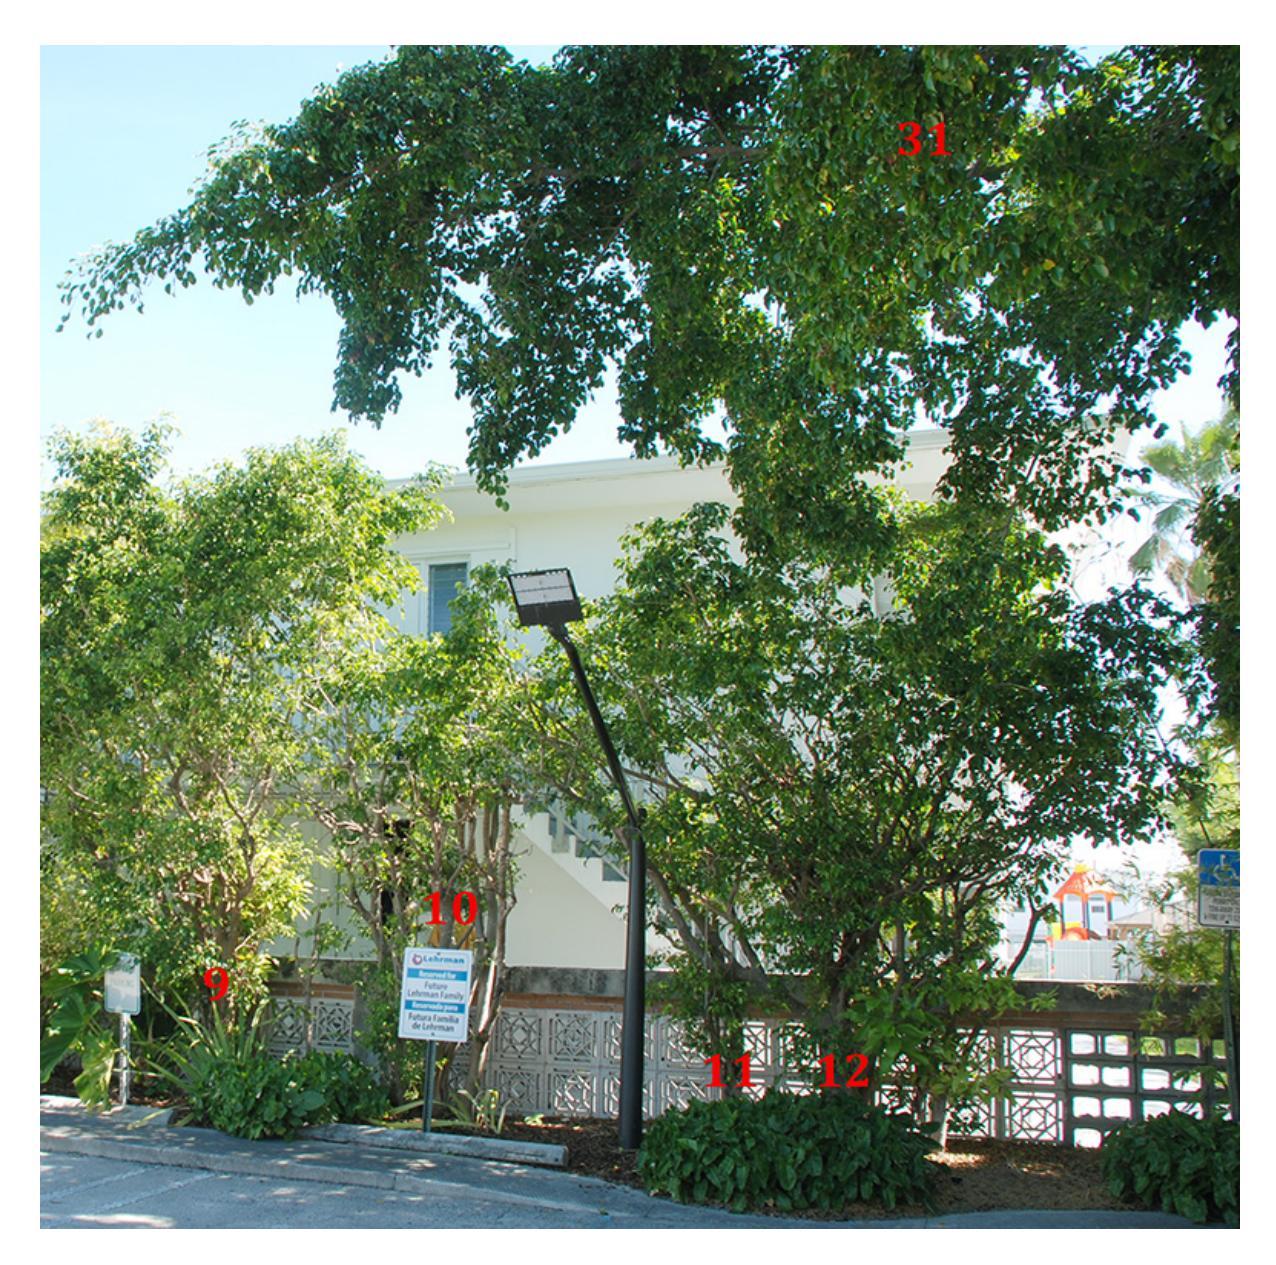
Photo 3 above is trees 9, 10, 11 & 12, part of an over-grown *Ficus benjamina* hedge.

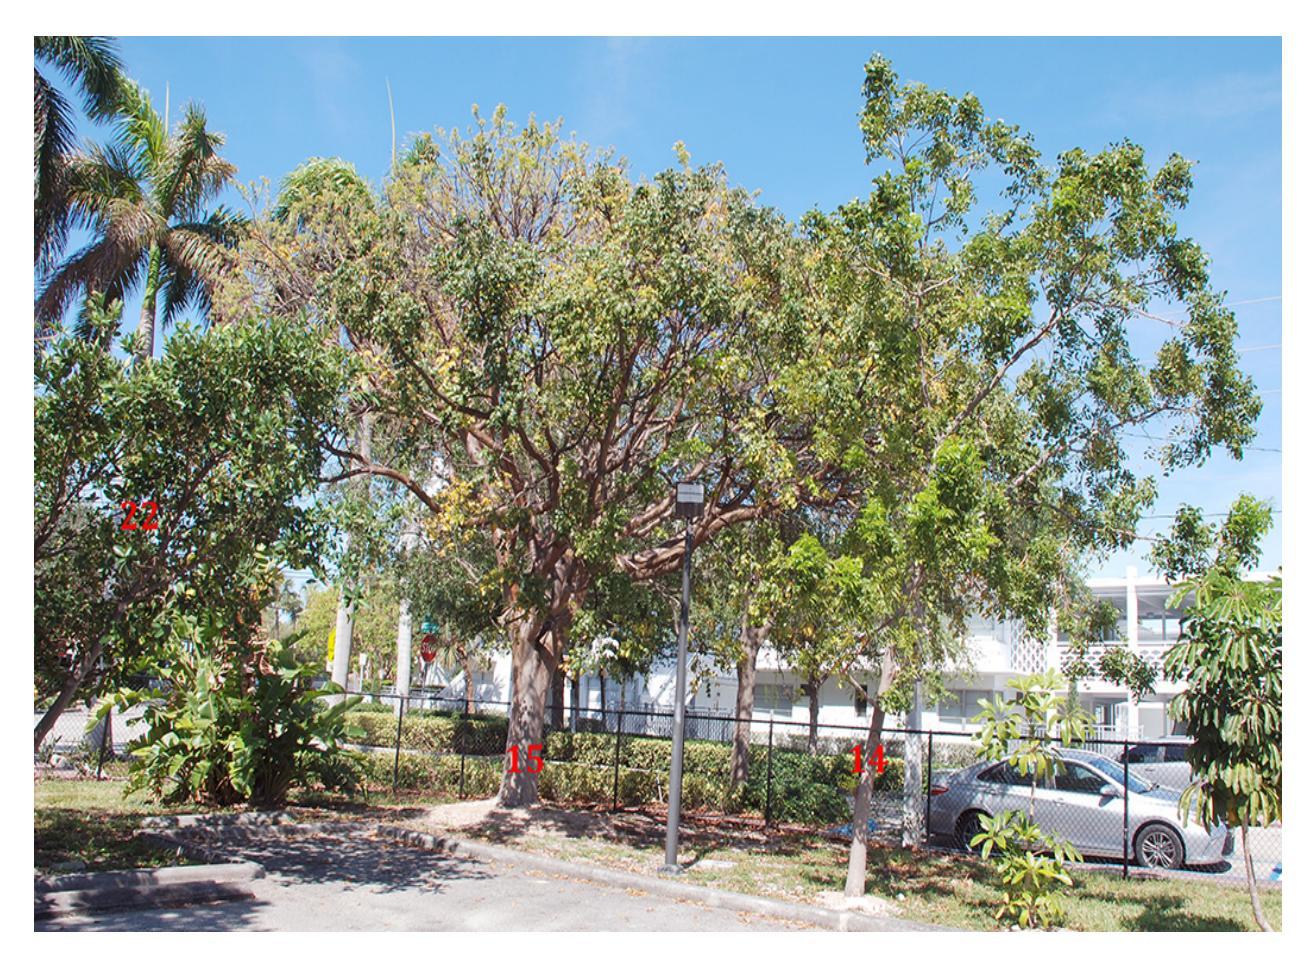
Photo 5 above is trees 14, 15 & 22 viewed from the east. I found no signs of decay, cavities, or fungal fruiting bodies on the root collar or trunk of these trees. See following photos.

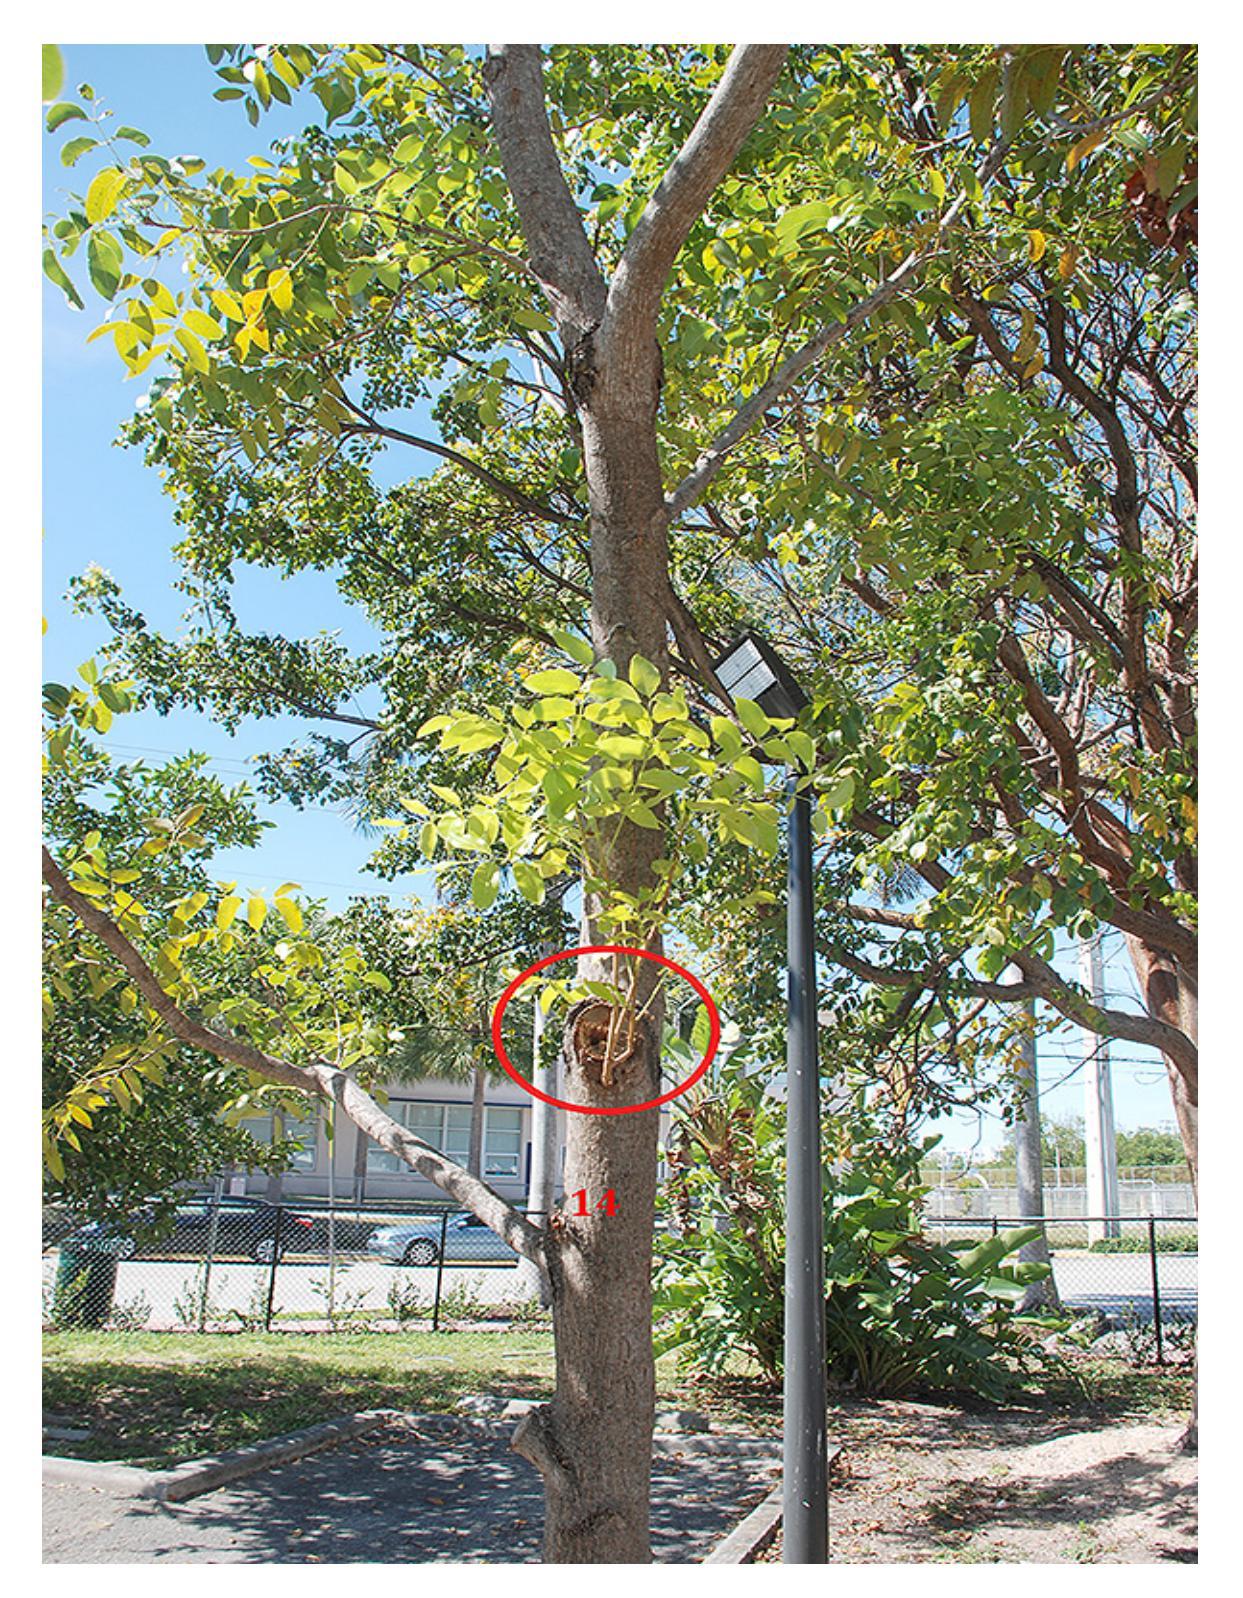
Photo 6 above the trunk of tree 14 with a large pruning wound indicated.
