4880 PINE TREE DRIVE

LANDSCAPE SET

CONTINUANCE SUBMITTAL

Arborist Report

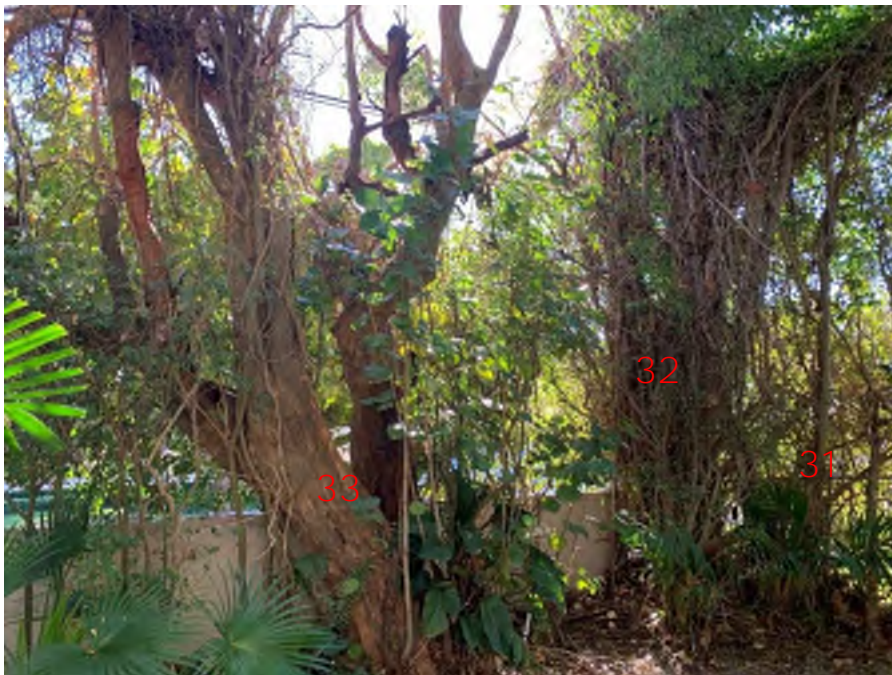
Photo 8
Trees
#31, 32 & 33

#	SCIENTIFIC NAME	COMMON NAME	DBH	HGT	CAN	CRZ	CONDITION
31	<i>Ficus benjamina</i>	Weeping Fig	5"	16"	10'	5'	Poor
32	<i>Ficus benjamina</i>	Weeping Fig	22"	20'	18'	15'	Poor
33	<i>Coccoloba uvifera</i>	Seagrape	Multi 20" / 21	35'	28'	41'	Poor
34	<i>Bauhinia variegata</i>	Bauhinia butterfly	6"	17'	10'	6'	Good
35	<i>Adonidia merrillii</i>	Manila palm	12"	20'	15'	12'	Good
36	<i>Syagrus romanzoffiana</i>	Queen palm	15"	15'	12'	15'	Good
37	<i>Bauhinia variegata</i>	Bauhinia butterfly	8"	13'	15'	8'	Good
38	<i>Adonidia merrillii</i>	Manila palm	10"	12'	10'	10'	Good
39	<i>Adonidia merrillii</i>	Manila palm	9"	12'	10'	9'	Good
40	<i>Ficus benjamina</i>	Weeping Fig	Multi (4x) 4"	18'	8'	16'	Good
41	<i>Ficus benjamina</i>	Weeping Fig	Multi (2x) 4"	17'	8'	8'	Good
D	<i>Ficus benjamina</i>	Weeping Fig	3"	16'	7'	3'	Good
E	<i>Ficus benjamina</i>	Weeping Fig	Multi 3" /5"	18'	8'	8'	Good
F	<i>Ficus benjamina</i>	Weeping Fig	Multi 3"/3.5"/3"	16'	8'	10'	Good
