# ILLUSION LANDSCAPE & DESIGN

Arborist report / Tree assessment:

Jan. 15, 2020

7835 Harding Ave. Miami Bch, Fl. 33141

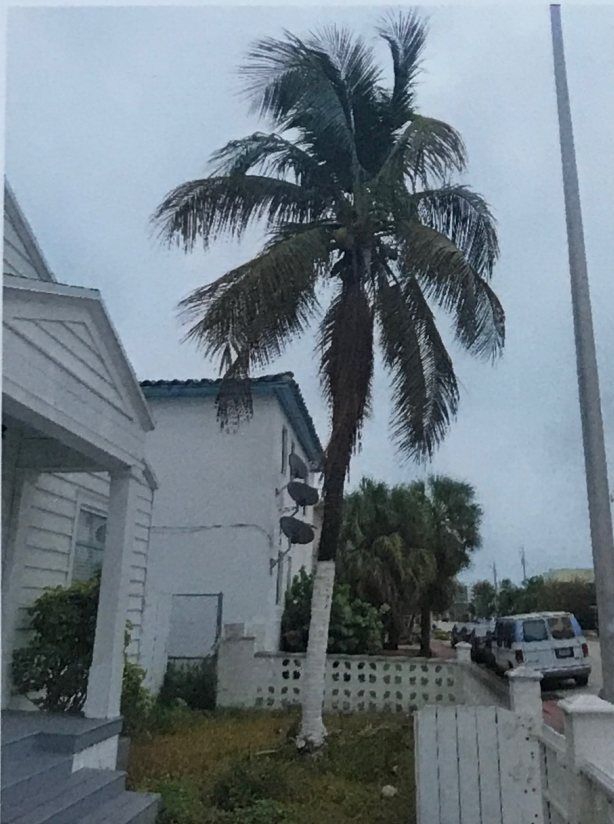
Tree #1- Cocos nucifera, pictured in #1, The palm is in good condition.

Cocos nucifera

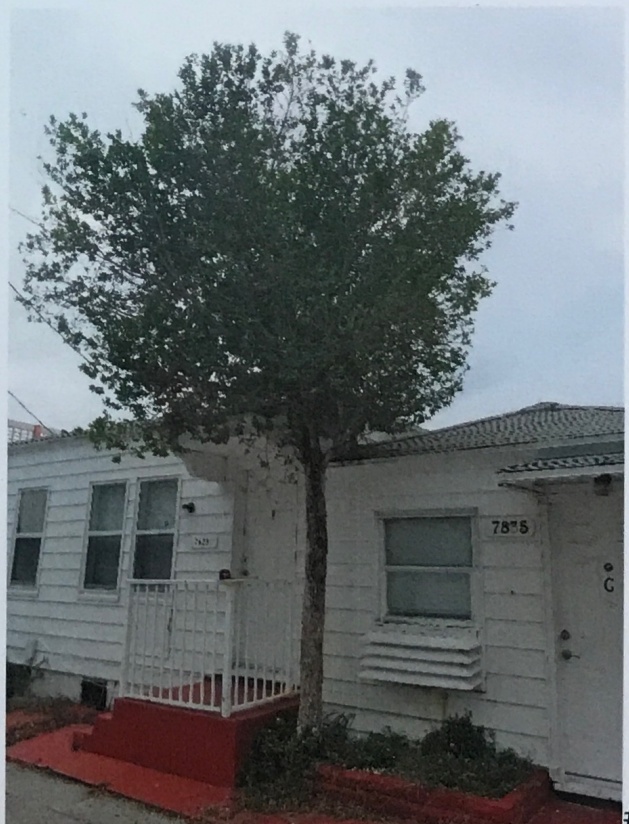
Tree #2- Murraya paniculata, pictured in #2, shrub that has been pruned into a tree.  
The tree is in good condition

#2- Murraya paniculata
