Arborist Report Tree Inspections for 4541 N Bay Road Miami Beach, FL

Report date: April 7, 2022

Property: 4541 N Bay Road Miami Beach, FL

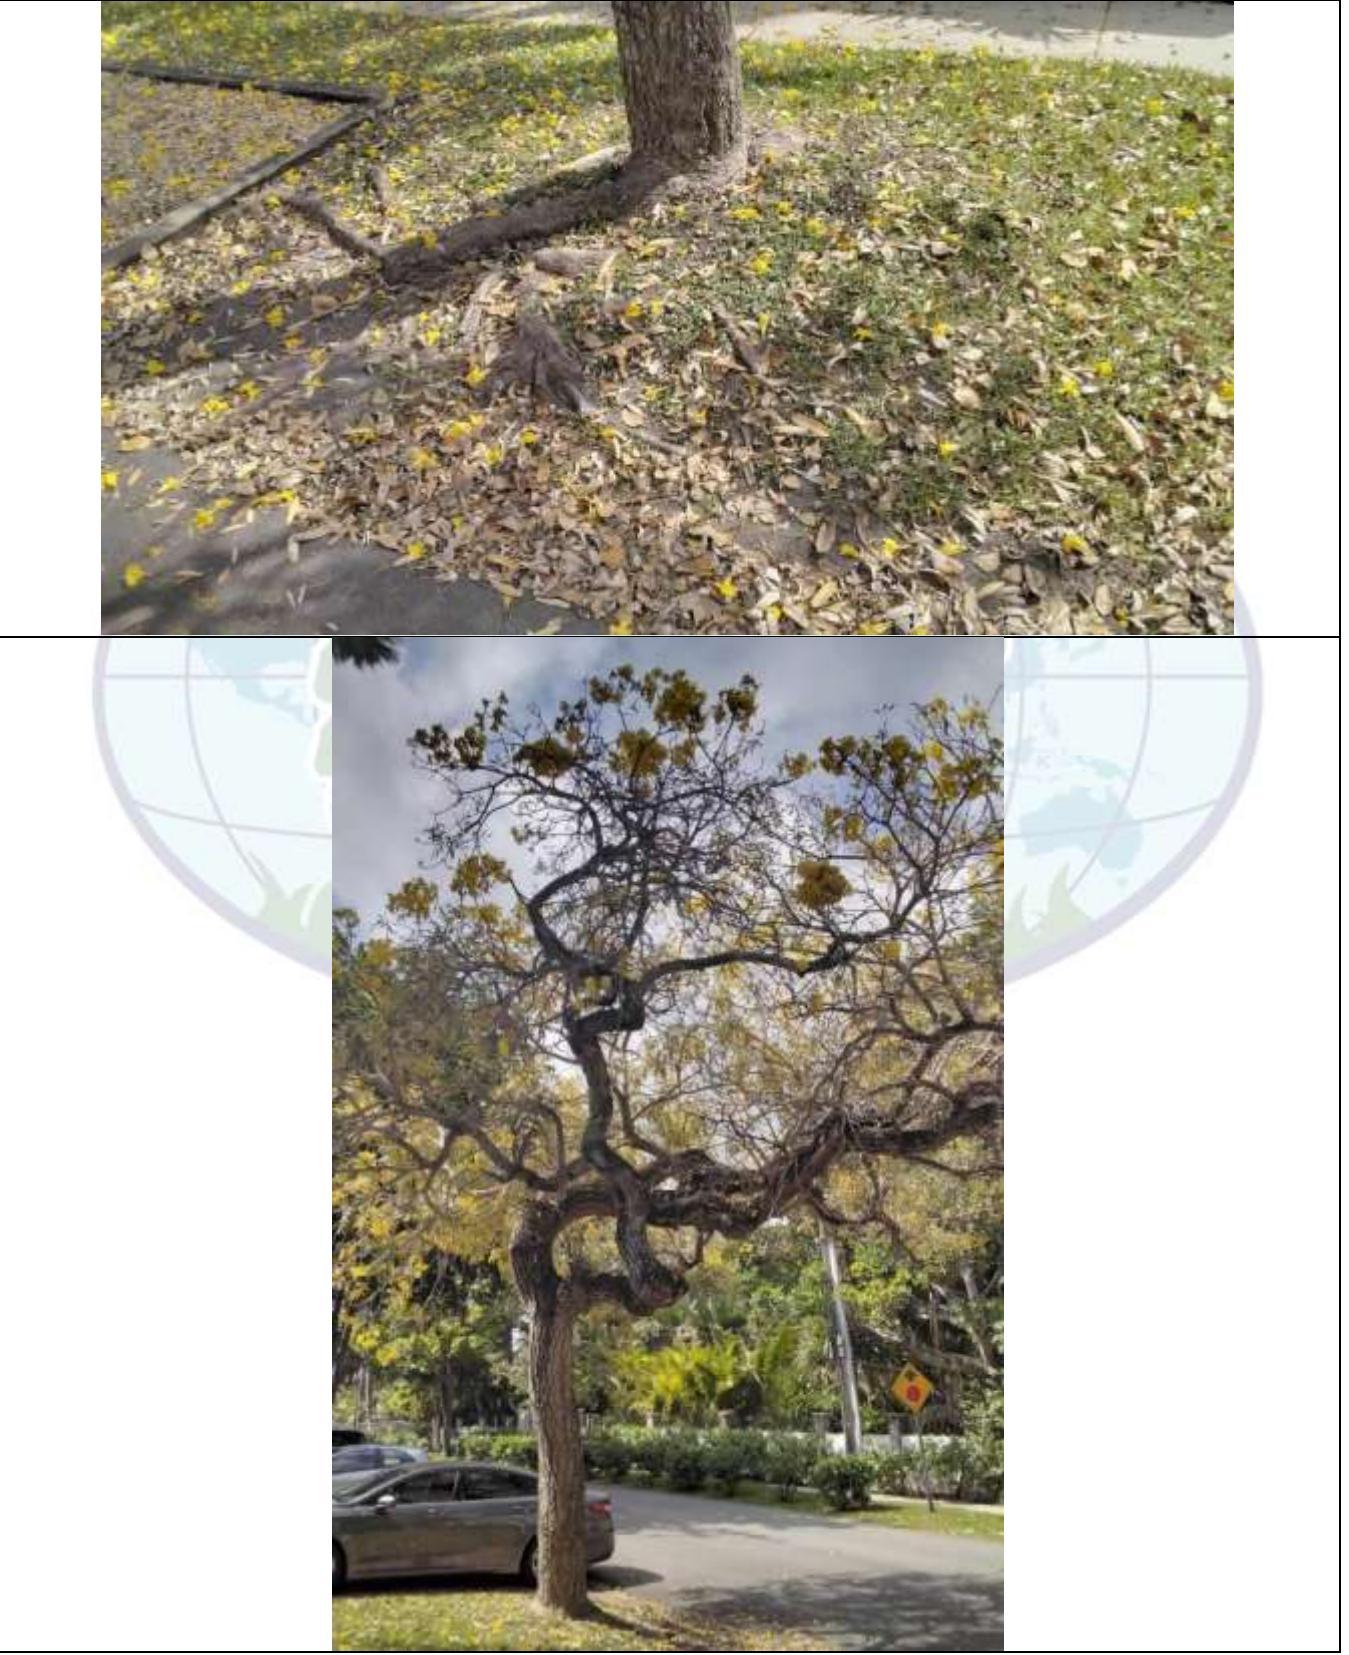
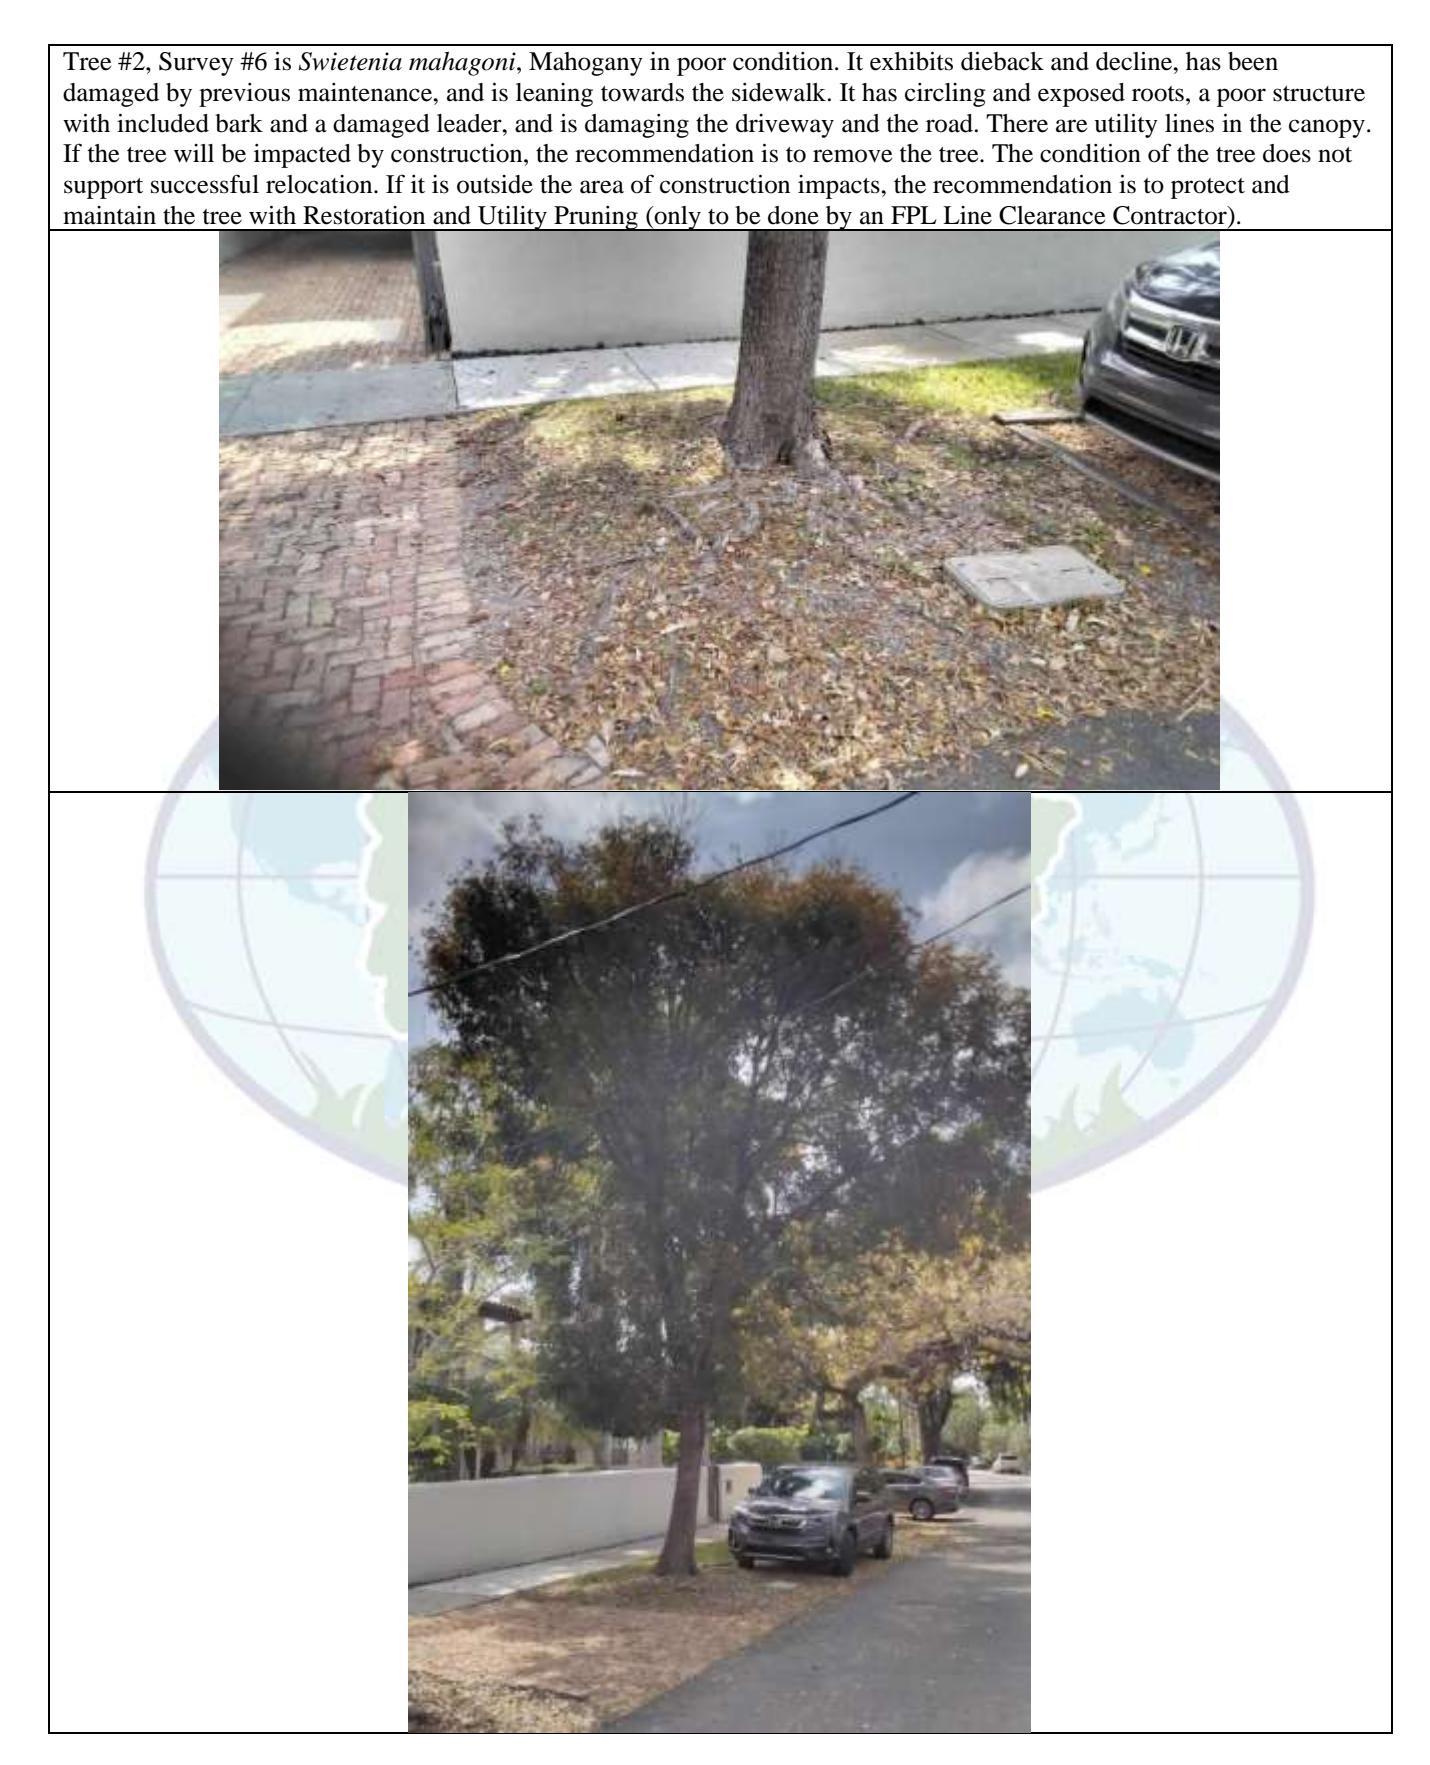
John A. Harris, Landscape Economist; MS, MBA, BS, AAS Certified Arborist #OH-0274A, Certified Forester, Registered Consulting Arborist, Certified Landscape Inspector, Qualified Tree Risk Assessor, Professional Mangrove Trimmer, Nursery Tree Grader, Tree and Plant Appraisal Qualified Tree #1, Survey #5 is *Tabebuia aurea*, Tabebuia in poor condition. It exhibits dieback and decline, has been damaged by previous maintenance, and is leaning towards the structure. It has circling and exposed roots, a poor structure with included bark, and is damaging the driveway and the road. If the tree will be impacted by construction, the recommendation is to remove the tree. The condition of the tree does not support successful relocation. If it is outside the area of construction impacts, the recommendation is to protect and maintain the tree with Restoration Pruning.
