TREE RESOURCE EVALUATION

1771 Purdy Avenue
Miami Beach, FL 33139

March 02, 2022

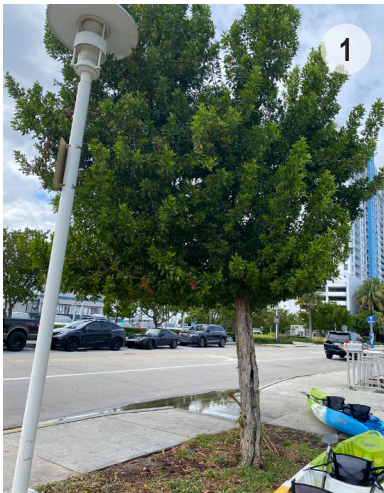
TREE INVENTORY LIST									
TREE #	BOTANICAL NAME	COMMON NAME	DBH (in)	HEIGHT (ft)	SPREAD (DIA)(ft)	TPZ (R)(ft)	DISPOSITION	CONDITION	NOTES
1	<i>Conocarpus erectus</i>	GREEN BUTTONWOOD	10	16	12	N/A	REMOVE	GOOD	MINOR FLUSH CUT
2	<i>Hyophorbe verschaffeltii</i>	SPINDLE PALM	13	10	6	N/A	REMOVE	POOR	PENCILLED TRUNK, NUTRIENT DEFICIENCY
3	<i>Hyophorbe verschaffeltii</i>	SPINDLE PALM	13	12	6	N/A	REMOVE	MODERATE	TRUNK WOUNDS
4	<i>Roystonea regia</i>	ROYAL PALM	17	16	10	N/A	REMOVE	POOR	TRUNK DAMAGE
