PROPOSED REMODELING/ADDITIONS:

5446 N. BAY RD

Subject: Building Forensic Test Report

Subject: Building Envelope Visual Assessment Report

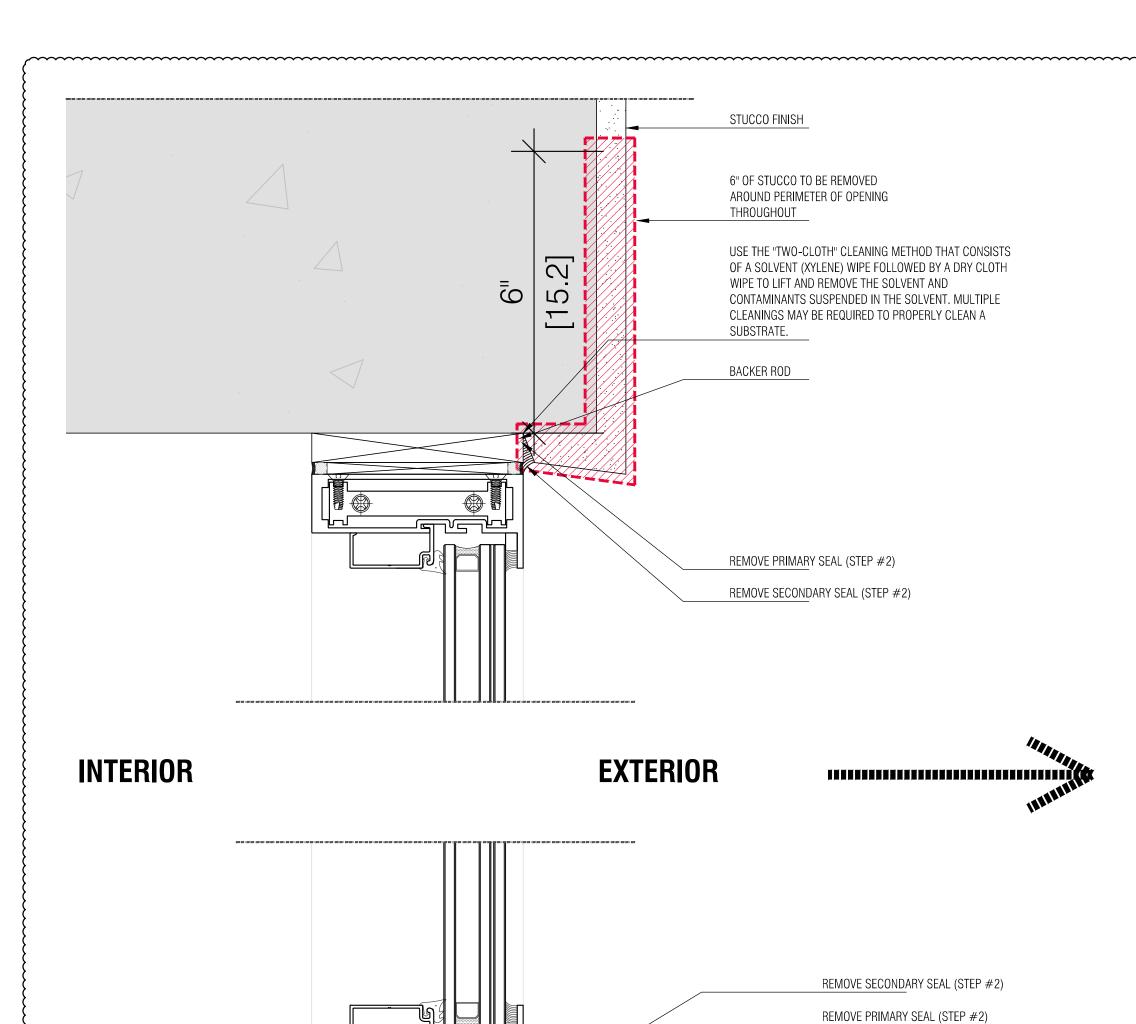
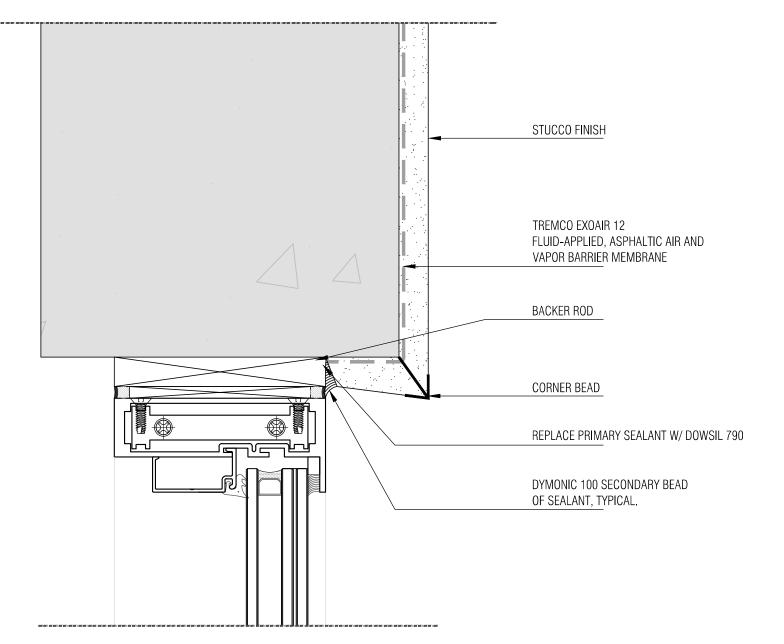
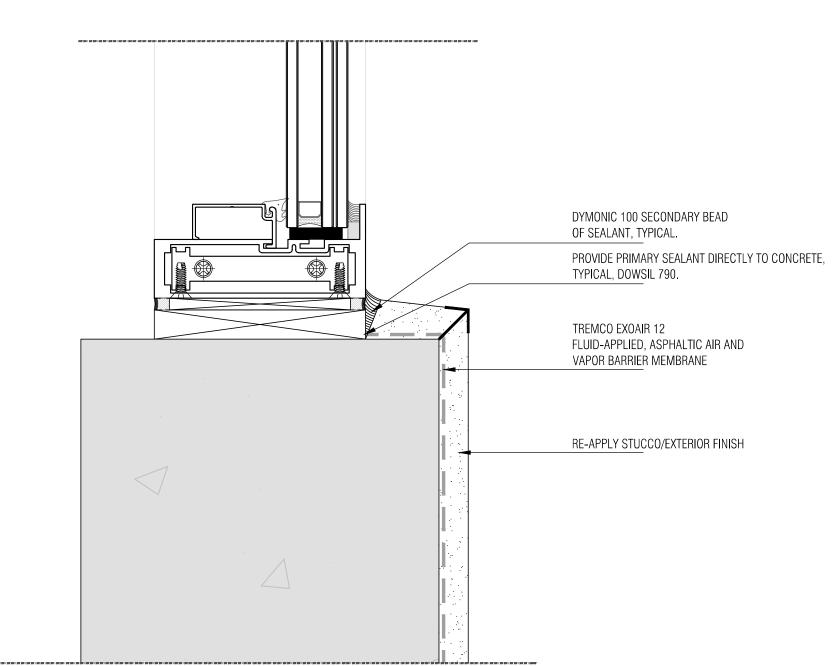
EXTERIOR OPERABLE/FIXED OPENING W/ STUCCO ON PERIMETER

STUCCO W/ CRACKS AND DELAMINATION TO BE TREATED AS FOLLOWS:

- 1. REMOVE STUCCO ON THE PERIMETER OF THE GLAZING SYSTEM. MINIMUM 6" STUCCO TO BE REMOVED
- 2. REMOVE PRIMARY SEAL, SECONDARY SEAL, SCREW SEALANT AND METAL TO METAL JOINT SEALANT.
- 3. USE THE "TWO-CLOTH" CLEANING METHOD THAT CONSISTS OF A SOLVENT (XYLENE) WIPE FOLLOWED BY A DRY CLOTH WIPE TO LIFT AND REMOVE THE SOLVENT AND CONTAMINANTS SUSPENDED IN THE SOLVENT. MULTIPLE CLEANINGS MAY BE REQUIRED TO PROPERLY CLEAN A SUBSTRATE.
- 4. SLIDING GLASS DOOR SUB-SILL SCREW TO BE REMOVED AT ONE LOCATION TO CONFIRM IF PRIMARY SILL HAS A PENETRATION HOLE
- 4. THEN REAPPLY CAULKING DOWSIL 790 OR APPROVED SEALANT BY GLAZING MANUFACTURER AROUND THE PERIMETER OF THE OPENING WITH AN OPEN CELL BACKED ROD AS NEEDED.
- 5. RE-APPLY STUCCO/EXTERIOR FINISH WITH SECONDARY BEAD OF CAULKING SUCH AS DYMONIC 100 OR SIMILAR

- 1. STUCCO CRACK OR DELAMINTAION MUST BE MARKED WITH A SQUARE SHAPE
- 2. USE A SMALL DRILL INO THE STUCCO TO DETERMINE THE THICKNESS. 3. CUT STUCCO TO THE DIMENSION NOT TO JEOPARDIZE MIN SUBSTRATE IN A SQUARE SHAPE FASHION.
- 4. THIS WILL BE FOLLOWED BY A SERIES OF VERTICAL CUT TO FACILITATE STUCCO REMOVAL AND NOT TRANSMIT PRESSURE TO THE ADJACENT SOUND STUCCO. 5. EXPOSE THE MAIN SUBSTRATE.
- 6. APPLY "STO POWERWALL STUCCO PREBLEND 102" UP TO FINISH LEVEL AS PER MANUFACTURER RECOMMENDATIONS.

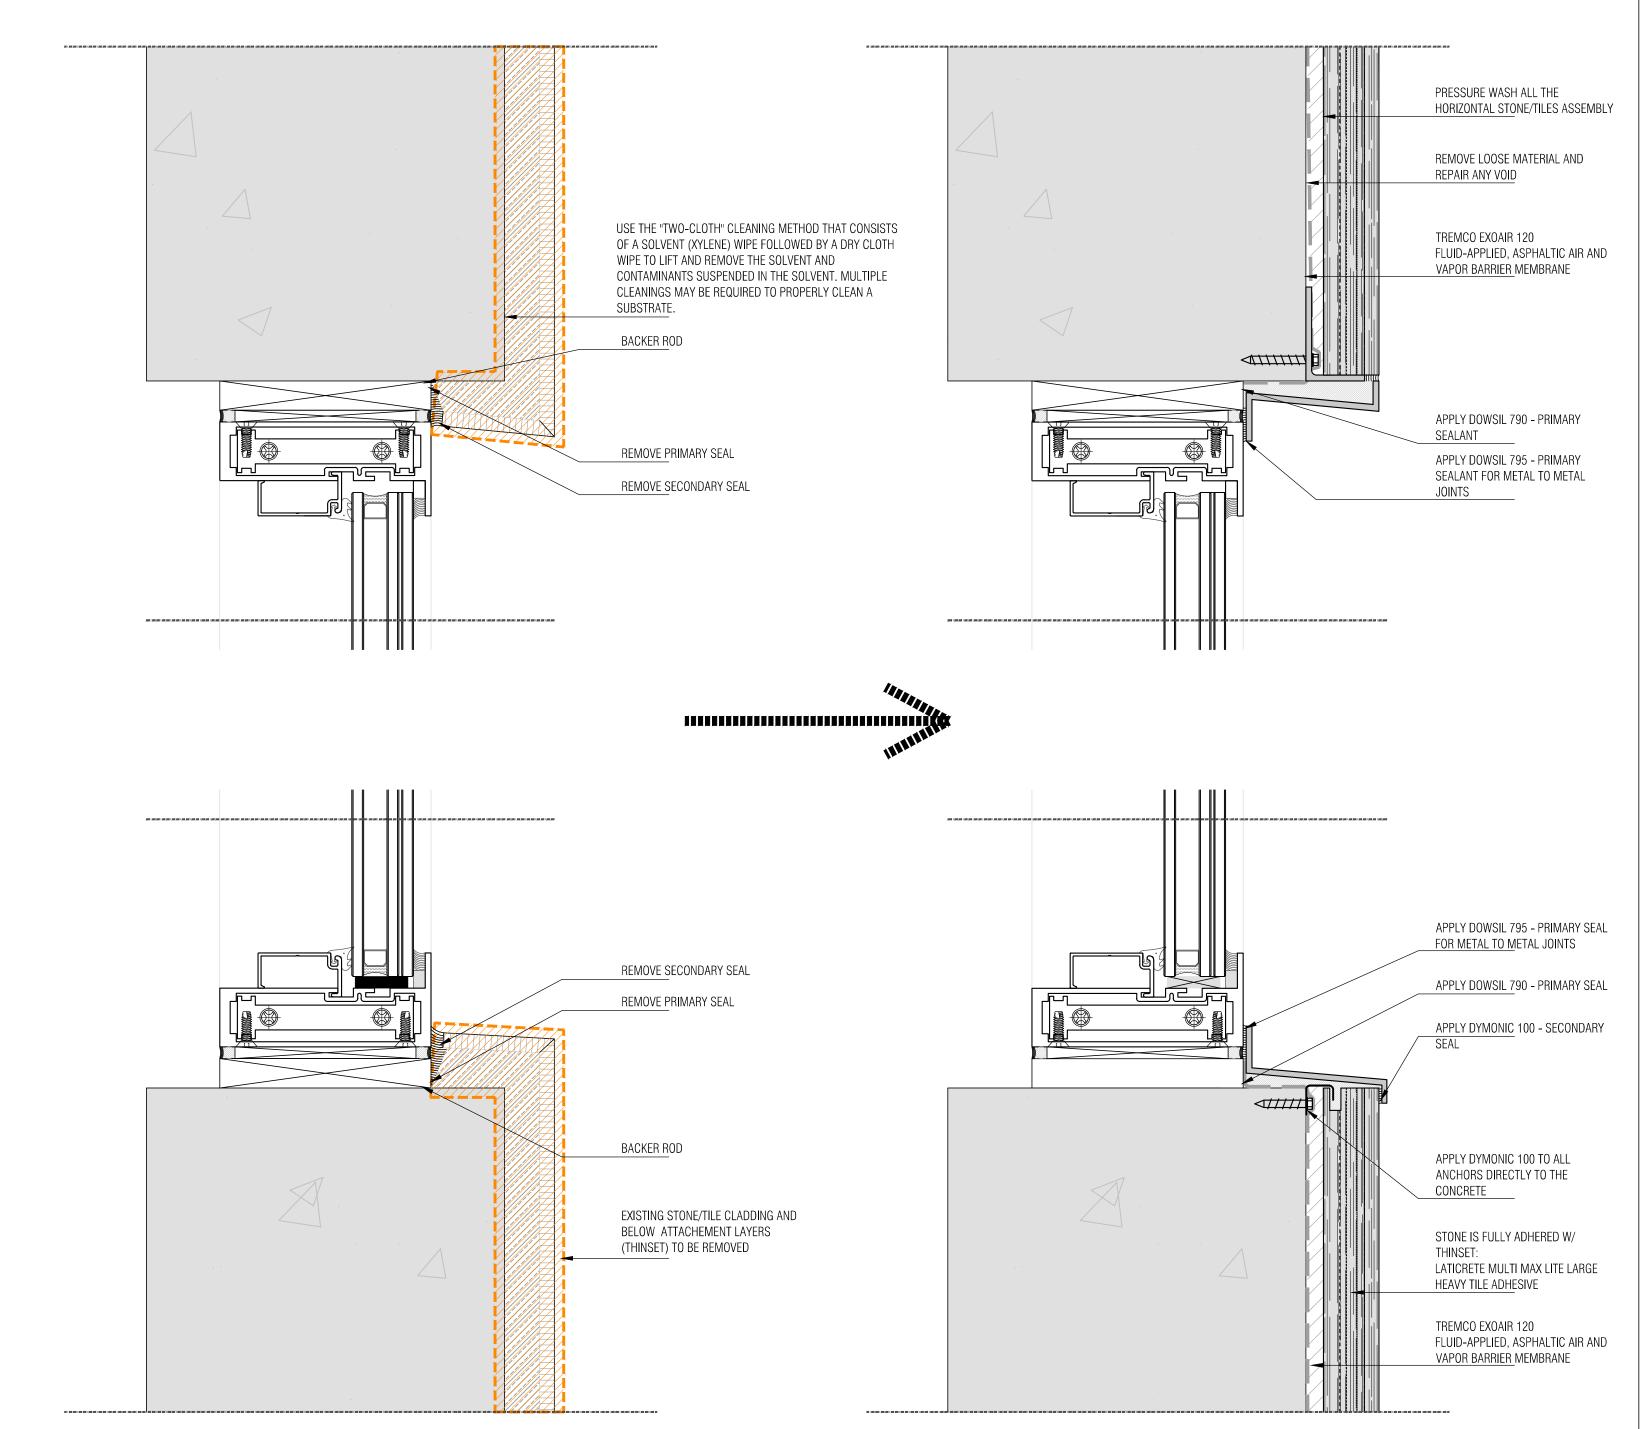
EXTERIOR OPERABLE / FIXED OPENING W/ STONE CLADDING ON PERIMETER

PREPARE AND CLEAN THE TILE/STONE TO RECEIVE SEALER AS FOLLOW:

- 1. PRESSURE WASH ALL THE HORIZONTAL STONE/TILES ASSEMBLY.
- 2. REMOVE LOOSE MATERIAL AND REPAIR ANY VOID.
- 3. ONCE ALL THE SUBSTRATE IS CLEAN AND DRY, APPLY DYMONIC 100 AS PER
- MANUFACTURER RECOMMENDATIONS AS STONE/TILE TRANSITION INTO STUCCO WITH CLOSED
- CELL BACKED ROD. STUCCO AND PAINT MUST BE A SOUND SUBSTRATE.
- 4. ONCE DYMONIC 100 IS CURED AND THE SURFACES IS THOROUGHLY CLEAN AND FREE OF
- DUST, SURFACE DIRT, OIL, GREASE AND OTHER CONTAMINANTS THAT MIGHT PREVENT
- PENETRATION. APPLY SL100 WATER REPELLENT OR STONETECH HEAVY DUTY EXTERIOR
- SEALER AT A MOCK-UP AREA FOR APPROVAL FROM OWNER IN CASE OF CHANGES OF
- STONE/TILES APPEARANCE. STONE/TILE TYPE MUST BE IDENTIFIED PRIOR APPLICATION TO CONFIRM COMPATIBILITY WITH PRODUCT.
