NEW RESIDENCE | 421 EAST SAN MARINO | MIAMI BEACH, FLORIDA

C.M.B. EXISTING TREE INVENTORY + DISPOSITION CHART - 421 EAST SAN MARINO DRIVE

RE: 421 E. San Marino Drive, Miami Beach
Evaluation of Existing Tree Resources
BEI Project No. 2017-11

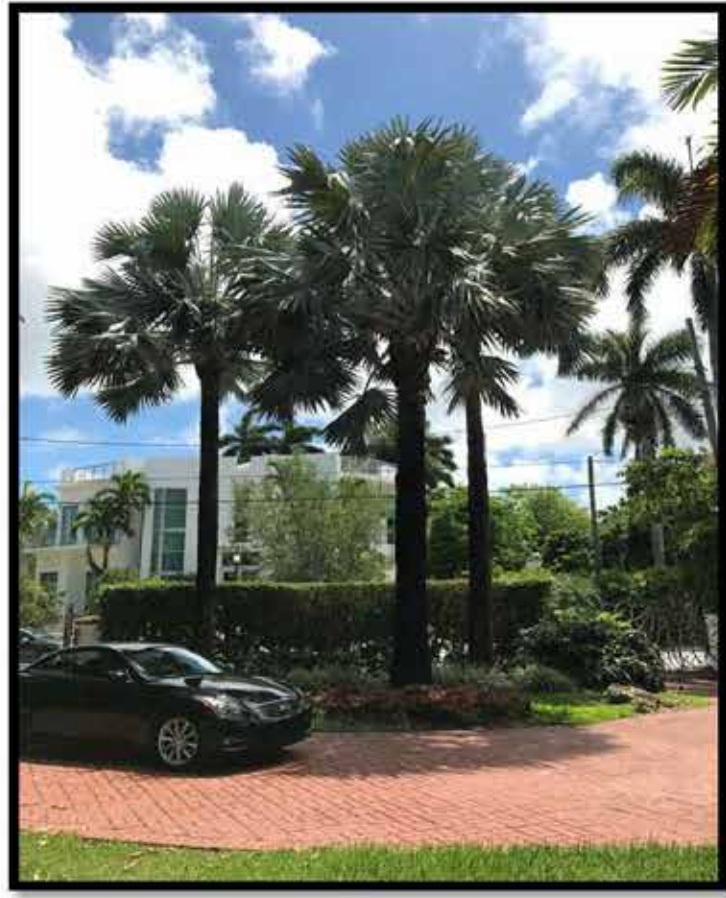
Photo 1 Bismarck palms in center of circular driveway.

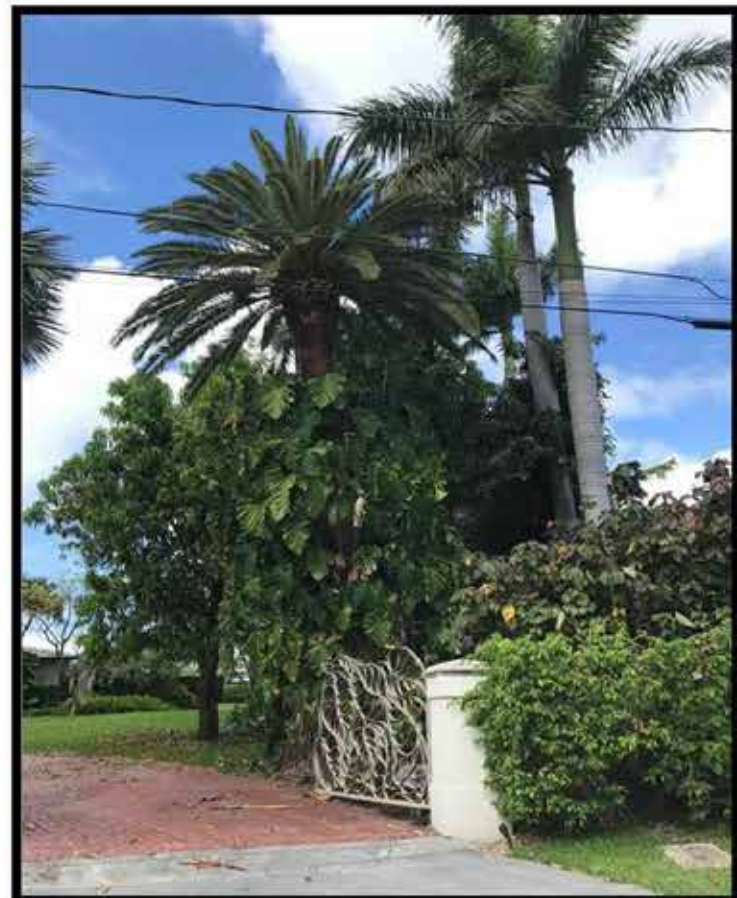
Photo 2 Canary Island date palm at southwest corner of property.

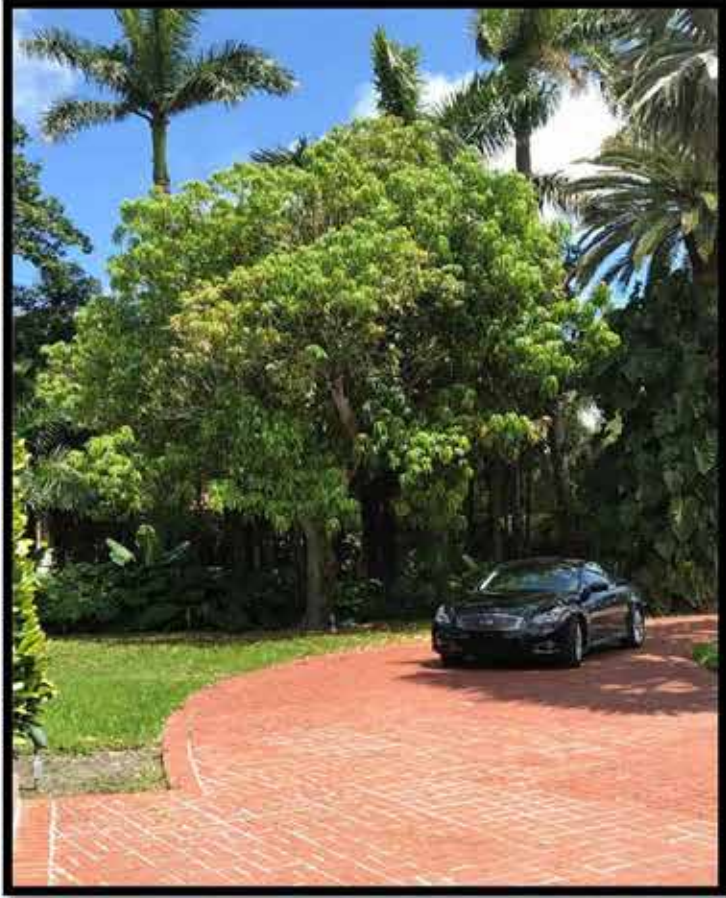
Photo 3 Mango tree at southwest corner of property.

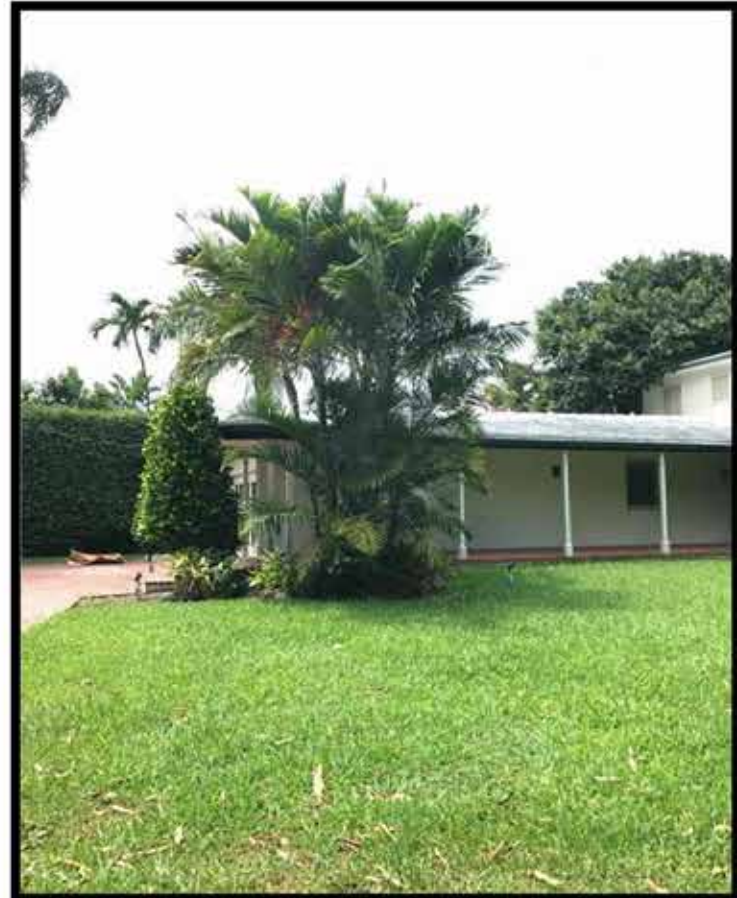
Photo 4 Cabada cluster at front entryway of house.

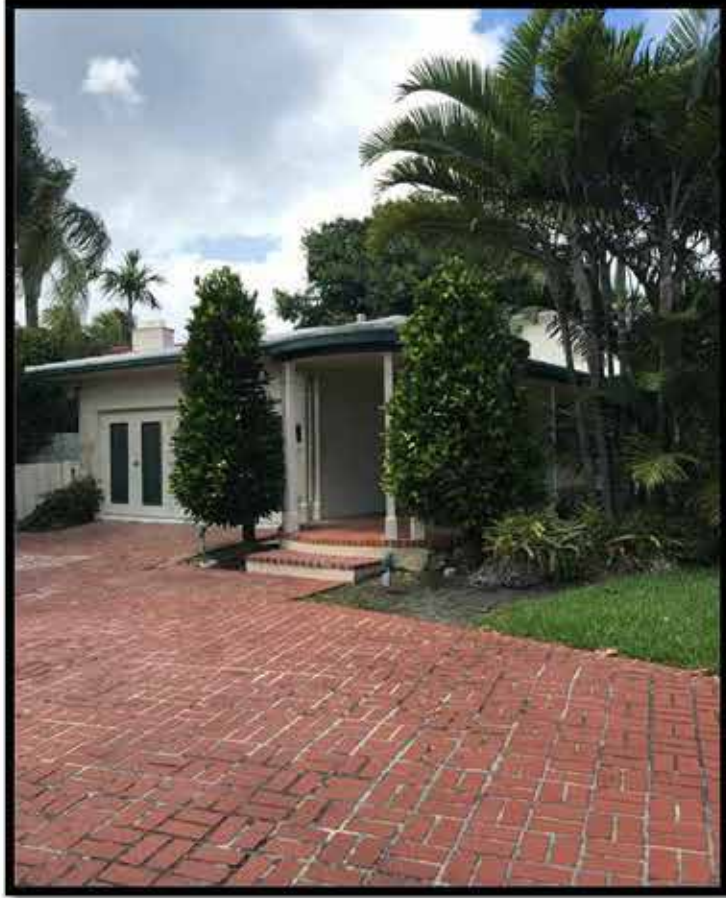
Photo 5 Garcinas at front entrance of house.

Because of their location along the north property line, the royal palms should be able to remain in place. All of the other palms could either remain in place (Canary Island date palm in particular), or be relocated on-site, or replaced by other desirable trees. The bottlebrush at the southeast corner of the property by the seawall should be removed and the 2 garcinia trees at the entrance of the house could either be removed or replaced.

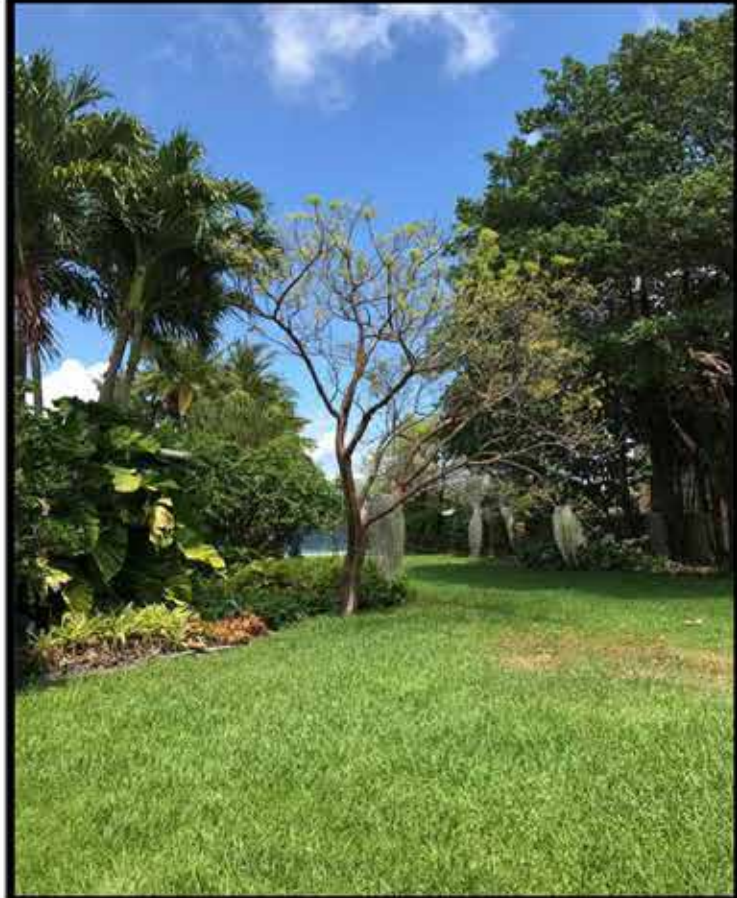
Photo 6 Gumbo limbo in front yard.

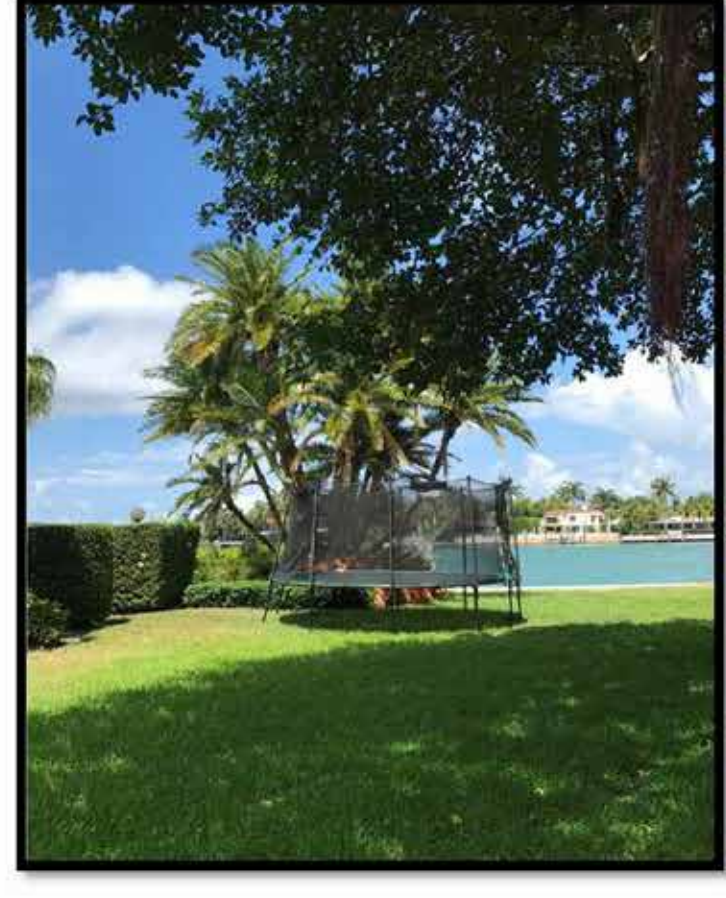
Photo 7 Reclining date palm cluster in side yard.

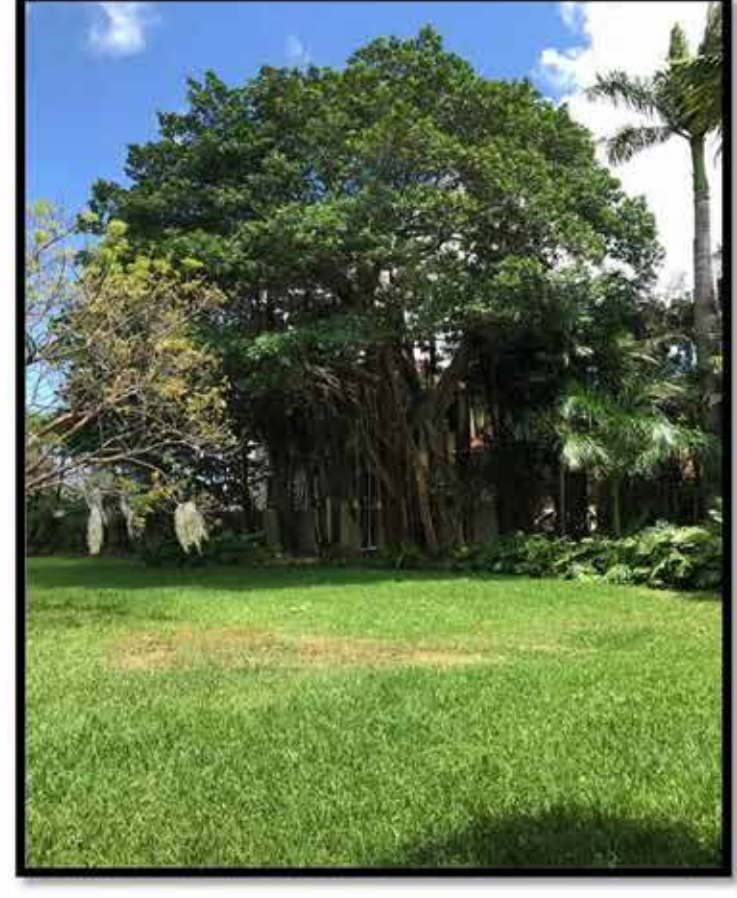
Except for the large strangler fig on the south property line and the banyan tree along the north property line, the trees have been generally well maintained and are in good condition. The large ficus tree has a number of rotten trunks and structural damage to major canopy branches from prior storm damage and recent pruning that occurred (see attached photographs). Therefore, it is recommended that this strangler fig be removed and replaced with desirable native shade trees. The banyan tree on the north property line is growing in a very limited area between the two houses which has resulted in the canopy being cut back significantly (see attached photographs). The banyan tree also shows evidence of previous storm damage and the root system is running along the surface due to its close proximity to a CBS wall and the house. For these reasons, the banyan tree should be removed.

Photo 8 Strangler fig along south property line.

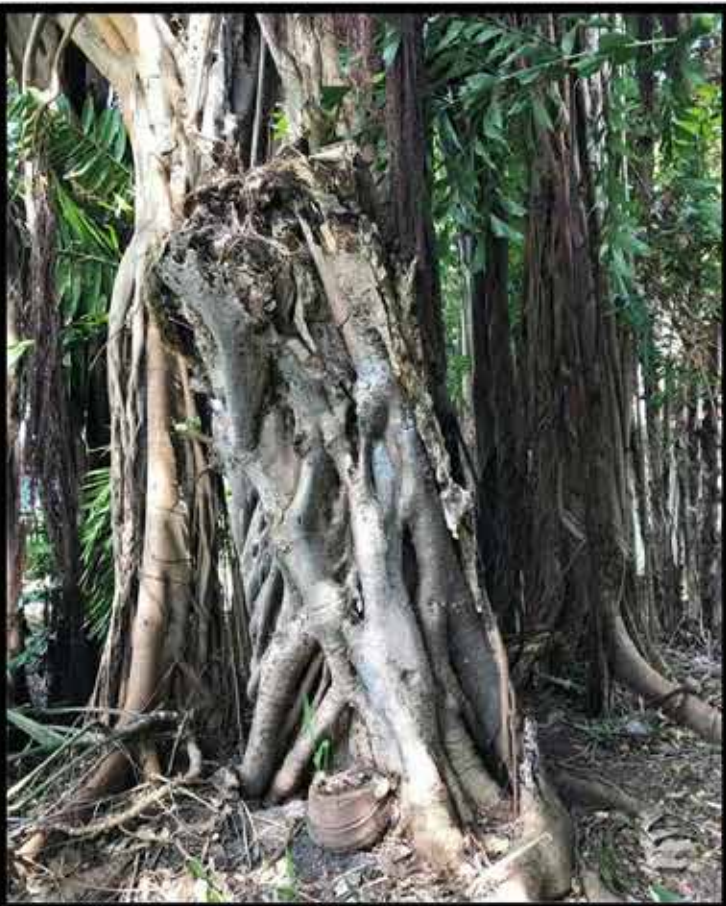
Photo 9 Rotten trunk on west face of strangler fig.

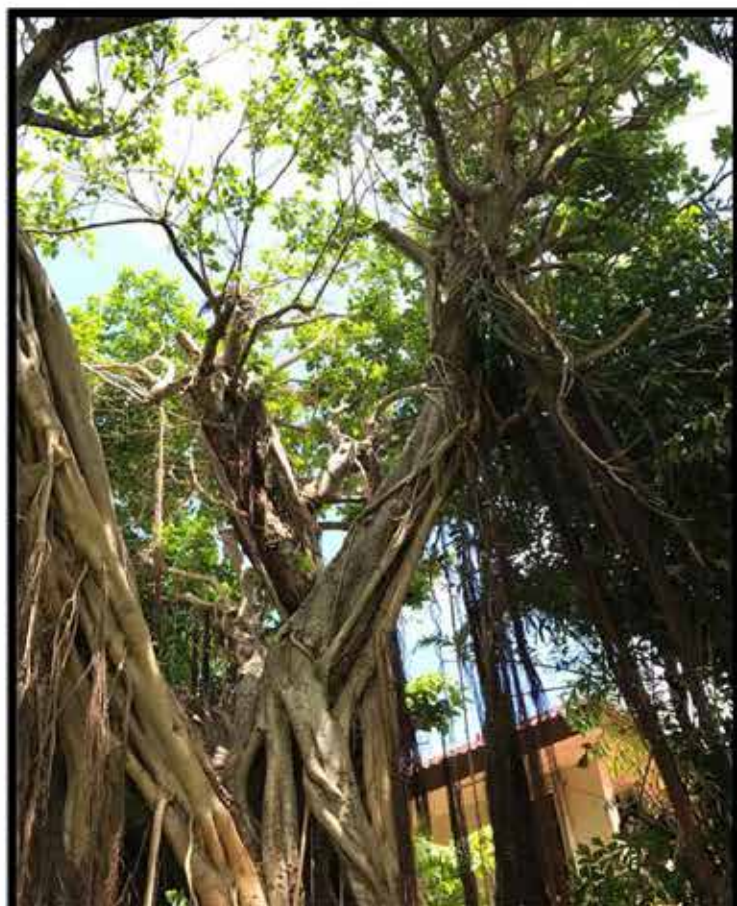
Photo 10 Structural damage to canopy branches of strangler fig.

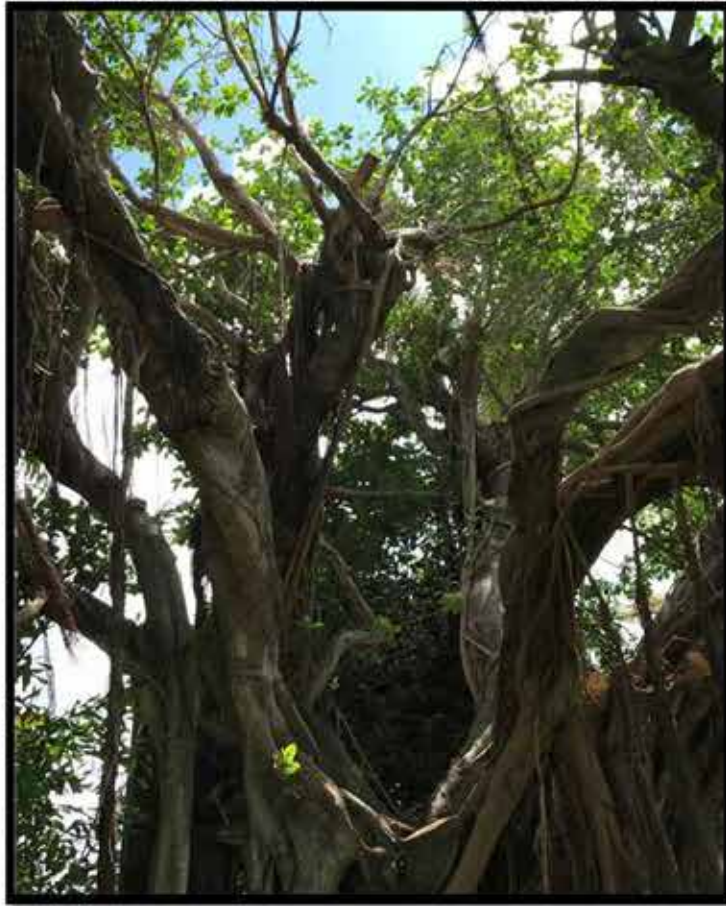
Photo 11 Close-up of structural branch damage.

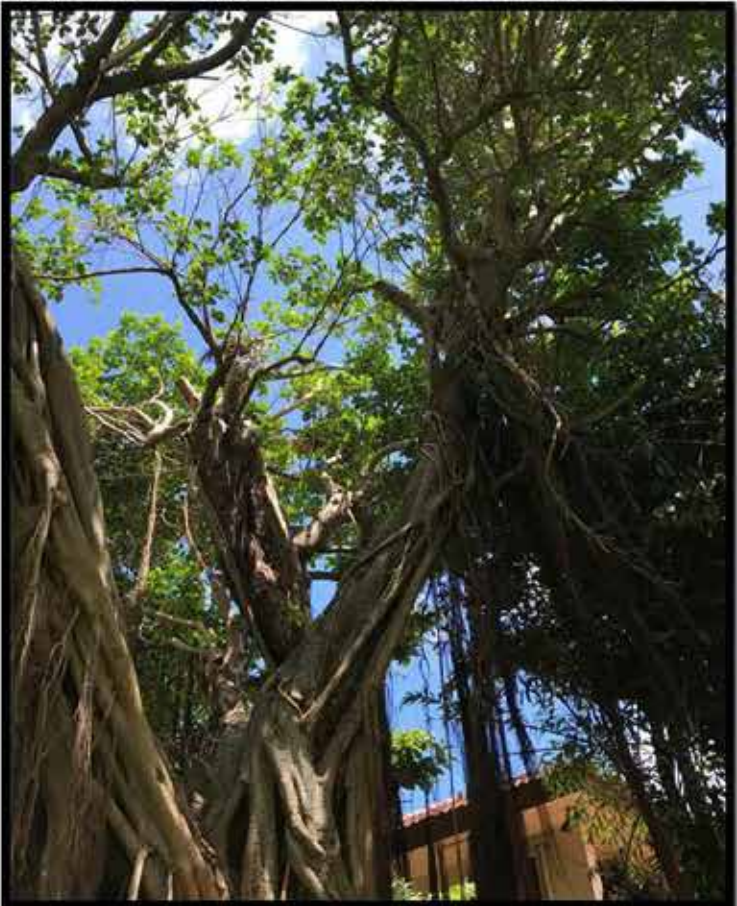
Photo 12 Branch cluster on right half of photo resulting from storm damage regrowth.

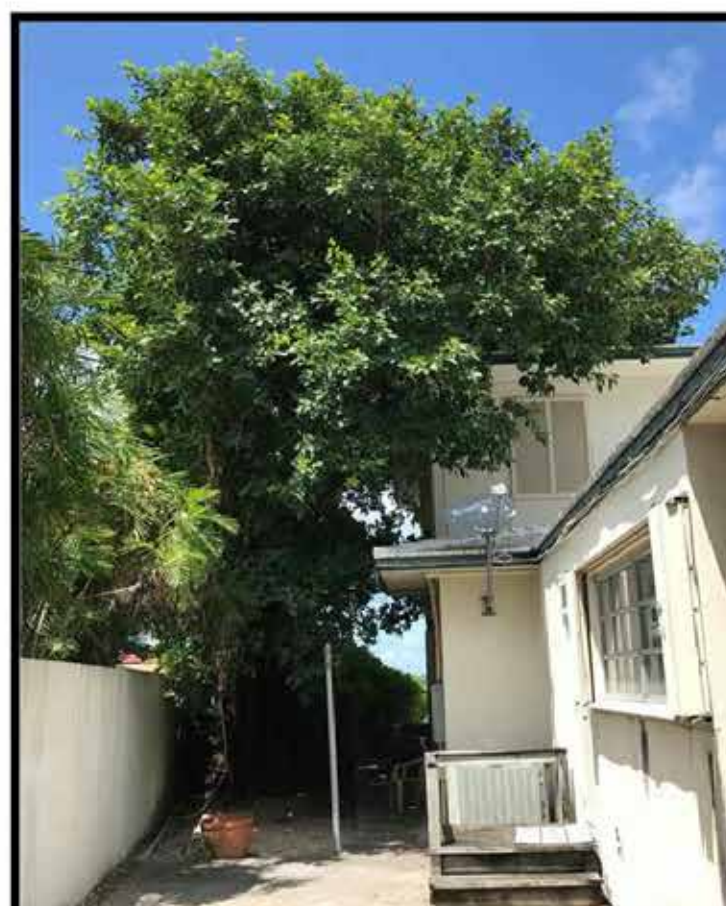
Photo 13 Banyan tree along north property line growing in confined space.

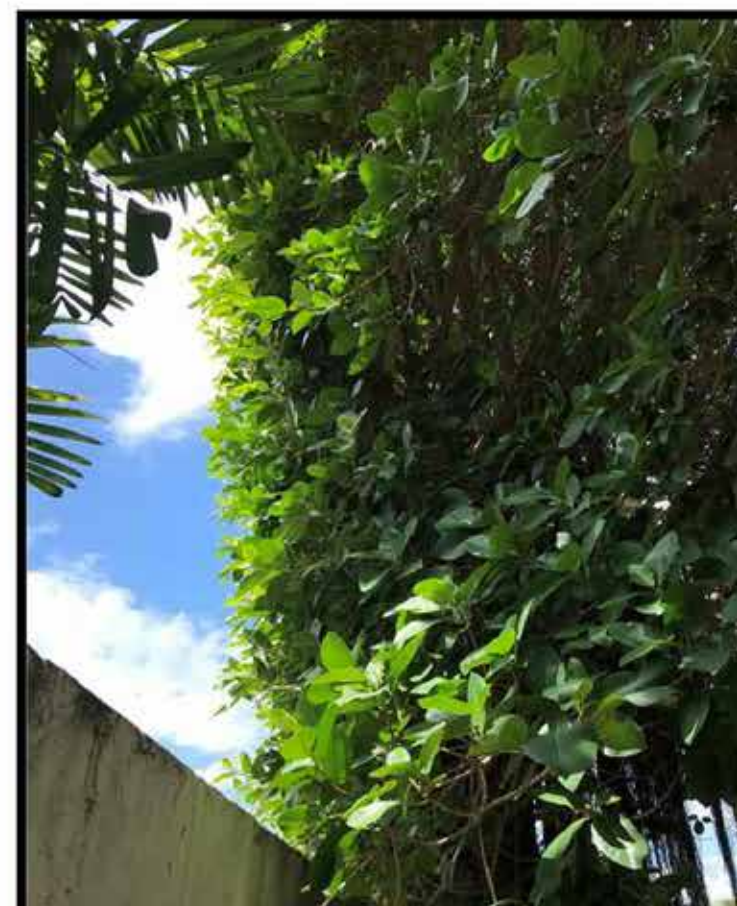
Photo 14 Close-up of banyan canopy showing shaving off of canopy on north side.

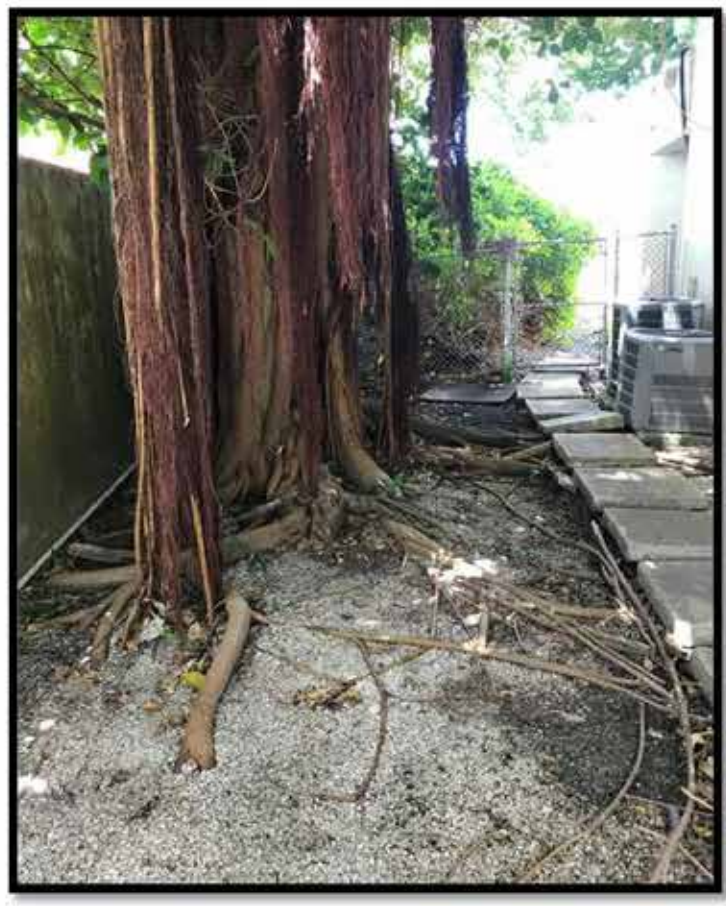
Photo 15 Exposed roots of banyan tree.

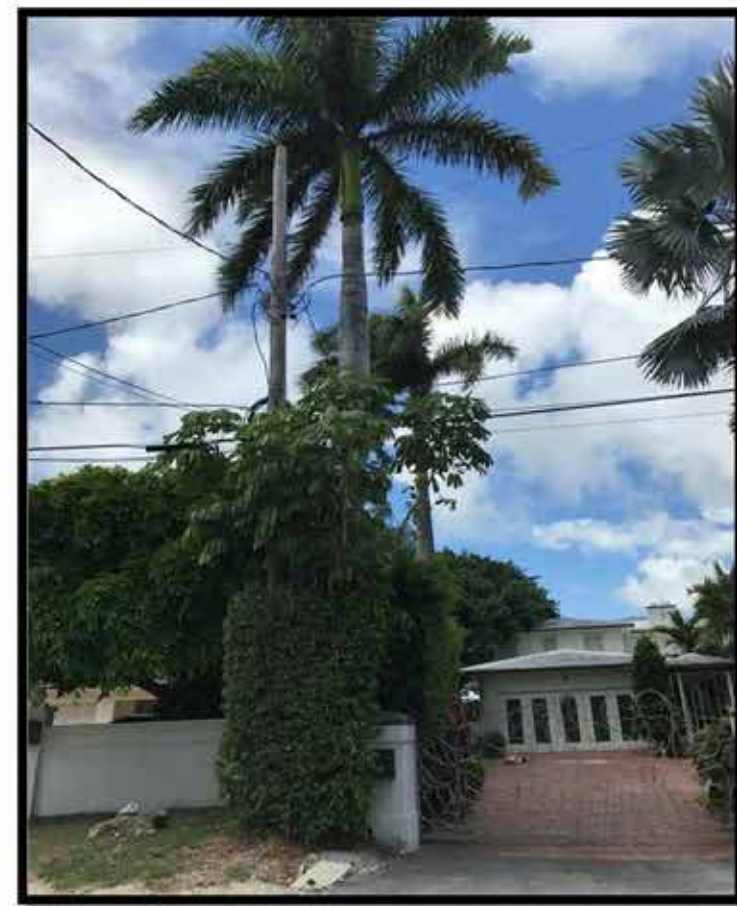
Photo 16 Royal palms along north property line.
