Tree Resource Evaluation for The Continuum, Miami Beach

May 21, 2018

Summary

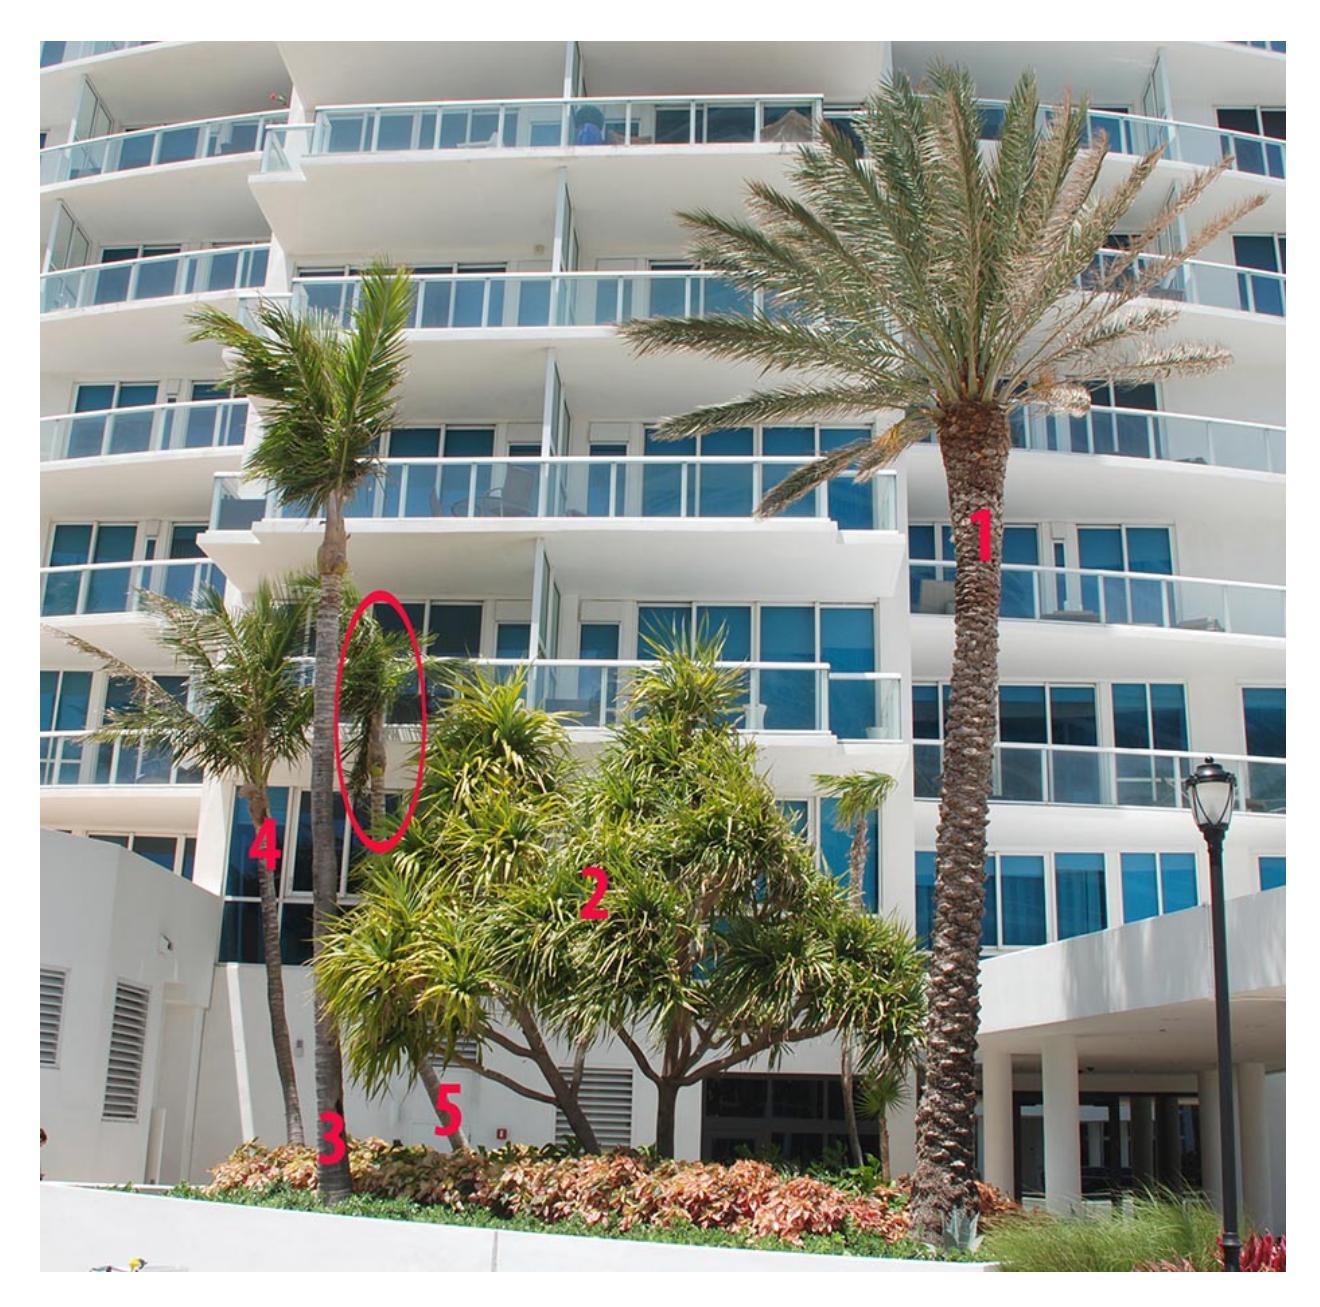
Photo 1 above is palms 1, 3, 4, & 5 and pandanas 2viewed from the south. Palm 5 is in poor condition. All of the palms on this site appear to be over-pruned causing nutrient deficiencies.

I rate trees and palms in accordance with ANSI A300 (Part 5) – 2005, Annex A, Management Report Information. Trees are rated Good, Moderate or Poor, see Appendix C. I recommend the removal of trees or palms that I rate as Poor.

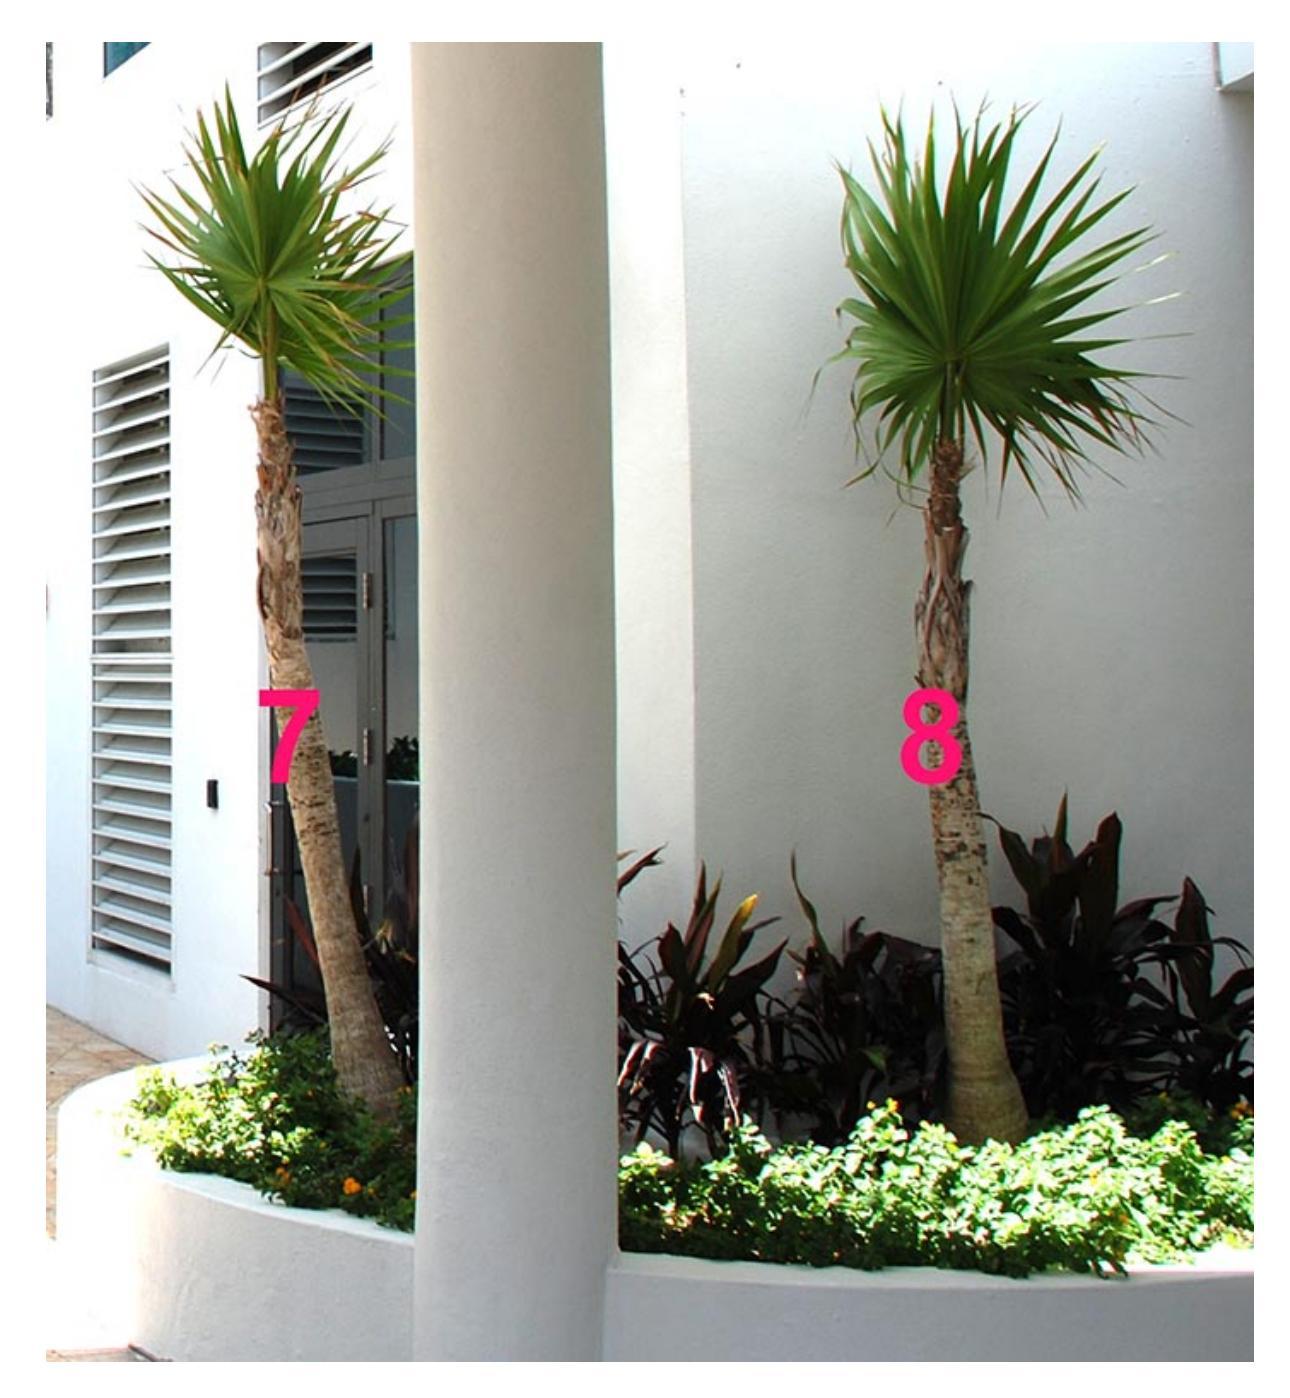
Photo 3 above is palms 7 & 8. They are over-pruned and growing in a too dark situation.

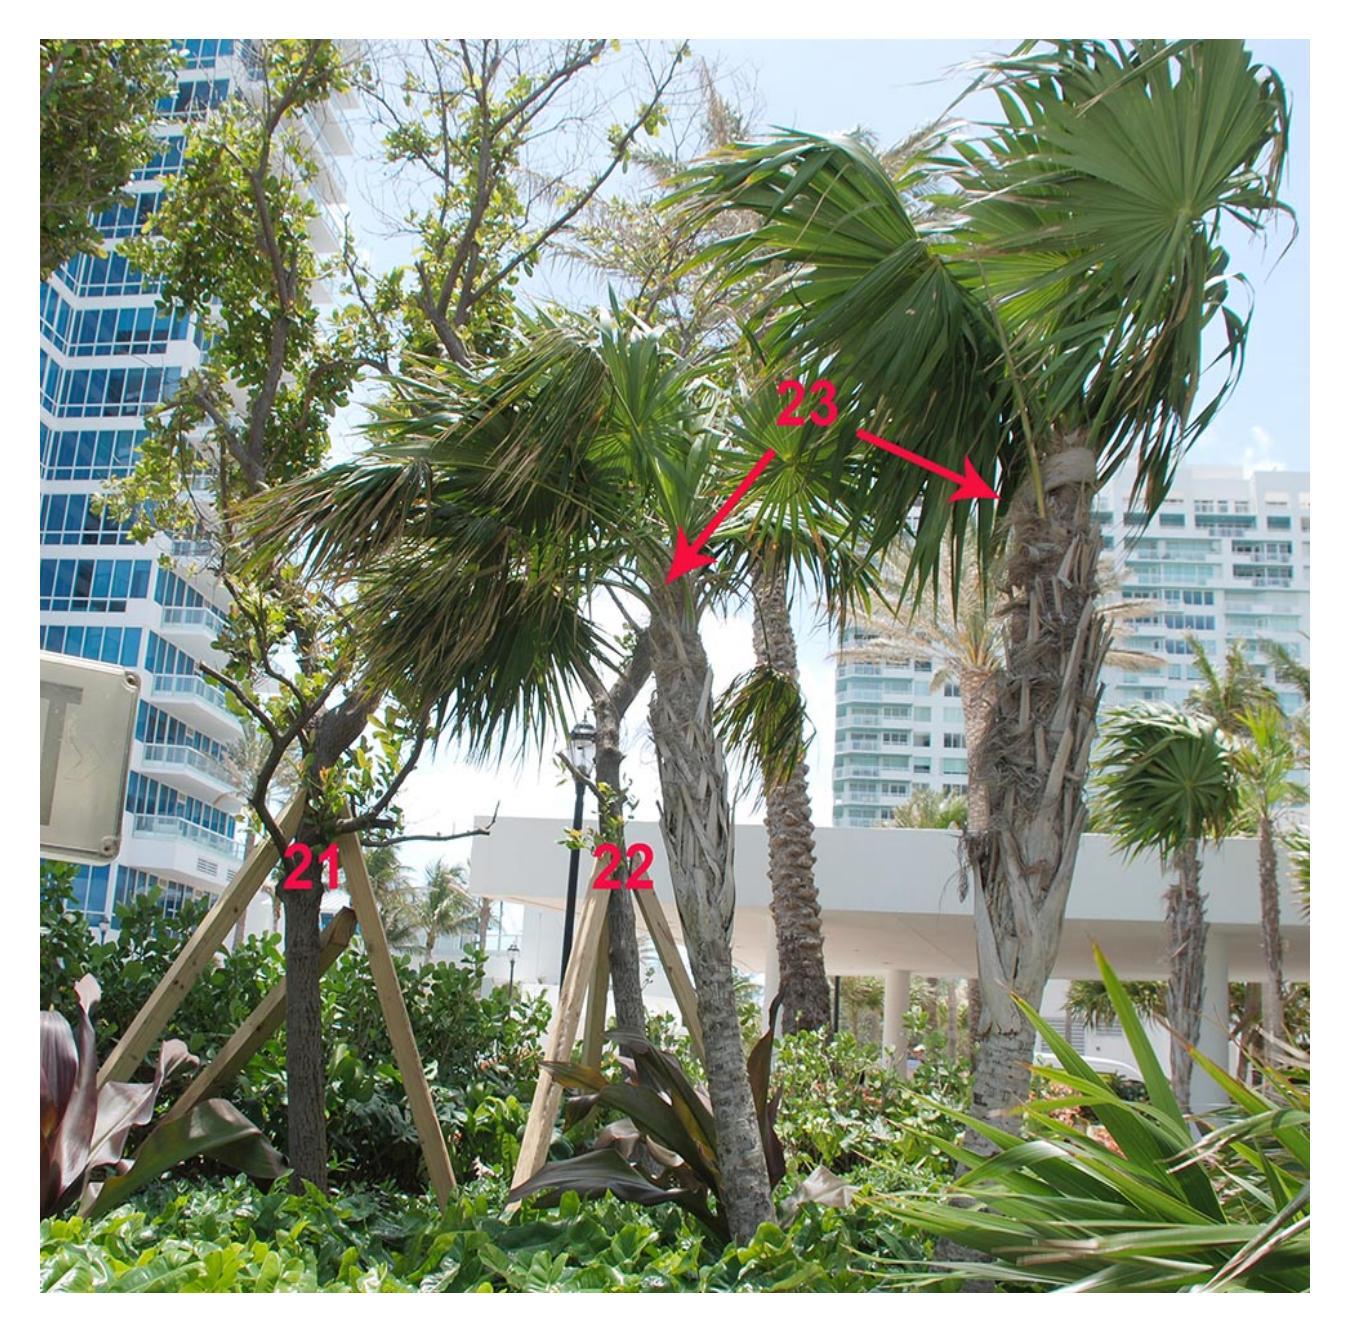
Photo 7 above is beautyleafs 21 & 22 with stakes nailed directly into their trunks. This is not an acceptable practice. These trees should be removed.

There are a number of trees with stakes nailed directly into their trunks. This is not an acceptable Best Management Practice and is not permitted by the ANSI A-300 Standards. These trees should be removed.

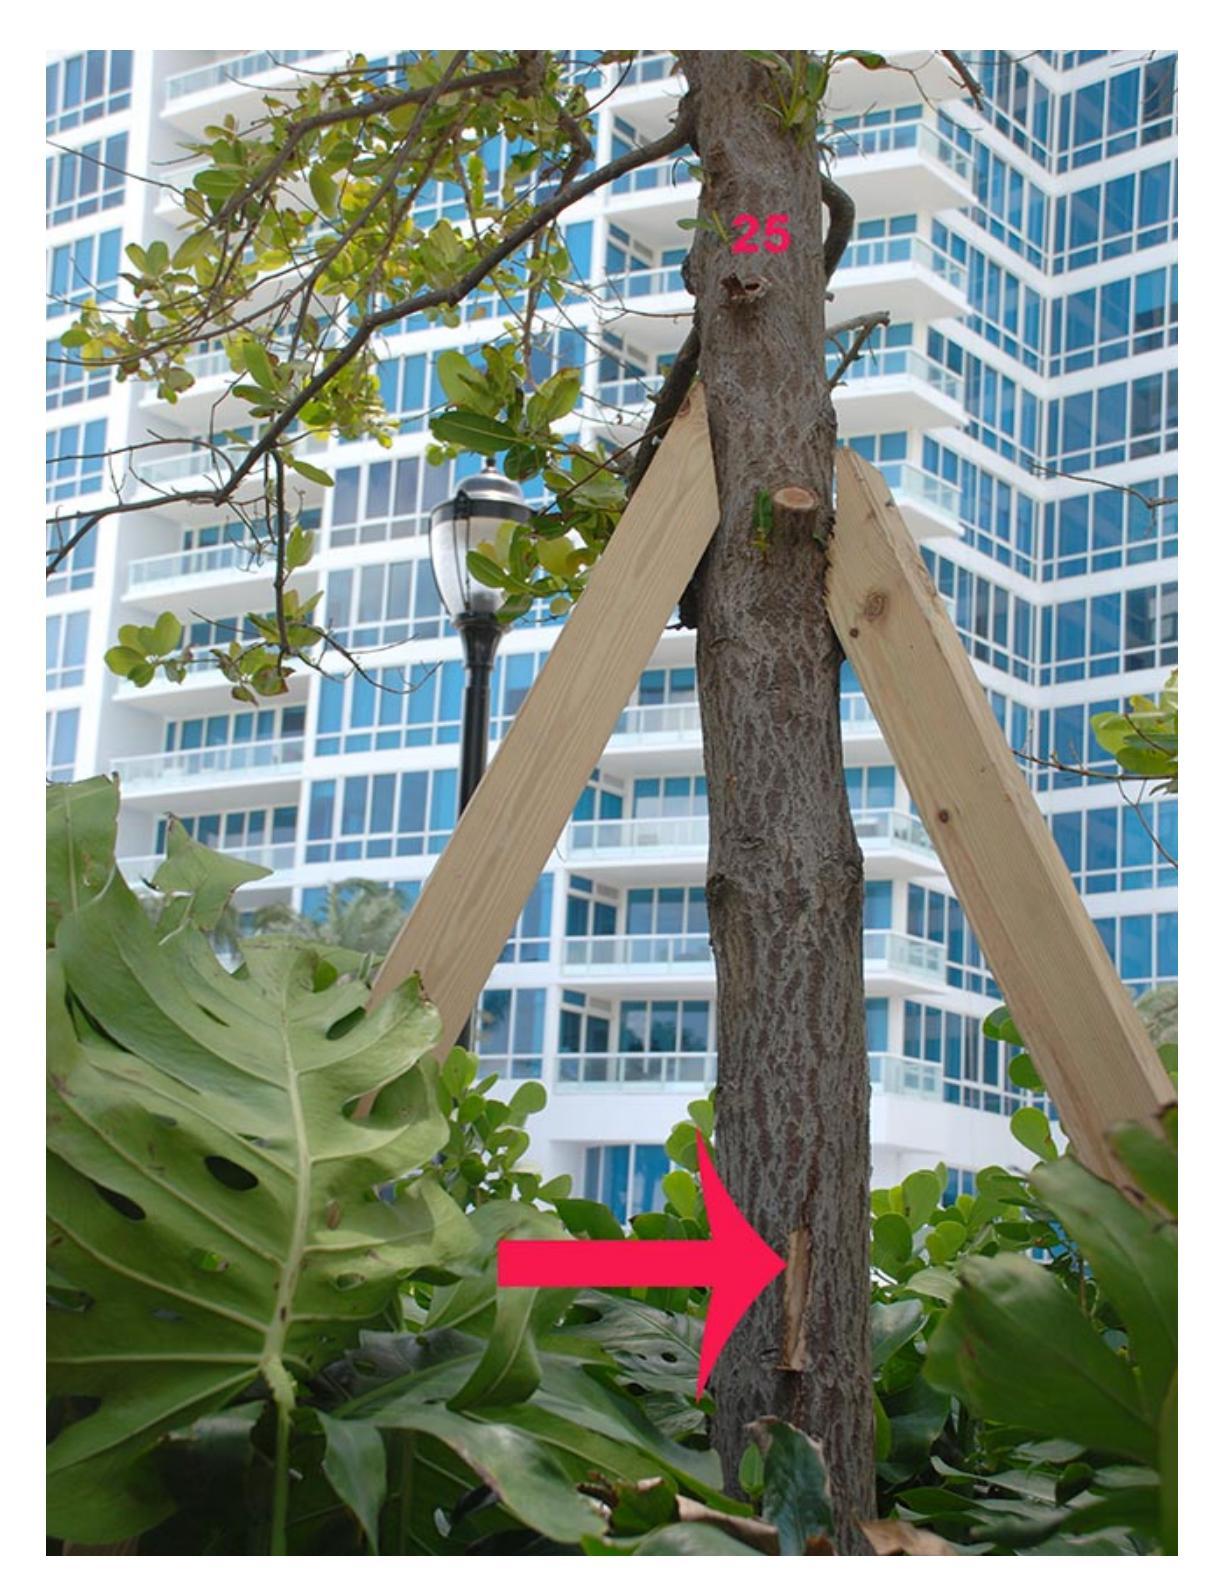
Photo 8 above is tree 25 with a large crack at the base of the trunk. The stakes are also nailed to the tree. This tree should be removed.

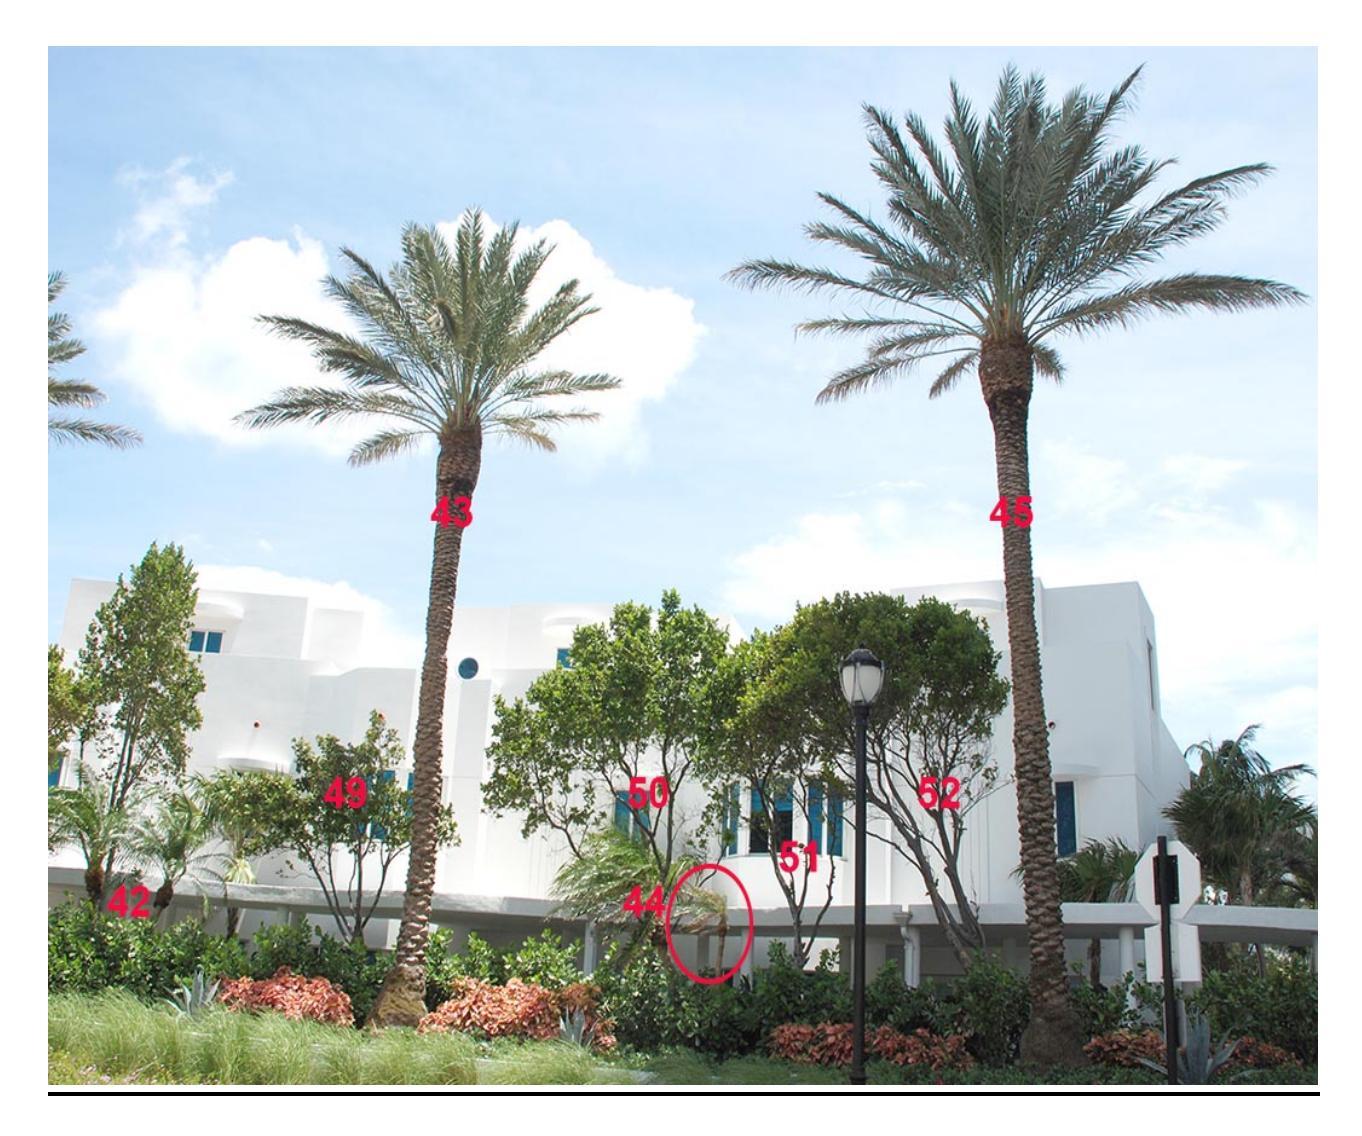
Photo 14 above is palms 42 through 45. All of the palms on this property are over-pruned.

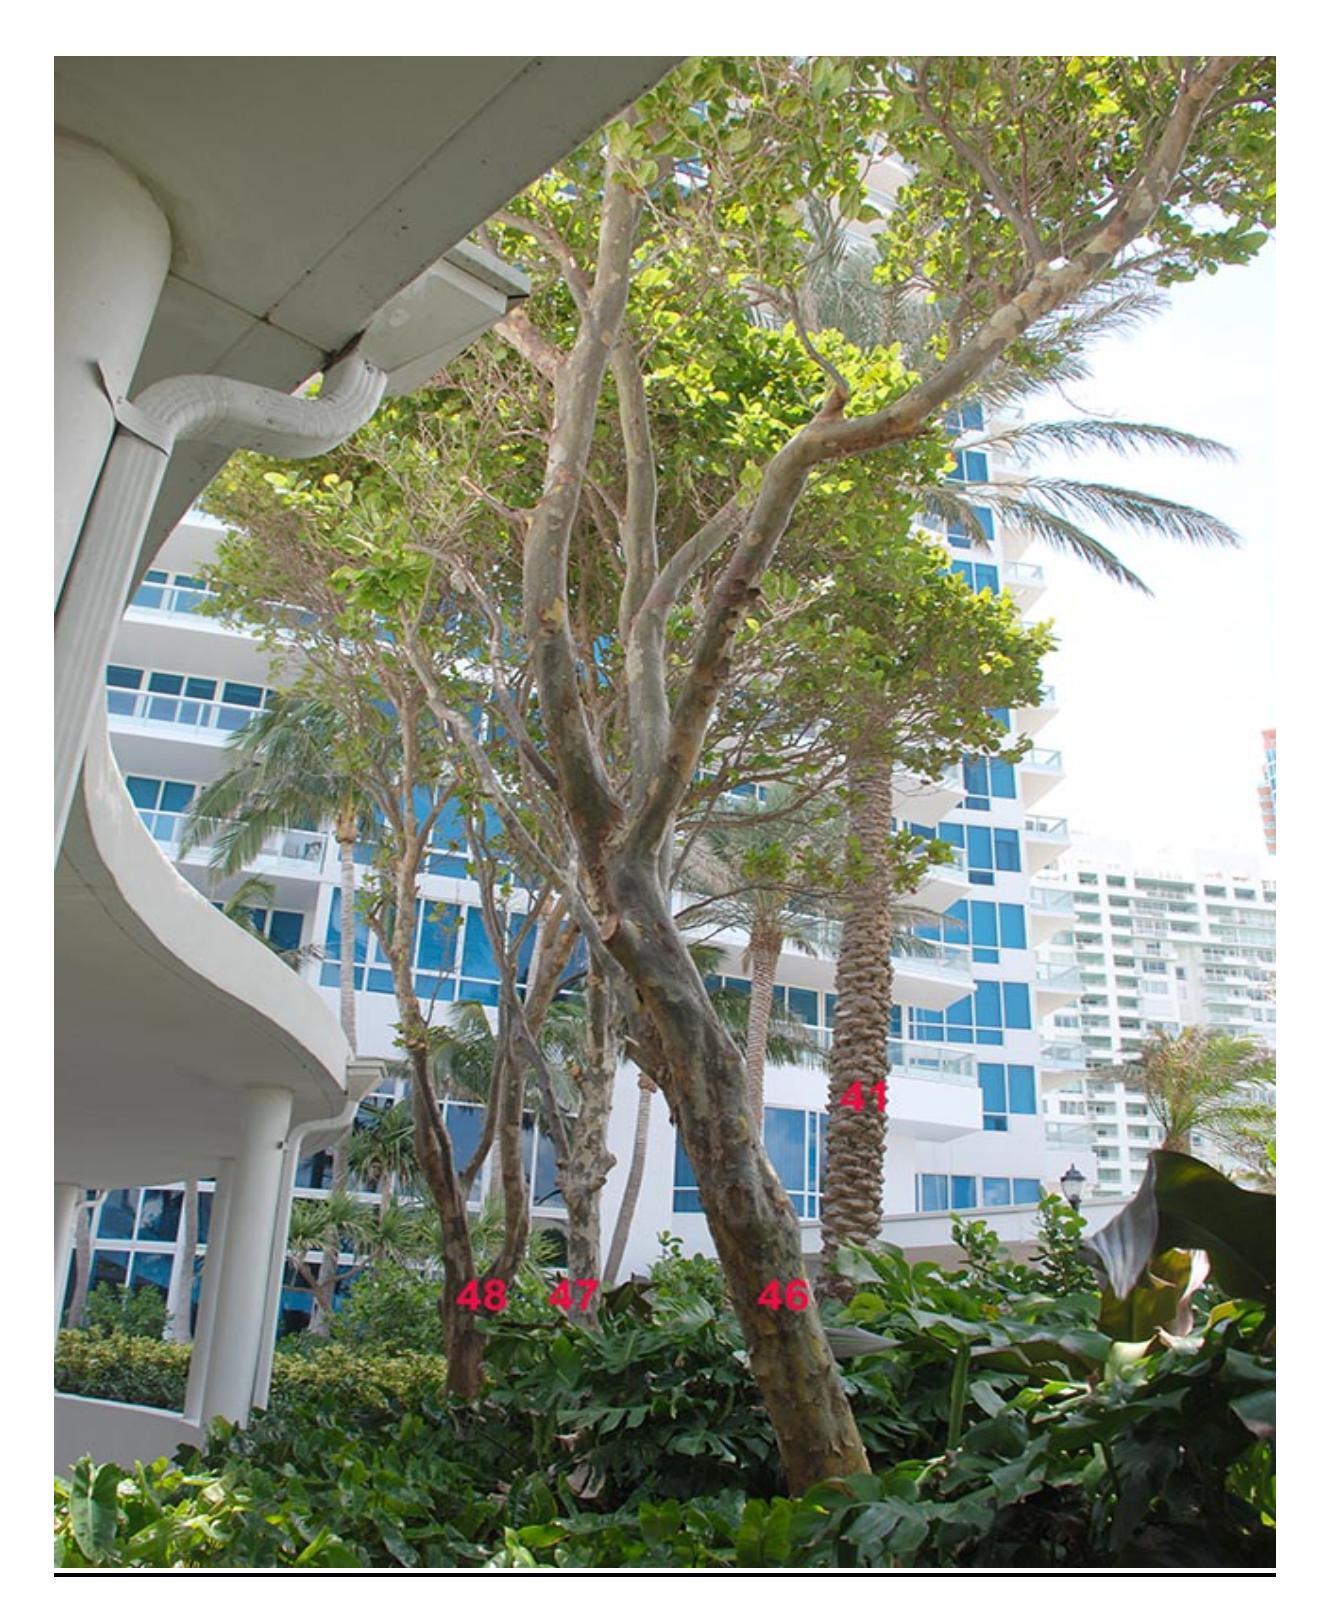
Photo 15 above is trees 46, 47 & 48. Most of the trees on this site are in need of structural pruning.

Most of the trees on this site are in need of structural pruning to reduce overextended branches. I advise that any new trees to be installed receive formative pruning upon installation to improve long term branch structure.

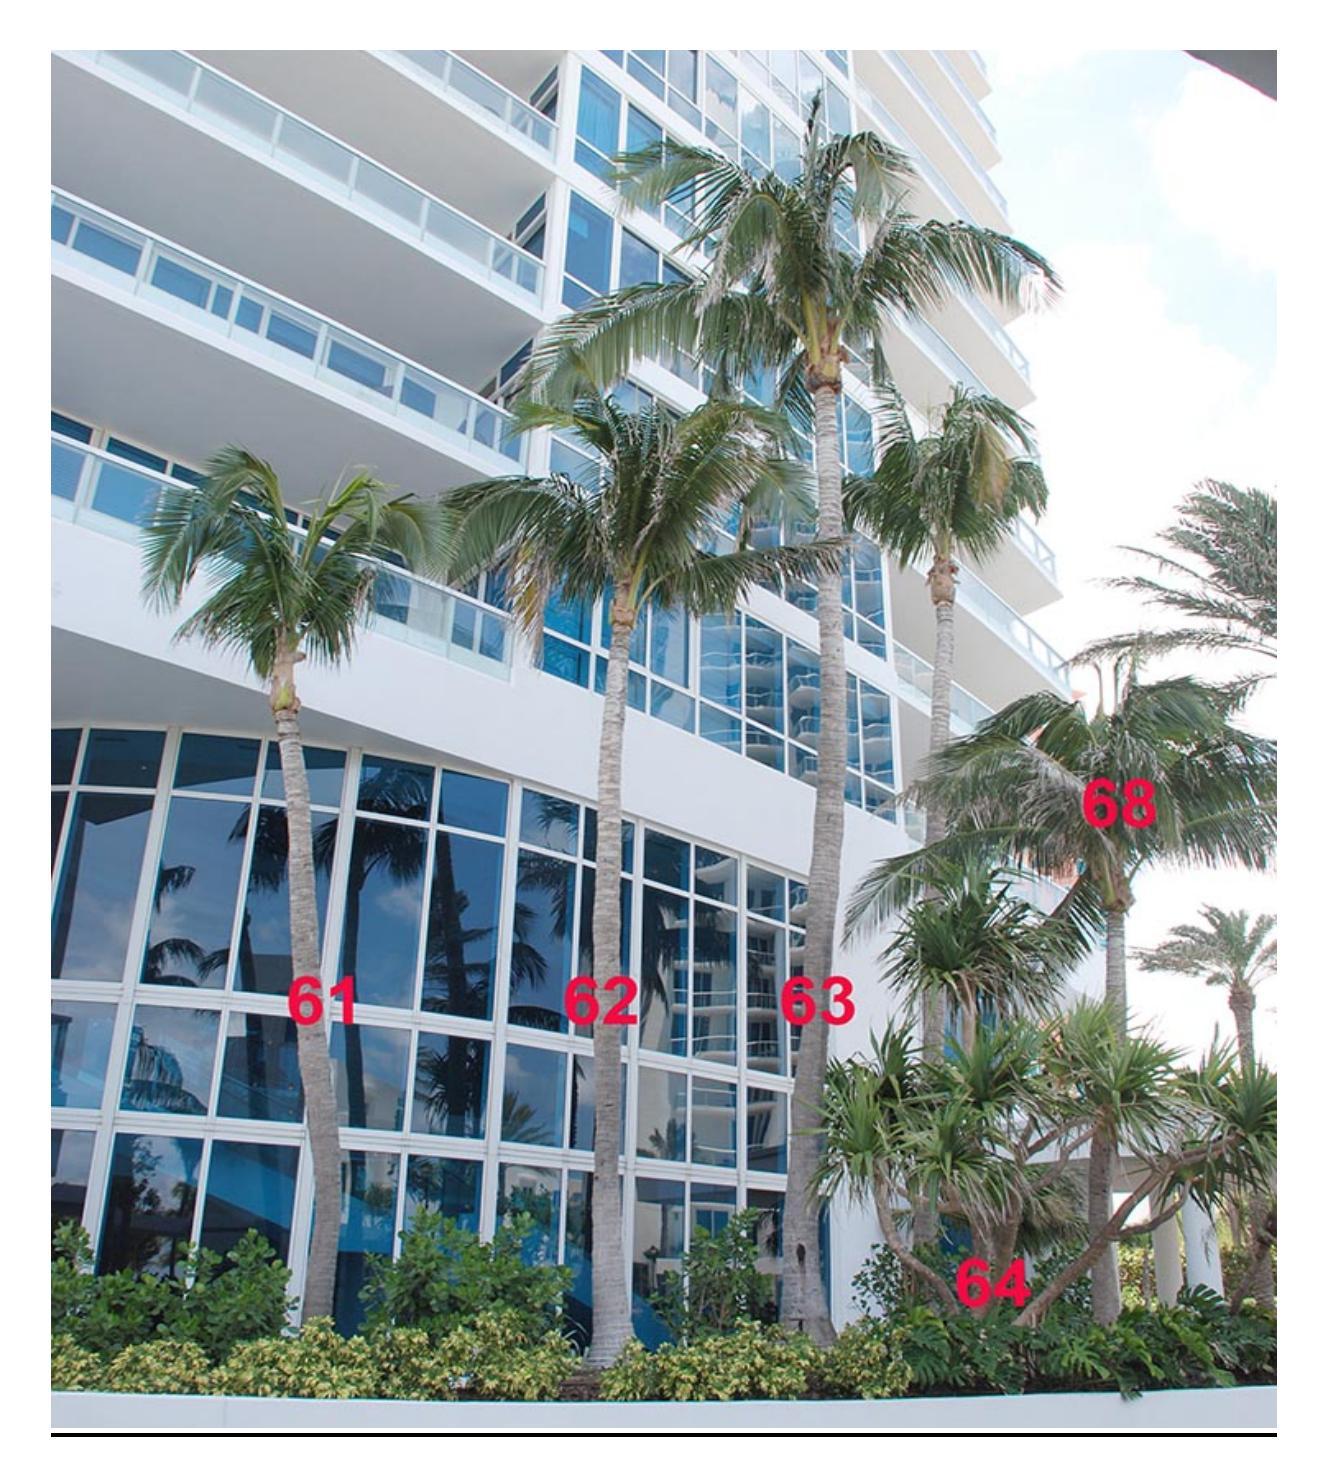
Photo 21 above is palms 61 through 63. Many of the palms onsite have holes from previous injections that are oozing. These holes will never heal and can be entry points for pathogens that can eventually cause the trunk to fail. I do not recommend the relocation of any palms that have holes in their trunks.

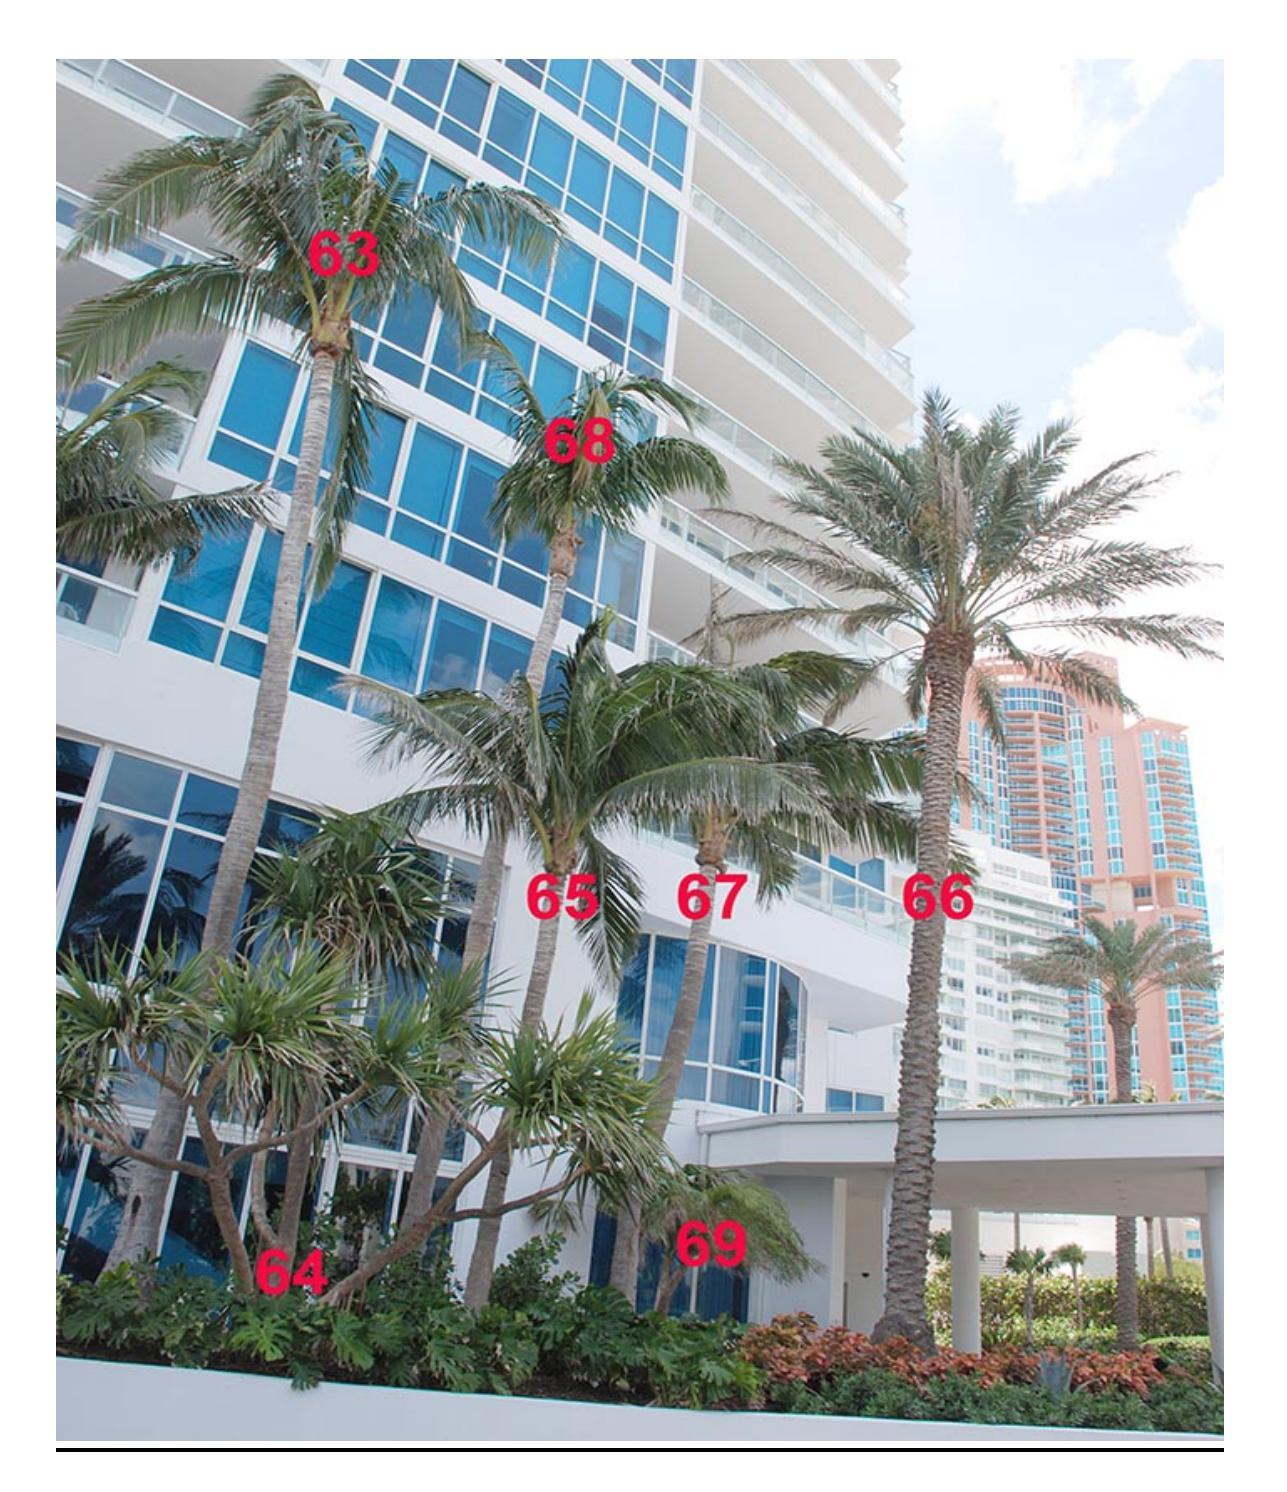
Photo 22 above is pandanas 64 and palms 66 through 69. Many of the palms onsite have holes from previous injections that are oozing. These holes will never heal and can be entry points for pathogens that can eventually cause the trunk to fail. I do not recommend the relocation of any palms that have holes in their trunks.

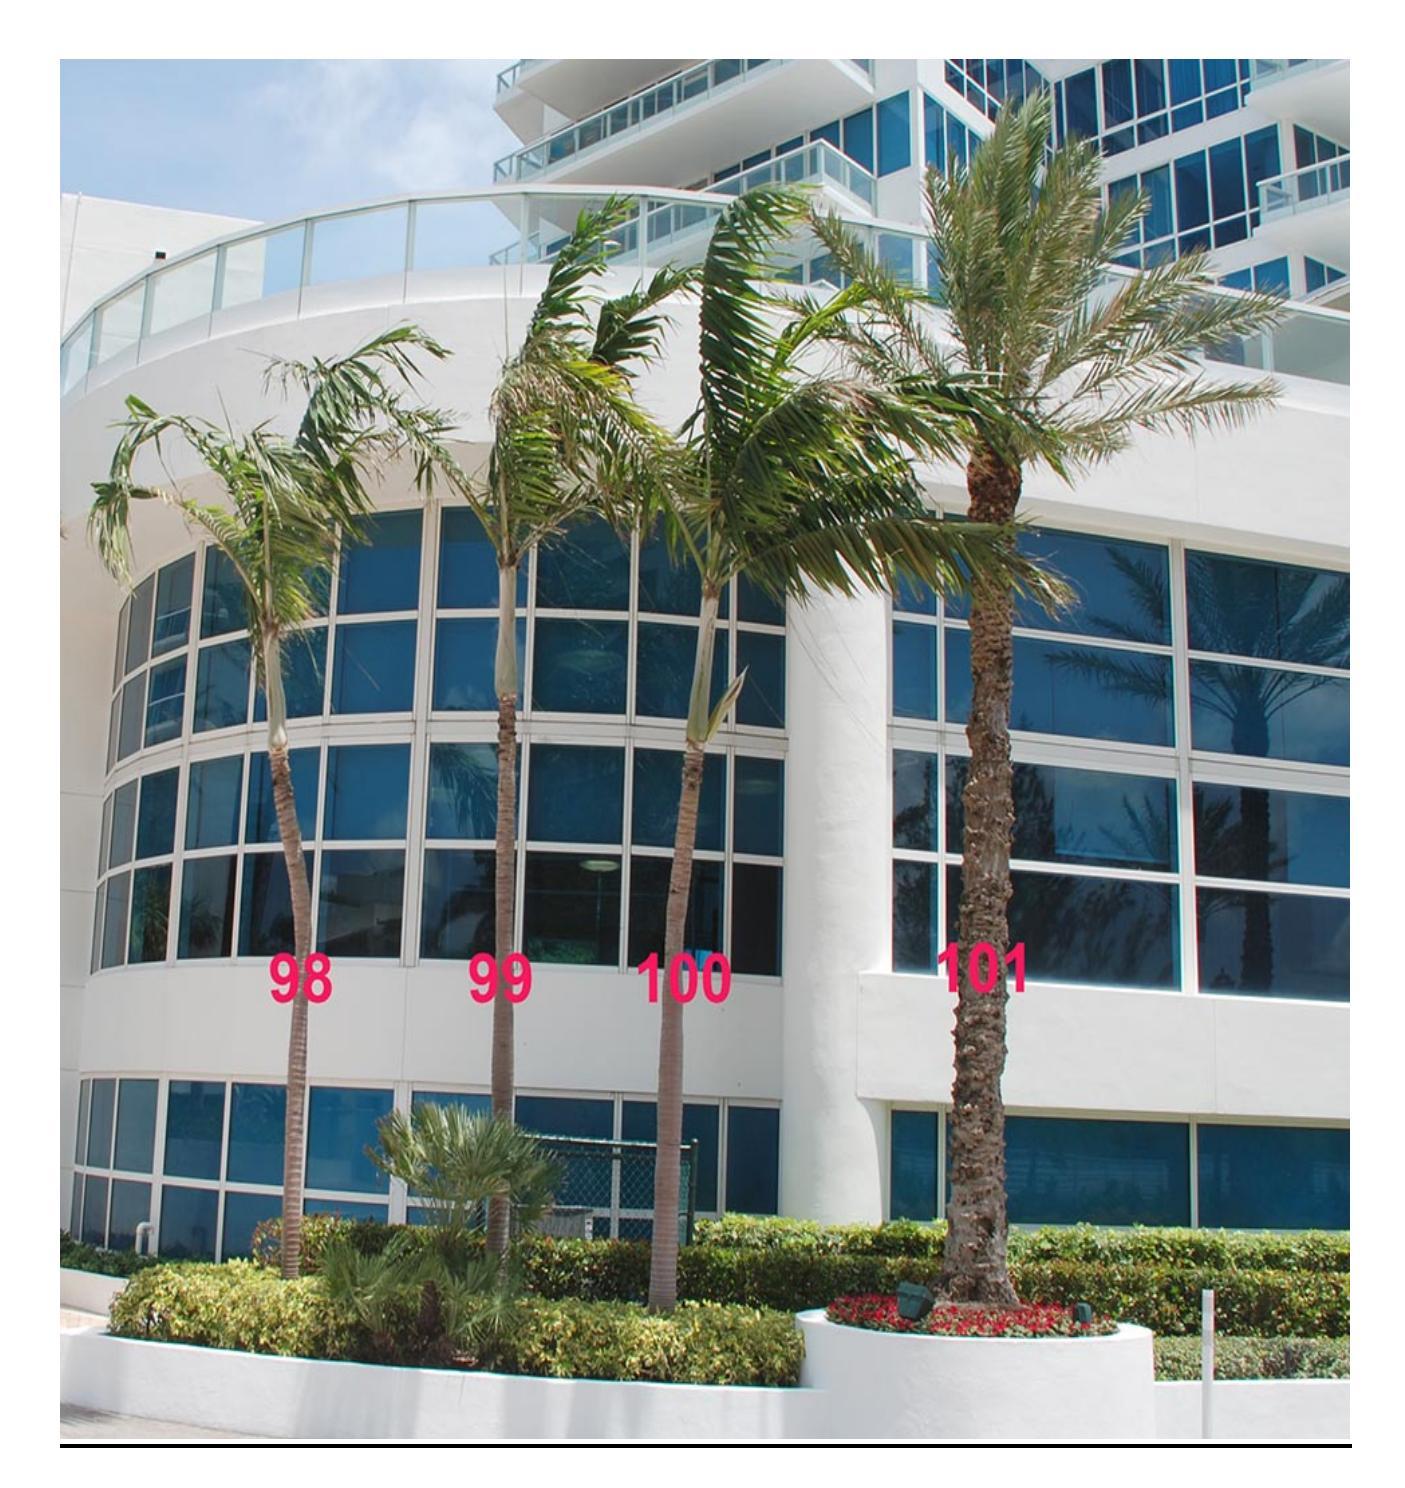
Photo 31 above is palms 98 through 101. The date palms growing in the round containers have flowering impatiens planted around their trunks. Most if not all of the root balls on these palms have been cut to accommodate the flowering plants. This practice of cutting the roots exposes these palms to virulent fungal pathogens.

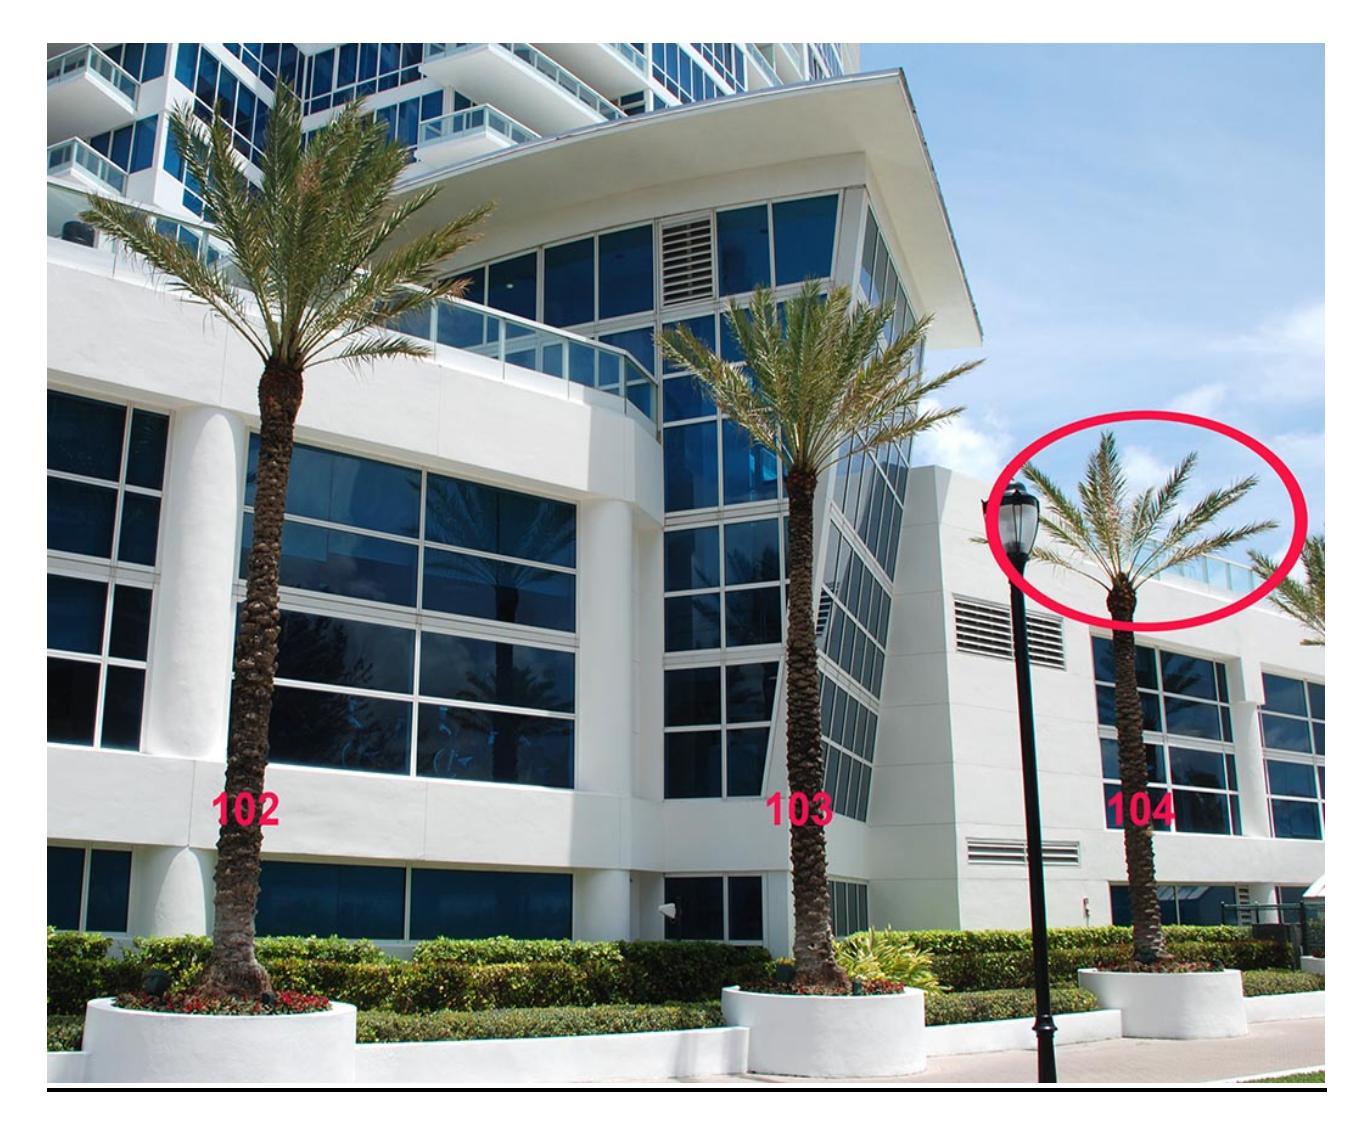
Photo 32 above is palms 102 through 104. The date palms growing in the round containers have flowering impatiens planted around their trunks. Most if not all of the root balls on these palms have been cut to accommodate the flowering plants. This practice of cutting the roots exposes these palms to virulent fungal pathogens.

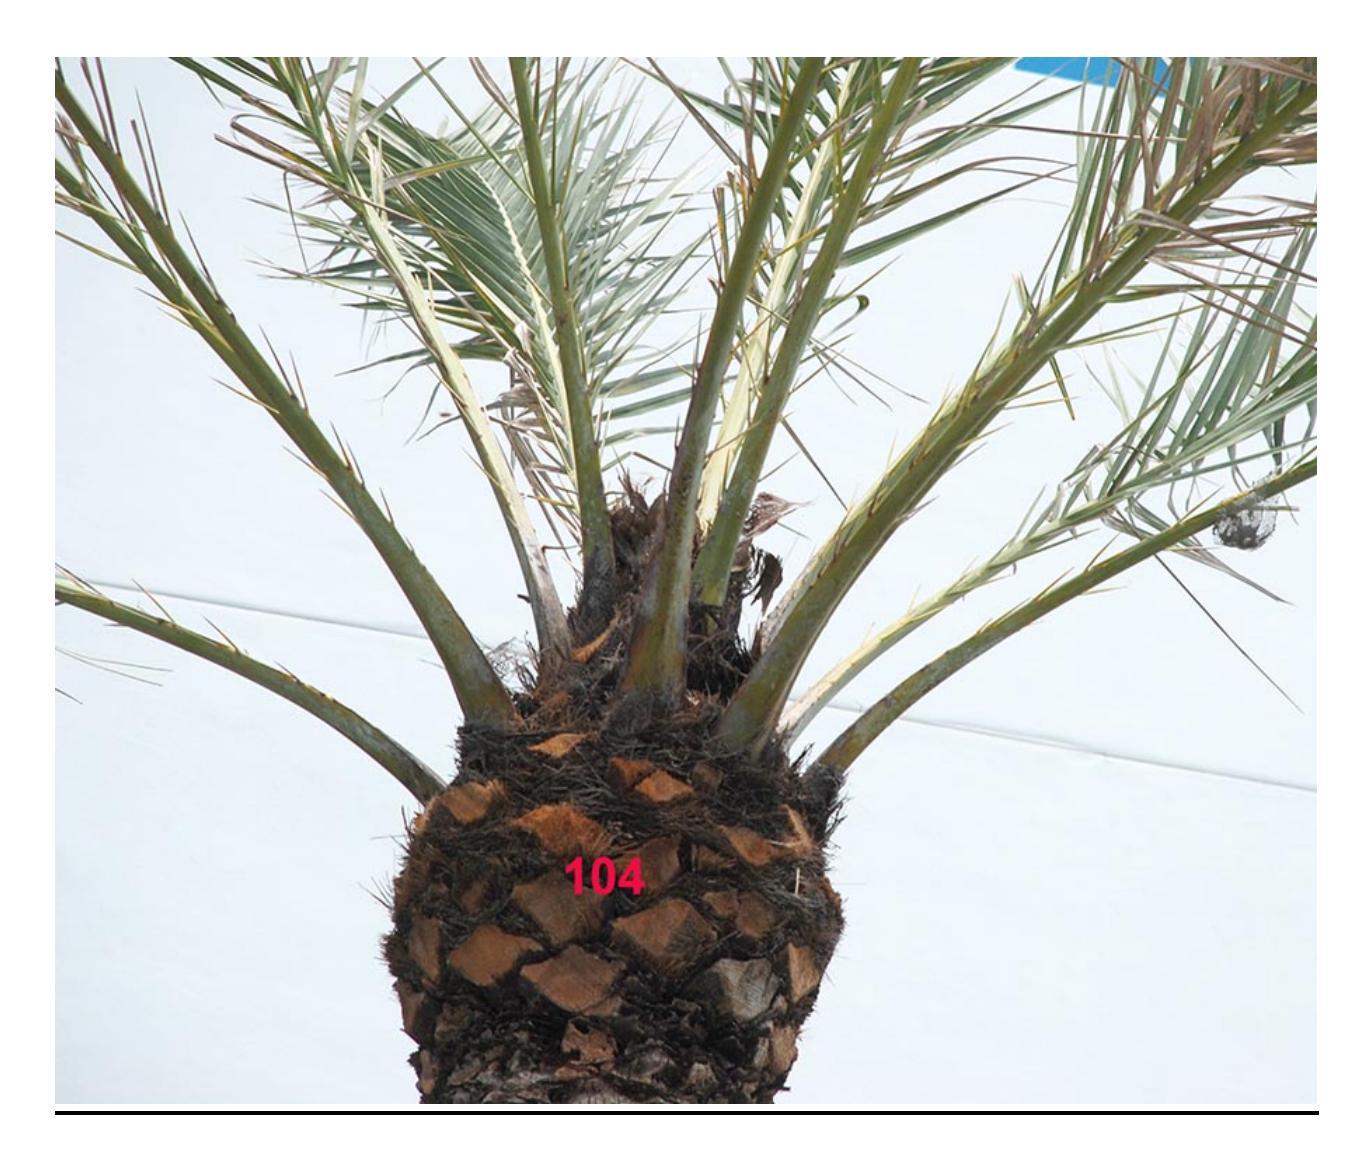
Photo 33 above is the head of palm 104. This palm appears to be dying.

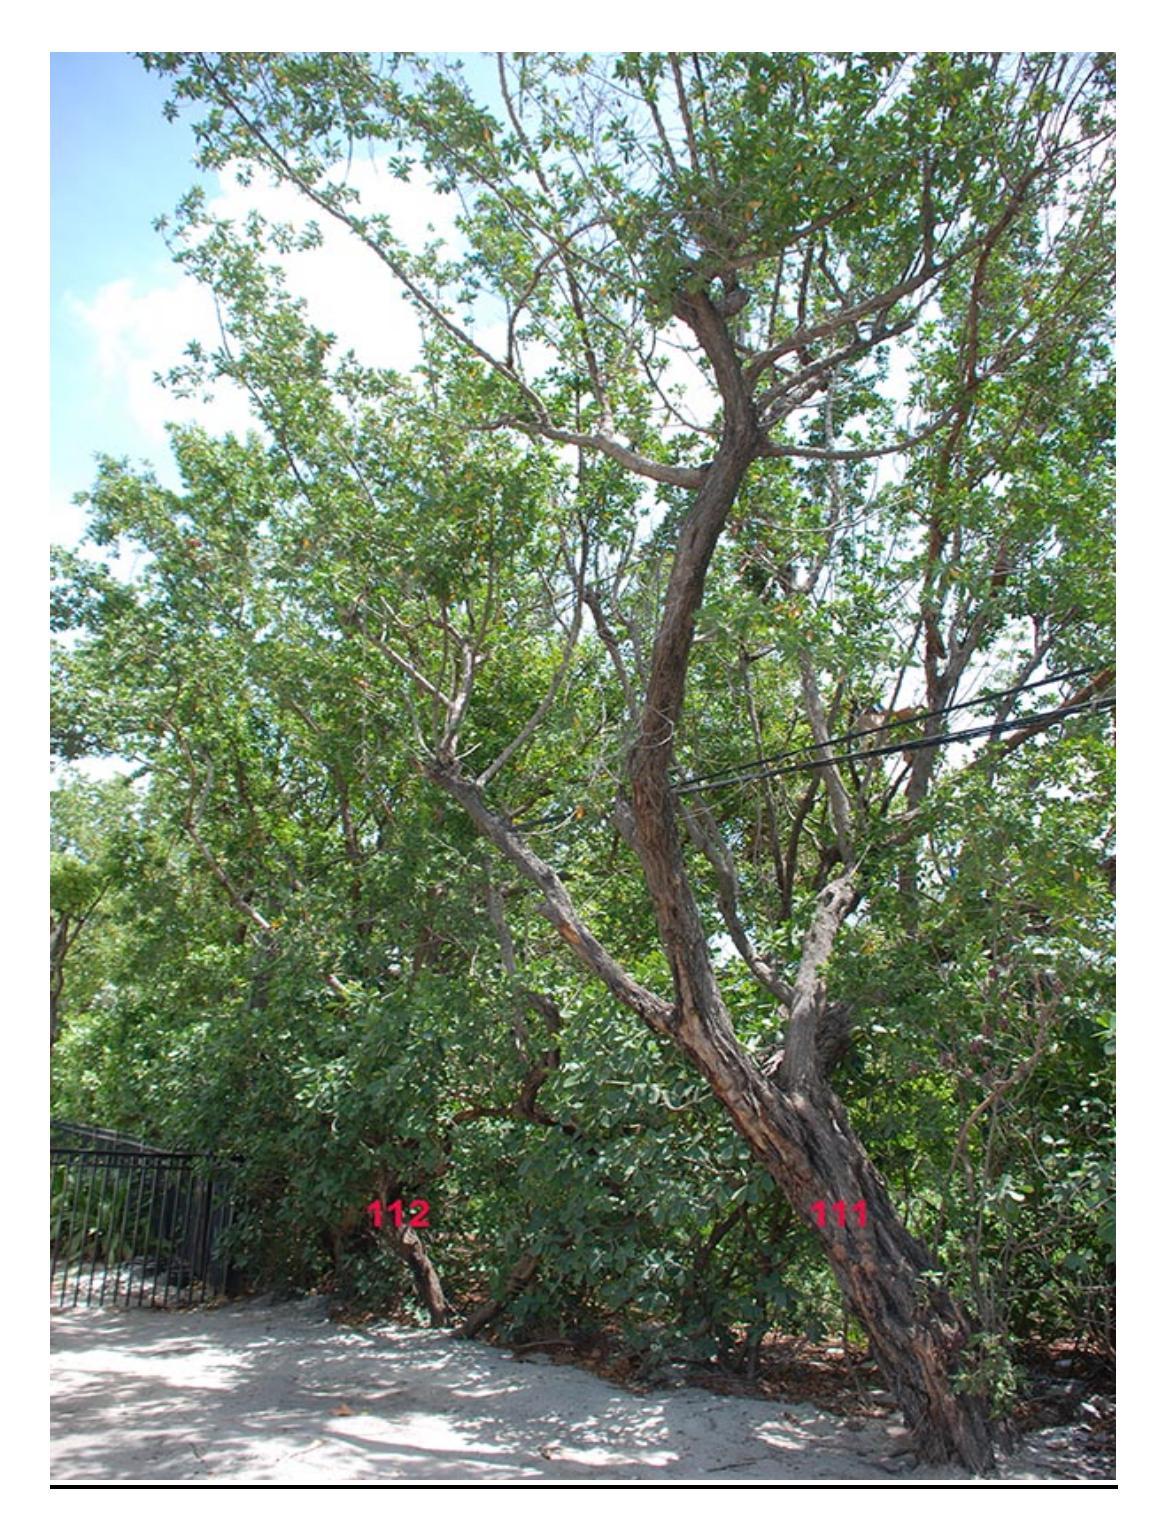
Photo 37 above is green buttonwood trees 111 & 112. These trees were difficult to assess and measure as the foliage was very dense and they are over-grown. These trees should be structurally pruned.
