Tree Resource Evaluation for The Continuum, Miami Beach

May 21, 2018

Summary

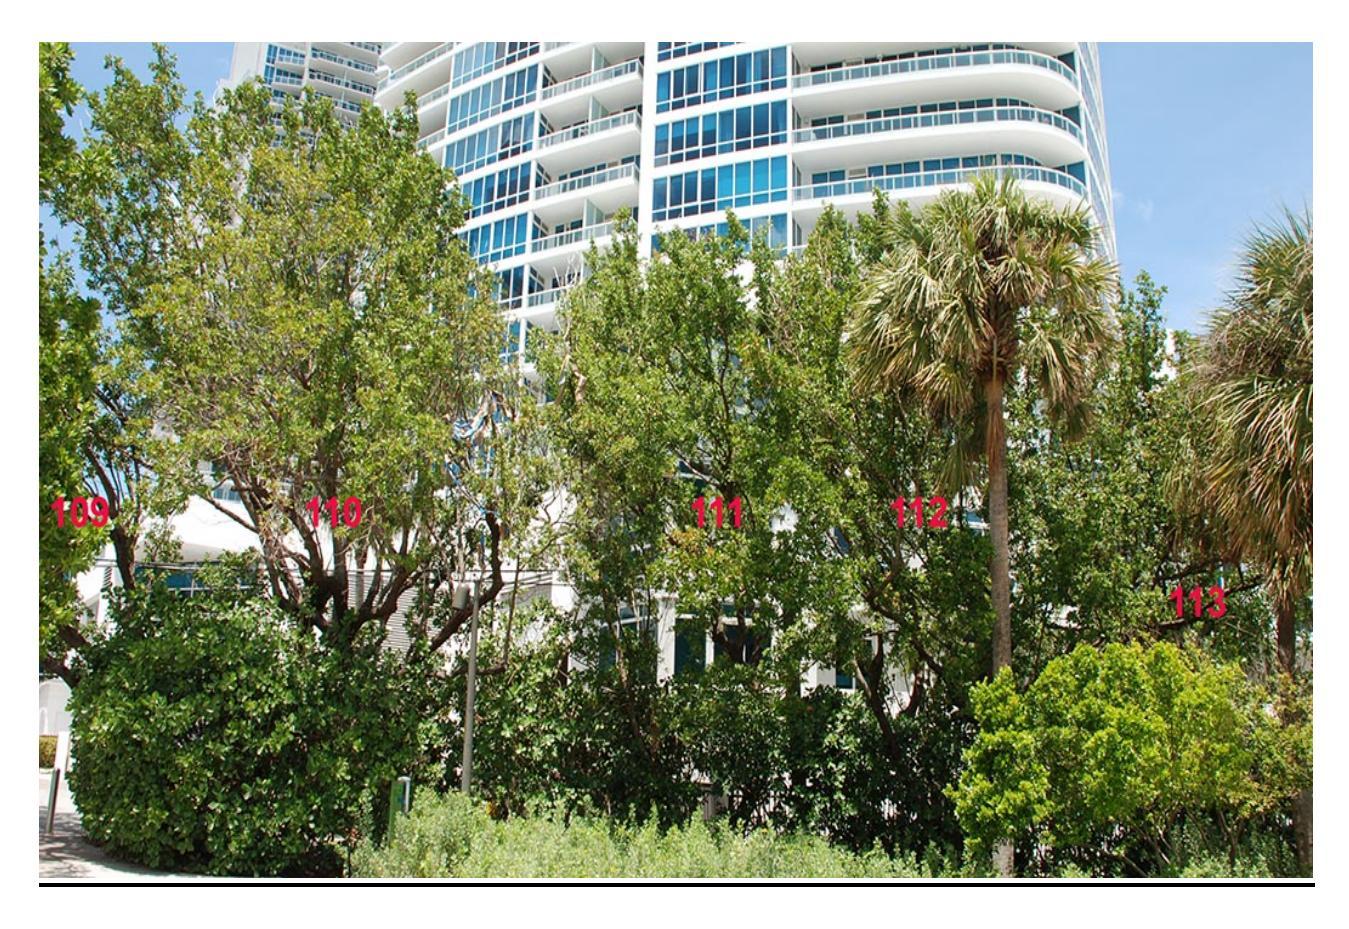
Photo 38 above is green buttonwood trees 109 through 113. These trees were difficult to assess and measure as the foliage was very dense and they are overgrown. These trees should be structurally pruned.

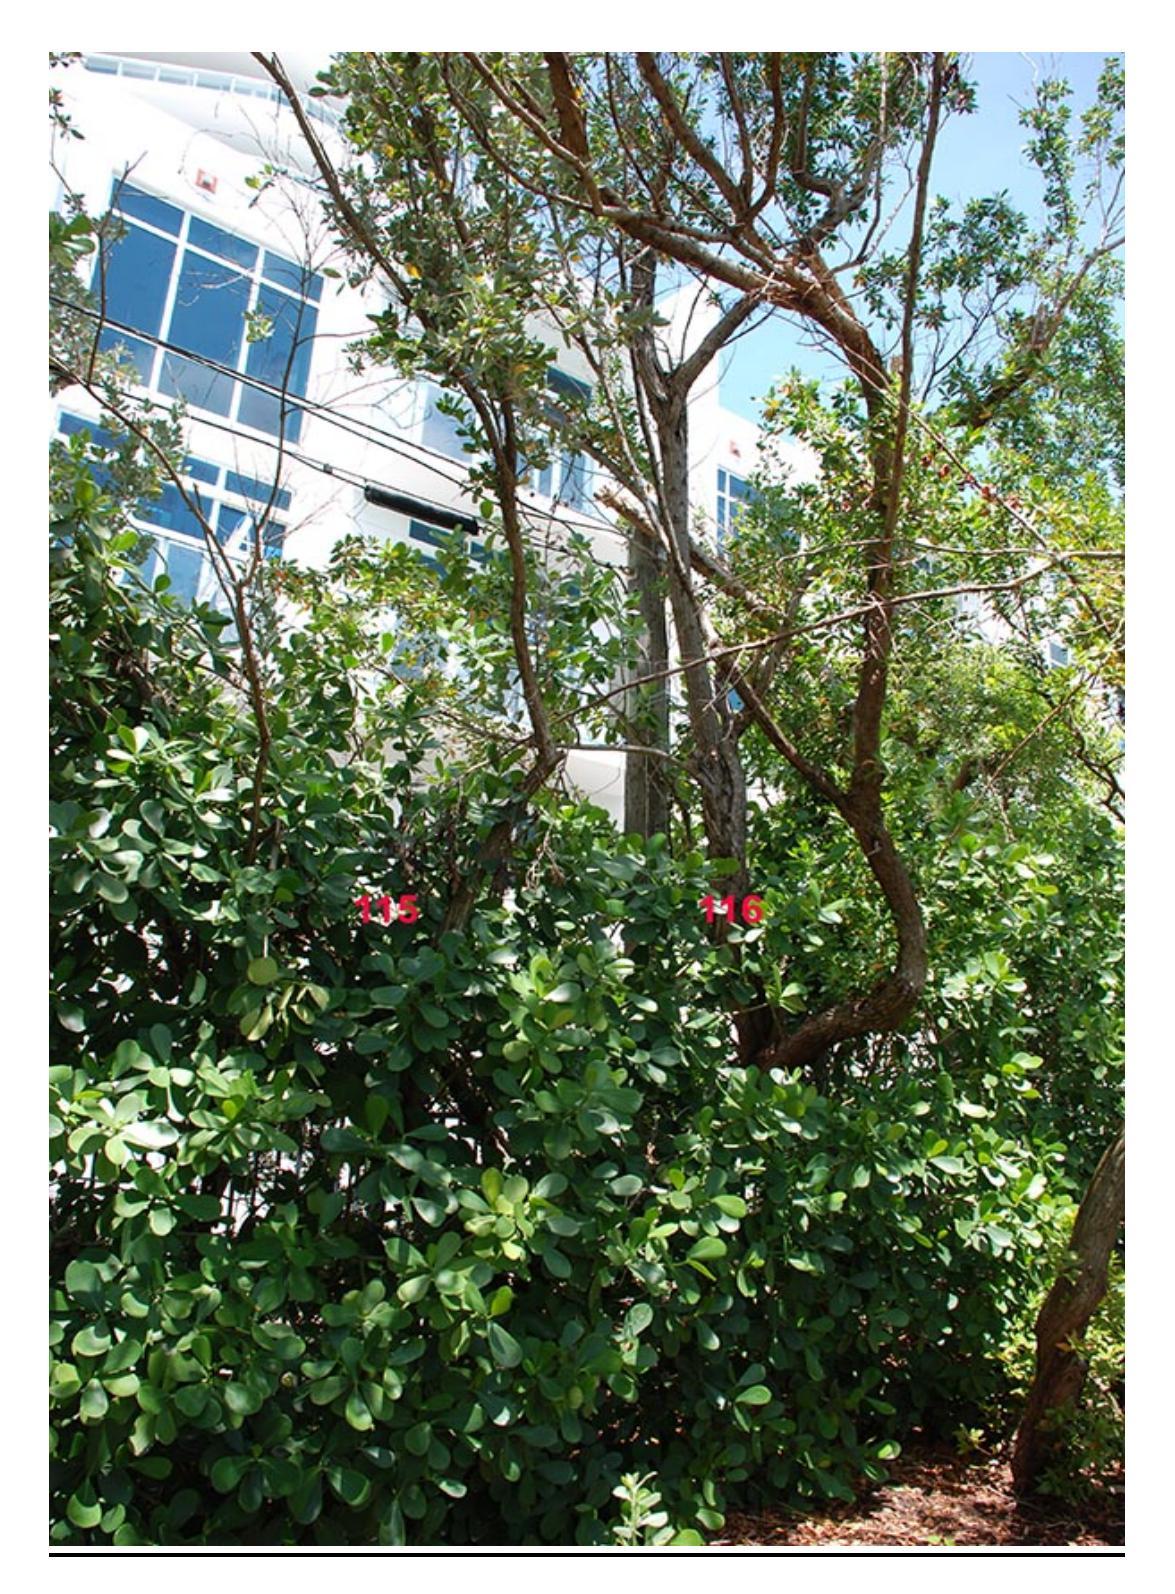
Photo 39 above is green buttonwood trees 115 & 116. These trees were difficult to assess and measure as the foliage was very dense and they are over-grown. These trees should be structurally pruned.

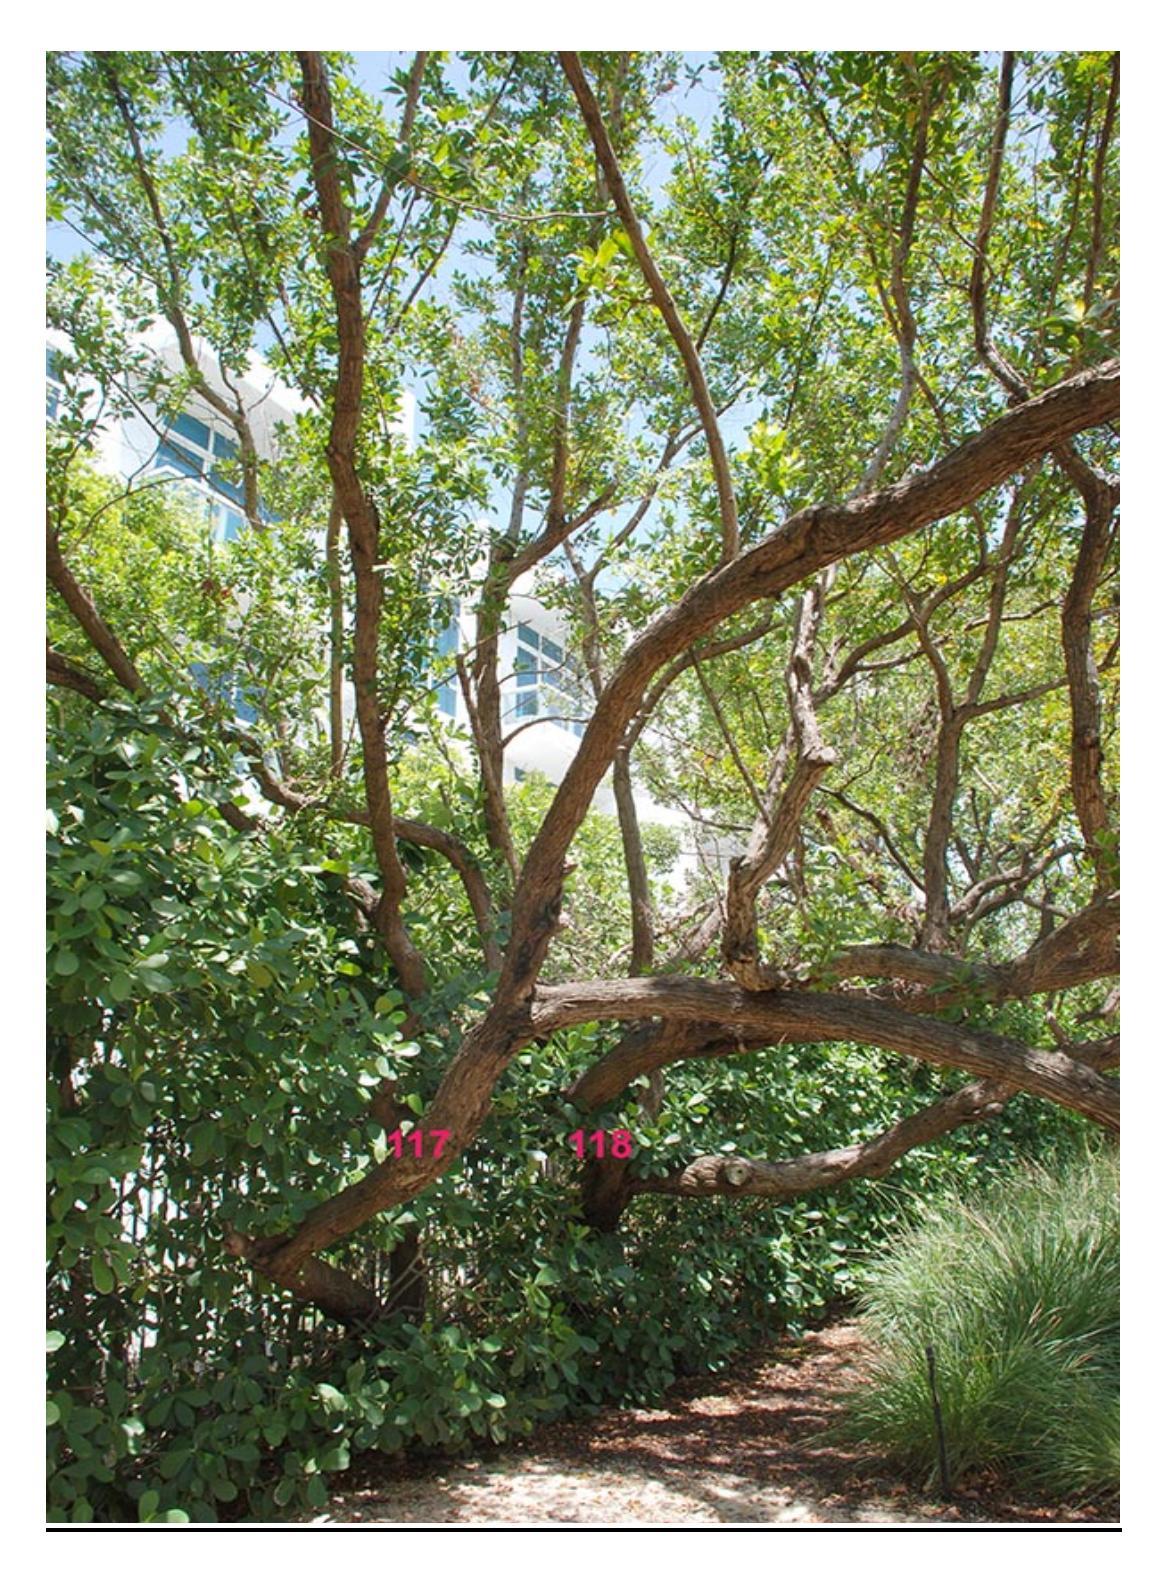
Photo 40 above is green buttonwood trees 1117 & 118. These trees were difficult to assess and measure as the foliage was very dense and they are overgrown. These trees should be structurally pruned.

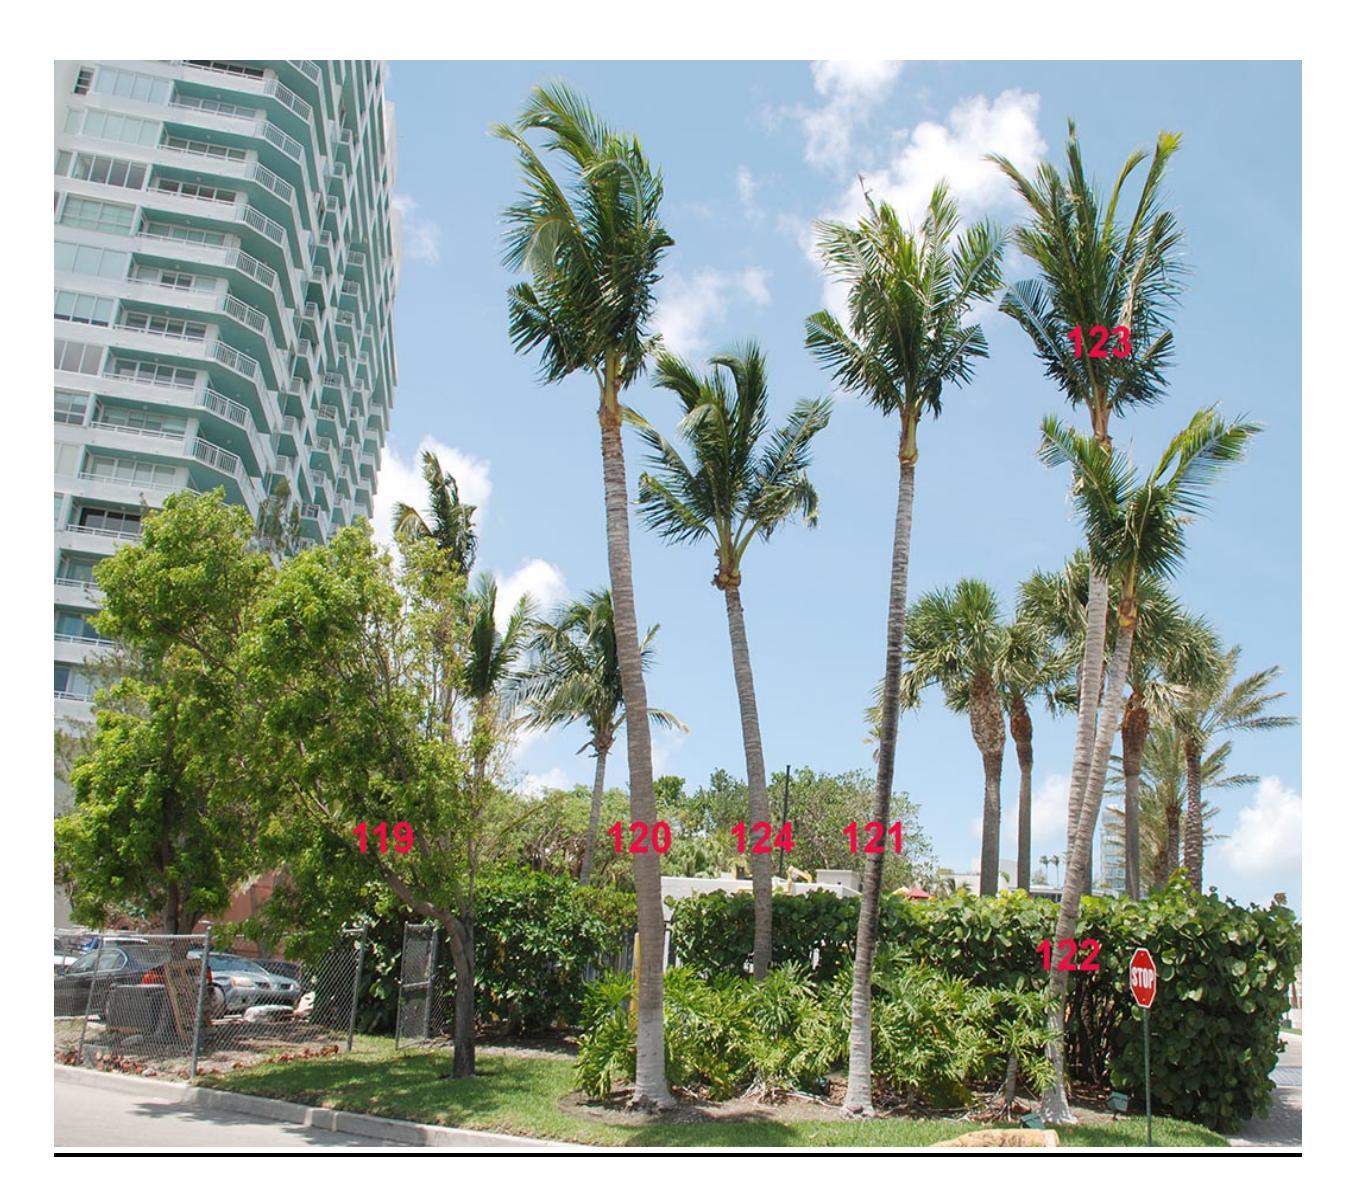
Photo 41 above is mahogany tree 119 that needs to be structurally pruned and palms 120 through 124.

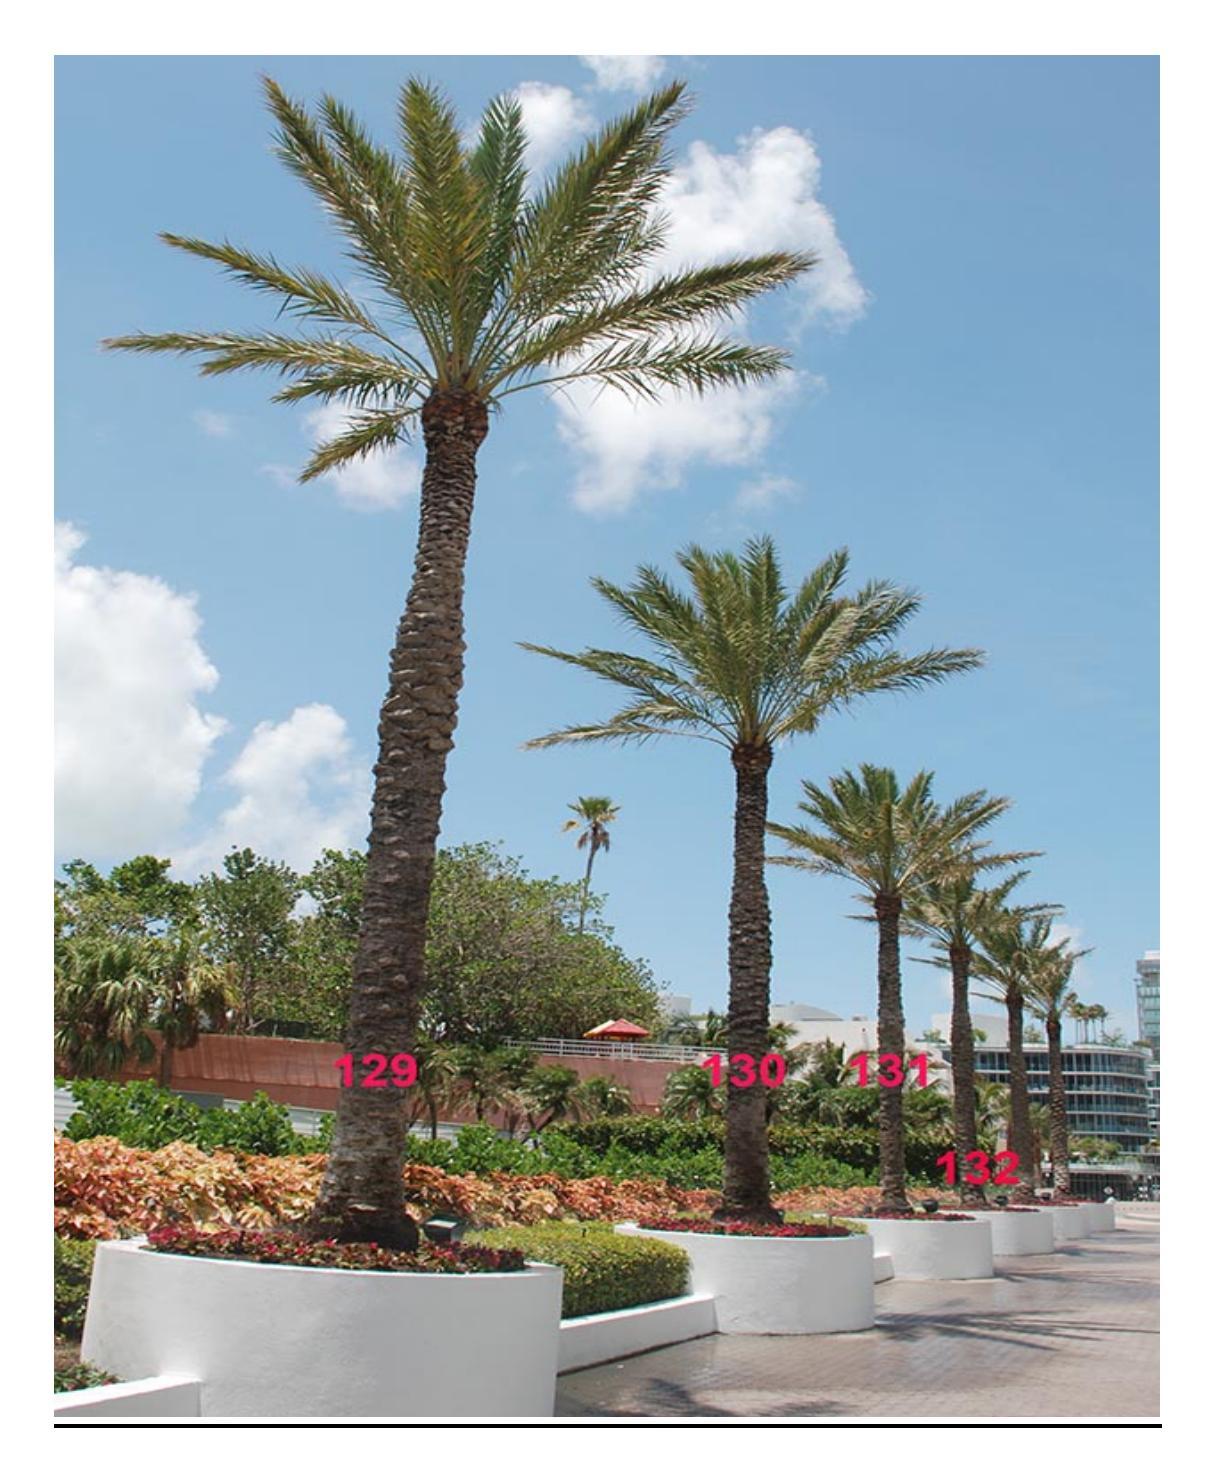
Photo 43 above is palms 129 through 132. The date palms growing in the round containers have flowering impatiens planted around their trunks. Most if not all of the root balls on these palms have been cut to accommodate the flowering plants. This practice of cutting the roots exposes these palms to virulent fungal pathogens.

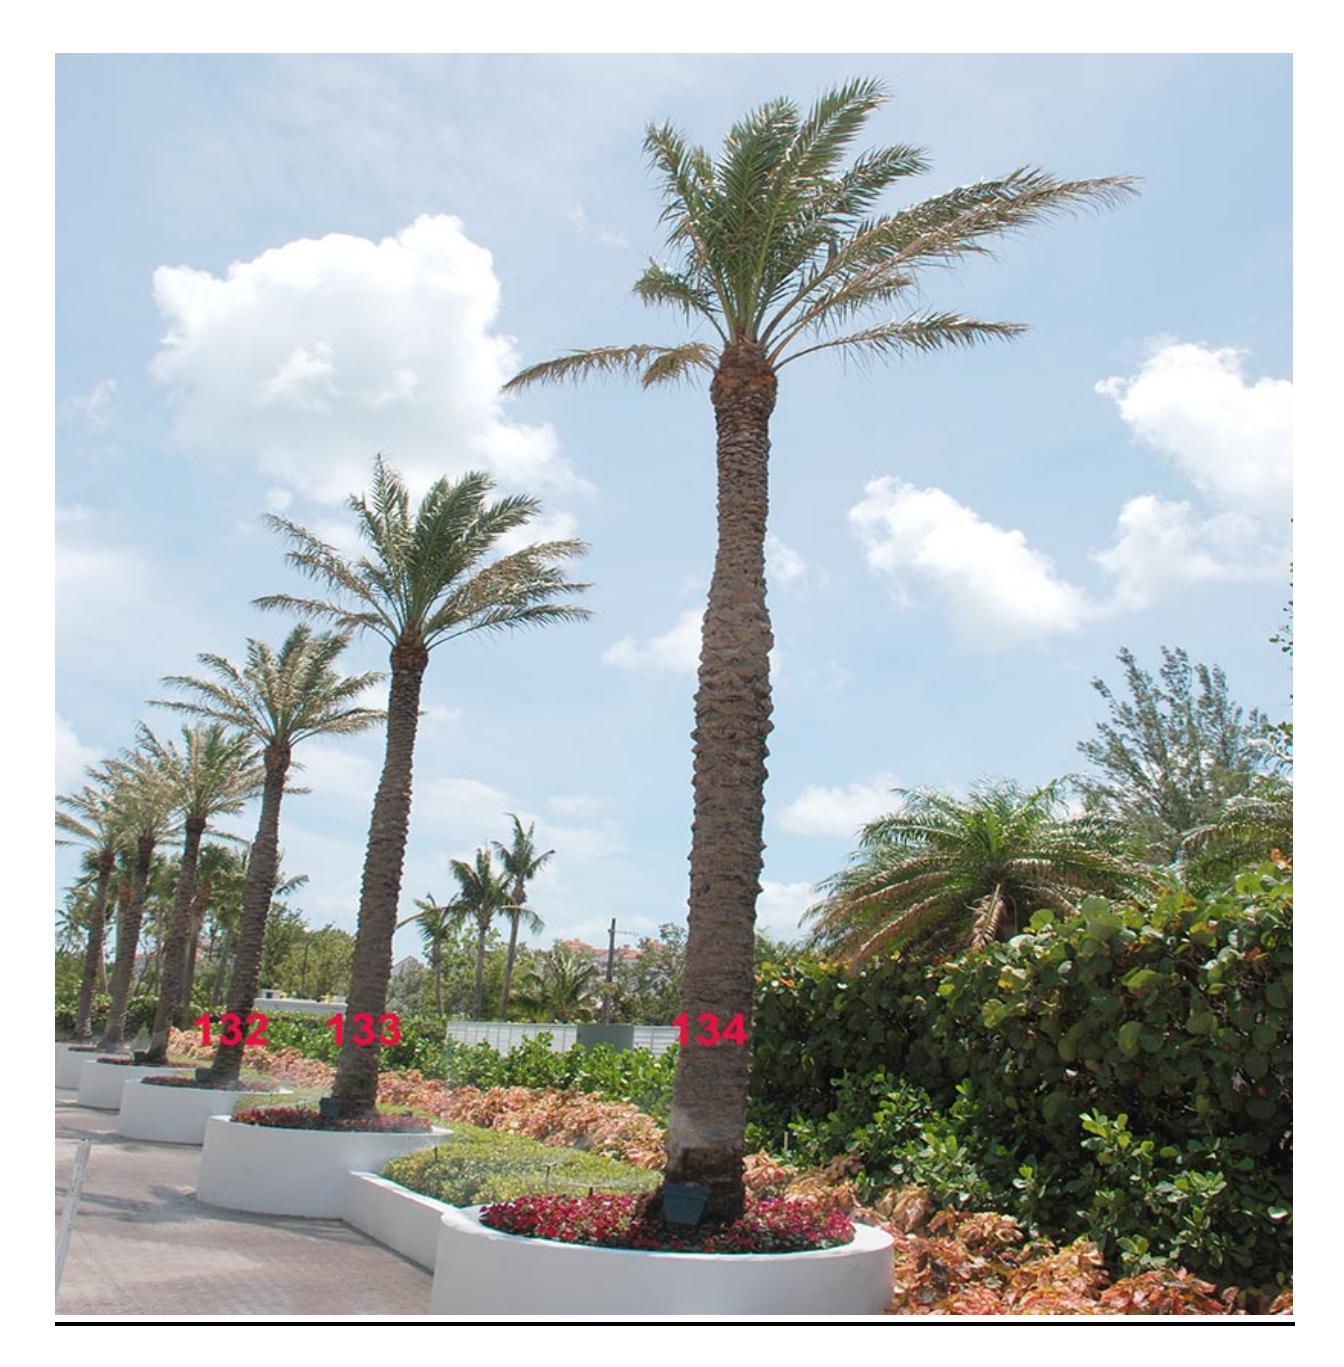
Photo 44 above is palms 132 through 134. The date palms growing in the round containers have flowering impatiens planted around their trunks. Most if not all of the root balls on these palms have been cut to accommodate the flowering plants. This practice of cutting the roots exposes these palms to virulent fungal pathogens.

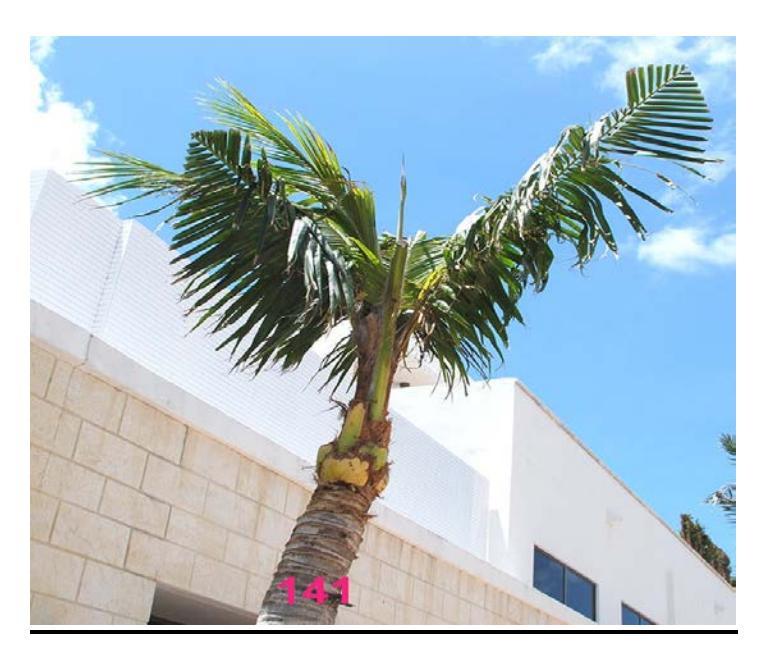
Photo 47 above is nutrient deficient palm 141. This palm should be removed

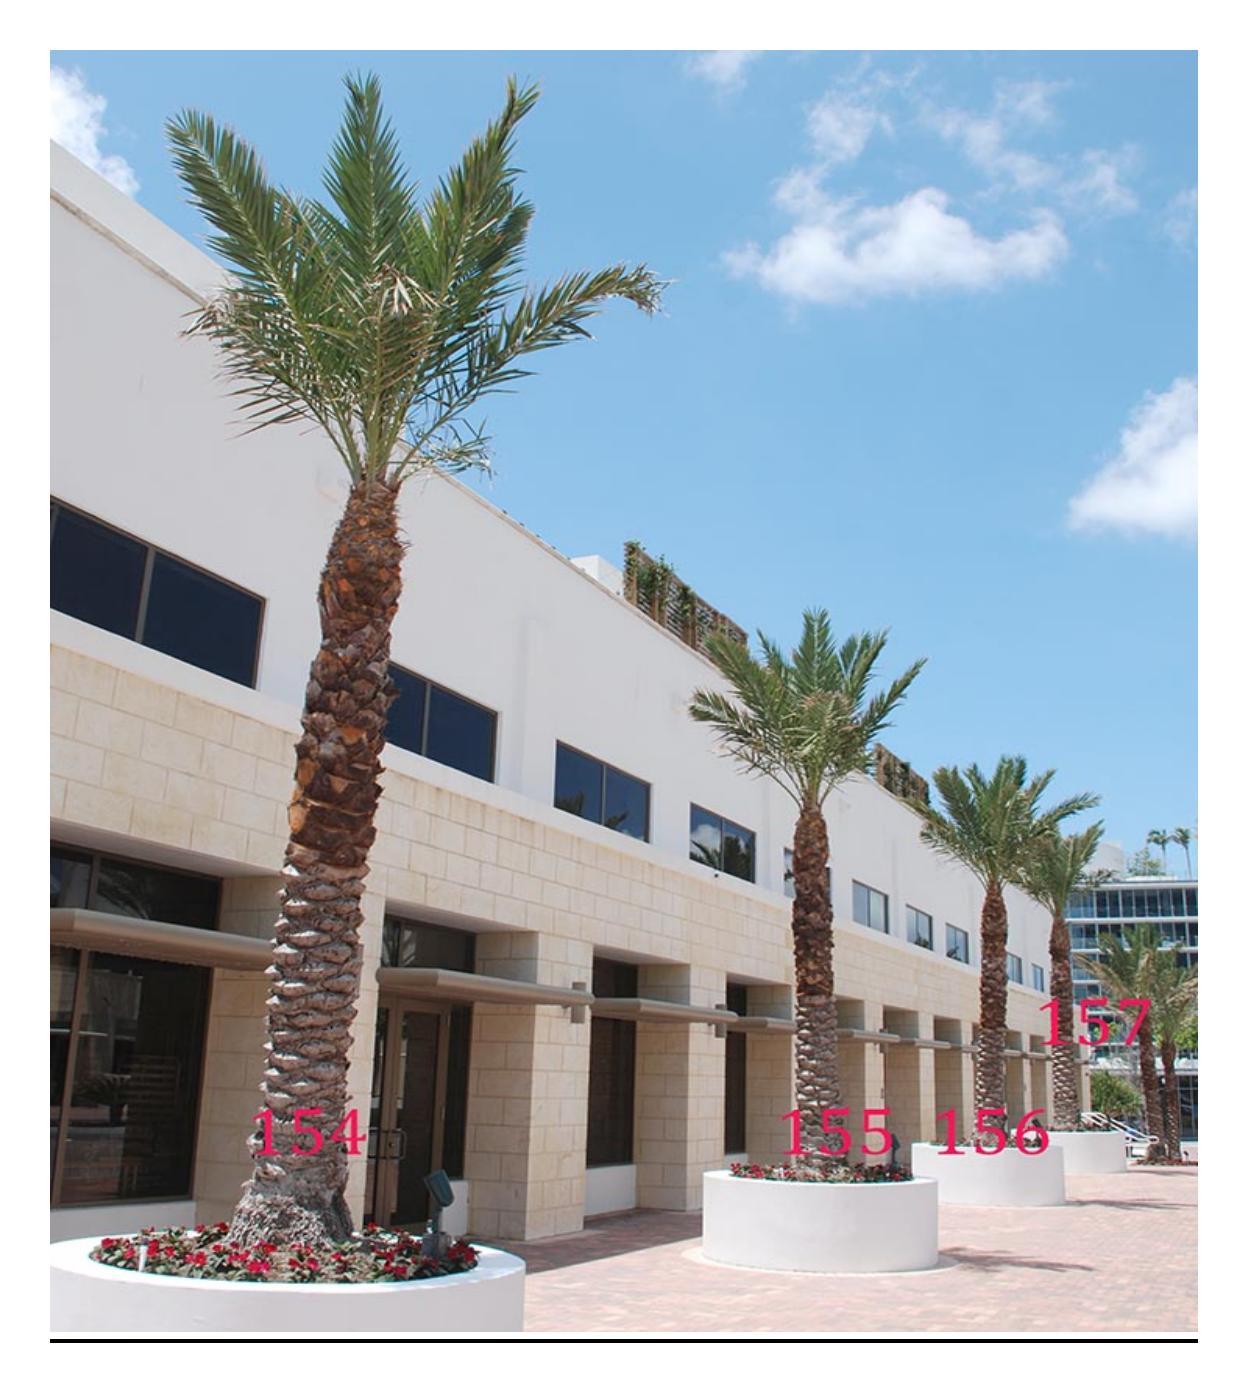
Photo 50 above is palms 154 through 157. The date palms growing in the round containers have flowering impatiens planted around their trunks. Most if not all of the root balls on these palms have been cut to accommodate the flowering plants. This practice of cutting the roots exposes these palms to virulent fungal pathogens.

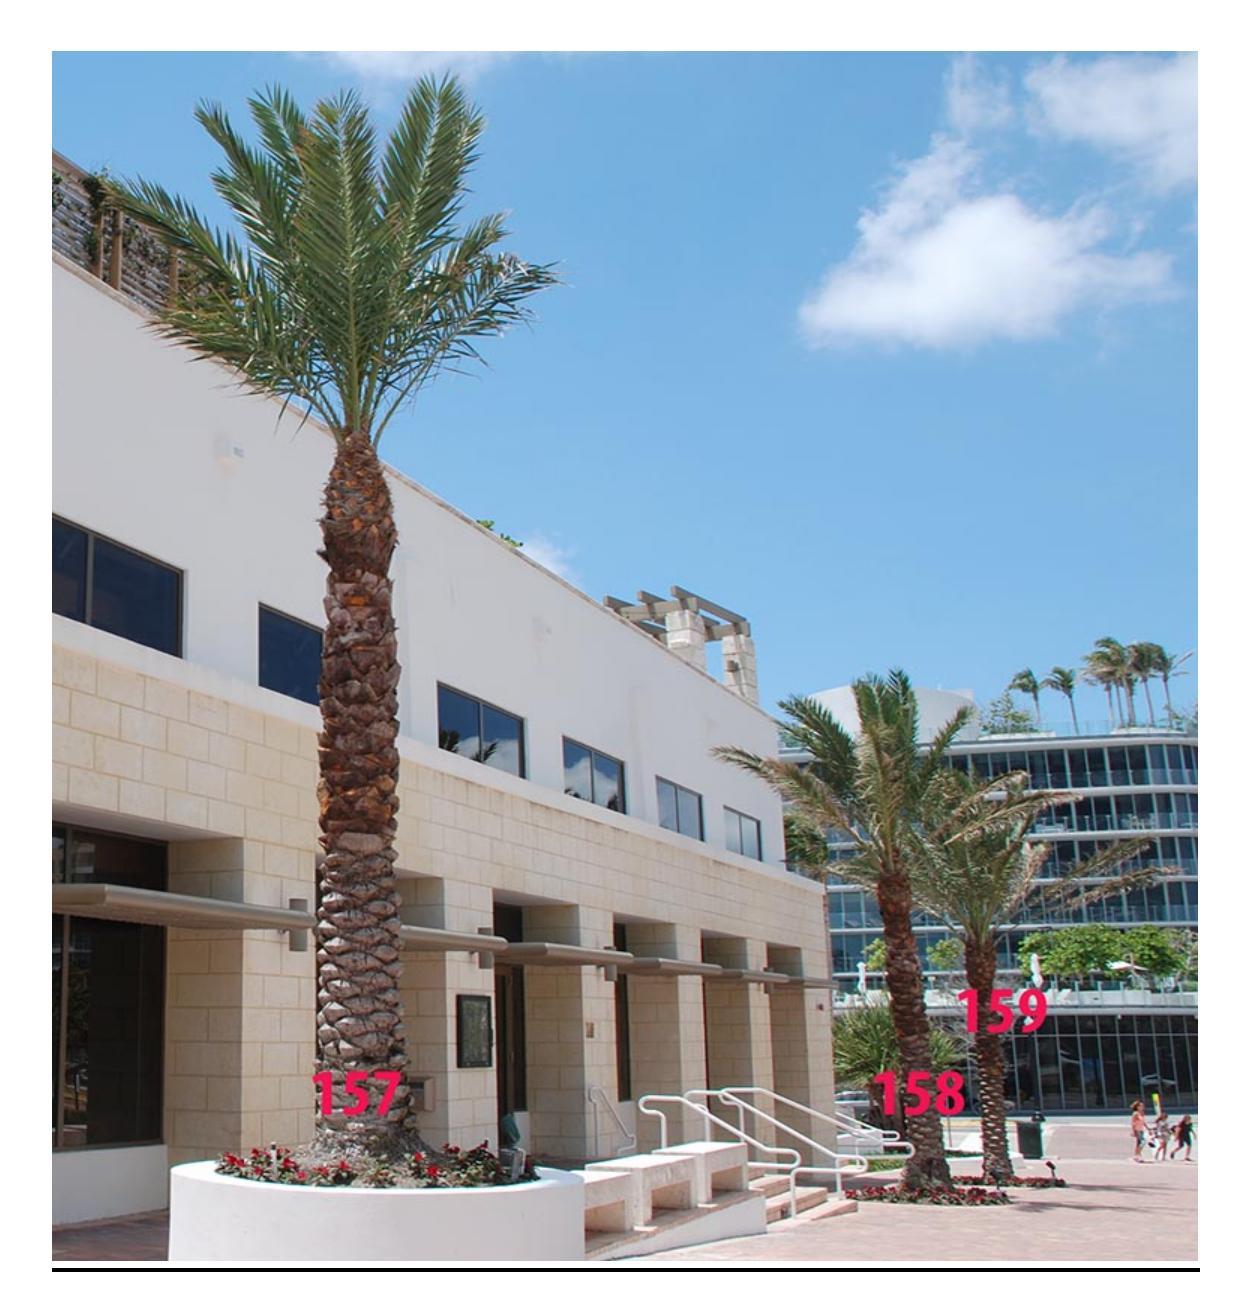
Photo 51 above is palms 157 through 159. The date palms growing in the round containers have flowering impatiens planted around their trunks. Most if not all of the root balls on these palms have been cut to accommodate the flowering plants. This practice of cutting the roots exposes these palms to virulent fungal pathogens.

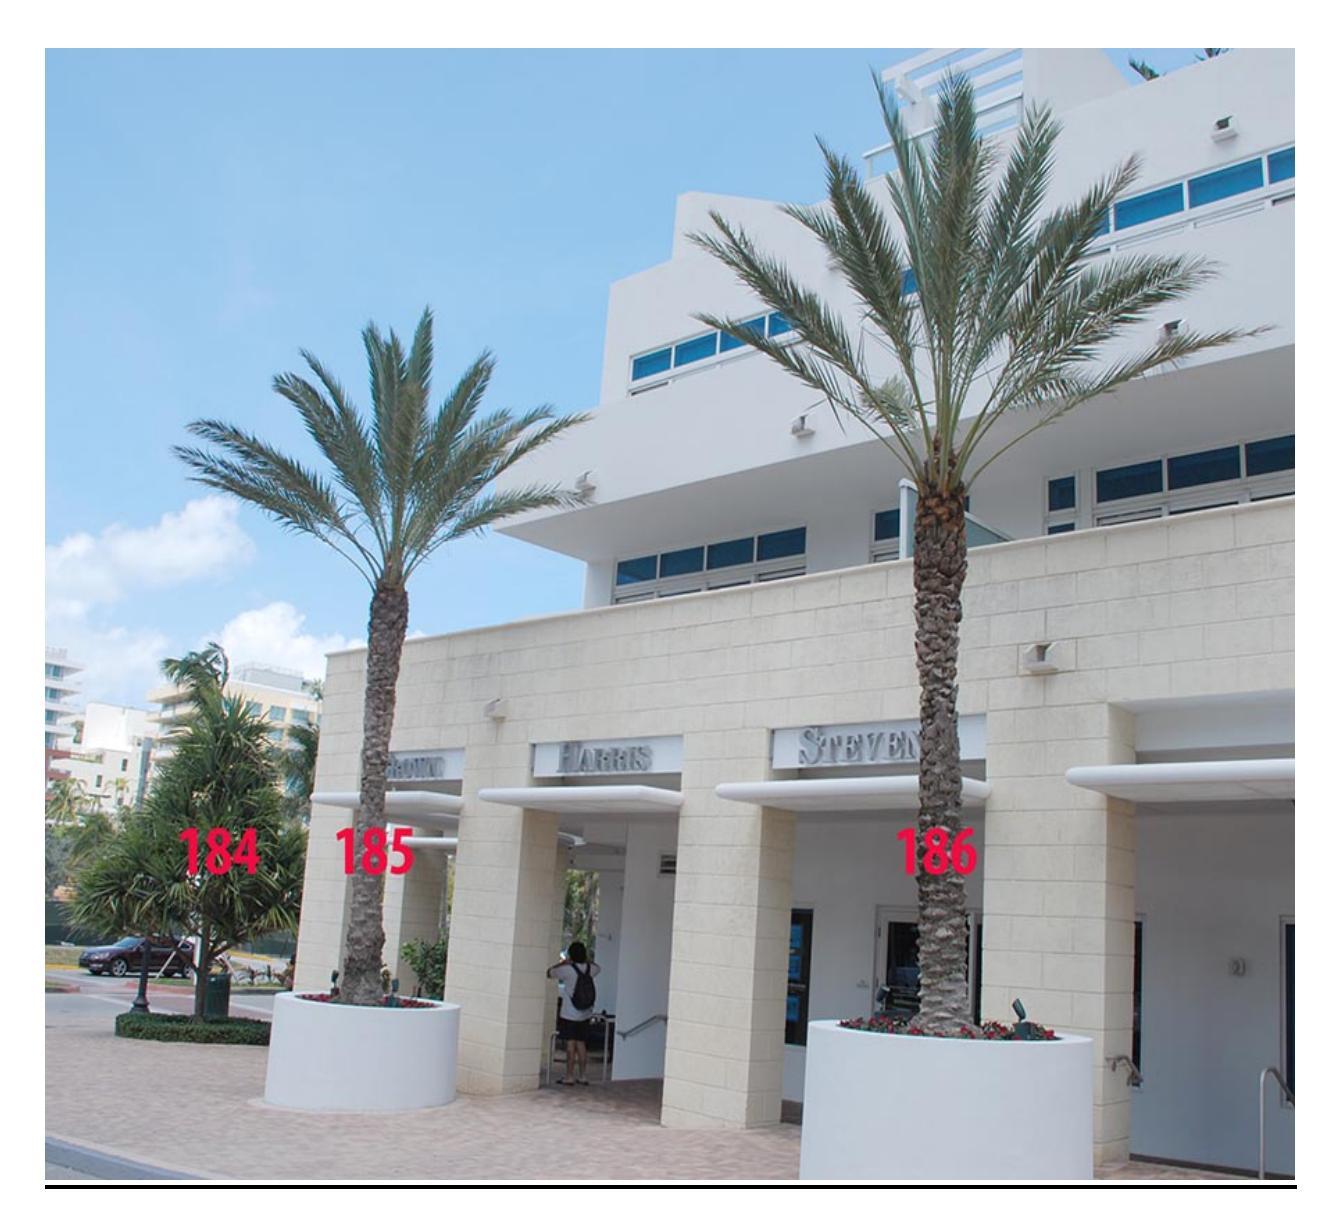
Photo 61 above is palms 185 & 186. The date palms growing in the round containers have flowering impatiens planted around their trunks. Most if not all of the root balls on these palms have been cut to accommodate the flowering plants. This practice of cutting the roots exposes these palms to virulent fungal pathogens.

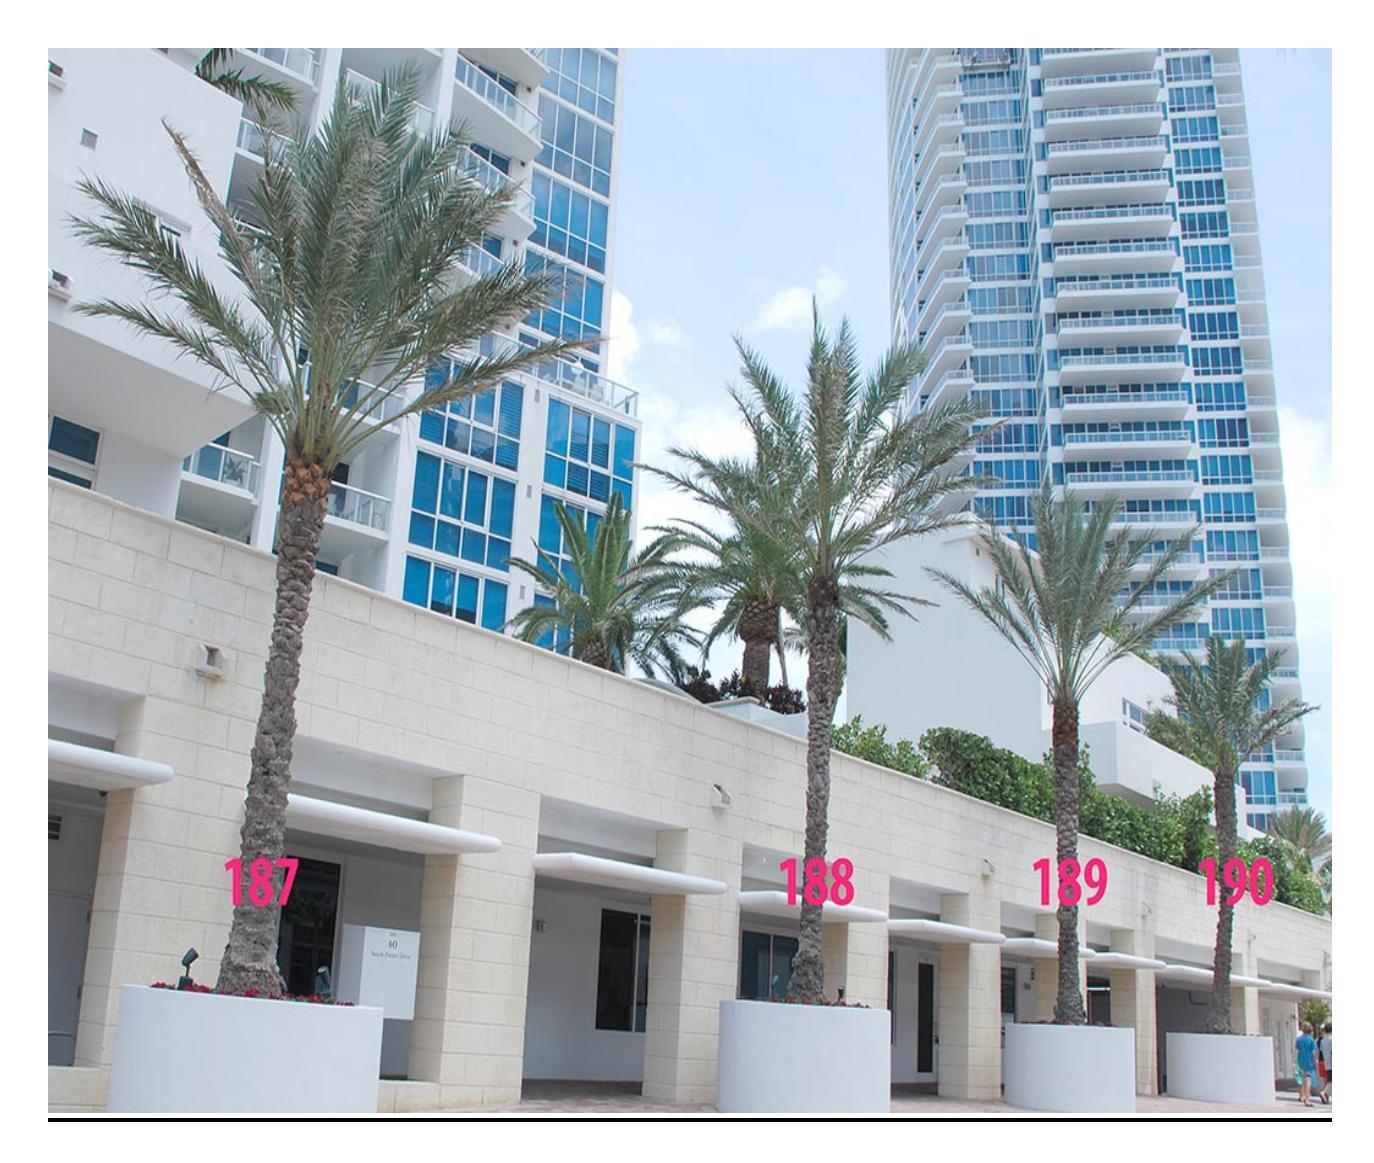
Photo 62 above is palms 187 through 190. The date palms growing in the round containers have flowering impatiens planted around their trunks. Most if not all of the root balls on these palms have been cut to accommodate the flowering plants. This practice of cutting the roots exposes these palms to virulent fungal pathogens.

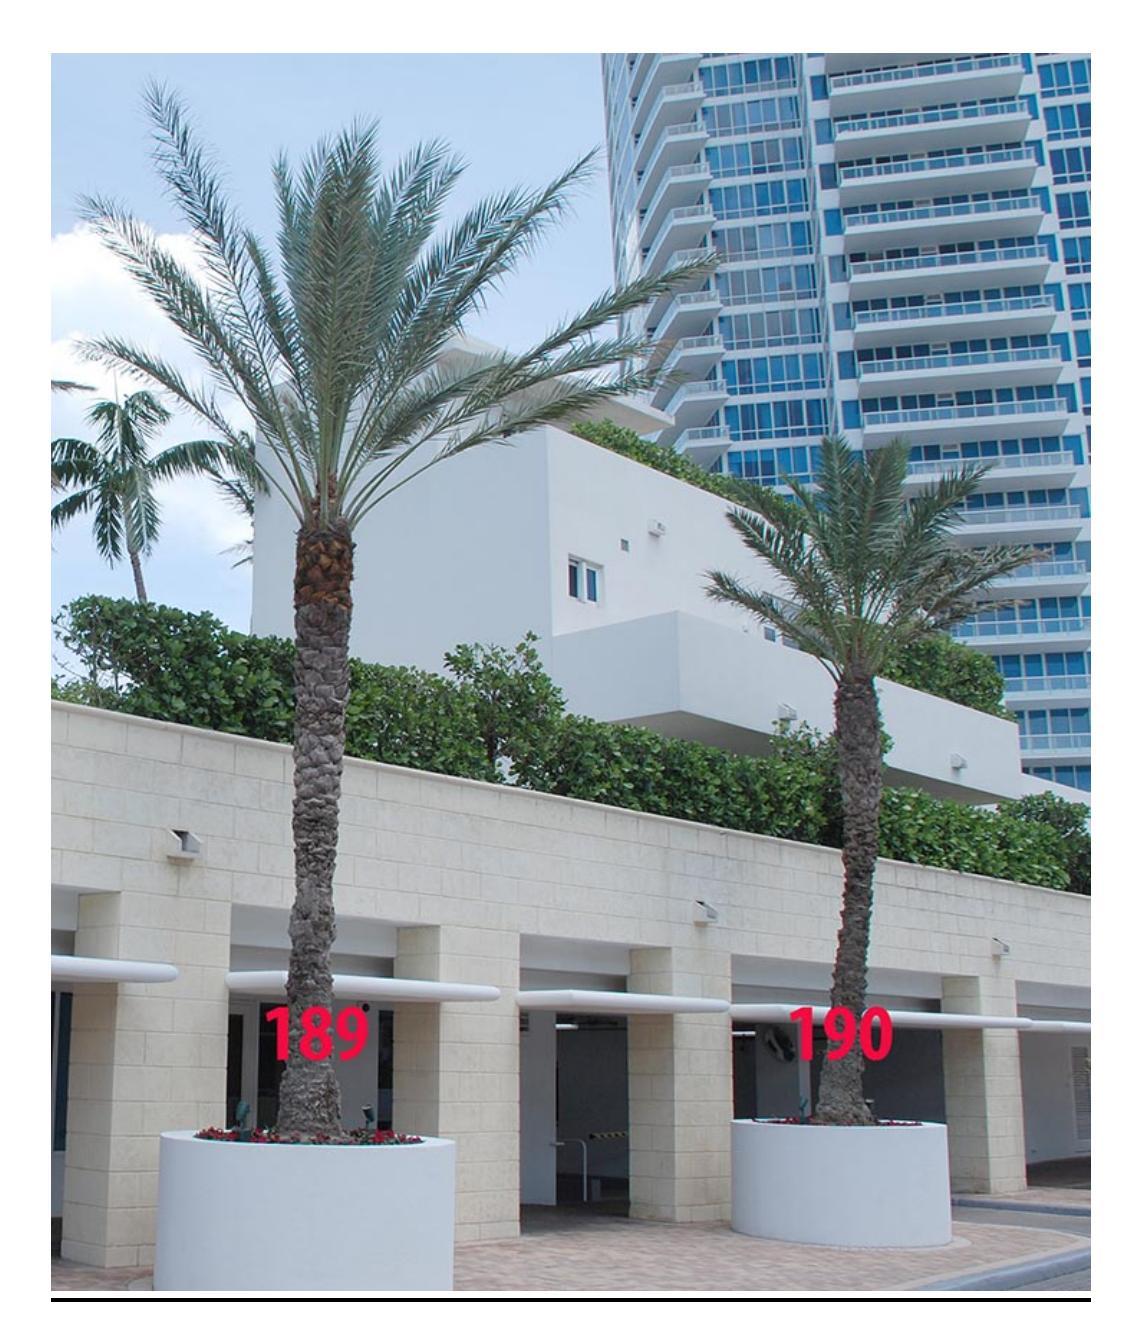
Photo 63 above is palms 189 & 190. The date palms growing in the round containers have flowering impatiens planted around their trunks. Most if not all of the root balls on these palms have been cut to accommodate the flowering plants. This practice of cutting the roots exposes these palms to virulent fungal pathogens.
