DAMAGES DUE TO CORROSION BEYOND PROJECT SCOPE FINDINGS AS OF 08/16/2023 DURING REMOVAL OF THE EASTBOUND LINE 20" DIP WATER MAIN REHABILITATION PROJECT CITY OF MIAMI BEACH

Prepared by: Jenner M. Alfaro, PE 09/ 11/ 2023

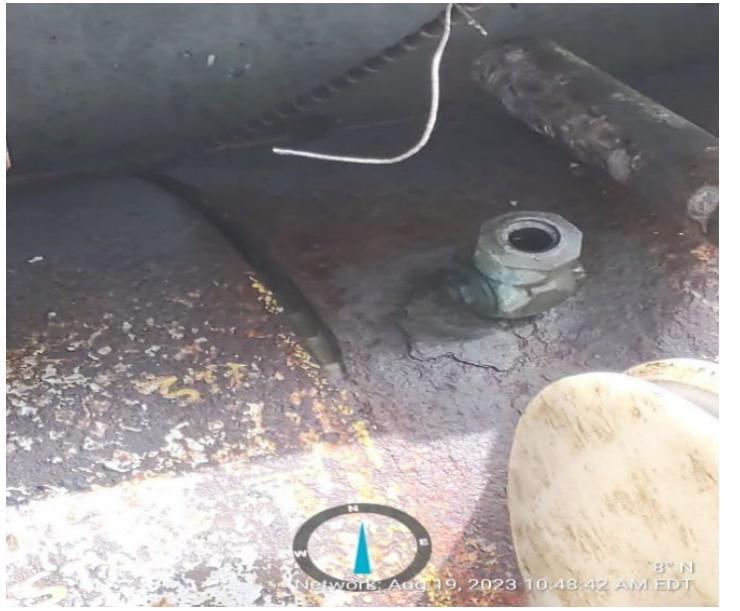
Cutting line West end East bound line. Start 135' of additional replacement top surface of pipe corroded.

Considering the high level of deterioration found beyond Pier 4 to the west, and the fact that the original scope did not include the replacement of this segment; proceeding with the original scope could originate system failures of the line in the future, a recommendation to replace 135' of additional pipe was presented to the City.

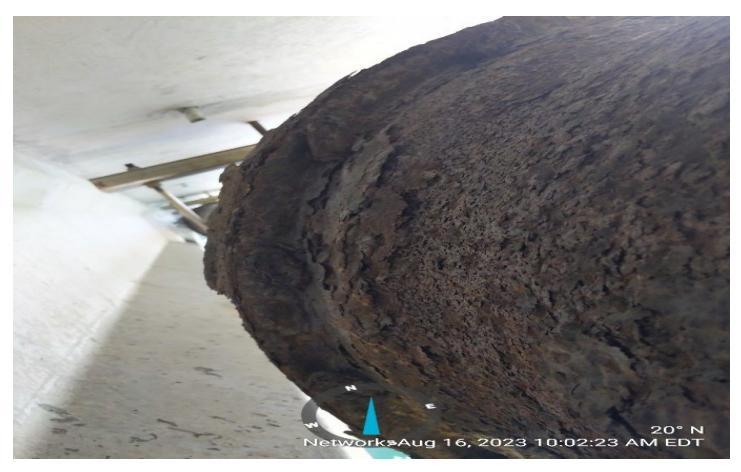
Severe corrosion on the inside surface of the pipe.

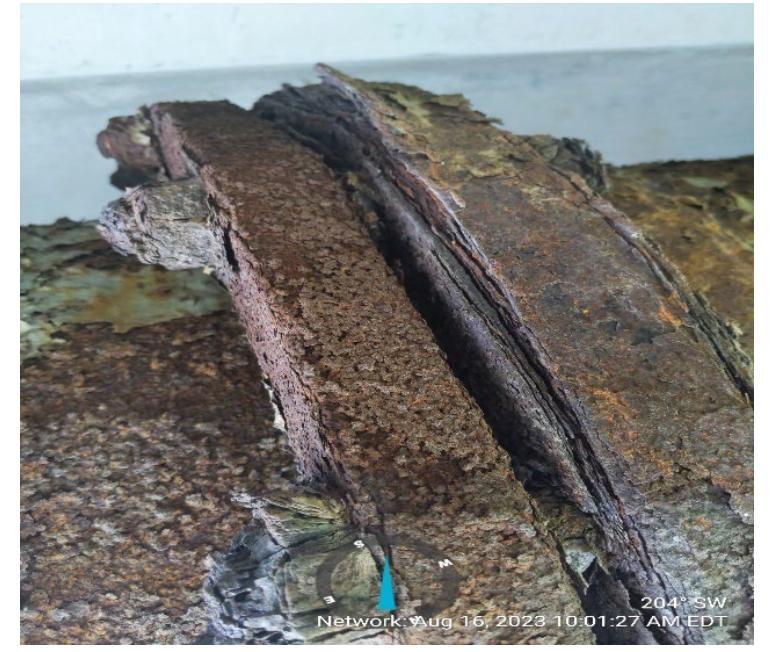
Pipe flanges at joint with severe corrosion.

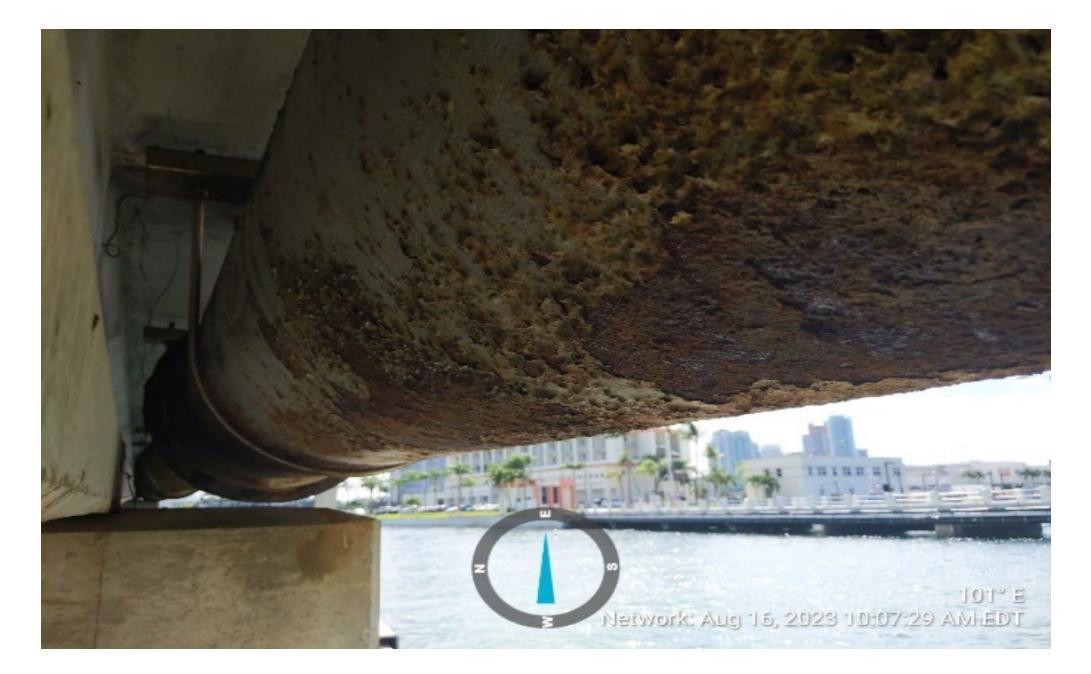
Joint flanges underneath with severe corrosion.

Uniform and peeling corrosion.

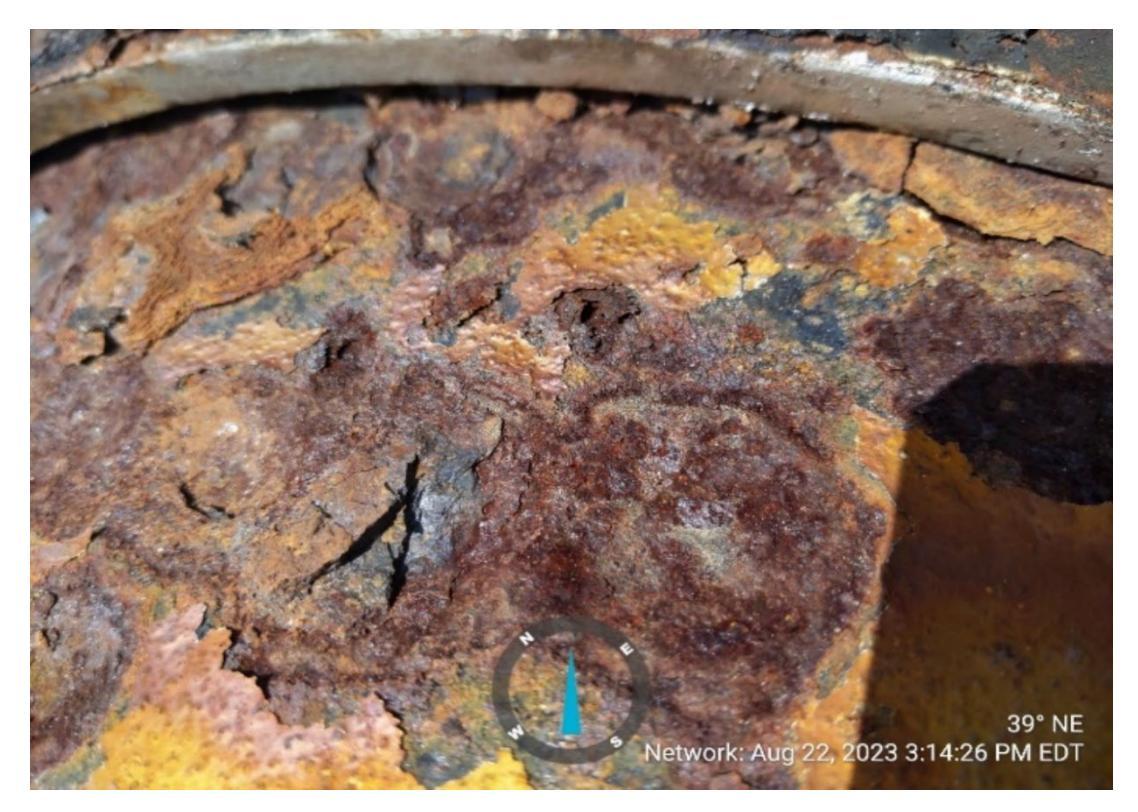
Internal corrosion at the joint.

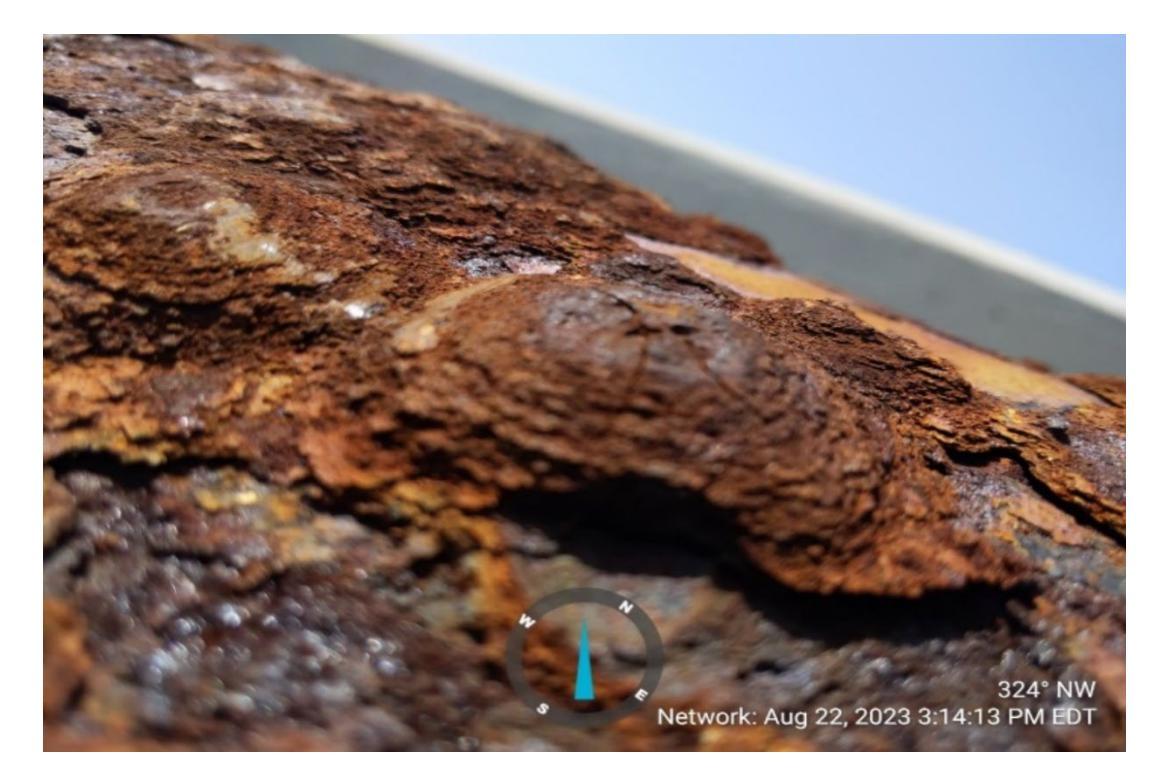
Scamming corrosion on the top surface of the pipe.

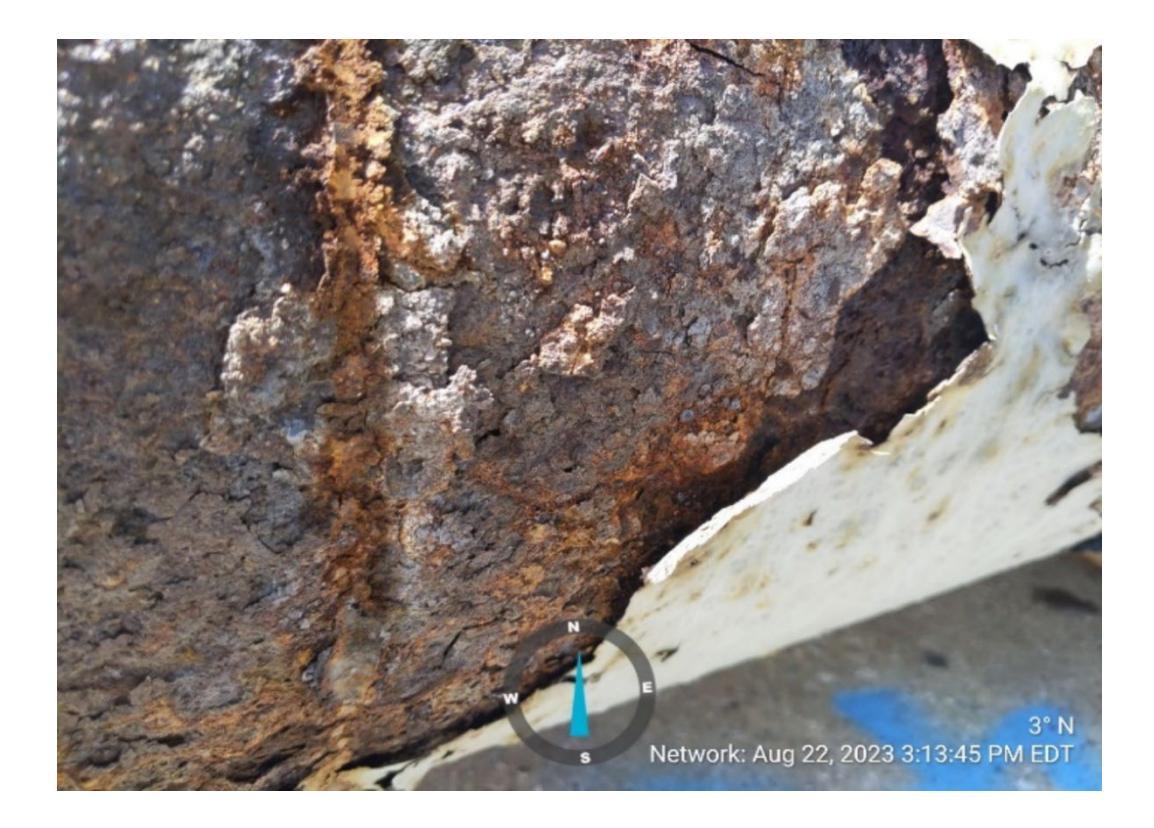
Pitting corrosion and separation of existing paint.

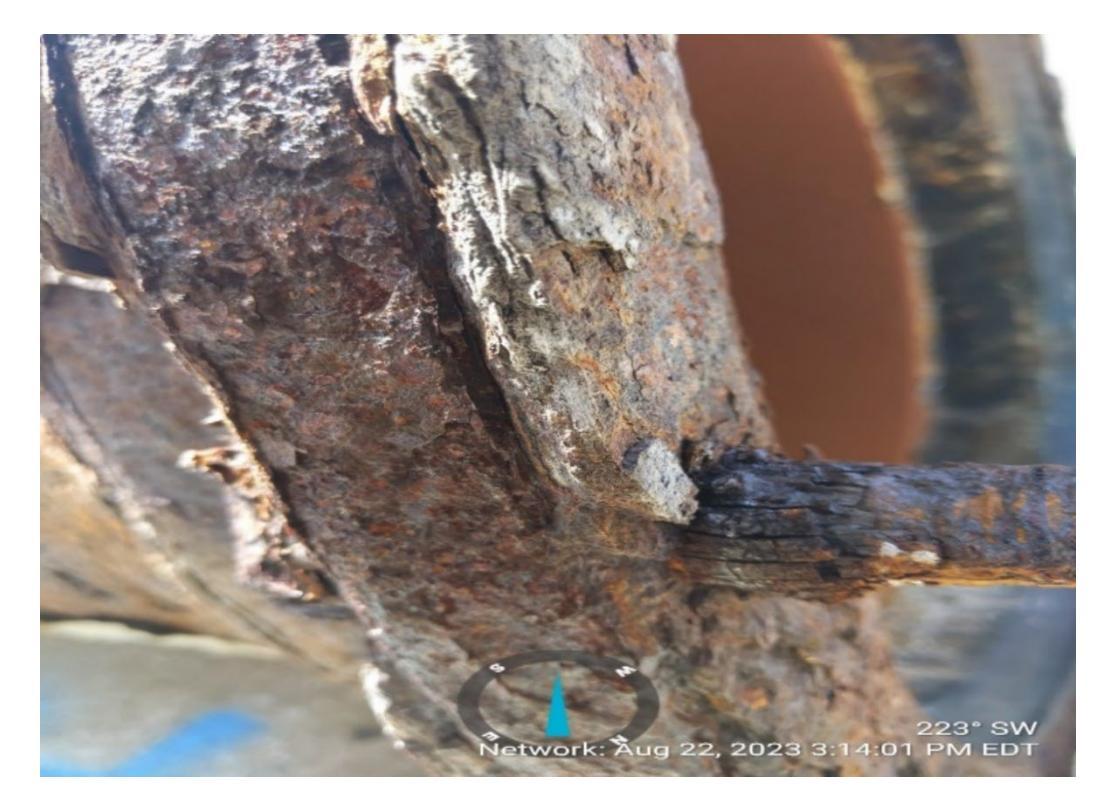
Severe corrosion at joint.

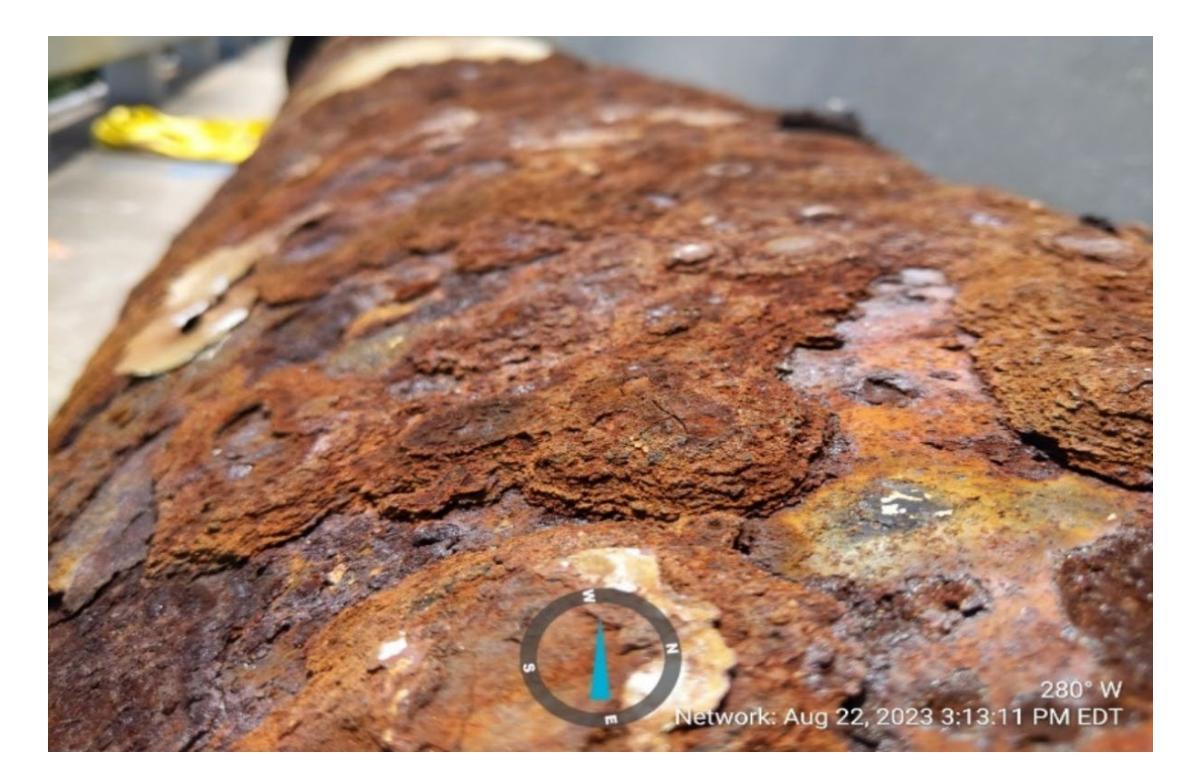
High degradation of pipe and loss of thickness at top.

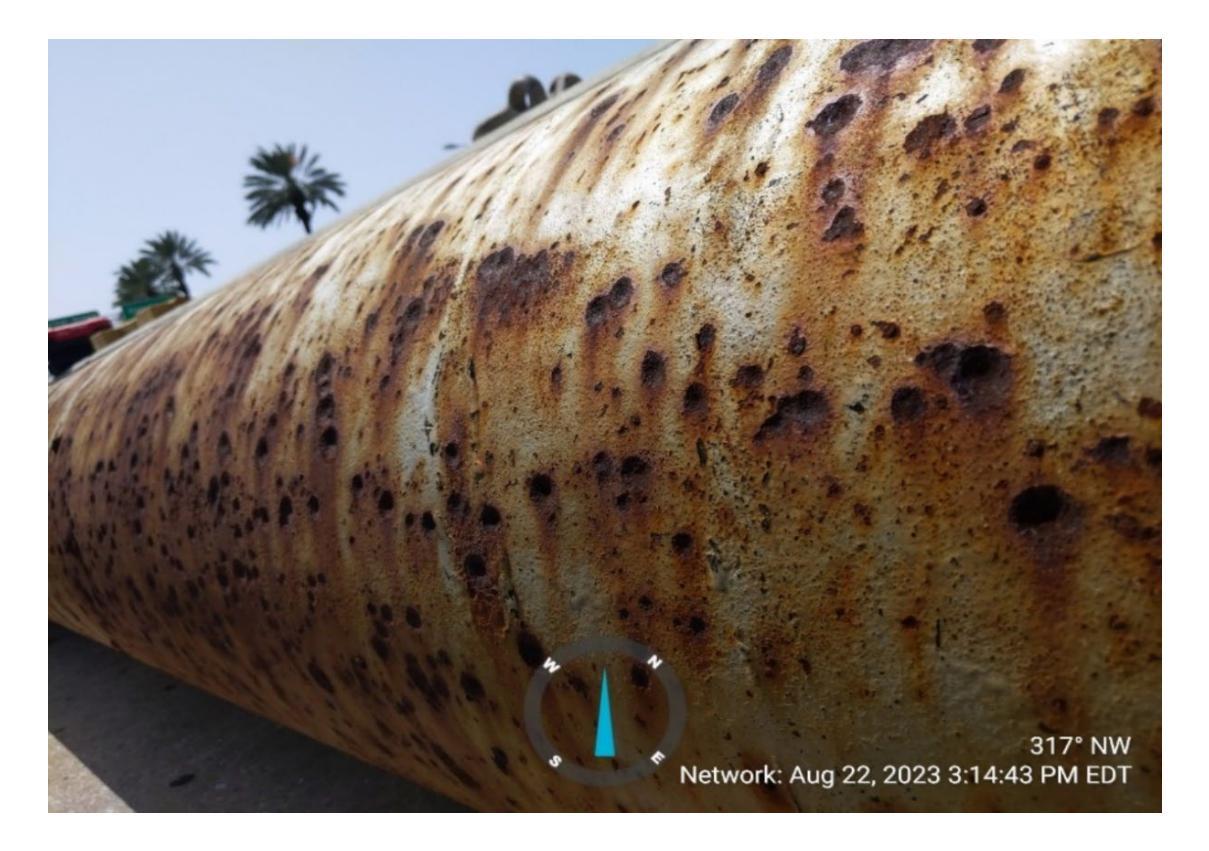
Uniform rounded holes corrosion.

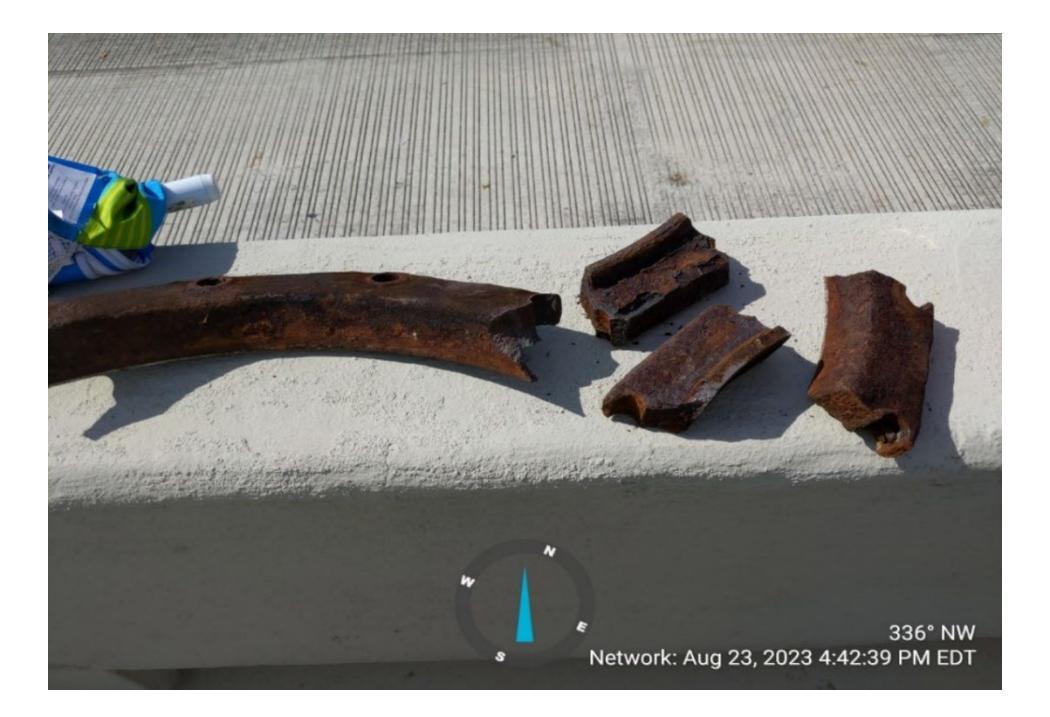
Stress corrosion caused cracking failure of the flange at joint.

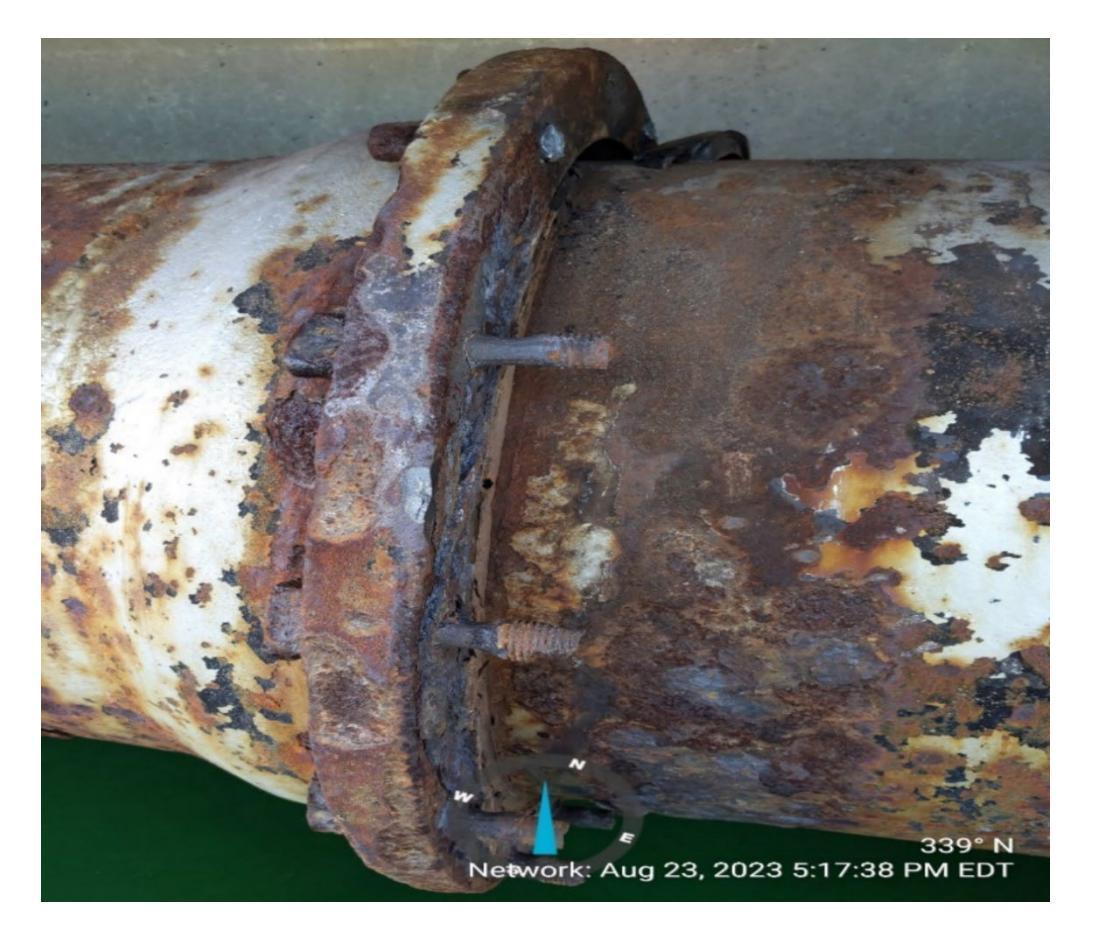
Pitting and crevice corrosion at joint.

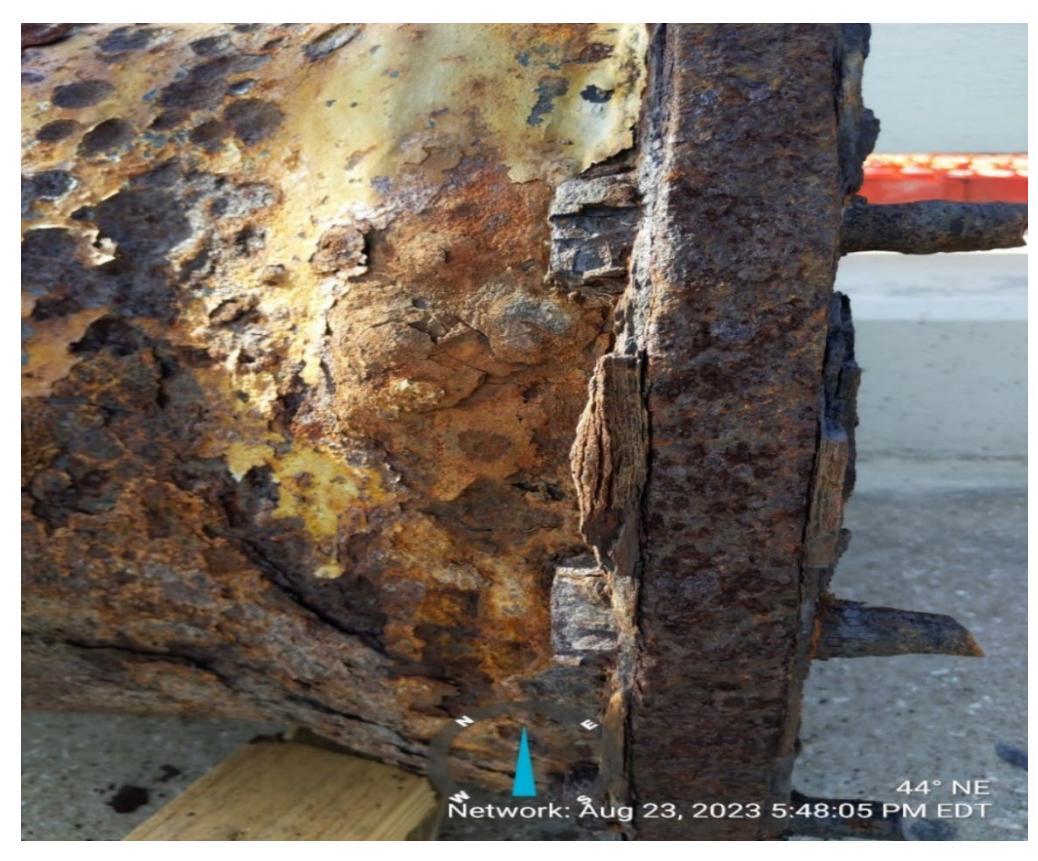
Pitting corrosion on pipe. Joint flange and bolts with severe corrosion.

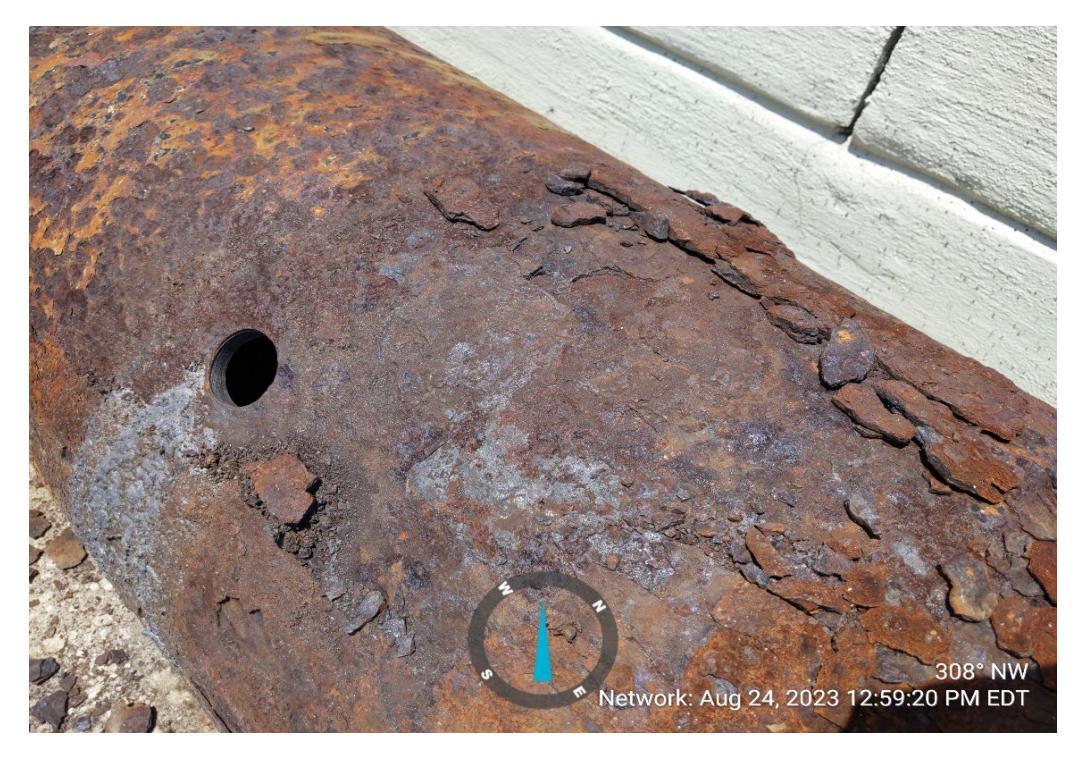
Surface corrosion and thickness tapping.

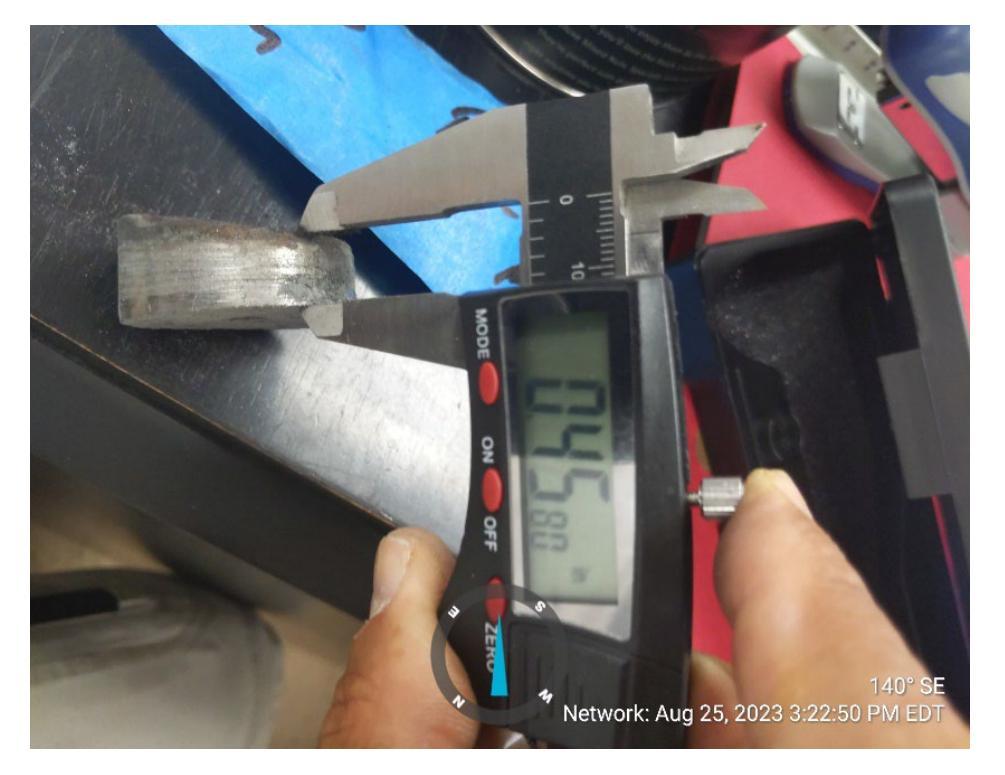
40% of thickness loss.

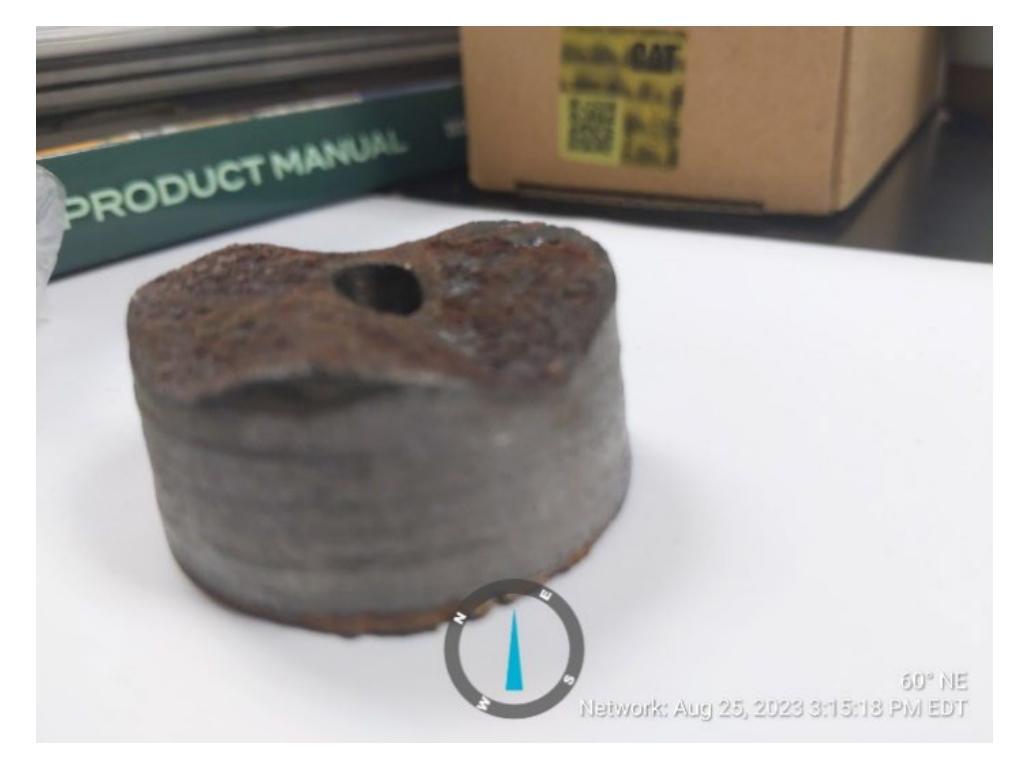
Tapping showing variable thickness loss.

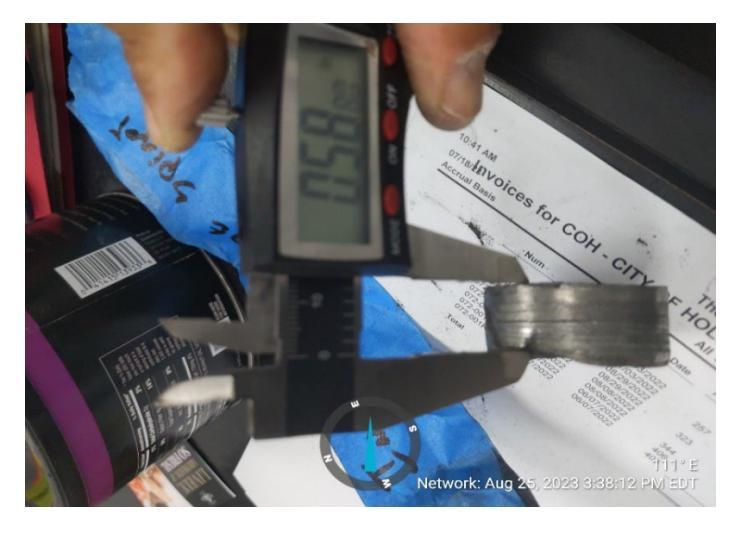
25% of thickness loss.

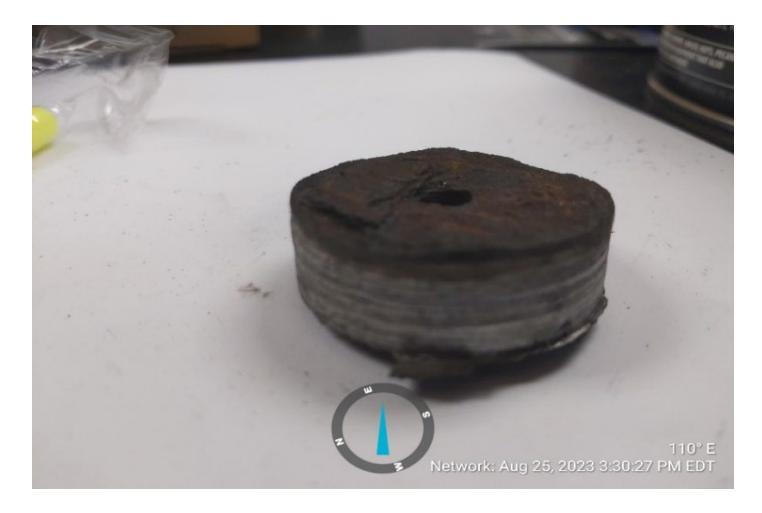
Tapping showing internal corrosion of pipe.

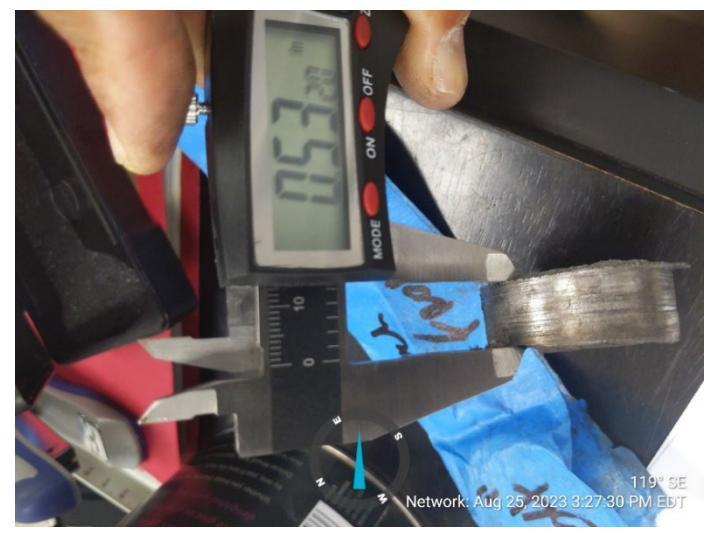
30% of thickness loss.

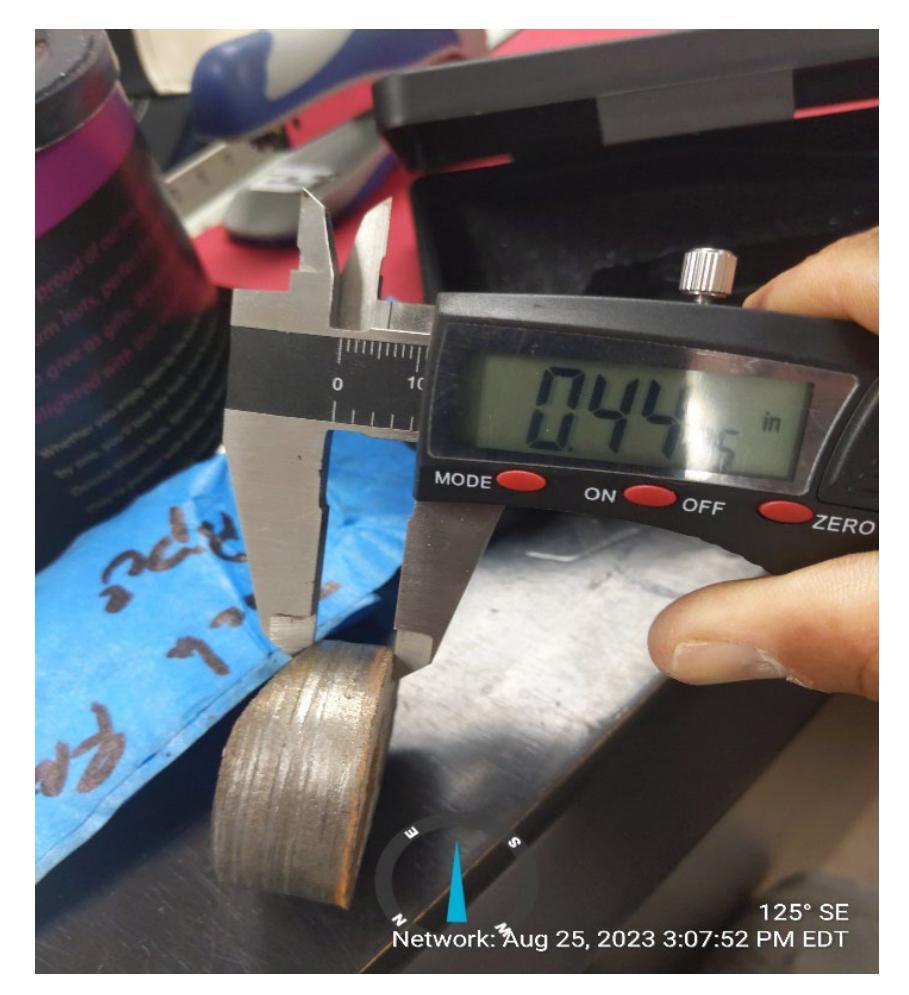
41% of thickness loss.
