Tree Resource Evaluation for 3115 Pine Tree Drive, Miami Beach

December 6, 2016

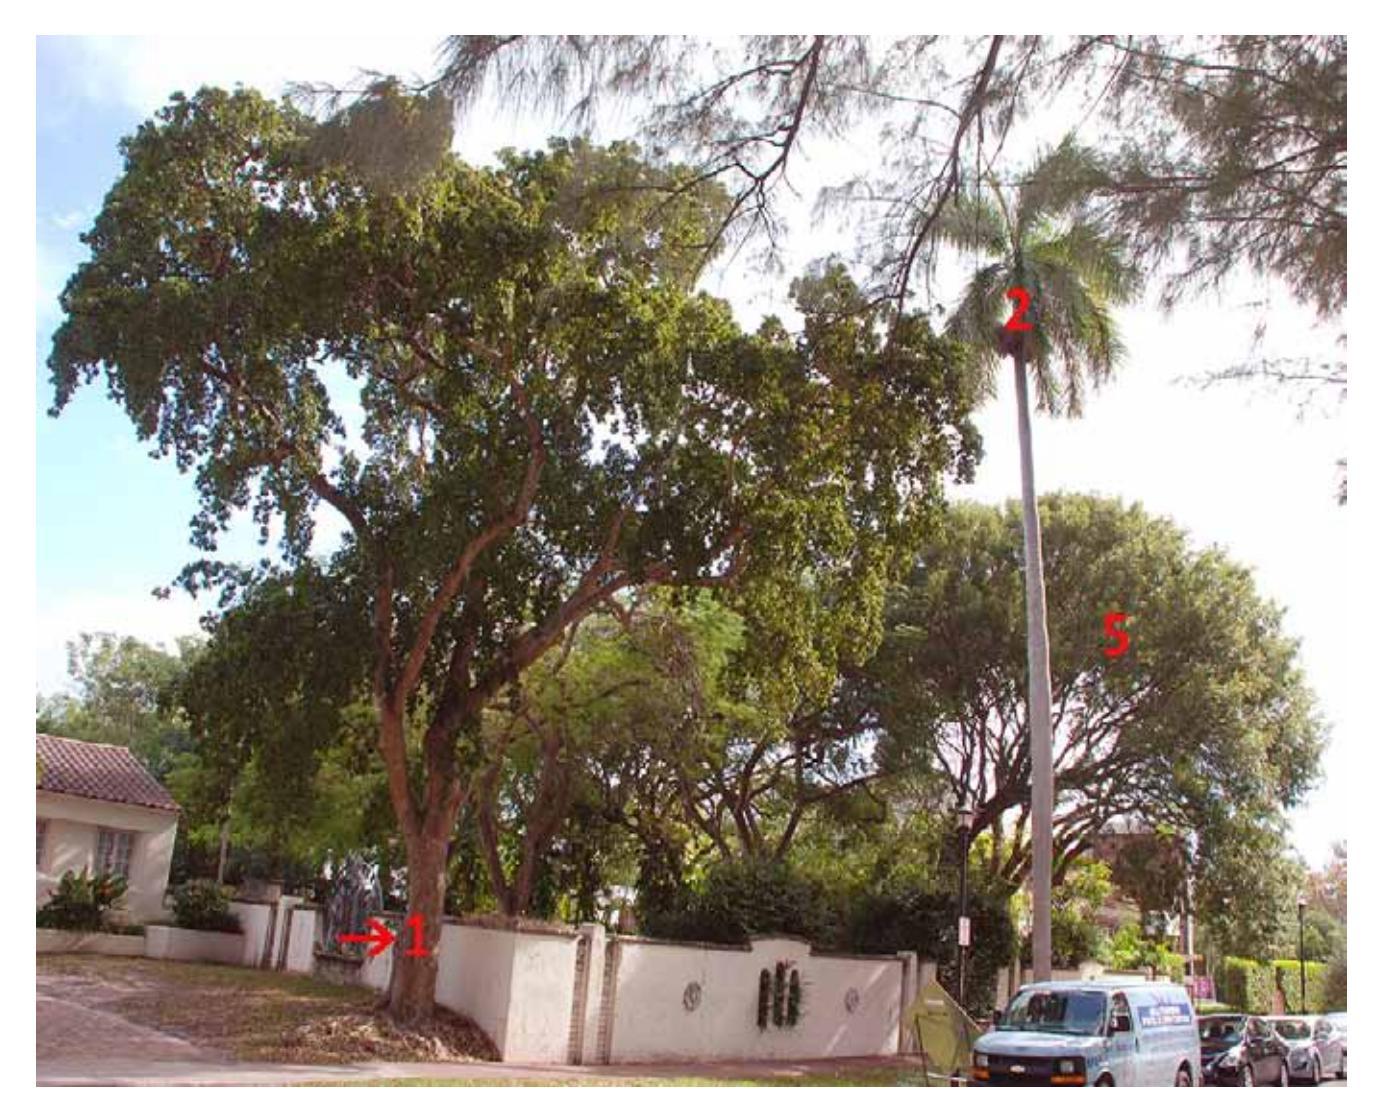
Photo 1 above is tree 1, a black olive outside the northwest corner of the section. I added this tree because it is cracking the sidewalk and adjacent wall. See following photo for close-up view of trunk location indicated by red arrow.

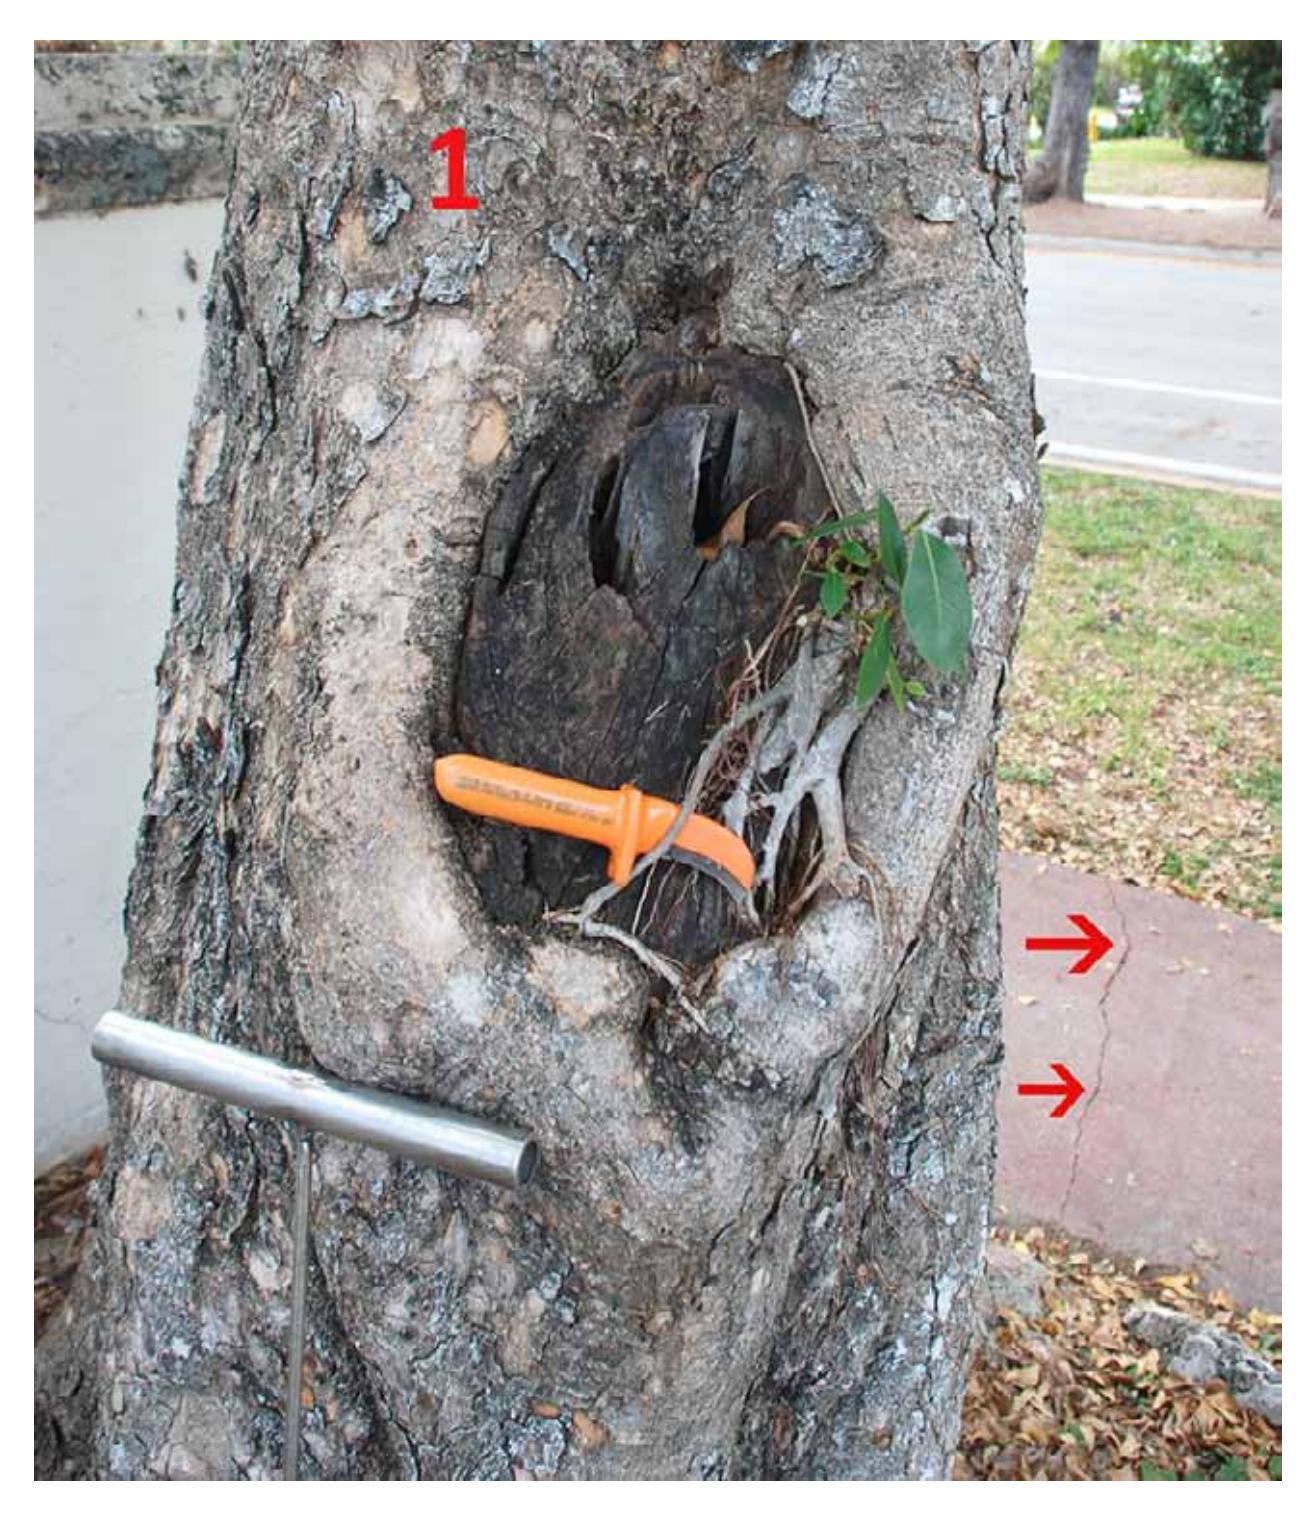
Photo 2 above is a decayed section of the trunk on tree 1. The orange knife is 7 inches in length. This tree would not be a good candidate for relocation.

Note the red arrows indicating a crack on the sidewalk due to roots from this tree.

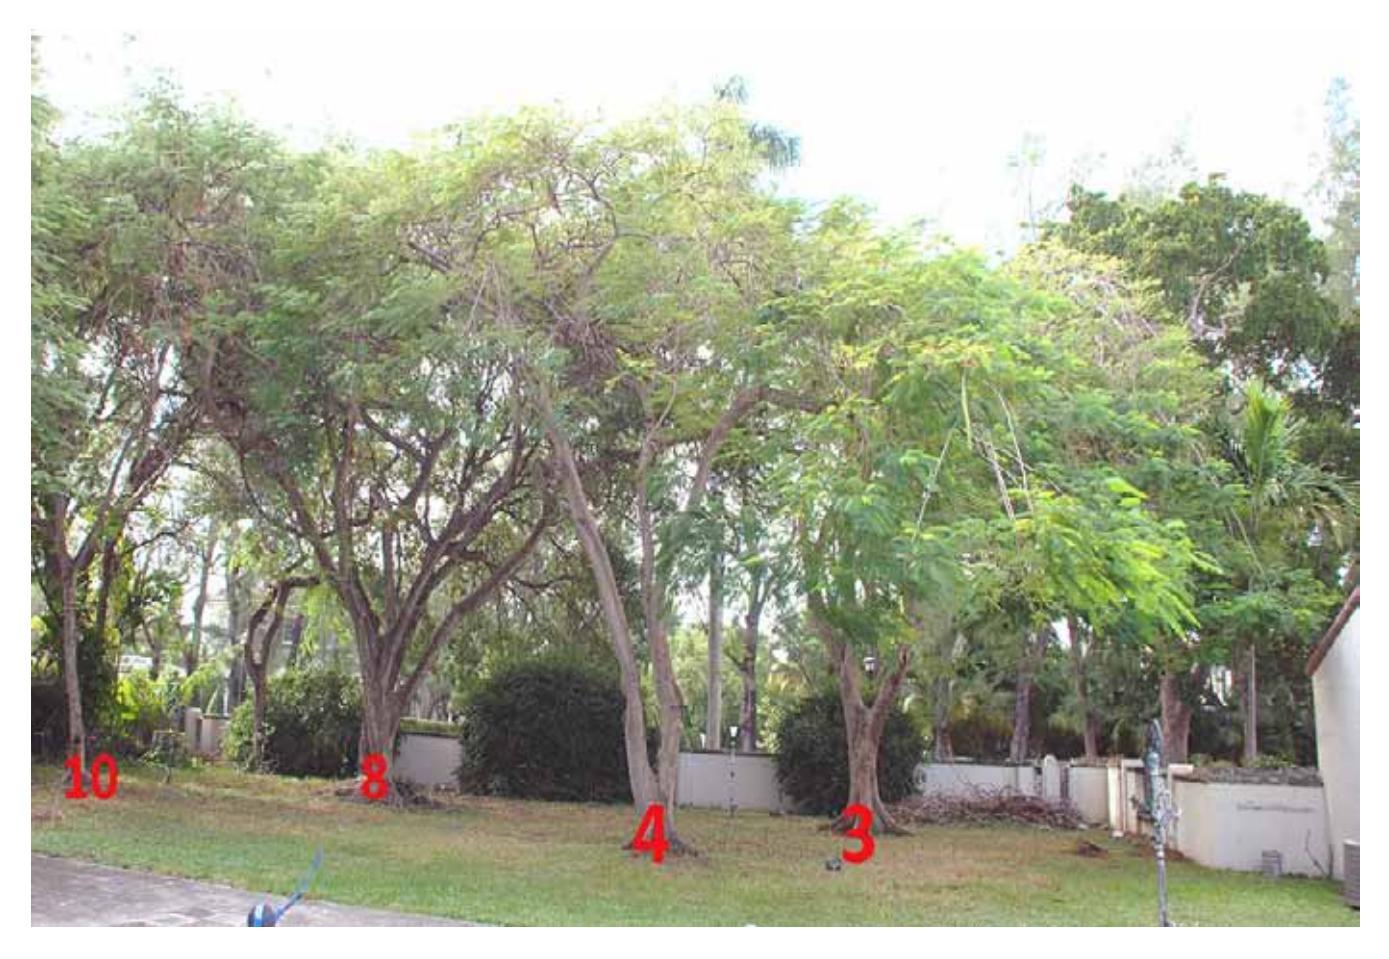
Photo 3 above is trees 3, 4, 8 & 10 viewed from the east. See following photo for closer view of the codominant trunks on tree 4.

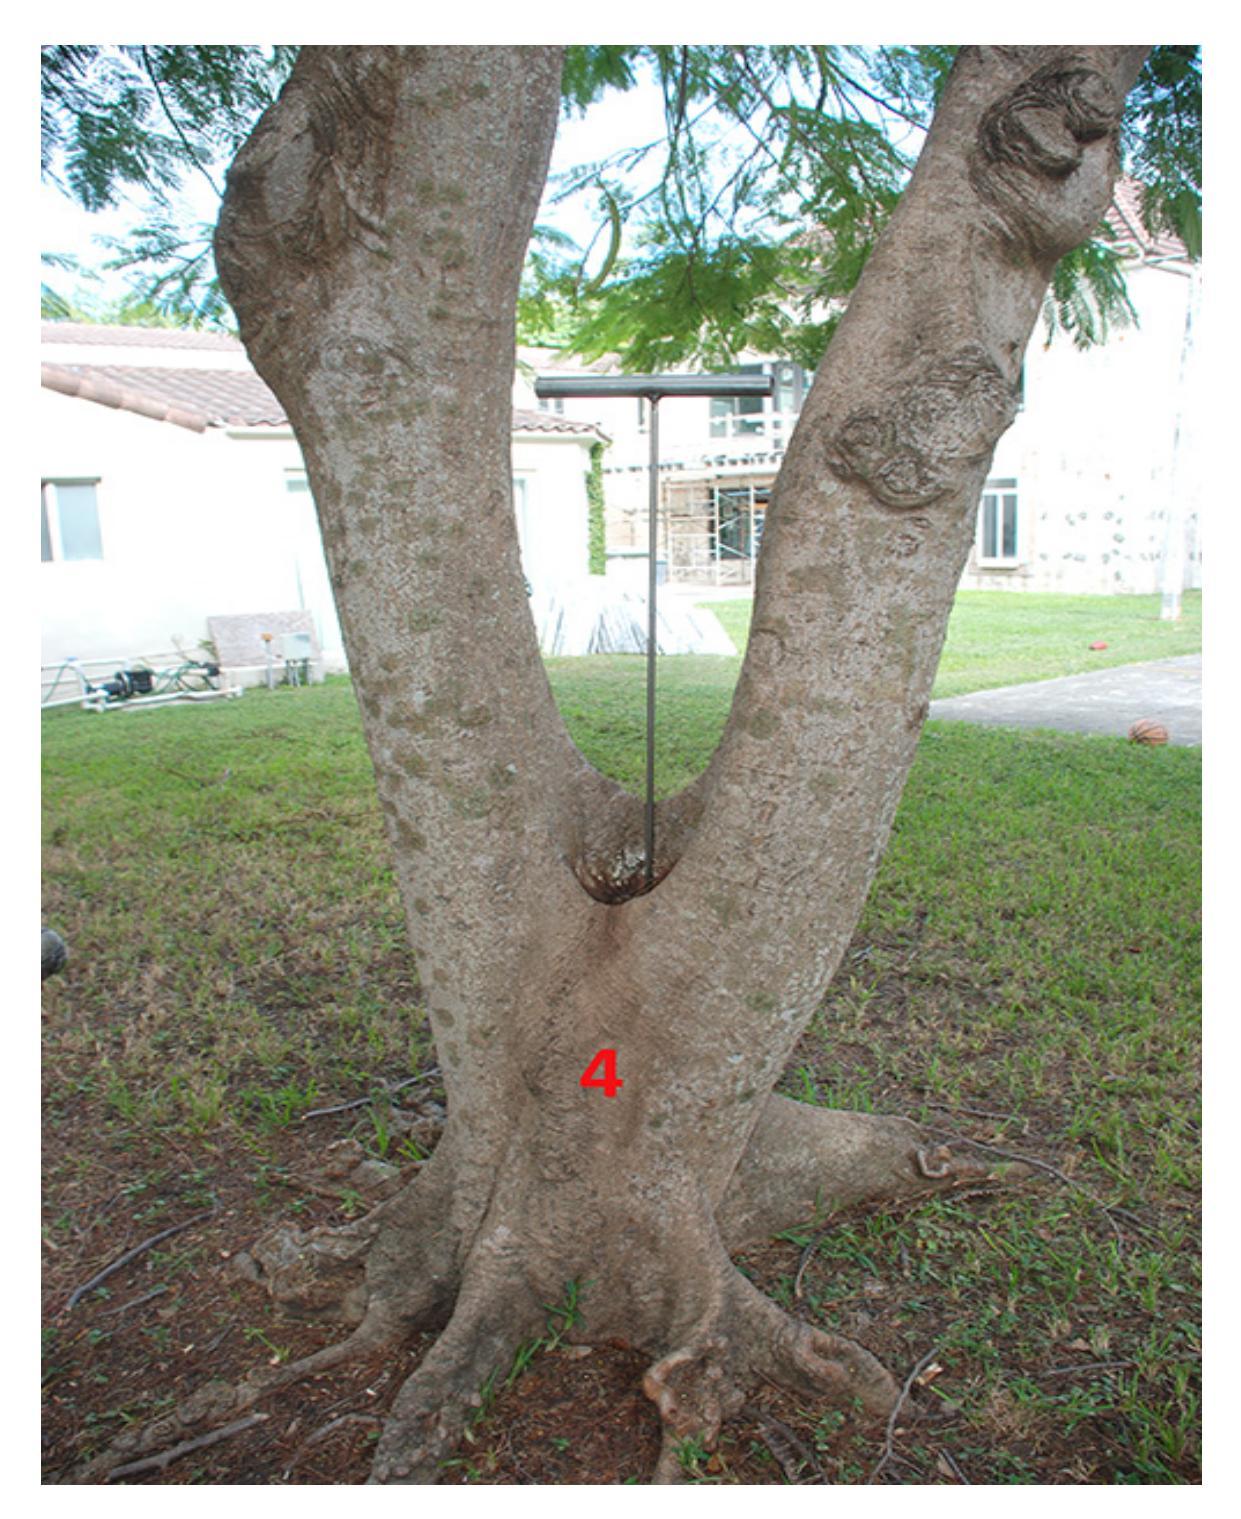
Photo 4 above is the trunk of tree 4 with a steel spike inserted about 12 inches into a cavity between the two codominant trunks. This tree is small now but as it grows larger this section of the trunk will present a critical hazard that will be vulnerable in wind events. I recommend the removal of this tree.

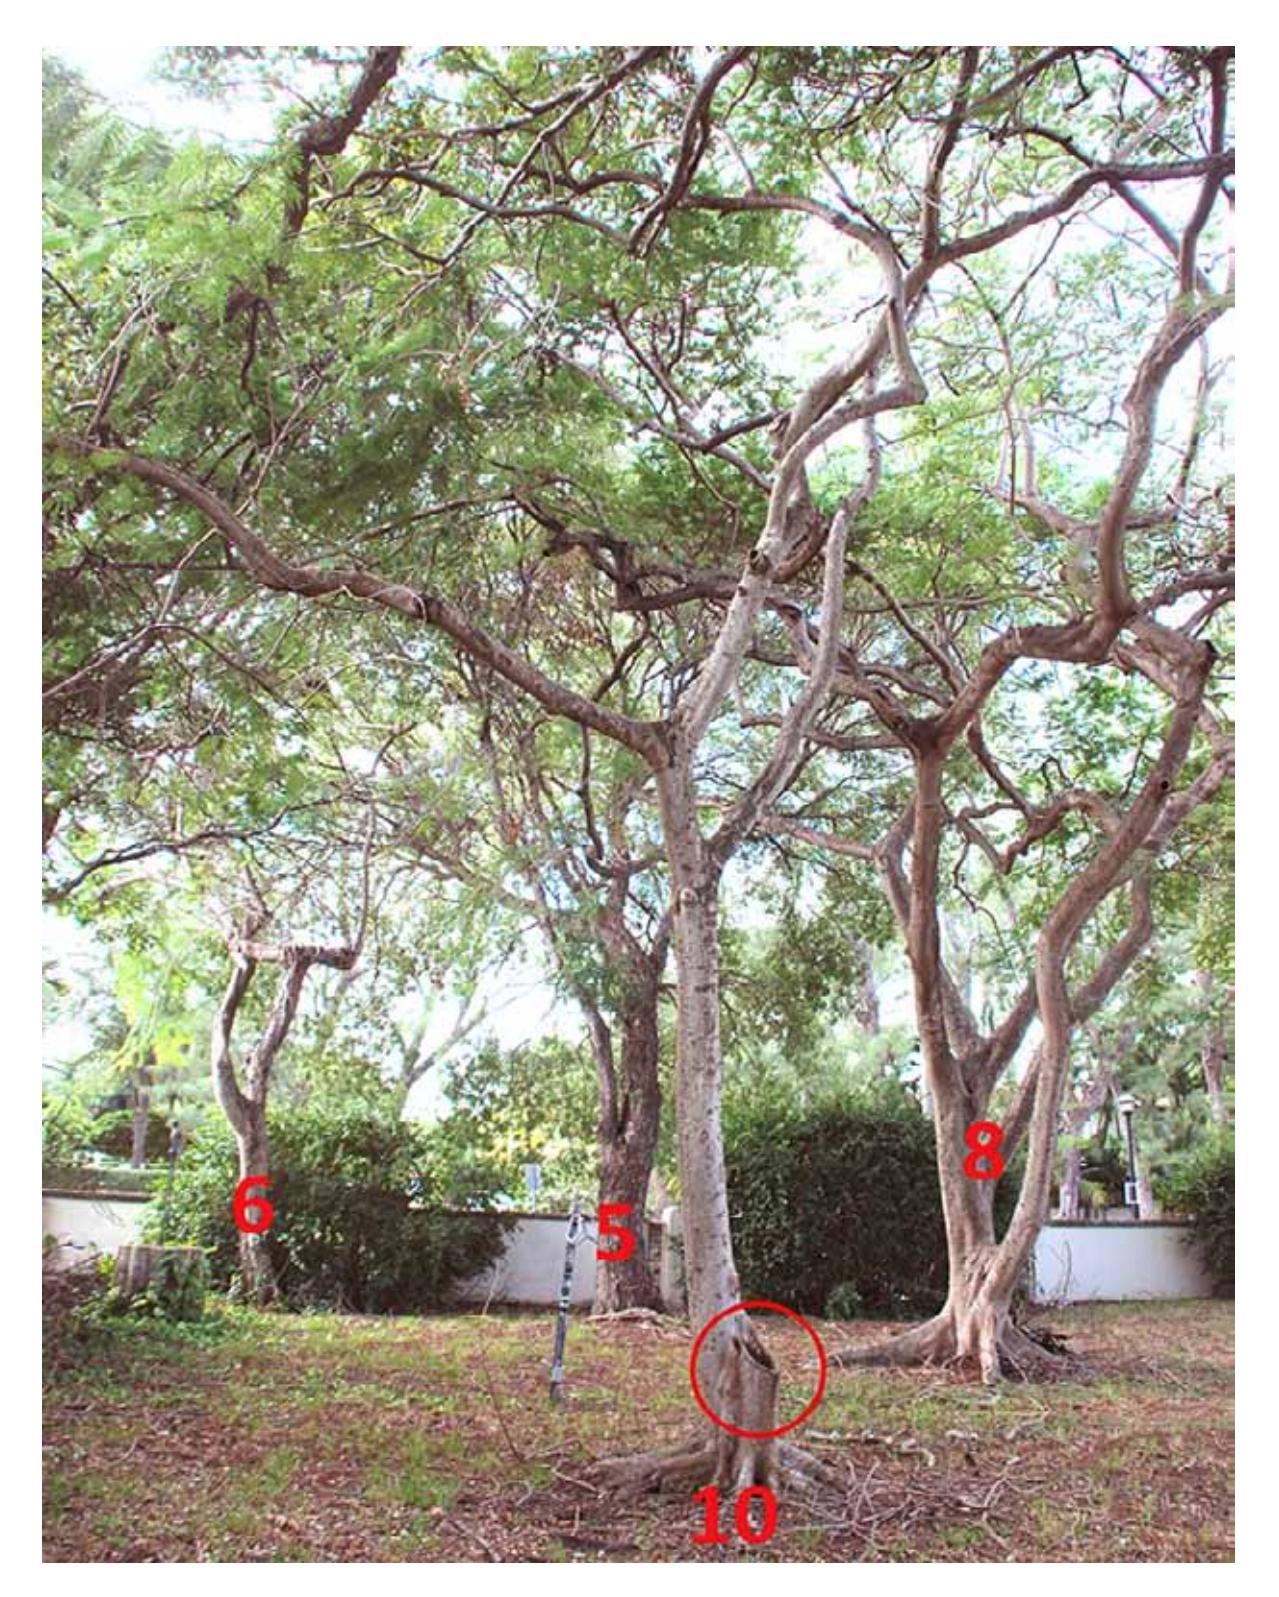
Photo 5 above is trees 5, 6, 8 & 10 viewed from the east. See following photo for close-up of red circled area on the trunk of tree 10.

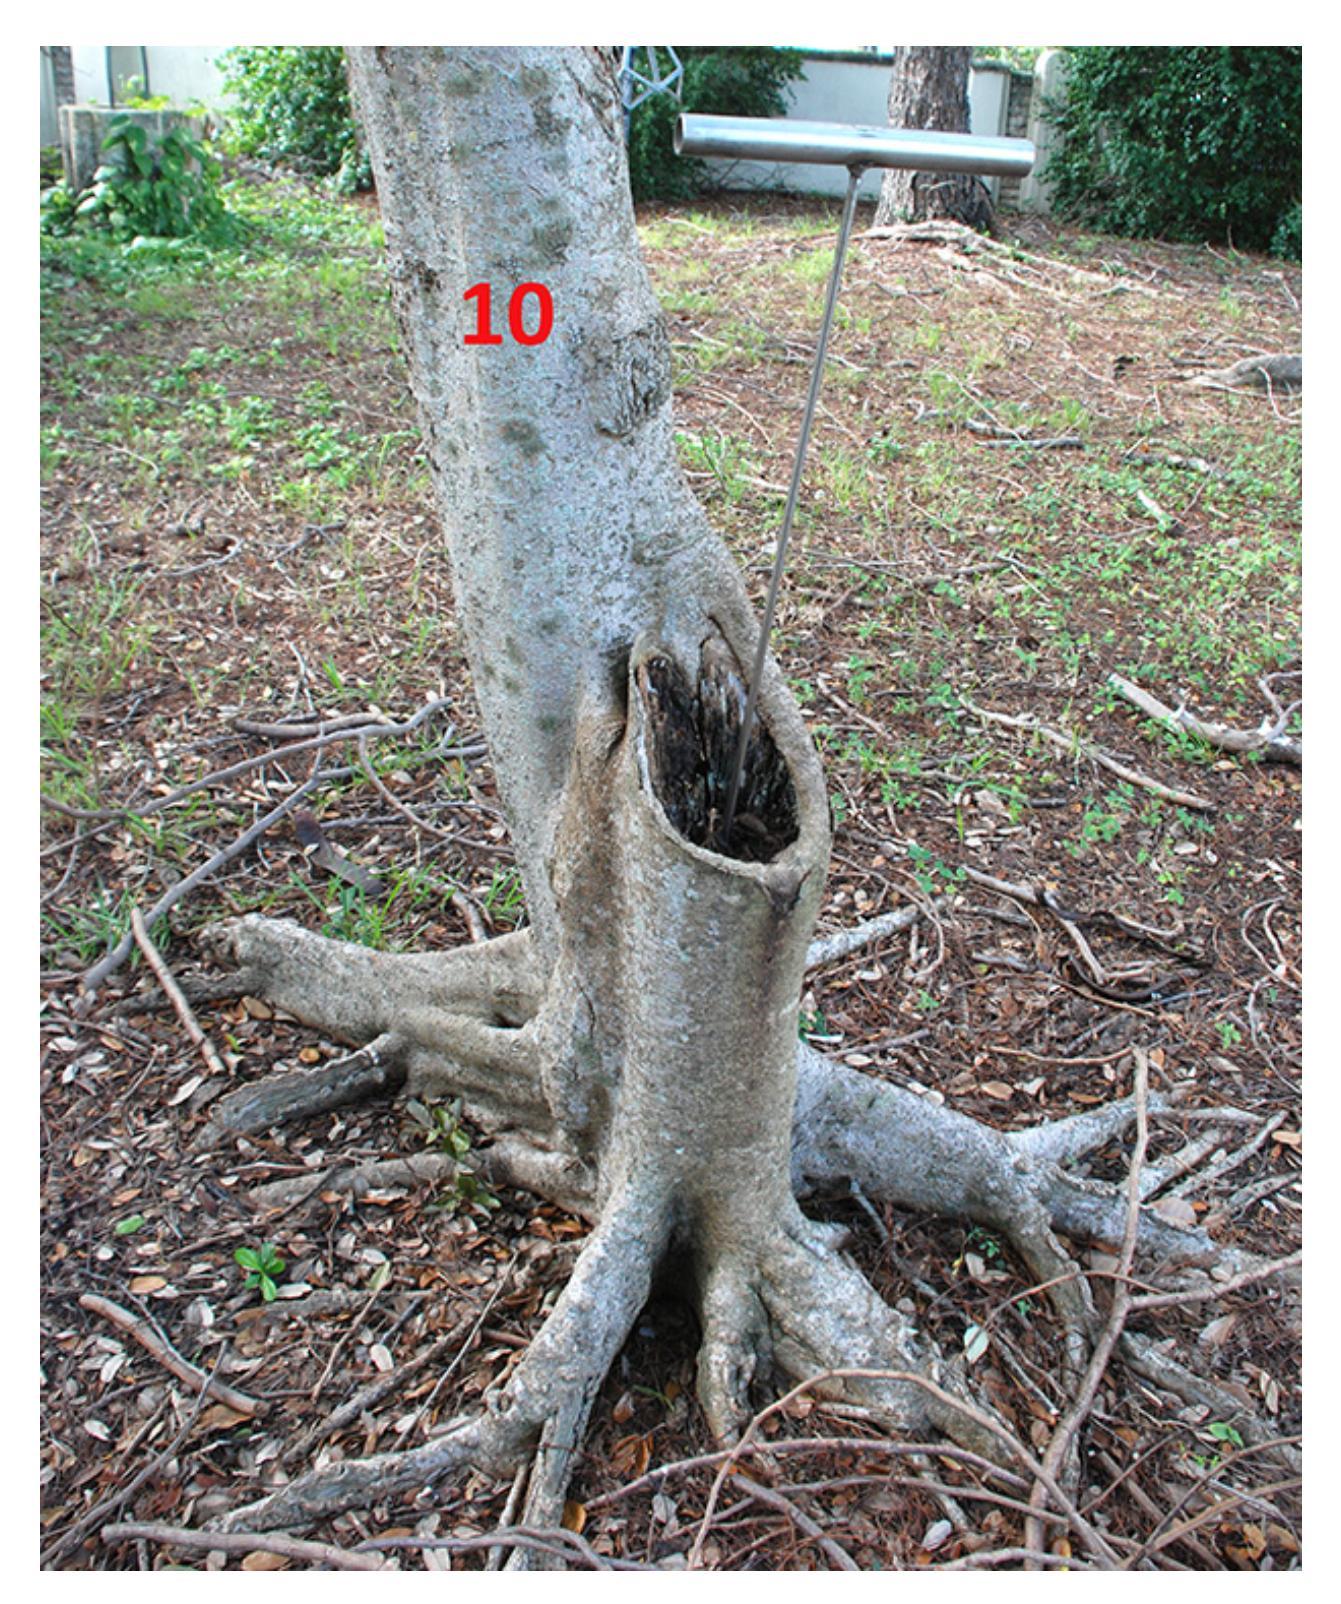
Photo 6 above is a closer view of a cavity at the base of the trunk on tree 10. I recommend the removal of this tree. The steel spike is inserted about 12 inches.

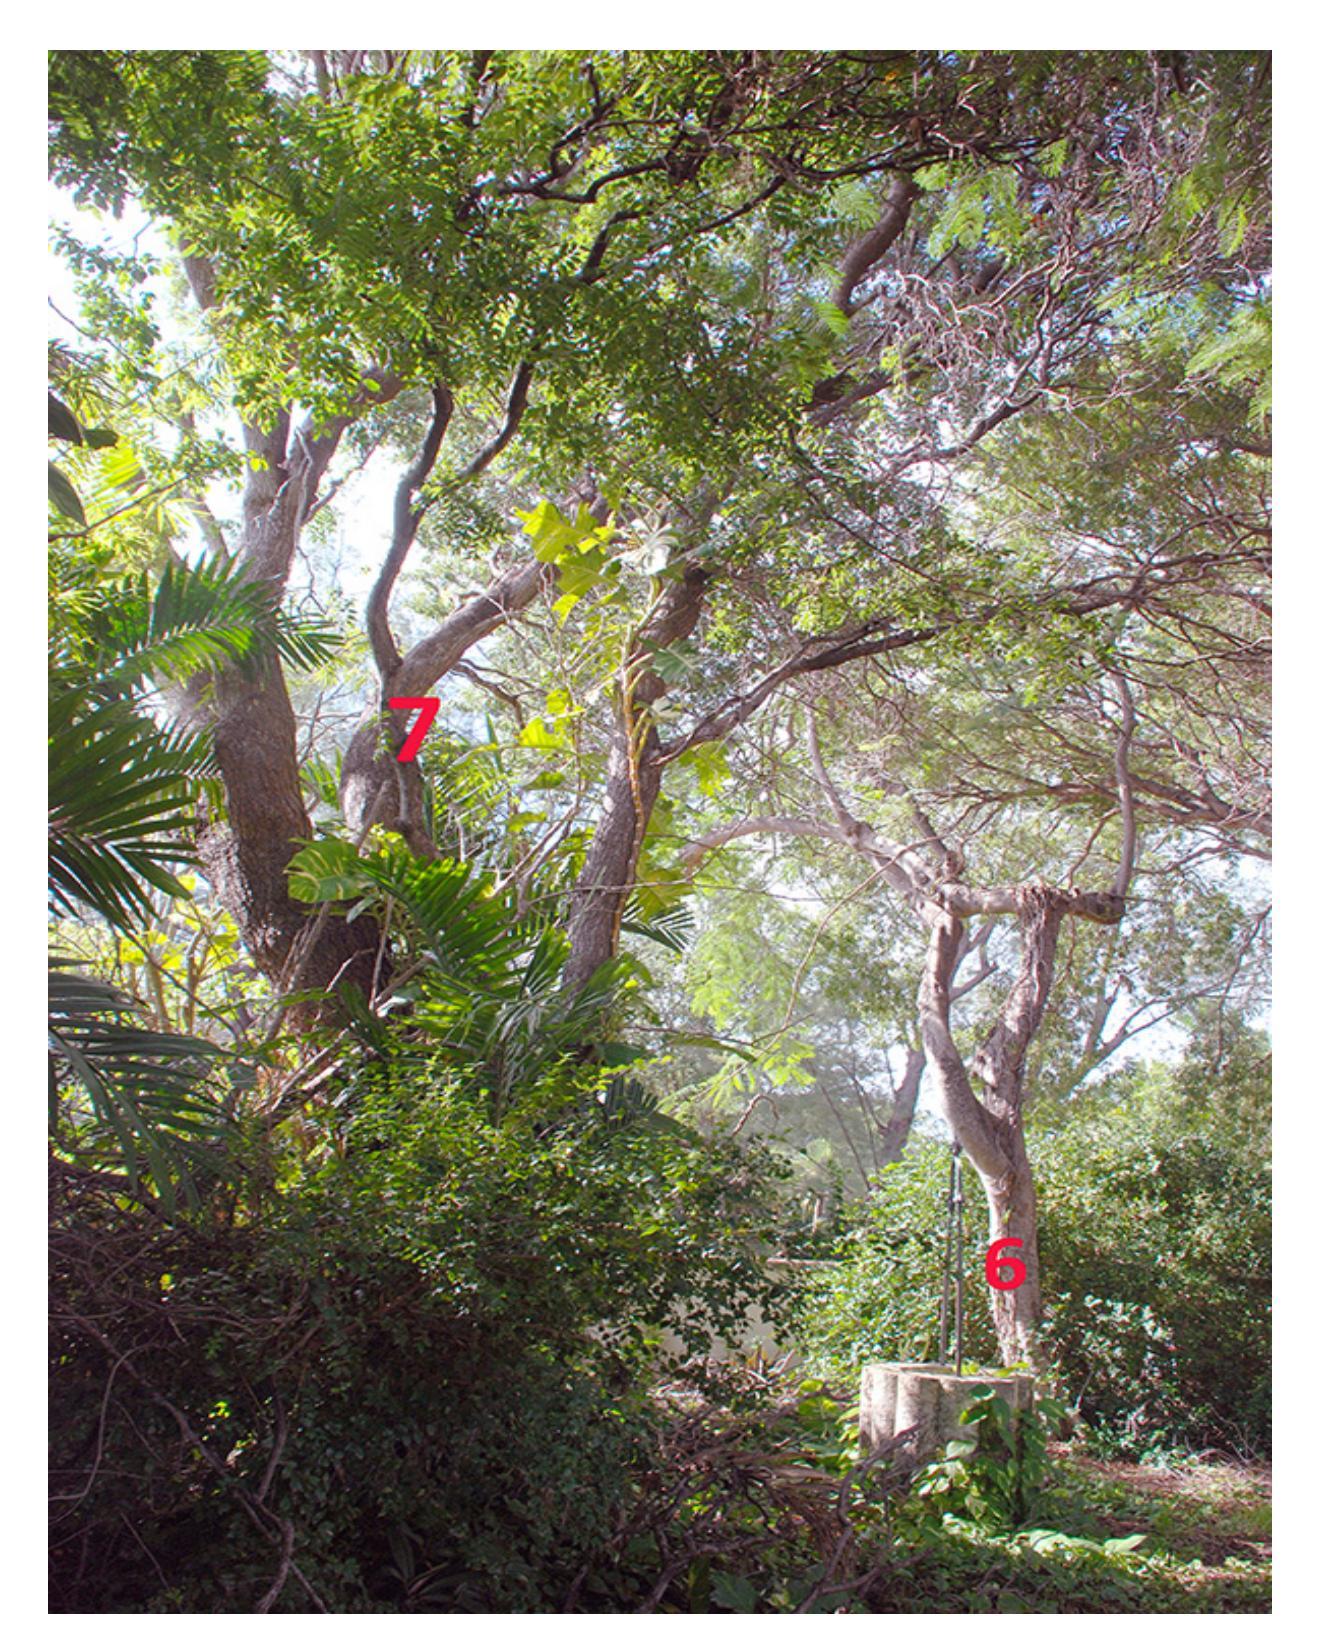
Photo 7 above is trees 6 & 7 near the southeast corner of the property. See following photo for a close-up of the trunk on tree 6>
