## Arborist Report

5226 N Bay Rd  
Miami Beach, FL 33140

06/14/2021

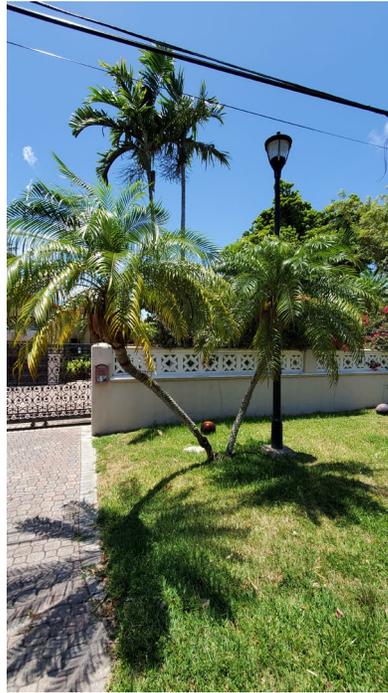
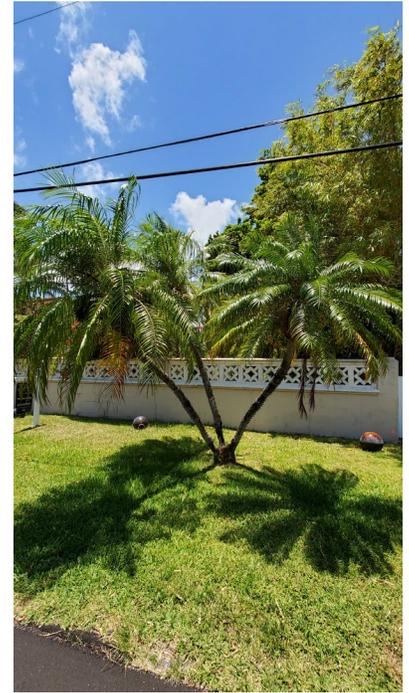
Tree #	Scientific Name	Common name	DBH	Height	Spread	Native
1	<i>Phoenix roebelenii</i>	Double Pygmy Date Palm	10 "	10 '	12 '	No
2	<i>Phoenix roebelenii</i>	Triple Pygmy Date Palm	14 "	10 '	12 '	No

Trees #1 and #2 are Pigmy Date Palms located in front of the property at the Public Right of Way. These palms are in fair condition. Based on Landscape Architects Tree Disposition Plan, these palms are proposed for removal.

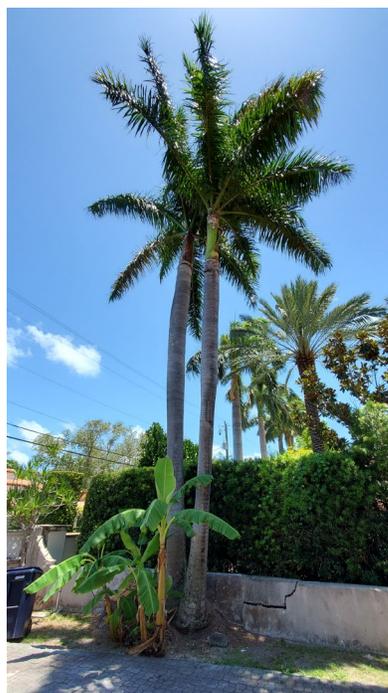
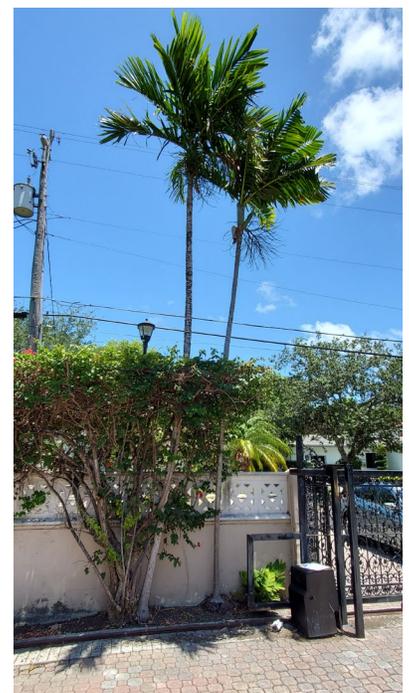
Tree #	Scientific Name	Common name	DBH	Height	Spread	Native
3	<i>Roystonea elata</i>	Royal Palm	12 "	32 '	18 '	Yes
4	<i>Roystonea elata</i>	Royal Palm	14 "	34 '	18 '	Yes
5	<i>Ptychosperma elegans</i>	Solitaire Palm	4 "	23 '	6 '	No
6	<i>Ptychosperma elegans</i>	Solitaire Palm	4 "	21 '	6 '	No

Trees #3 and #4 are Royal Palms located on the south side of the driveway next to the 3' tall CMU property wall. Trees #5 and #6 are Solitaire Palms located on the east side of the driveway next to the 6' tall front property wall. These palms are in fair condition and based on Landscape Architects Tree Disposition Plan, they are proposed for removal.

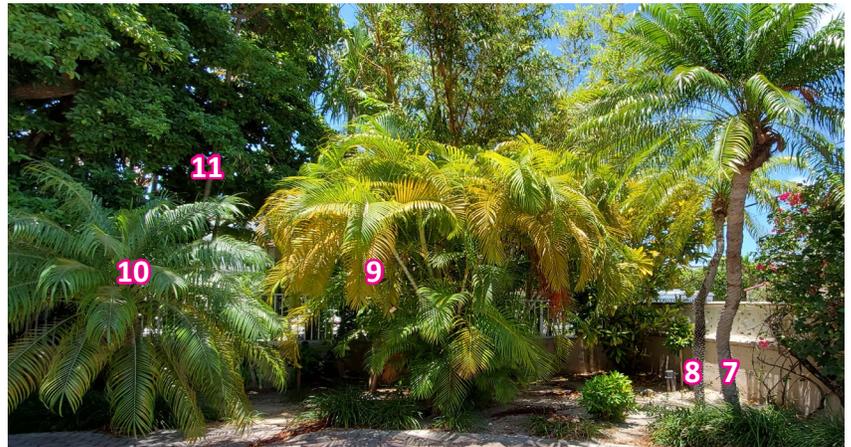
Trees #7-#11 is a group of palms located at the east corner of the property. All these palms are in poor condition with many structural defects and signs of nutrient deficiency. These palms are proposed for removal.

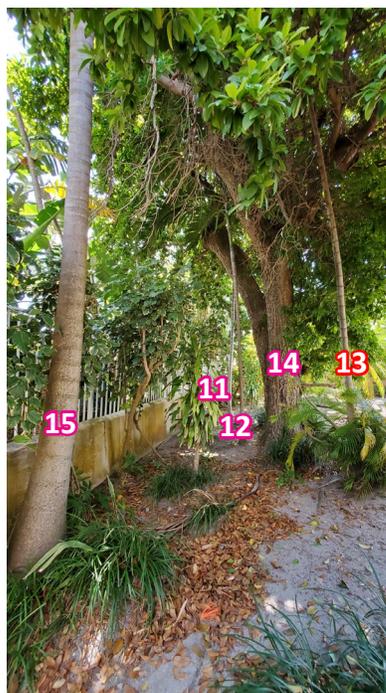
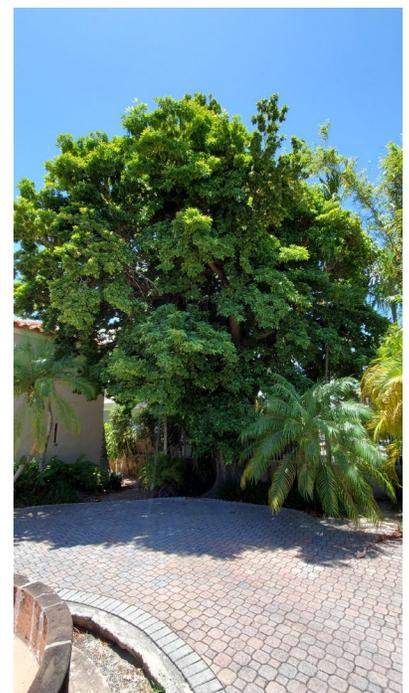
Tree #	Scientific Name	Common name	DBH	Height	Spread	Native
12	<i>Ptychosperma elegans</i>	Solitaire Palm	4 "	22 '	6 '	No
13	<i>Ptychosperma elegans</i>	Solitaire Palm	4 "	22 '	6 '	No
14	<i>Manilkara zapota</i>	Sapodilla Tree	31 "	28 '	30 '	No
15		Dead Palm Tree

Trees #12-#15 are located on the north side of the driveway. Trees #12 and #13 are Solitaire Palms that are in conflict with the canopy of the Sapodilla Tree #14. These palms are proposed for removal. Sapodilla Tree is in good condition with good vigor and a well-developed structure. Canopy holds some dead and broken branches and crown cleaning is recommended. Due to the conflict of CRZ with the proposed architecture, this tree is proposed for relocation. Root pruning by Certified Arborist should be performed in accordance with ANSI A3000 (Part 8) standards prior to relocation of this tree.

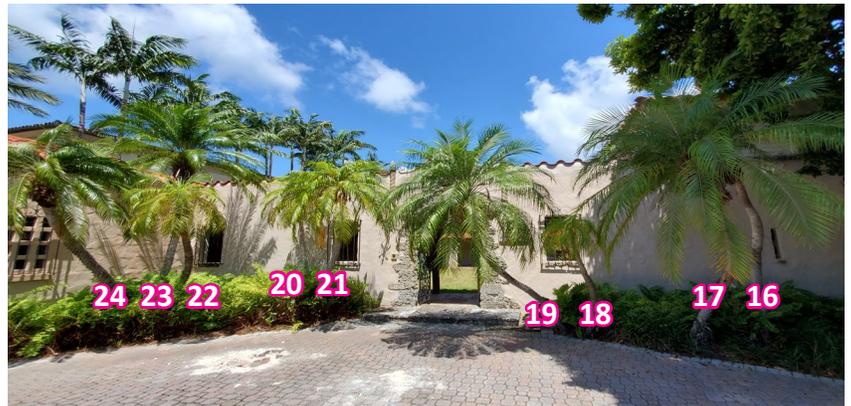
Trees #16- #24, are Pigmy Date Palms located in front of the existing house. These palms are in poor condition, overgrown with some structural defects and signs of nutrient deficiency. These palms are proposed for removal.

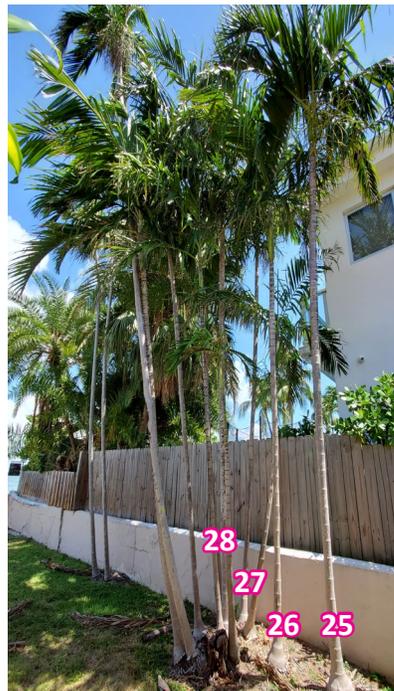
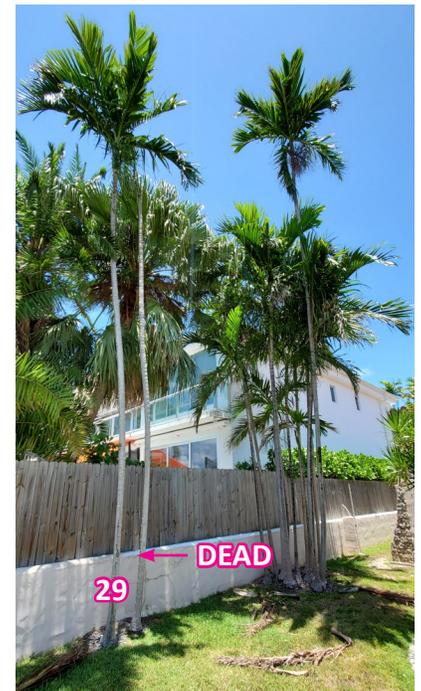
Trees #25-#29 are Solitaire Palms located in the back of the house along the north property line. These palms are in fair condition. Based on Landscape Architects Tree Disposition Plan, these palms are proposed for removal.

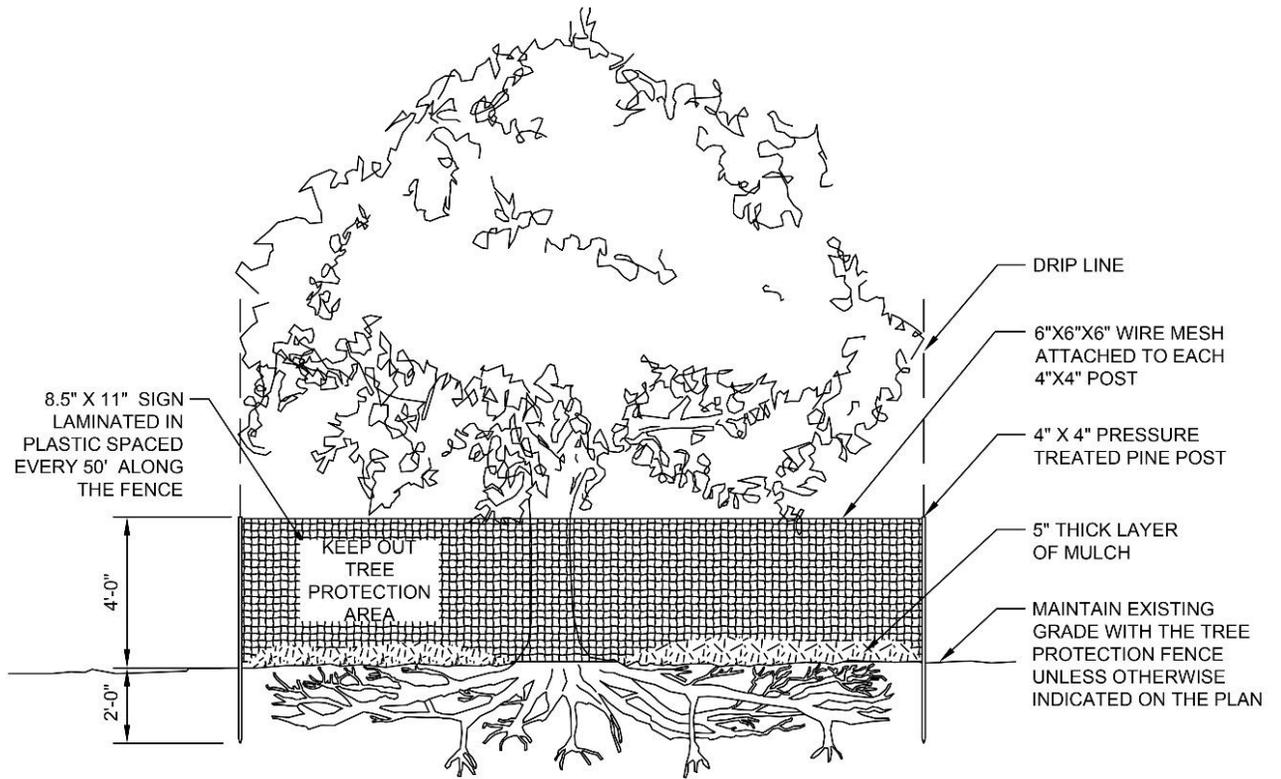
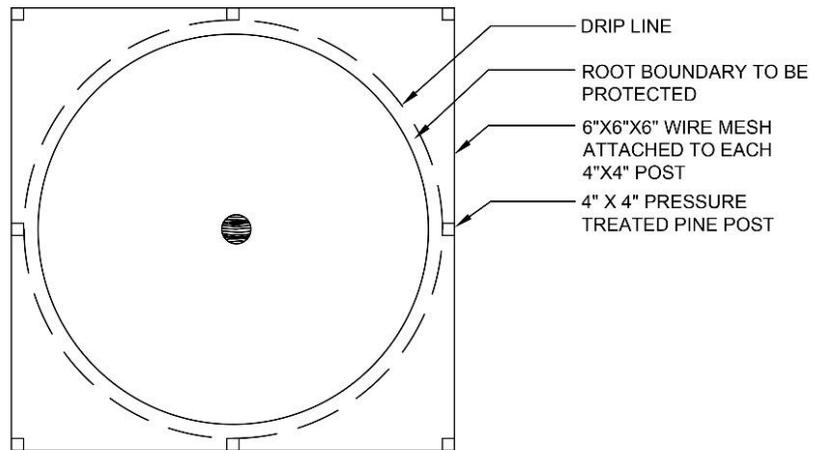
**Tree Protection Fence Detail  
(Not to scale)**

**SECTION VIEW**

**PLAN VIEW**

Tree Protection Zones will need to be erected for all of the trees that are on the site that could be affected during the demolition and process. Radius of the TPZ shall be measured from the tree trunk to the edge of the protective fence. Fencing shall be composed of 4" x 4" wood framing, minimum 4 feet tall, and no equipment shall enter this area during the entirety of the demolition and construction process. Proper installation of the TPZ shall be ensured by the Certified Arborist. Natural grade shall be maintained within the TPZ. All remaining trees will need to be verified for viability by the Certified Arborist upon project completion.
