SUBJECT: Art in Public Places Committee Motions—October 19, 2021

**1. The Conservation of Kevin Arrow's *Beatles Mandala (Amor = Love)*, 2014
Bandshell Park, Collins Avenue and 72nd Street**

CONDITION ASSESSMENT REPORT
CITY OF MIAMI BEACH/KEVIN ARROW'S BEATLES MANDALA (AMOR = LOVE)

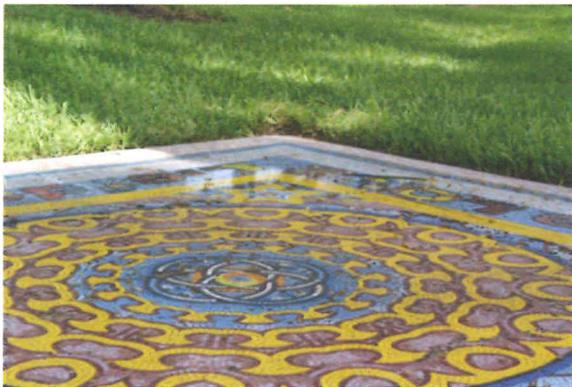
DISCUSSION AND RECOMMENDATIONS: This mosaic has been problematic almost since it was installed. The underlying issue in its damage seems most likely to be the result of the concrete slab onto which it has been set, which was not canted to slough off water. Standing water appears to be the issue in the deterioration of the artwork. The areas of tesserae detachment clearly correspond to dips in the mosaic surface. Moreover, there does not appear to be any drainage on the slab itself that might help mitigate this condition. Rainwater appears to be the main source of the puddling, however, given that the artwork sits within a grassy space, it may also be impacted by sprinkler water, which adds another layer of environmental deterioration. The good news for the work is that the tesserae themselves are not exhibiting damage. No breakage of the tesserae or delamination of the top surfaces was observed. The tesserae themselves were well fabricated.

Standing water on southeast side of the mosaic.

1. Document with photographs high resolution digital photographs.
2. Conduct a thorough delamination assessment of the entire mosaic surface.
3. Select an area of the SE side of the mosaic where water pools.
4. Drill a hole into the concrete slab to penetrate down into the ground below the slab. Hole should be the size of 1-2 tesserae as to not be significantly visually obtrusive. Location and exact size to be determined.
5. Once drilling is complete, observe area to determine if water drains immediately and/or over time.
6. Set tesserae around this hole, leaving the hole uncovered for drainage.
7. Secure the area around the hole with a UV resistant epoxy. This will add another layer of

- protection to tesserae that are subjected to constant water pooling.
8. Consider installing a stainless-steel small funnel drain in the hole. This could aid in more effective draining in the drilled location.
 9. Inspect after 2 weeks to see if this improves water pooling. If so, prepare a proposal for carrying this out throughout the mosaic. Based on the results, it can be determined how many additional drainage holes are needed on the mosaic.

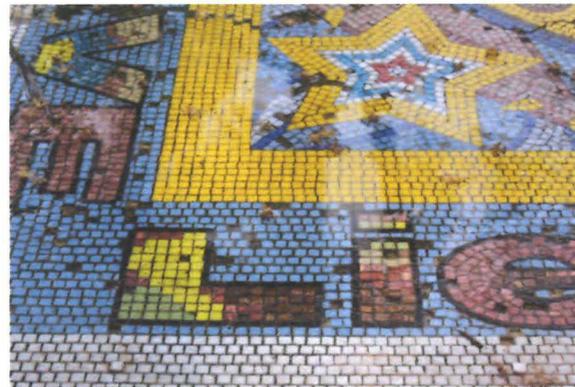
Where the tesserae have been displaced, adjacent tesserae pop out with ease. Approximately 50% of the tesserae remain securely attached, specifically if the adjacent tesserae are secure as well. The intact tiles are in fair condition with no delamination or breakage observed. There are multiple areas of minor repairs. These include tesserae that have been reattached using an unknown likely commercial grade adhesive. Areas such as these are minimal and though the material are likely incompatible with the original, they do not appear to be causing additional deterioration to the mosaic. In general, the surface is slightly dirty with debris and the grout is stained a dark grey color. Algae was visible where the tesserae had been displaced, likely due to the stagnant water.

Detail of pooling water with visible algae on the grout and in areas where tiles have been displaced. .

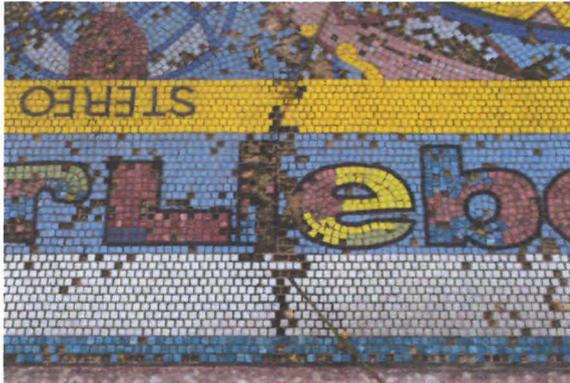
Approximately 5-8% of the tesserae are displaced or missing altogether. Several large sections of tile are missing in each color. Many of these losses occur throughout the mosaic with no identifiable pattern; however, there are 2-3 areas of linear losses. In these areas, there are linear losses spanning a width of 1-6 tesserae that suggest their detachment could possibly correspond to a subsurface condition. Underlying conditions could include pooling of water or an additional fault with the concrete pad and/or bedding mortar.

Detail of missing tesserae both spread out and in a linear pattern as seen in the center of the image.

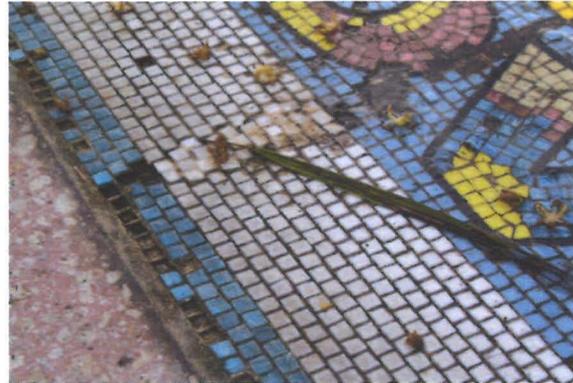
Detail of tile loss, standing water, dirt, and debris sitting on the mosaic

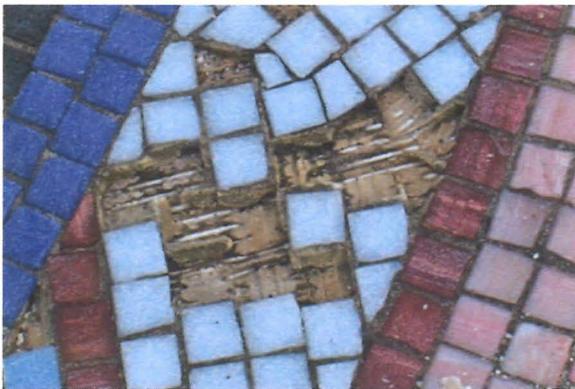
Grout remains overall but is missing where there are larger areas of missing tesserae. In instances where only one or two tesserae have been displaced, the grout line appears to remain in place. Bedding mortar also appears to remain in most locations. The fiberglass mesh is visible in some areas but appears to be missing in areas where tesserae are lost. This condition suggests that the issue appears to be one of poor bonding between the tesserae and the bedding mortar.

Detail of visible fiberglass mesh

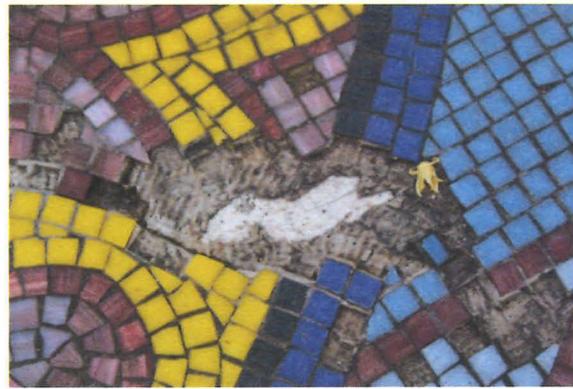
Detail of the bedding mortar and underlying fiberglass and mesh.
