HISTORIC CHARACTER AND DESIGN ANALYSIS

7418 Harding Avenue
Miami Beach, Florida

7418 Harding Avenue
Historic Character and Design Assessment

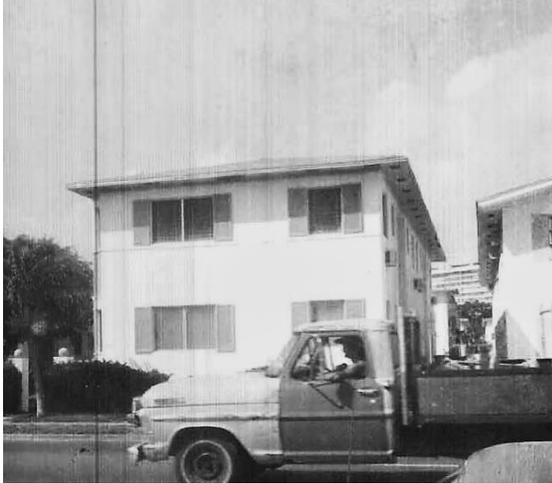
Fig. 5. View of the north building from Harding Ave, January 1963 (Office of the Property Appraiser, Miami-Dade County).

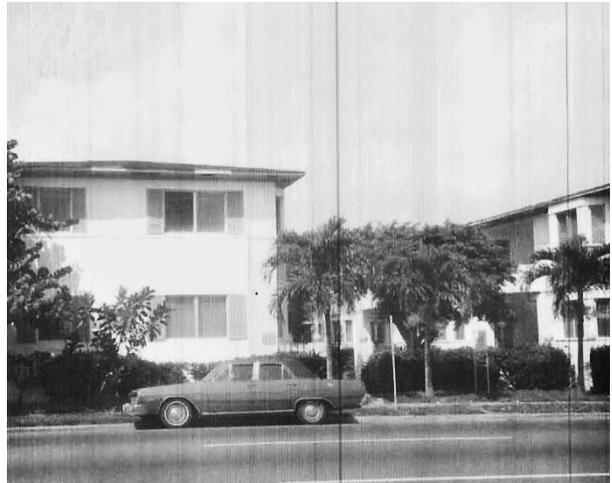
Fig. 6. View of the south and north buildings from Harding Ave, January 1963 (Office of the Property Appraiser, Miami-Dade County).

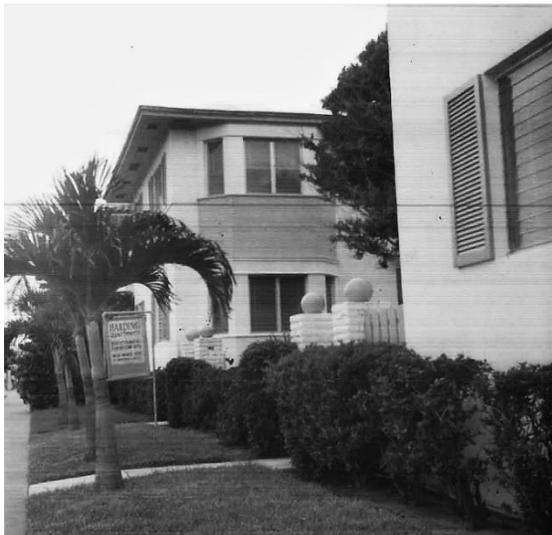
Fig. 7. View of the south and north buildings from sidewalk, January 1963 (Office of the Property Appraiser, Miami-Dade County).

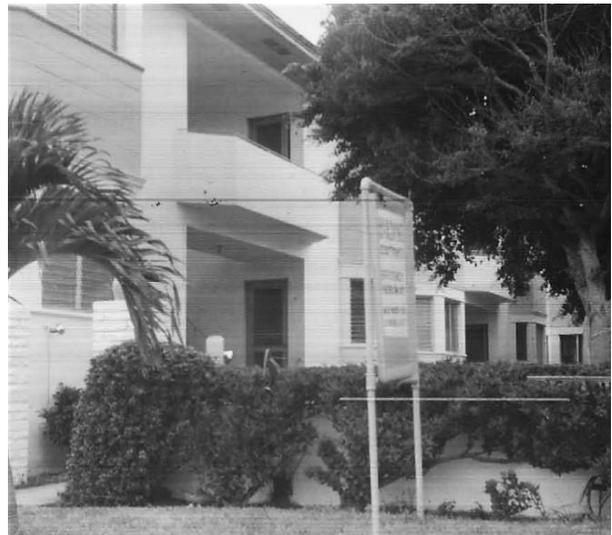
Fig. 8. View of the south building entrance from courtyard, January 1963 (Office of the Property Appraiser, Miami-Dade County).

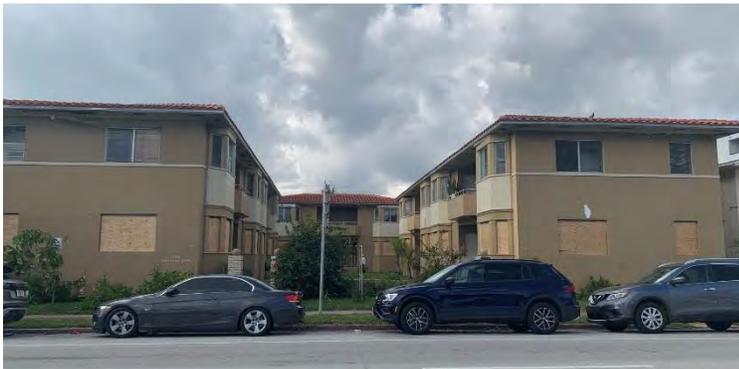
Three free-standing structures are located on the site. The east buildings (N and S bars) are on Harding Avenue and are clearly visible from the street (Fig. 24 & 25). They are fronted by a sidewalk and are accessed via the Harding Avenue. The west building is situated near the rear lot line and is only slightly visible from Harding Avenue. The property is accessed from the ally and the open front area.

Fig. 24. View of the site looking east from Harding Avenue, January 2022.

The primary historic structures are the 2-story buildings facing Harding Av. (Fig. 24 & 26) The main buildings are parallel and face an open grass area. The building is constructed with concrete block clad with stucco and features simple post war style. The structure has a low sloped clay tiled roof with slightly overhangs (Fig. 35).

The south building is a secondary historic structure. It is 2 stories and closes off the courtyard space. It has similar features to the two front buildings, with one entry space in its center. (Fig. 24 & 25)

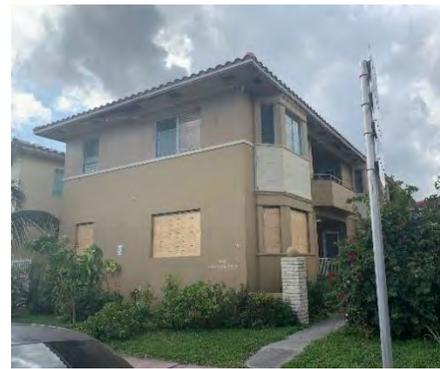
Fig. 25. View of the south building looking east from Harding Avenue, January 2022.

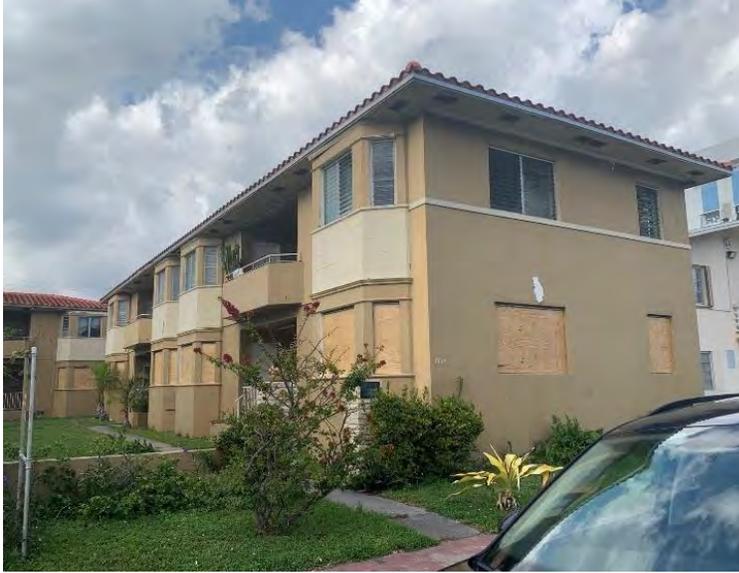
Fig. 26. View of the north building looking east from Harding Avenue, January 2022.

At the front facade, the buildings are simple, and each have 2 windows per floor. The windows are not original to the building (Fig 26). The door is accessed from a stoop covered with non-original square gray tile. The stoop appears to be larger than the original and the handrail configuration is blocking part of the window on the north side. (Fig. 32).

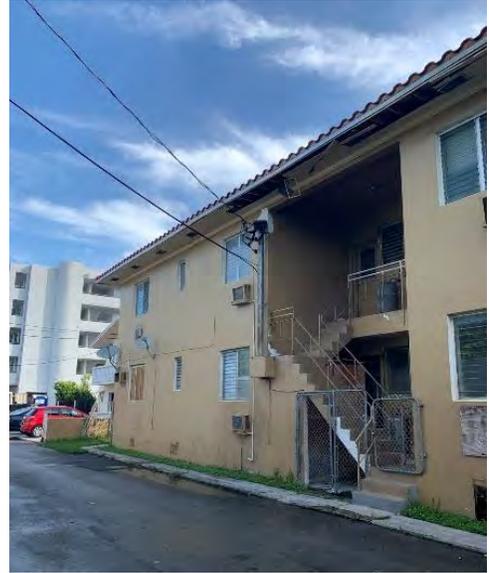
Fig. 27. View of the East building from back alley, January 2022.

The rear (west) elevation features a secondary exterior stair with stucco walls and non-original handrail that gives an access to the back alley. (Fig. 27)

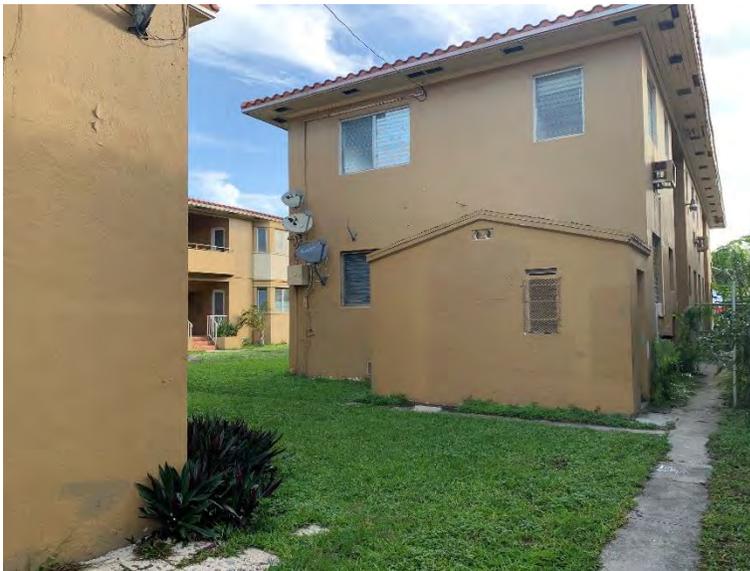
Fig. 28. View of the south building from its rear side, January 2022.

The west elevations of the North and South Buildings are not visible from the street and have 1 story sheds attached. (Fig. 28)

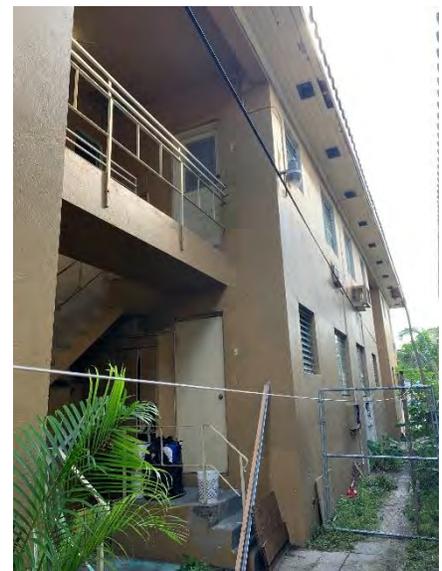
Fig. 29. View of the rear side of the south building, January 2022.

The rear (north/south) elevation features a secondary exterior stair with stucco walls and non-original handrail. (Fig. 29) The door hood at the 2nd Level is the same type as at the other doors. The stair has a non-original notched opening at the 1st Level that provides access to a small stoop with the same paving as at the front entrance. A door at the 1st Level is directly below the door at the 2nd Level. The secondary exterior stairs are partially hidden behind the building and are partially visible from the street.

4. Front stoop – level with site.
5. Primary Exterior Stairs – replace tile and railings.
6. Light fixtures– remove.
7. West elevation shed buildings – remove. Replace with windows.

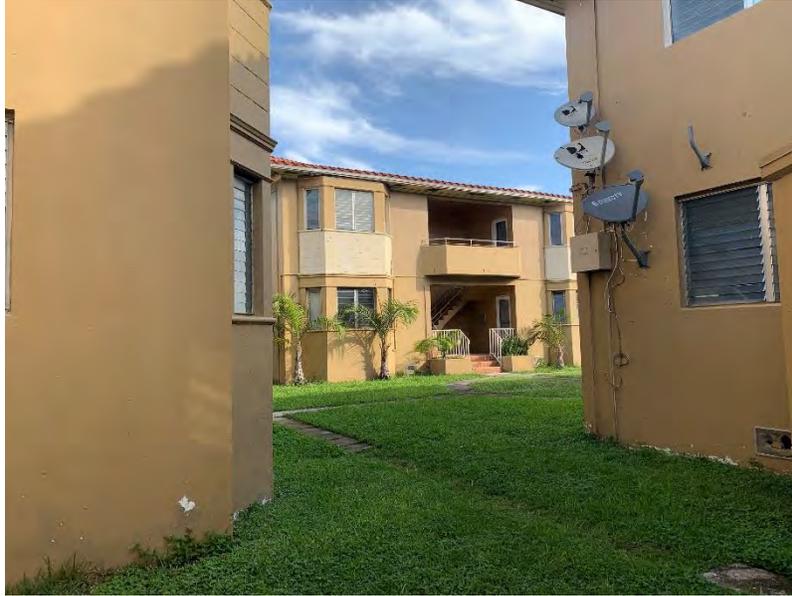
Fig. 30. View of the open area side of the north building, January 2022.

Each residential unit has exterior access from the central open area. The ground floor units have entry's directly from a stoop covered in tile. The exposed stair goes up to a landing balcony between two additional units. (Fig. 34) This elevation is composed of repeating bay windows (Fig. 33) and is duplicated once more along a central axis (Fig. 30).

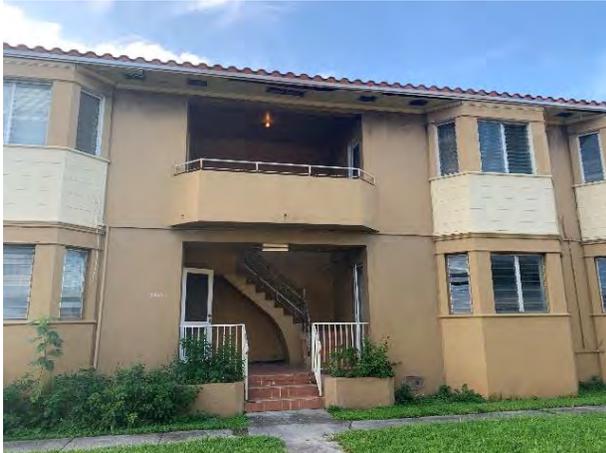
At the front facade, the building is identical to the open area elevations of the north & south buildings, with repeating bay windows & exposed staircases. (Fig. 31 & 32)

*Fig. 31. North façade of south site building,
January 2022.*

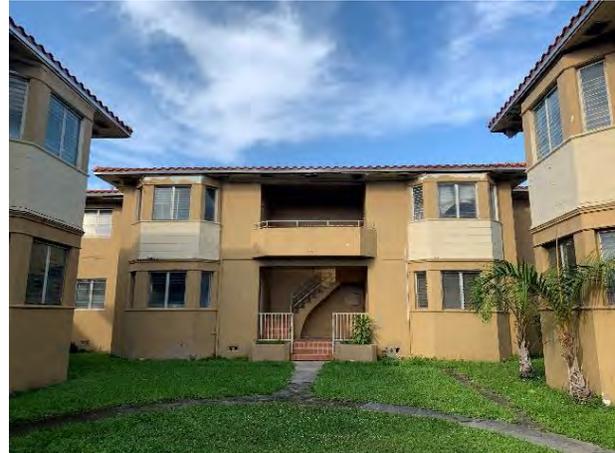
*Fig. 32. East façade of West site building,
January 2022.*

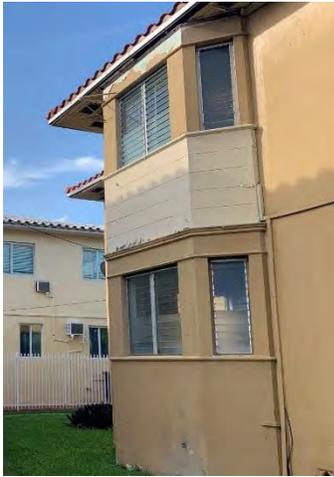
Fig. 33. Detail of bay window/jalousie window

1. Windows – replace with windows that meet current code requirements. Modify to match historical drawings.
2. Doors – replace to meet current code requirements.
3. Clay tile – strip paint; if not possible, replace with new terra cotta to match original.

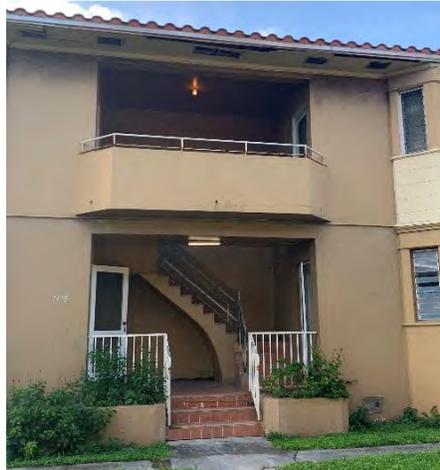
Fig. 34. Detail of outdoor staircases with inset balcony..

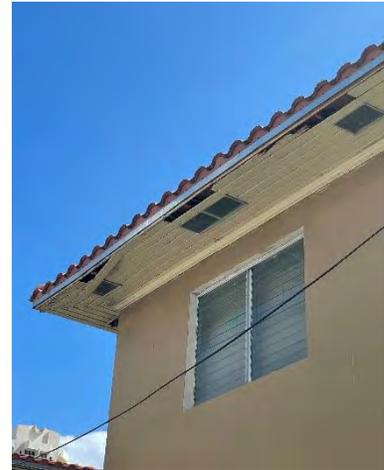
Fig. 35. Detail Flat tiles roof slightly overhangs.
