## Assessment of 269 Palm Flooding during Tropical Storm Alex

Land Use and Sustainability Committee

September 28, 2022

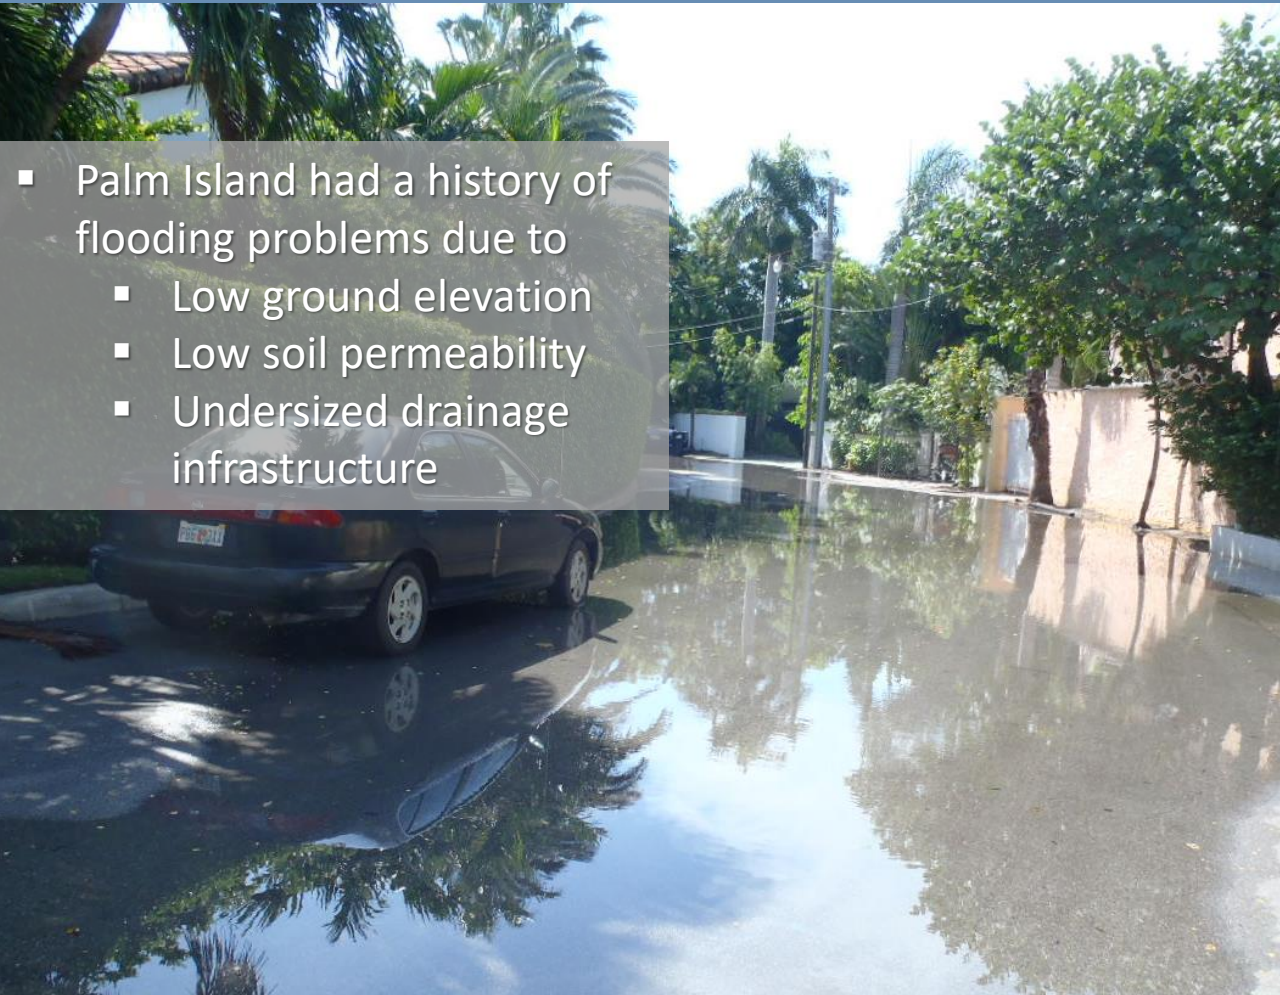
Palm Island 316 South Coconut Ln

- Palm Island had a history of flooding problems due to
  - Low ground elevation
  - Low soil permeability
  - Undersized drainage infrastructure

Tides: 1.4 ft NAVD | 10/17/12

**BEFORE**

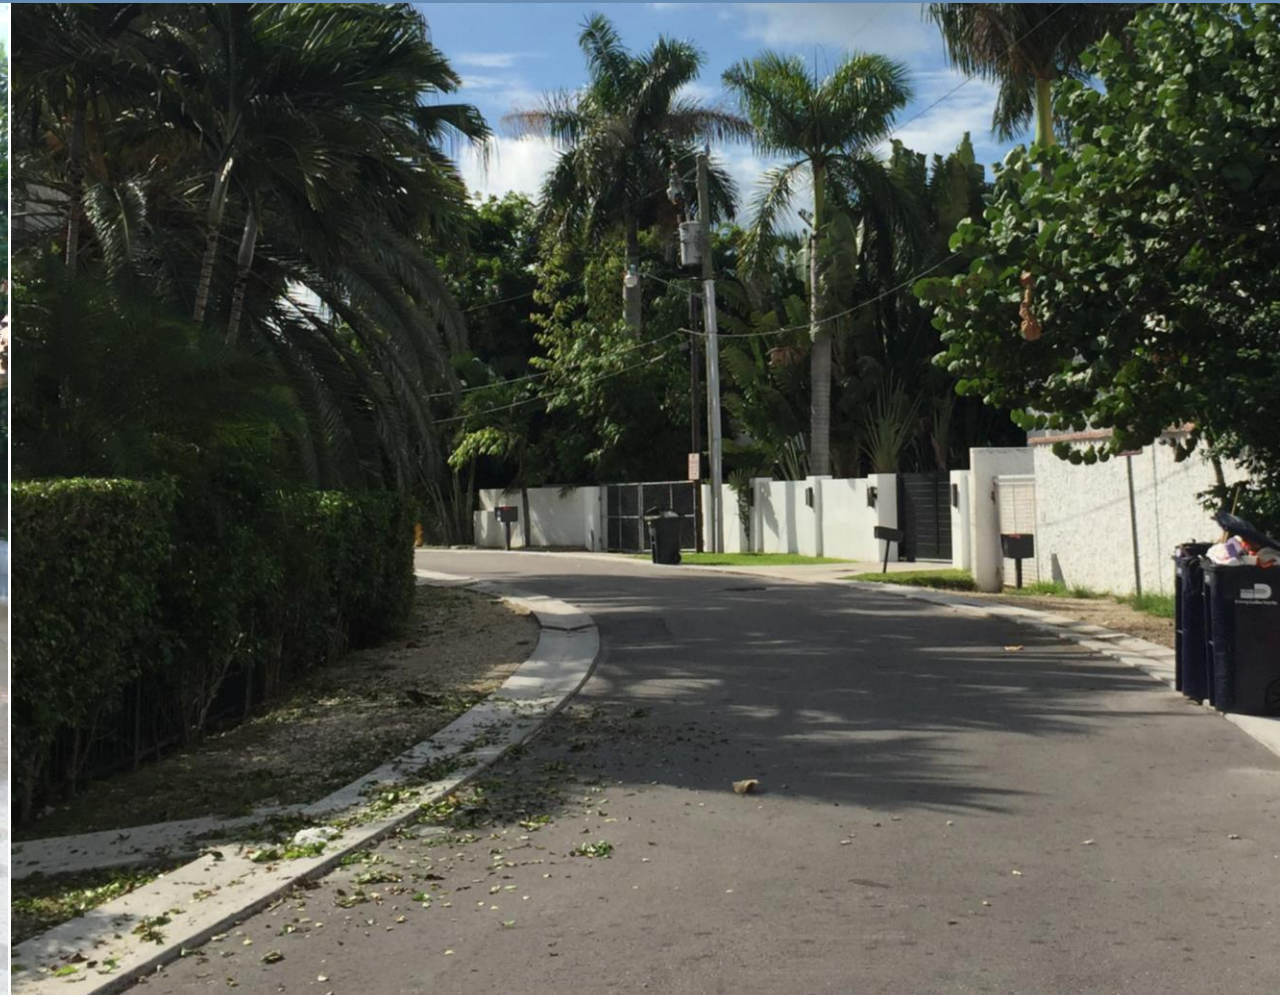
Tides: 1.88 ft NAVD | 10/15/19

**AFTER**

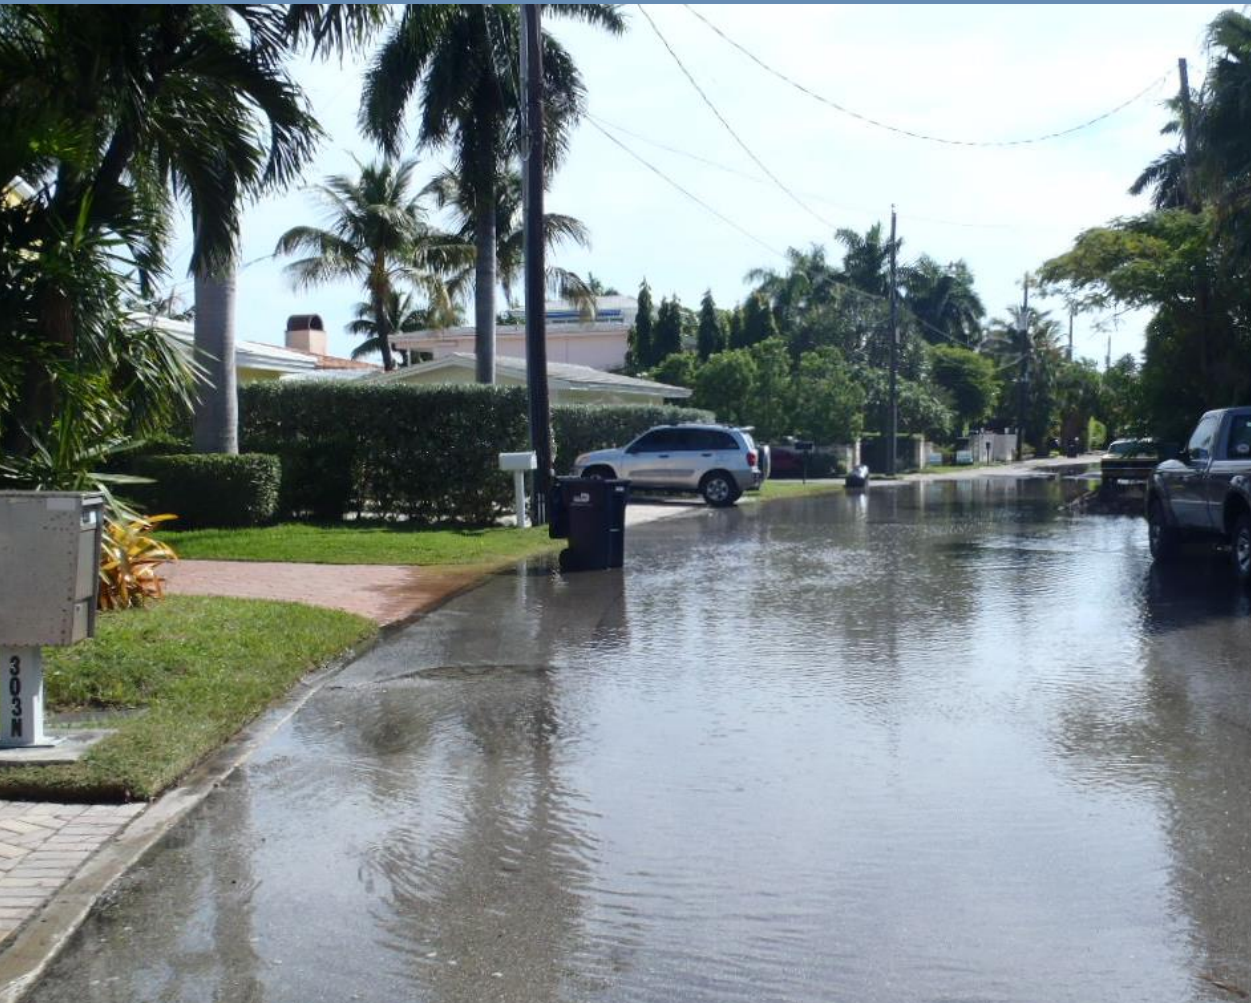
Palm Island 303 North Coconut Ln

**BEFORE**

Tides: 1.4 ft NAVD | 10/17/12

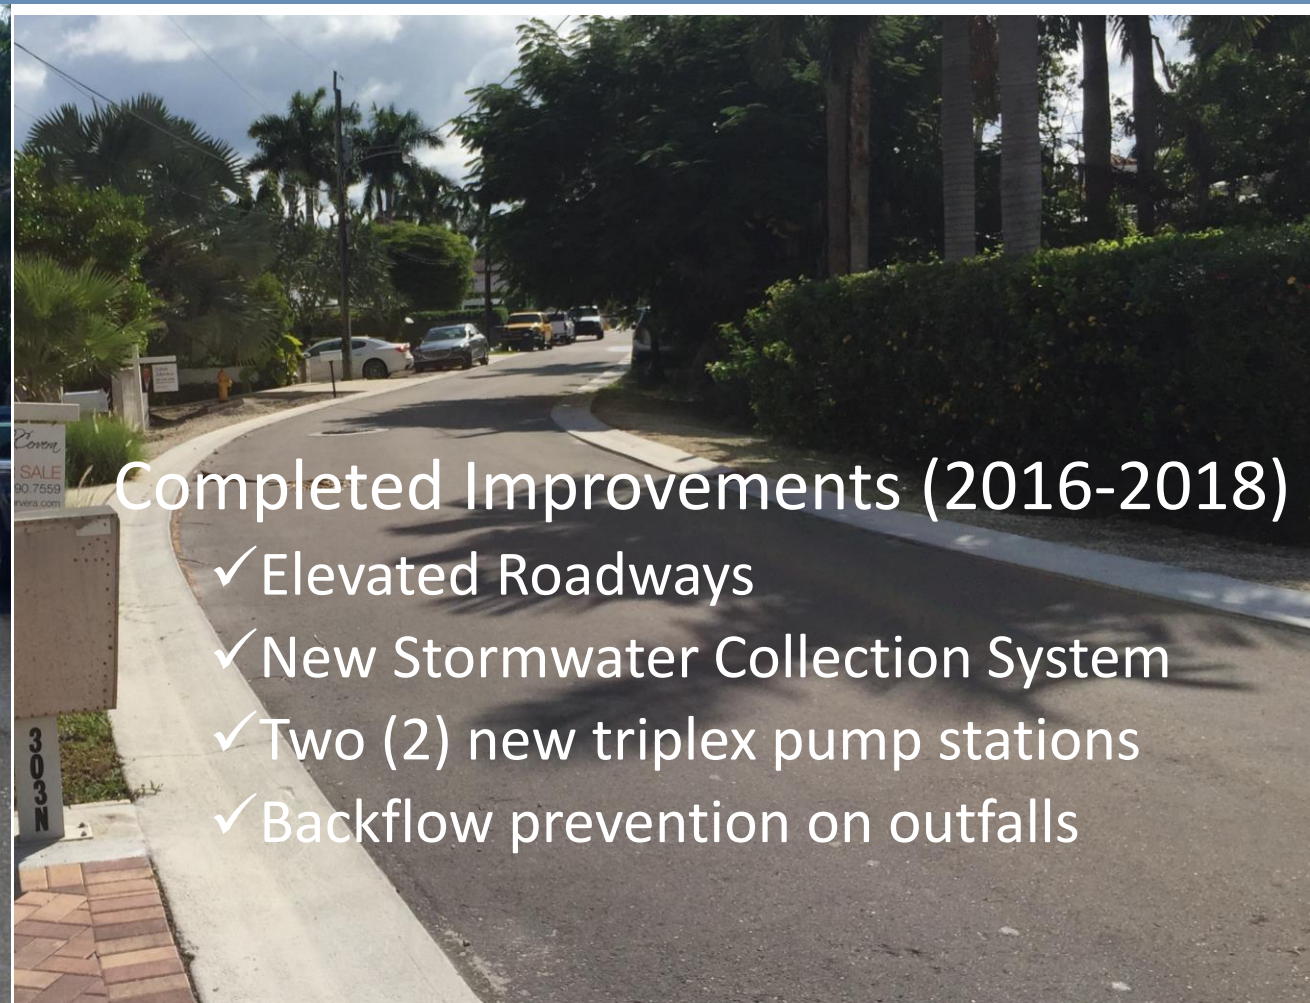
- ✓ Elevated Roadways
- ✓ New Stormwater Collection System
- ✓ Two (2) new triplex pump stations
- ✓ Backflow prevention on outfalls

**AFTER**

Tides: 1.88 ft NAVD | 10/15/19

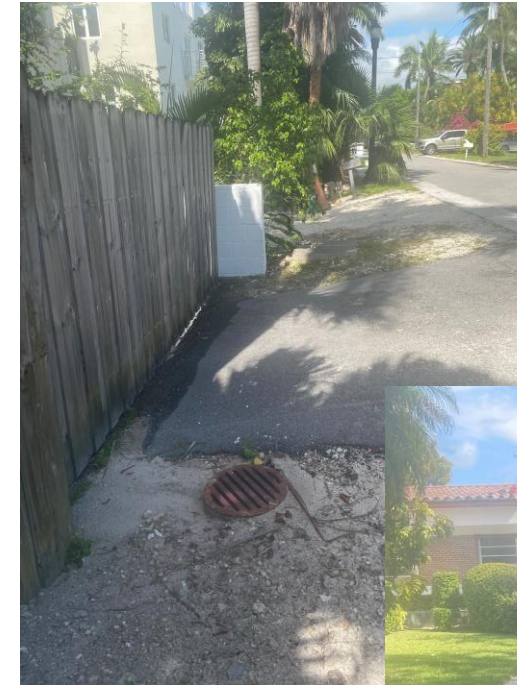
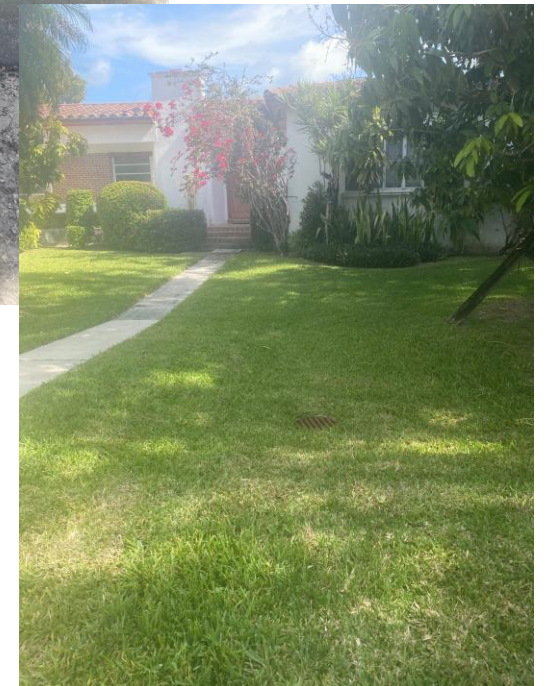
# Road Raising and Harmonization

- Harmonization License Agreements were required for the City to perform any harmonization effort within private property.
- If the Finish Floor Elevation (FFE) was at or below the NEW crown of road, a private property was able to receive a drainage connection.
- Properties that elected to connect to the City's system had to obtain a building permit.
- Properties that did not sign harmonization agreement were harmonized at the ROW Line.
- Special harmonization efforts were made on a case-by-case basis as needed and as agreed upon with the property owner.

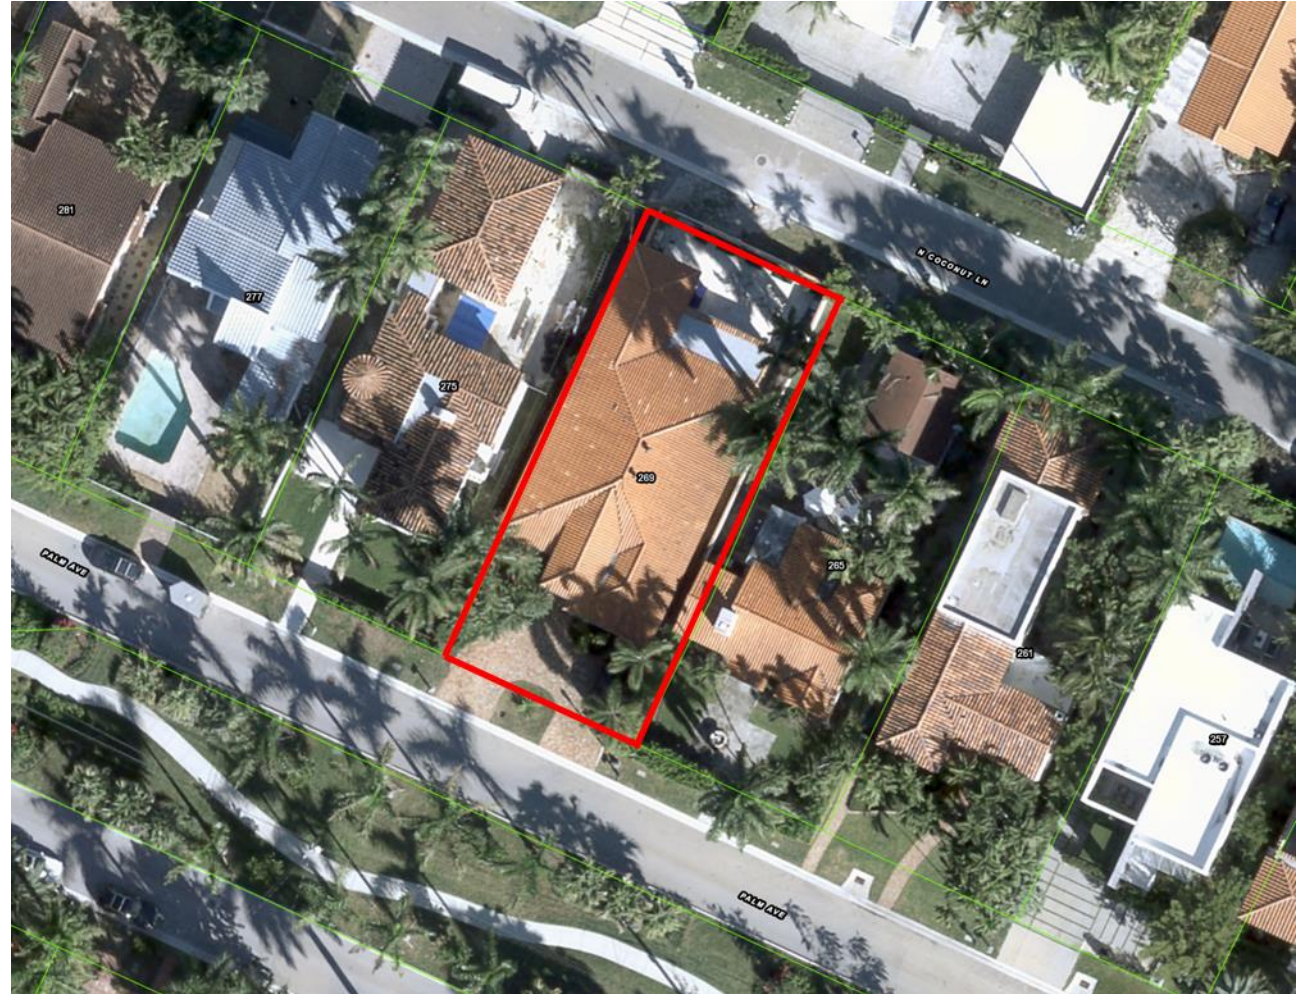
# 269 Palm

- Single lot between two roads
- Raised roads on both sides of property
- 90% impervious property (excluding ROW)

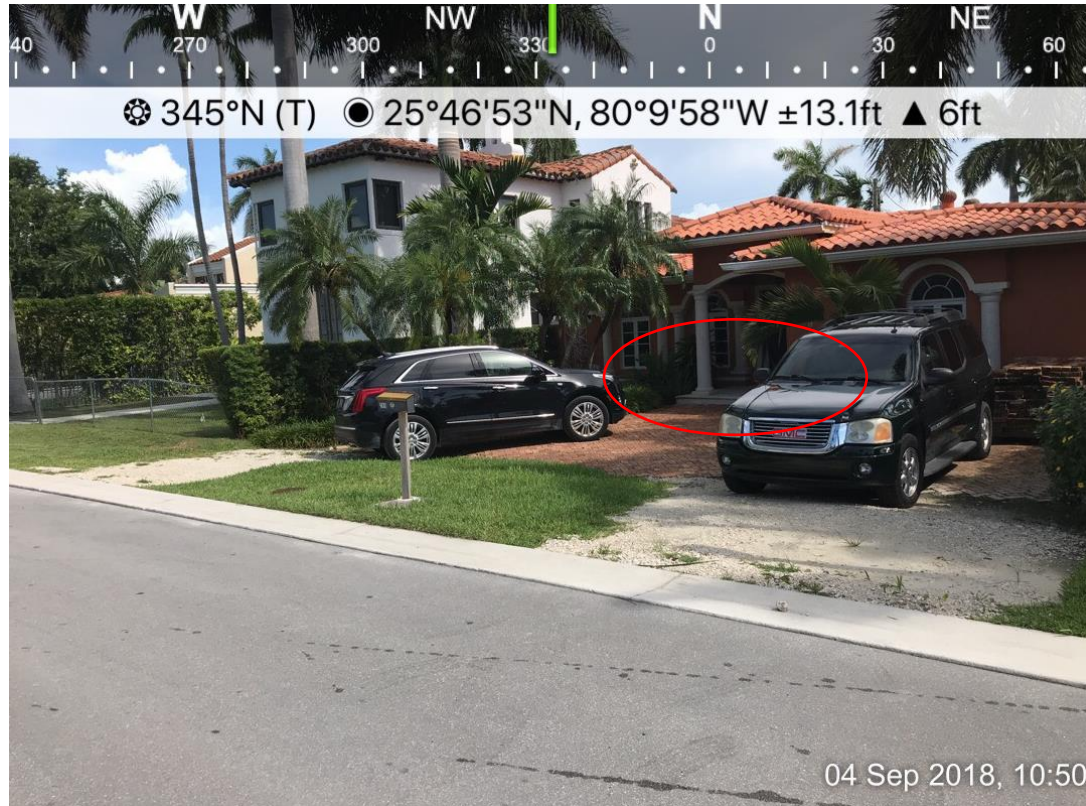
# 269 Driveway Raising

Construction Impacts to driveway due to road raising and harmonization September 4, 2018

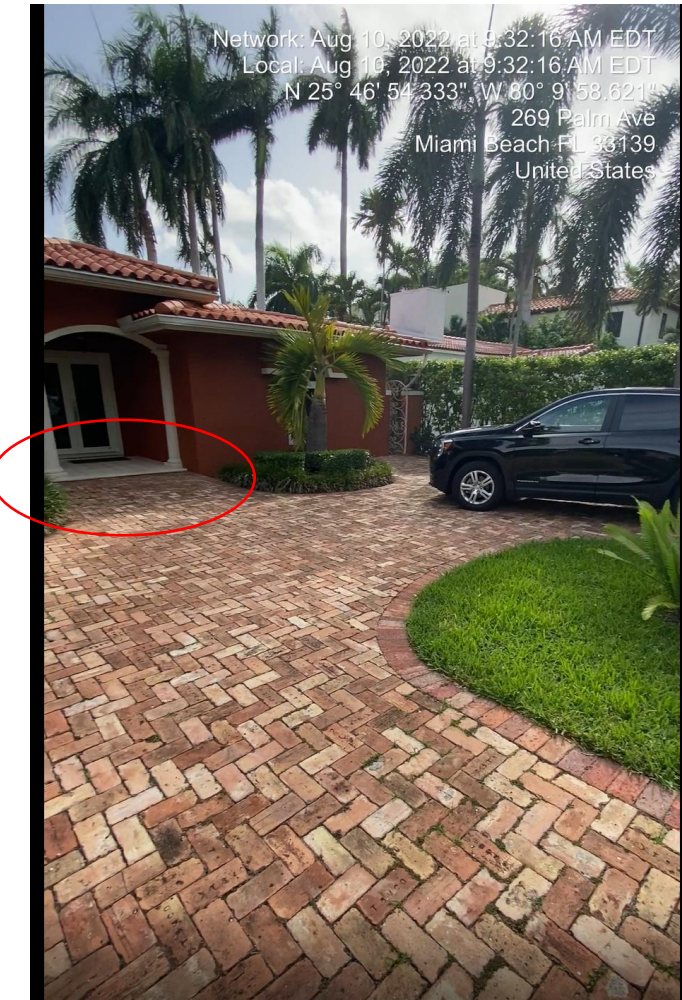
Site Visit August 10, 2022

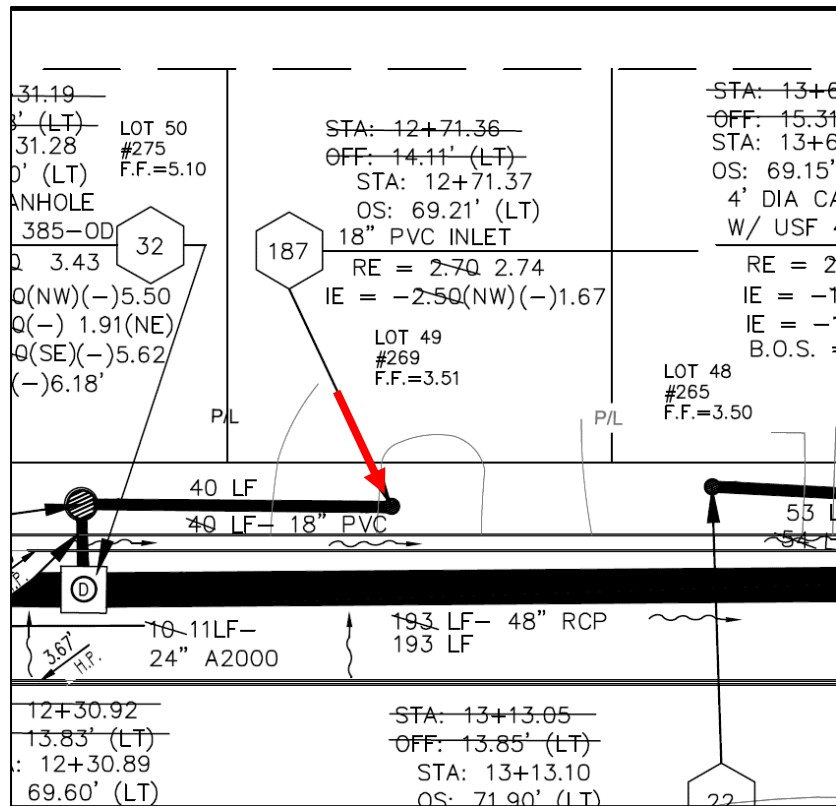
- Front of Property: Stormwater Inlet in Swale Area at low point to capture water

Flooding Problem / Contribution	Solution	Responsible Party
Partial stormwater sheet flow from ROW on northwest side ramp -, possibly contributing to flooding on west side lot	<b>1) Stormwater collection point to be installed at the ramp landing to collect stormwater sheet flowing from ROW.</b>	City
Stormwater sheet flow from building roof, driveway, and backyard contributing to flooding on sides	<b>2) Remove concrete slabs from both sides and install sod to increase permeable area and improve stormwater percolation. 269 Palm is grandfathered in and does not meet Miami Beach Building Code. The building code requires 30% of front lot and 70% of rear lot be sodded or landscaped.</b>	Property Owner
Stormwater seeping into the house from side concrete slabs during heavy rainfall	<b>3) Proposed to raise sunken floor elevations.</b>	Property Owner

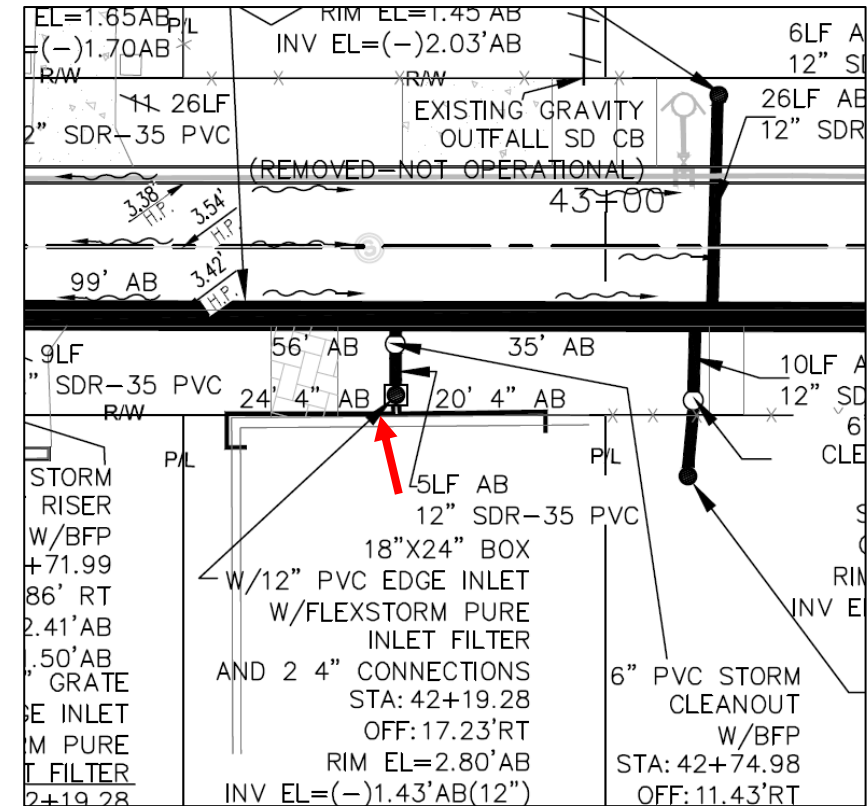
- Back of Property: 4" drain pipes in concrete wall, connected to a drainage structure

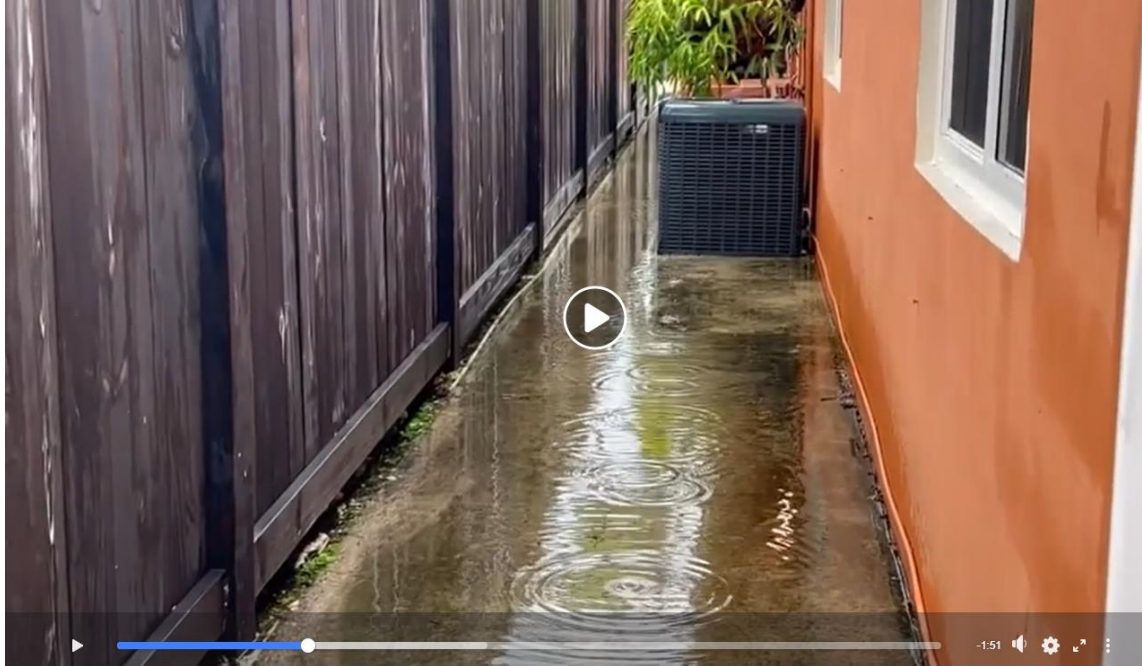
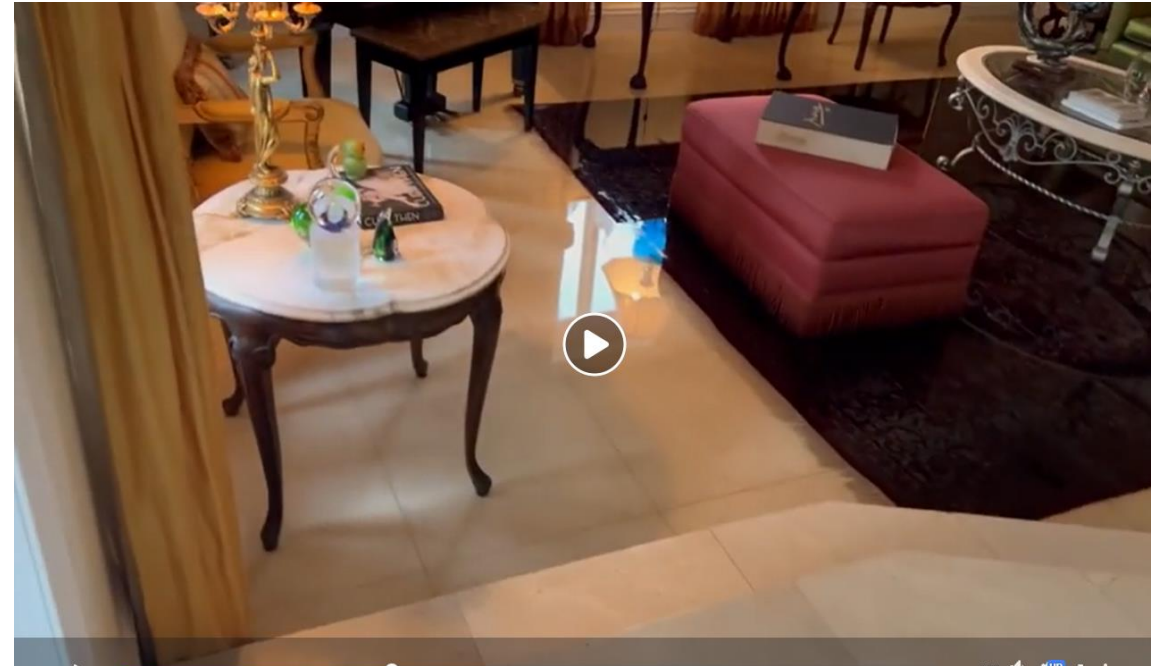
# 269 Palm on June 4<sup>th</sup>, 2022 – Tropical Storm Alex

- **>100 Year Storm:** 12" of rain in less than 24 hours, with intensity over 4.3 inches per hour
- Private property flooded on east and west sides of properties
- Flooding internal to house in locations with lower floors

Note: As PW Engineering coordinates with the EOR to address solution #1 above, additional or more detailed/refined solutions may be implemented.
