**Assessment of Water Quality
at the Miami Beach Park View Canal
to Identify Sources of the Fecal Indicator Bacteria,
Enterococci**

FINAL REPORT

University of Miami, Coral Gables, FL
Department of Chemical, Environmental, and Materials Engineering

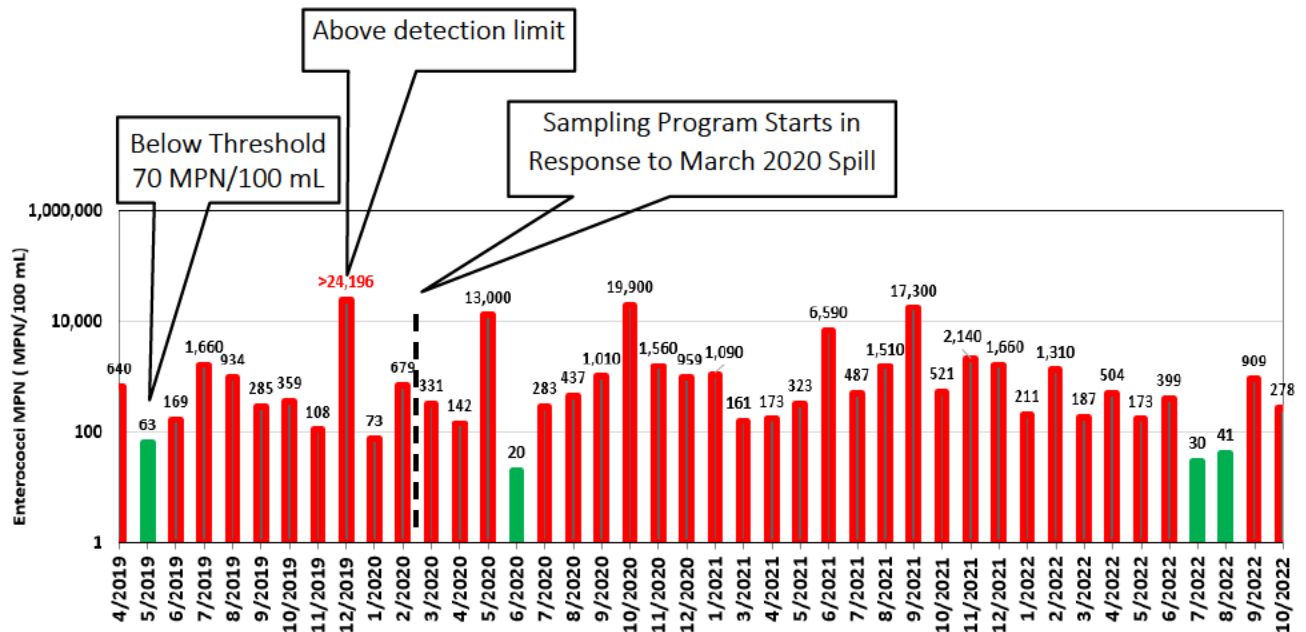
Figure II.1: Results from Monthly Enterococci Measurements at PVC from 4/2019 to 10/2022. Green bars correspond to data points within the 70 MPN/100 mL recommended recreational level whereas red bars correspond to data points which exceed this level. Note the data are plotted on a logarithmic scale due to the wide range of measurements.

Since the monitoring program started in 2019, the fraction of the time the PVC waterway has exceeded the 70 MPN/100 mL threshold has been at or above 80%, with the highest number of exceedances observed for year 2021 when all samples collected exceeded the regulatory threshold 70 MPN/100 mL. For the entire period of record evaluated (April 2019 to October 2022) the PVC exceeded the 70 MPN/100 mL threshold 90% of the time.

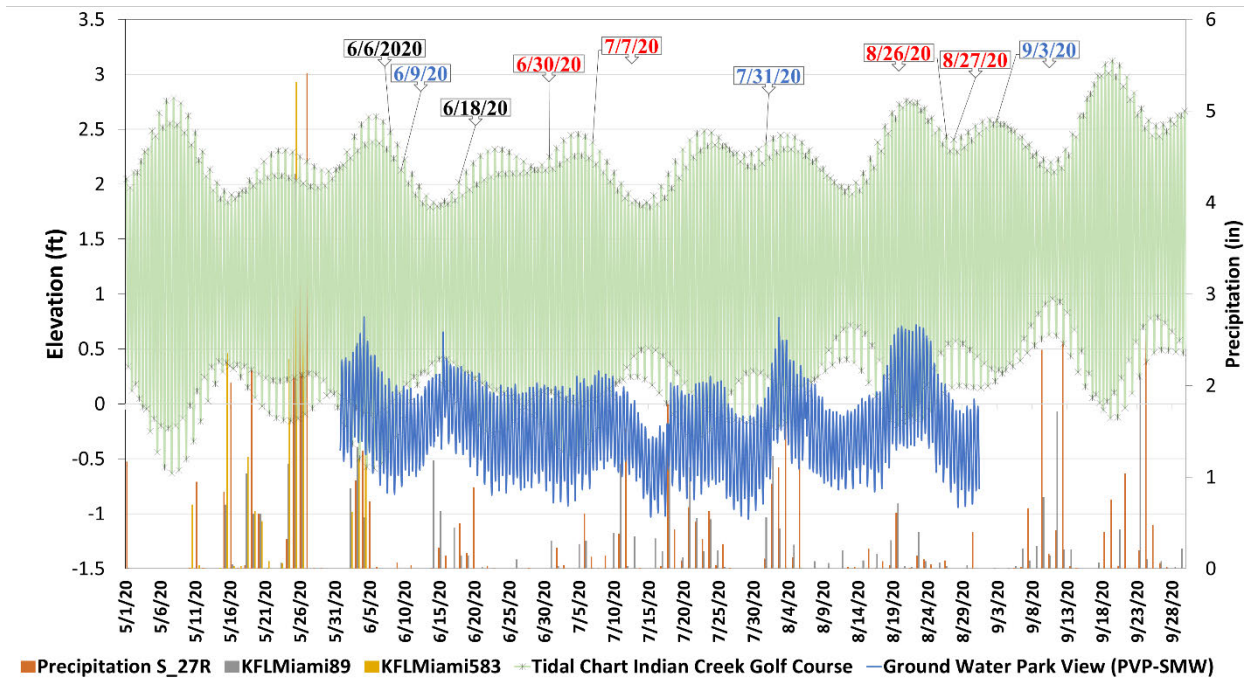
Figure II.3: Time series plot of rainfall, tides and groundwater superimposed on dates and peak enterococci levels measured in catch basins. Elevation corresponds to NAVD.

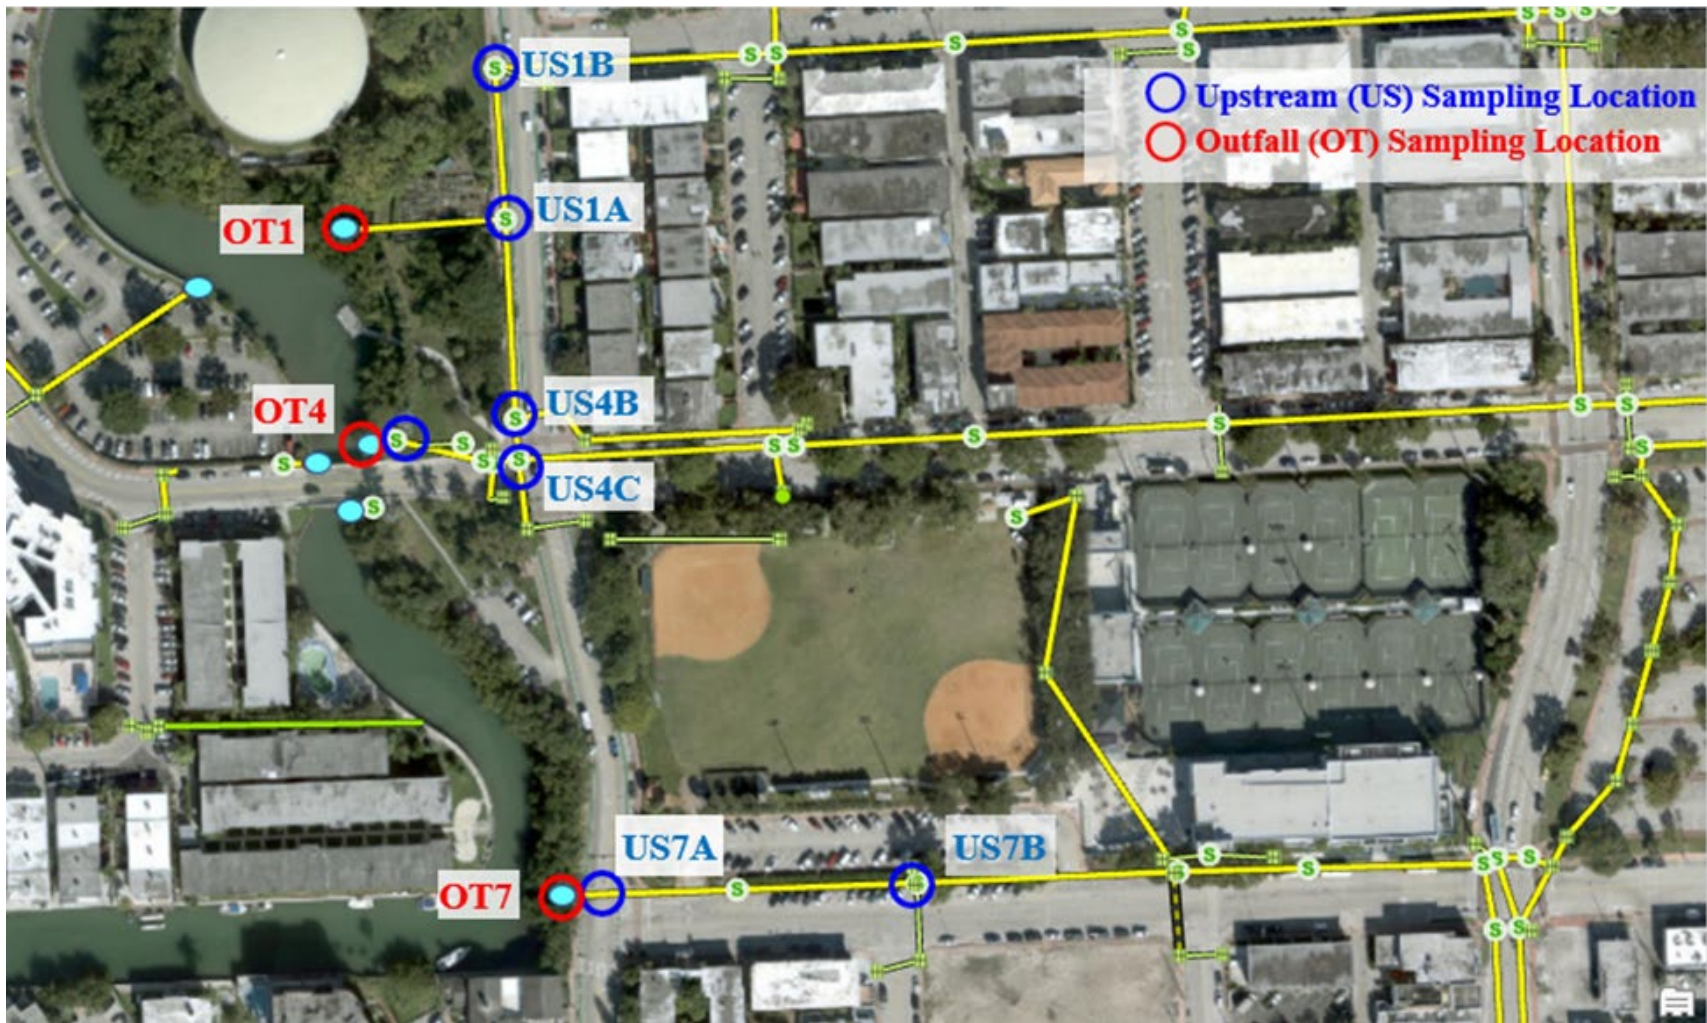
Figure II.5: Sampling locations of the upstream (US) and outfall (OT) shown in the blue and red circles within the map. Original map provided by the CMB containing data collected by E Sciences Inc.

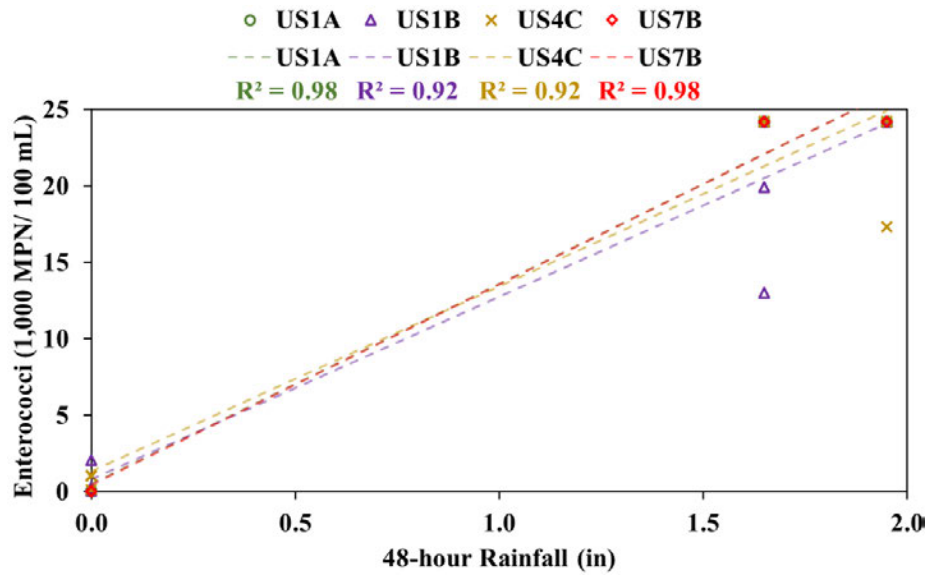
Figure II.8: Linear correlation between enterococci in the upstream samples (US1A, US1B, US4C, and US7B) and 48-hour cumulative precipitation prior to the sampling time based on the Pearson's analysis (R^2).

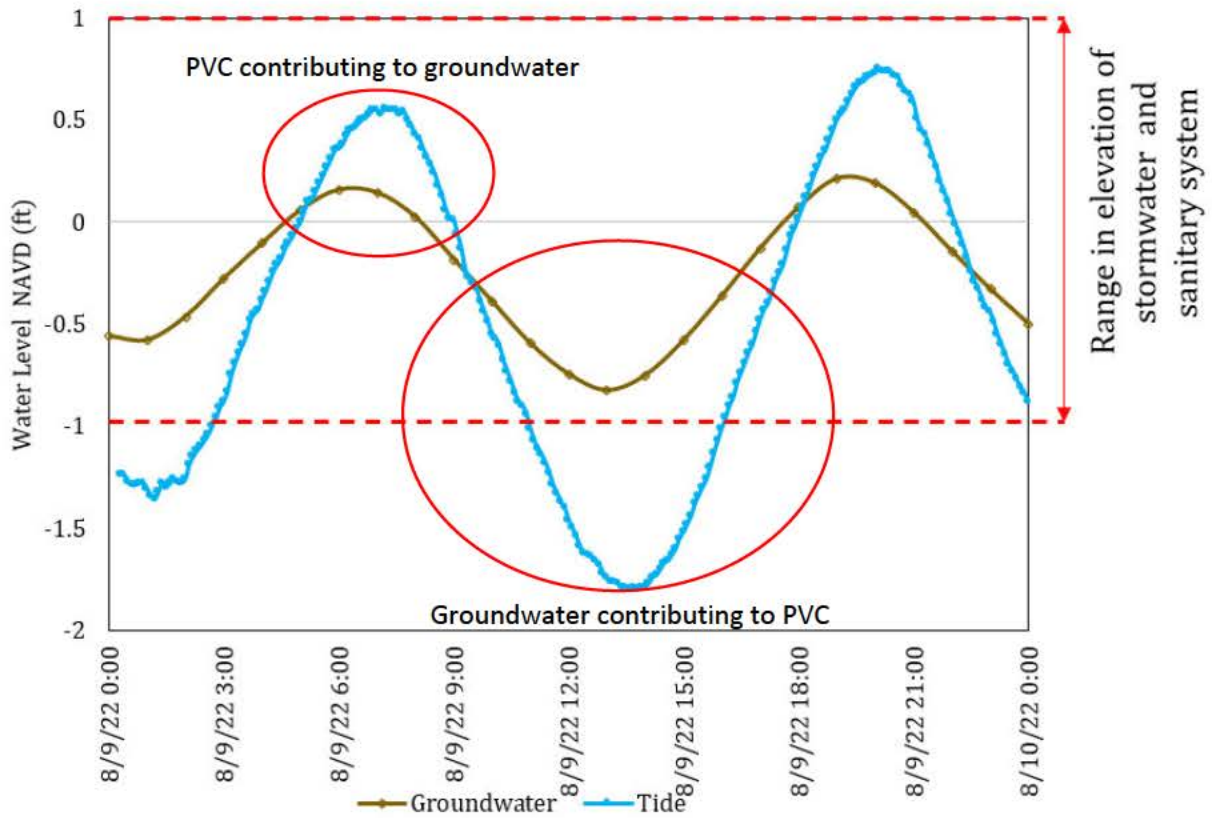
Figure III.5: Estimated tidally driven water levels at PVC and measured groundwater elevation at Parkview Island Park monitoring well.

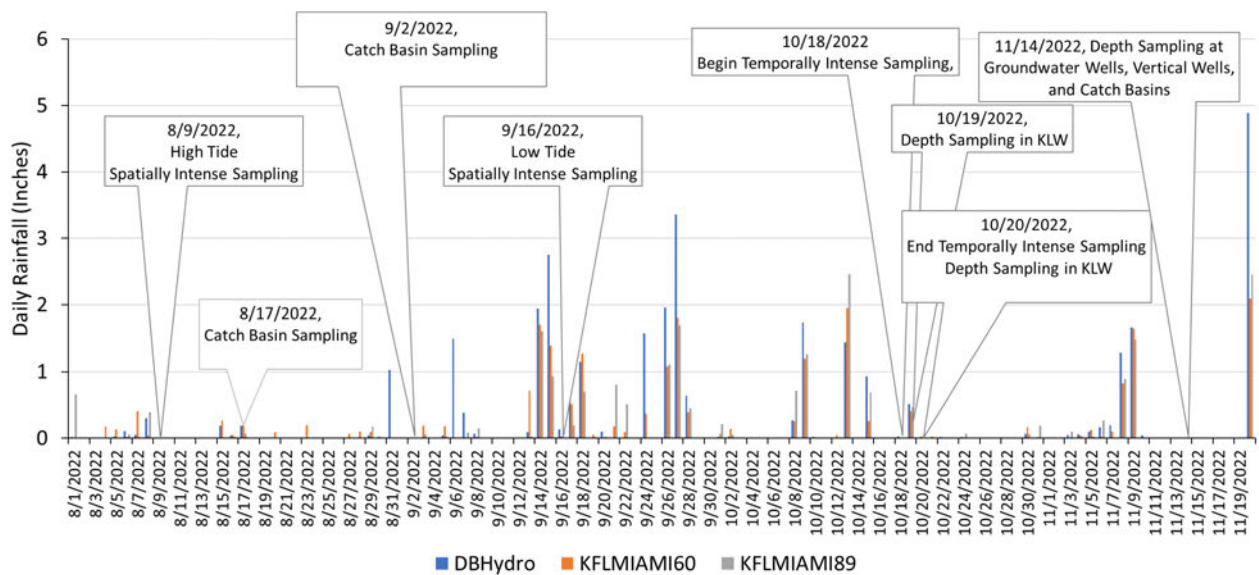
Figure V.1: Sample collection timeline superimposed on daily rainfall record. Of note, low tide spatial sampling occurred during an antecedent wet period. Period corresponding to the hourly sampling period (over 48 hours) is highlighted by a red circle.

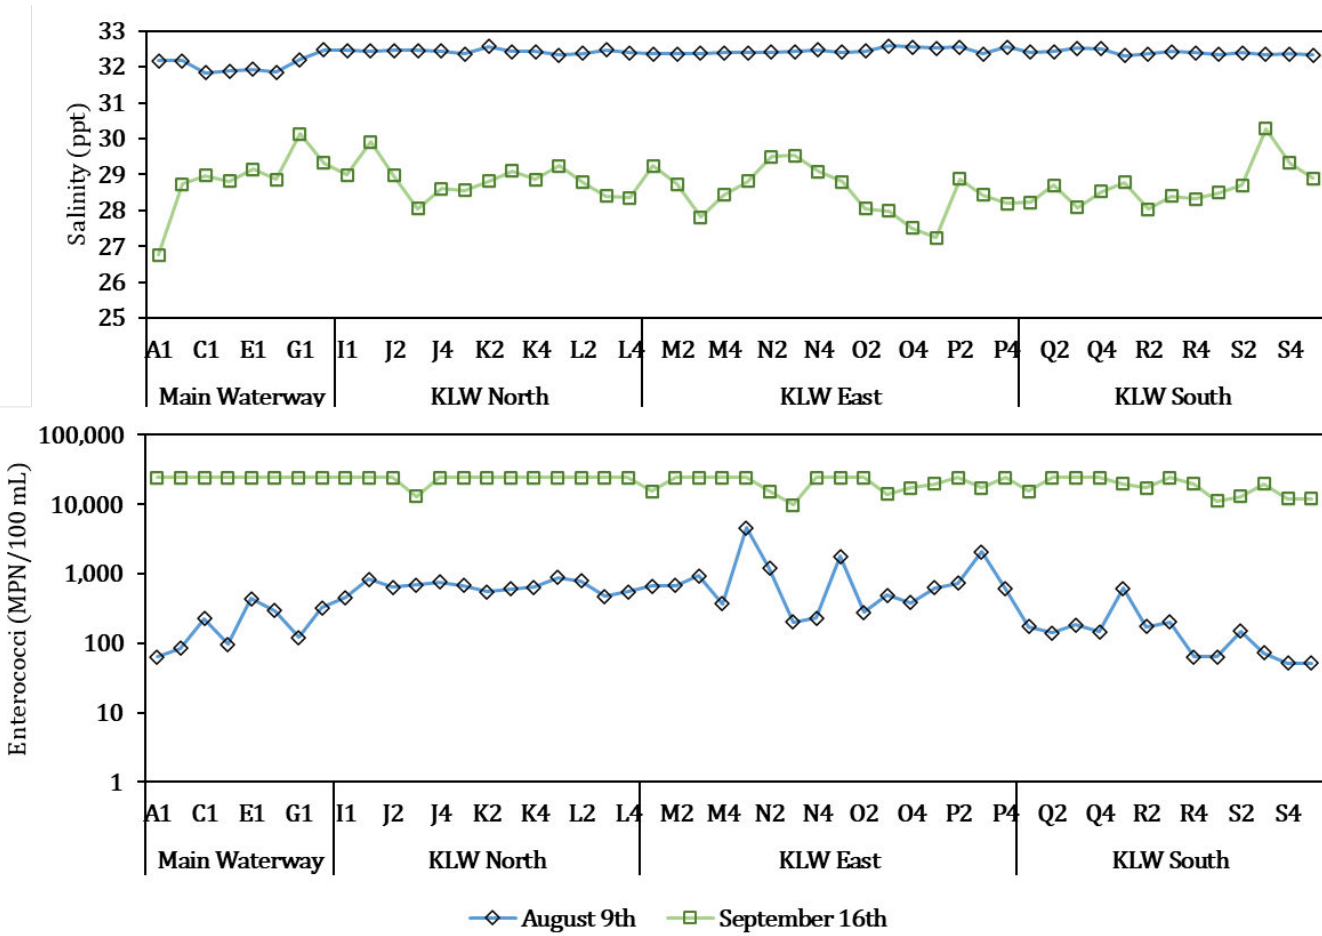
Figure V.6: Results from spatially intense sampling around the perimeter of Parkview Island, comparing the results from the August 19th sampling event (high tide) and the September 16th sampling event (low tide). Top panel compares salinity and lower panel compares enterococci.

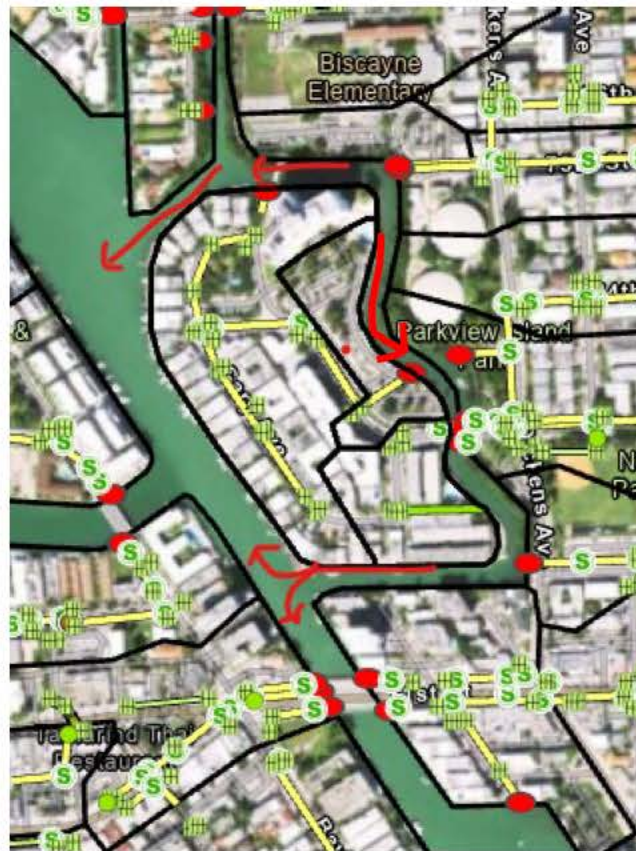
Figure V.7: Schematic of conceptualized tidal flushing during ebb tide, with more tidal flushing towards the south of Parkview Island. It is possible that tidal flushing through the PVC North is limited by the sharp 45-degree angles created by Biscayne Point Island and flows from the waterways to the north. In contrast, water exiting the PVC South could flow to the main waterway with less impedances.

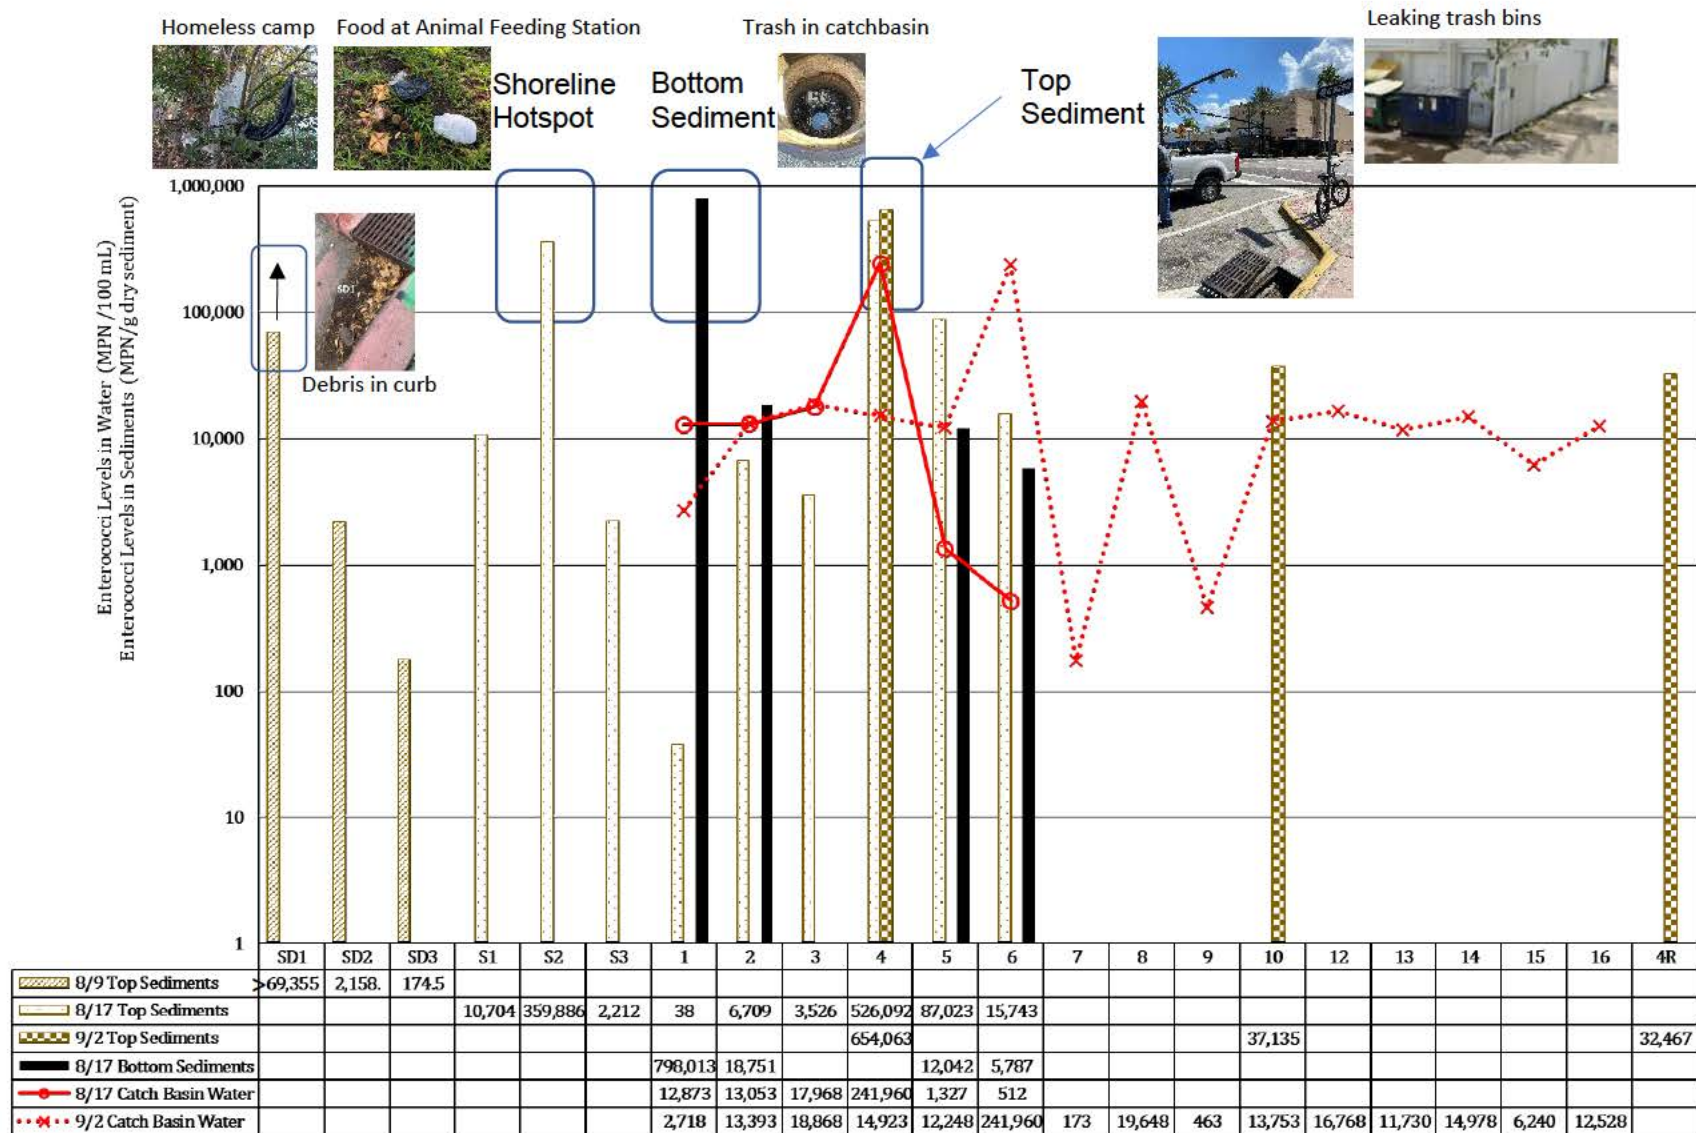
Figure V.10: Results from sediment and water sampling of channel banks and catch basins (August 17 and September 2). Sediment results shown by bar plots and water results shown by lines.

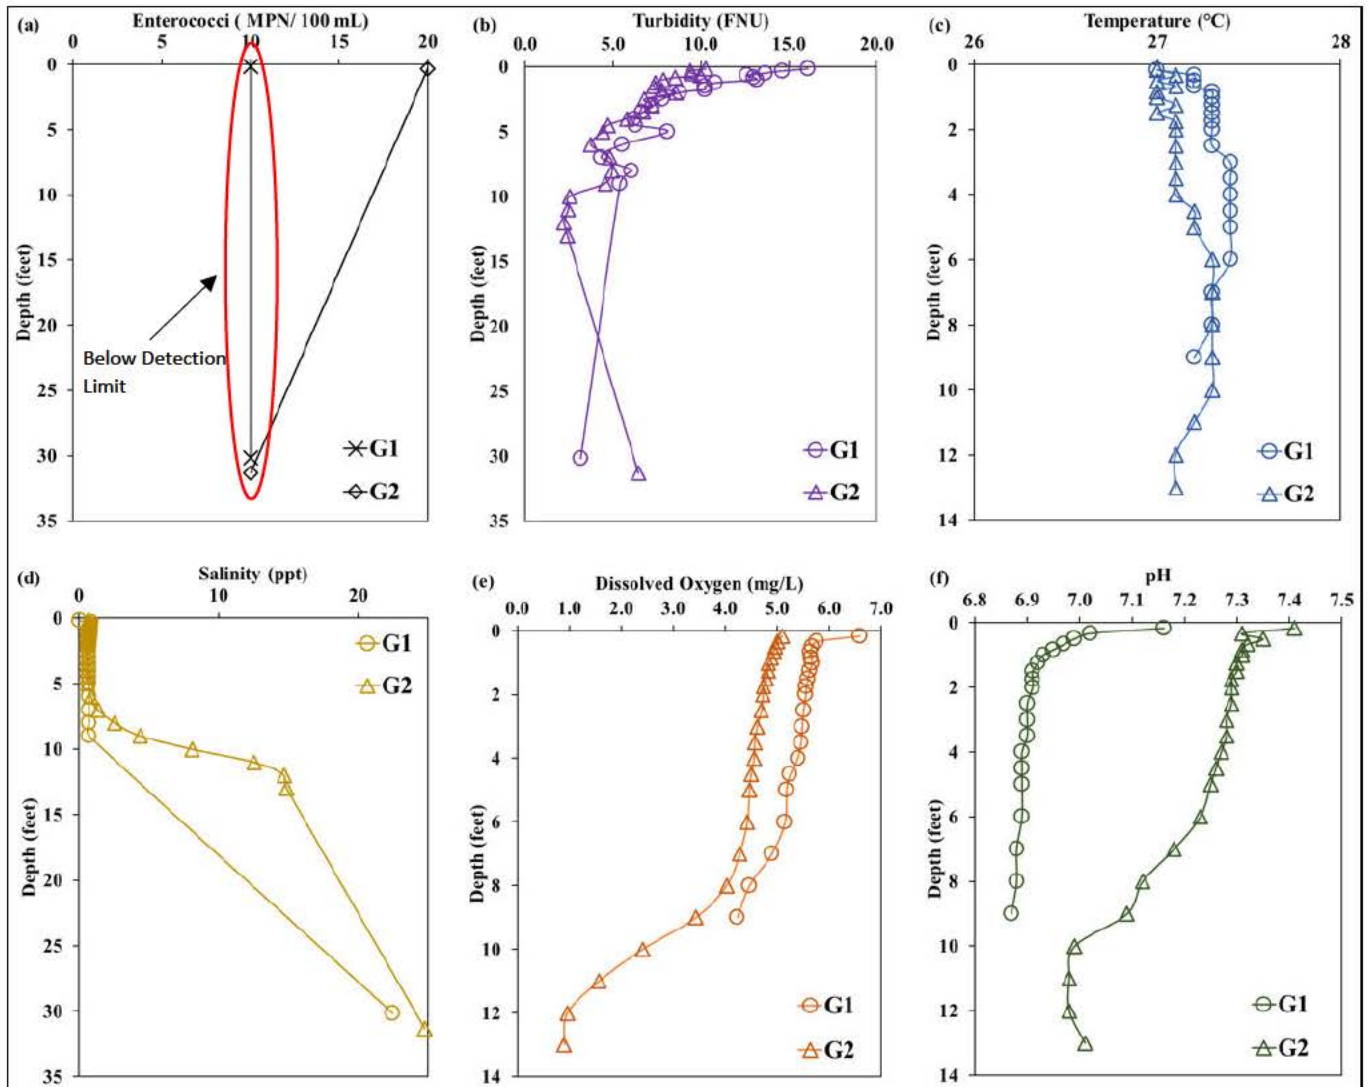
Figure V.18: Groundwater measurements at stations G1 (Bandshell) and G2 (Parkview Island) collected on November 14, 2022. Panel (a) enterococci concentration; Panel (b) turbidity; Panel (c) temperature; Panel (d) salinity; Panel (e) dissolved oxygen; and Panel (f) pH.

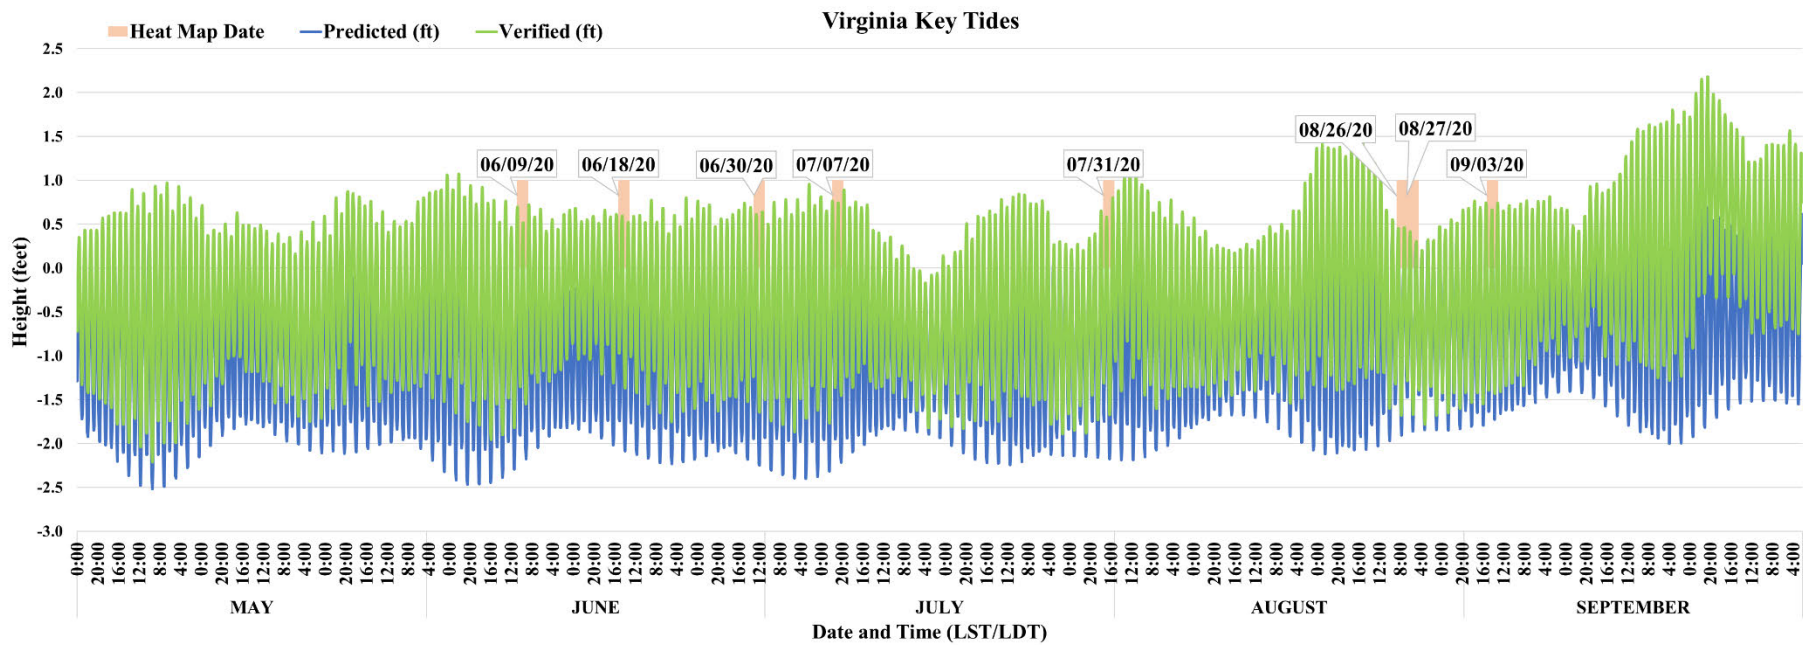
Figure B.4: Virginia Key predicted and verified tides, dates from Heat Maps with FIB peaks. Heights are referenced to NAVD.

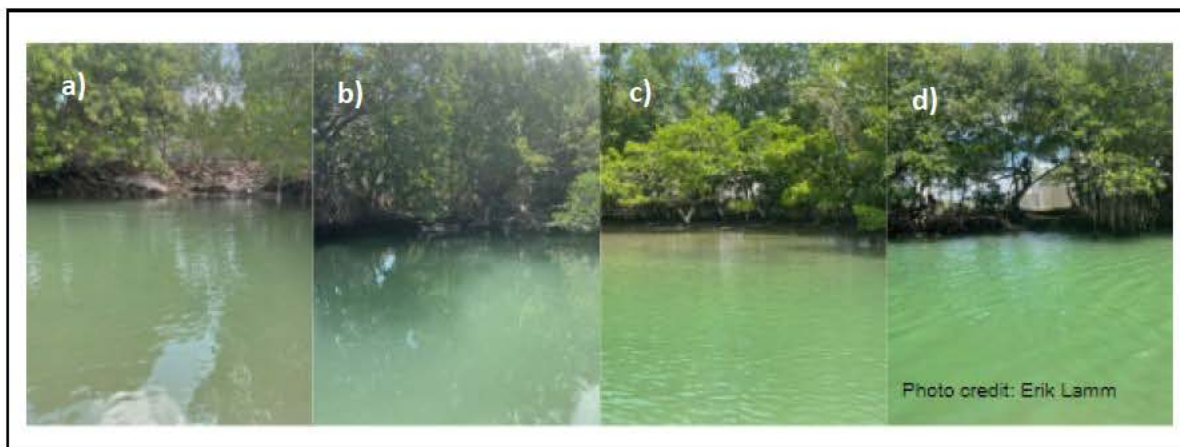
Figure D.4: Locations along the PVC with shallow water during low tide which are more highly influenced by channel bank sediments. Channel bank sediments have been shown to have elevated levels of enterococci.

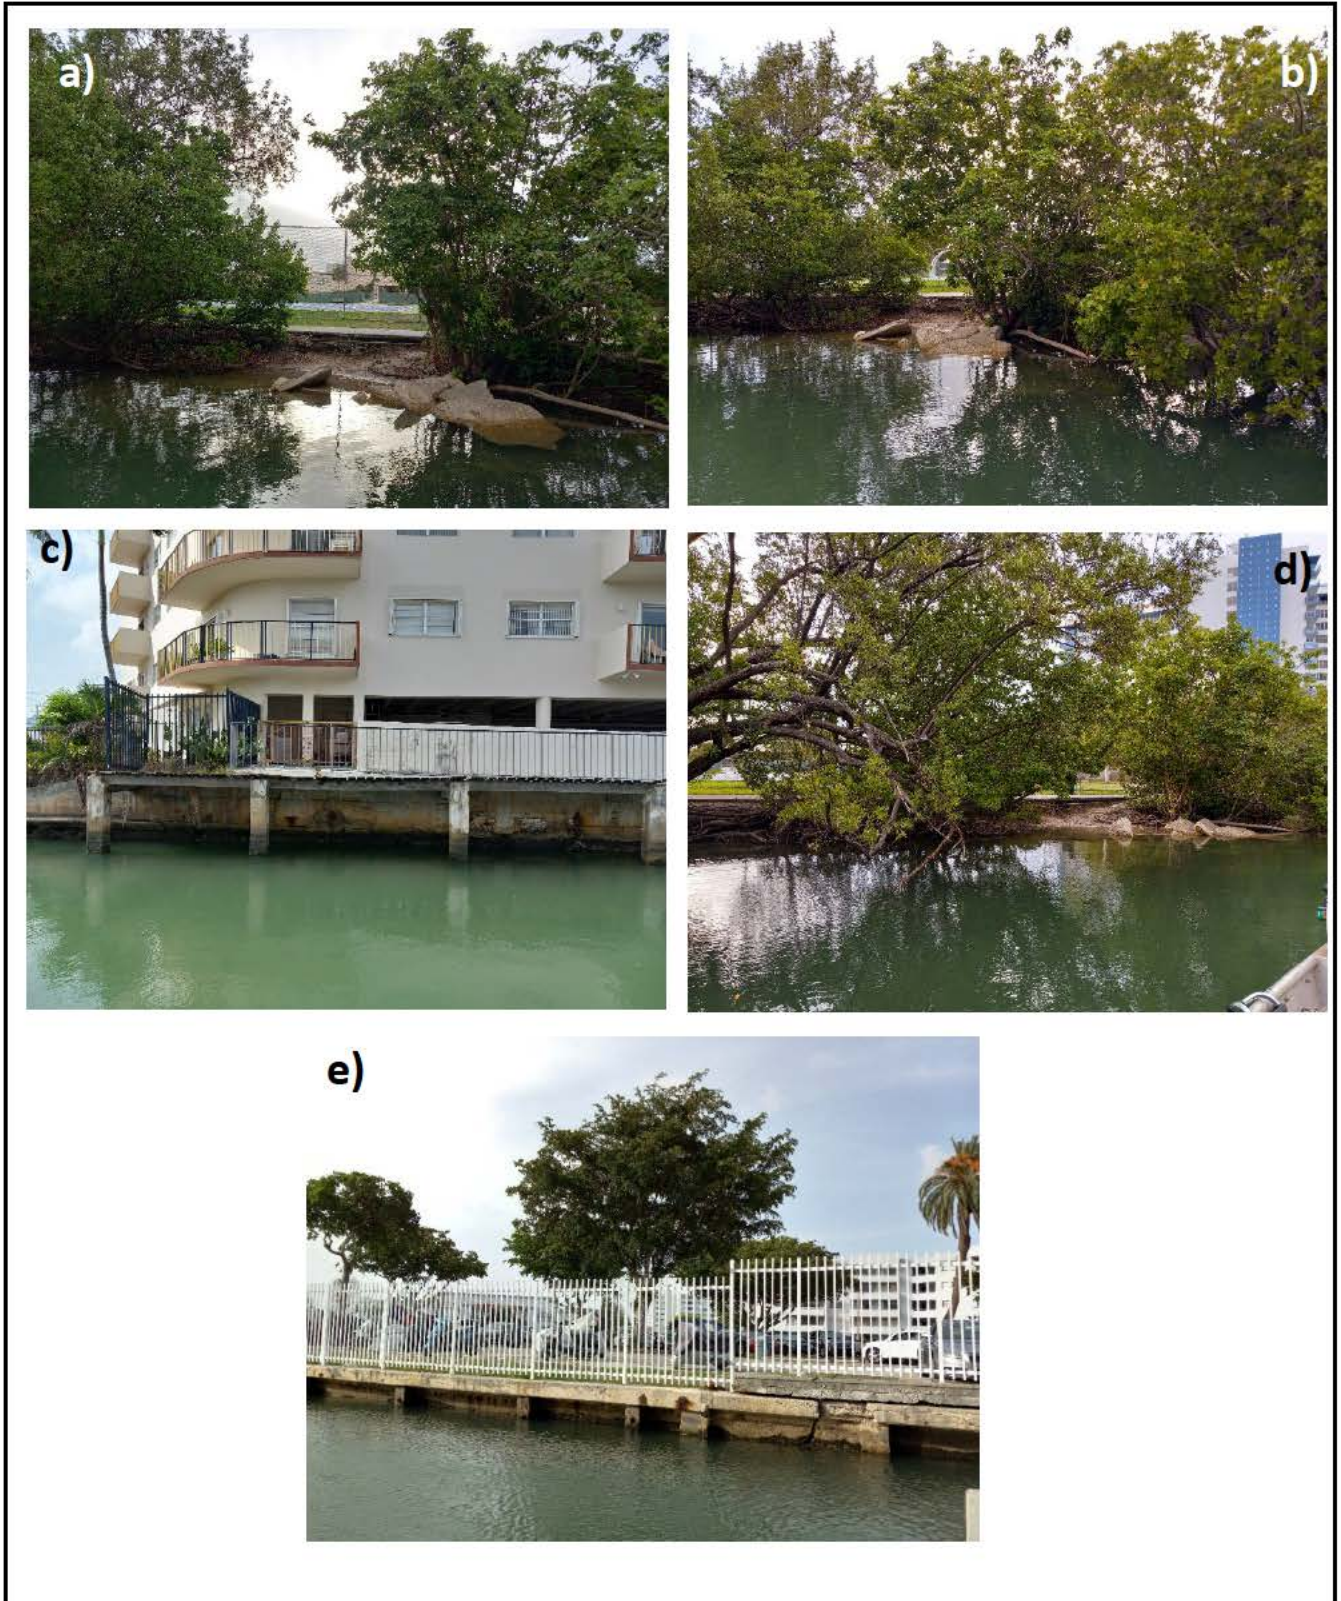
Figure D.7: Shoreline types along PVC varies from sediment shoreline with dense mangrove canopy, exposed sediments showing signs of erosion, sediment shoreline reinforced with human-made walls, and a retaining wall extending to an undetermined depth
