**Assessment of Water Quality
at the Miami Beach Park View Canal
to Identify Sources of the Fecal Indicator Bacteria,
Enterococci**

FINAL REPORT

University of Miami, Coral Gables, FL
Department of Chemical, Environmental, and Materials Engineering

City of Miami Beach (c/o Lindsey Precht)
1700 Convention Center Drive
Miami Beach, FL 33139

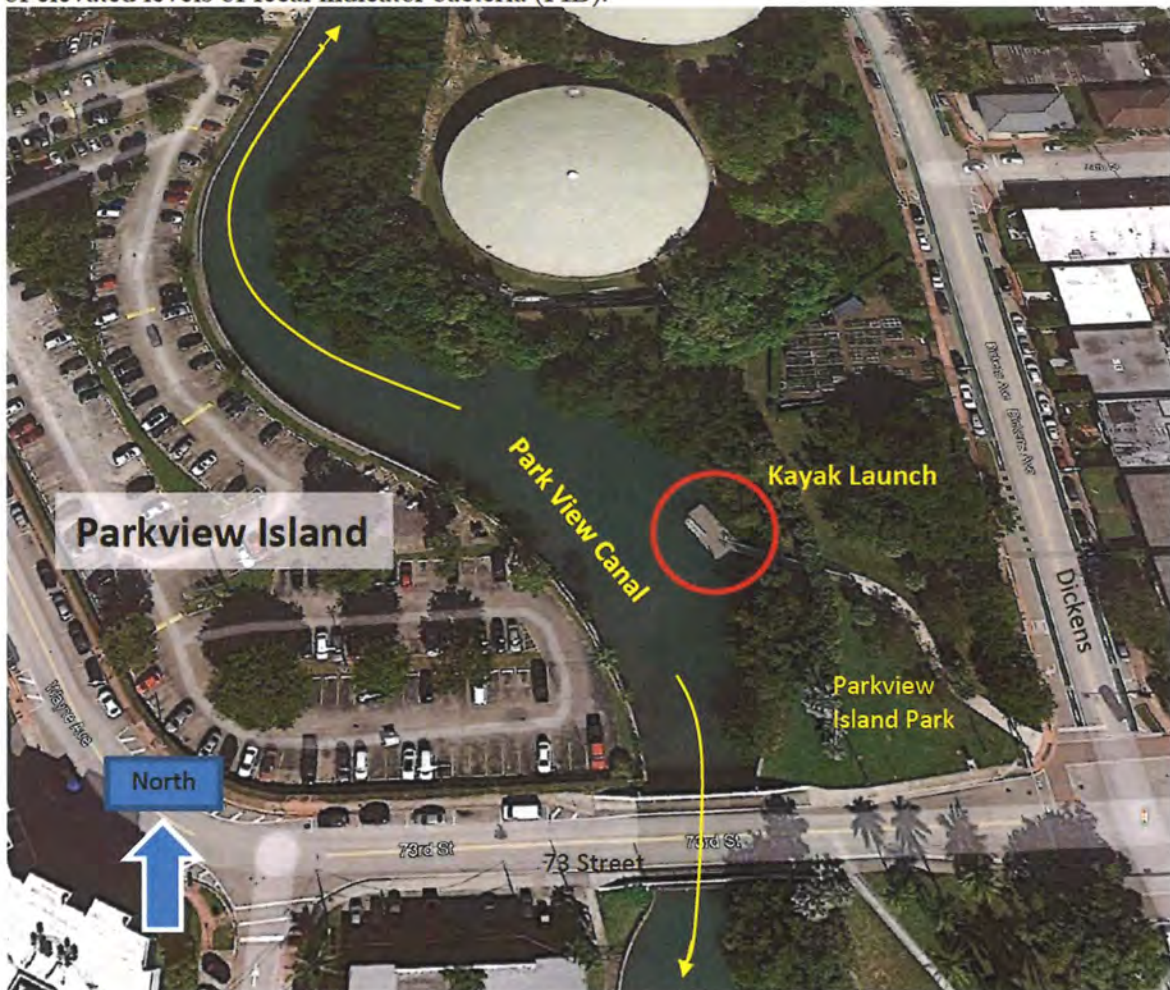
Figure I.1: The PVC emphasizing the location of the Kayak Launch ($25^{\circ} 51' 31.20''$ N. $80^{\circ} 07' 33.00''$ W), near 73 Street and Dickens Avenue Miami Beach, FL. Basemap from Google Earth.

The Park View Canal (PVC) at the City of Miami Beach (CMB) (GPS: $25^{\circ} 51' 31.20''$ N. $80^{\circ} 07' 33.00''$ W for the Launch) located near 73 Street and Dickens Avenue (Figure I.1) has a history of elevated levels of fecal indicator bacteria (FIB).

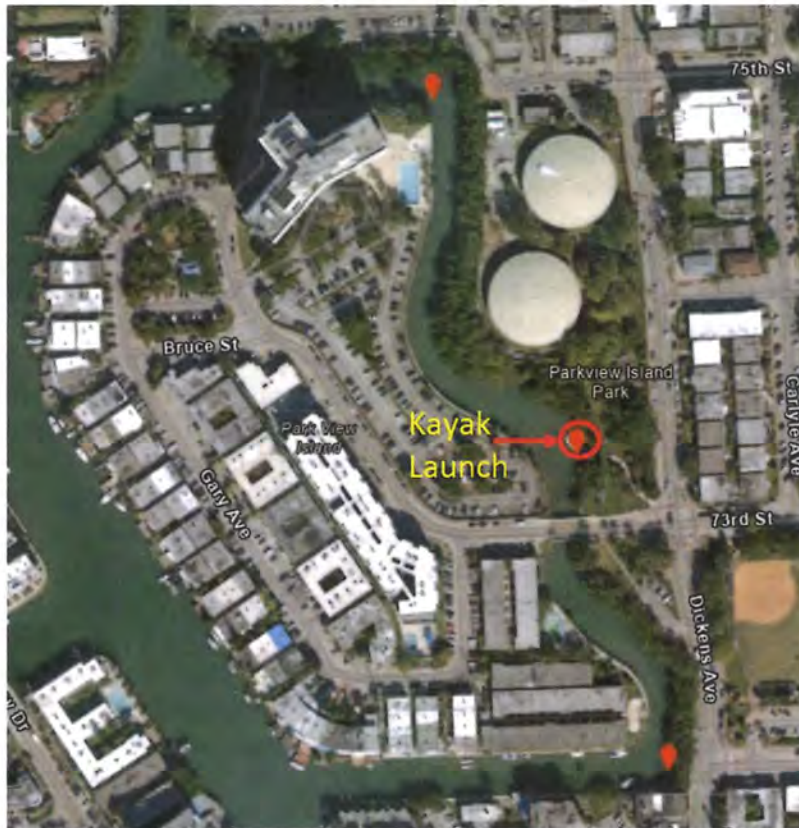
Figure I.3: Location of Surfrider Foundation Study Sampling Sites Shown in red pins.

Despite the implementation of these measures focused on dog waste removal, the levels of FIB at the PVC remained elevated. Given these continued elevated levels of FIB, Surfrider Foundation initiated its own MST studies (JV 2022a,b). Three samples were collected in the PVC on July 14, 2022, one at the Kayak Launch, one to the north, and one to the south (Figure I.3). Results from the first Surfrider Foundation study suggest that the fecal indicator bacteria levels in the waterway come from human and dog sources. The human marker was found in 2 out of 3 replicates at the south end, and in one replicate at the Kayak Launch. However, human was not detected at the North end. The average number of copies detected for the Human01 assay were almost double at the south (477 per 100 mL) end than at the Kayak launch (257 per 100 mL). Three additional samples were collected on August 18, 2022 at the same locations. Results from the second Surfrider Foundation study also suggest that the fecal indicator bacteria levels at the canal also come from humans. However, no dog markers were detected in any of the three samples collected in August. The average number of copies detected for the Human01 assay were about one order of magnitude greater in the samples collected at the north (3,222 per 100 mL) and at the Kayak Launch (1,445 per 100 mL). In contrast to the July sampling activity, the sample collected at the south end of the canal had lower concentrations of the Human01 marker (213 per 100 mL). Results from the second Surfrider study show human DNA was present, in all three locations, and the two locations that tested positive on July 14, 2022, had higher levels during the second sampling on August 18, which could be due to heavy rainfall recorded prior to the sampling. The southern area of the canal coincides with the storm sewer conveyance line along 72 Street which is in-line with the location of the March 5, 2020, line break at Harding Avenue and 72 Street. Given these data, the sample collection plan developed for this current study takes this information into account by first establishing a spatially intense sampling effort to confirm the geographic location of enterococci sources along the entire perimeter of Parkview Island to identify the location of hot spots in the area.

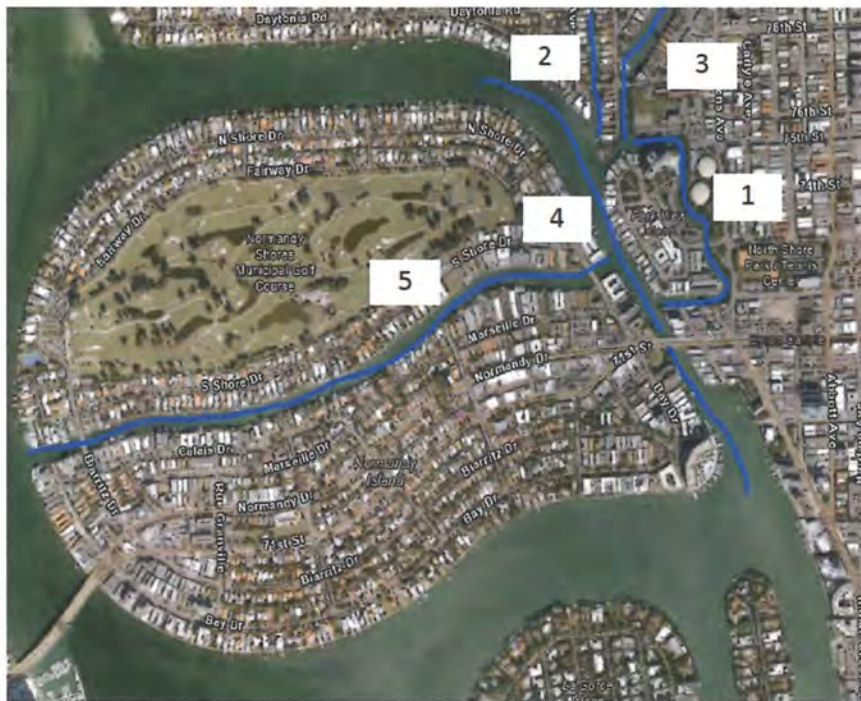
Figure I.4: Map showing locations of 1) Park View Canal, 2) Biscayne Point Waterway, 3) Tatum Waterways, 4) Normandy Waterway N-S, and 5) Normandy Waterway E-W.

View Island. The PVC is connected to a network of waterways that run north to south (Tatum, Biscayne Point and Normandy Waterway N-S) and east to west (Normandy Waterway E-W) (Figure I.4). Most of the waterways in this network have direct access to Biscayne Bay, however the PVC does not. It is important to note that the waterway has bends in the longitudinal direction (Northeast and Southeast banks of Park View Island) that impede the natural circulation of the water which is mainly driven by tides. Studies have shown that the degree of water circulation impacts the levels of FIB within waterways. Other studies have shown that ocean facing beaches in the State of Florida have better water quality than bay facing beaches (Kelly et al. 2018). The PVC is on the bay side of Miami Beach on a narrow waterway within another narrow waterway, thereby greatly limiting tidal flushing of the waterway and allowing for the accumulation of FIB. Other waterway characteristics include its relatively shallow depth, its numerous bends, and the mangroves and shallow banks along its edge which have been shown to allow for FIB persistence and growth (Desmarais et al. 2002). Additionally, the area is very highly urbanized with significant sanitary and storm sewer systems. The following sections of this report provide details on measured PVC depth in the longitudinal direction and also observed shoreline types (mangroves, retention walls, exposed sediments, and others).

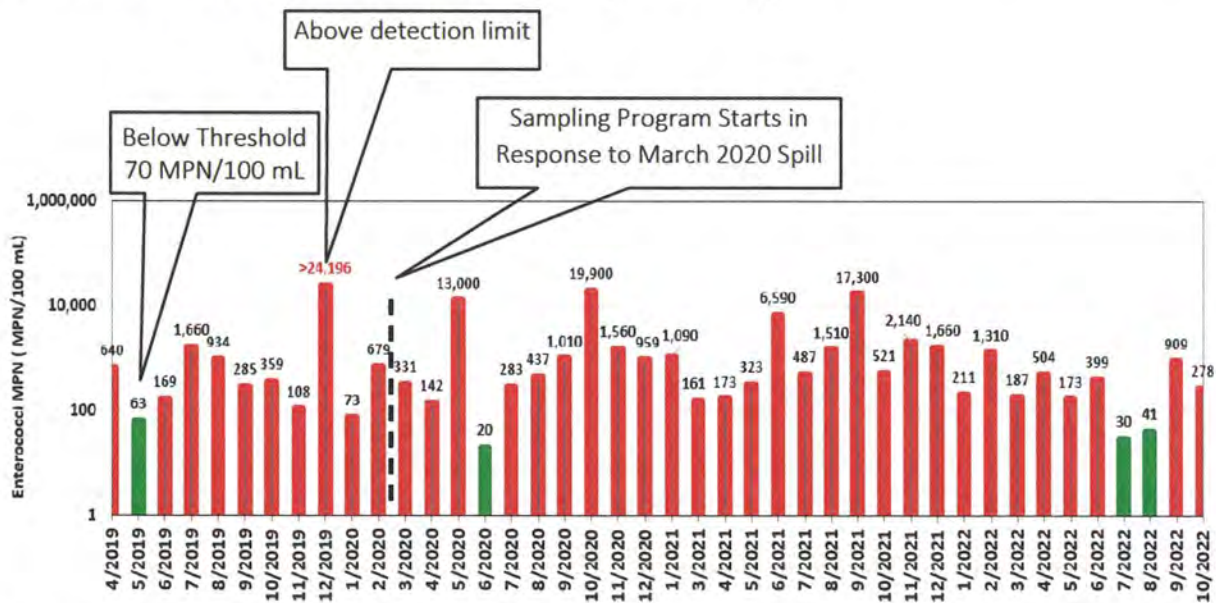
Figure II.1: Results from Monthly Enterococci Measurements at PVC from 4/2019 to 10/2022. Green bars correspond to data points within the 70 MPN/100 mL recommended recreational level whereas red bars correspond to data points which exceed this level. Note the data are plotted on a logarithmic scale due to the wide range of measurements.

Since the monitoring program started in 2019, the fraction of the time the PVC waterway has exceeded the 70 MPN/100 mL threshold has been at or above 80%, with the highest number of exceedances observed for year 2021 when all samples collected exceeded the regulatory threshold 70 MPN/100 mL. For the entire period of record evaluated (April 2019 to October 2022) the PVC exceeded the 70 MPN/100 mL threshold 90% of the time.

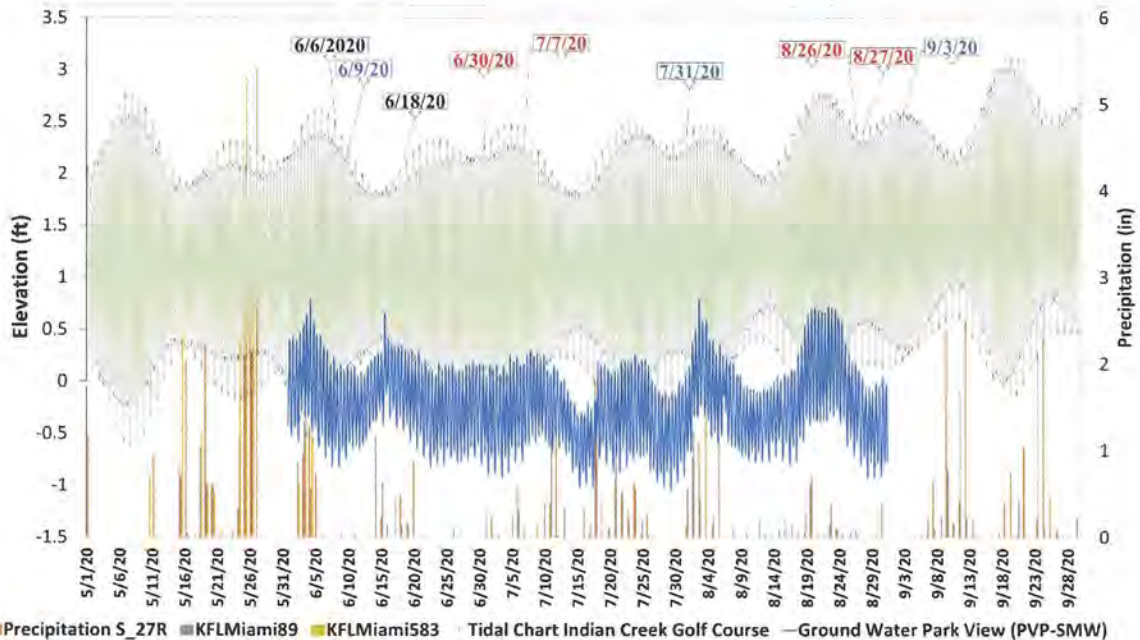
Figure II.3: Time series plot of rainfall, tides and groundwater superimposed on dates and peak enterococci levels measured in catch basins. Elevation corresponds to NAVD.

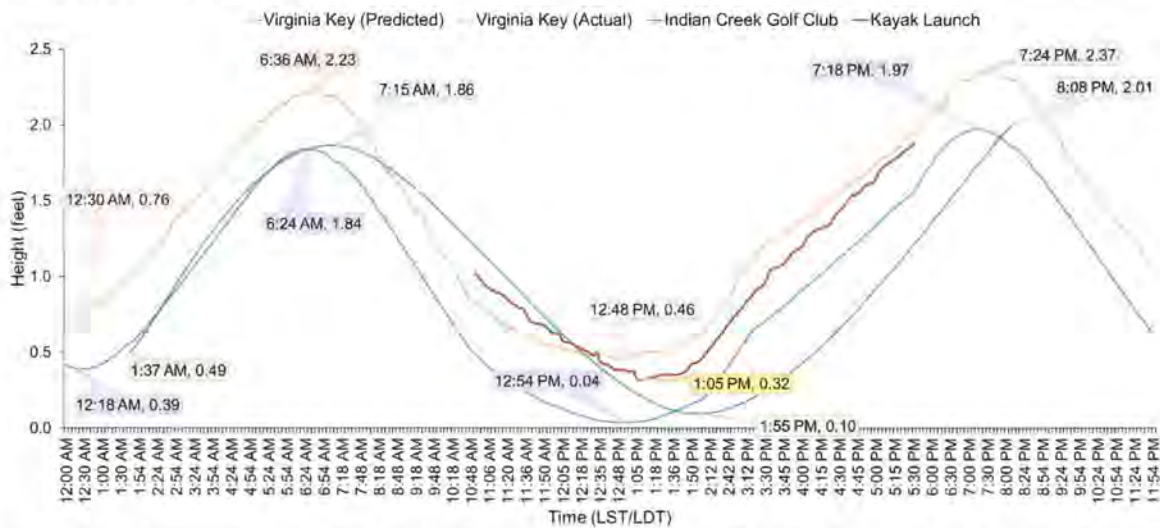
Figure II.4: Measured tidal data at the Park View Canal on July 24, 2022, and tide predictions at the NOAA tidal stations located at Indian Creek Golf Club and Virginia Key stations. The data labels represent the high and low tides. All heights except for the Kayak Launch reference NAVD. Water levels at the kayak launch were measured against a fixed location on the piling and were not tied to a datum.

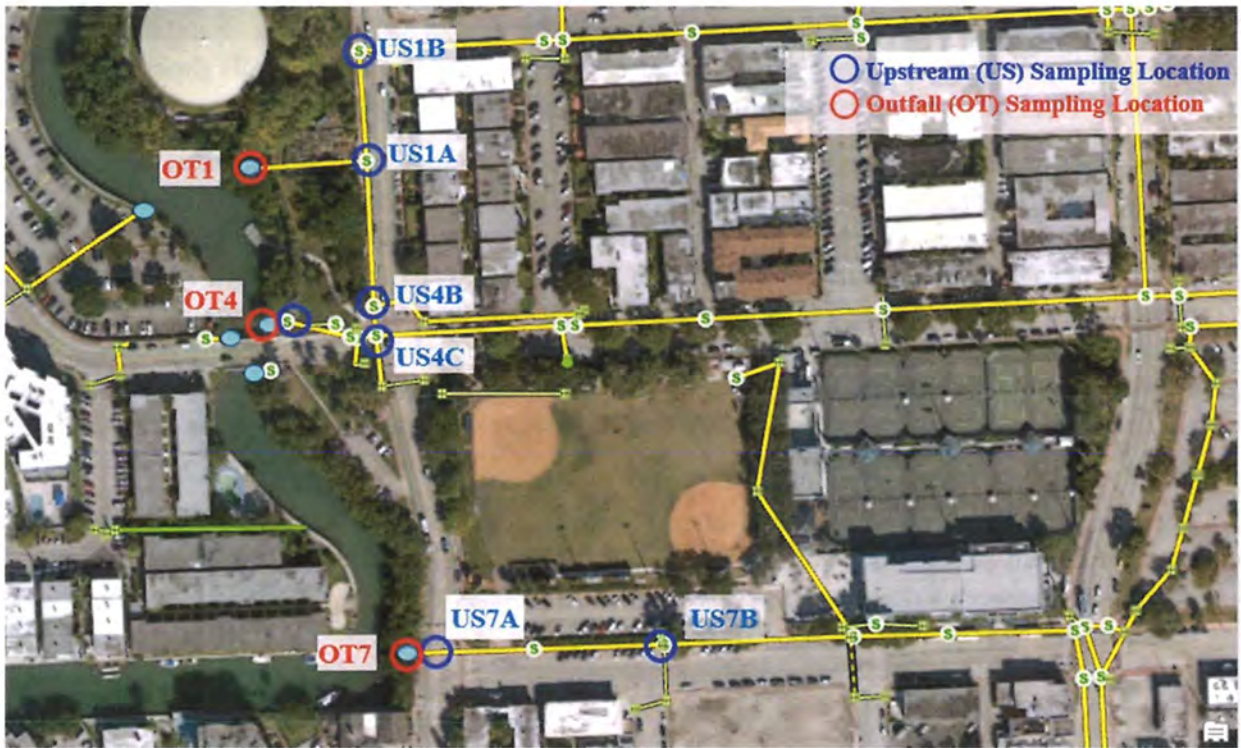
Figure II.5: Sampling locations of the upstream (US) and outfall (OT) shown in the blue and red circles within the map. Original map provided by the CMB containing data collected by E Sciences Inc.

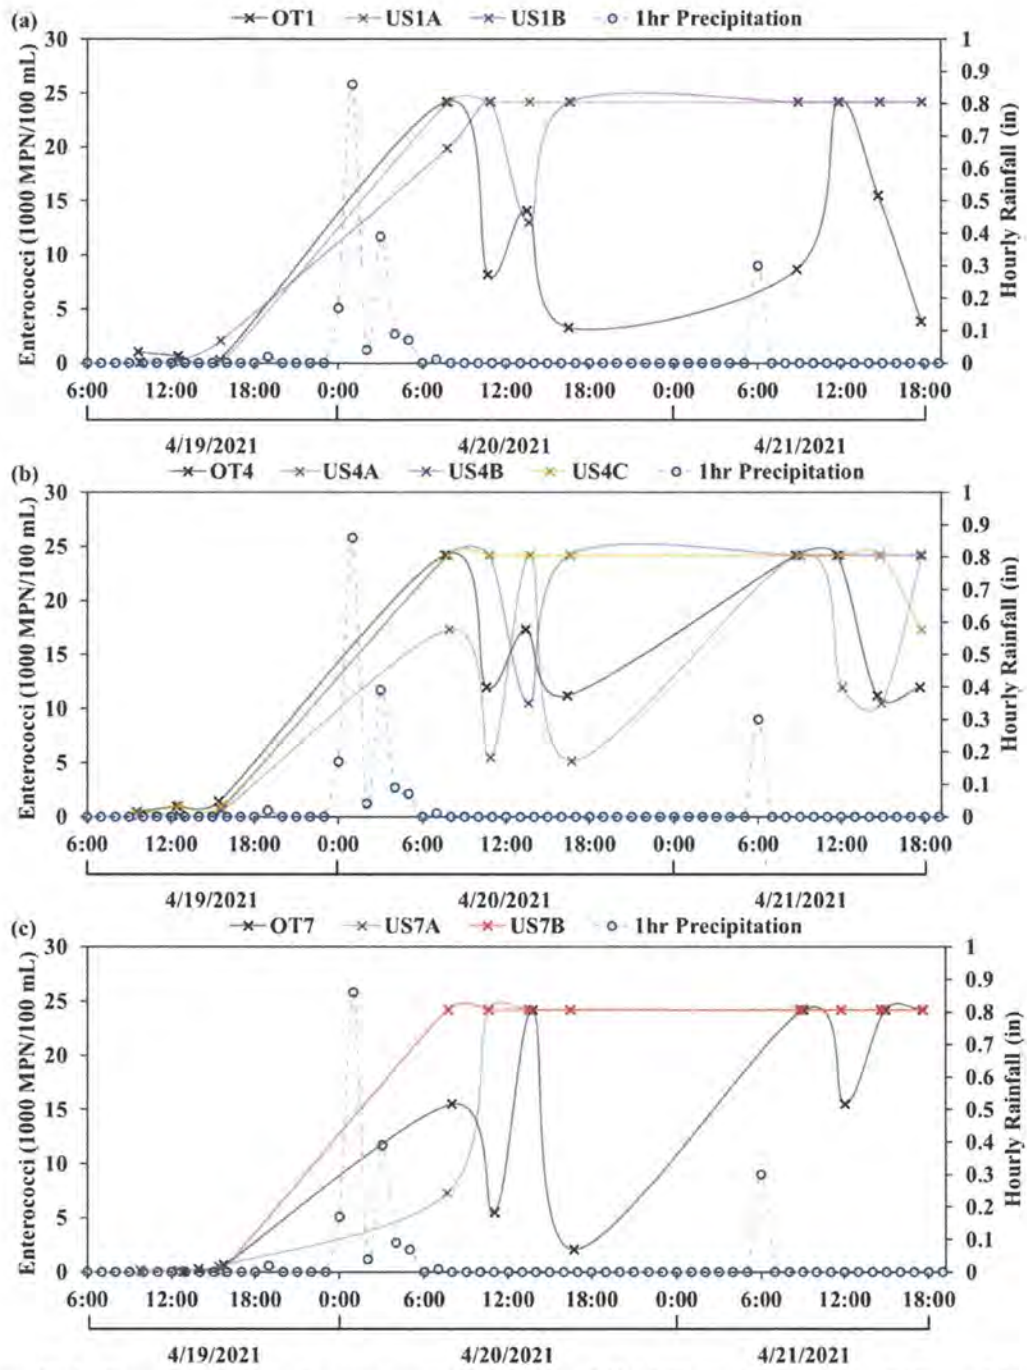
Figure II.6: Concentration of enterococci in the outfall (OT) and upstream (US) and hourly rainfall based on the time series. Panel (a) includes outfall and upstream for the first location; Panel (b) includes outfall and upstream for the fourth location; Panel (c) includes outfall and upstream for the seventh location.

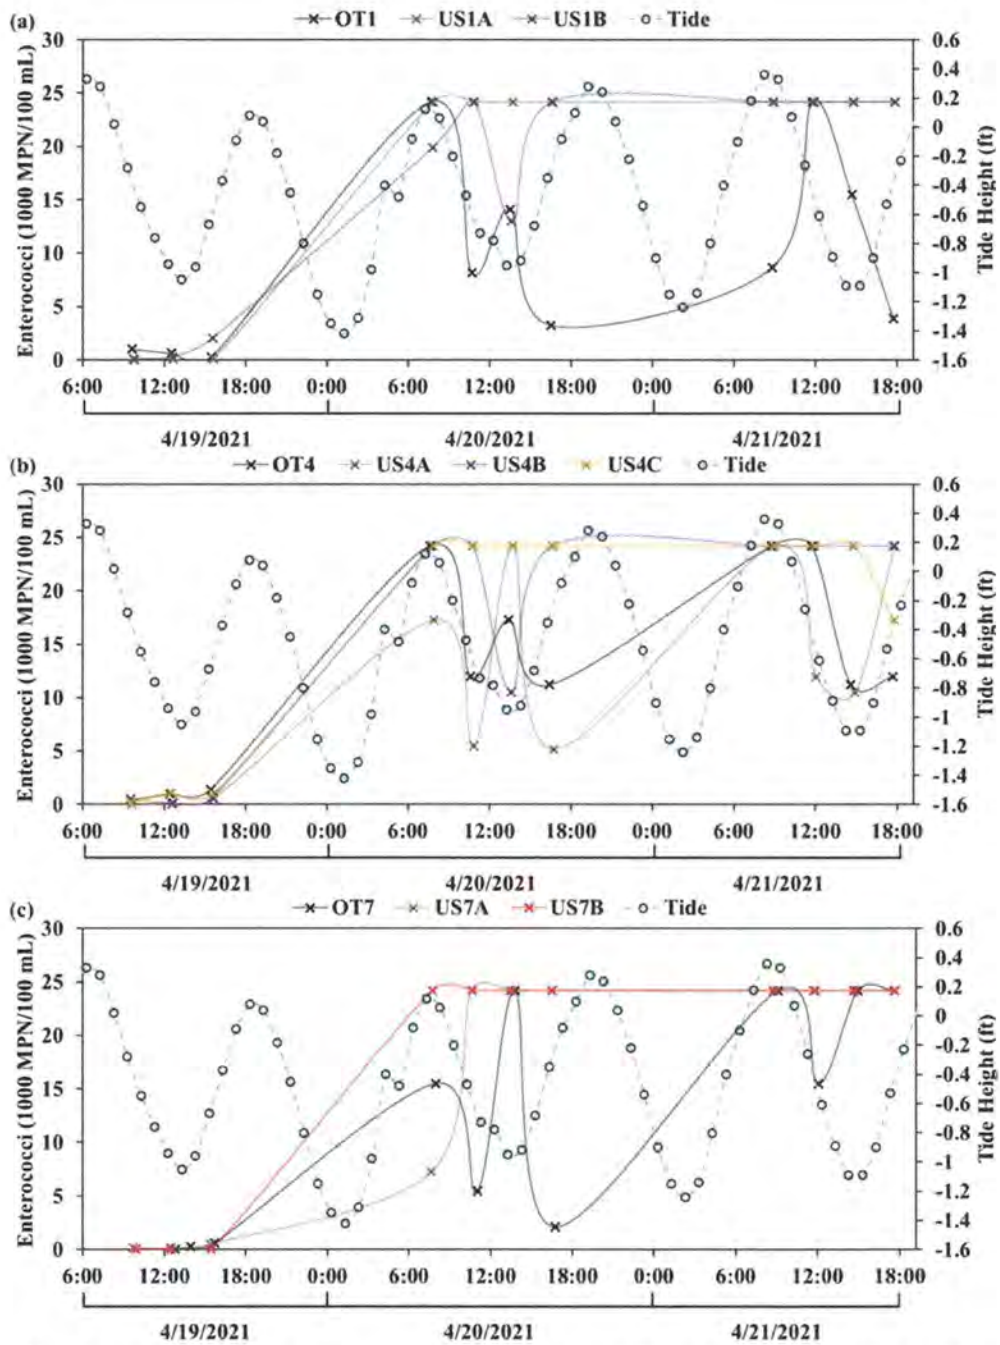
Figure II.7: Concentration of enterococci in the outfall (OT) and upstream (US) and height of sea tide based on the time series. Panel (a) includes outfall and upstream for the first location; Panel (b) includes outfall and upstream for the fourth location; Panel (c) includes outfall and upstream for the seventh location.

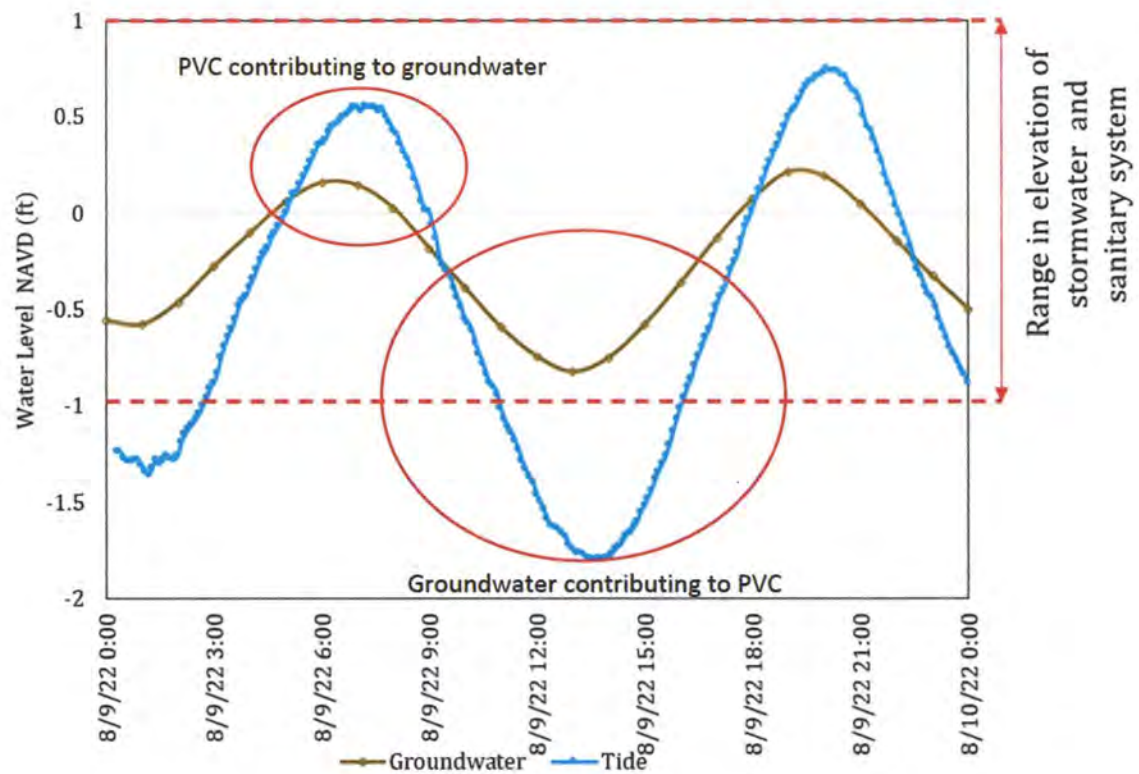
Figure III.5: Estimated tidally driven water levels at PVC and measured groundwater elevation at Parkview Island Park monitoring well.

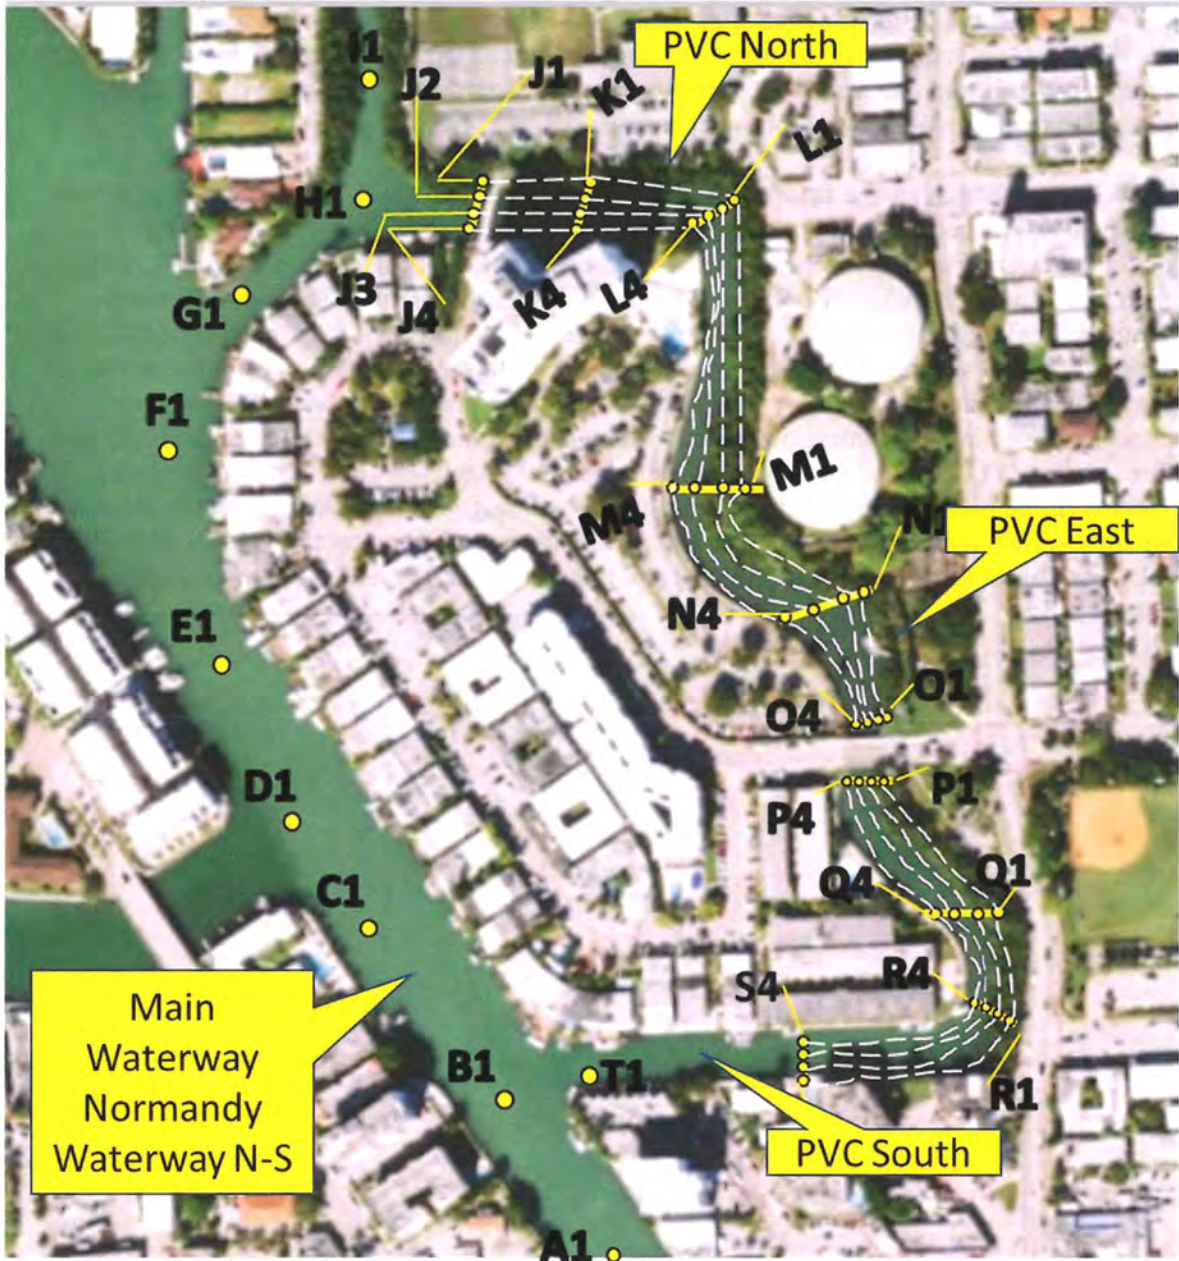
Figure V.2: Map showing transects with sampling locations for intense spatial sampling activity conducted on August 9th and September 16th. Red points show the location of the stormwater outfalls, green lines show the location of the stormwater mains, orange line on the northeast bend of the canal shows the location of the siphon, brown lines show the location of the sanitary sewer system force and gravity mains.

On both sampling days, the first sample was collected at Transect A, and the last sample was collected at Transect S, as the boat transporting our team travelled in a counterclockwise direction around Parkview Island. Enterococci concentrations measured on August 9, during high tide, ranged from 52 MPN/100 mL to 4,611 MPN per/100 mL (Figure V.3). Several samples measured below the 70 MPN/100 mL threshold value, including the sample collected at Transect A, and several samples collected just before exiting the waterway on the south leg of the PVC. Sampling results show, a well-defined spatial pattern, of increasing enterococci concentrations, in the counterclockwise direction starting along the north leg of the PVC, and through the PVC East and moving south. This trend of increasing concentration, peaked in the vicinity of the Kayak launch Pad, along transects N through O. Three hotspots were identified, where the highest enterococci concentrations were measured at transect N1 (4,611 MPN/100 mL), at transect P3 (2,064 MPN/100 mL) and transect O1 (1,785 MPN/100 mL) (Figure V.5, panel a).

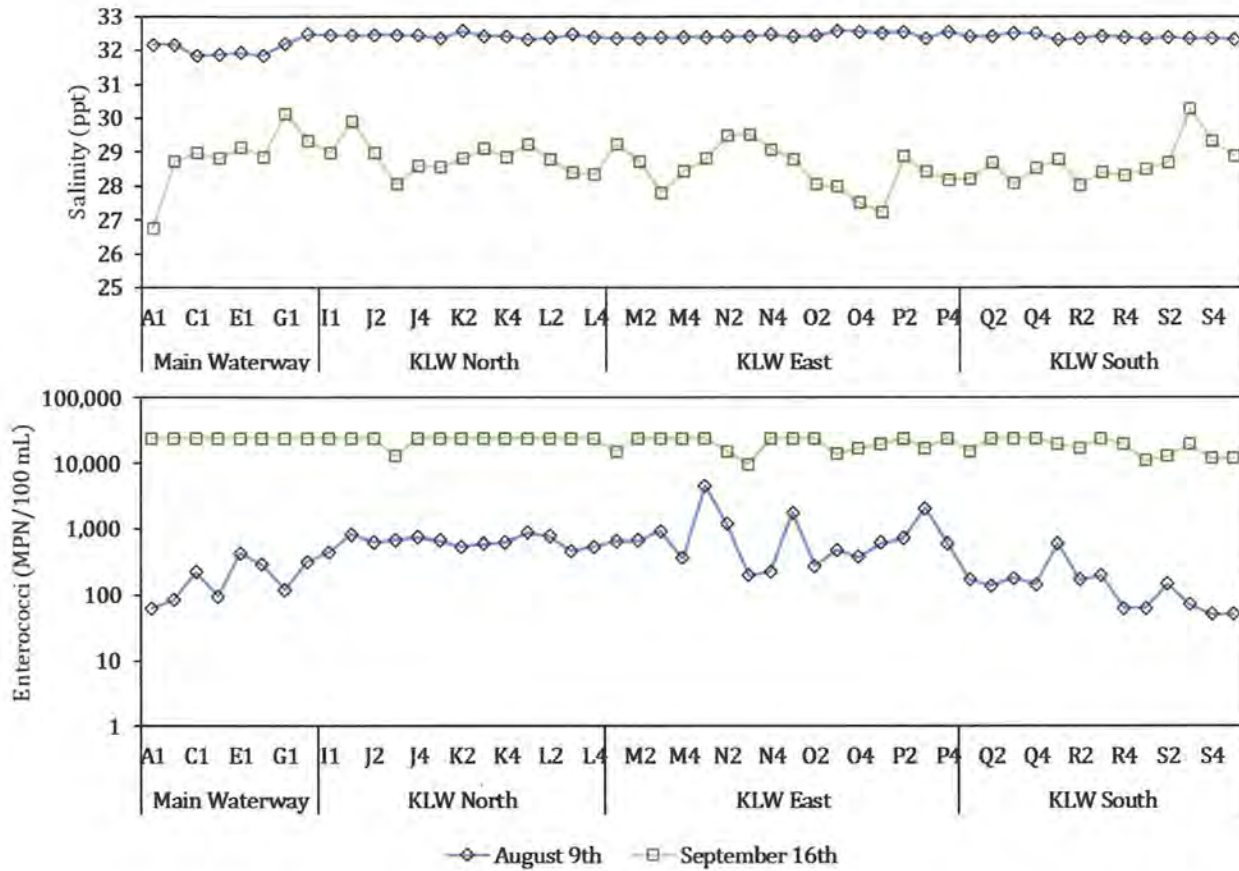
Figure V.6: Results from spatially intense sampling around the perimeter of Parkview Island, comparing the results from the August 19th sampling event (high tide) and the September 16th sampling event (low tide). Top panel compares salinity and lower panel compares enterococci.

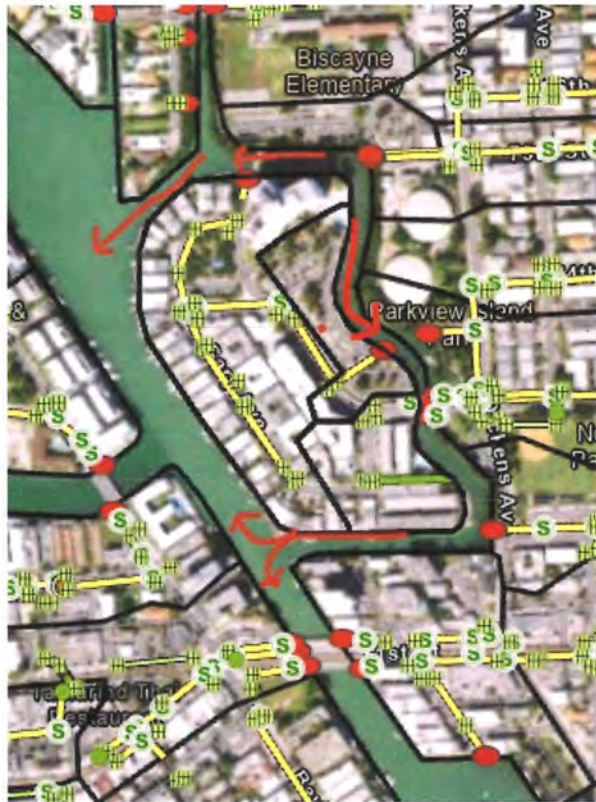
Figure V.7: Schematic of conceptualized tidal flushing during ebb tide, with more tidal flushing towards the south of Parkview Island. It is possible that tidal flushing through the PVC North is limited by the sharp 45-degree angles created by Biscayne Point Island and flows from the waterways to the north. In contrast, water exiting the PVC South could flow to the main waterway with less impedances.

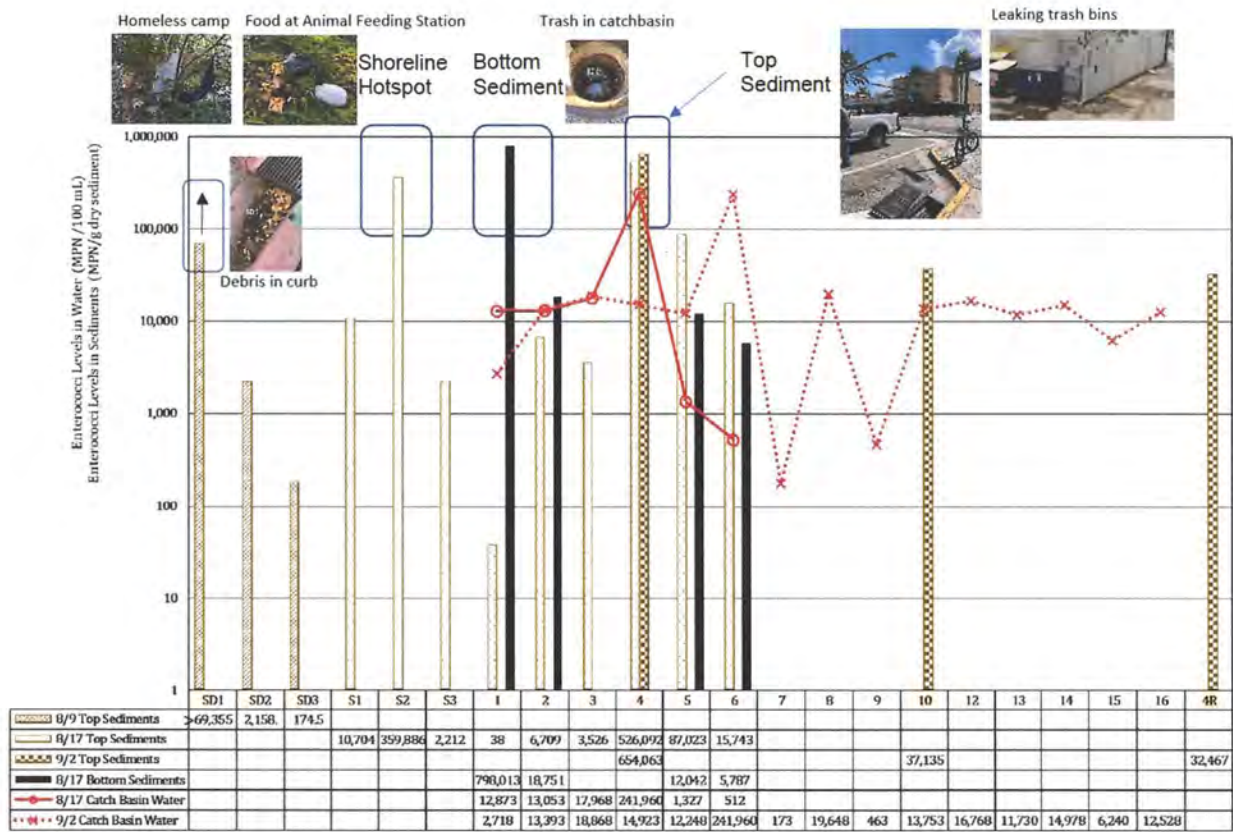
Figure V.10: Results from sediment and water sampling of channel banks and catch basins (August 17 and September 2). Sediment results shown by bar plots and water results shown by lines.

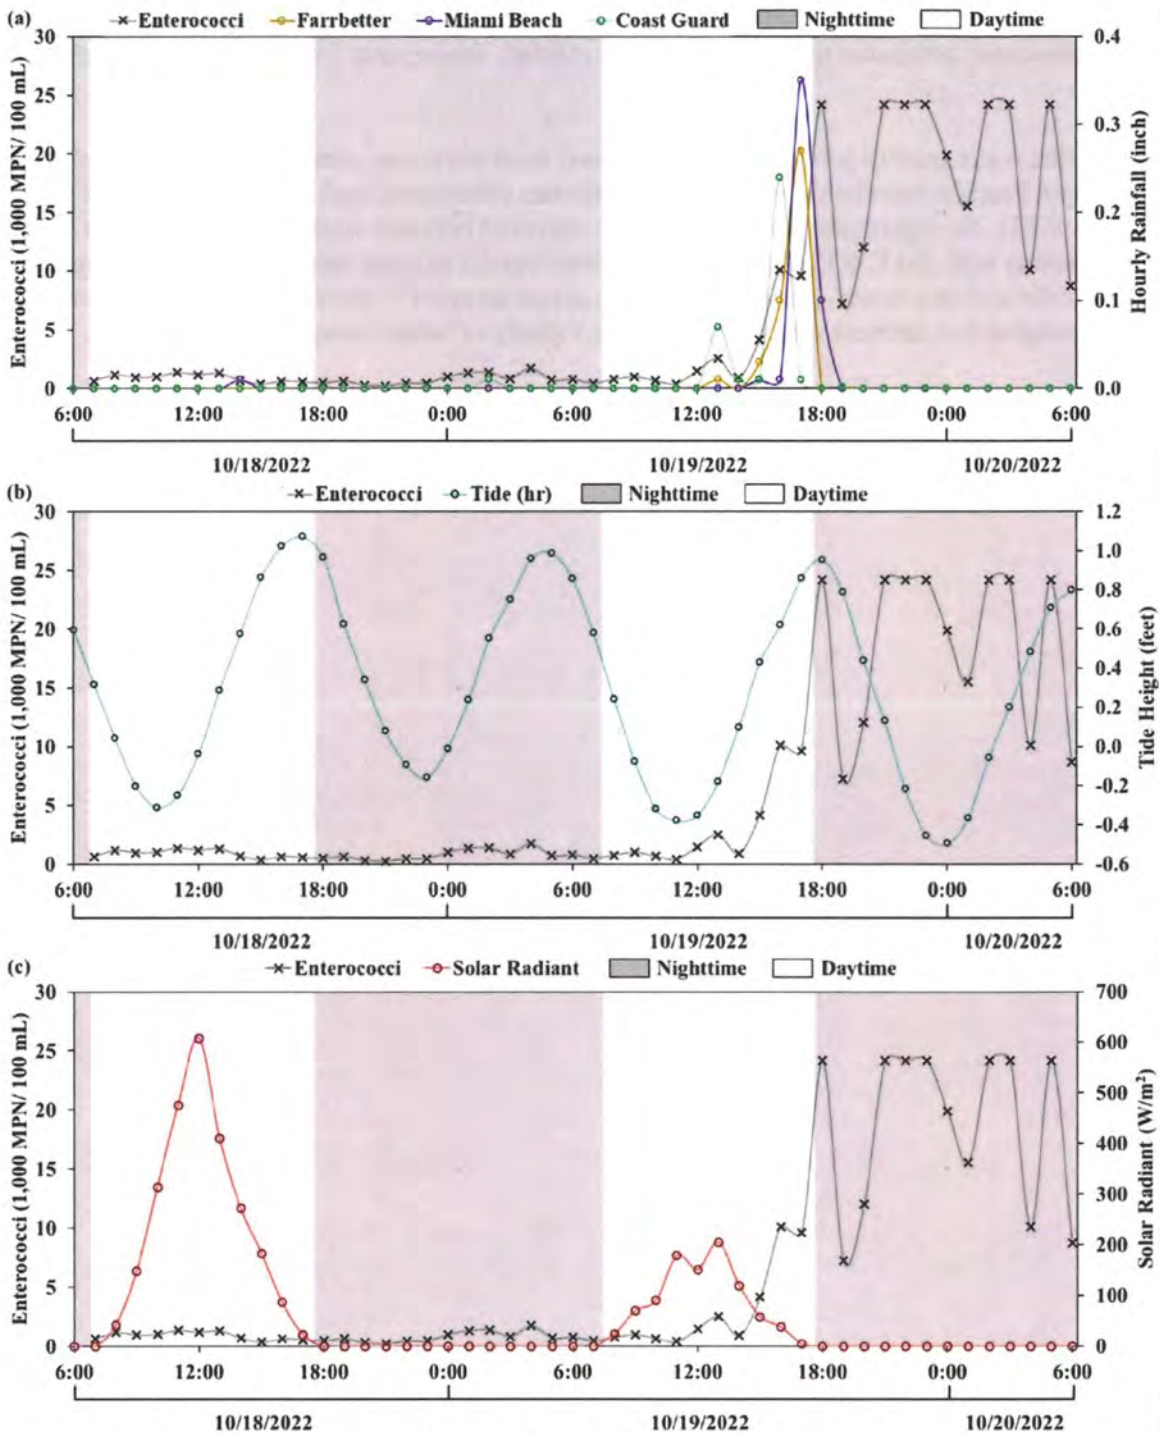
Figure V.11: Enterococci concentration at the KLV during the 48-hour sampling effort along with: Panel (a) hourly rainfall from three closest weather stations; Panel (b) tidal height; and Panel (c) solar radiation. White and grey background indicated daytime and nighttime during the sampling, respectively.

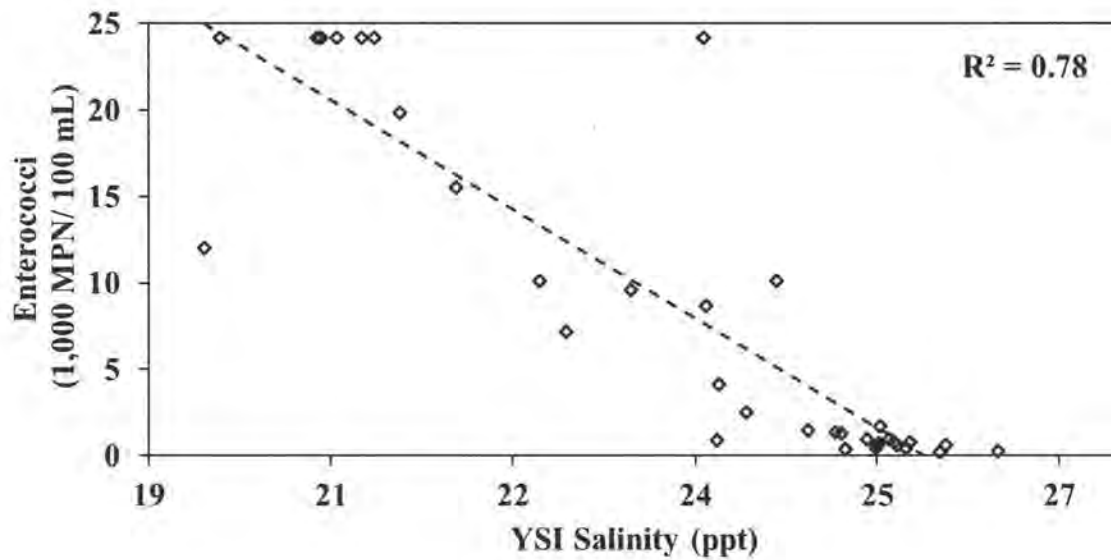
Figure V.13: Linear correlation between the concentration of enterococci and YSI salinity from 19:00 on Oct. 18, 2022, to 6:00 on Oct. 20, 2022.

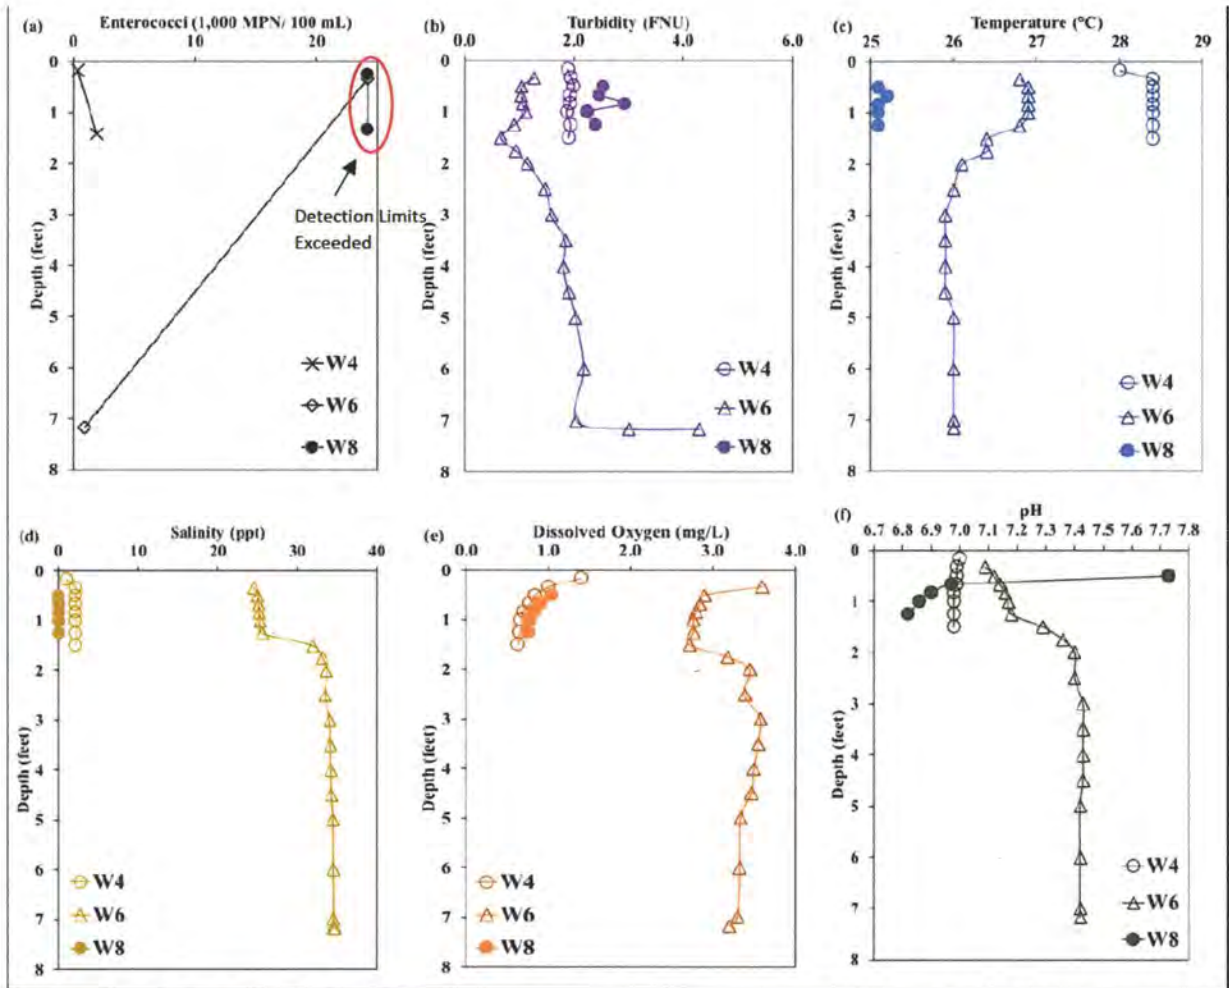
Figure V.16: Catch basin measurements (W4, W6 and W8) collected on November 14, 2022. Panel (a) enterococci concentration; Panel (b) turbidity; Panel (c) temperature; Panel (d) salinity; Panel (e) dissolved oxygen; and Panel (f) pH.

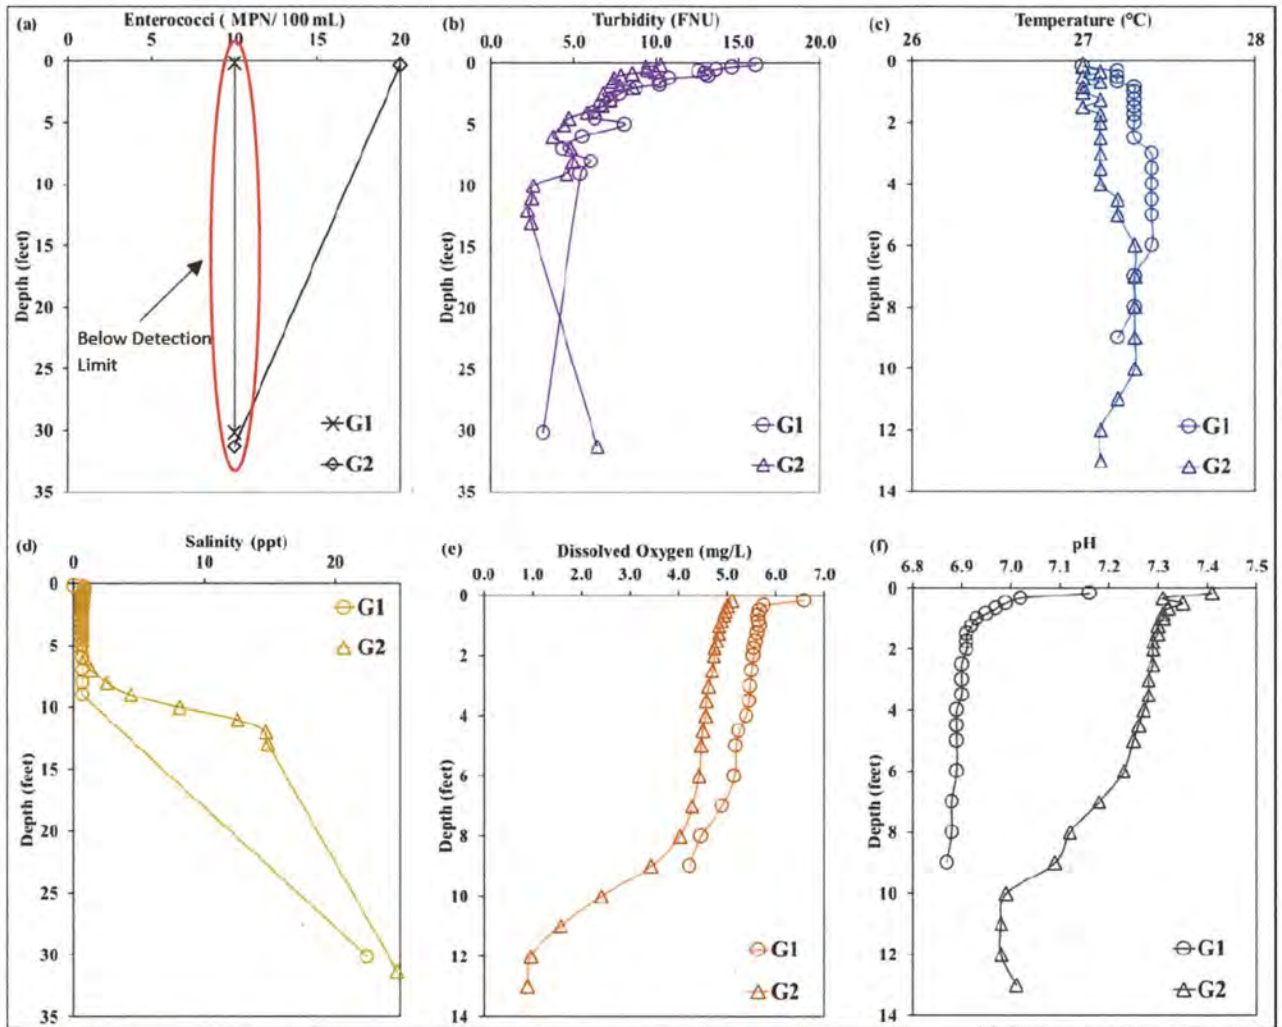
Figure V.18: Groundwater measurements at stations G1 (Bandshell) and G2 (Parkview Island) collected on November 14, 2022. Panel (a) enterococci concentration; Panel (b) turbidity; Panel (c) temperature; Panel (d) salinity; Panel (e) dissolved oxygen; and Panel (f) pH.

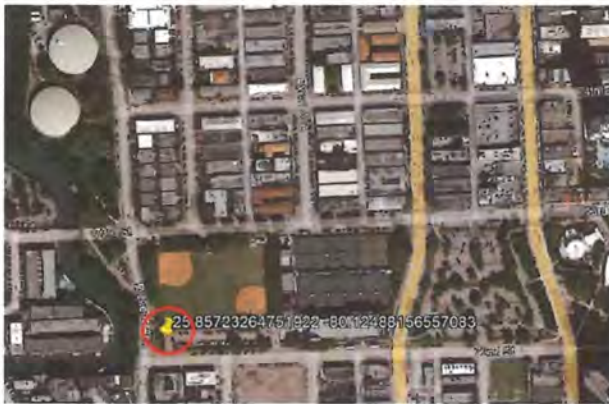
Figure A.1: Location of groundwater well for which data were included in the shared folder. Background image from Google Earth.

A map of groundwater wells is provided in the folder called, “Groundwater Wells.” The nearest groundwater well is “Parkview Park (PVP)”. Physical Chemical data is provided for this site (GPS 25.85723264751922 -80.12488156557083, located on Google Earth to be on the southwest corner of the baseball fields, See Figure A1 below). Results show salinities in the 25 to 29 psu range. Recommendation: As part of a preliminary reconnaissance – collect a sample of this groundwater to determine whether it is impacted fecal indicator bacteria.

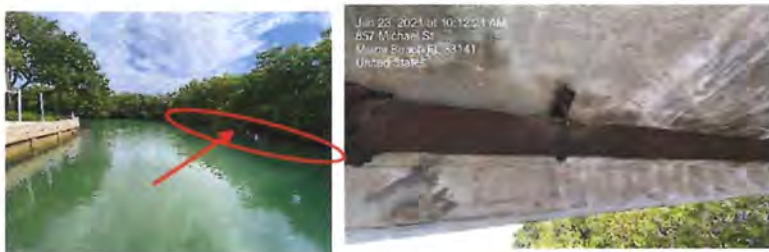
Figure A.2: Photo of canal where kayak launch is located and photo of pipe under bridge at 857 Michael Street.
