**Assessment of Water Quality
at the Miami Beach Park View Canal
to Identify Sources of the Fecal Indicator Bacteria,
Enterococci**

FINAL REPORT

University of Miami, Coral Gables, FL
Department of Chemical, Environmental, and Materials Engineering

City of Miami Beach (c/o Lindsey Precht)
1700 Convention Center Drive
Miami Beach, FL 33139

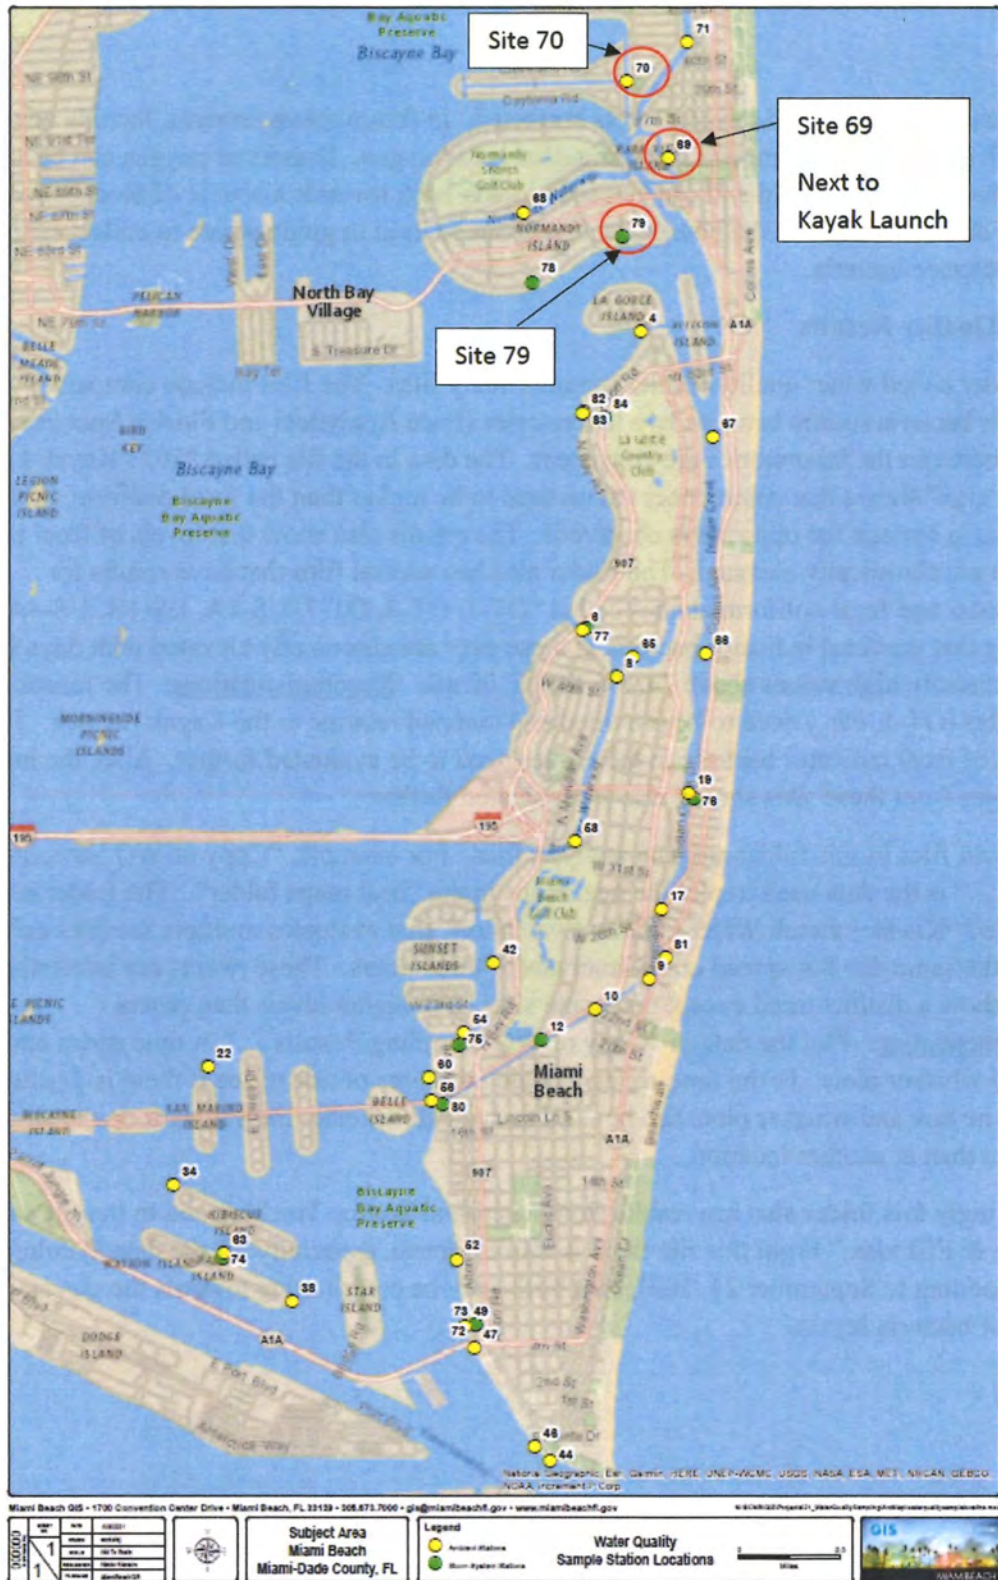
Figure A.4: Map showing locations of sampling sites for Bay-Wide Water Quality Study. From City of Miami Beach in folder called “Test Results” and file called “Current WQ Sampling Locations.pdf”.

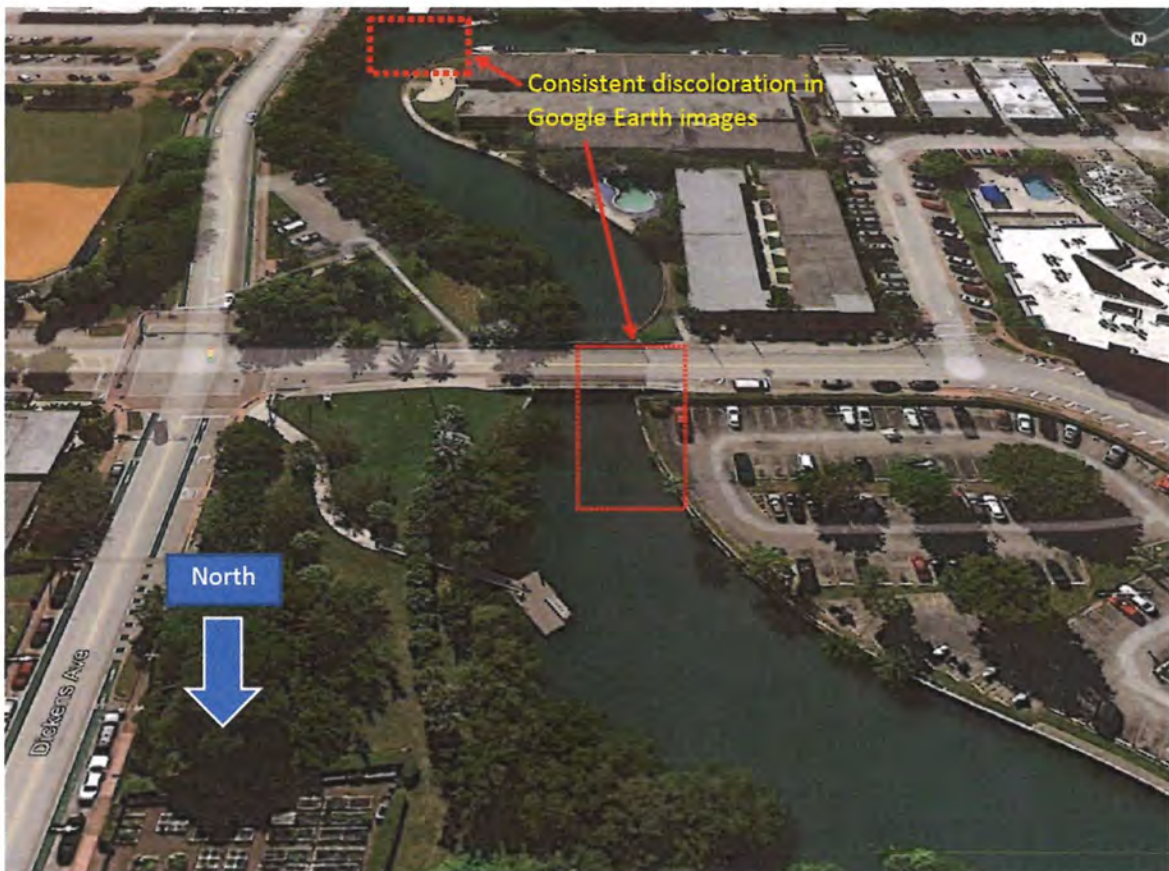
Review of Google Earth maps of the Kayak Launch area shows that the launch is first seen in May of 2017. Images since 2013 show a consistent darker colored water to the west of the launch, north of 73 street. The clearest recent image is dated January 2021 (Figure A5).

Recommendation: Conduct a detailed sampling program collecting samples along perpendicular transects. See Phase 1c and Figure 2 in the main report.

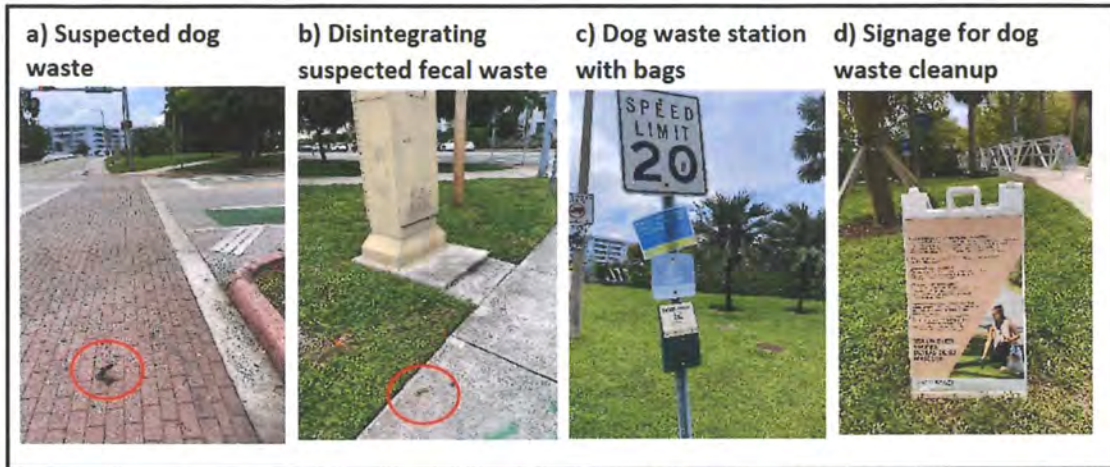
Figure D.1: Suspected dog feces and doggie disposal stations and educational materials (Photos taken June 11, 2022)

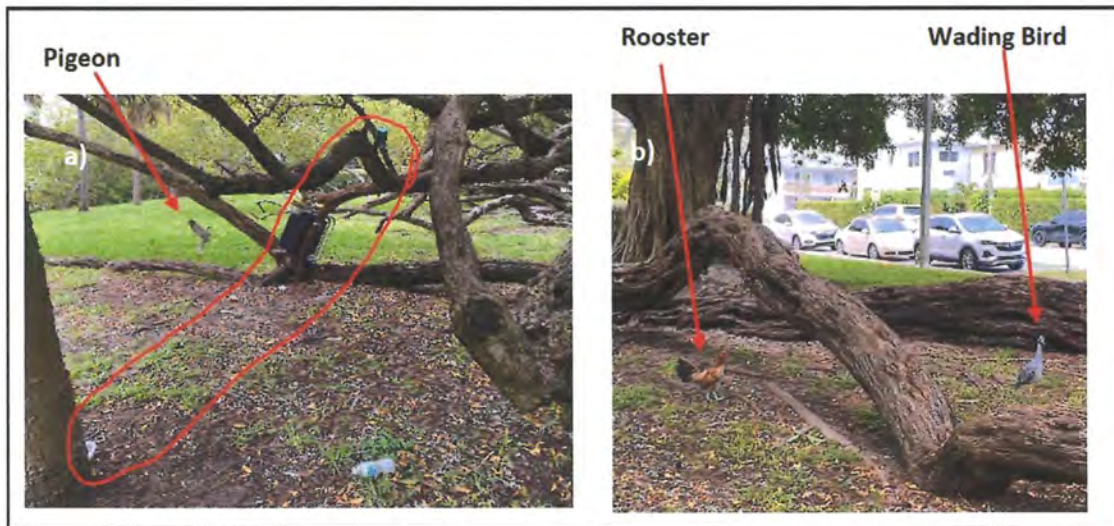
Figure D.2: Birds in park area that leads to the PVC Kayak Launch. Lawn chair, cup and water tray circled in red. At the time of the visit there was a flock of pigeons observed at the site which scattered prior to the photo (Photos taken June 11, 2022)

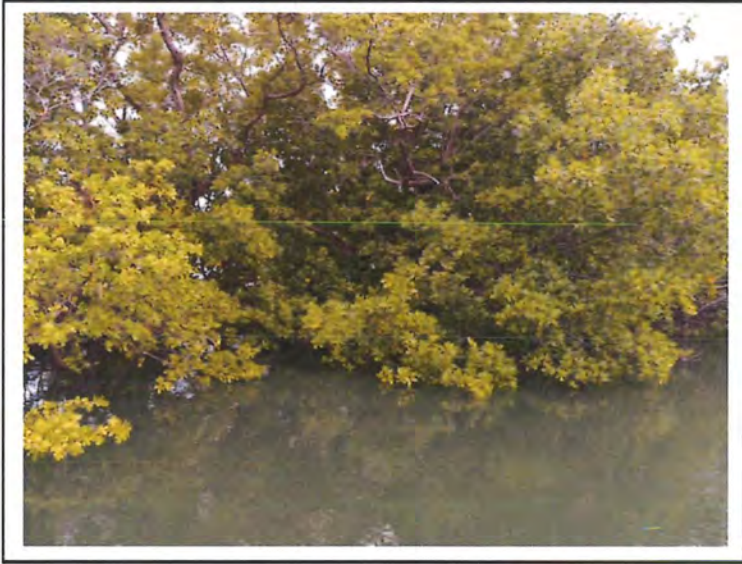
Figure D.3: Mangrove canopy at PVC, extending several feet from the banks providing shade and potential protection against UV light which is known to inactivate microbes

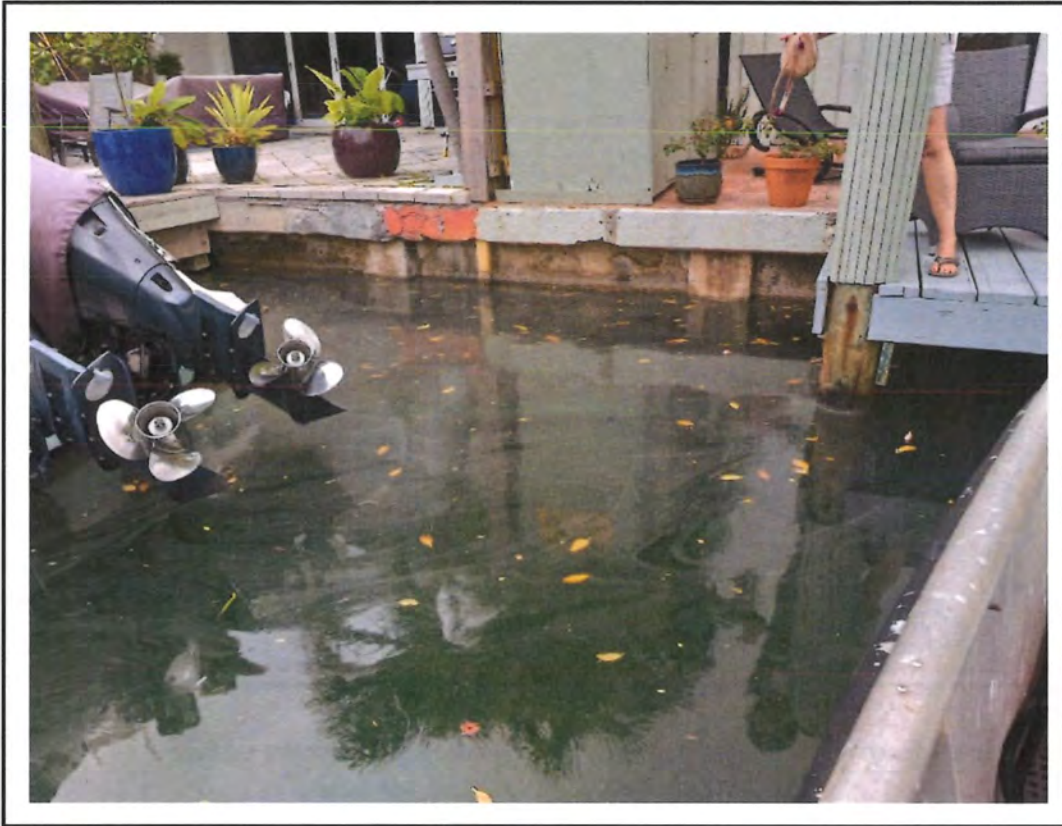
Figure D.6: Water showing discoloration and white foam

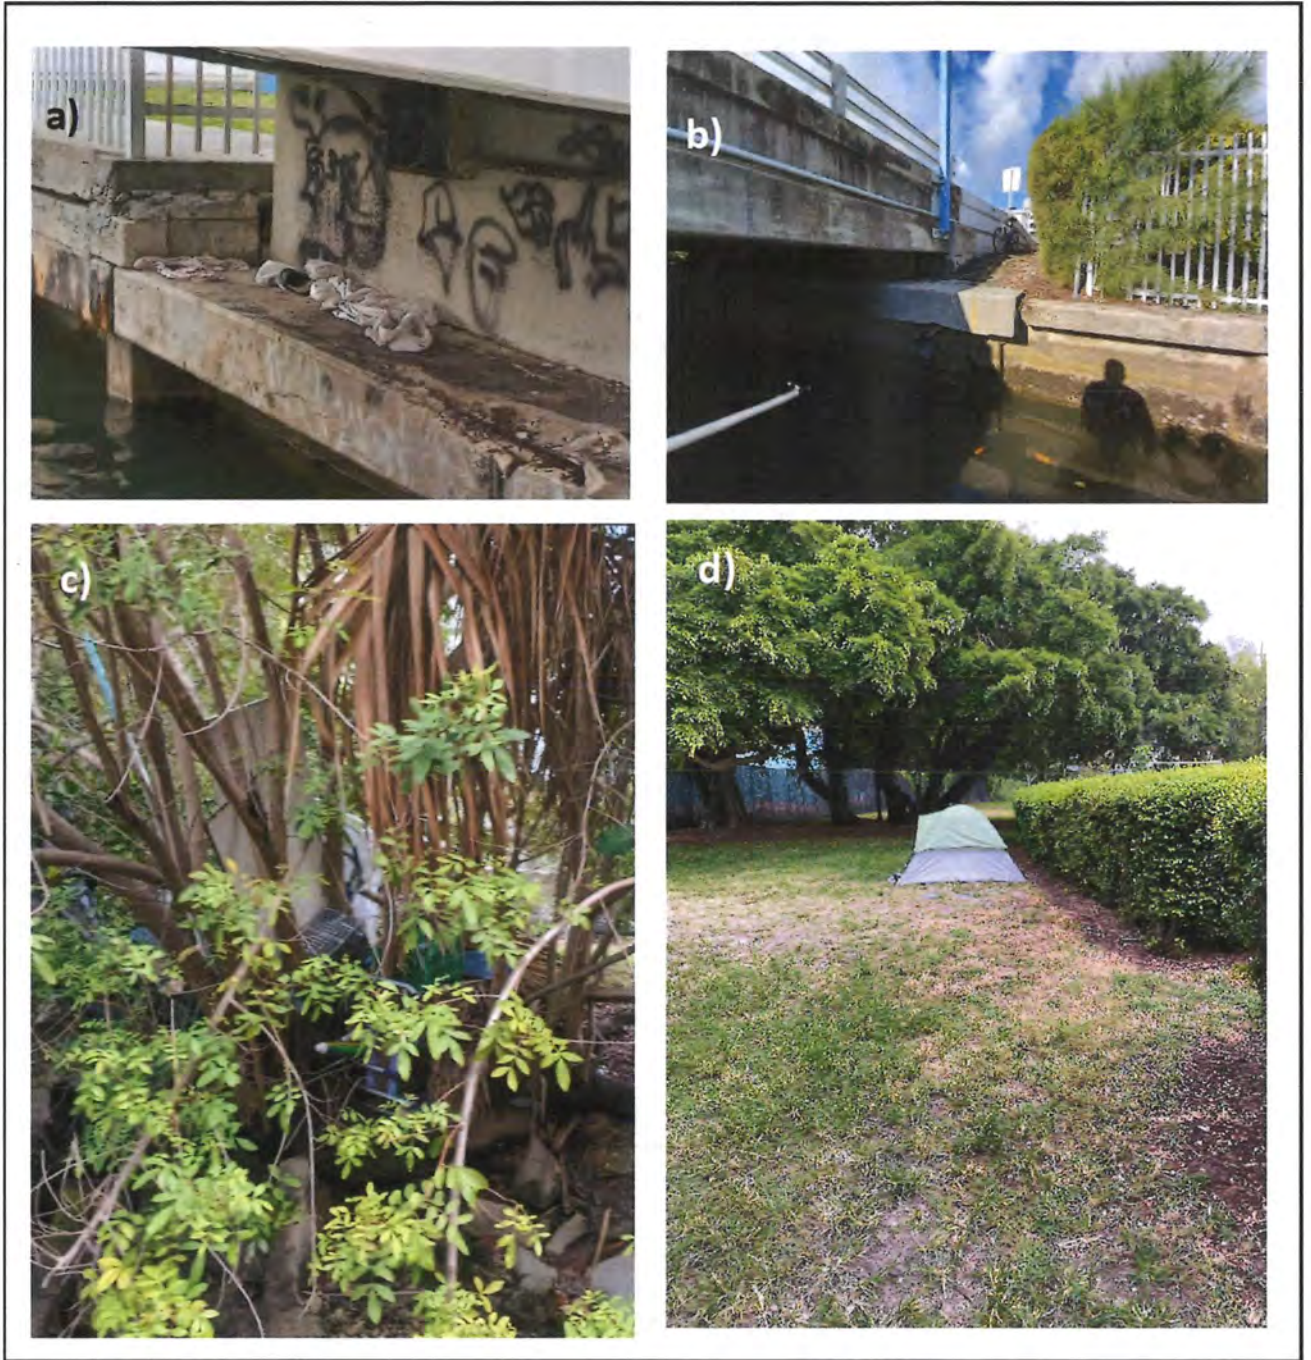
Figure D.8: Pictures of homeless encampments that were found immediately adjacent to the PVC. These encampments were located: a) underneath the bridge from PVI to Biscayne Shores Elementary School, b) bridge from PVI to Dickens Ave, c) mangroves in the vicinity of the park adjacent to the PVC Kayak Launch, and d) immediately west of the community garden area adjacent to Park View Island park.

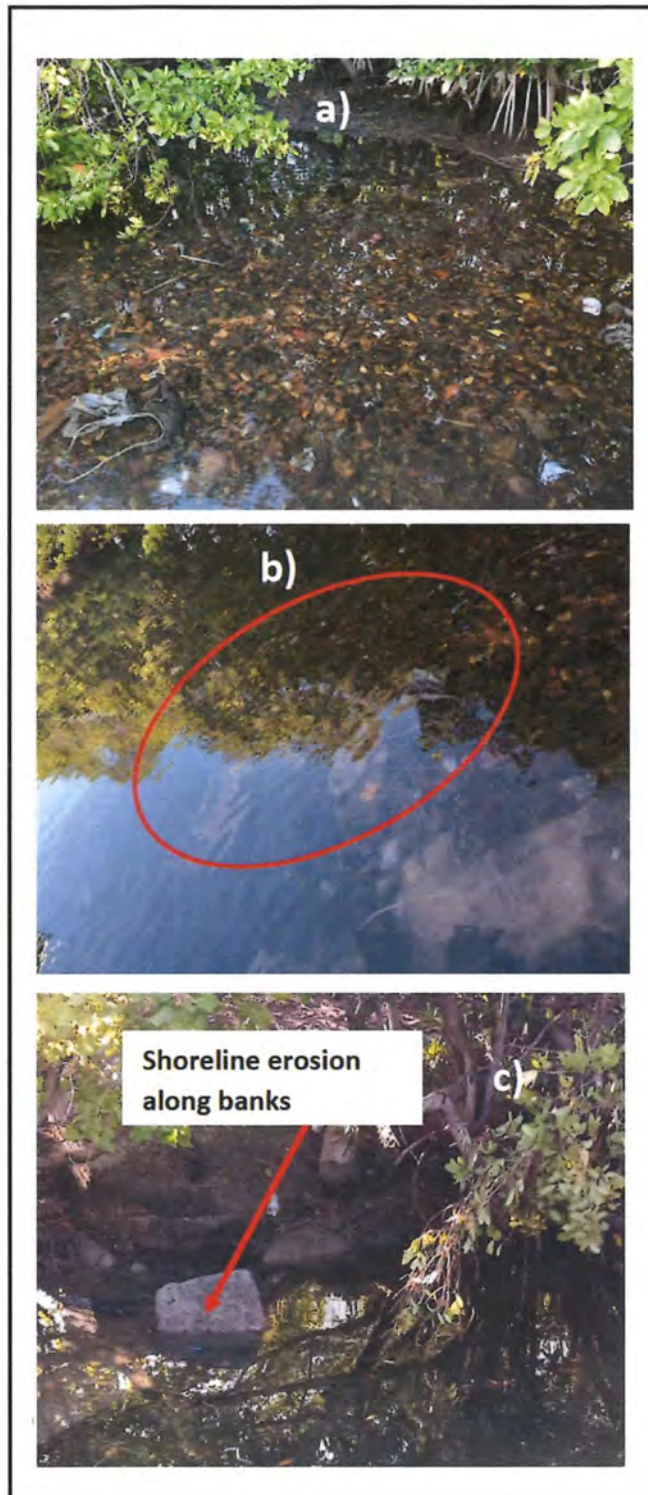
Figure D.10: Shoreline details. a) and b) Shallow banks exposed during low tide are covered with trash. c) Shoreline showing signs of erosion. At the shallow banks trash covered the sediment bottom
